**Region 6 - Enforcement & Compliance Assurance Division**  
**INSPECTION REPORT**

| Inspection Date(s): | 09/23-24/2021 | |
| Company Name: | City of Dallas | |
| Facility Name: | McCommas Bluff Landfill | |

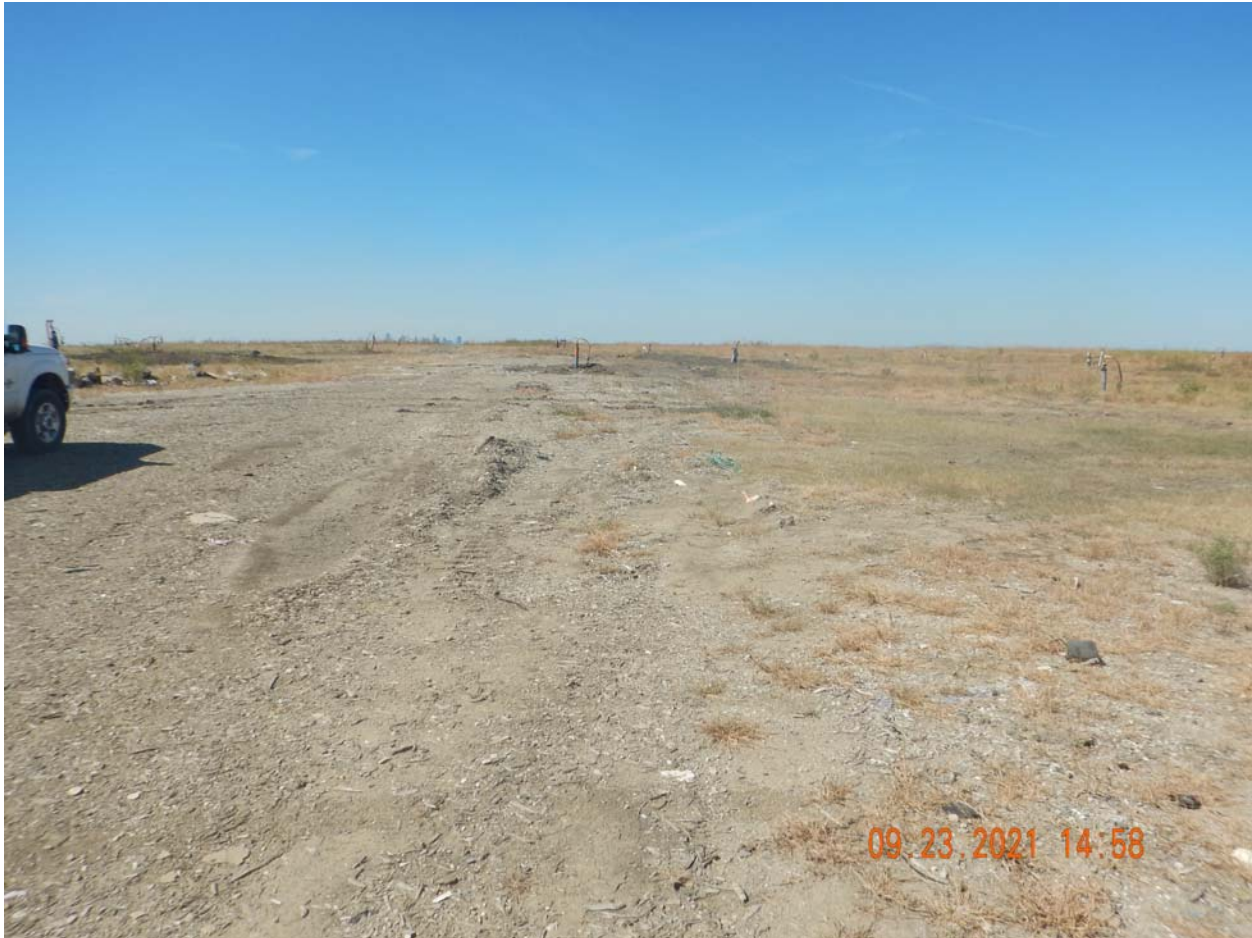
Photo No. 1

Description: Typical conditions encountered by Inspectors at Cell 5

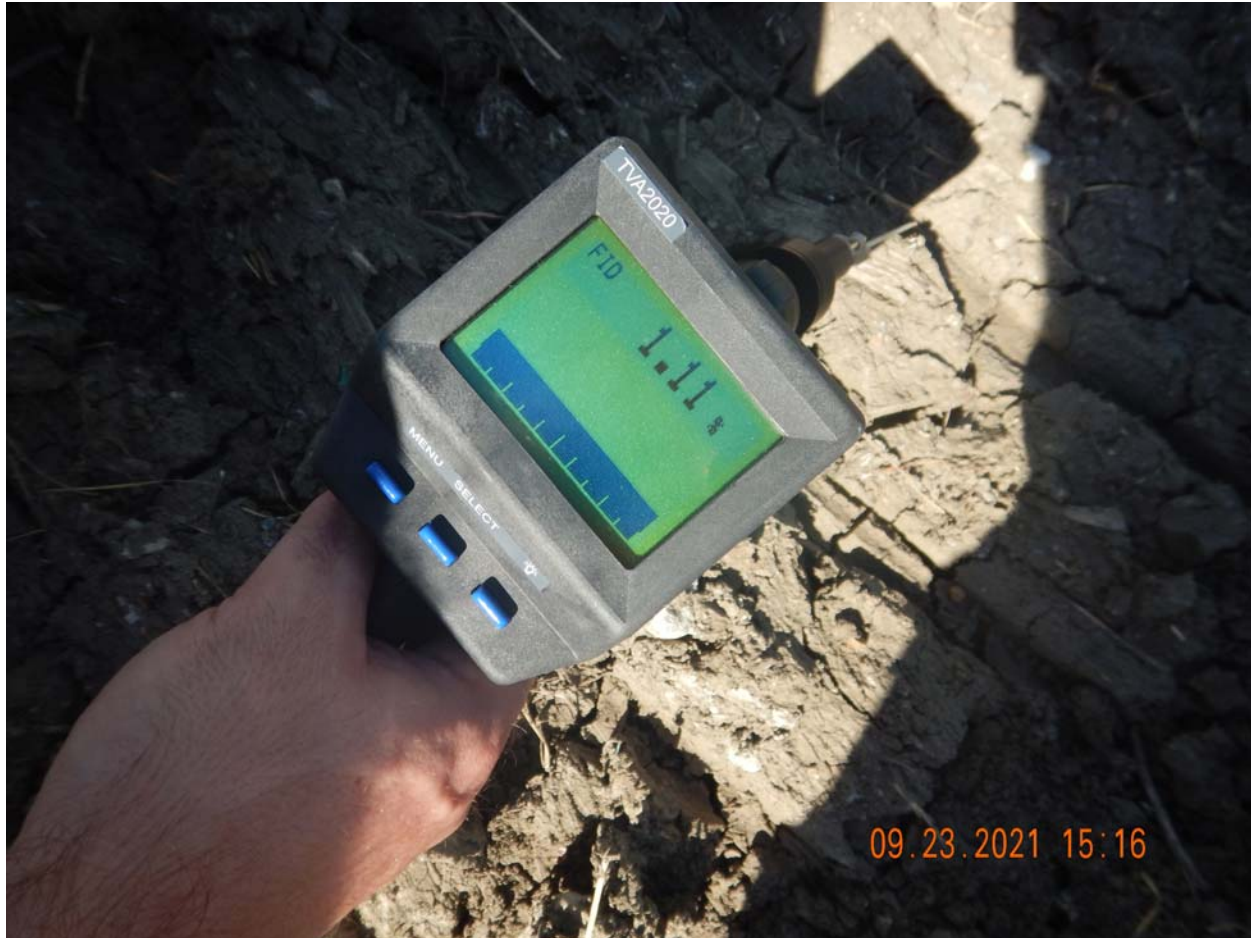
Photo No. 2

Description: 1.11 % VOC reading in the vicinity of Sump 25.

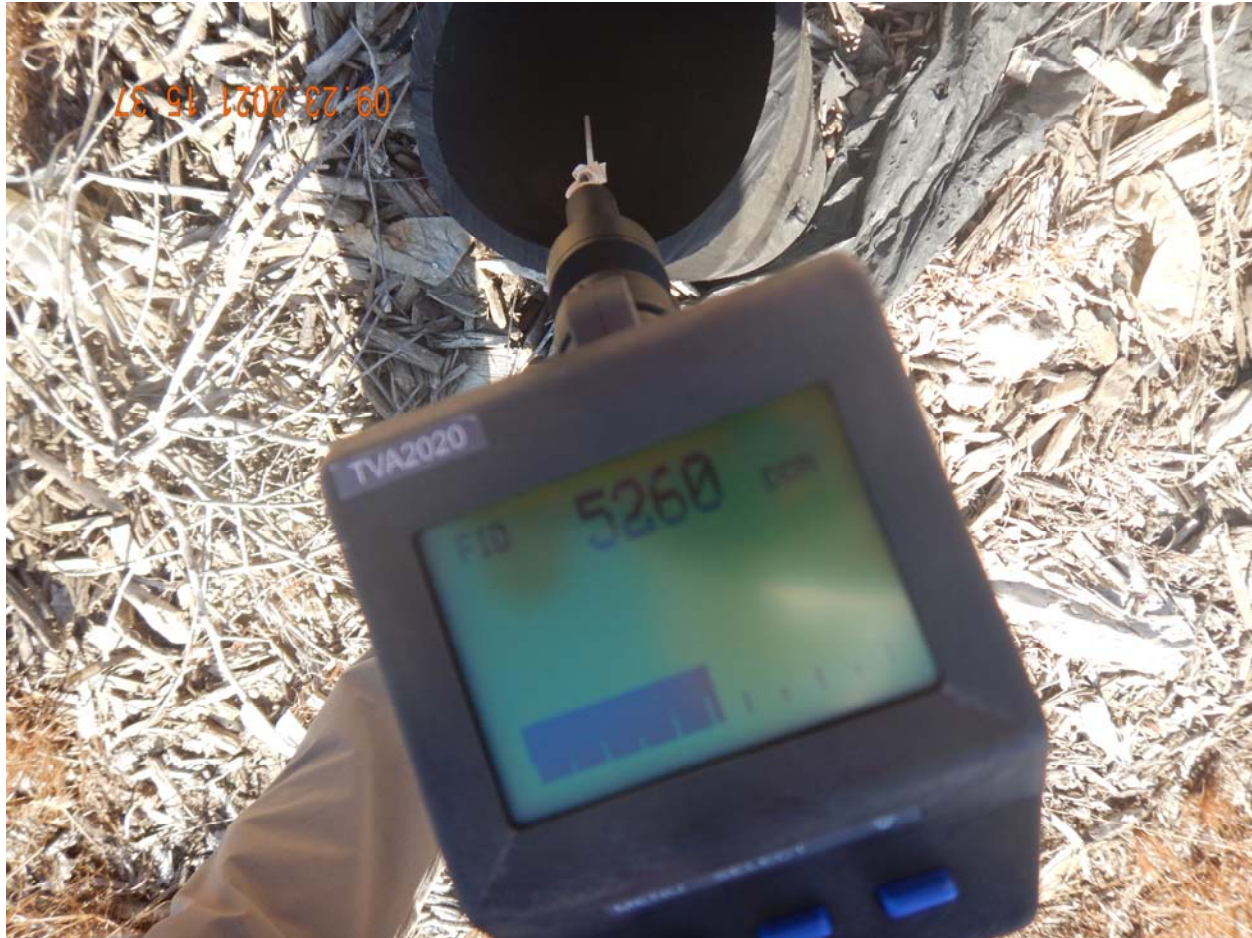
Photo No. 3

Description: 5260 ppm VOC reading above a witness pipe.

"Witness" survey pipes on-site that were monitored during the inspection were surveyed by SCS's SEM 5000 which logs GPS coordinates to 5 decimal degrees. All on-site witness pipes were then removed from the landfill, and the cover restored. The restored locations of where the witness pipes were monitored during the inspection will be rescanned with the SEM 5000 on Monday, October 4<sup>th</sup> along with the other wells/areas that showed concentrations over 500 ppm. We will follow the normal surface emissions monitoring (SEM) procedures and timelines per regulatory requirements. All remonitoring information will include calibration records, logger line of data to confirm the timestamp, GPS coordinates, and gas ppm. Any remonitored location that is still exceeding 500 ppm above background will need additional corrective action and be rescanned within 10 days. All locations that were below 500 ppm above background will be rescanned again at 30 days to confirm the exceedance has been resolved.

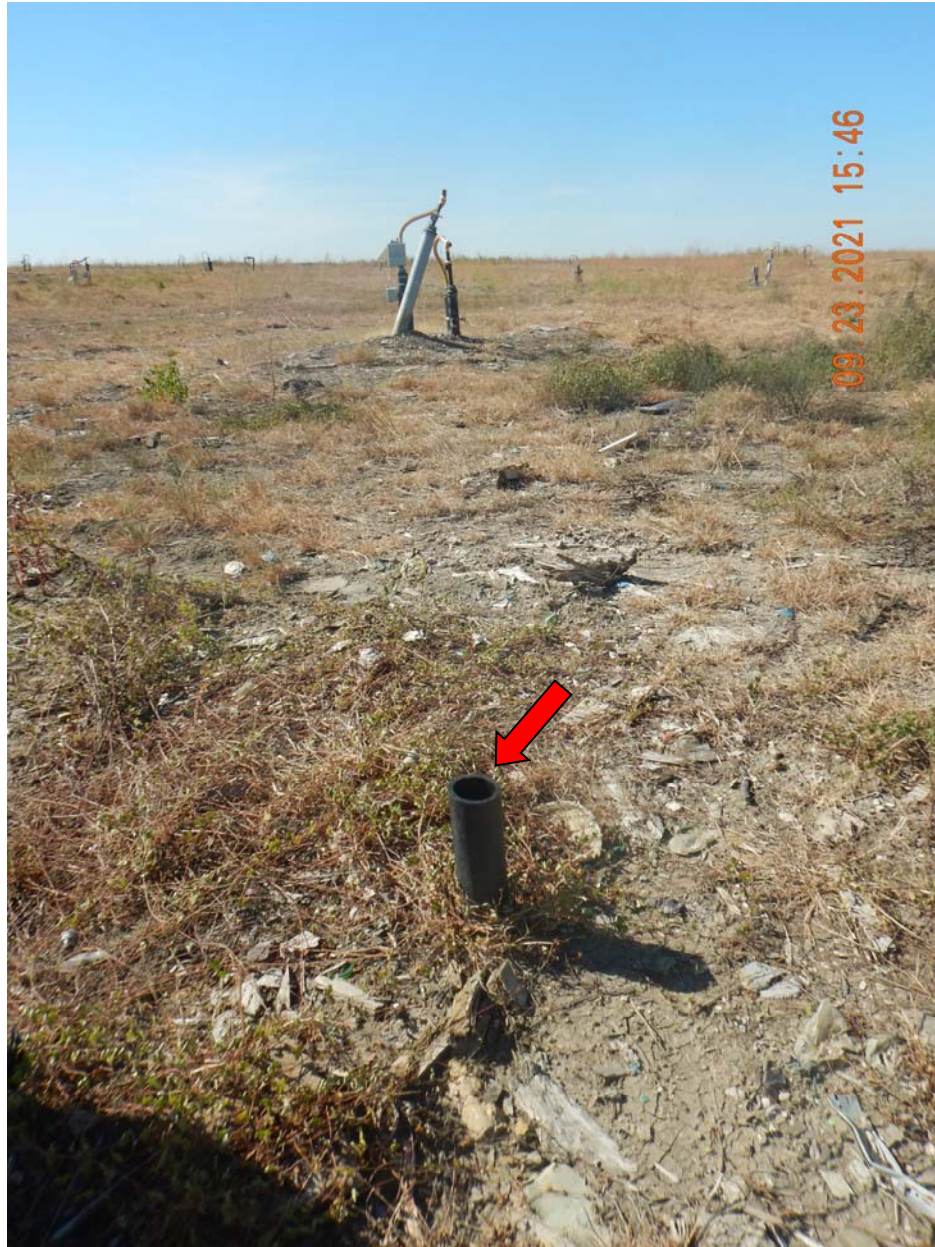
Photo No. 4

Description: Witness pipe with Wells K-20A and K-19S in the background. Arrow notes location at which EPA observed hydrocarbon emissions with the FLIR camera.

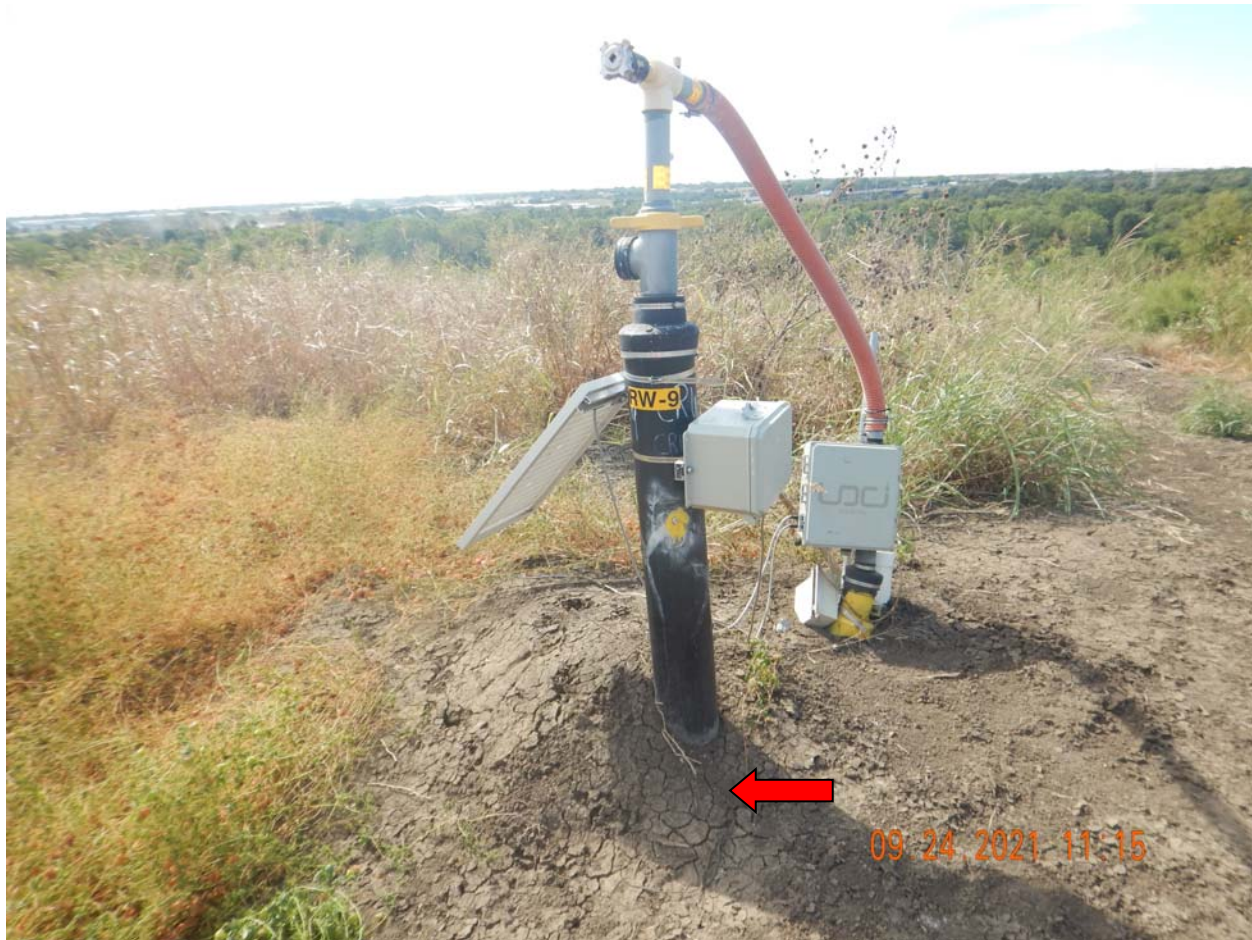
Photo No. 5

| Area/Landmark | Reading on the SEM5000 | Photograph No. |
|---|---|---|
| Well RW-9 | 3500 ppm | 5 |

Description: Well RW-9. Arrow notes location where SEM5000 detected an exceedance of 500 ppm methane.

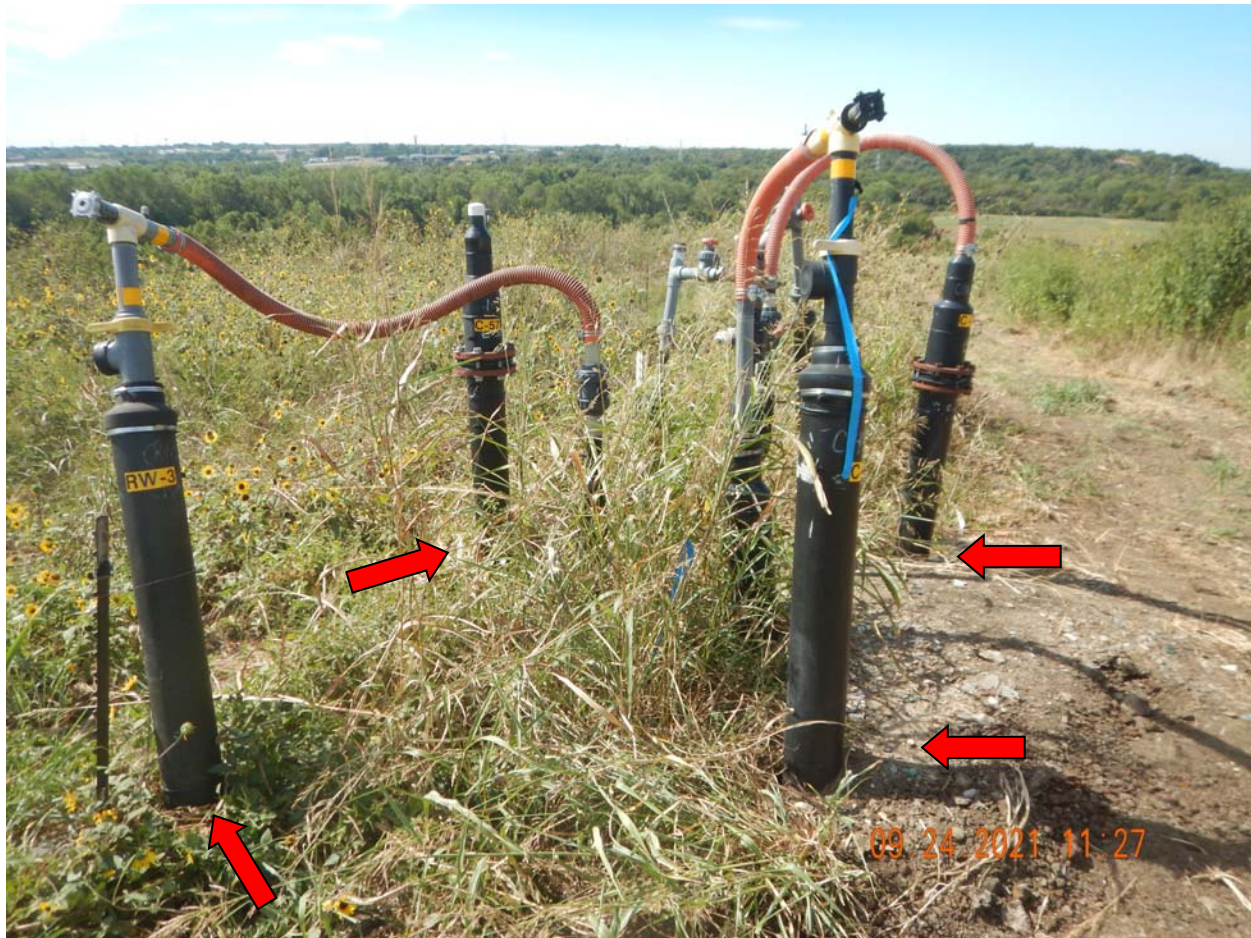
Photo No. 6

| Area/Landmark | Reading on the SEM5000 | Photograph No. |
|---|---|---|
| Base of Wells RW-3, C-57, C-13A | 5800 ppm | 6 |
| Well C-49 | 8% [80,000 ppm] | 6 |

Description: Cluster of wells including Wells RW-3, C-57, C-13A, C-49. Arrows note locations where SEM5000 detected exceedances of 500 ppm methane.

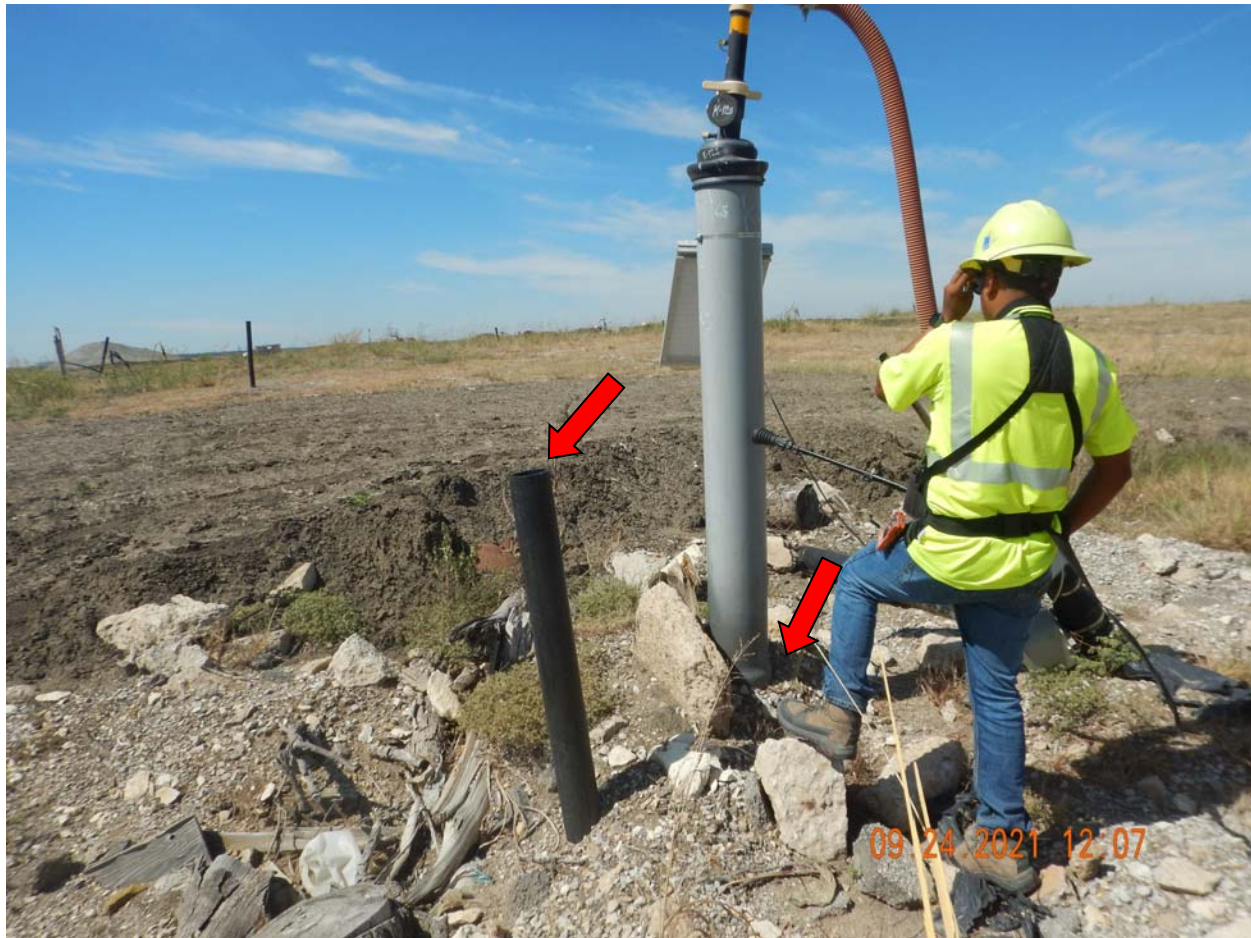
Photo No. 7

| Area/Landmark | Reading on the SEM5000 | Photograph No. |
|---|---|---|
| Well K-12S at witness pipe | 10.3 % [103,000 ppm] | 7 |
| Well K-12S base | 2,000 ppm | 7 |

Description: SCS using SEM5000 to monitor surface emissions around Well K-12S. Arrow notes locations where SEM5000 detected exceedances of 500 ppm methane.

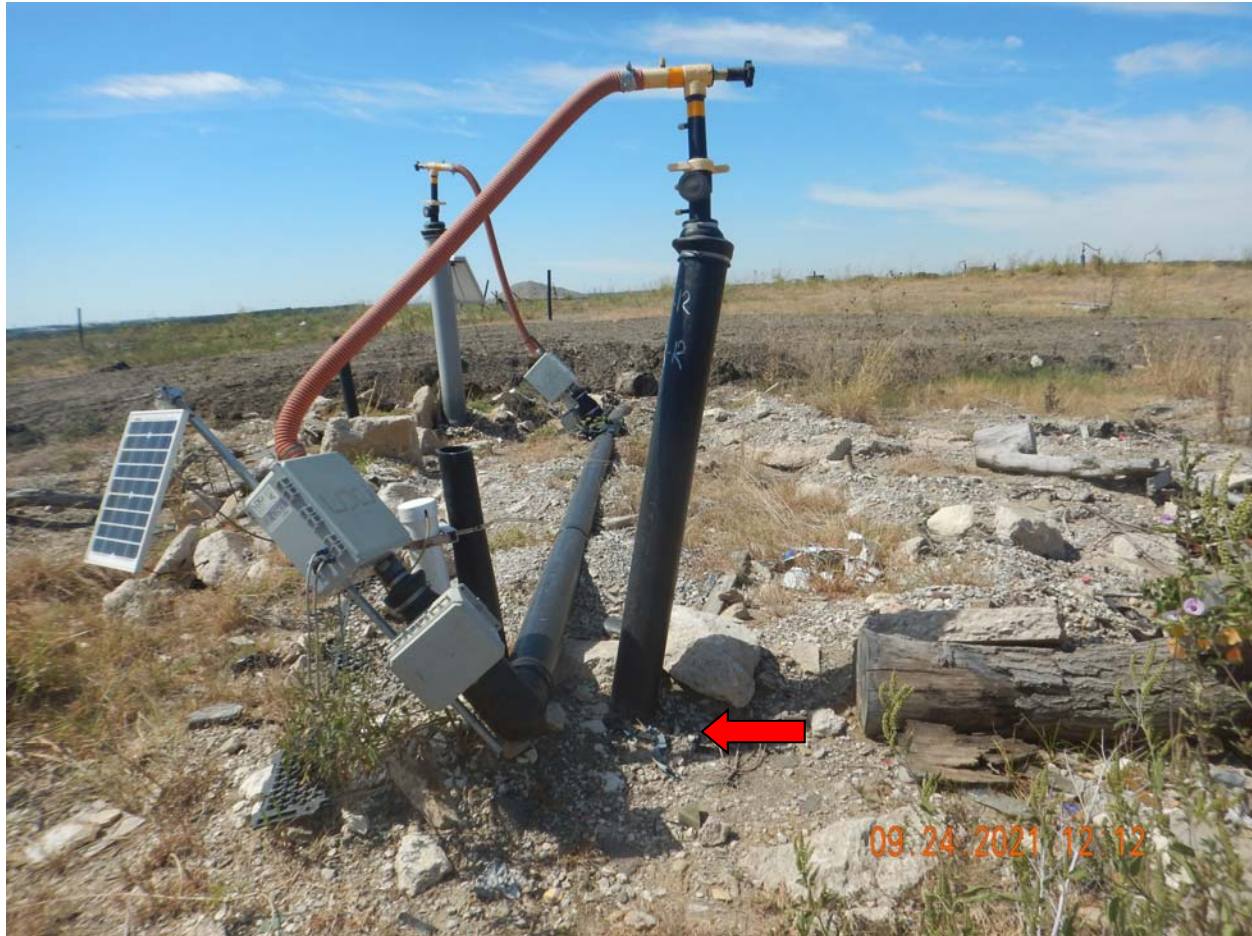
Photo No. 8

| Area/Landmark | Reading on the SEM5000 | Photograph No. |
|---|---|---|
| Well K-12R | 5,000 ppm | 8 |

Description: Well K-12R(foreground). Arrow notes location where SEM5000 detected exceedances of 500 ppm methane.

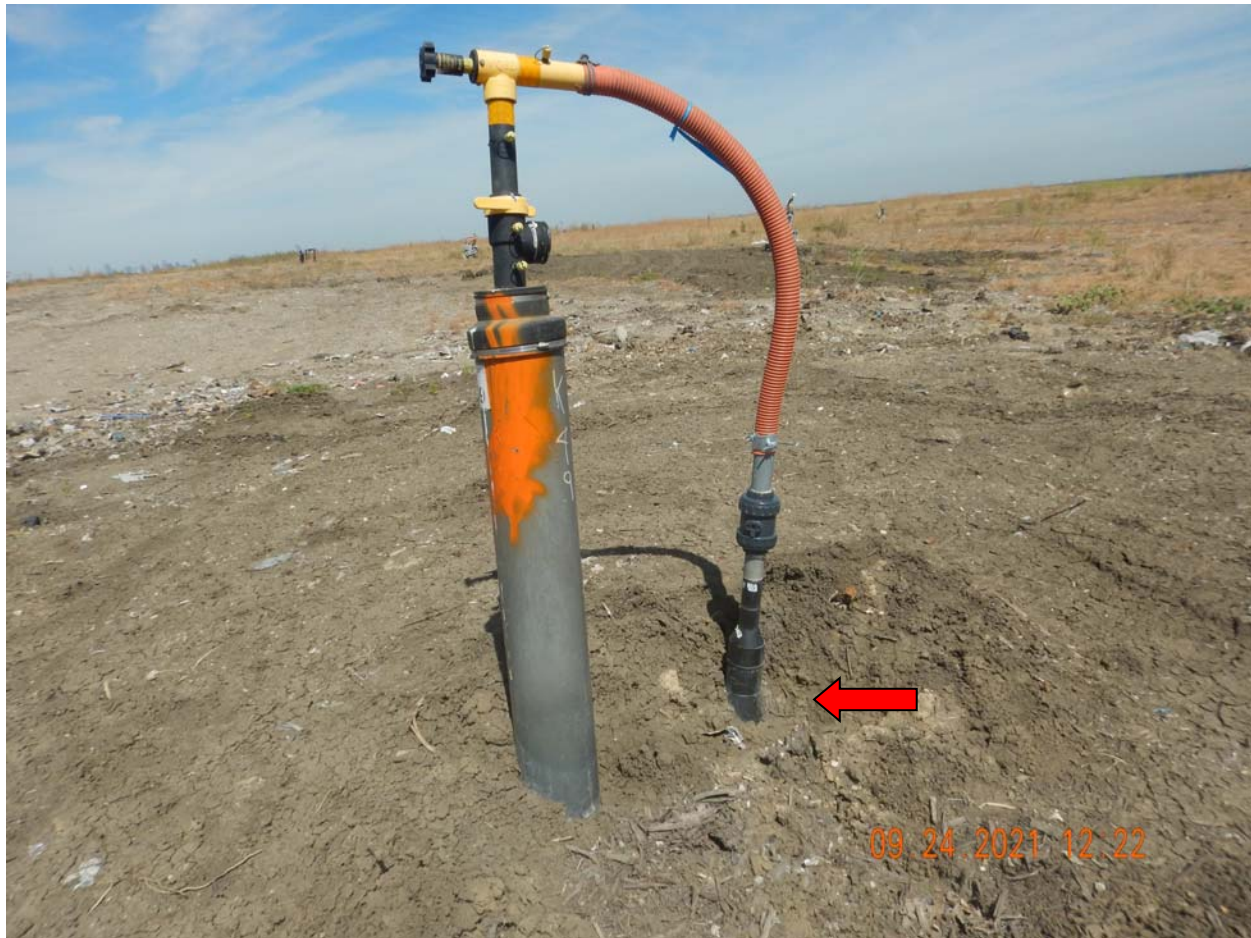
Photo No. 9

| Area/Landmark | Reading on the SEM5000 | Photograph No. |
|---|---|---|
| Well K-49 | 2,700 ppm | 9 |

Description: Well K-49. Arrow notes location where SEM5000 detected exceedances of 500 ppm methane.

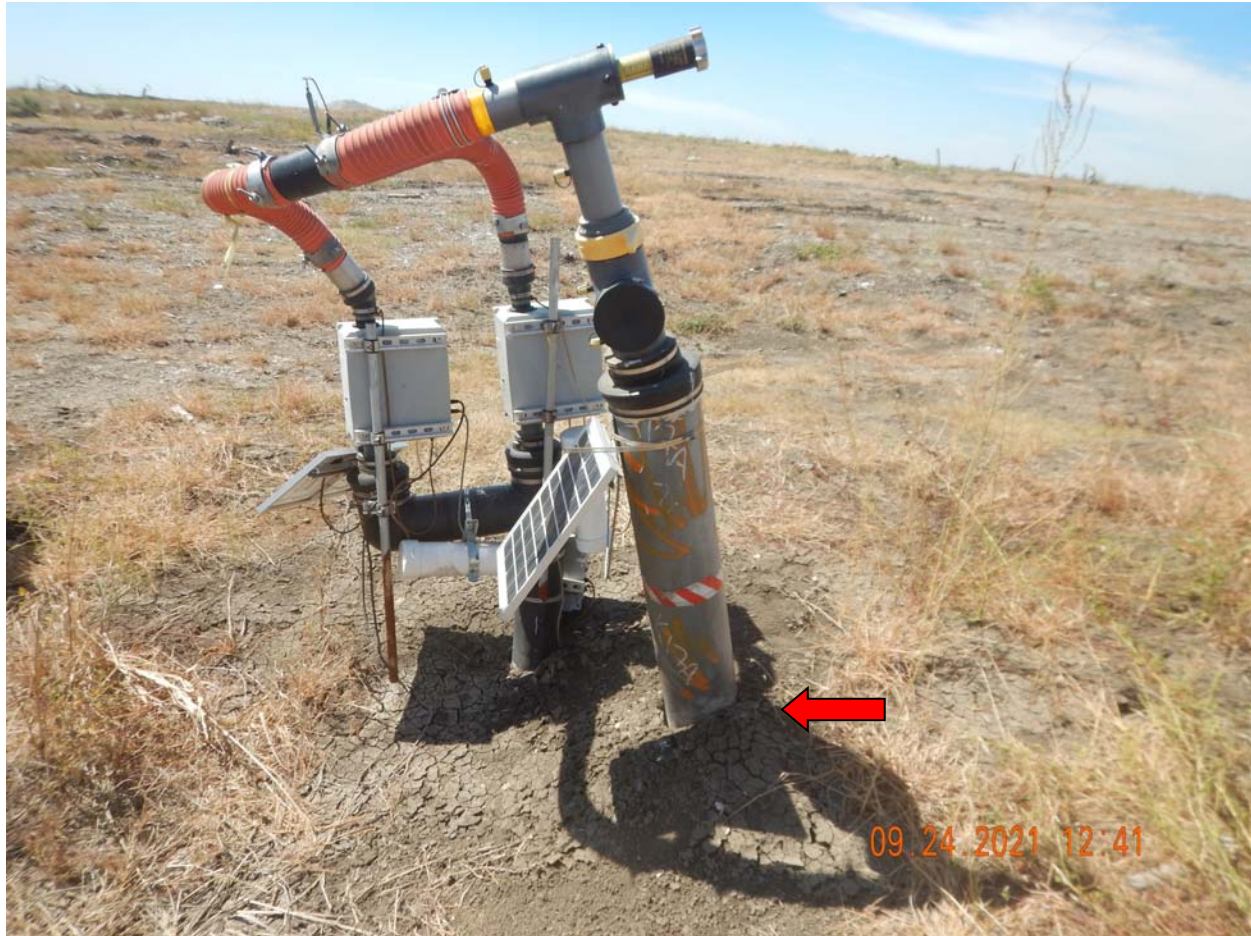
Photo No. 10

| Area/Landmark | Reading on the SEM5000 | Photograph No. |
|---|---|---|
| Well K-17A | 1,250 ppm | 10 |

Description: Well K-17A. Arrow notes location where SEM5000 detected exceedances of 500 ppm methane.

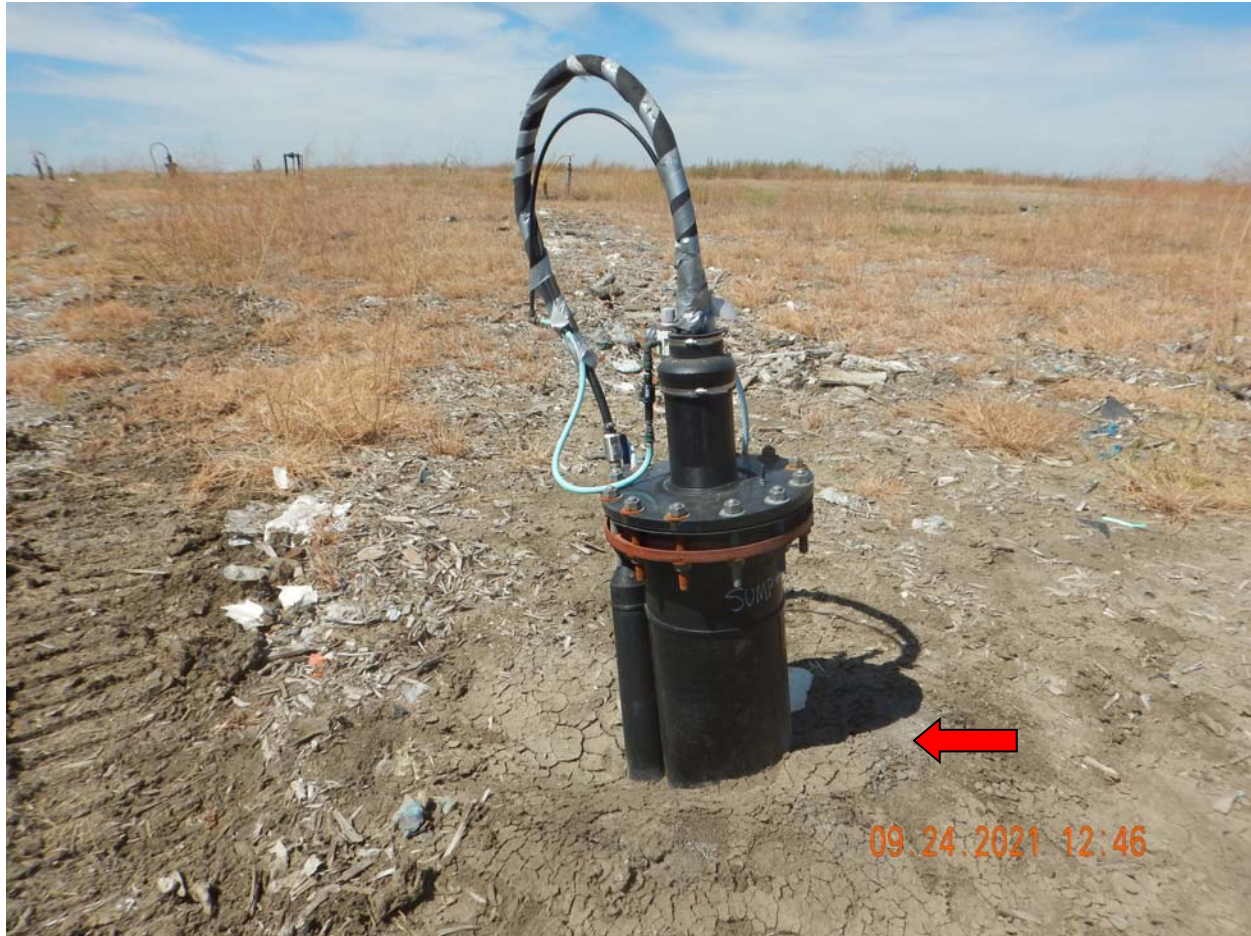
Photo No. 11

| Area/Landmark | Reading on the SEM5000 | Photograph No. |
|---|---|---|
| Sump 25 riser | 2,500 ppm | 11 |

Description: Sump 25 Riser. Arrow notes location where SEM5000 detected exceedances of 500 ppm methane.

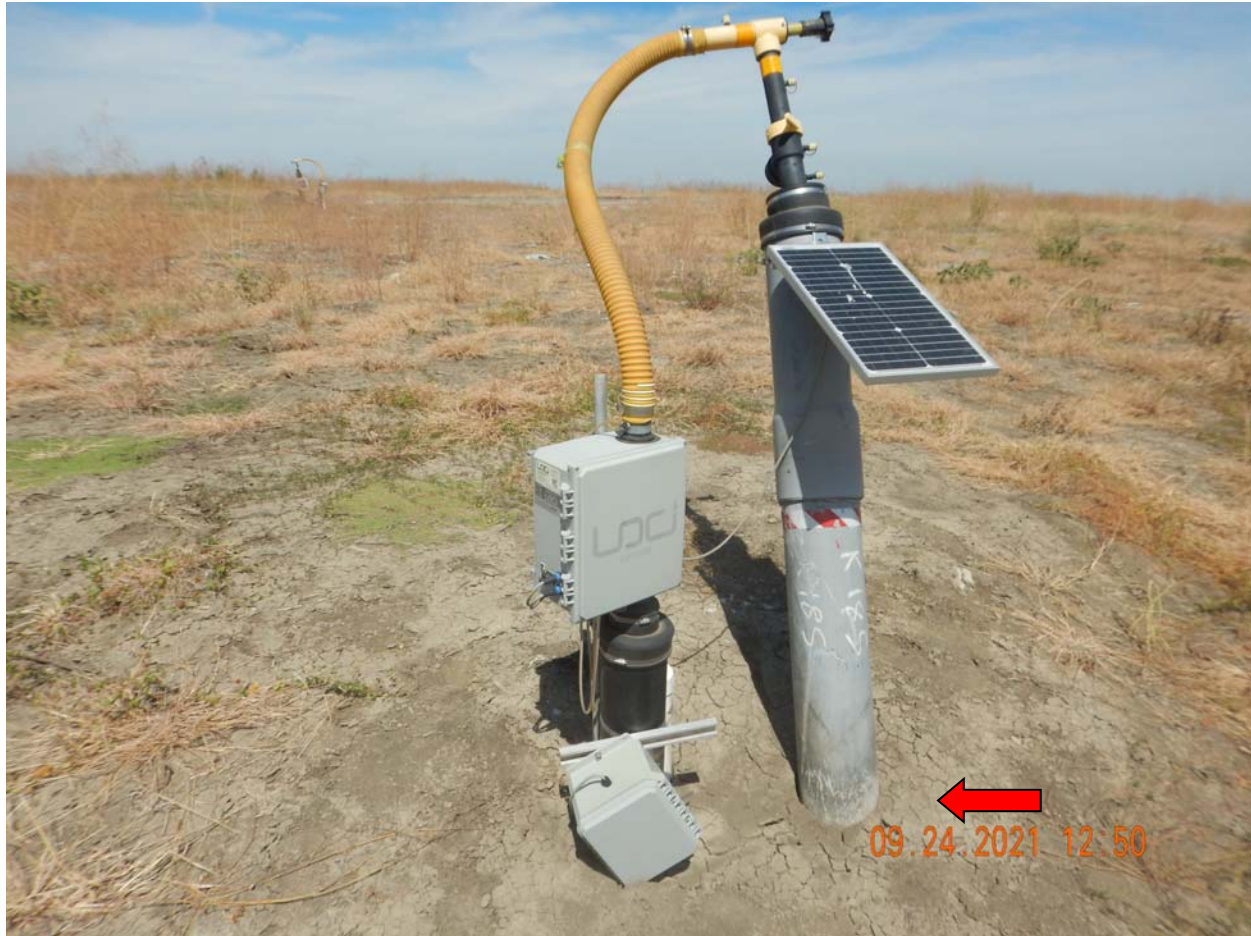
Photo No. 12

| Area/Landmark | Reading on the SEM5000 | Photograph No. |
|---|---|---|
| Well K-18S | 4,500 ppm | 12 |

Description: Well K-18S. Arrow notes location where SEM5000 detected exceedances of 500 ppm methane.

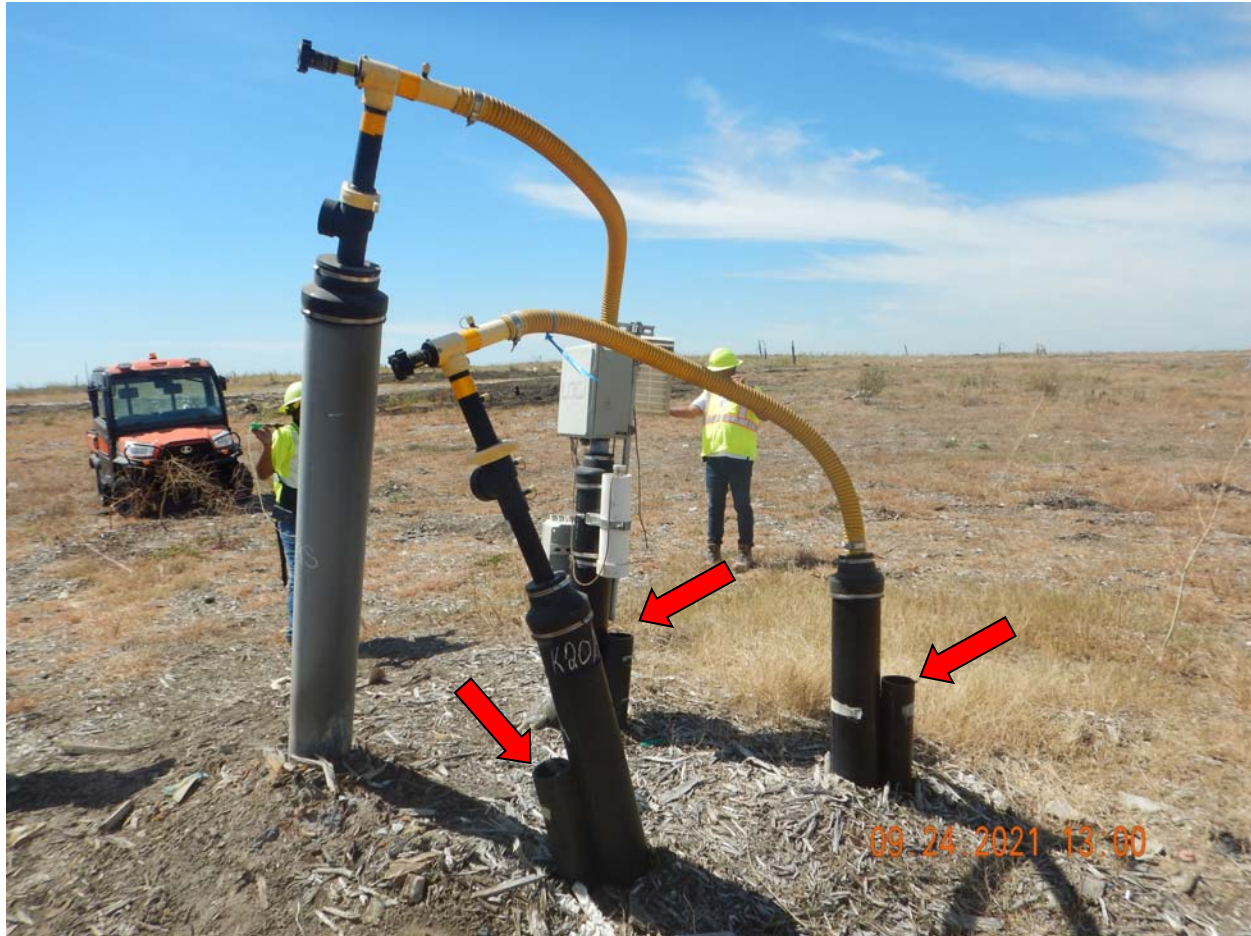
Photo No. 13

| Area/Landmark | Reading on the SEM5000 | Photograph No. |
|---|---|---|
| Well K-20A at witness pipe | 10% [100,000 ppm] | 13 |
| Well K-19S back-end riser | 16% [160,000 ppm] | 13 |

Description: Wells K-19S, K-20A. Arrows note locations where SEM5000 detected exceedances of 500 ppm methane.

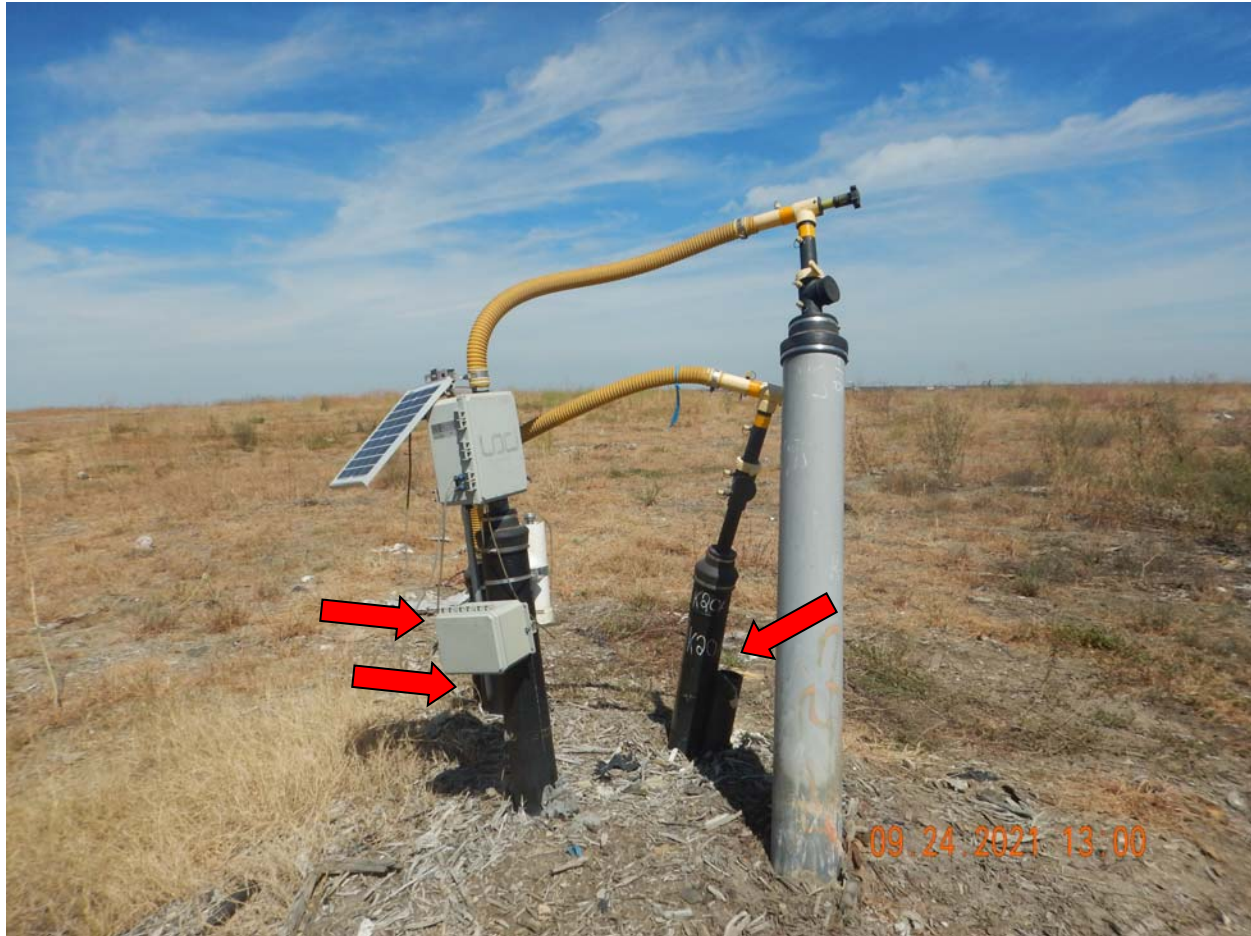
Photo No. 14

Description: Wells K-19S, K-20A (reverse view of Photo No. 13). Arrows note locations where SEM5000 detected exceedances of 500 ppm methane.

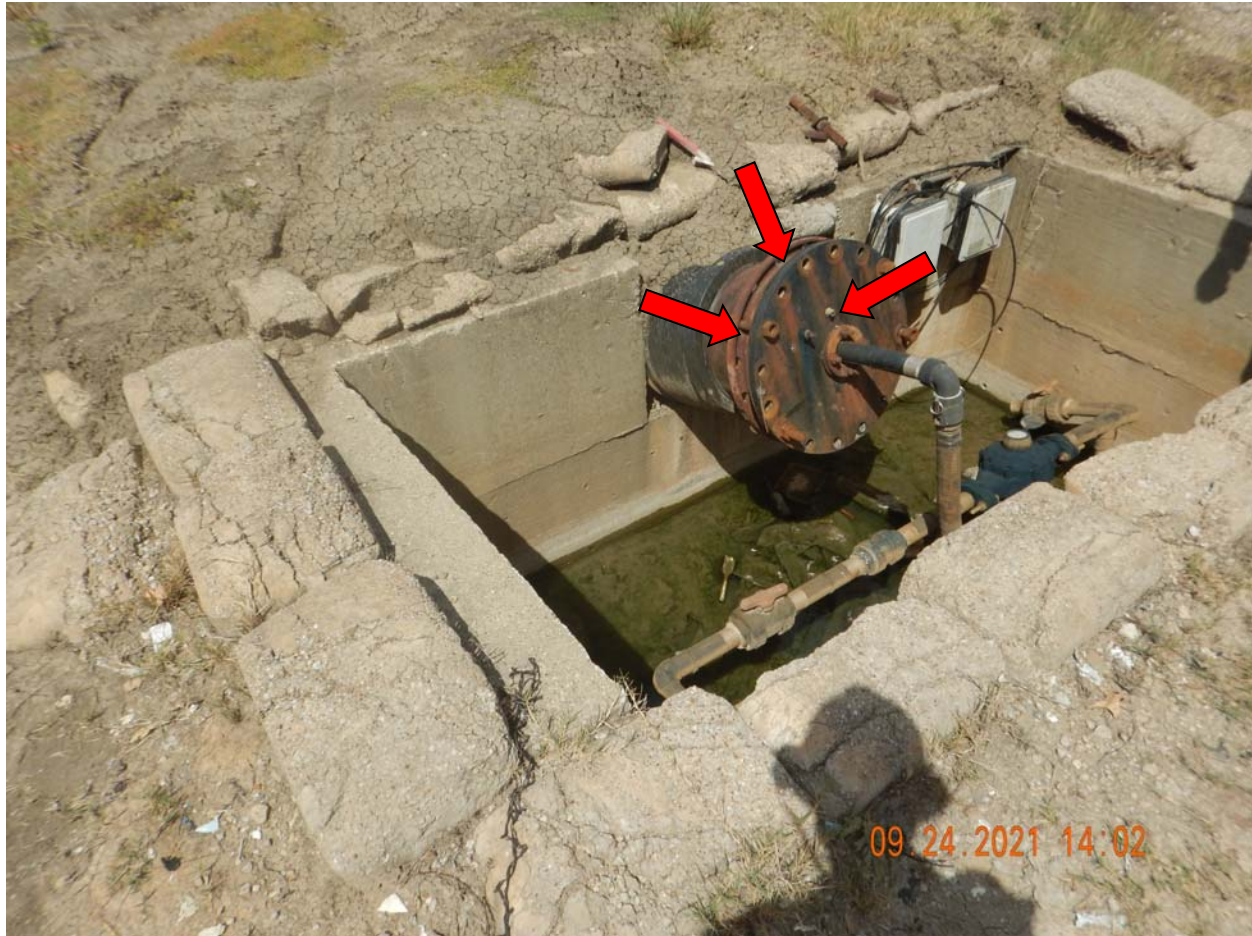
During the inspection, we observed hydrocarbon emissions with the OGIC and detected landfill gas odors around Leachate Riser 1. City personnel stated that components of the leachate systems, including the risers, were not monitored or evaluated pursuant to an air compliance program. 40 C.F.R. § 63.1962(a)(1) states that the collection system must address “leachate and condensate management”. Further, 40 C.F.R. § 63.1981(d)(6) addresses the variety of possible system designs that may be approved by the administrator, including “leachate collection systems”. According to the plot plan, only 4 of the 11 leachate risers are incorporated into the GCCS from collection piping originating at the respective leachate riser cleanouts. We observed the gas collection system valve interconnection for Leachate Riser 1 during the inspection (see Photograph No. 18). Additionally, 40 C.F.R. § 60.753(d) requires owners and operators to monitor surface methane concentrations around the perimeter of the collection area. In response to our inspection observations of the leachate system components, the City stated that they would conduct leachate riser repairs within the next two weeks to replace worn bolts and gaskets. See Appendix 5: Inspection Follow-up Actions by the City of Dallas.

Description: Leachate Riser 1. Arrow notes locations at which EPA observed hydrocarbon emissions with the FLIR camera.

Regarding the leachate collection system components, we expect completion of leachate riser repairs in approximately two weeks, October 15. This includes replacing worn bolts and gaskets.

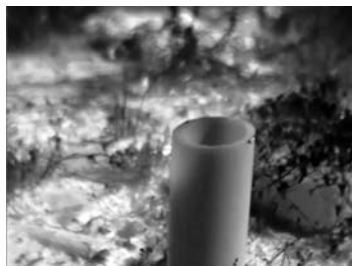
Video File Name: MOV\_0037.mp4  
 Date of Video: 09/23/2021  
 Time of Video: 15:40  
 Videographer: James Haynes  
 Description: OGIC visualized emissions from a witness pipe in Cell 5.\*

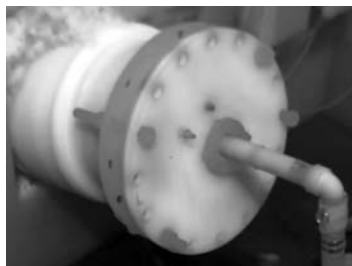
Video File Name: MOV\_0038.mp4  
 Date of Video: 9/24/2021  
 Time of Video: 14:00 pm  
 Videographer: James Haynes  
 Description: Leachate Riser 1: OGIC visualized emissions from bolts, bolt holes, and flange around riser cap.\*

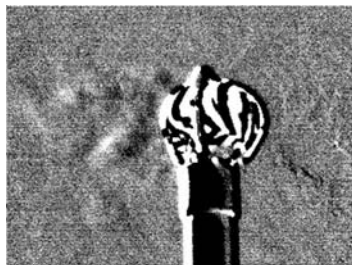
During the inspection, we observed emissions with the OGIC from an uncontrolled turbine ventilator at the perimeter of the landfill. The City explained that the purpose of the ventilators is to disperse migrating subsurface gas to prevent it from collecting in low lying areas and mitigate associated hazards. 40 C.F.R. §§ 60.759(a)(2), 60.769(a)(2), and 63.1959(b)(2)(ii)(B)(4) designate provisions for a sufficient density of the GCCS to address landfill gas migration issues including augmentation of the system through wells at the perimeter or exterior of the landfill. The rules state that the GCCS shall be designed to minimize off-site migration of subsurface gas. The uncontrolled turbine ventilators are outside the boundary of the landfill waste mass and are not listed components of the GCCS. Our observations of emissions from these components indicate subsurface gas migration is not being adequately mitigated by the GCCS.

Video File Name: MOV\_0039.mp4  
 Date of Video: 9/24/2021  
 Time of Video: 13:45 pm  
 Videographer: James Haynes  
 Description: OGIC visualized emissions from a turbine ventilator located on the perimeter of the landfill in the area of Leachate Riser 1.\*
