**Region 2 Caribbean Environmental Protection Division
Multimedia Permits and Compliance Branch
Air Protection Team**

CAA Inspection Report

Inspection Date: May 2, 2024

Facility Name: Municipality of Toa Baja Landfill

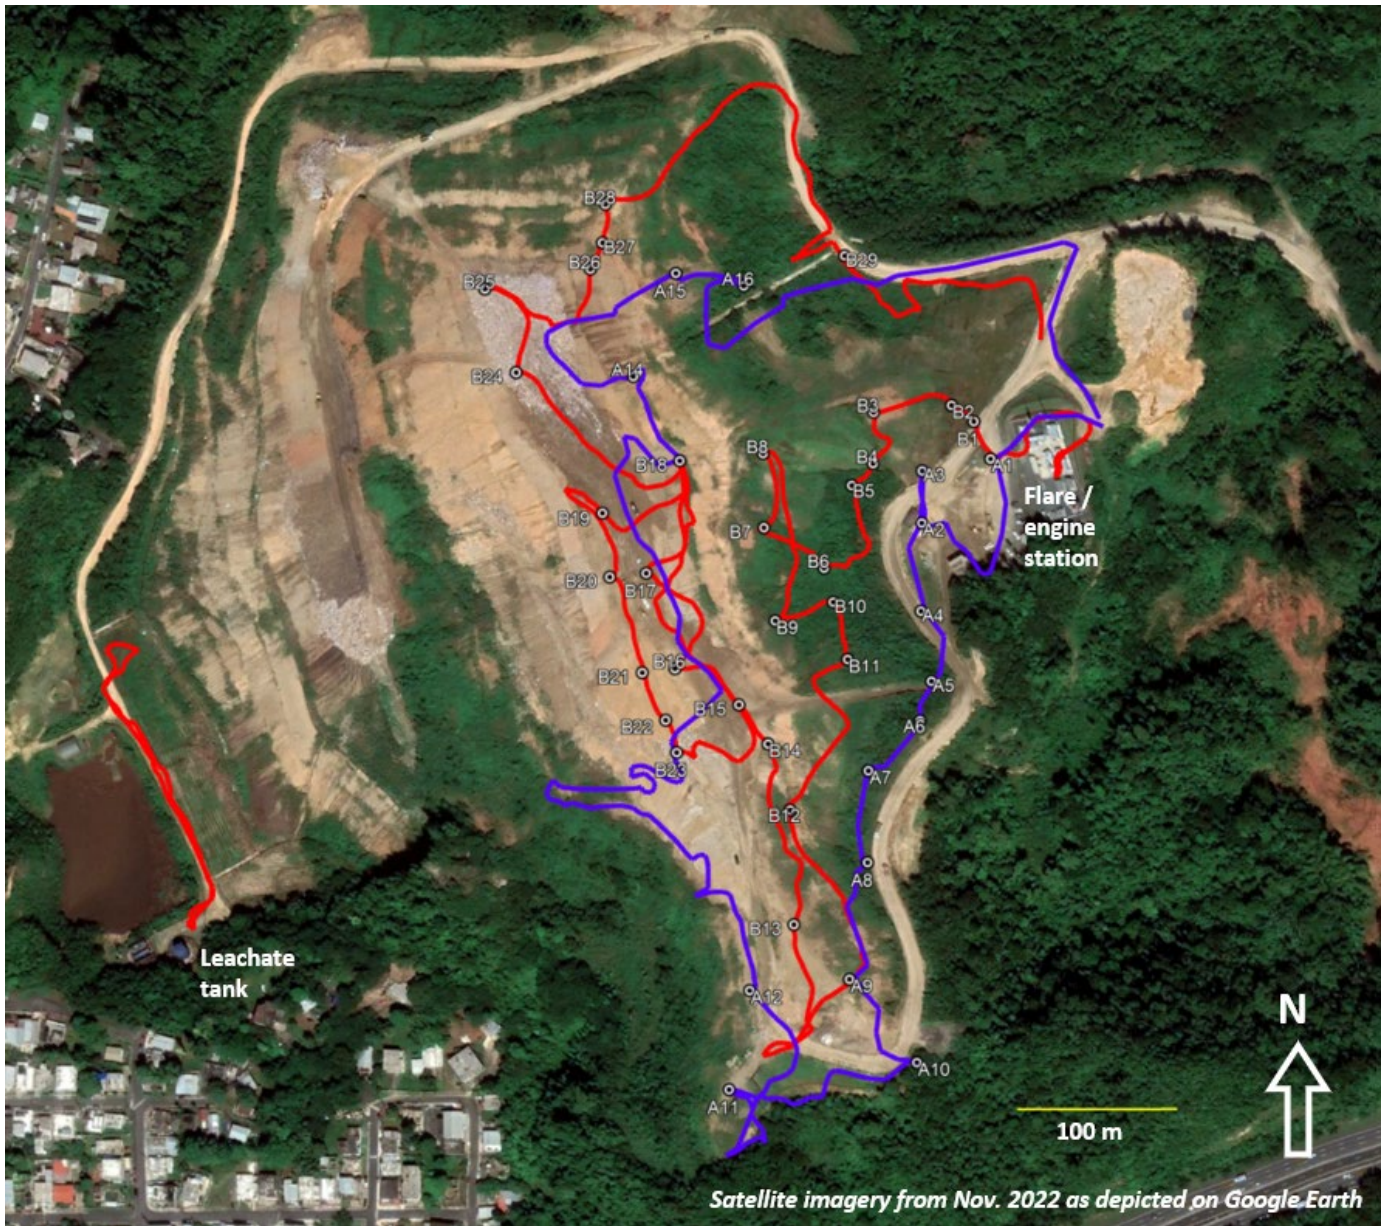
Blue and red lines trace each team's monitoring path. Exceedances are plotted and labeled as described in Appendix B.

The primary surveys covered approximately 32 acres on the eastern half of the landfill (with some gaps in that area, as depicted), in addition to approximately 175 meters on the western perimeter, including the leachate riser, with minimal survey over the waste mass on that side.

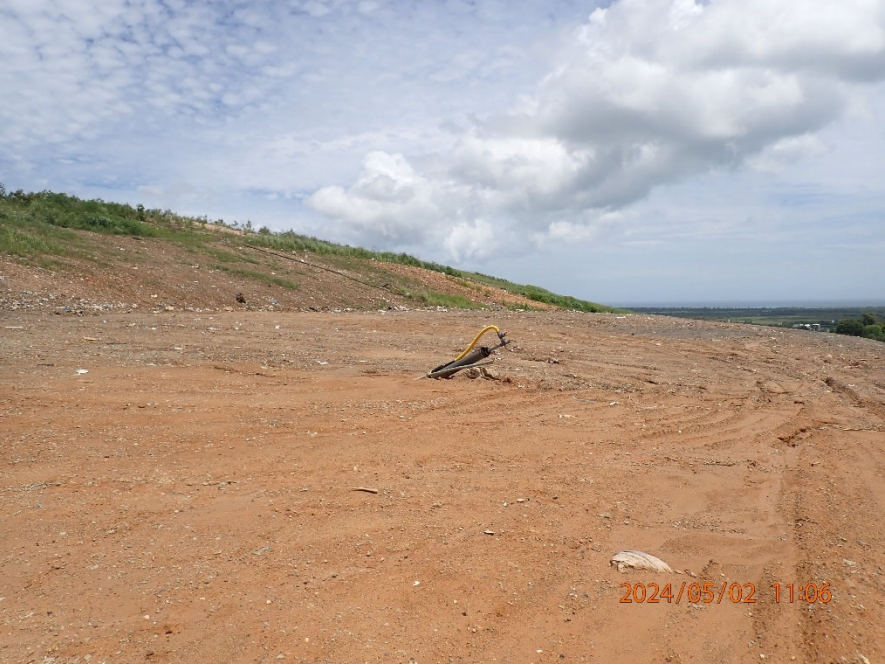
5/2/2024	1106
		<p data-bbox="575 699 1081 727">Slanted unidentified landfill gas monitoring well</p>

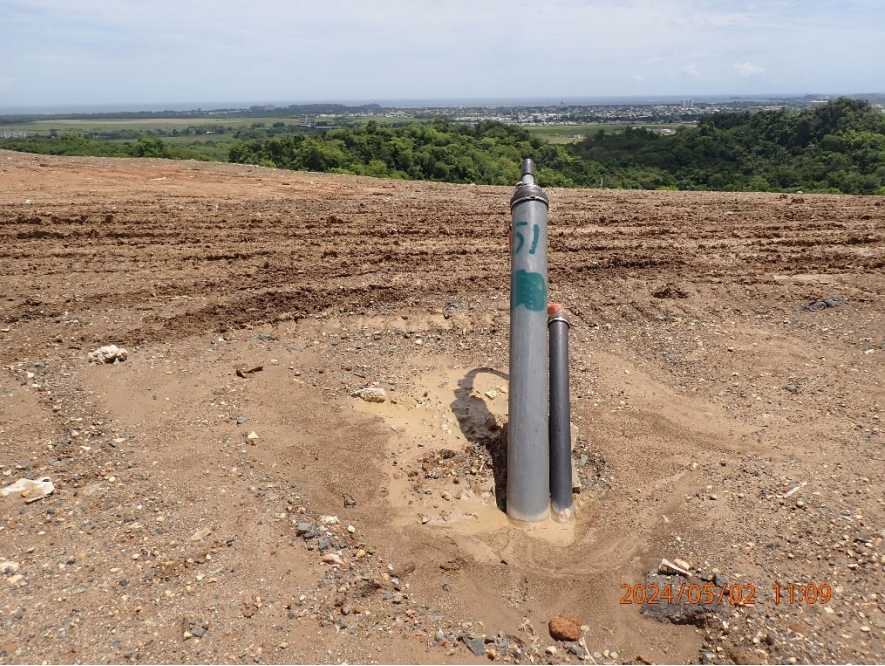
5/2/2024	1109
		<p data-bbox="575 1393 913 1421">Landfill gas monitoring well #51</p>

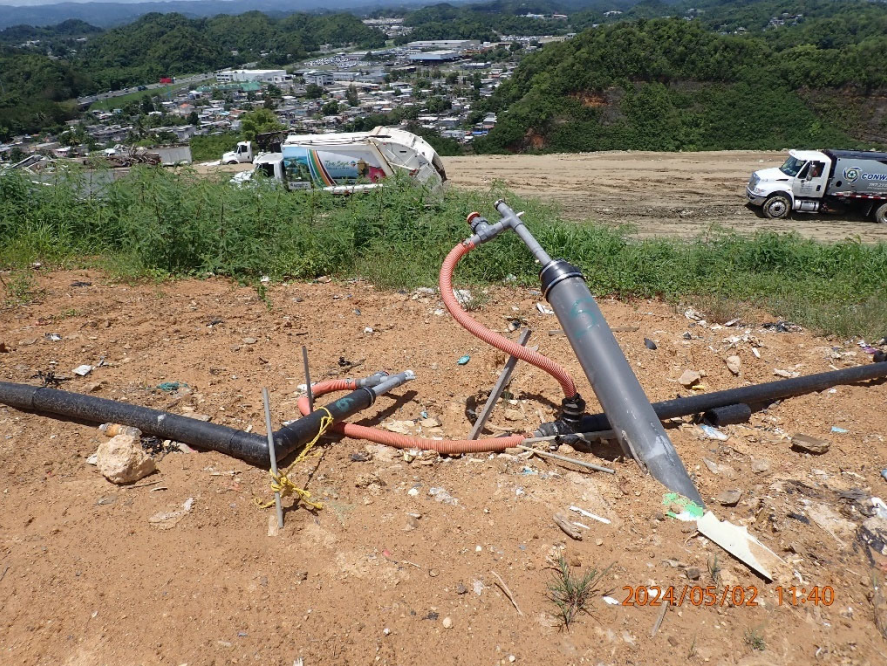
<p data-bbox="1192 613 1409 646">2024/05/02 13:40</p> <p data-bbox="575 703 911 727">Landfill gas monitoring well #57</p>	5/2/2024	1140
20	P5020020.JPG

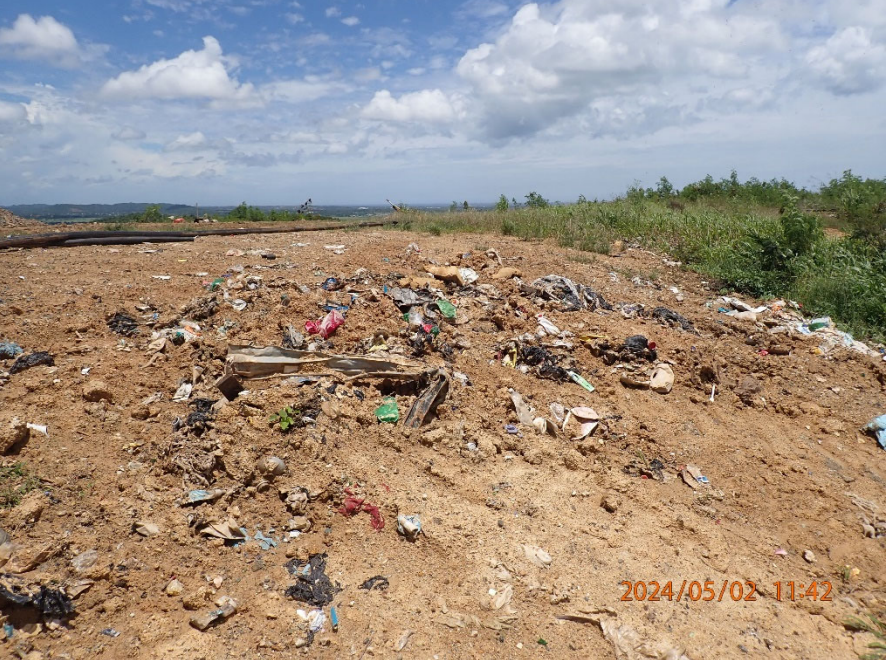
<p data-bbox="1192 1312 1409 1344">2024/05/02 11:42</p> <p data-bbox="575 1398 737 1425">Exposed waste</p>	5/2/2024	1142

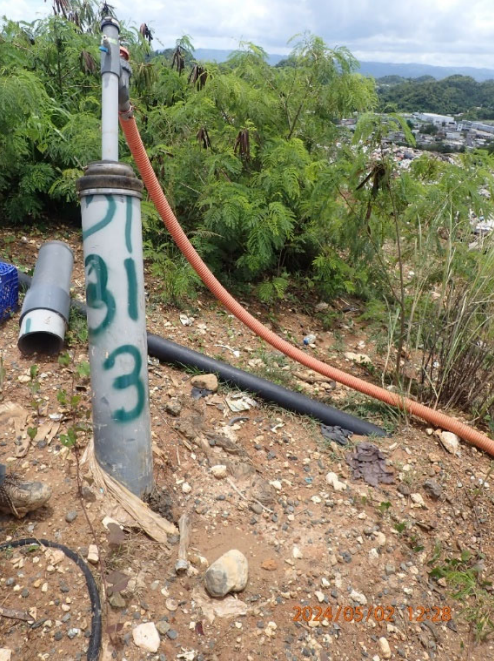
<p data-bbox="575 699 913 727">Landfill gas monitoring well #31</p>	5/2/2024	1228
30	P5020030.JPG

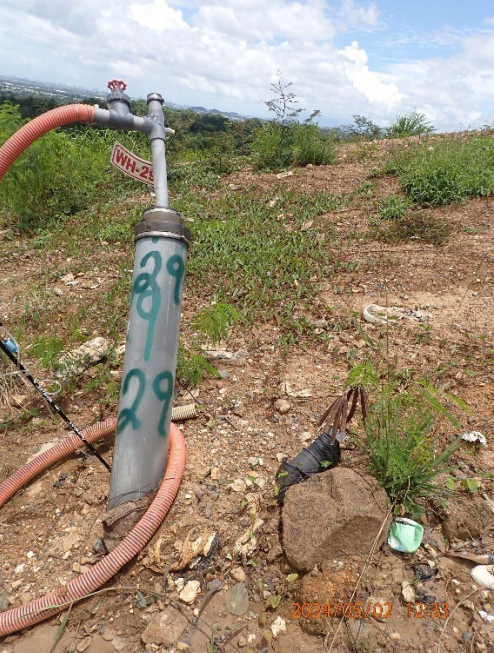
<p data-bbox="575 1386 913 1416">Landfill gas monitoring well #29</p>	5/2/2024	1233

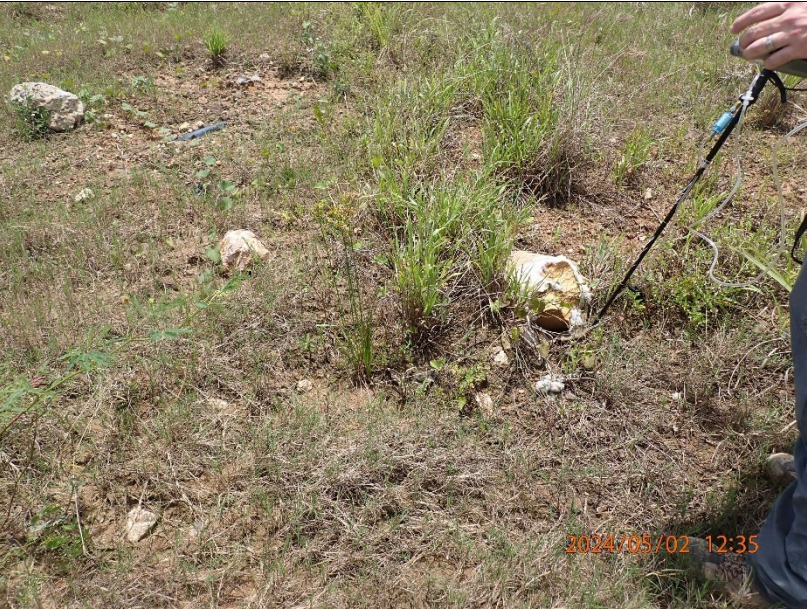
<p data-bbox="575 646 735 670">Exposed waste</p>	5/2/2024	1235
32	P5020032.JPG

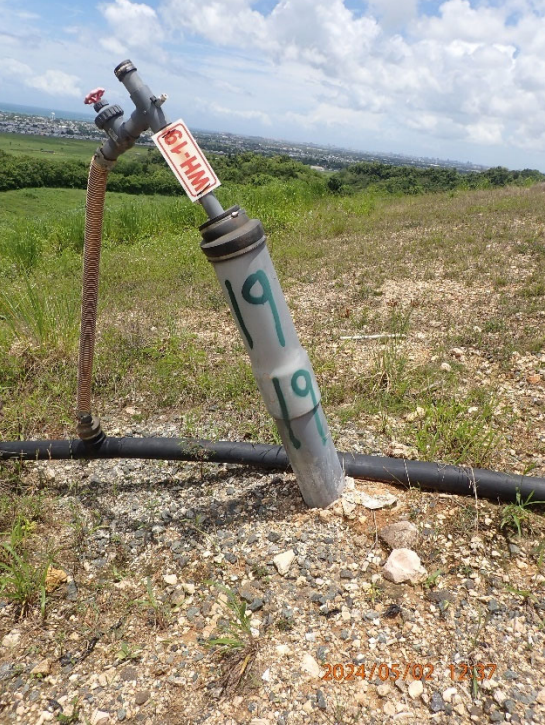
<p data-bbox="575 1404 913 1429">Landfill gas monitoring well #19</p>	5/2/2024	1237

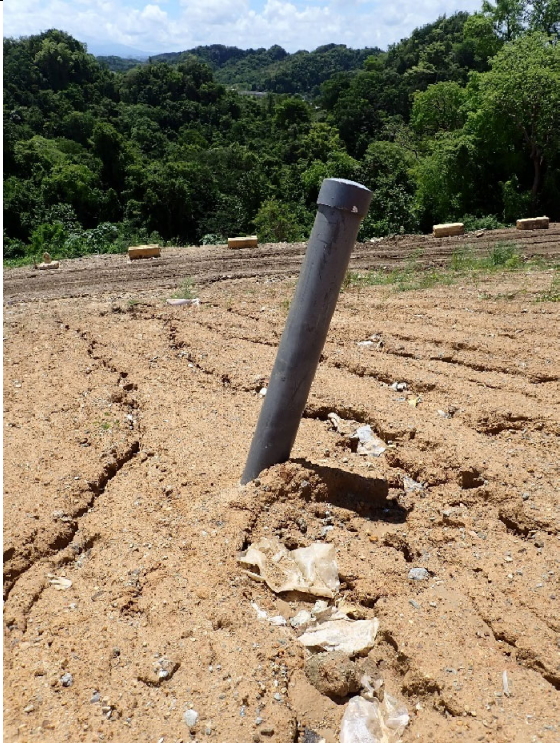
5/2/2024	1057
		Landfill gas monitoring well #50 (capped)		
44	P5020073.JPG

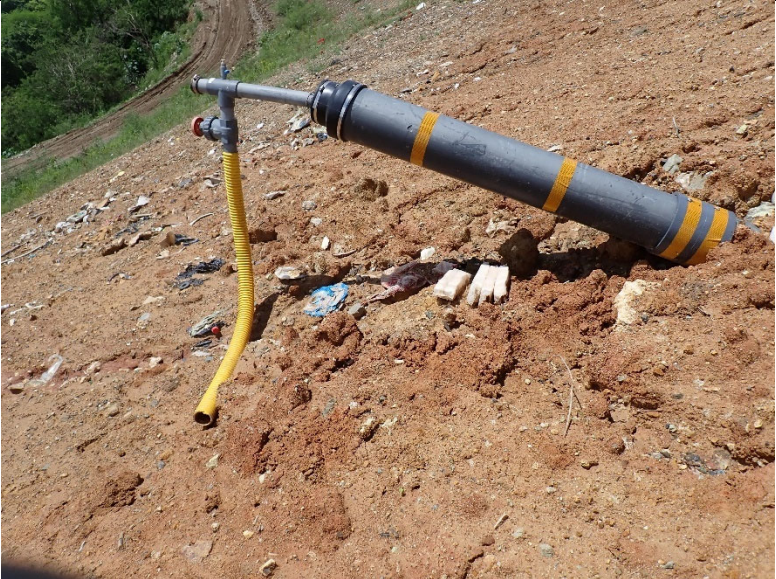
5/2/2024	1102
		Unidentified landfill gas monitoring well

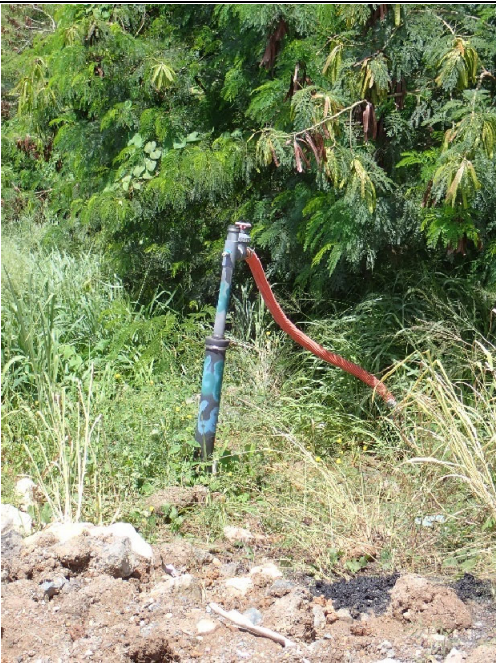
<p data-bbox="573 695 1066 727">Landfill gas monitoring well #68</p>	5/2/2024	1135
52	P5020081.JPG

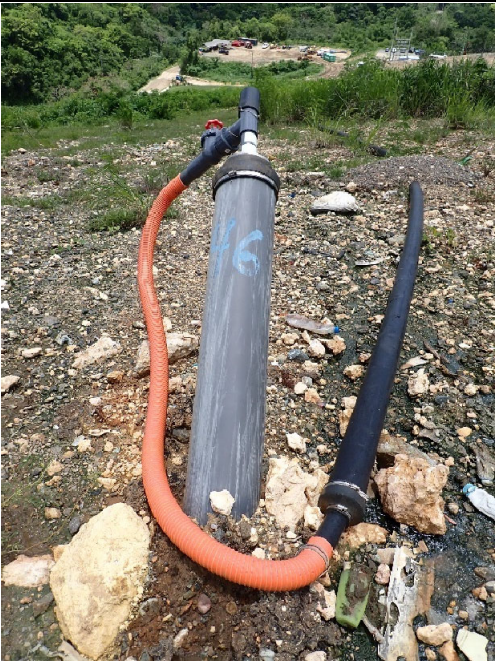
<p data-bbox="573 1385 1066 1416">Landfill gas monitoring well #46</p>	5/2/2024	1216

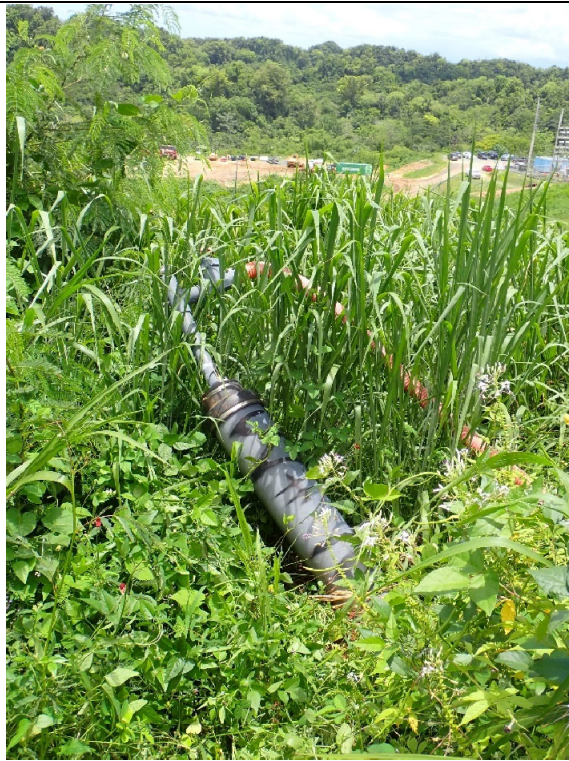
Landfill gas monitoring well #16
