## How We Cured Condenser Tube Corrosion

Sudden tube leakage on a special heater-condenser demanded quick solution to avert catastrophe. Here is an account of how some simple methods pinned down trouble and controlled it

By H WELDINGH, Odense Lighting Dept, Denmark

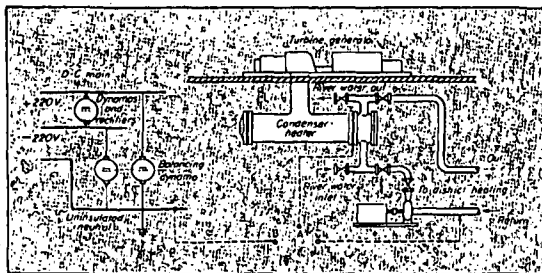
1 During winter season condenser acts as heat exchanger to produce hot water for district heating. In summer it functions as condenser using circulating water
