## Region 6 - Enforcement & Compliance Assurance Division

### INSPECTION REPORT

| Facility Name: | <b>Southeast White County Public Water System</b> | |

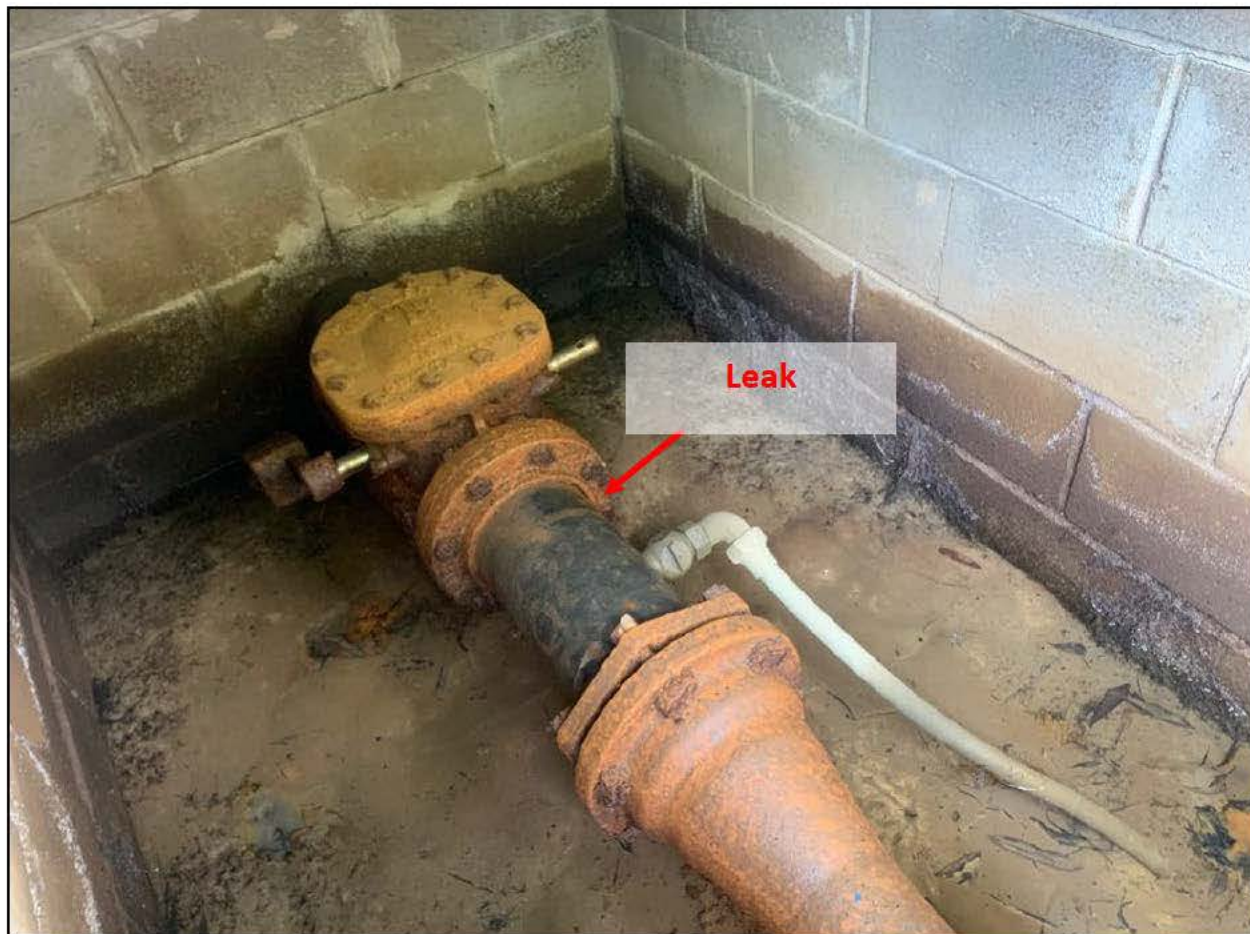
inside of the meter vault (refer to [Appendix 2, Photographs 2 and 3](#)). A small water leak in the meter line was observed downstream of the meter. Water was dripping from the meter line at approximately one drop per second.

**Observation 15.** Water was constantly dripping out of the Master Meter #1 line downstream of the meter, causing flooding in the meter box (refer to [Appendix 2, Photographs 2 and 3](#)). There was approximately one drip coming from the line per second. During the inspection, the water level was below the meter line but there were water marks on the wall of the vault indicating that the water level had been higher than the meter line at some point.

**Photograph 2. Master Meter #1 Line** View of the Master Meter #1 line. There were approximately five inches of water below the line, and water was dripping constantly from the line downstream of the meter.

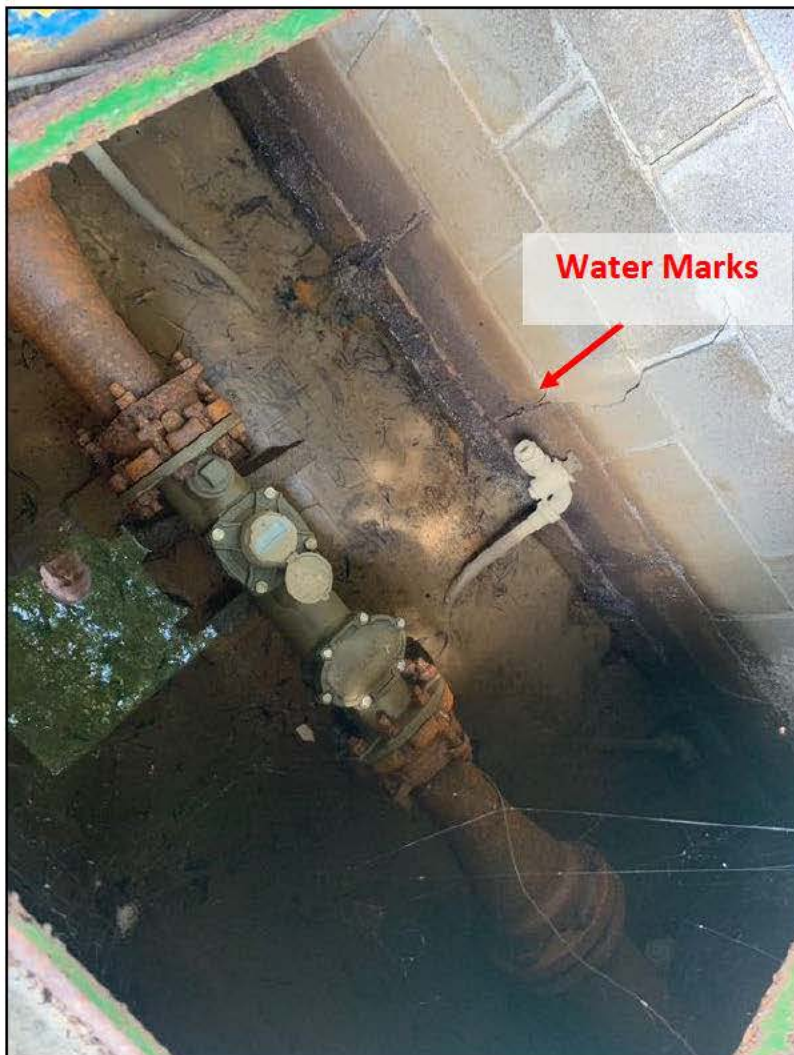
**Photograph 3. Master Meter #1 Line** View of the Master Meter #1 Line. Water marks on the wall show that the water level had been higher than the meter line at some point.

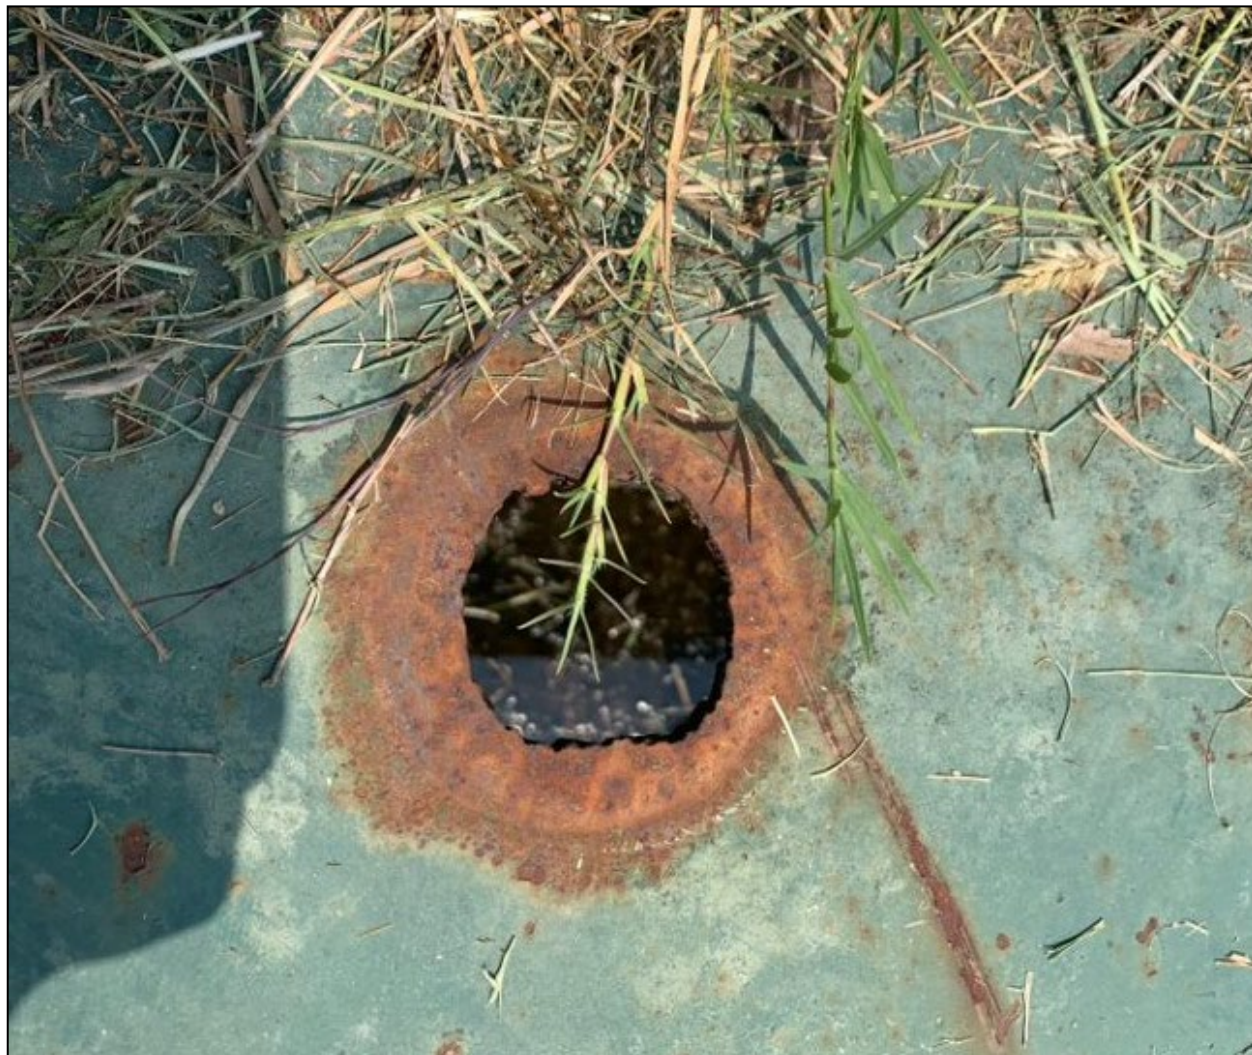
Master Meter #2 was observed next, and it was also located in an underground meter vault (refer to [Appendix 2, Photograph 5](#)). There was corrosion/metal loss on the surface of the meter vault which created a small hole (refer to [Appendix 2, Photograph 6](#)). [REDACTED]

**Observation 16.** The Master Meter #2 line was completely submerged with water, including the telemetry wiring to the meter (refer to [Appendix 2, Photograph 7](#)). Metal loss on the surface of the meter vault created a hole leading directly into the vault (refer to [Appendix 2, Photograph 6](#)). [REDACTED]

**Photograph 6. Master Meter #2 Vault** View of a hole in the surface of the Master Meter #2 vault caused by corrosion and metal loss.

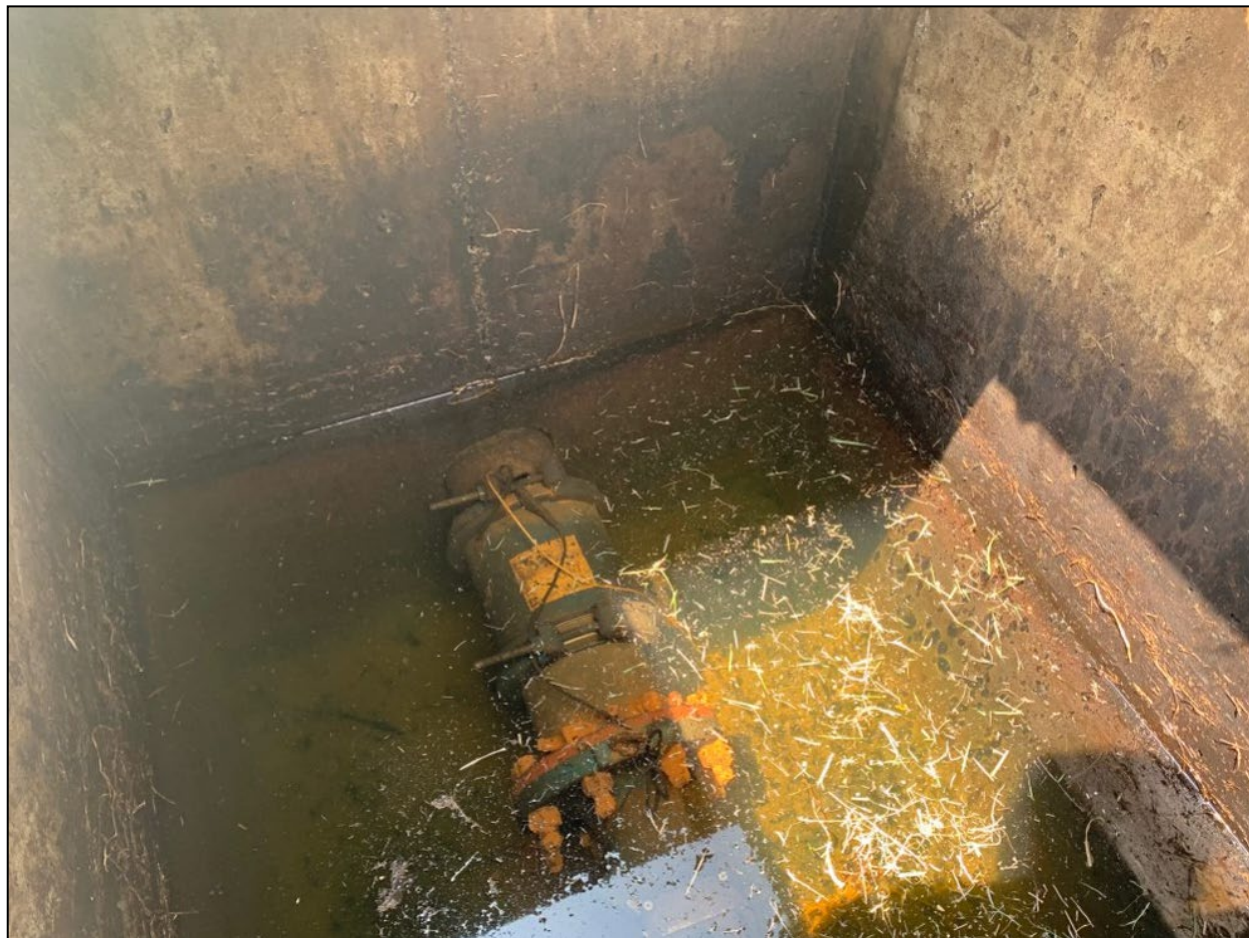
[REDACTED] The meter vault was flooded when the EPA Inspector arrived, and the meter line was completely submerged (refer to [Appendix 2, Photographs 7 and 8](#)).

**Photograph 7. Master Meter #2 Line** View the Master Meter #2 line that was completely submerged. The wiring associated with the meter telemetry was also fully submerged.

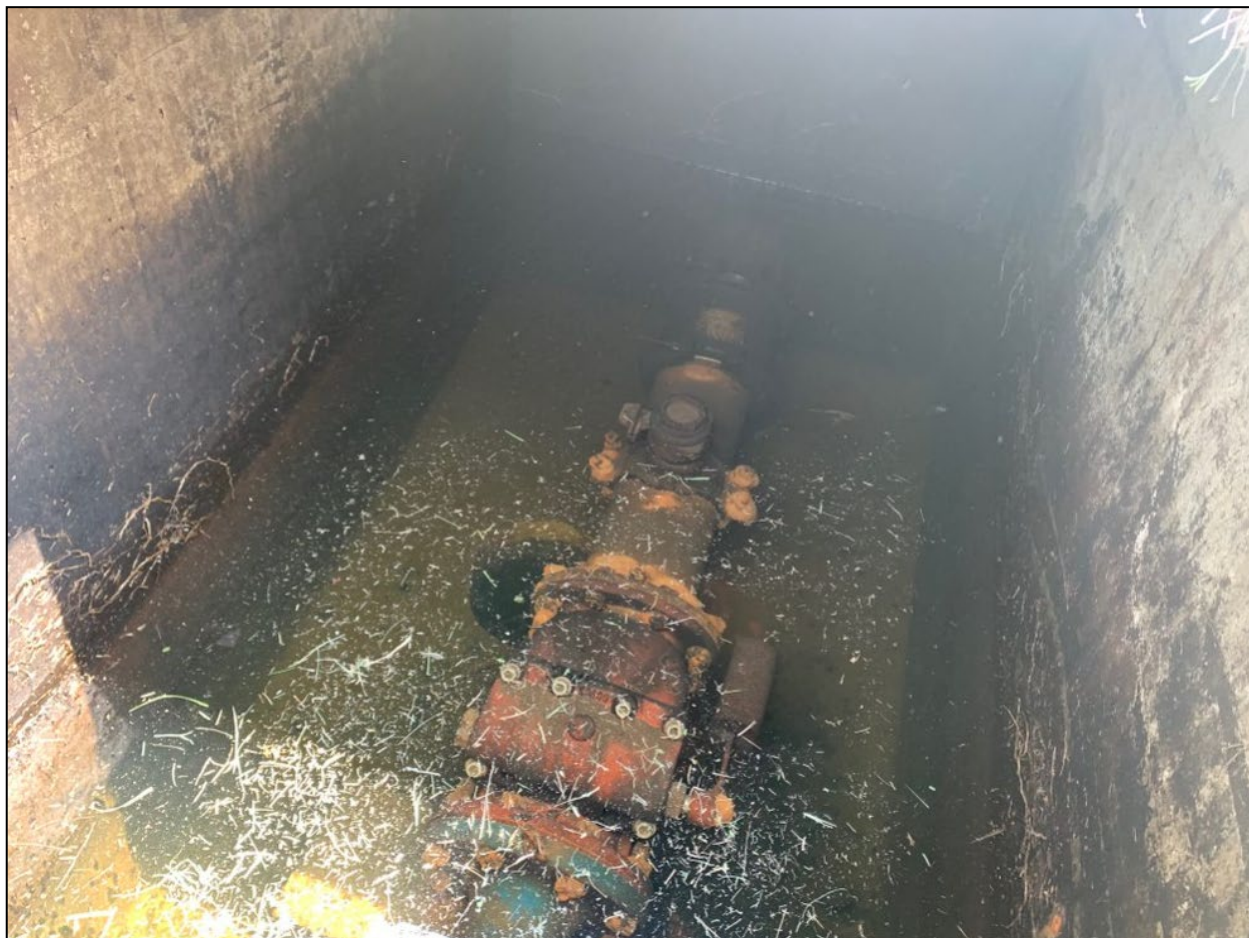
**Photograph 8. Master Meter #2 Line** Alternate view of the fully submerged Master Meter #2 line.

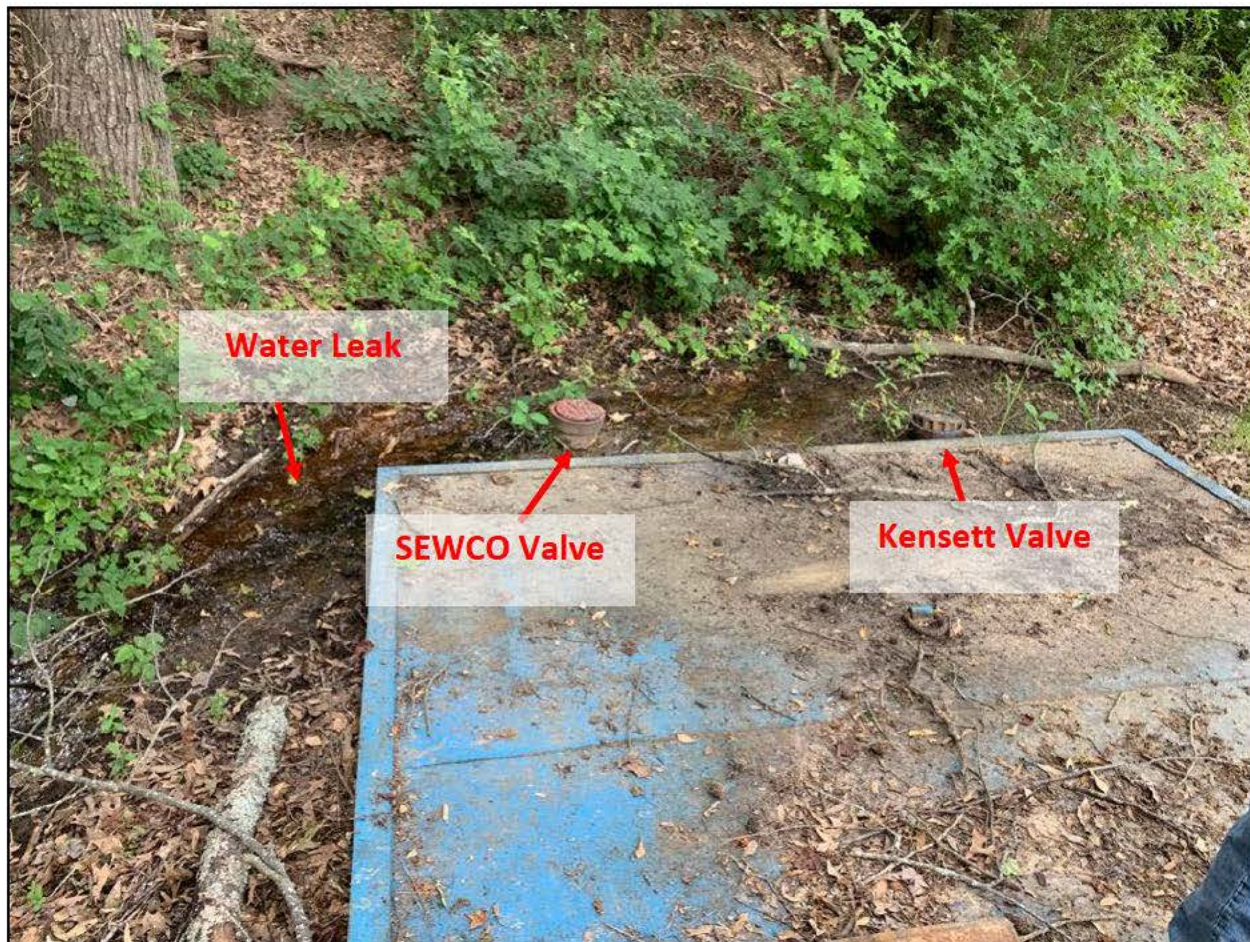
**Photograph 10. Kensett Water and SEWCO Valves** View of the City of Kensett Water valve and the SEWCO Master Meter #3 valve that can be used to shut off water supply from Searcy Waterworks. There was a leak coming through the ground, but it was unclear if the leak was coming from a line or one of the valves.

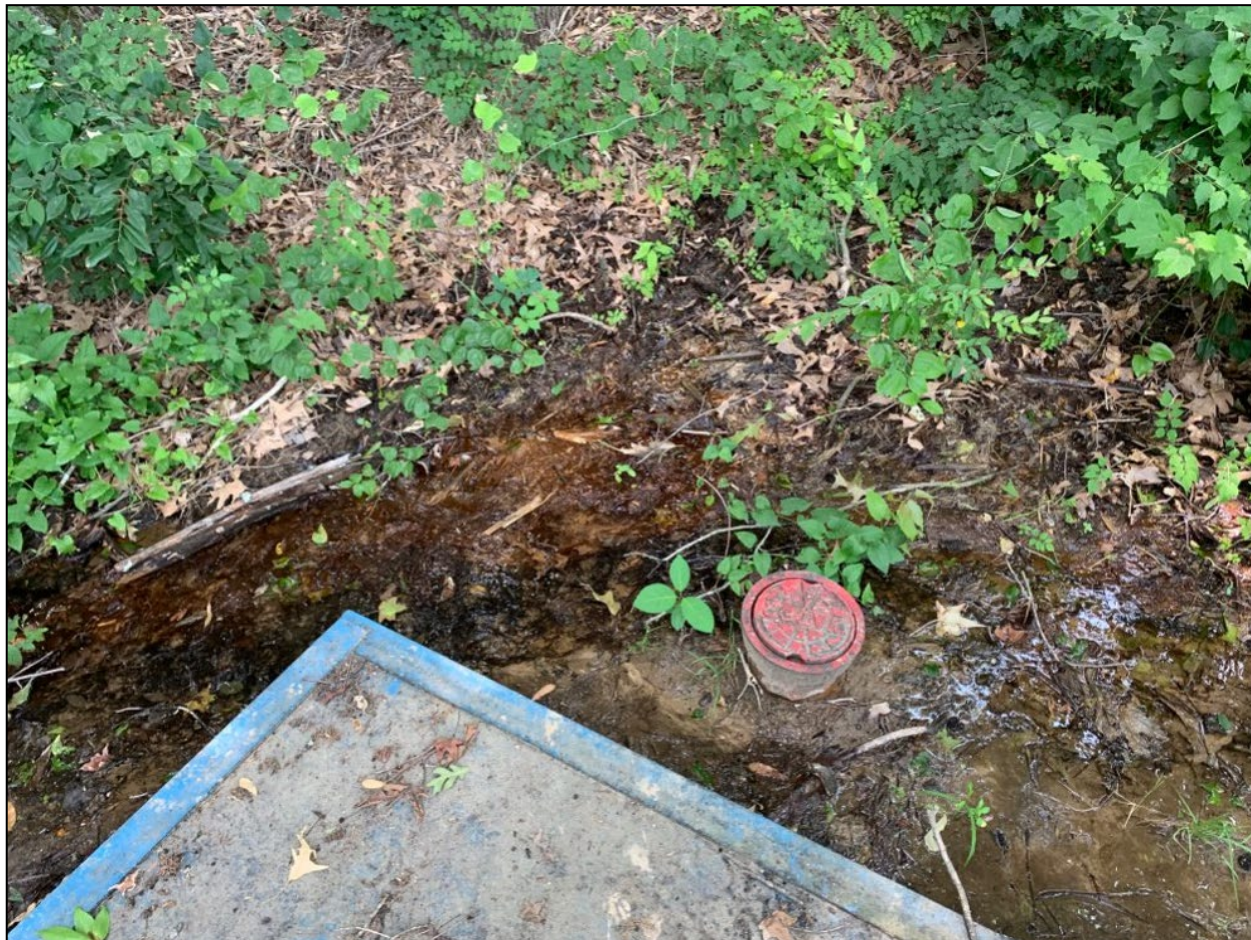
**Observation 17.** A leak was observed upstream of Master Meter #3 (refer to [Appendix 2, Photographs 11 and 12](#)). It was unknown if the leak was coming from a valve or a buried line leading to the valves. It was also unknown if the leak was coming from the City of Kensett Water side or the System side since the meter lines and valves ran parallel to each other into the meter vault. The leaking water was running down the hill away from the meter vault.

**Photograph 11. Water Leak, Master Meter #3** Close up view of the water leak upstream of Master Meter #3. It was unclear where the leak was coming from.

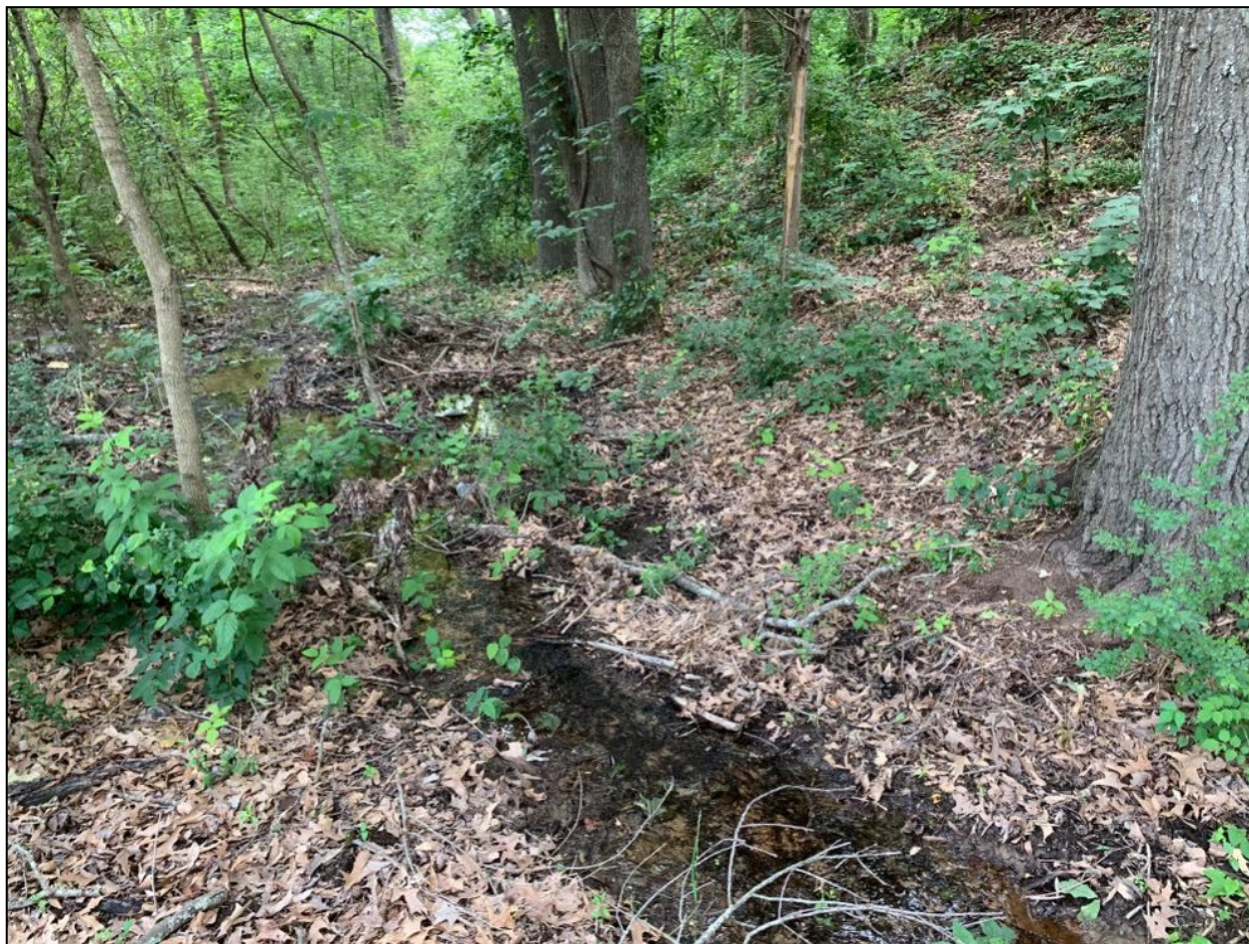
**Photograph 12. Water Leak, Master Meter #3** View of the water leak upstream of Master Meter #3 running downhill away from the meter vault.

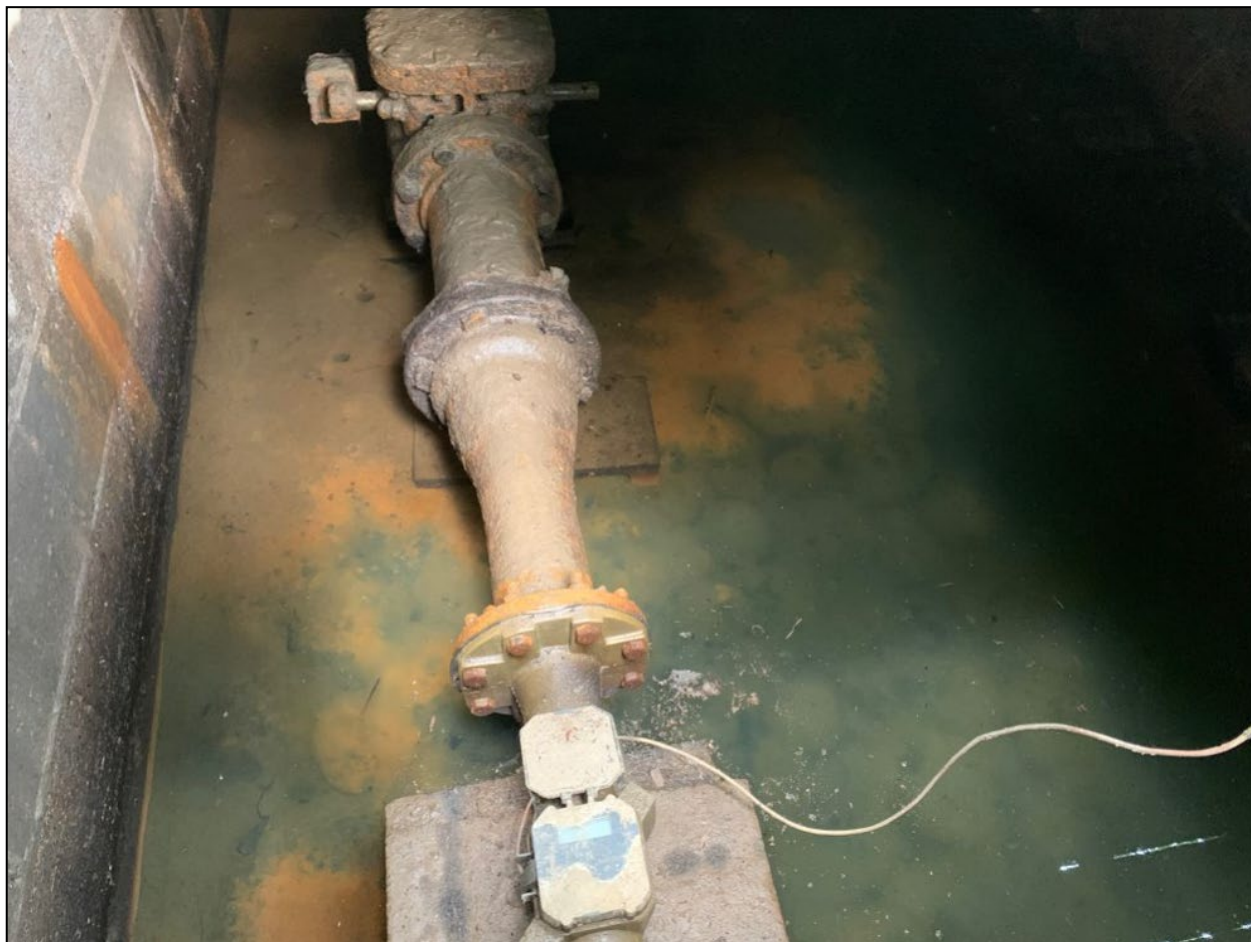
[REDACTED] The meter vault was flooded with approximately 4 inches of water (refer to [Appendix 2, Photographs 13 and 14](#)). The water level was below the meter line. The System representative stated that the meter box often flooded with rainwater due to the meter vault's low lying position relative to the surrounding area (refer to [Appendix 2, Photograph 15](#)).

**Observation 18.** The Master Meter #3 vault was flooded with approximately four inches of water, and water marks on the walls of the meter vault indicate that water levels had been higher in the past (refer to [Appendix 2, Photographs 13 and 14](#)). The meter vault was placed in a low lying area relative to the rest of the surrounding area, and the General Manager stated that flooding was a challenge in this meter vault due to rain runoff (refer to [Appendix 2, Photograph 15](#)).

**Photograph 13. Master Meter #3 Line** View of the water flooded below the Master Meter #3 line. There were approximately four inches of water below the line.

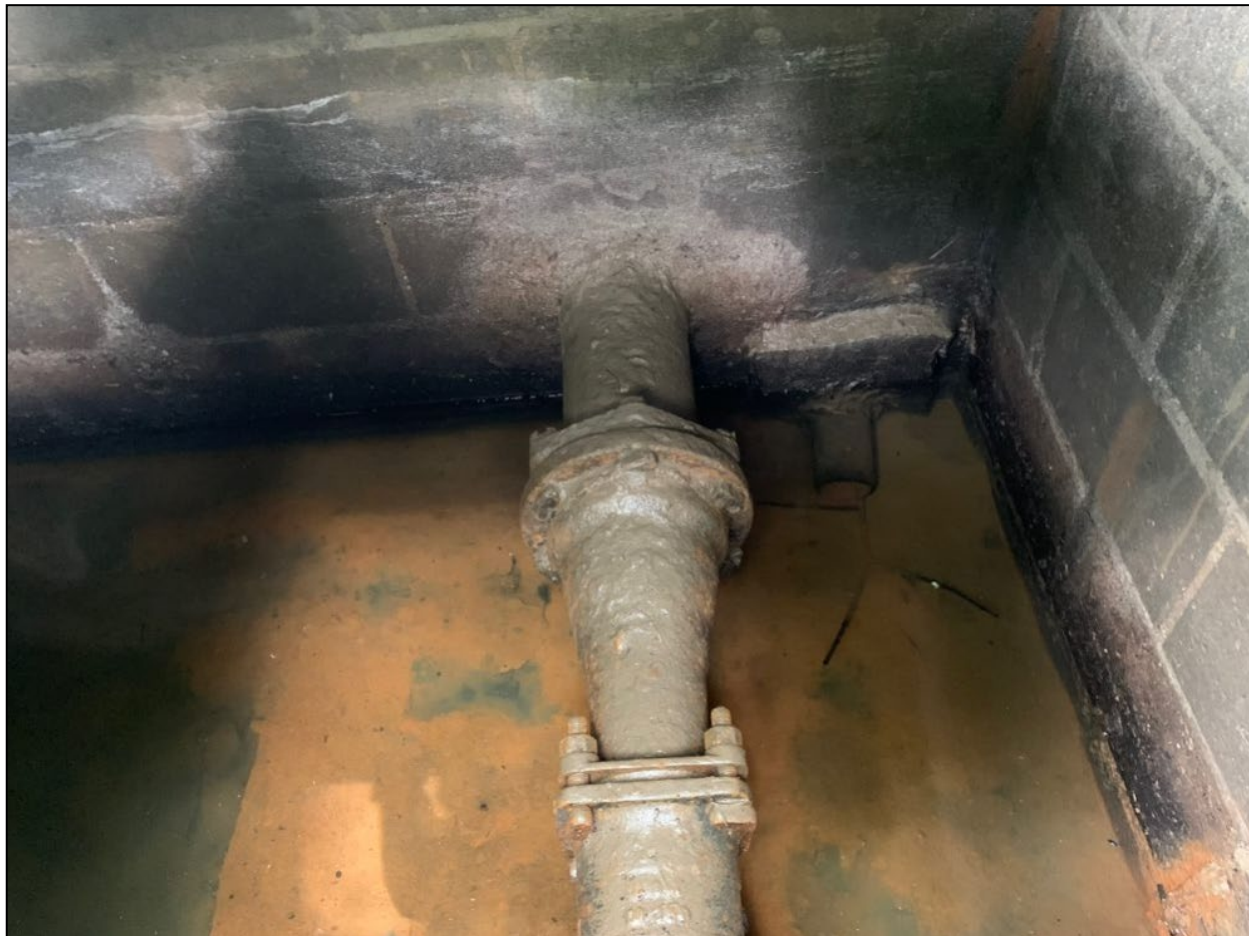
**Photograph 14. Master Meter #3 Line** Alternate view of the Master Meter #3 line which had approximately four inches of water beneath it.

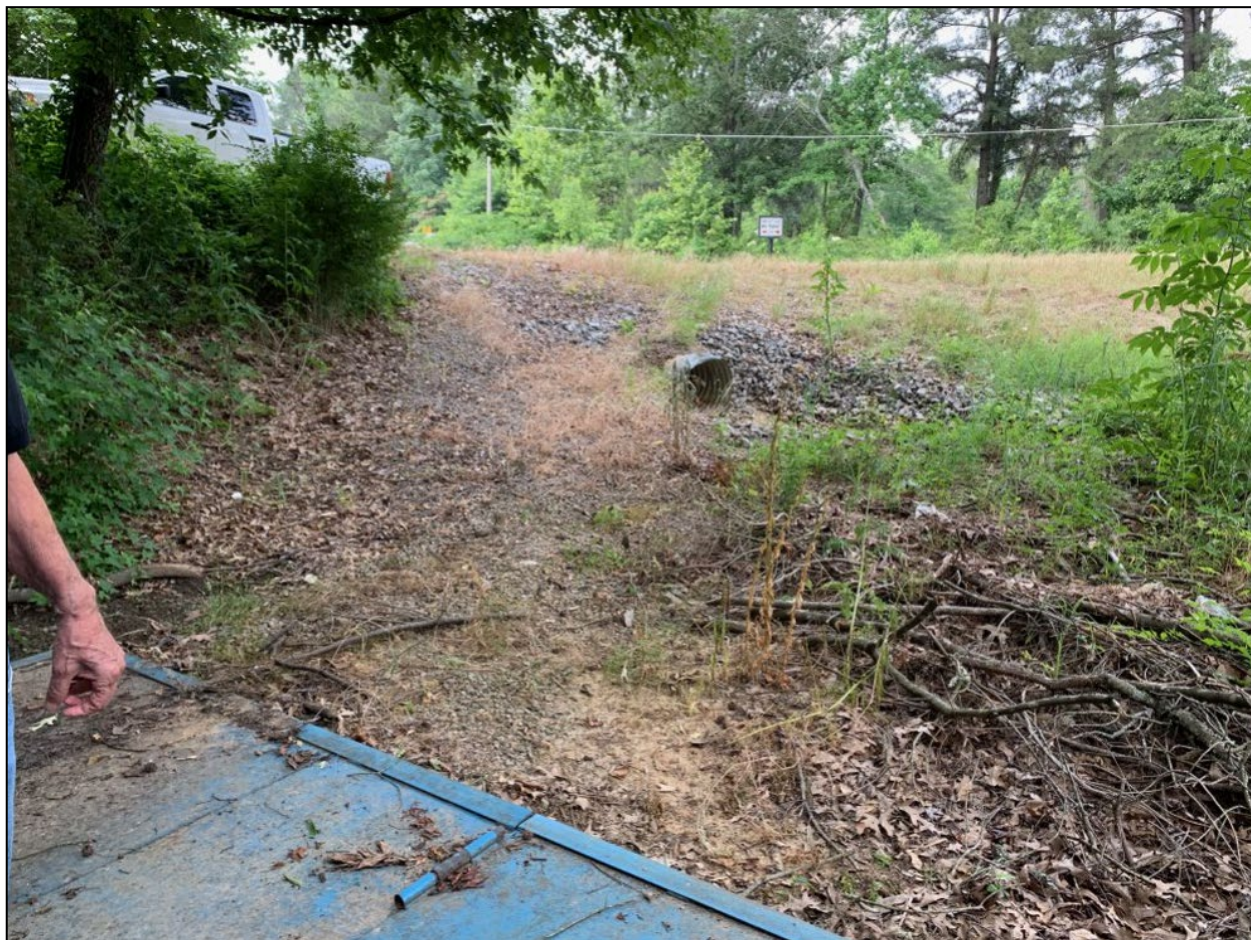
**Photograph 15. Master Meter #3 Vault** View of the area surrounding the Master Meter #3 vault. The vault was located in a relatively low position compared to the surrounding area.

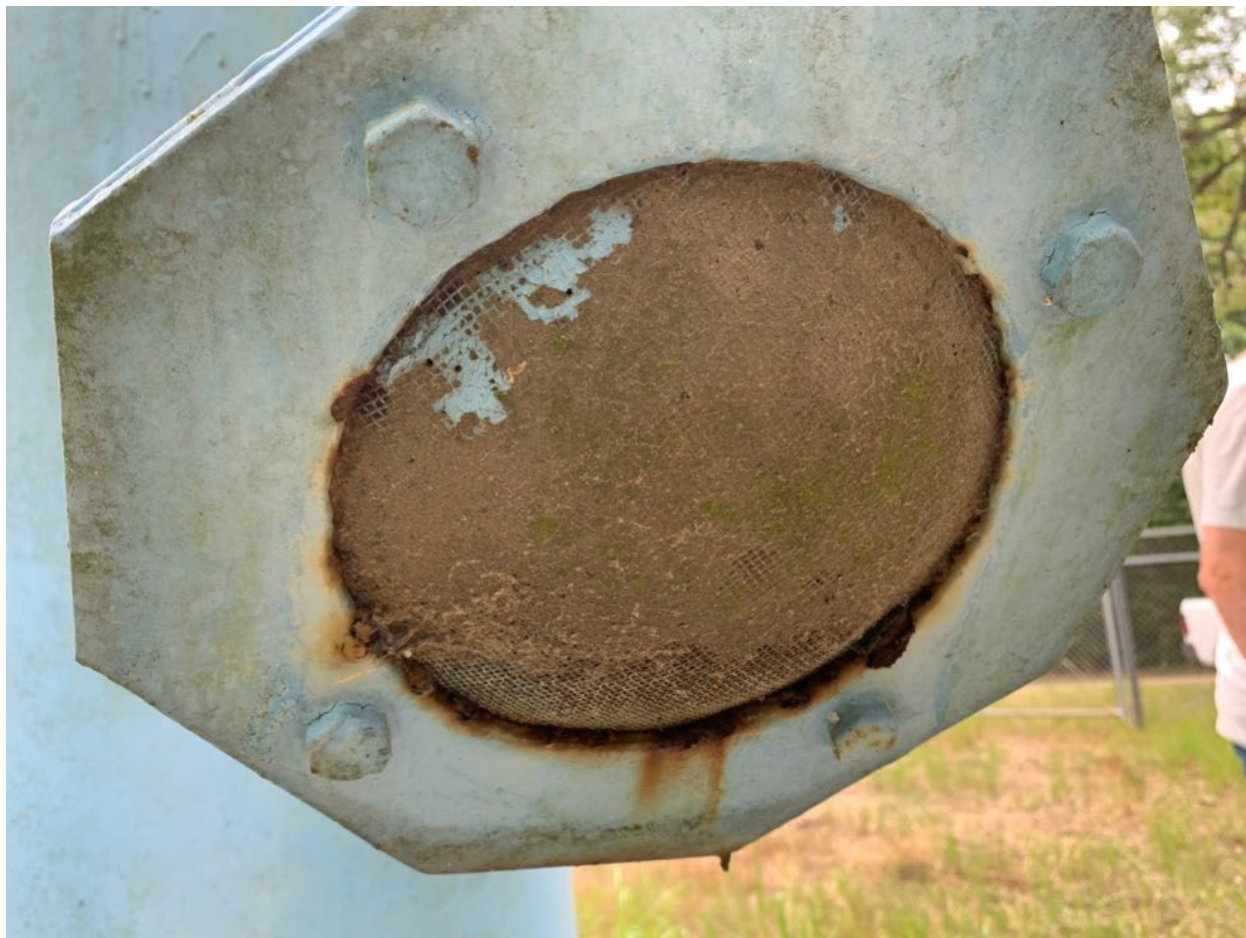
**Observation 21.** At the terminus of the Griffithville Water Tank overflow pipe, there was debris covering the majority of the mesh screen, clogging most of the mesh (refer to [Appendix 2, Photograph 20](#)).

**Photograph 20. Overflow Pipe, West Point Water Tank** Close up view of the screen covering the end of the overflow pipe at the West Point Water Tank. The screen was mostly covered with debris that was clogging the mesh screen.

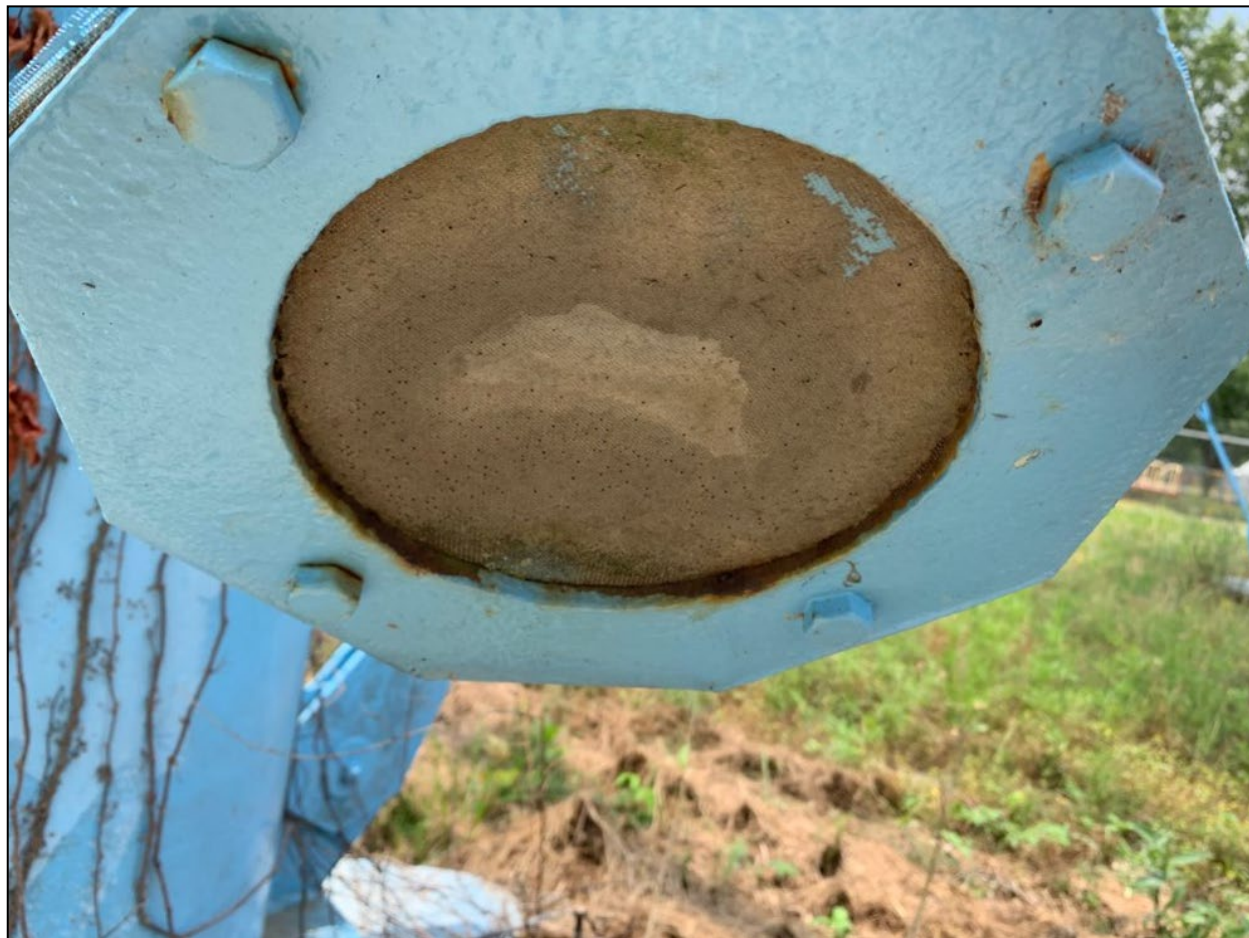
**Observation 20.** At the terminus of the West Point Water Tank overflow pipe, there was debris covering the majority of the mesh screen, clogging most of the mesh (refer to [Appendix 2, Photograph 26](#)).

**Photograph 26. Overflow Pipe, Griffithville Water Tank** View of the mesh screen covering the end of the overflow pipe at the Griffithville Water Tank. The screen was mostly clogged with debris.

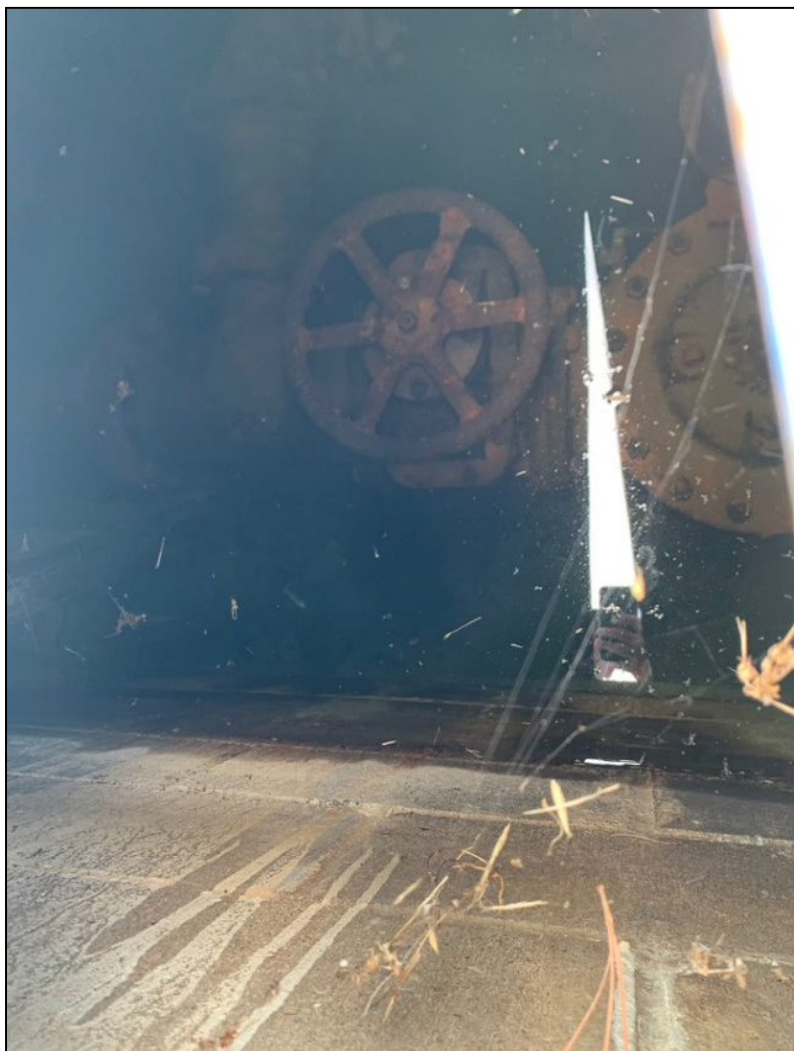
[REDACTED] The vault was flooded at the time of the inspection, and the General Manager stated that the sump pump that is ordinarily used to empty the vault was not functioning (refer to Appendix 2, Photograph 29).

valve was completely submerged (refer to Appendix 2, Photograph 29). The General Manager stated that a sump pump is usually used to empty out the tank, but the pump had failed.

**Photograph 29. Valve Vault, Griffithville Water Tank** View of the inside of the valve vault at the Griffithville Water Tank. The vault was flooded, and the valves were completely submerged. The sump pump that was typically used to empty the valve vault was not functional.
