**Region 6 - Enforcement & Compliance Assurance Division**  
**INSPECTION REPORT**

| Media Program: | Water | |
| Company Name: | LaRay Oil, LLC | |
| Facility Name: | Morgan #1 | |

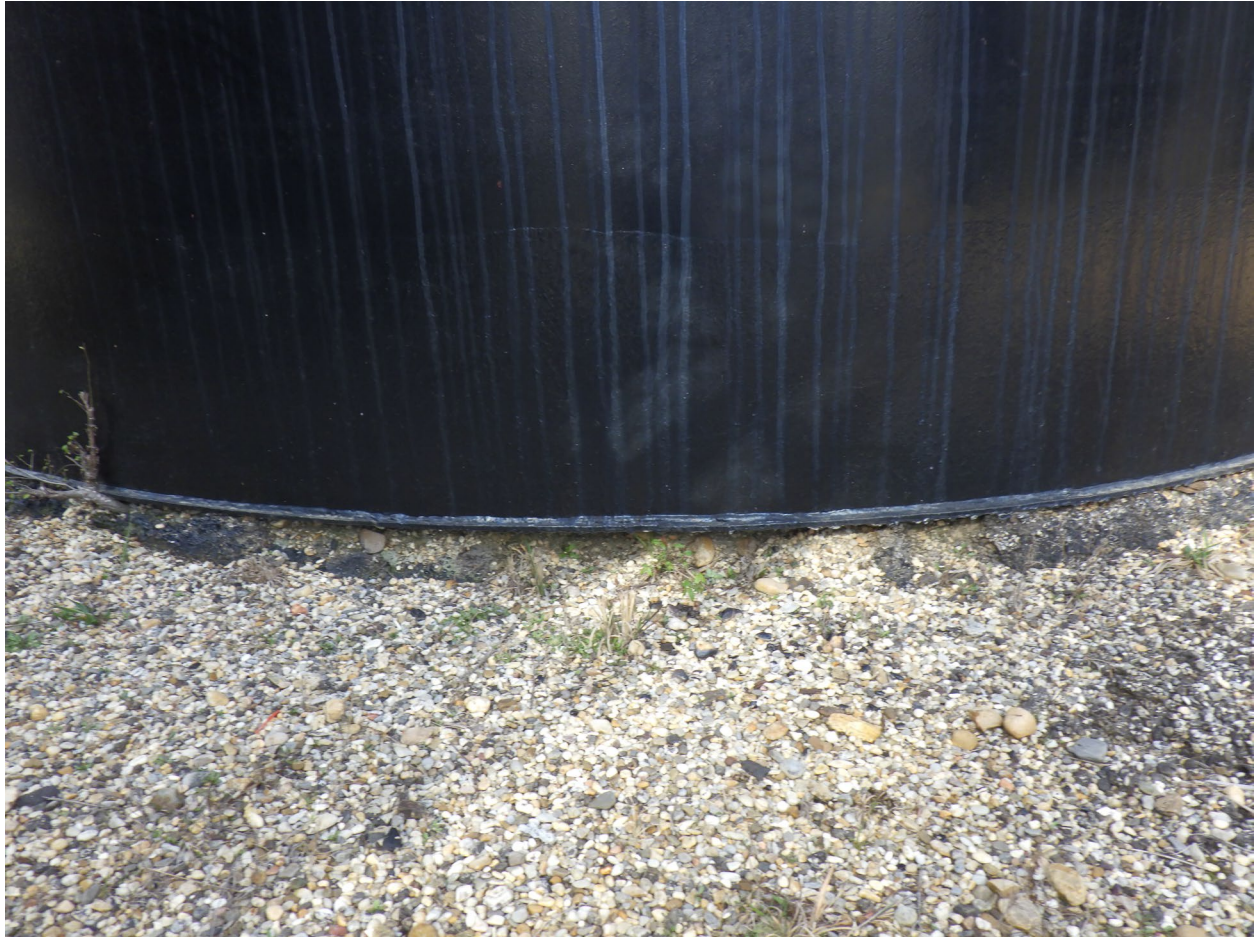
Photo No. 3

I observed a gap at the base of one (1) crude oil storage tank and corrosion at the base of one (1) saltwater and crude oil storage tank, see photo No. 3 and No. 4.

No closing conference was held due to no LaRay Oil, LLC staff being present during the inspection. Areas of concern at the time of the inspection include the gap at the base of the crude oil storage tank, corrosion at the base of the saltwater and crude oil storage tank, the leaking secondary containment discharge valve, and the elevated TDS reading outside of secondary containment in the leached water from the secondary containment berm.

**Photo File Name:** R0010147**Orientation:** N**Date of Photo:** 03/11/2024**Time of Photo:** 4:49 PM**Latitude:** 33.33491**Longitude:** -92.50951**Photographer:** Kerri McCabe**Description:** This photo was taken looking north and shows a gap at the base of a crude oil tank.

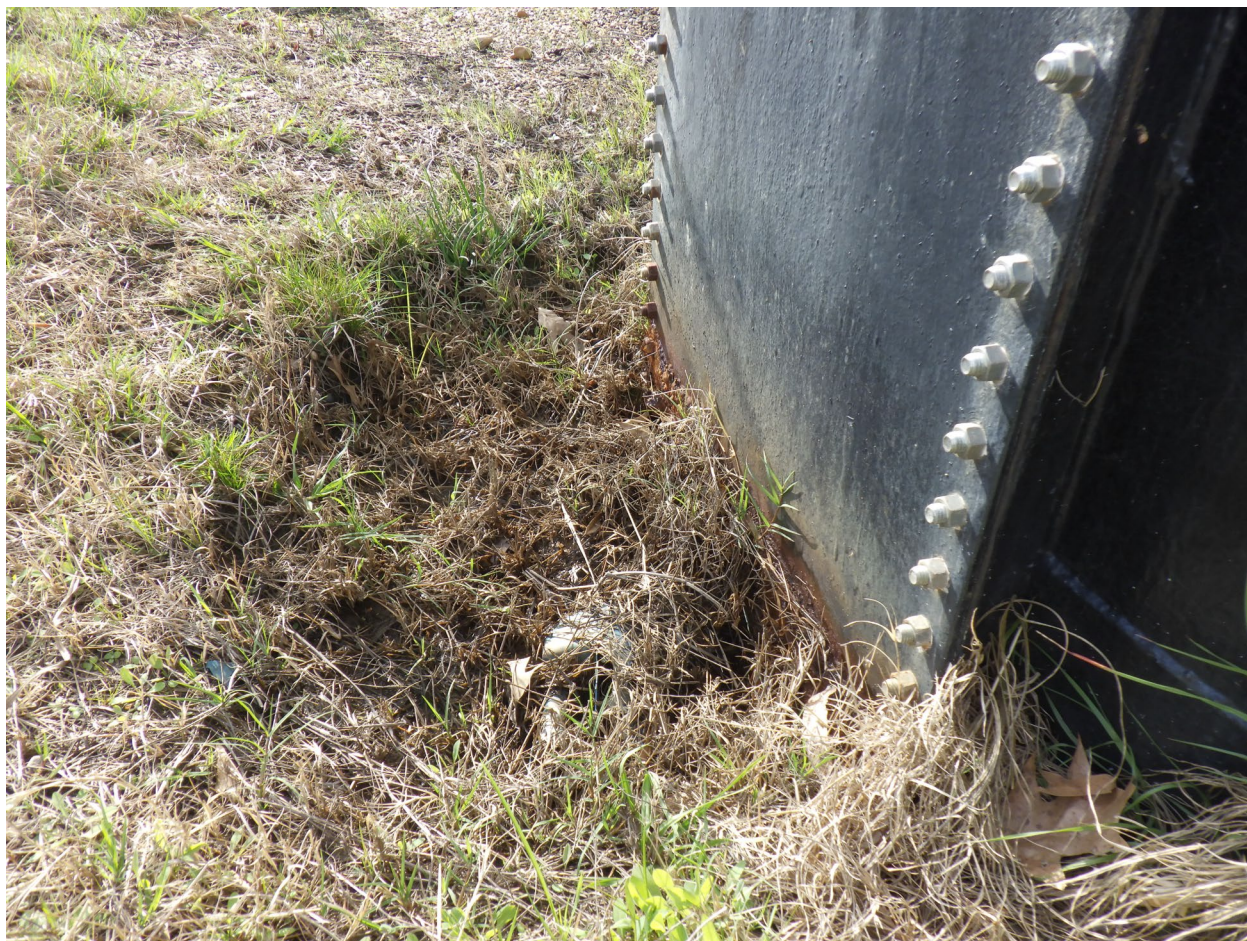
Photo No. 4

**Photo File Name:** R0010149**Orientation:** NW**Date of Photo:** 03/11/2024**Time of Photo:** 4:51 PM**Latitude:** 33.33492**Longitude:** -92.50945**Photographer:** Kerri McCabe**Description:** This photo was taken looking northwest and shows corrosion at the base of a tank storing saltwater and crude oil.

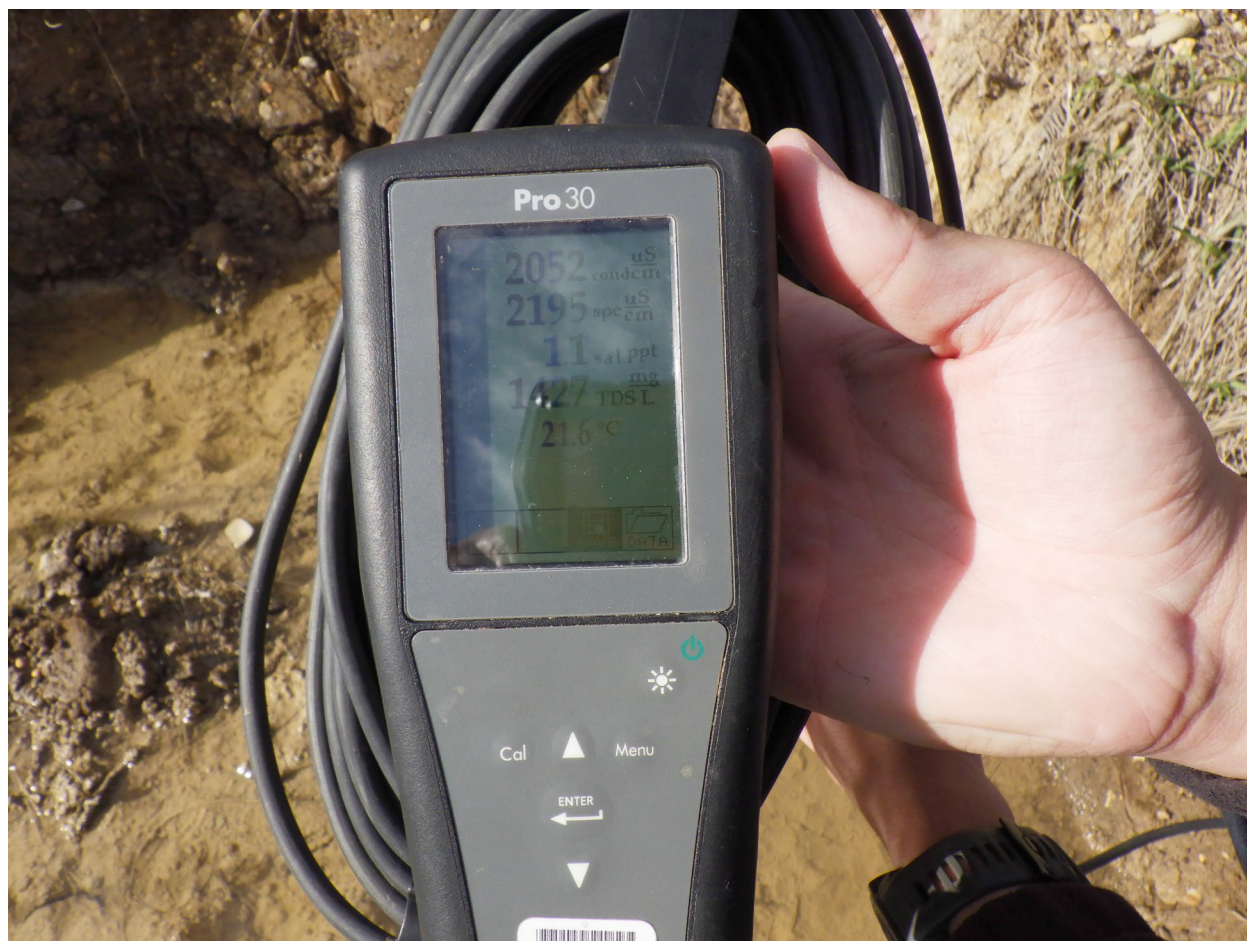
Photo No. 5

Outside of secondary containment, I observed standing water that leached through secondary containment with a total dissolved solids (TDS) reading of 1,427 mg/L, see photo No. 5 through No. 7.

**Photo File Name:** R0010152**Orientation:** N/A**Date of Photo:** 03/11/2024**Time of Photo:** 4:53 PM**Latitude:** 33.33487**Longitude:** -92.50946**Photographer:** Kerri McCabe**Description:** This photo shows a TDS reading of 1,427 mg/L in standing water that leached through secondary containment.

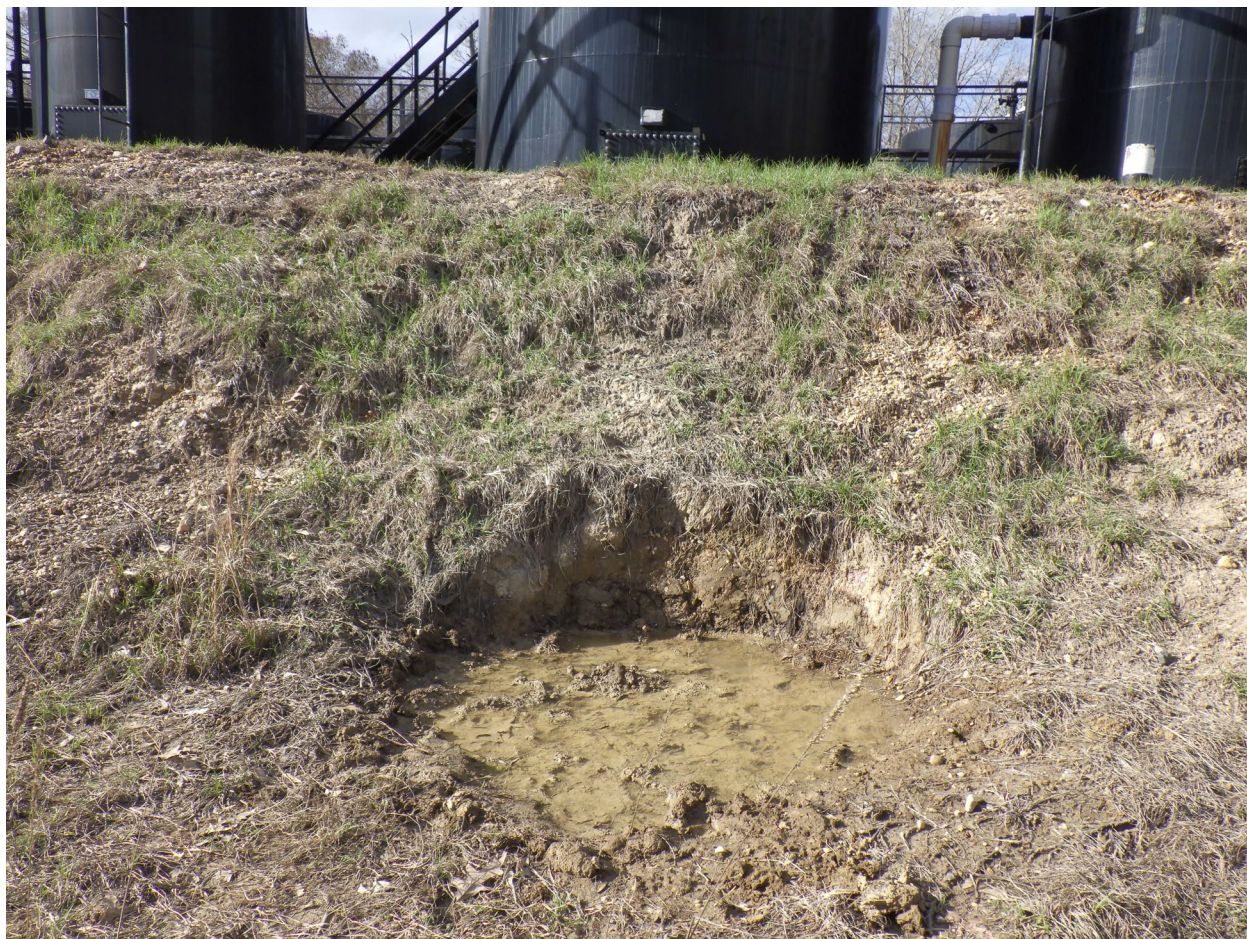
Photo No. 6

**Photo File Name:** R0010153**Orientation:** NW**Date of Photo:** 03/11/2024**Time of Photo:** 4:53 PM**Latitude:** 33.33483**Longitude:** -92.50942**Photographer:** Kerri McCabe**Description:** This photo was taken looking northwest and shows standing water that leached through secondary containment with the TDS reading of 1,427 mg/L.

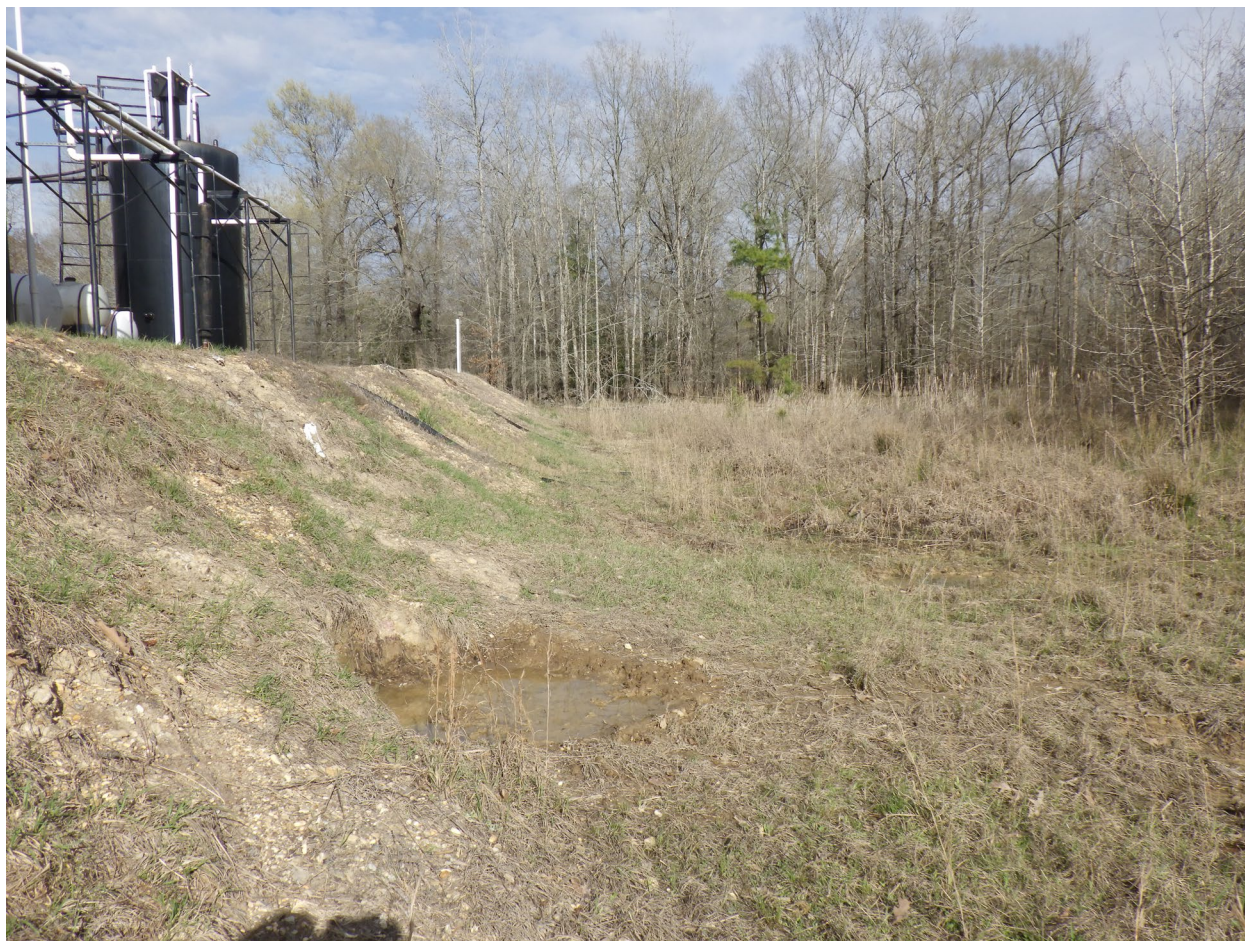
Photo No. 7

**Photo File Name:** R0010155**Orientation:** E**Date of Photo:** 03/11/2024**Time of Photo:** 4:54 PM**Latitude:** 33.33482**Longitude:** -92.50944**Photographer:** Kerri McCabe**Description:** This photo was taken looking west and shows the standing water that leached through secondary containment and vegetation in the area.

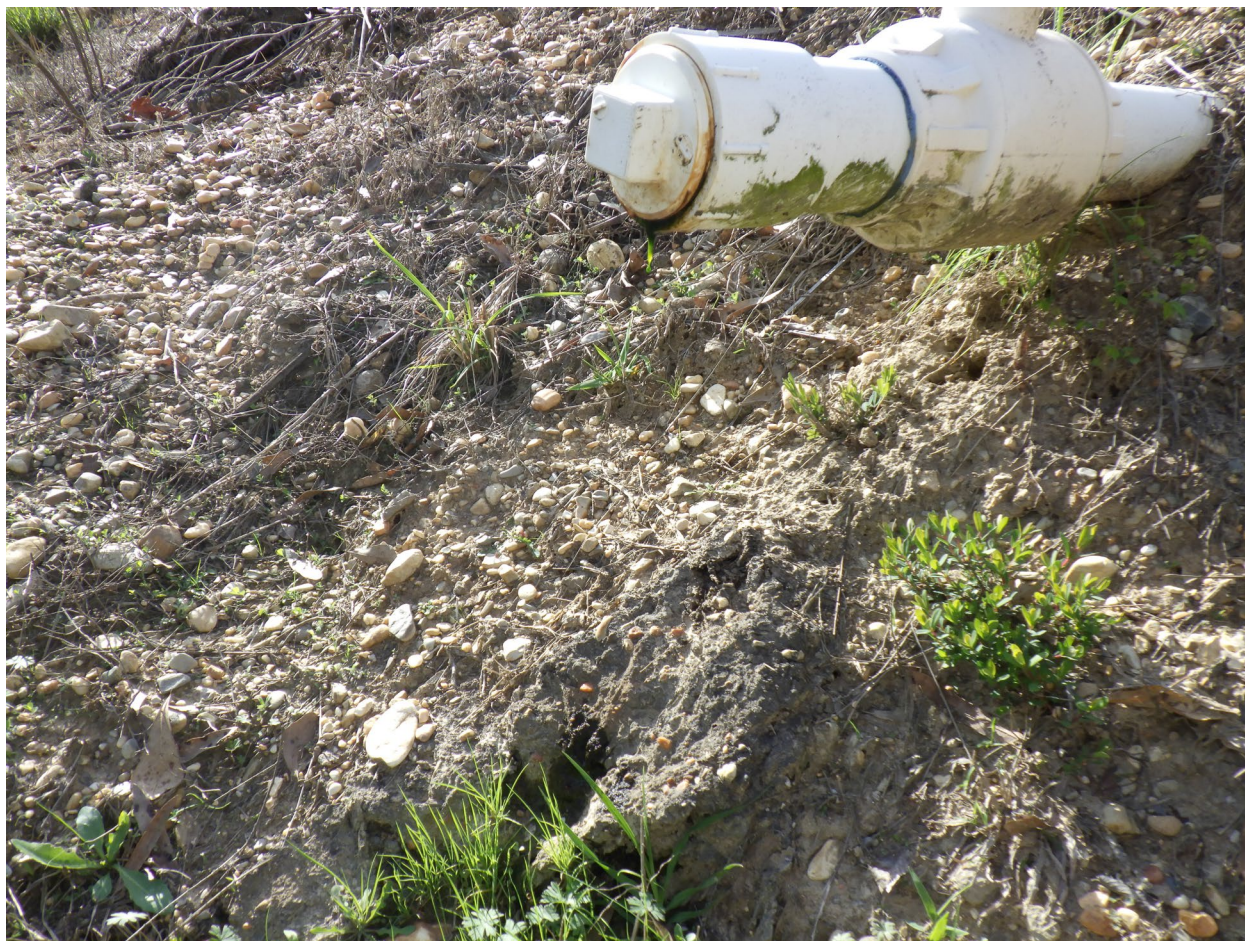
Photo No. 8

I observed a capped secondary containment discharge pipe that was leaking, see photo No. 8 through No. 10.

**Photo File Name:** R0010156**Orientation:** NW**Date of Photo:** 03/11/2024**Time of Photo:** 4:57 PM**Latitude:** 33.33493**Longitude:** -92.50902**Photographer:** Kerri McCabe**Description:** This photo was taken looking northwest and shows a capped secondary containment discharge pipe that is leaking.

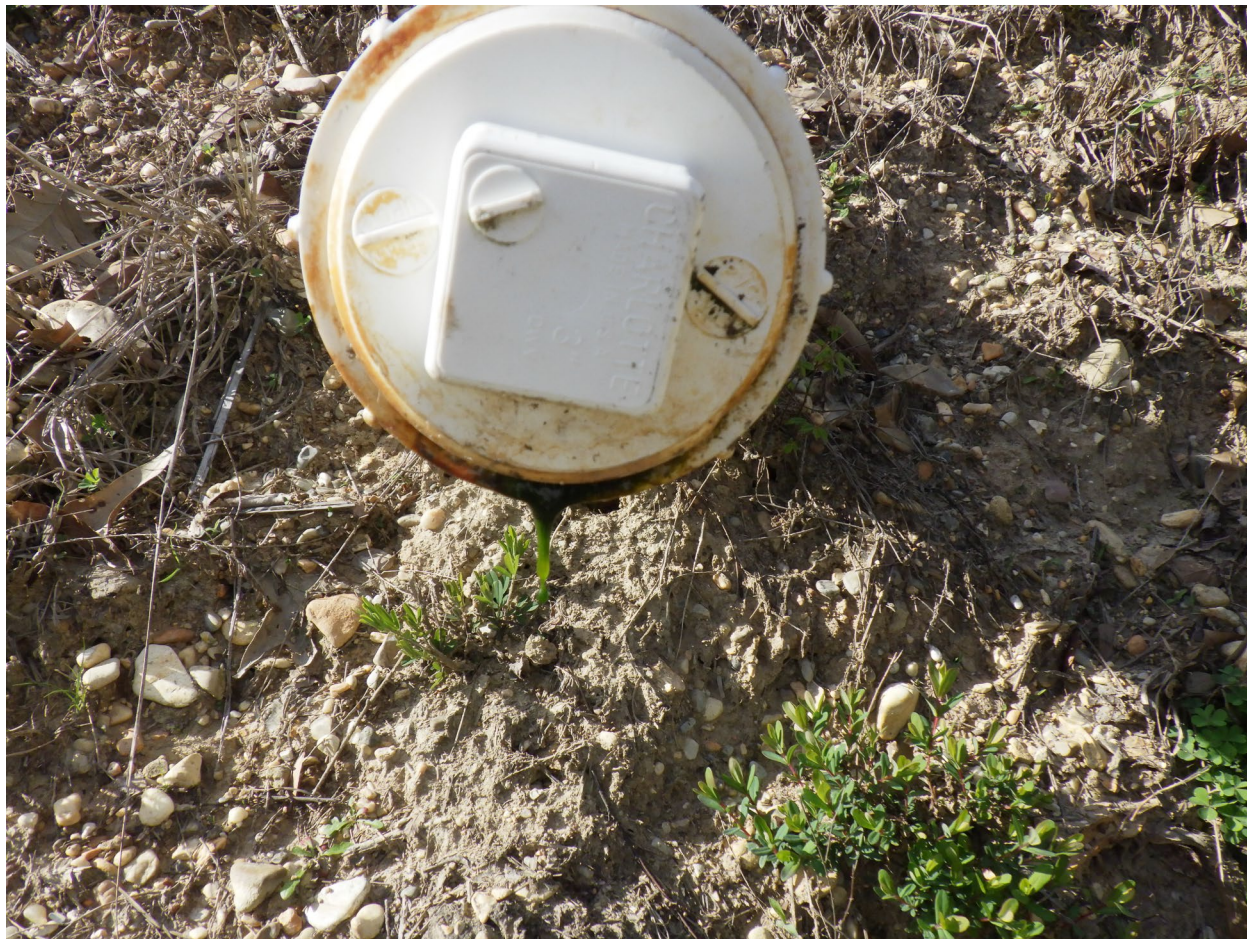
Photo No. 9

**Photo File Name:** R0010158**Orientation:** N**Date of Photo:** 03/11/2024**Time of Photo:** 4:57 PM**Latitude:** 33.33493**Longitude:** -92.50905**Photographer:** Kerri McCabe**Description:** This photo was taken looking north and shows a capped secondary containment discharge pipe that is leaking.

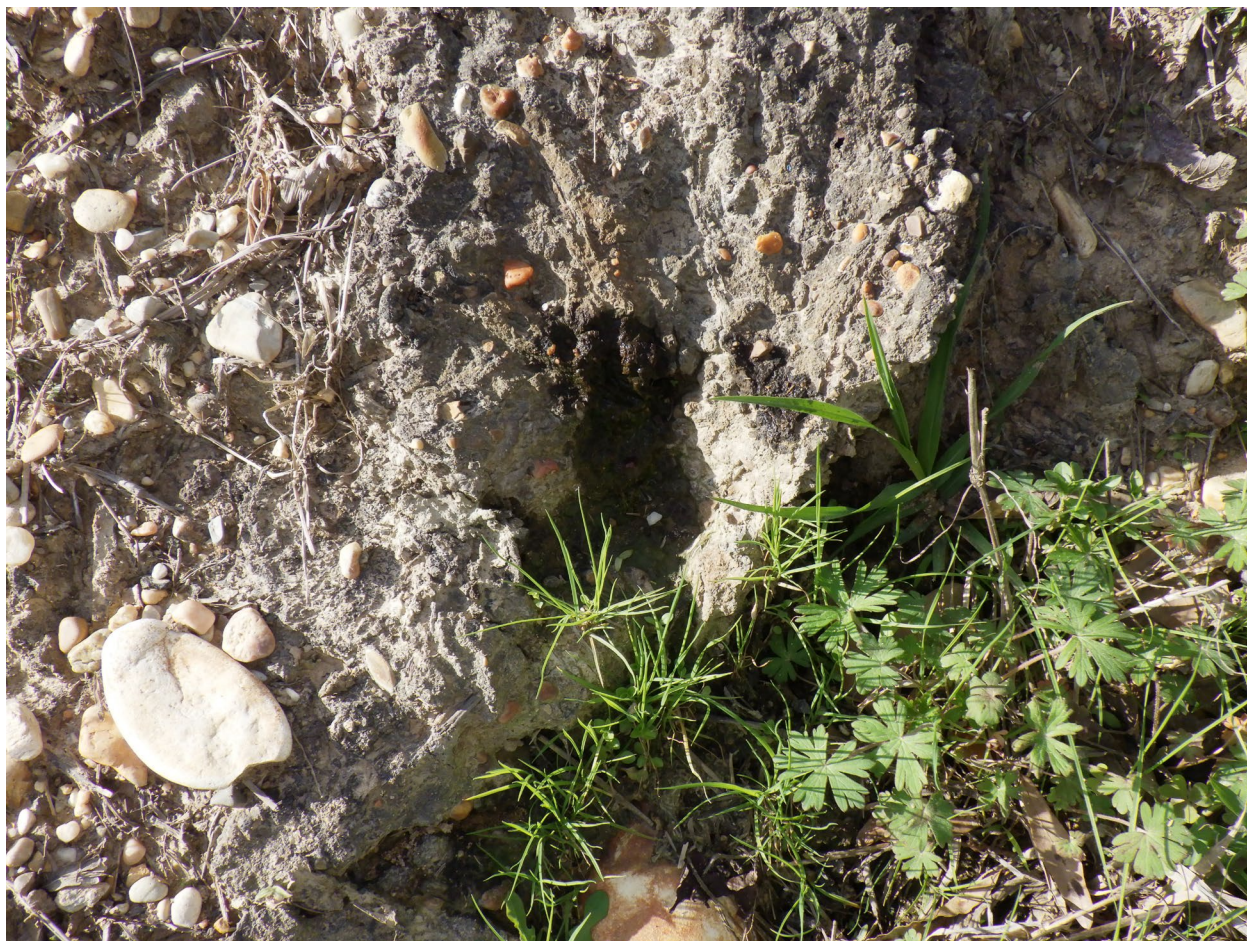
Photo No. 10

**Photo File Name:** R0010159**Orientation:** N**Date of Photo:** 03/11/2024**Time of Photo:** 4:57 PM**Latitude:** 33.33494**Longitude:** -92.50905**Photographer:** Kerri McCabe**Description:** This photo was taken looking north and shows erosion from the leaking secondary containment discharge valve.

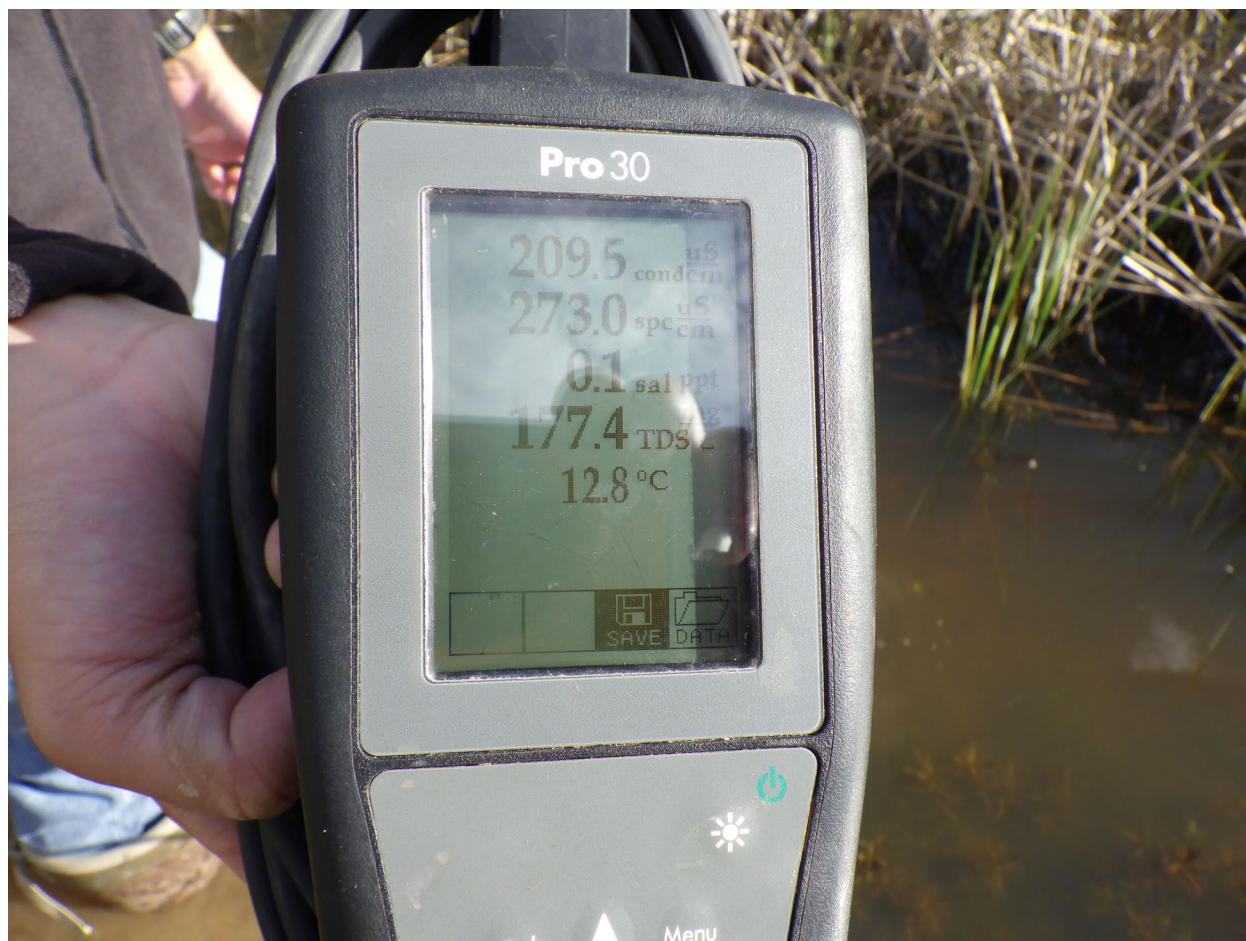
Photo No. 11

In a pond at the southeast corner of the facility, I observed a TDS reading of 177.4 mg/L, see photo No. 11.

**Photo File Name:** R0010160**Orientation:** N/A**Date of Photo:** 03/11/2024**Time of Photo:** 4:58 PM**Latitude:** 33.33491**Longitude:** -92.50896**Photographer:** Kerri McCabe**Description:** This photo shows a TDS reading of 177.4 mg/L from a pond at the southeast corner of the facility.

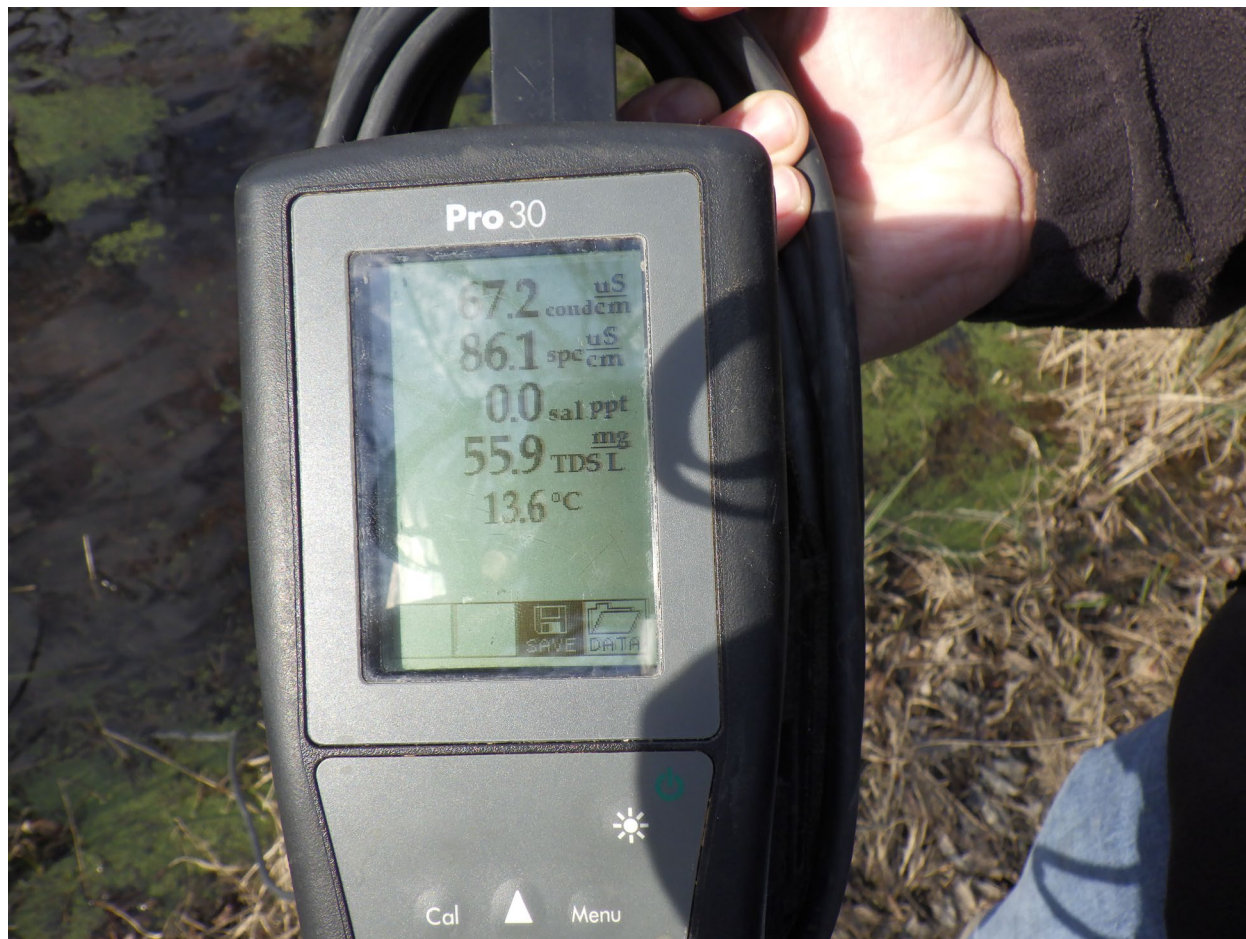
Photo No. 12

In a water body north of the facility and across East Calhoun County Road 244, I observed a background TDS reading of 55.9 mg/L, see photo No. 12.

**Photo File Name:** R0010161**Orientation:** N/A**Date of Photo:** 03/11/2024**Time of Photo:** 5:03 PM**Latitude:** 33.33558**Longitude:** -92.50889**Photographer:** Kerri McCabe**Description:** This photo shows a background TDS reading of 55.9 mg/L from a pond north of the facility, across from East Calhoun County Road 244.
