## EPA REGION 10 Enforcement Division

### INSPECTION REPORT

| <b>Type of Inspection</b> | Compliance Evaluation Inspection (CEI) | | |
| <b>Facility or Site Name</b> | Coeur Alaska, Inc. - Kensington Gold Mine | | |

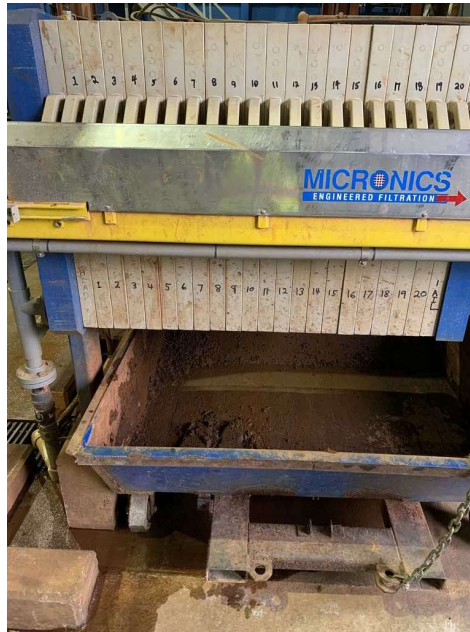
| Tailings Treatment Facility (TTF)/Filter Press | | | 58.81415833, -135.03846666 |

| Close-up view of the filter press. | | | |

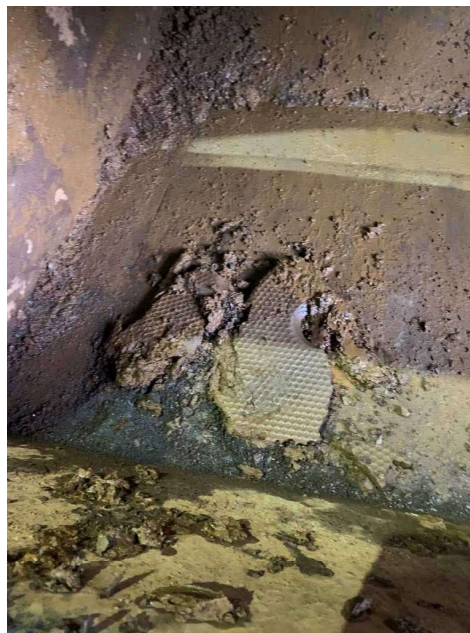
| Tailings Treatment Facility (TTF)/Filter Press | | | 58.81414166, -135.03854444 |

| View of sludge in trough beneath filter press. | | | |

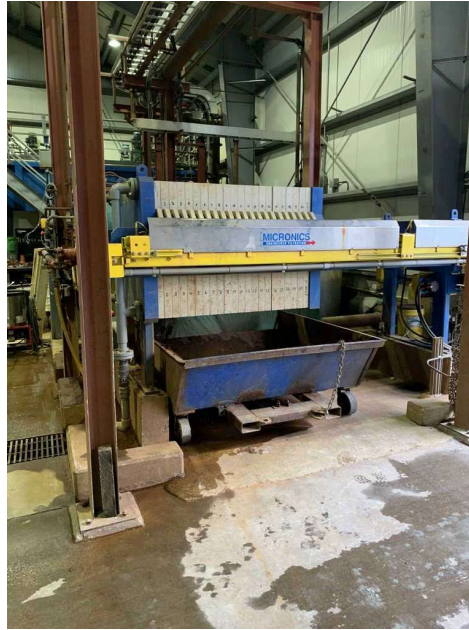
| Tailings Treatment Facility (TTF)/Filter Press | | | 58.81406666, -135.03875833 |

| View of the filter press in the TTF. | | | |

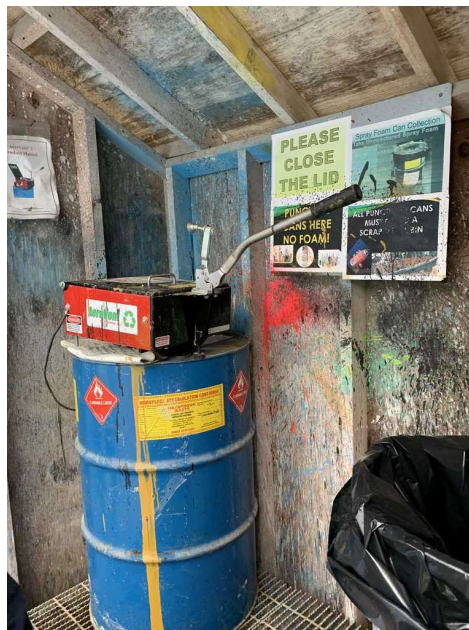
| Warehouse/Satellite Accumulation Area (SAA), outside and adjacent to the warehouse | | | 58.83980555, -135.045975 |

While inspecting this SAA, we observed quite a bit of overspray in the area from the aerosol can puncturing process. There was overspray on the surrounding walls of the SAA as well as paint that had run down the side of the 55-gallon SAA container and on the cover of the puncturing device. Later, while reviewing the photos, I noticed that at the time of the inspection the closure device on the attached aerosol can popper was not closed down onto the cover of the puncturing device so the SAA container was not closed during the inspection.

| View of SAA, showing 55-gallon container of waste aerosol residue with attached aerosol can popper is not closed. | | | |

- Overspray was noted in one of the aerosol can puncture units. We were unable to determine where the overspray was coming from but decided the best management practice would be to change the

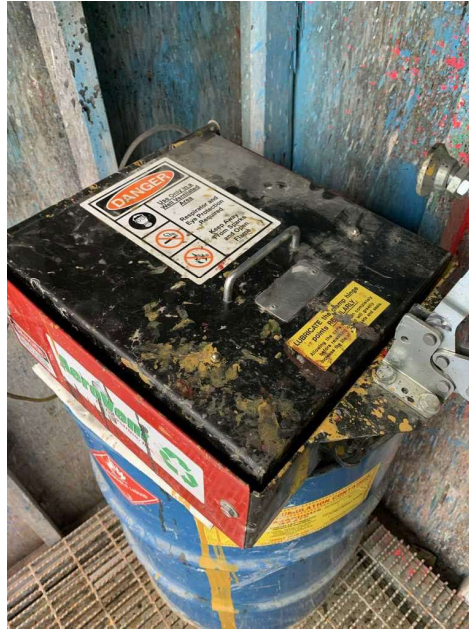
| Warehouse/Satellite Accumulation Area (SAA), outside and adjacent to the warehouse | | | 58.84001944, -135.04605 |

| Close-up view of the SAA, showing 55-gallon container of waste aerosol residue with attached aerosol can popper is not closed. | | | |

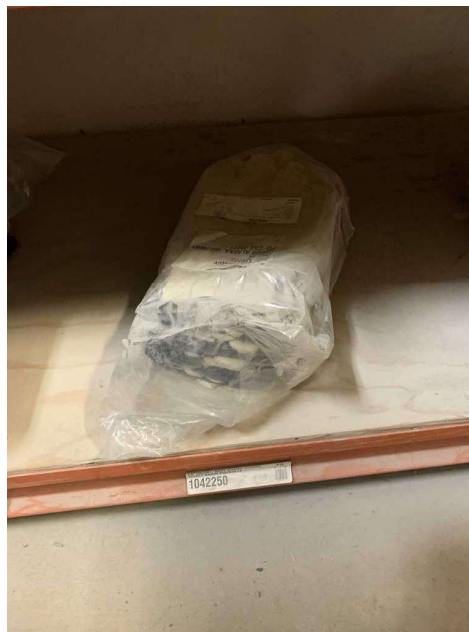
| Warehouse | | | 58.83957777, -135.04615833 |

During the inspection, we asked Ms. Joos about the facility's use of leather products, such as gloves and mine belts. I explained that waste leather gloves will fail for chromium (D007) when tested. Ms. Joos indicated that she was unaware of this. I asked Ms. Joos if they issued these leather items to facility personnel, and she said these items were issued out of the Warehouse. When we got to the Warehouse, supply personnel took us to where they store these leather products. While there we saw a plastic sleeve on the bottom shelf that, according to the label, held 10 pair of leather gloves. We also saw some of the mining belts that are used to carry self-contained breathing devices. I explained that the belts may also have leather components. I explained that the facility would be required to make a waste determination for their facility's waste leather.

| View of a plastic sleeve, holding 10 pair of leather gloves. | | | |

- Leather items, goods may fail TCLP. Has a waste determination been completed on leather gloves or other PPE? Coeur Alaska has created a list of all leather goods and PPE that may be ordered. Waste determination of those items is in process.

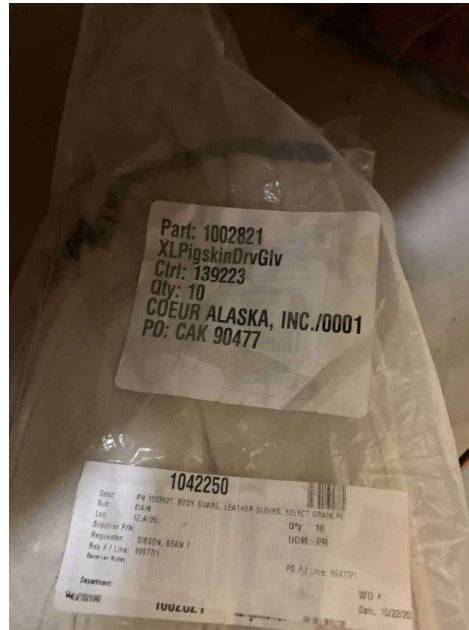
| Warehouse | | | 58.83963333, -135.04611111 |

| Close-up view of the information marked on the sleeve of gloves. | | | |

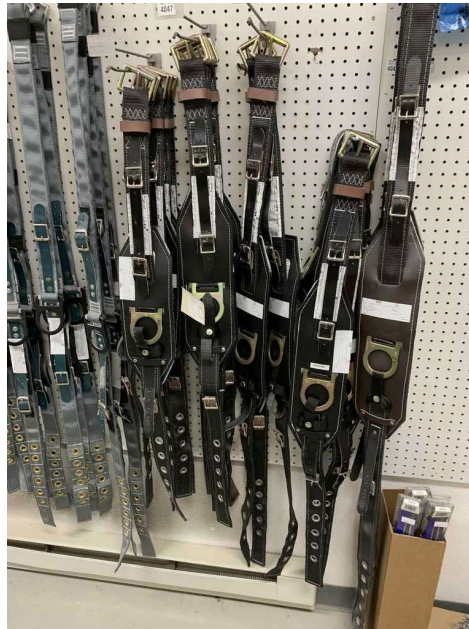
| Warehouse | | | 58.83963333, -135.04609722 |

| View of the mining belts that may contain leather components. | | | |

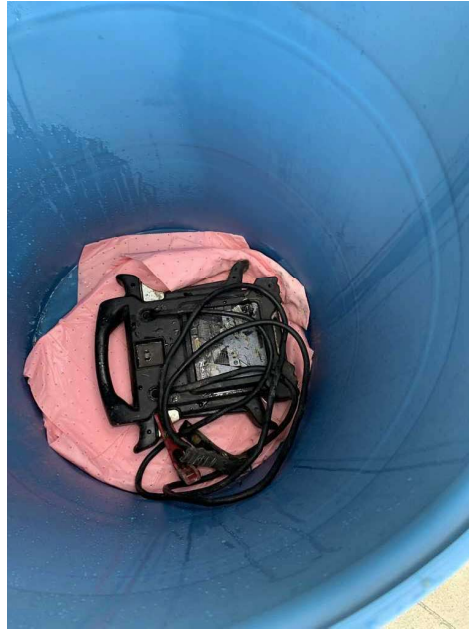
| Surface Maintenance Shop/Area outside and adjacent to the Surface maintenance Shop | | | 58.84078333, -135.04586666 |

While walking up to the Surface Maintenance Shop, we saw a blue, 55-gallon poly container that was being used to accumulated sealed, lead-acid battery jump packs. We asked Ms. Joos about the batteries, and she told us that they manage the batteries as universal waste. The container was labeled with the words "Jump Pack Collection Drum" and was marked with a DOT label for corrosivity. At the time of the inspection, the 55-gallon container held one sealed, lead-acid battery jump pack and was not labeled with either the phrase "Universal Waste - Batteries," "Waste Batteries," or "Used Batteries."

| View of a sealed, waste lead-acid battery jump pack inside of a container that is not labeled in a way to indicate it's managed as a universal waste. | | | |

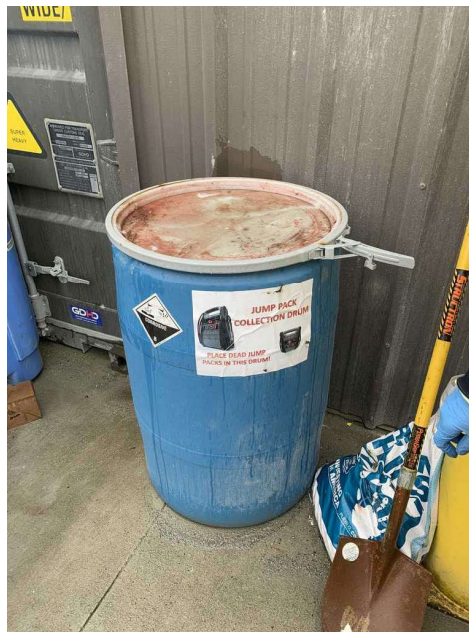
| Surface Maintenance Shop/Area outside and adjacent to the Surface maintenance Shop | | | 58.84075555, -135.04583611 |

| View of the universal waste battery jump pack container, showing that it's not labeled with either the phrase "Universal Waste - Batteries," "Waste Batteries," or "Used Batteries." | | | |

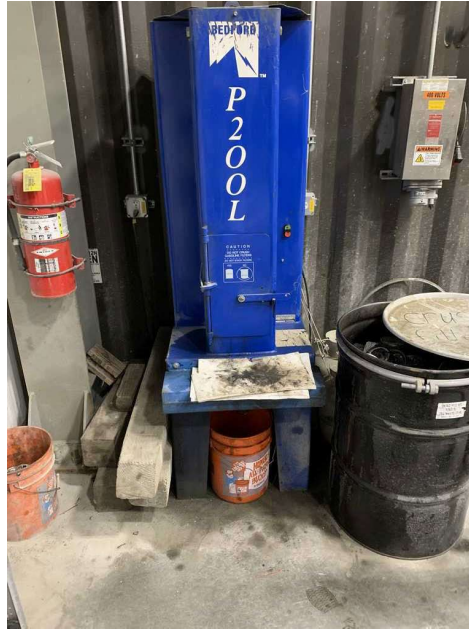
| Surface Maintenance Shop/Oil filter crusher | | | 58.8409, -135.04600555 |

| View of the filter crusher, showing the unlabeled container of used oil beneath the crusher. | | | |

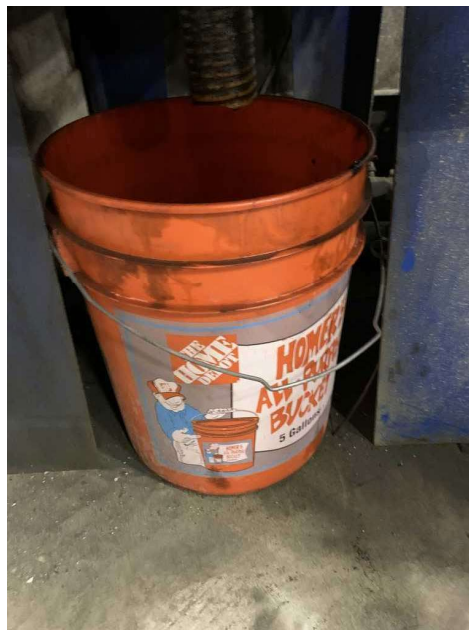
| Surface Maintenance Shop/Oil filter crusher | | | 58.84086944, -135.04571666 |

| Close-up view of the used oil container, showing that it is not labeled with the words "Used Oil." | | | |

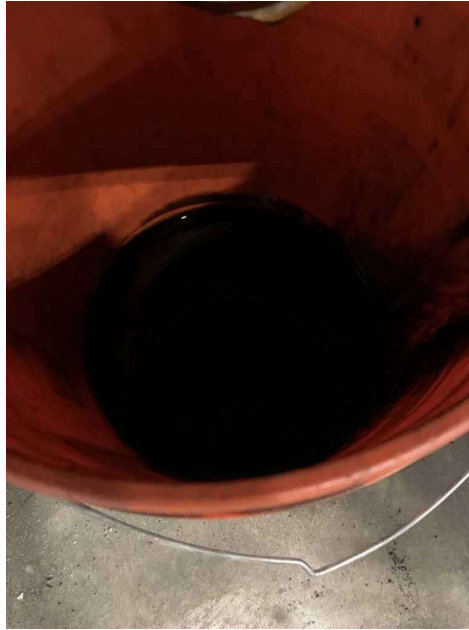
| Surface Maintenance Shop/Oil filter crusher | | | 58.840875, -135.04565555 |

| Close-up view of the used oil container, showing that it contains used oil and is not labeled with the words "Used Oil." | | | |

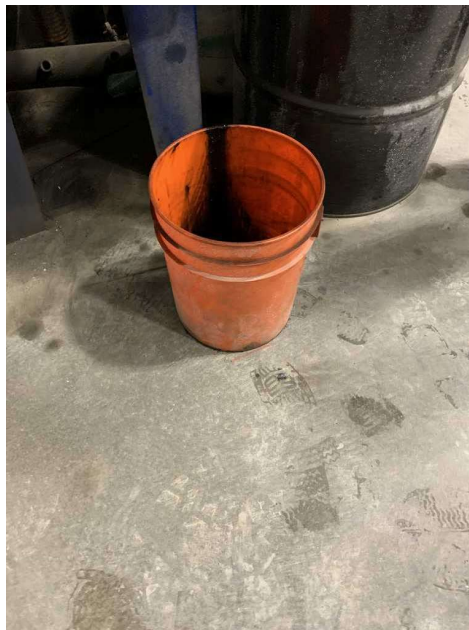
| Surface Maintenance Shop/Oil filter crusher | | | 58.84109444, -135.04606666 |

| Another view of the used oil container, showing that it is not labeled with the words "Used Oil." | | | |

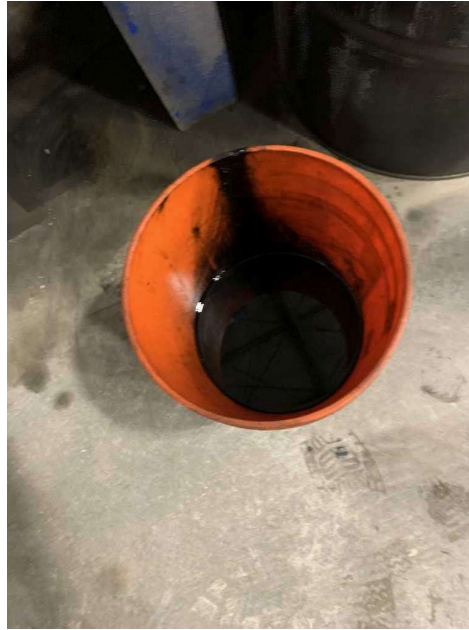
| Surface Maintenance Shop/Oil filter crusher | | | 58.84108055, -135.04603611 |

| Another view of the container, showing that it holds used oil and is not labeled with the words "Used Oil." | | | |

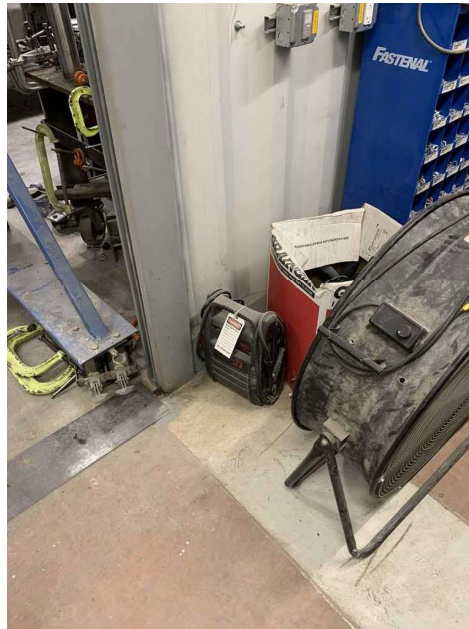
| Surface Maintenance Shop/Parts Room | | | 58.8409, -135.04600555 |

| View of a waste lead-acid battery jump pack on the floor in the Part Room. | | | |

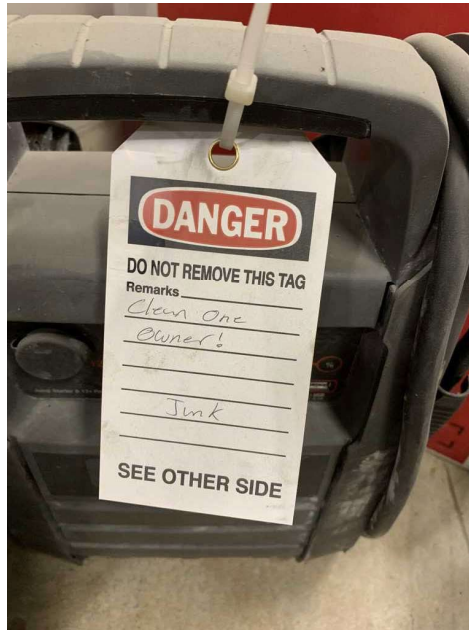
| Surface Maintenance Shop/Parts Room | | | 58.8409, -135.04600555 |

| Close-up view of the waste lead-acid battery jump pack, showing that it is labeled as "Junk" and not labeled with either the phrase "Universal Waste - Battery," "Waste Battery," or "Used Battery." | | | |

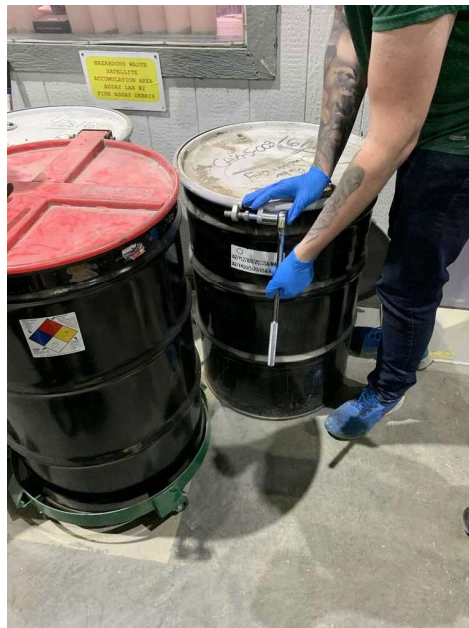
| Assay Lab/Area just outside the lab | | | 58.84554722, -135.05026111 |

| At the time of the inspection, the facility had not made a hazardous waste determination on either the used crucibles or the slag. | <b>Regulation:</b> | <b>Sections:</b> |

| View of the 55-gallon container (white lid) holding used crucibles. | | | |

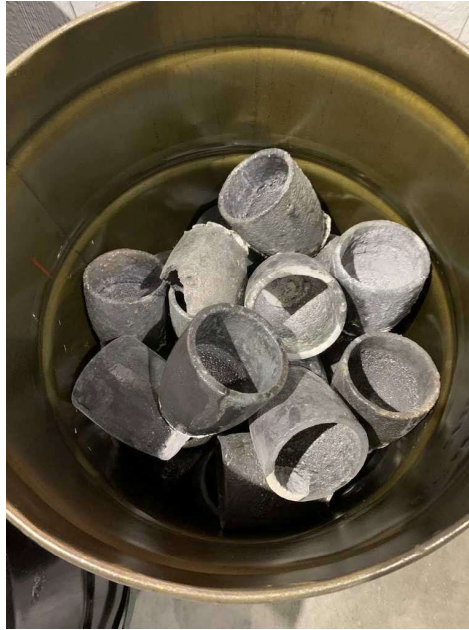
| Assay Lab/Area just outside the lab | | | 58.84554722, -135.05026111 |

| View of the used crucibles in the container. | | | |

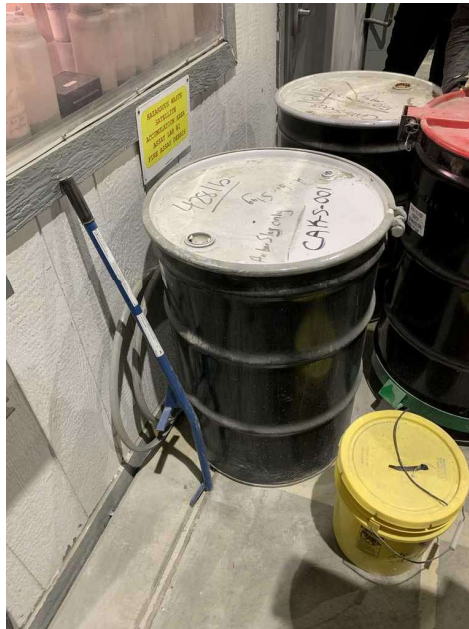
| Assay Lab/Area just outside the lab | | | 58.84554722, -135.05026111 |

| View of the 55-gallon container holding the gold bar slag. | | | |

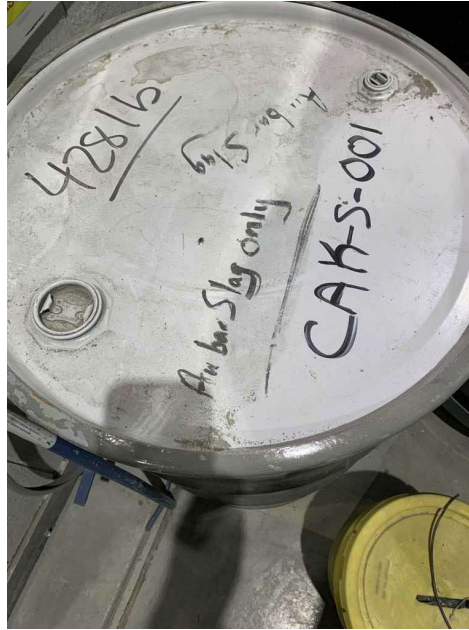
| Assay Lab/Area just outside the lab | | | 58.84554722, -135.05026111 |

| View of the top of the 55-gallon container holding the gold bar slag. | | | |

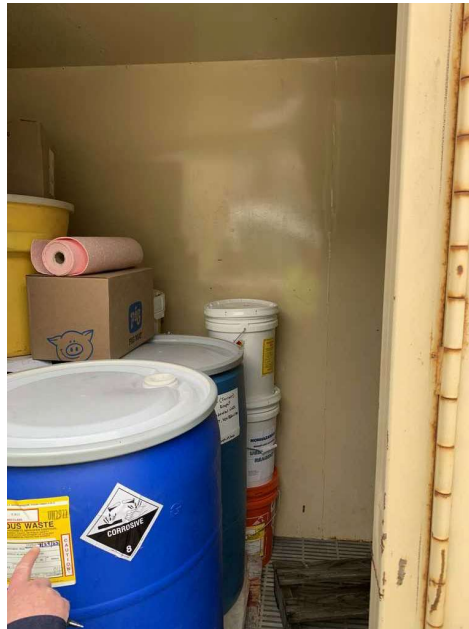
| Central Accumulation Area (CAA) | | | 58.84586388, -135.0504 |

During the inspection, we went across the road from the Assay Lab to inspect the facility's CAA. The facility uses a large metal HAZMAT storage locker for the accumulation of hazardous waste. Upon opening the doors of the CAA, we saw a five-gallon poly container containing hazardous waste that was not closed. The container held waste test kits for ultra-low chlorine. At the time of the inspection, the lid on the container was not snapped down all the way, making a complete seal with the container.

| View of five-gallon waste container, shown here with the lid not fully closed. | | | |

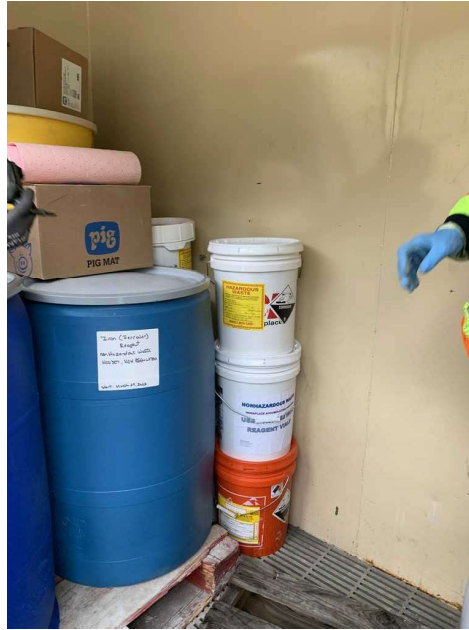
| Central Accumulation Area (CAA) | | | 58.84563055, -135.05015555 |

| View of the five-gallon waste container after Ms. Joos closed the container. | | | |

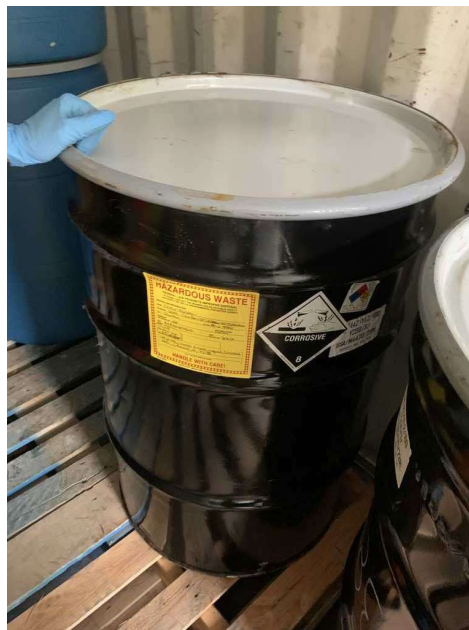
| Central Accumulation Area (CAA)/Green Connex adjacent to CAA accumulation locker | | | 58.84598055, -135.05046111 |

While still at the CAA, we saw a large green Connex box, adjacent to the large HAZMAT storage locker, that was also being used as a CAA. The Connex had signage posted on the door that stated, "Non-Hazardous Waste Storage Room." When we entered the Connex, we saw that there were two 55-gallon containers and one 35-gallon container of hazardous waste being accumulated inside. At the time of the inspection, we saw a 55-gallon container that was labeled as containing waste amines (D002). Additional labeling indicated that it contained a Part B hardener. Upon closer inspection, we saw that there was no accumulation start date (ASD) marked on the container.

| The Connex had signage posted on the door that stated, "Non-Hazardous Waste Storage Room." When we entered the Connex, we saw that there were two 55-gallon containers and one 35-gallon container of hazardous waste being accumulated inside. At the time of the inspection, we saw a 55-gallon container that was labeled as containing waste amines (D002). Additional labeling indicated that it contained a Part B hardener. Upon closer inspection, we saw that there was no accumulation start date (ASD) marked on the container. | <b>Regulation:</b> | <b>Sections:</b> |

| View of the 55-gallon container with the missing ASD. | | | |

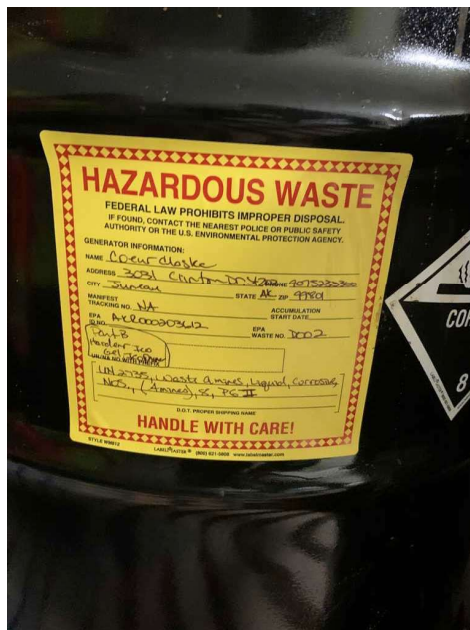
| Central Accumulation Area (CAA)/Green Connex adjacent to CAA accumulation locker | | | 58.84609166, -135.05059722 |

| View of the label on the container, showing that it is not marked with an ASD. | | | |

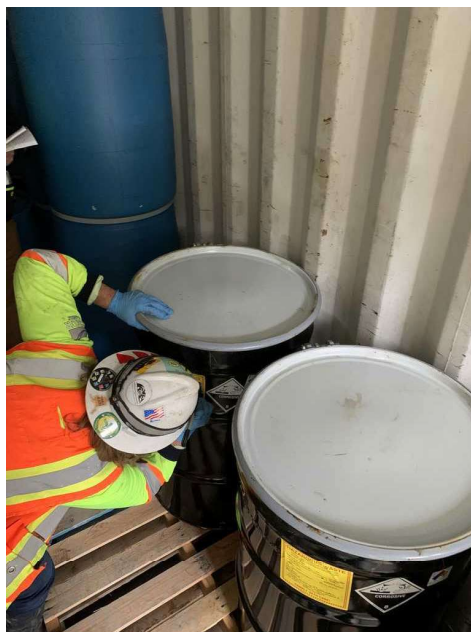
| Central Accumulation Area (CAA)/Green Connex adjacent to CAA accumulation locker | | | 58.846175, -135.05073611 |

| View of Ms. Joos marking the ASD of 9/2/23 on the container during the inspection. | | | |

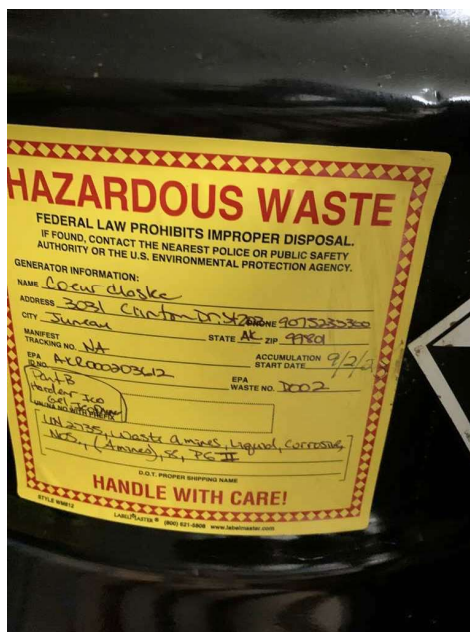
| Central Accumulation Area (CAA)/Green Connex adjacent to CAA accumulation locker | | | 58.84613888, -135.05064444 |

| View of the label showing the ASD of 9/2/23 that was marked on the container by Ms. Joos during the inspection. | | | |

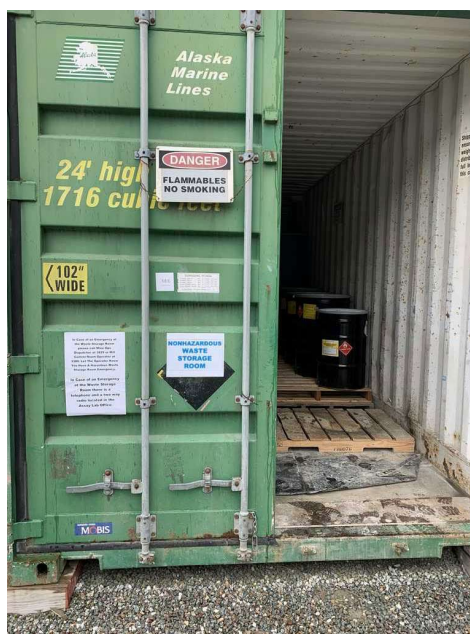
| Central Accumulation Area (CAA)/Green Connex adjacent to CAA accumulation locker | | | 58.84592777, -135.05052222 |

| View of the waste from the door of the green Connex. | | | |

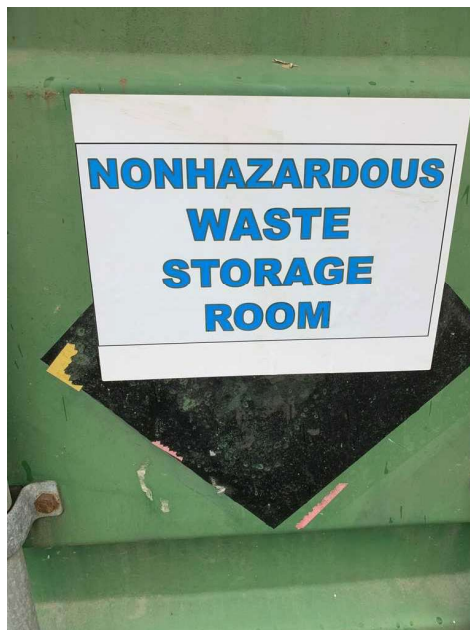
| Central Accumulation Area (CAA)/Green Connex adjacent to CAA accumulation locker | | | 58.84586666, -135.05050555 |

| View of the signage on the door of the green Connex, showing that it is marked "Non-Hazardous Waste Storage Room." | | | |

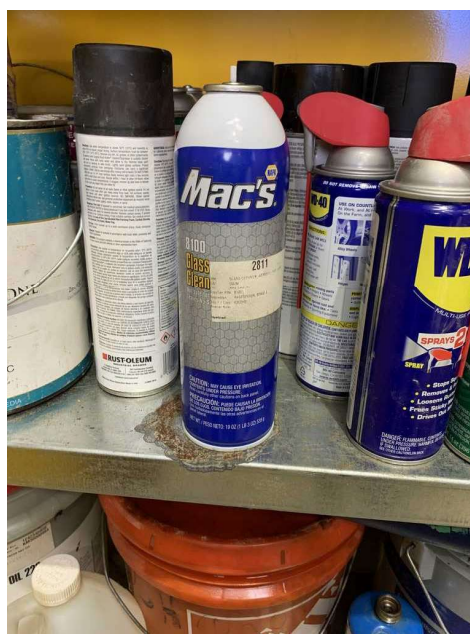
| Comet Mine Water Treatment Plant (MWTP)/Flammable storage cabinet | | | [Geographic Coordinates] |

While inspecting the Comet Mine WTP, we opened a flammable storage cabinet. Once opened, we saw an assortment of products being used at the WTP including aerosol cans. We checked some of the aerosol cans in the storage cabinet, by shaking them, to determine if any were empty/waste aerosol cans. While checking the various aerosol cans in the cabinet, we identified one waste aerosol that was still pressurized and contained some material. Ms. Joos confirmed that the aerosol can was a waste aerosol can. At the time of the inspection, the waste aerosol can was not labeled with the words "Hazardous Waste" or marked with a hazard indicator.

| View of waste aerosol can that was found inside of a flammable storage cabinet. | | | |

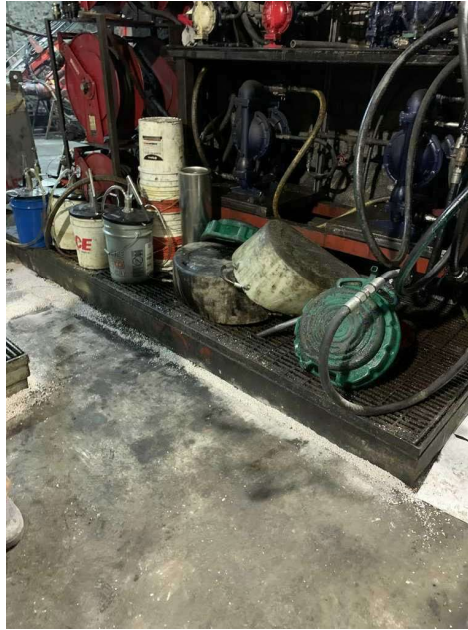
| Underground Maintenance at the 900 Main | | | [Geographic Coordinates] |

| Another view of used oil drain pad that is not labeled with the words "Used Oil." | | | |

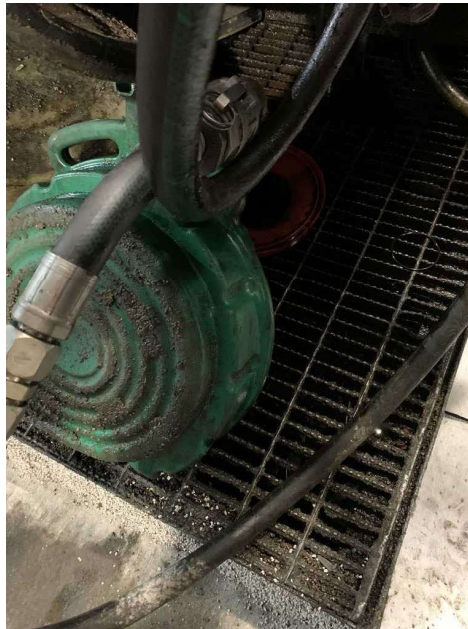
| Underground Maintenance at the 900 Main | | | [Geographic Coordinates] |

| View of used oil drain pads that are not labeled with the words "Used Oil." | | | |

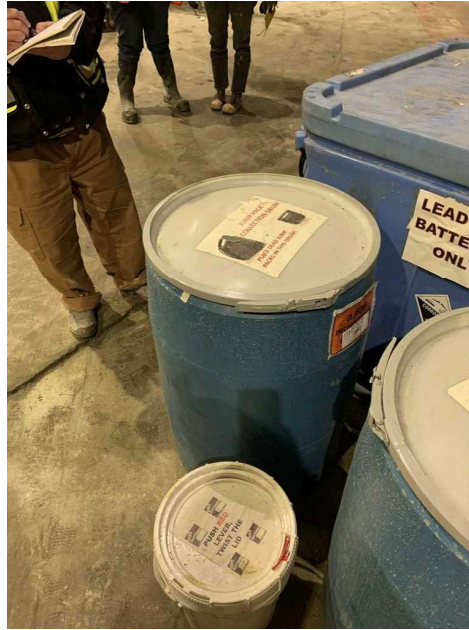
| Underground Maintenance at the 900 Main | | | [Geographic Coordinates] |

| View of container, holding a waste lead-acid battery jump pack, seen here not labeled with either the phrase "Universal Waste - Batteries," "Waste Batteries," or "Used Batteries." | | | |

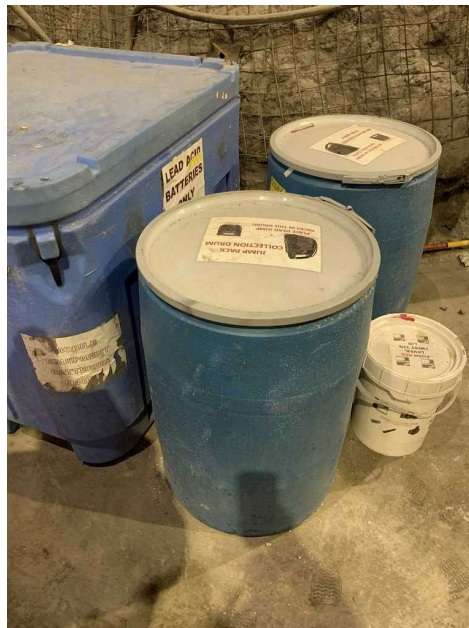
| Underground Maintenance at the 900 Main | | | [Geographic Coordinates] |

| Another view of container, holding a waste lead-acid battery jump pack, seen here not labeled with either the phrase "Universal Waste - Batteries," "Waste Batteries," or "Used Batteries." | | | |

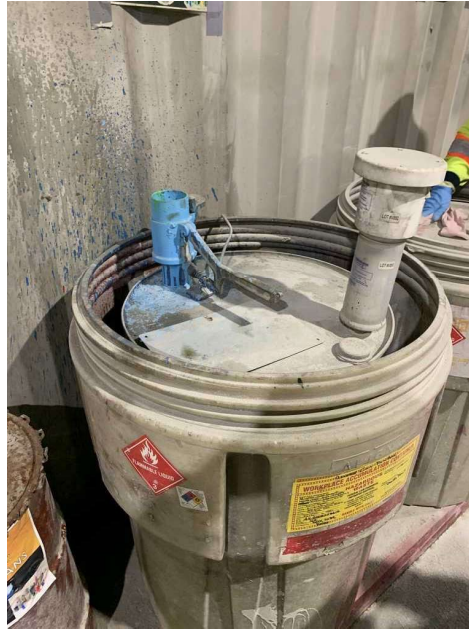
| Underground Maintenance 940 Paste Plant | | | [Geographic Coordinates] |

While inspecting the 940 Paste Plant, we saw a 55-gallon SAA container with an attached aerosol can popper. At the time of the inspection, the SAA container contained hazardous waste, but the cover on the attached aerosol can popper was not closed; therefore, the container was not closed.

| View of the SAA container, showing that the attached aerosol can popper cover is open, and the container is not closed. | | | |
