**U.S. Environmental Protection Agency  
Region 5**

**Purpose:** Clean Water Act National Pollutant Discharge Elimination System Compliance Evaluation Inspection

**Facility:** Martin Marietta – Kellogg Avenue Yard  
4439 Kellogg Ave.  
Cincinnati, Ohio 45226

**Inspection Date:** May 23, 2023

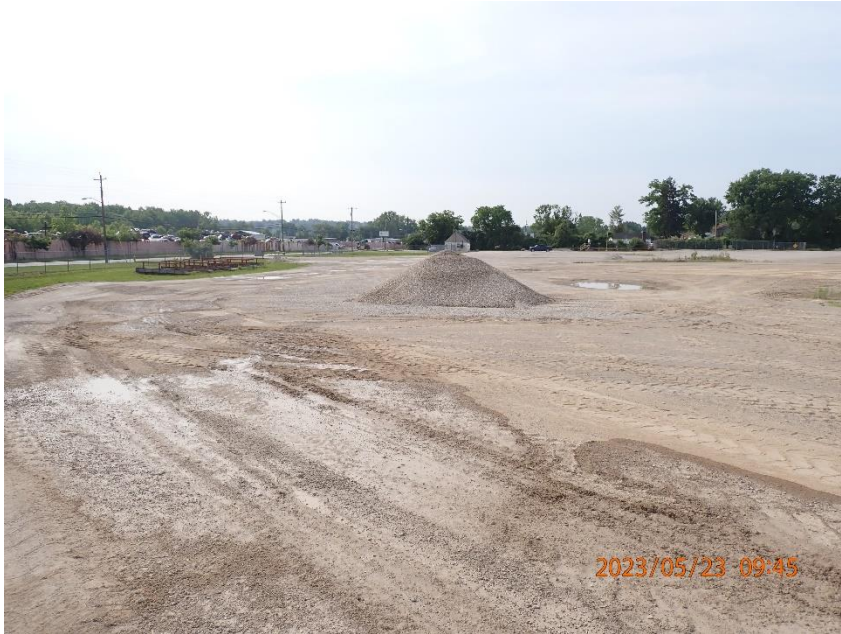
1: P5230001

- All stockpiles are stored uncovered (Photo 1 and Photo 2).
- Dredged material from the stormwater basin is stored in a pile in the northwest corner of the yard (Photo 3). This has no containment or coverage.

Description: Gravel pile and front of yard

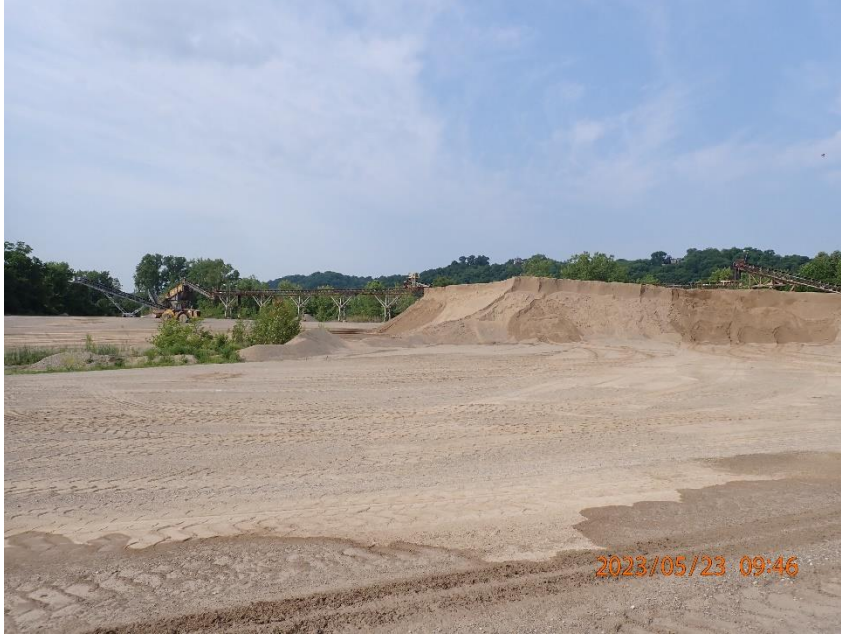
2: P5230002

Description: Sand pile and conveyer belt (in background)

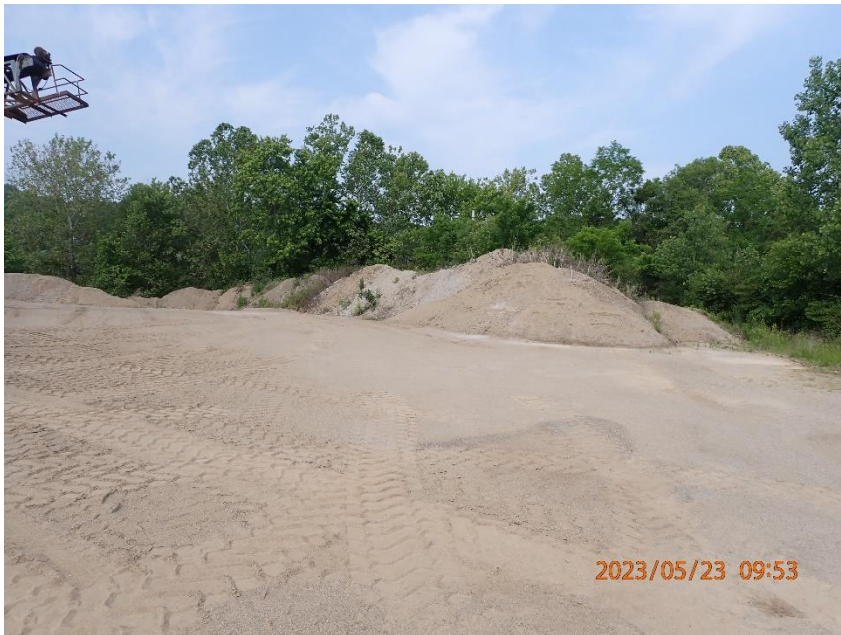
3: P5230003

- The retaining area and stormwater basin was dredged in April 2023 following a flood event. Greg Curry noted this is the deepest the stormwater basin has been dug to his knowledge in order to better handle flooding at the Facility (Photo 3, Photo 5, Photo 6, Photo 9, and Photo 13).

Description: Dredged material and scrap pile

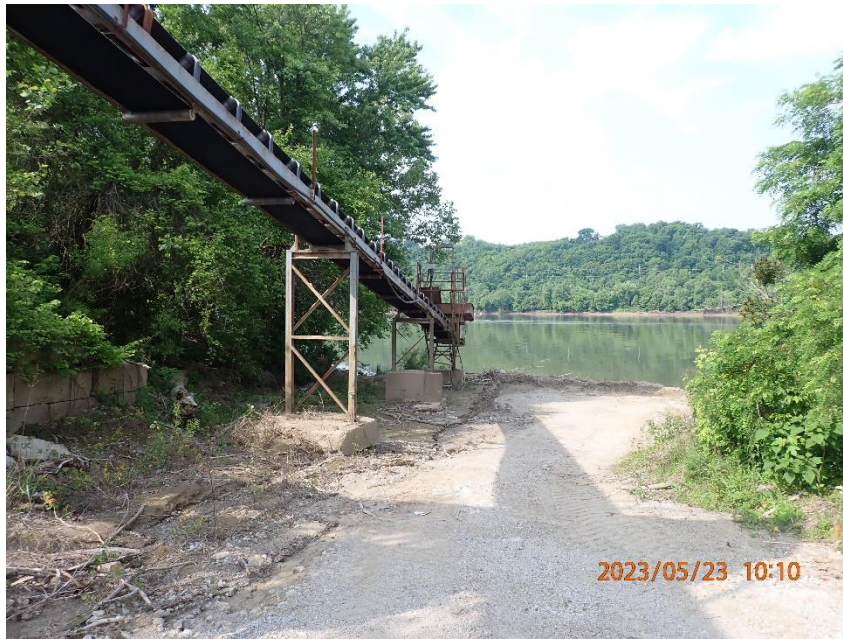
4: P5230004

Description: Conveyer belt for barge unloading

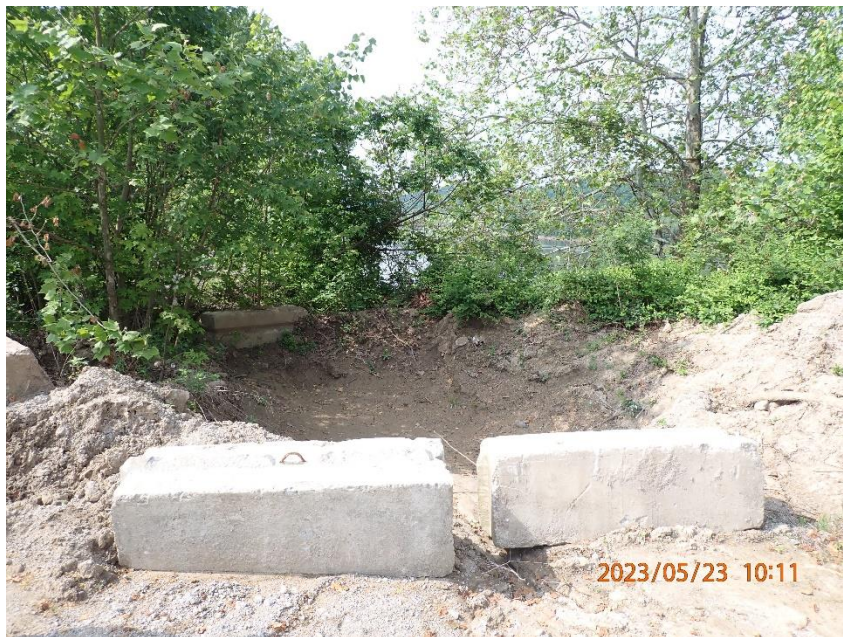
5: P5230005

Description: Stormwater catch basin

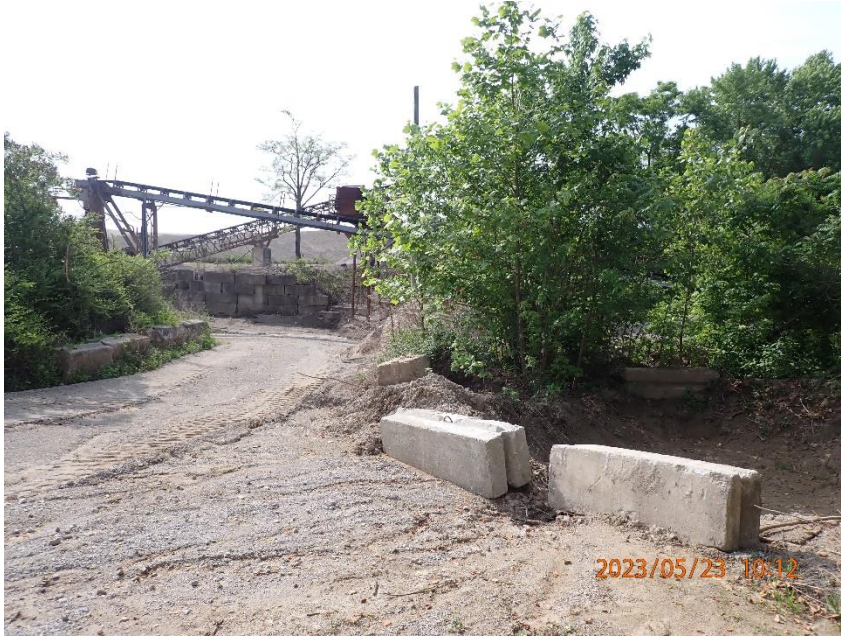
6: P5230006

Description: Stormwater catch basin with ramp in background

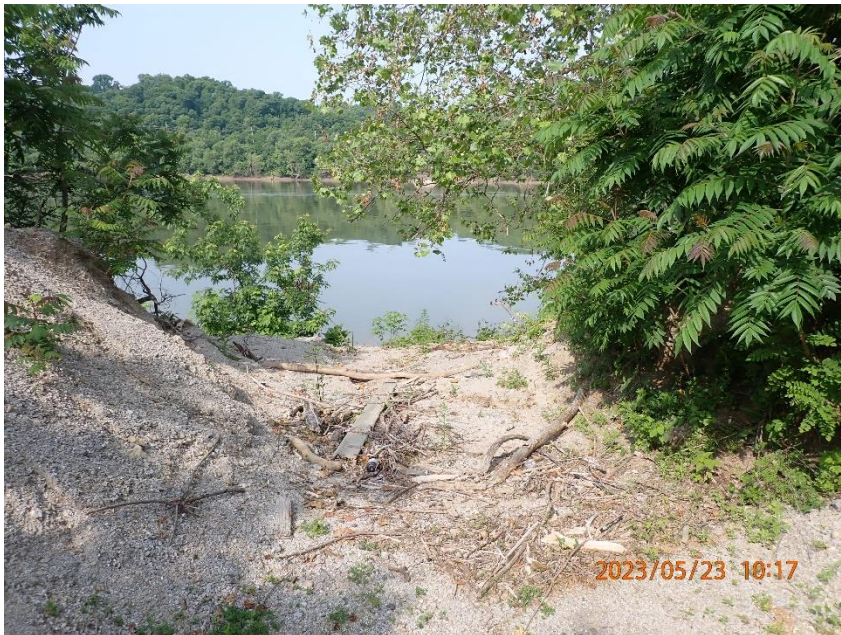
7: P5230007

- Significant flooding from the Ohio River occurs onsite (Photo 7, Photo 8, Photo 11, and Photo 12). Greg Curry said that extreme past flood events have resulted in the water level rising to the material storage yard.

Description: Material from flooding event 2023

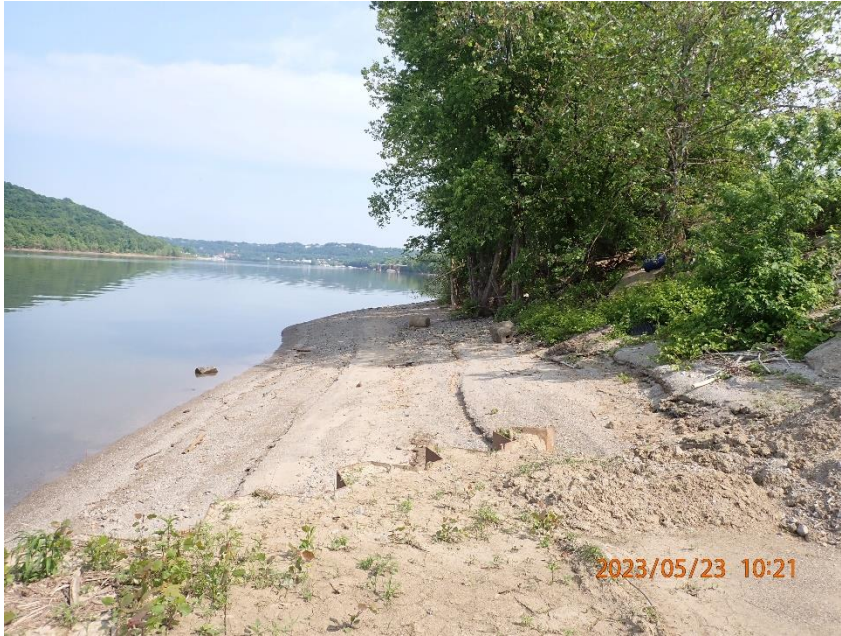
8: P5230008

Description: High water lines from 2023 floods

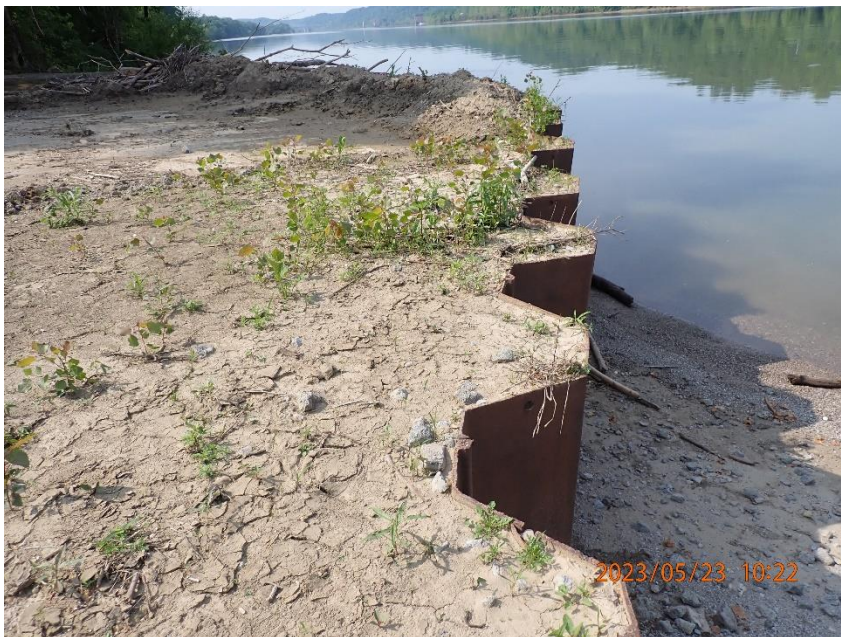
9: P5230009

- Retaining wall at end of conveyer belt ramp is filled with excess scraps and material, with minimal capacity for additional stormwater events. (Photo 9 and Photo 10).

Description: Retaining wall

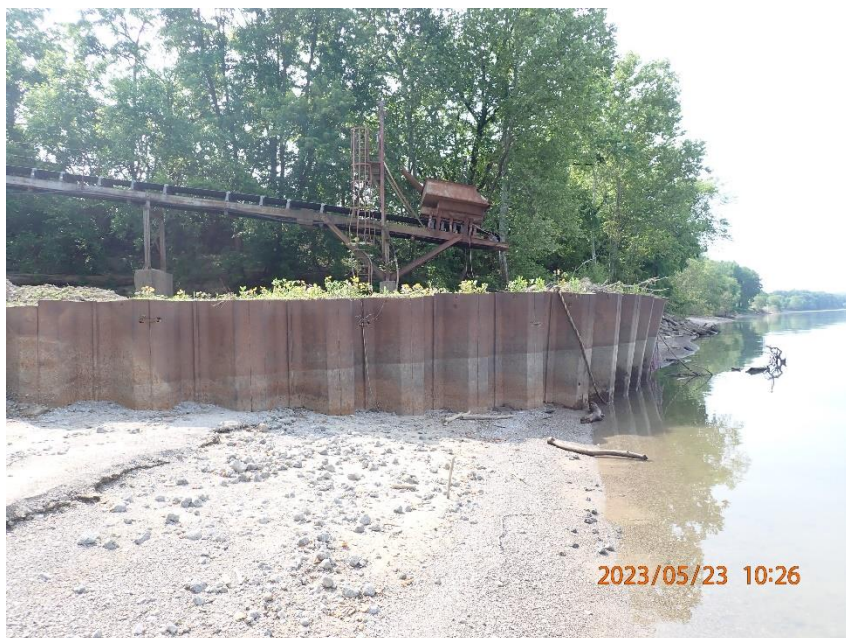
10: P5230010

Description: Retaining wall from shoreline

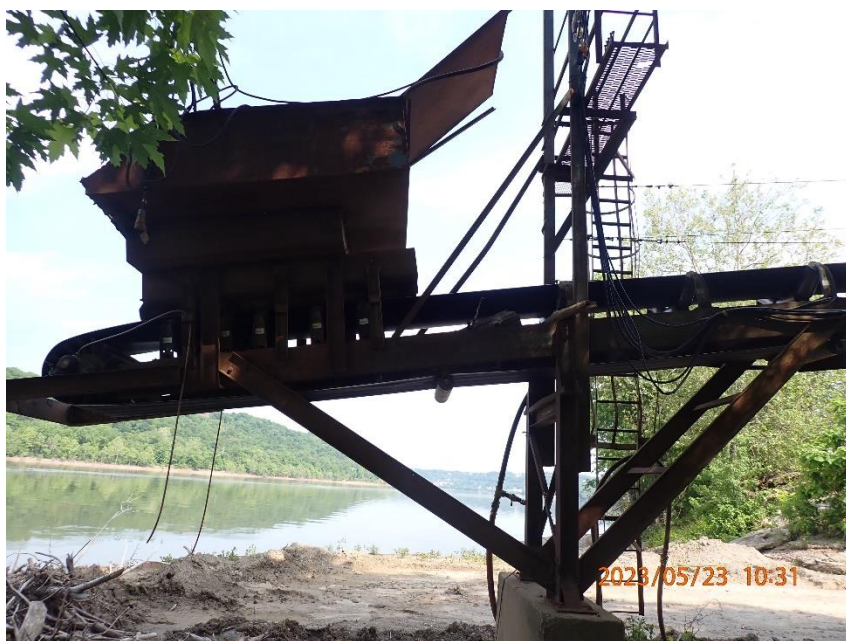
11: P5230011

Description: Log in conveyer belt from flood

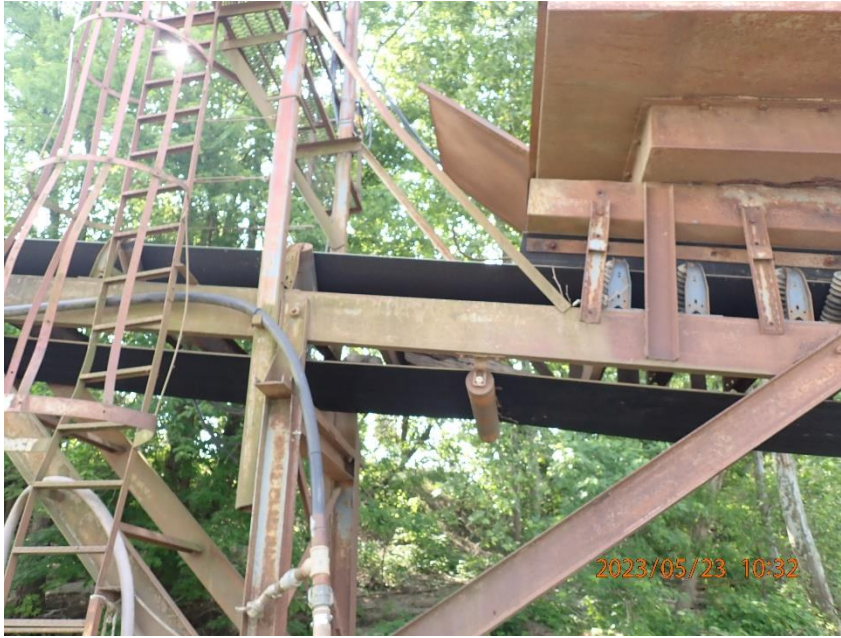
12: P5230012

Description: Log in conveyer belt from other side previous photo

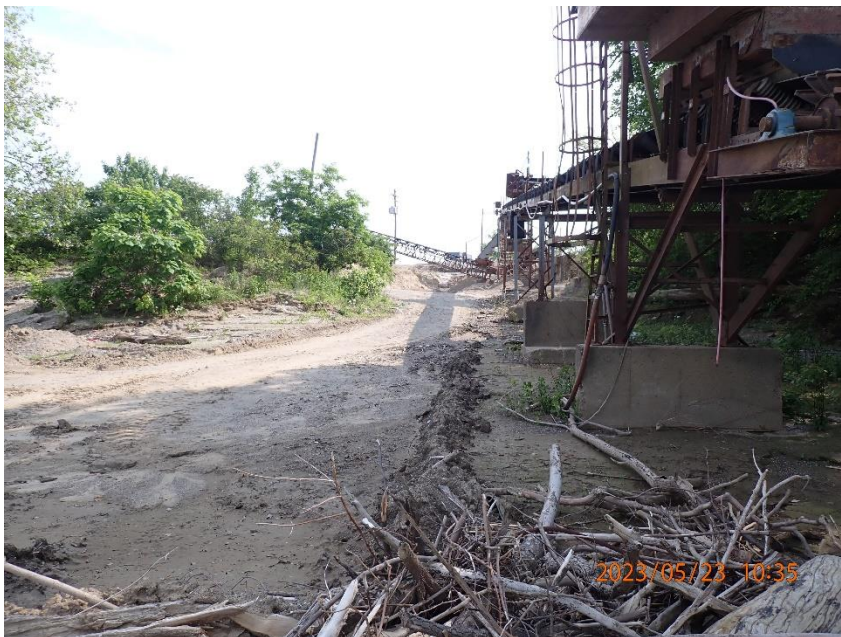
13: P5230013

Description: Ramp down to loading area from retaining wall area

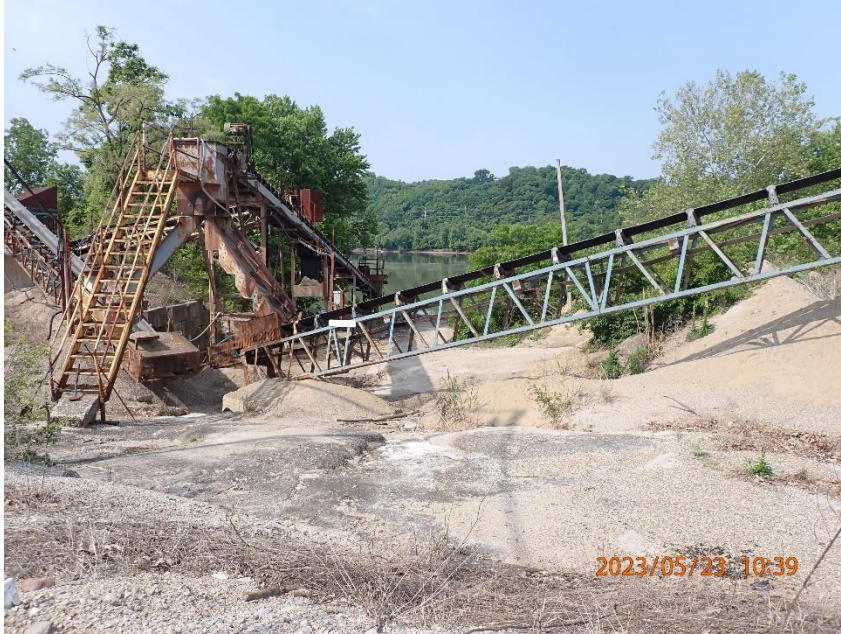
14: P5230014

- There is no management or implementation of best management practices for storm water that comes in contact with the stockpiles in the storage area near the conveyer belt split at the top of the ramp. Sediment runoff and erosion into the ramp area towards the Ohio River is evident (Photo 14).

Description: Ramp down to river

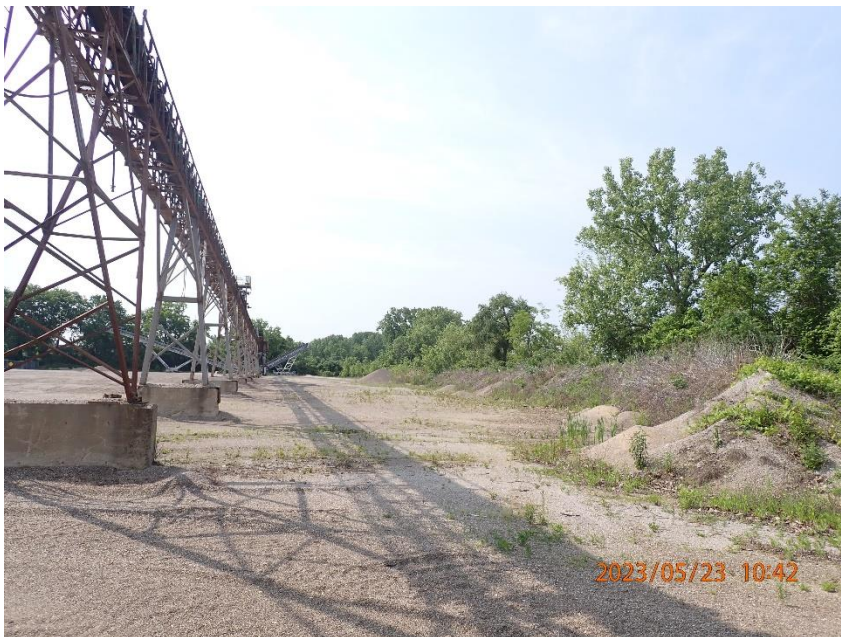
15: P5230015

Description: Conveyer belt for P Gravel and berm on west side

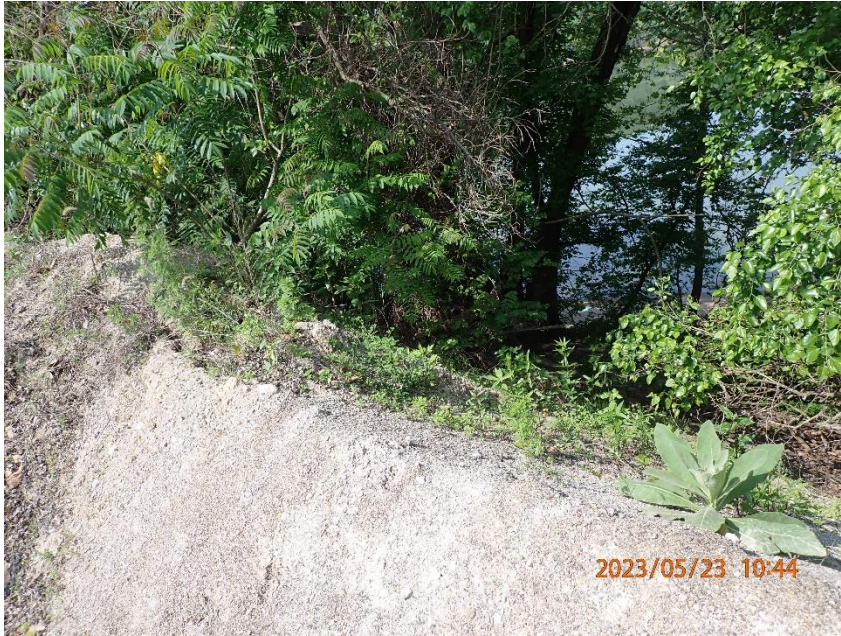
16: P5230016

Description: Top of berms (vegetated)

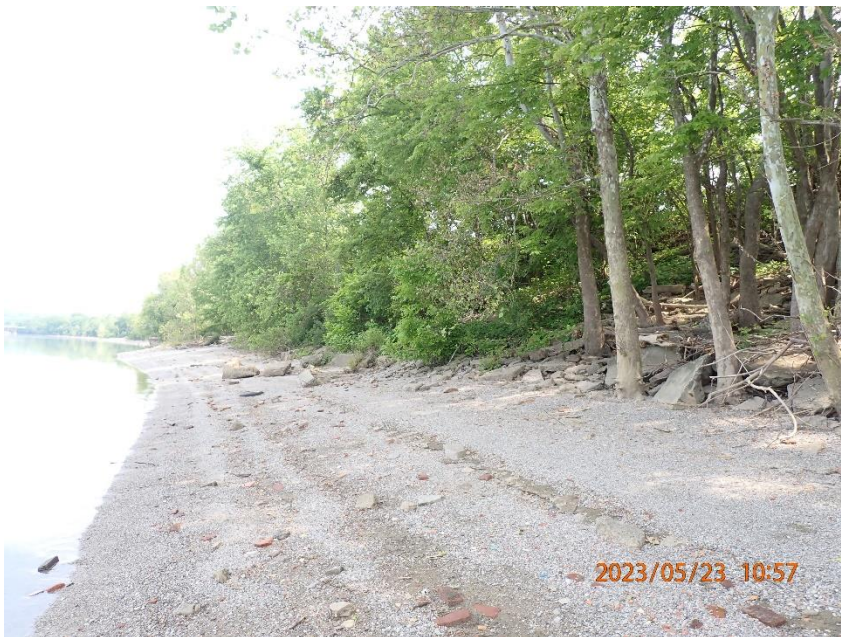
17: P5230017

Description: Shoreline behind vegetated ridge/berm

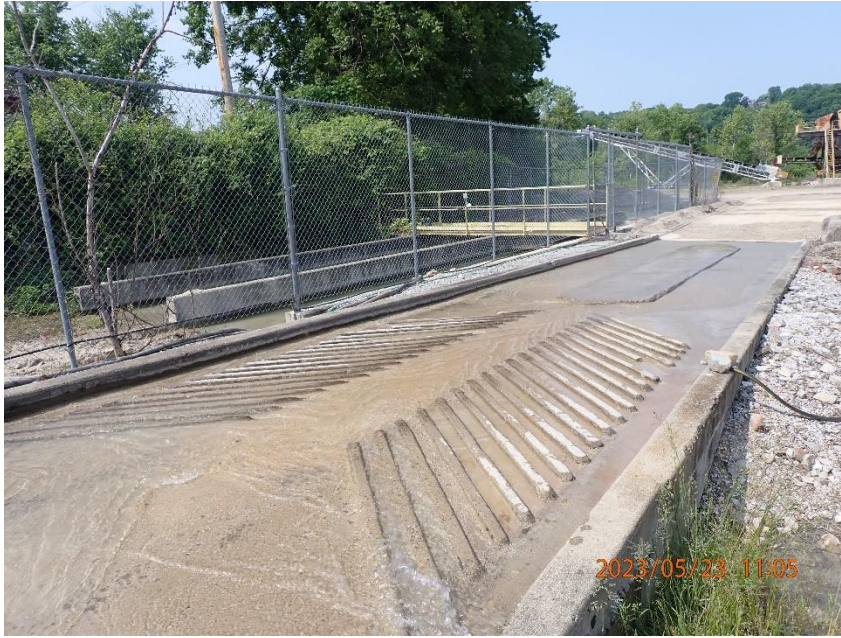
18: P5230018

Description: Truck rinse area/wheel wash station with holding pond in background

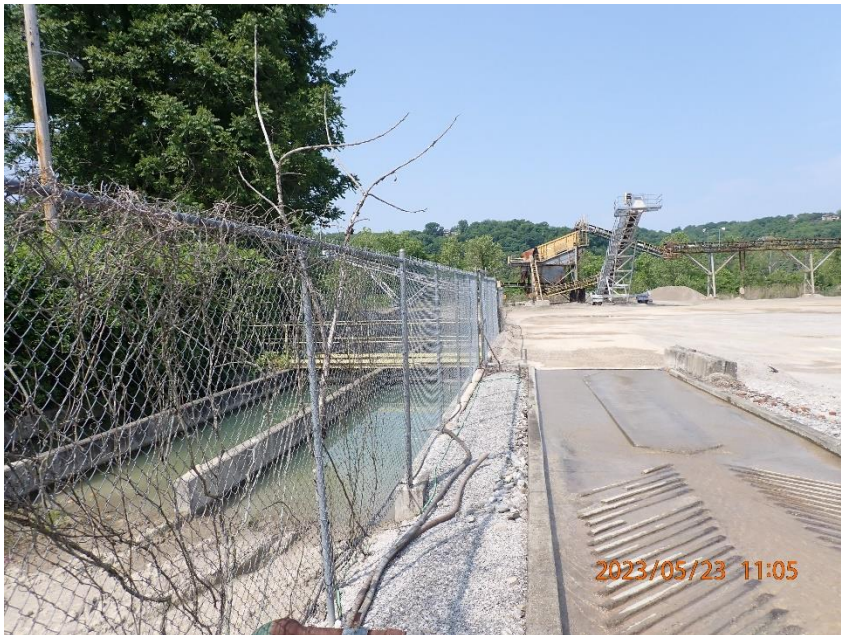
19: P5230019

Description: Wheel wash and holding ponds
