Clean Water Act Section 404: Site Visit/Case Development

Site Name	Puerto Rico Asphalt, LLC (hereinafter as "PR Asphalt")	Start Date	January 23, 2023
		End Date	January 23, 2023
Inspection Purpose	Initial site visit		
Opening Conference			
<input checked="" type="checkbox"/> Presentation of Inspector Credentials			
Name and Title (Use N/A if owner/operator not available to join the inspection)			
Inspector, Seika Robinson presented credentials the day of the inspection to Pedro Rosa, Site Operations Manager for PR Asphalt and to Jose Colon, Plan Manager for PR Asphalt.			
<input checked="" type="checkbox"/> Opening Conference			
Name of person authorizing access if applicable			
EPA was unable to reach the property owner, Empire Gas Company, Inc. via phone and email prior to the time of visit. The day of the inspection, PR Asphalt self identified as the lessee and site operator. Pedro Rosa and Jose Colon, on behalf of PR Asphalt, authorized access of the Site.

Attachment A: Map with GPS Points

Attachment B: Photolog

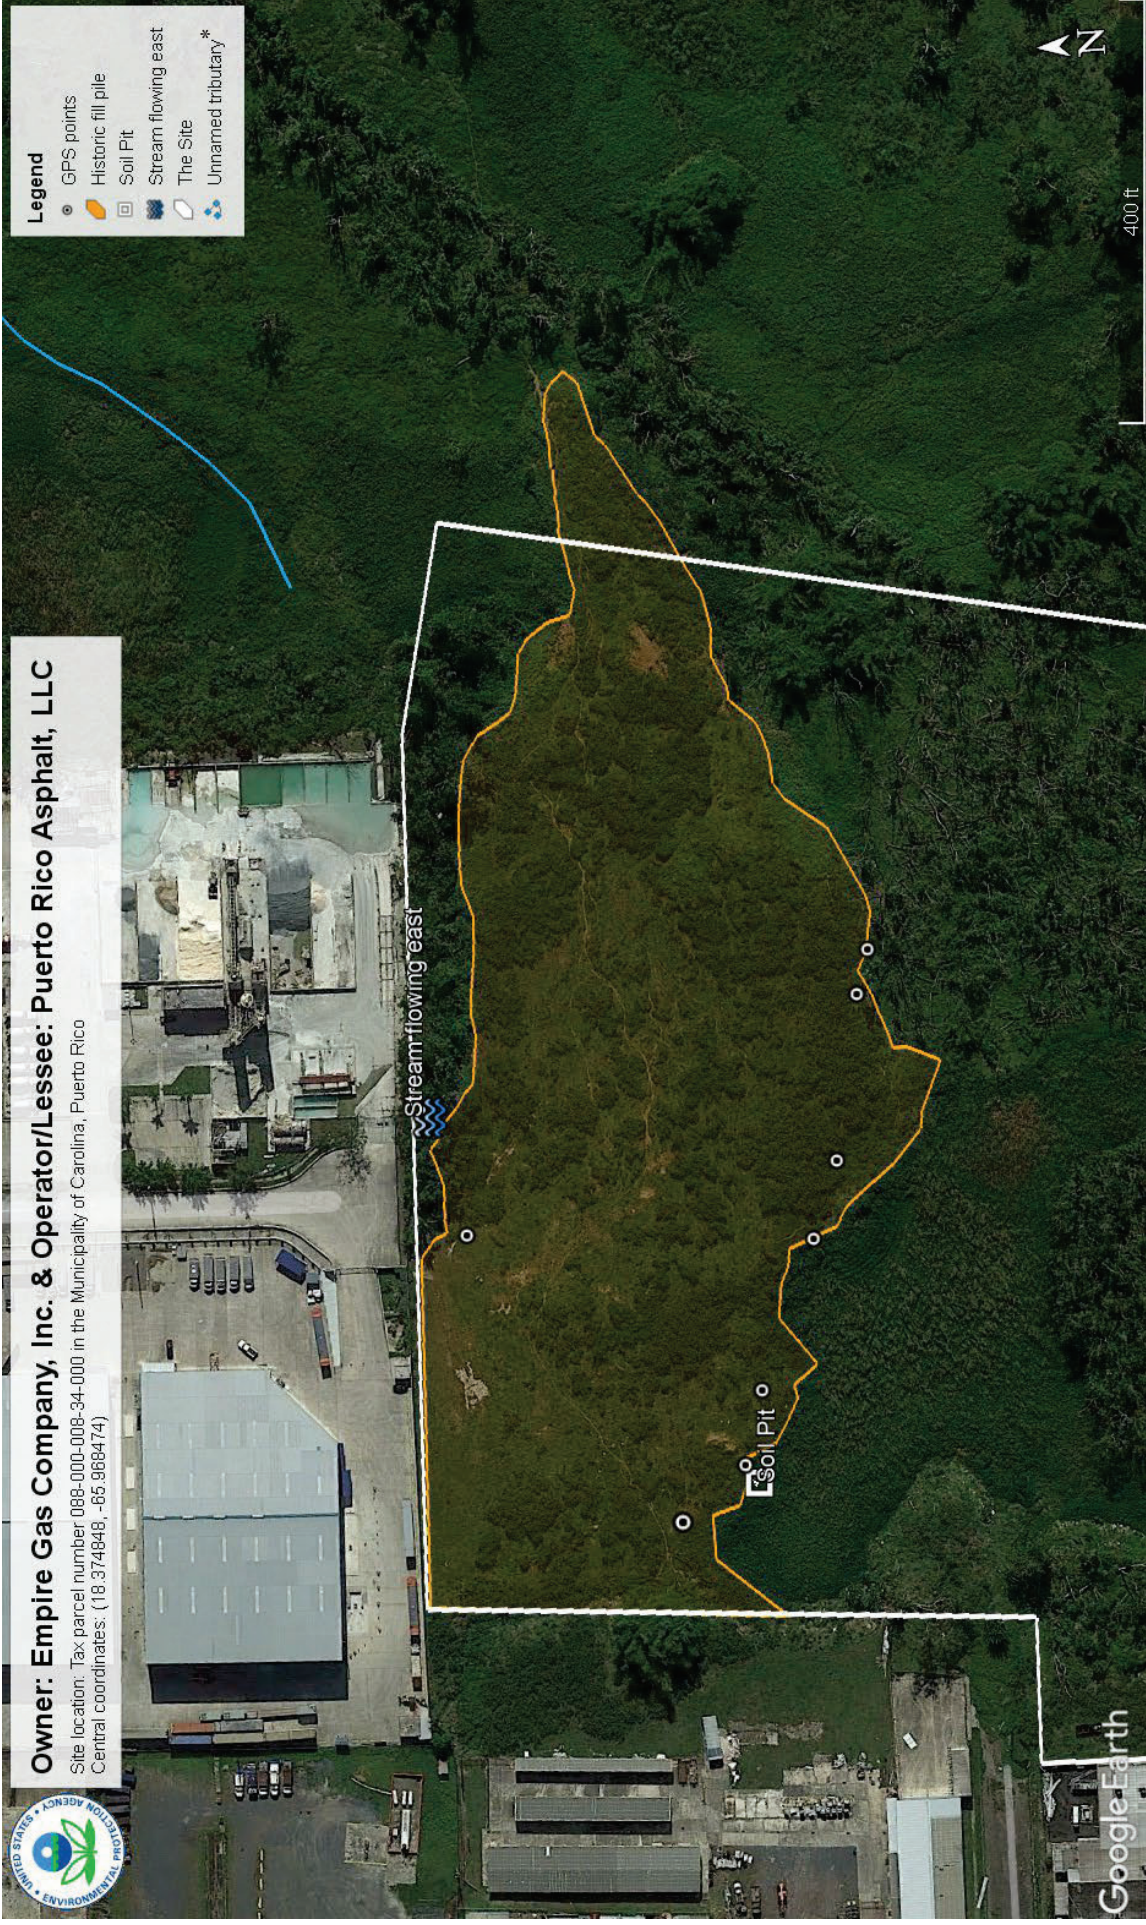
The Site is comprised of piles of various aggregate material. According to historical aerial imagery, the largest pile (hereinafter as "the historic fill pile") was constructed throughout 2013 and 2014. The historic fill pile is approximately 15-20 feet higher in elevation than the surrounding habitat. See Attachment A for a map containing details of the inspection findings.

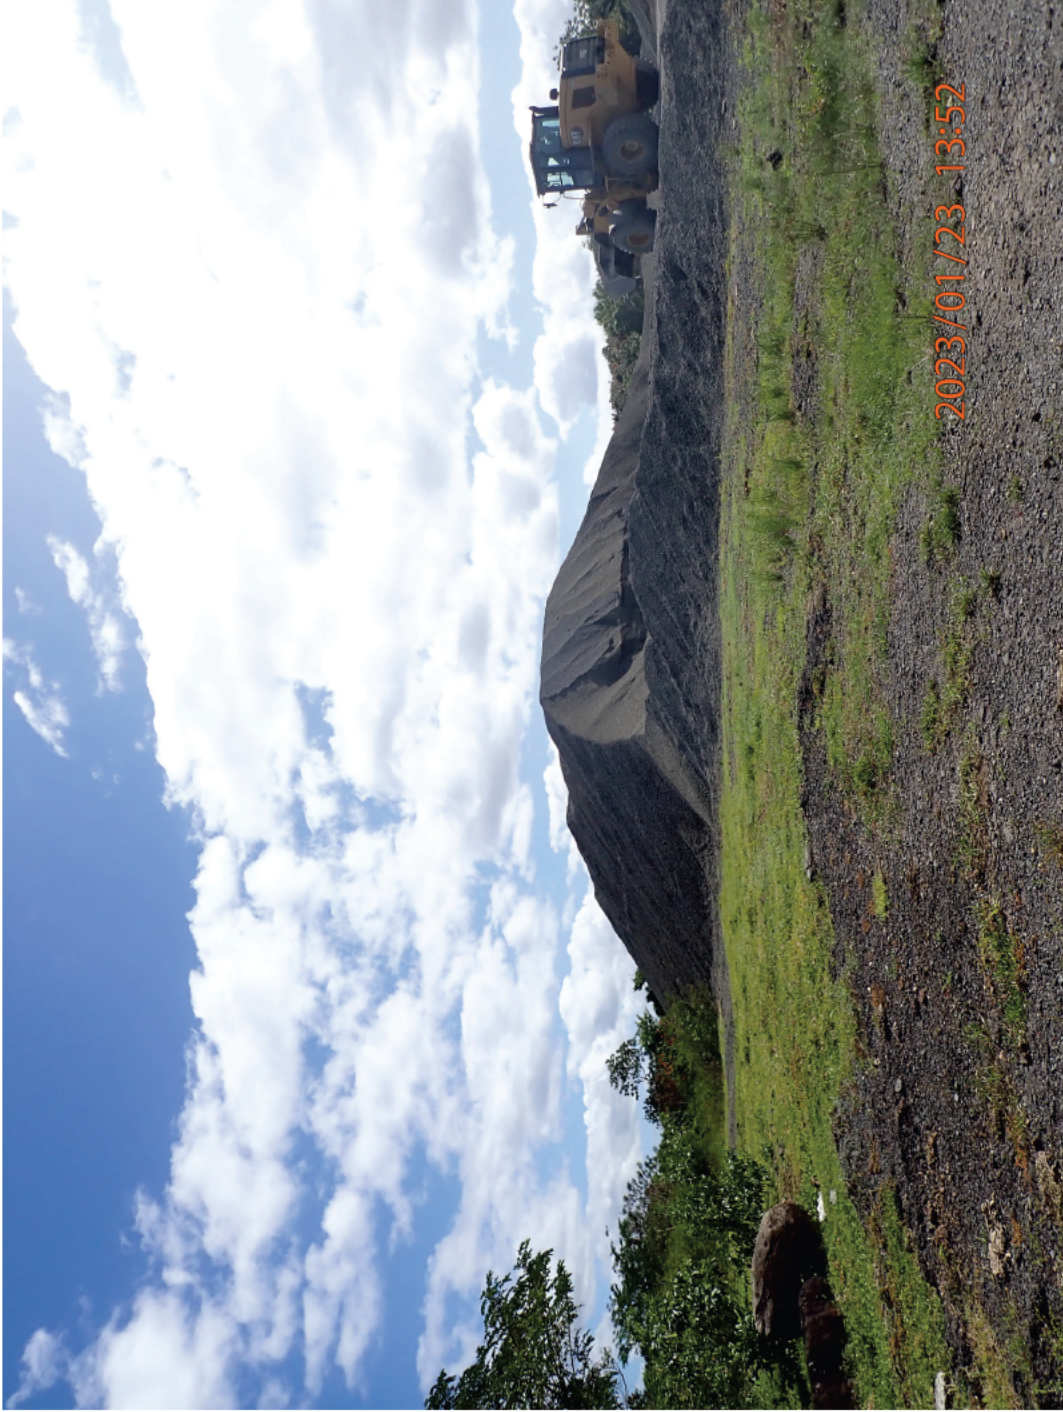
Photo ID: P1230285

Description: A large pile of aggregate material was seen being slowly removed from the Site.

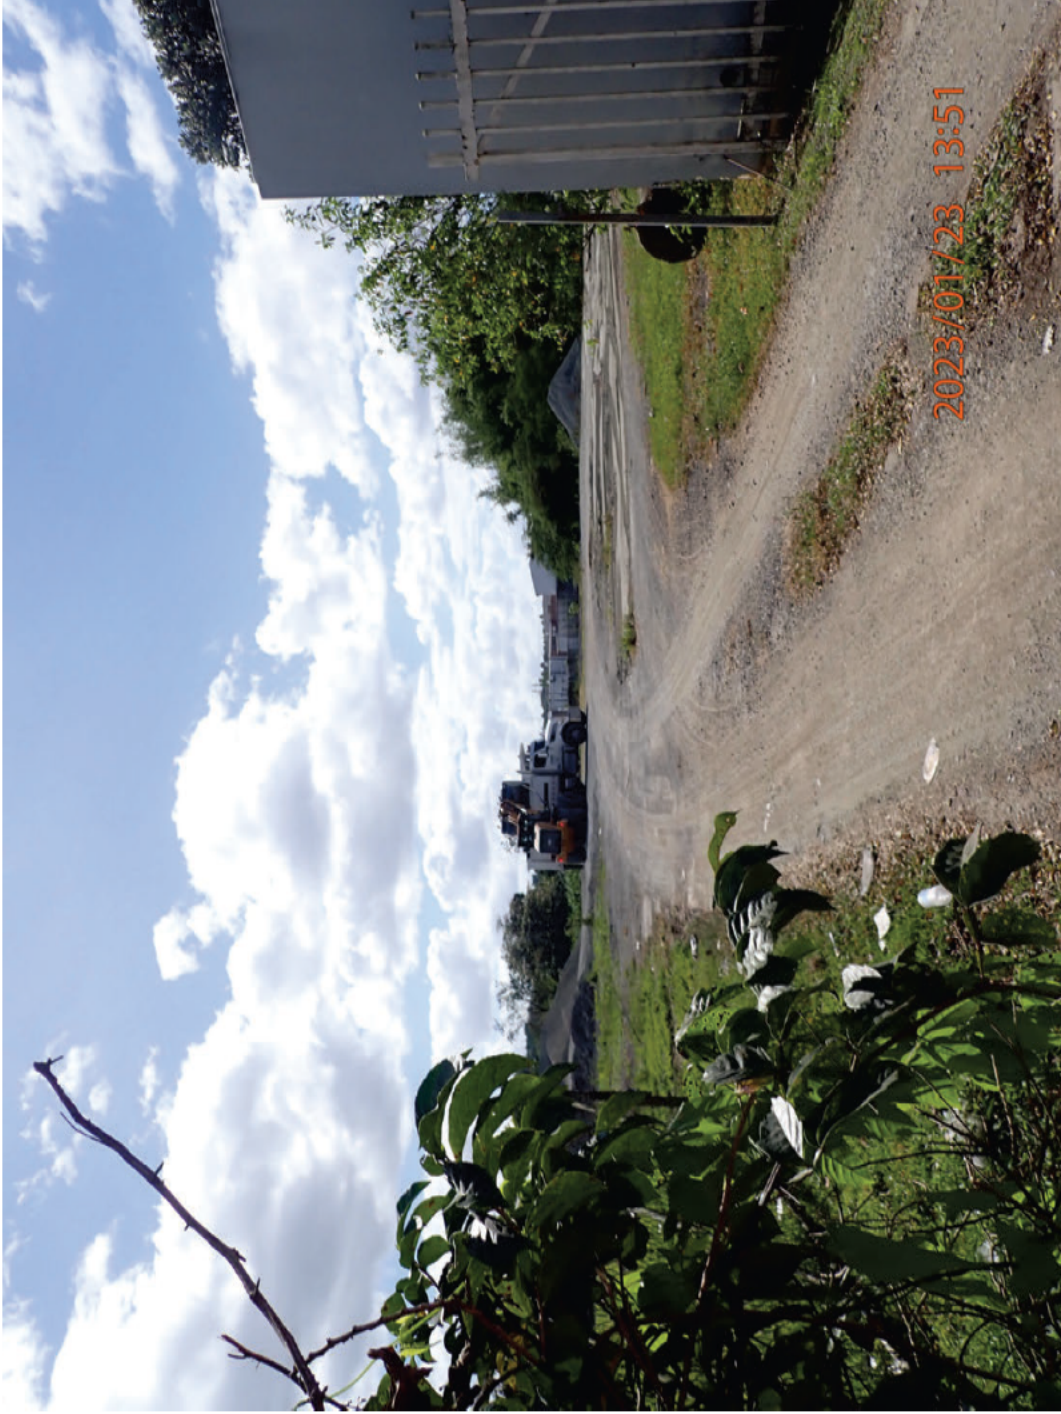
Photo ID: P1230284

Description: Entrance of the Site as seen from the road 887 C. A.

During the time of the visit, aggregate material was being loaded onto trucks via a digger, as shown.

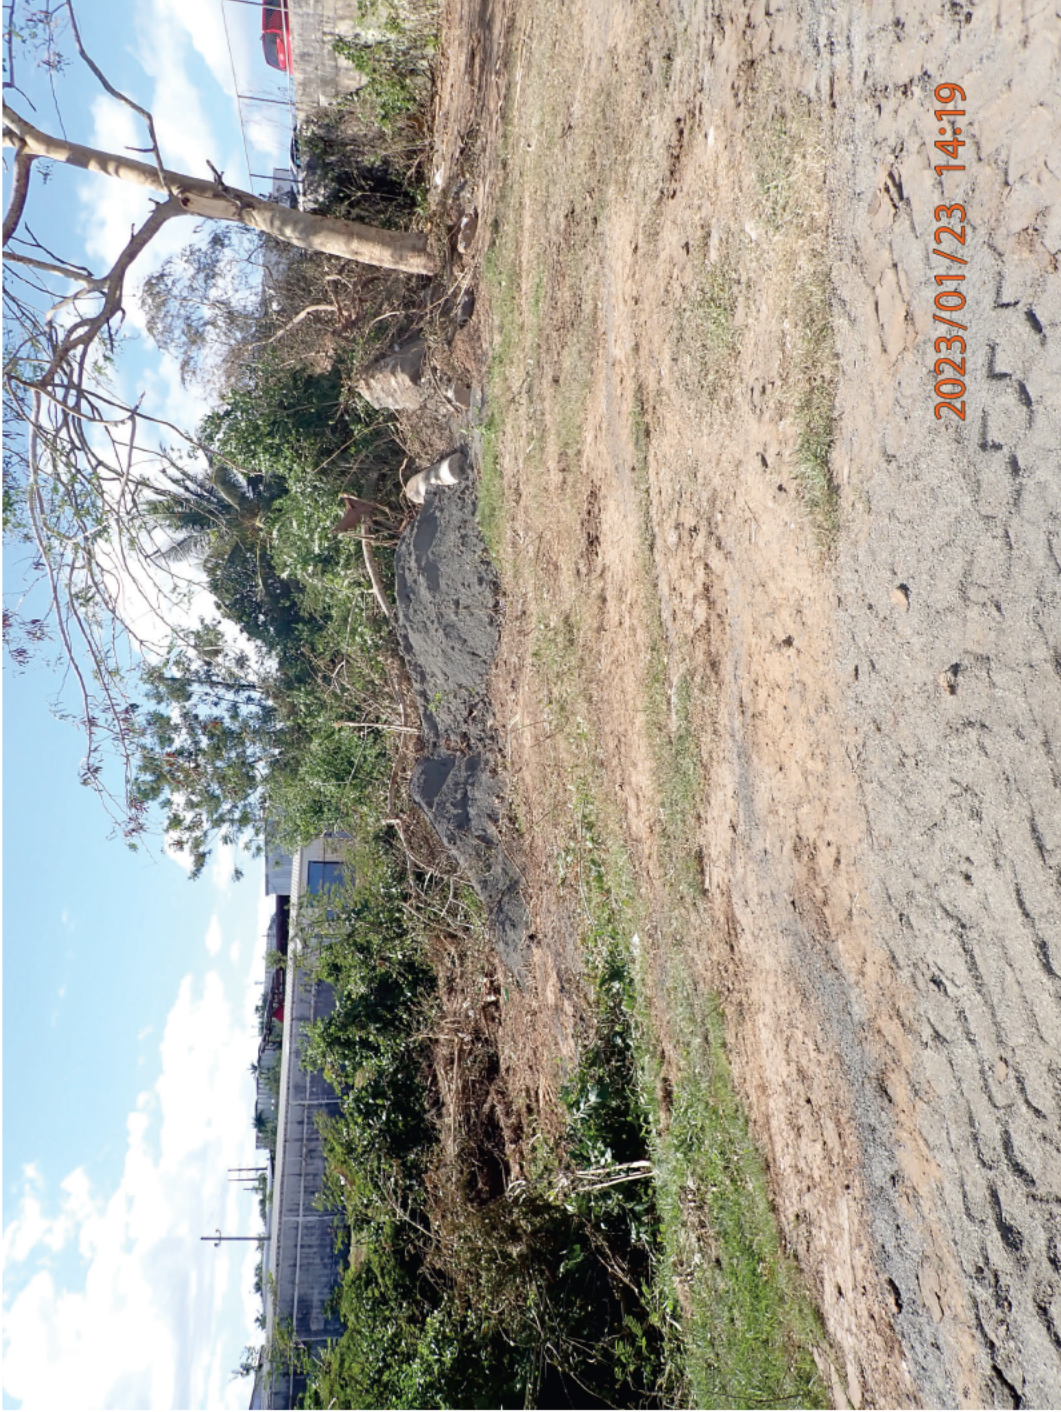
Photo ID: P1230287

Description: Northwestern corner of the Property.

Small piles of various aggregate materials can be seen throughout the Site. Some piles are newer than others.

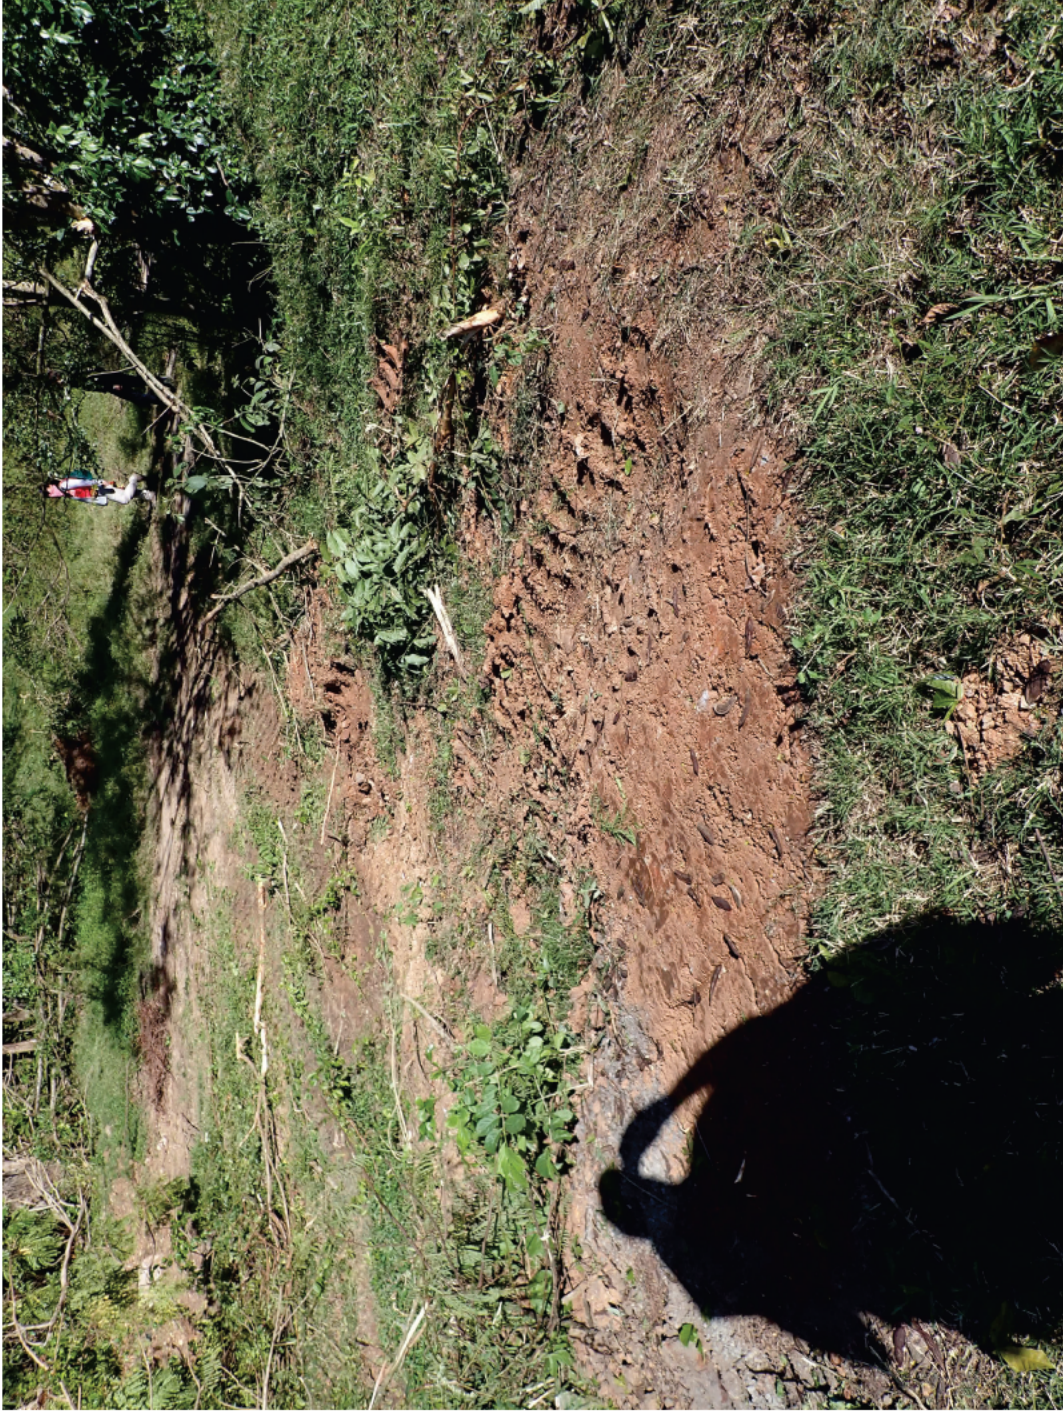
Photo ID: P1230323

Description: Tracks from heavy machinery was found throughout the Site

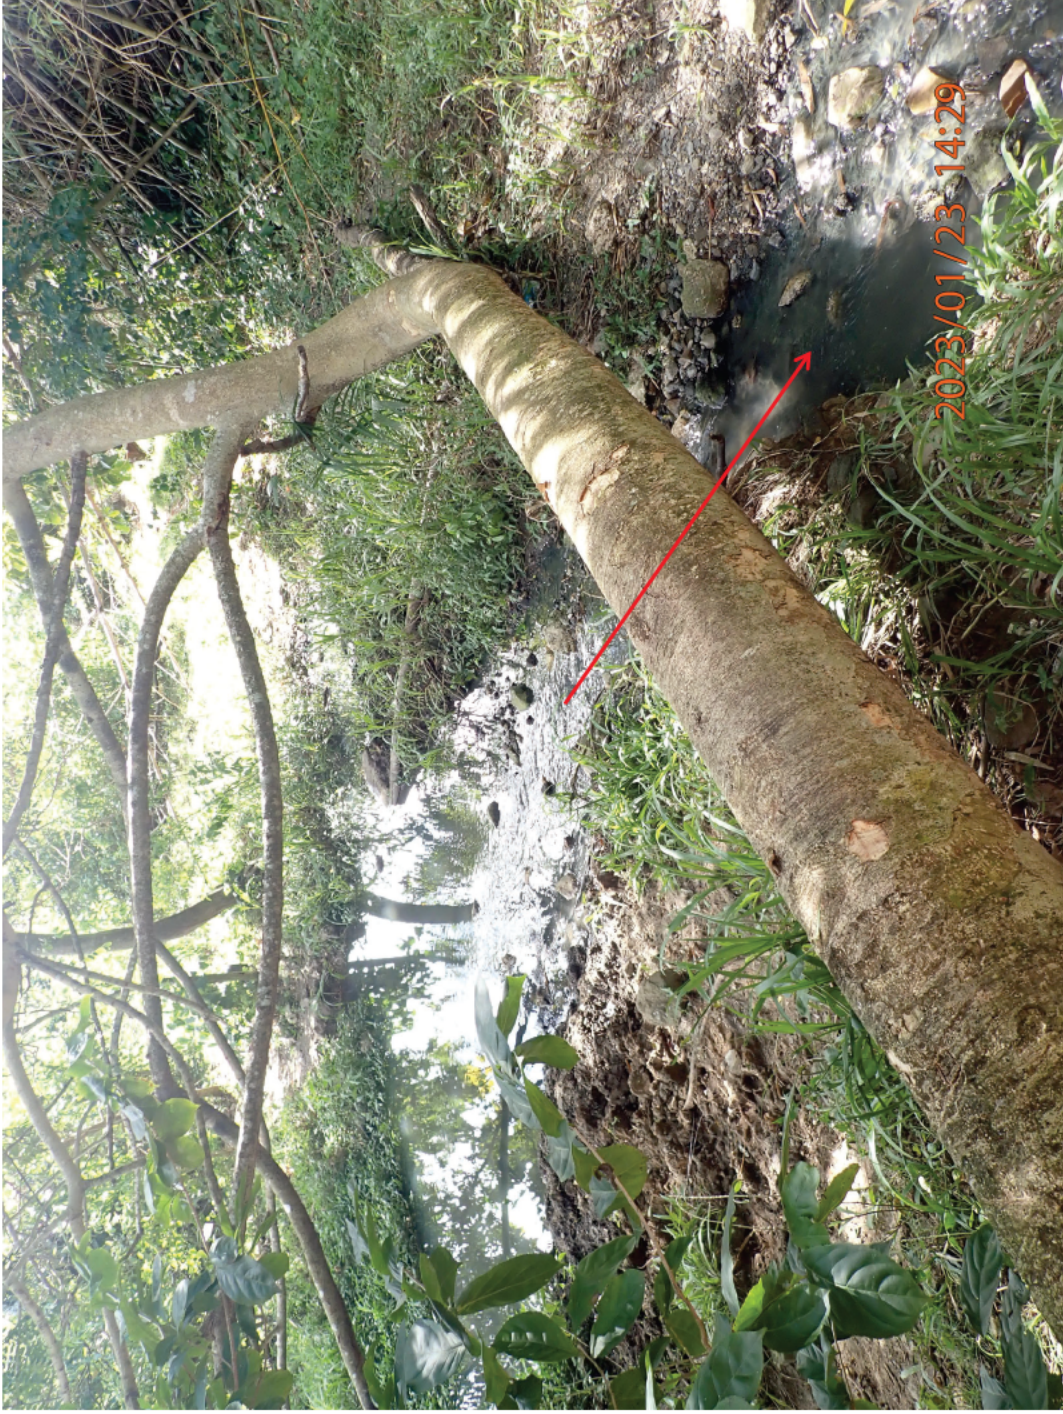
Photo ID: P1230293

Description: An unnamed stream found on the northern border of the Site.

*Red arrow marks the direction of the flow.

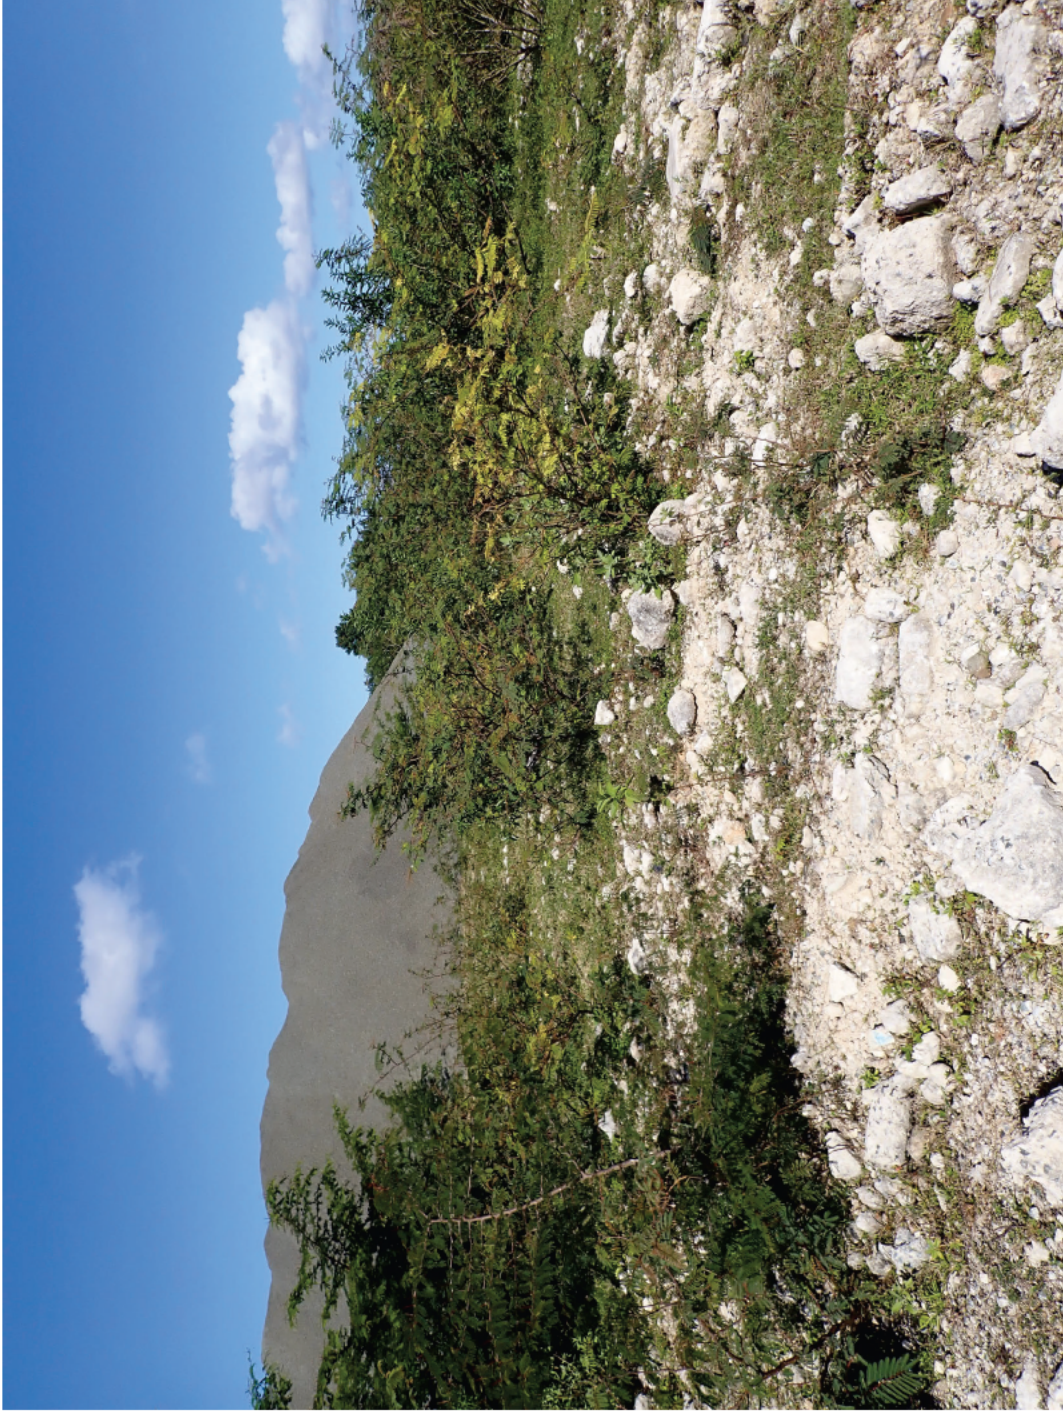
Photo ID: P1230319

Description: View of the large aggregate pile from the northeast portion of the Site.

Historic fill material can be seen in the foreground. Upland vegetation can be seen in most of the historic fill area to the east.

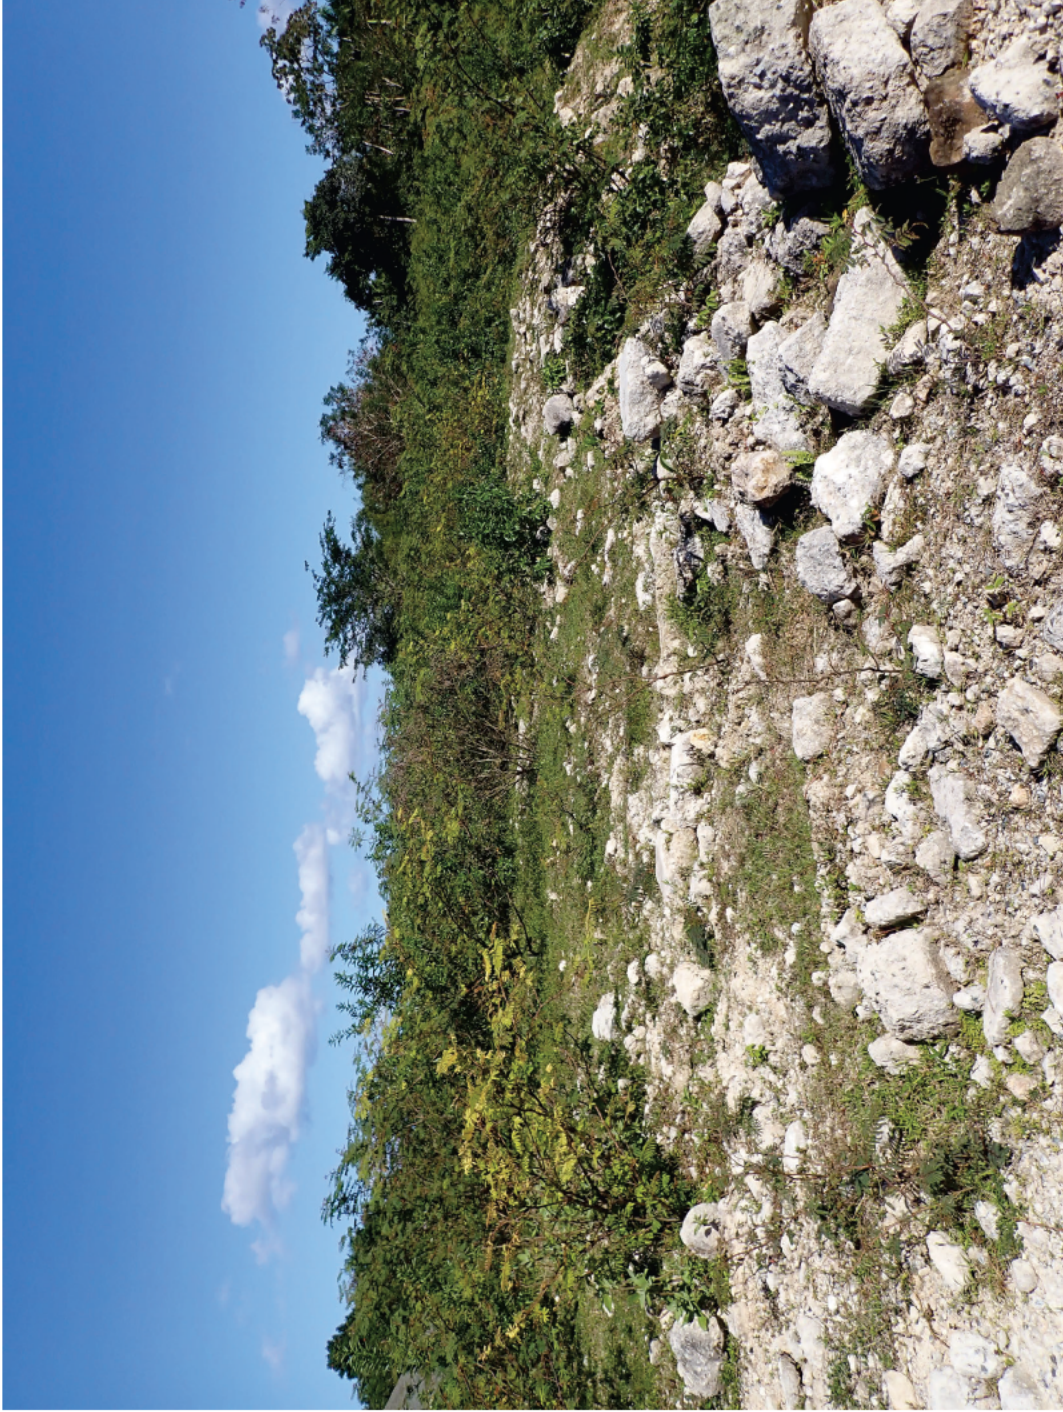
Photo ID: P1230320

Description: Panorama of the eastern portion of the Site from on top of the historic material. Some vegetation on the historic fill are over 8 feet tall.

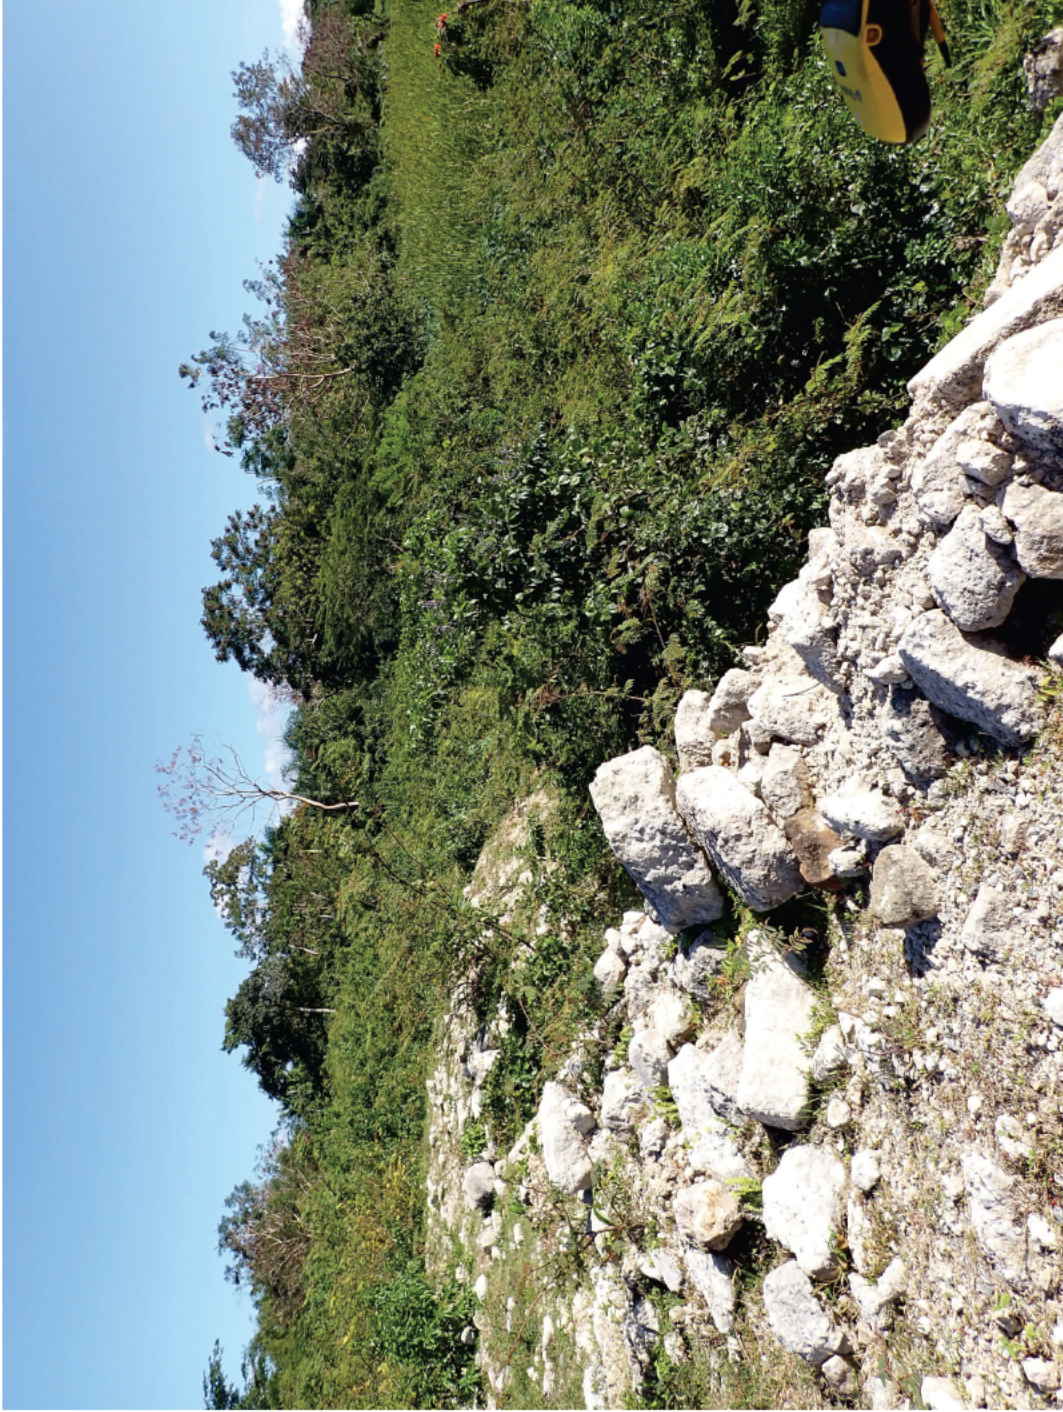
Photo ID: P1230321

Description: View of the historic fill sloping into vegetated habitat below.

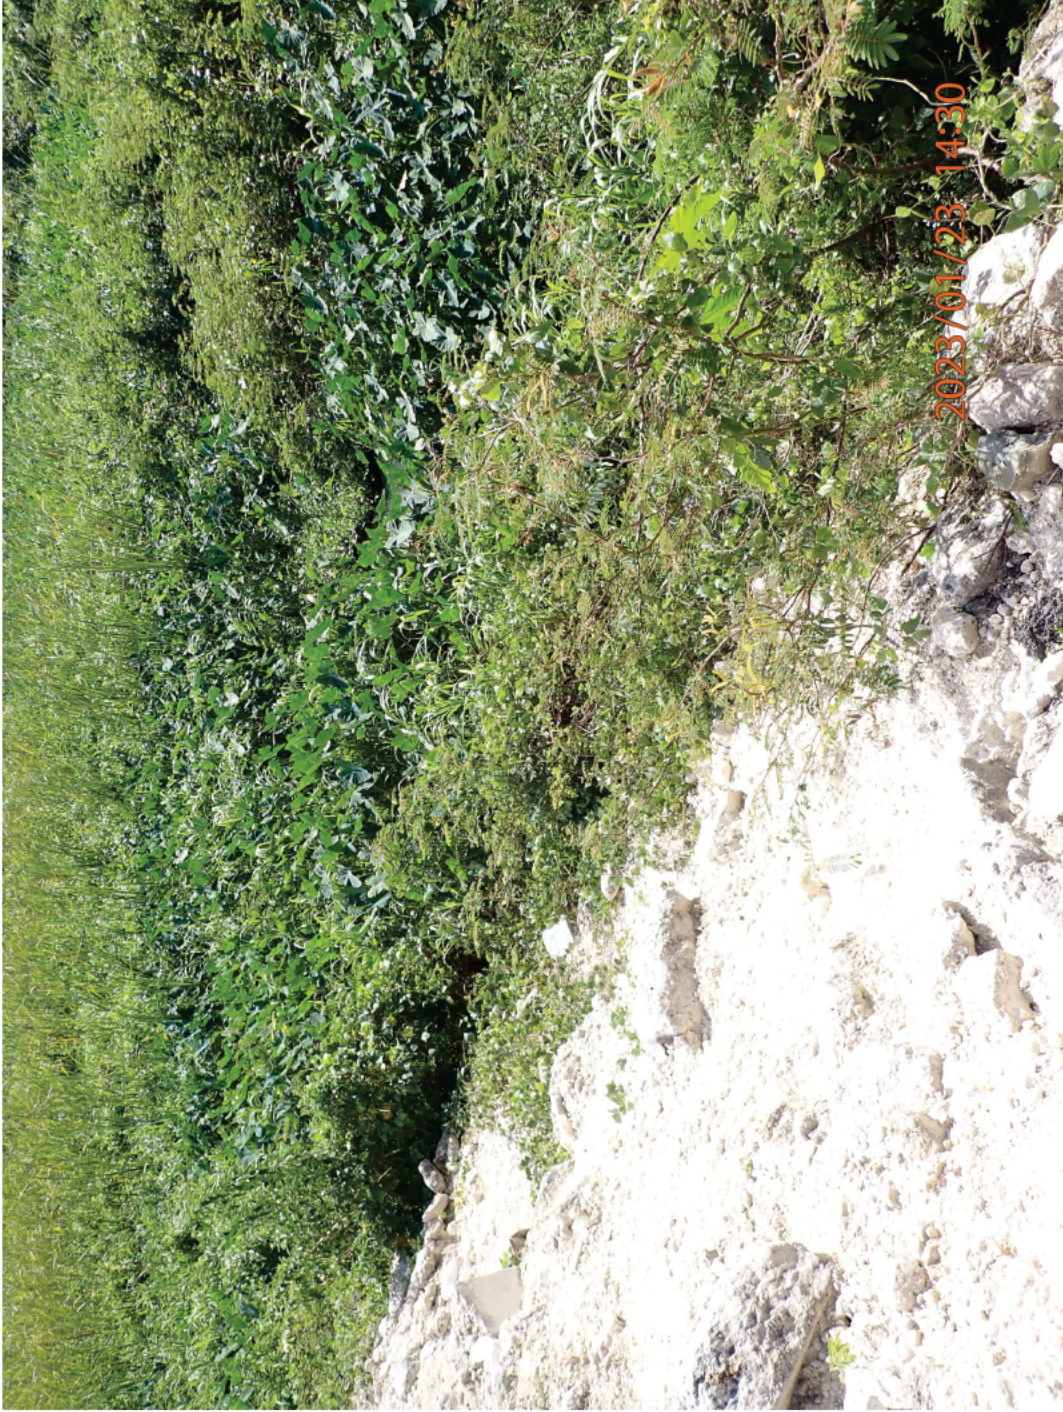
Photo ID: P1230294

Description: View of the vegetation below from on top of the historic fill.

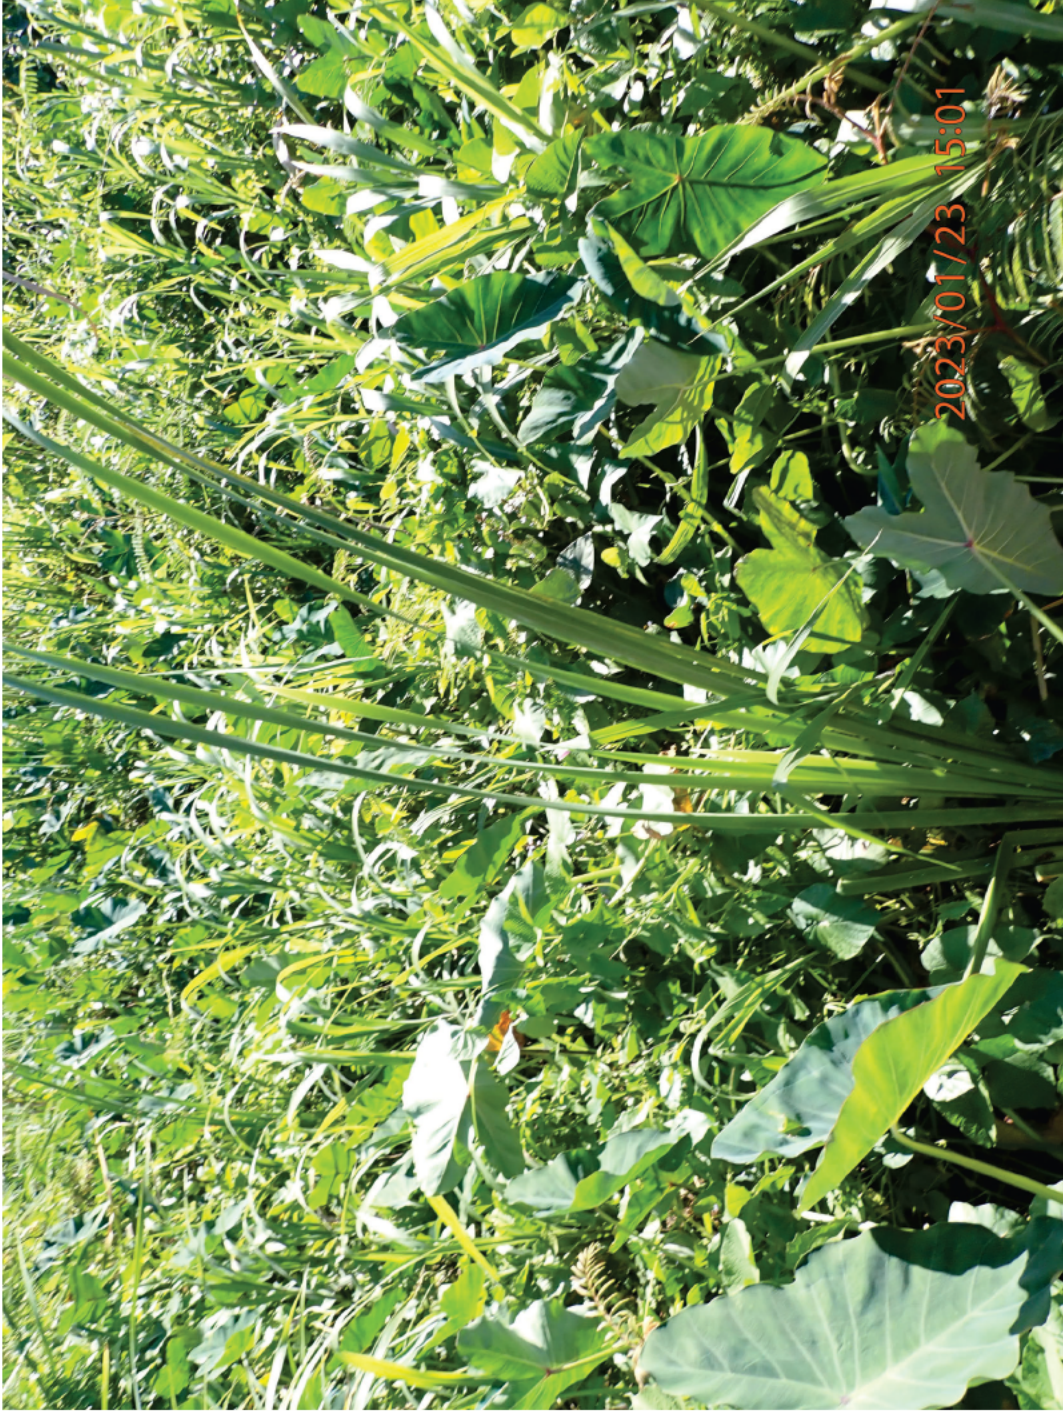
Photo ID: P1230314

Description: Vegetation surrounding the soil pit dug.

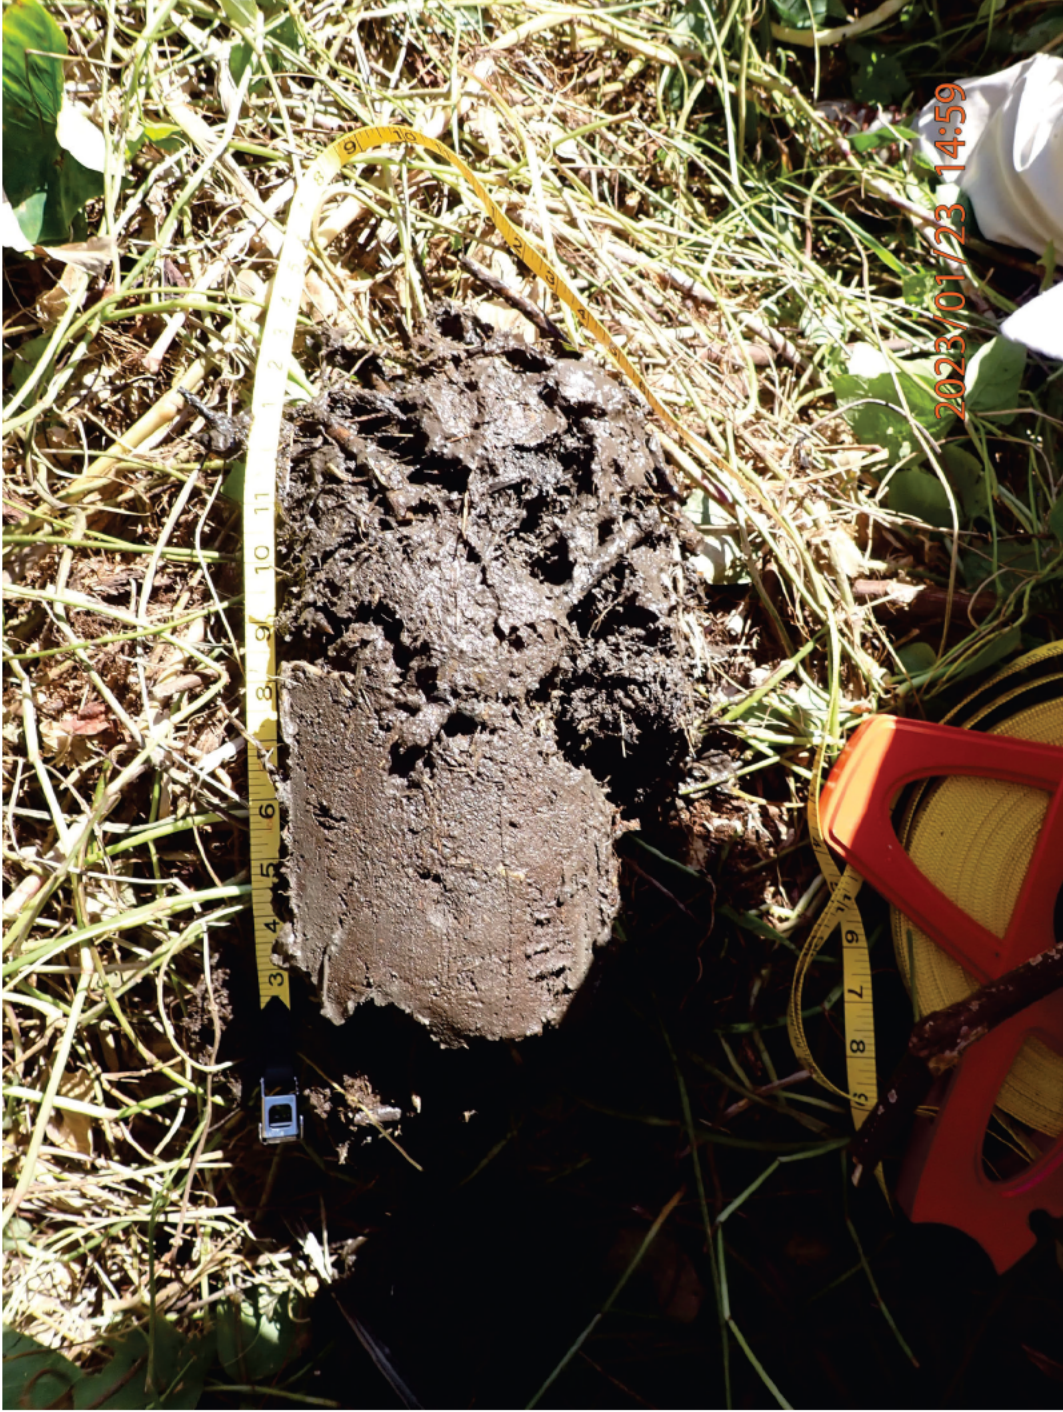
Photo ID: P1230307

Description: Soil core from the soil pit dug.

Soil pit was dug to test for field indicators of hydraulic soils. Wetland indicators were found.

Closing Conference			
Documents Received and/or Requested During the Inspection			
N/A			
Compliance Assistance Provided (If any)			
EPA recommended to PR Asphalt representatives to consult with the Corps on the possible need for CWA Section 404 permits before beginning any expansion of the fill material, which includes the aggregate materials on the Site, within WOTUS.			
Observations Relayed to Site Owner/Operator			
N/A			
Actions Taken by Owner/Operator During the Inspection (If any)			
During the entire duration of the inspection, PR Asphalt had machinery operating within the Site, removing material off the property to another PR Asphalt facility nearby.			
Potential Issues of Concern Including Regulatory Citations			
Potential areas of jurisdictional wetlands and streams may be present on the site. A wetland delineation should be done for the site

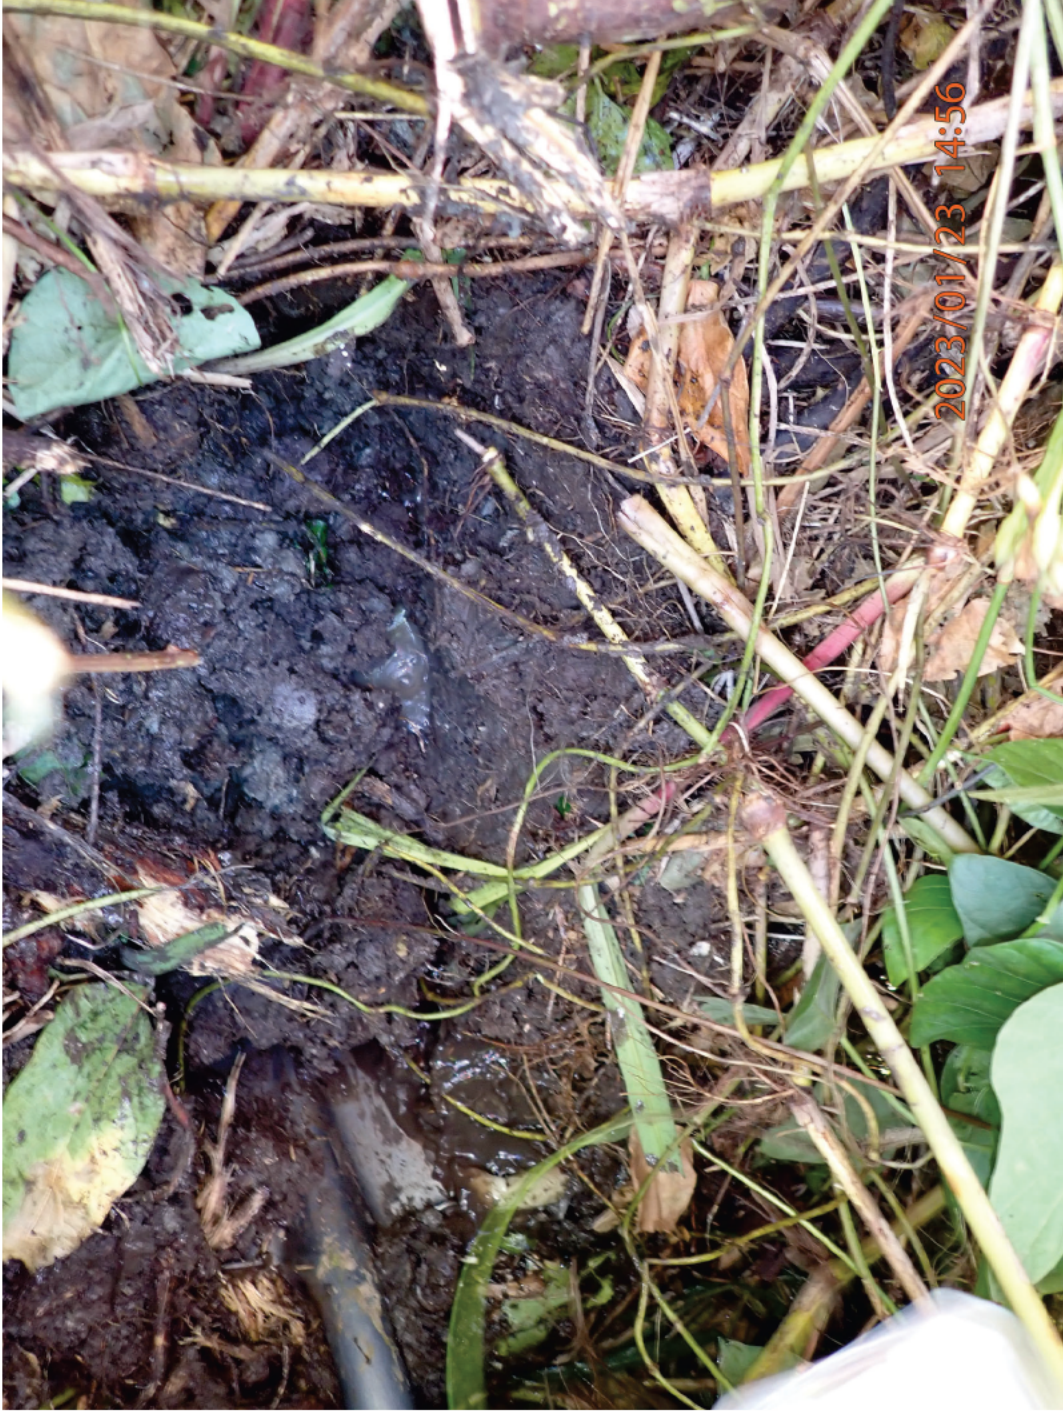
Photo ID: P1230298

Description: Surface saturation observed around the soil pit dug.
