**Region 6 - Enforcement & Compliance Assurance Division**  
**INSPECTION REPORT**

| <b>Inspection Date(s):</b> | 10/08/2024 and 10/09/2024 | |
| <b>System Name:</b> | Barksdale AFB Water System | |
| <b>PWS ID:</b> | LA1015022 | |

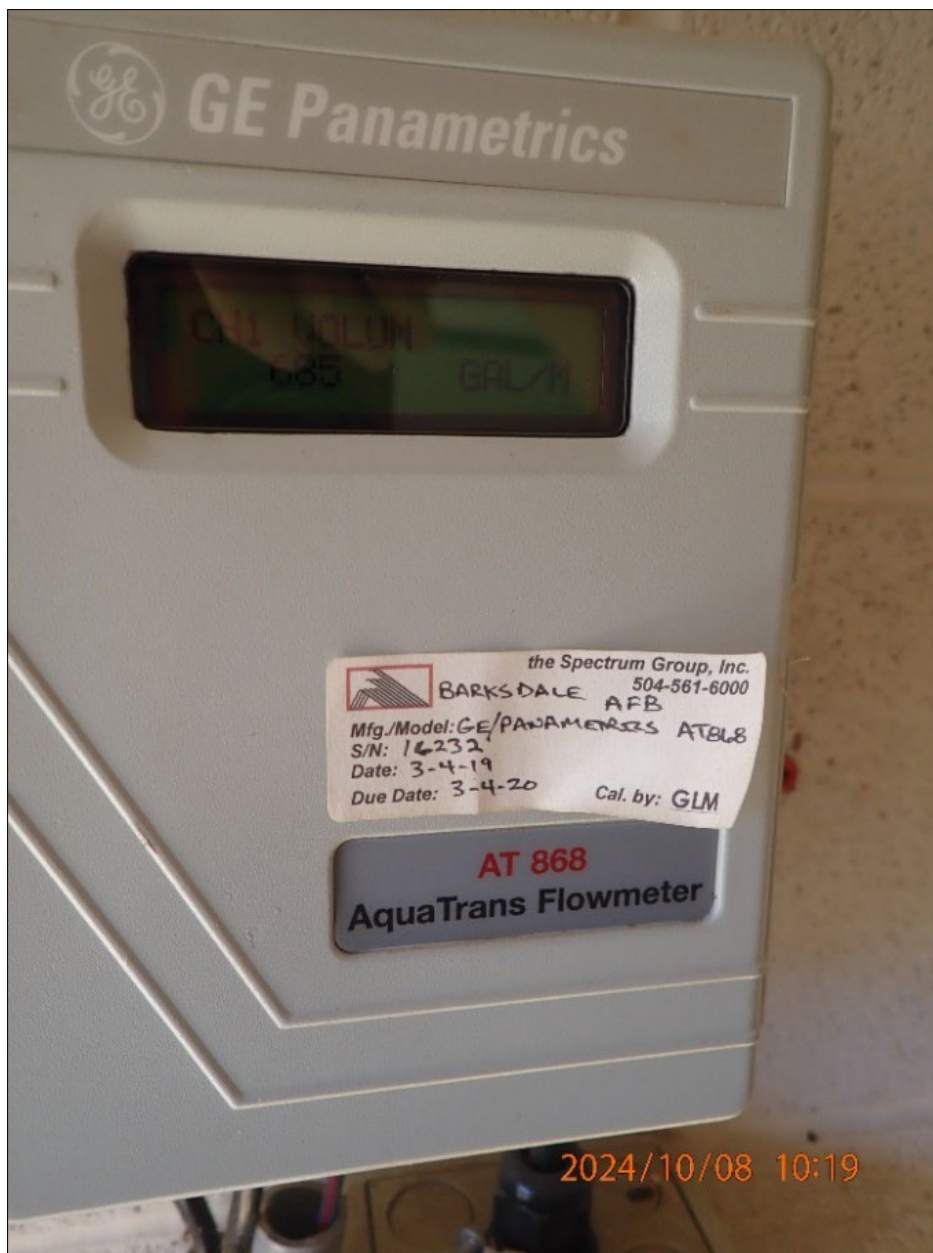
**Photograph 2. Treatment Plant at Entry Point 10/08/2024 10:19 PA080185.JPG**

Description: View of the controller for the flow meter. The service tag documented a service date of March 4, 2019. The due date for the next service date is documented as March 4, 2020.

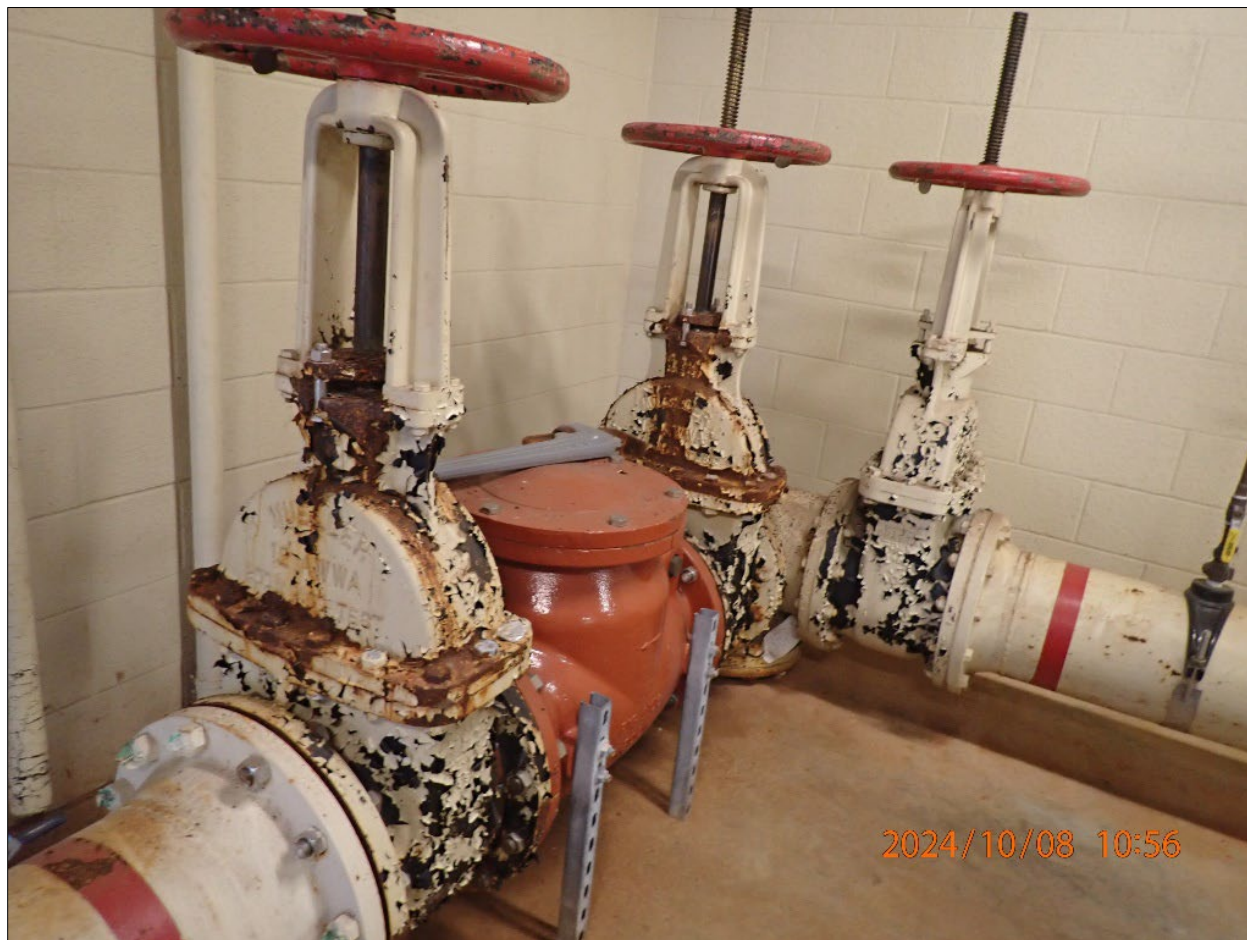
**Photograph 3. West Gate Elevated Storage Tower 10/08/2024 10:56 PA080201.JPG**

**Area of Concern 4.** The EPA Inspection Team observed cracked and peeling pipe coating inside the booster station at the West Gate Elevated Storage Tower (refer to [Appendix 1, Photograph 3](#)).

Description: View of cracked and peeling pipe coating inside the booster station.

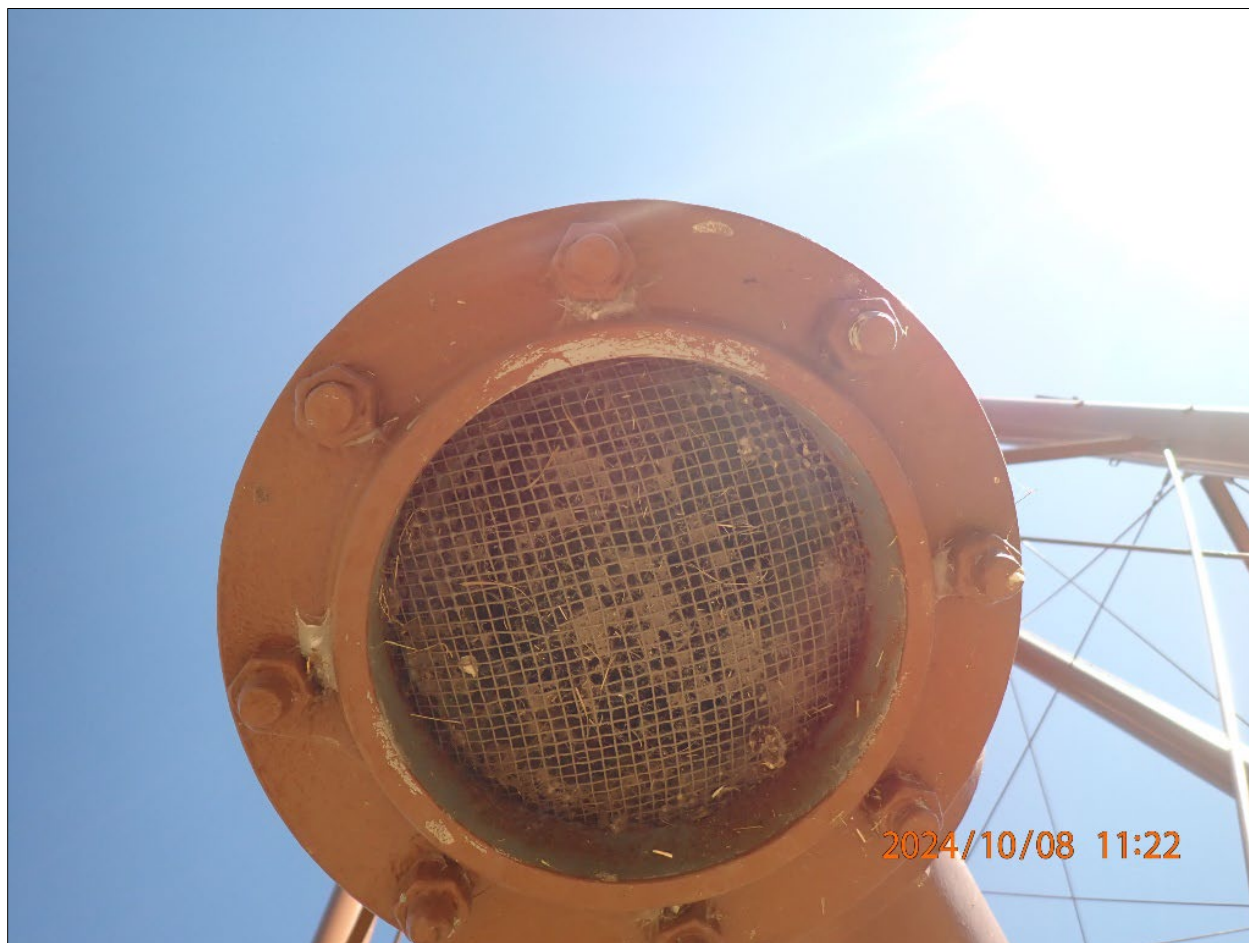
**Photograph 4. Supply Elevated Storage Tower 10/08/2024 11:22 PA080215.JPG**

The altitude valve vault was equipped with a sump pump and was free of standing water. The end of the overflow pipe had a screen with a mesh size larger than #24. The EPA Inspection Team observed debris inside the screen.

**Area of Concern 5.** The EPA Inspection Team observed that the overflow pipes at the Supply Elevated Storage Tower (refer to [Appendix 1, Photograph 4](#)), the MSA Elevate Storage Tower (refer to [Appendix 1, Photograph 5](#)), and East Side Elevated Storage Tower (refer to [Appendix 1, Photograph 6](#)) had screens with a mesh size larger than #24. Also note the EPA Inspection Team observed debris inside the overflow screens.

Description: View of the overflow pipe with a screen with a mesh size larger than #24. Also note debris inside the screen.

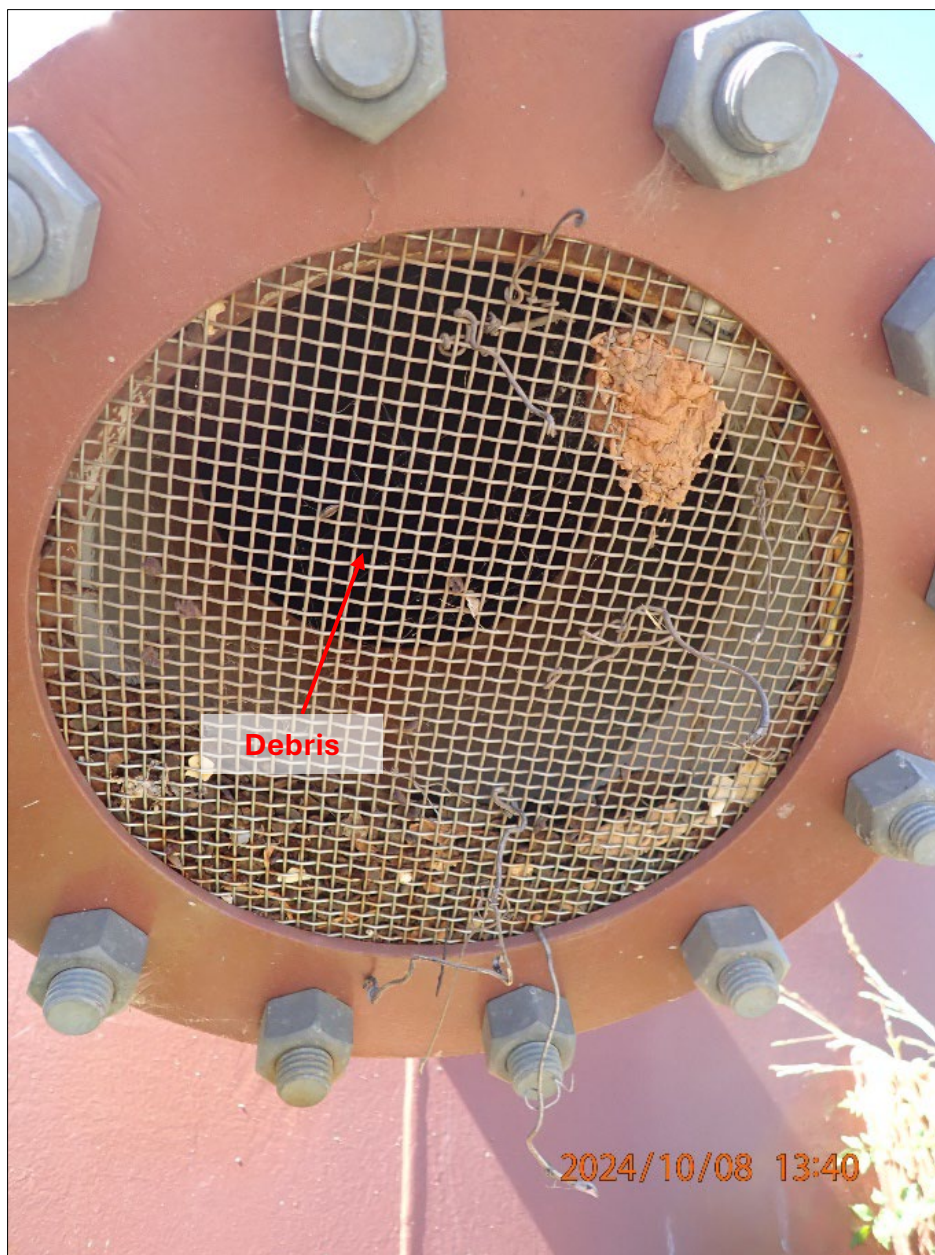
**Photograph 5. MSA Elevated Storage Tower 10/08/2024 13:40 PA080235.JPG**

The overflow pipe had a screen with a mesh size larger than #24. The EPA Inspection Team observed debris inside the screen; the debris appeared to be piping material or coating from the tank interior.

Description: View of the overflow pipe with a screen with a mesh size larger than #24. Also note the debris inside the screen, which appeared to be metallic.

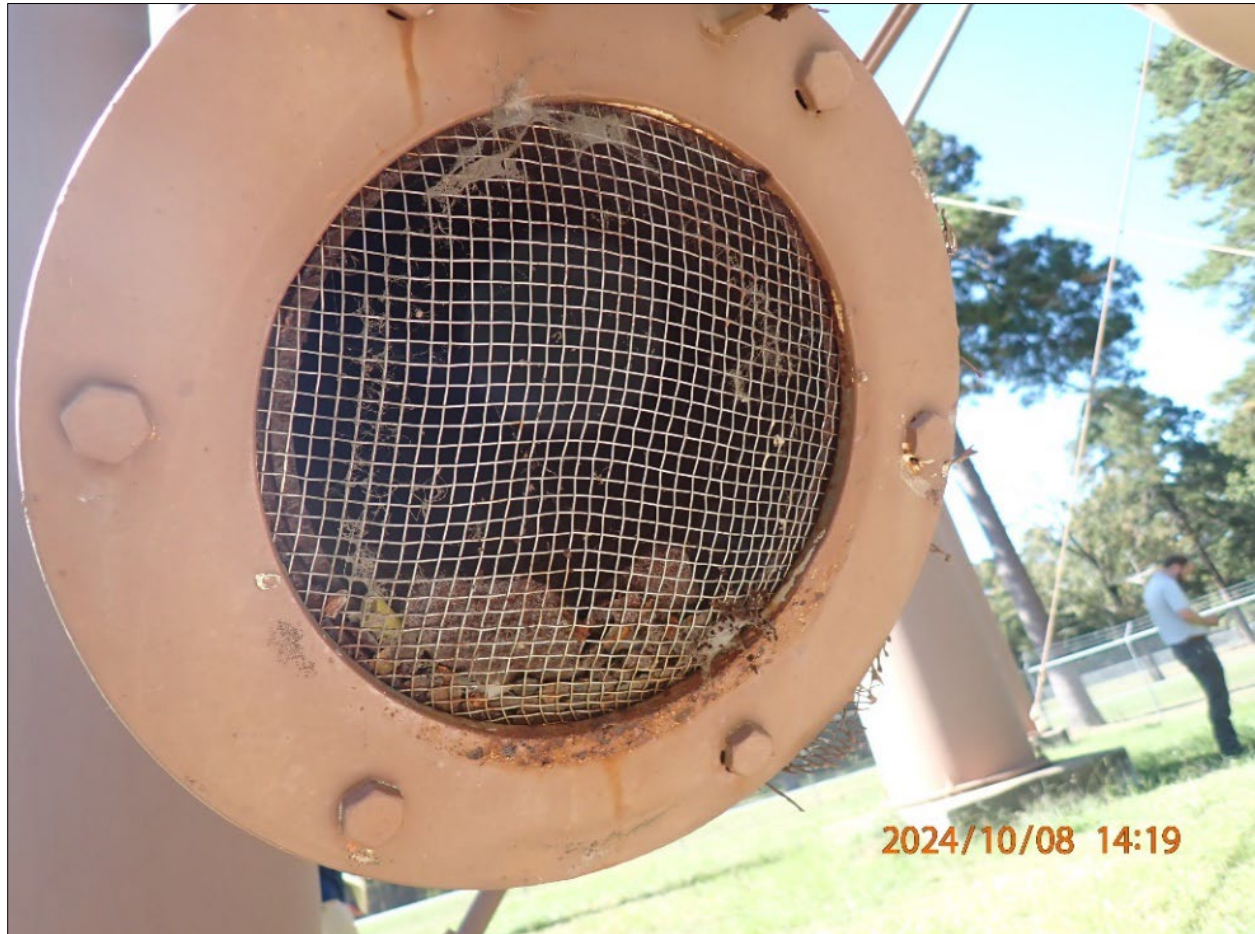
**Photograph 6. East Side Elevated Storage Tower 10/08/2024 14:19 PA080251.JPG**

The overflow pipe drained to cinderblocks placed over a splash pad and had a screen with a mesh size larger than #24. The EPA Inspection Team observed what appeared to be metallic debris inside the screen. Additionally, spider webbing was present on the screen.

Description: View of the overflow pipe with a screen with a mesh size larger than #24. Also note the debris inside the screen, which appeared to be metallic.

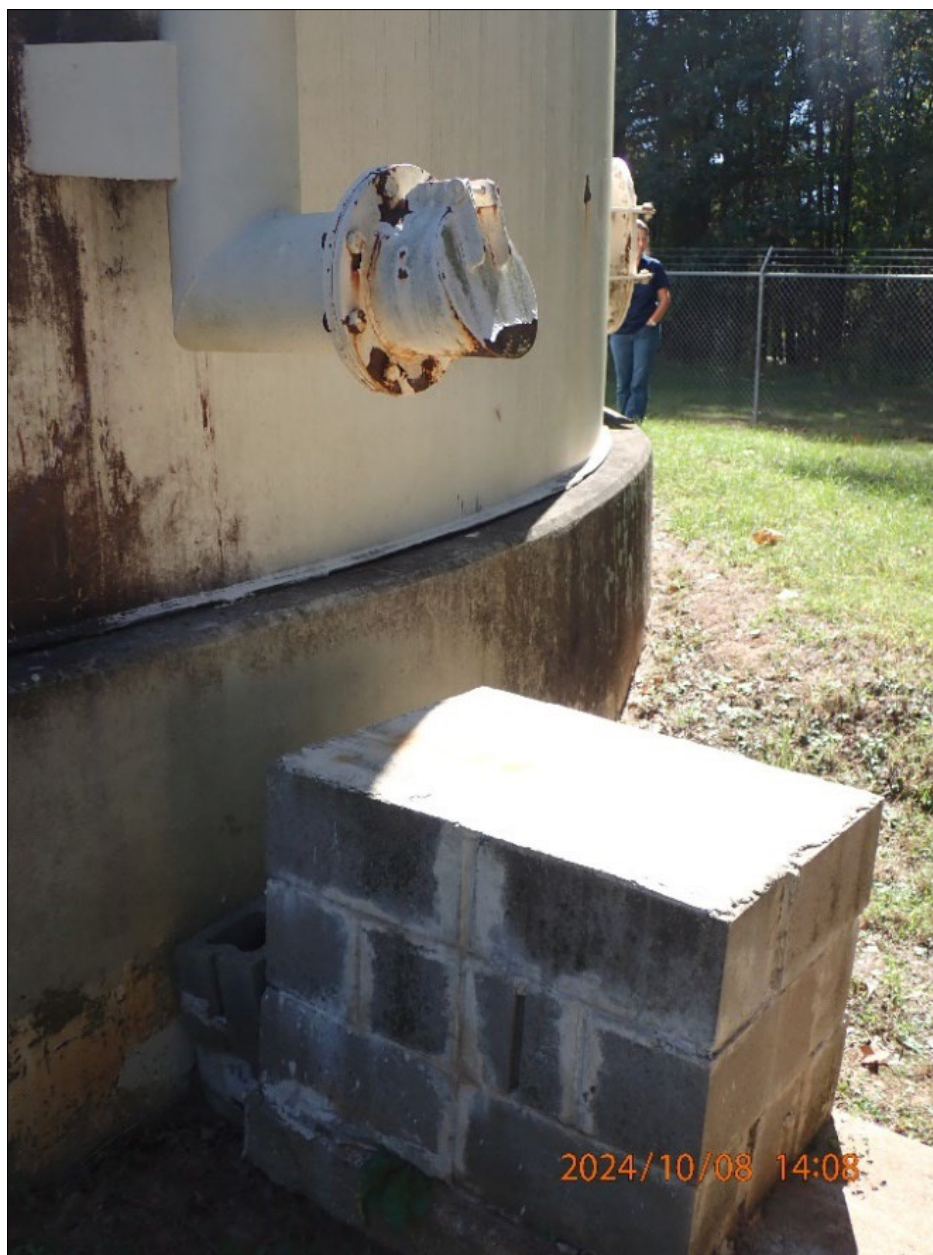
**Photograph 7. East Housing Ground Storage Tank 10/08/2024 14:08 PA080244.JPG**

**Area of Concern 6.** The EPA Inspection Team observed that the overflow pipe at the East Housing Ground Storage Tank drained to cinderblocks placed on top of a concrete splash pad (refer to [Appendix 1, Photographs 7 and 8](#)). At the time of the inspection, it was unclear to the EPA Inspection Team if this structure would adequately direct water beyond the tank exterior permit to avoid damage to the tank grade or foundation. The EPA Inspection Team also observed cinderblocks placed on top of the splash pad at the East Side Elevated Storage Tower (refer [Appendix 1, Photograph 9](#))

Description: View of the overflow pipe draining to cinderblocks placed over a concrete splash pad. It was unclear to the EPA Inspection Team if this structure would adequately direct water away from the tank foundation.

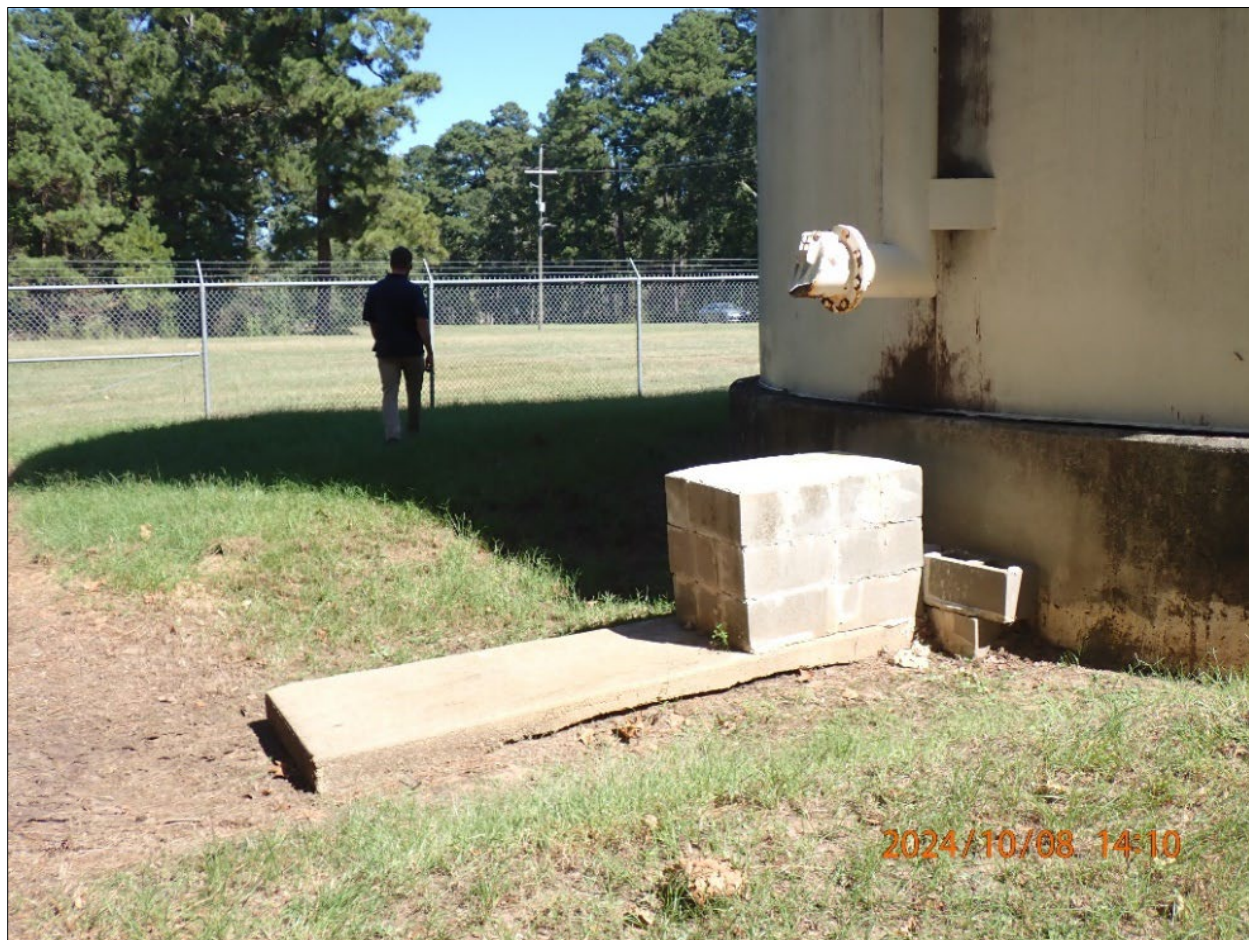
**Photograph 8. East Housing Ground Storage Tank 10/08/2024 14:10 PA080245.JPG**

Description: Additional view of the tank overflow, cinderblocks, and concrete splashpad.

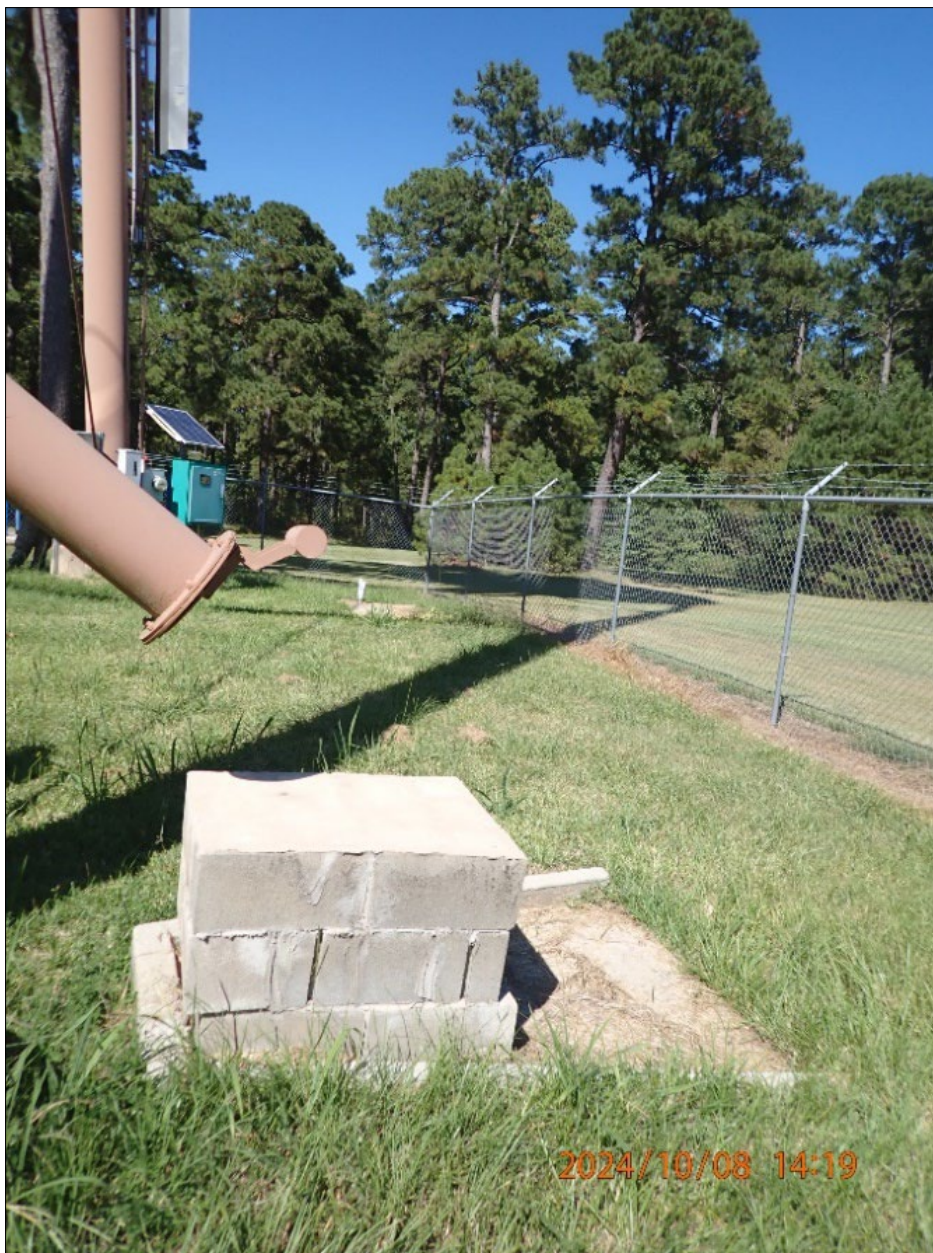
**Photograph 9. East Side Elevated Storage Tower 10/08/2024 14:19 PA080250.JPG**

Description: View of the overflow pipe draining to cinderblocks placed over a concrete splash pad.

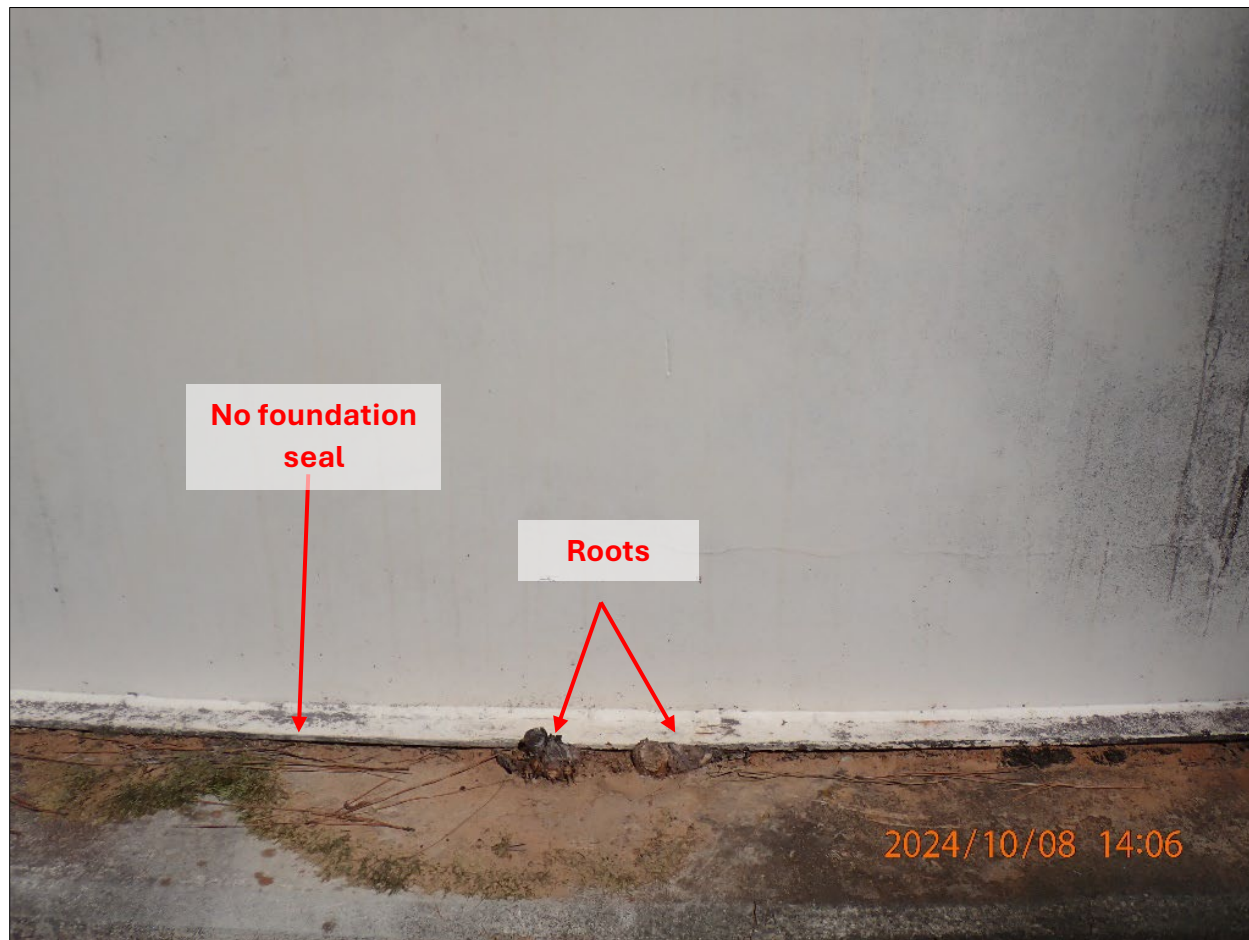
**Photograph 10. East Housing Ground Storage Tank 10/08/2024 14:06 PA080239.JPG**

**Area of Concern 7.** The EPA Inspection Team observed that the foundation seal for the East Side Ground Storage Tank was missing in areas. Additionally, roots were observed at the interface of the tank bottom plate and tank foundation (refer to [Appendix 1, Photographs 10 and 11](#)).

Description: View of the interface of the tank bottom plate and concrete foundation. Note lack of foundation seal and roots from vegetation that had been removed.

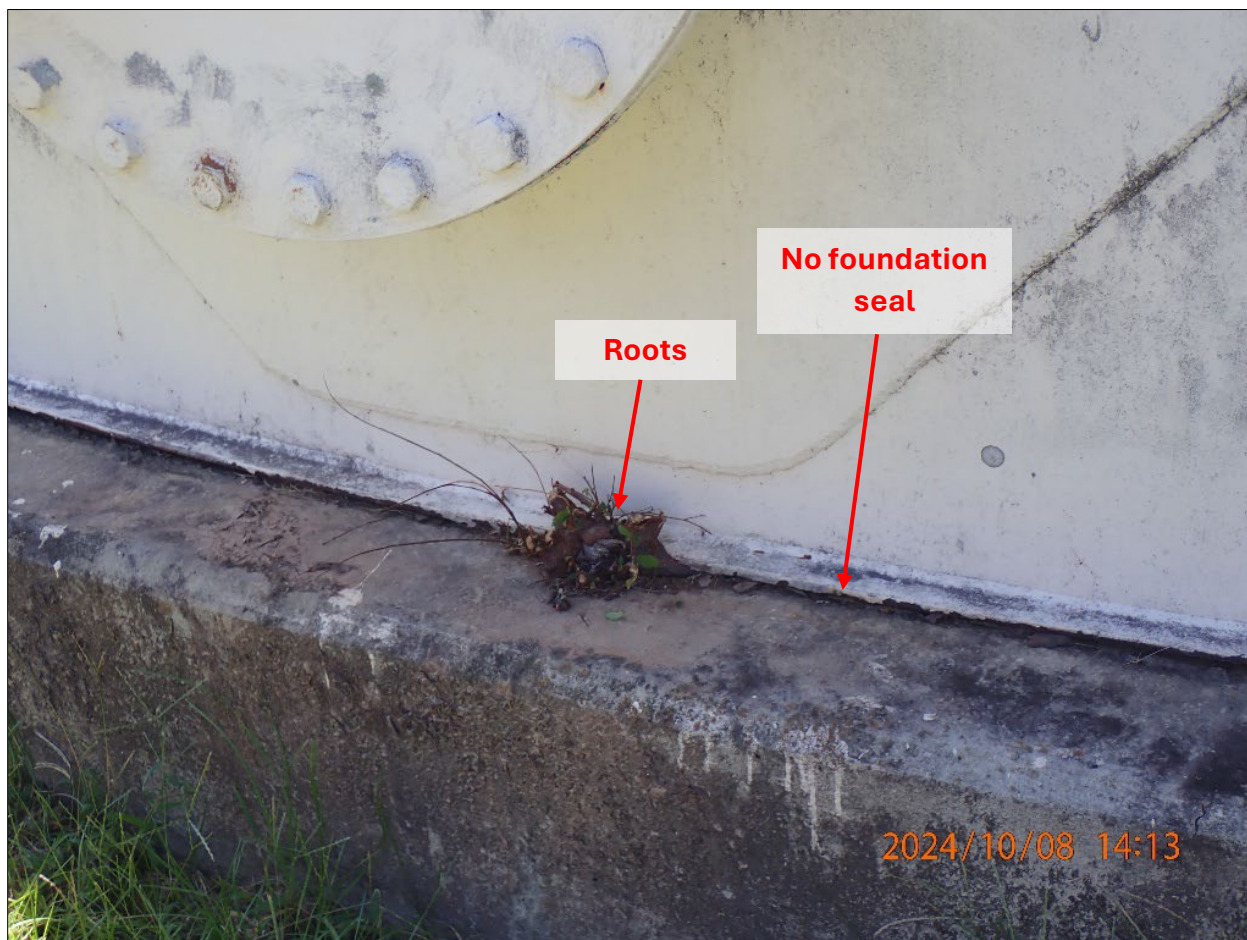
**Photograph 11. East Housing Ground Storage Tank 10/08/2024 14:13 PA080247.JPG**

Description: View of the interface of the tank bottom plate and concrete foundation. Note lack of foundation seal and roots from vegetation that had been removed.

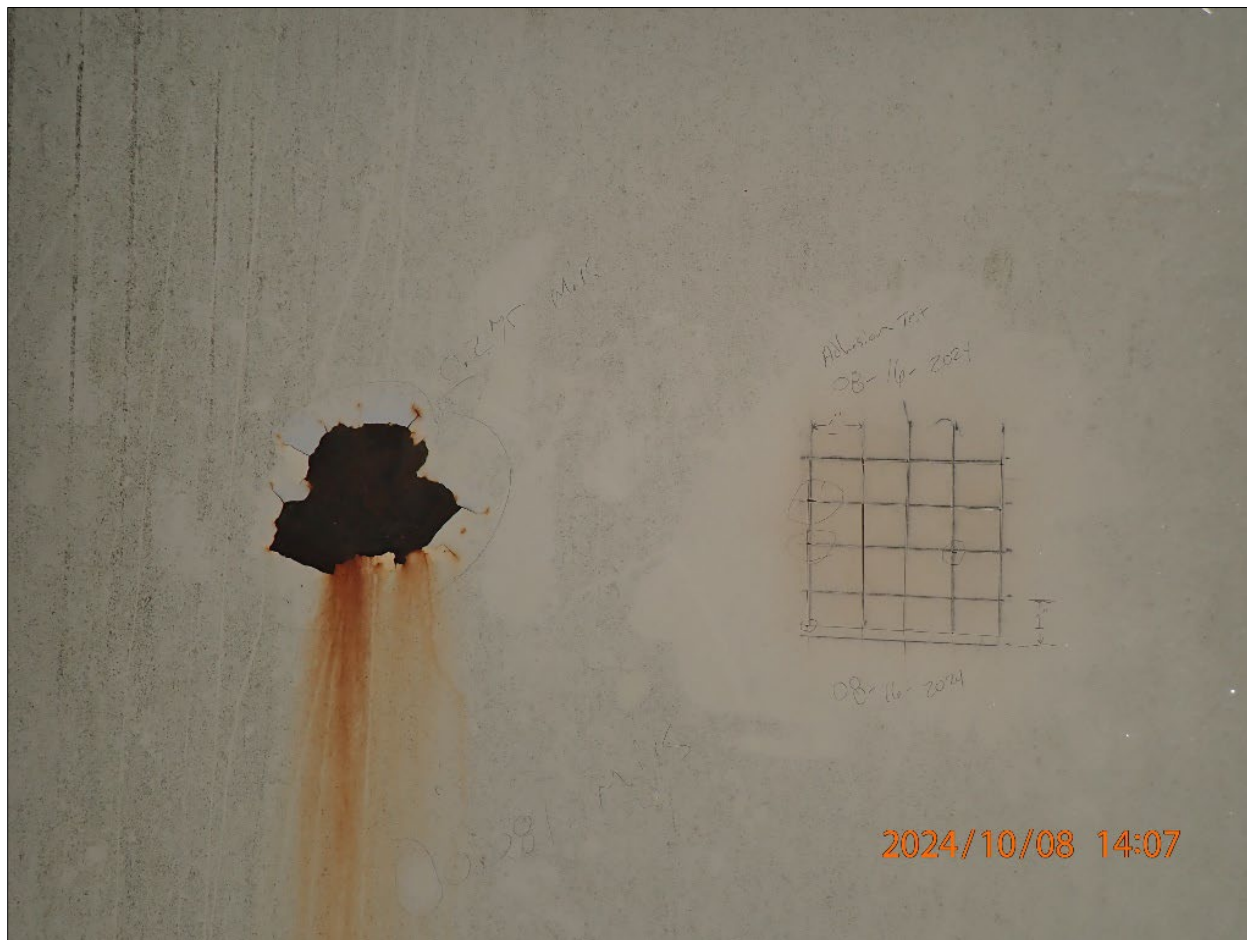
**Photograph 12. East Housing Ground Storage Tank 10/08/2024 14:07 PA080241.JPG**

**Area of Concern 8.** The EPA Inspection Team observed an area of missing exterior coating at the East Housing Ground Storage Tank (refer to [Appendix 1, Photograph 11](#)).

Description: View of an area of missing tank exterior coating.
