**Region 6 - Enforcement & Compliance Assurance Division**  
**INSPECTION REPORT**

| Regulatory Program(s) | NPDES | |
| Facility Name: | <b>City of Rio Rancho Wastewater Treatment Plant #2</b> | |
| Identification/Permit Number: | NM0027987 | |

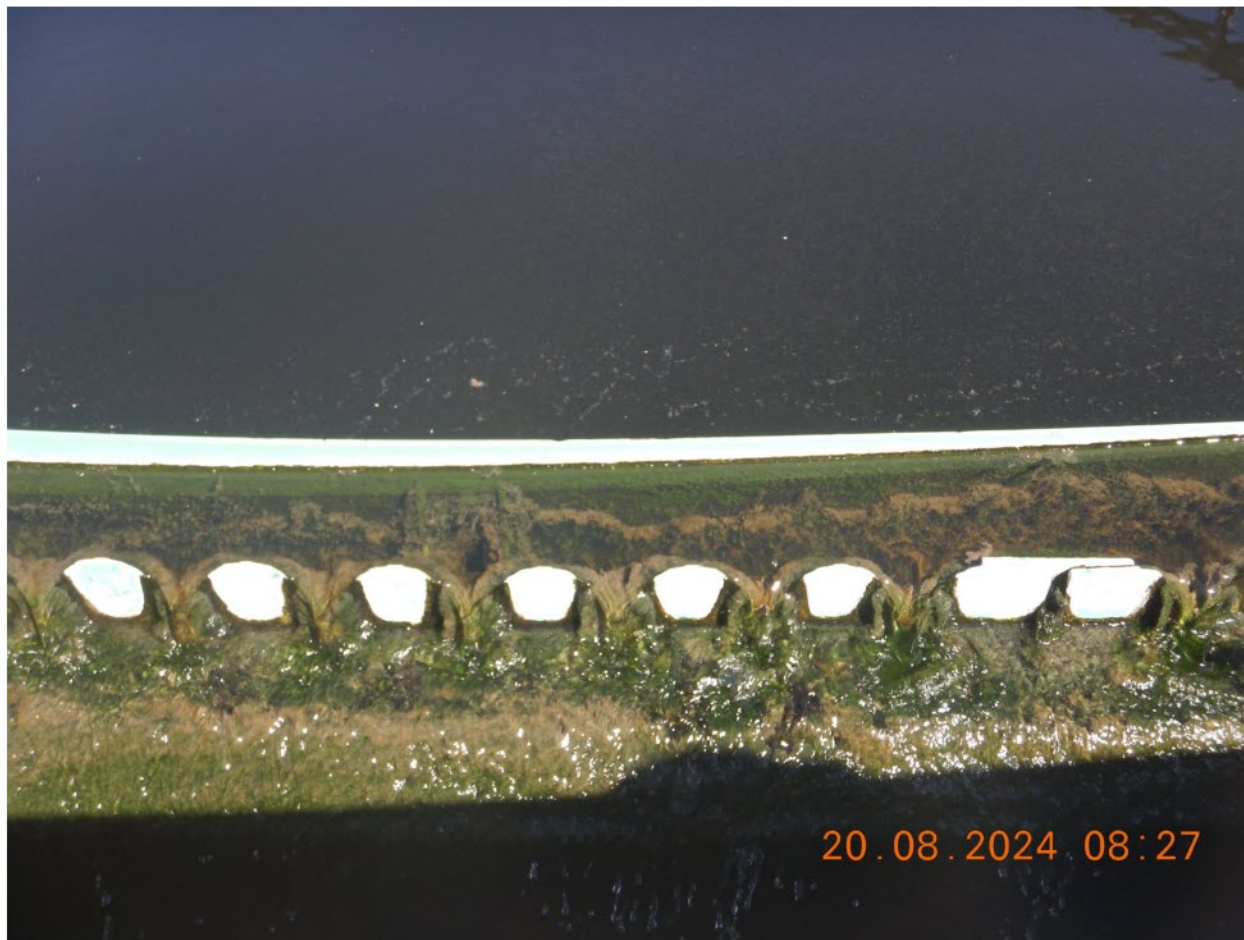
Photo No. 1

- The clarifiers exhibited excessive algae growth along the weirs and the consultants stated they are washed and/or cleaned approximately once per month.

View of the excessive algae growth on the clarifiers along the weirs. **Note:** the consultants stated they are washed and/or cleaned approximately once per month. (DSCN2711). Photographed by E. Yurk

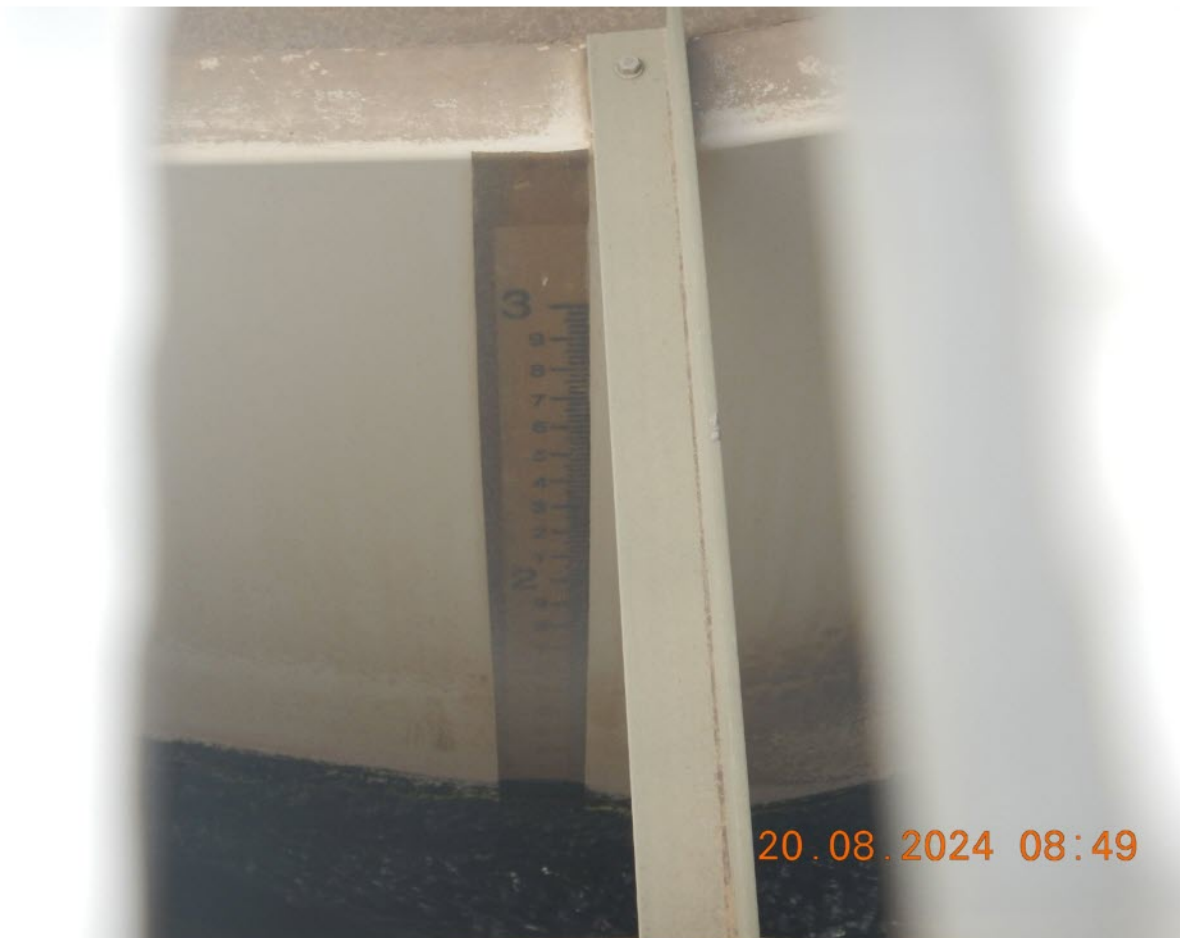
Photo No. 2

- Rio Rancho utilizes a sonic meter for flow measurement within a Parshall flume after UV disinfection and staff gauge as confirmation. However, the staff gauge was difficult to read and required cleaning.

Rio Rancho utilizes a sonic meter for flow measurement within a Parshall flume after UV disinfection and staff gauge as confirmation. However, the staff gauge was difficult to read and required cleaning. (DSCN2714). Photographed by E. Yurk

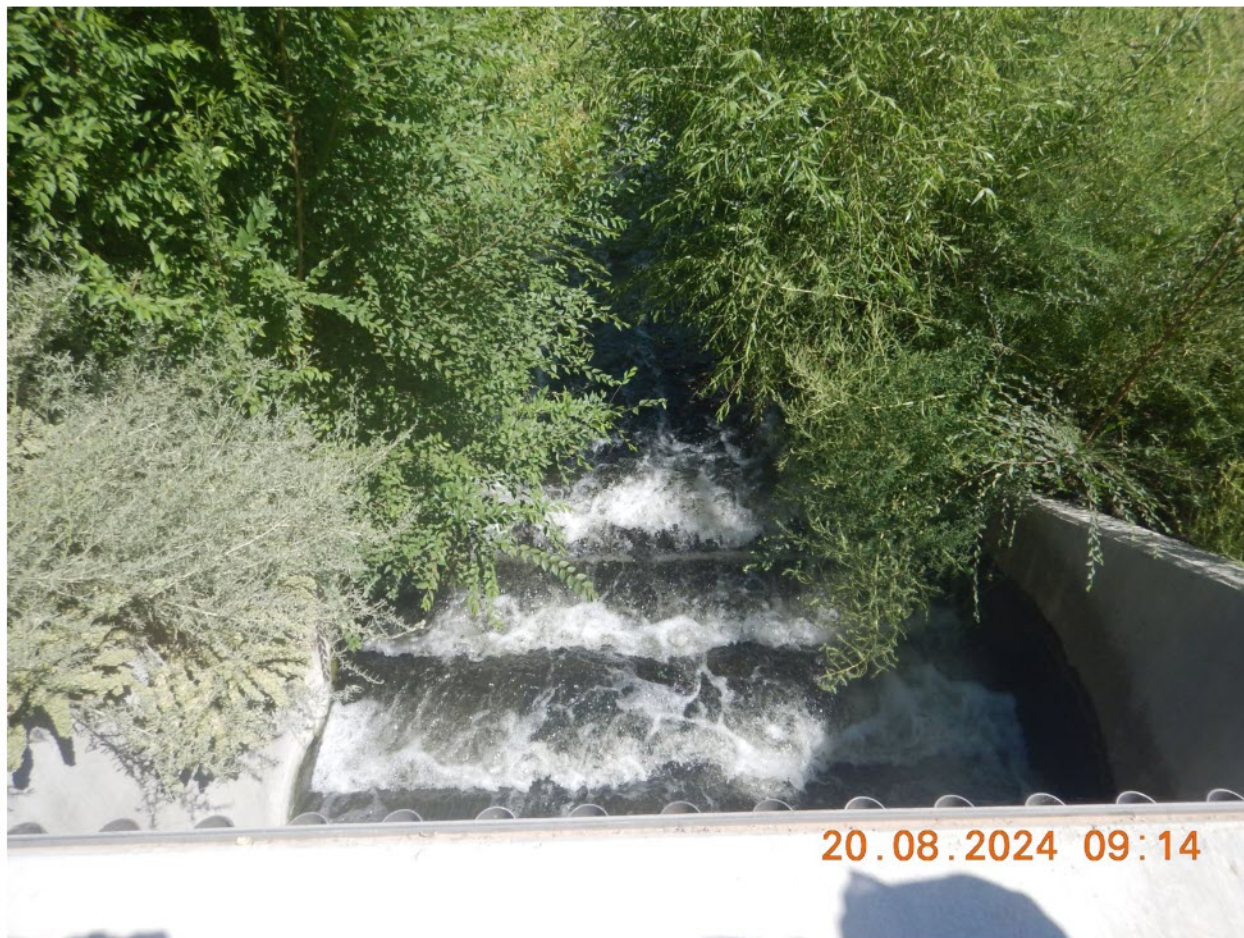
Photo No. 3

View of Outfall 001 downgradient toward the Rio Grande. (DSCN2716) Photographed by E. Yurk

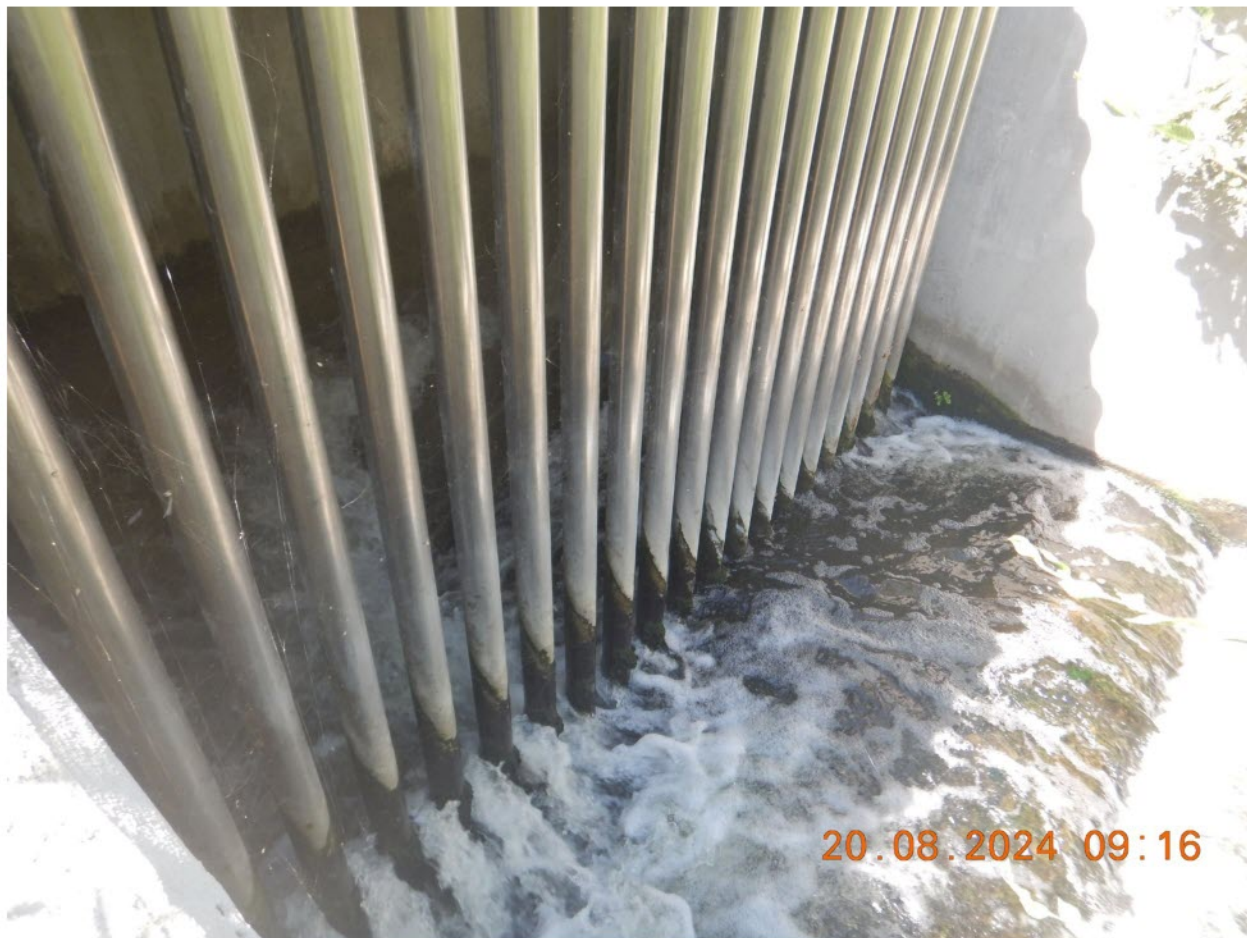
Photo No. 4

View of Outfall 001 at the discharge orifice. Note: there was no evidence of aromatics, stressed vegetation, or staining (sheen). (DSCN2718) Photographed by E. Yurk

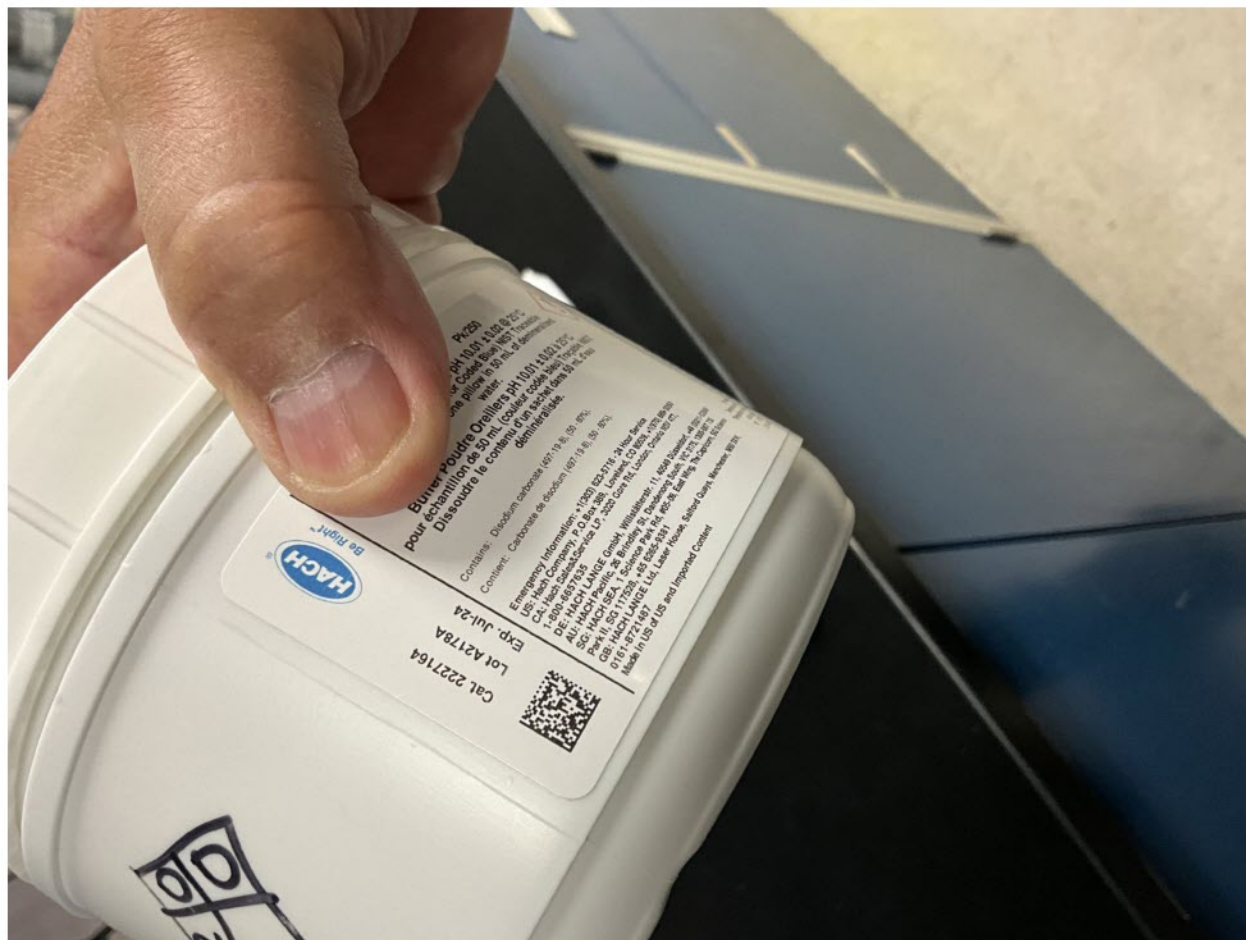
Photo No. 5

- The on-site laboratory pH-10 buffer had expired (July 2024).
- Rio Rancho consultants stated the sludge blanket within the treatment basins is approximately 1-foot thick and the basins were last cleaned in 2013.

View of the on-site laboratory pH-10 buffer that had expired (July 2024). (IMG\_0010). Photographed by D. Esparza
