RCRA COMPLIANCE EVALUATION INSPECTION

Wood Group Pratt & Whitney
Industrial Turbine Services
38 Colorado Street
Plattsburgh, New York

NY2570006088

February 28, 2024

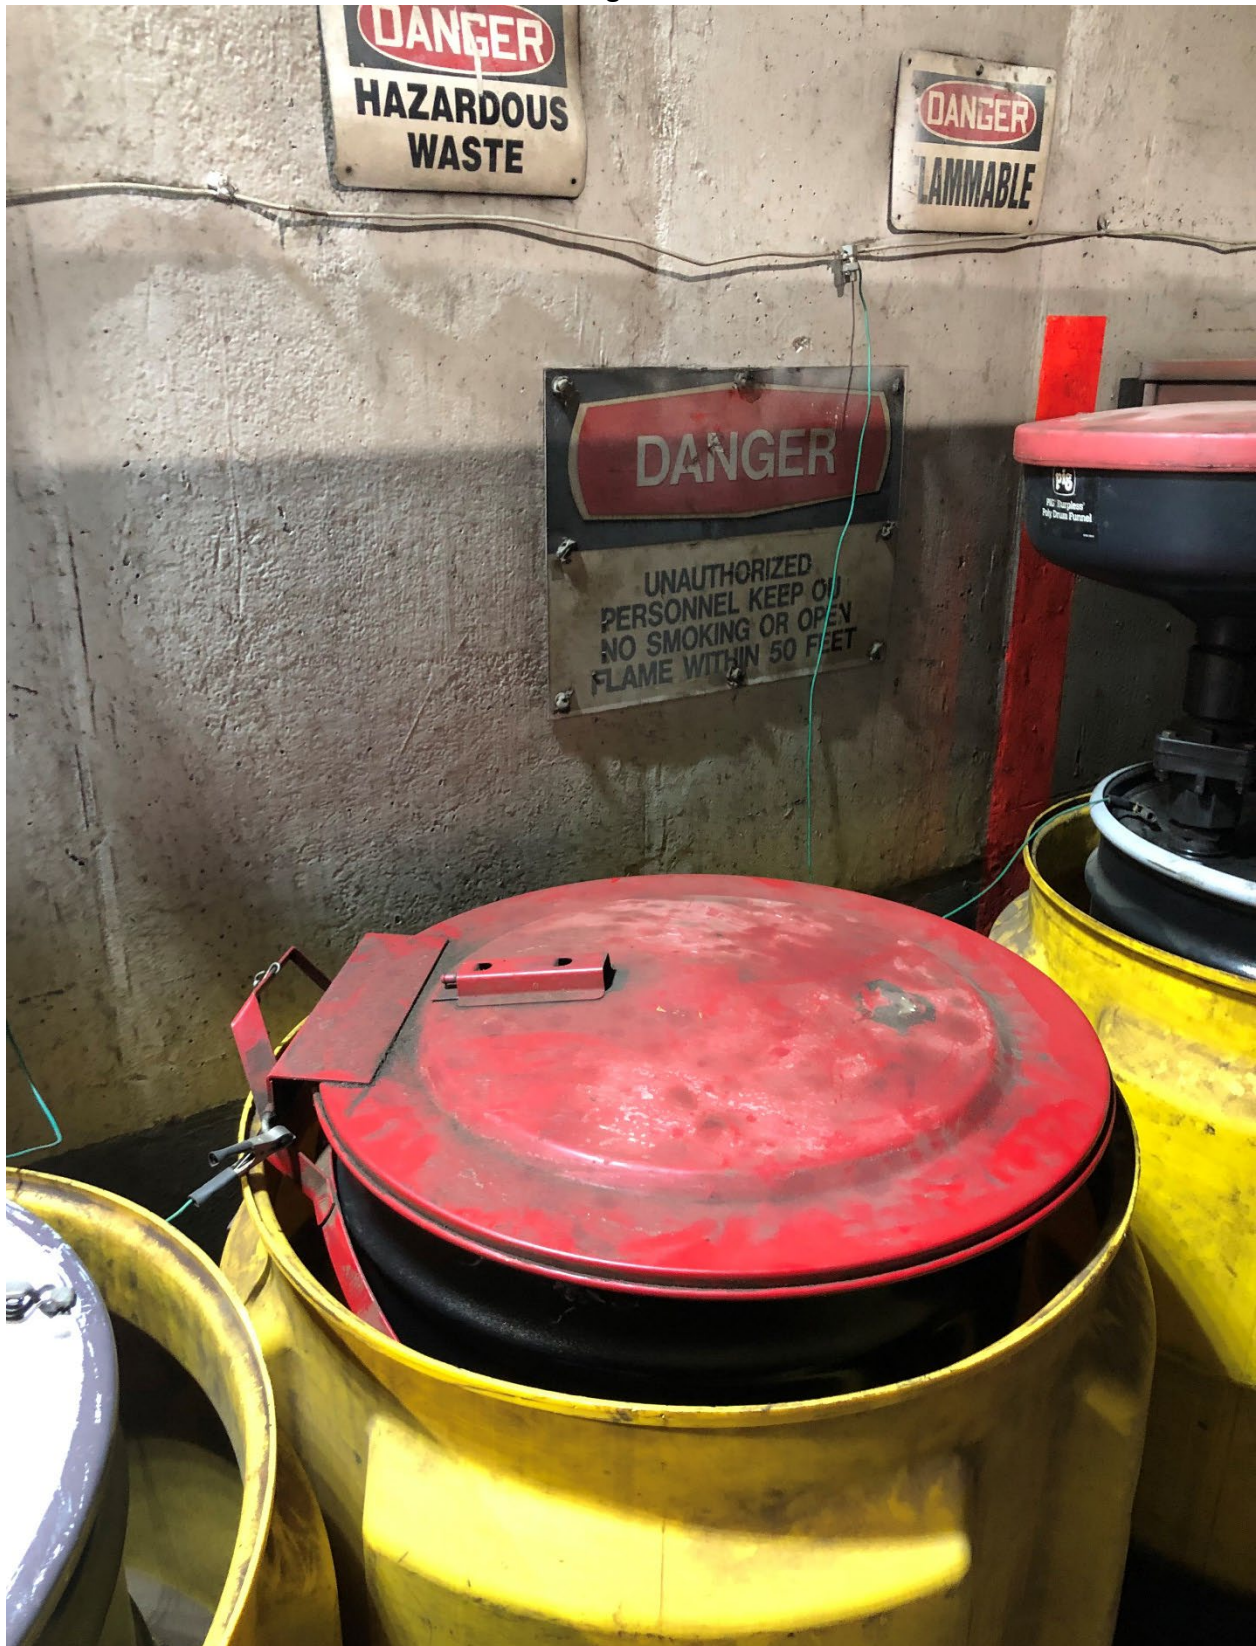
Photograph (#1)

Photo #1: View of the hazardous waste storage area.
