Clean Water Act Section 404: Site Visit/Case Development

Site Name: Jajoa Holding Corp. Property

EPA CWA 404 Inspection Photolog
Jajoa Holding Corp.
Kauneonga Lake, Sullivan County, NY

September 12, 2023

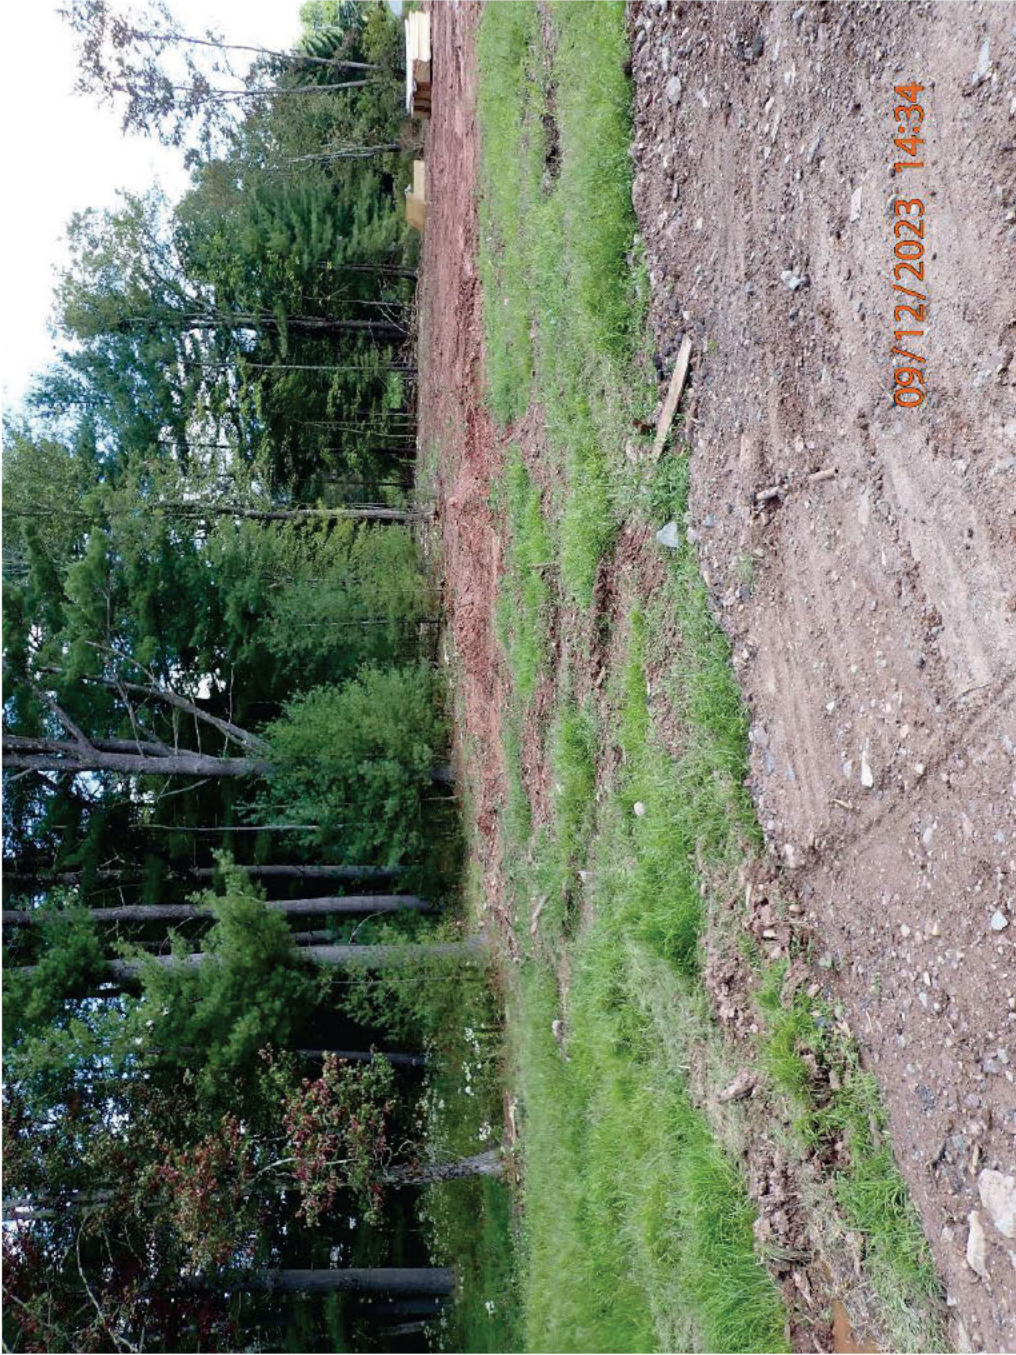
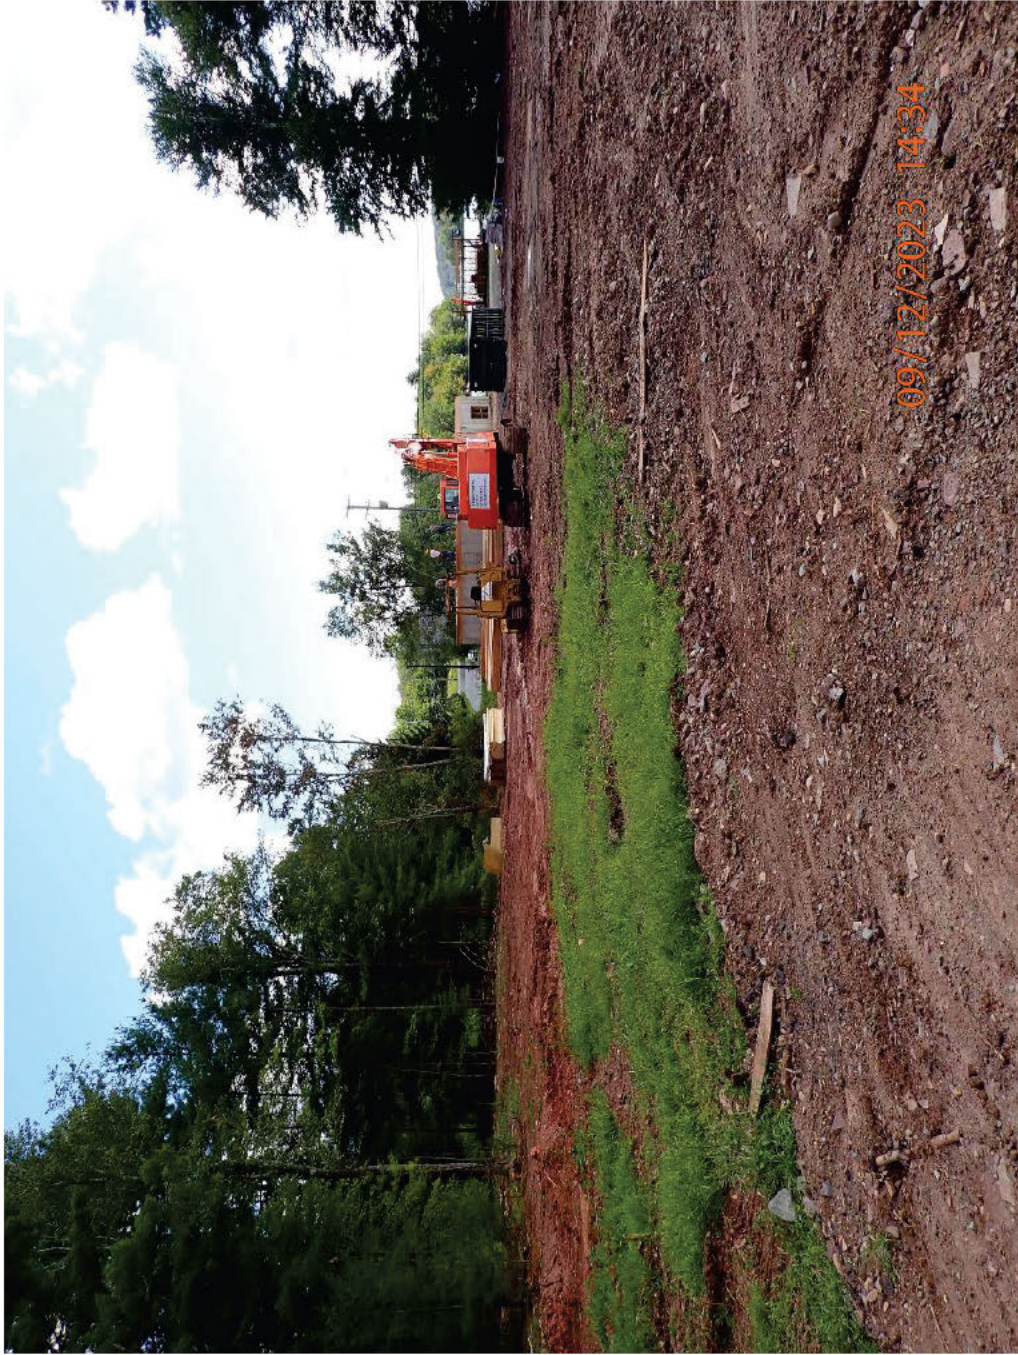
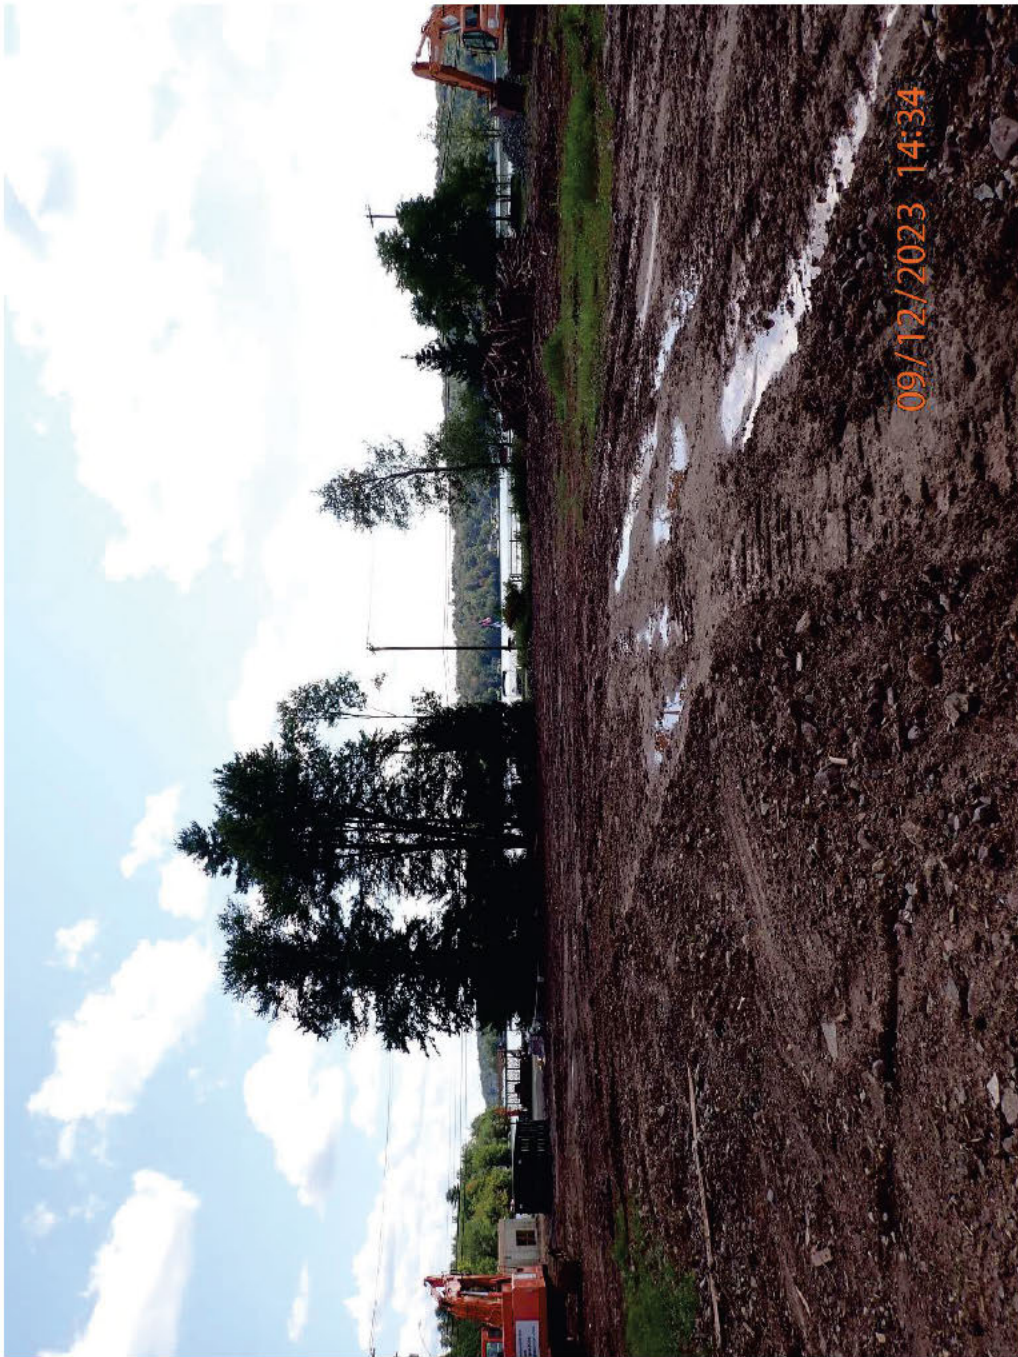
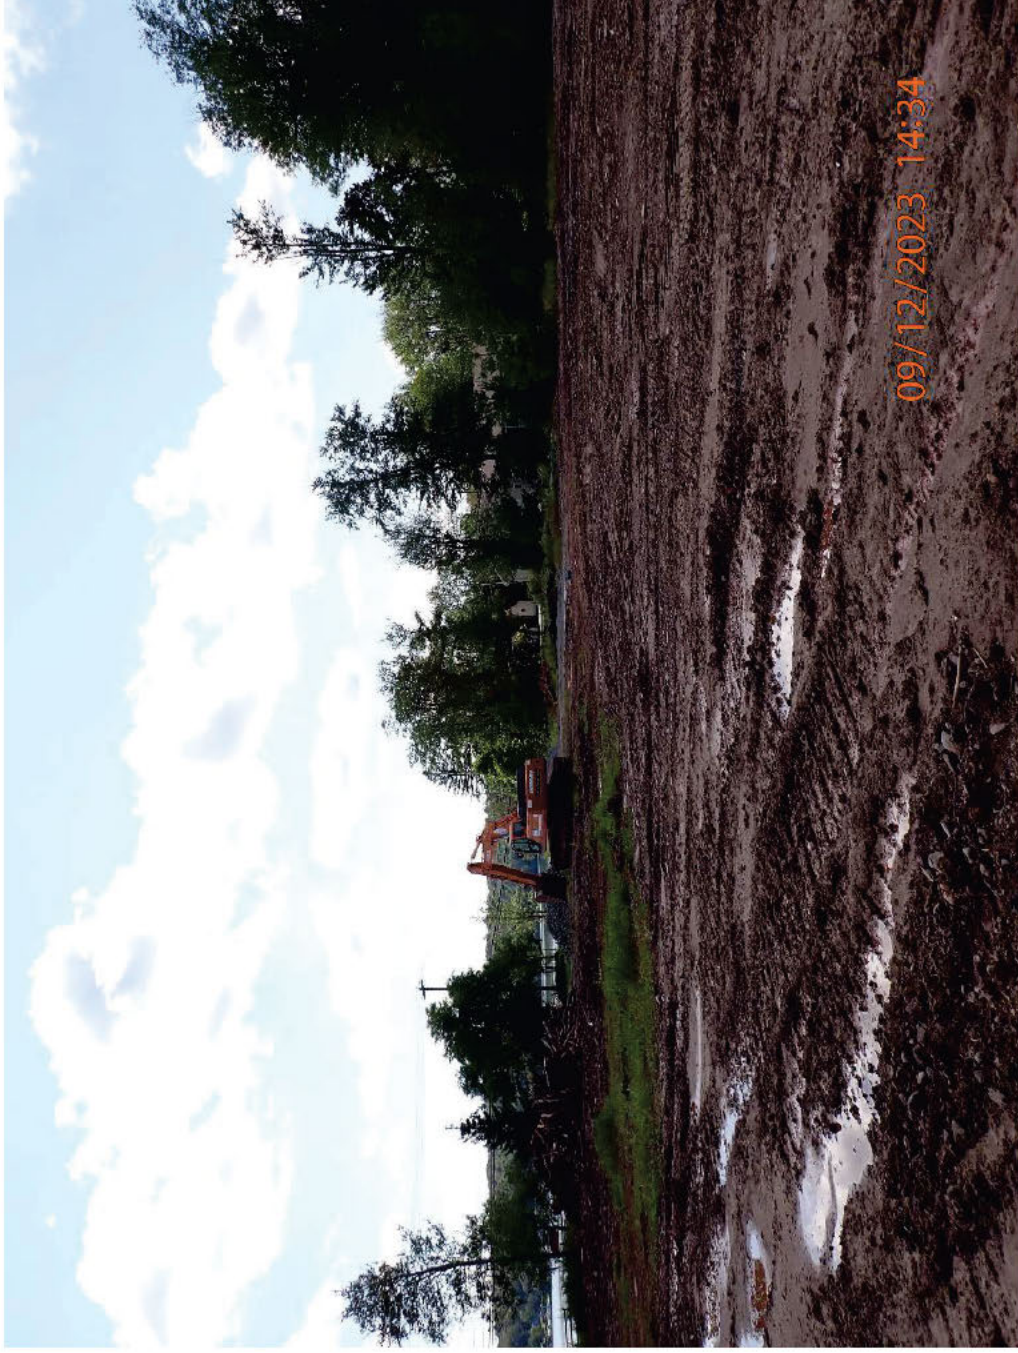
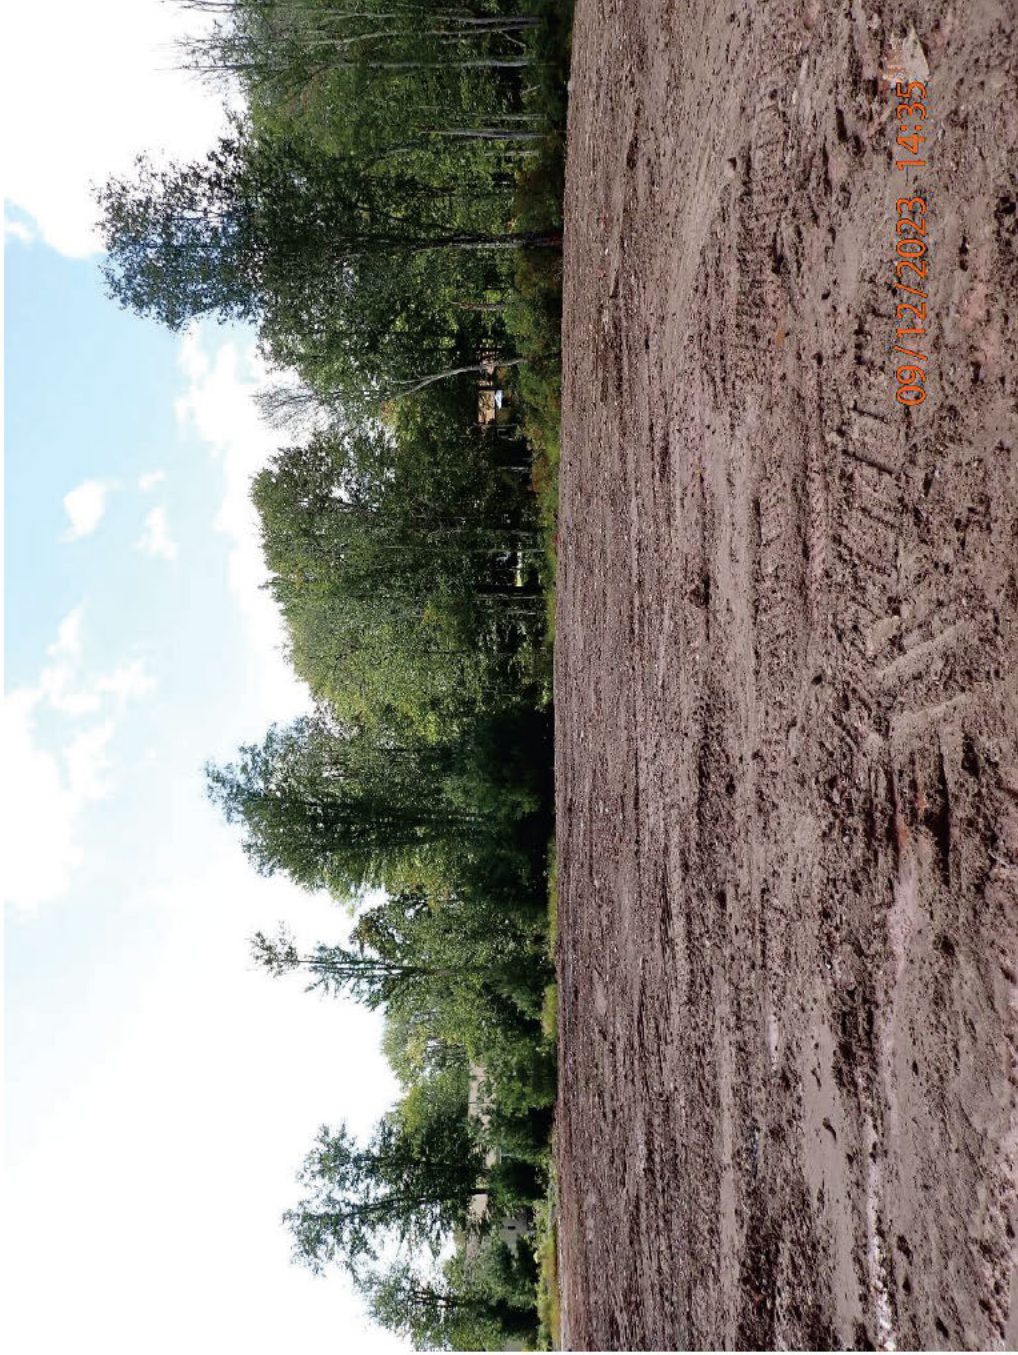
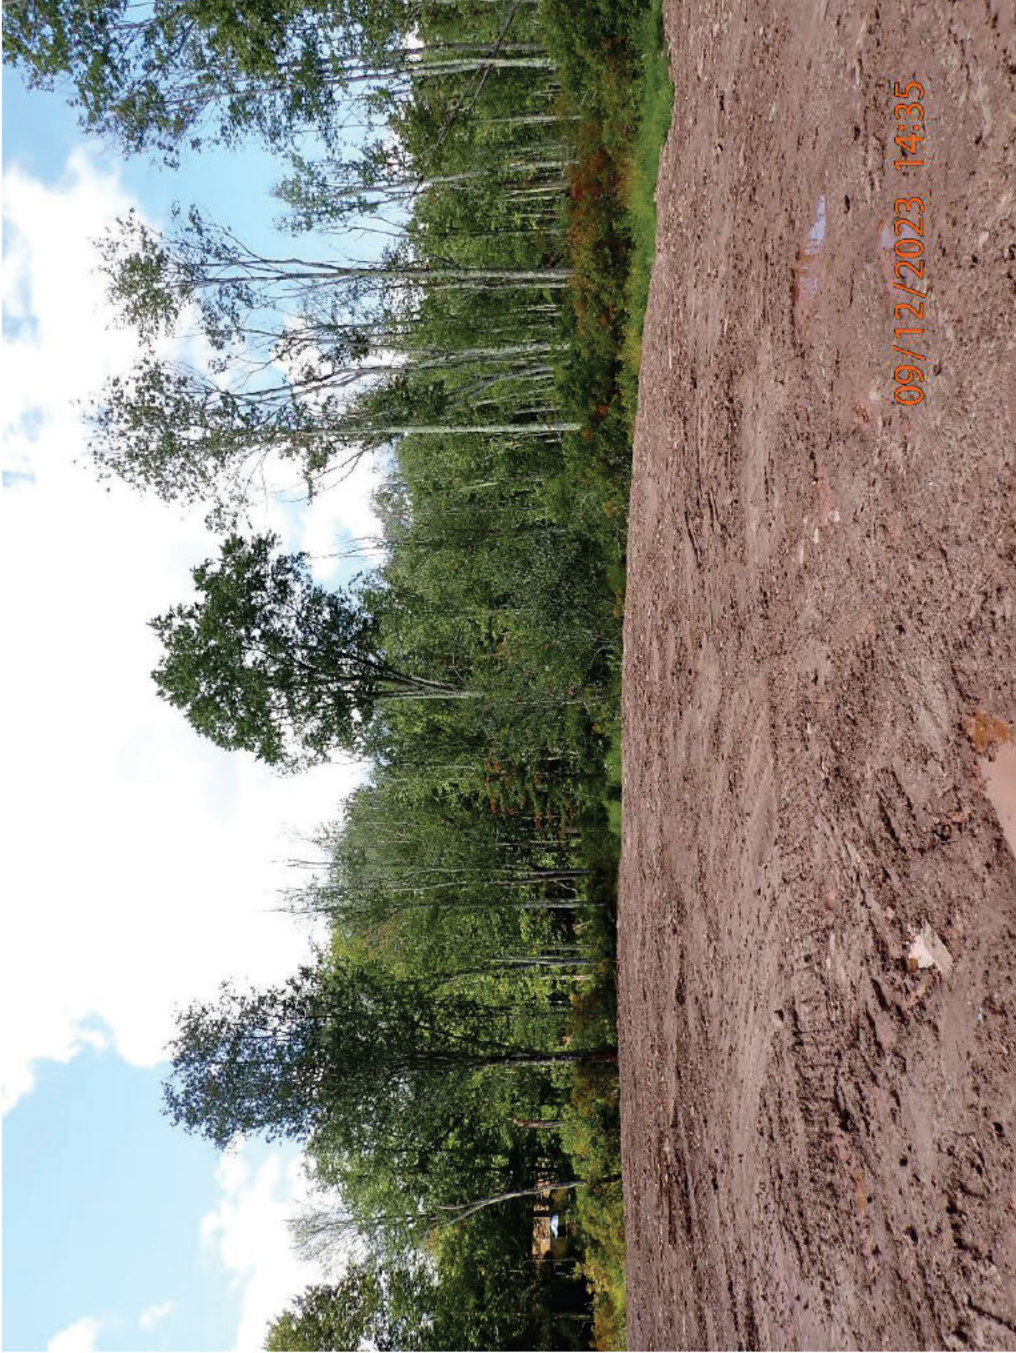
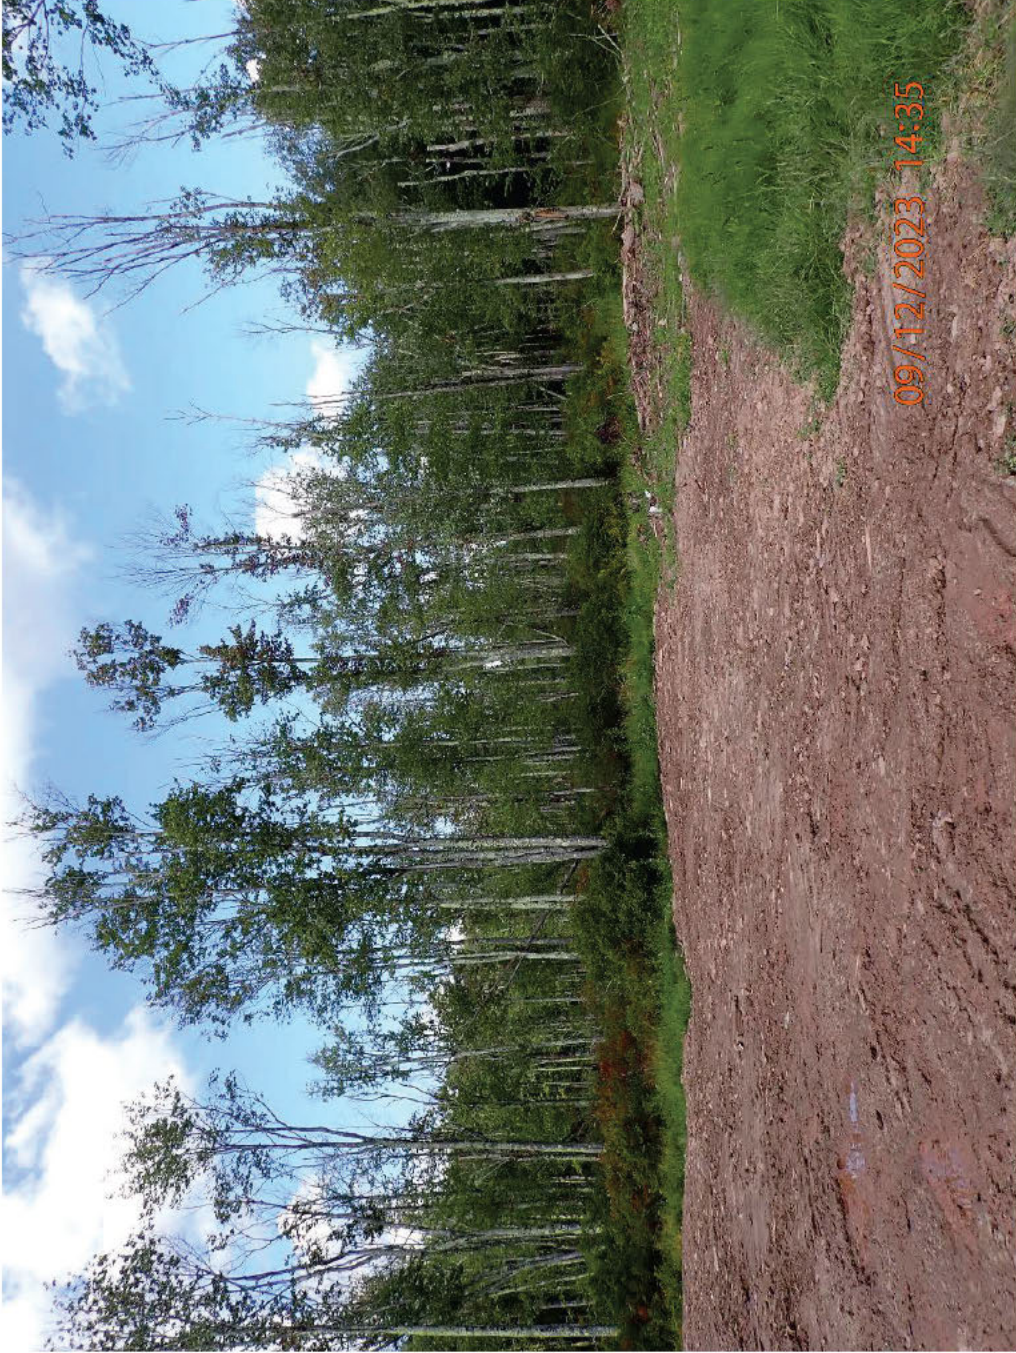
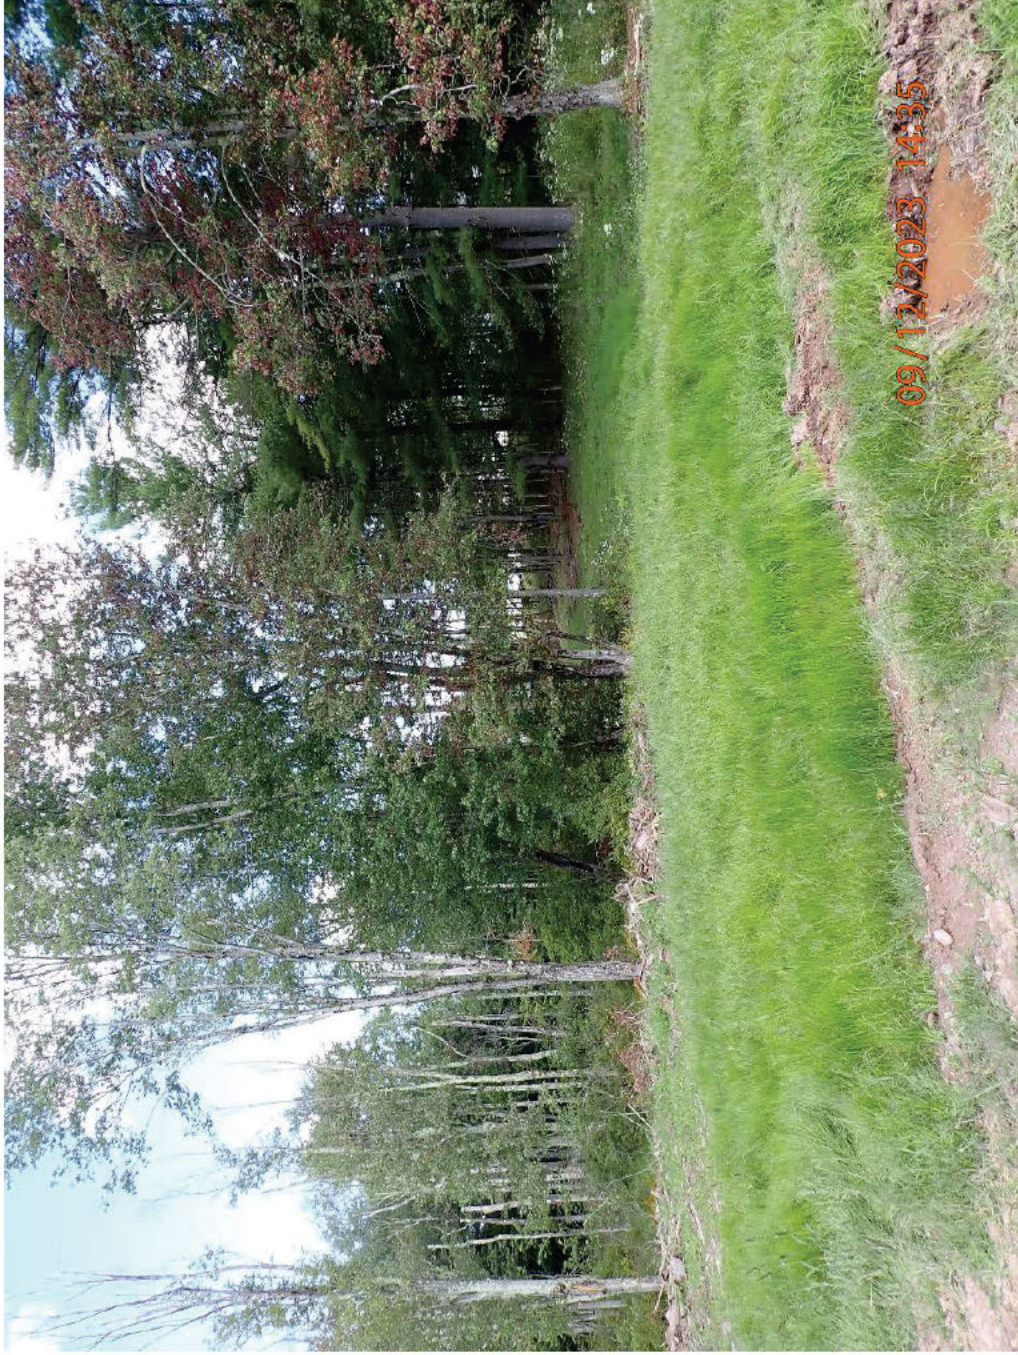
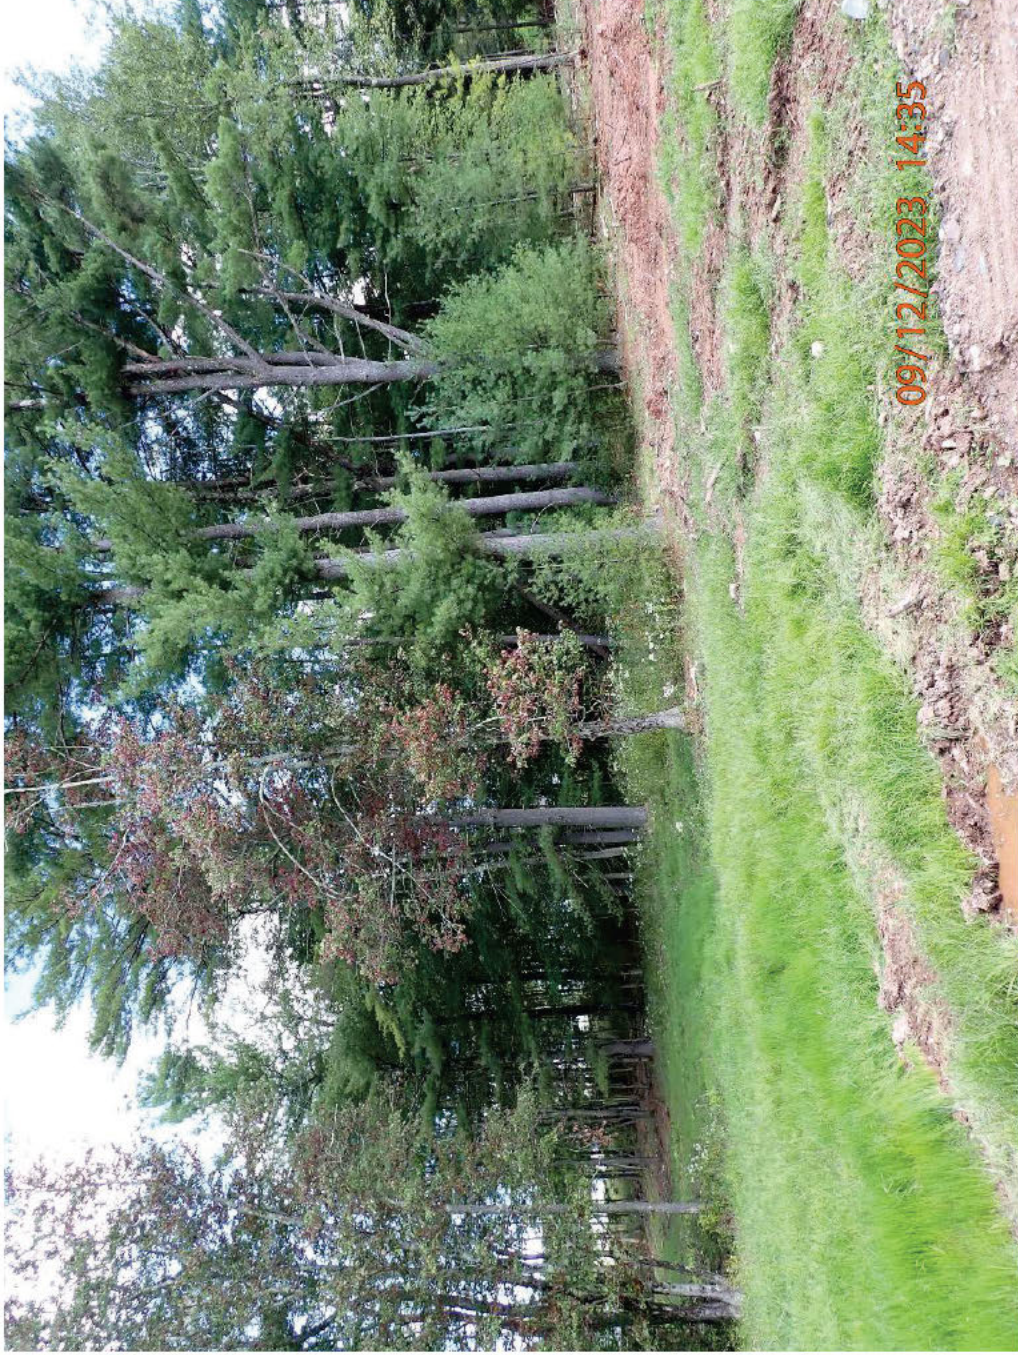
Description:
(1/9) Panorama of disturbed portion of site

Description:
(2/9) Panorama of disturbed portion of site

Description:
(3/9) Panorama of disturbed portion of site

Description:
(4/9) Panorama of disturbed portion of site

Description:
(5/9) Panorama of disturbed portion of site

Description:
(6/9) Panorama of disturbed portion of site

Description:
(7/9) Panorama of disturbed portion of site

Description:
(8/9) Panorama of disturbed portion of site

Description:
(9/9) Panorama of disturbed
portion of site

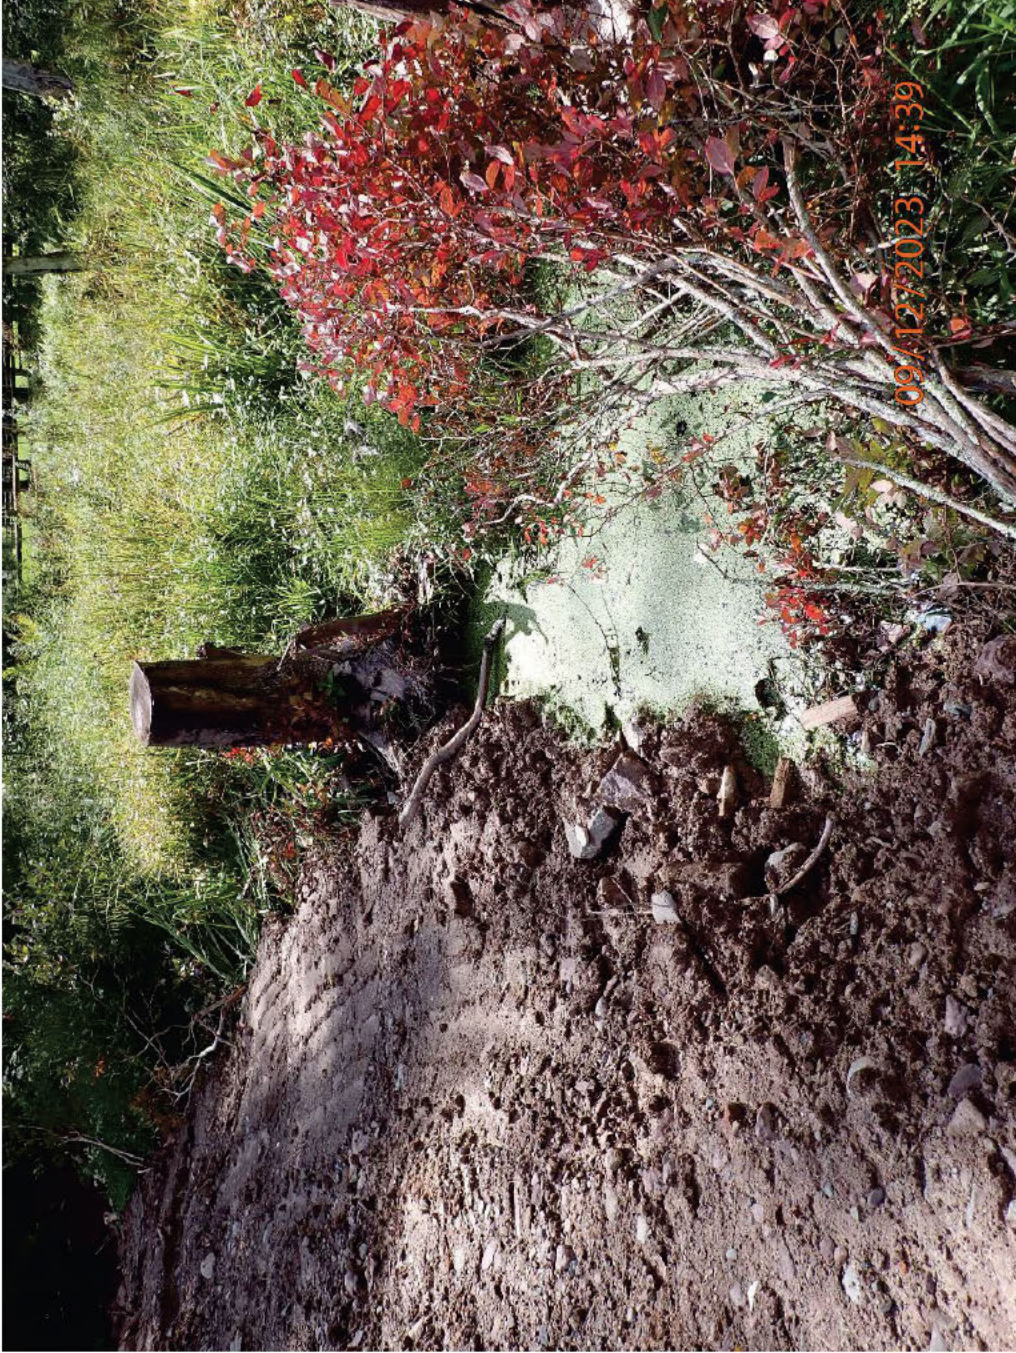
Date: 9/12/2023
Time: 2:39 PM
Photographer: S. Andreescu
Photo ID: 10 – P9120191

Limit-of-disturbance

Fill material adjacent to wetland area

Duckweed present in standing water

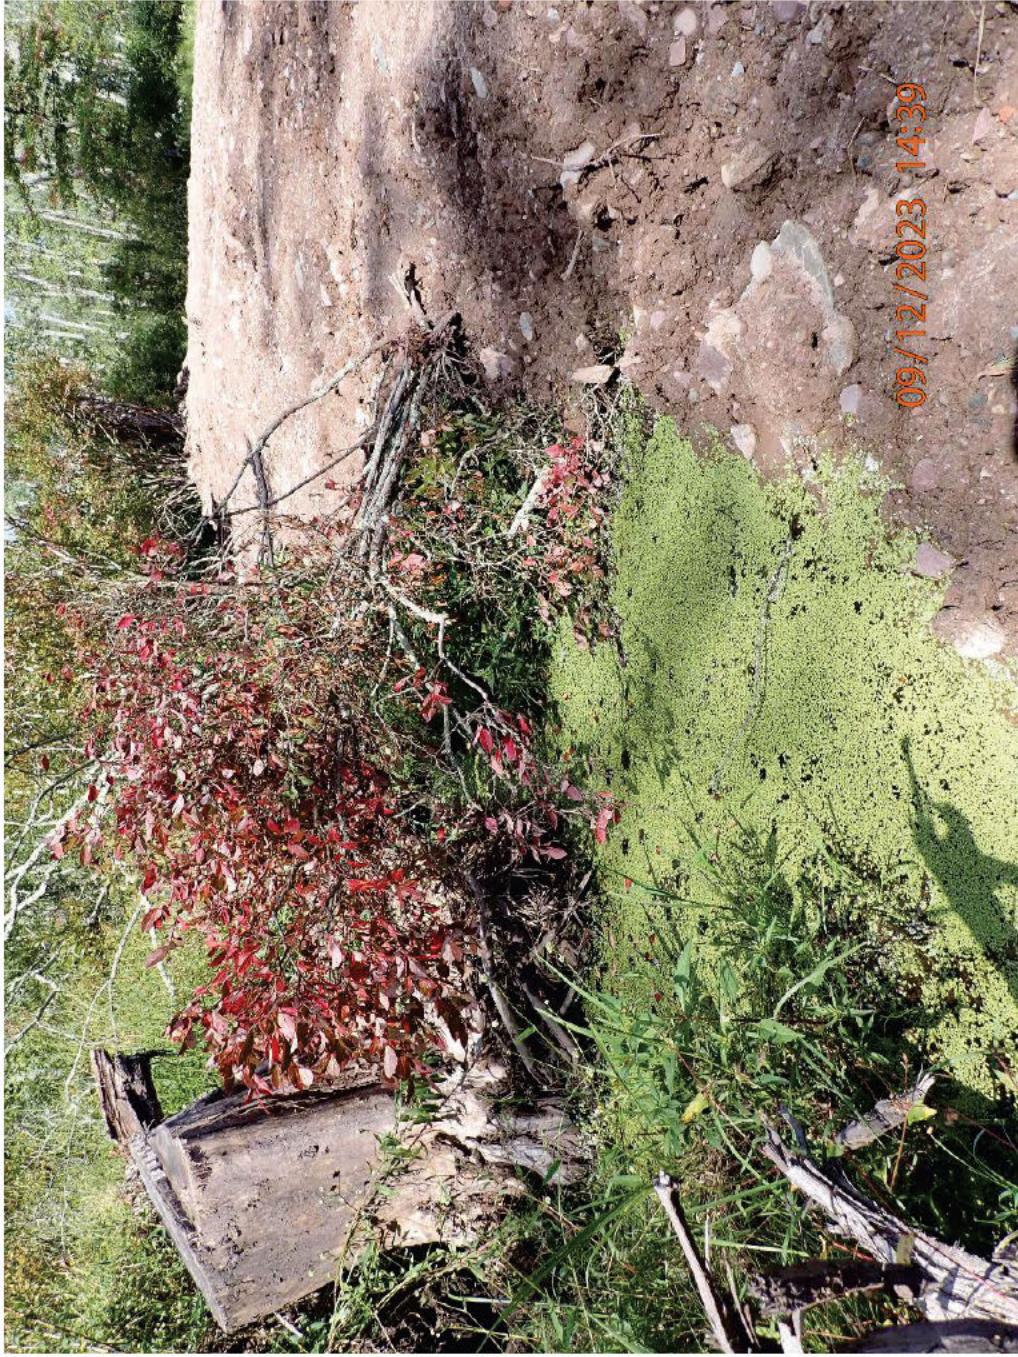
Date: 9/12/2023
Time: 2:39 PM
Photographer: S. Andreescu
Photo ID: 11 – P9120192

Limit-of-disturbance
Fill material adjacent to wetland area
Duckweed present in standing water

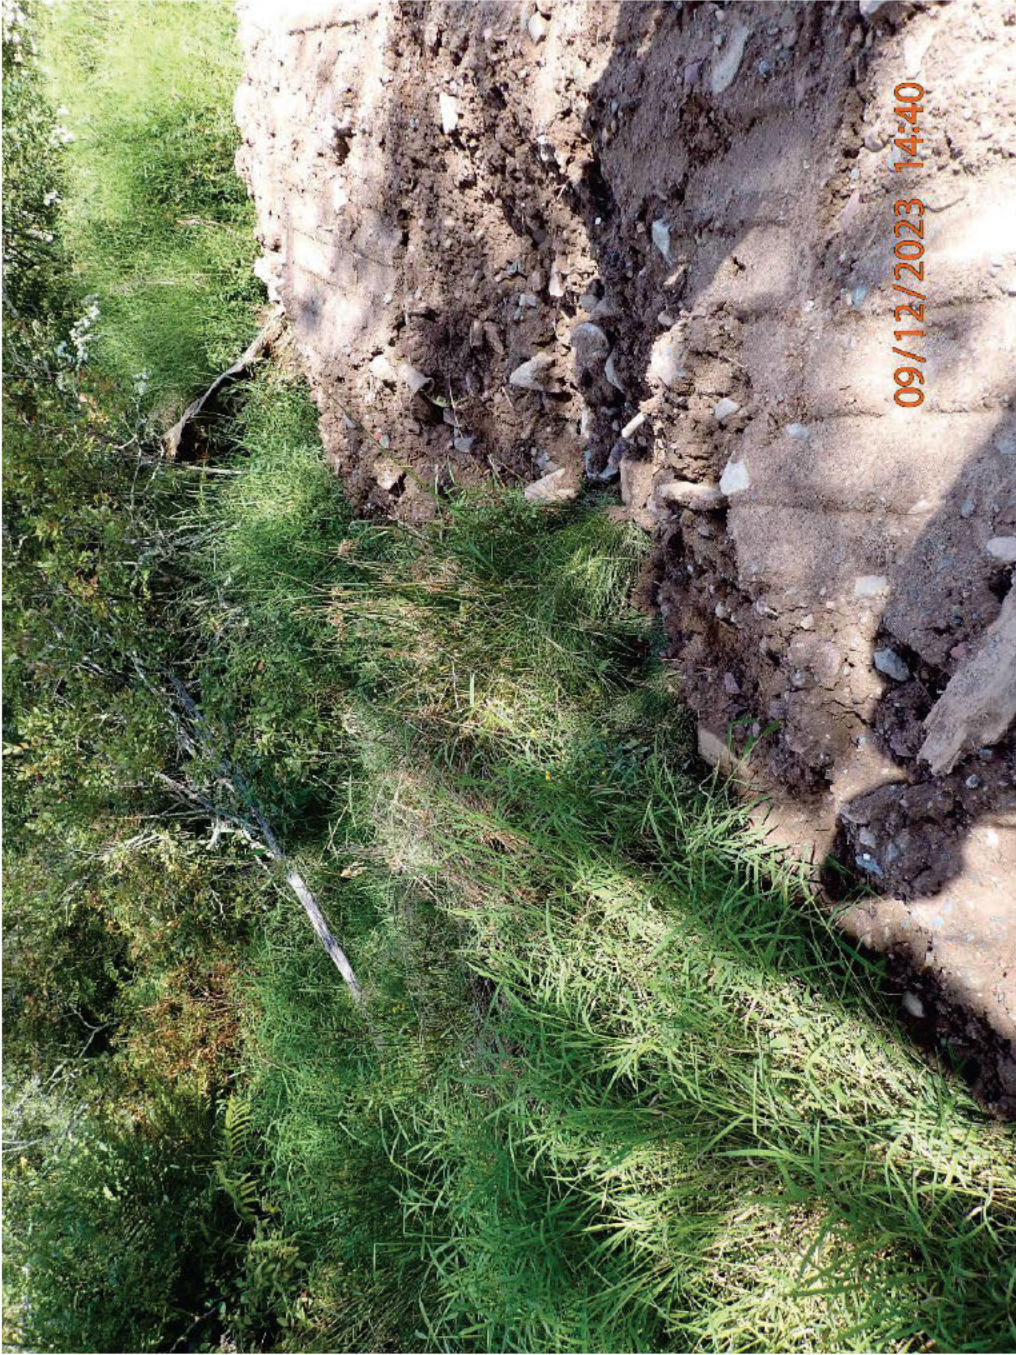
Date: 9/12/2023
Time: 2:40 PM
Photographer: S. Andreescu
Photo ID: 12 – P9120193

Limit-of-disturbance

Fill material adjacent to wetland area

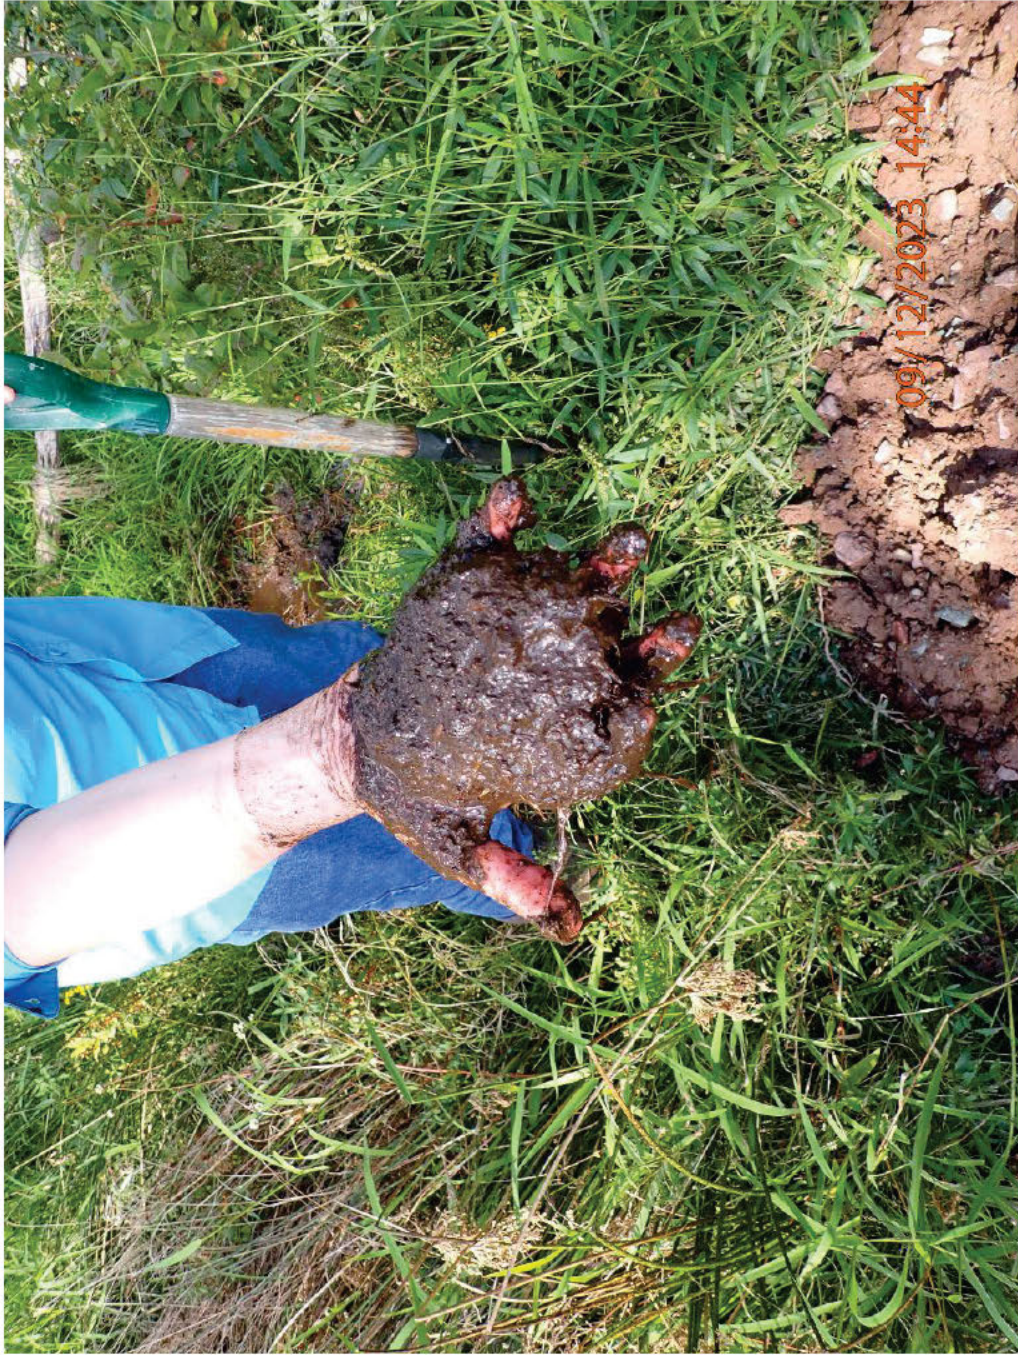
Date: 9/12/2023
Time: 2:44 PM
Photographer: S. Andreescu
Photo ID: 13 – P9120194

Muck from soil sample location
#1

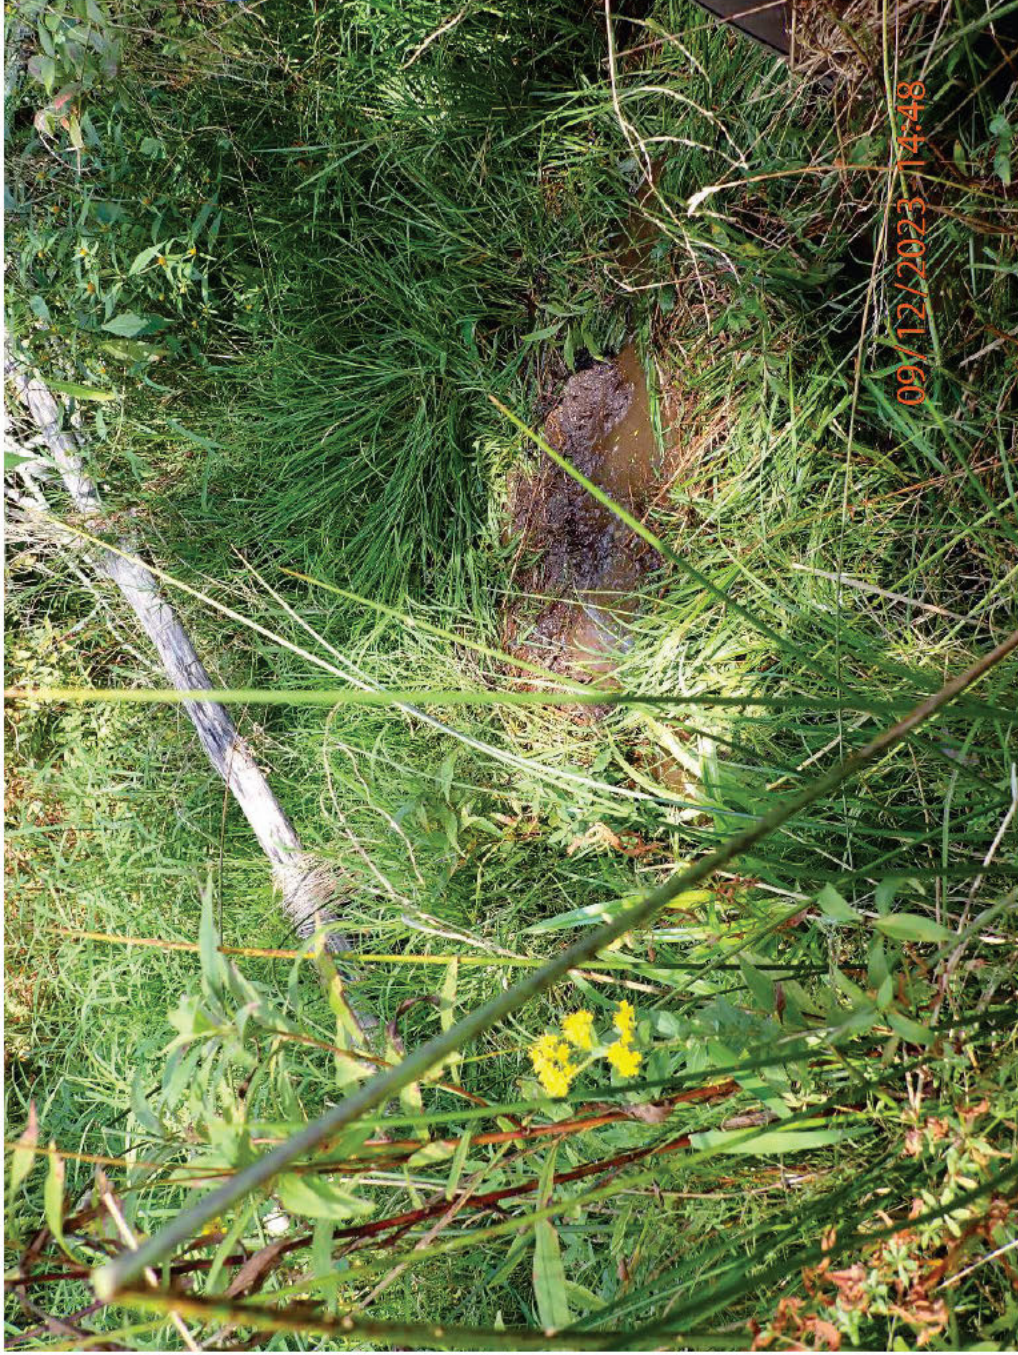
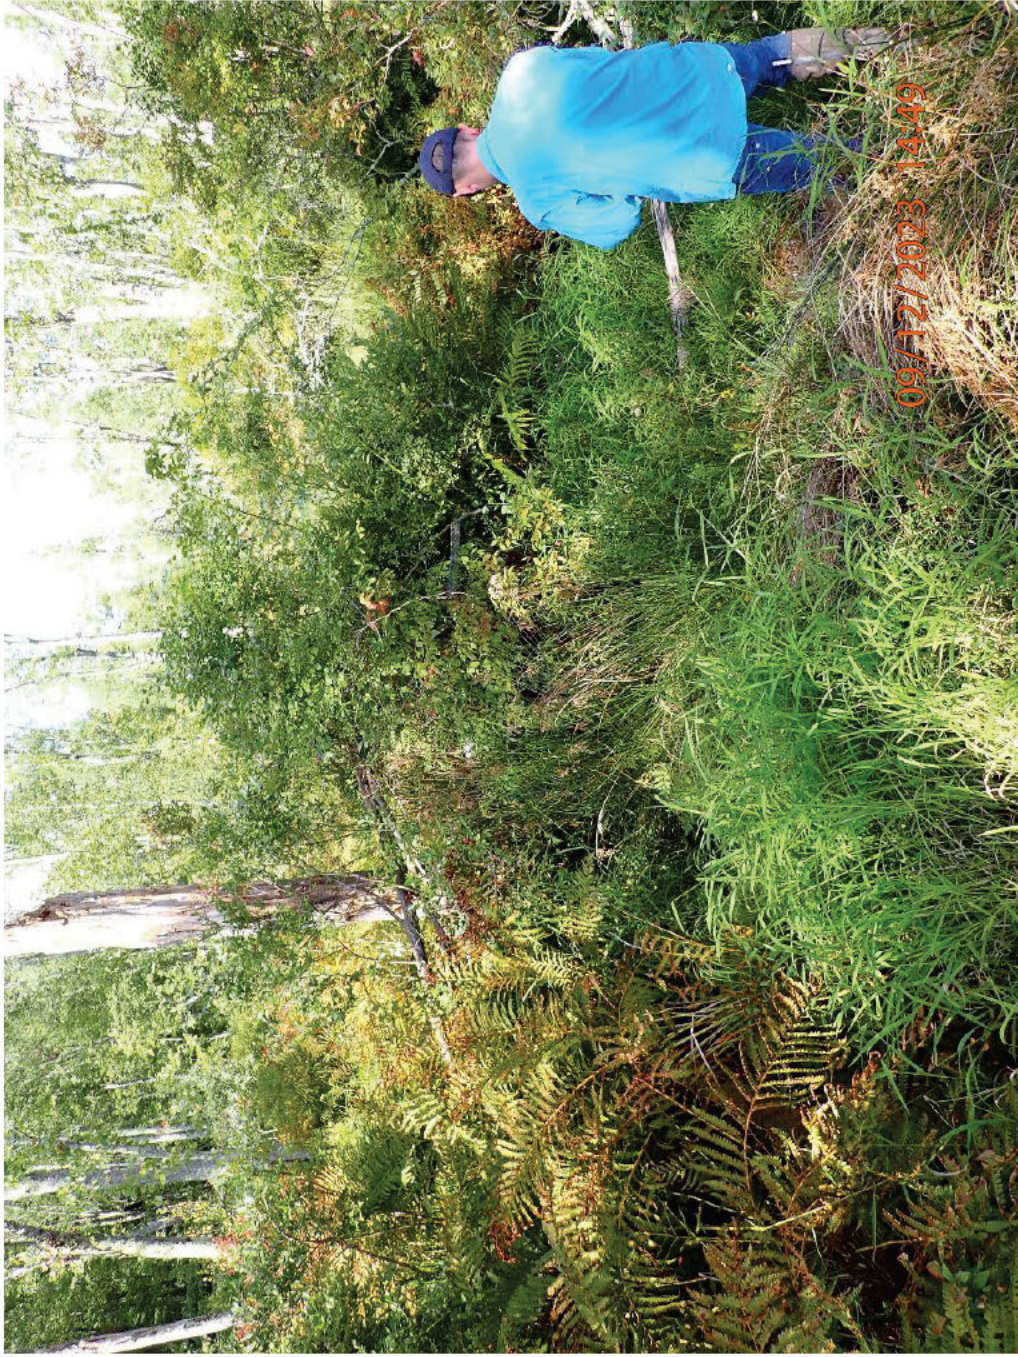
Description:
Soil sample location #1

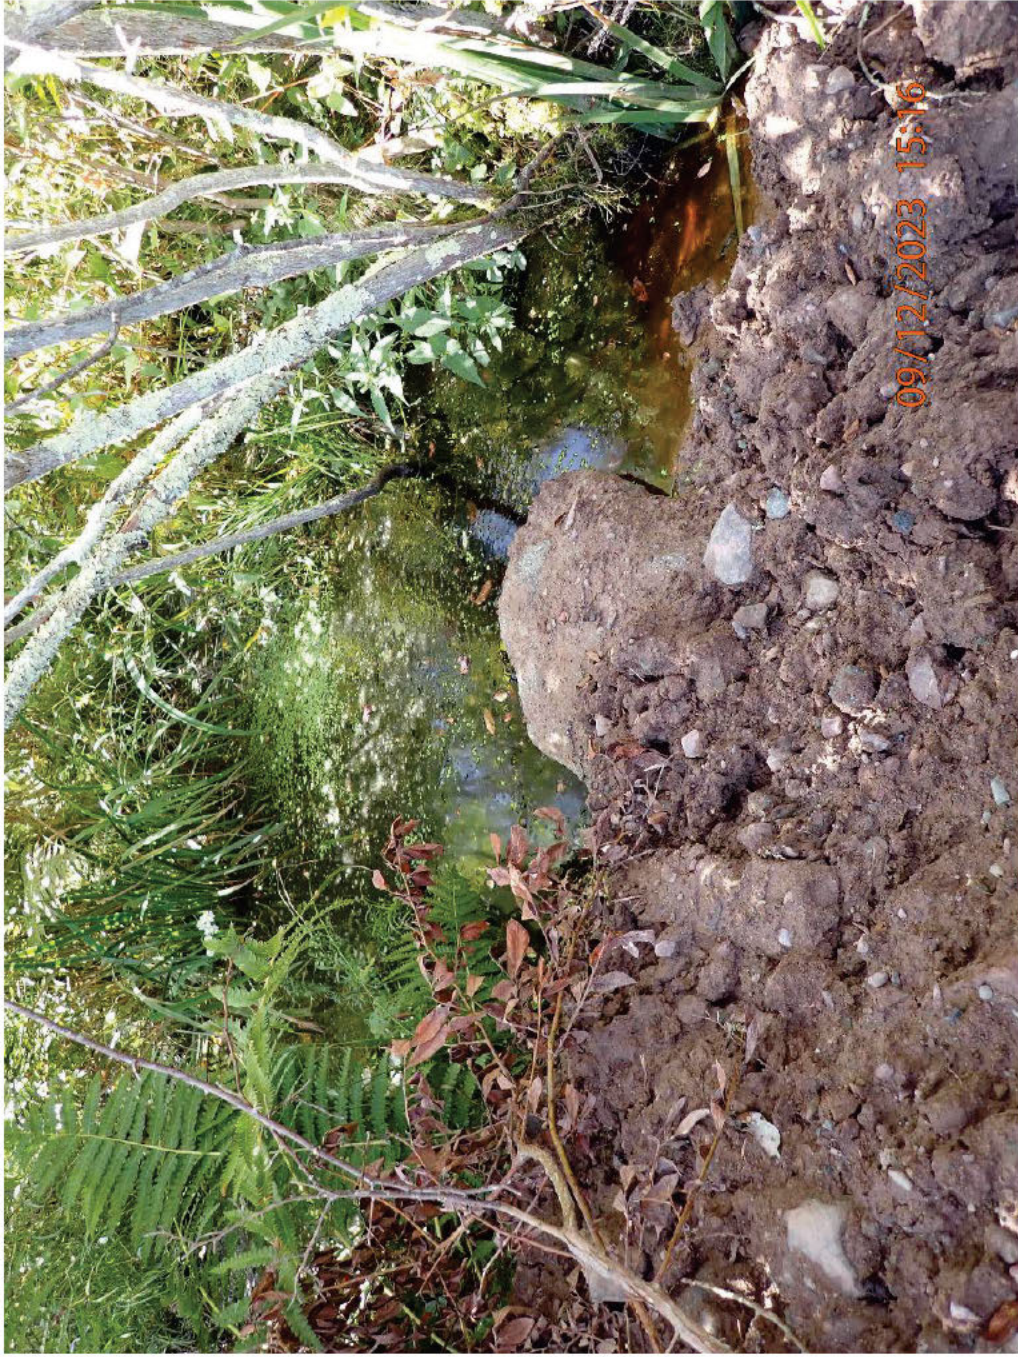
Date: 9/12/2023
Time: 3:16 PM
Photographer: S. Andreescu
Photo ID: 16 – P9120197

Limit-of-disturbance

Fill material adjacent to wetland area

Duckweed present in standing water
