Clean Water Act Section 404: Site Visit/Case Development

Site Name: Jajoa Holding Corp. Property

EPA CWA 404 Inspection Photolog
Jajoa Holding Corp.
Kauneonga Lake, Sullivan County, NY

September 12, 2023

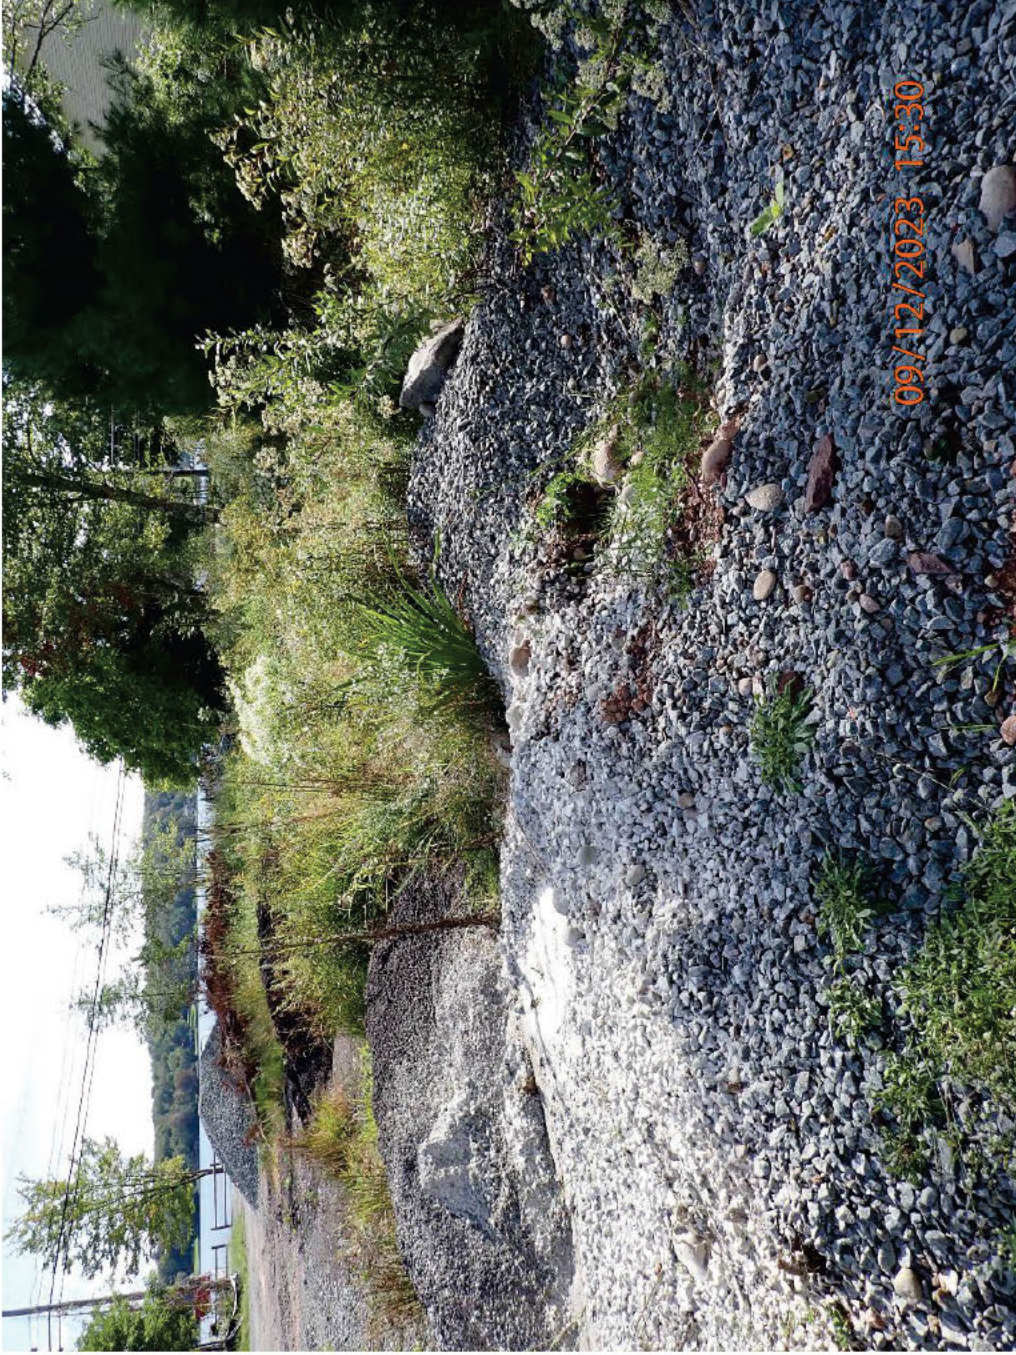
Date: 9/12/2023
Time: 3:30 PM
Photographer: S. Andreescu
Photo ID: 17 – P9120198

Piles of gravel near edge of disturbance

Lake in background

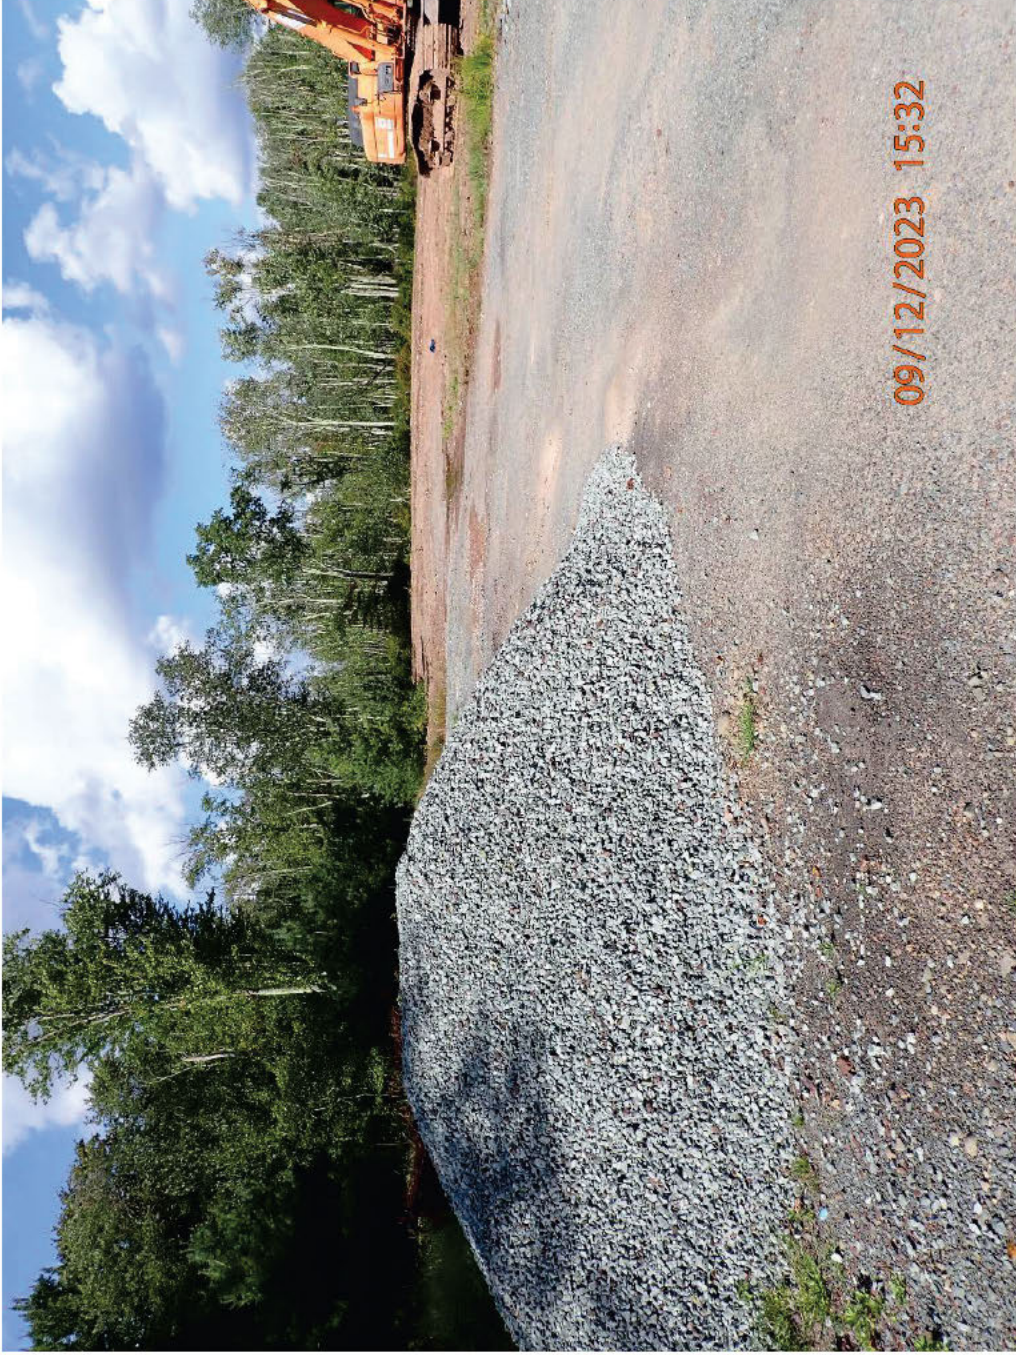
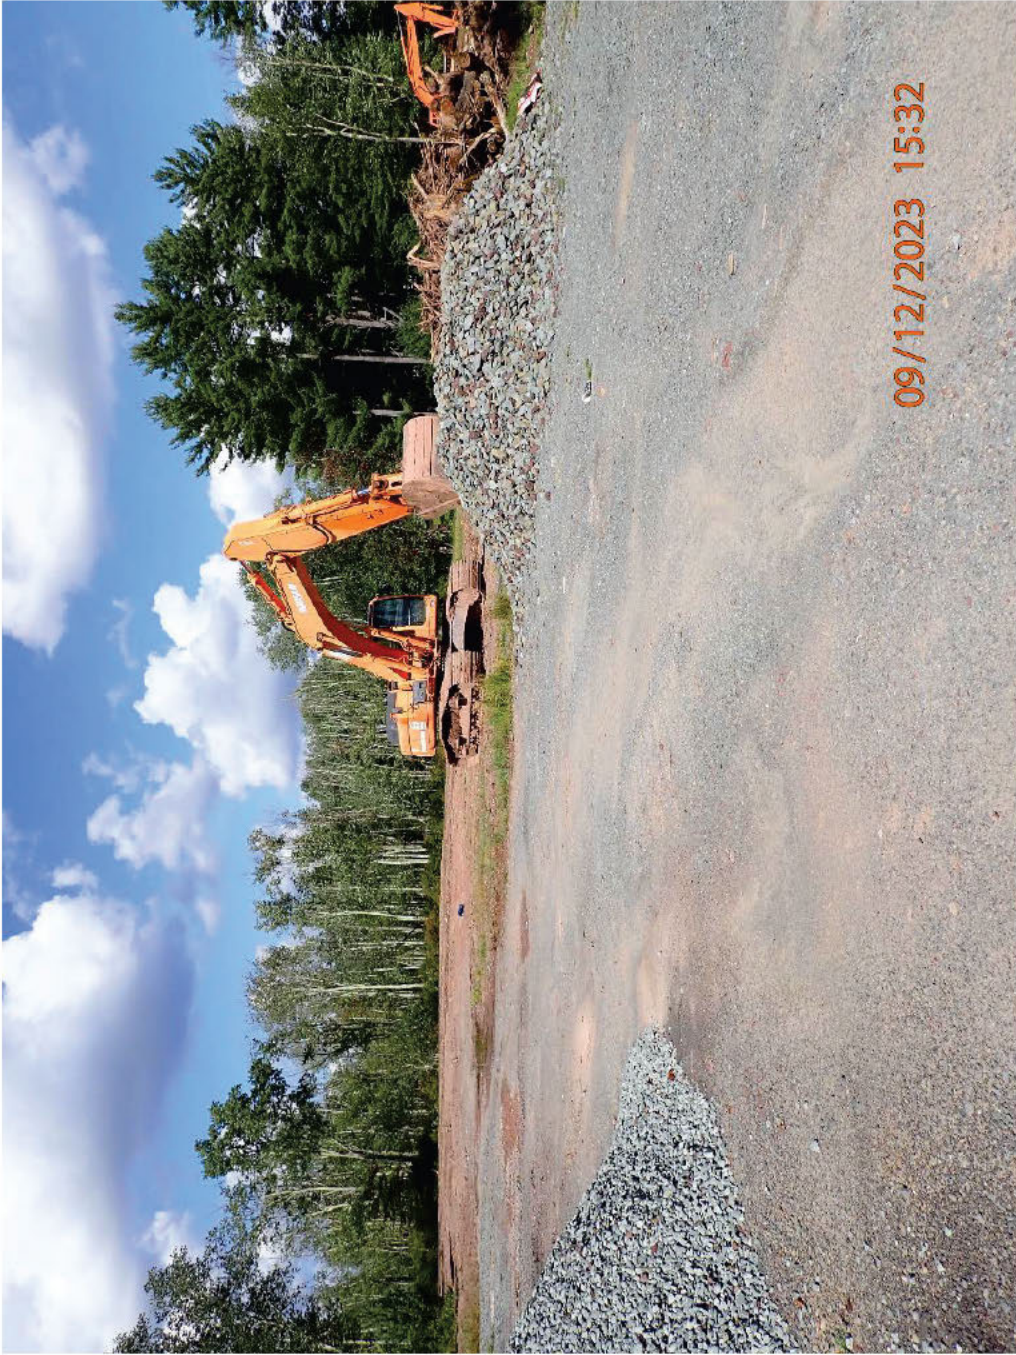
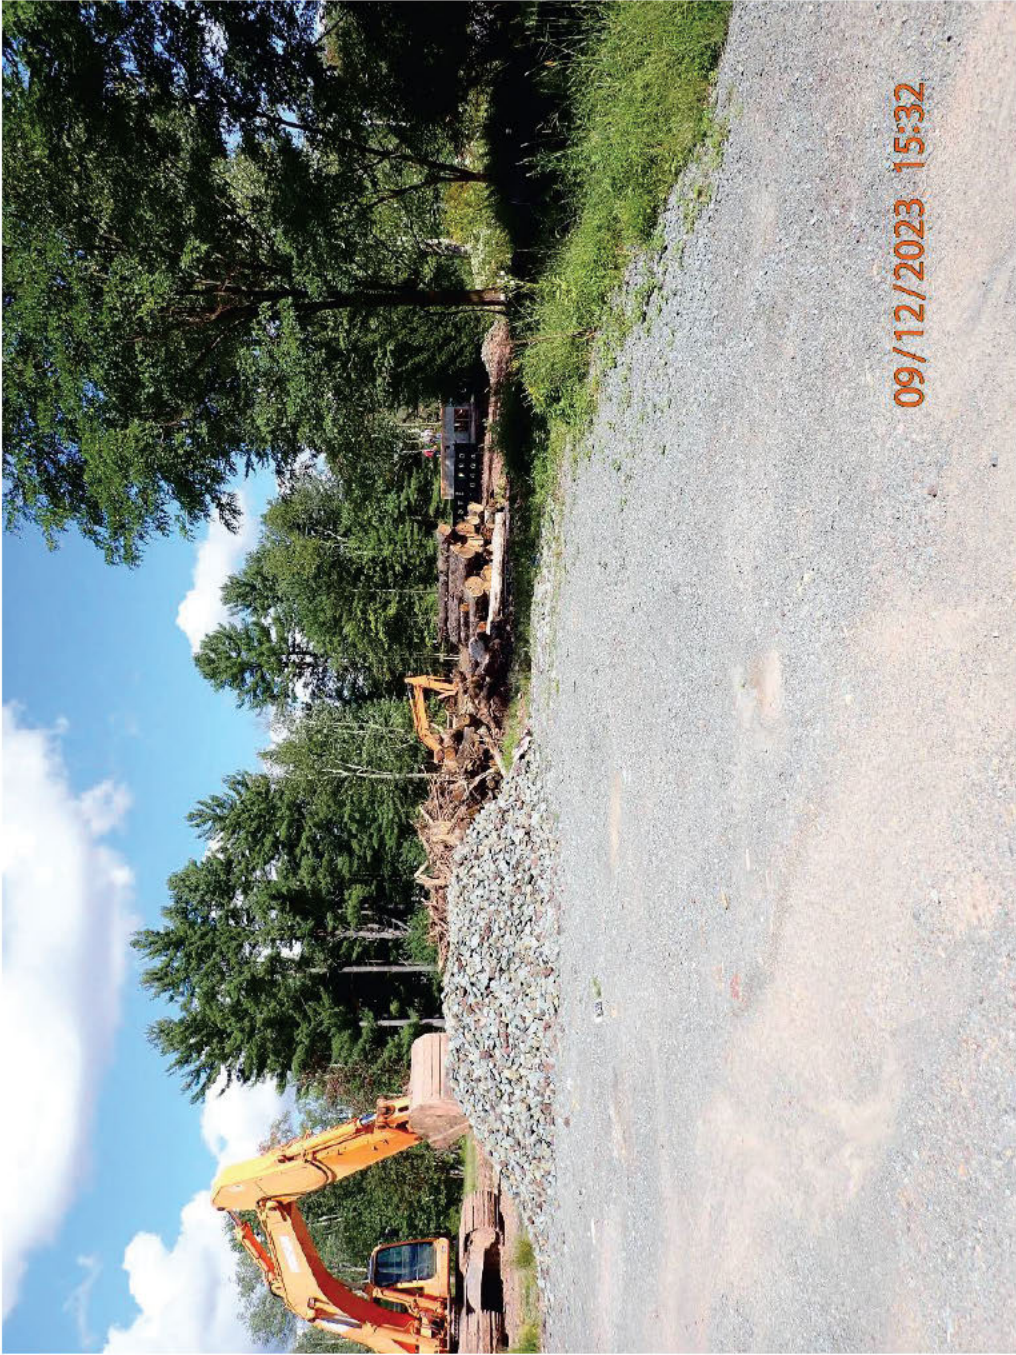
(1/3) Panorama of site and equipment from near West Shore Road

(2/3) Panorama of site and equipment from near West Shore Road

(3/3) Panorama of site and equipment from near West Shore Road

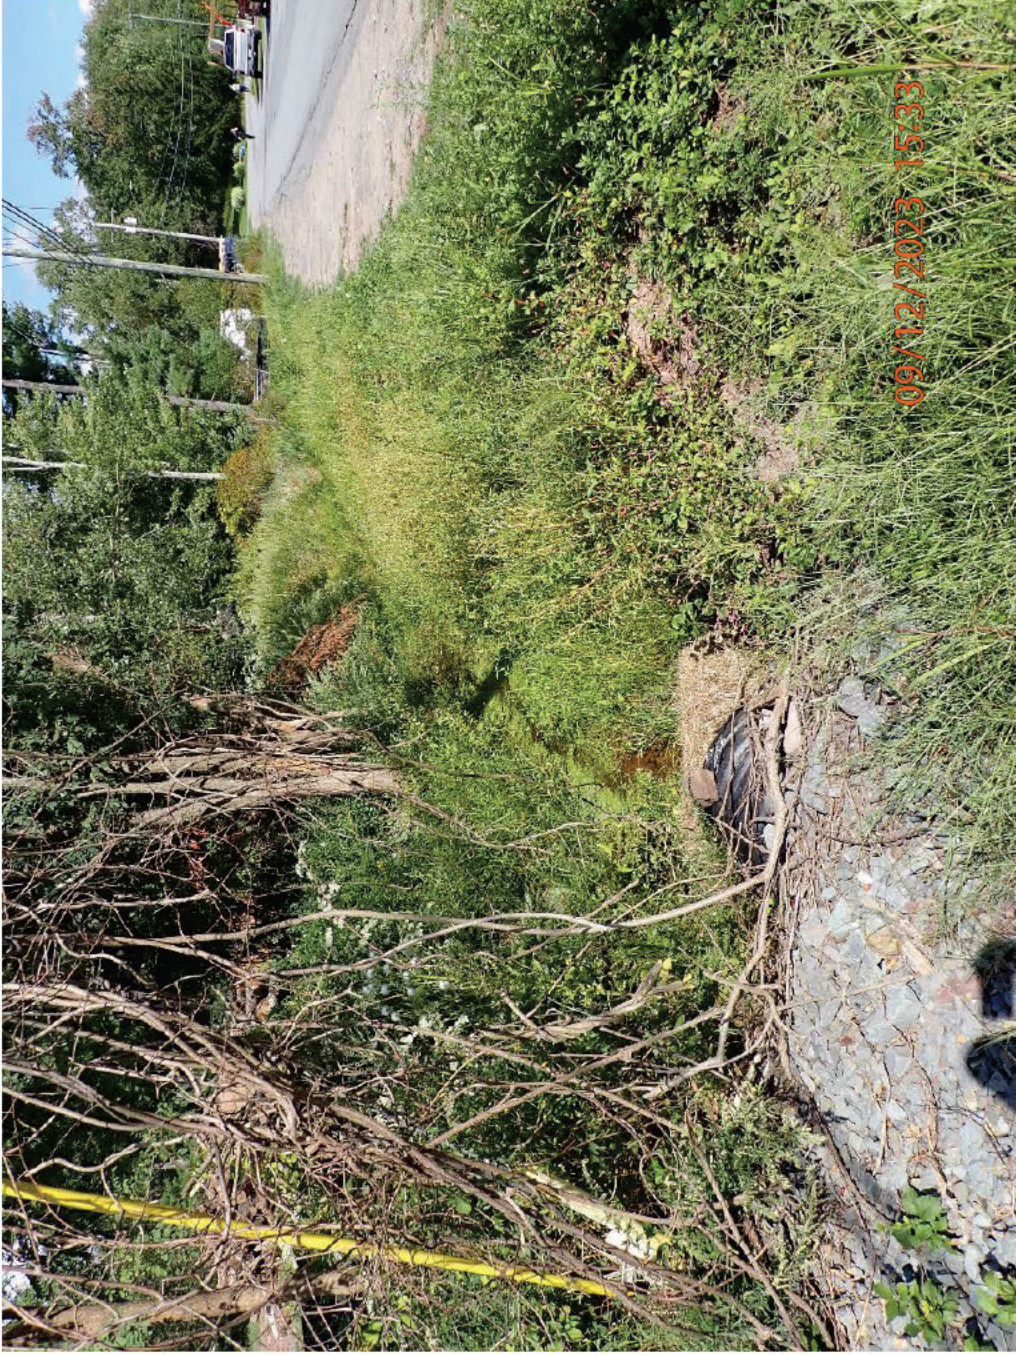
Date: 9/12/2023
Time: 3:33 PM
Photographer: S. Andreescu
Photo ID: 21 – P9120202

Roadside ditch along West Shore Road
Culvert under one of two access driveways to site
Photo facing east

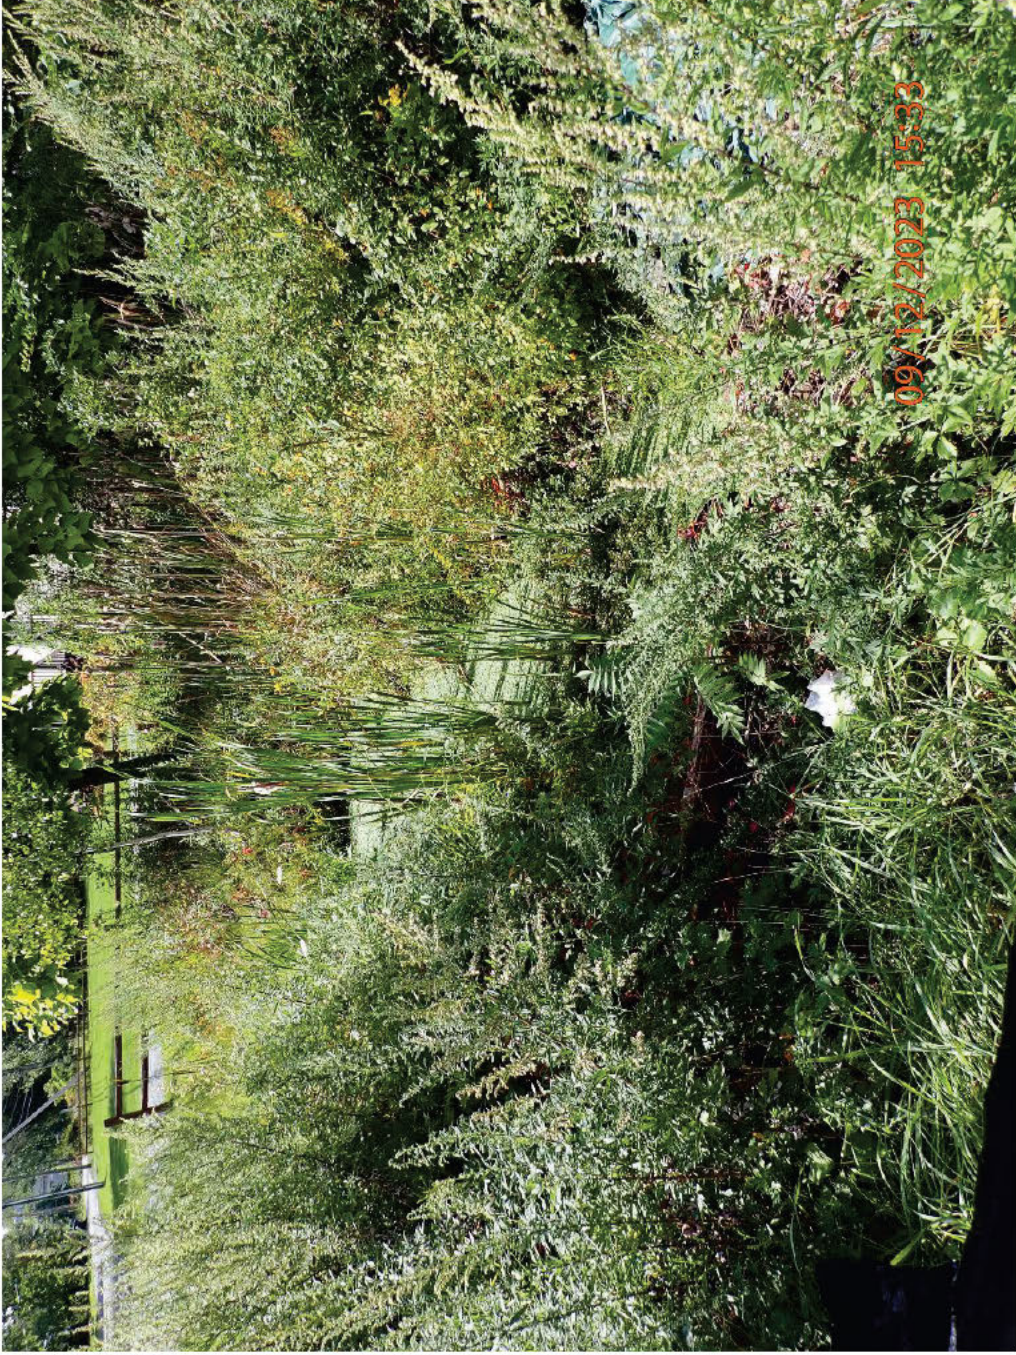
Date: 9/12/2023
Time: 3:33 PM
Photographer: S. Andreescu
Photo ID: 22 – P9120203

Description:
Roadside ditch along West
Shore Road
Photo facing west
