**Region 6 Compliance Assurance and Enforcement Division  
INSPECTION REPORT**

| Inspection Date(s): | 10/25/18 | | |
| Facility Name: | XXX Dairy | | |
| Identification/Permit Number: | TXG920040 | | |

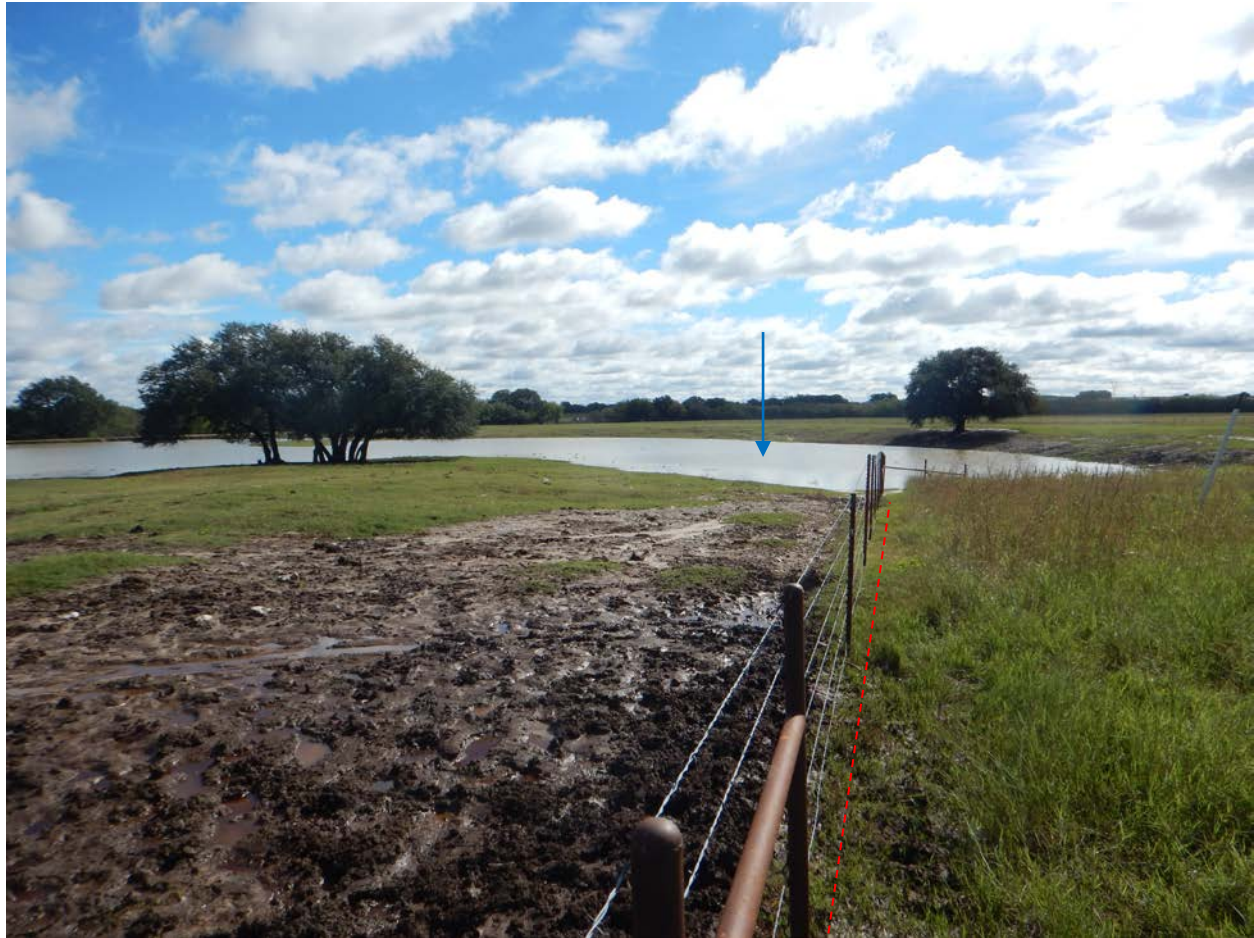
Photo No. 1

On the day of the inspection, I observed an area approximately 0.25 acres in size in the southwest corner of the south lots which showed evidence of ponding. The grading of this area did not allow for wastewater to be conveyed to the adjacent RCS (Photo #4). Additionally, I observed that the berm intended to convey wastewater from the heifer pens toward RCS G3 was not functioning as designed. At the time of the inspection there was evidence of manure solids which appeared to have flowed over the berm and towards the freshwater pond adjacent to RCS G3 (Photos #1-2).

Description: This photo was taken facing southeast toward the freshwater tank adjacent to RCS #G3.

Note the manure solids which have not been contained and redirected towards RCS #G3. The blue arrow denotes the freshwater tank and the red-dashed line denotes the ineffective berm.

- Wastewater from the heifer pens was not being properly routed to RCS G3. The residual manure solids will need to be removed and land applied or transferred offsite. Additionally, the berm will need to be restored to its original design to ensure that wastewater is routed to a RCS per TXG920040 Part 3.A.5(a)(4)
- An area approximately 0.25 acres located in the southwest corner of the south lots was not graded in a way that allowed for proper drainage to RCS #2 per TXG920040 Part 3.A.6(c)(3)
- Some small woody vegetation had taken root within the embankment of RCS #2. This vegetation will need to be removed to prevent the root zone from intruding upon the RCS liner per TXG920040 Part 3.A.10(f)(3).
- There was some mild erosion along the western berm of RCS #2. This embankment needs to be monitored to ensure that the erosion does not worsen per TXG920040 Part 3.A.6(f)(3).

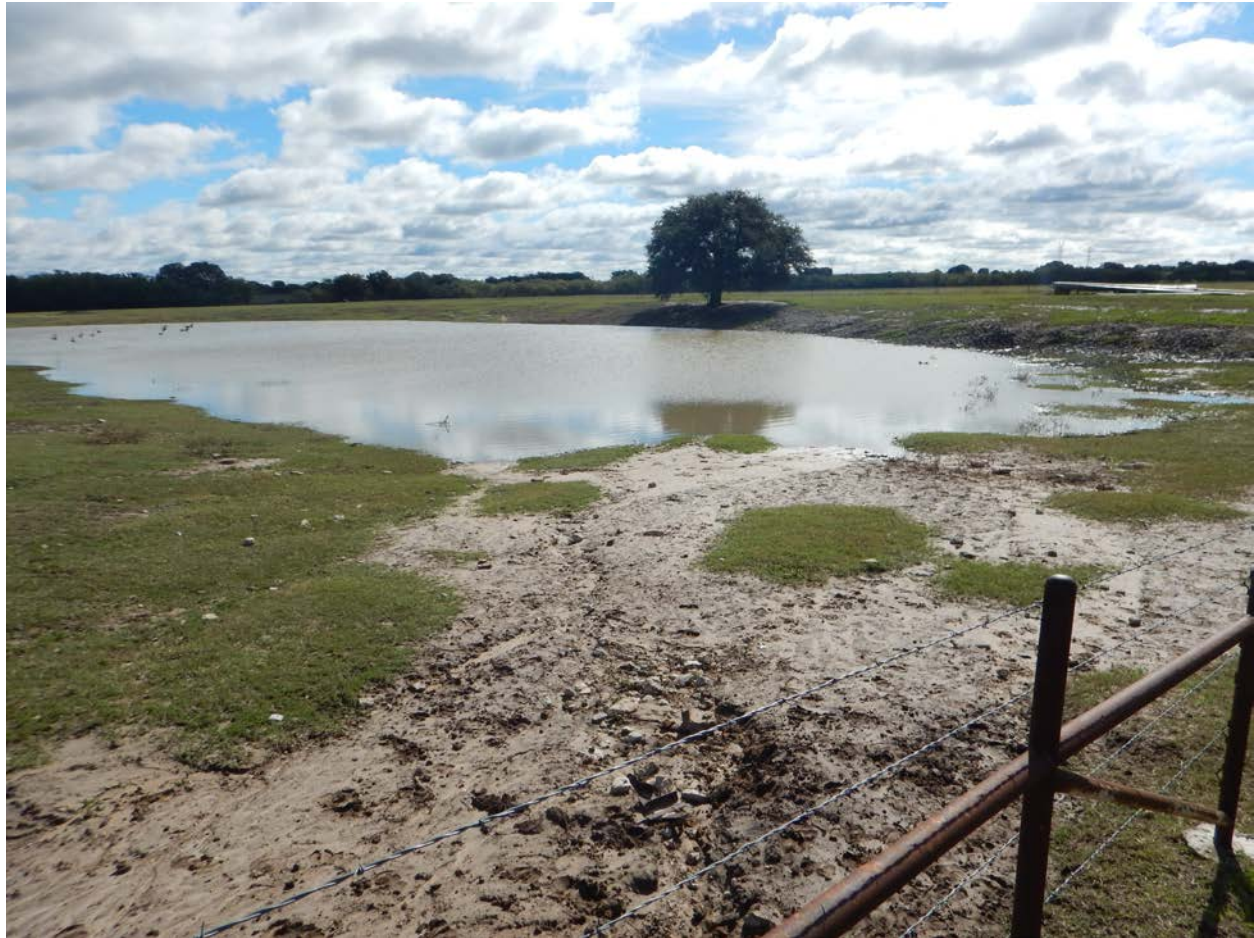
Photo No. 2

Description: This photo was taken facing southeast toward the freshwater tank adjacent to RCS #G3.  
Note the manure solids from the heifer pens which flowed into the tank.

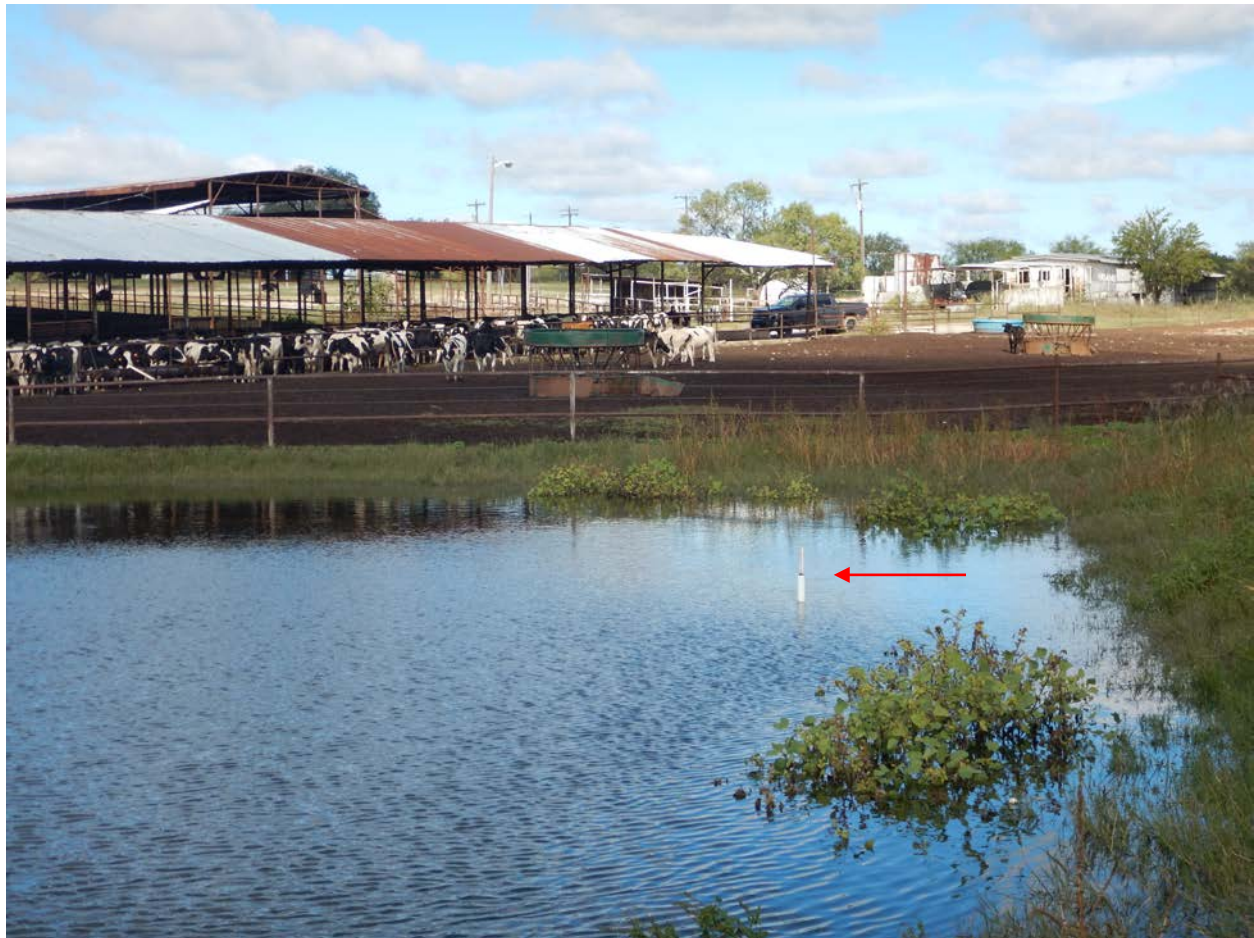
Photo No. 3

Description: This photo was taken facing northeast toward the heifer containment area. Note the pond marker.

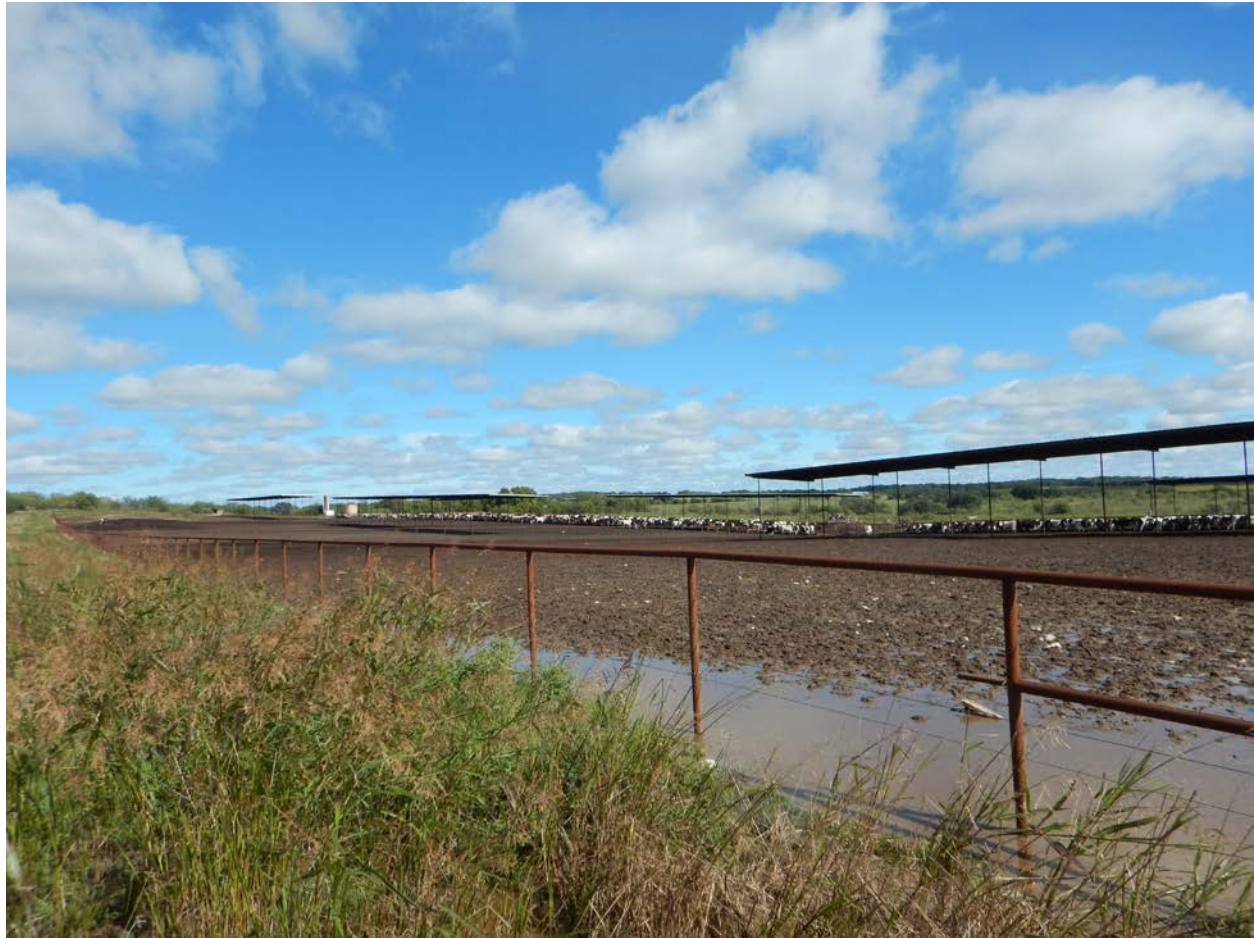
Photo No. 4

Description: This photo was taken facing northeast toward the low point of the south lots. This area in the southwest corner of the lot was not graded in a way which allowed for drainage to RCS #2

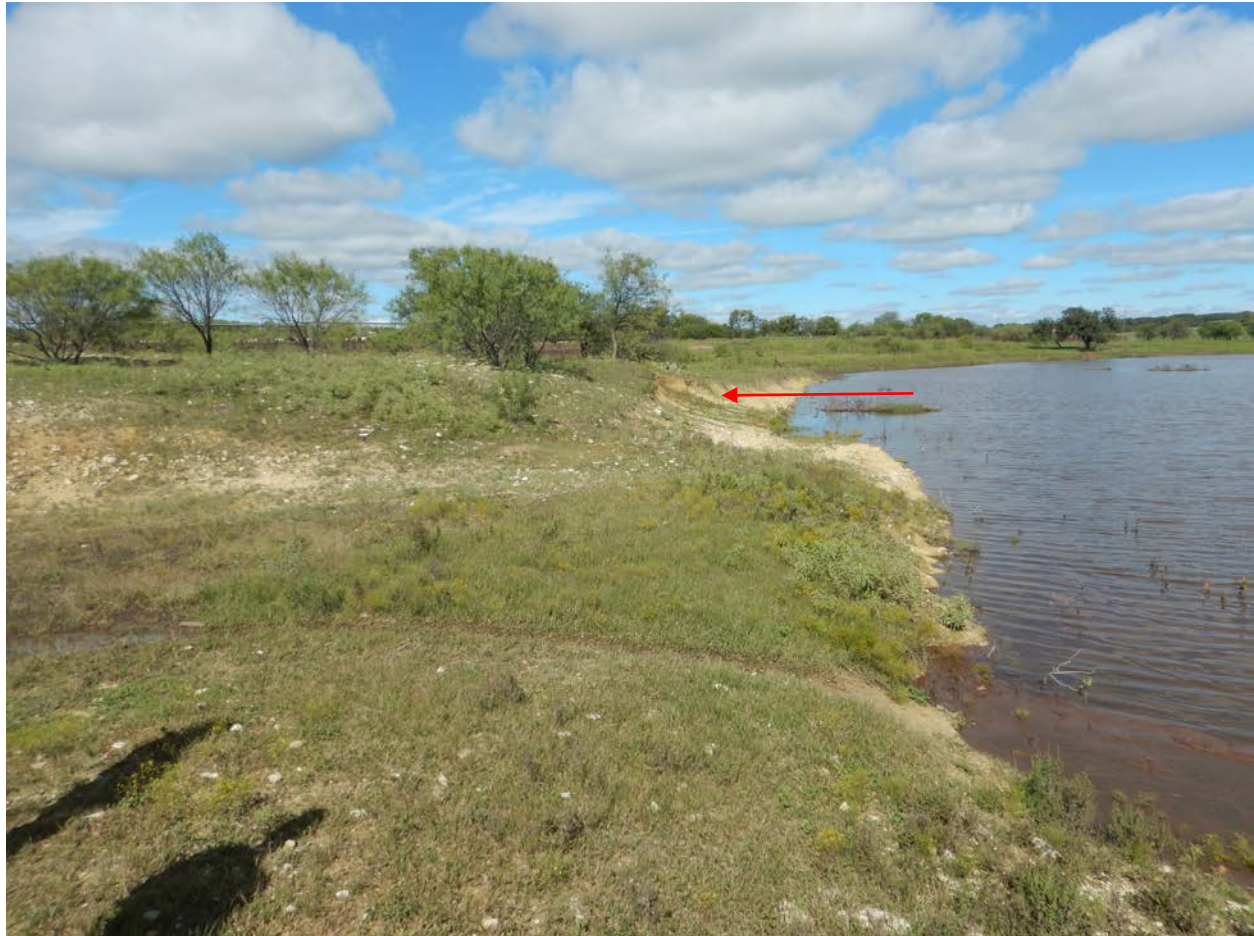
Photo No. 5

On the day of the inspection I observed that RCS' #1 and #3 had adequate freeboard and pole markers which were intact and readable. Upon inspection of RCS #2, I observed some small woody vegetation which had taken root within the embankment and evidence of some erosion along the RCS' upper embankments. I observed the fencing to be in good shape and functioning as intended for all three RCSs.

Description: This photo was taken facing north along the western berm of RCS #2. Note the erosion along the embankment. This area will need to be monitored to ensure no further erosion occurs.

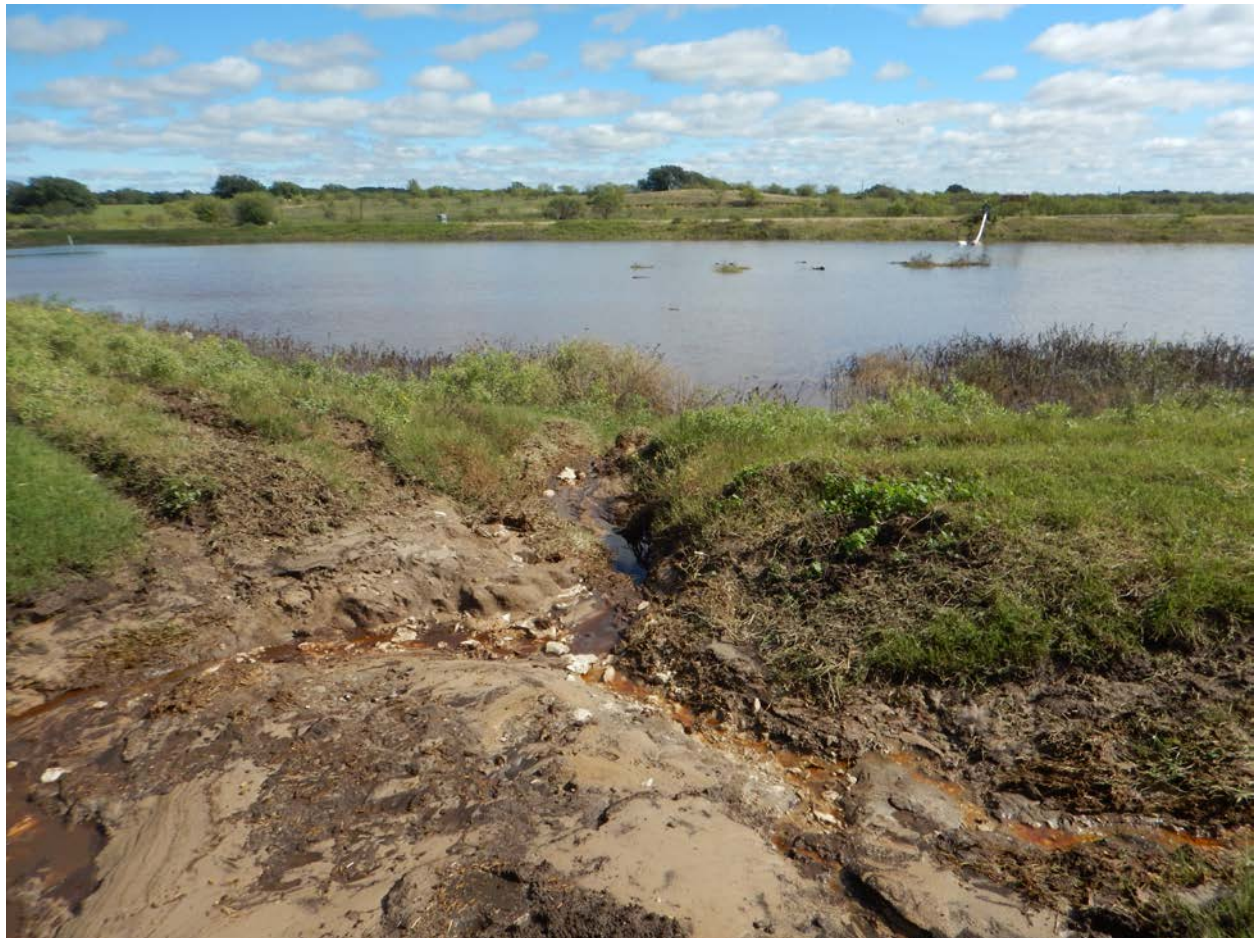
Photo No. 6

Description: This photo was taken facing east across the western berm of RCS #2. Note the erosion along the embankment. This area will need to be monitored to ensure no further erosion occurs.

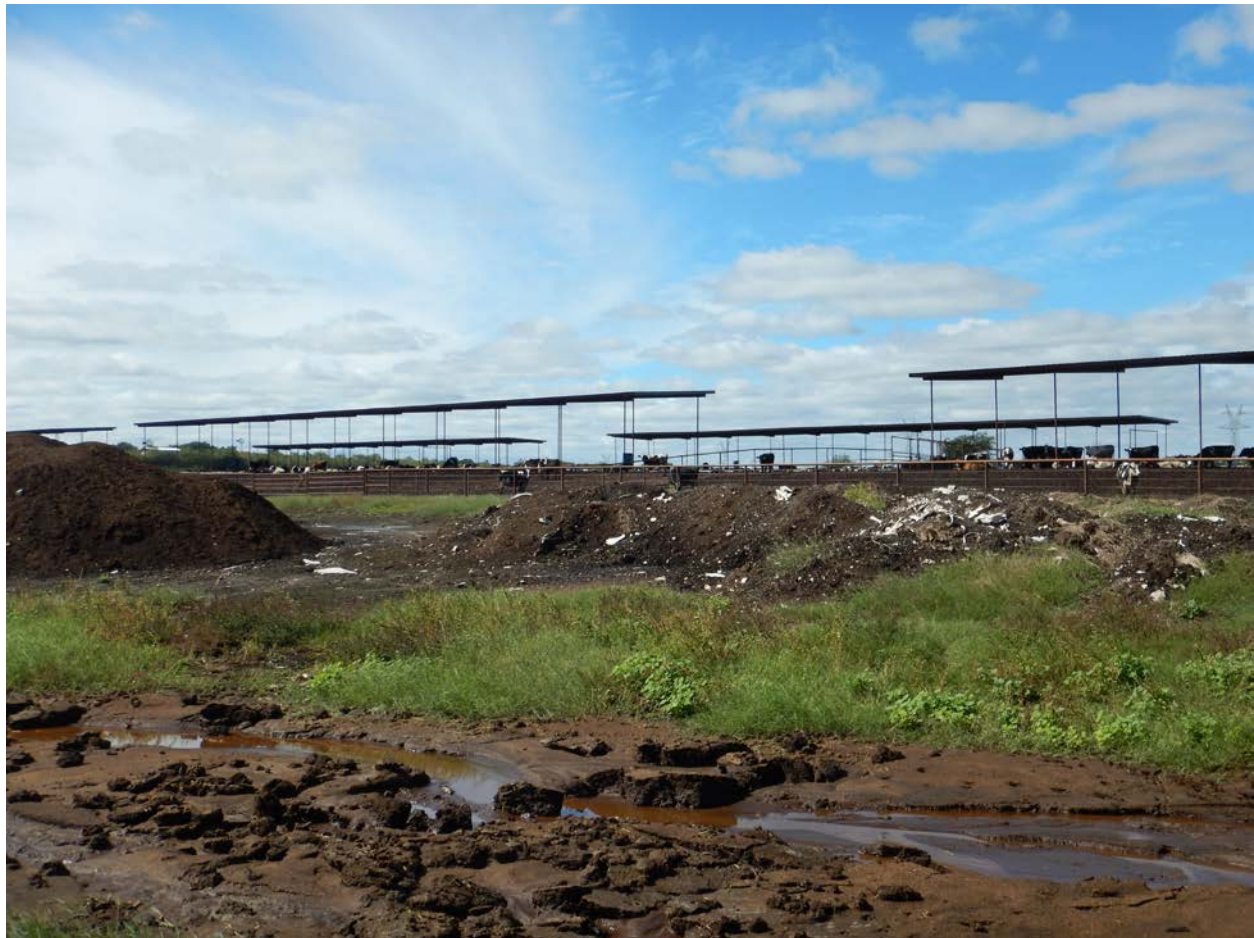
Photo No. 7

Description: This photo was taken facing east toward the flow of wastewater coming off the north lots and heading to RCS #1.

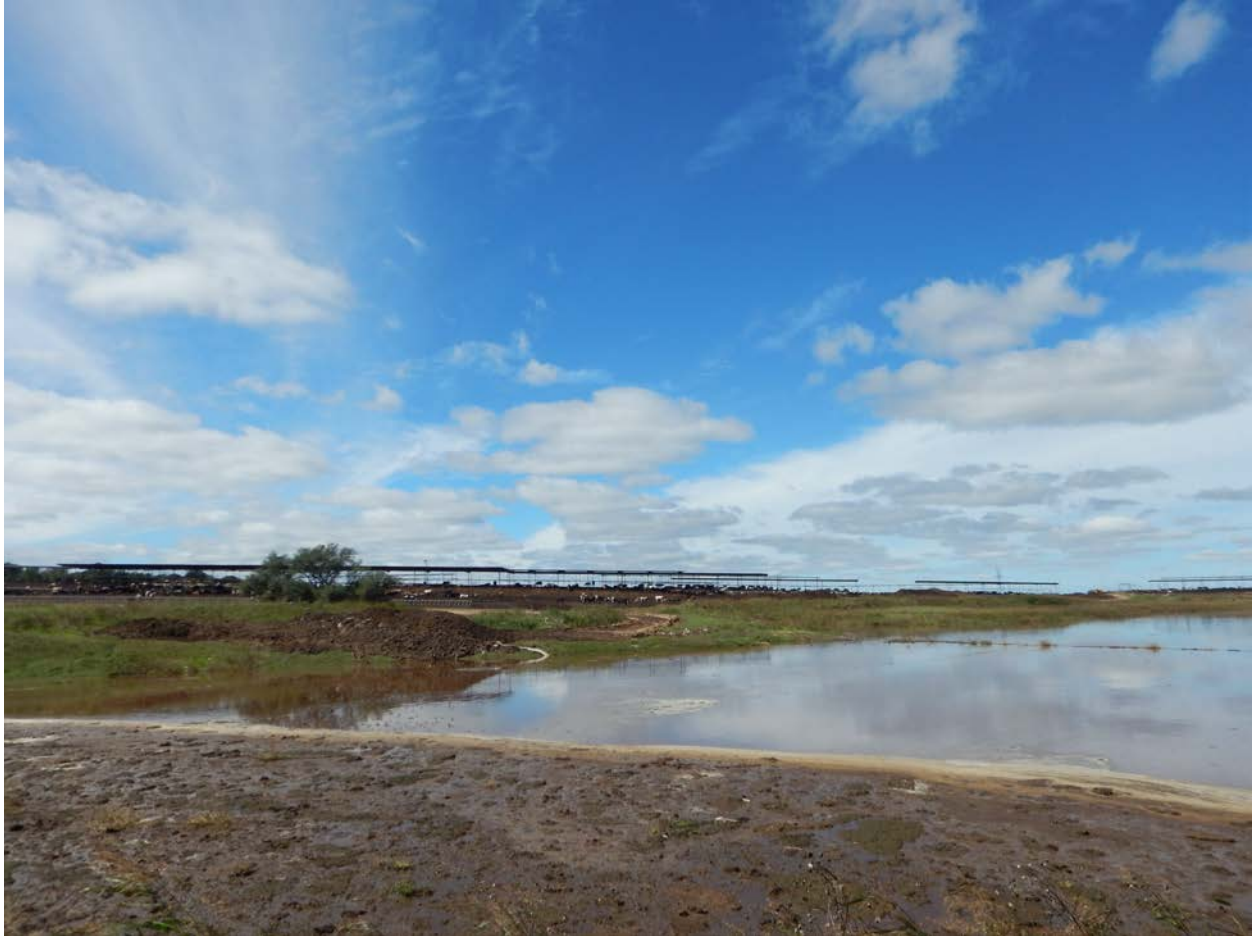
Photo No. 8

Description: This photo was taken facing west towards RCS #1 and the north lots.

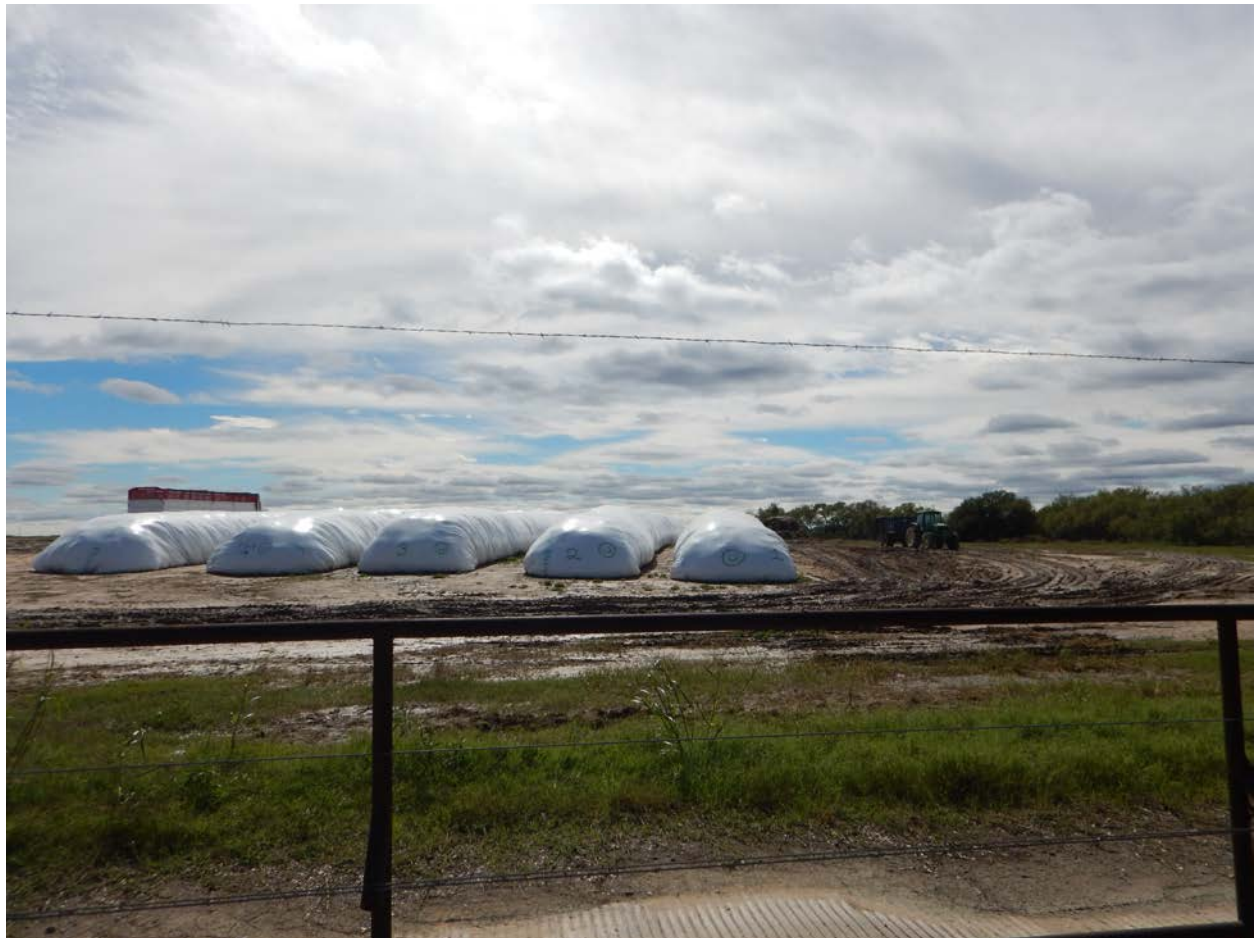
Photo No. 9

On the day of our inspection I observed the commodity storage barns to be in good condition. I observed silage which was stored securely in large plastic bags just southeast of the north lots (Photo #9).

Description: This photo was taken facing east toward the silage storage area.
