**Region 6 - Enforcement & Compliance Assurance Division**  
**INSPECTION REPORT**

| Inspection Date(s): | 06/06/2023 | |
| Facility Name: | <b>Greenbrier Water Works</b> | |

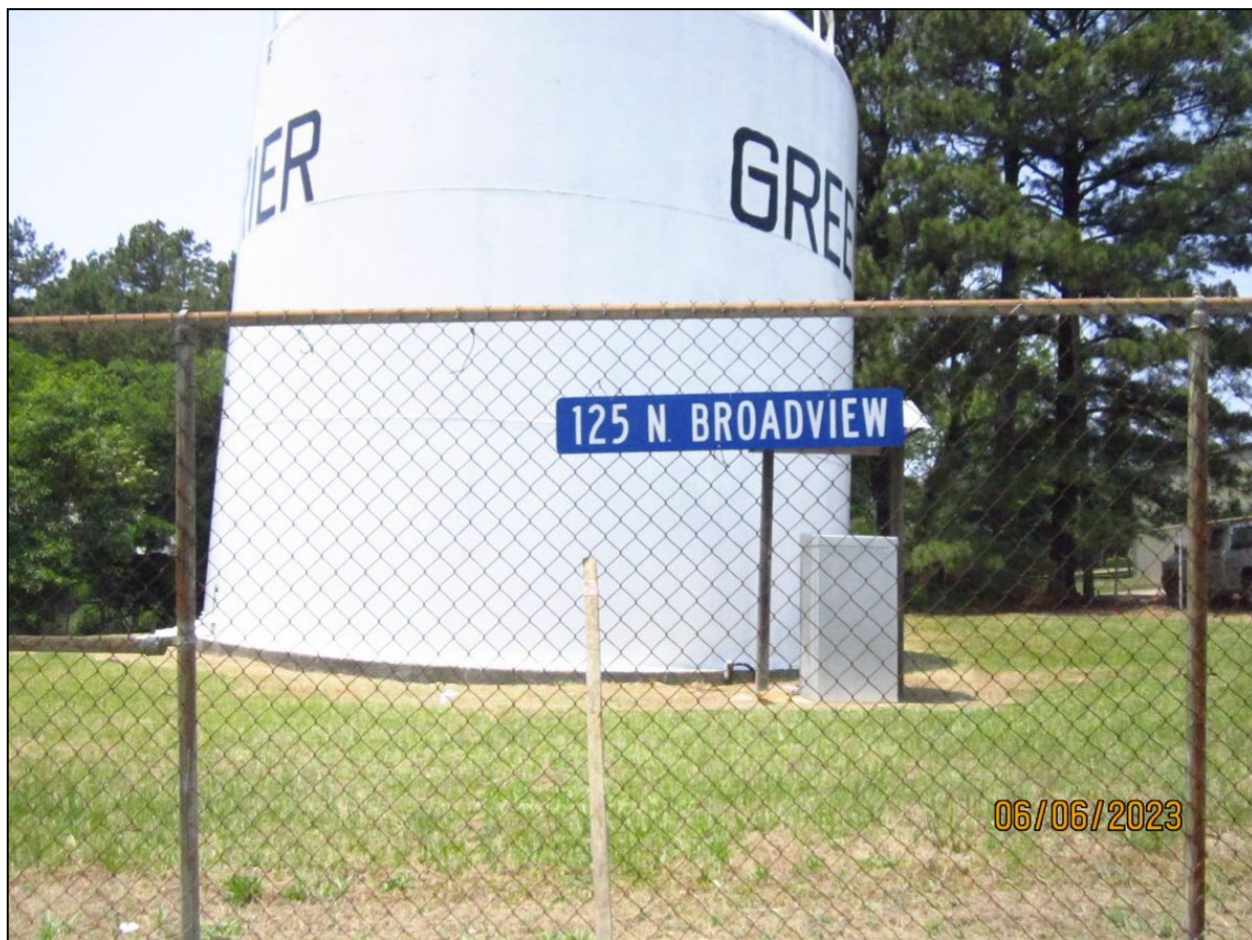
**Photograph 1. North Water Tank** View of the North Water Tank. The tank is 100,000 gallons and was surrounded by a locked perimeter fence.

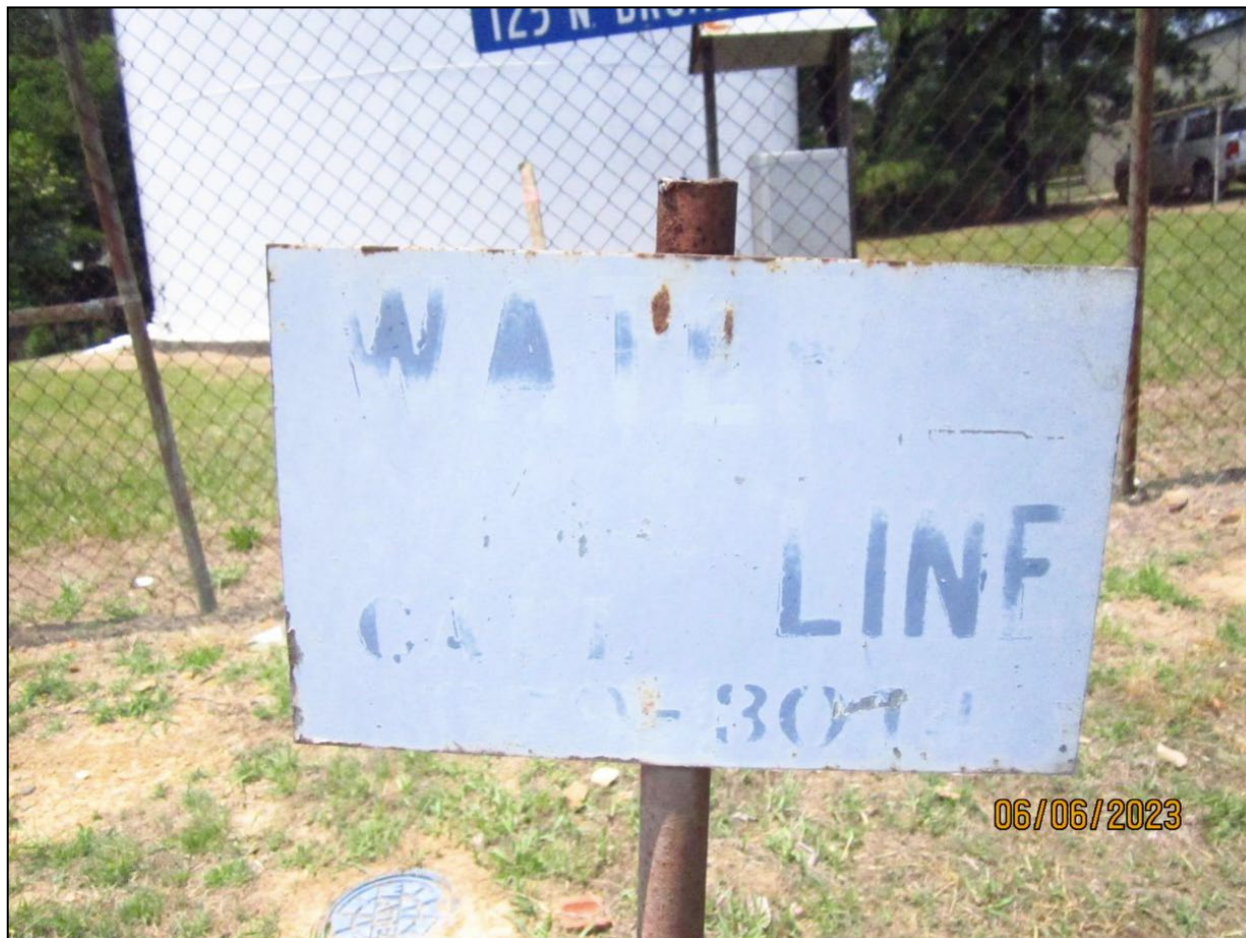
**Observation 12.** While some of the assets throughout the distribution system (storage facilities, booster stations) had security signs posted on their perimeter fences, the System as a whole did not have standard signage providing critical information including ownership, restrictions, or a contact number to call in case of an emergency. Some assets had signs, but they were heavily damaged and difficult to read. For example, a sign was posted at the North Water Tank that appeared to have critical security information on it, but the sign was faded from the sun and therefore illegible (refer to [Appendix 2, Photograph 2](#)).

**Photograph 2. Security Sign, North Water Tank** View of the security sign that was posted in front of the perimeter fence at the North Water Tank. The sign was sun bleached and illegible.

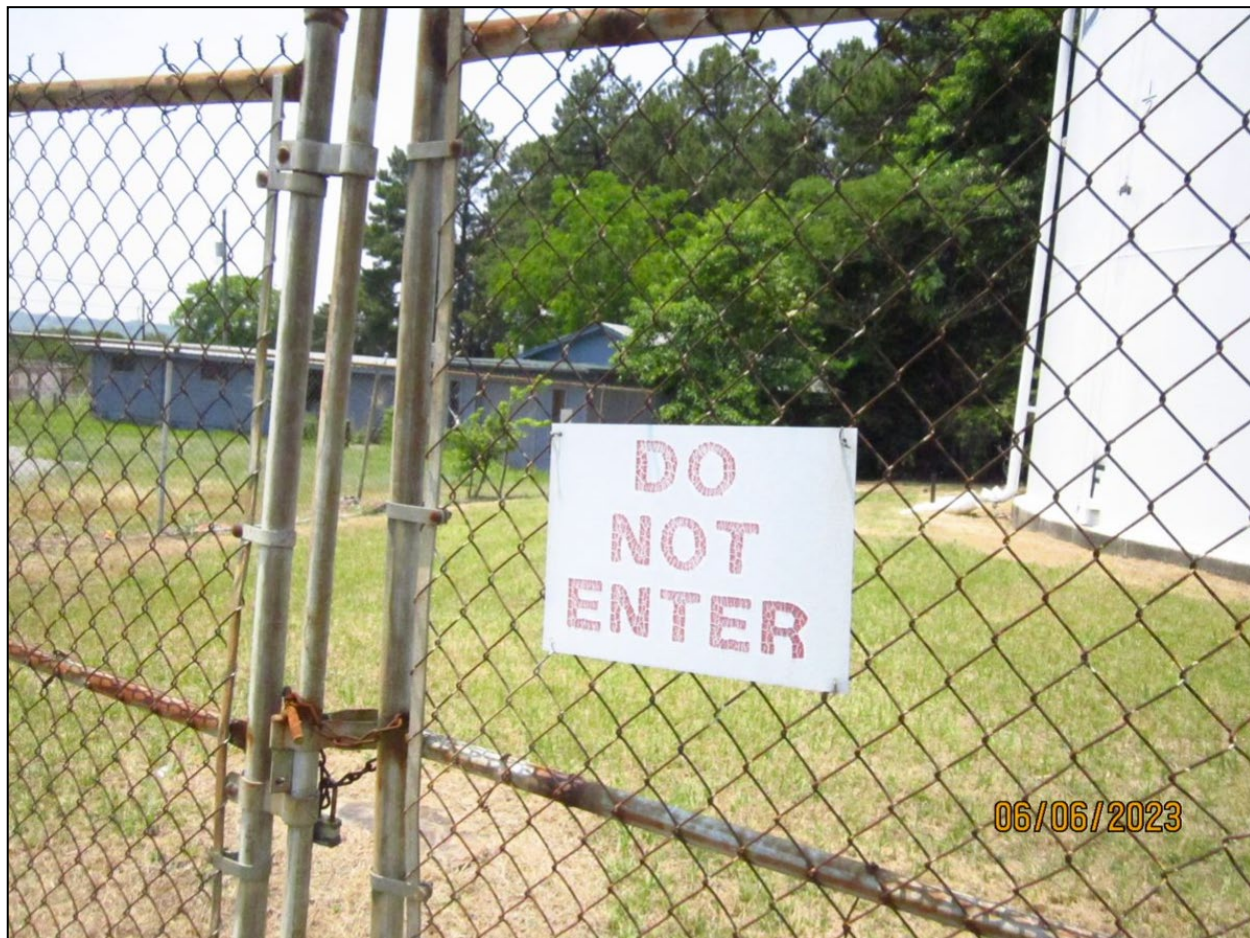
**Photograph 3. North Water Tank Perimeter Fence** View of a "Do Not Enter" sign that was posted on the locked perimeter fence of the North Water Tank.

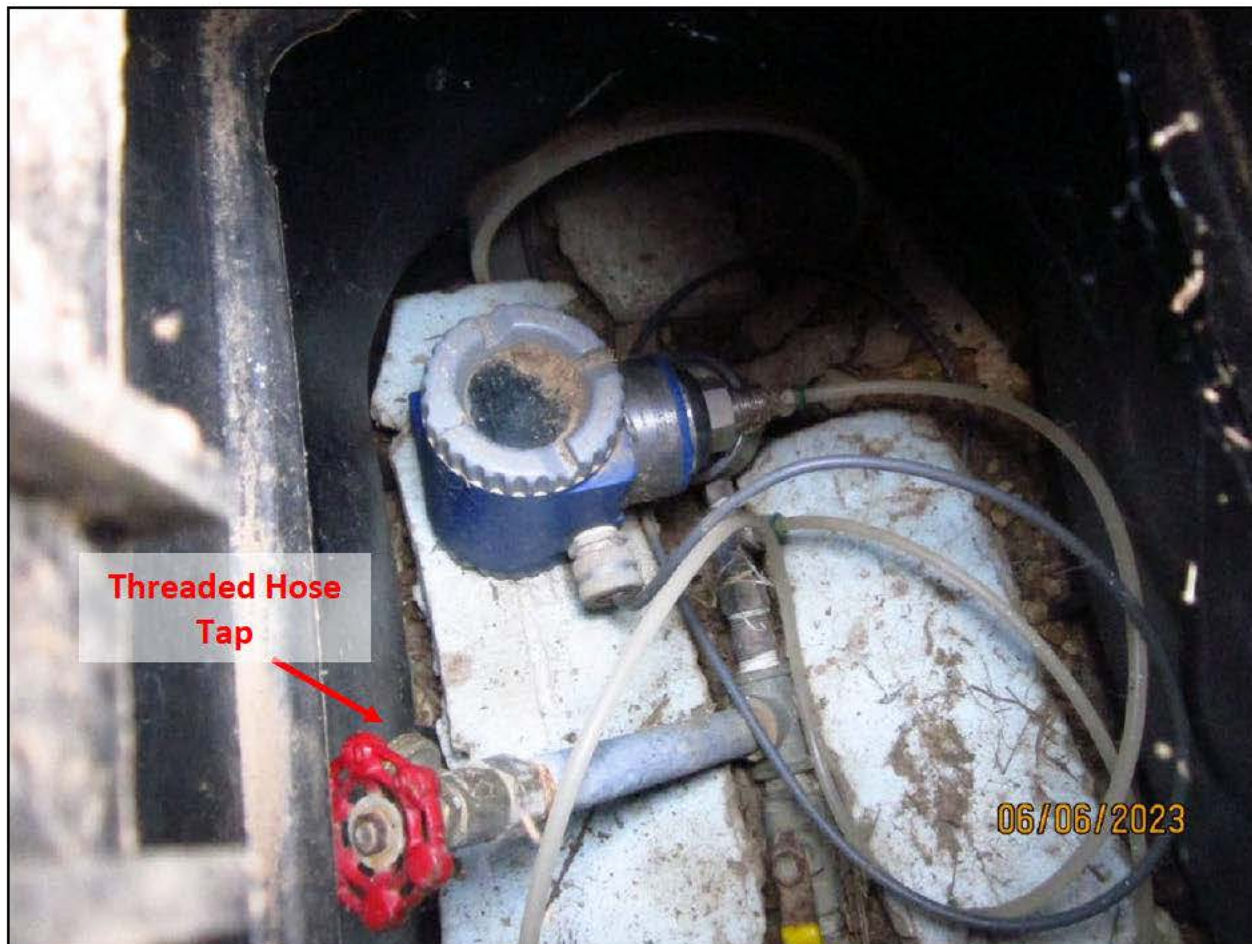
**Observation 13.** A valve box at the North Water Tank contained a pressure gauge and a water spicket with a threaded hose connection (refer to [Appendix 2, Photograph 4](#)).

**Photograph 4. Valve Box, North Water Tank** View of the inside of a valve box at the North Water Tank that contained a pressure gauge indicator and a threaded hose tap without backflow prevention.

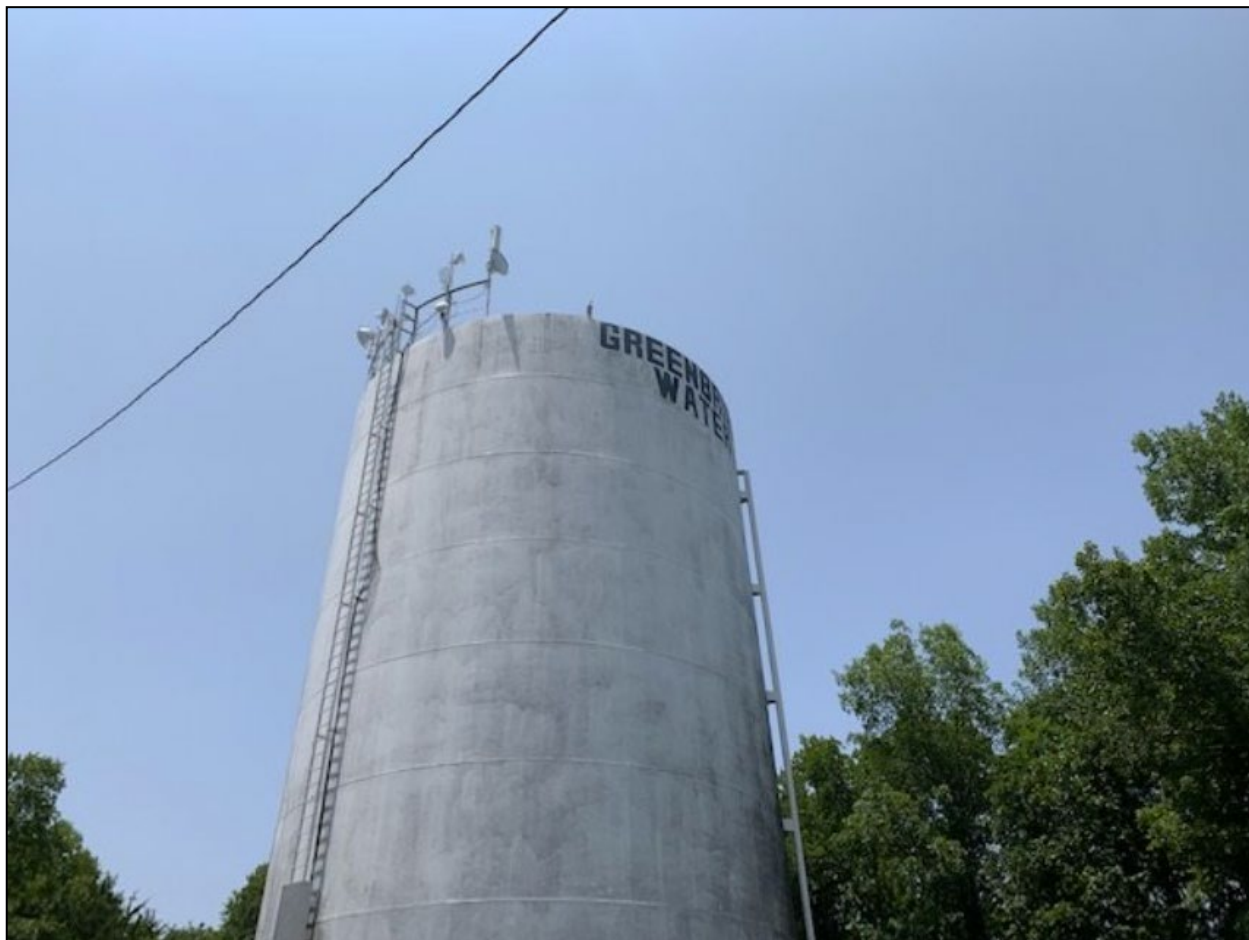
**Photograph 6. Horseshoe Mountain Water Tank** View of the Horseshoe Mountain Water Tank. The tank is 100,000 gallons and was surrounded by a locked perimeter fence.

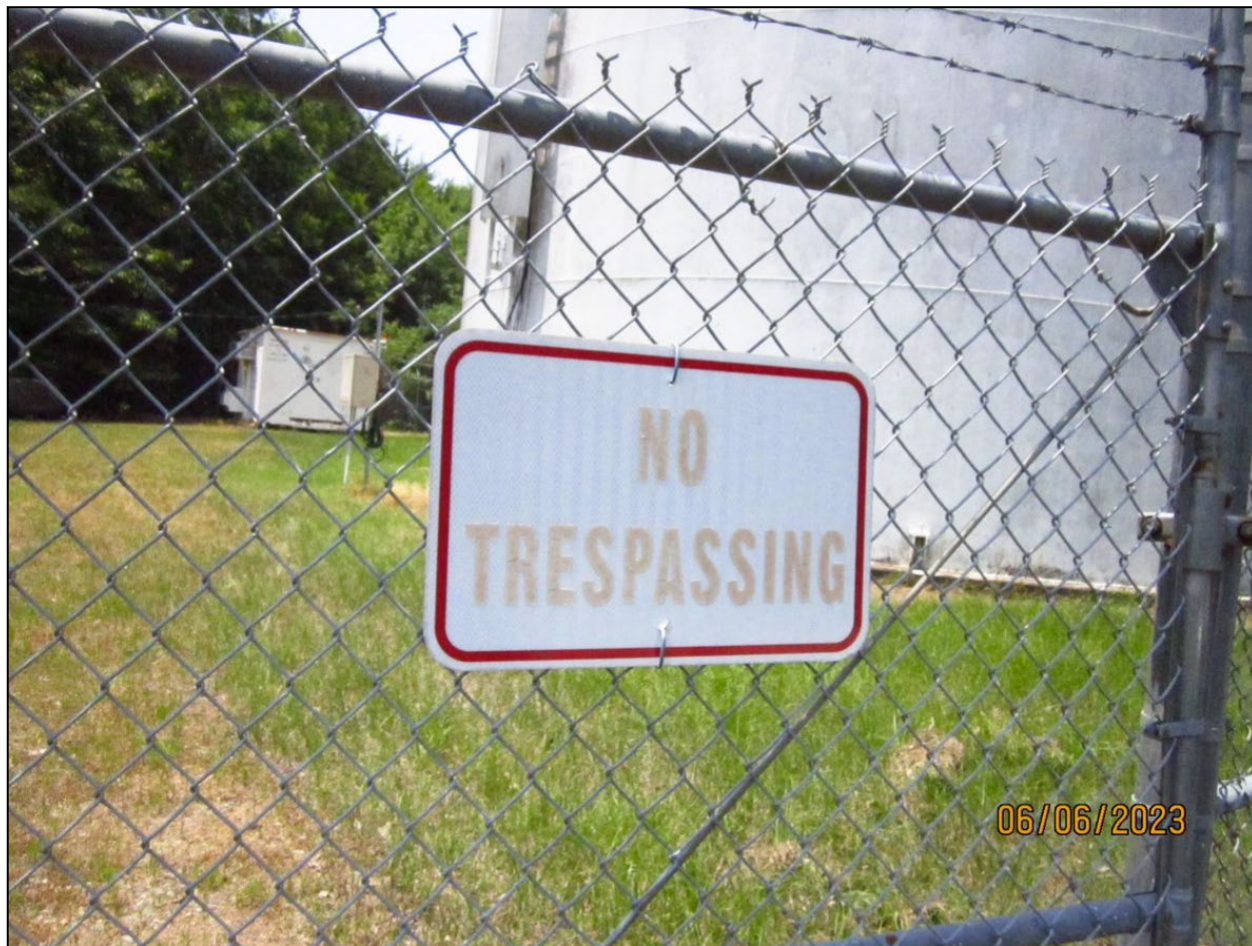
**Photograph 7. Horseshoe Mountain Tank Perimeter Fence** View of a "No Trespassing" sign that was posted on the locked perimeter fence of the Horseshoe Mountain Water Tank.

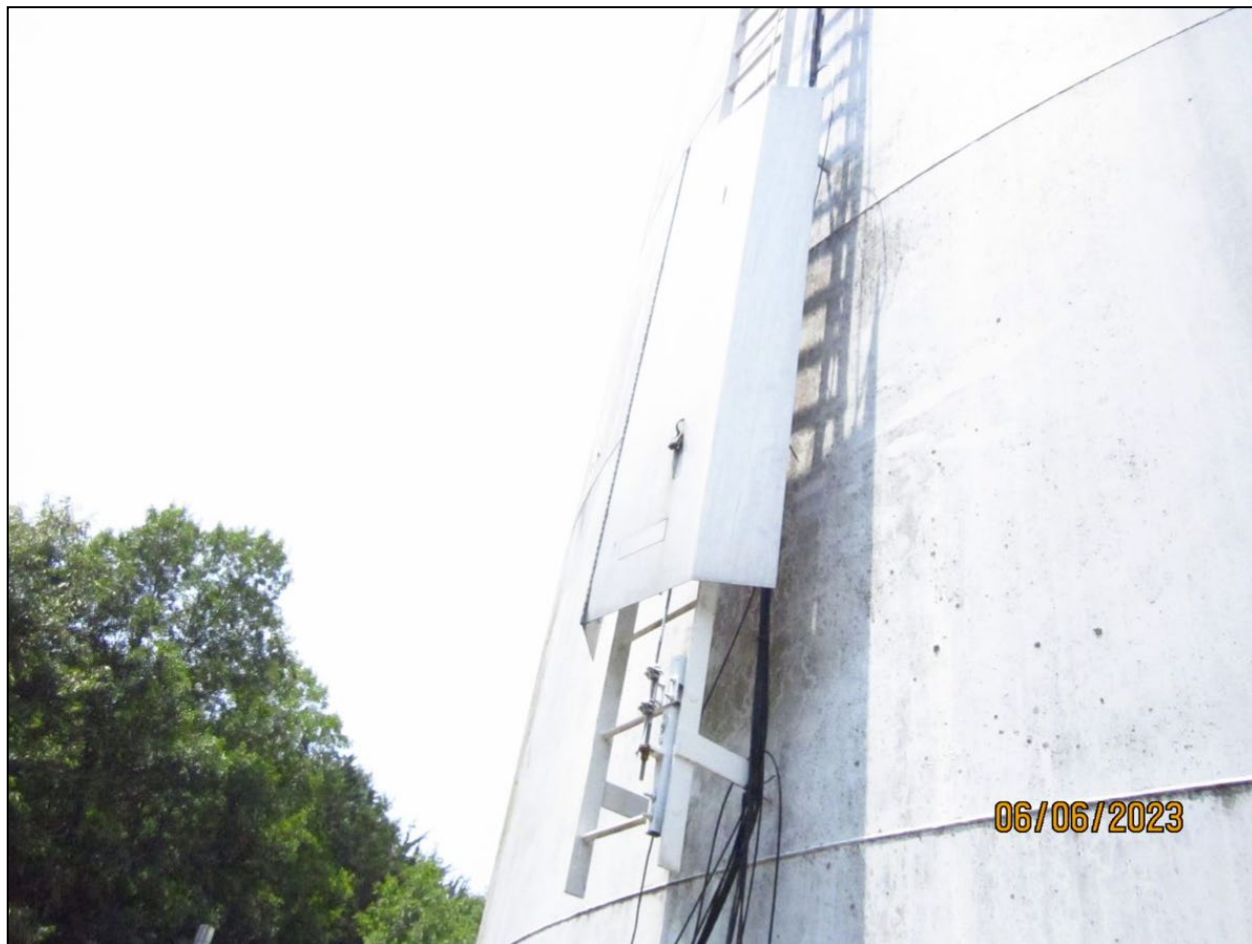
[REDACTED] The bottom rungs of the ladder on the side of the tank had been removed, and there was a locked plate over the bottom rungs of the ladder (refer to [Appendix 2, Photograph 8](#)). [REDACTED]  
[REDACTED]  
[REDACTED]

**Photograph 8. Horseshoe Mountain Water Tank** View the locked security plate over the bottom rungs of the ladder at the Horseshoe Mountain Water Tank.

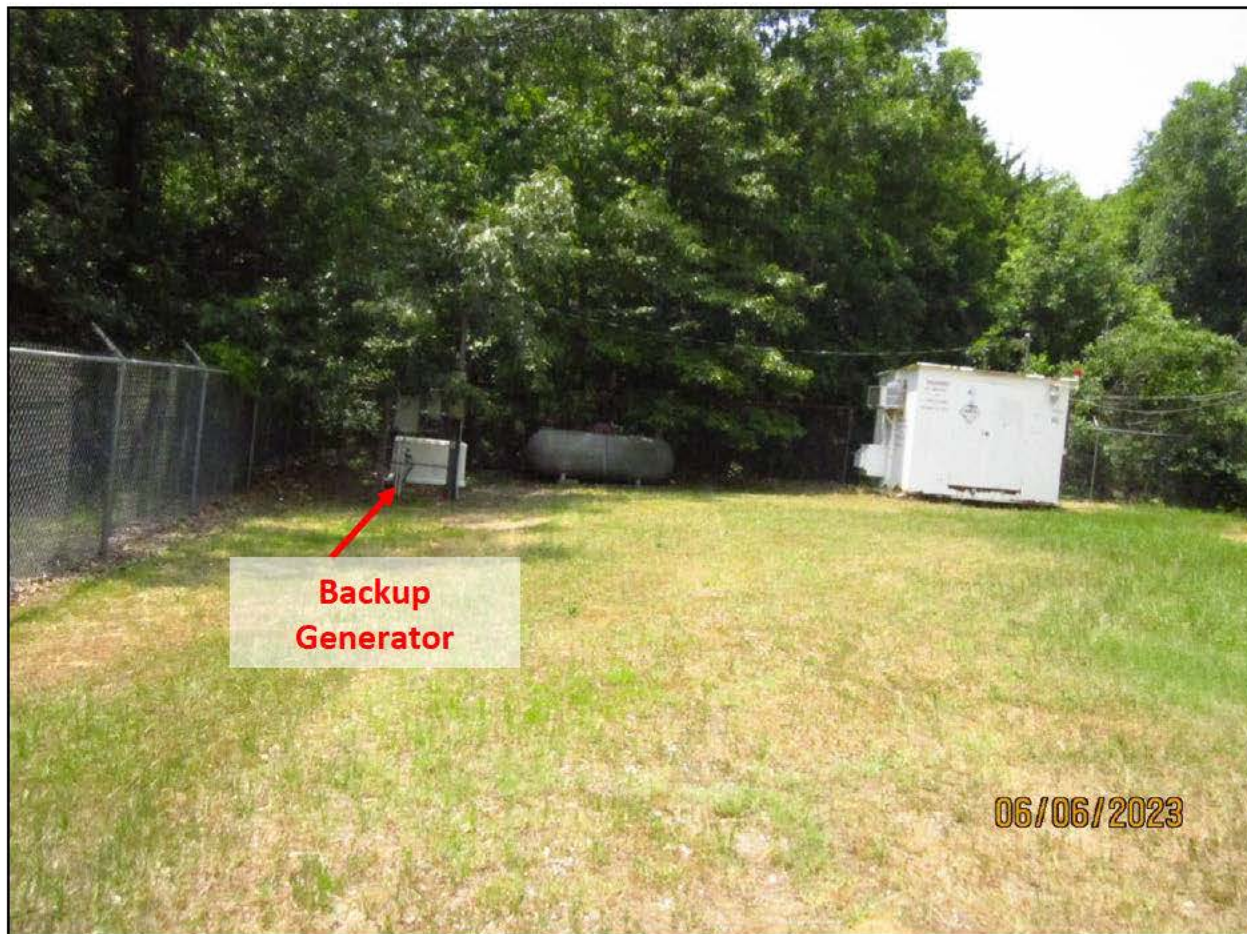
**Photograph 9. Backup Generator, Horseshoe Mountain Water Tank** View of the backup generator and propane tank that were positioned next to the Horseshoe Mountain Water Tank. System representatives stated that the generator was owned by Community Water. [REDACTED]

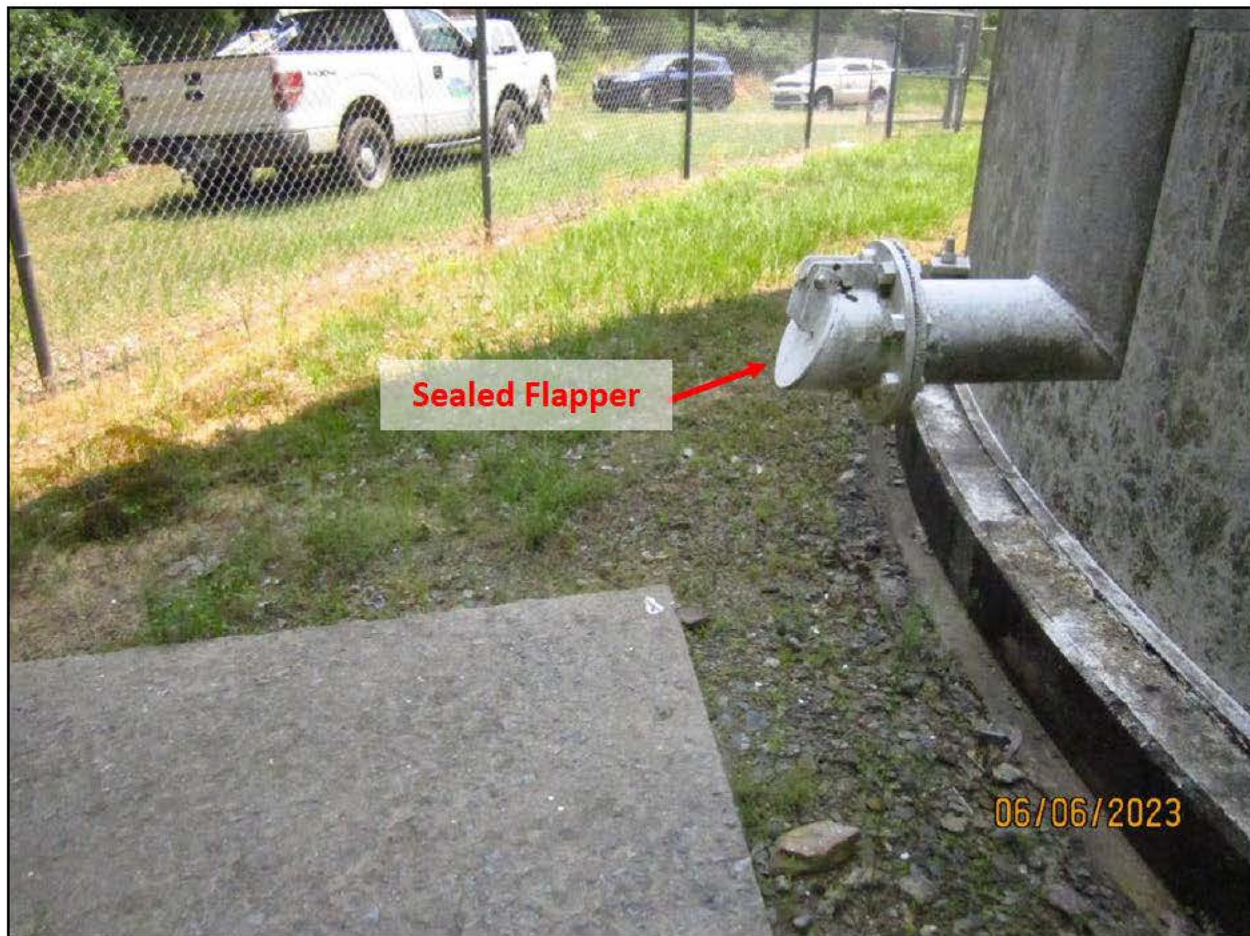
**Photograph 10. Horseshoe Mountain Water Tank Overflow Pipe** View of the overflow pipe that extended out of the Horseshoe Mountain Water Tank. The end of the pipe was covered by a flapper valve with a tight seal. A concrete splash pad was positioned under the end of the overflow pipe.

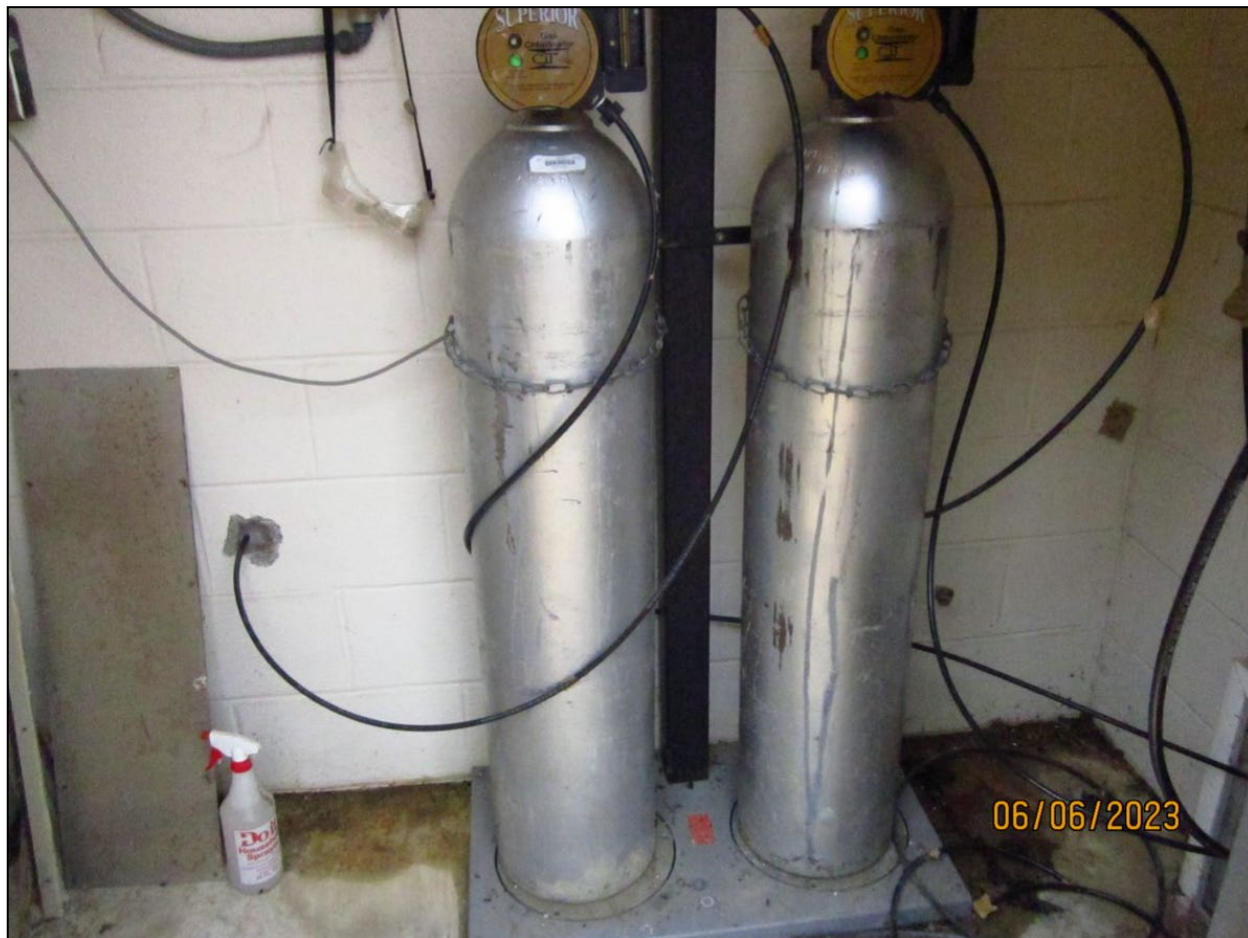
**Photograph 14. Chlorine Storage Room, Master Meter #1** View of the inside of the chlorine storage room at Master Meter #1. There were two, 150 lb. cylinders with one in use and one on standby. The chlorinator vent lines were run through an exhaust vent with moveable louvers. It was unclear if the lines will negatively impact the rooms design ability to properly manage a release of chlorine gas.

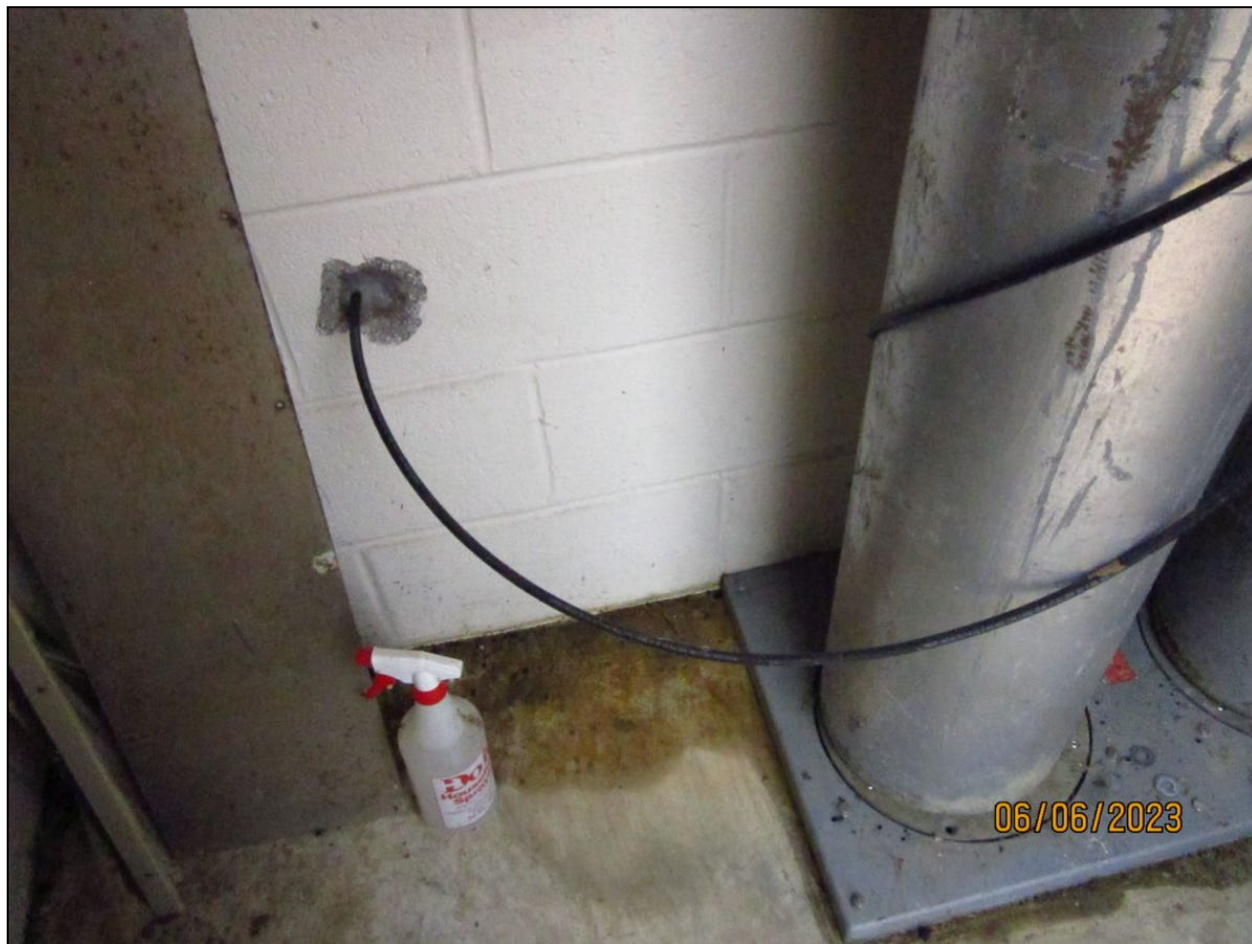
**Observation 19.** Chlorine was being injected into carry water in a separate room than where the chlorine gas cylinders were being stored at Master Meter #1 (refer to Appendix 2, Photographs 15 and 16). Additionally, the chlorine gas injection line was resting on the floor of the backflow protection/chlorine injection room, creating a potential tripping hazard which could trigger a gas leak if the line was jostled.

**Photograph 15. Chlorine Storage Room, Master Meter #1** View of the chlorine gas line that feeds through the wall into the backflow protection/chlorine injection room where it is injected into carry water before final injection downstream of Master Meter #1.

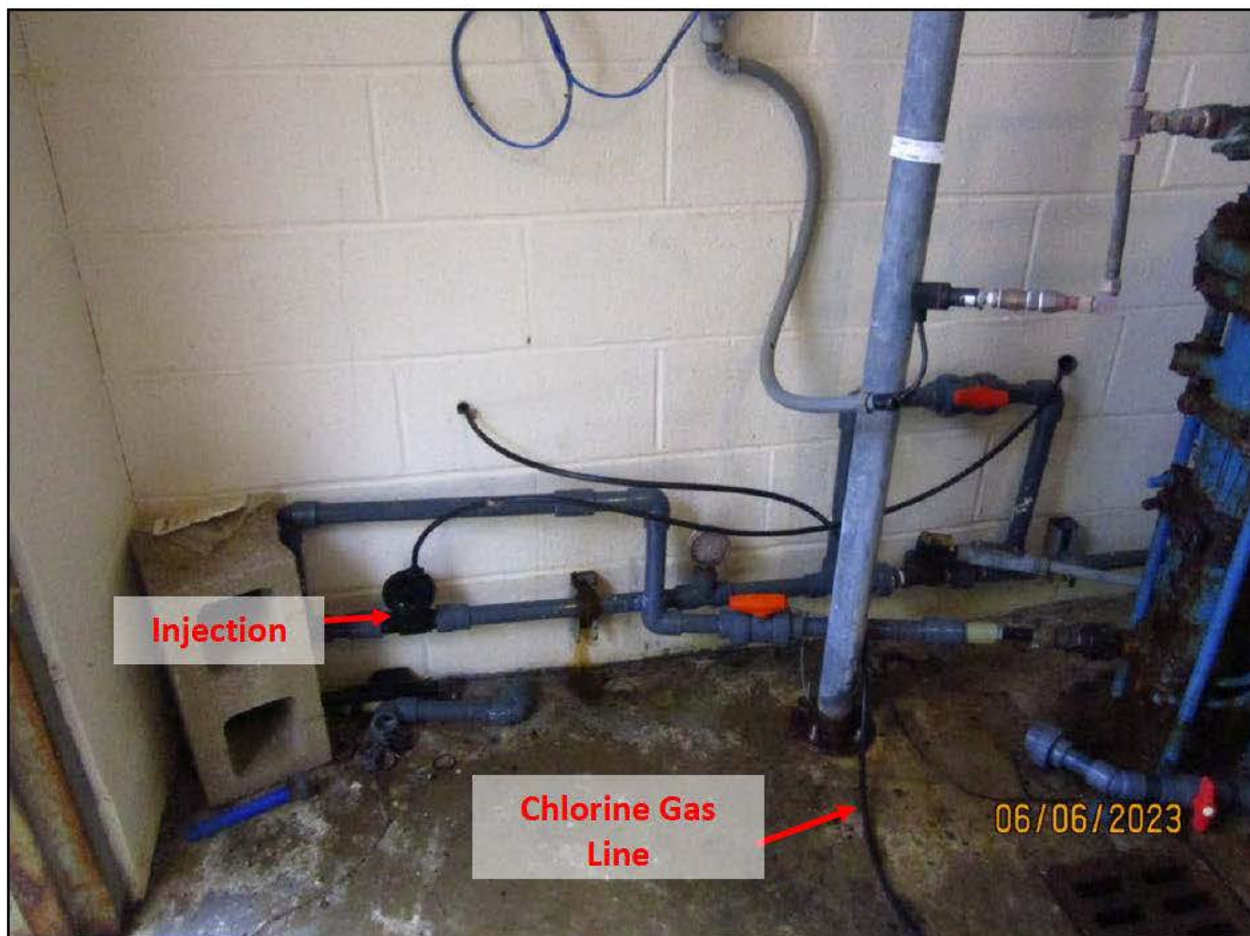
**Photograph 16. Chlorine Injection, Master Meter #1** View of the inside of the backflow protection/chlorine injection room where chlorine gas was being injected into carry water. This injection was in a separate room from the chlorine storage room. The chlorine gas line was resting on the floor, creating a potential tripping and disconnection hazard.

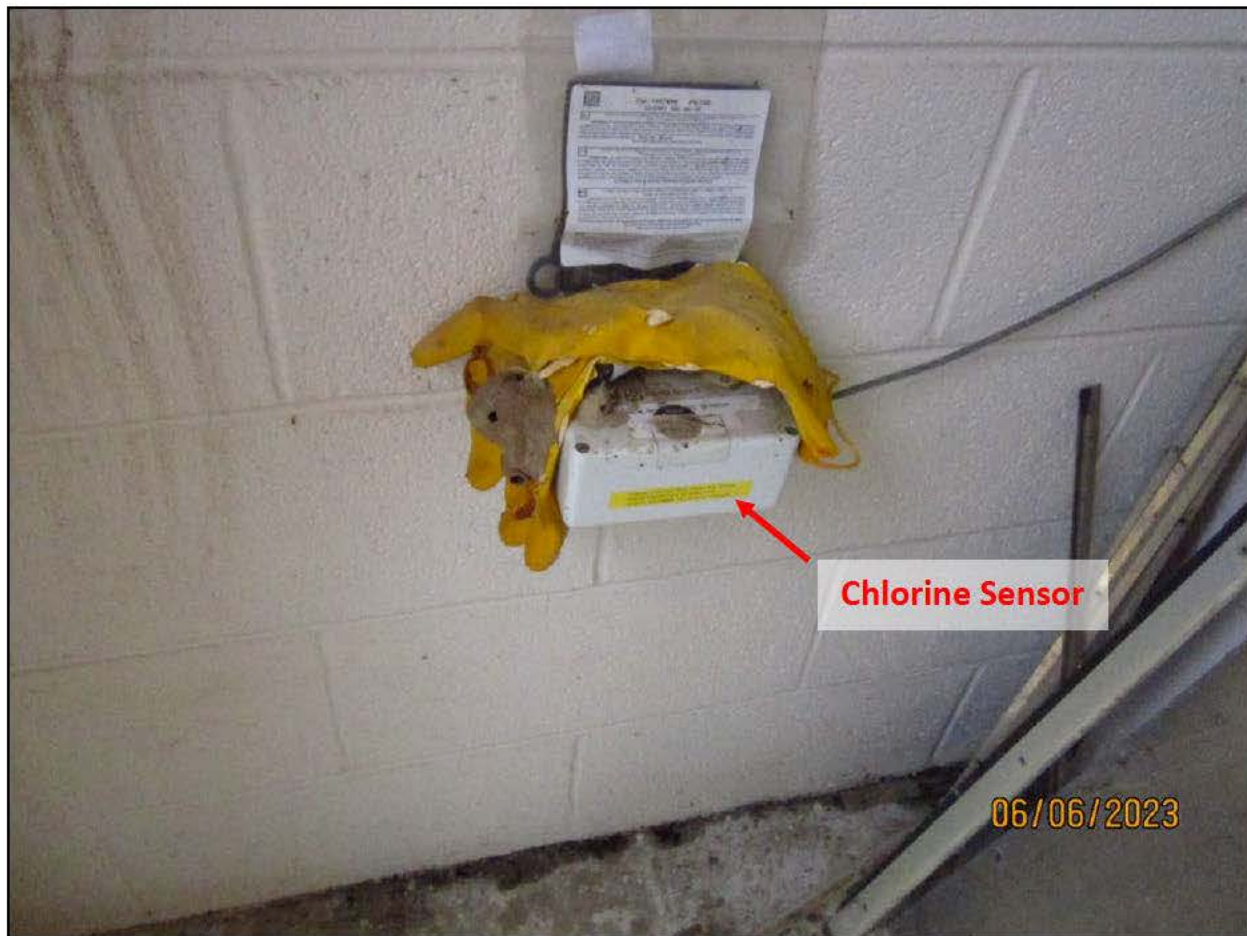
**Observation 18.** It was unclear if the chlorine alarm and sensor in the Master Meter #1 chlorine storage room was functional. There was a large wasp nest on top of old rubber gloves that was resting on the sensor, and it appeared that it had not been cleaned/serviced recently (refer to Appendix 2, Photograph 17).

**Photograph 17. Chlorine Sensor, Master Meter #1** View of the sensor near the floor of the chlorine storage room at Master Meter #1. It was unclear if the sensor was functional. There was a large wasp nest on top of old rubber gloves that were resting on the chlorine gas alarm sensor, and it appeared that it had not been cleaned/serviced recently. In addition, the sensor was positioned approximately 20-inches off the floor. Since chlorine gas settles close to the ground, the position of this sensor is concerning because it may not detect a chlorine gas leak until levels of chlorine become dangerously high.

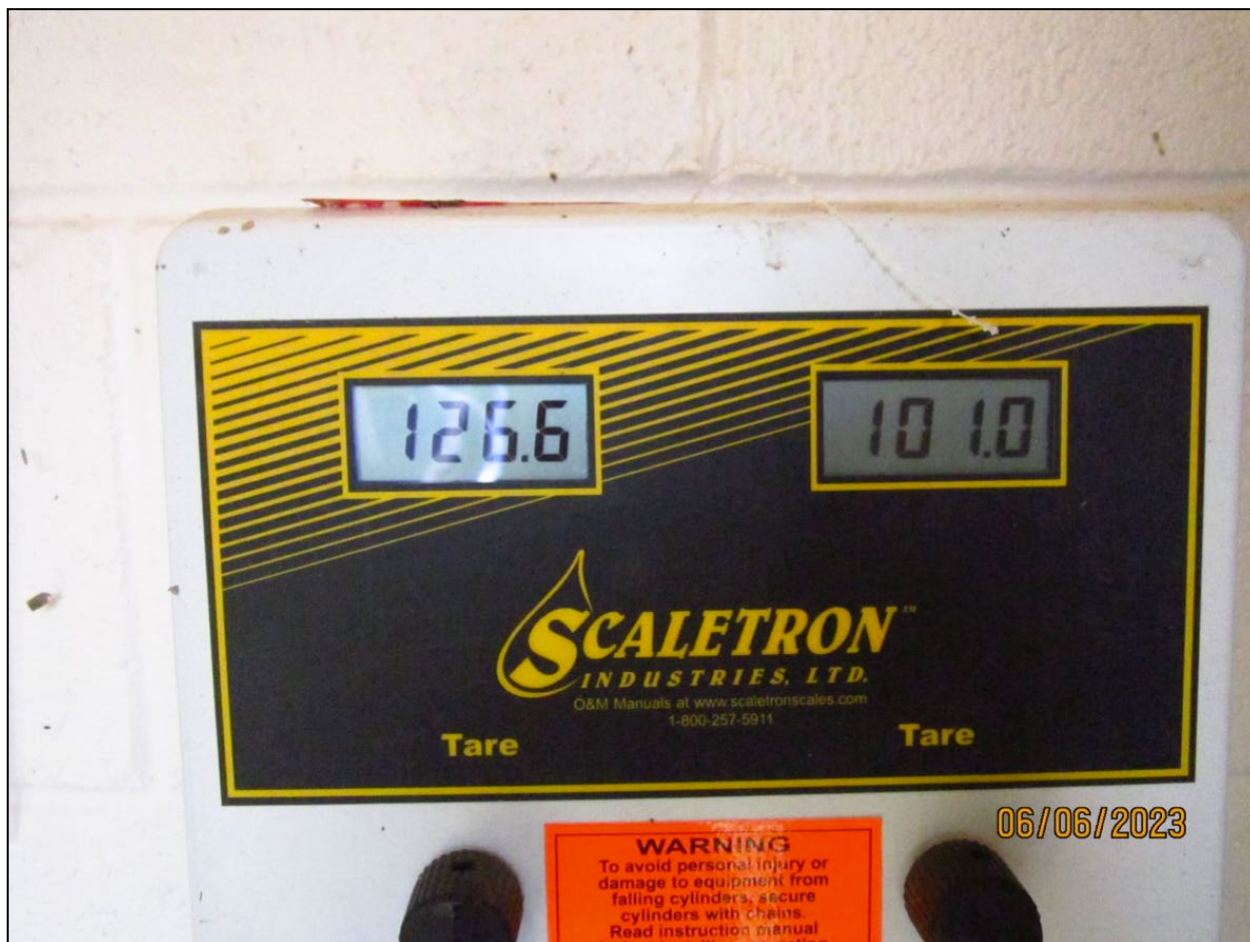
**Photograph 18. Chlorine Cylinder Scale, Master Meter #1** View of the functional chlorine cylinder scale in the chlorine gas storage room at Master Meter #1.

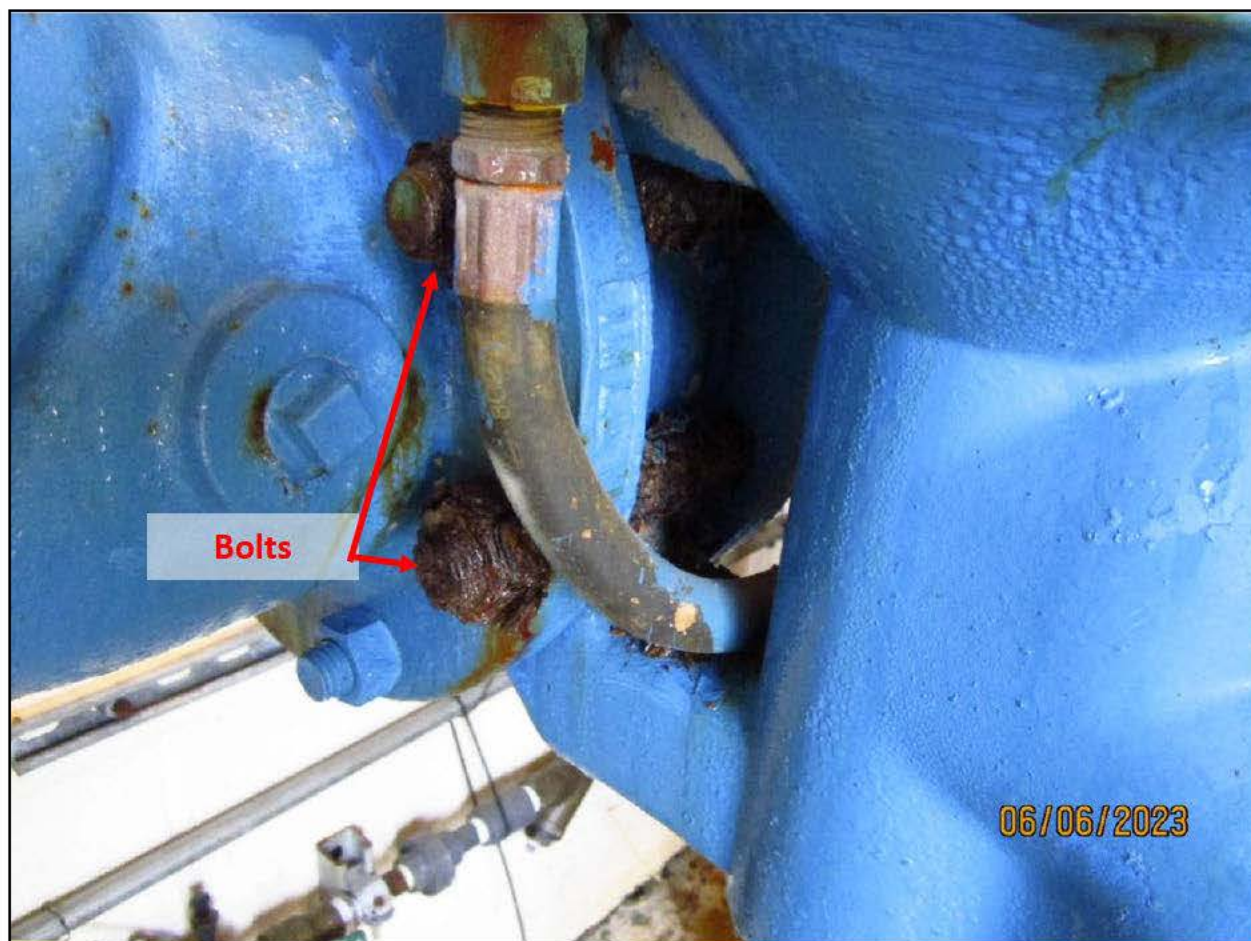
**Observation 20.** Some of the bolts that were securing a flange in the backflow protection/chlorine injection room at Master Meter #1 were experiencing substantial metal loss (refer to Appendix 2, Photograph 19).

**Photograph 19. Master Meter #1 Line** View of the bolts that secured one of the flanges at the location. Some of the bolts were experiencing substantial rust and metal loss.

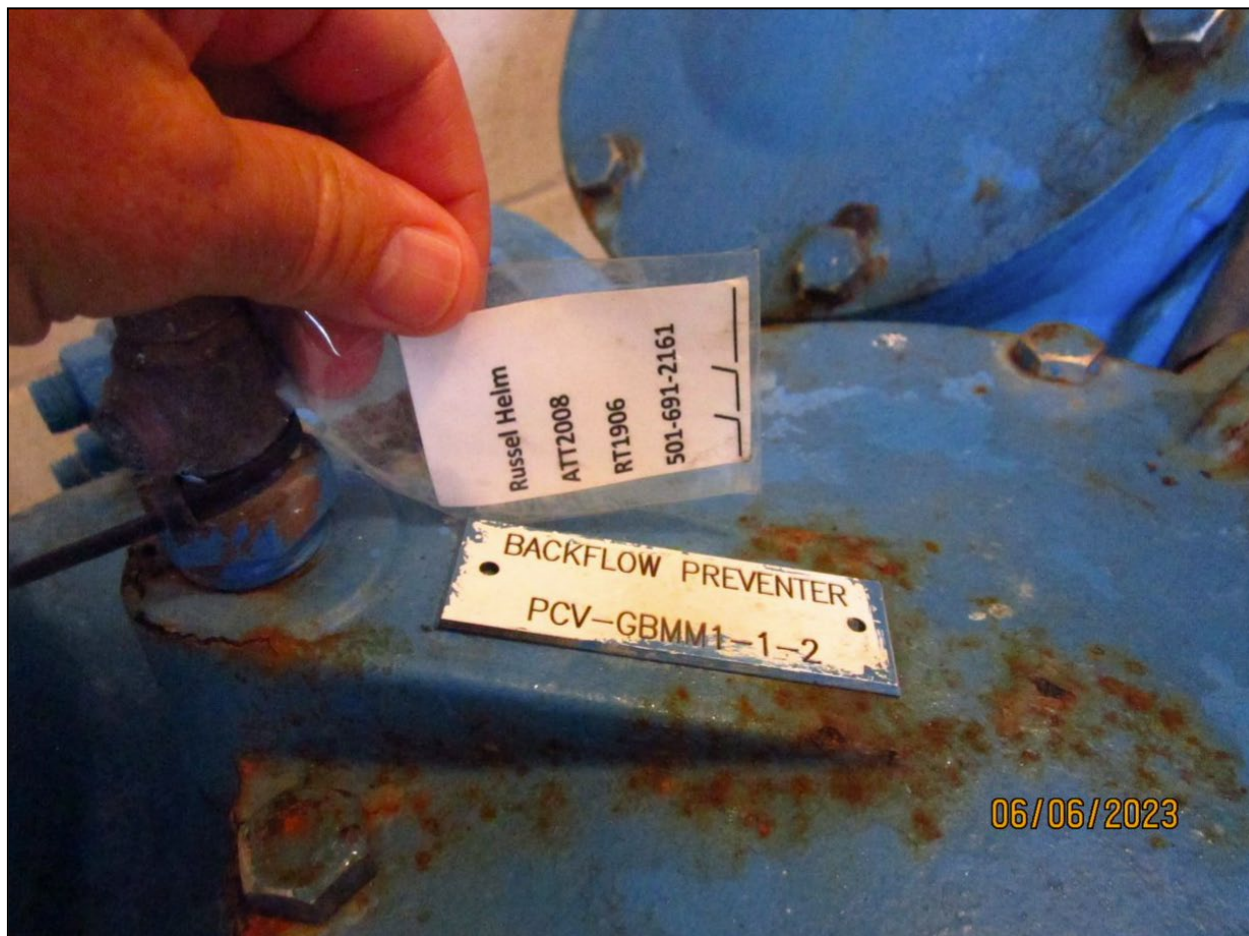
**Photograph 20. Backflow Preventer, Master Meter #1** View of the backflow preventer on the Master Meter #1 line that appeared to contain an asset identification nameplate.

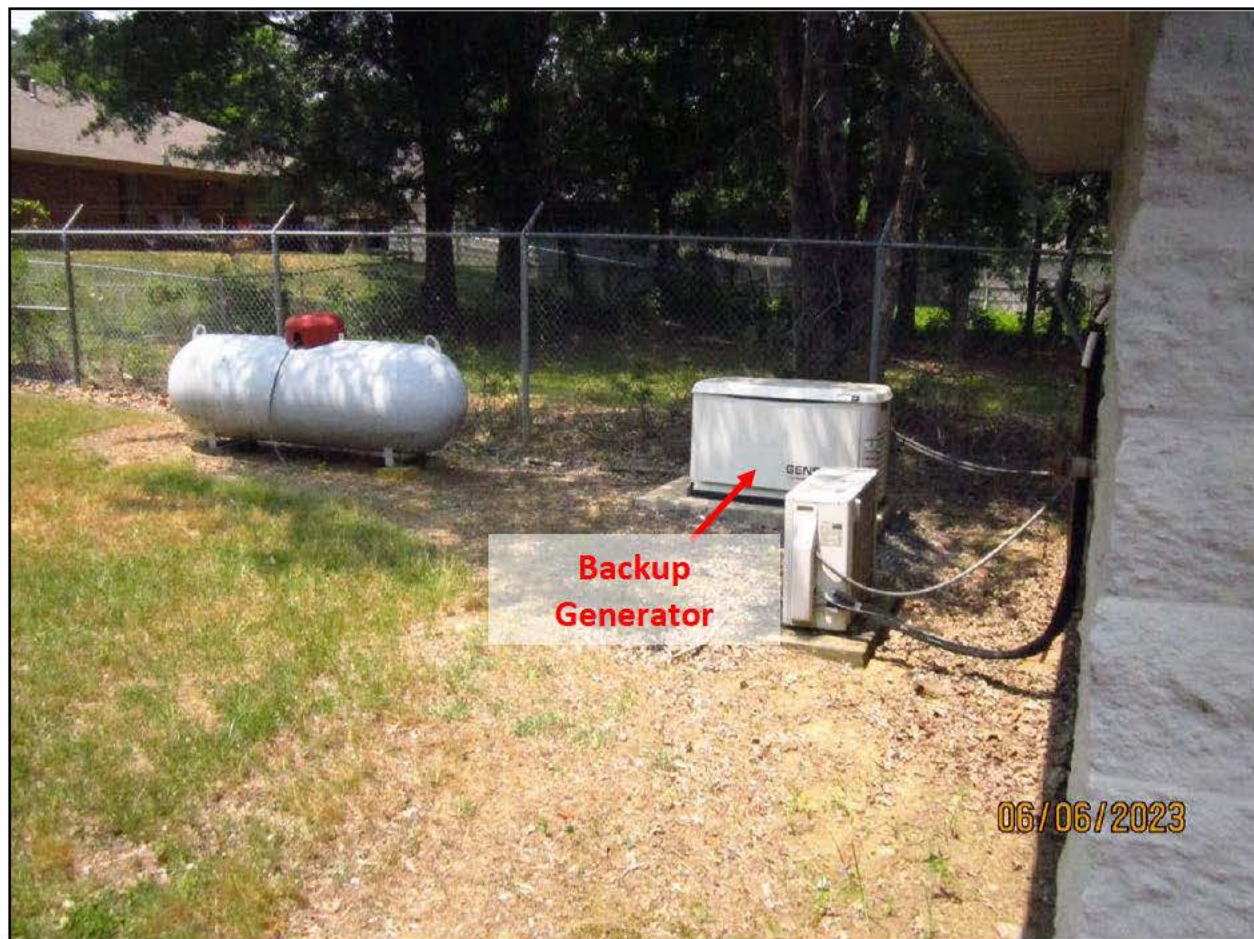
**Photograph 21. Backup Generator and Propane Tank, Master Meter #1** View of the backup generator and propane tank that were located inside of fence line at Master Meter #1. System representatives stated that the generator was owned by Community Water.

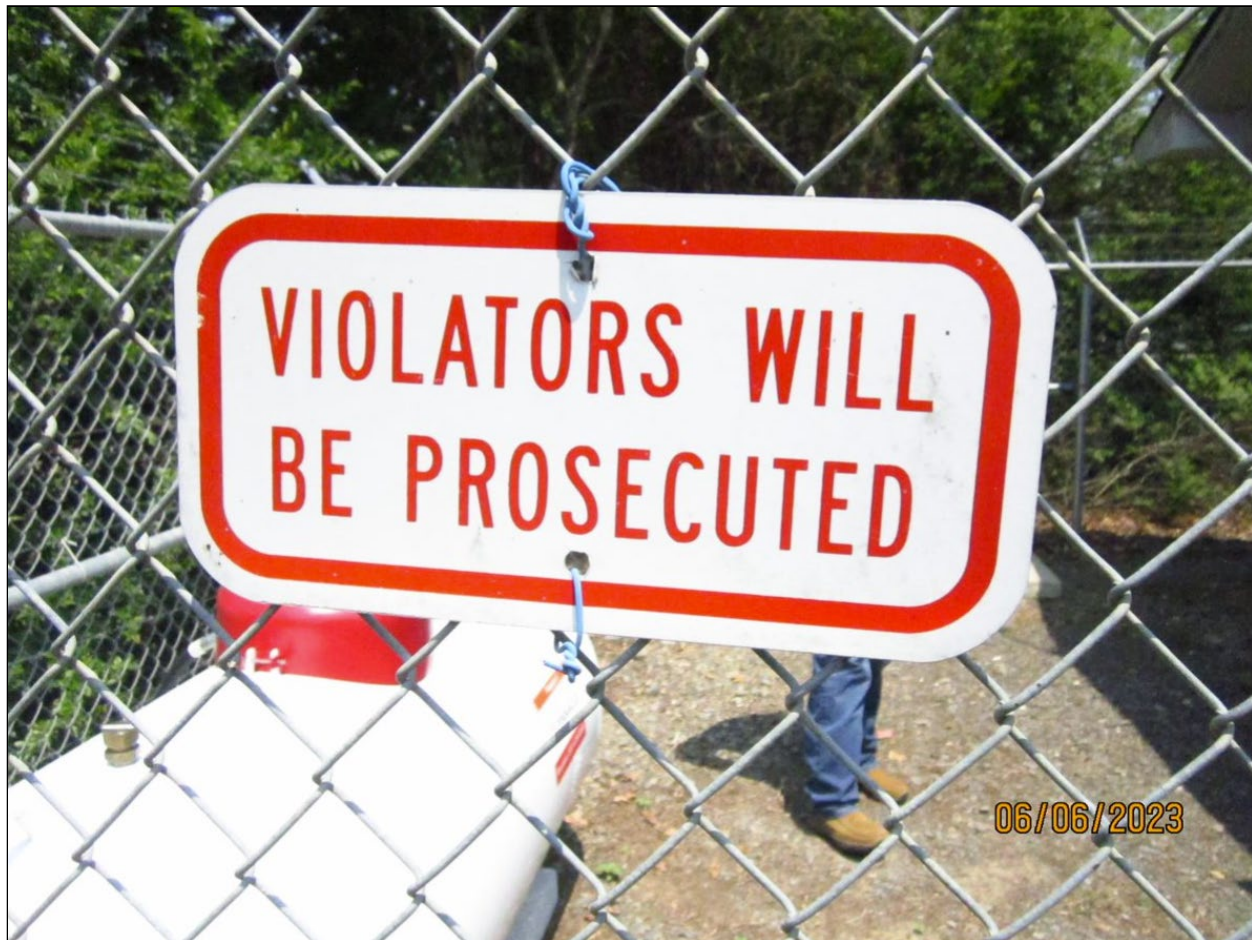
**Photograph 22. Master Meter #2 Security Fence** View of the sign that said "Violators Will Be Prosecuted" on the perimeter fence of Master Meter #2.
