**Region 6 - Enforcement & Compliance Assurance Division**  
**INSPECTION REPORT**

| Inspection Date(s): | 06/06/2023 | |
| Facility Name: | <b>Greenbrier Water Works</b> | |

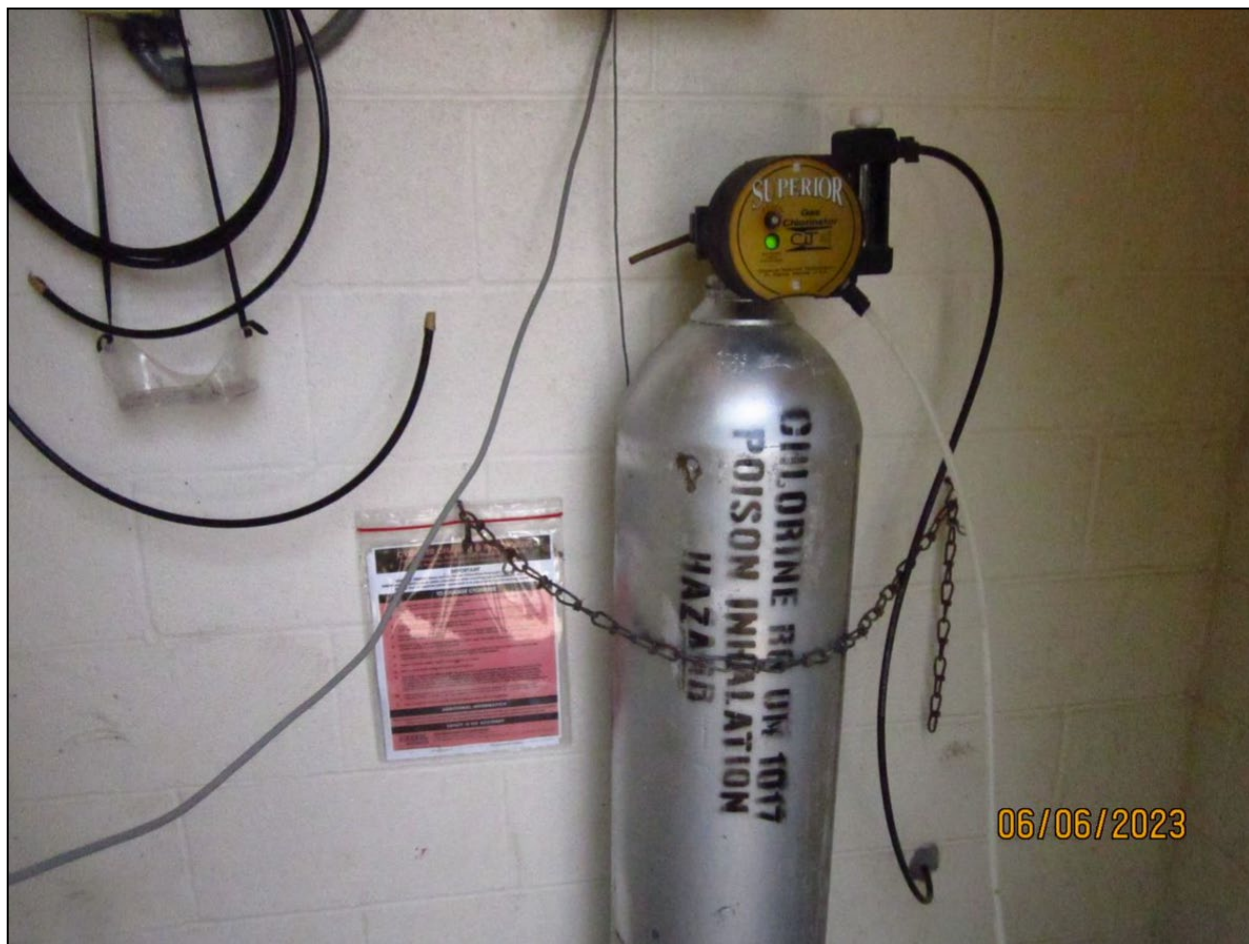
**Photograph 23. Chlorine Gas Storage Room, Master Meter #2** View of the 150 lb. chlorine gas cylinder inside the Master Meter #2 chlorine storage room. The gas was being fed through the wall into the backflow protection/chlorine injection room.

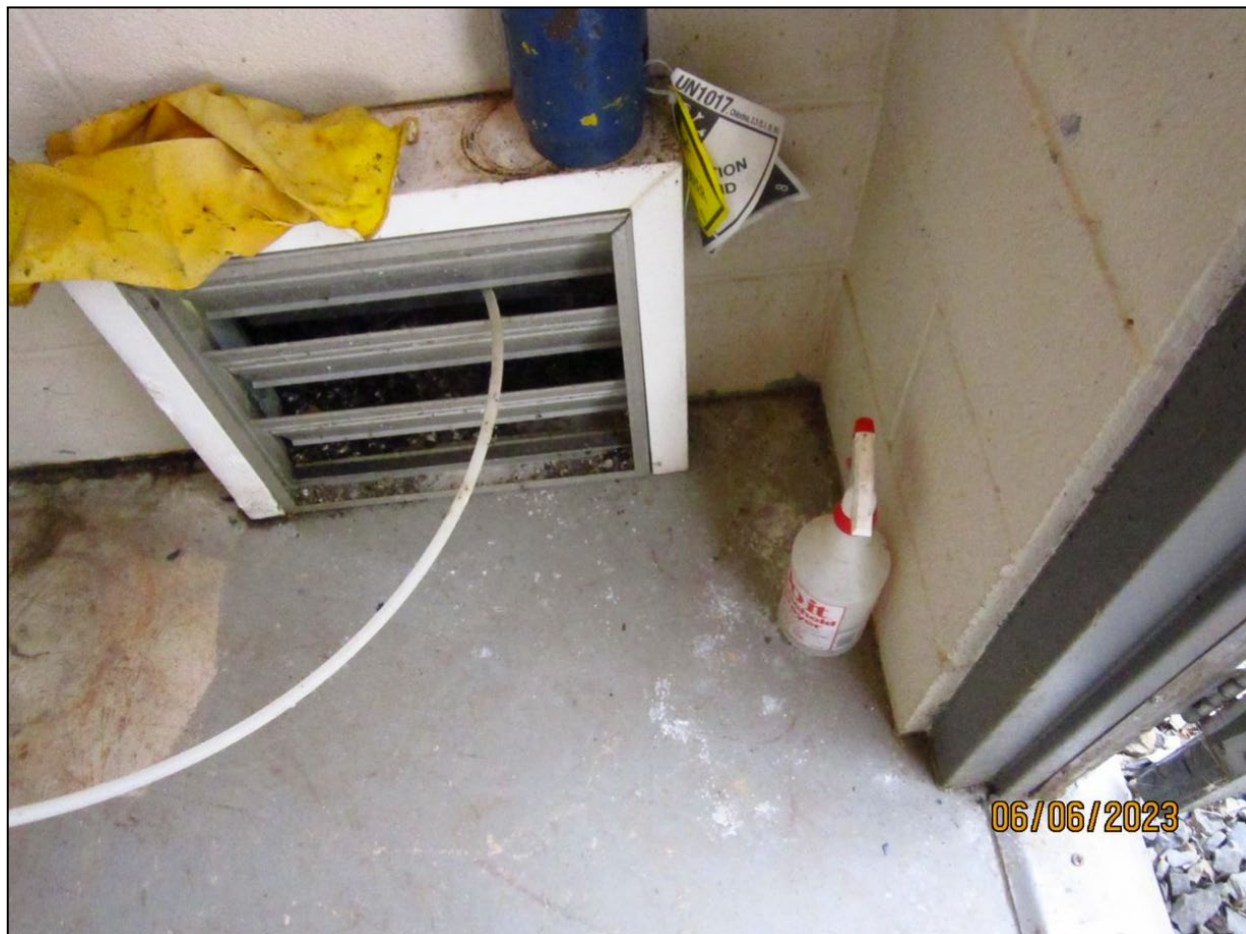
**Photograph 24. Chlorinator Vent Line, Master Meter #2** View of a chlorinator vent line in the chlorine storage room at Master Meter #2. The chlorinator vent lines were run through the exhaust vent moveable louvers. It was unclear if the lines would negatively impact the room's designed ability to properly manage a release of chlorine gas.

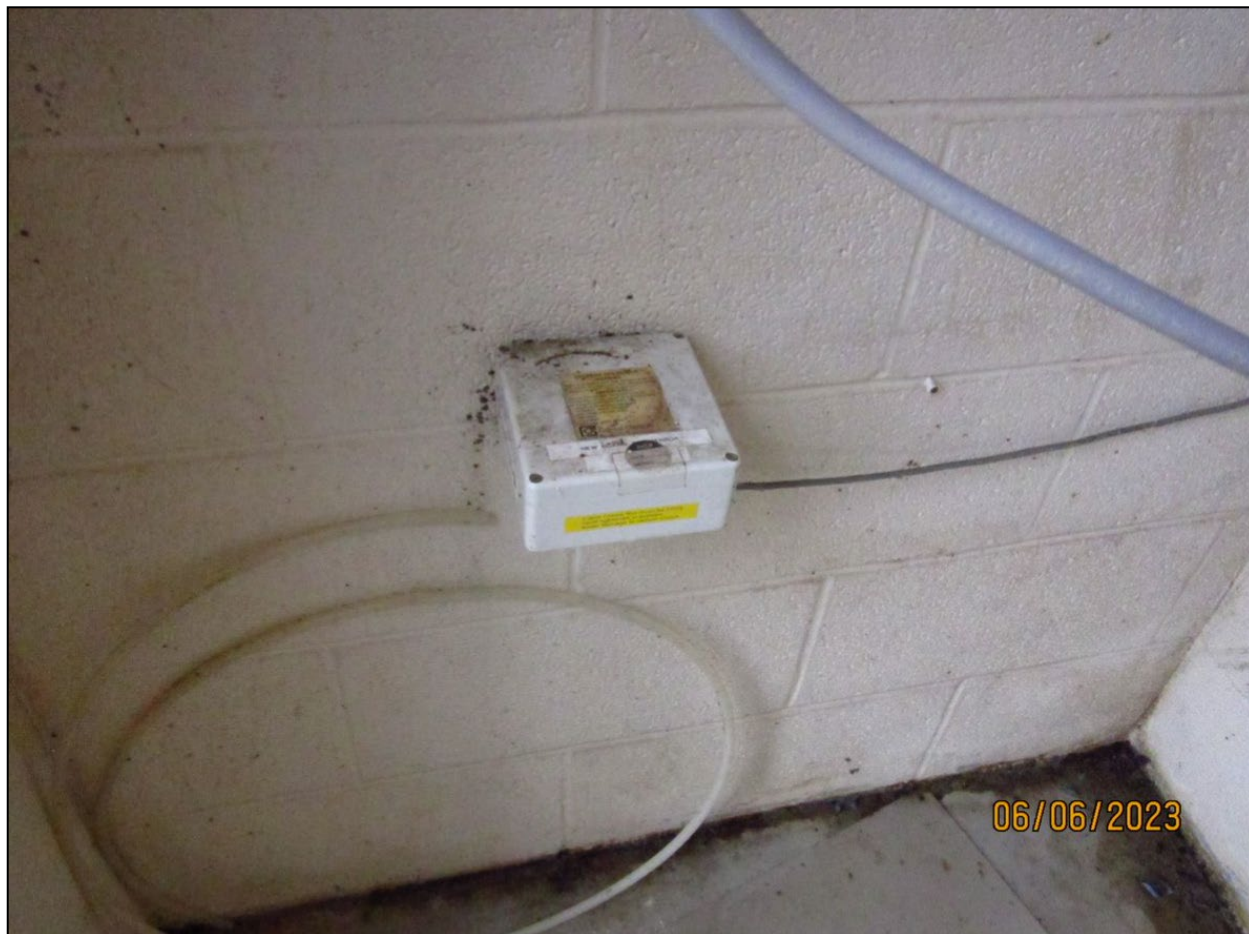
**Photograph 25. Chlorine Sensor, Master Meter #2** View of the chlorine gas sensor in the chlorine storage room at Master Meter #2. It appeared that the sensor had not been cleaned/serviced recently. In addition, the sensor was positioned over 20-inches off the floor. Since chlorine gas settles close to the ground, the position of this sensor is concerning because it may not detect a chlorine gas leak until levels of chlorine become dangerously high.

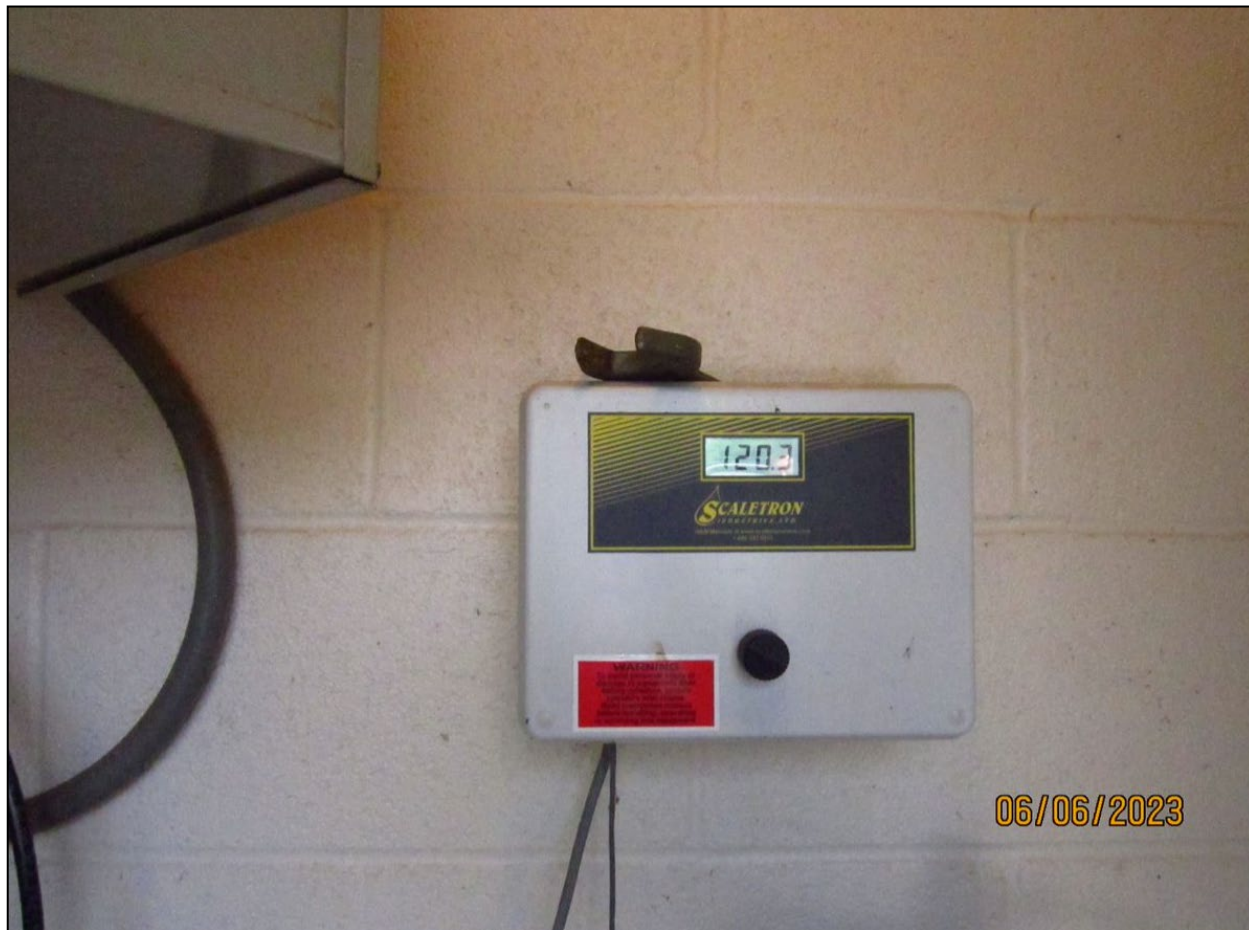
**Photograph 26. Chlorine Cylinder Scale, Master Meter #2** View of the functional chlorine cylinder scale in the chlorine gas storage room at Master Meter #2.

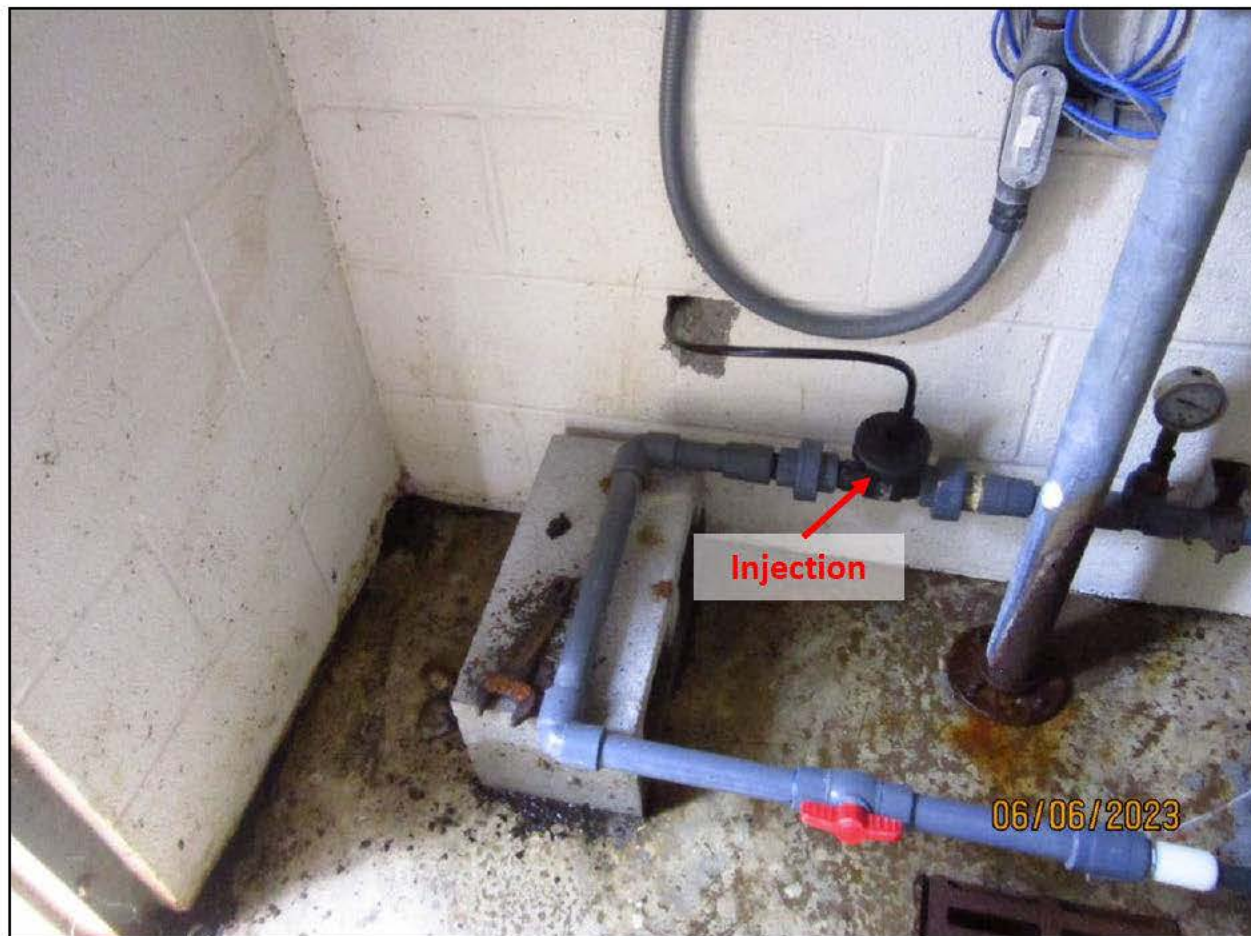
**Observation 21.** Chlorine was being injected into carry water in a separate room than where the chlorine gas cylinders were being stored at both Master Meter #1 and #2 (refer to Appendix 2, Photograph 27). Additionally, there was a chlorinator vent line extending off of the 150 lb. chlorine gas cylinder at the Master Meter #1 chlorine booster station, and it was being fed through an exhaust vent with movable louvers (refer to Appendix 2, Photograph 24). It was unclear if the line was negatively impacting the room's designed ability to properly manage a chlorine gas leak.

**Photograph 27. Chlorine Injection, Master Meter #2** View of the inside of the backflow protection/chlorine injection room where chlorine gas was being injected into carry water. This injection was in a separate room from the chlorine storage room.
