**Well Inspection**  
**Osage DNR / Environmental Protection Agency**  
**1201 Elm Street, Suite 500**  
**Dallas, Texas 75270**

| <b>Operator Info</b> | Bandwheel Production Company, LLC<br>P.O. Box 700426<br>Tulsa, OK 74170<br>Phone: 918-932-8418 | <b>Inventory ID</b> | OS1014000 | | |
| | | <b>Well ID</b> | 13W7-3 | | |
| <b>Inspection Reason</b> | Plugging Witnessed | <b>Responsible Company at Time of Inspection</b> | Bandwheel Production Company | | |

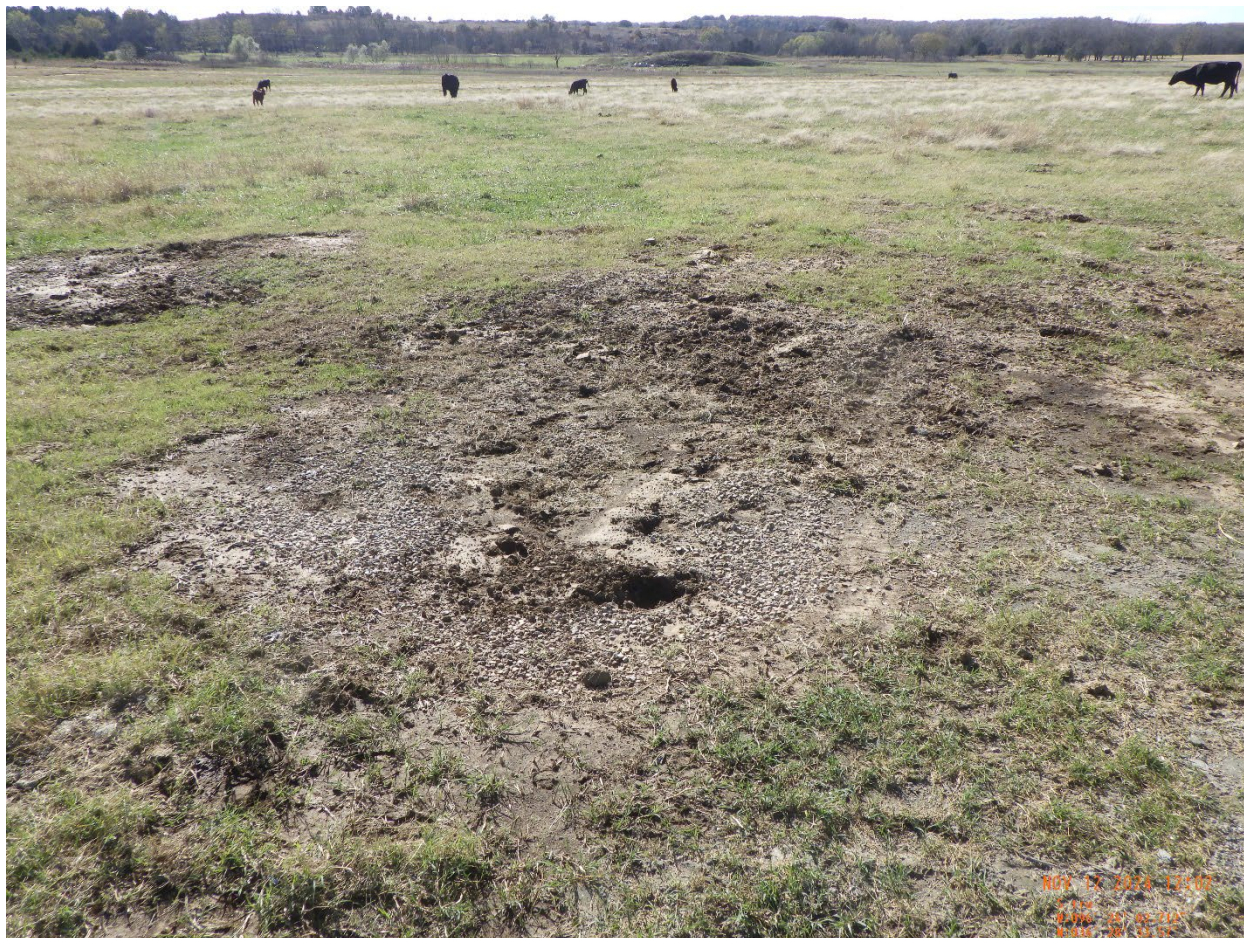
Photo No. 1

**Description:** This was the location for well OS1014000 at the time of the inspection. Post-plugging surface restoration was completed.
