**Region 6 - Enforcement & Compliance Assurance Division**  
**INSPECTION REPORT**

| Inspection Date(s): | 03/16/2026 | |
| Company Name: | CapturePoint, LLC | |
| Facility Name: | South Burbank Unit (SBU) R Battery | |

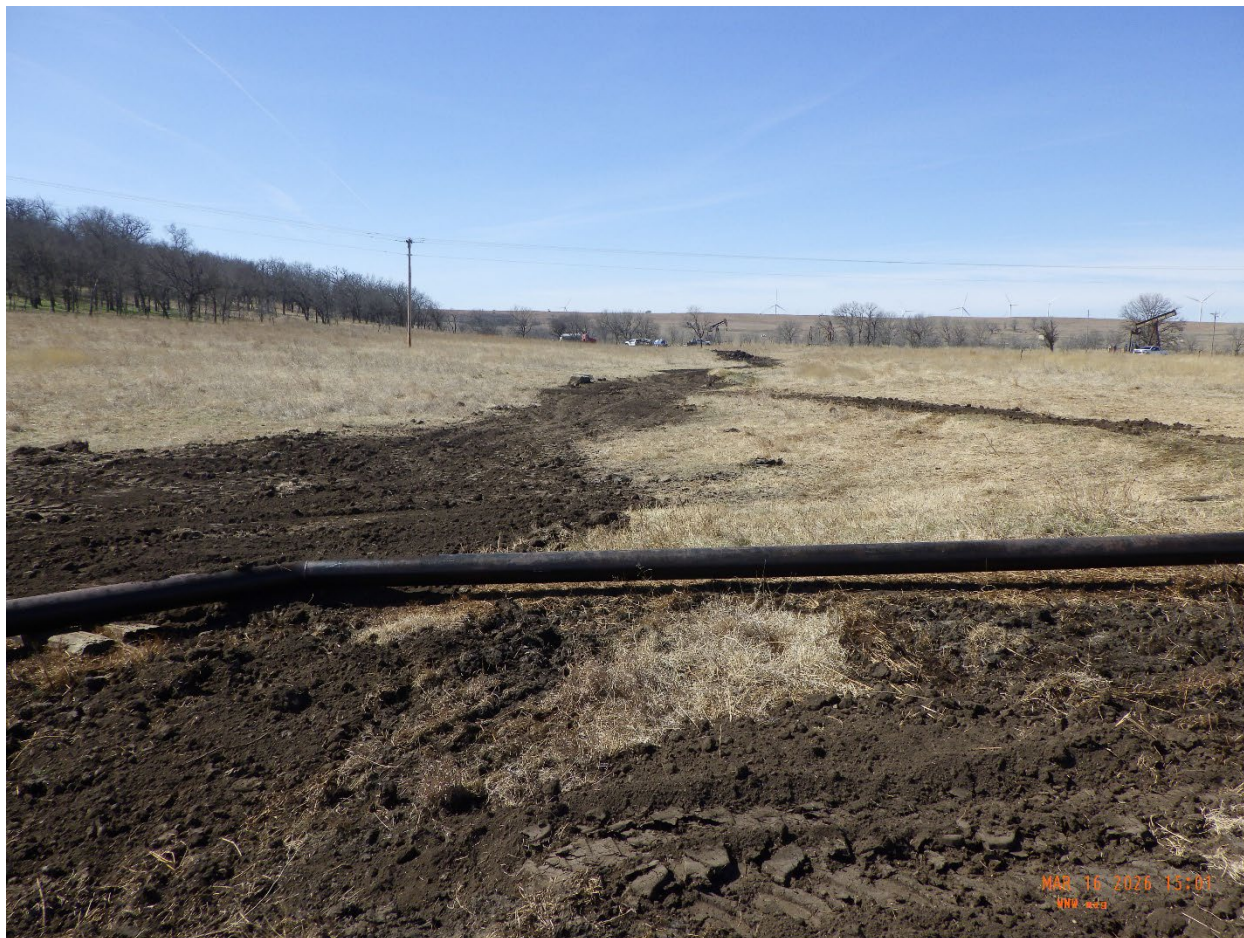
Photo No. 1

I observed the release point of the spill (see Appendix 1, Photo Log) Photo No. 1, which was a steel production flowline which failed due to corrosion, releasing a company estimated 500 barrels of saltwater and 10 barrels to the land surface. At the time of the inspection, the failed flowline was repaired and the facility was returned to normal operation. For GPS location information and additional meta data, please see the photo log.

**Description:** This was the release point of the spill, a steel production flowline which failed due to corrosion.

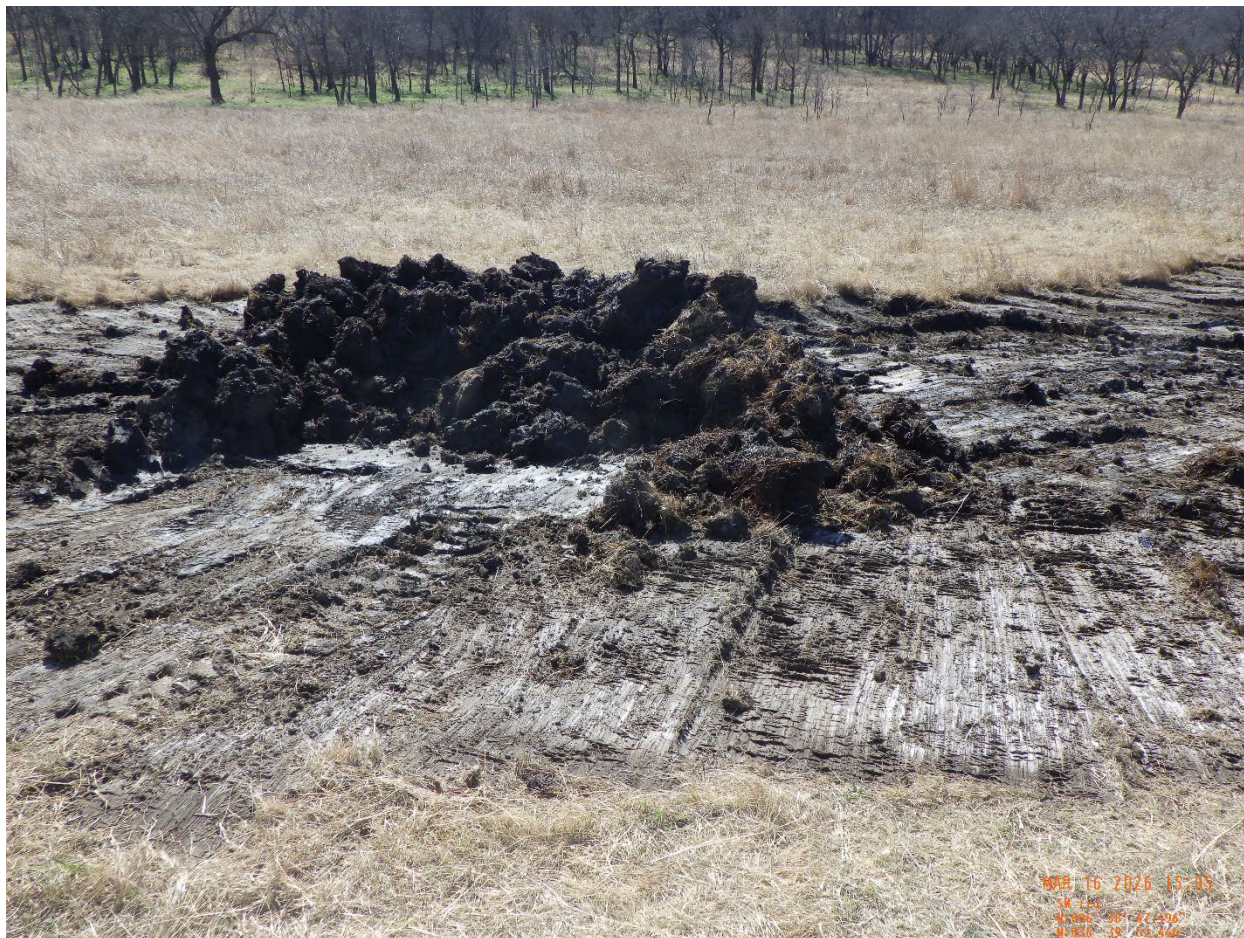
Photo No. 2

I observed the overland flowpath which migrated west from the release point. Along the flowpath, I observed a pile of oil stained soil which was being scraped and removed from the area. See photo No. 2.

**Description:** This was oil soaked soil which had been scraped up for removal along the overland flowpath.

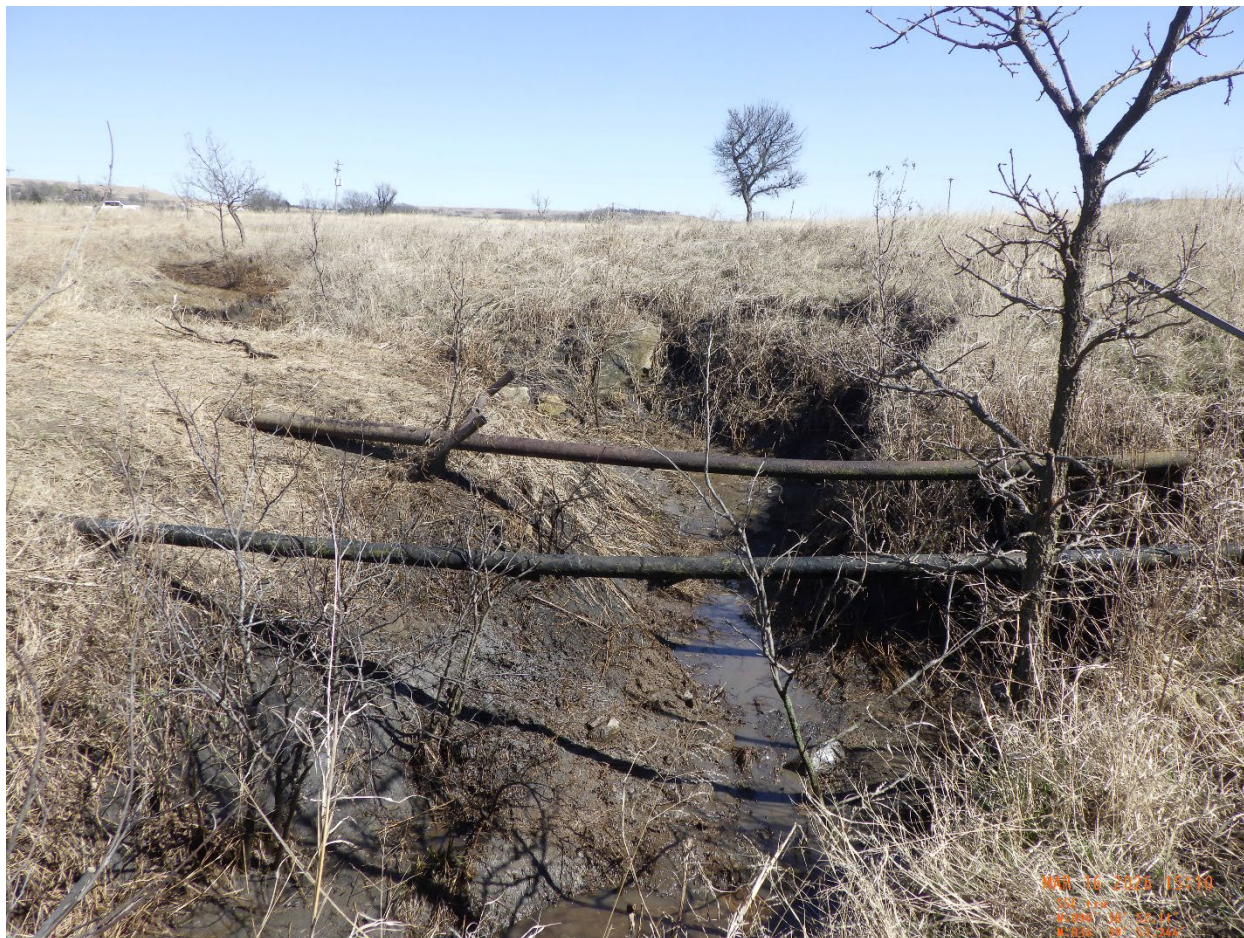
Photo No. 3

I observed cleanup and “flushing” operations along the impacted tributary of Little Chief Creek, see photos No. 3 and 4.

**Description:** This was an area along the impacted, unnamed tributary of Little Chief Creek. At the time of the inspection, CapturePoint, LLC was actively flushing the area with freshwater.

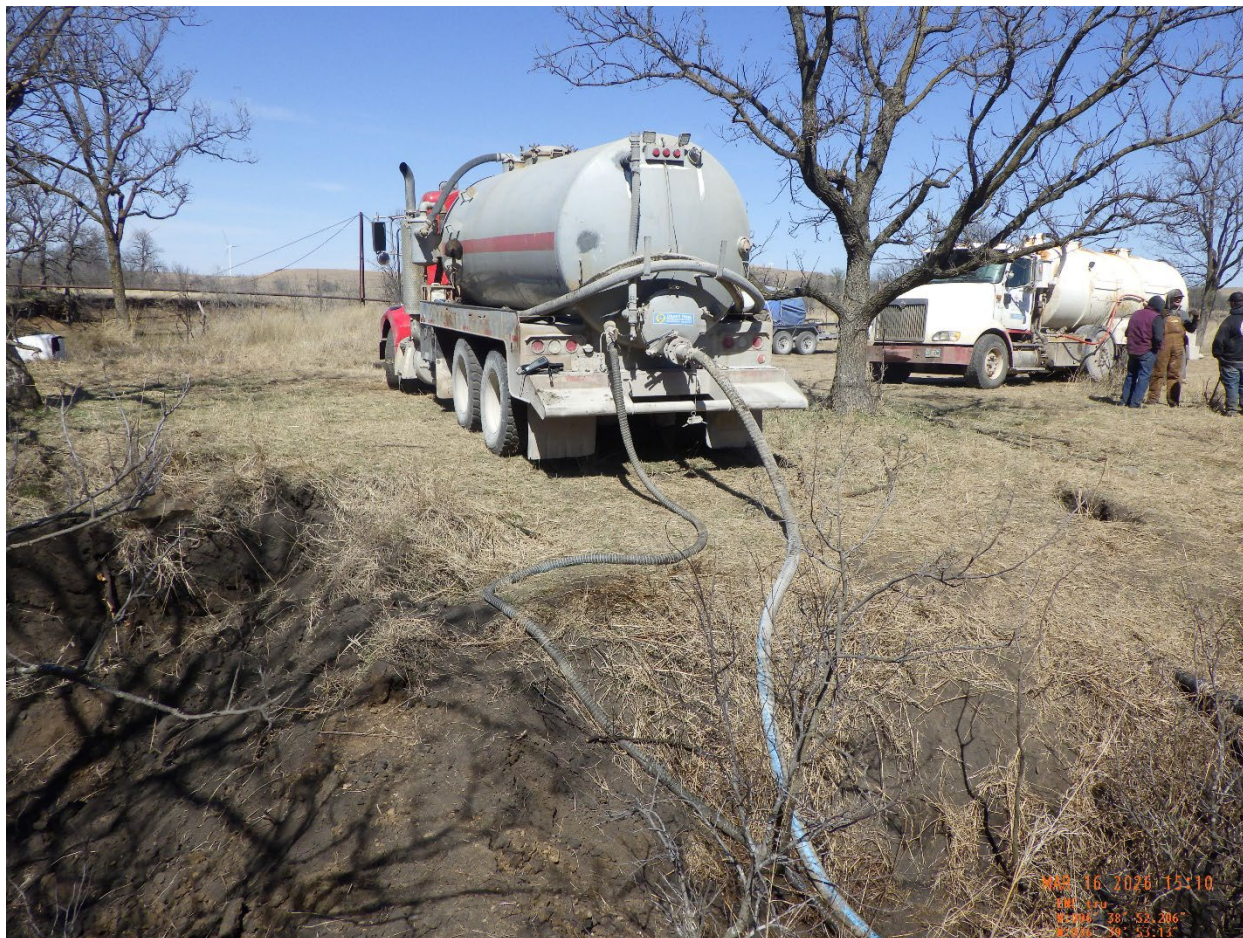
Photo No. 4

**Description:** This was a vacuum truck removing flush water from the impacted tributary.

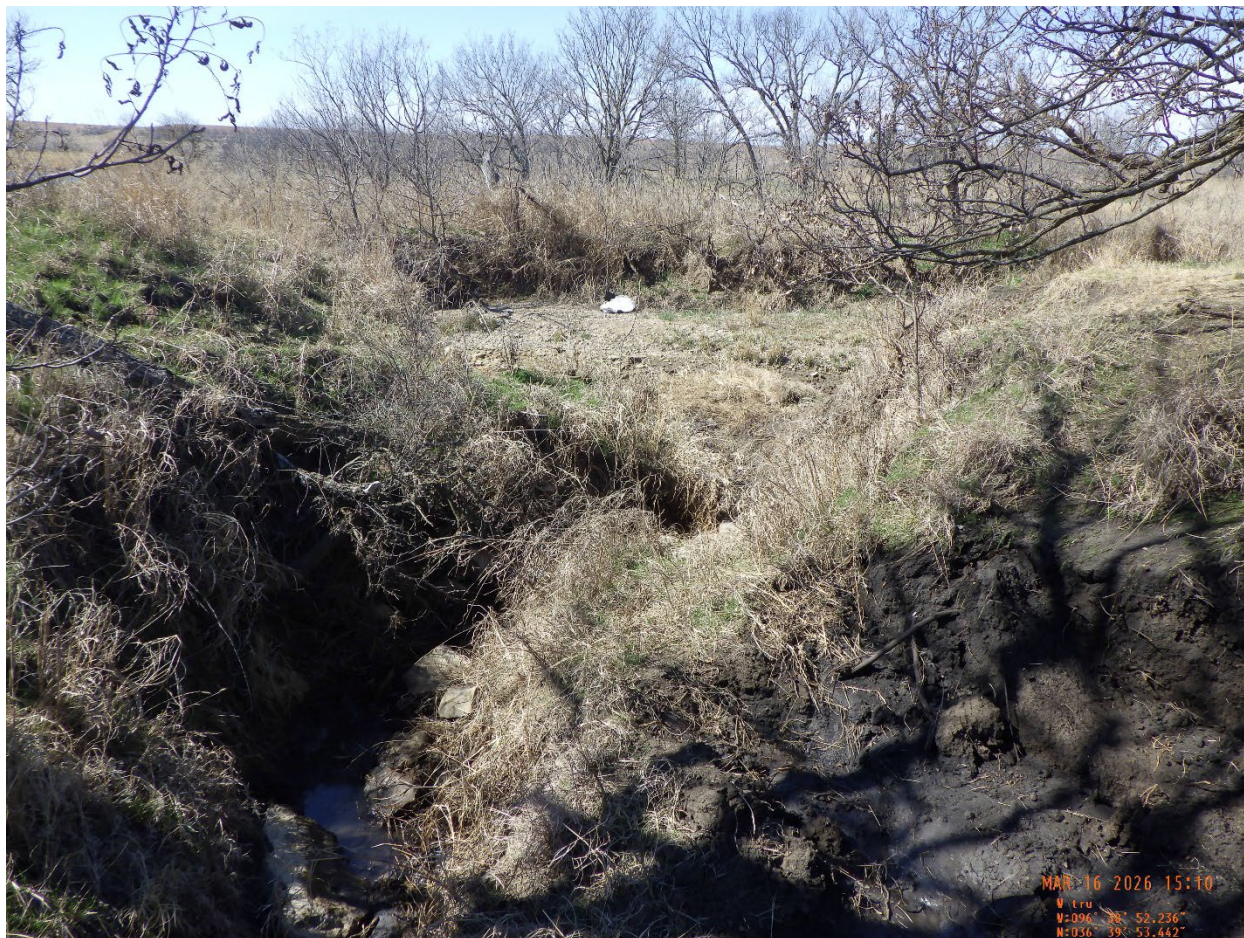
Photo No. 5

I observed the Point of Entry (POE) into a braided side channel of Little Chief Creek. See photo No. 5.

**Description:** This was a view from the mouth of the impacted tributary looking into the braided side channel of Little Chief Creek.

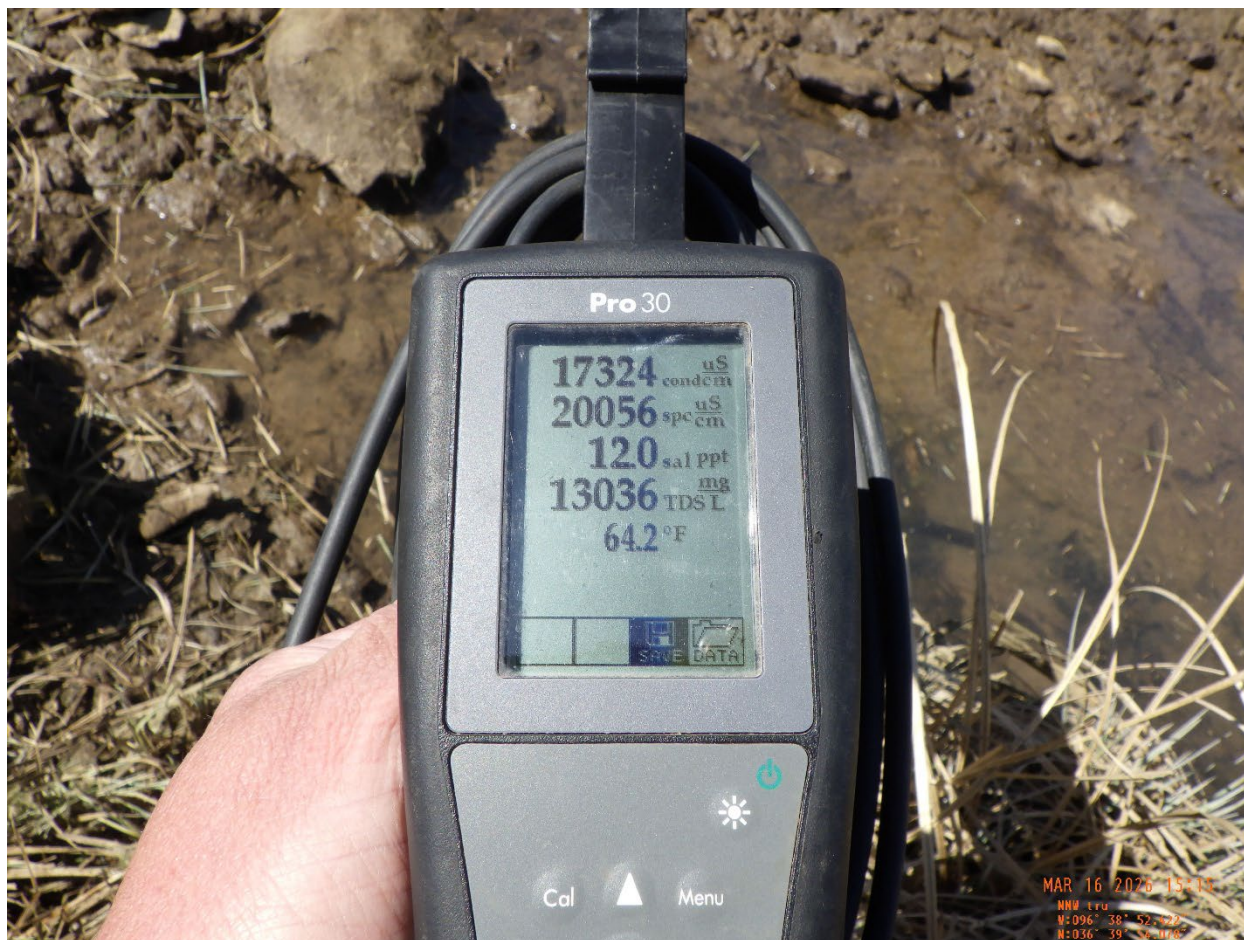
Photo No. 6

At the POE into Little Chief Creek, I observed a TDS field reading of 13,036 mg/L. This was the highest TDS level observed during the inspection. See photos No. 6 and 7.

**Description:** This was a TDS field reading of 13,036 mg/L taken in the side channel of Little Chief Creek, at the point of entry (POE) into Little Chief Creek.

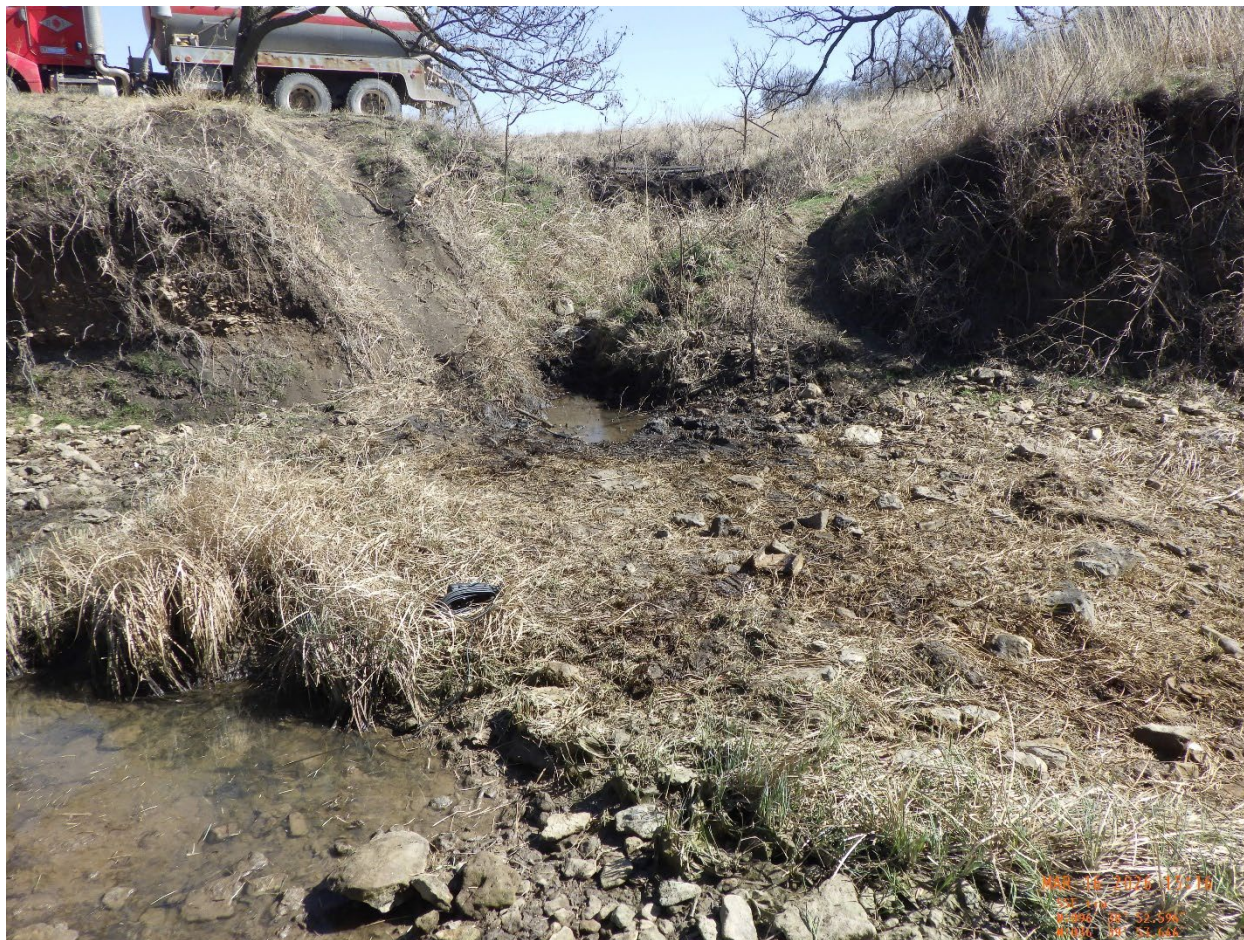
Photo No. 7

**Description:** This was a view from the channel of Little Chief Creek looking east, toward the impacted tributary. This was the POE into Little Chief Creek.

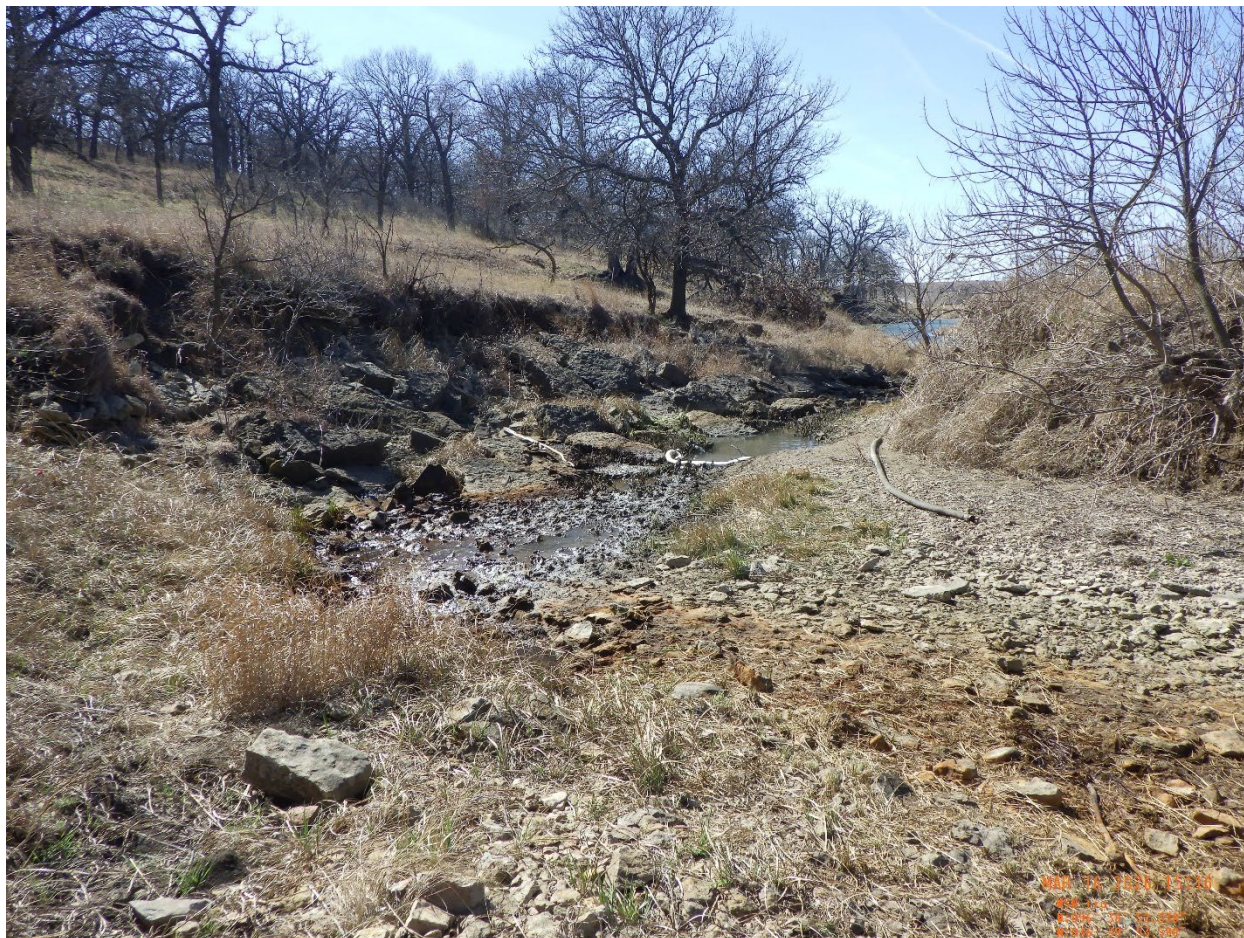
Photo No. 8

I observed the bed and bank features of the side channel of Little Chief Creek, with a view from the POE, looking WSW along the side channel toward the main channel of Little Chief Creek. See photo No. 8.

**Description:** This was a downstream view along Little Chief Creek from the POE.

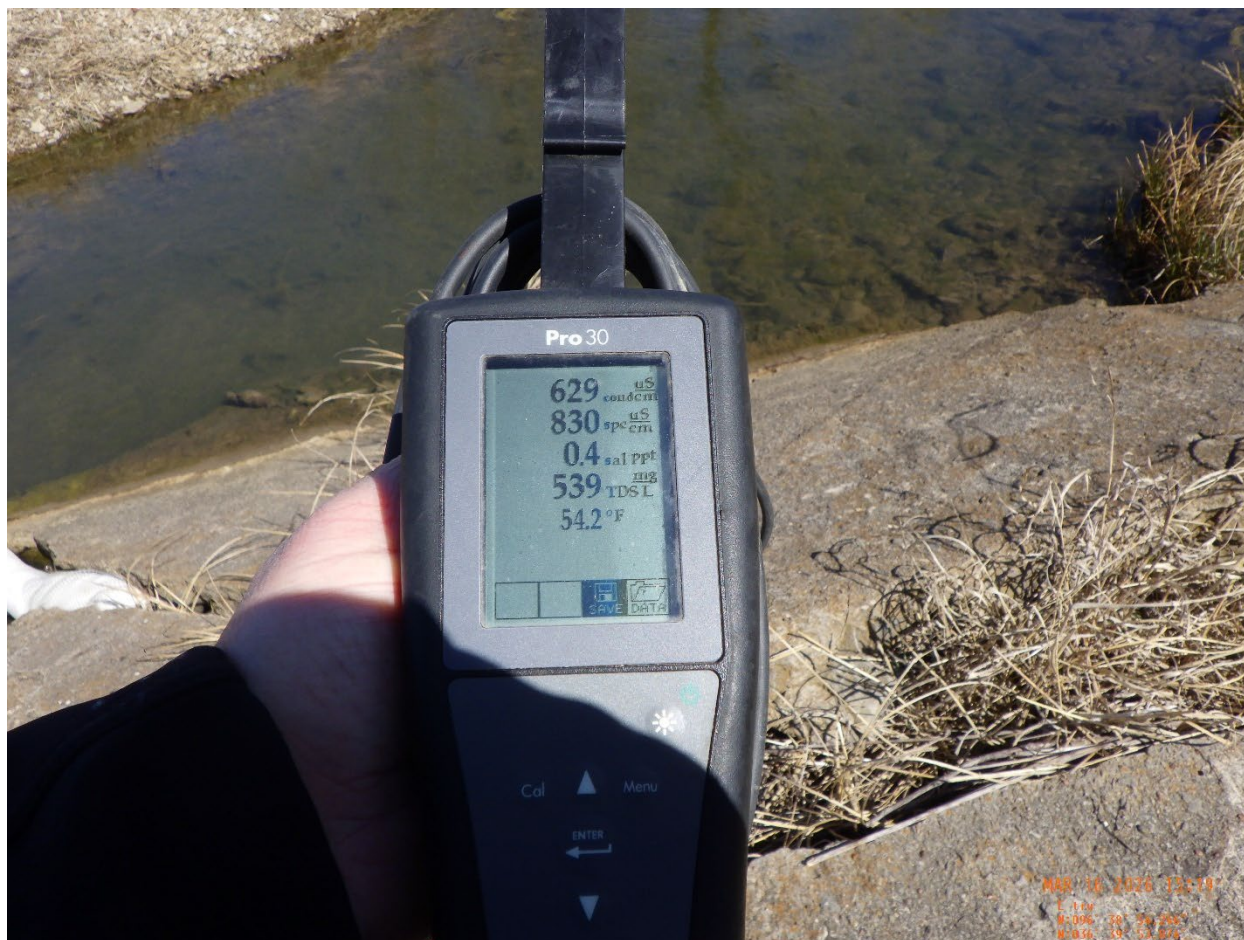
Photo No. 9

I observed a TDS field reading of 539 mg/L in the side channel of Little Chief Creek, just before entering the main channel of Little Chief Creek. This was the last observed spill impacts. At this same location, I observed a floating, oil-absorbent containment boom installed by the operator to prevent downstream migration of spill impacts. See photos No. 9 and 10.

**Description:** This was a TDS field reading of 539 mg/L taken in braided side channel of Little Chief Creek at the first significant pool of water located downstream from the POE.

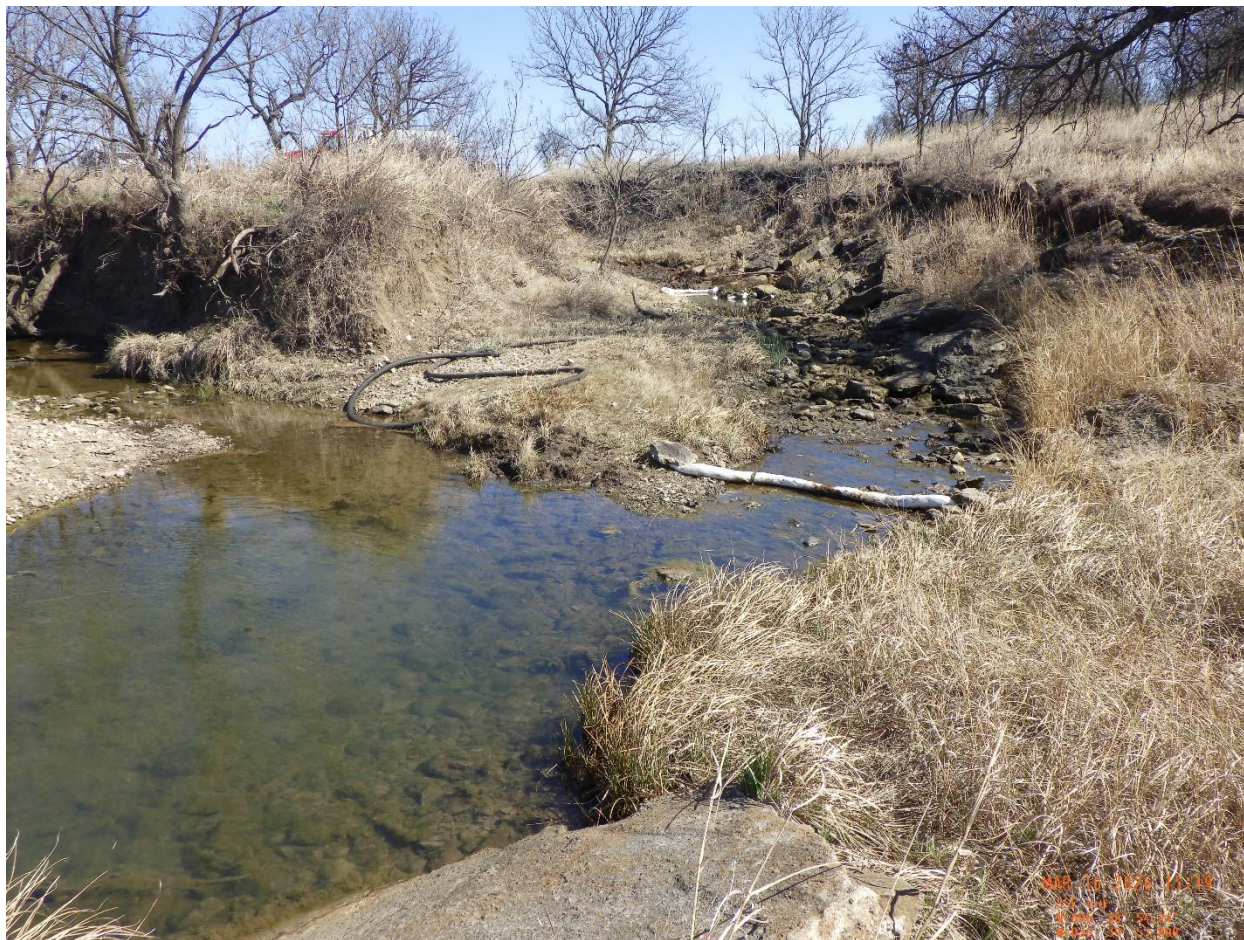
Photo No. 10

**Description:** This was the location where the TDS reading from photo No. 9 was taken. The absorbent boom marks the end of observed spill impacts.

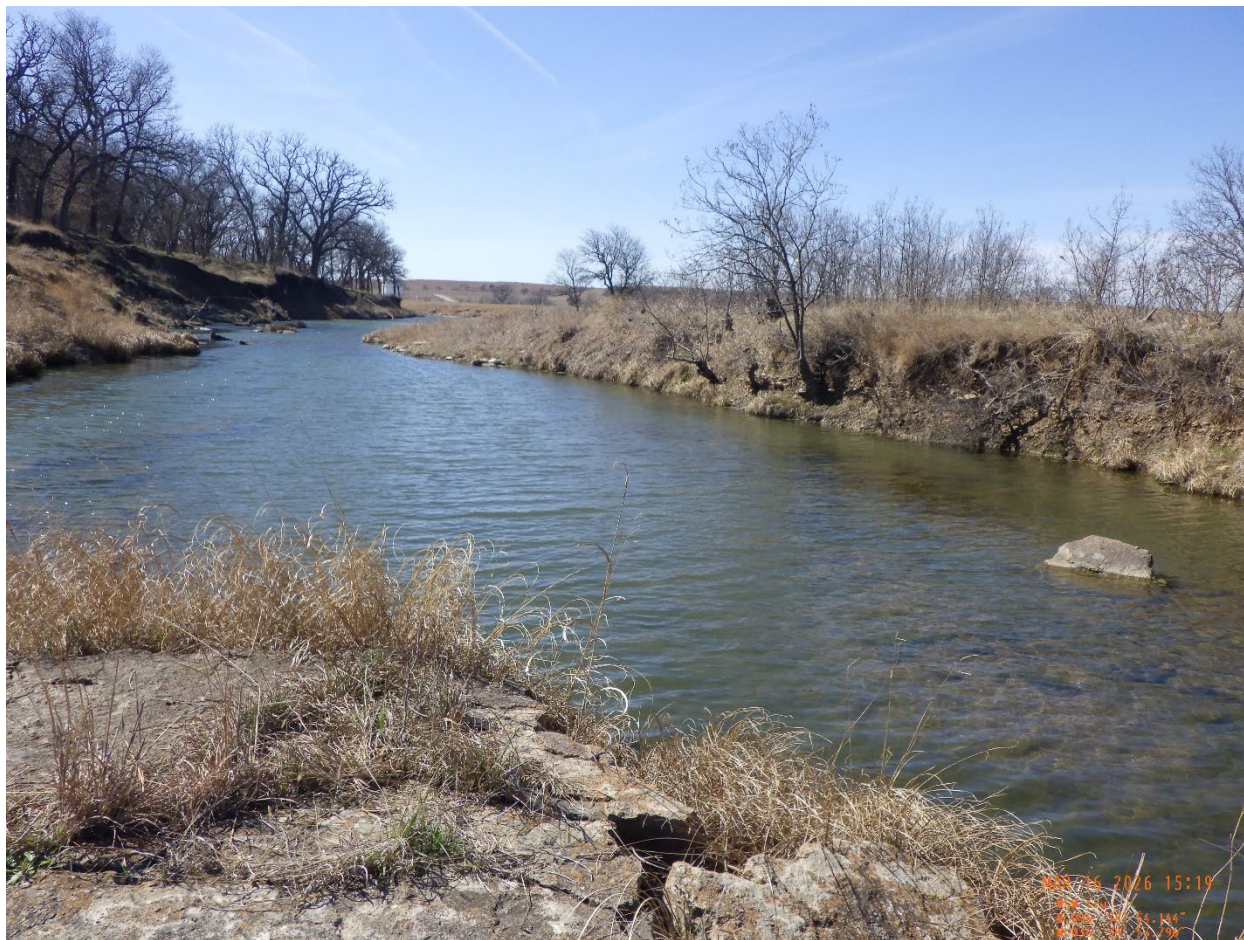
Photo No. 11

I observed the bed and bank features of the main channel of Little Chief Creek, downstream from the last spill impacts. See photo No. 11.

**Description:** This was a view downstream along the main channel of Little Chief Creek. Spill impacts did not reach this main channel.

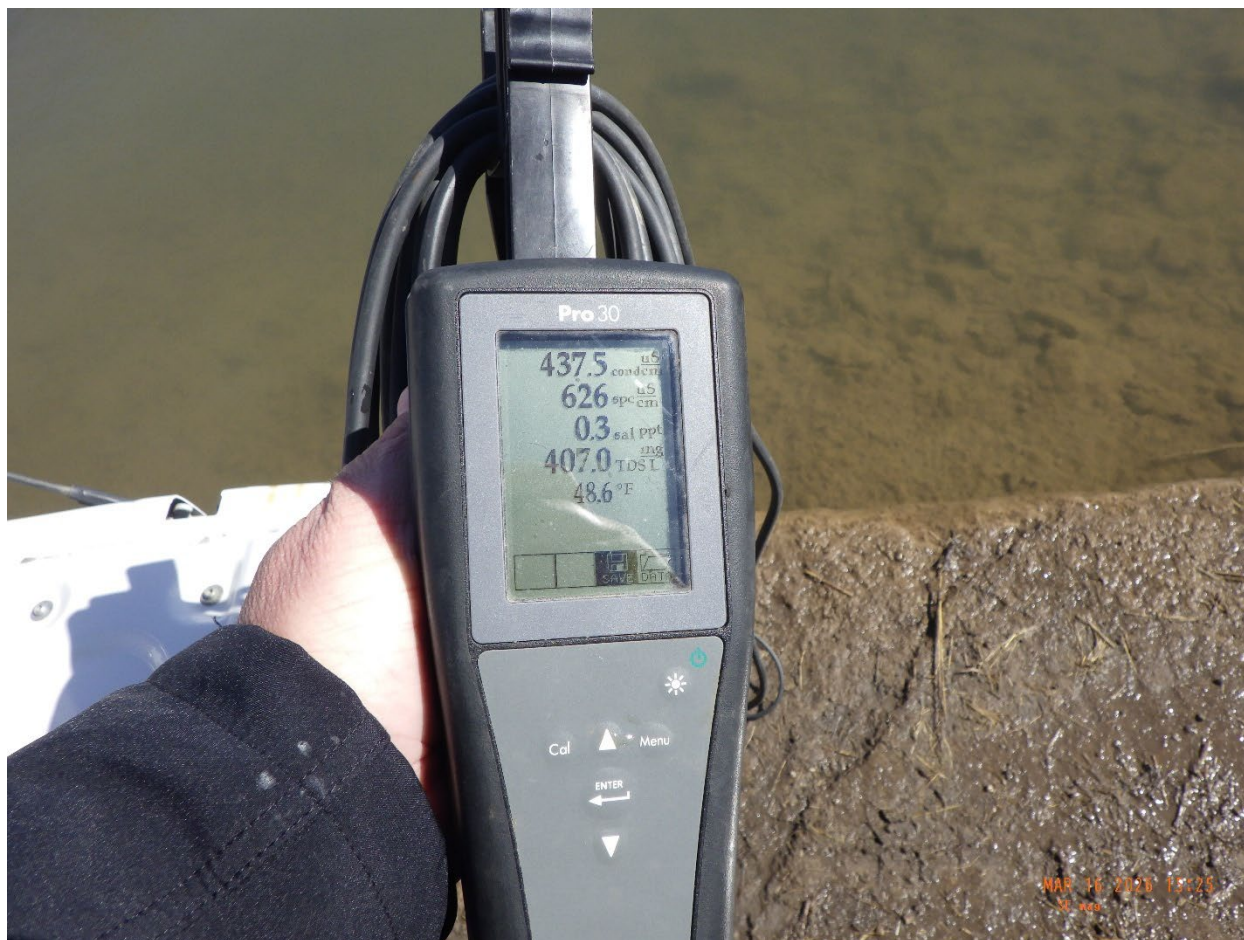
Photo No. 12

I observed a “background” TDS field reading of 407 mg/l, upstream from the spill impacts, in the main channel of Little Chief Creek. This observation should be used when establishing background TDS levels for the area. See photos No. 12 and 13.

**Description:** This was a TDS field reading observed in the main channel of Little Chief Creek, upstream from all spill impacts. This reading should be used when establishing background TDS levels in the area.

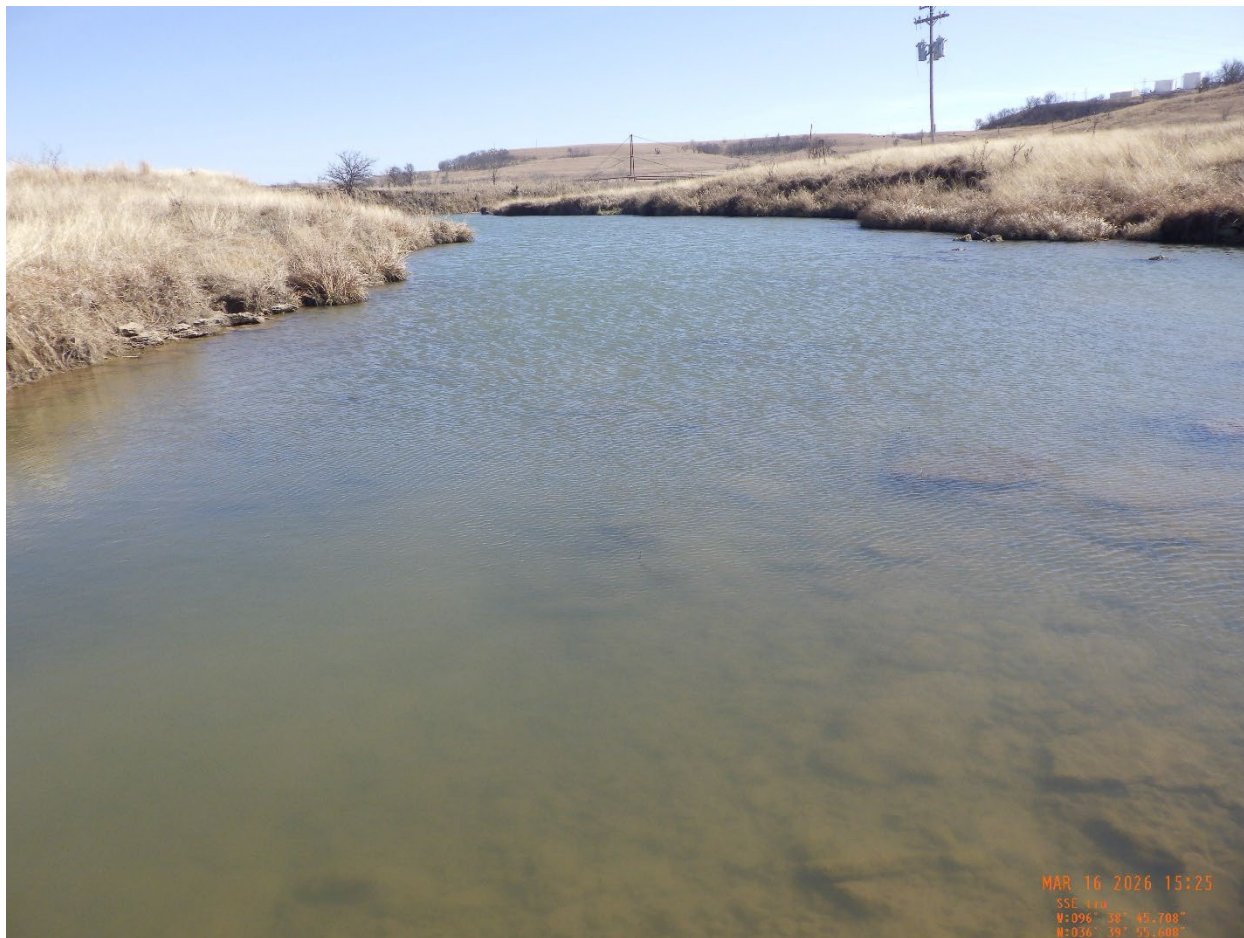
Photo No. 13

**Description:** This was the location of the TDS reading from photo No. 12.
