Sunset Dairy  
Inspection Date 06/08/2022

**Region 6 - Enforcement & Compliance Assurance Division**  
**INSPECTION REPORT**

| Regulatory Program(s) | CAFO | |
| Facility Name: | <b>Sunset Dairy</b> | |

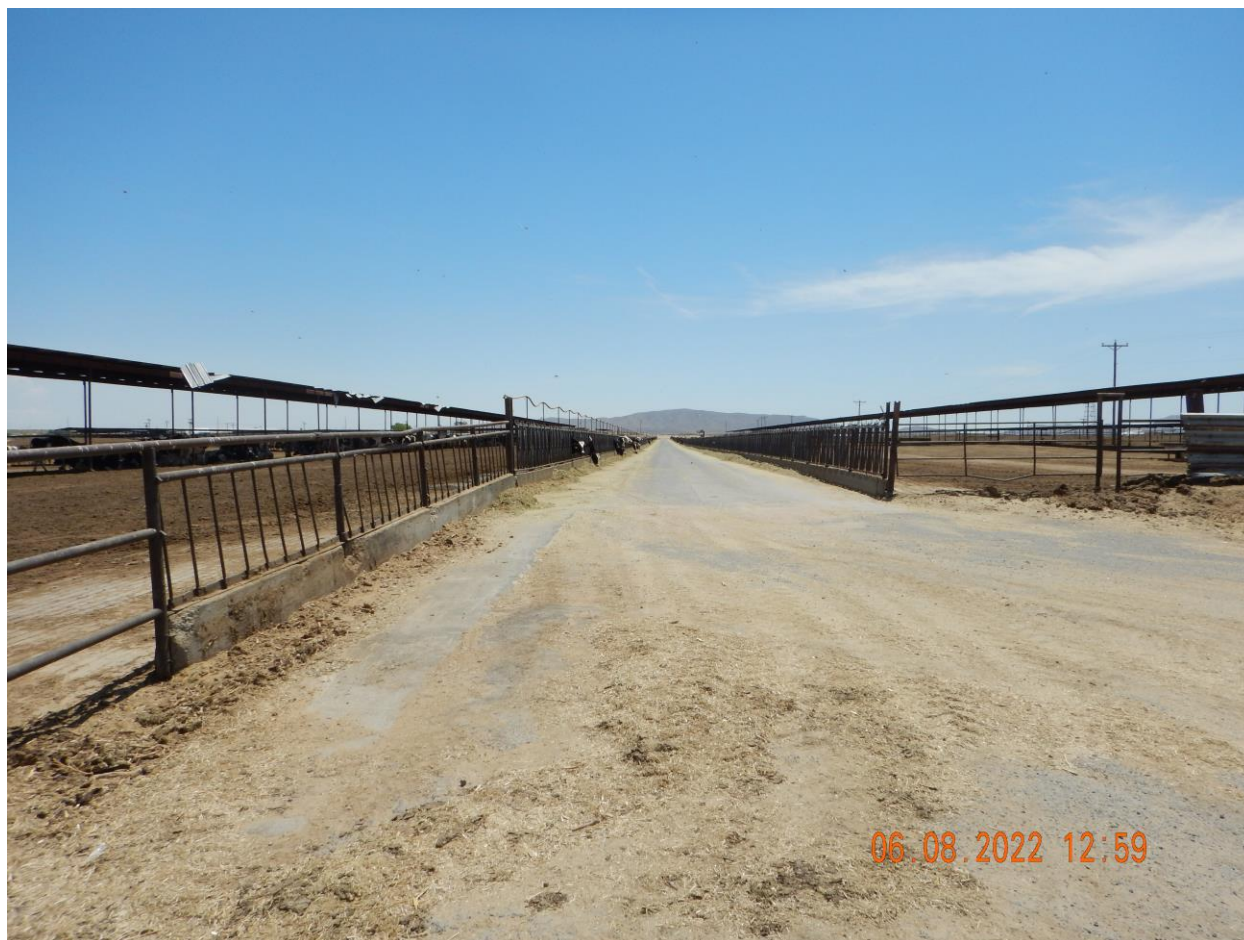
Photo No. 1

Description: The driveway which separates Desertland Dairy on the left (north) and Sunset Dairy on the right (south). The Sunset Dairy pens shown in this photograph are the northwestern most pens of Sunset Dairy. These pens would discharge storm water runoff into the Desertland Dairy Wastewater and Storm Water Combo Lagoon RCS. The view is toward the east.

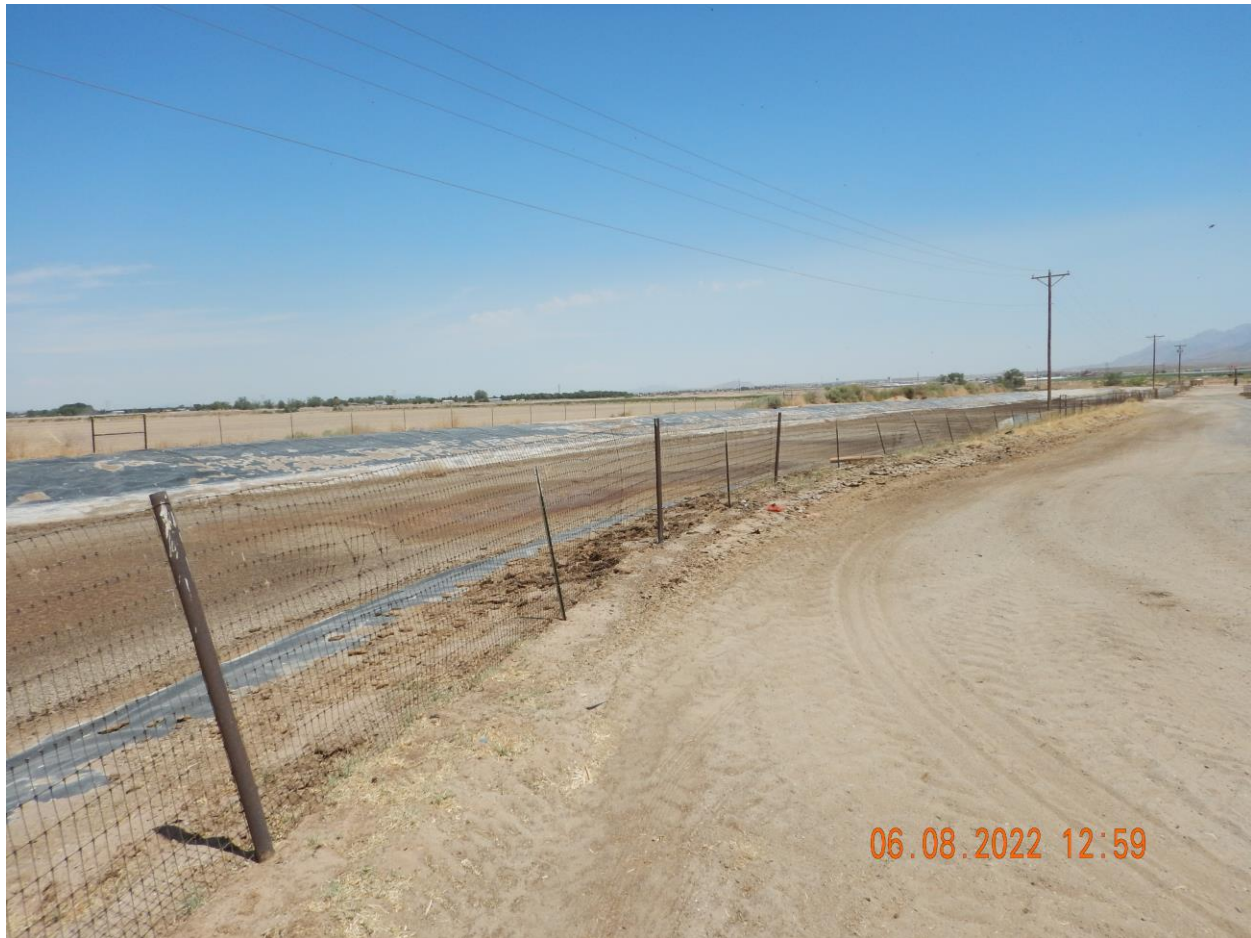
Photo No. 2

Description: Looking north at the dry portion of the Desertland Dairy Wastewater and Storm Water Combo Lagoon RCS which would receive storm water runoff from the most northwest pens of Sunset Dairy.

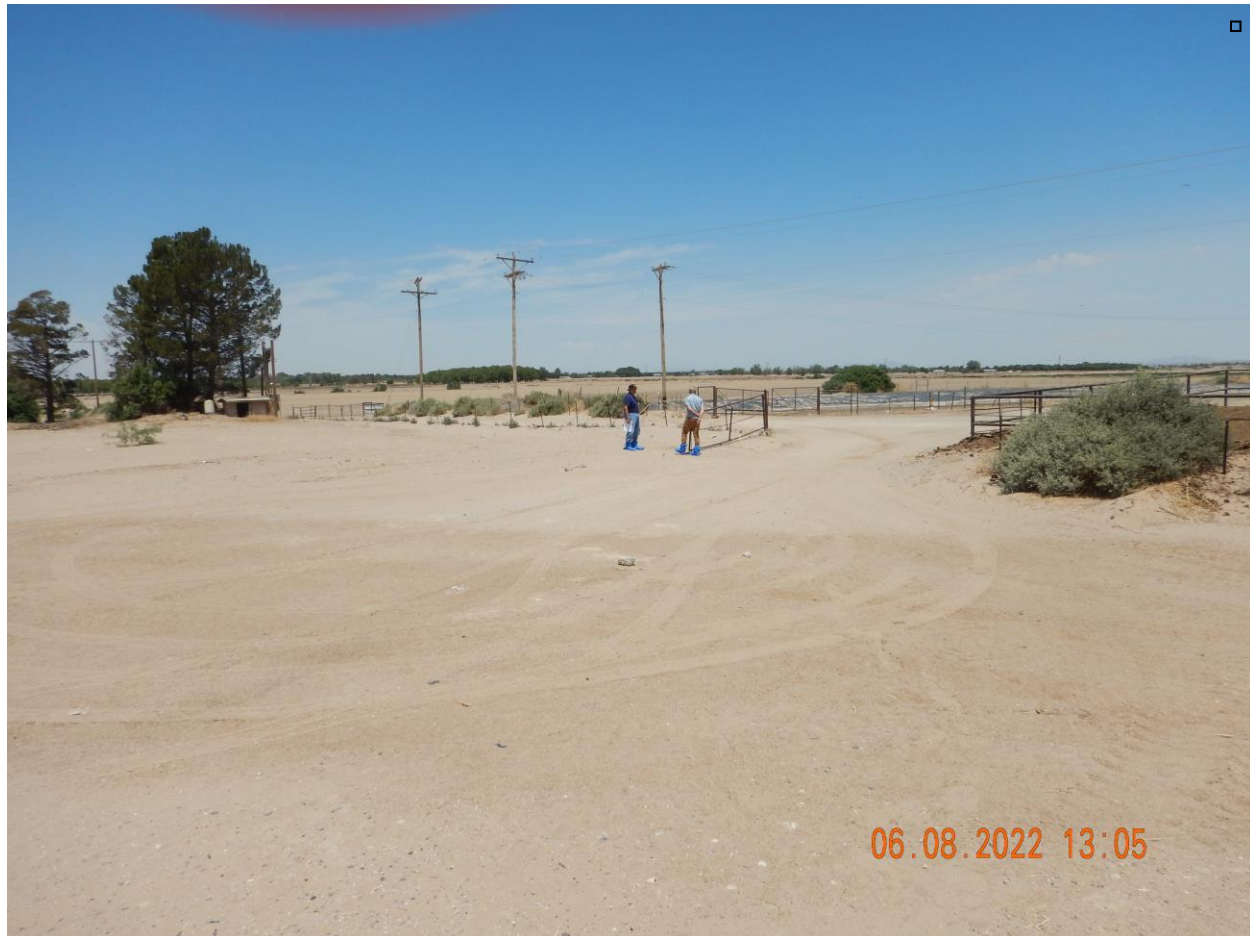
Photo No. 3

There appears to be a significant accumulation of manure solids in the Wastewater RCS as shown in Photo 4 (of Appendix 1). See AOC 1 which describes the concern and lists the requirement for RCS maintenance in the EPA permit. There are also two areas where berm maintenance is required to ensure that storm water runoff from the cattle pens is directed into one of the storm water RCSs during the 25-yr/24-hr rain event as shown in Photos 3 and 5 (see AOC 2).

Description: Berm maintenance is needed at the northwest pen area to ensure that runoff from the 25-yr/24-hr rain event is channeled to the Desertland Dairy Wastewater and Storm Water Combo Lagoon RCS (seen in the background right). The view is toward the west.

AOC 2 - The runoff diversion berm located north of the manure screen needs to be improved to ensure that runoff from the pens is directed into the Storm Water Runoff RCS. Also, the runoff diversion berm located on the south side of the access road next to the new pen area needs maintenance to ensure that runoff from that area is also directed into the Storm Water Runoff RCS. The dairy shall prevent any discharge of manure or process wastewater pollutants into waters of the U.S. by ensuring proper design, construction, operation of maintenance to contain all manure and process wastewater from the 25-yr/24-hr storm event as required in Part II.A.1.a.i. of the EPA permit.

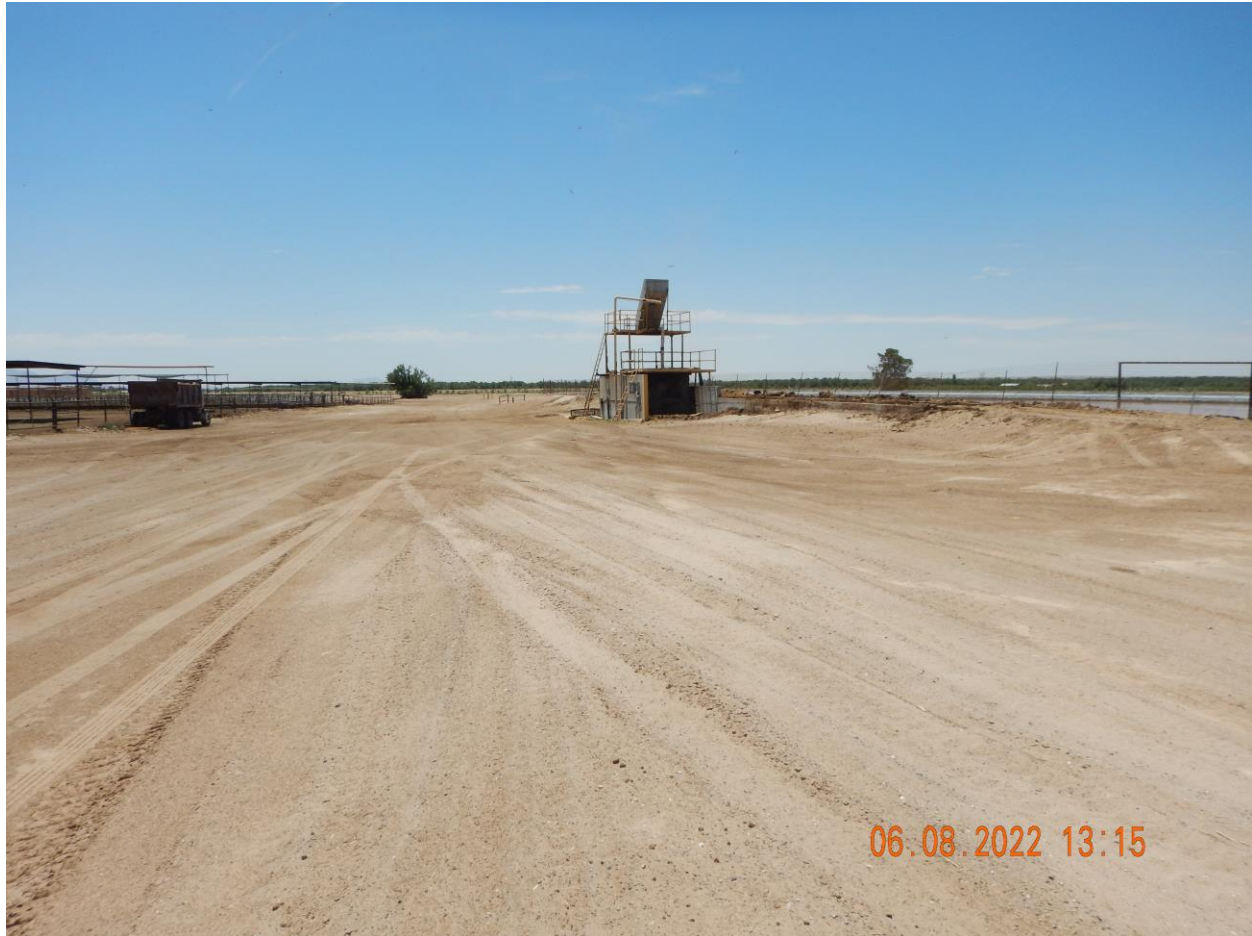
Photo No. 4

Description: The Sunset Dairy manure screening/settling area located on the east side of the Wastewater RCS (seen on the right side of the screen). The view is toward the south.

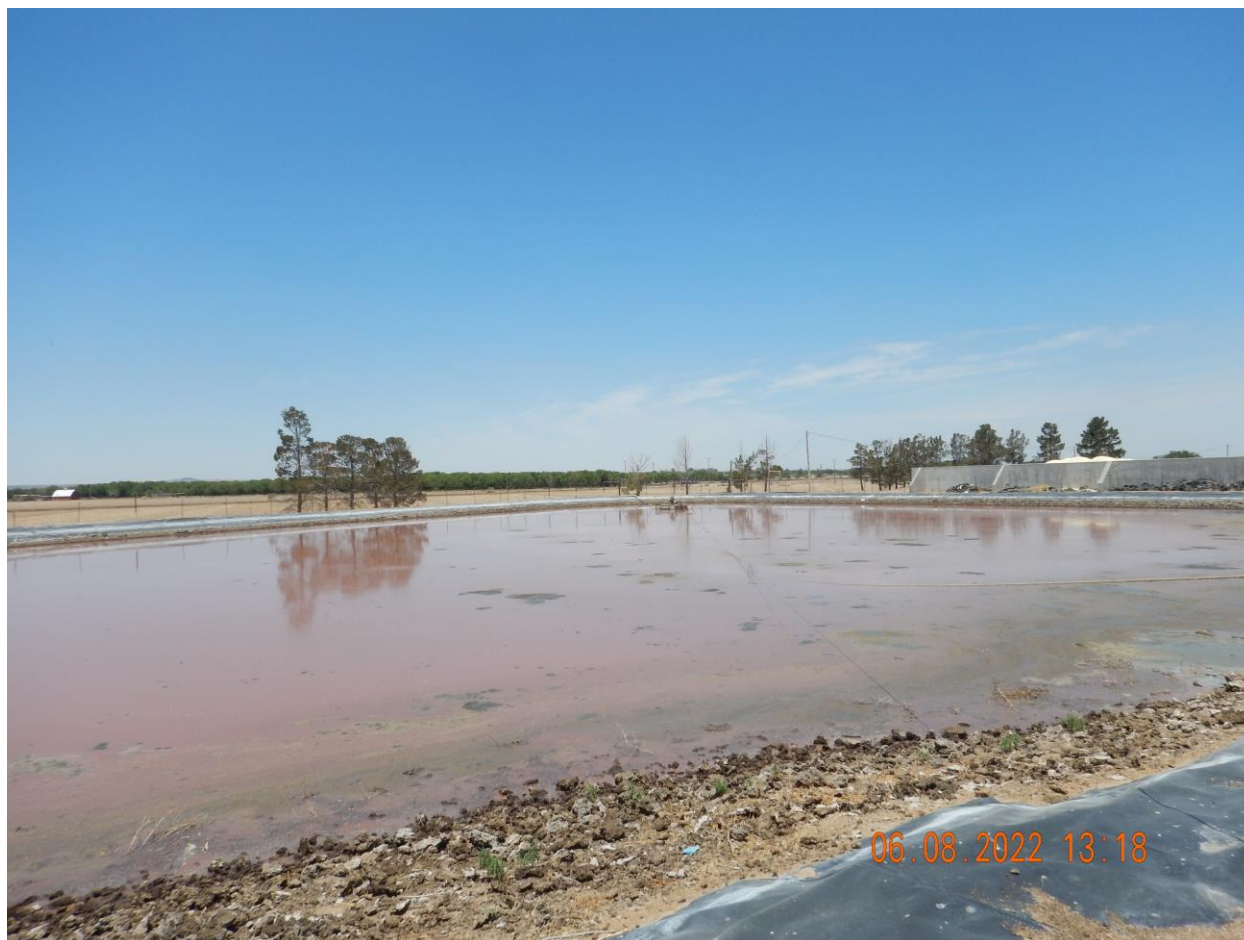
Photo No. 5

Description: The Sunset Dairy Wastewater RCS appears to have a significant amount of solids accumulation. An engineer should evaluate the RCS capacity for wastewater containment and determine if the unit has exceeded its solids retention capacity, or the facility may choose to remove these solids themselves. The view is toward the northwest.

AOC 1 - The manure solids level in the Wastewater RCS should be evaluated for design solids capacity to determine if the RCS has sufficient capacity for the 60 days of operation and the 25-yr/24-hr rainfall event. The Wastewater RCS either needs to be assessed by an engineer to ensure that sufficient wastewater capacity still exists within this RCS, and that the solids accumulation has not exceeded the units design limits, or the dairy may choose to remove the excess manure solids from the unit and give them to a third party. Part III.A.3.a. of the EPA permit requires “....adequate storage of manure.....including procedures to ensure proper operation and maintenance of the storage facilities. All wastewater and manure containment structures shall at a minimum be designed, constructed, operated, and maintained in accordance with the standards of the Natural Resources Conservation Service, Field Office Technical Guide.” Additionally, Part III.D.2 also requires that “The operator shall restore the storage capacity as soon as possible after any rainfall event or accumulation of wastes reduces such storage capacity...”. This would include manure solids accumulation within an RCS.

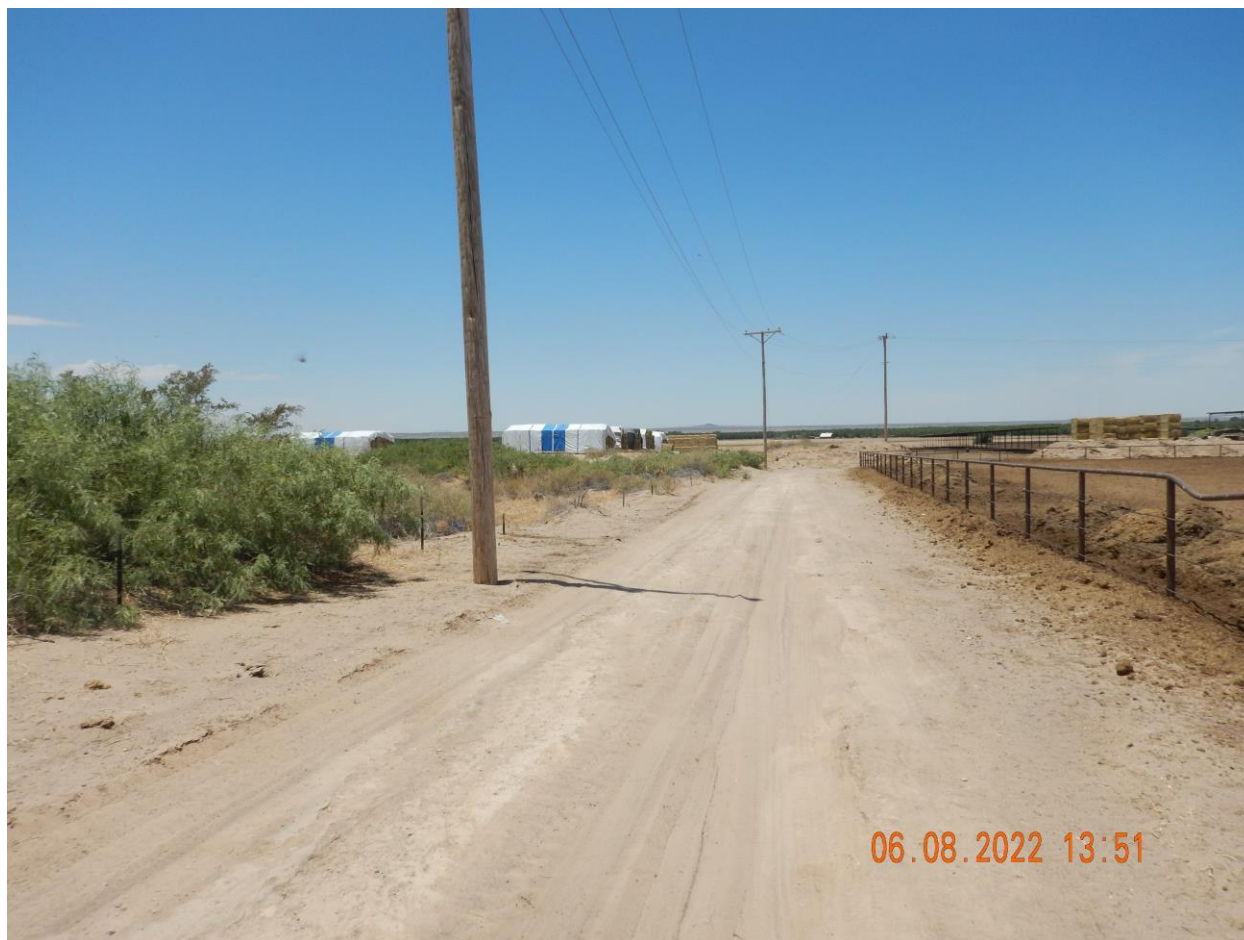
Photo No. 6

Description: The berm on the south side of the road next to the new pen area needs to be improved to ensure that runoff from the 25-yr/24-hr rain event is channeled into the Storm Water Runoff RCS. The view is toward the west.

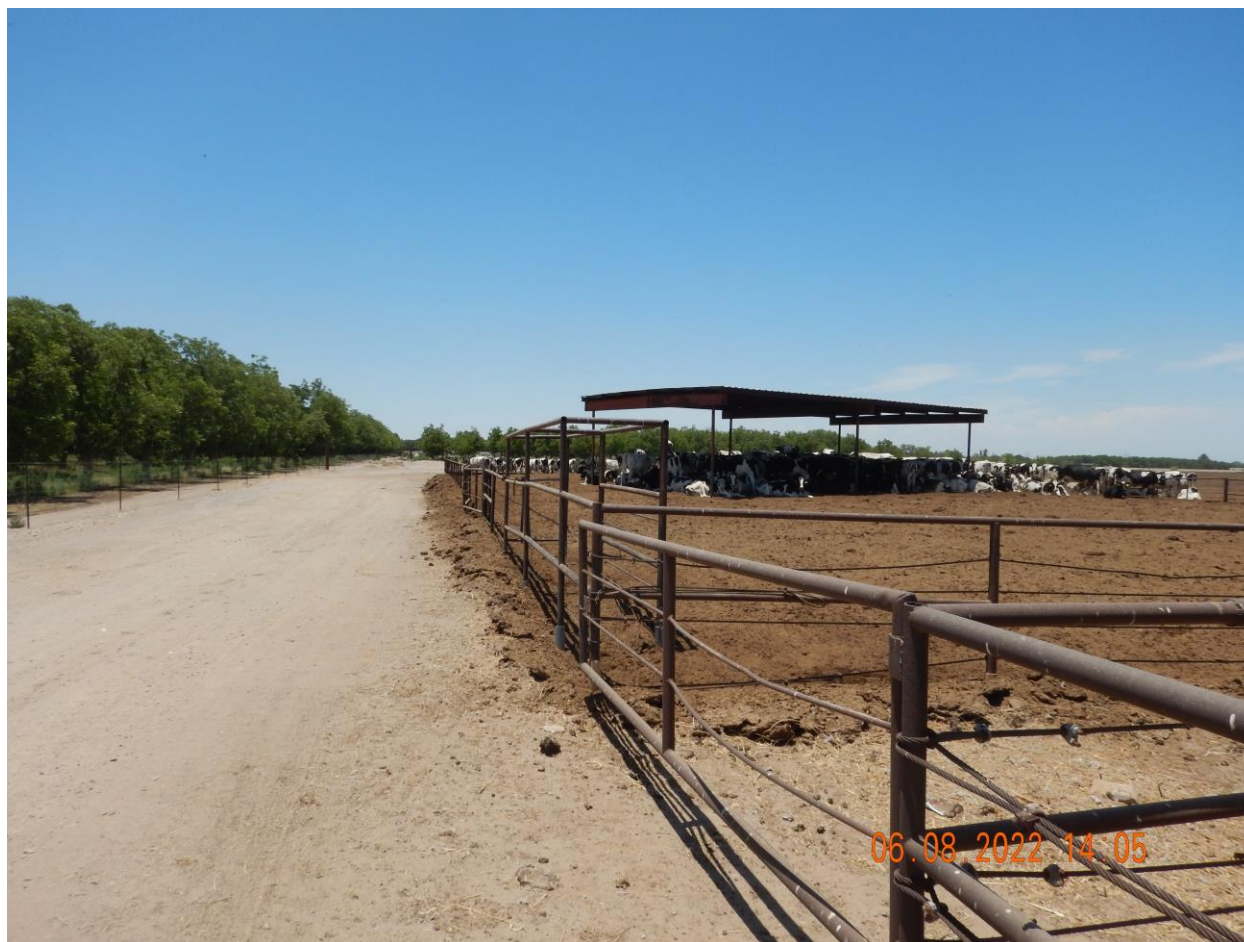
Photo No. 7

An excessive amount of manure has accumulated at the south end of the feedlot pen (see Photo 6) which may cause contaminated storm water runoff to flow to the south and west, potentially leaving the production area instead of being directed to the Feedlot Storm Water RCS (see AOC 5).

Description: An excessive amount of manure solids has accumulated on the south side of the feedlot pens next to the road. These manure solids need to be removed to help ensure that contaminated runoff from the built-up manure does not discharge off-site during the 25-yr/24-hr rain event. Berm improvement may also be needed to ensure that the pen's storm water runoff is channeled to the north (right) into the Feedlot Storm Water RCS. The view is toward the west.

AOC 5 – An excessive amount of manure has accumulated at the south end of the feedlot pen which may cause contaminated storm water runoff to flow to the south and west, possibly leaving the production area instead of being directed to the Feedlot Storm Water RCS. Part II.A.2.b.vii of the EPA permit requires that the dairy remove excess manure from the south end of the feedlot pen to ensure that contaminated storm water runoff doesn’t leave the production area and that it is directed to the Feedlot Storm Water RCS. If needed, additional berms may be required.

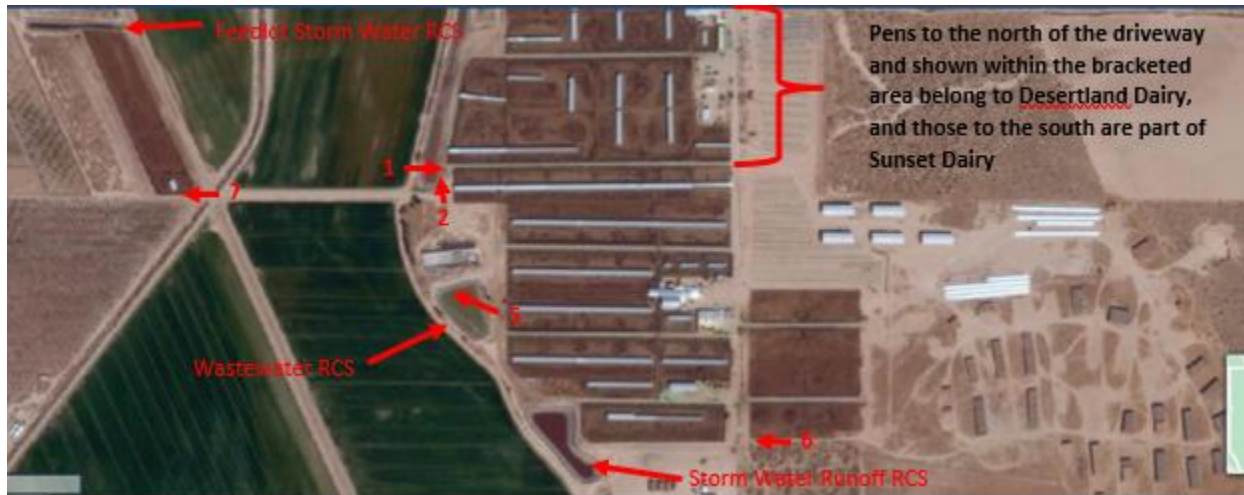
Photo No. 8

Sunset Dairy aerial taken from DigitalGlobe 2/27/2022 and location of significant photographs
