**Well Inspection**  
**Osage DNR / Environmental Protection Agency**  
**1201 Elm Street, Suite 500**  
**Dallas, Texas 75270**

| <b>Operator Info</b> | Contango Resources, LLC | <b>Inventory ID</b> OS5749010 | | | | |
| <b>Inspection Reason</b> | Plugging Witnessed | <b>Responsible Company at Time of Inspection</b> | | Contango Resources, LLC | | |

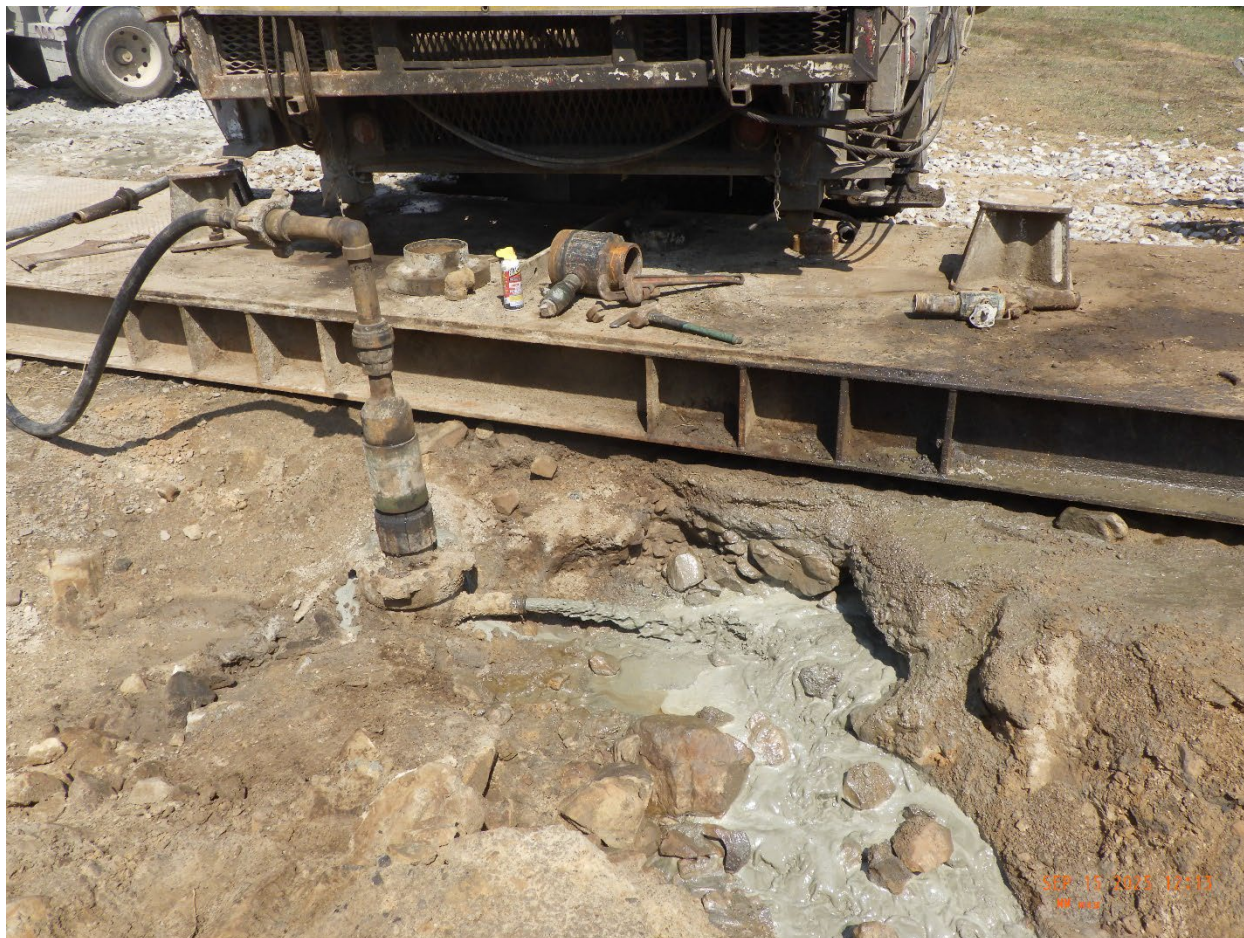
Photo No. 1

**Description:** This was well OS5749010 at the time of the inspection with cement circulating to the surface.
