## REGION 10 Enforcement Division

### INSPECTION REPORT

| <b>Company Name:</b> | United States Postal Service (USPS) | | |
| <b>Facility or Site Name:</b> | USPS Seattle Network Distribution Center (NDC) | | |

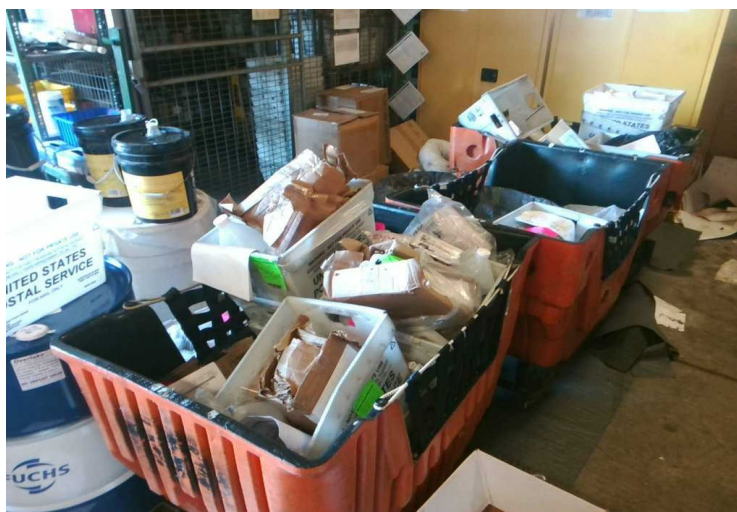
View of an abundance of waste, including waste marked either as hazardous or non-hazardous. All waste with a green or pink label had been internally designated. All waste unlabeled was waiting on Clean Harbor/Safety Kleen for designation.

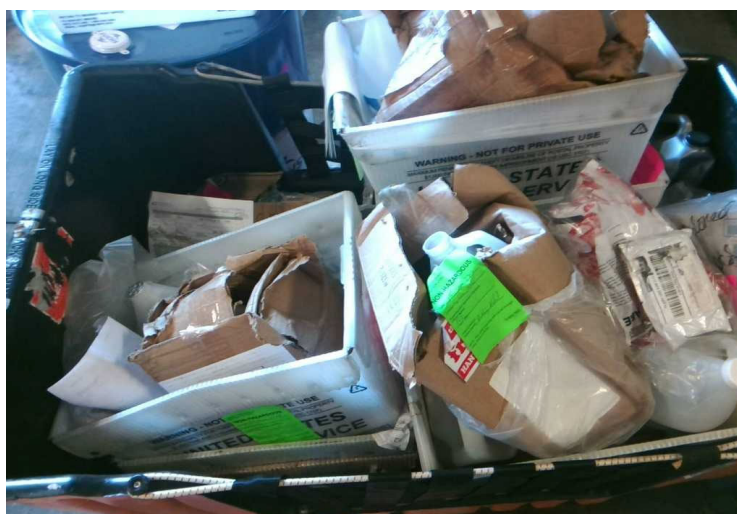
Another view of an abundance of waste, including both hazardous and non-hazardous waste. Some was internally designated, and some is waiting on Clean Harbors/Safety Kleen for designation.

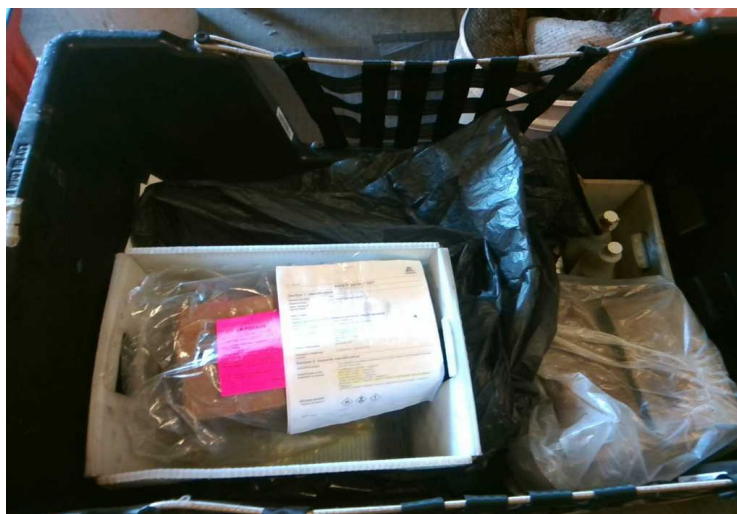
Another view of an abundance of waste, including waste marked as either hazardous or non-hazardous waste. Some was internally designated, and some is waiting on Clean Harbors/Safety Kleen for designation.

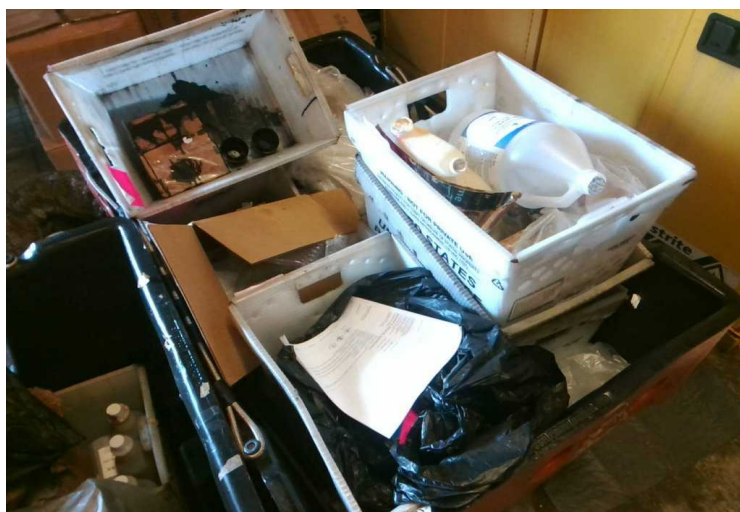
Another view of an abundance of waste, including waste marked as either hazardous or non-hazardous waste. Some was internally designated, and some is waiting on Clean Harbors/Safety Kleen for designation.

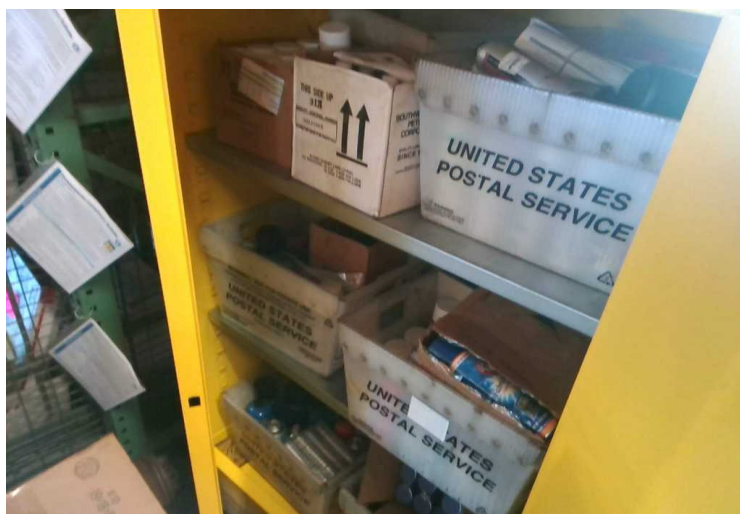
Another view of an abundance of waste, including waste marked as either hazardous or non-hazardous waste. Some was internally designated, and some is waiting on Clean Harbors/Safety Kleen for designation.

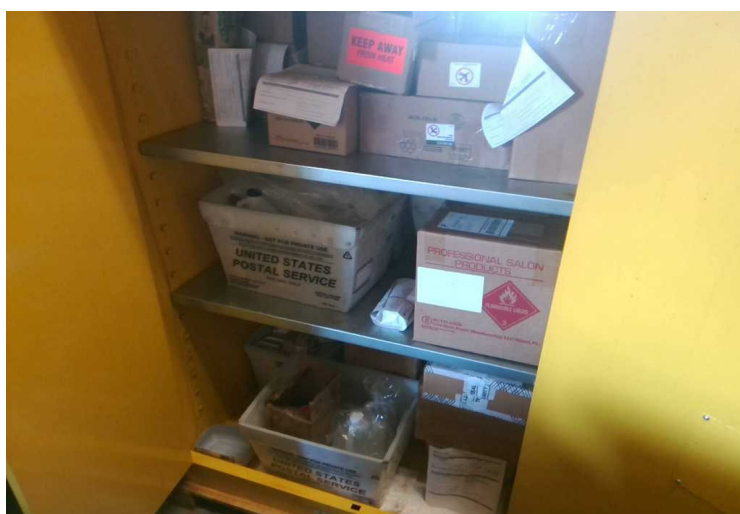
Another view of an abundance of waste, including waste marked as either hazardous or non-hazardous waste. Some was internally designated, and some is waiting on Clean Harbors/Safety Kleen for designation.

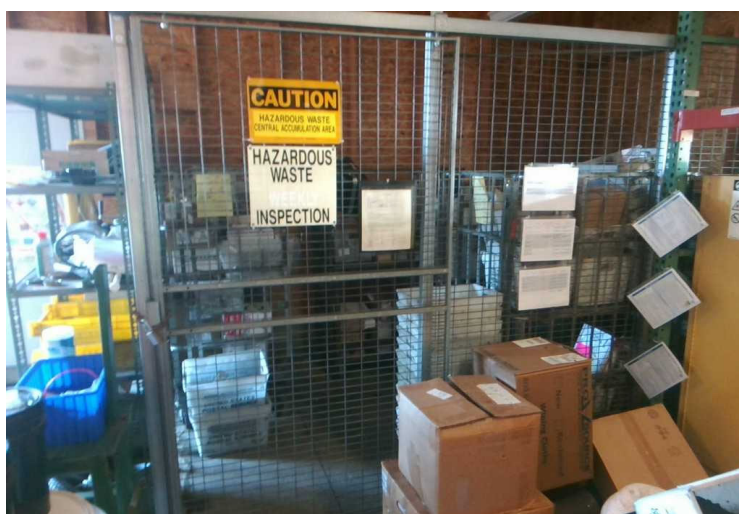
Another view of an abundance of waste, including waste marked as either hazardous or non-hazardous waste. Some was internally designated, and some is waiting on Clean Harbors/Safety Kleen for designation.

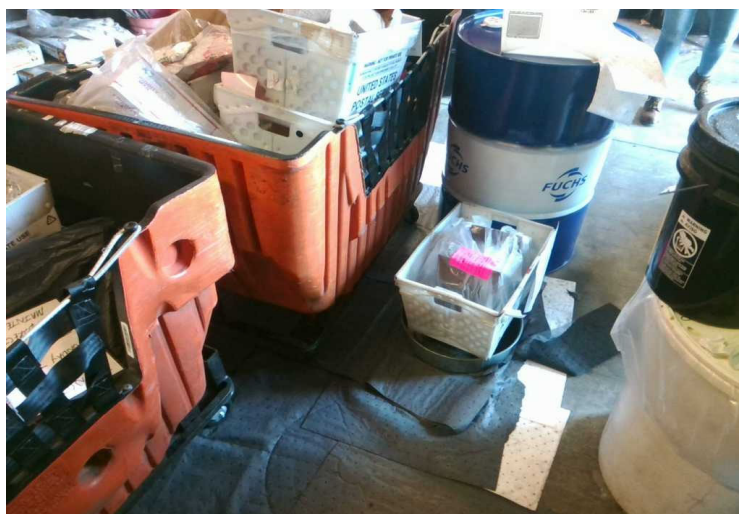
Another view of an abundance of waste, including waste marked as either hazardous or non-hazardous waste. Some was internally designated, and some is waiting on Clean Harbors/Safety Kleen for designation.

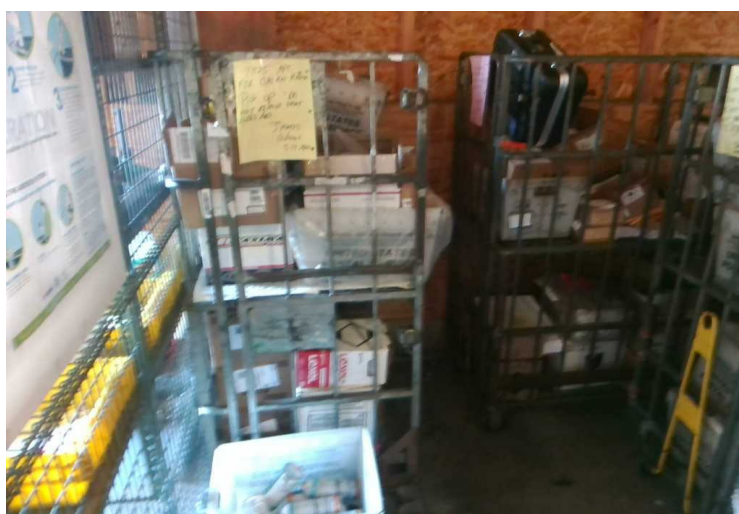
Another view of an abundance of waste, including waste marked as either hazardous or non-hazardous waste. Some was internally designated, and some is waiting on Clean Harbors/Safety Kleen for designation.

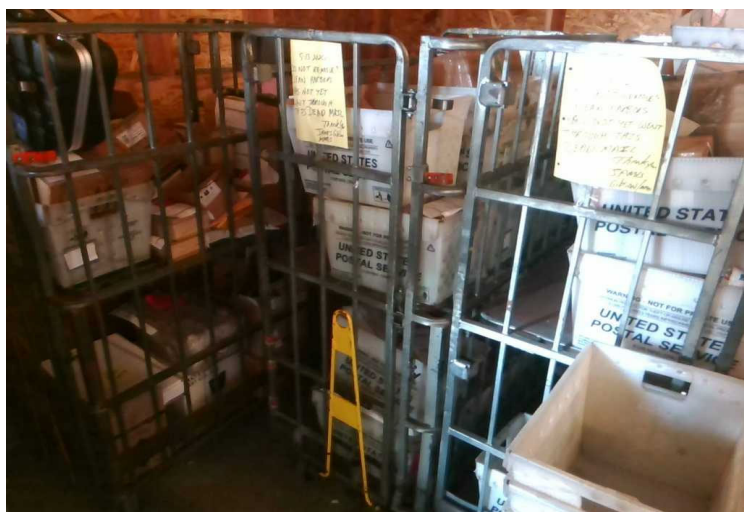
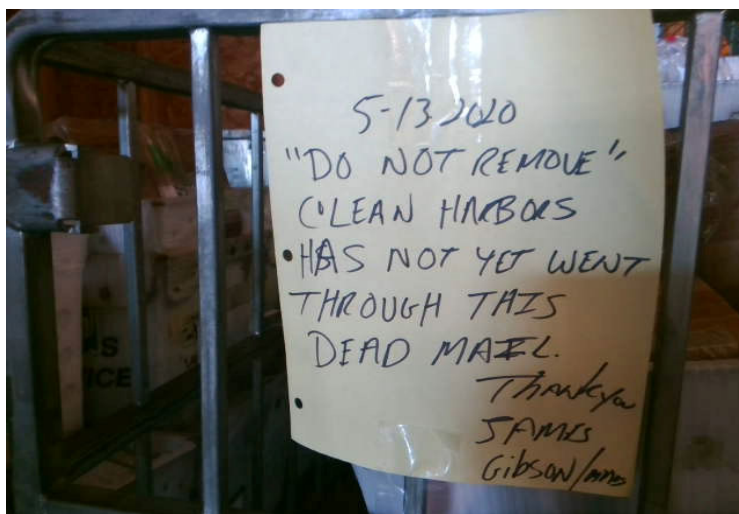
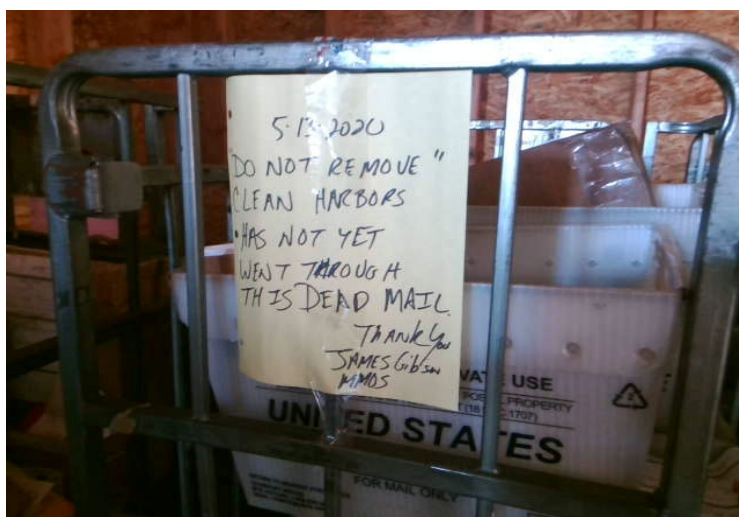
| View of signage on carts showing that the waste has been onsite and undesignated since 5/13/2020. |

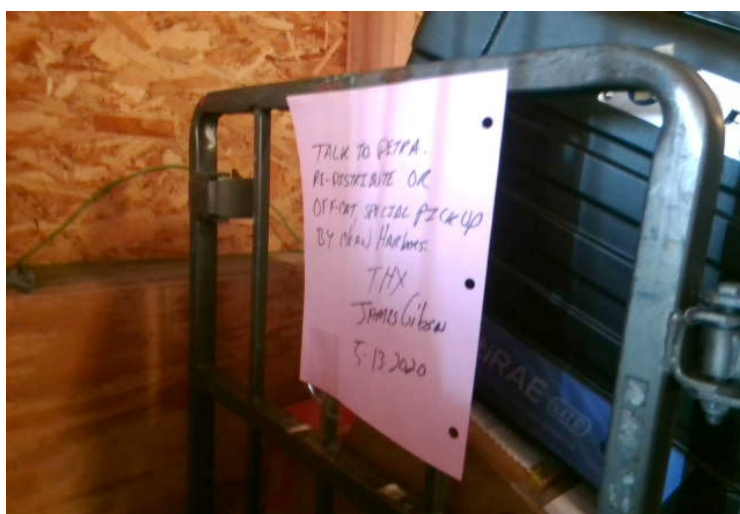
| View of signage on carts showing that the waste has been onsite and undesignated since 5/13/2020. |

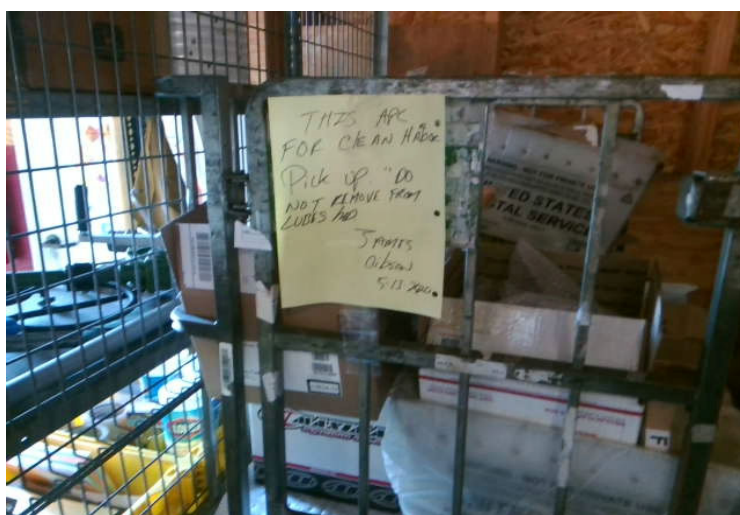
| View of signage on carts showing that this waste has been onsite and undesignated since 5/13/2020. |

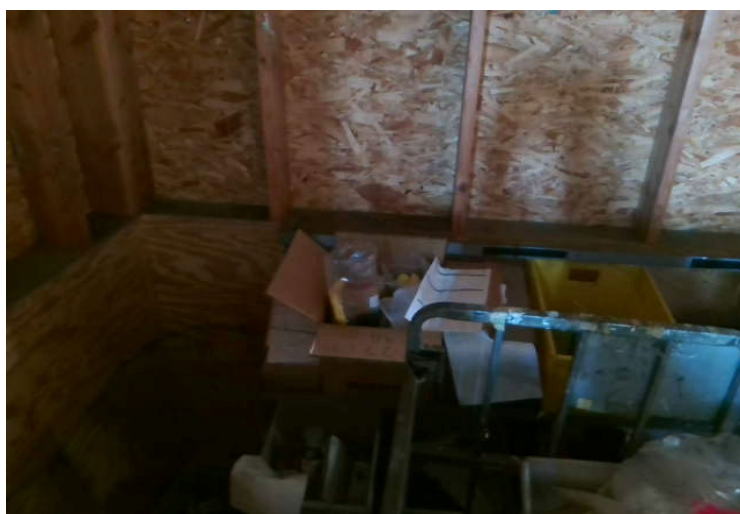
| Another view of an abundance of waste, including waste marked as either hazardous or non-hazardous waste. Some was internally designated, and some is waiting on Clean Harbors/Safety Kleen for designation. |

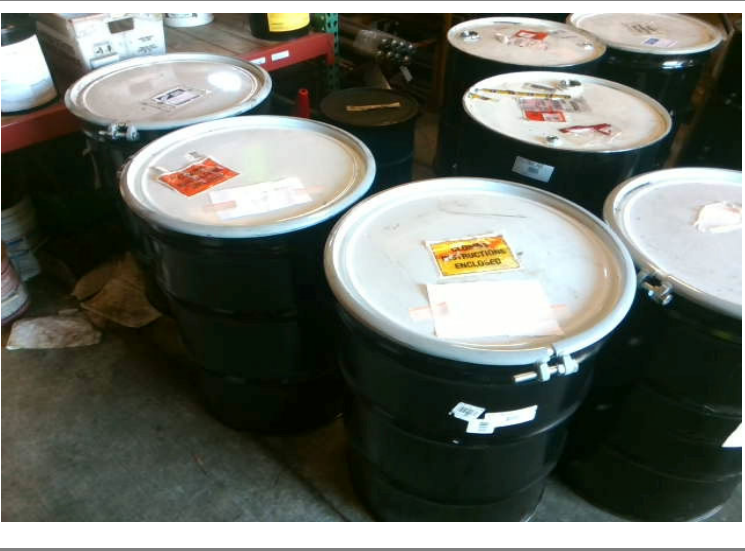
We went to the Maintenance Lube Area, across from the "Loose-in-the-mail" area and south of the Battery Shop. While there we saw two 5-gallon containers being used to accumulate used oil from the process of draining used oil filters. At the time of the inspection these two 5-gallon containers were not labeled with the words "Used Oil."

| <p>[Title]</p> <p>IMG-202203091125382538195762.jpg</p> <p>03/09/2022 11:25 AM (AKT)</p> <p>Jon Jones</p> <p>Lubrication Shed</p> <p>No CBI</p> <p>No PII</p> <p>View of 55-gallon containers holding various wastes. Two of these contained oil-soaked rags that were not labeled with the words "Used Oil."</p> | |

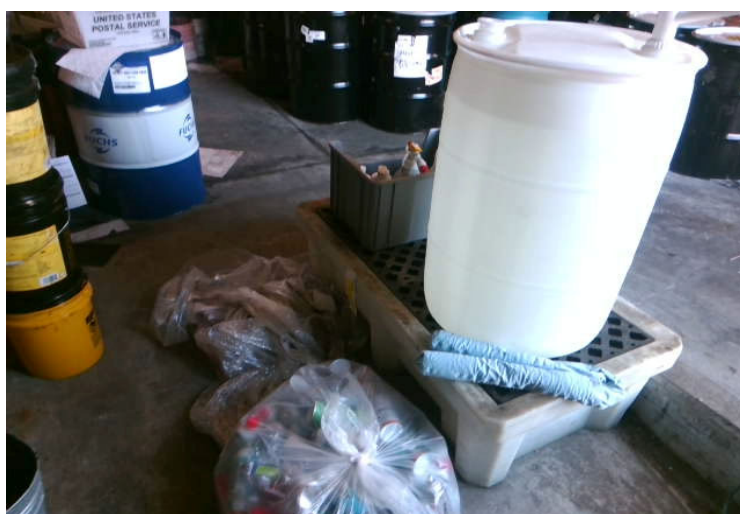
| <b>Building:</b> Lubrication Shed | <b>Area:</b> | <b>Sub-area:</b> |
|---|---|---|
| There was a clear plastic trash bag that was full of approximately 40 to 50 waste aerosols. At the time of the inspection, this trash bag was not labeled with the words, "Hazardous Waste" or "Dangerous Waste" and was not marked with a hazard indicator. | <b>Regulation:</b> | <b>Sections:</b> |

View of a bag of waste aerosols. I was told by Mr. Gibson that all waste aerosols generated on-site are managed as hazardous waste. The bag is not labeled as either Hazardous or Dangerous Waste or marked with a hazard indicator.

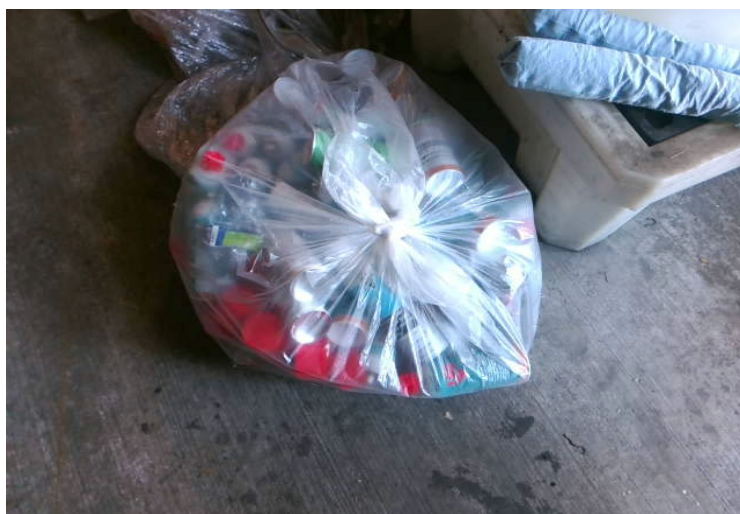
Close-up view of a bag of waste aerosols. I was told by Mr. Gibson that all waste aerosols generated on-site are managed as hazardous waste. The bag is not labeled as either Hazardous or Dangerous Waste or marked with a hazard indicator.

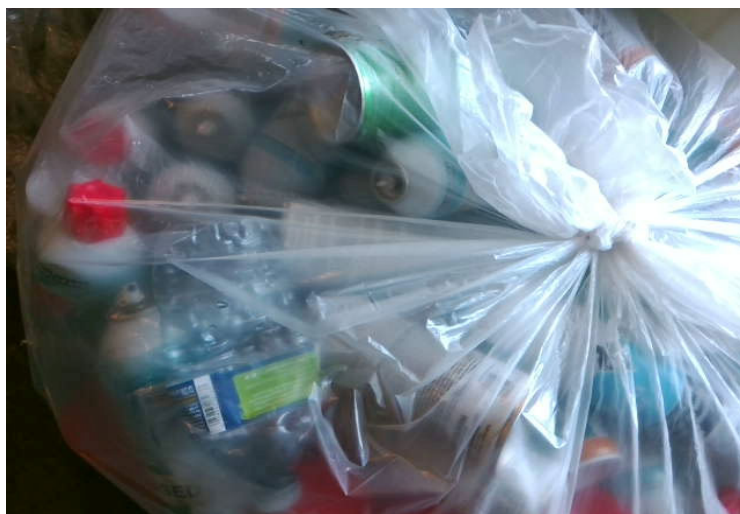
Another close-up view of a bag of waste aerosols. I was told by Mr. Gibson that all waste aerosols generated on-site are managed as hazardous waste. The bag is not labeled as either Hazardous or Dangerous Waste or marked with a hazard indicator.

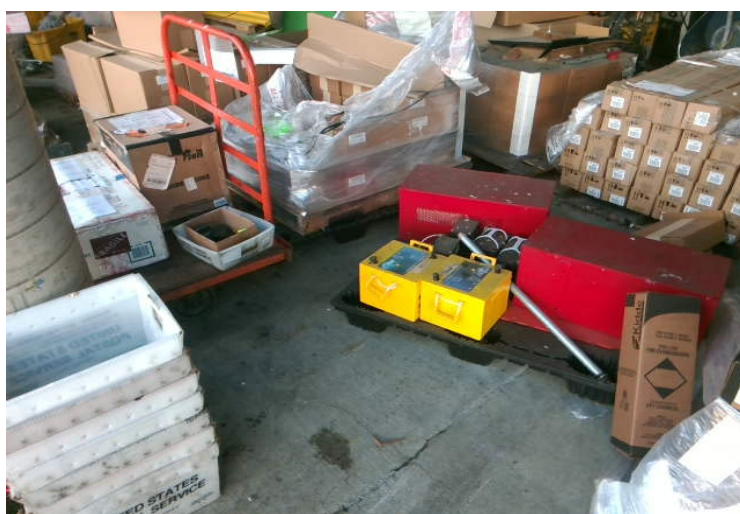
View of 17 waste lead-acid batteries. Mr. Gibson told us these batteries would be managed by the site as Universal Waste. The batteries are not labeled as "Universal Waste – Batteries," "Waste Batteries," or "Used Batteries."

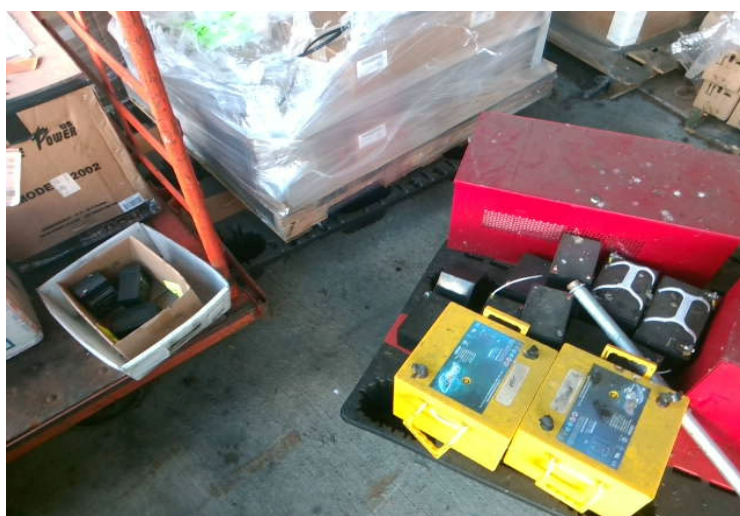
Another view of 17 waste lead-acid batteries. Mr. Gibson told us these batteries would be managed by the site as Universal Waste. The batteries are not labeled as "Universal Waste – Batteries," "Waste Batteries," or "Used Batteries."

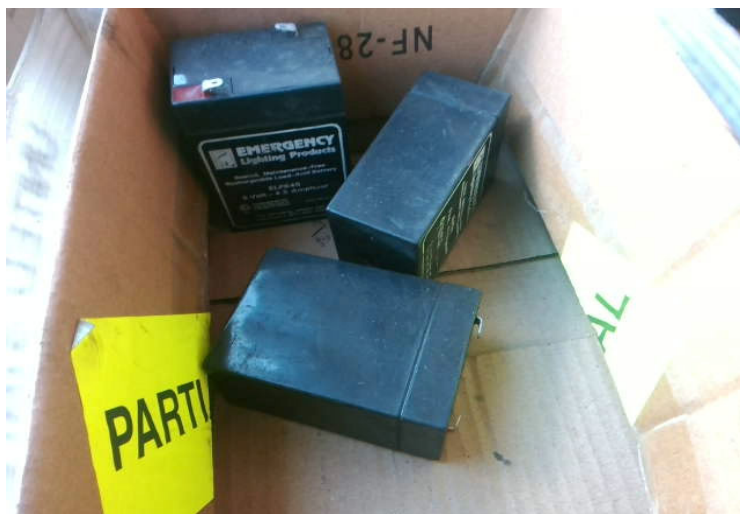
Close-up view of waste lead-acid batteries. Mr. Gibson told us these batteries would be managed by the site as Universal Waste. The batteries are not labeled as "Universal Waste – Batteries," "Waste Batteries," or "Used Batteries."

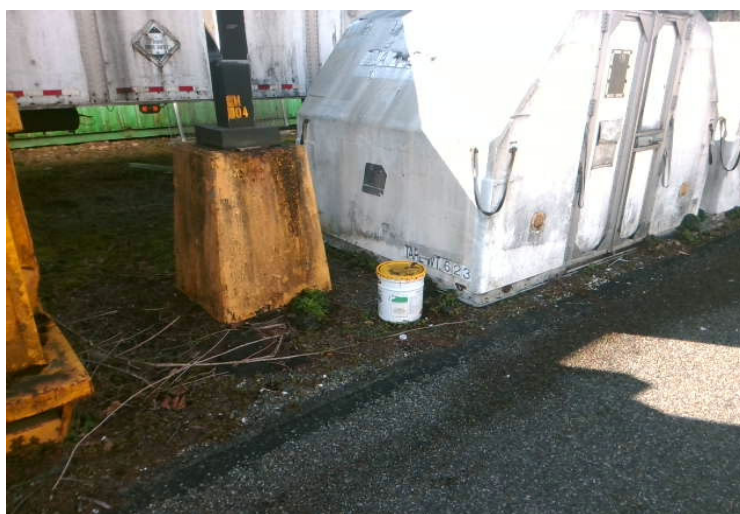
| Multiple 5-gallon containers of waste solvent-based traffic paint observed in an aircraft cargo container and a 5-gallon container of an unknown liquid had not been designated. | <b>Regulation:</b><br><br>WAC 173-303-070(3) | <b>Sections:</b> |

View of a 5-gallon container of solvent-based yellow traffic paint that has been sitting outside and allowed to freeze and thaw over the winter. Leaving paint out is not managing it as a valuable product, but as a waste. Therefore, this waste requires a waste designation.

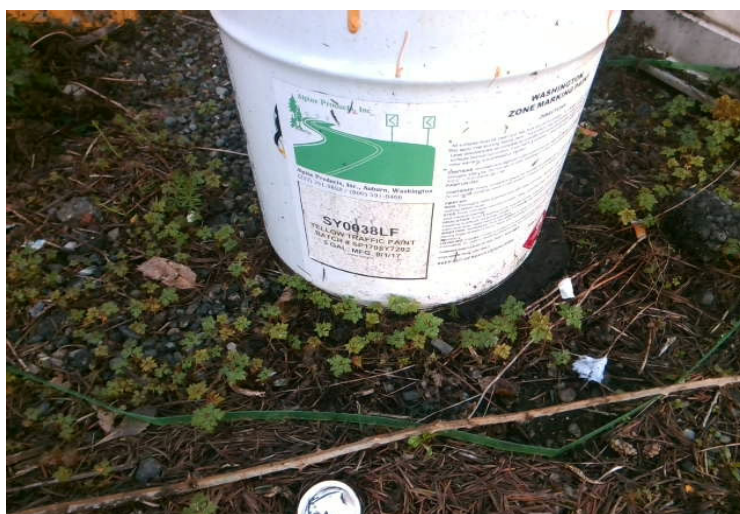
Close-up view of a 5-gallon container of solvent-based yellow traffic paint that has been sitting outside and allowed to freeze and thaw over the winter. Leaving paint out is not managing it as a valuable product, but as a waste. Therefore, this waste requires a waste designation.

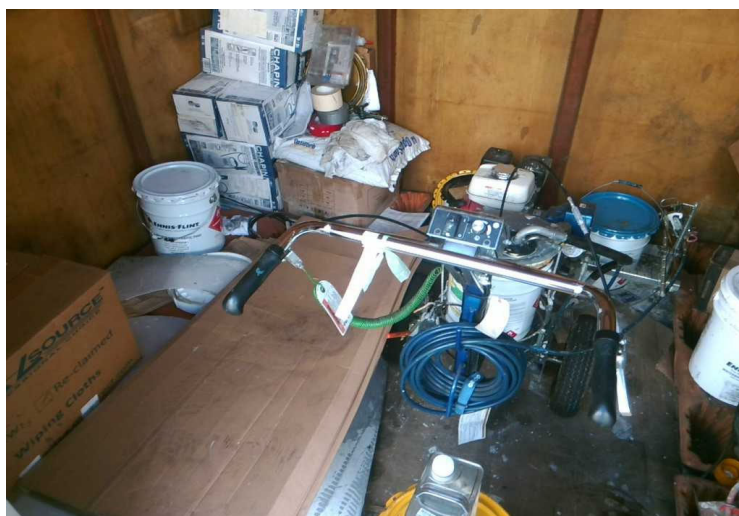
| Another view of 5-gallon containers of solvent-based traffic paint that has been left inside of an unheated storage container and allowed to freeze and thaw over the winter. Some of the containers had not been closed and may have been allowed to dry out. |

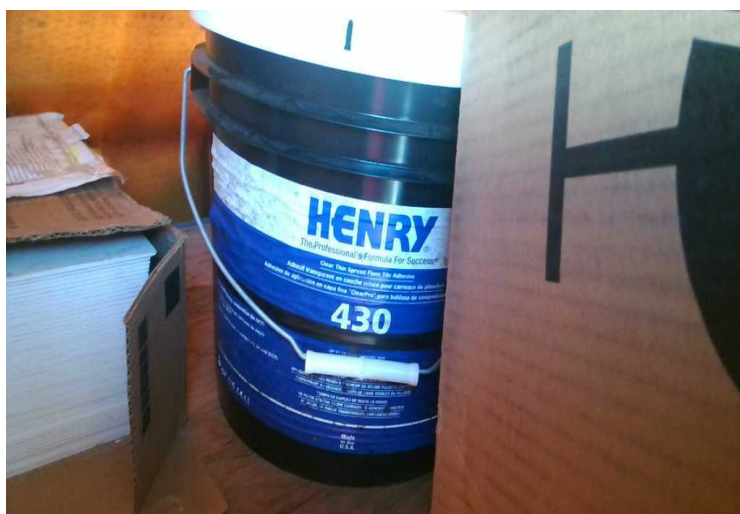
View of container of flooring adhesive left inside an unheated storage container and allowed to freeze and thaw over the winter. Leaving chemical products out is not managing them as a valuable product, but as wastes.

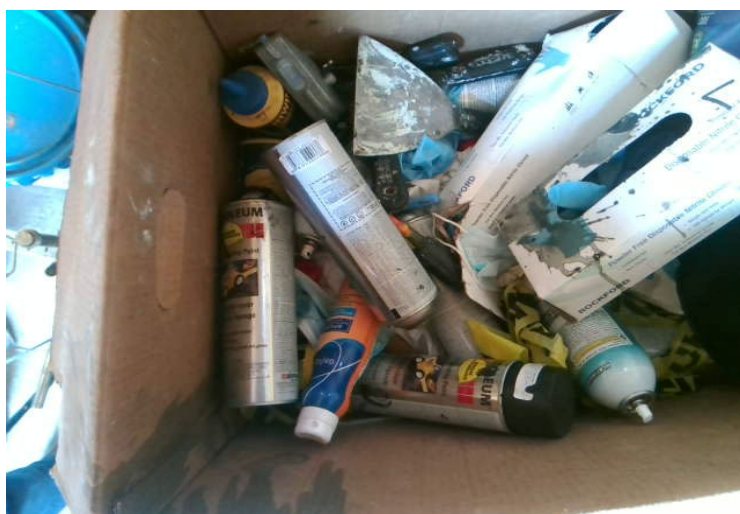
| Aerosols observed in the aircraft cargo container were inherently waste-like and undesignated. | <b>Regulation:</b><br><br>WAC 173-303-070(3) | <b>Sections:</b> |

View of aerosol cans inside of a cardboard box left inside an unheated storage container. Leaving cans of paint out is not managing them as a valuable products, but as a waste. Therefore, these aerosol cans waste requires a waste designation, especially since Mr. Gibson told me the site manages waste aerosol cans as hazardous waste.

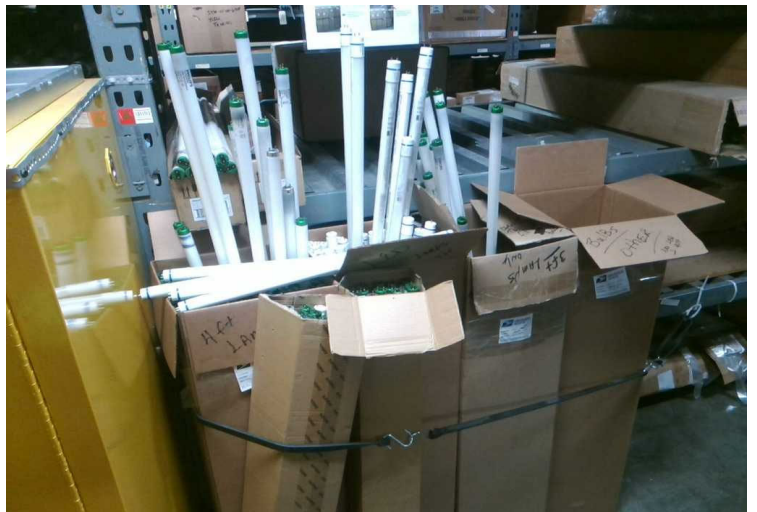
View of eight cardboard boxes, containing waste fluorescent/LED lamps. Mr. Gibson told us the site manages all lamps as universal waste. Each of the boxes were not closed and four of the eight boxes are also seen here not labeled as either "Universal Waste – Lamps", "Waste – Lamps", or "Used Lamps."

Prior to leaving the area, I explained the labeling, container, and accumulation requirements for universal waste lamps to Mr. Gibson. Additionally, in this area I observed a sign directly above the containers of universal waste that described proper procedures for the management of universal waste.

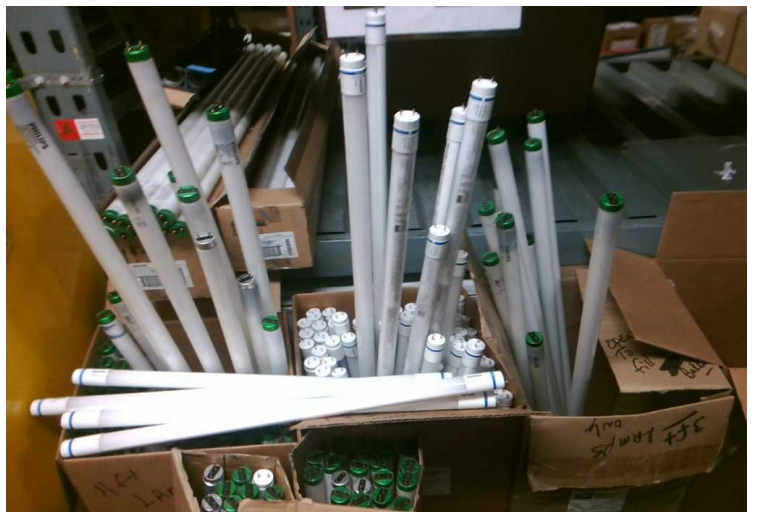
Close-up view of eight cardboard boxes, containing waste fluorescent/LED lamps. Mr. Gibson told us the site manages all lamps as universal waste. Each of the boxes were not closed and four of the eight boxes are also seen here not labeled as either "Universal Waste – Lamps", "Waste – Lamps", or "Used Lamps."

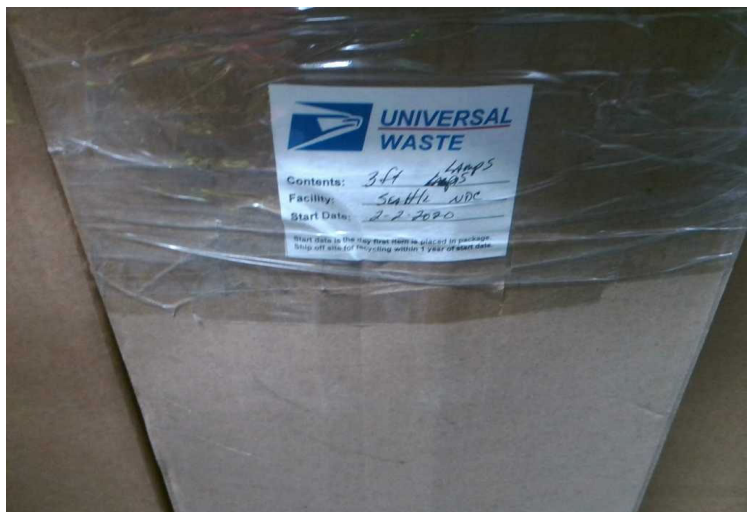
View of the label on one box of universal waste lamps that is seen here, dated 2/2/2020, indicating that the lamps have been in accumulation for greater than one year.

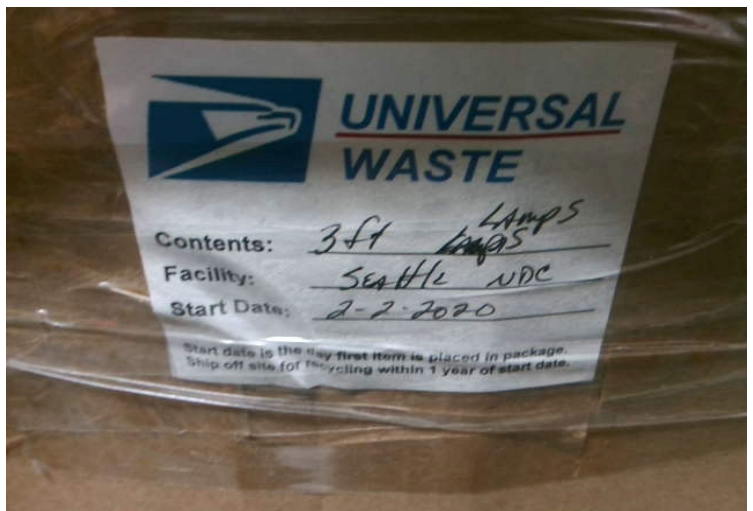
Close-up view of the label on one box of universal waste lamps that is seen here, dated 2/2/2020, indicating that the lamps have been in accumulation for greater than one year.

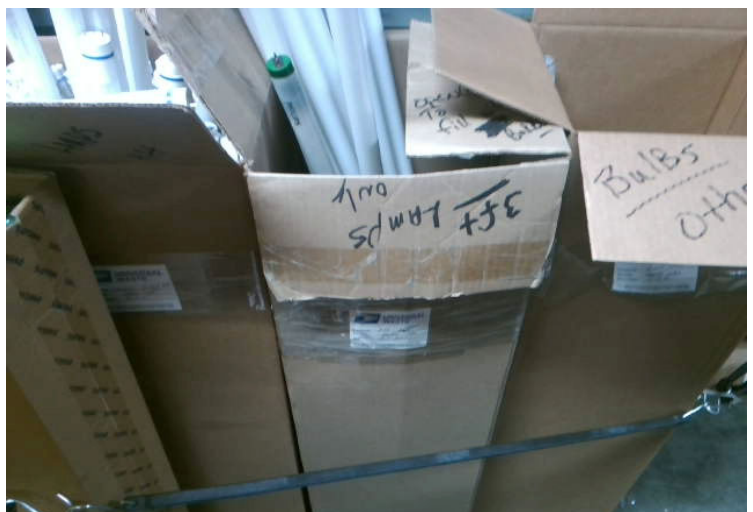
Another view of the box of universal waste lamps that is seen here in the center of the photo, dated 2/2/2020, indicating that the lamps have been in accumulation for greater than one year.

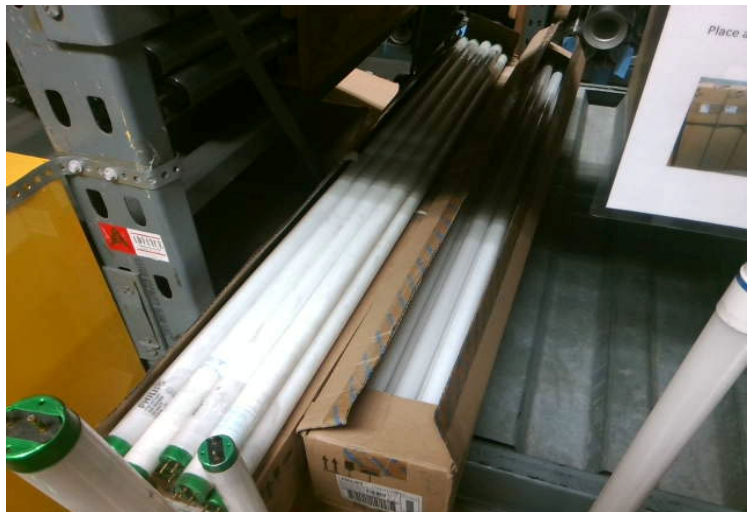
Additional close-up view of some of the cardboard boxes, containing waste fluorescent/LED lamps managed by the site as universal waste, that were not closed or labeled as either "Universal Waste – Lamps", "Waste – Lamps", or "Used Lamps."

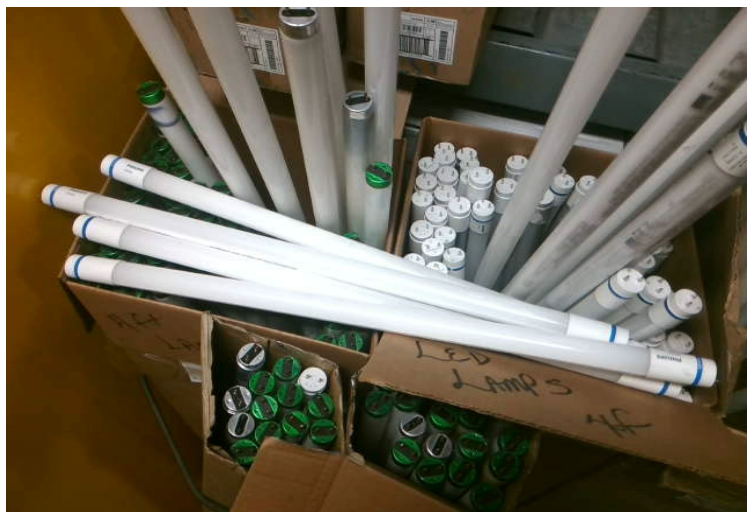
Additional close-up view of some of the cardboard boxes, containing waste fluorescent/LED lamps managed by the site as universal waste, that were not closed or labeled as either "Universal Waste – Lamps", "Waste – Lamps", or "Used Lamps."

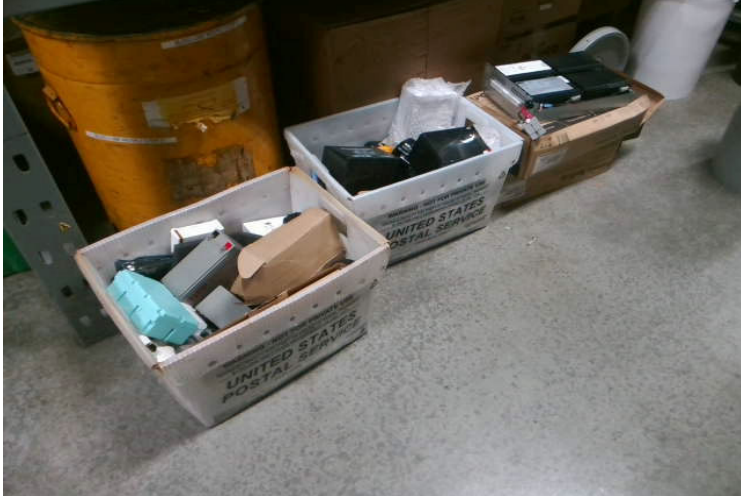
| There were two small flat tubs that contained a mix of waste batteries and six loose lead-acid batteries that were not labeled as "Universal Waste – Batteries," "Waste Batteries," or "Used Batteries." | <b>Regulation:</b><br><br>WAC 173-303-573(10) | <b>Sections:</b> |

| <p>[Title]</p> <p>IMG-202203090939143914178511.jpg</p> <p>03/09/2022 09:39 AM (AKT)</p> <p>Jon Jones</p> <p>Seattle NDC Room 133A</p> <p>No CBI</p> <p>No PII</p> <p>View of two flat tubs that contain a mix of batteries and six loose lead-acid batteries. Mr. Gibson told me that the site manages all batteries generated by the site as universal waste. None of the tubs, batteries, or the box were labeled as either "Universal Waste – Batteries", "Waste Batteries", or "Used Batteries."</p> | |

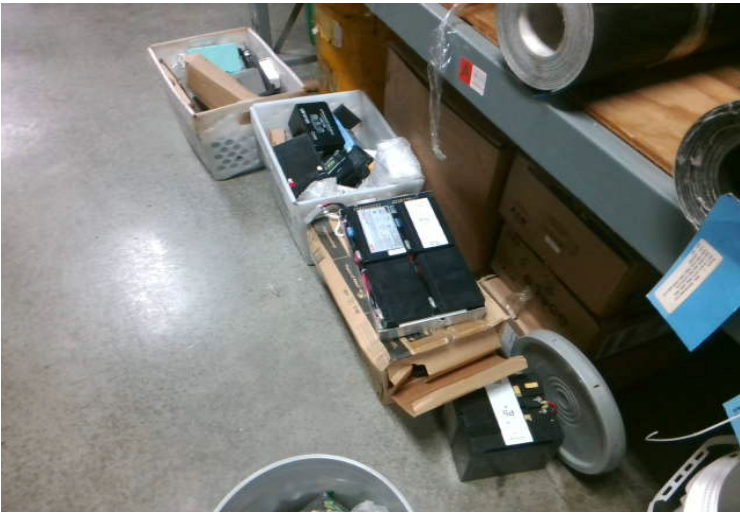
| Another view of the two flat tubs that contain a mix of batteries and six loose lead-acid batteries. Mr. Gibson told me that the site manages all batteries generated by the site as universal waste. None of the tubs or the batteries are labeled as "Universal Waste – Batteries", "Waste Batteries", or "Used Batteries." | |

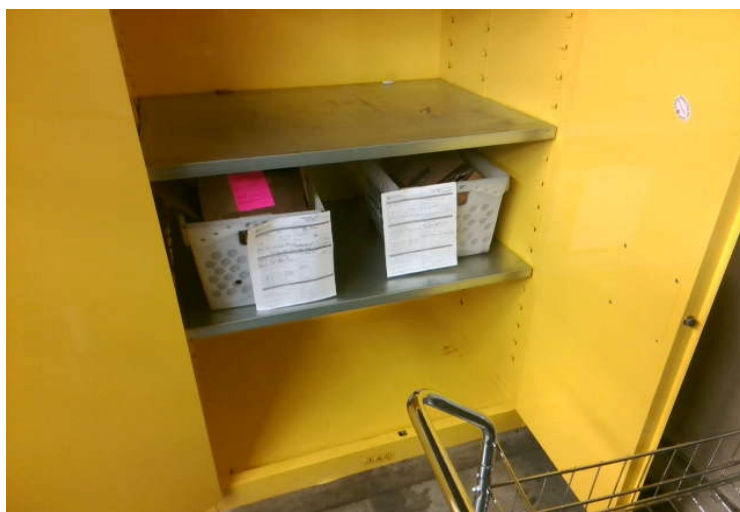
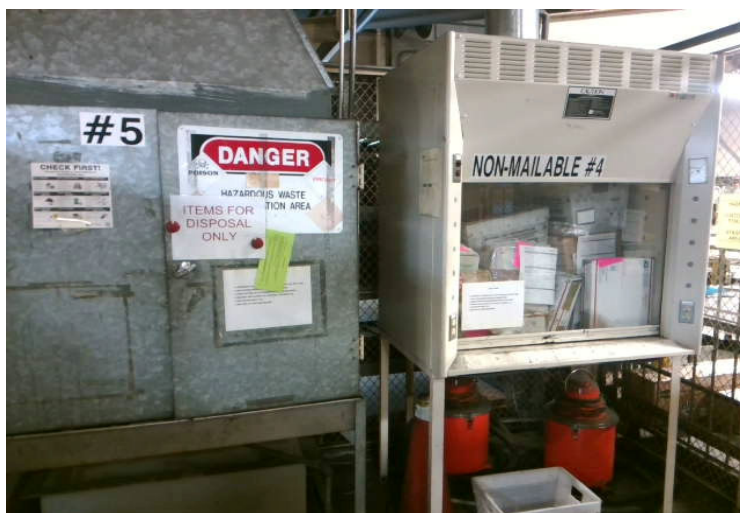
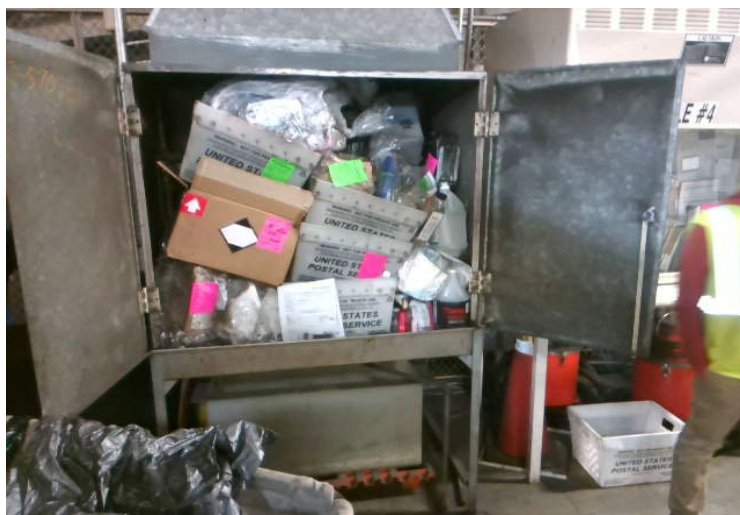
| <p>A significant number of Damaged items referred to as "Loose-in-the-mail" located in flammable storage lockers, two vent hood type storage areas, and on carts were either undesignated or if designated as either "Hazardous/Dangerous Waste" were not marked with hazard indicators.</p> | <p><b>Regulation:</b></p> | <p><b>Sections:</b></p> |

| View of "Loose-in-the-Mail" wastes inside one of the small, vented accumulation areas. Note: Pink labels were observed with the word "Hazardous" printed on them. |

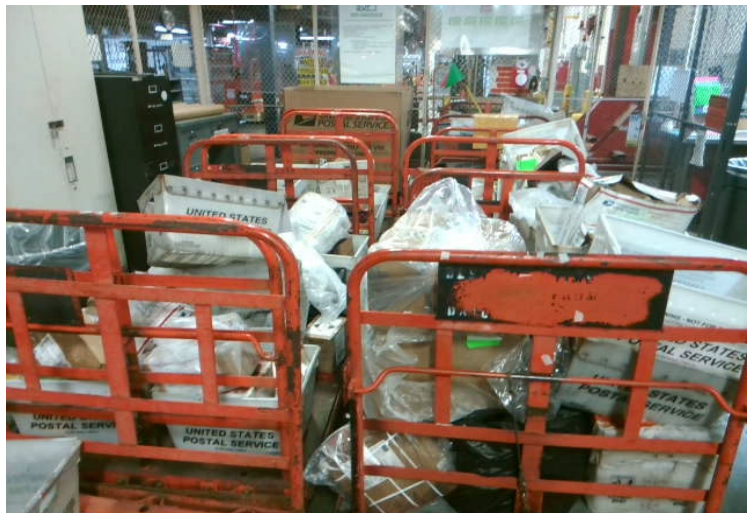
View of additional carts containing "Loose-in-the-Mail" waste. Note: green labels were observed with the word "Non-hazardous" on them.

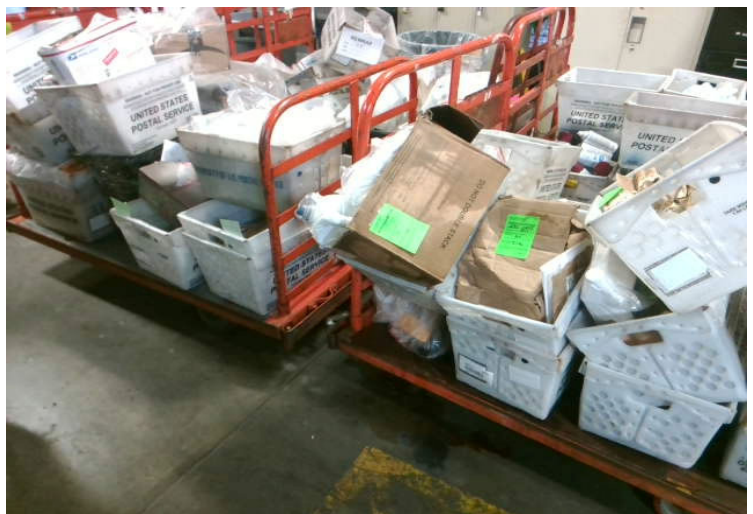
Another view of the same carts containing "Loose-in-the-Mail" waste. Note: green labels were observed with the word "Non-hazardous" on them.

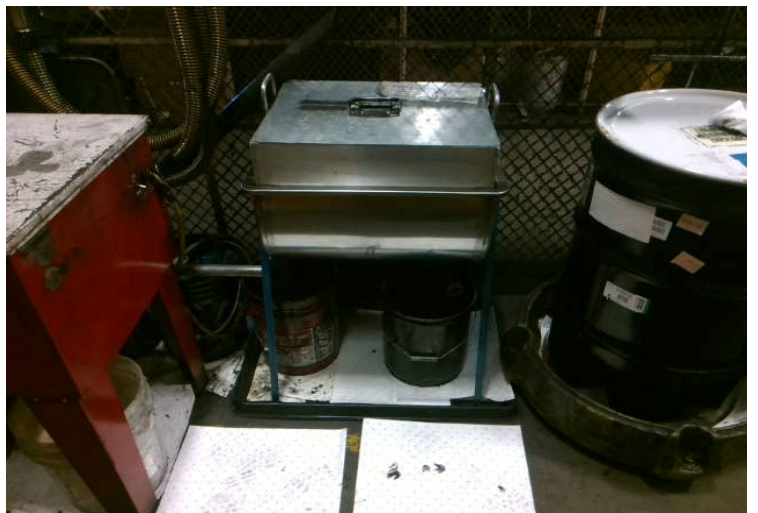
View of two, 5-gallon containers, being used to accumulate used oil from the process of draining used oil filters, that are not labeled with the words "Used Oil."

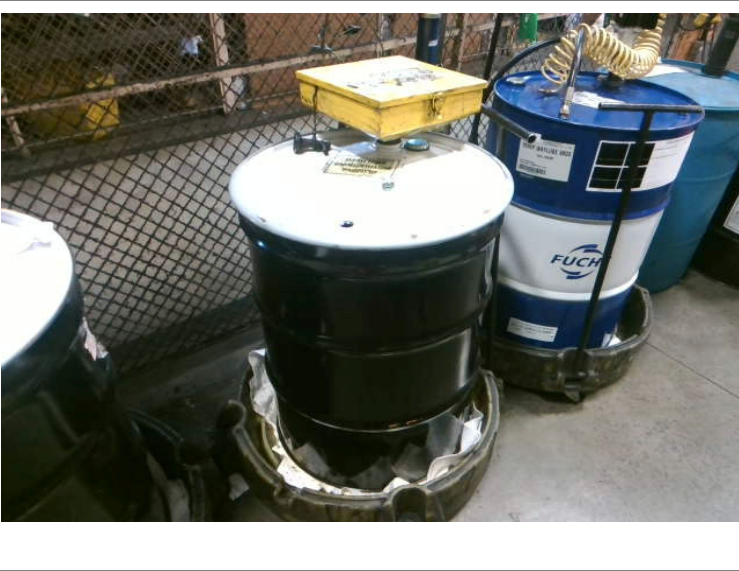
| <p>[Title]</p> <p>IMG-202203091224322432212910.jpg</p> <p>03/09/2022 12:24 PM (AKT)</p> <p>Jon Jones</p> <p>Seattle NDC Maintenance Lube Area</p> <p>No CBI</p> <p>No PII</p> <p>View of 55-gallon container, labeled as "Non-regulated alternative fuel mix", containing material managed as used oil, seen here not labeled with the words "Used Oil" and not closed.</p> | |

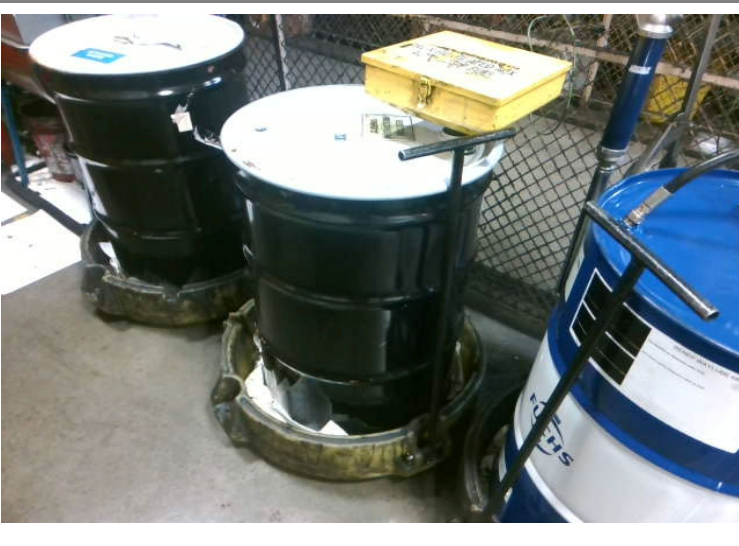
| <p>[Title]</p> <p>IMG-202203091224432443218761.jpg</p> <p>03/09/2022 12:24 PM (AKT)</p> <p>Jon Jones</p> <p>Seattle NDC Maintenance Lube Area</p> <p>No CBI</p> <p>No PII</p> <p>Another view of the same 55-gallon container, seen here not labeled with the words "Used Oil" and not closed.</p> | |

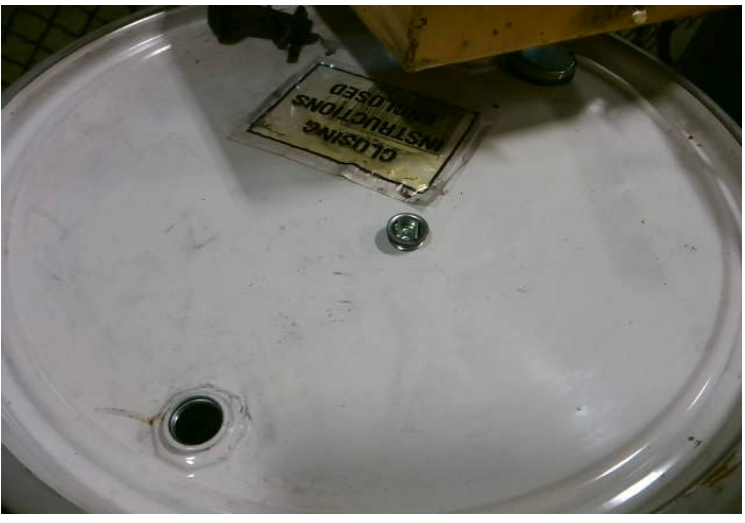
| A view of the funnel on top of the same 55-gallon used oil container labeled as "Non-regulated alternative fuel mix" instead of labeled with the words "Used Oil." | |

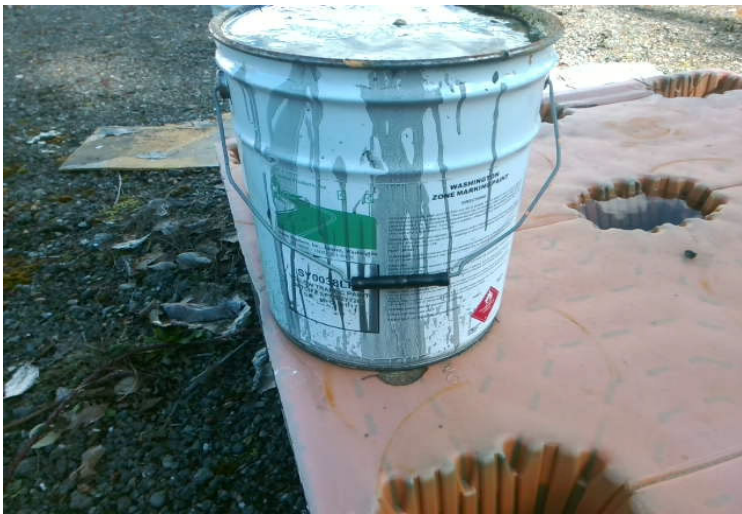
| Another close-up view of the 5-gallon containers, seen here on the pallet, that contain what appeared to be rainwater and paint scum floating on top of the water. | |
