**Region 6 - Enforcement & Compliance Assurance Division**  
**INSPECTION REPORT**

| Inspection Date(s): | 01/25/2024 | |
| Company Name: | <b>Calgary Energy, LLC</b> | |
| Facility Name: | <b>AWFU Cold Springs Battery</b> | |

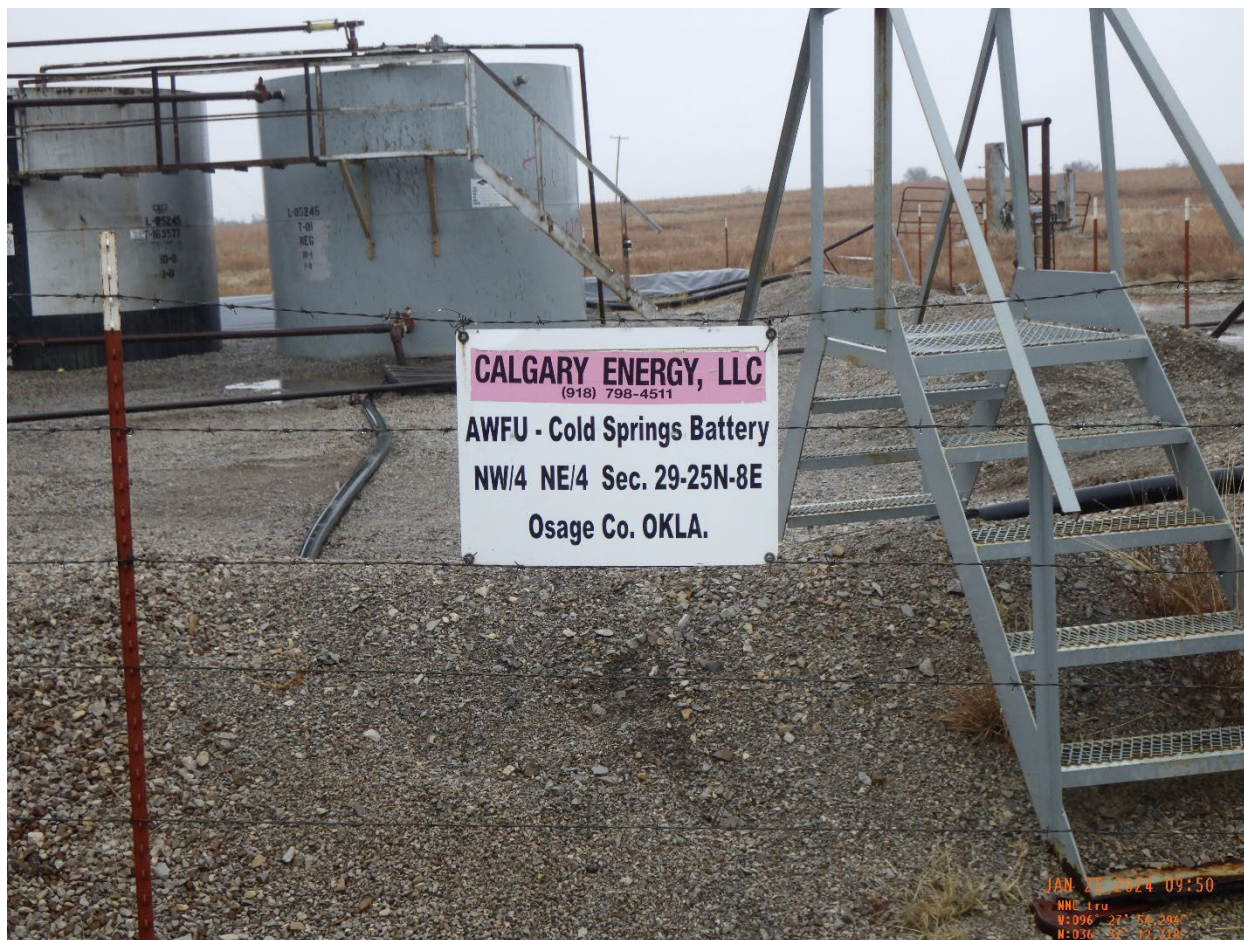
Photo No. 1

I observed the AWFU Cold Springs Battery, which was the release point of the spill. See photo No. 1 of appendix 1 (photo log). For additional GPS location information and photo metadata, see the attached photo log.

**Description:** This was the AWFU Cold Springs Battery and facility sign.

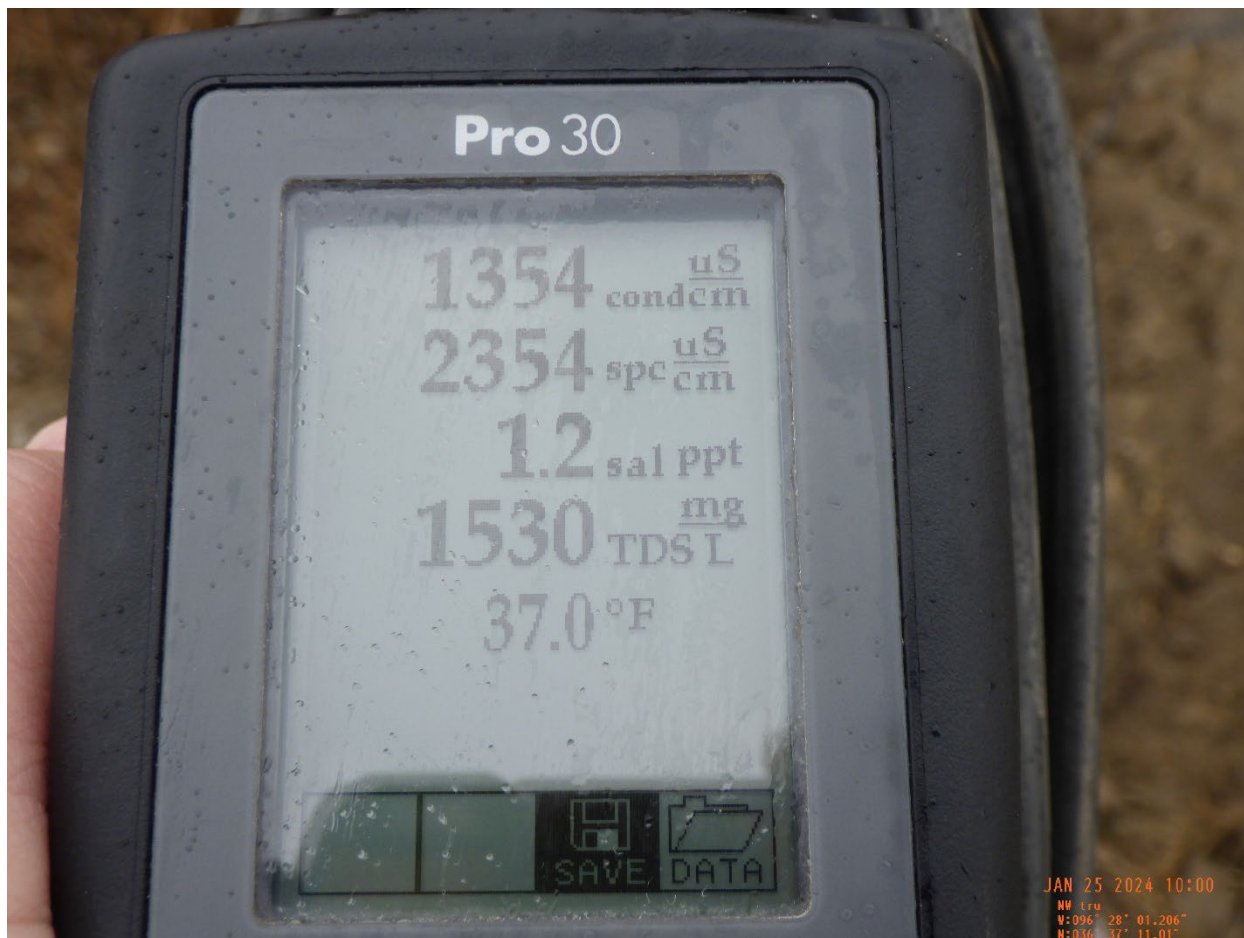
Photo No. 2

I observed an elevated Total Dissolved Solids (TDS) field reading of 1530 mg/L. This field reading was observed in the first pools of water downgradient from the release point. See photos No. 2 and 3 in the photo log. Through discussion with Mike Perrier, the BIA Field Inspector who responded to the spill at the time of discovery, this observation was at the location where the spill was initially contained with a temporary dam. Calgary Energy, LLC used this location as the catch and removal point for clean-up and flushing operations.

During the closing conference via phone call with Duane Easley, representing Calgary Energy, LLC, I noted my primary area of concern being the elevated TDS field reading observed in the small pool of water.

**Description:** This was an elevated Total Dissolved Solids (TDS) field reding of 1530 mg/L taken in the only pools of water observed during the inspection.

Duane Easley with Calgary Energy, LLC stated he would have a vacuum truck empty the holes of water where I observed the mildly elevated TDS field readings.

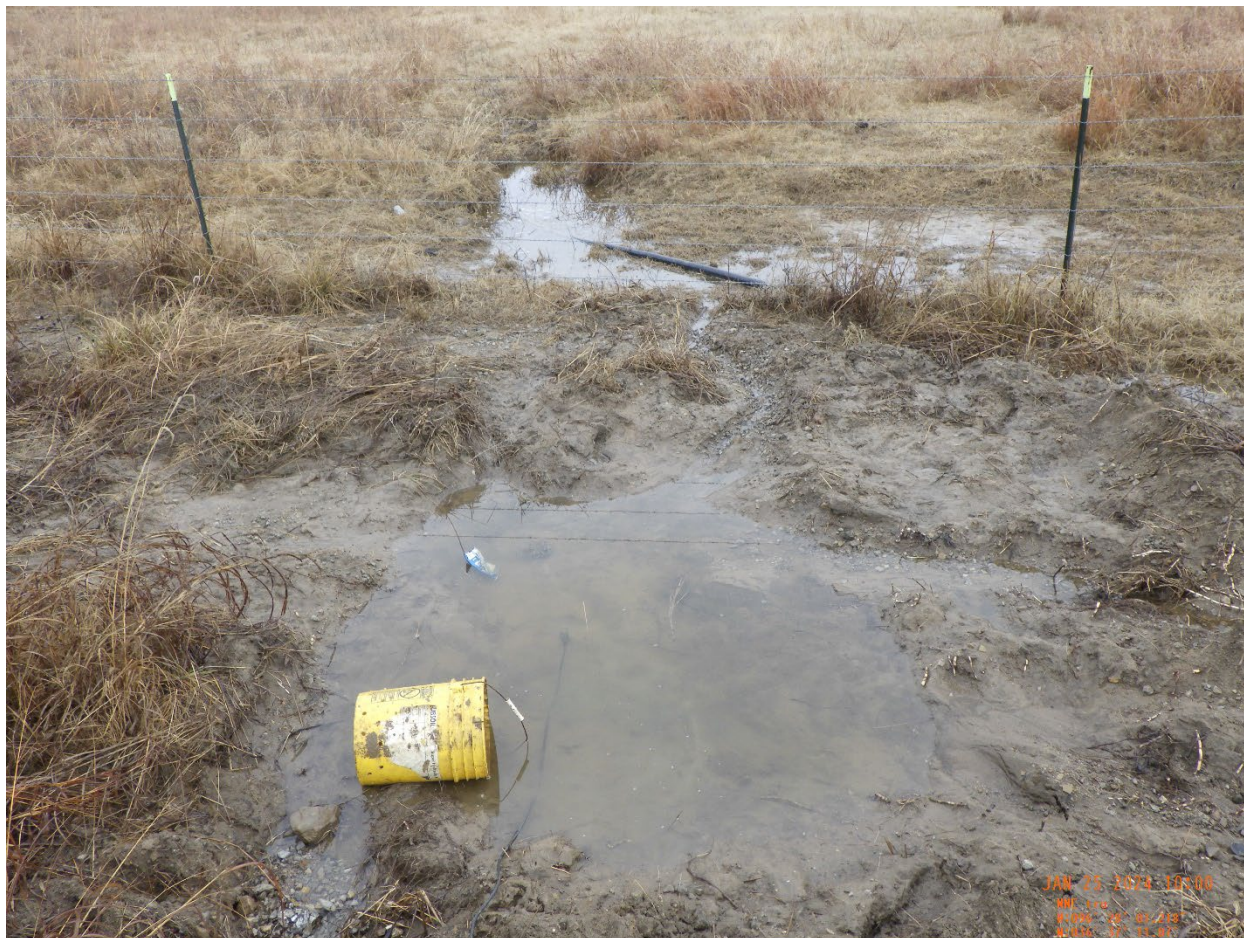
Photo No. 3

I observed no additional spill impacts beyond the location of photo No. 3.

**Description:** This was the location where the TDS field reading from photo No. 2 was taken. This location was also the point where the spill was initially contained with a temporary dam. Calgary Energy, LLC used this location as the collection and removal point for impacted waters during clean-up activities.
