**Region 6 - Enforcement & Compliance Assurance Division**  
**INSPECTION REPORT**

| Inspection Date(s): | 06/07/2023 | |
| Facility Name: | <b>Mountain Top Water Association Public Water System</b> | |
| Identification/Permit Number: | AR0000454 | |

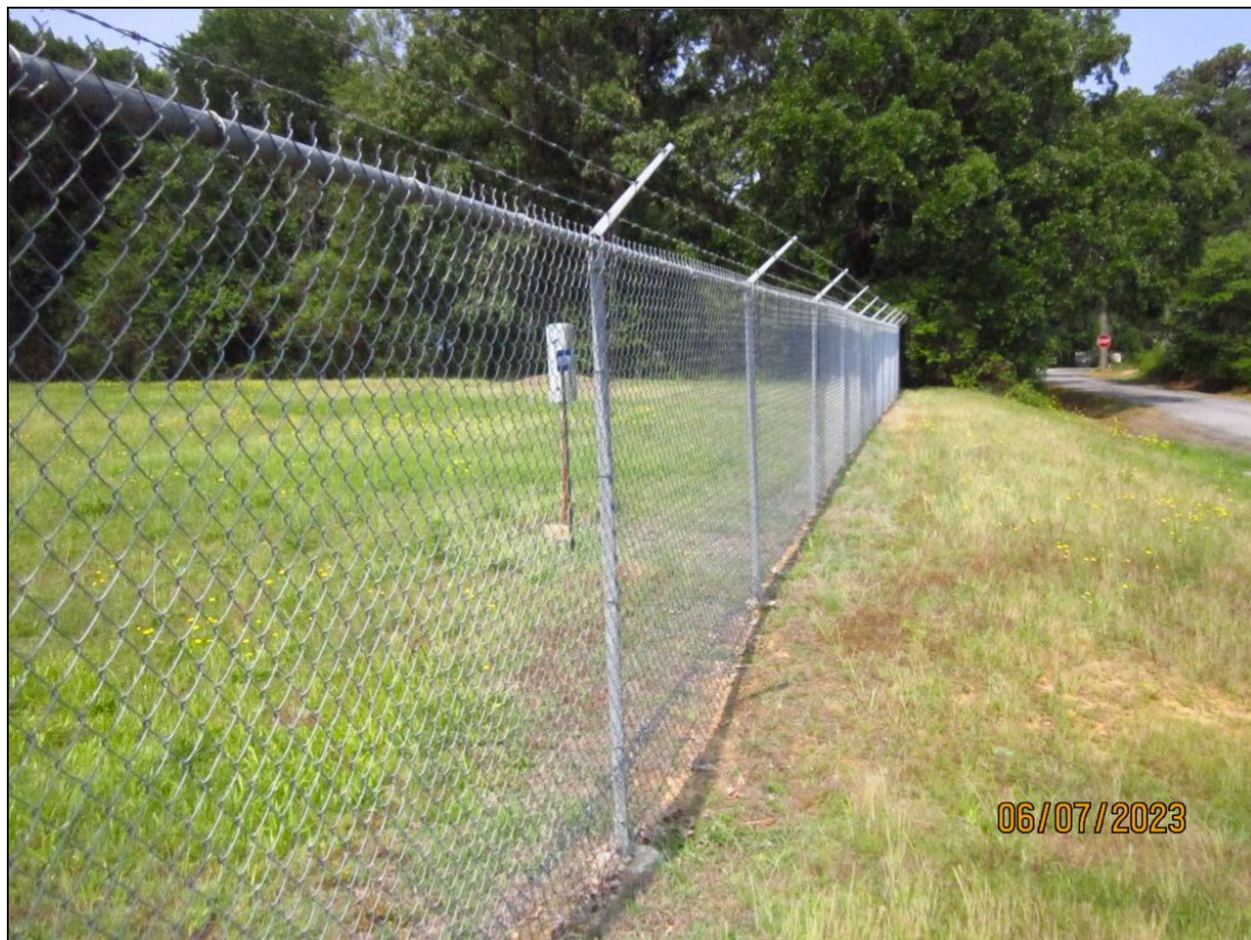
First, the EPA Inspection Team observed the Hopewell Water Tank. The Hopewell Tank was elevated and had a capacity of 250,000 gallons. The tank was surrounded by a locked perimeter fence with barbed wire (refer to [Appendix 2, Photograph 1](#)). [REDACTED]

**Photograph 1. Perimeter Fence, Hopewell Water Tank** View of the locked perimeter fence with barbed wire that surrounded the Hopewell Water Tank. The tank was approximately 50 yards from a church.

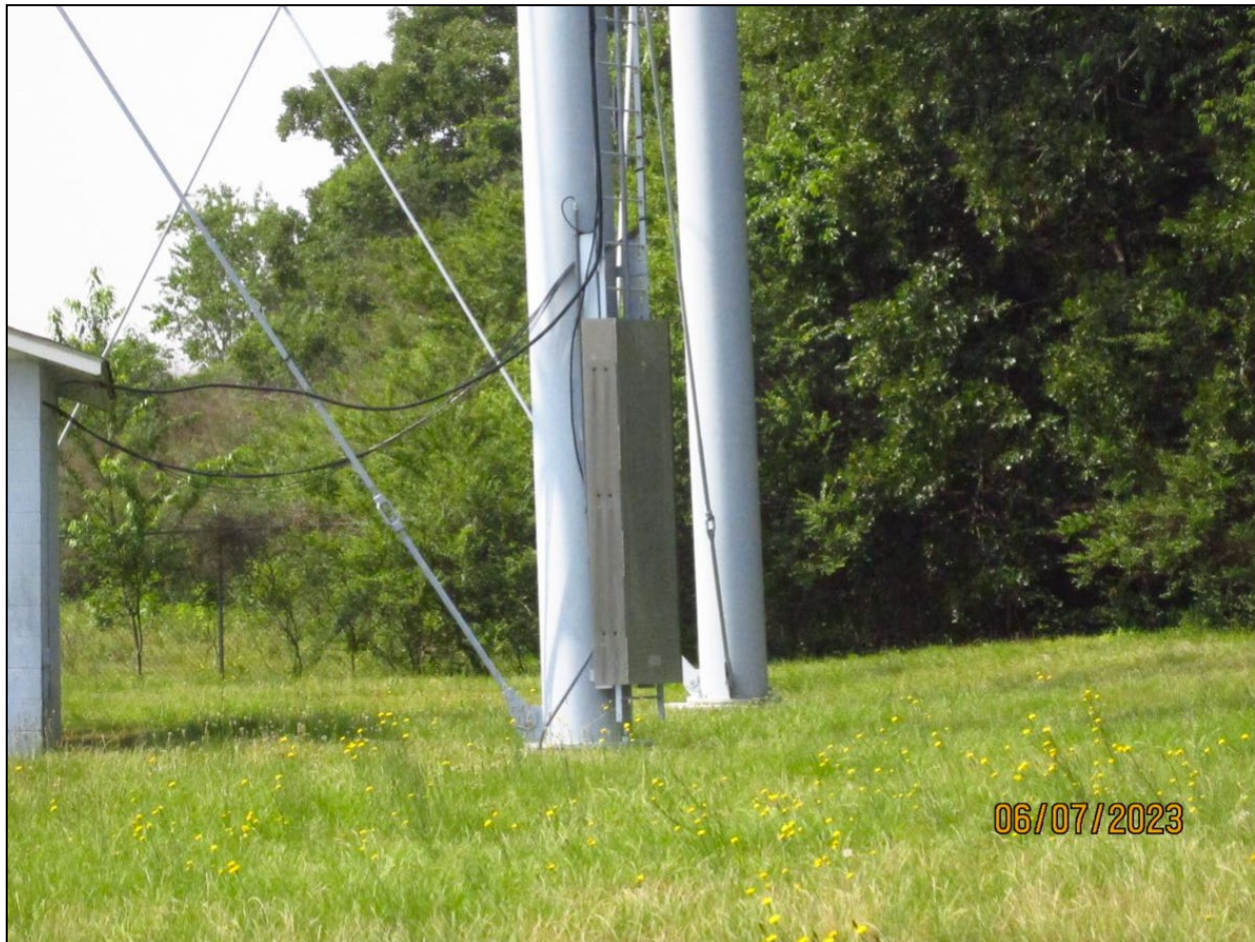
**Photograph 2. Security Ladder Shield, Hopewell Water Tank** View of the security shield that was covering the bottom rungs of the ladder at the Hopewell Water Tank. [REDACTED]

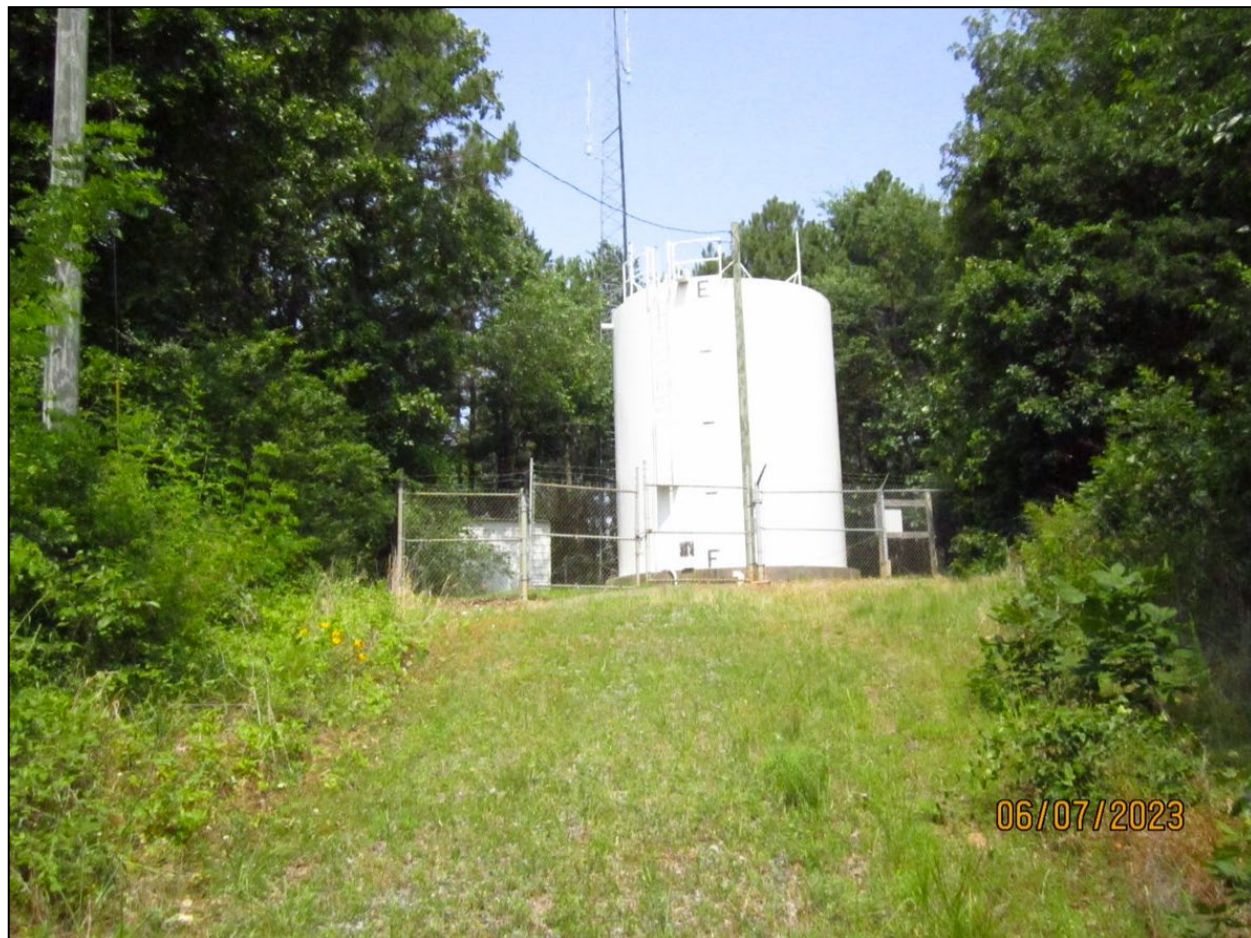
Following the Hopewell Tank, the Rosebud Water Tank was observed (refer to [Appendix 2, Photograph 5](#)). The Rosebud Tank is a 59,000 gallon standpipe tank. The tank was surrounded by a locked perimeter fence with barbed wire (refer to [Appendix 2, Photograph 6](#)). [REDACTED]

**Photograph 5. Rosebud Water Tank** View of the Rosebud Water Tank located at the end of a grass covered dirt and graveled road in a heavily wooded, undeveloped area. The tank is 59,000 gallons and was surrounded by a locked perimeter fence.

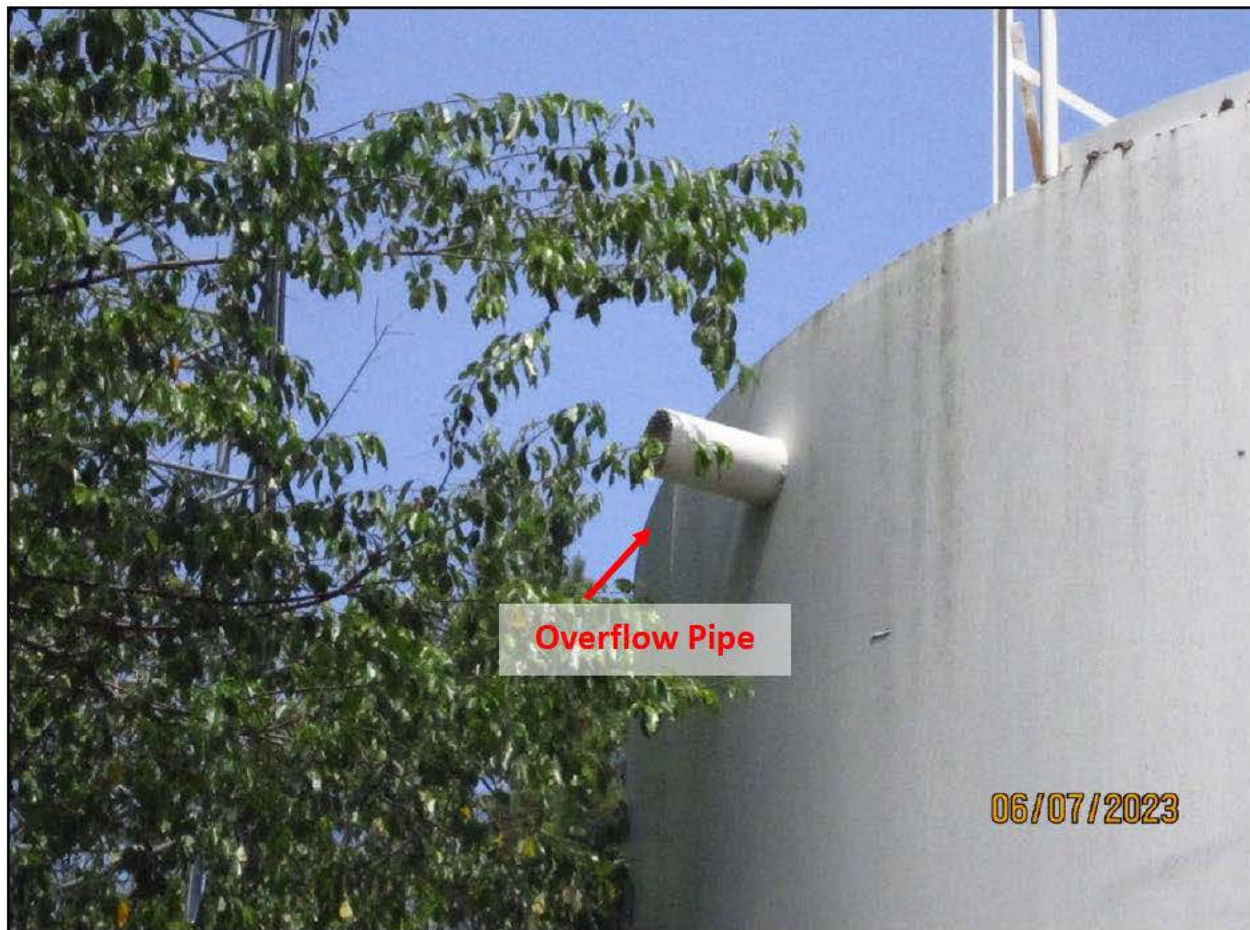
[REDACTED] An overflow pipe extending out of the top of the tank did not contain a flapper (refer to [Appendix 2, Photograph 8](#)). There were signs of erosion (e.g., no grass and exposed rocks in a low laying area) beneath the overflow line (refer to [Appendix 2, Photograph 9](#)). It was unclear what size screen was placed over the opening of the overflow pipe.

**Photograph 8. Overflow Pipe, Rosebud Water Tank** View of the overflow pipe that extended out of the top of the Rosebud Water Tank. There appeared to be a coarse screen over the opening of the pipe, but it was unclear what size the screen was. There was no splash pad beneath the pipe.

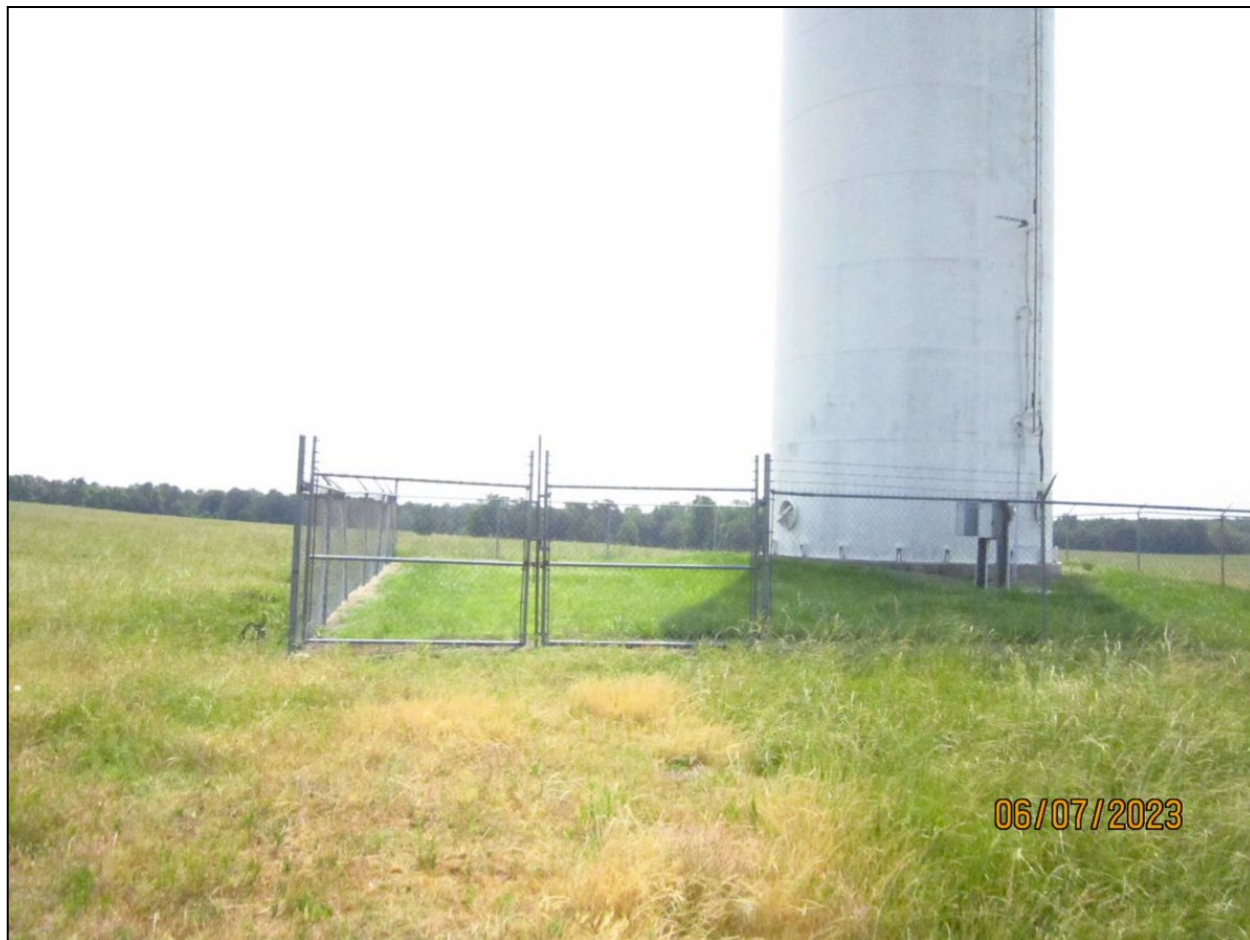
The Liberty Hill Water Tank was observed next (refer to [Appendix 2, Photograph 11](#)). The Liberty Hill Water Tank is a 199,400 gallon standpipe tank. The tank was surrounded by a locked perimeter fence with barbed wire (refer to [Appendix 2, Photograph 12](#)). [REDACTED]

**Photograph 11. Liberty Hill Water Tank** View of the Liberty Hill Water Tank located in an open field approximately 150 yards from local homes. The Liberty Hill Water Tank is a 199,400 gallon standpipe tank, and it was surrounded by a locked perimeter fence with barbed wire.

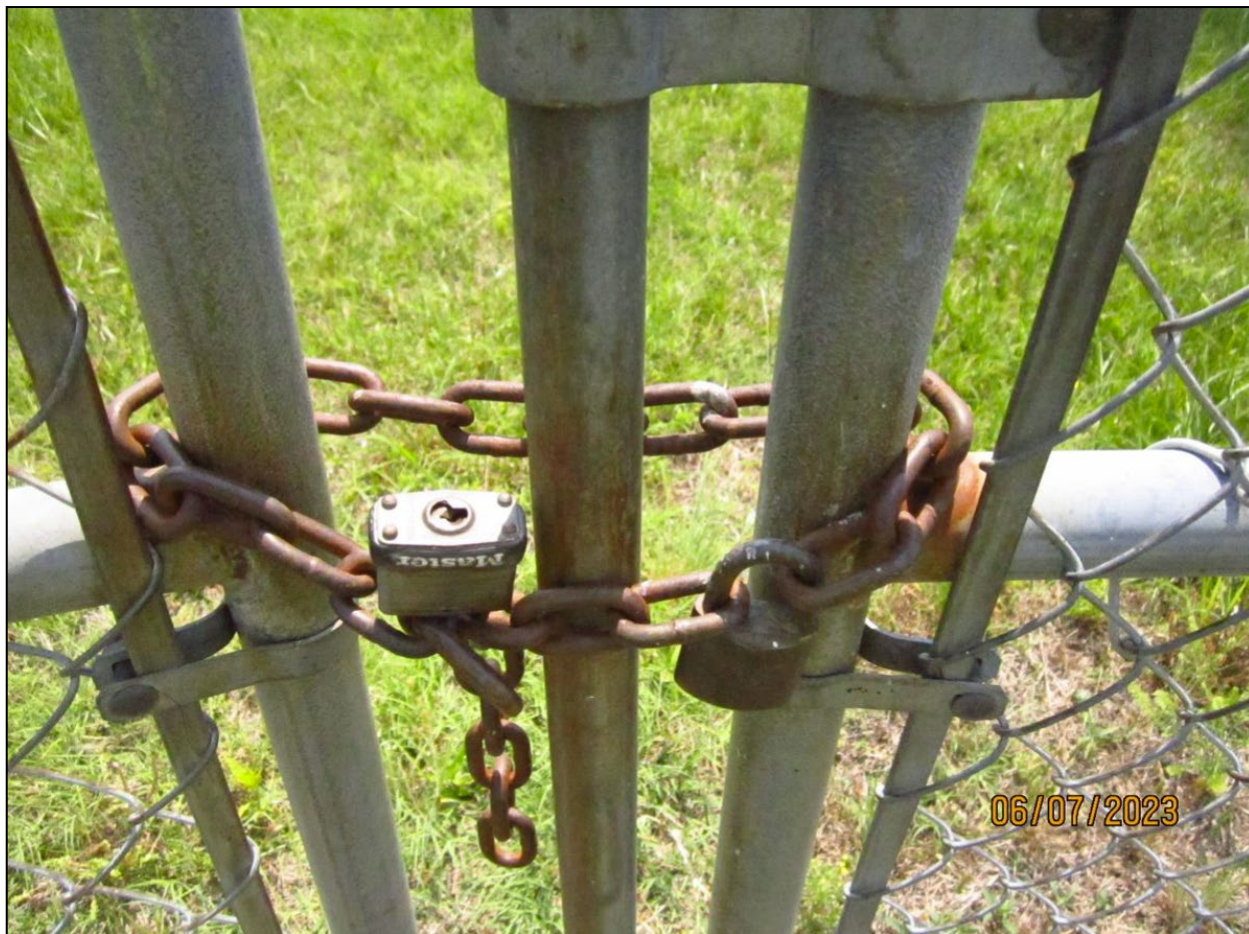
**Photograph 12. Perimeter Fence Lock, Liberty Hill Water Tank** View of the locks on the security fence that was surrounding the Liberty Hill Water Tank. The fence also contained barbed wire.

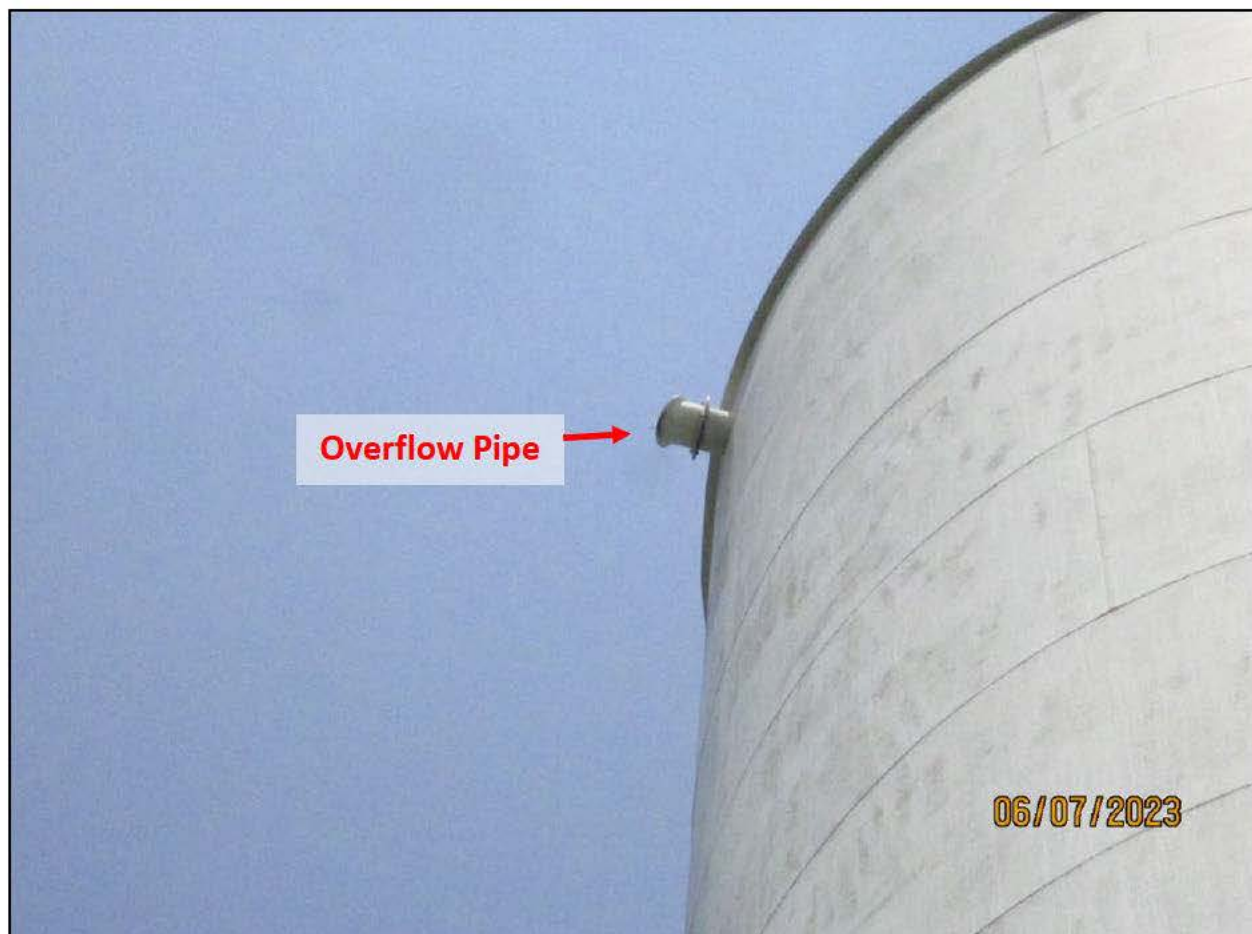
An overflow pipe extended out of the top of the tank; it was unclear if the pipe opening was covered by a screen (refer to [Appendix 2, Photograph 14](#)).

**Photograph 14. Overflow Pipe, Liberty Hill Water Tank** View of the overflow pipe that extended out of the top of the Liberty Hill Water Tank. It was unclear if the pipe was covered by a screen, and there was no splash pad beneath the pipe.

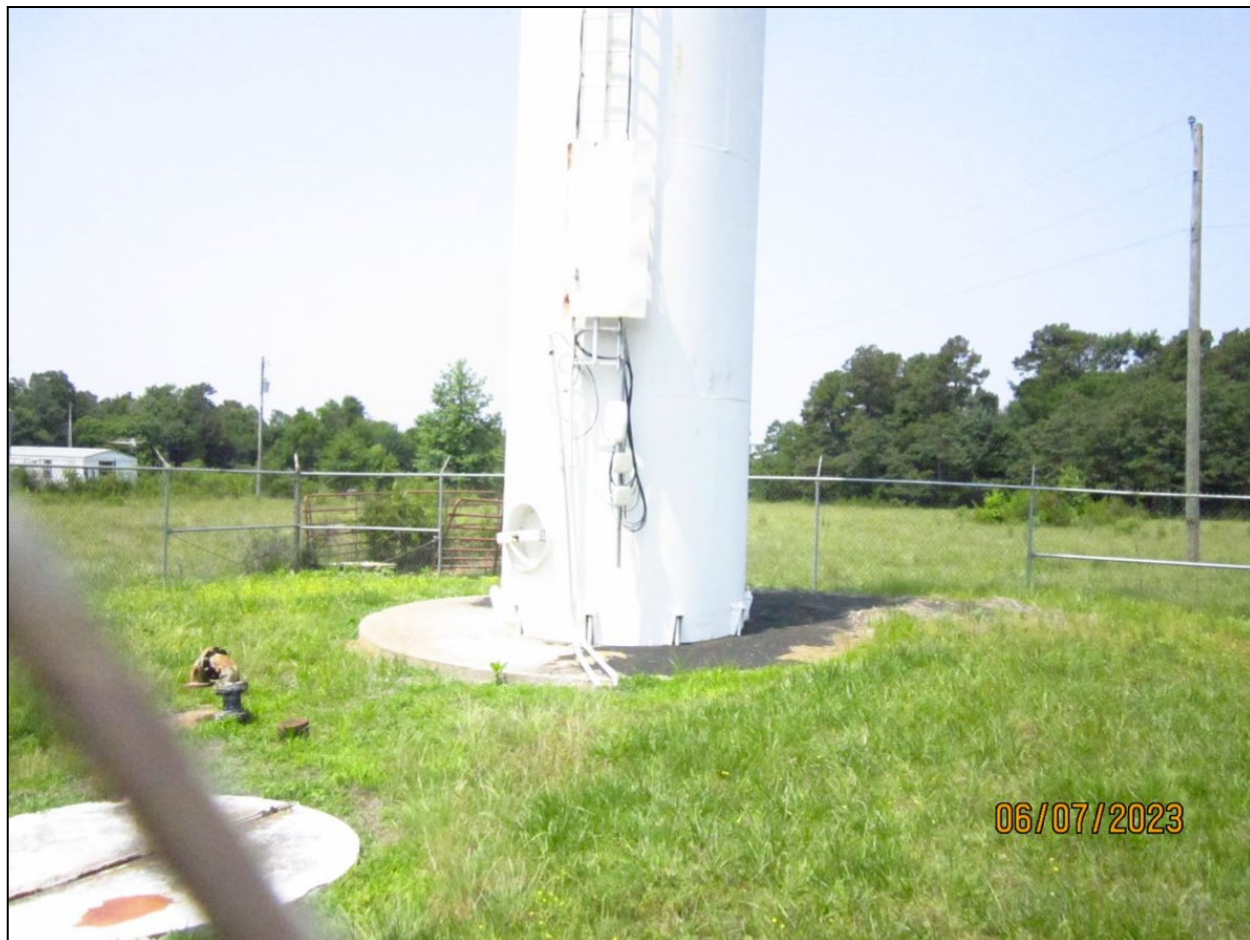
After the Liberty Hill Water Tank, the Joy Water Tank was observed (refer to [Appendix 2, Photograph 15](#)). The Joy Water Tank is a 28,950 gallon standpipe tank. The tank was surrounded by a locked perimeter fence with barbed wire (refer to [Appendix 2, Photograph 16](#)). The bottom rungs of the ladder were removed, and there was a locked security shield over the ladder. There was some rust at the top of the tank, and an overflow pipe extended from the top of the tank (refer to [Appendix 2, Photograph 17](#)). It was unclear if the overflow pipe opening was covered by a screen.

**Photograph 15. Joy Water Tank** View of the Joy Water Tank. The Joy Water Tank is a 28,950 gallon standpipe tank, and it was surrounded by a locked perimeter fence with barbed wire. The tank is approximately 50 yards from the nearest home.

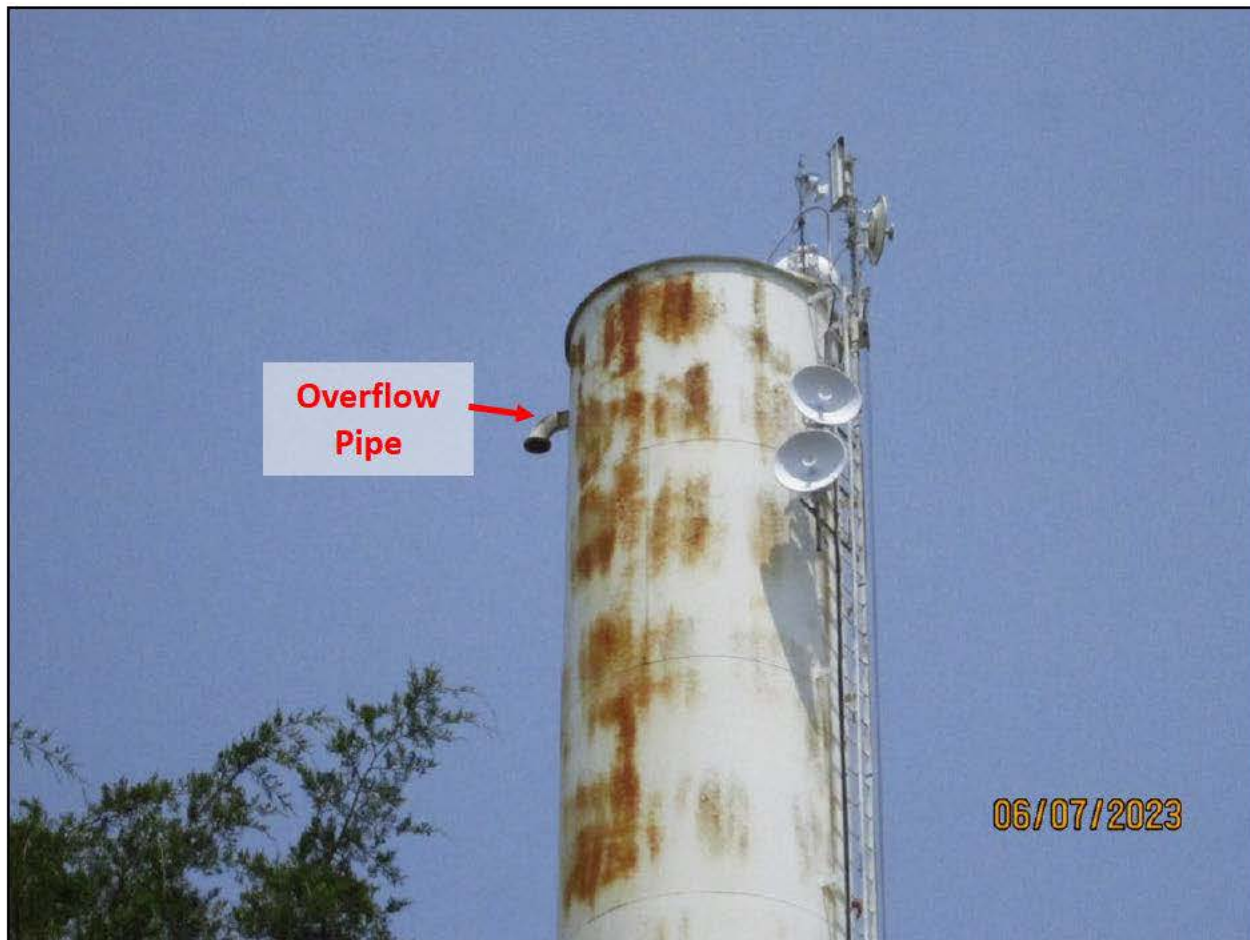
**Photograph 17. Joy Water Tank** View of the overflow pipe at the Joy Water Tank. It was unclear if the opening of the pipe was covered by a screen, and there was no splash pad beneath the pipe. Also visible in this image is rust on the side of the tank. There were multiple pieces of communication equipment attached to the tank's ladder structure (not the tank shell).

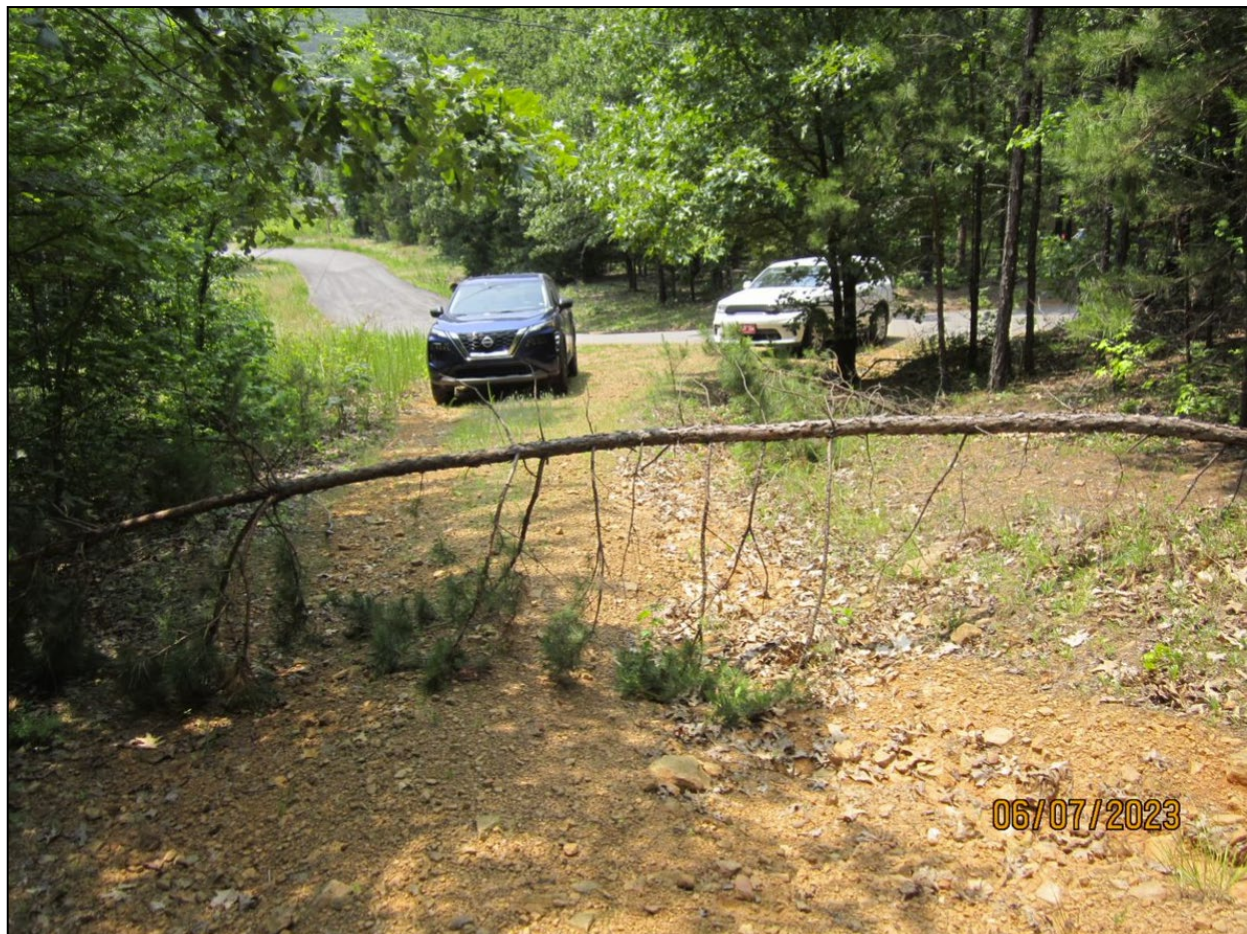
Water Tank #1 was also observed. The road leading up to the tank had a fallen tree across it, making it so that vehicles could not pass (refer to [Appendix 2, Photograph 18](#)). Additionally, the dirt road was heavily eroded due to past rainfall. [REDACTED]

**Photograph 18. Access Road, Water Tank #1** View of a fallen tree that was blocking the access road to Water Tank #1. The tree made it so that vehicles could not access the tank. Also visible in this image is heavy erosion in the road due to rainfall.

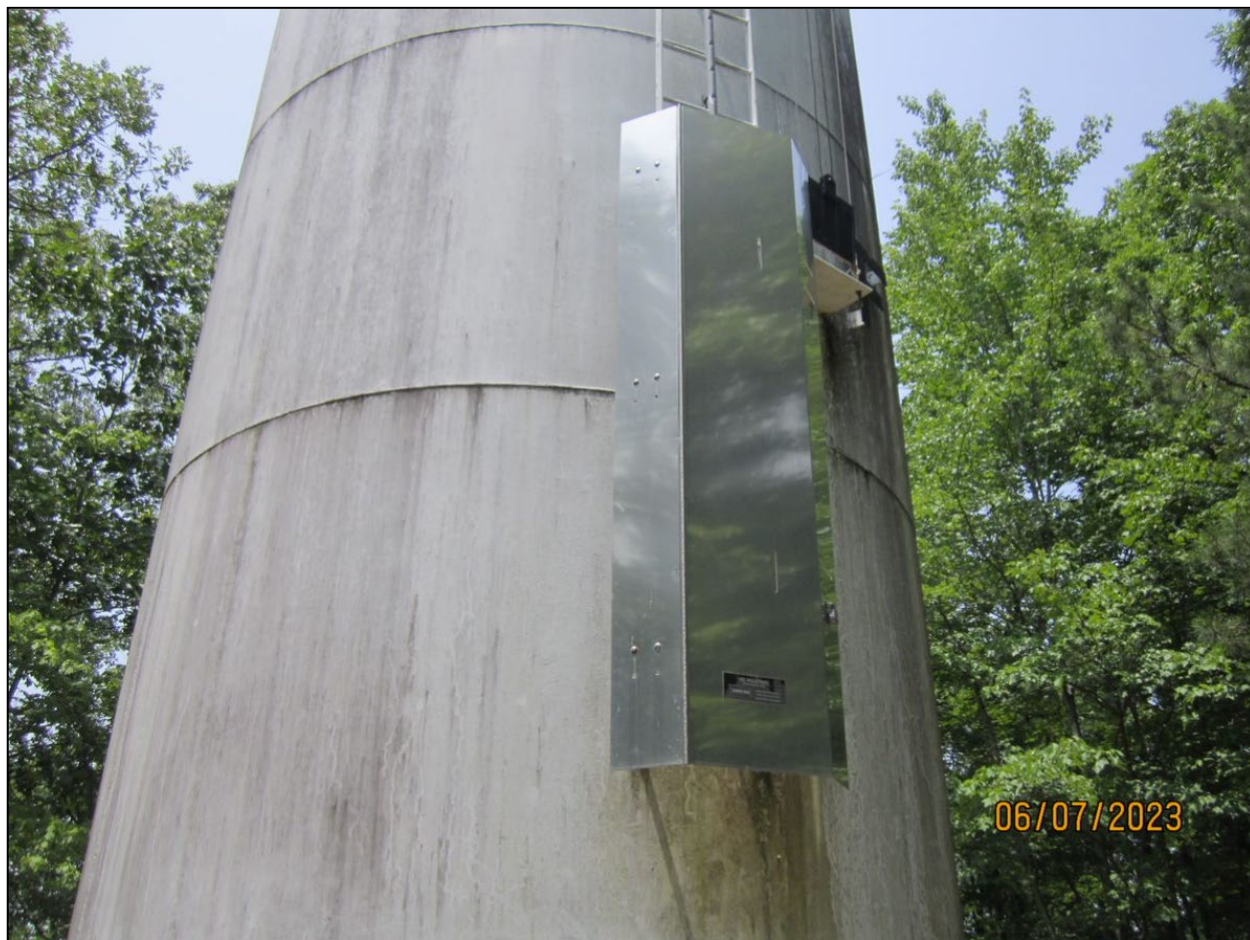
[REDACTED] The lower rungs of the tank ladder were removed, and there was a locked security shield over the lower rungs of the ladder (refer to [Appendix 2, Photograph 20](#)). An overflow pipe extended from the top of the tank; it was unclear if the opening of the pipe was covered by a screen.

**Photograph 20. Security Ladder Shield, Water Tank #1** View of the security ladder shield at Water Tank #1. The security shield was locked.

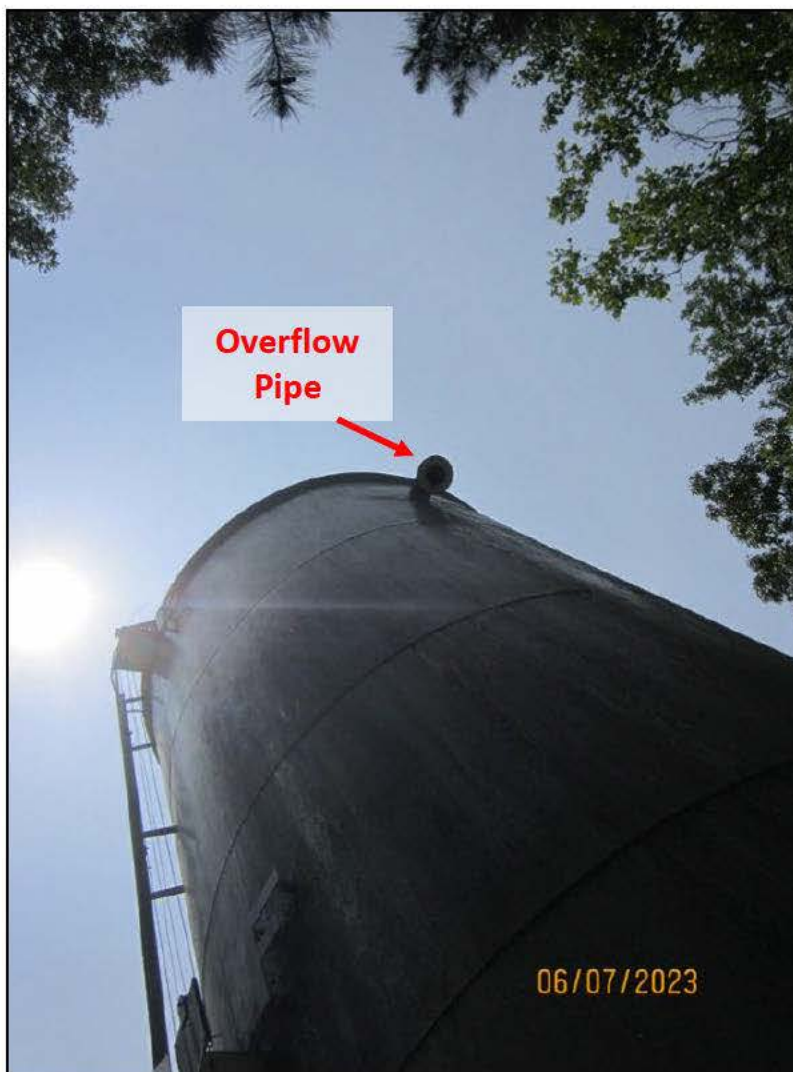
**Observation 21.** The terminus of the overflow pipe extending out of Water Tank #1 was near the top of the tank, and there was no splash pad beneath the pipe at the bottom of the tank (refer to [Appendix 2, Photograph 21](#)). Additionally, erosion was observed next to the water tank beneath the terminus of the overflow pipe (refer to [Appendix 2, Photograph 22](#)).

**Photograph 21. Water Tank #1** View of the overflow pipe extending out of the top of Water Tank #1. There was no splash pad beneath the overflow pipe.

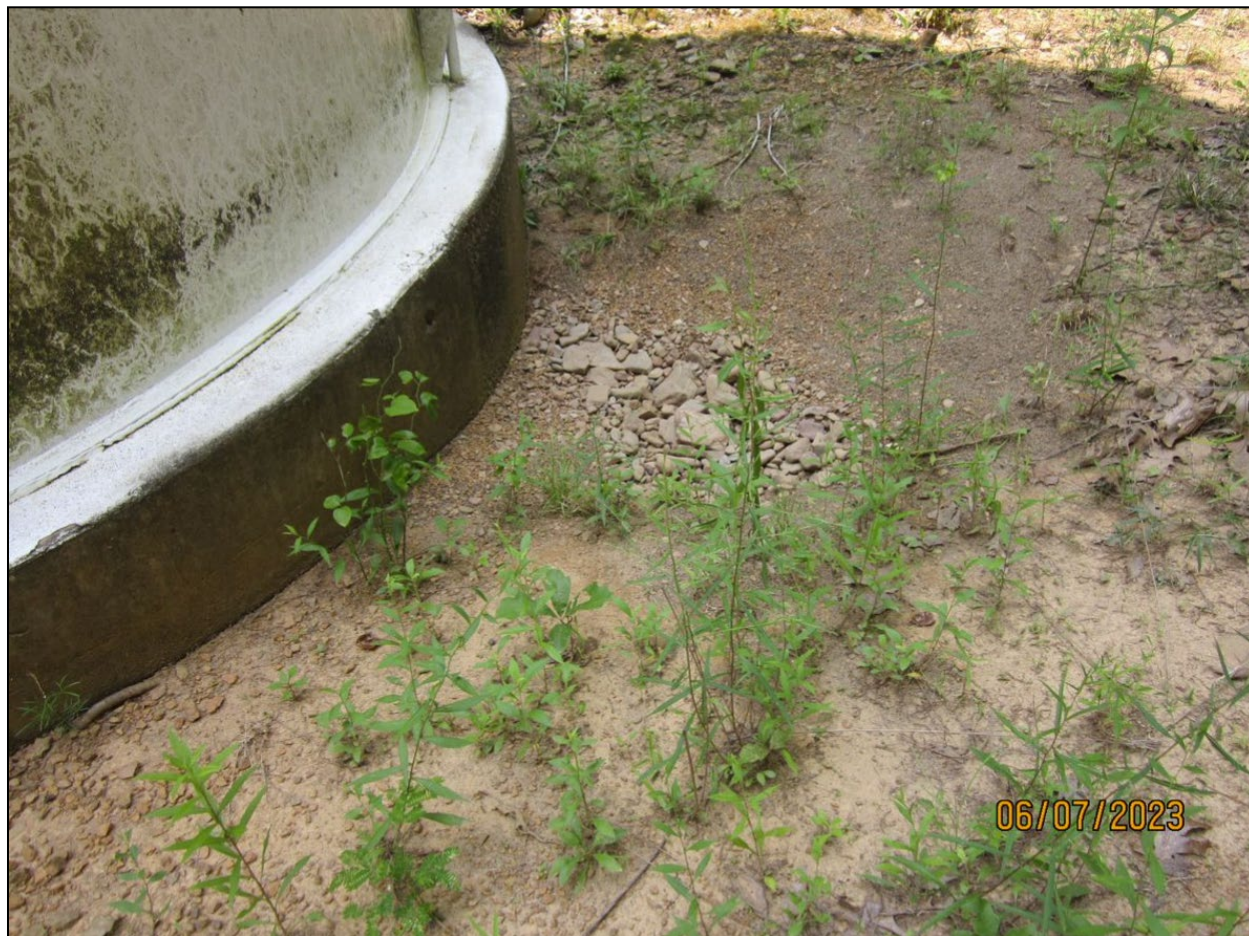
**Photograph 22. Water Tank #1** View of the erosion underneath the overflow pipe at Water Tank #1.

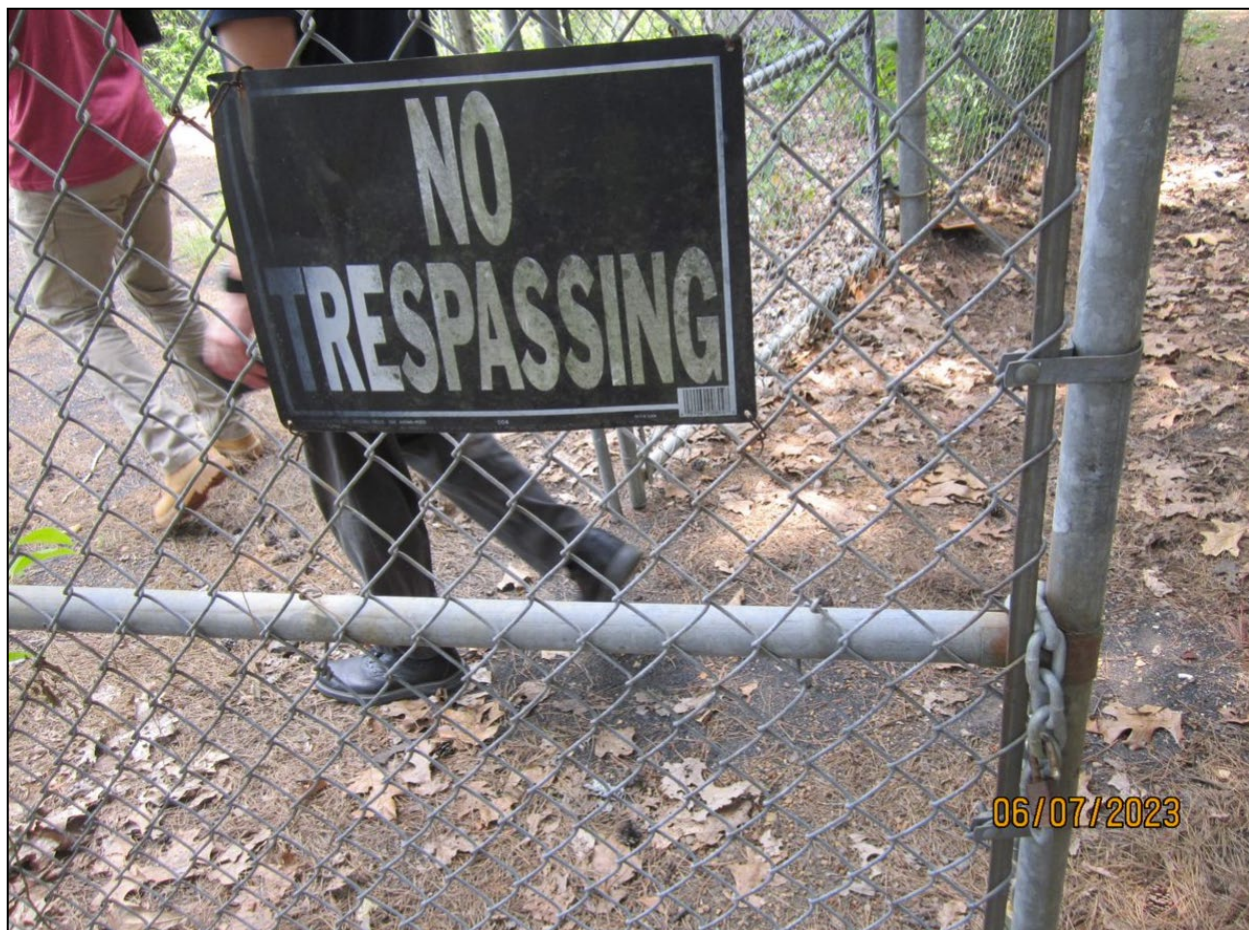
Finally, the Ridgecrest Water Tank was observed (refer to [Appendix 2, Photograph 23](#)). A “No Trespassing” sign was present on the perimeter security fence which was locked and had barbed wire (refer to [Appendix 2, Photograph 24](#)). The System Manager stated that the Ridgecrest Tank received extensive maintenance approximately one year ago, and that it was their most updated tank. [REDACTED]

**Photograph 24. Perimeter Security Fence, Ridgecrest Water Tank** View of a “No Trespassing” sign that was posted on the security fence of the Ridgecrest Water Tank.

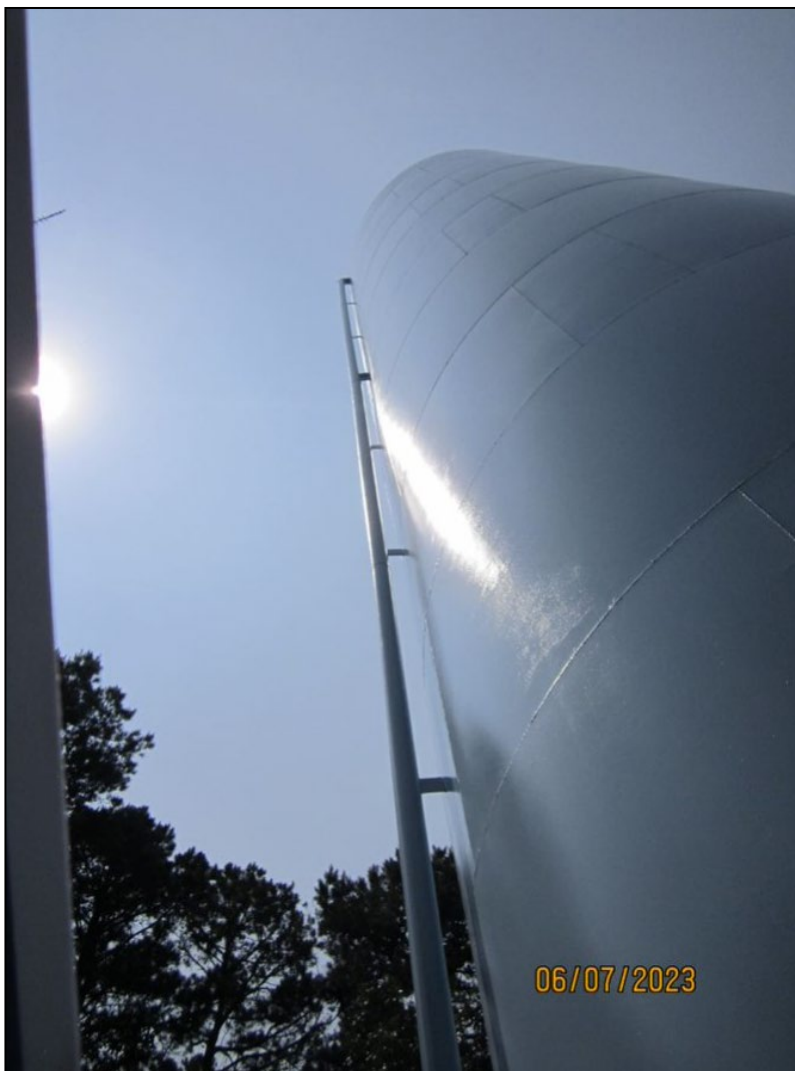
[REDACTED] The tank contained an overflow pipe that extended out of the top of the tank down to the ground (refer to [Appendix 2, Photograph 25](#)). The pipe opening had a flapper valve that was open. There was no concrete splash pad beneath the pipe’s terminus (refer to [Appendix 2, Photograph 26](#)). A 24-inch mesh screen was present inside of the pipe (refer to [Appendix 2, Photograph 27](#)). Alarms associated with the tank were tied into the System’s SCADA system. [REDACTED]

**Photograph 25. Ridgecrest Water Tank** View of the overflow pipe that extended off of the side of the Ridgecrest Water Tank to the ground.

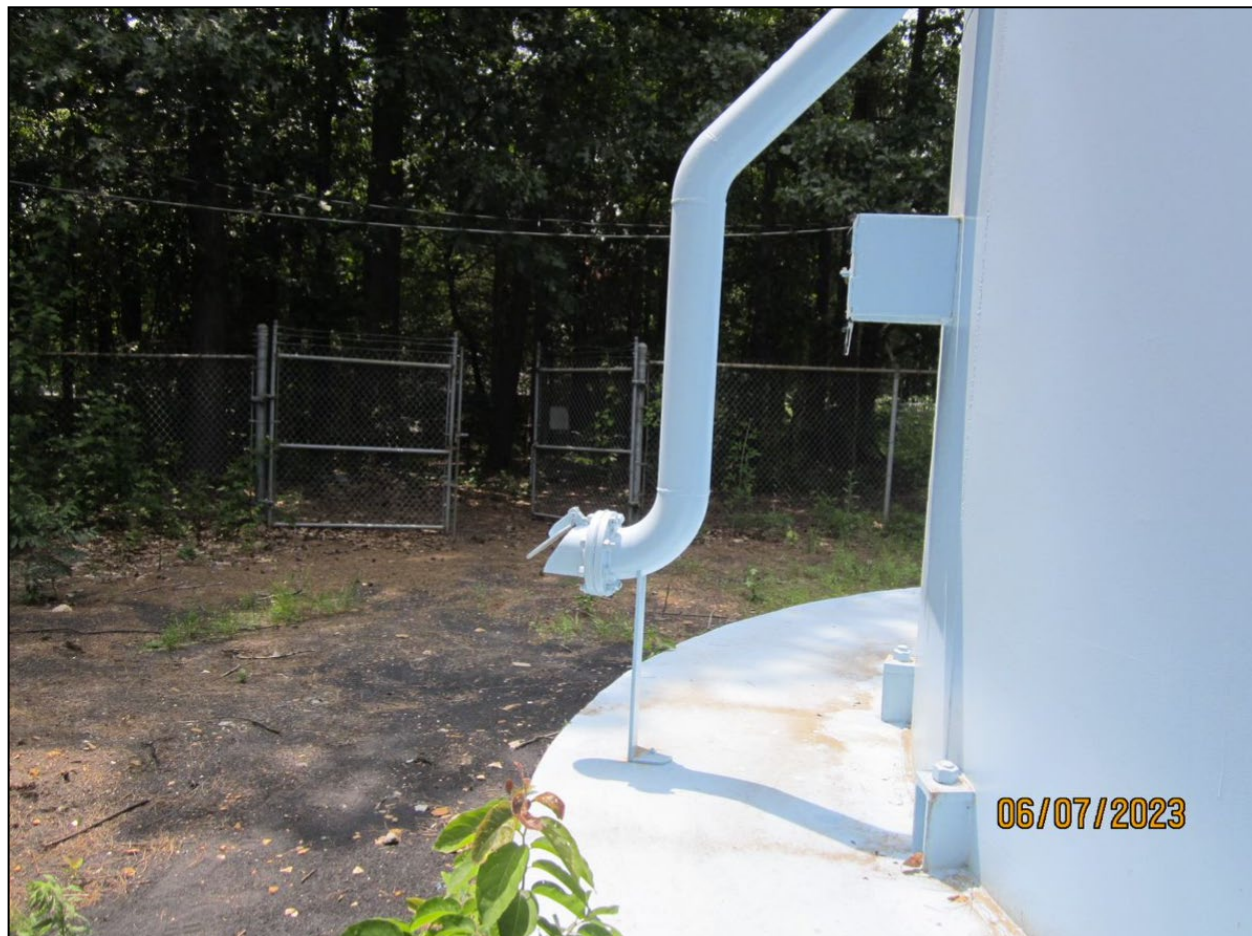
**Photograph 26. Overflow Pipe, Ridgecrest Water Tank** View of the end of the overflow pipe that extended out of the Ridgecrest Water Tank. The flapper valve was open and there was no concrete splash pad beneath the pipe.

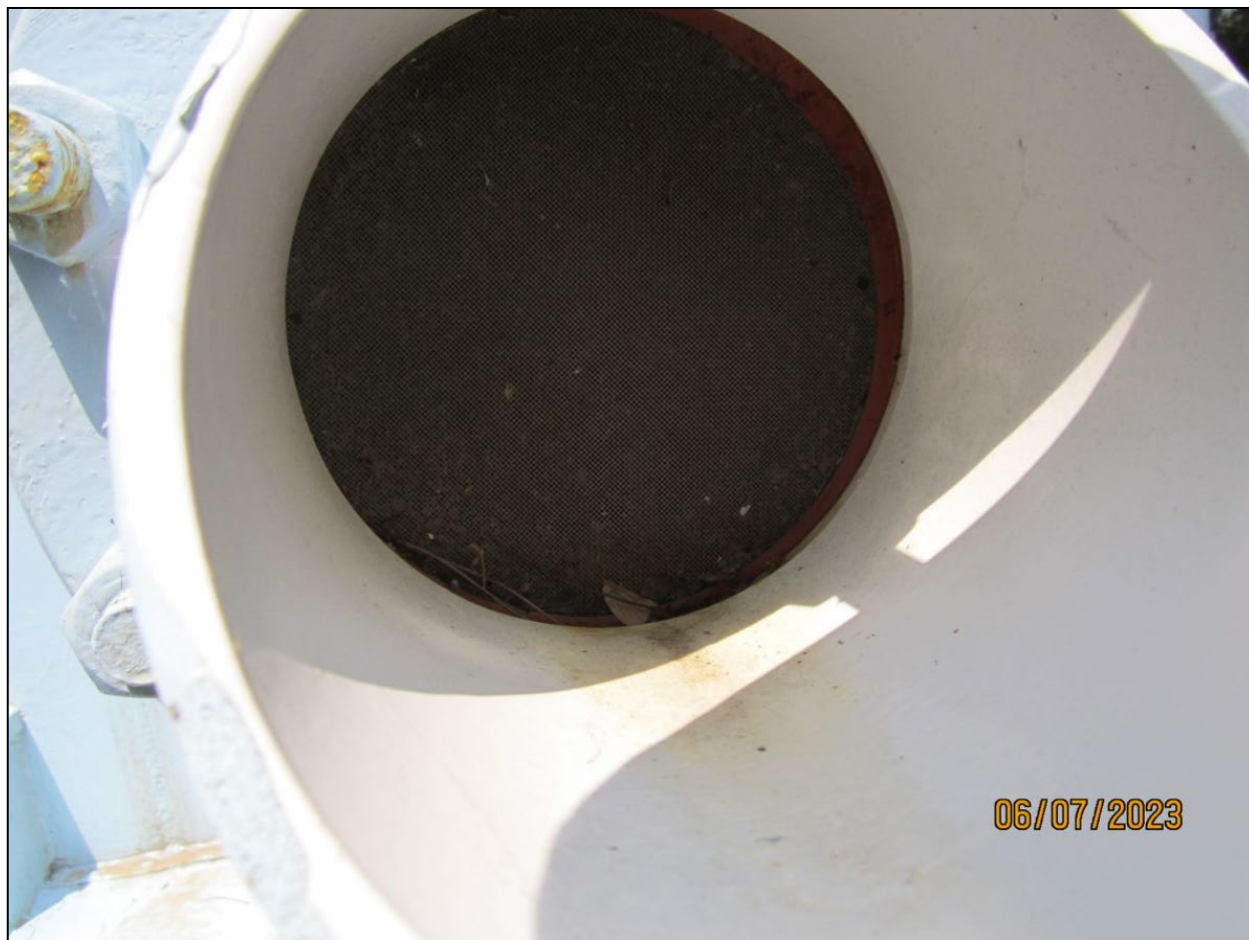
**Photograph 27. Overflow Pipe, Ridgecrest Water Tank** View of the inside of the overflow pipe that extended off of the Ridgecrest Water Tank. The opening was covered by a 24-inch mesh screen beneath a flapper valve.

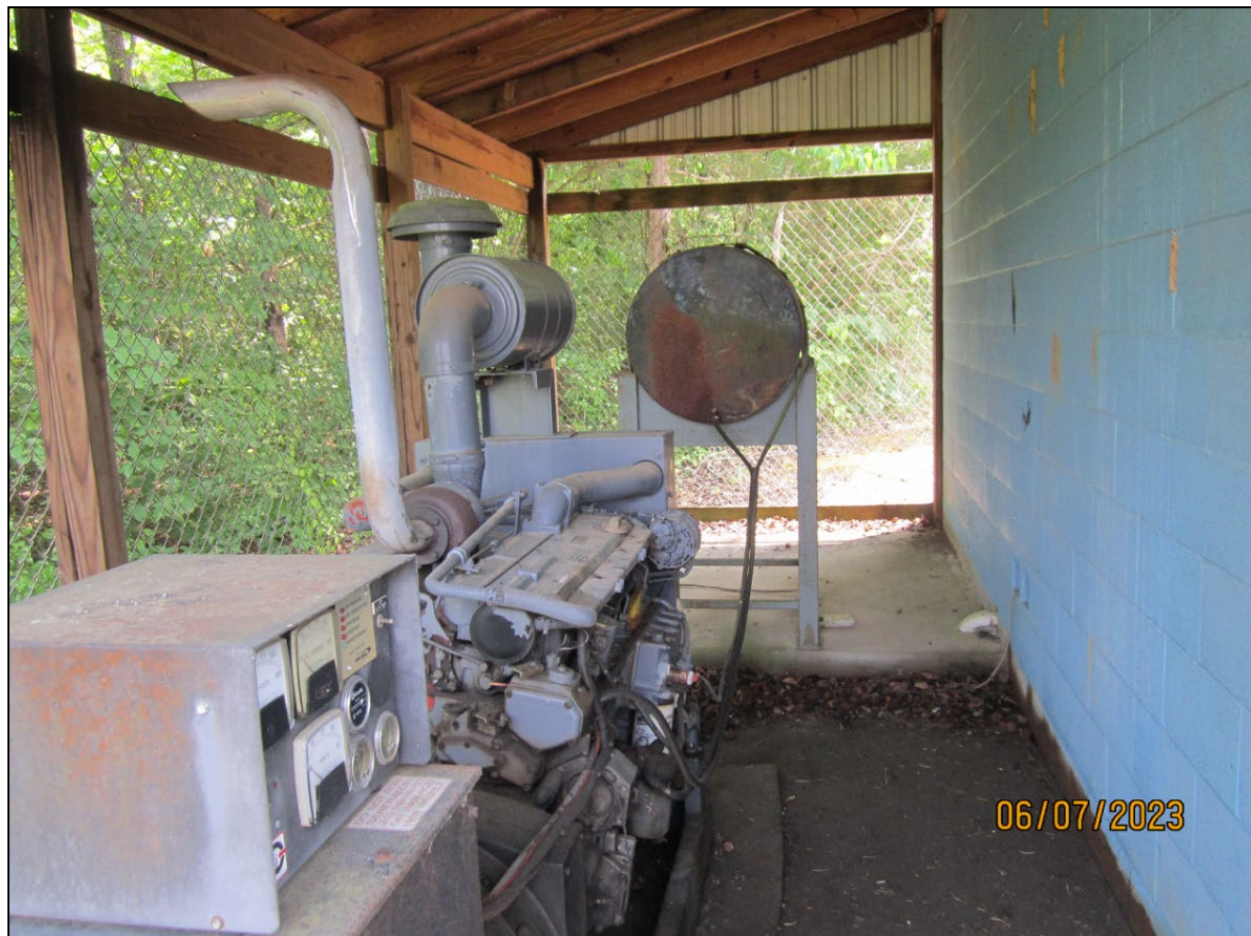
A backup generator was positioned next to the pump/meter room at the pump station (refer to [Appendix 2, Photograph 31](#)). The System Manager stated that the generator was not functional and that they were in the process of fixing it. The generator did not contain a battery. The fuel tank standing next to the generator was empty. [REDACTED]

**Photograph 31. Backup Generator, Pump Station #1** View of the backup generator that was positioned next to Pump Station #1. The generator was not functional and did not contain a battery.
