**Region 6 - Enforcement & Compliance Assurance Division**  
**INSPECTION REPORT**

| Inspection Date(s): | 06/07/2023 | |
| Facility Name: | <b>Mountain Top Water Association Public Water System</b> | |
| Identification/Permit Number: | AR0000454 | |

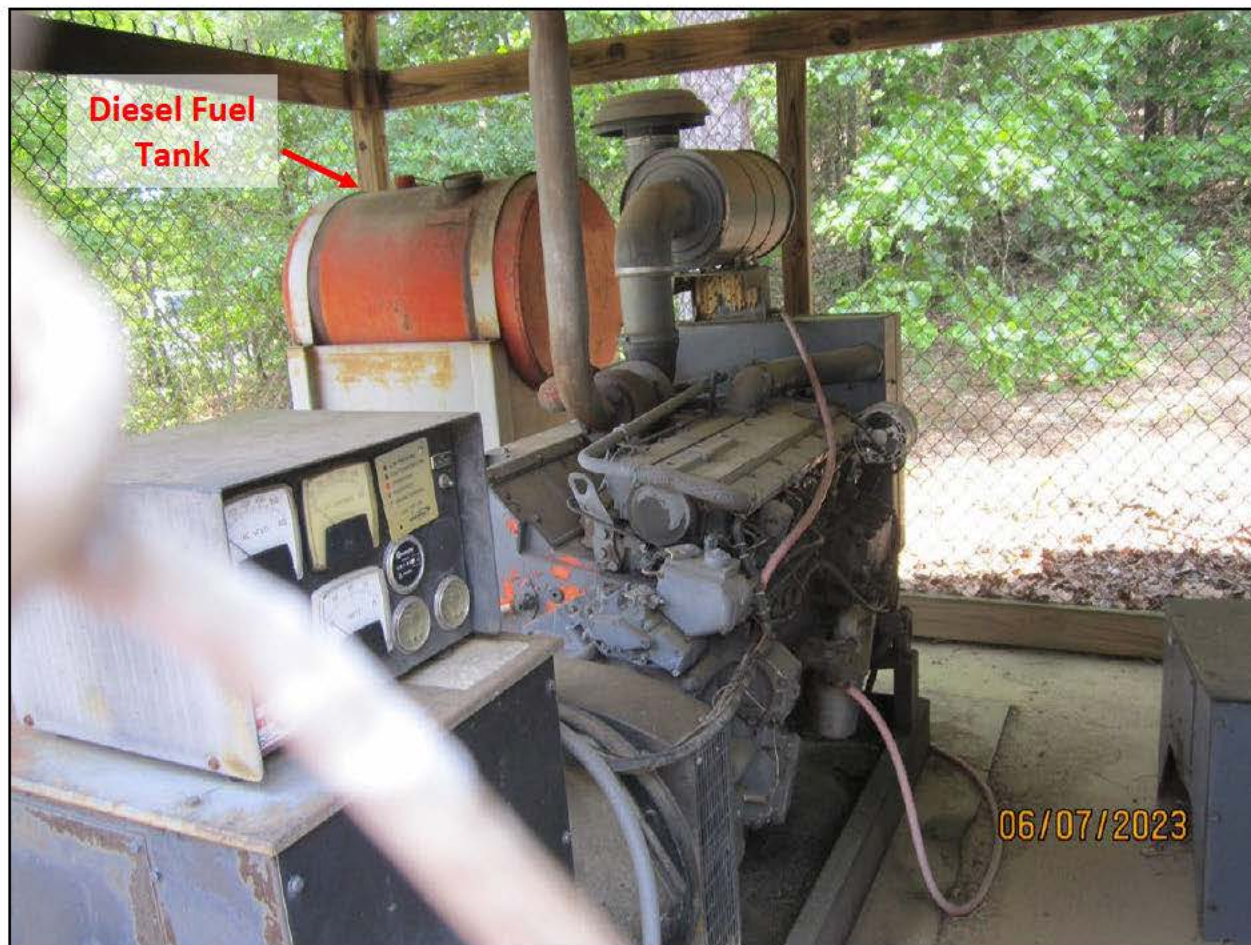
**Photograph 32. Backup Generator, Pump Station #2** View of the backup generator that was positioned next to Pump Station #2. The generator was not functional, and there was sludge at the bottom of the diesel fuel tank next to the generator.

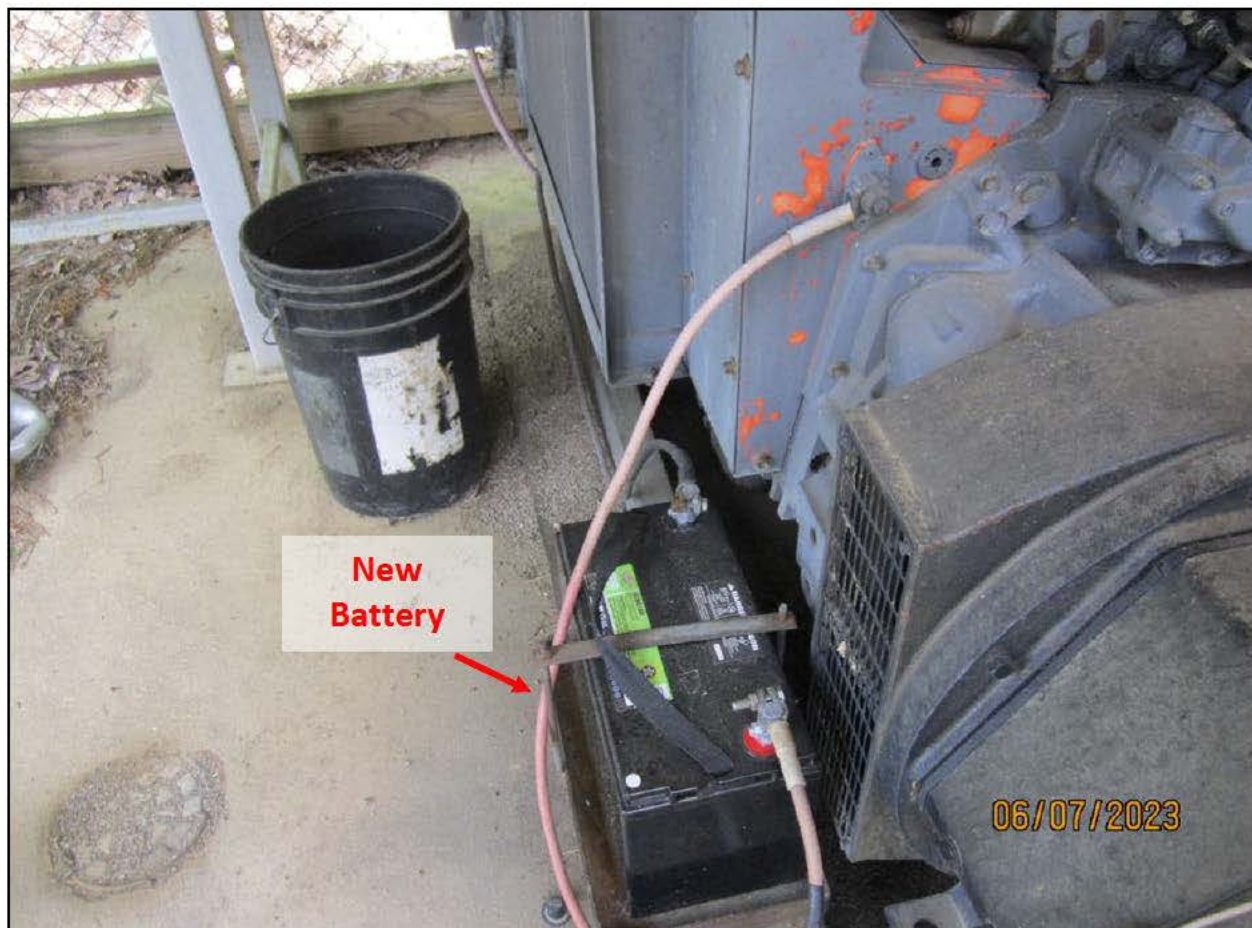
**Photograph 33. Backup Generator, Pump #2** View of the battery sitting next to the backup generator next to Pump #2. The generator was not functional, but System representatives stated that the battery was new.

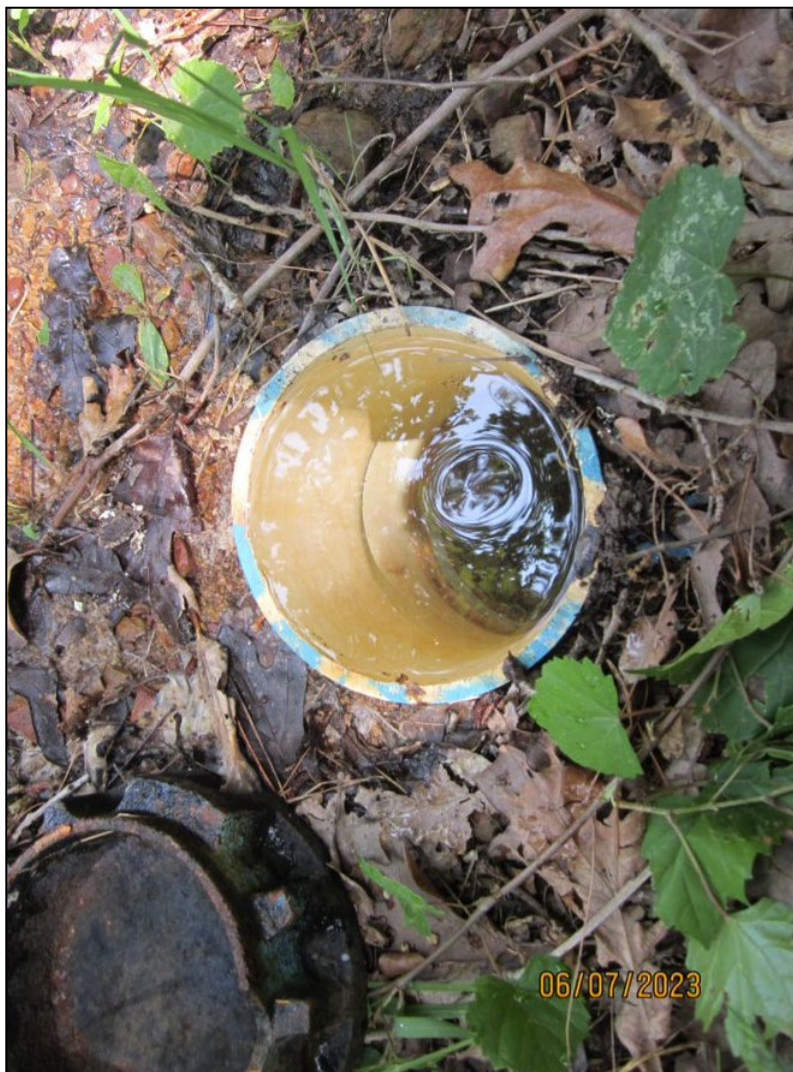
**Observation 25.** There was a potable water leak occurring from one of the valves adjacent to Pump Station #2 (refer to [Appendix 2, Photographs 34 and 35](#)). The water was leaking out of the valve and running downhill toward the pump station. The System Manager stated that he was aware of the leak, and the ground had been painted to reflect the location of future repairs to the line (refer to [Appendix 2, Photograph 36](#)).

**Photograph 34. Valve Port, Pump Station #2** View of a valve box PVC line to valve stem that was leaking potable water. The water was running down the hill toward the pump station, and the System Manager stated that he was aware of the leak. The area had blue spray paint line on the ground in preparation for excavation.

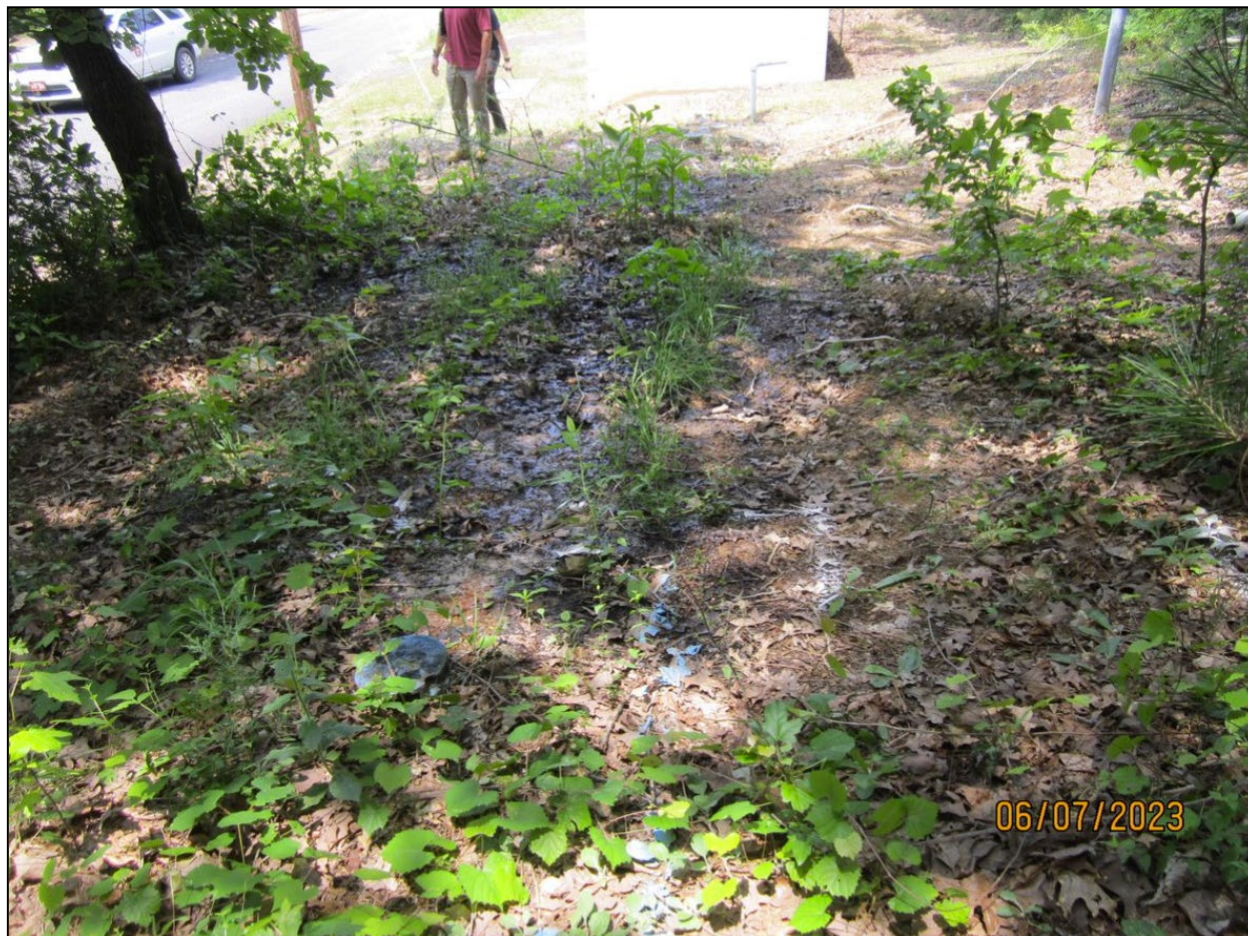
**Photograph 35. Valve, Pump Station #2** View of hill sloping toward Pump Station #2 where potable water leaking from the valve was draining. Blue paint was observed on the ground in this area.

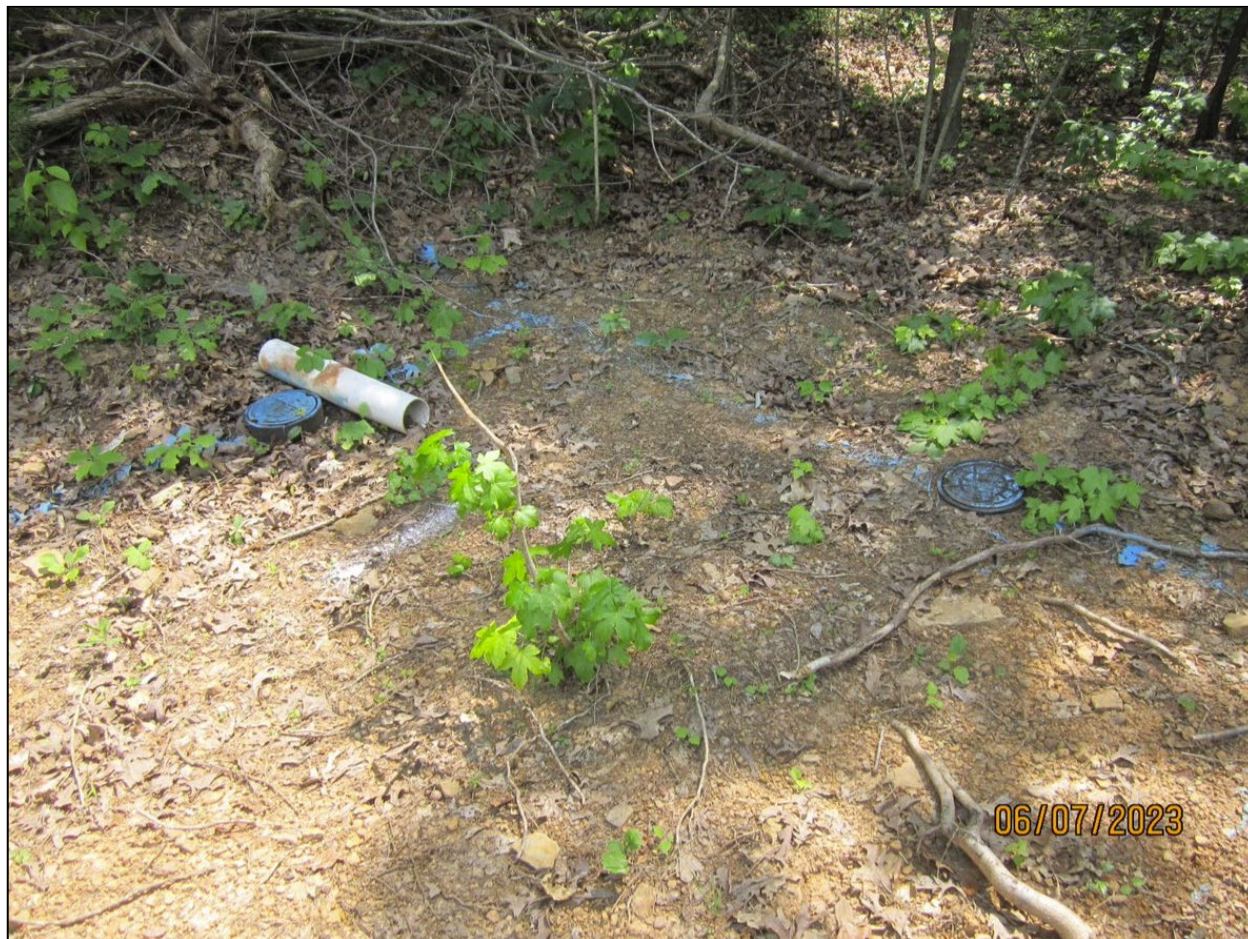
**Photograph 36. Valves, Pump Station #2** View of the ground at Pump Station #2, downhill of the leaking valve. Paint showed where water lines were located so that the scheduled excavation and repairs could take place.

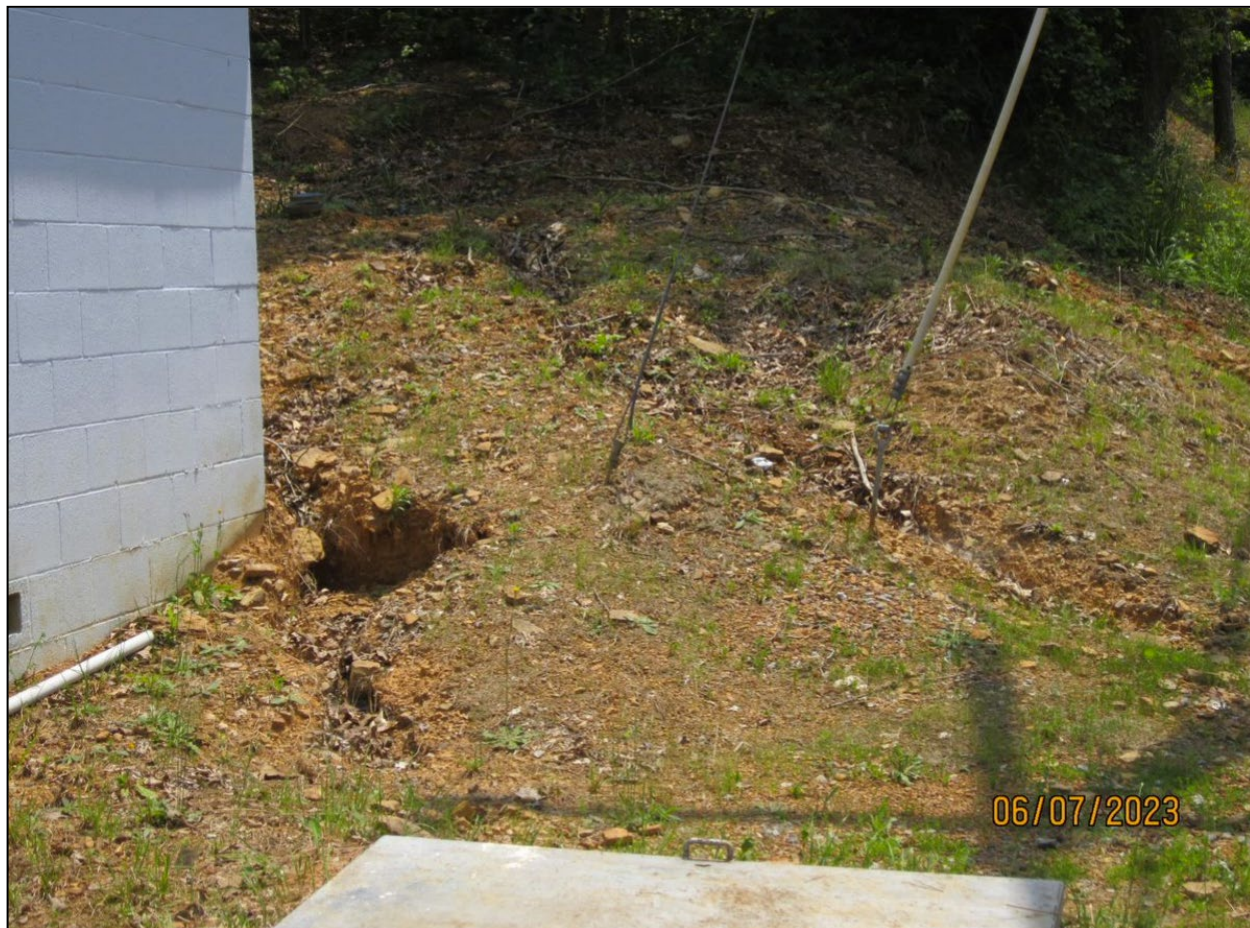
**Photograph 37. Pump Station #2** View of the erosion next to Pump Station #2. The hill was sloped toward the pump station, causing rainwater to erode the ground on either side.
