# **REPORT OF PUBLIC WATER SYSTEM COMPLIANCE INSPECTION**

**City of Emporia, Public Water Supply  
1220 Hatcher St. Emporia, KS 66801**

**Public Water Supply ID#: KS2011105**

**July 14, 2025 – July 15, 2025**

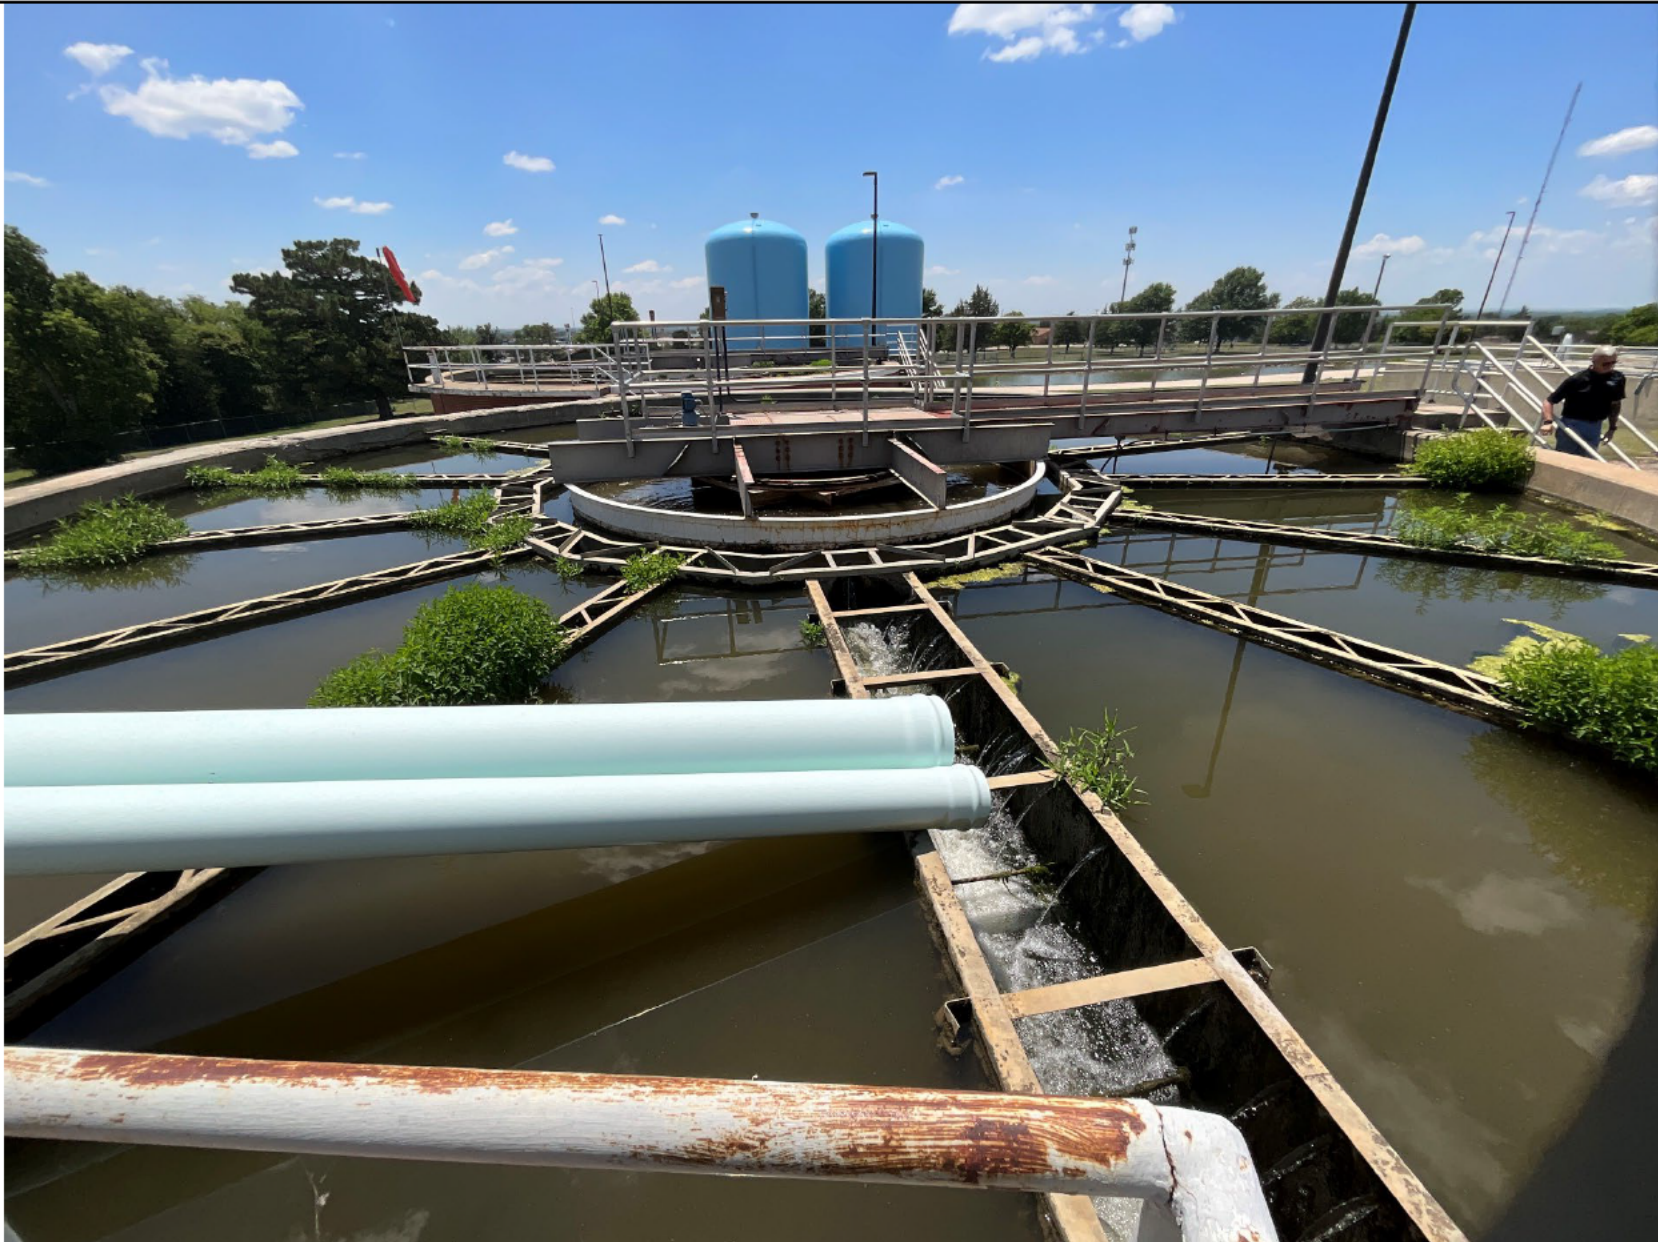
During the inspection I observed the presedimentation basins, which had a minor amount of vegetation growing in the weirs (photo #1) (NOPF #1). Vegetation growing on the weirs can impact the efficiency of the basin and should be removed to maintain optimal use of the presedimentation basins. Mr. Mason stated that the presedimentation basins are cleaned out

annually, however he stated they were overdue for clean out. On August 5, 2025, Mr. Grant sent photos showing the vegetation had been removed from the presedimentation basin (Attachment 3).

| Number | Photo |
|---|---|
| 1 | <p data-bbox="711 1382 1514 1417">Presedimentation basin #1 showing vegetation growing in the weirs.</p> <p data-bbox="930 1453 1299 1485">20250714 181100310 iOS.jpg</p> |

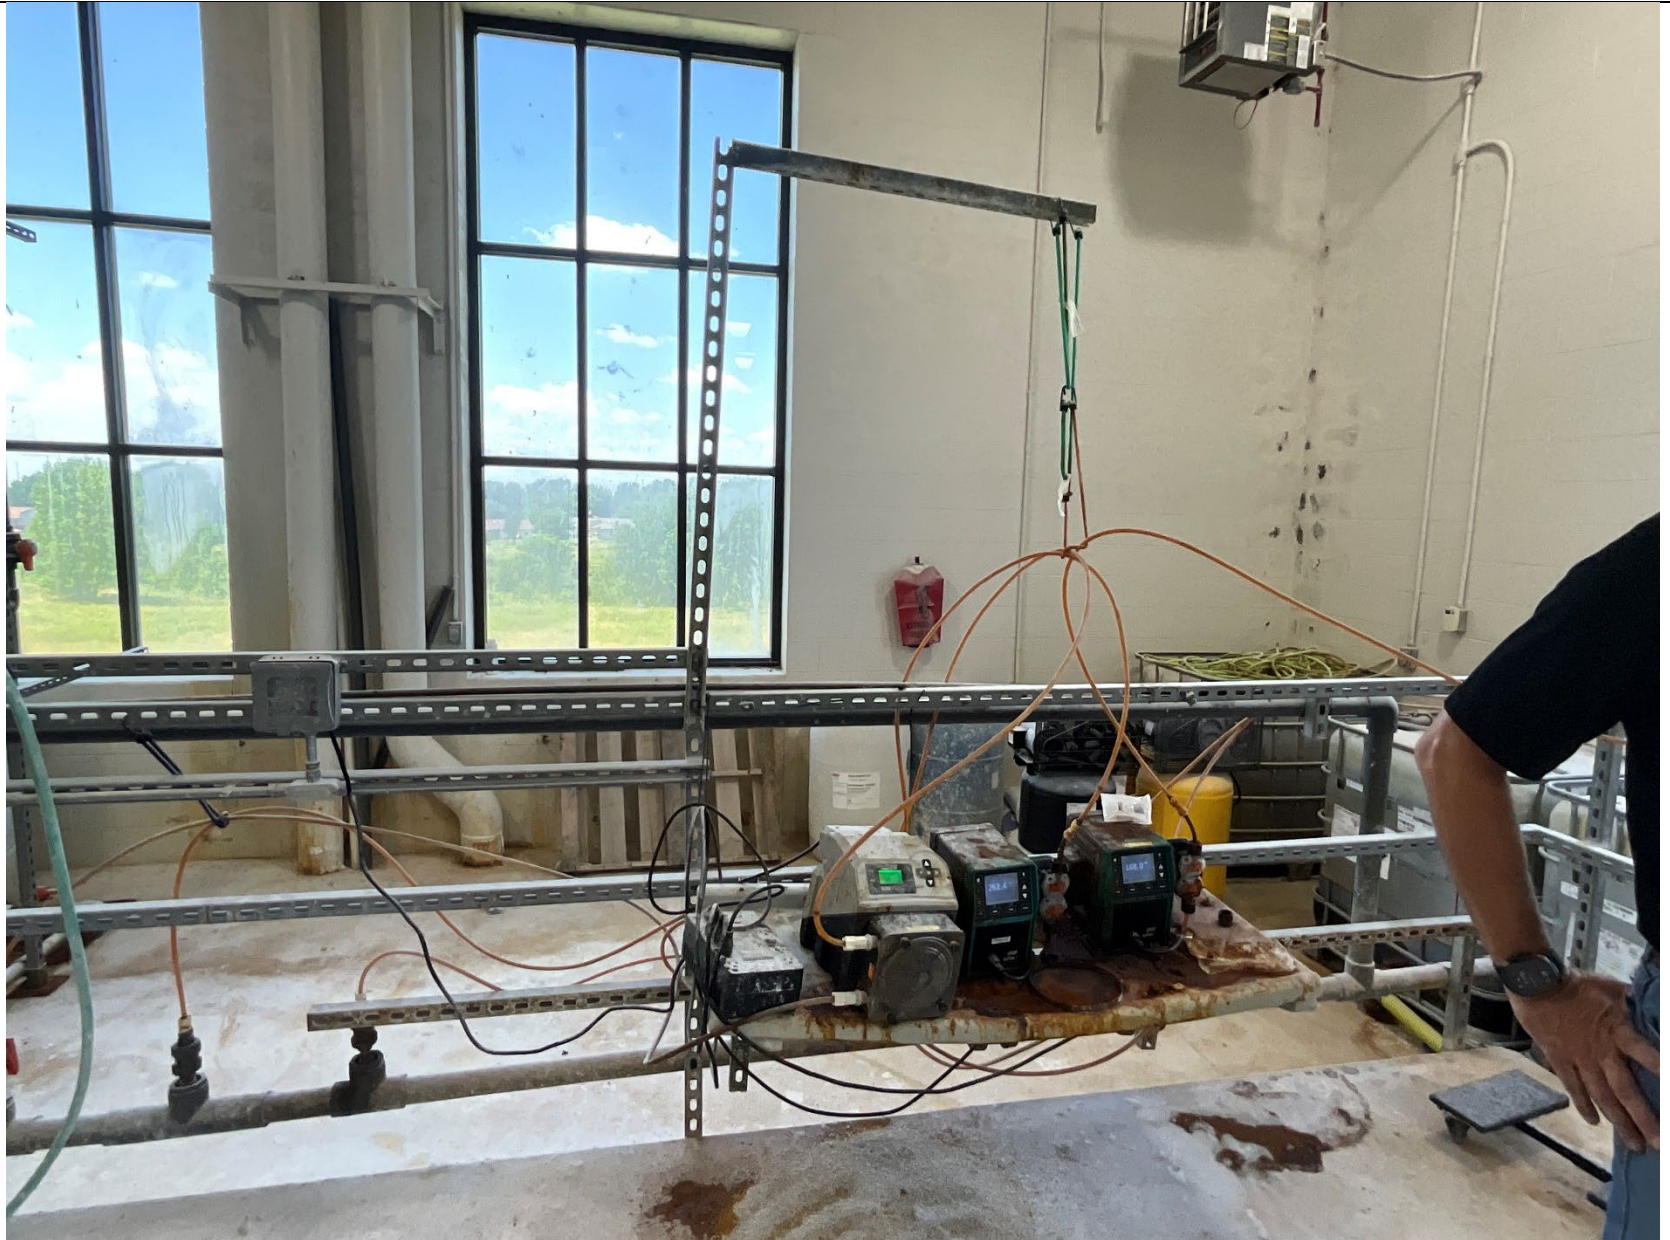
I observed the lime softening building, which houses the ferric chloride feed pumps and the ferric chloride storage totes. The ferric chloric feed pumps were seated on a metal shelf that showed significant deterioration and rusting, making it unstable (photo #2) (NOPF #2). Addressing the shelf is needed to ensure the proper handling and storage of the chemicals, chemical equipment, and chemical feed lines. I also observed staining on the ground around the ferric chloride totes indicating spills or leaking of chemicals on the ground, without any secondary containment (photo #3) (NOPF #3). Maintaining and cleaning the area ensures chemicals are not left on the ground.

| Digital Image Number | File Name | Description | Date and Time Digital Image Taken |
|---|---|---|---|
| 2 | 20250714_181905599_iOS.jpg | Lime softening building, ferric chloride feed pumps sitting of unstable shelf, significant rusting and deterioration observed. | 2025:07:14 13:19:05 |

Lime softening building, ferric chloride feed pumps sitting on unstable shelf, significant rusting and deterioration observed.

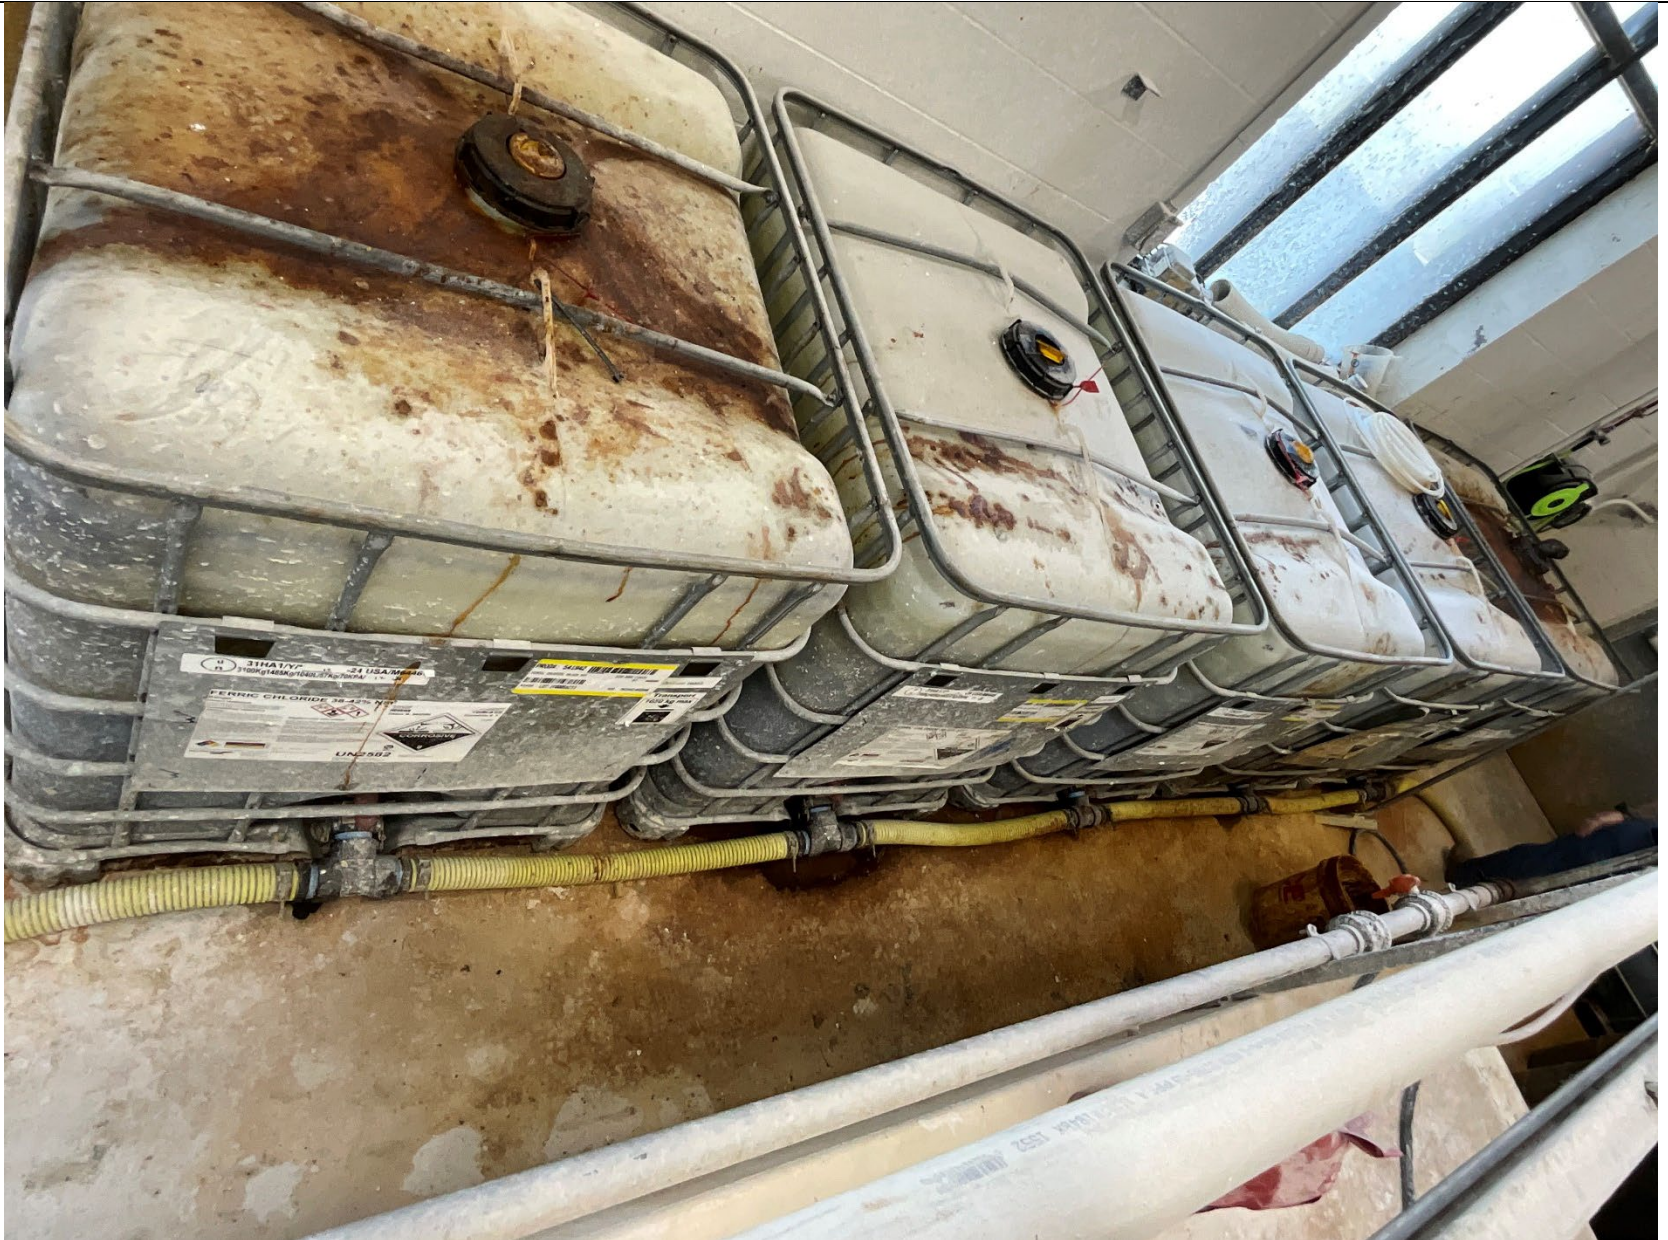
3. The ferric chloride spills were observed on and around the ferric chloride storage totes stored in the chemical building, and old chemical building.

| Digital Image Number | File Name | Description | Date and Time Digital Image Taken |
|---|---|---|---|
| 3 | 20250714_181927923_iOS.jpg | Lime softening building, ferric chloride totes had staining and evidence of leaking or spilling below and around the totes. | 2025:07:14 13:19:27 |

Lime softening building, ferric chloride totes had staining and evidence of leaking or spilling below and around the totes.

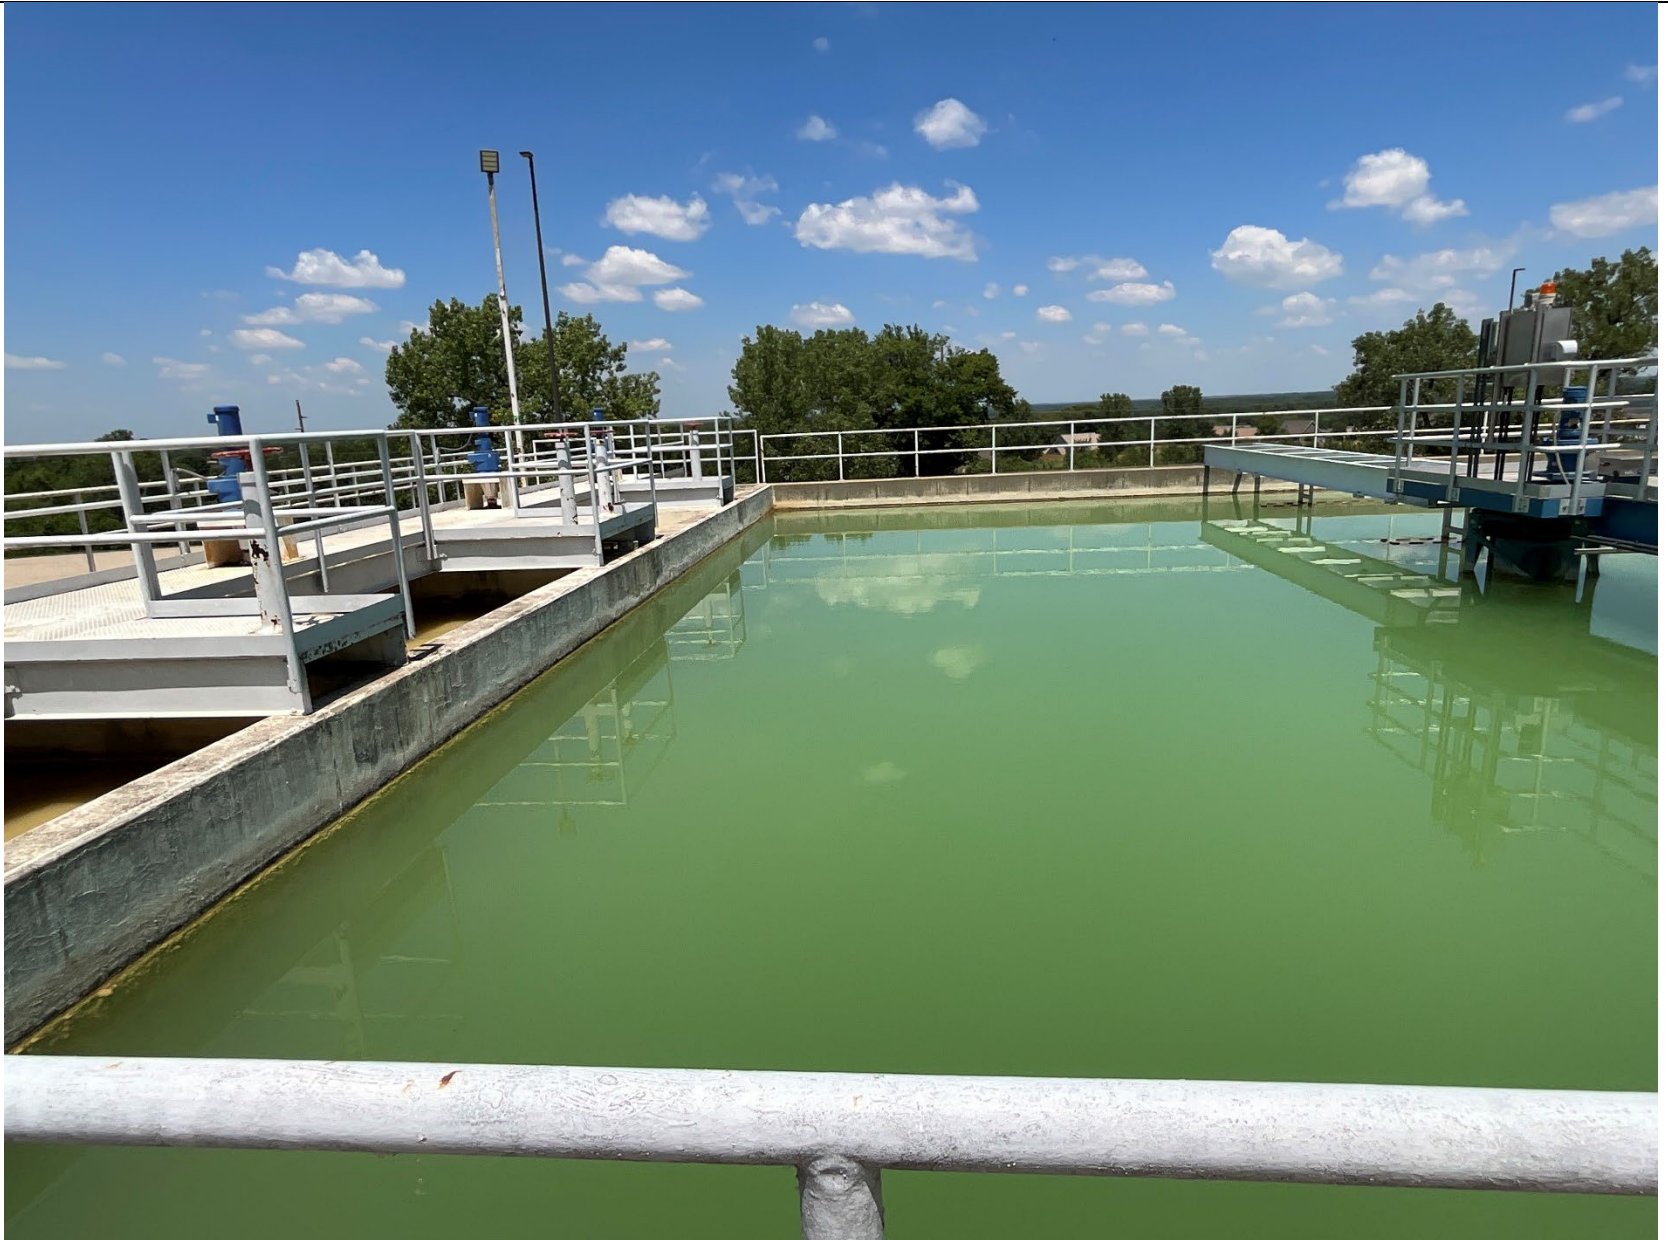
I observed the sedimentation basins, which showed some signs of buildup around the perimeter of the basins (NOPF #4 and photo #5). I asked about basin clean out frequency, and Mr. Mason stated that the basins were due for a clean out and are typically cleaned out on an annual basis. I visually observed the recarbonization basin #2 and observed some algae growth at the surface of the basin (photo #6).

4. The sedimentation basin #3 had build-up present on the outer perimeter of the basin.
5. The PWS did not have back-up power available for any components of the water system.

| Digital Image Number | File Name | Description | Date and Time Digital Image Taken |
|---|---|---|---|
| 5 | 20250714_182304274_iOS.jpg | Photo of sedimentation basin #3. Some build up observed around the perimeter of the basin. | 2025:07:14 13:23:04 |

Photo of sedimentation basin #3. Some build up observed around the perimeter of the basin.

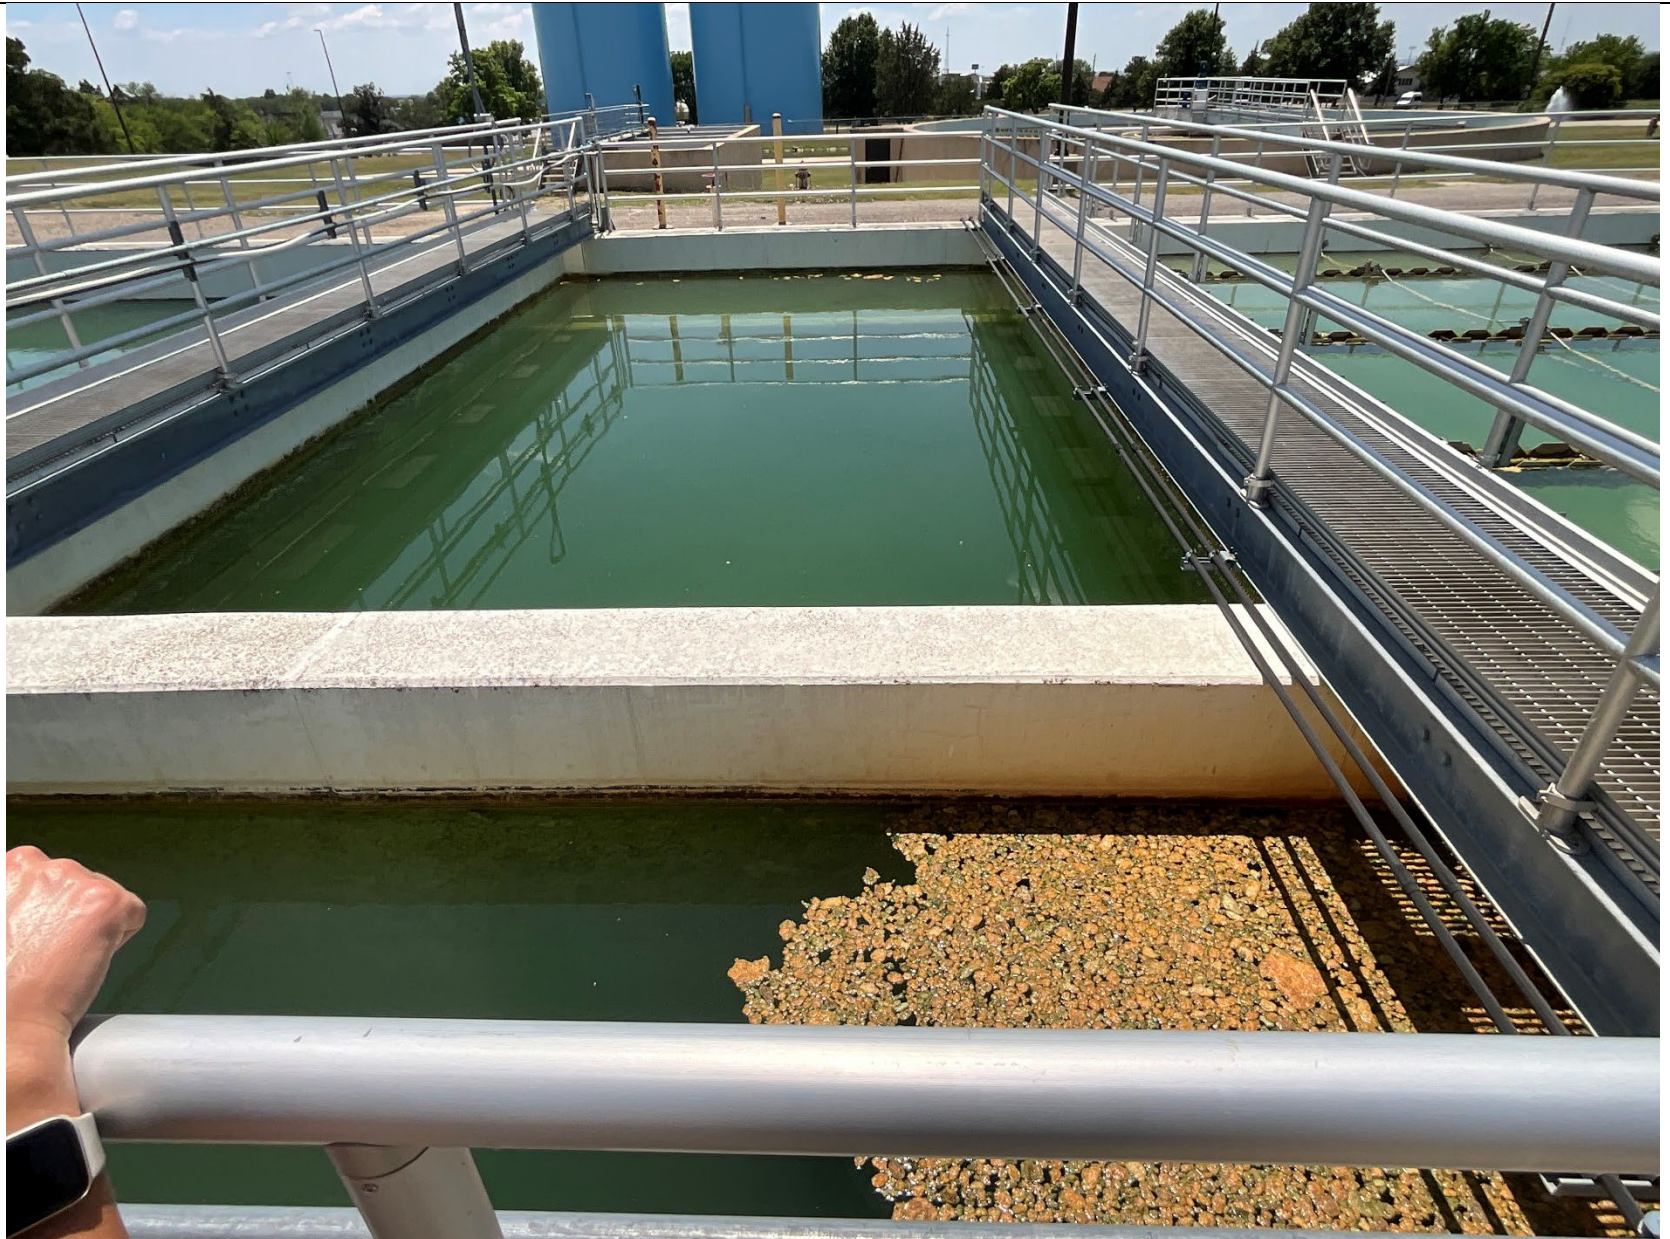
6

Photo of 1st recarbonization basin #2, showing algae growth floating on the surface of the water.

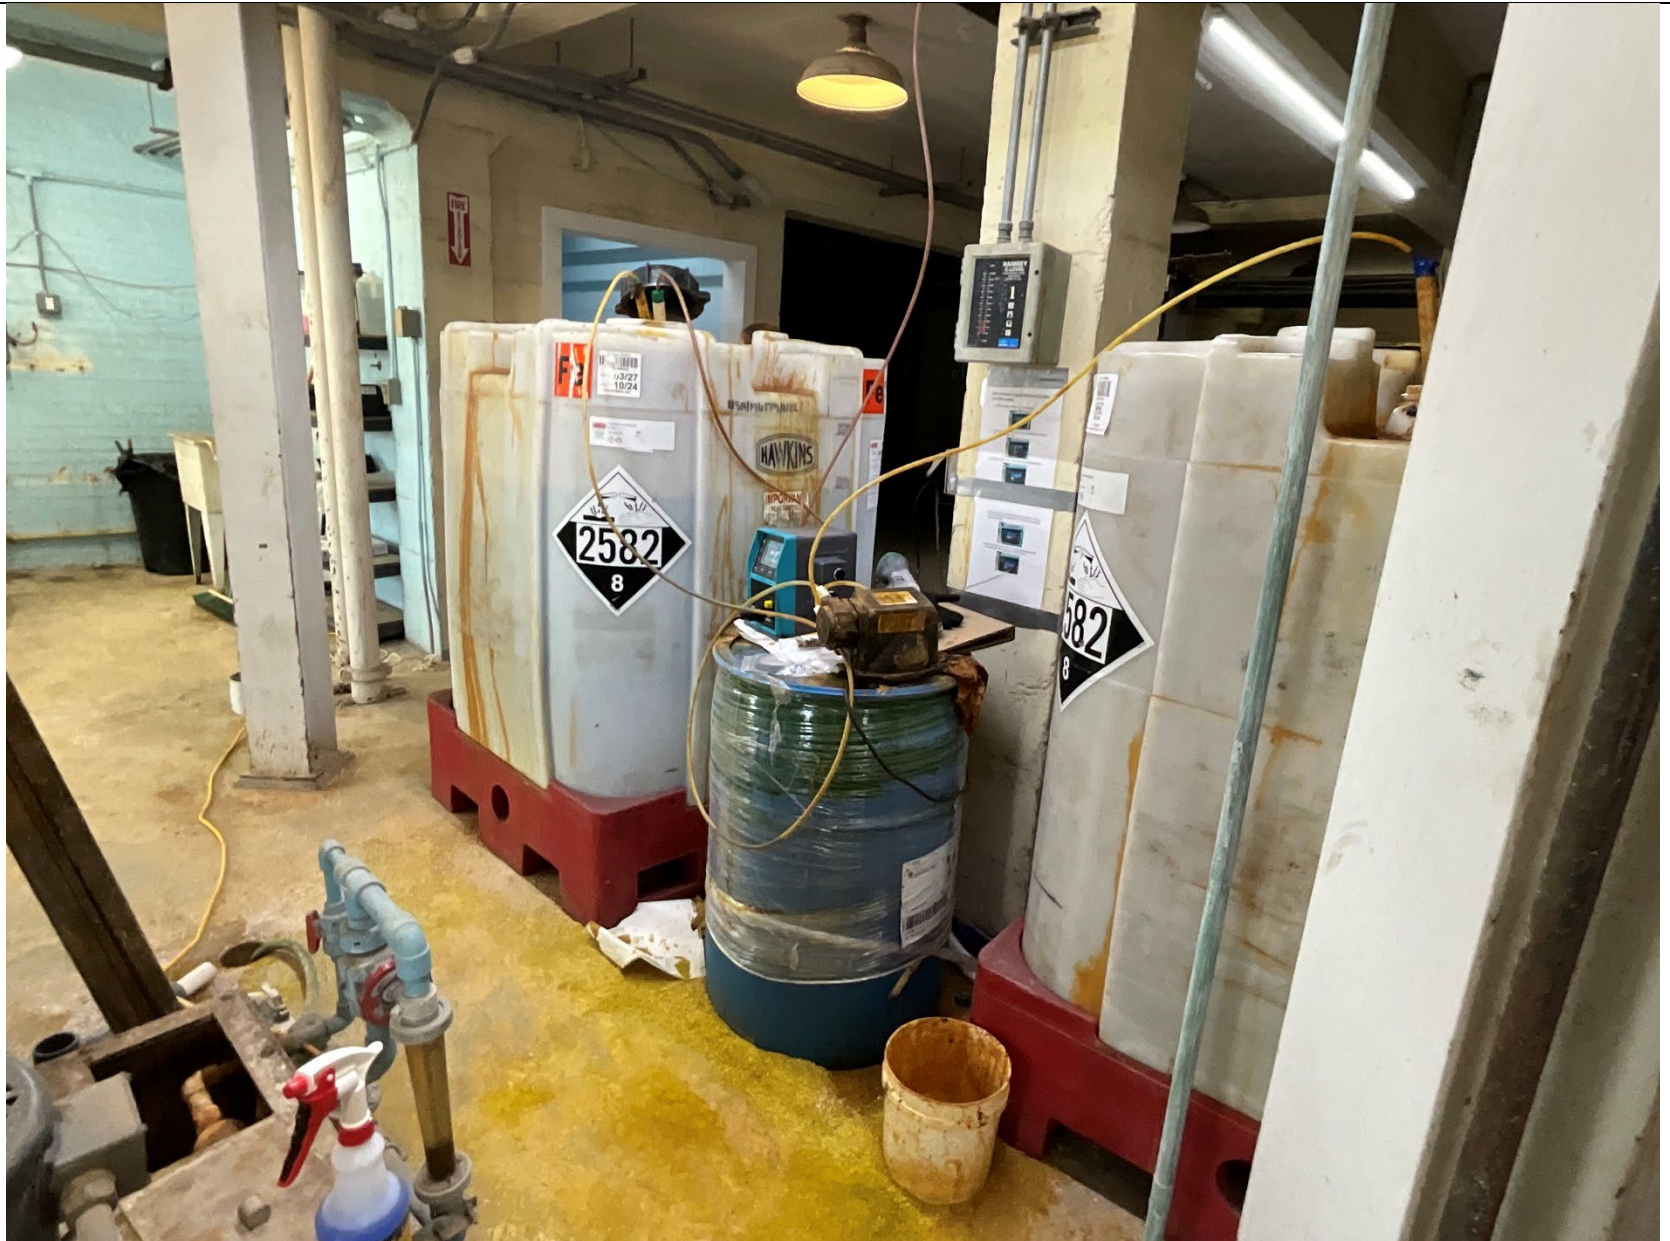
We did a walkthrough of the old chemical building and I observed spilled chemicals on the ground, and spill absorbant material (photo #7) (NOPF #9). Absorbant material should be swept off the ground as a best management practice. The system indicated that they use a combination of ozone and chloramines to disinfect the water. The ozone is the primary source of disinfection, and the chloramines provide a chlorine residual throughout the distribution system. PWS staff indicated that they do not have any issues maintaining an adequate chlorine residual.

Photo of old chemical building with chemical storage totes, showing spills and spill absorbant materials on the ground.

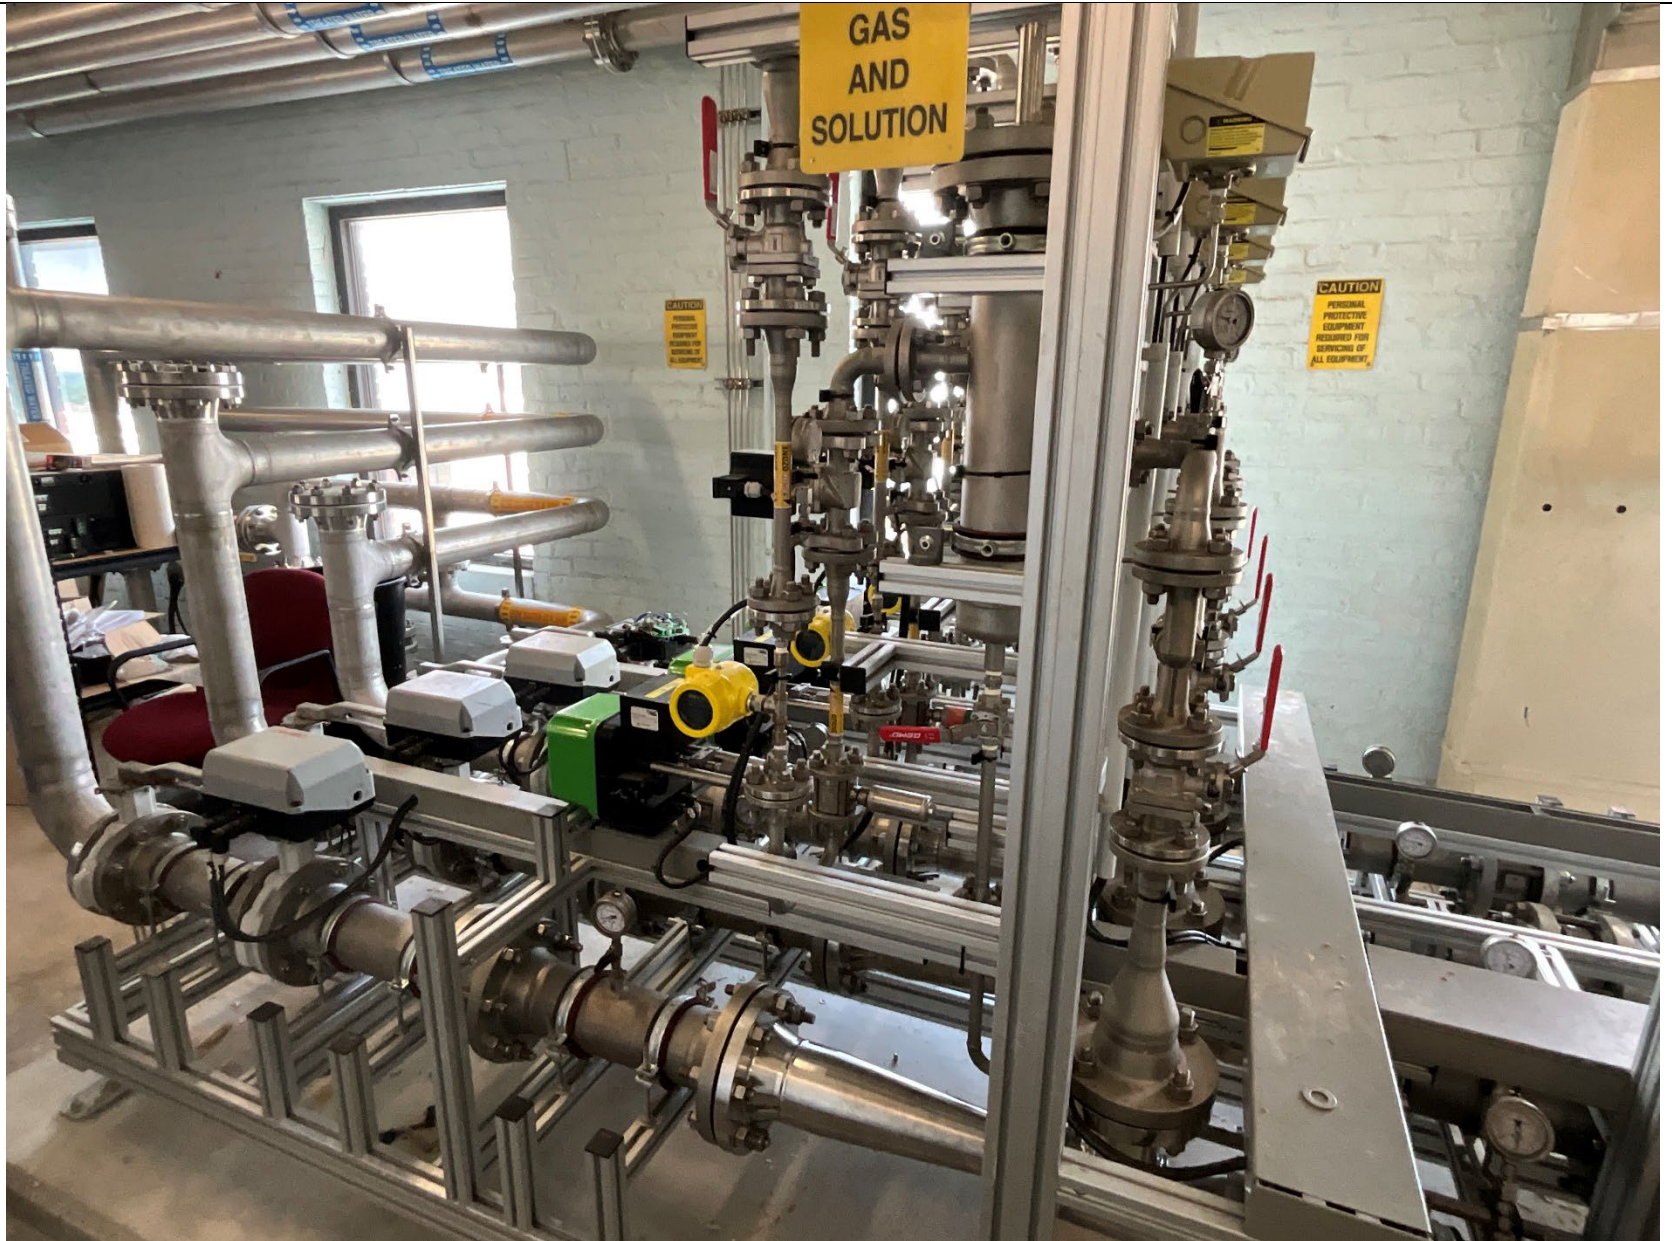
| Digital Image Number | File Name | Description | Date and Time Digital Image Taken |
|---|---|---|---|
| 9 | 20250714_185055313_iOS.jpg | Ozone contact building, showing the ozone injection points. The 4th injection point was down for repair. | 2025:07:14 13:50:55 |

Ozone contact building, showing the ozone injection points. The 4th injection point was down for repair.

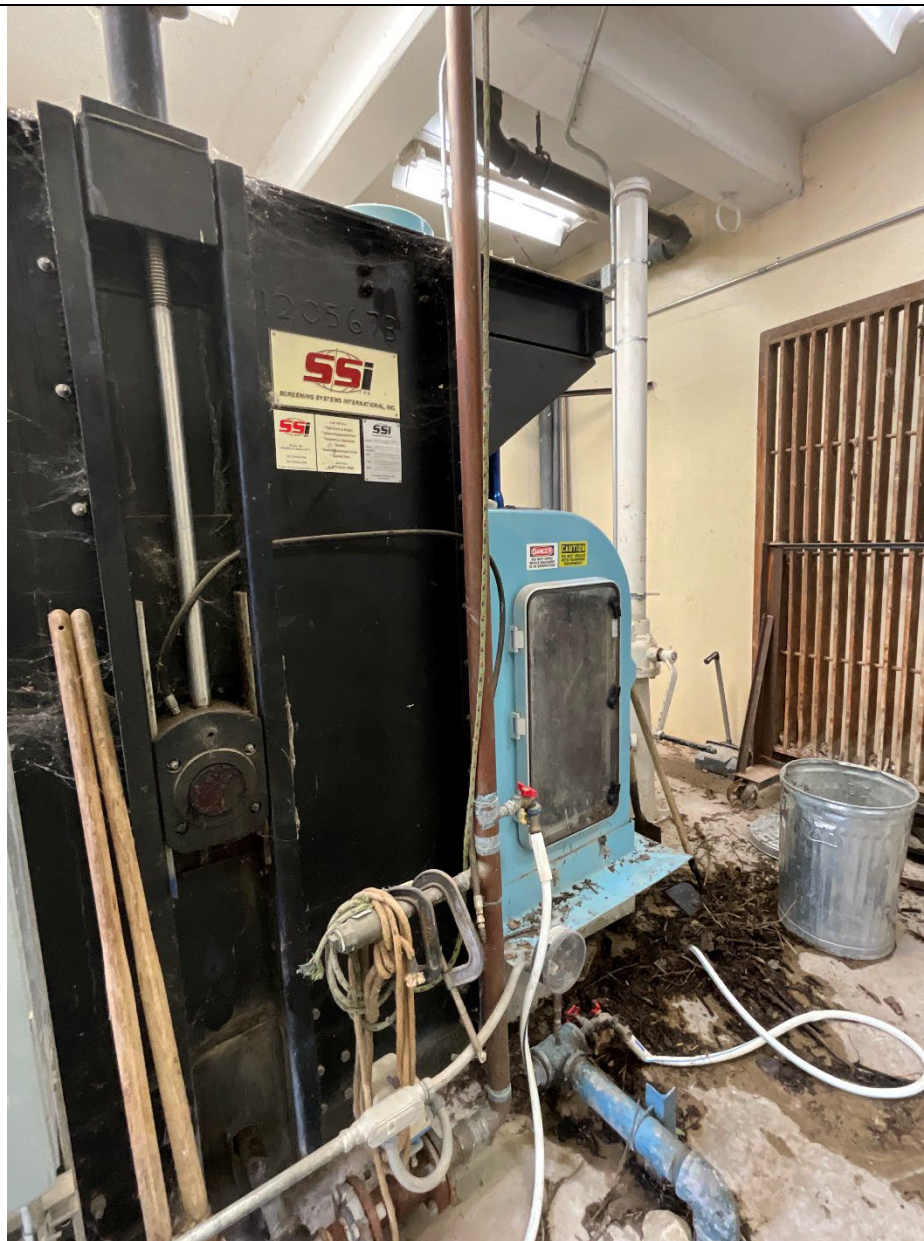
22

Intake mechanical bar screen with accumulated debris, twigs and leaves on the ground.

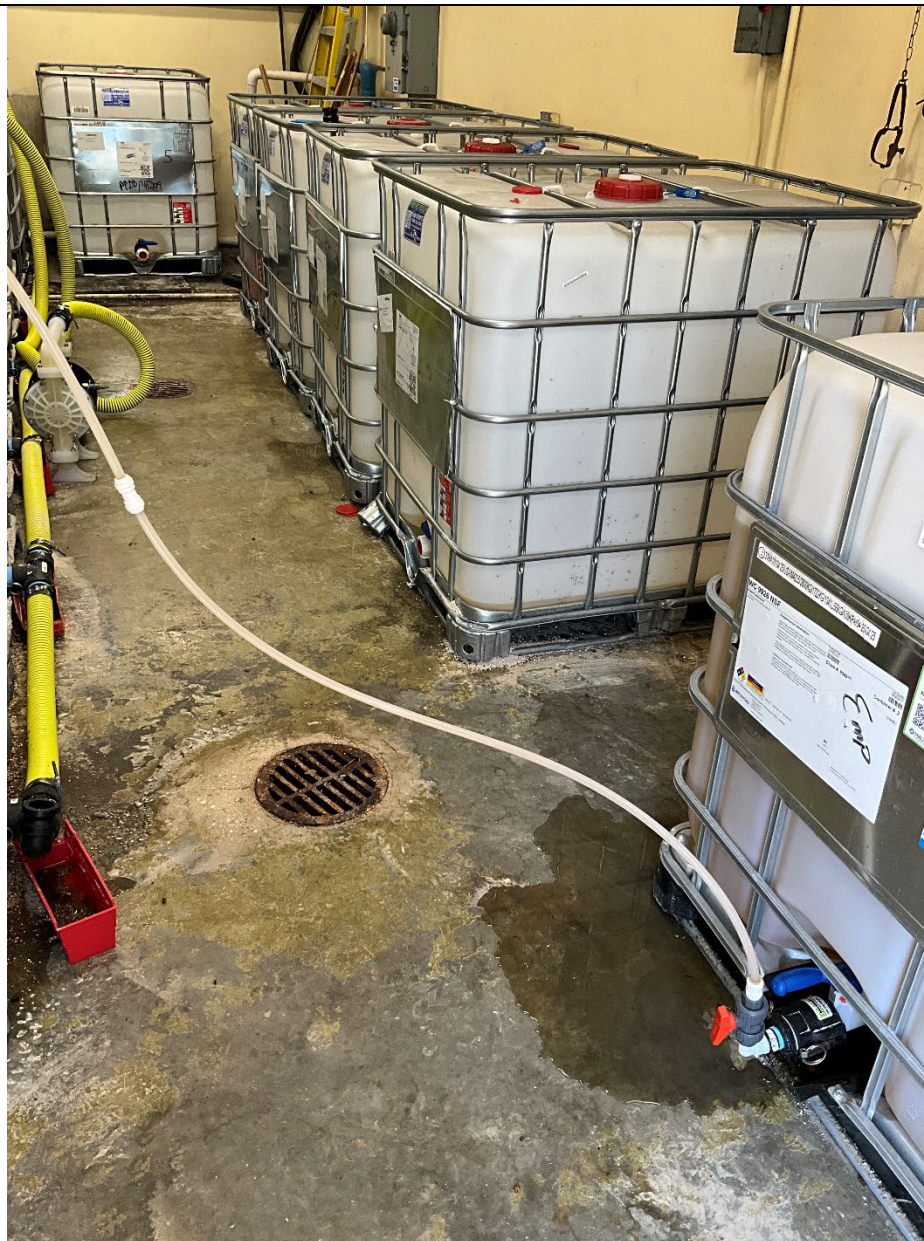
9. Spilled chemicals were observed around the chemical storage totes in the chemical building near the water intake building.
10. The PWS did not provide of inspection records for the West ground storage tank or the East ground storage tank. The PWS provided these inspection records following the inspection.

| 23 | 20250714_200724239_iOS.jpg | Intake chemical building housing several storage totes containing clarifloc 378 chemicals used for flocculation and sedimentations. Spills and leaking evident on the floor. | 2025:07:14 15:07:24 |

Intake chemical building housing several storage totes containing clarifloc 378 chemicals used for flocculation and sedimentations. Spills and leaking evident on the floor.

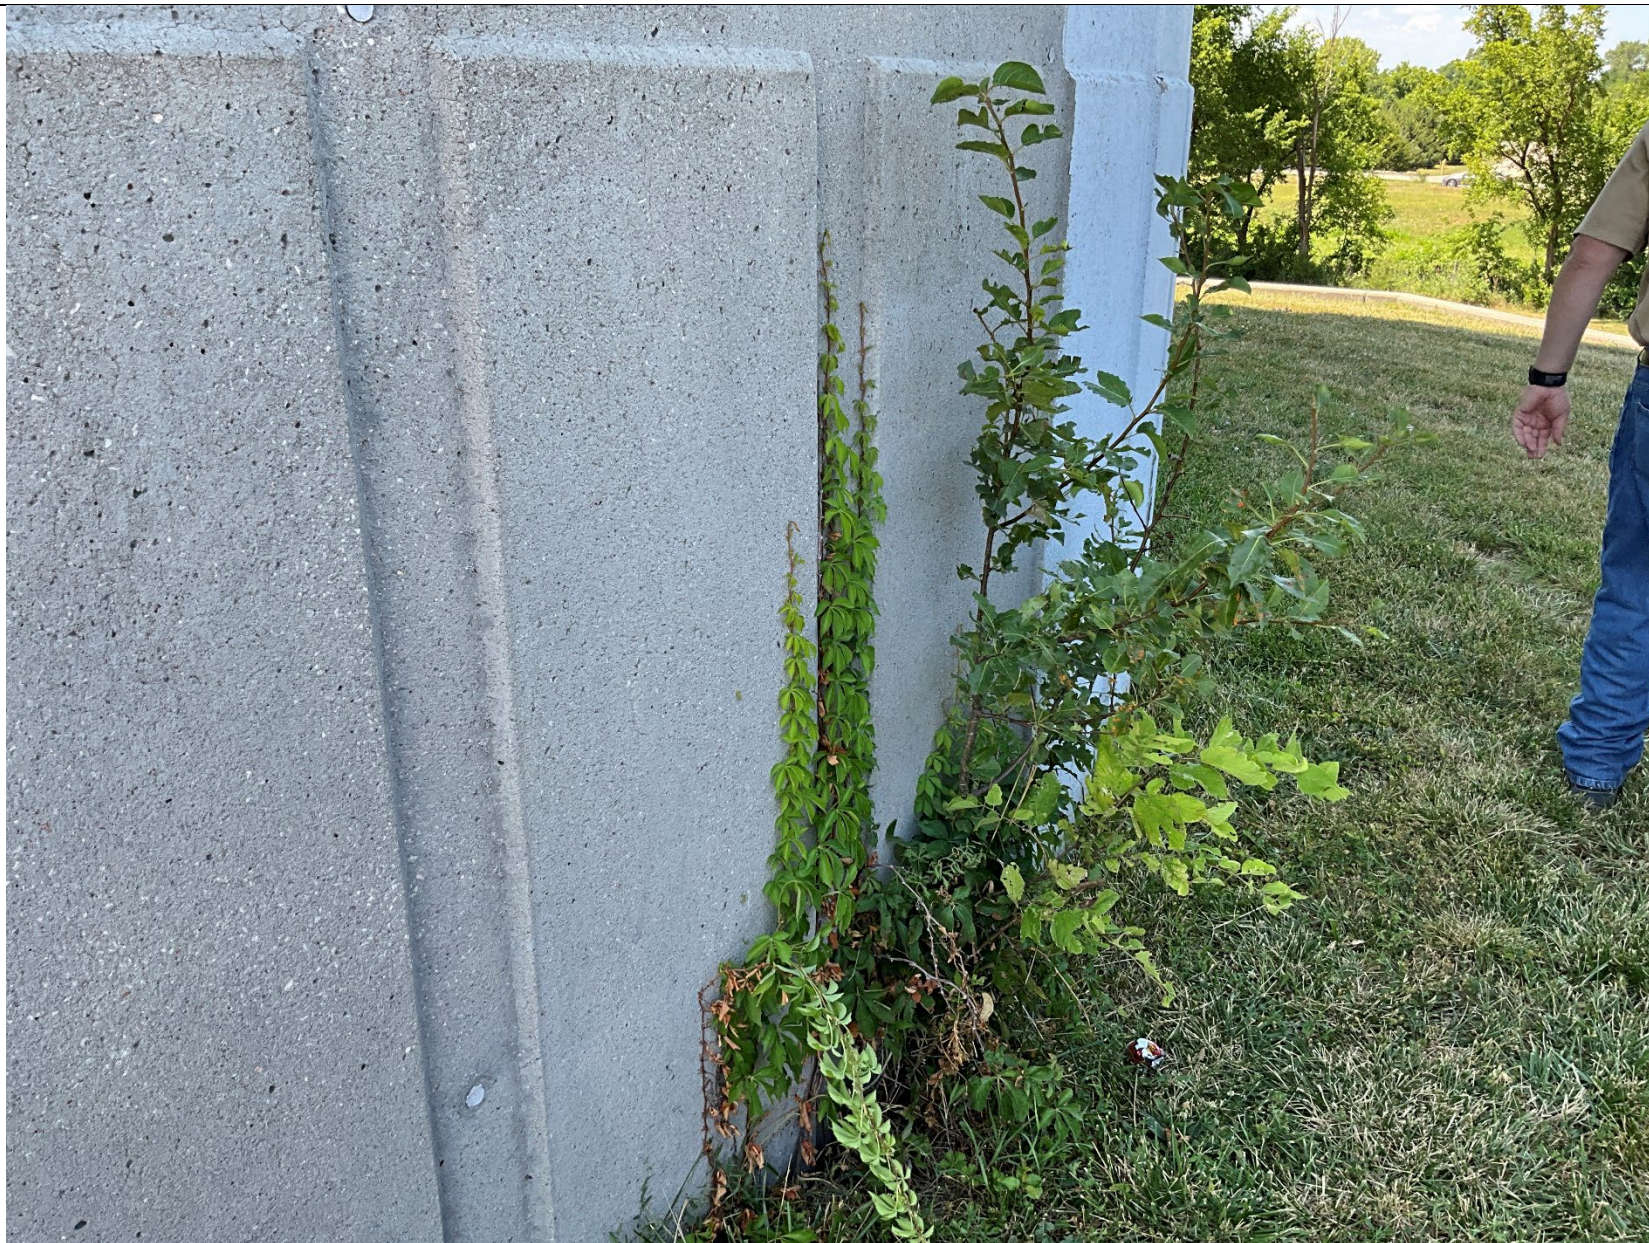
24

Photo of woody vegetation growing at the base of the 12th Avenue elevated water storage tower.

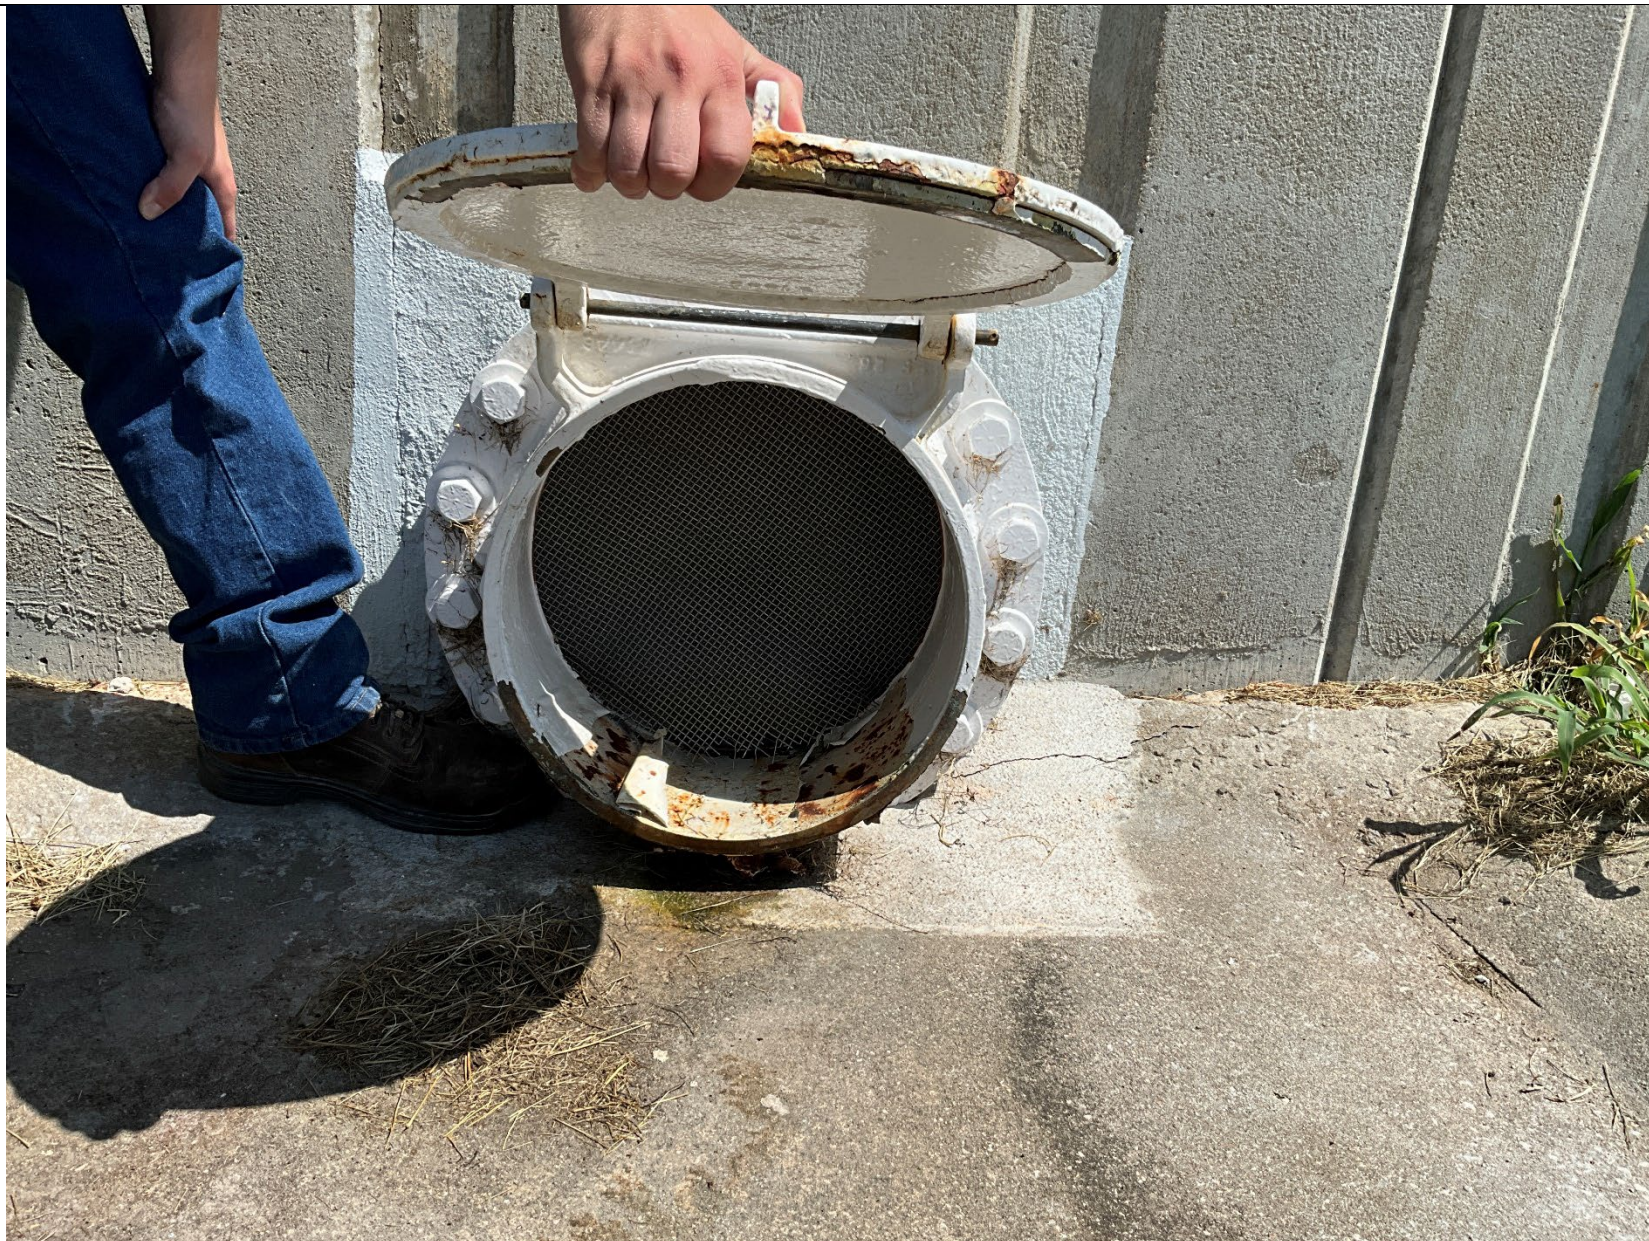
25

The 12th Avenue elevated water storage tower overflow fitted with a metal flap gate and mess screen. The bottom of mesh screen was blown out.
