# **REPORT OF PUBLIC WATER SYSTEM COMPLIANCE INSPECTION**

**City of Emporia, Public Water Supply  
1220 Hatcher St. Emporia, KS 66801**

**Public Water Supply ID#: KS2011105**

**July 14, 2025 – July 15, 2025**

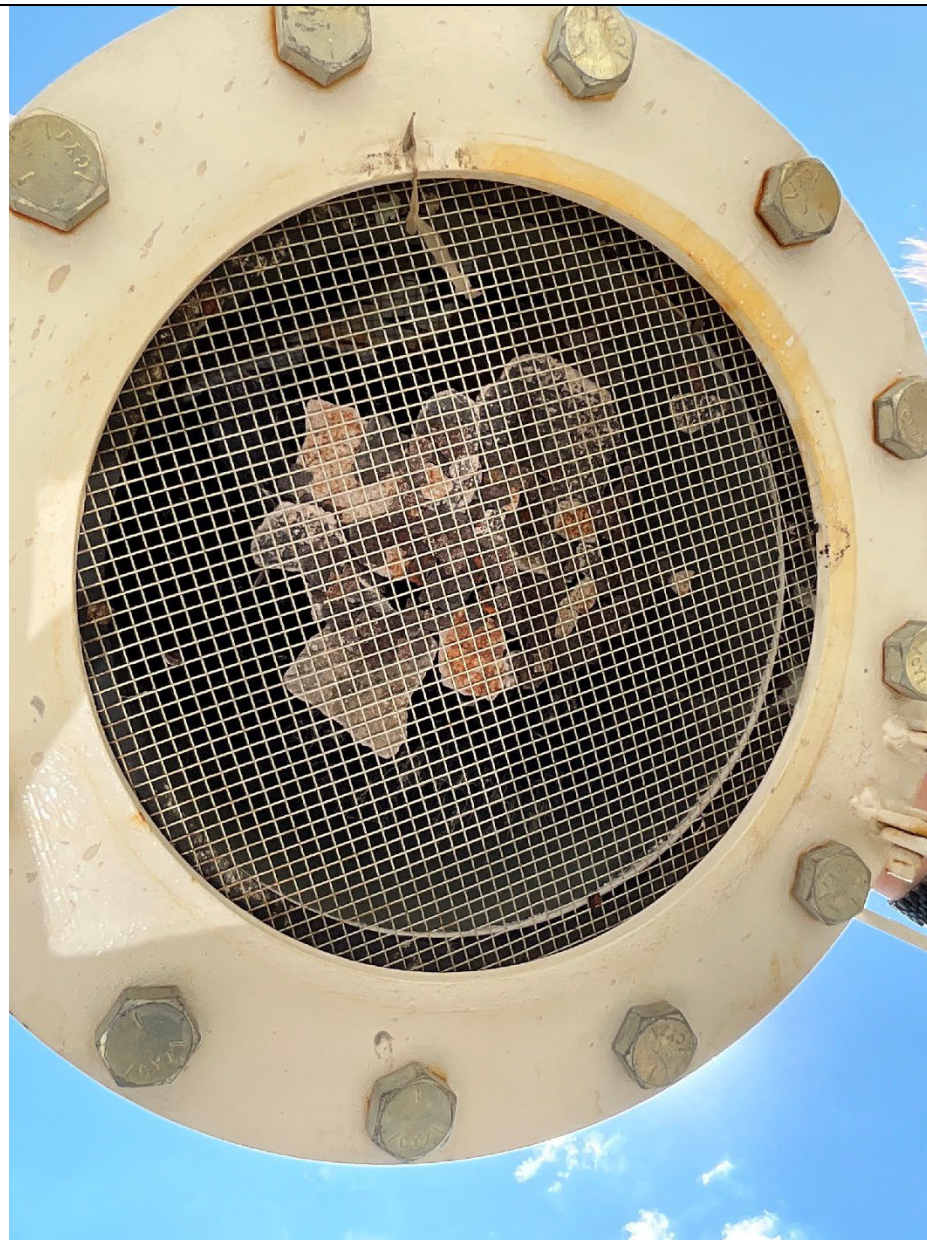
| 31 | 20250714_210750863_iOS.jpg | Warren Way elevated water storage tower overflow downturned fitted with metal gate flap and screened. Some flaked and rusted pipe material captured behind the screen. | 2025:07:14 16:07:50 |

Warren Way elevated water storage tower overflow downturned fitted with metal gate flap and screened. Some flaked and rusted pipe material captured behind the screen.
