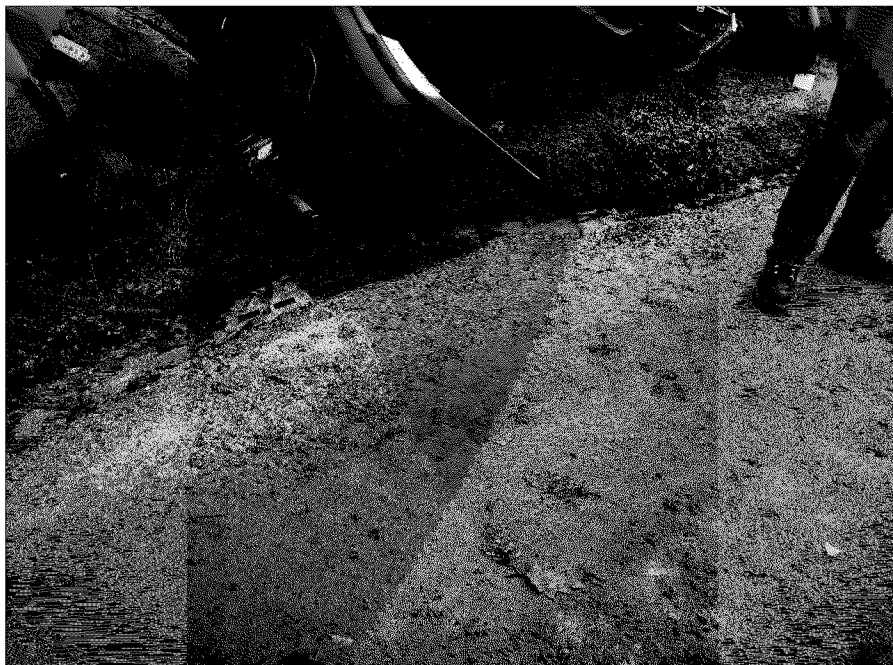
**Photograph 3.** Drew Auto Parts/Camaro Heaven 11/6/2023 21:12 DSCN0588.JPG

Description: Rill erosion observed on the east side of the access road shown in [Photograph 2](#).

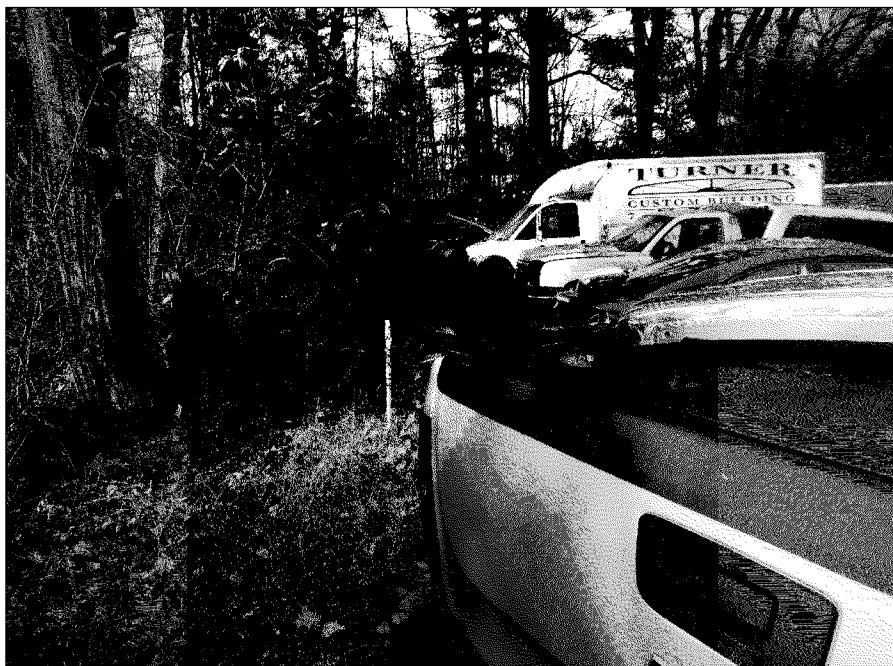
**Photograph 4.** Drew Auto Parts/Camaro Heaven 11/6/2023 21:27 DSCN0589.JPG

Description: View looking west across the Facility's southern border. Used tires were piled between the ELV storage area and the unnamed surface water that runs along the southern perimeter.

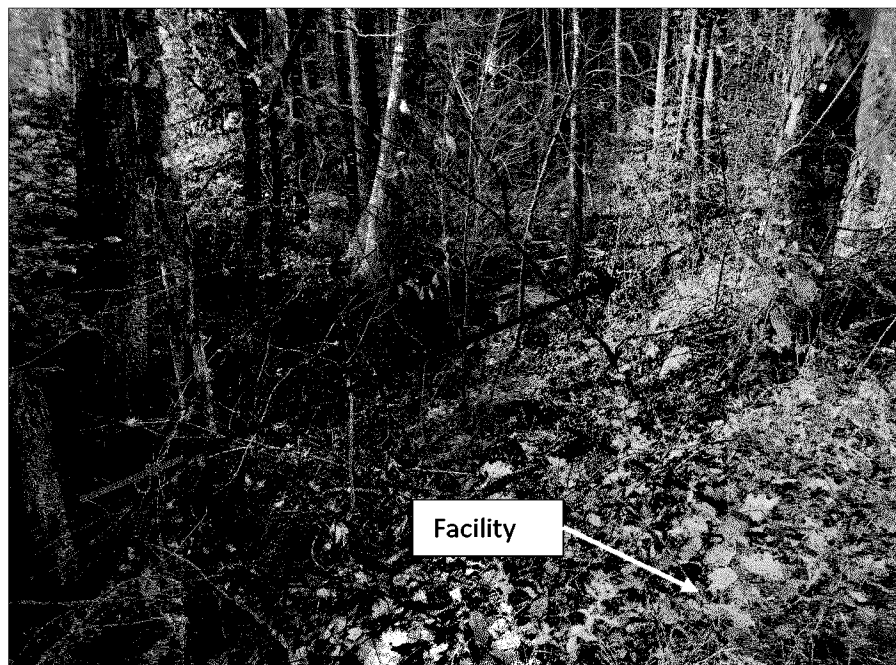
**Photograph 5.** Drew Auto Parts/Camaro Heaven 11/6/2023 21:27 DSCN0590.JPG  
Description: View of the unnamed surface water adjacent to the Facility's southern border, the unnamed surface water is depicted by the solid blue line. Photograph 5 was taken from the same location as Photograph 4.

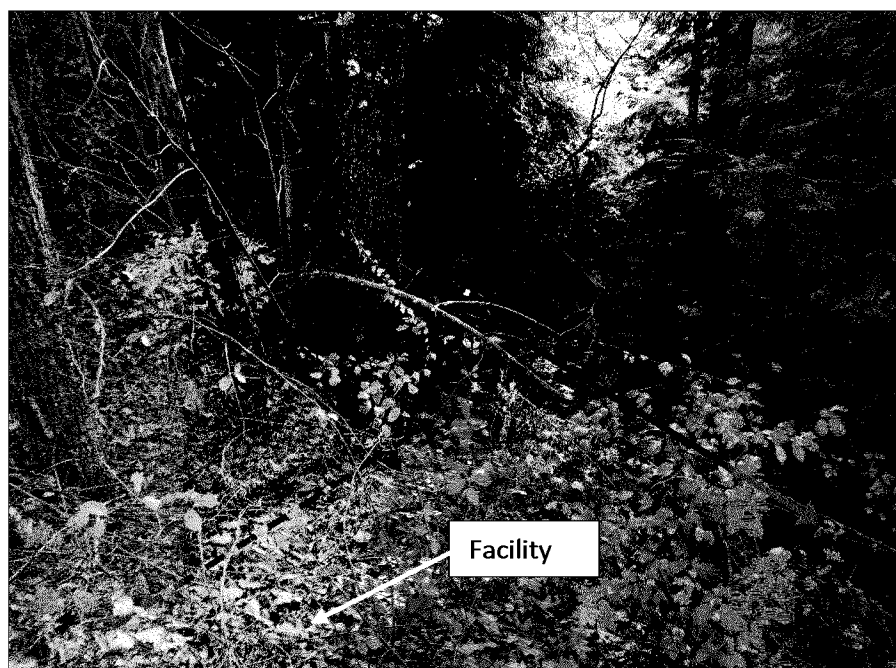
**Photograph 6.** Drew Auto Parts/Camaro Heaven 11/6/2023 21:27 DSCN0591.JPG  
Description: View of the unnamed surface water looking east from Photographs 4 and 5.

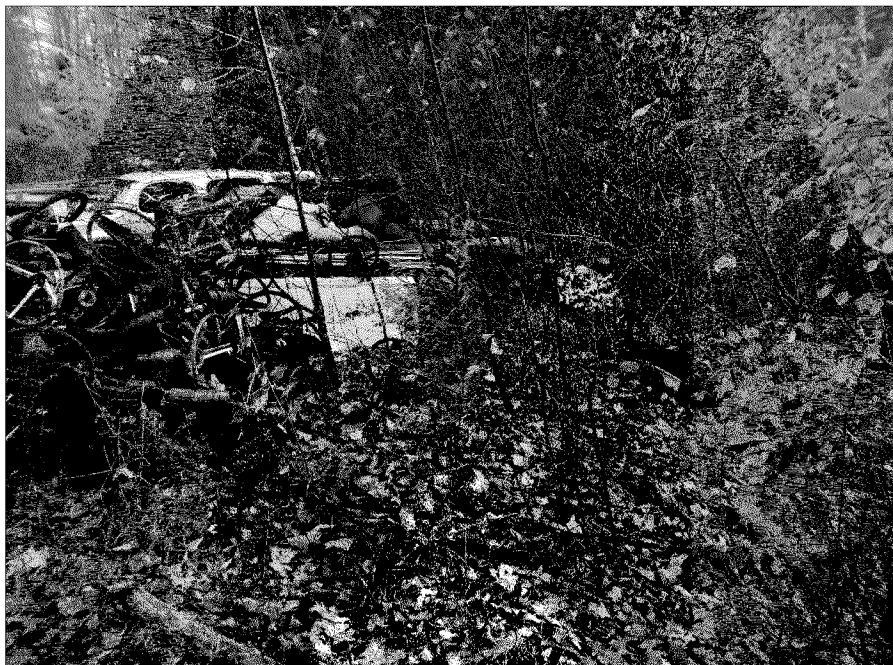
**Photograph 7.** Drew Auto Parts/Camaro Heaven 11/6/2023 21:27 DSCN0592.JPG

Description: View, looking east along the Facility's southern border, at ELVs and scrap parts. The Facility did not have a berm separating the Facility from the unnamed surface water.

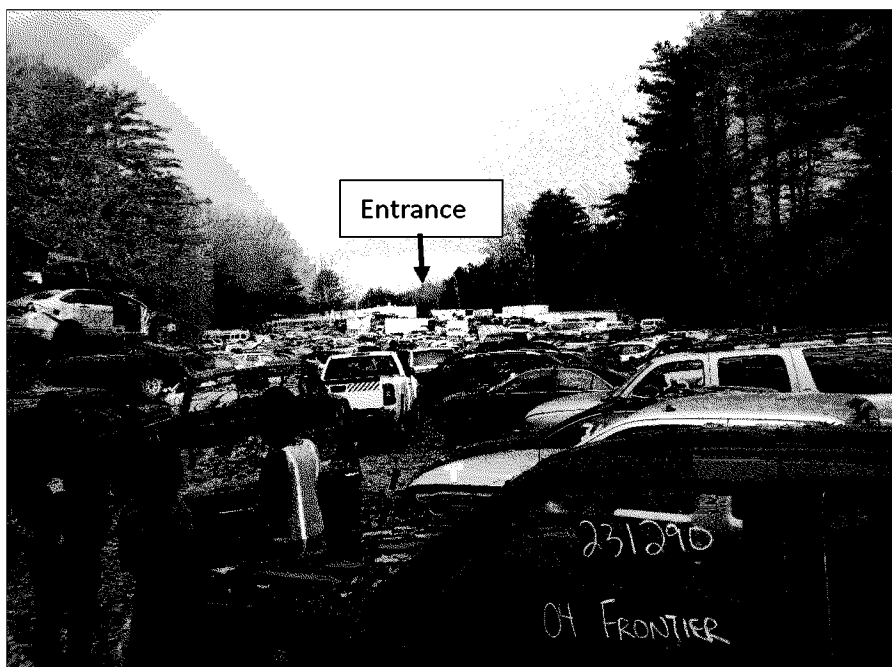
**Photograph 8.** Drew Auto Parts/Camaro Heaven 11/6/2023 21:35 DSCN0593.JPG

Description: View looking north from the Facility's southern border across the ELV storage area.

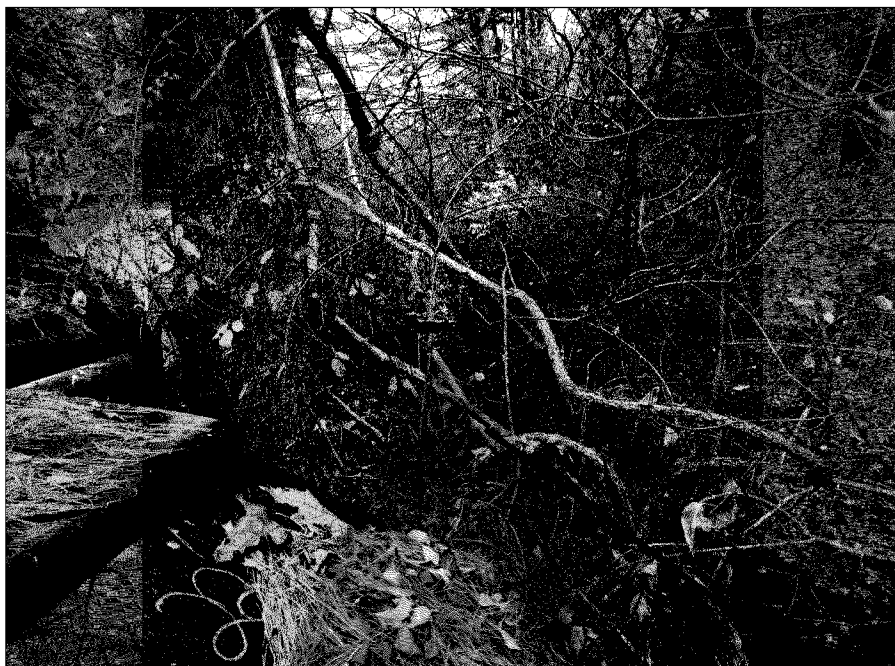
**Photograph 10.** Drew Auto Parts/Camaro Heaven 11/6/2023 21:36 DSCN0595.JPG  
Description: View of ELVs stored along the Facility's eastern border, adjacent to the unnamed surface water.

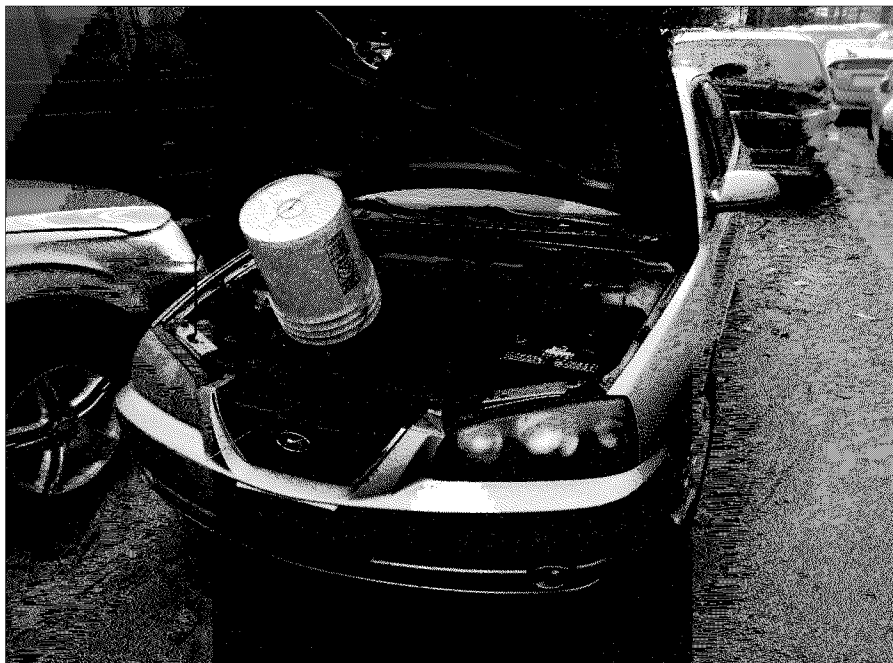
**Photograph 11.** Drew Auto Parts/Camaro Heaven 11/6/2023 21:37 DSCN0596.JPG

Description: View of an ELV stored with the engine still inside the vehicle and the hood up, exposing the engine to stormwater.

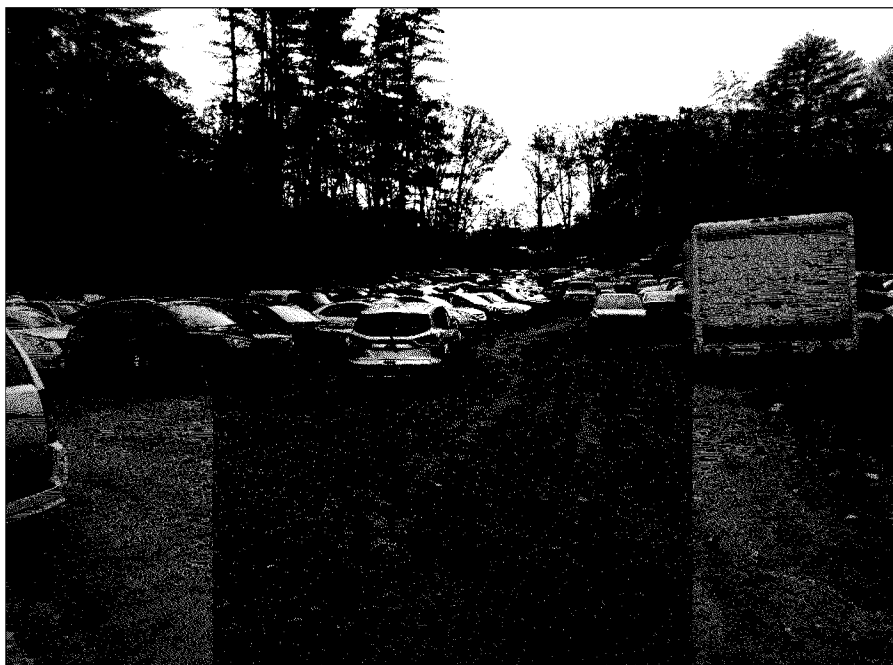
**Photograph 12.** Drew Auto Parts/Camaro Heaven 11/6/2023 21:39 DSCN0597.JPG

Description: View looking south toward the Facility's southern border. Stormwater in this area would flow north to south through the ELV storage.

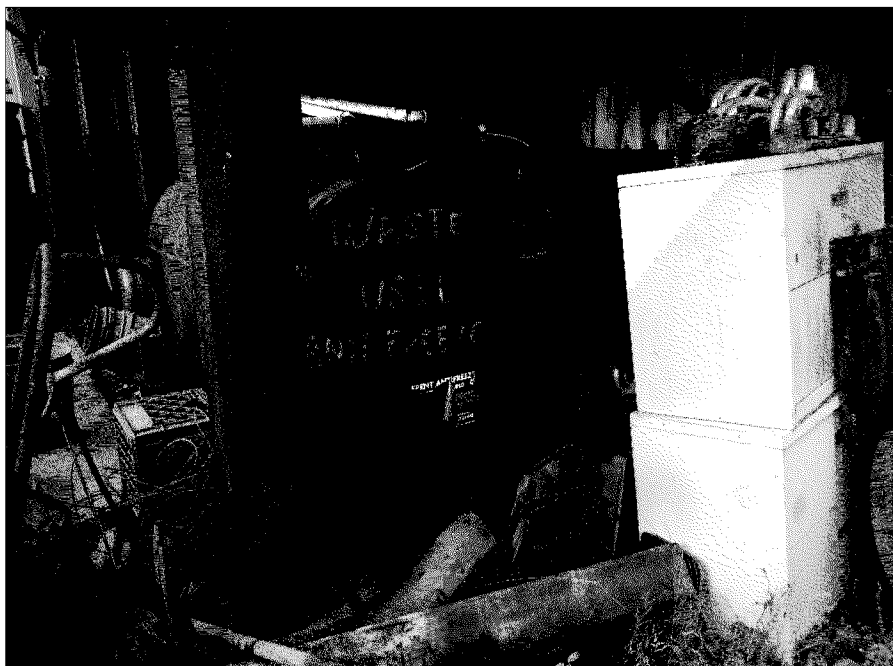
**Photograph 14.** Drew Auto Parts/Camaro Heaven 11/6/2023 21:40 DSCN0599.JPG  
Description: The Facility's 275-gallon waste antifreeze and waste oil tanks were under cover but not in secondary containment.

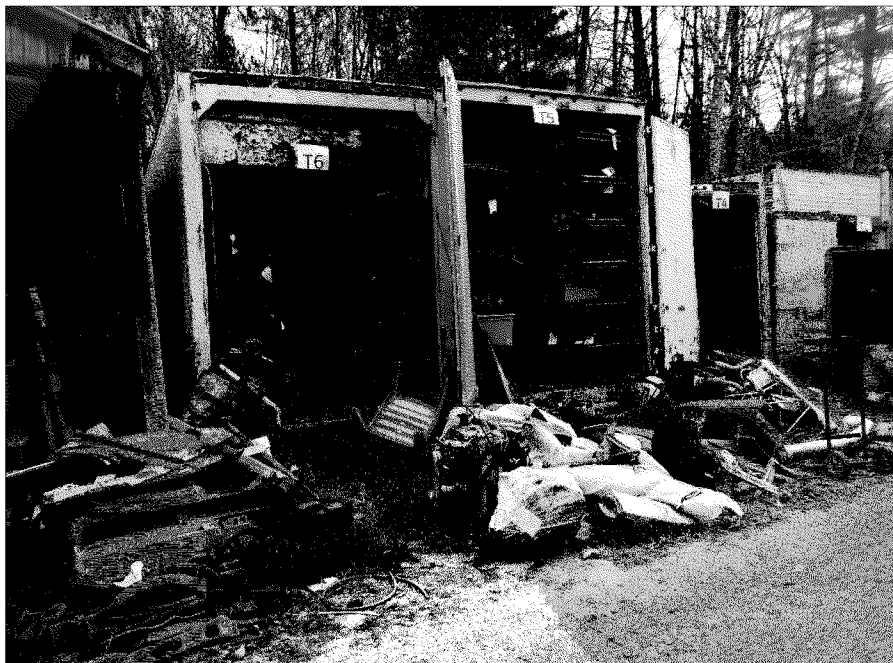
**Photograph 15.** Drew Auto Parts/Camaro Heaven 11/6/2023 21:41 DSCN0600.JPG  
Description: View of the containers storing resalable parts. Scrap vehicle parts were observed on the ground surface outside the containers.
