## **Appendix A**

### **Photograph Log**

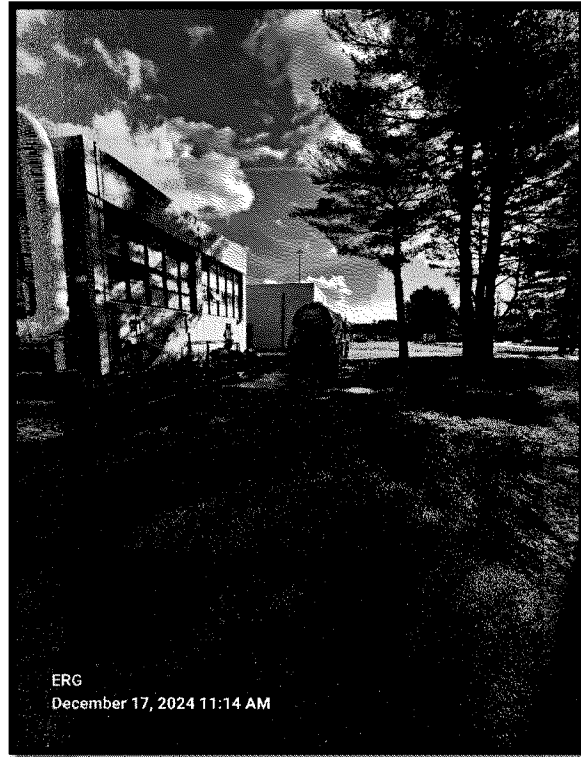
**Photograph 1.** Septage receiving station.

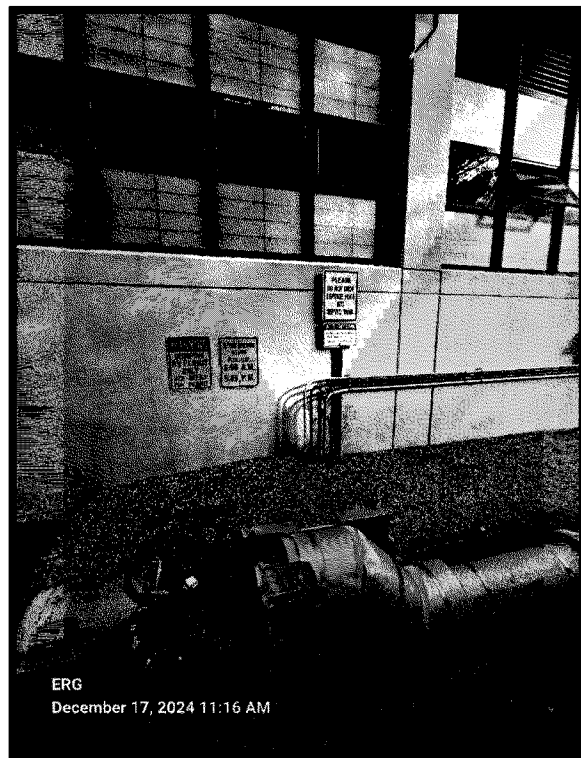
**Photograph 2.** Septage receiving station.

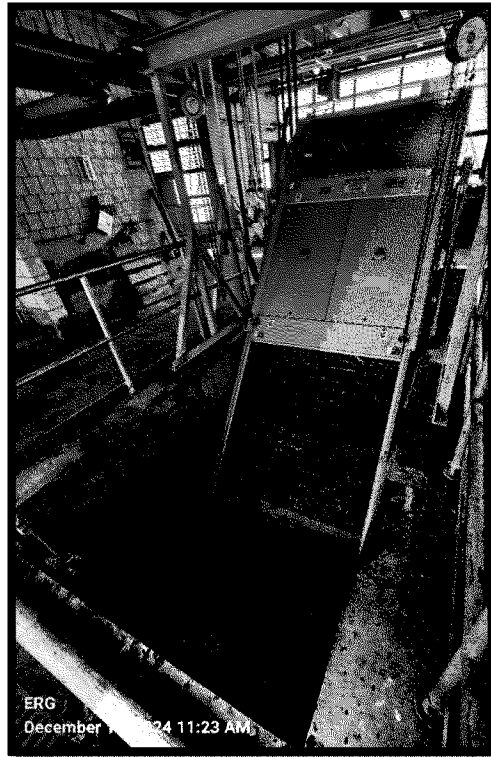
**Photograph 3.** Offline Step screen, the red arrow added by inspector to indicate a high-water level line.

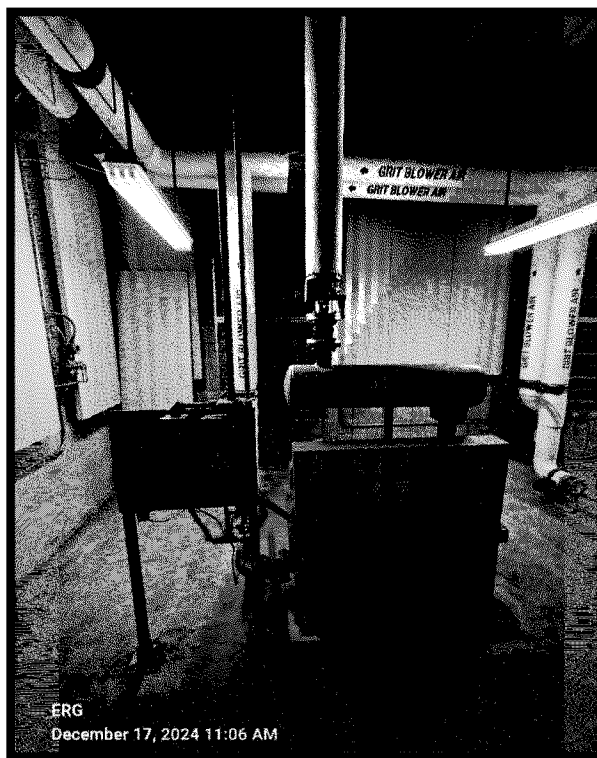
**Photograph 4.** Aerated grit removal blowers.

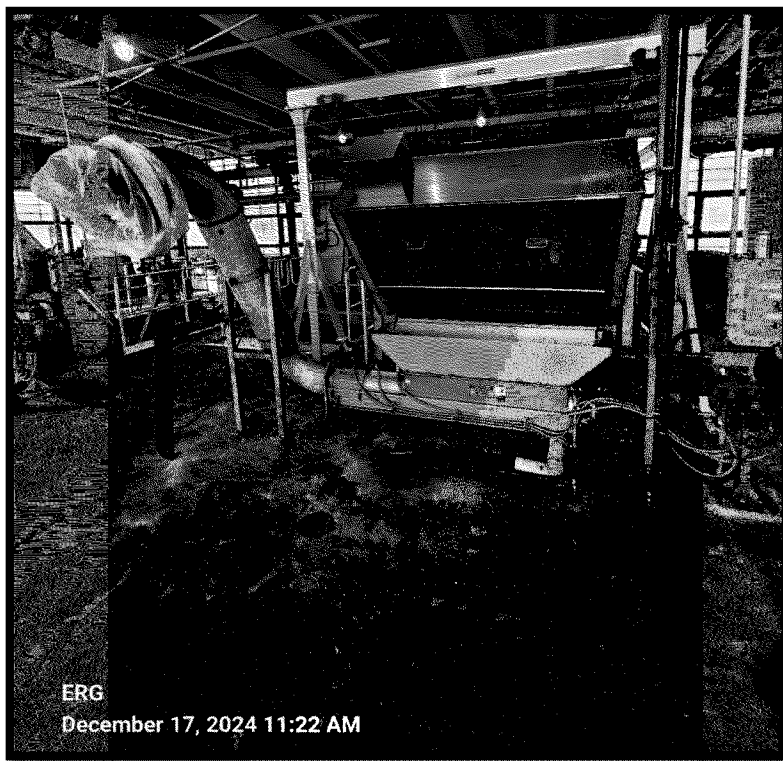
**Photograph 5.** Rinse stage for the aerated grit removal.

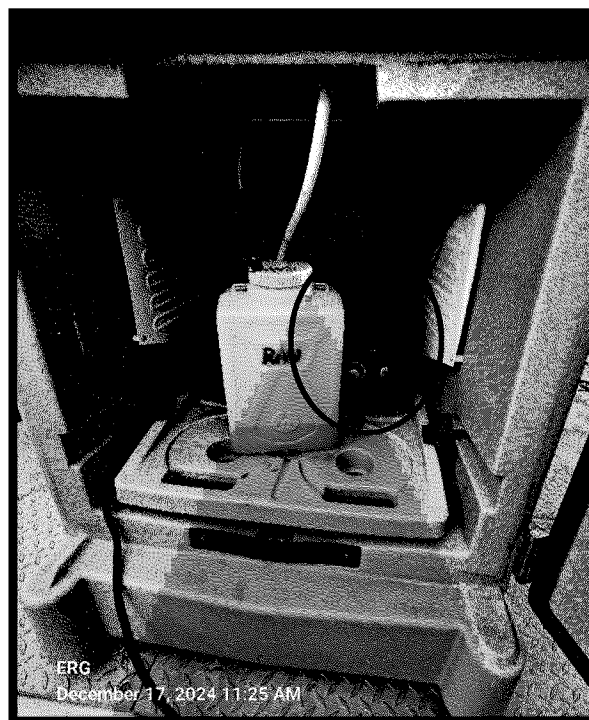
**Photograph 6.** Interior of the Influent sampler with portable space heater circled in red.

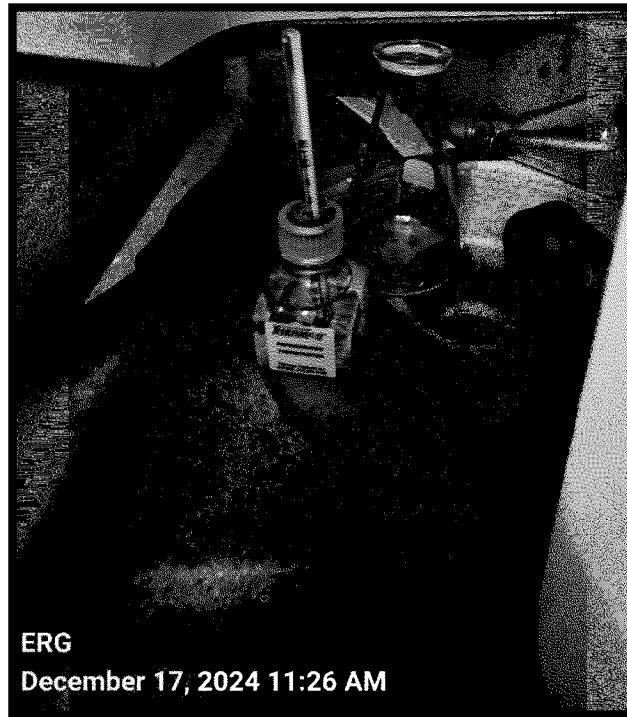
**Photograph 7.** Interior of the influent sampler, red arrow added by inspector to indicate the 10°C reading on the sampler thermometer.

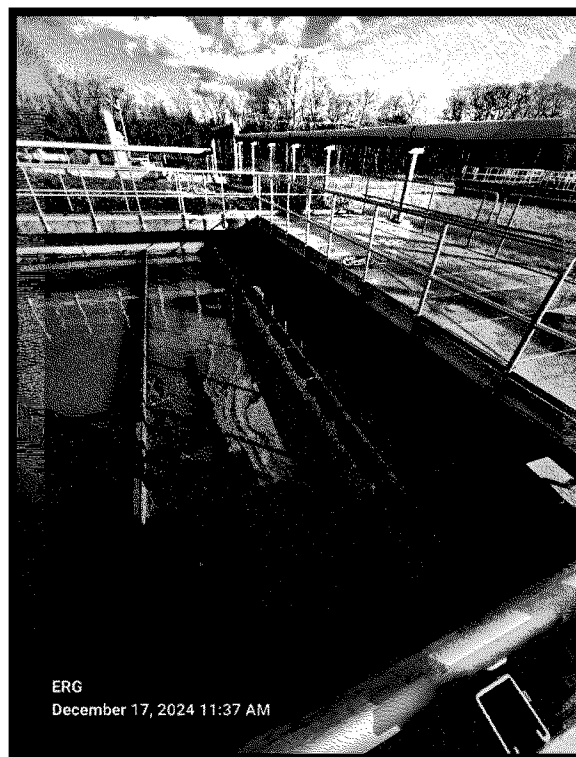
**Photograph 8.** Primary clarifier scum skimmer and floating sludge.

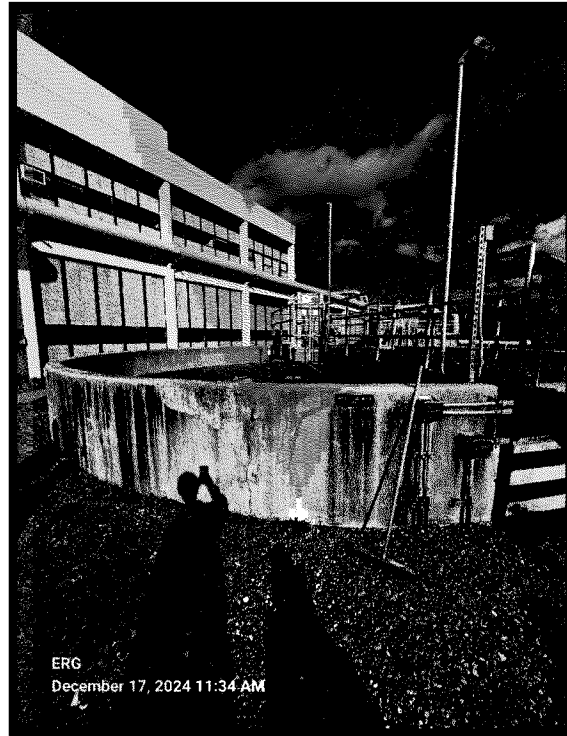
**Photograph 9.** Primary sludge gravity thickener.

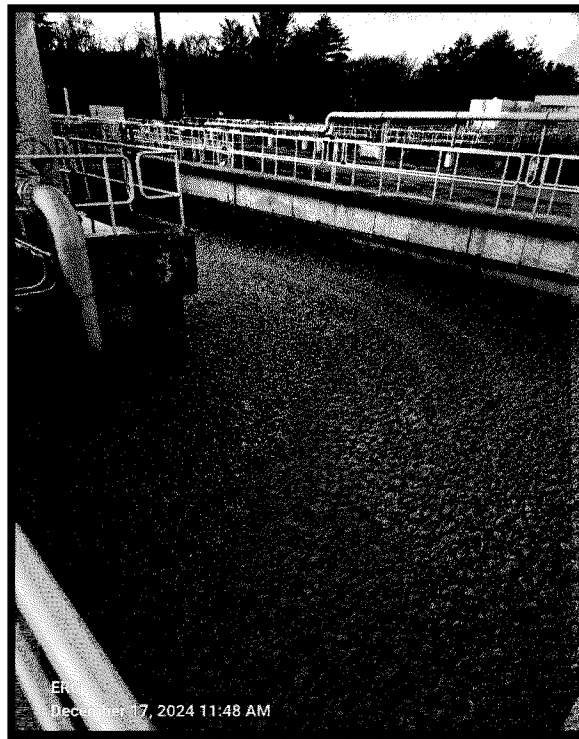
**Photograph 10.** First aeration basin that was not aerated at the time of the inspection.

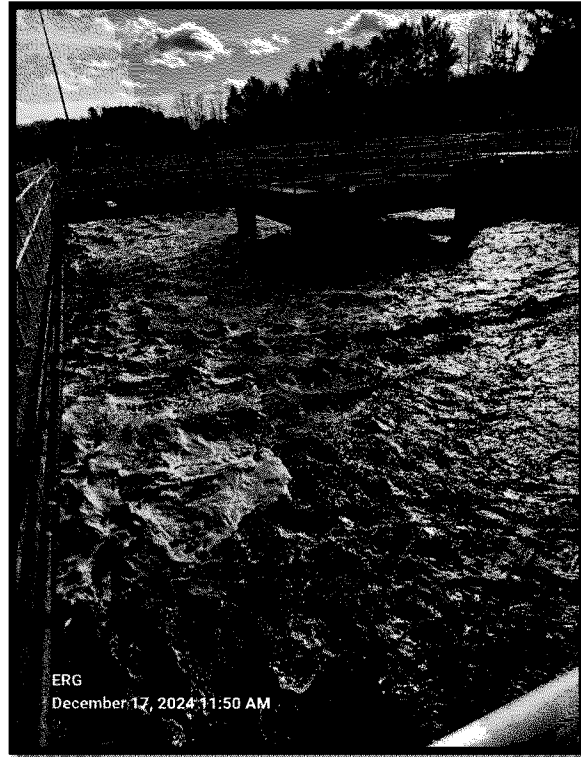
**Photograph 11.** Second aeration basin.

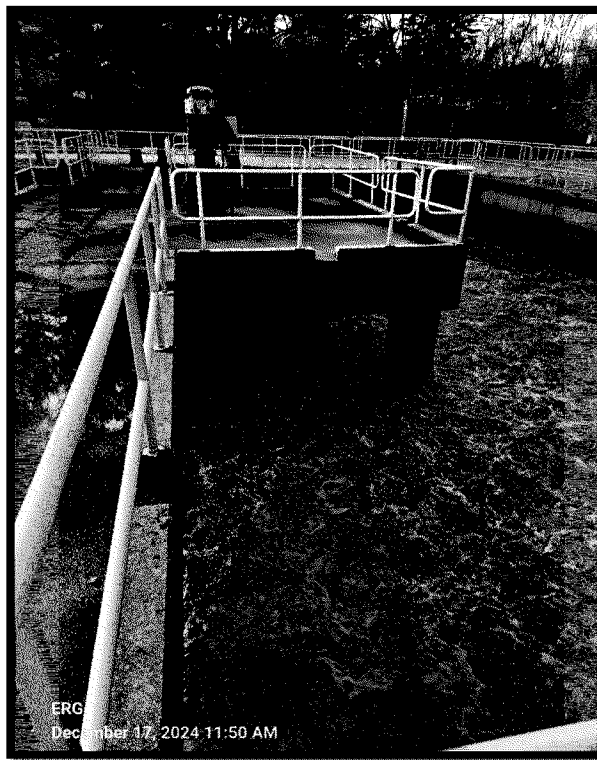
**Photograph 12.** Third aeration basin.

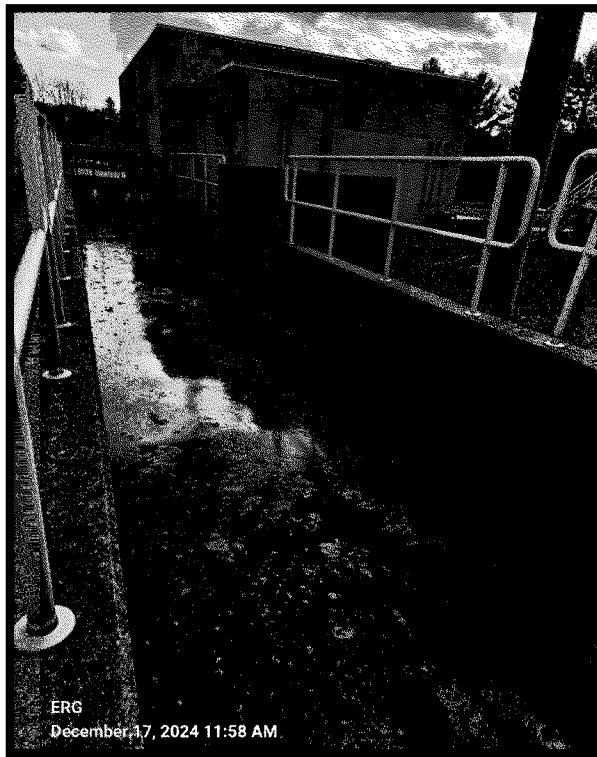
**Photograph 13.** Aeration basin effluent channel.

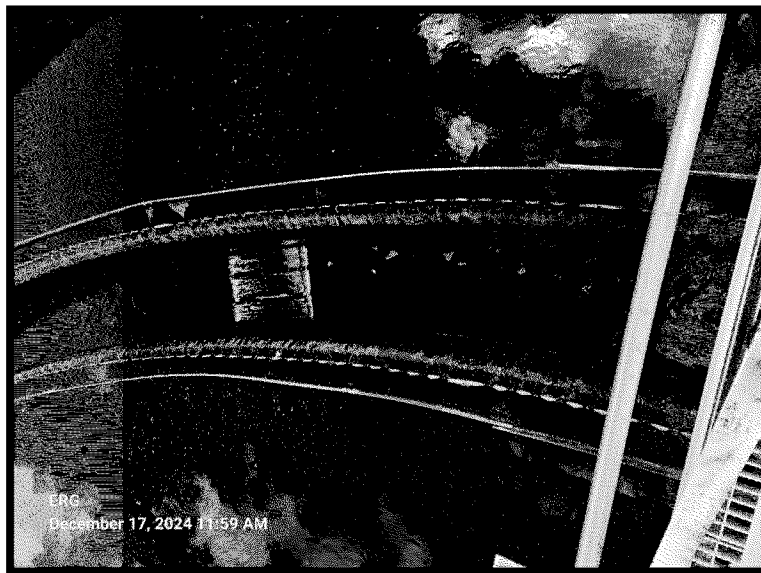
**Photograph 14.** Secondary clarifier weirs. Note the floating solids on the water surface and algae growth on the weirs.

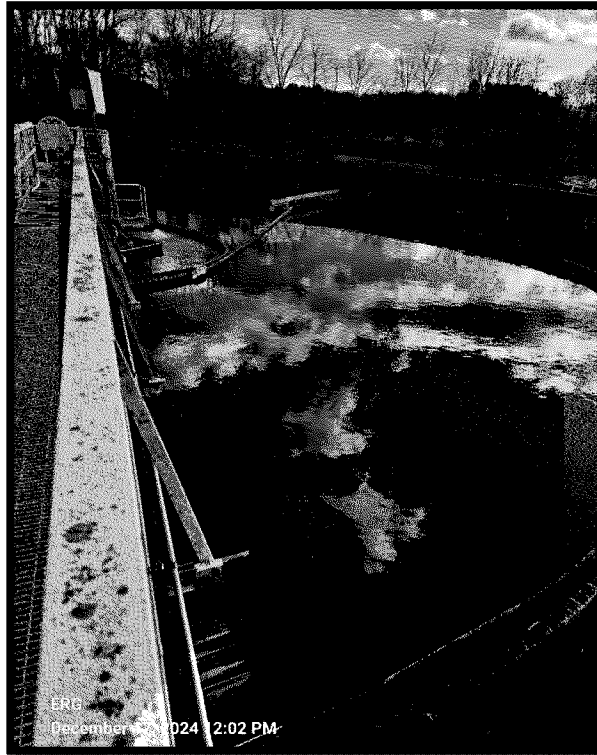
**Photograph 15.** Secondary clarifier scum skimmer arms. Note the floating solids on the water surface.

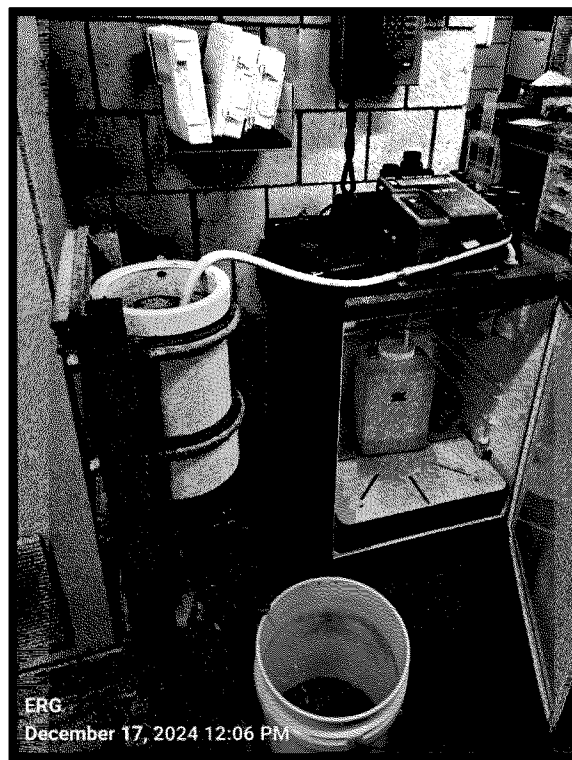
**Photograph 16.** Effluent sampler.

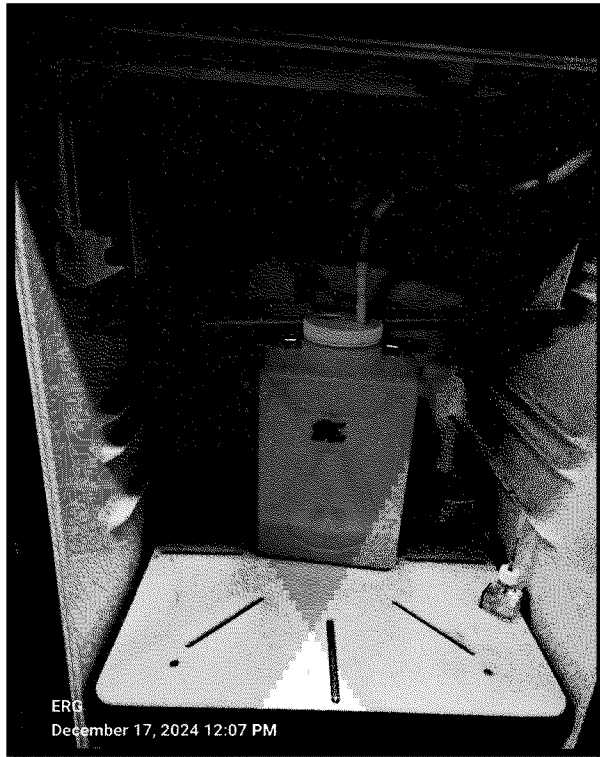
**Photograph 17.** Interior of the effluent sampler.

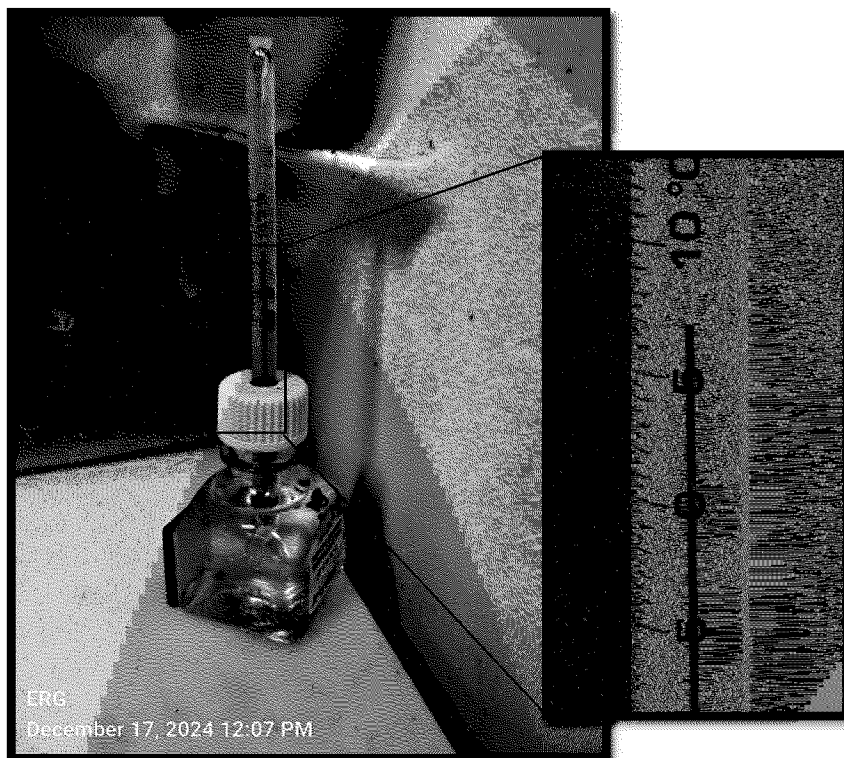
**Photograph 18.** Effluent sampler thermometer. The reading of the thermometer has been enlarged in the smaller photograph for easier reading of the temperature.

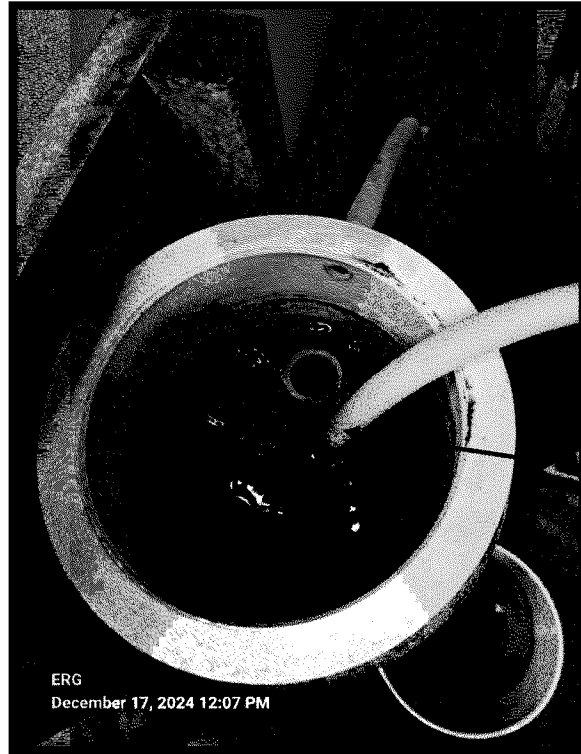
**Photograph 19.** Effluent sample chamber. Note the solids accumulated on the interior walls. The red arrow indicates the intake tube for the effluent auto sampler.

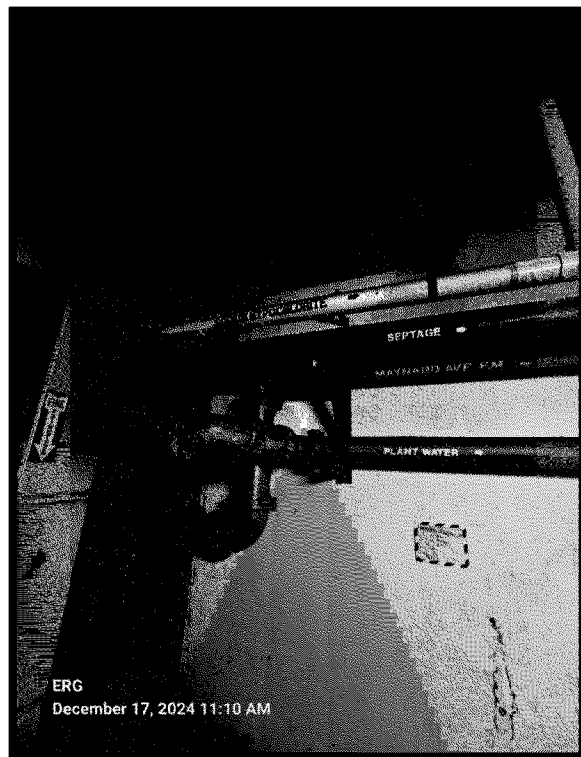
**Photograph 20.** Sodium hypochlorite line.

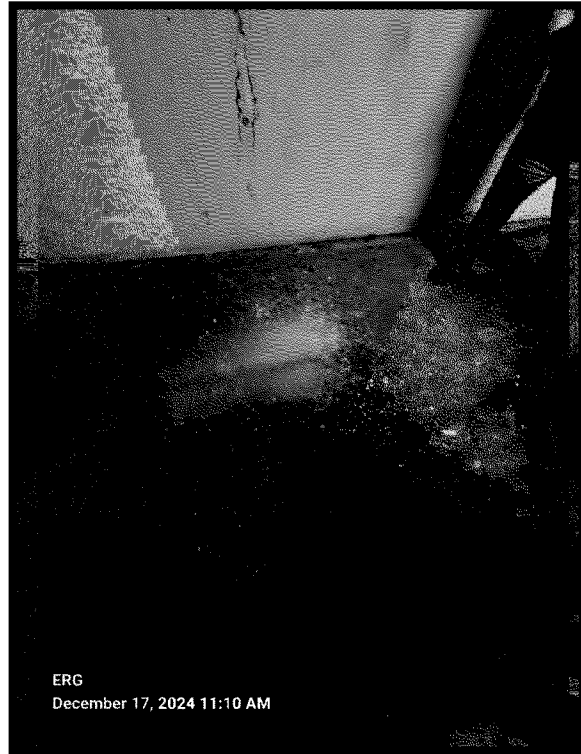
**Photograph 21.** Powdery white substance on the Pump Gallery floor beneath the sodium hypochlorite line.

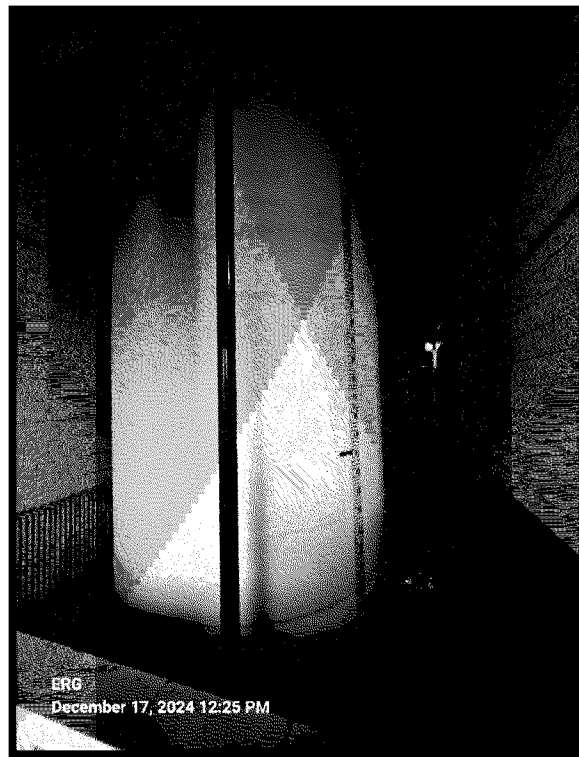
**Photograph 23.** Chlorine storage tanks

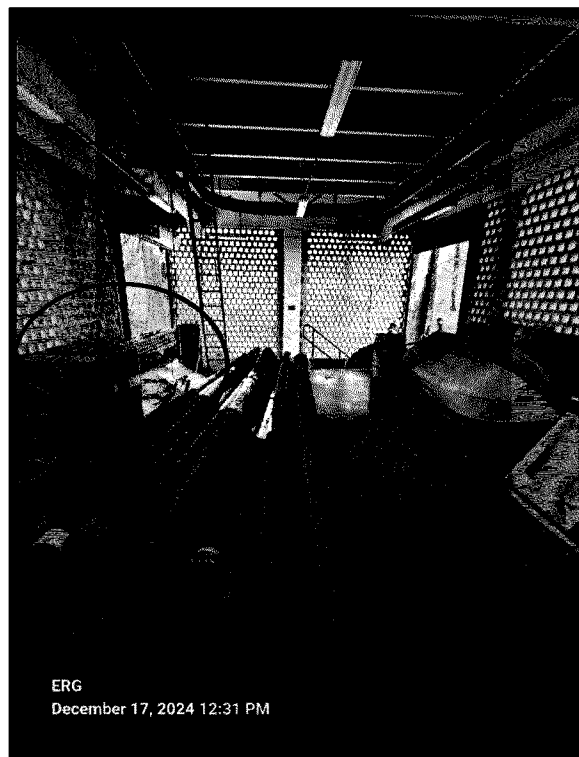
**Photograph 24.** Chlorine receiving bay. 55-gallon drums of sodium hypochlorite circled in red.

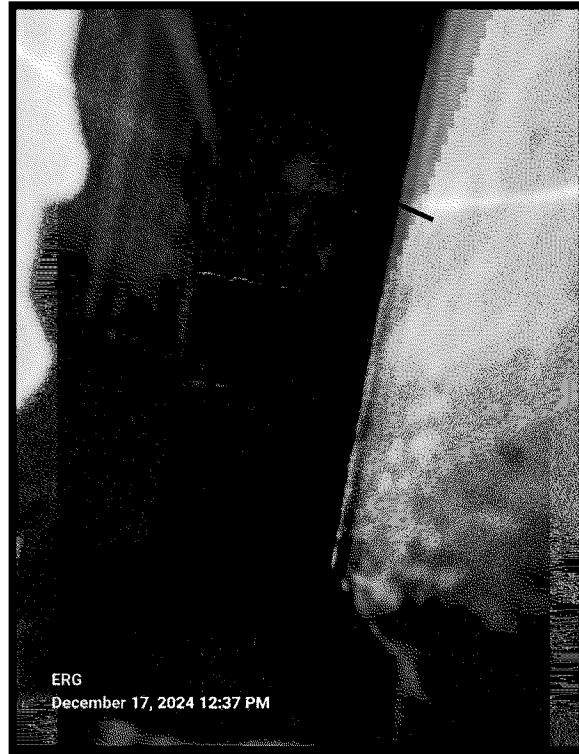
**Photograph 25.** Effluent step aeration. The red arrow indicated foam that was observed.

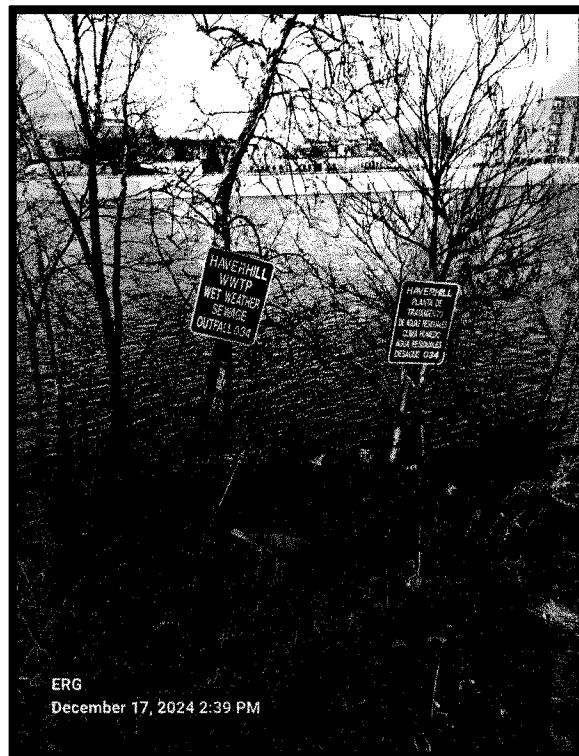
**Photograph 26.** Wet weather sewage outfall 034 signage.

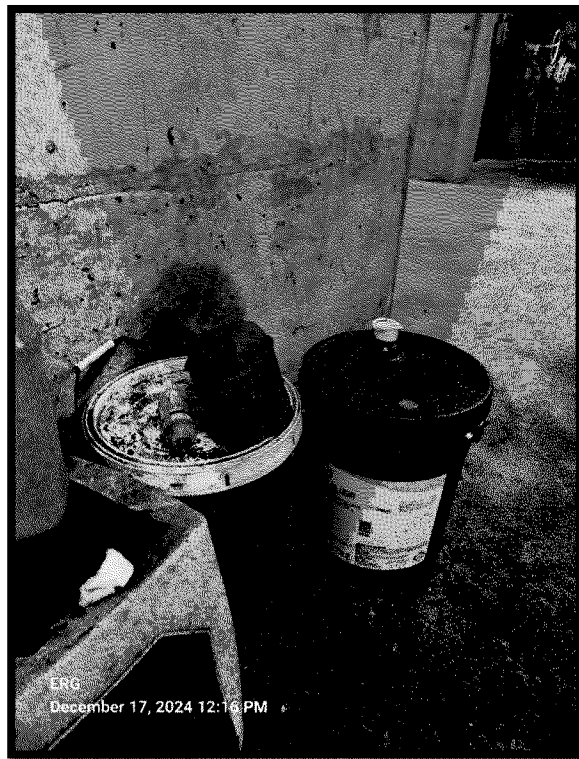
**Photograph 27.** Oil bucket without containment.

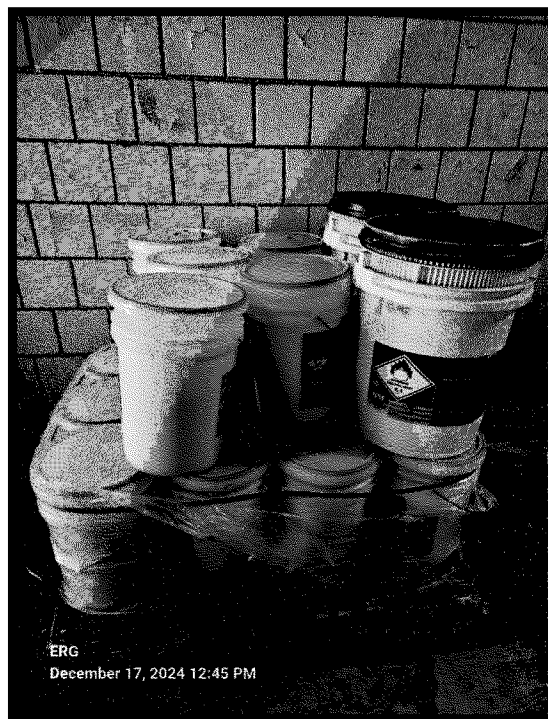
**Photograph 28.** Buckets of ProChlo stored on a pallet containment located between the gravity thickening area and the sludge blending area.

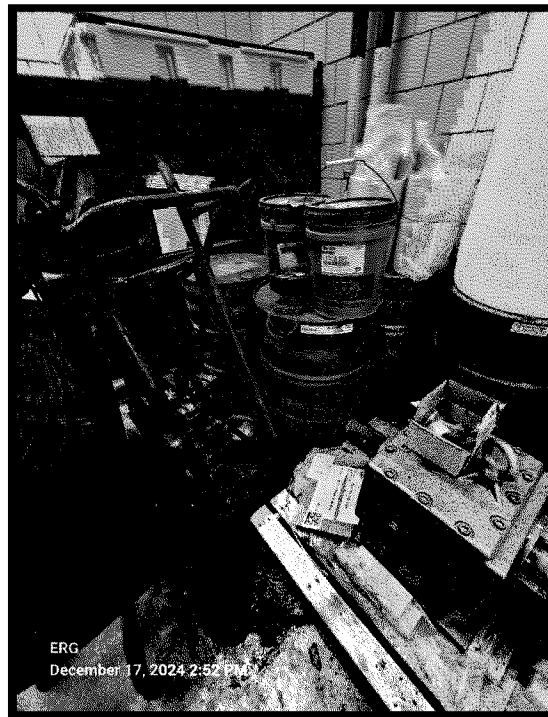
**Photograph 29.** Buckets and drums of oil and lubricants stored in the stock room without containment. Note the pathway of oil from the floor drain to the nearest 55-gallon drum.

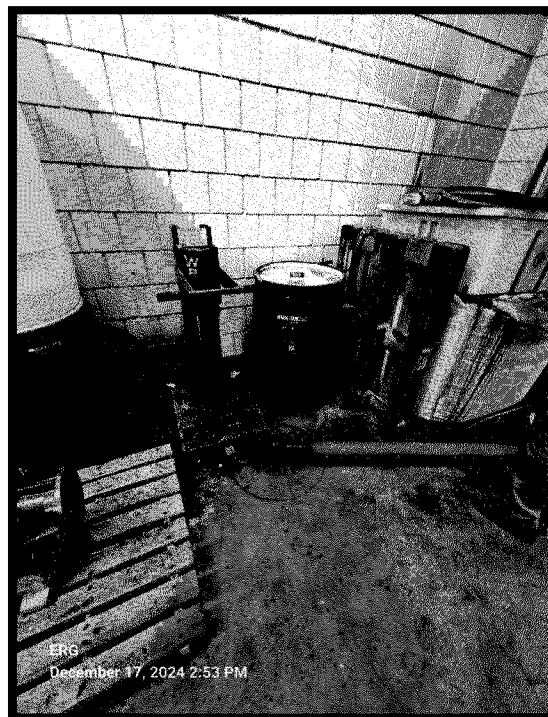
**Photograph 30.** Barrels filled with lubricant stored without containment. Note the brown staining down the side of the white bag on the pallet and the staining on the floor.

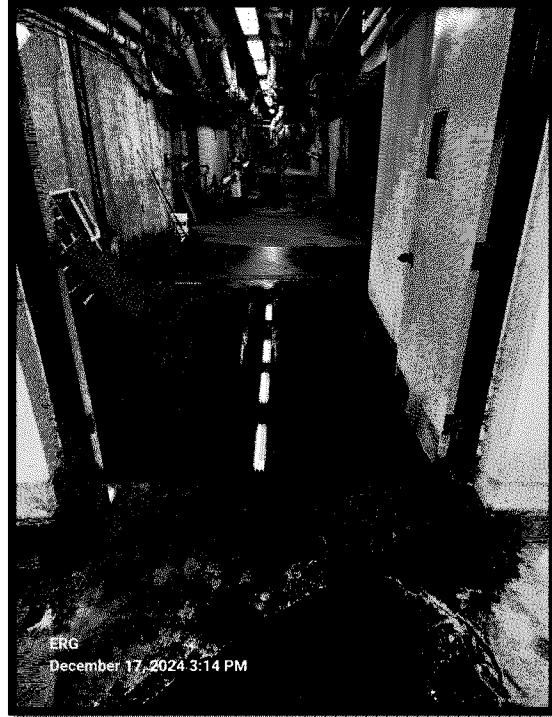
**Photograph 31.** Standing water on the ground near the WAS pumps. System representatives said it was due to ground water seepage.

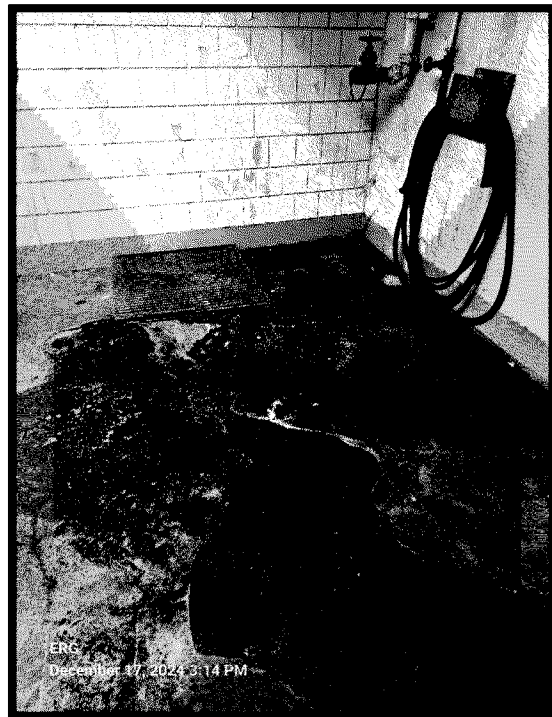
**Photograph 32.** Additional area of standing water on the ground in the pump room.

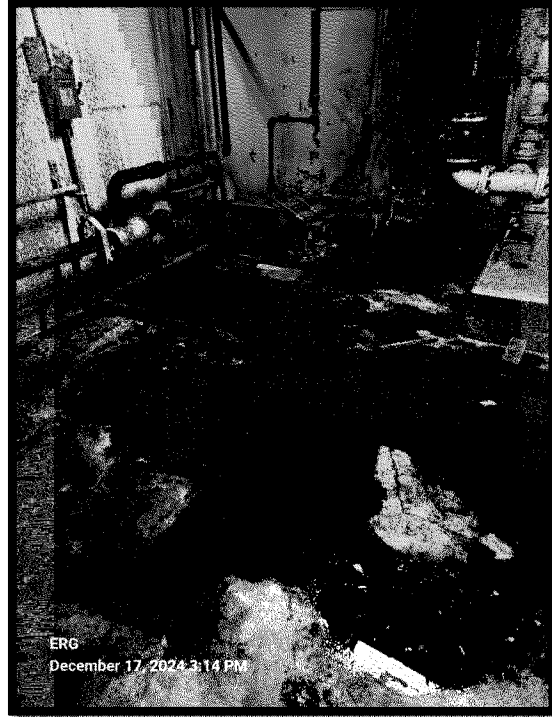
**Photograph 33.** Another instance of standing water observed in the pump room.

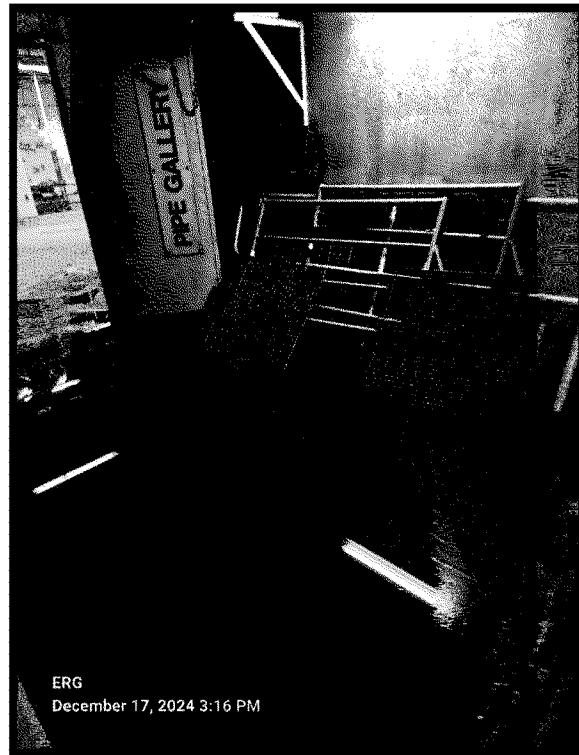
**Photograph 34.** Standing water on the ground in the pipe gallery.

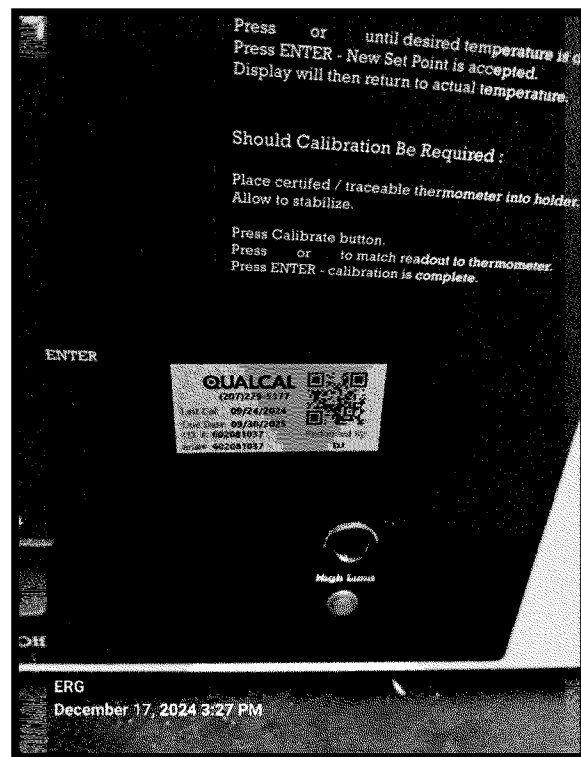
**Photograph 35.** Calibration sticker from QUALCAL for the incubator. QUALCAL calibrates much of the equipment in the laboratory.

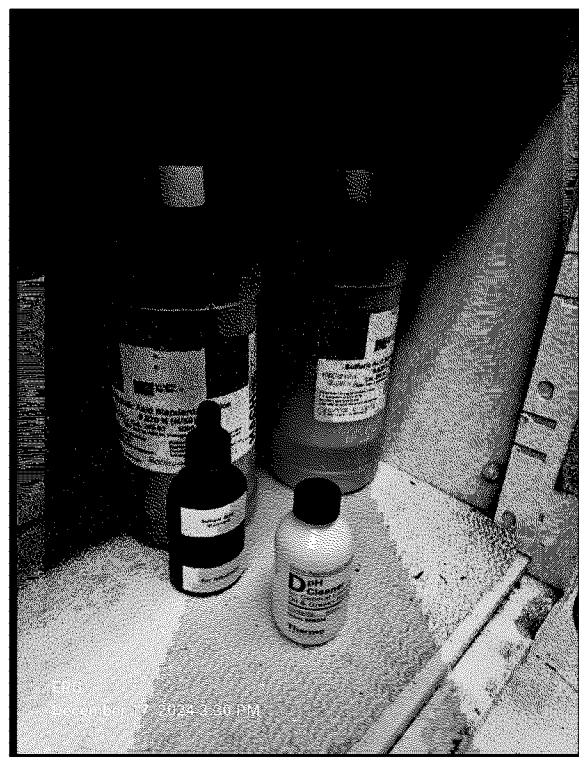
**Photograph 36.** Sulfuric Acid Standard in the laboratory expired in March 2016.

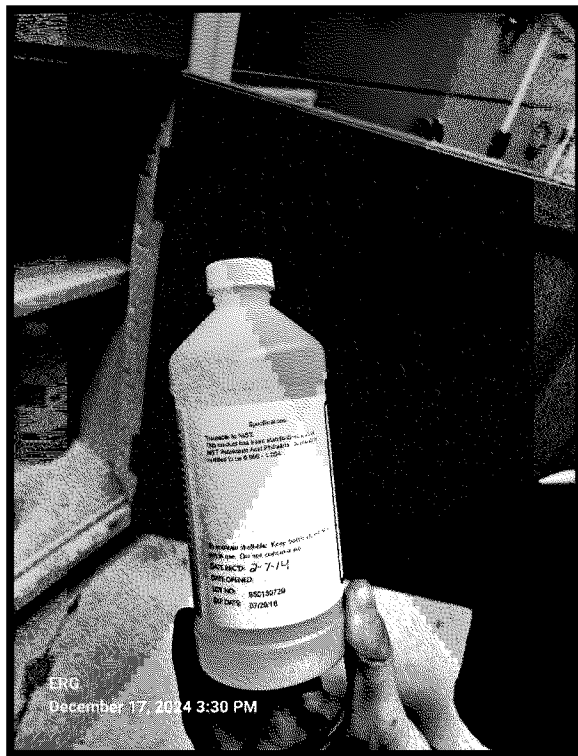
Photograph 37 Sulfuric Acid Standard in the laboratory, expired July 29, 2016.

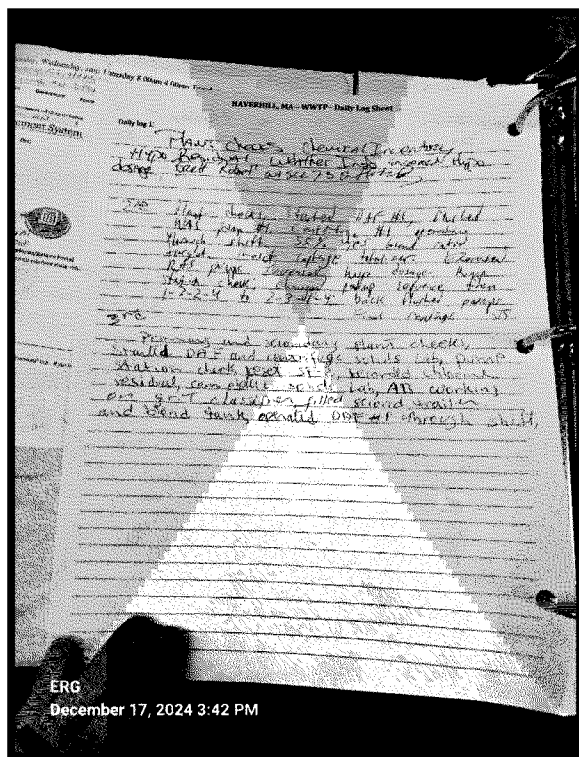
Photograph 41. Daily Log Sheet. Note the date of entry is missing.

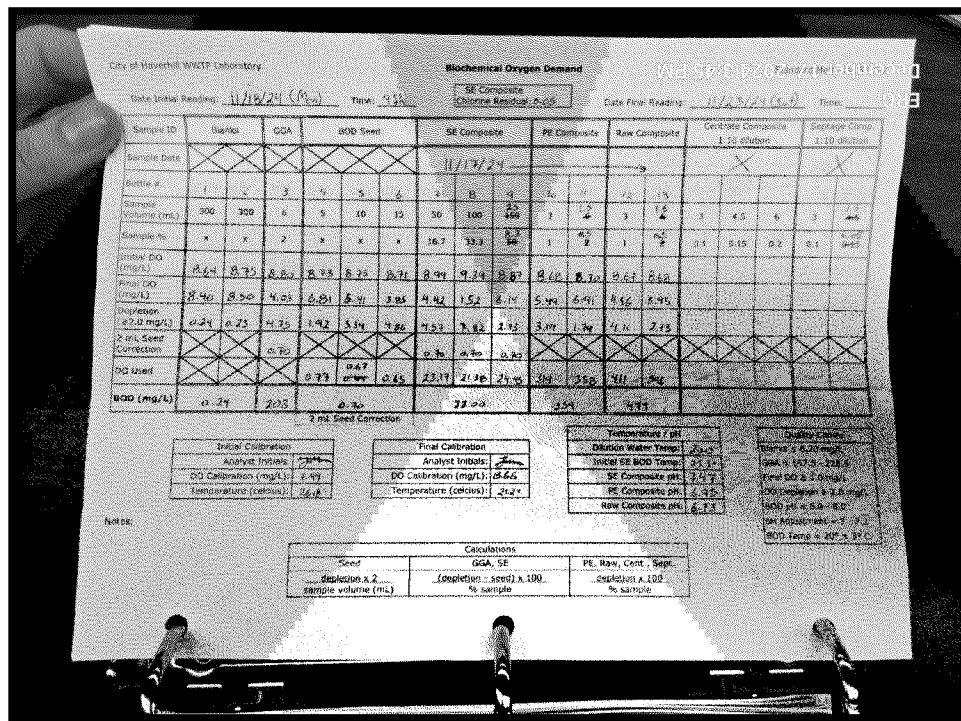
**Photograph 43.** BOD log sheet. Note the corrections made to log sheet without analyst initials and missing the time of the final DO reading.

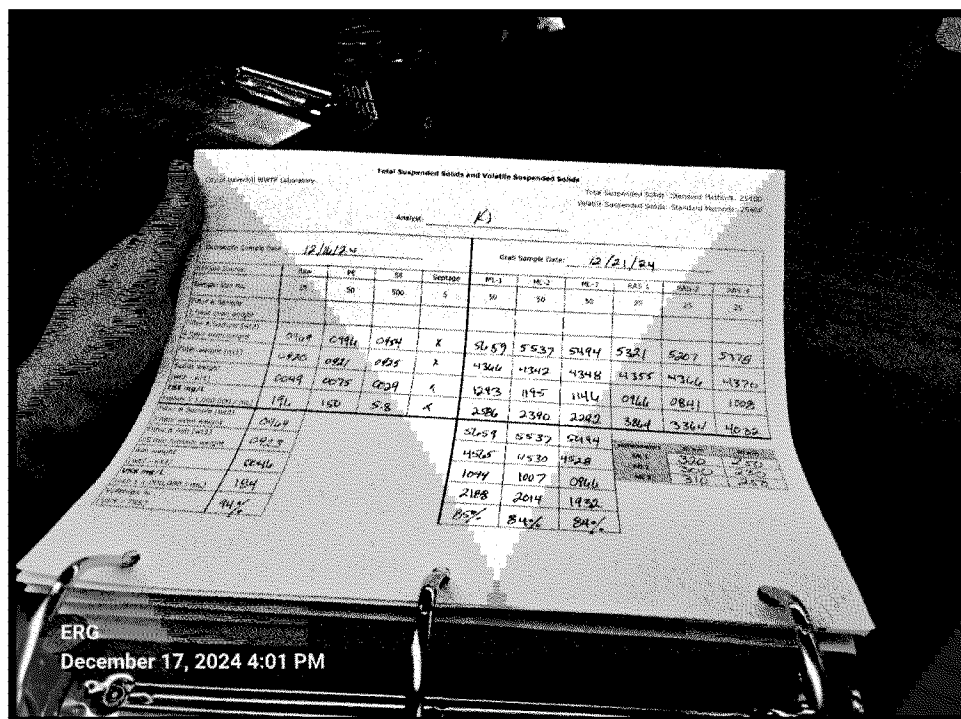
**Photograph 44.** Total suspended solids and volatile suspended solids lab sheet. Note that the date the photograph was taken was on December 17, 2024, while the grab sample is dated December 21, 2024.

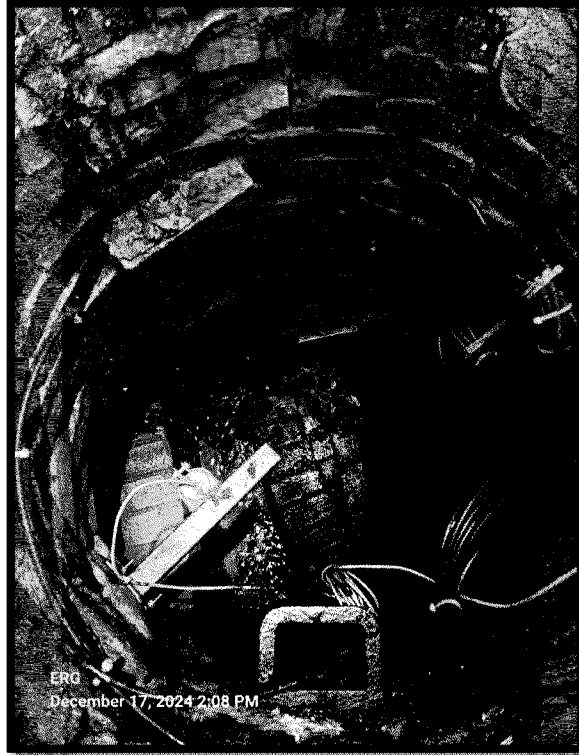
**Photograph 45.** South Webster combined sewer overflow manhole interior.

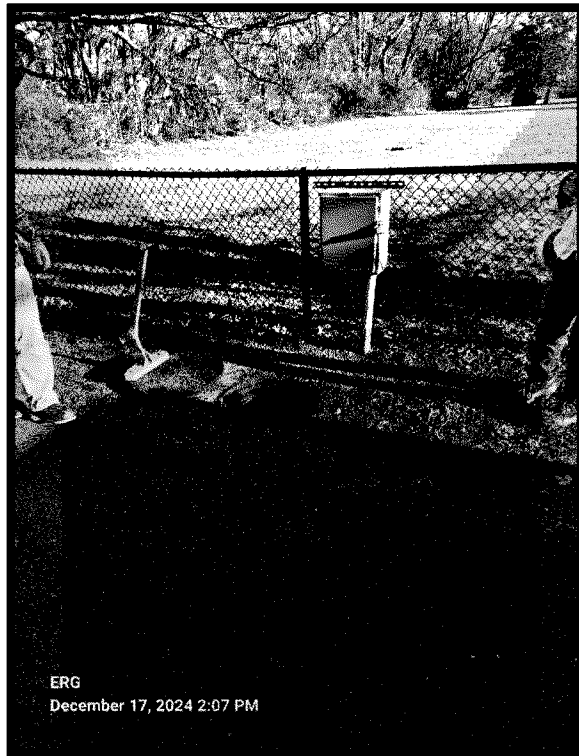
**Photograph 46.** South Webster combined sewer overflow manhole.

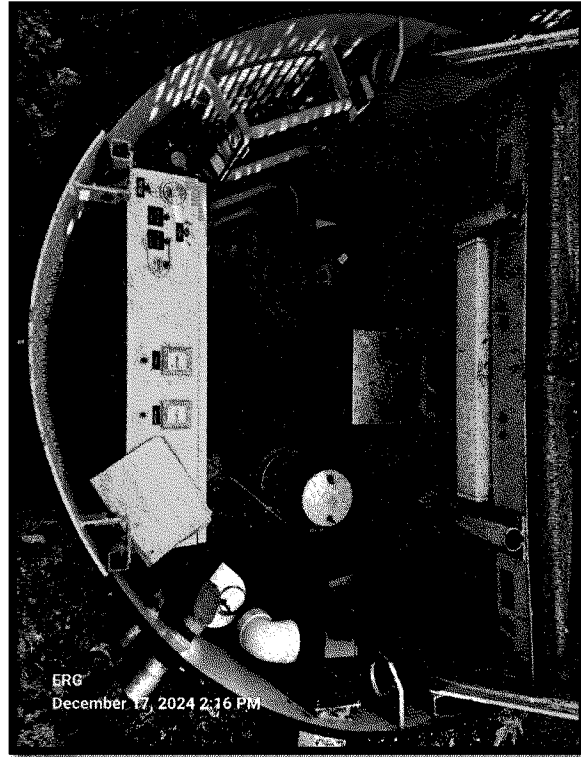
**Photograph 47.** Hyatt Avenue lift station interior.

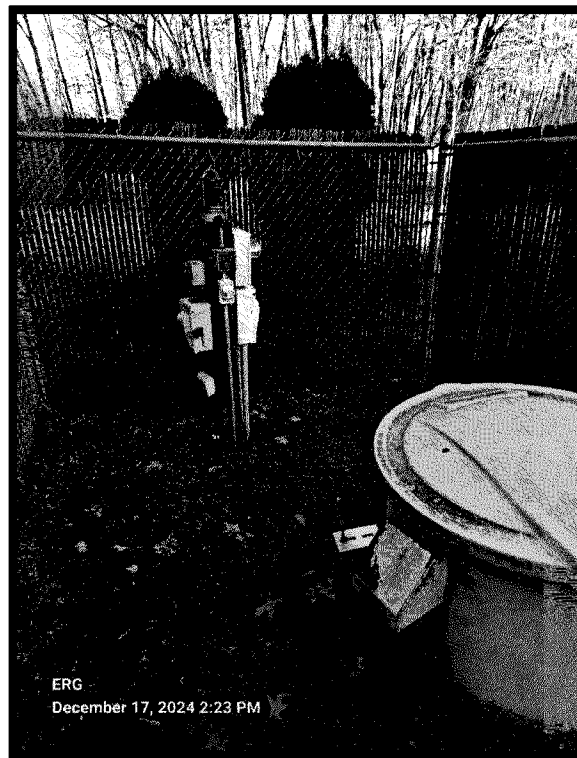
**Photograph 48.** Calewood lift station exterior. Note the missing lock on the far side of the hatch.

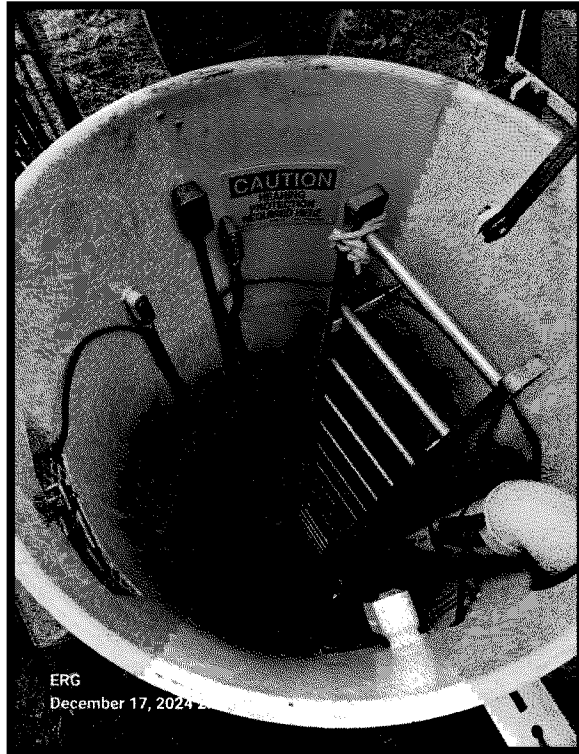
**Photograph 49.** Calewood lift station interior.

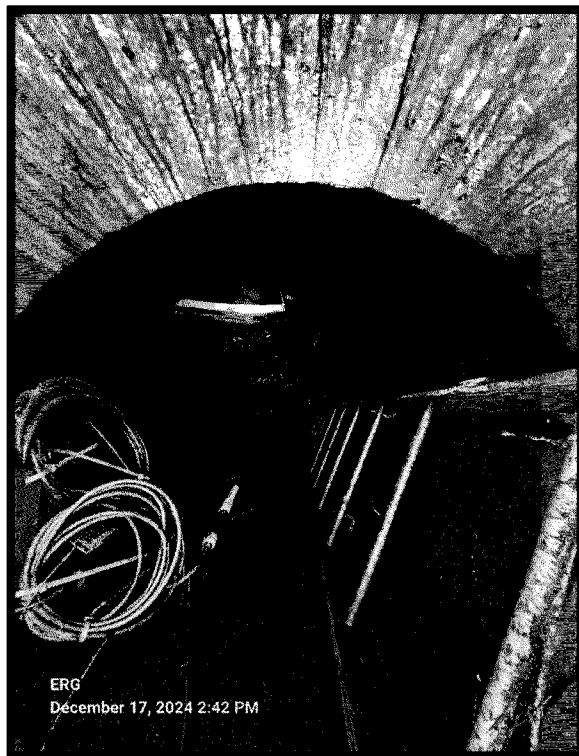
**Photograph 50.** Combined Sewer Overflow 034.
