Region 6 Compliance Assurance and Enforcement Division  
INSPECTION REPORT

| Company Name: | Energy Production Company | | |
| Facility Name: | Schneider Buda Unit Lease | | |
| | Subject: | Inspection Report Clean Water Act (CWA) Brine Discharge | |

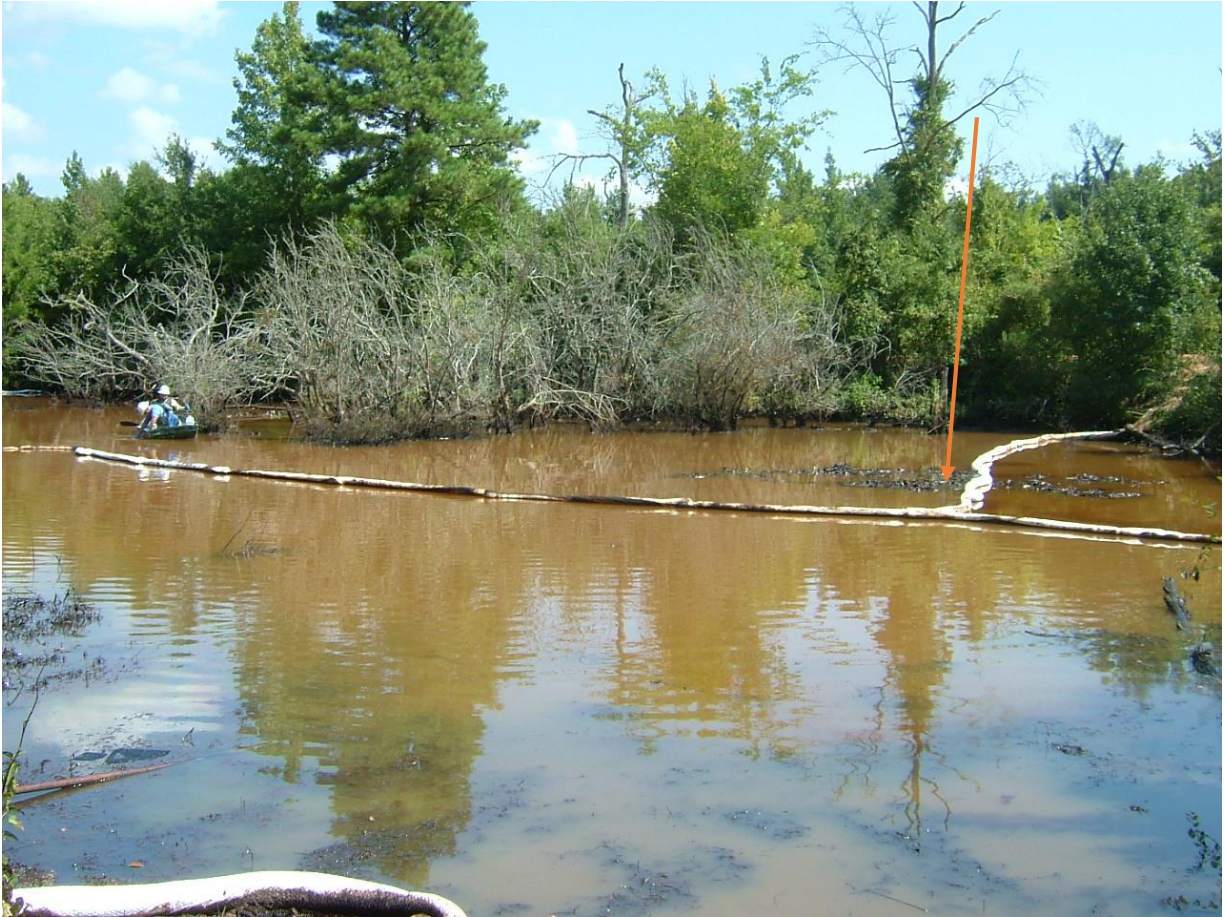
Photo File Name: Photo 1

I observed a pond to have been contaminated from both produced water and crude oil from the injection line which previously ruptured. The injection line is located under the pond. The pond is located on a tributary of Rock Falls Creek which outfalls to Shapps Lake which is also located on the tributary of Rock Falls Creek. During the inspection I determined the salinity of fluids with an YSI 30 meter at the following locations: fluids located in pond near its outfall at 32.680303', -95.390813' measured 1,100 ppm TSS; fluids located on flow path down gradient of pond at 32.680255', -95.390436' measured 200 ppm TSS; and, fluids located in Shapps Lake down gradient of pond at 32.680243', -95.389982' measured 200 ppm TSS.

Description: Photo taken to the north. This pond was affected from a produced water discharge. Standing at N32.680275' and W95.390891'. The arrow is pointing to the approximate location of where a produced water injection line ruptured discharging produced water and crude oil.

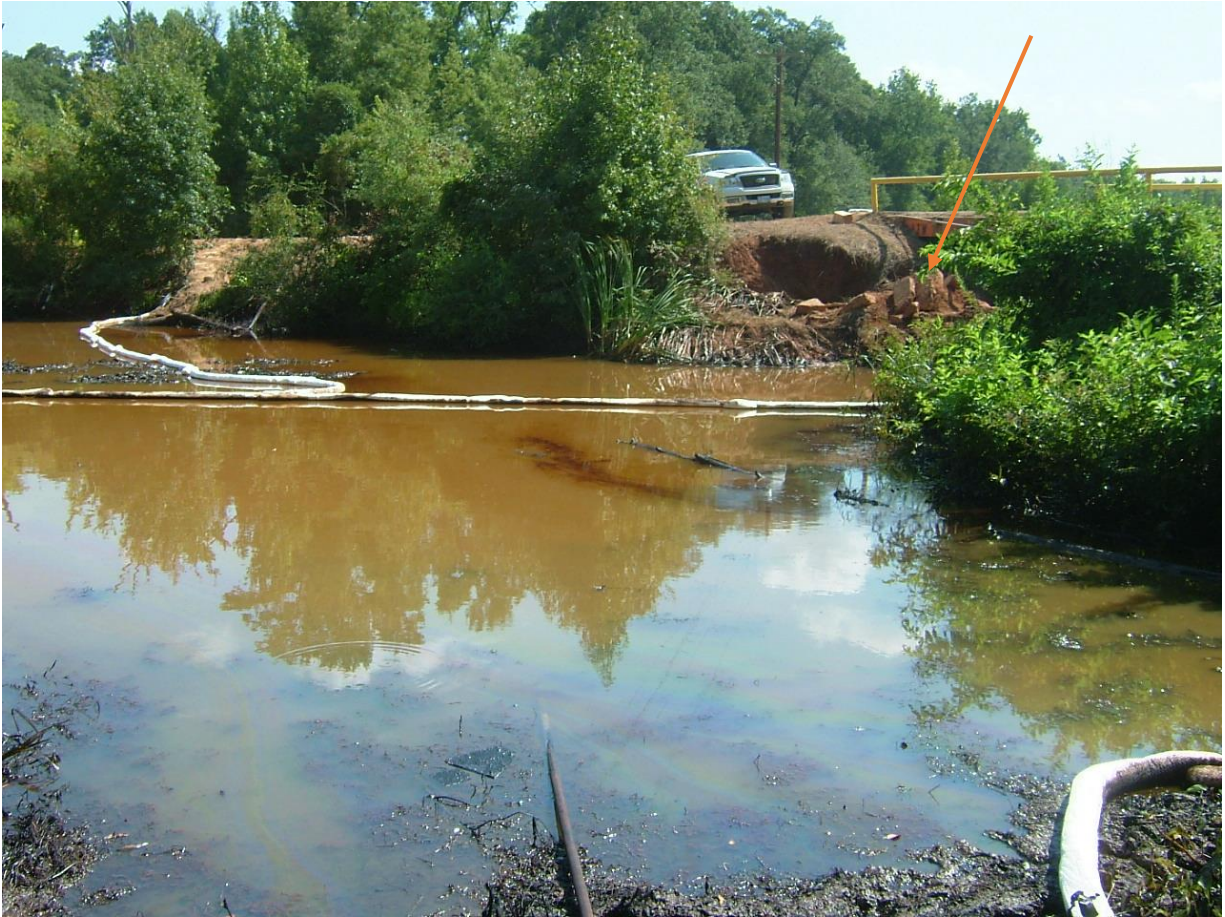
Photo File Name: Photo 2

Description: Photo taken to the northeast. I am standing at the same approximate location as previous photo. Red arrow points to a dam built on the ponds outfall where a beaver dam was previously located here.

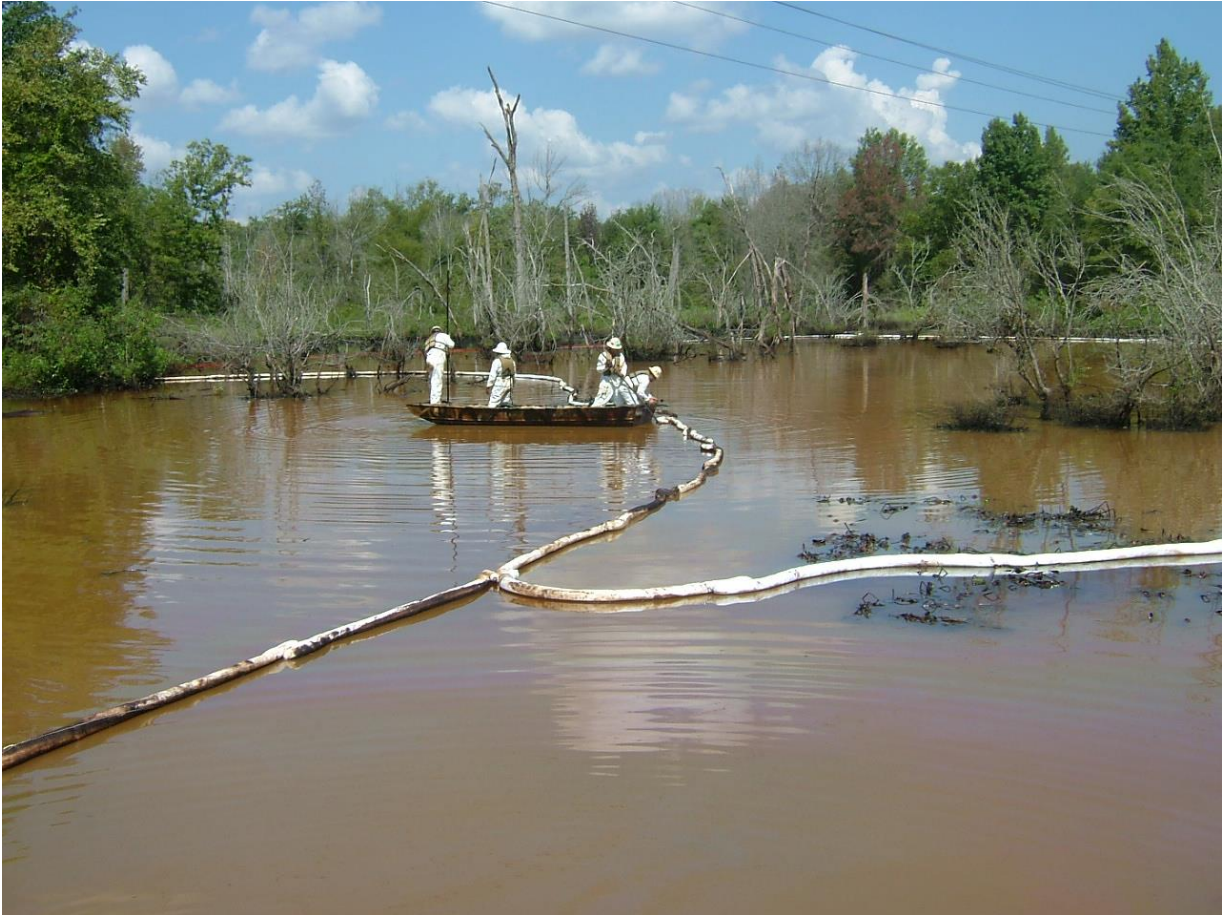
Photo File Name: Photo 3

Description: Photo taken to the west. I am standing on the dam built on the pond's outfall (dam). Fluids located here at N32.680303' and W9.390813' measured 1,100 ppm TSS.

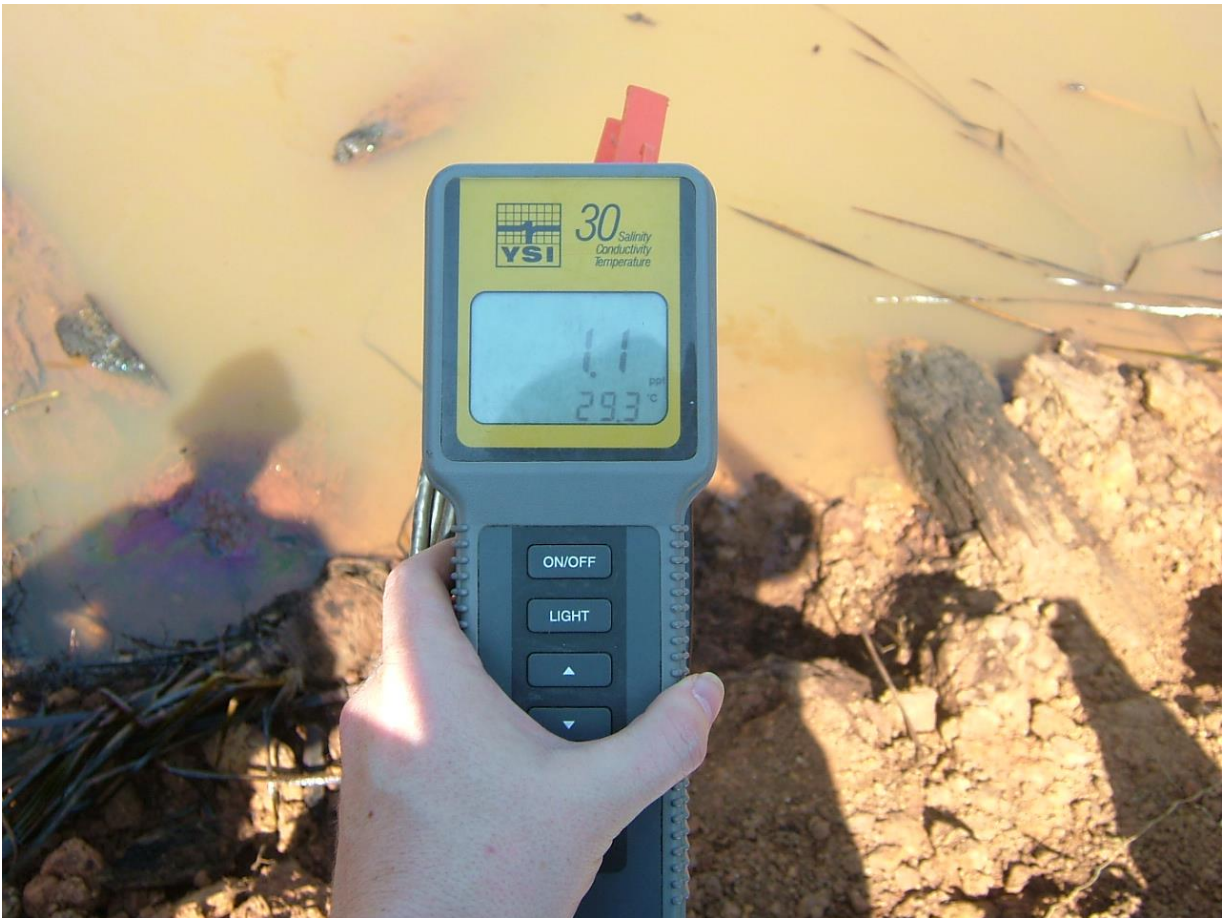
Photo File Name: Photo 4

Description: Photo taken to the west. I am standing at the same approximate location as the previous photo. YSI meter showing the 1,100 ppm TSS.

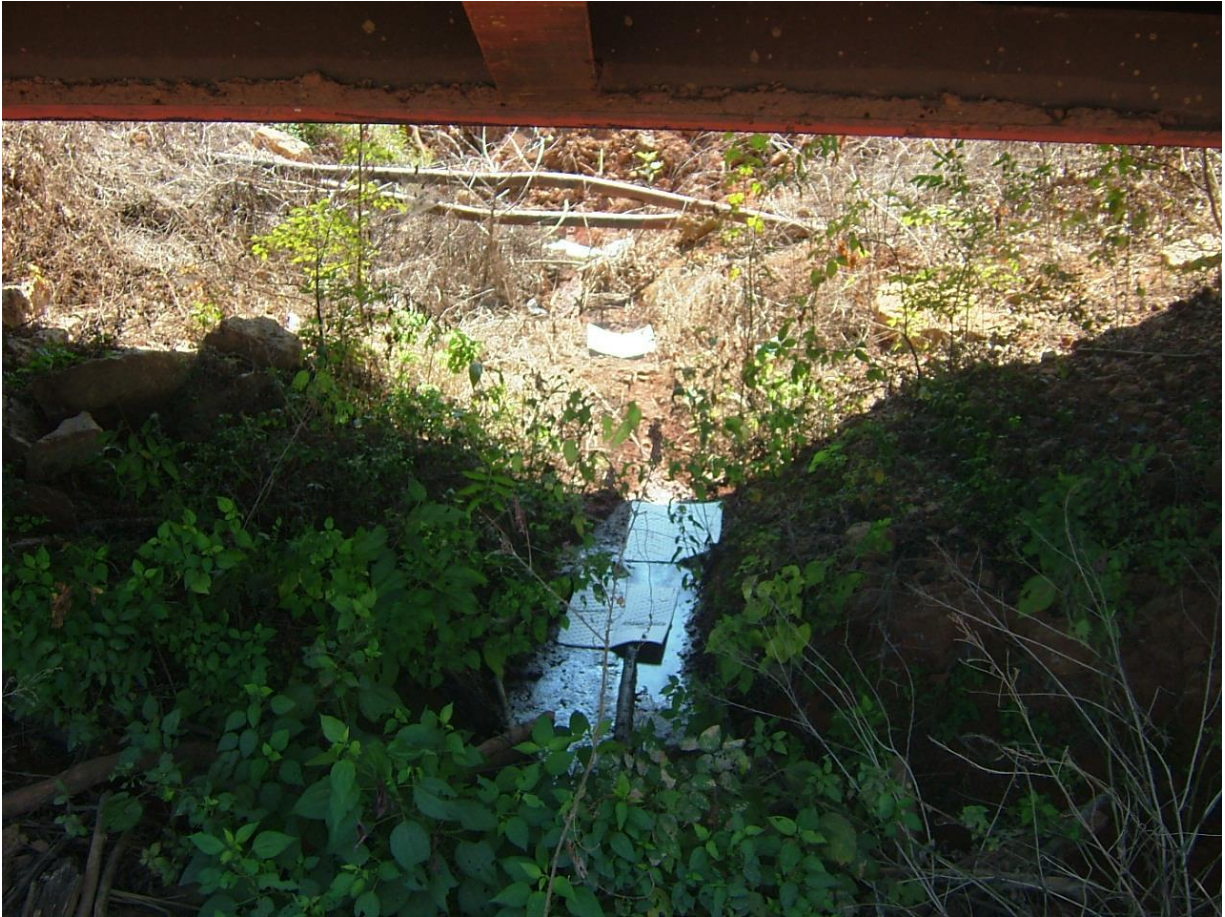
Photo File Name: Photo 5

Description: Photo taken to the southeast. I am standing on dam looking downgradient at the flow path from the pond's outfall (flow path).

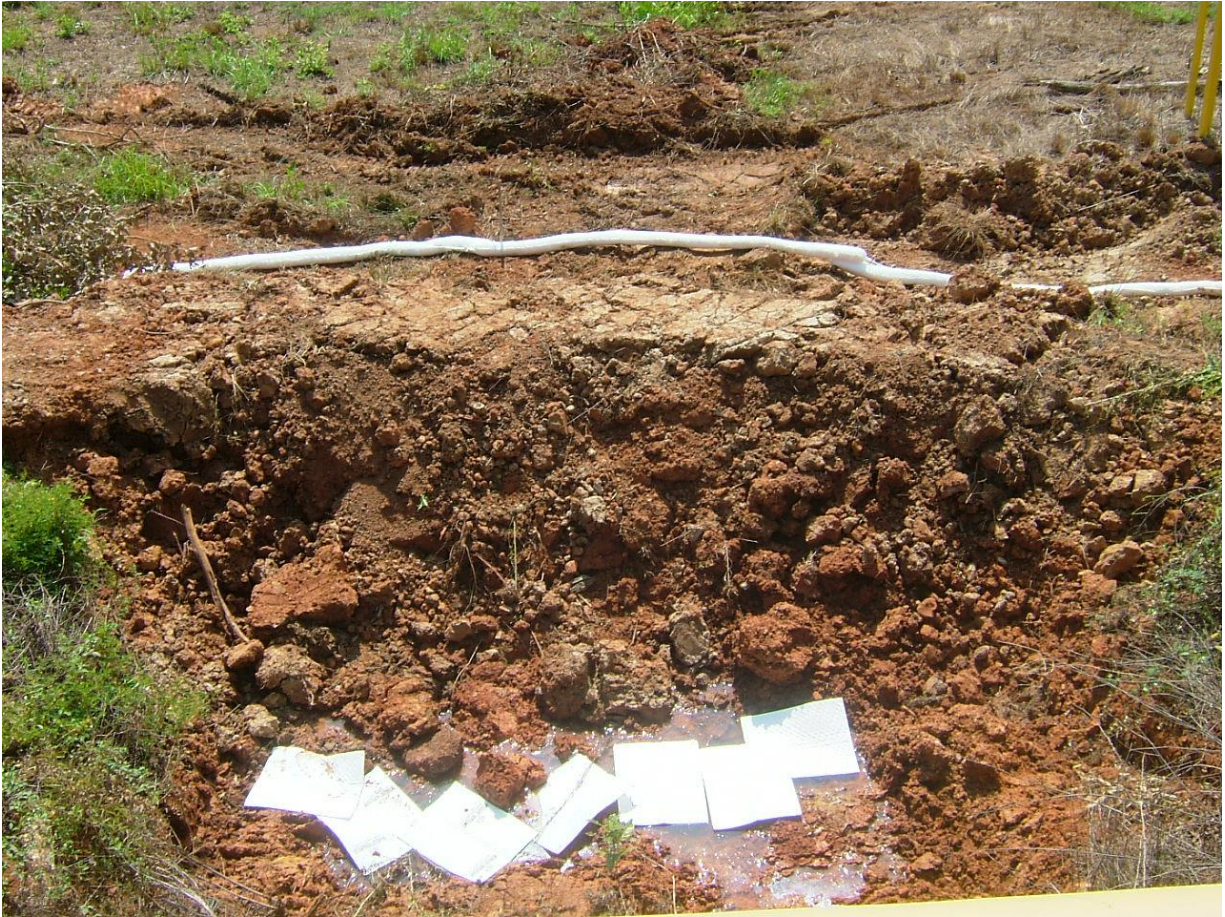
Photo File Name: Photo 6

Description: Photo taken to the southeast. I am standing on lease road. The is another dam built on flow path.

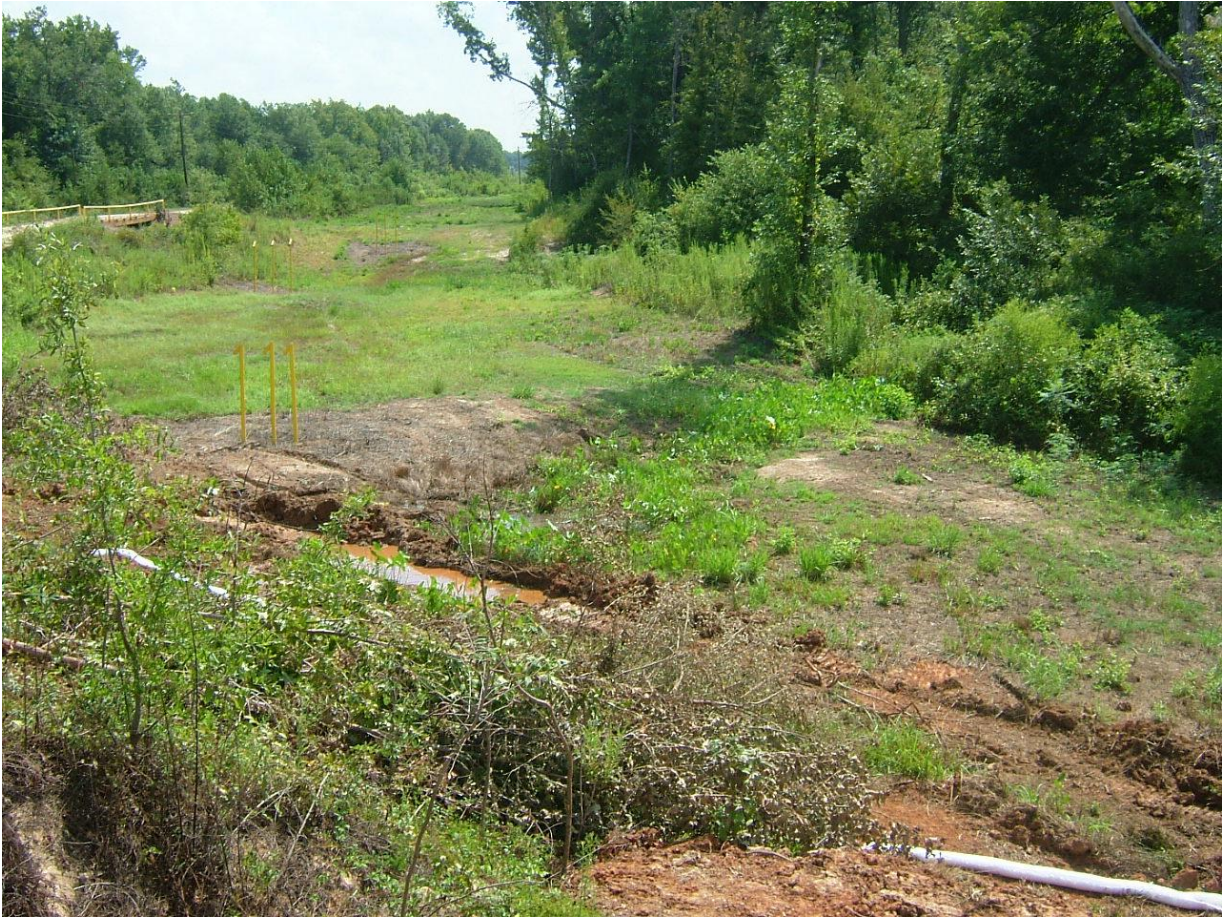
Photo File Name: Photo 7

Description: Photo taken to the east. I am standing on lease road looking at flow path. Shapps Lake is located just beyond the trees in the photos upper right.

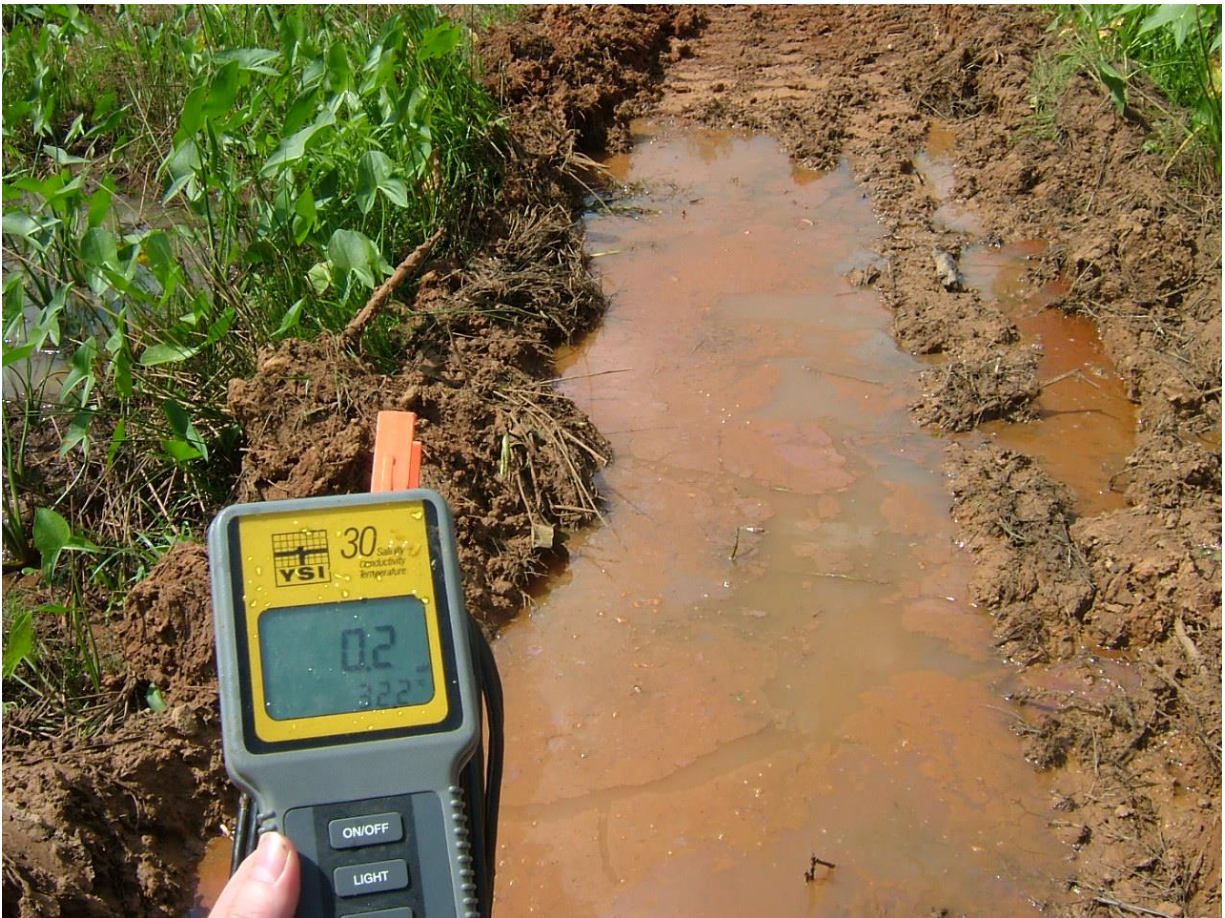
Photo File Name: Photo 8

Description: Photo taken to the south. Fluids located on flow path at N32.680255' and W95.390436' measured 200 ppm TSS.

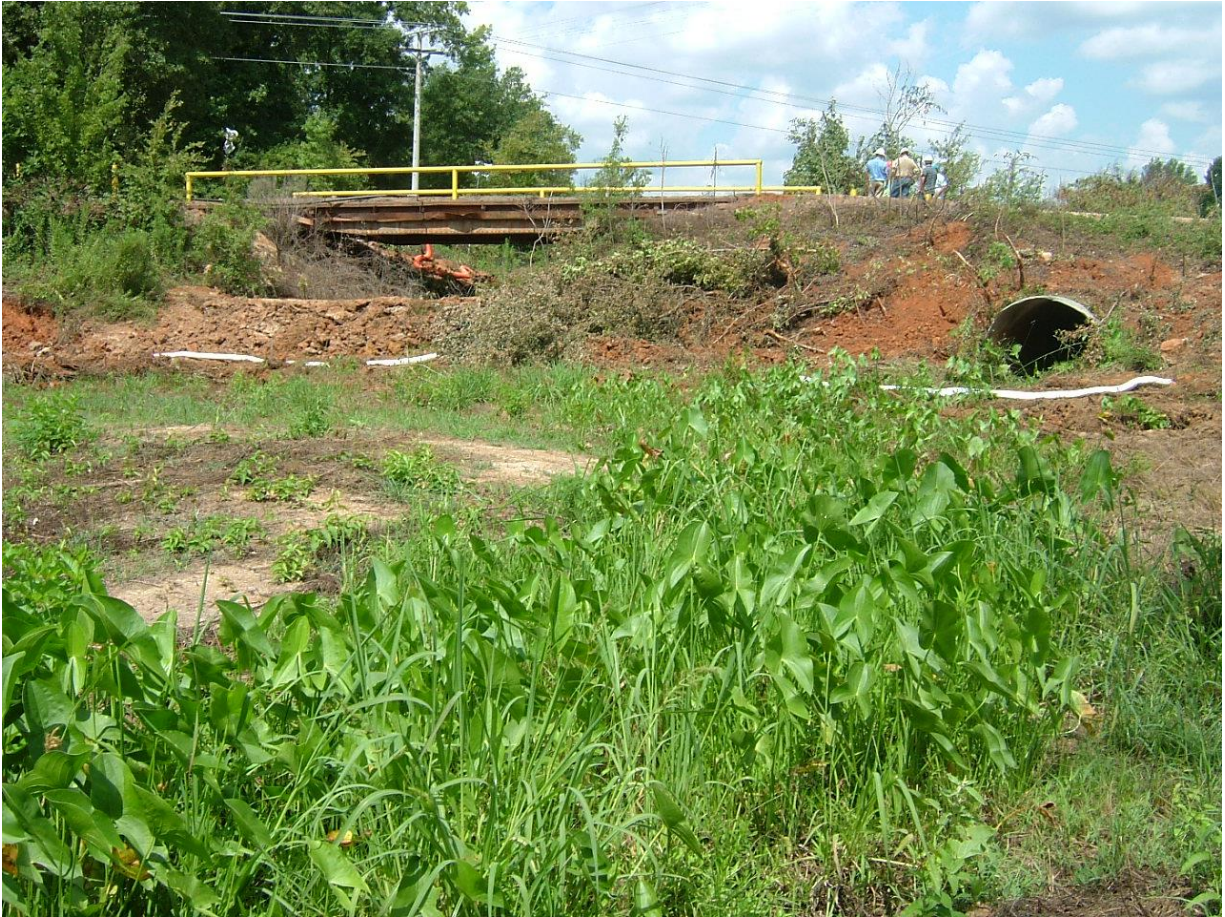
Photo File Name: Photo 9

Description: Photo taken to the west. I am standing with Shapps Lake to my back looking back at the pond's outfall flow path.

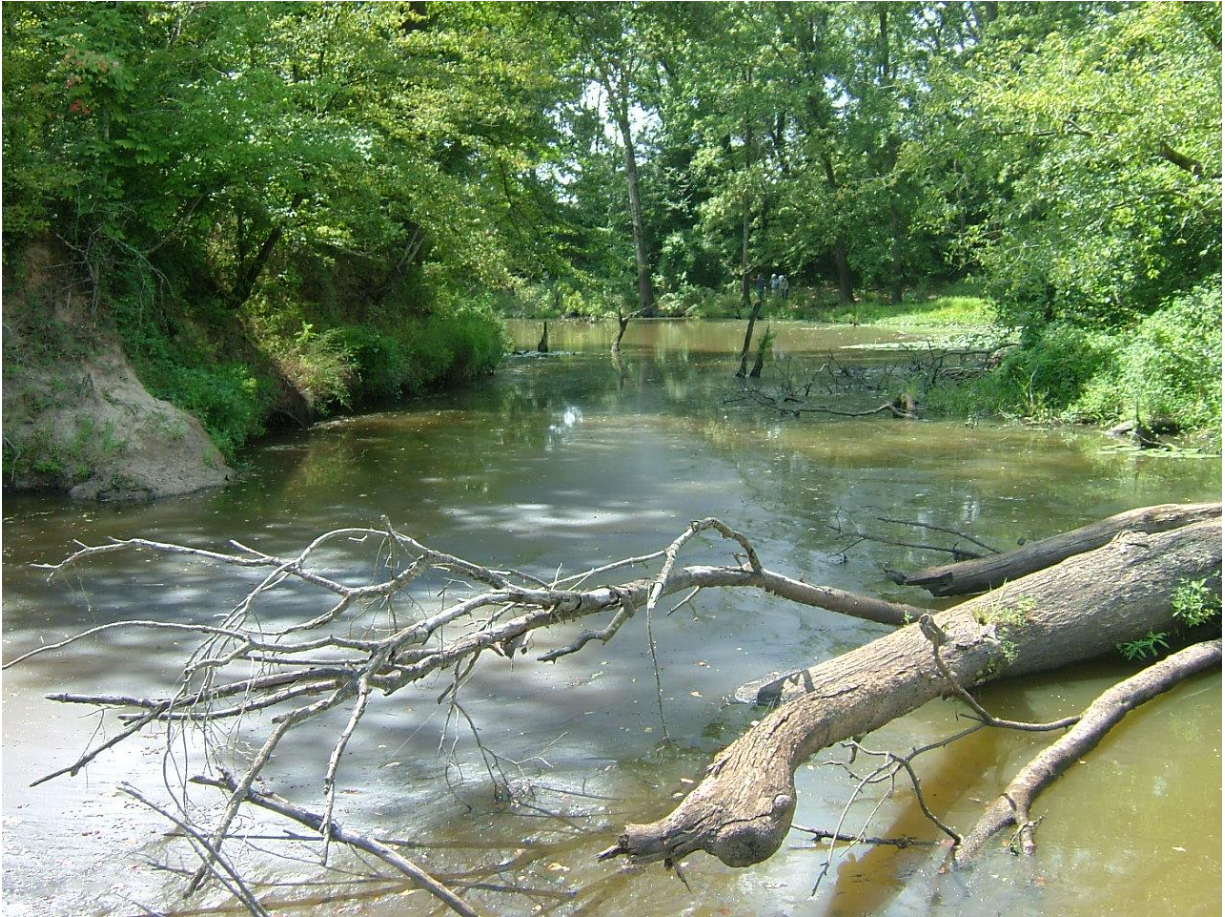
Photo File Name: Photo 10

Description: Photo taken to the south. I am standing at N32.680243' and W95.389982' looking at Shapps Lake. Fluids located here measured 200 ppm TSS.

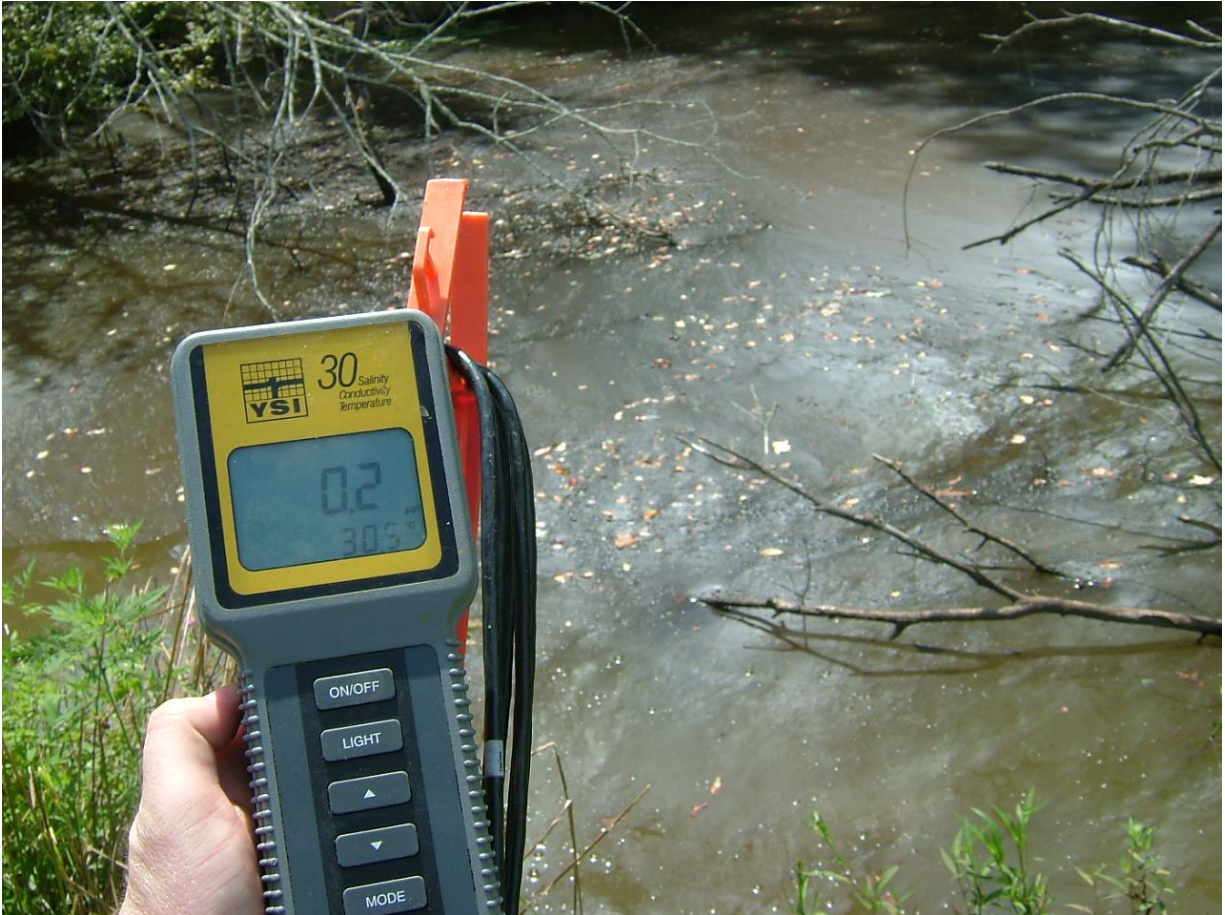
Photo File Name: Photo 11

Description: Photo taken to the south. I am standing at the same approximate location as the previous photo. Meter showing the 200 ppm TSS.
