# NPDES Compliance Inspection Report

## **Darigold – Chehalis Facility Chehalis, Washington**

**Permit #: WAR005575**

**Inspection Date: January 13, 2022**

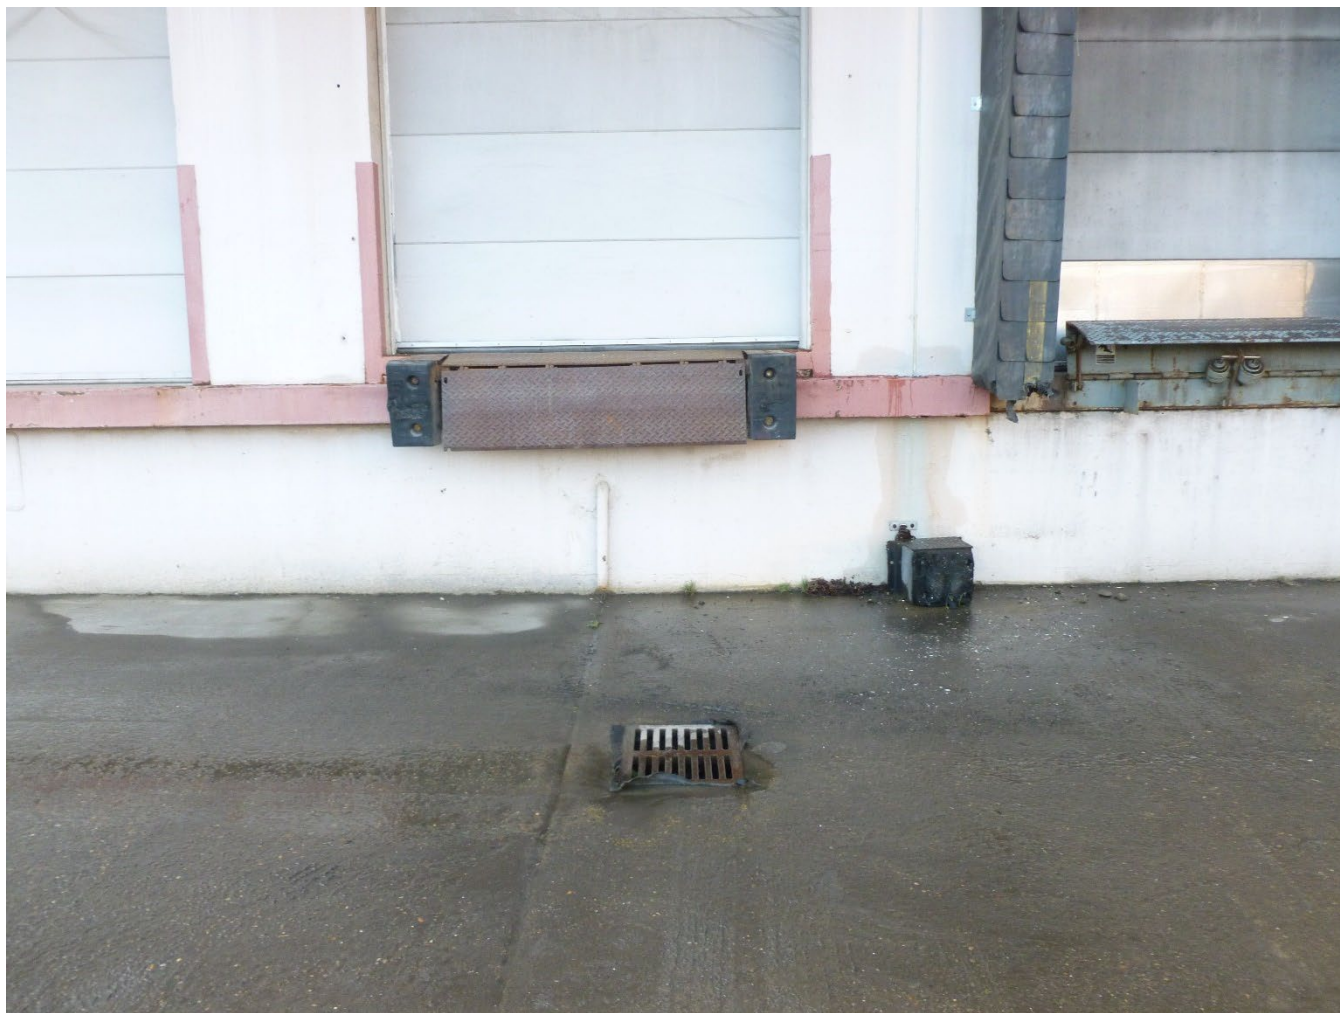
**Photo 1 / P1010151 – Catch Basin 1**

We started the site tour by exiting the offices on the east side of the facility adjacent to Southwest Chehalis Avenue. We walked around the building to the south to CB-1. CB-1 is near the truck loading/unloading dock (**Photo 1**). Water that enters CB-1 flows to a sump pump which pumps the stormwater to the City's storm drain located in the street.

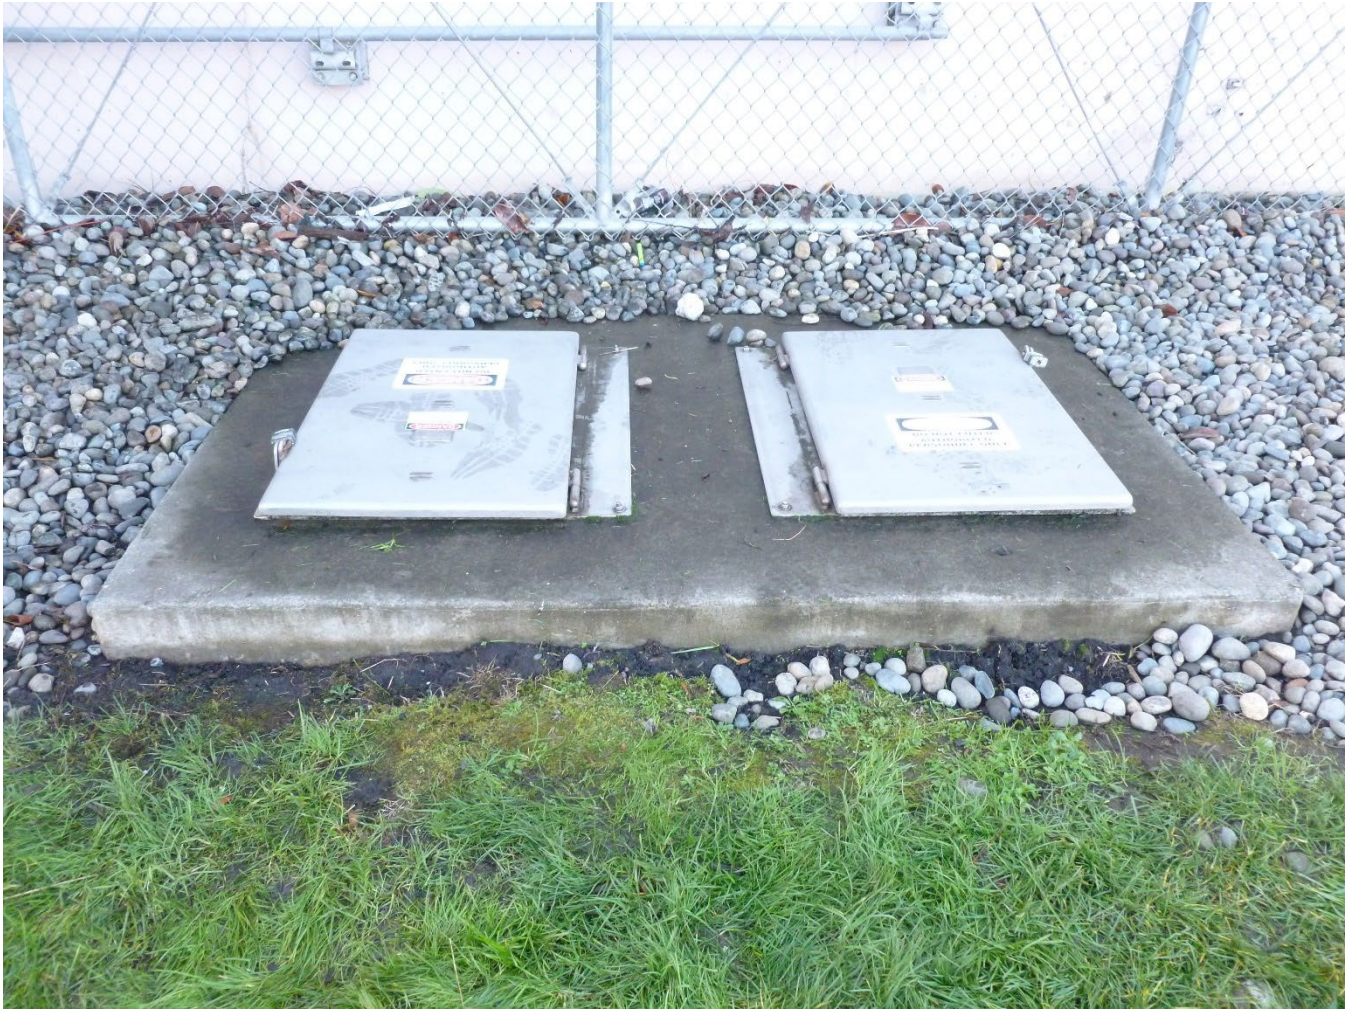
**Photo 2 / P1010154** – Catch Basin 5 Vault, exterior

We headed north back to the office to look at CB-5, which was past the office on Southwest Chehalis Avenue. CB-5 (**Photo 2**) is one of the facility's two sampling points. The facility collects a grab sample from the pipe that extends into the vault (**Photo 3**). The vault outlet (**Photo 4**) drains into the City's stormwater conveyance system. Stormwater collected by CB-5 comes from a strip drain inside the perimeter fence a short distance further to the west of the vault, which collects stormwater from the facility's parking lot and drainage from building rooftops. Prior to water from the rooftops entering CB-5, it is collected and filtered by a passive filtration system (**Photo 5**).

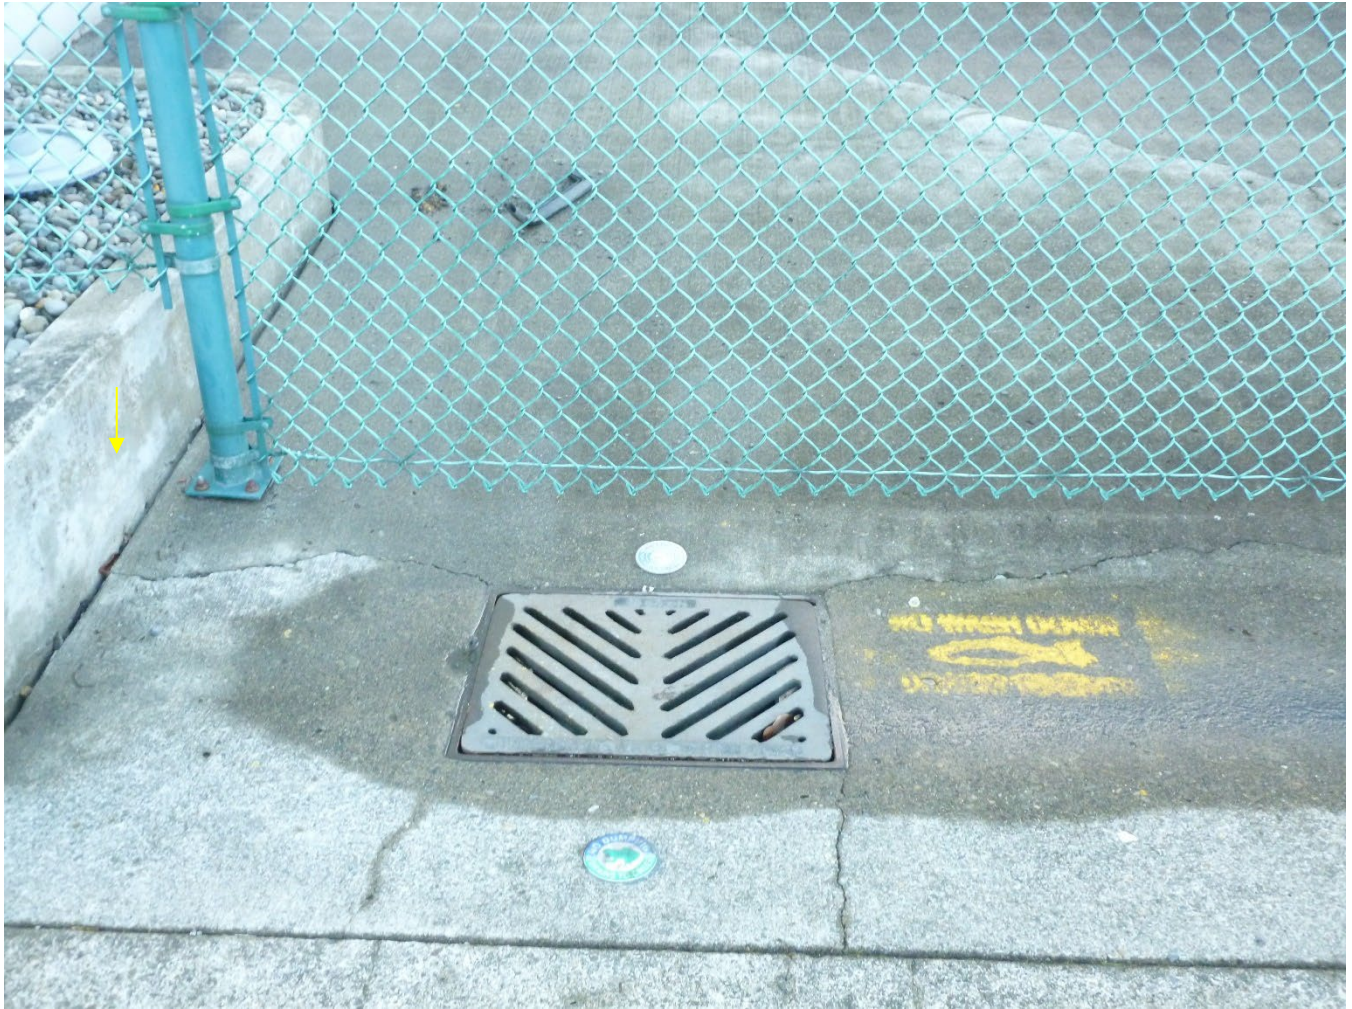
**Photo 6 / P1010157 – Catch Basin 7, sampling point**

We continued heading north to the northern edge of the facility site to CB-7 (**Photo 6**). CB-7 lies outside the site's perimeter fence and is the second point that the facility samples. CB-7 collects stormwater from the north parking lot and the rooftops on the northern side of the site.

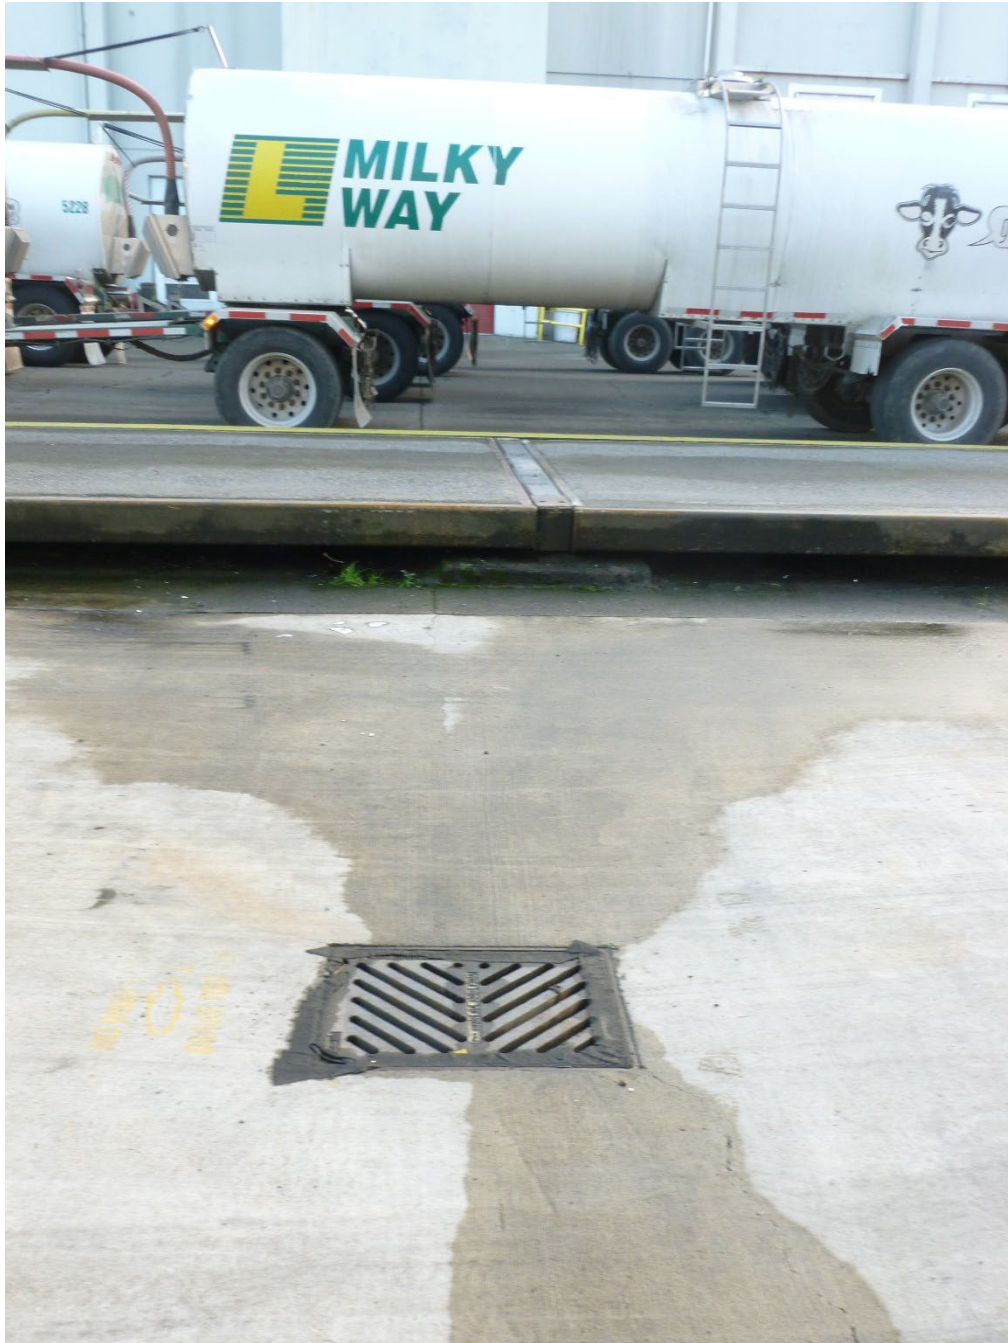
**Photo 7 / P1010160** – Catch Basin 4, facing north

Catch Basins 4 (**Photo 7**), 6 (**Photo 8**), and 8 (**Photo 9**) are all in relatively close proximity. Based on the locations of CB-4, CB-6 & CB-8, and the industrial activity at those locations, it is likely their discharges are substantially identical to CB-7 as claimed by the facility.

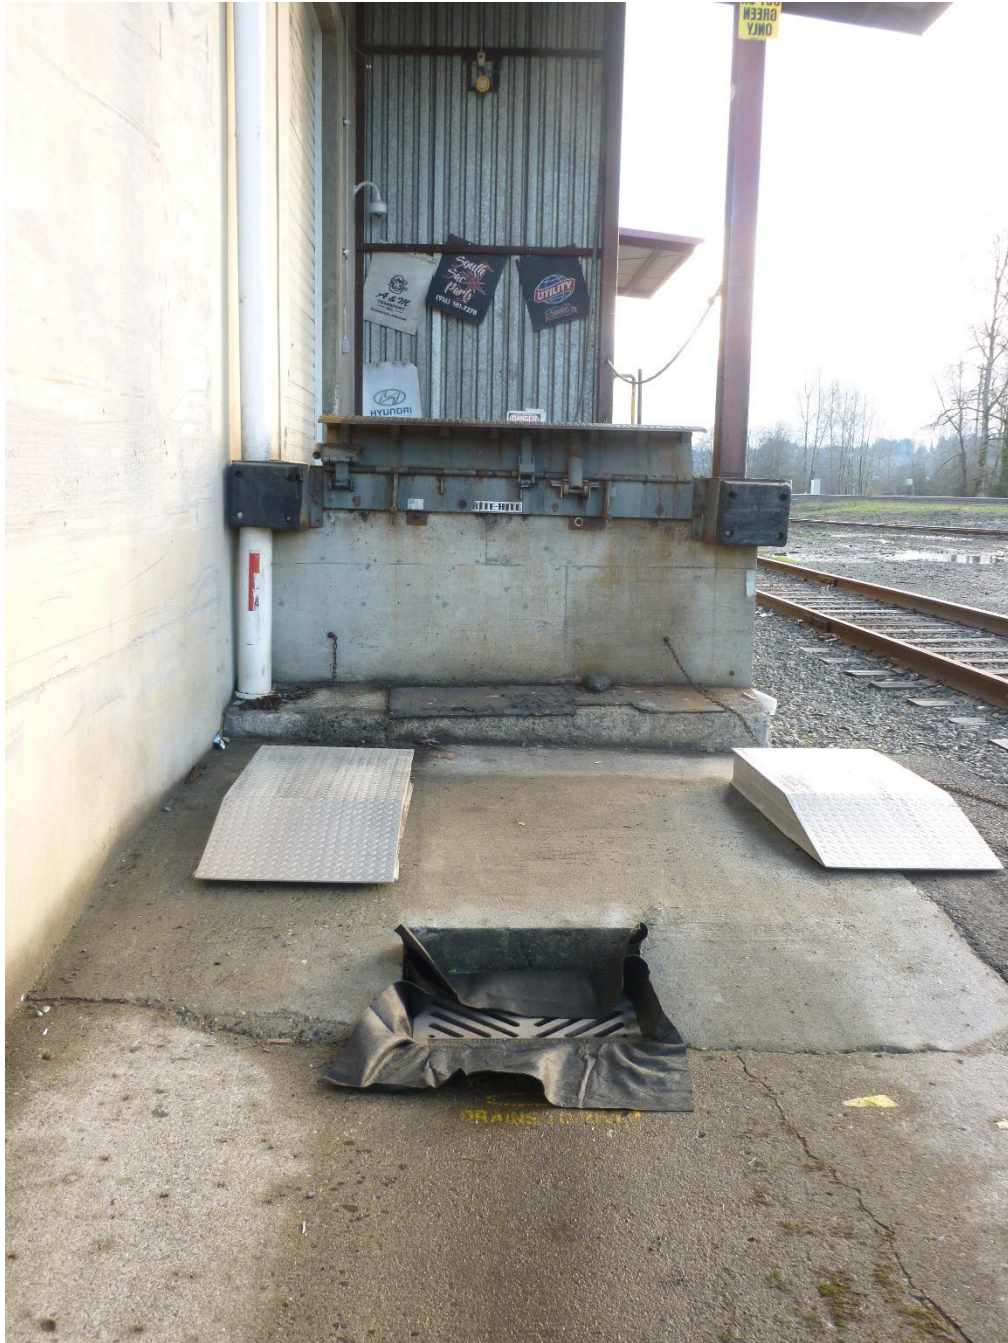
**Photo 10 / P1010161** – Catch Basin 3, facing north

We walked to the west side of facility to CB-3 (**Photos 10 – 12**). The Representatives said CB-3 is not sampled because it is plugged and stormwater drainage is directed to flow to the main stormwater conveyance that runs alongside Southwest Chehalis Avenue into the City's municipal storm sewer system which discharges into Dillenbaugh Creek, a tributary of the Chehalis River.

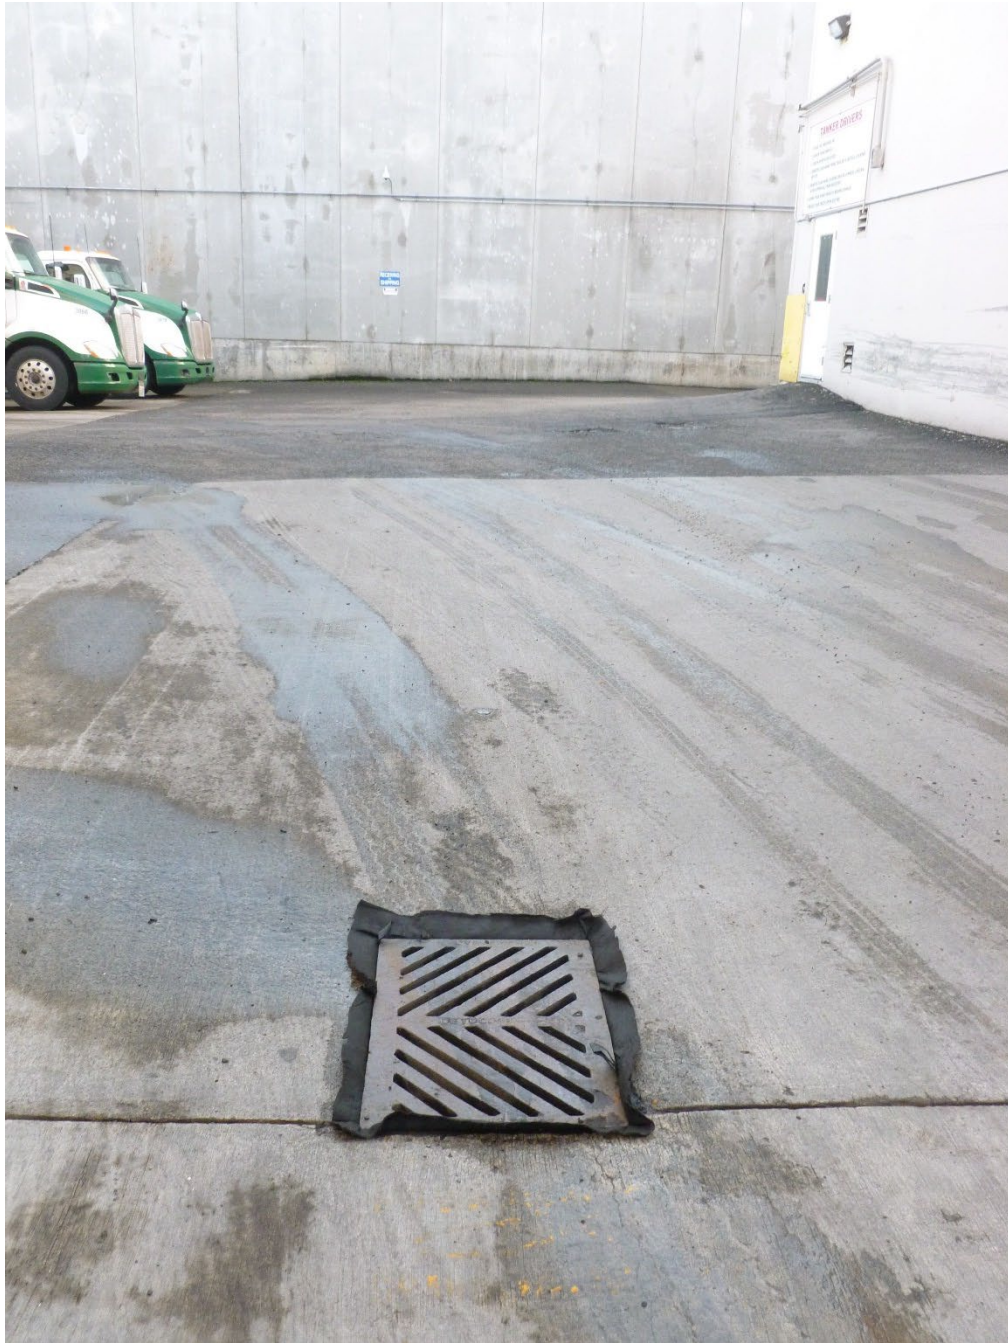
**Photo 13 / P1010165** – Catch Basin 2, facing north

We ended the industrial stormwater site inspection at CB-2 (**Photo 13**), which lies southwest of CB-3 and is the final Catch Basin associated with industrial stormwater management. Based on the location of CB-2 and the industrial activity nearby, it is likely that its discharge is substantially identical to CB-5 as claimed by the facility.
