**Region 6 - Enforcement & Compliance Assurance Division**  
**INSPECTION REPORT**

| Inspection Date(s): | June 26 – 29, 2023 | |
| Regulatory Program(s) | Large Quantity Generator | |
| Facility Name: | <b>Quala Rail and Specialty</b> | |

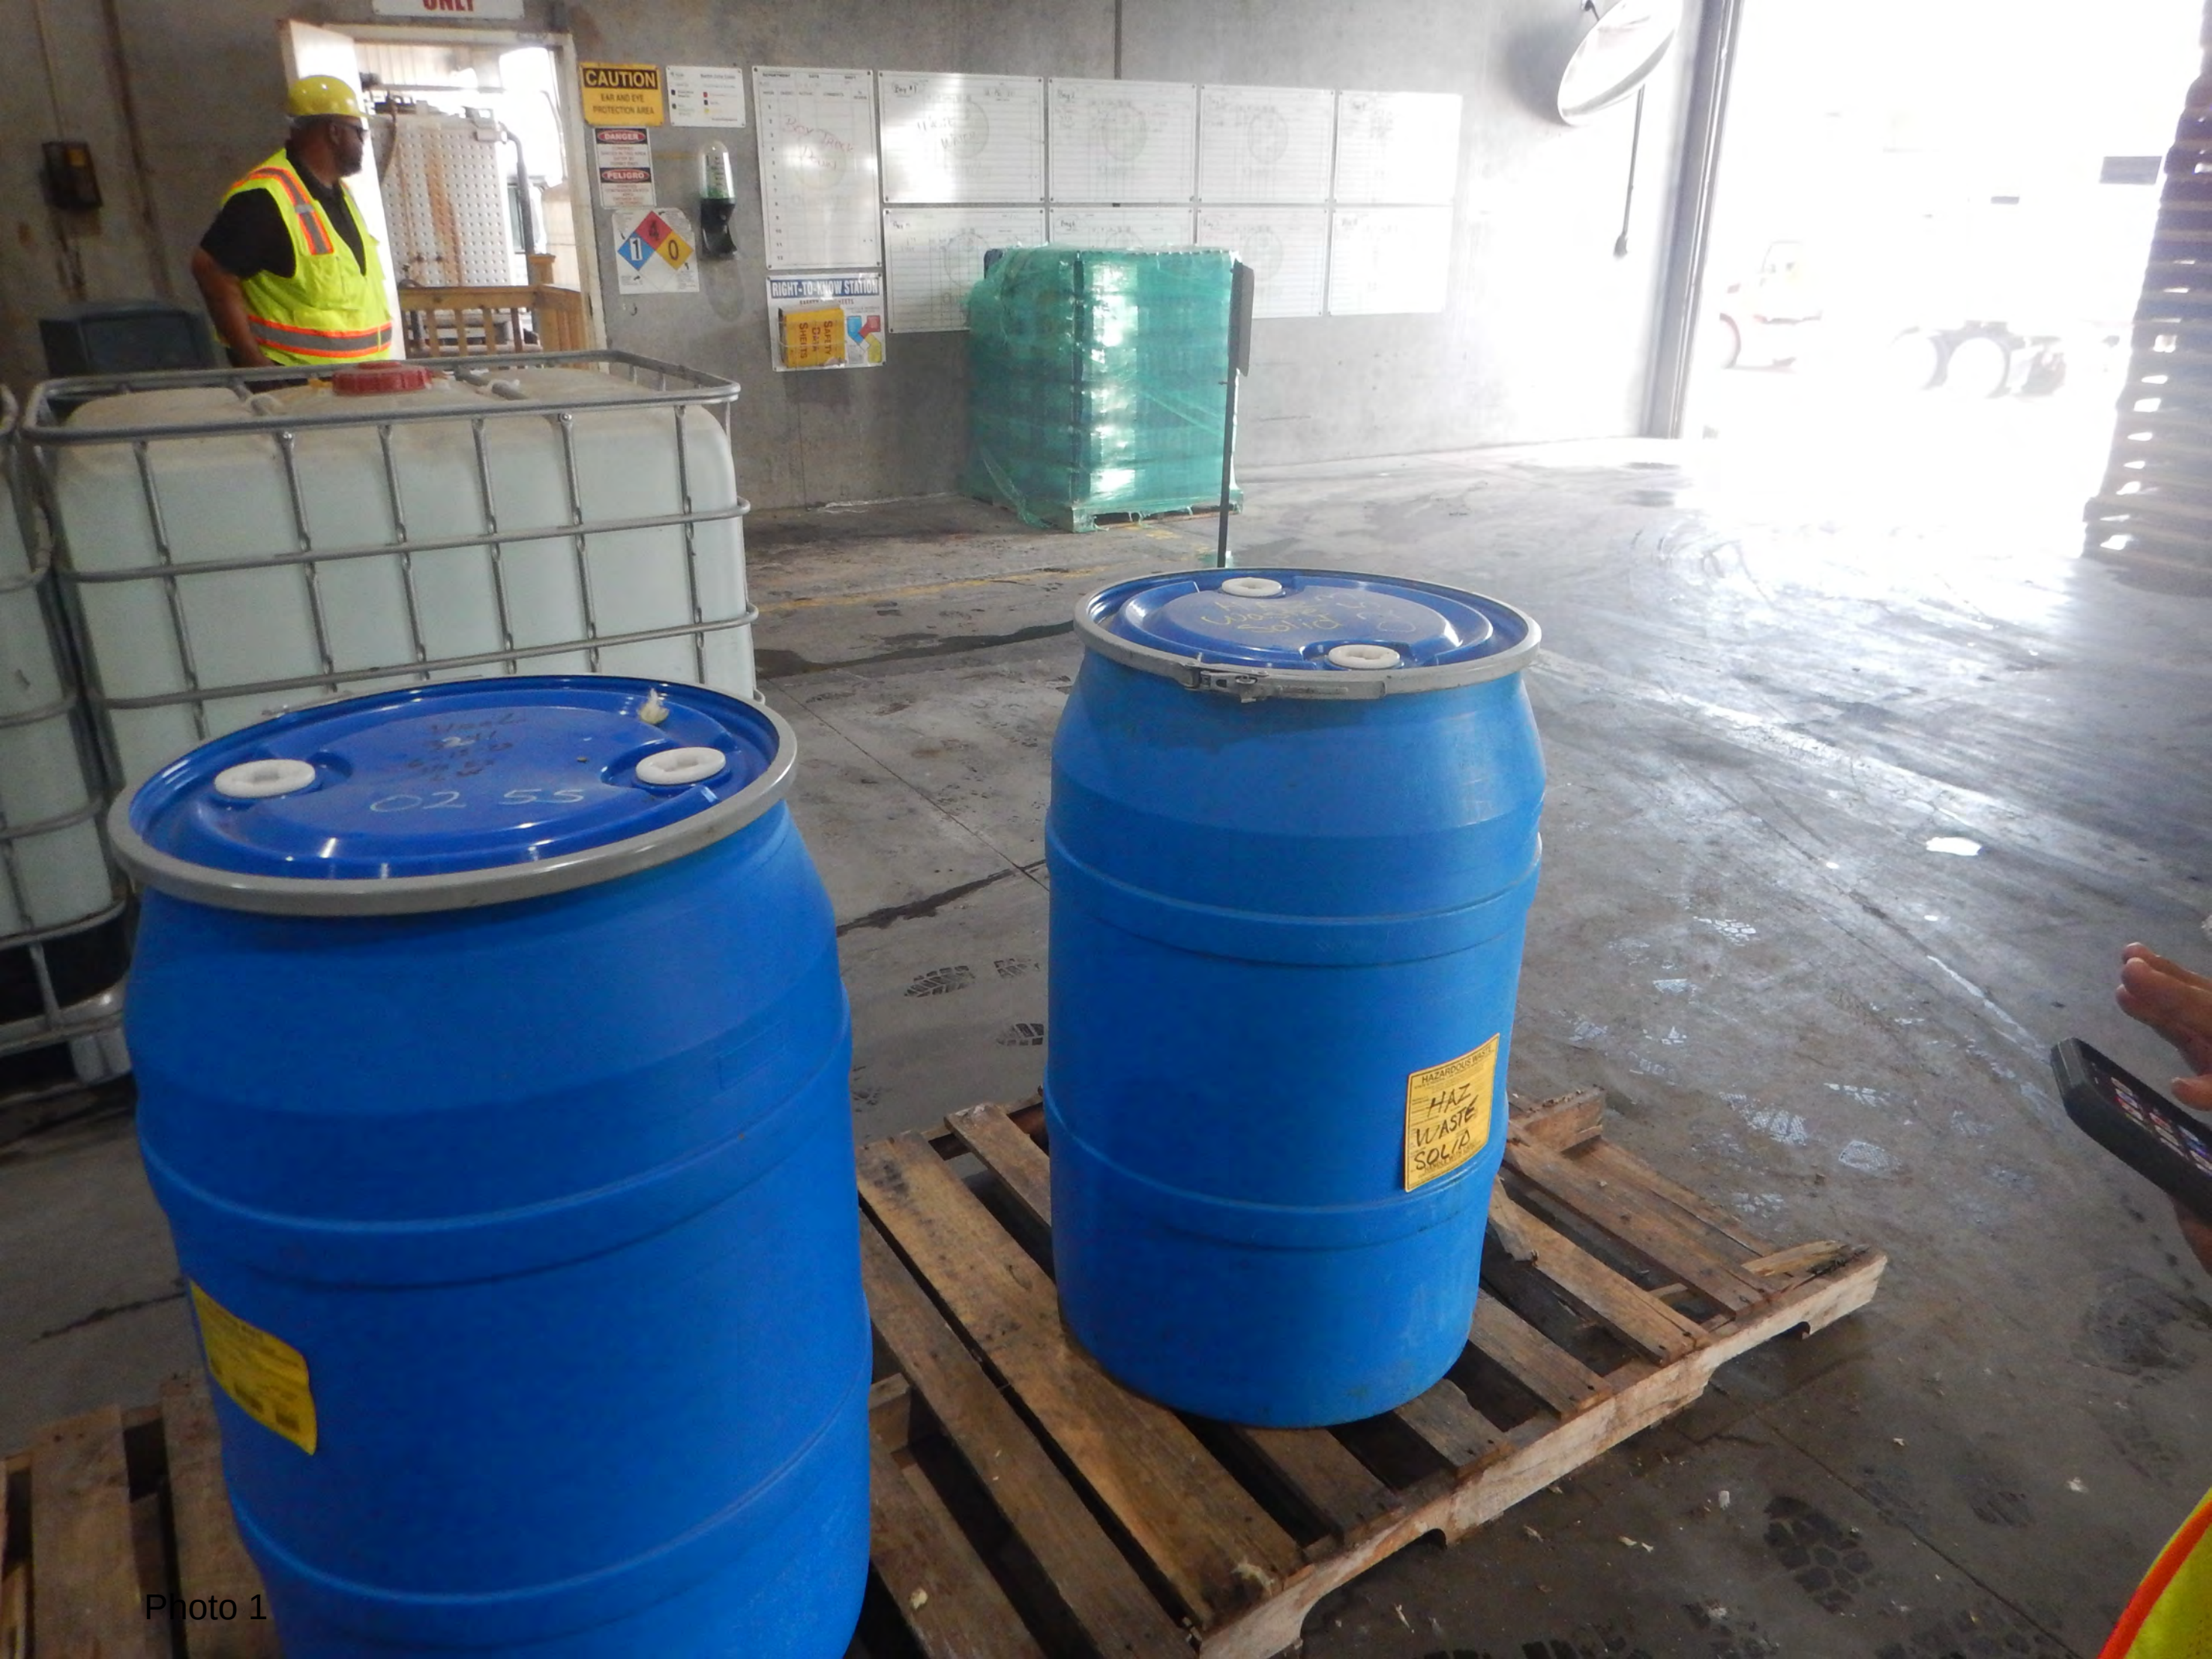
Photo 1

- On June 26, 2023, we found one 55-gallon drum of hazardous waste solids from the cleaning of tanker trailers missing an accumulation start date. This container was in the hazardous waste container central accumulation area (WMU 008). See photos 1 through 5.

| Photo Number | File Name | | Date | Time | Photographer | Description |
|---|---|---|---|---|---|---|
| 1 | DSCN1059 | .JPG | 26-Jun-23 | 1047 | John Penland | 55-gallon drum of hazardous waste solids from the cleaning of tanker trailers. Missing Accumulation Start Date. |

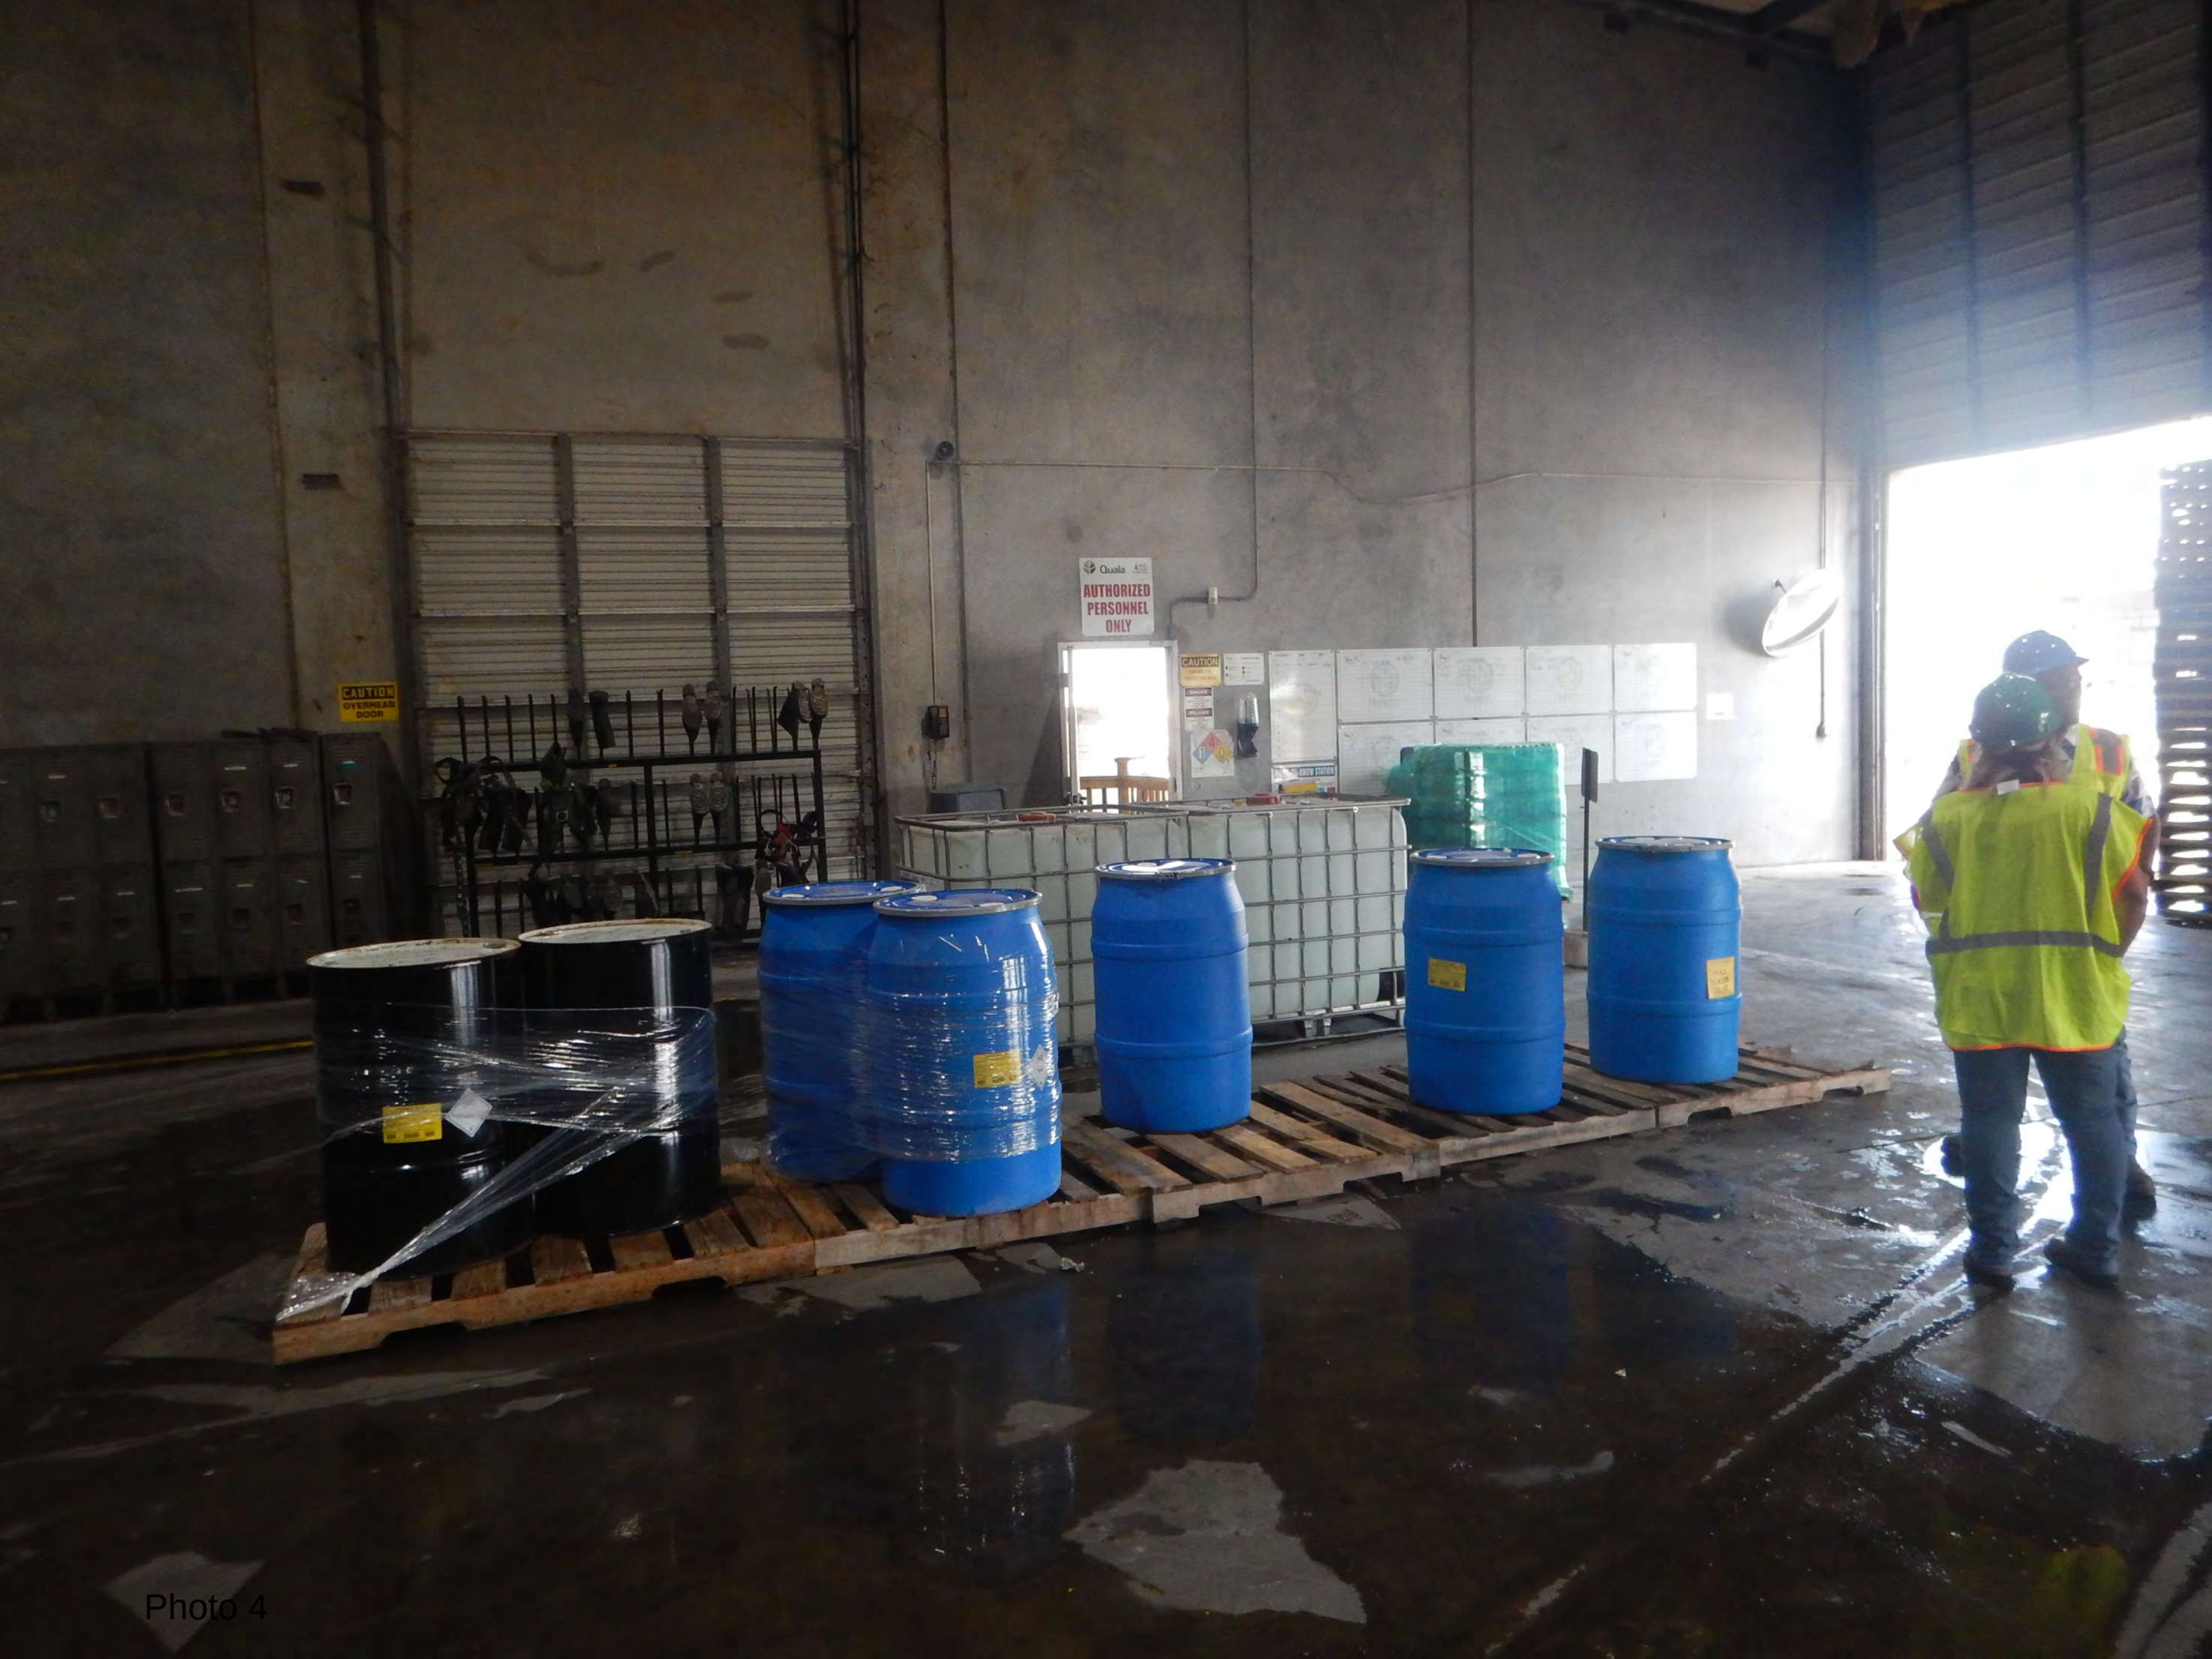
Photo 4

| Photo Number | File Name | | Date | Time | Photographer | Description |
|---|---|---|---|---|---|---|
| 4 | DSCN1062 | .JPG | 26-Jun-23 | 1048 | John Penland | Hazardous waste containers located on western side of the Central Accumulation Area (WMU 008). Includes drum in photos 1-3 |

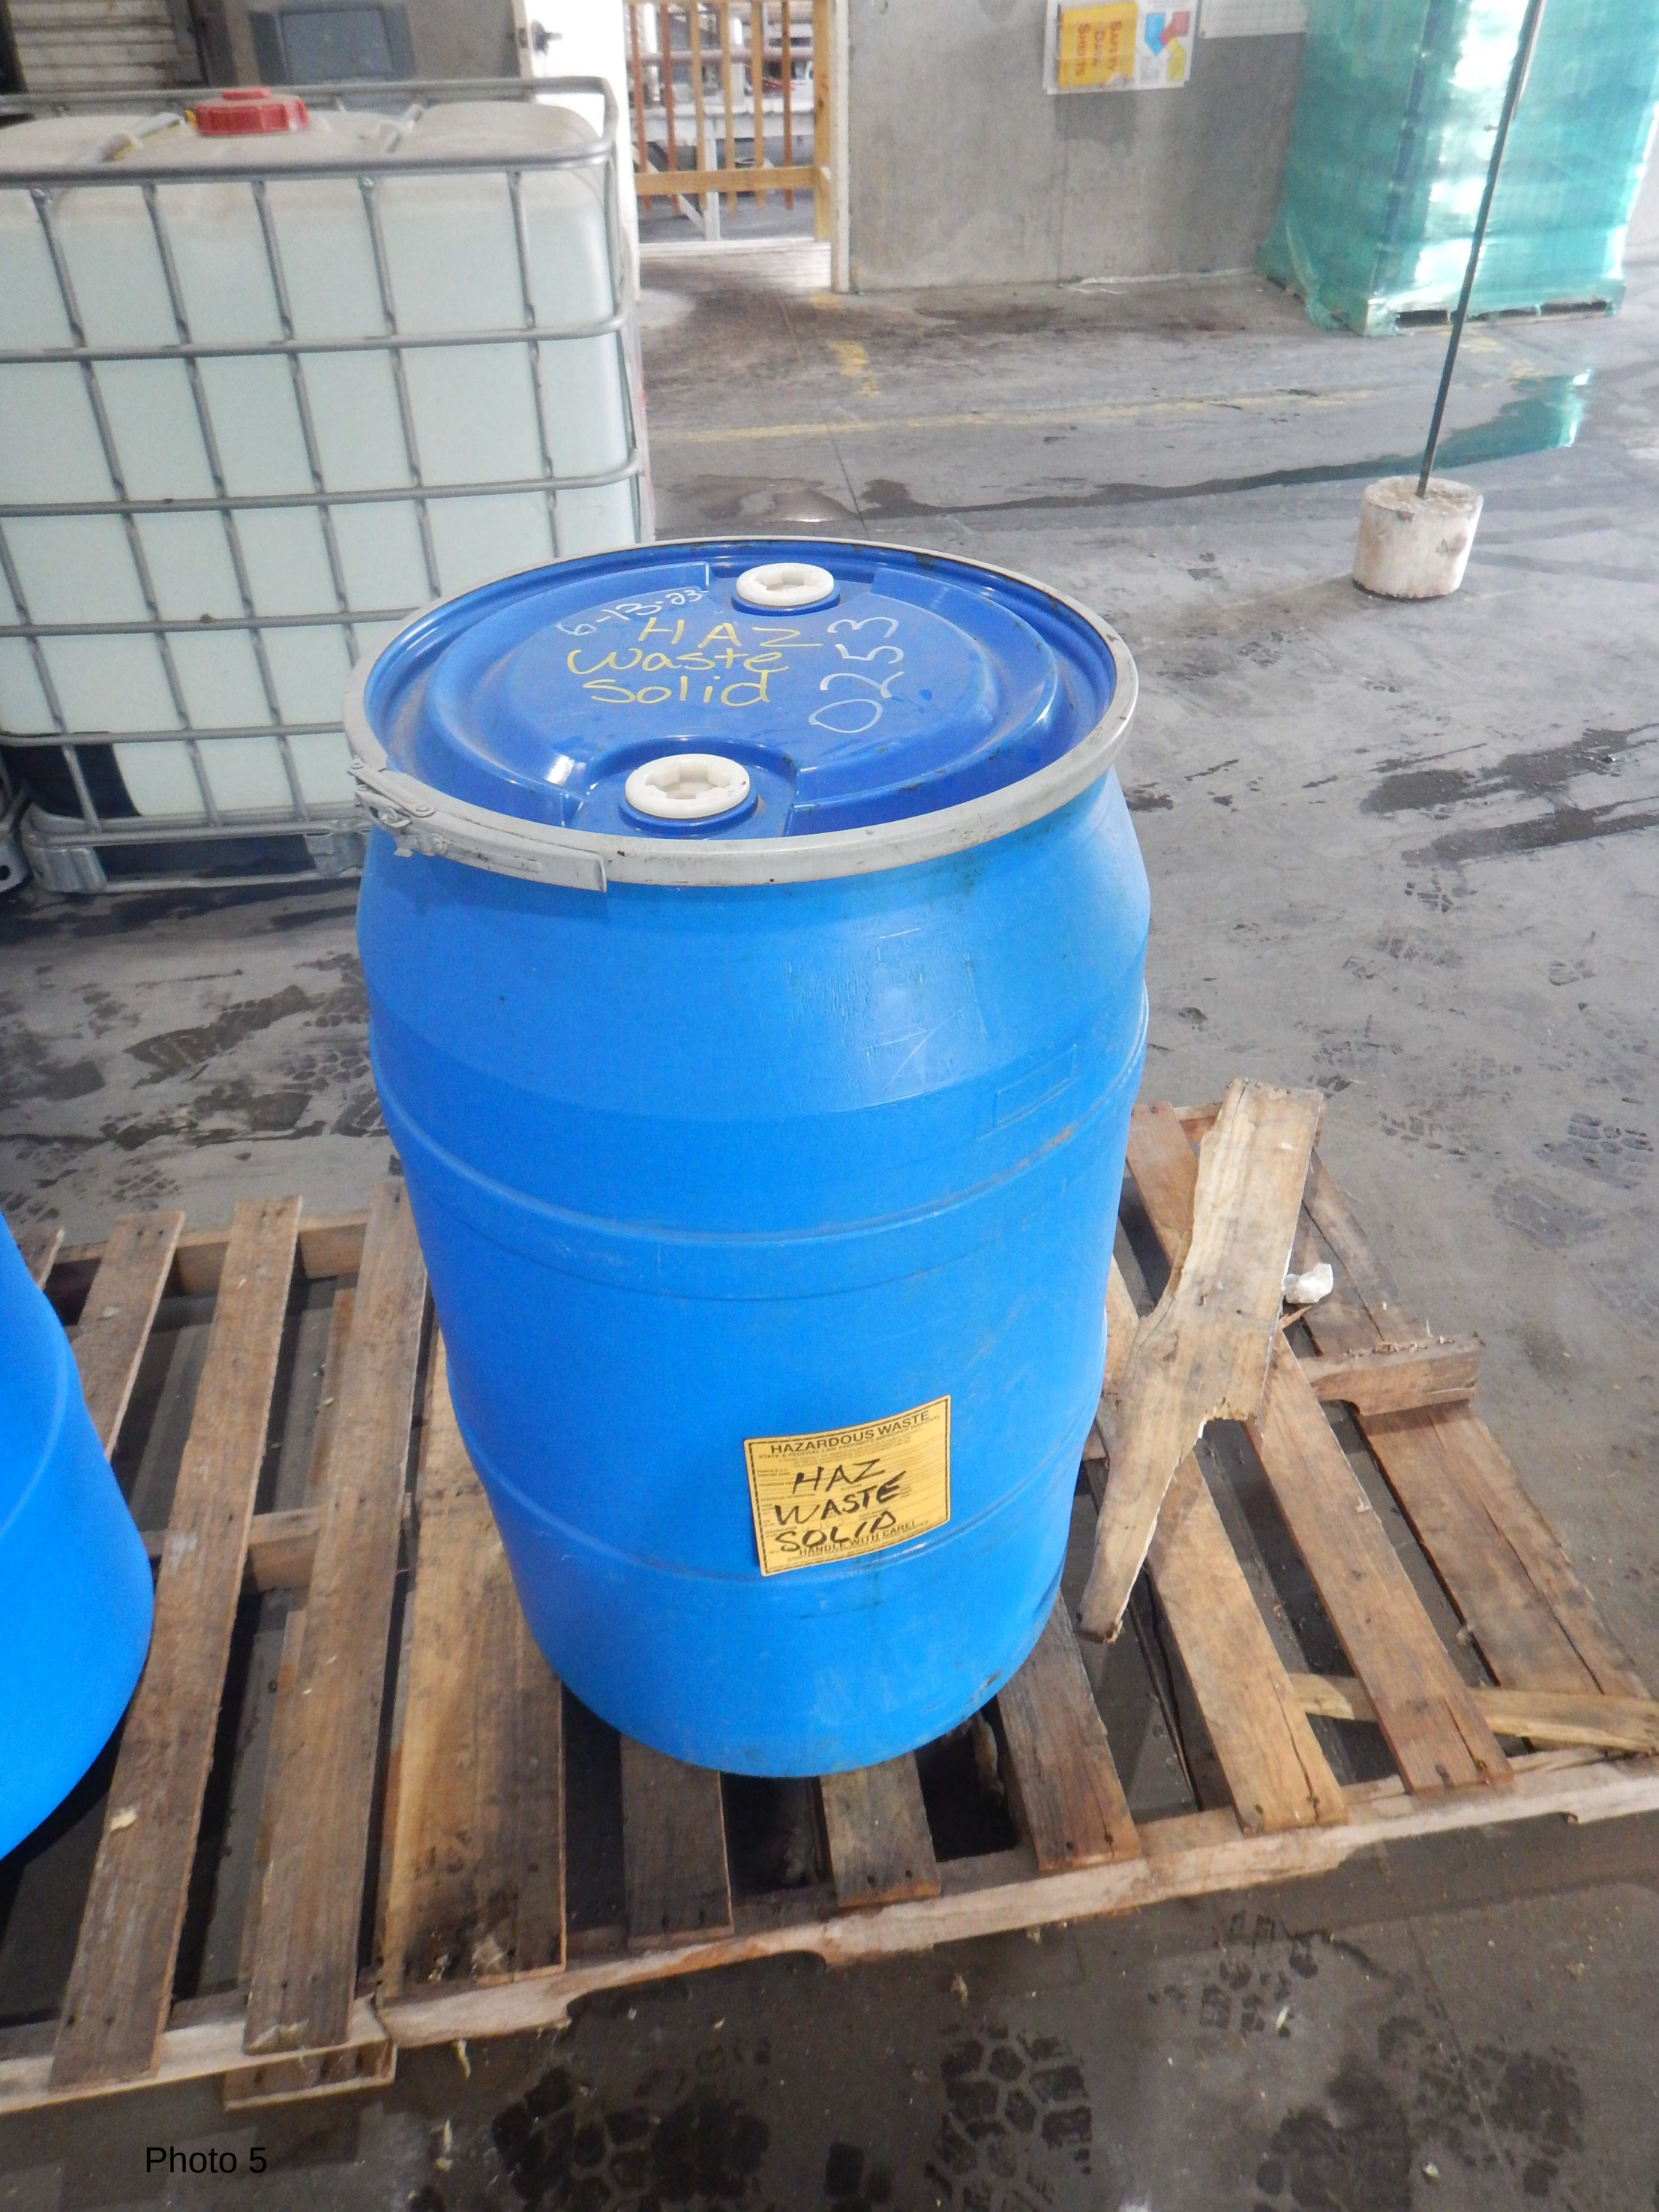
Photo 5

| Photo Number | File Name | | Date | Time | Photographer | Description |
|---|---|---|---|---|---|---|
| 5 | DSCN1063 | .JPG | 26-Jun-23 | 1052 | John Penland | Correction Photo: Drum of hazardous waste solids from the cleaning of tanker trailers. Accumulation Start Date added to lid with wax pencil. |

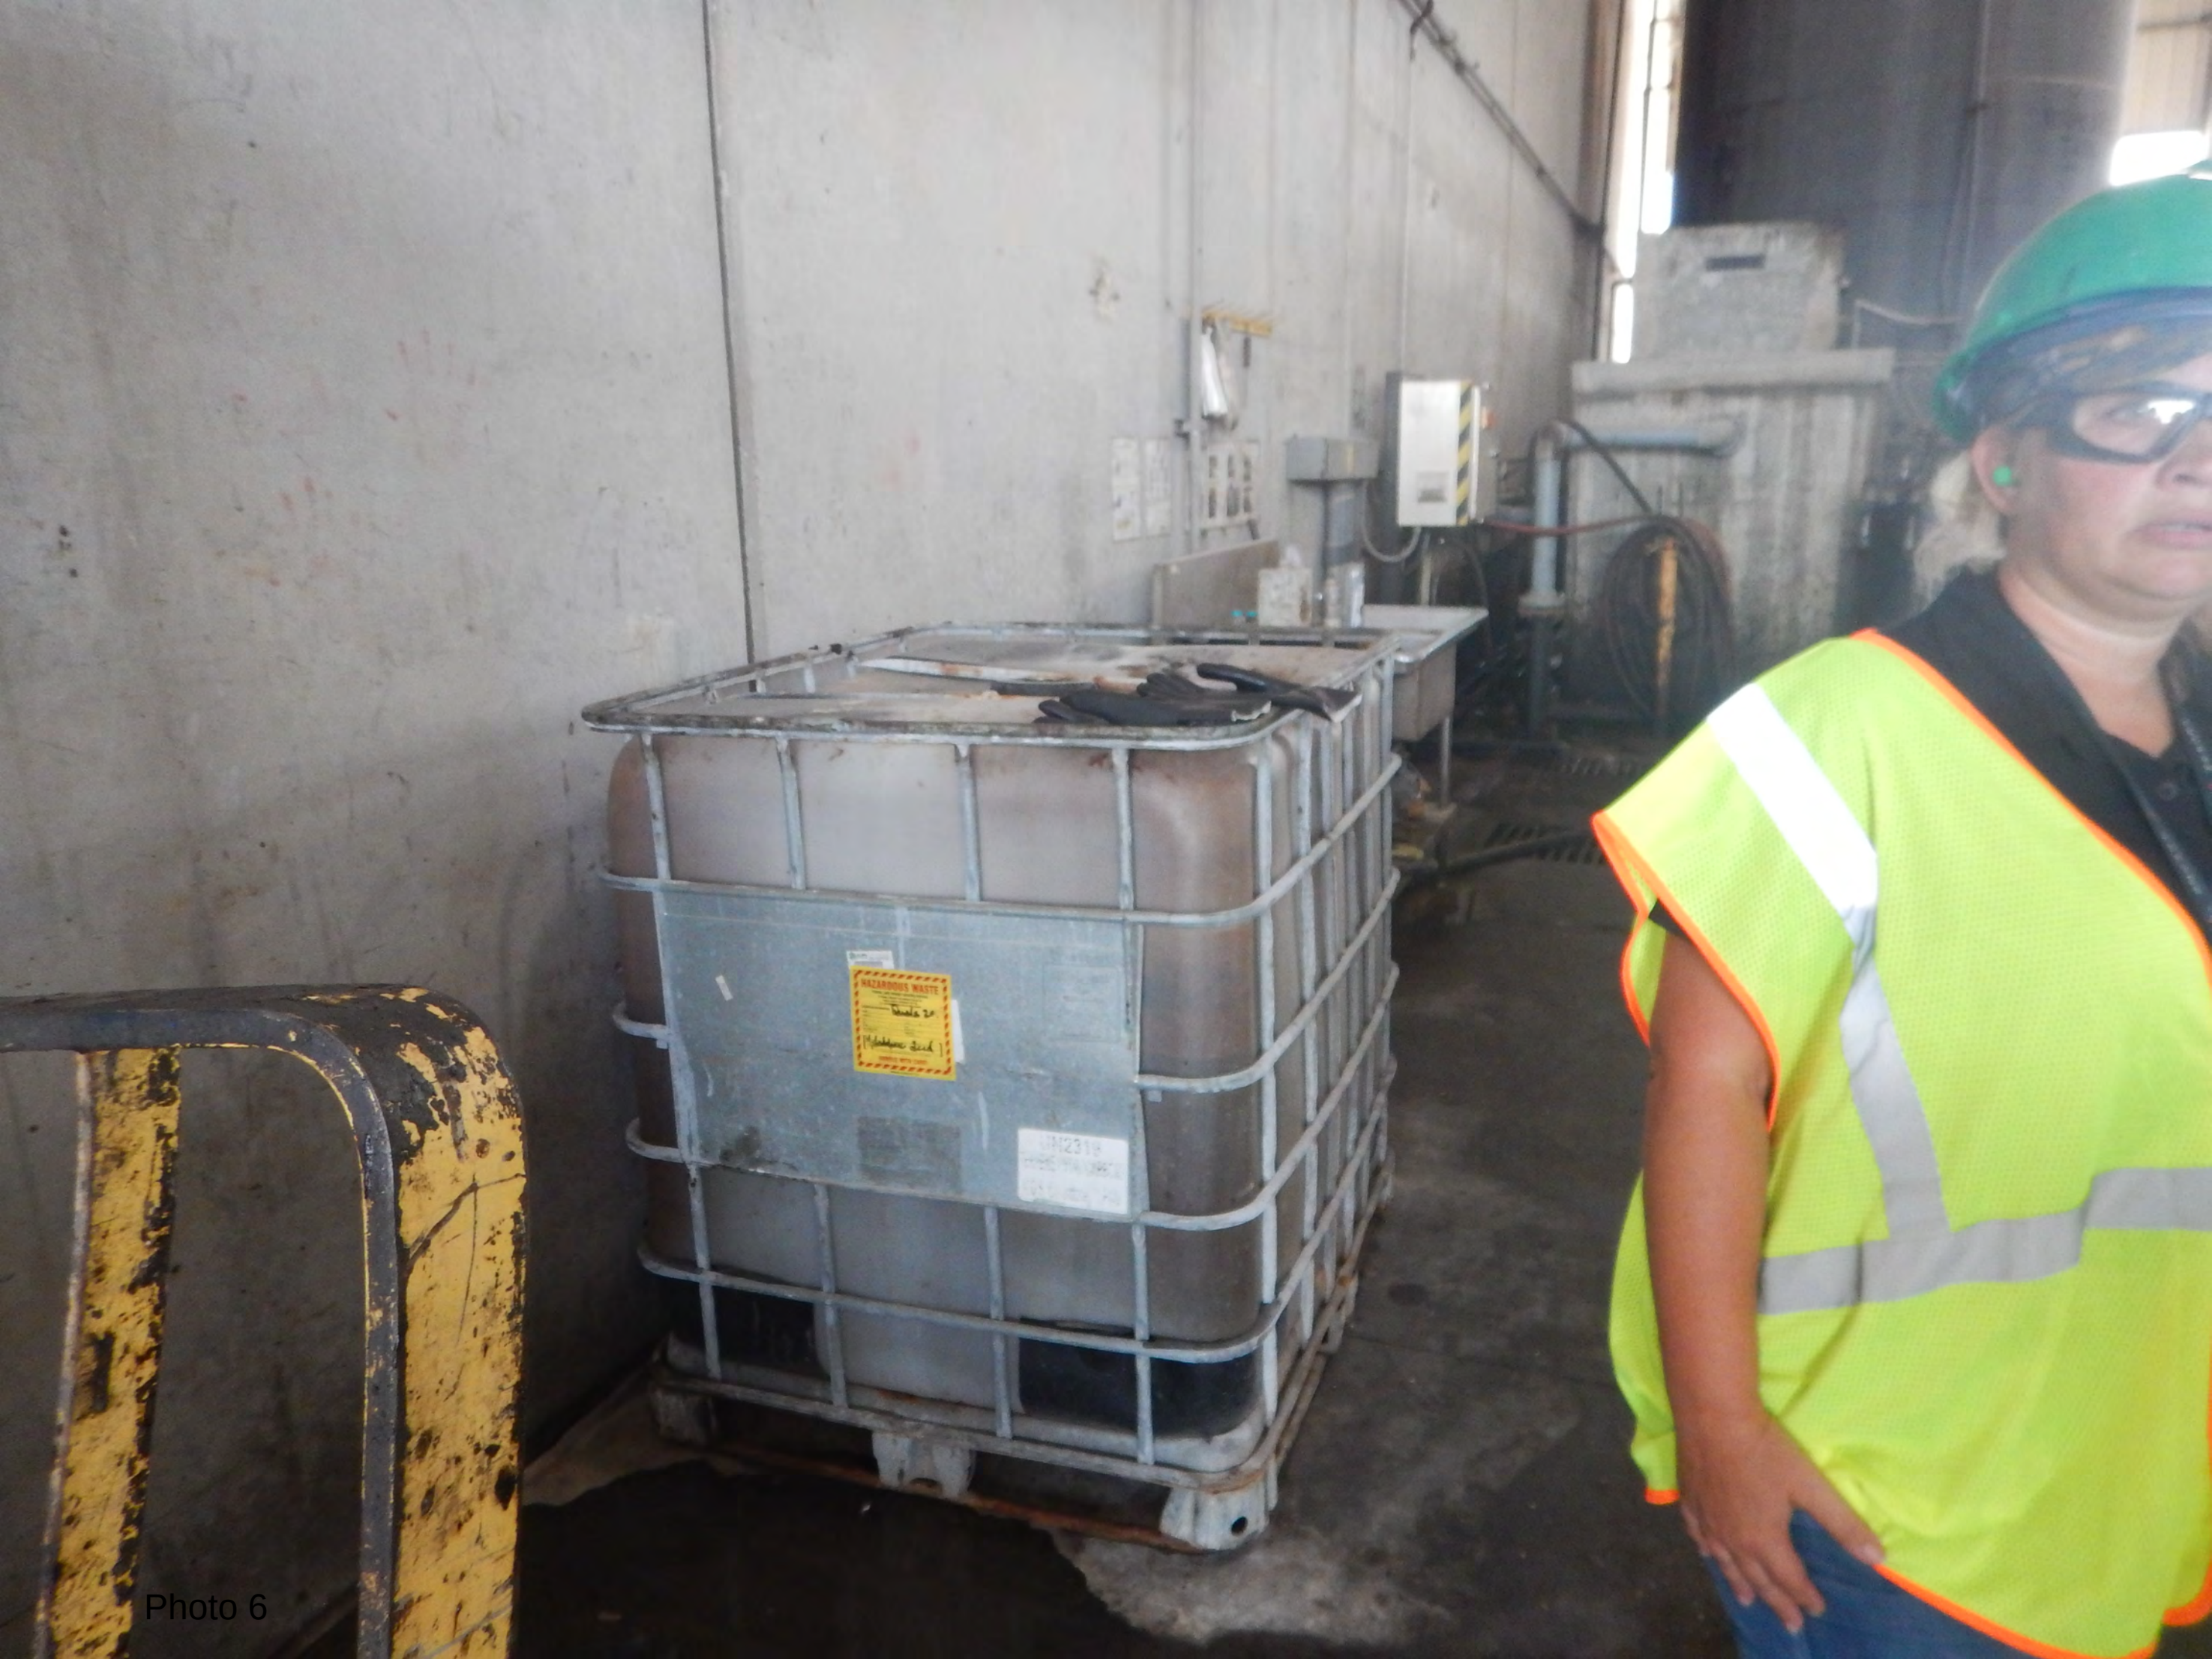
Photo 6

| Photo Number | File Name | | Date | Time | Photographer | Description |
|---|---|---|---|---|---|---|
| 6 | DSCN1064 | .JPG | 26-Jun-23 | 1111 | John Penland | Container of hydrochloric acid used for pH adjustment in the trailer wash wastewater treatment system. Container was determined to contain unused product. Operators inadvertently used a hazardous waste label on this container |

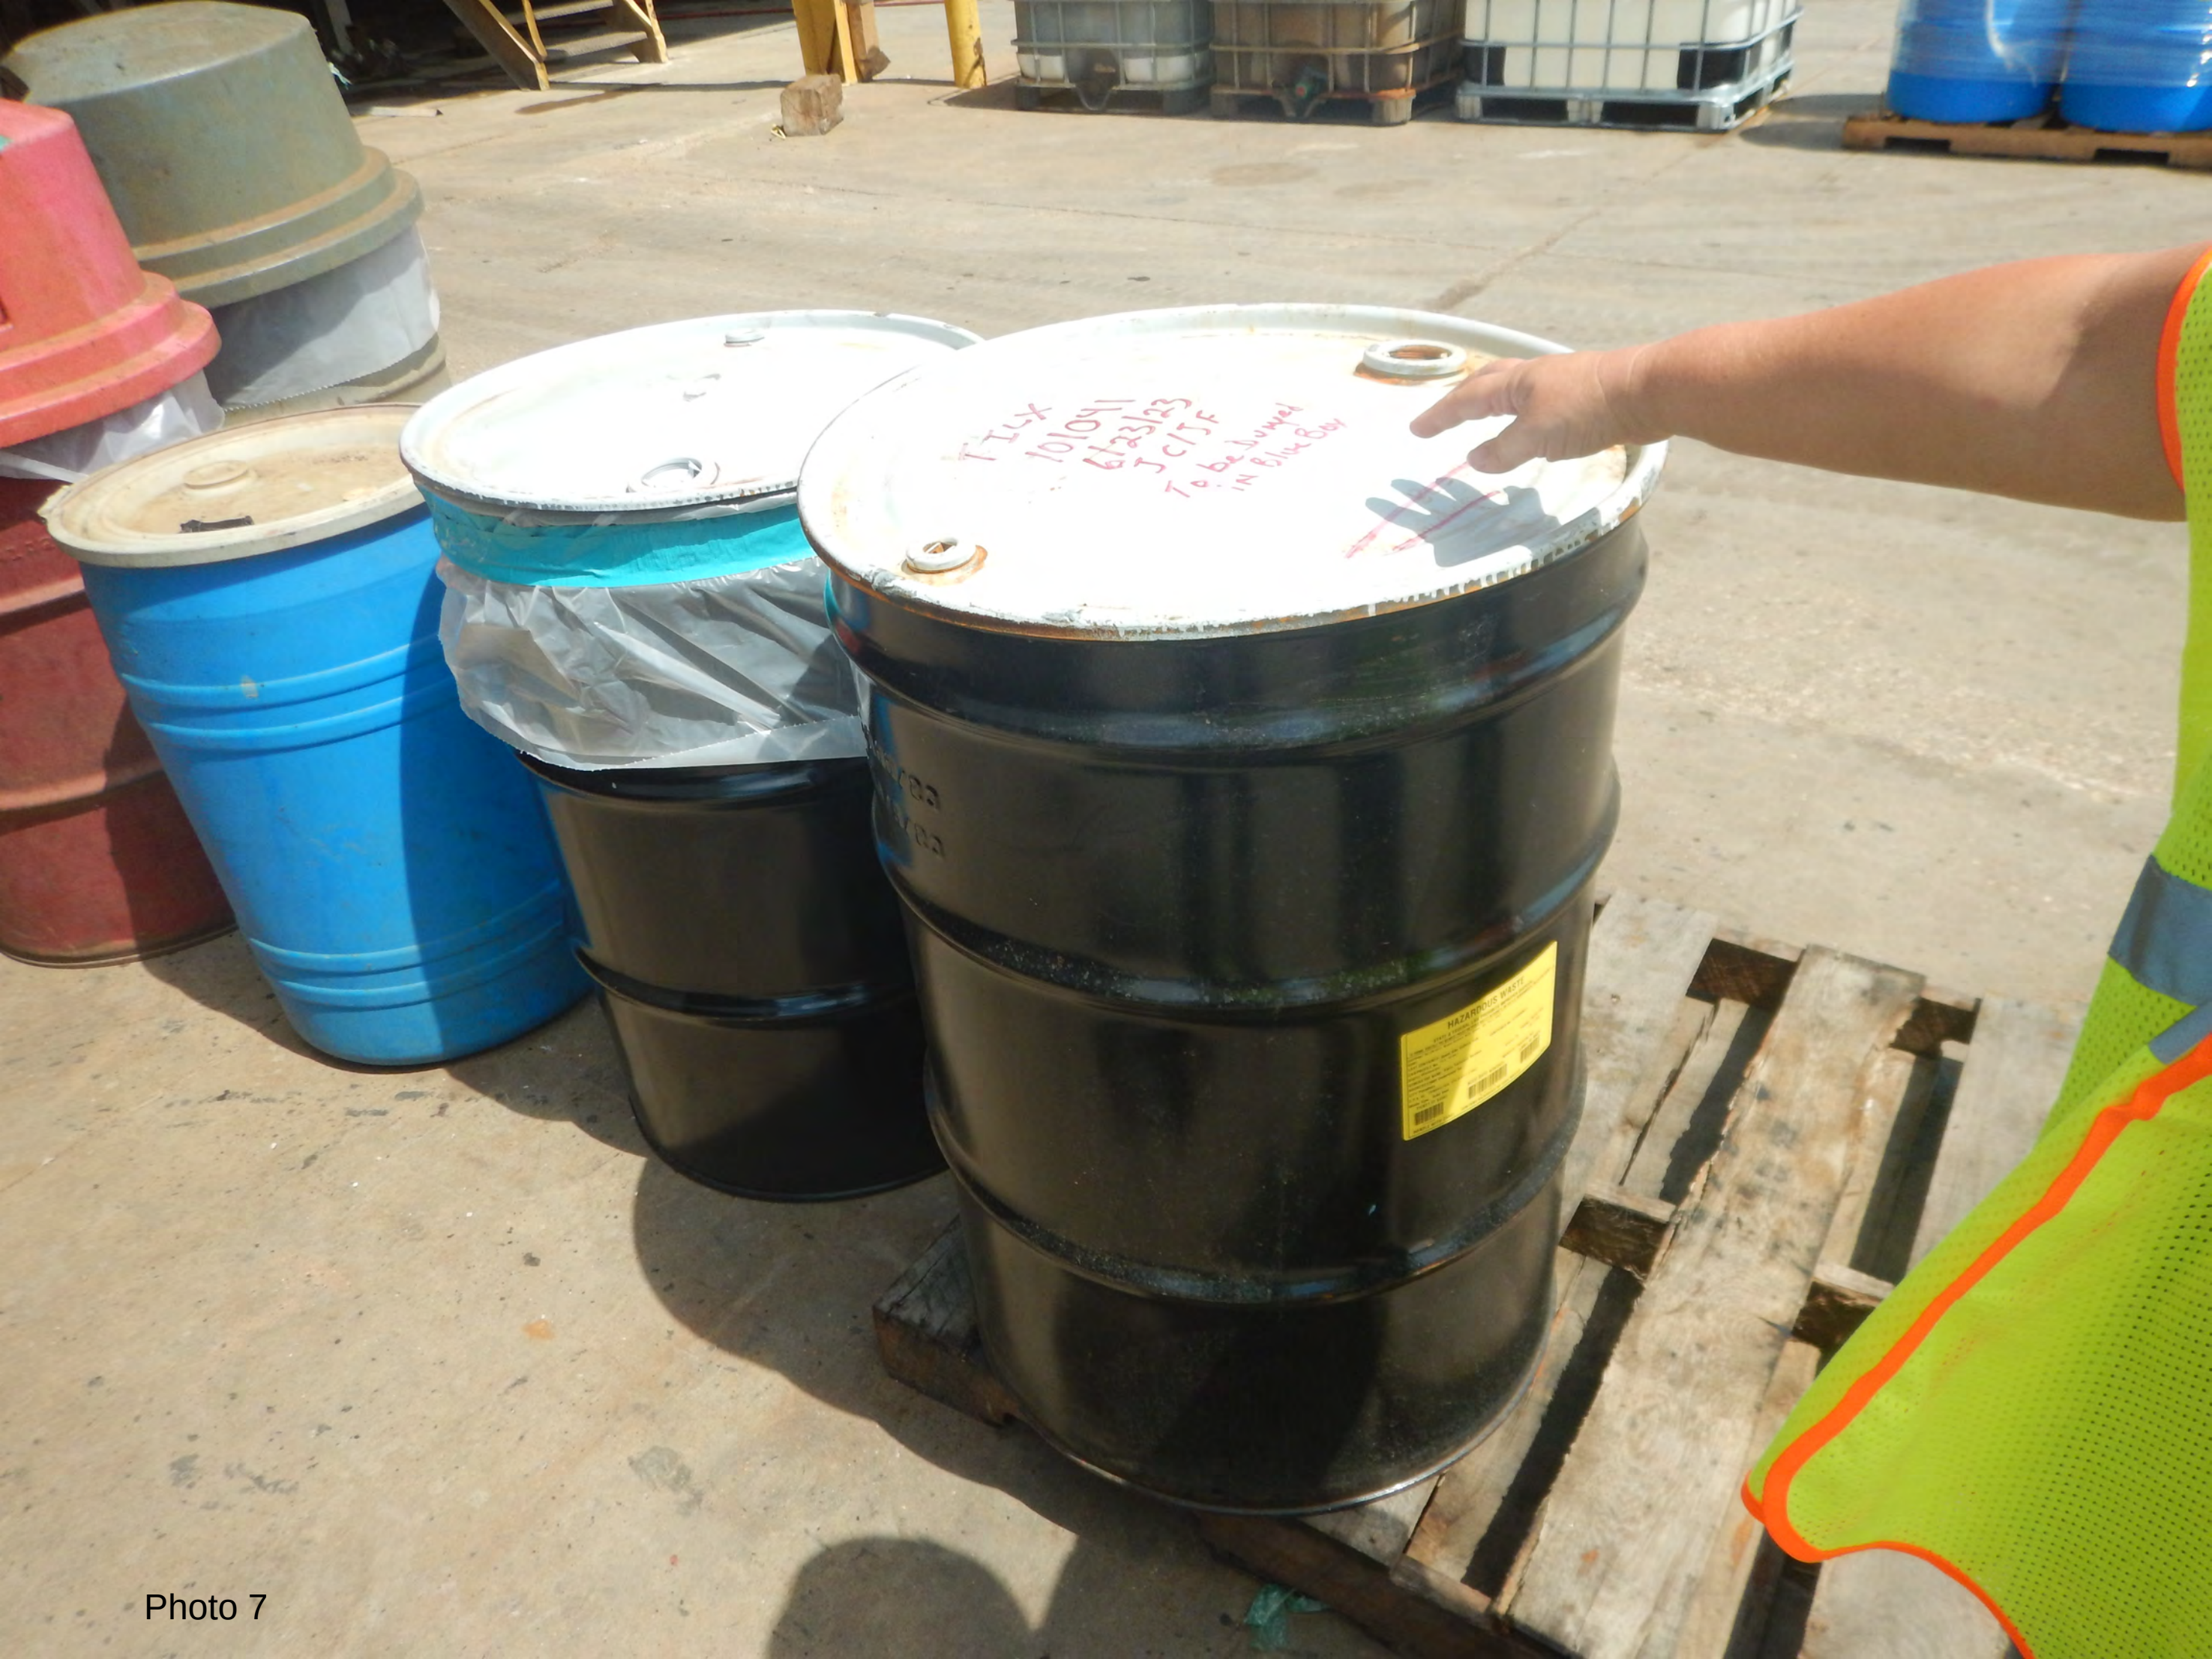
Photo 7

- On June 26, 2023, we found one open 55-gallon drum of alkylsulfuric acid residues in the rail and specialty wash area. See photos 7 and 8.
- On June 26, 2023, we found one open 55-gallon drum of “solid heel” in the rail and specialty wash area. See photos 23, 24, and 29.
- On June 26, 2023, we found one open 275-gallon tote of liquid hazardous waste residue in the rail and specialty wash area. See photo 25.
- On June 27, 2023, we found one open 55-gallon drum of hazardous waste in the trailer wash area. See photo 41.
- On June 27, 2023, we found one open 275-gallon tote of hazardous waste in the trailer wash area. See photo 42 and 43.

| Photo Number | File Name | | Date | Time | Photographer | Description |
|---|---|---|---|---|---|---|
| 7 | DSCN1065 | .JPG | 26-Jun-23 | 1128 | John Penland | Container of hazardous waste alkylsulfuric acid residues located at the rail and specialty wash area. Container was found open at the time of inspection. |
