**Region 6 - Enforcement & Compliance Assurance Division**  
**INSPECTION REPORT**

| Inspection Date(s): | June 26 – 29, 2023 | |
| Regulatory Program(s) | Large Quantity Generator | |
| Facility Name: | <b>Quala Rail and Specialty</b> | |

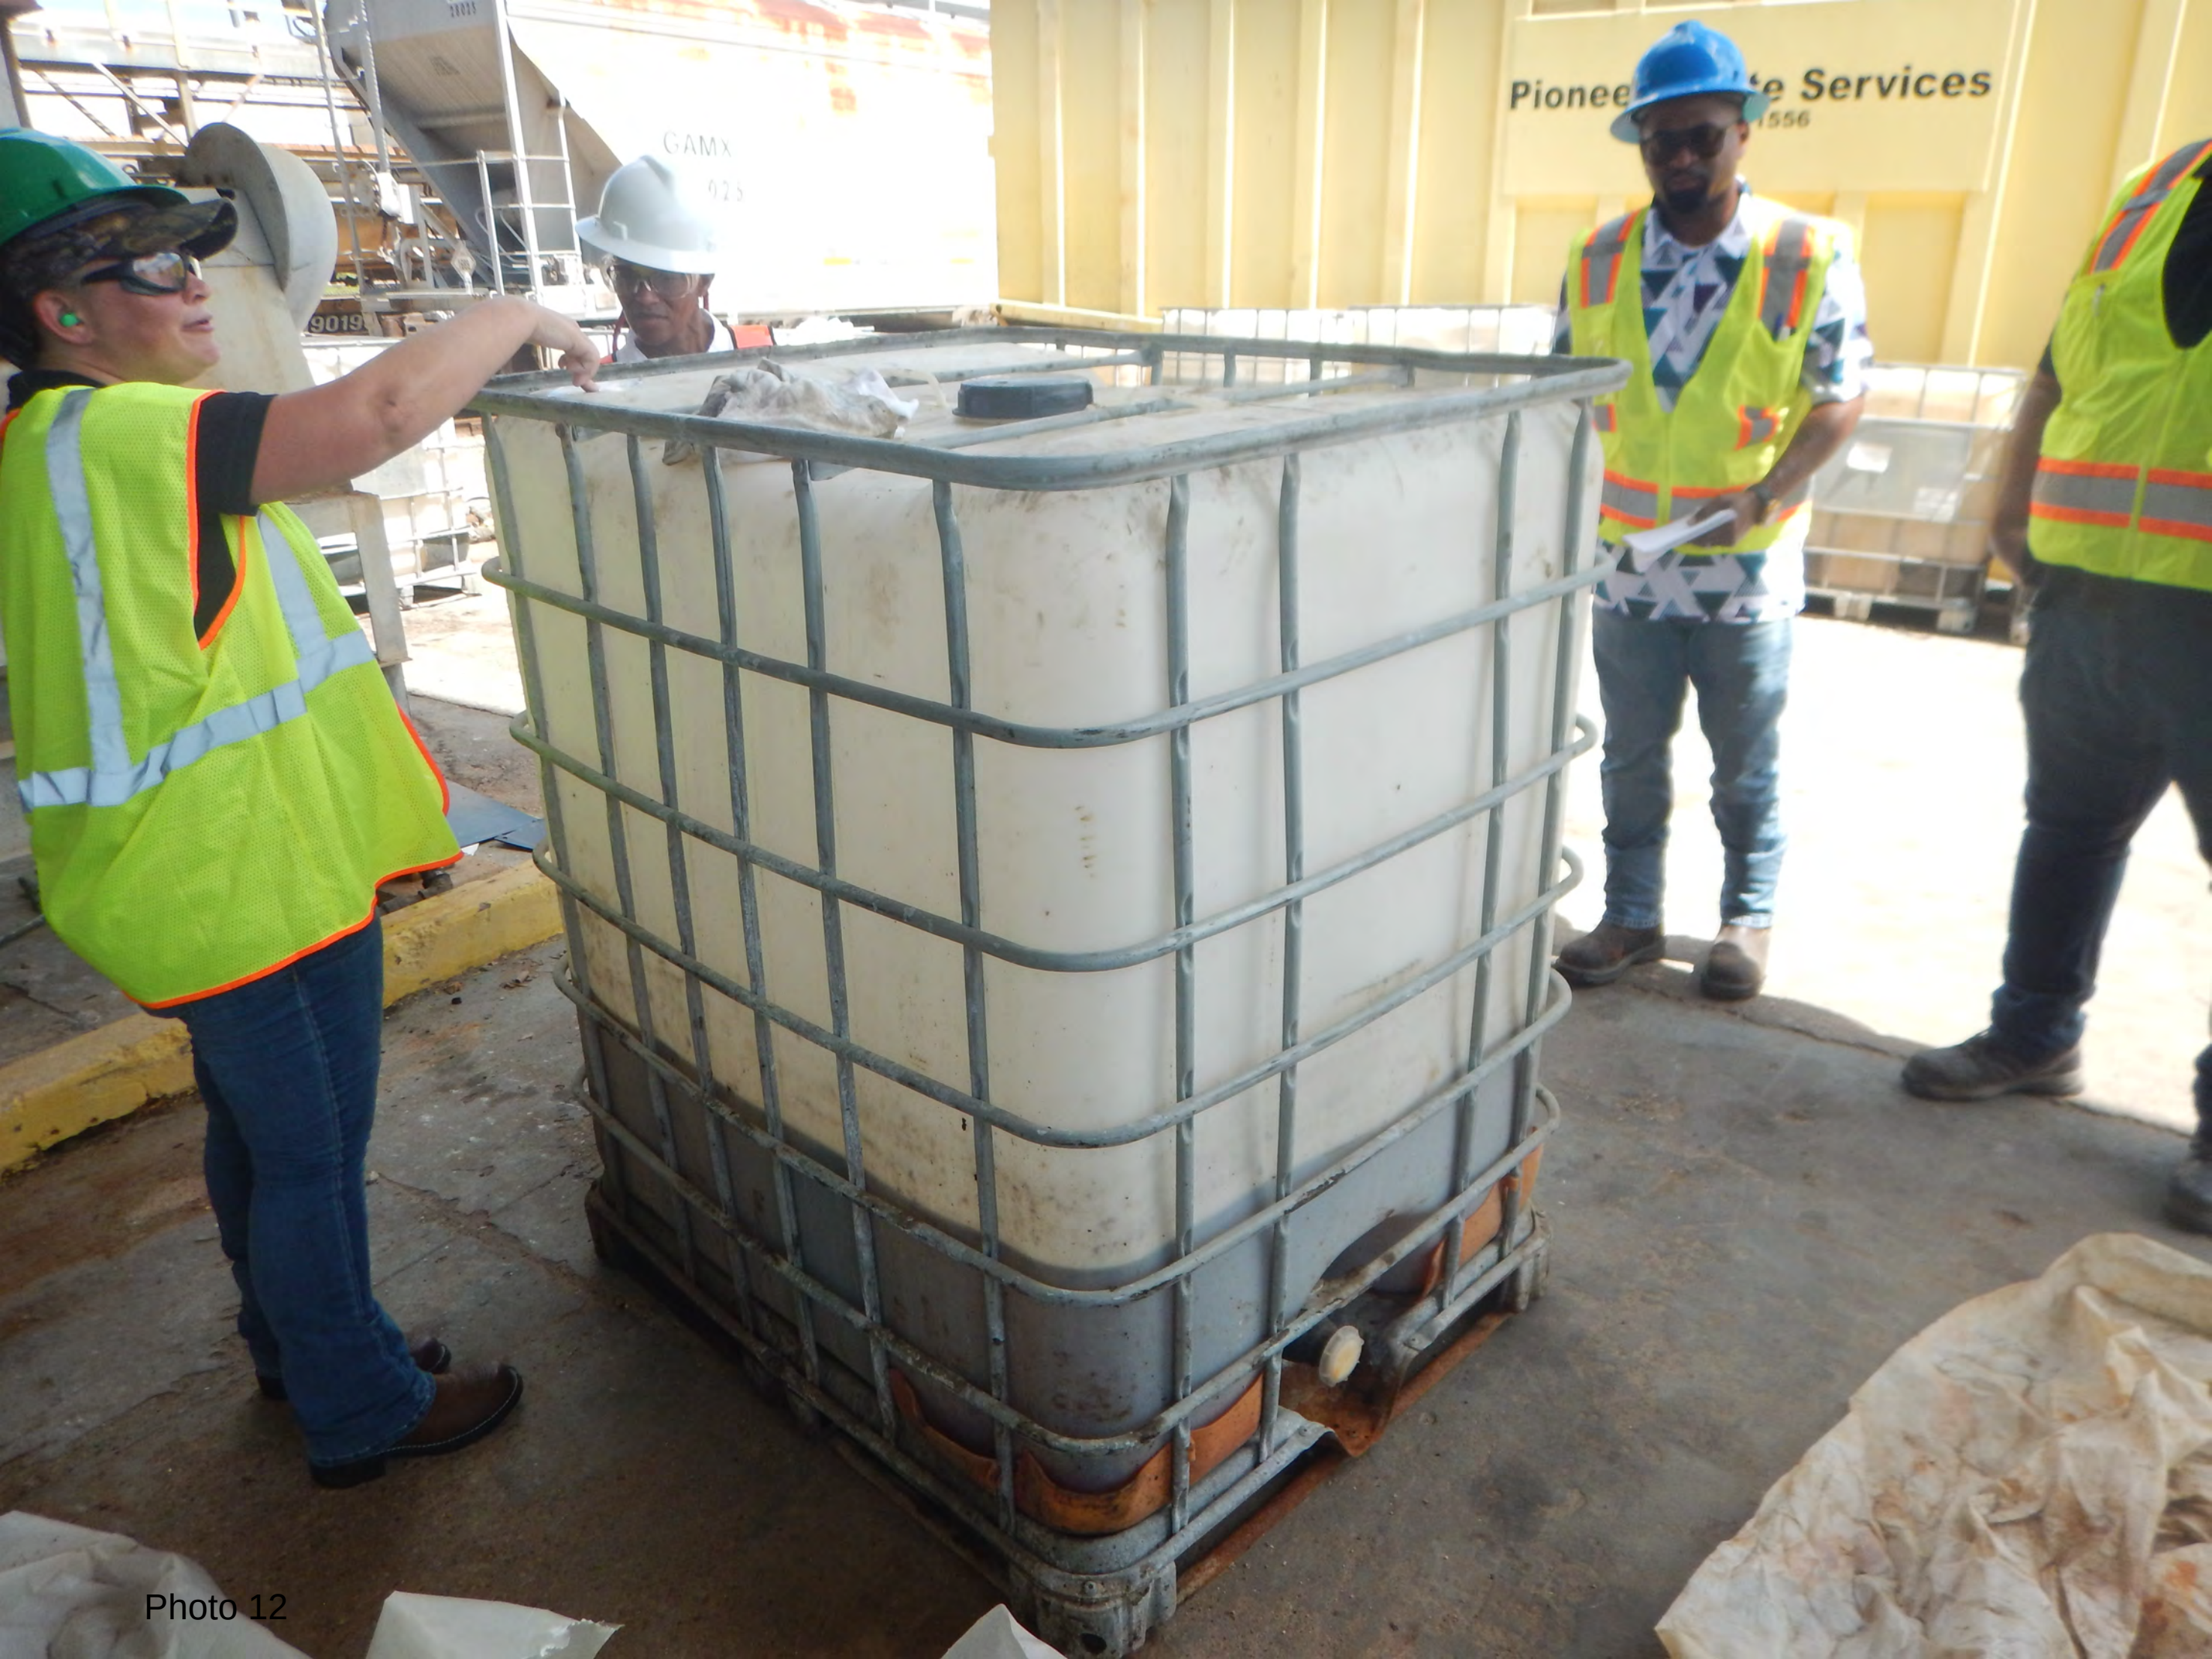
Photo 12

- On June 26, 2023, we found one unlabeled 275-gallon tote of hazardous waste in the rail and specialty wash area. See photos 12 and 13.
- On June 26, 2023, we found two unlabeled 55-gallon drums of hazardous waste in the rail and specialty wash area. See photos 14 through 17.

| Photo Number | File Name | | Date | Time | Photographer | Description |
|---|---|---|---|---|---|---|
| 12 | DSCN1070 | .JPG | 26-Jun-23 | 1133 | John Penland | One container of hazardous waste located near the rail and specialty wash rack. Container was found unlabeled at the time of inspection. |

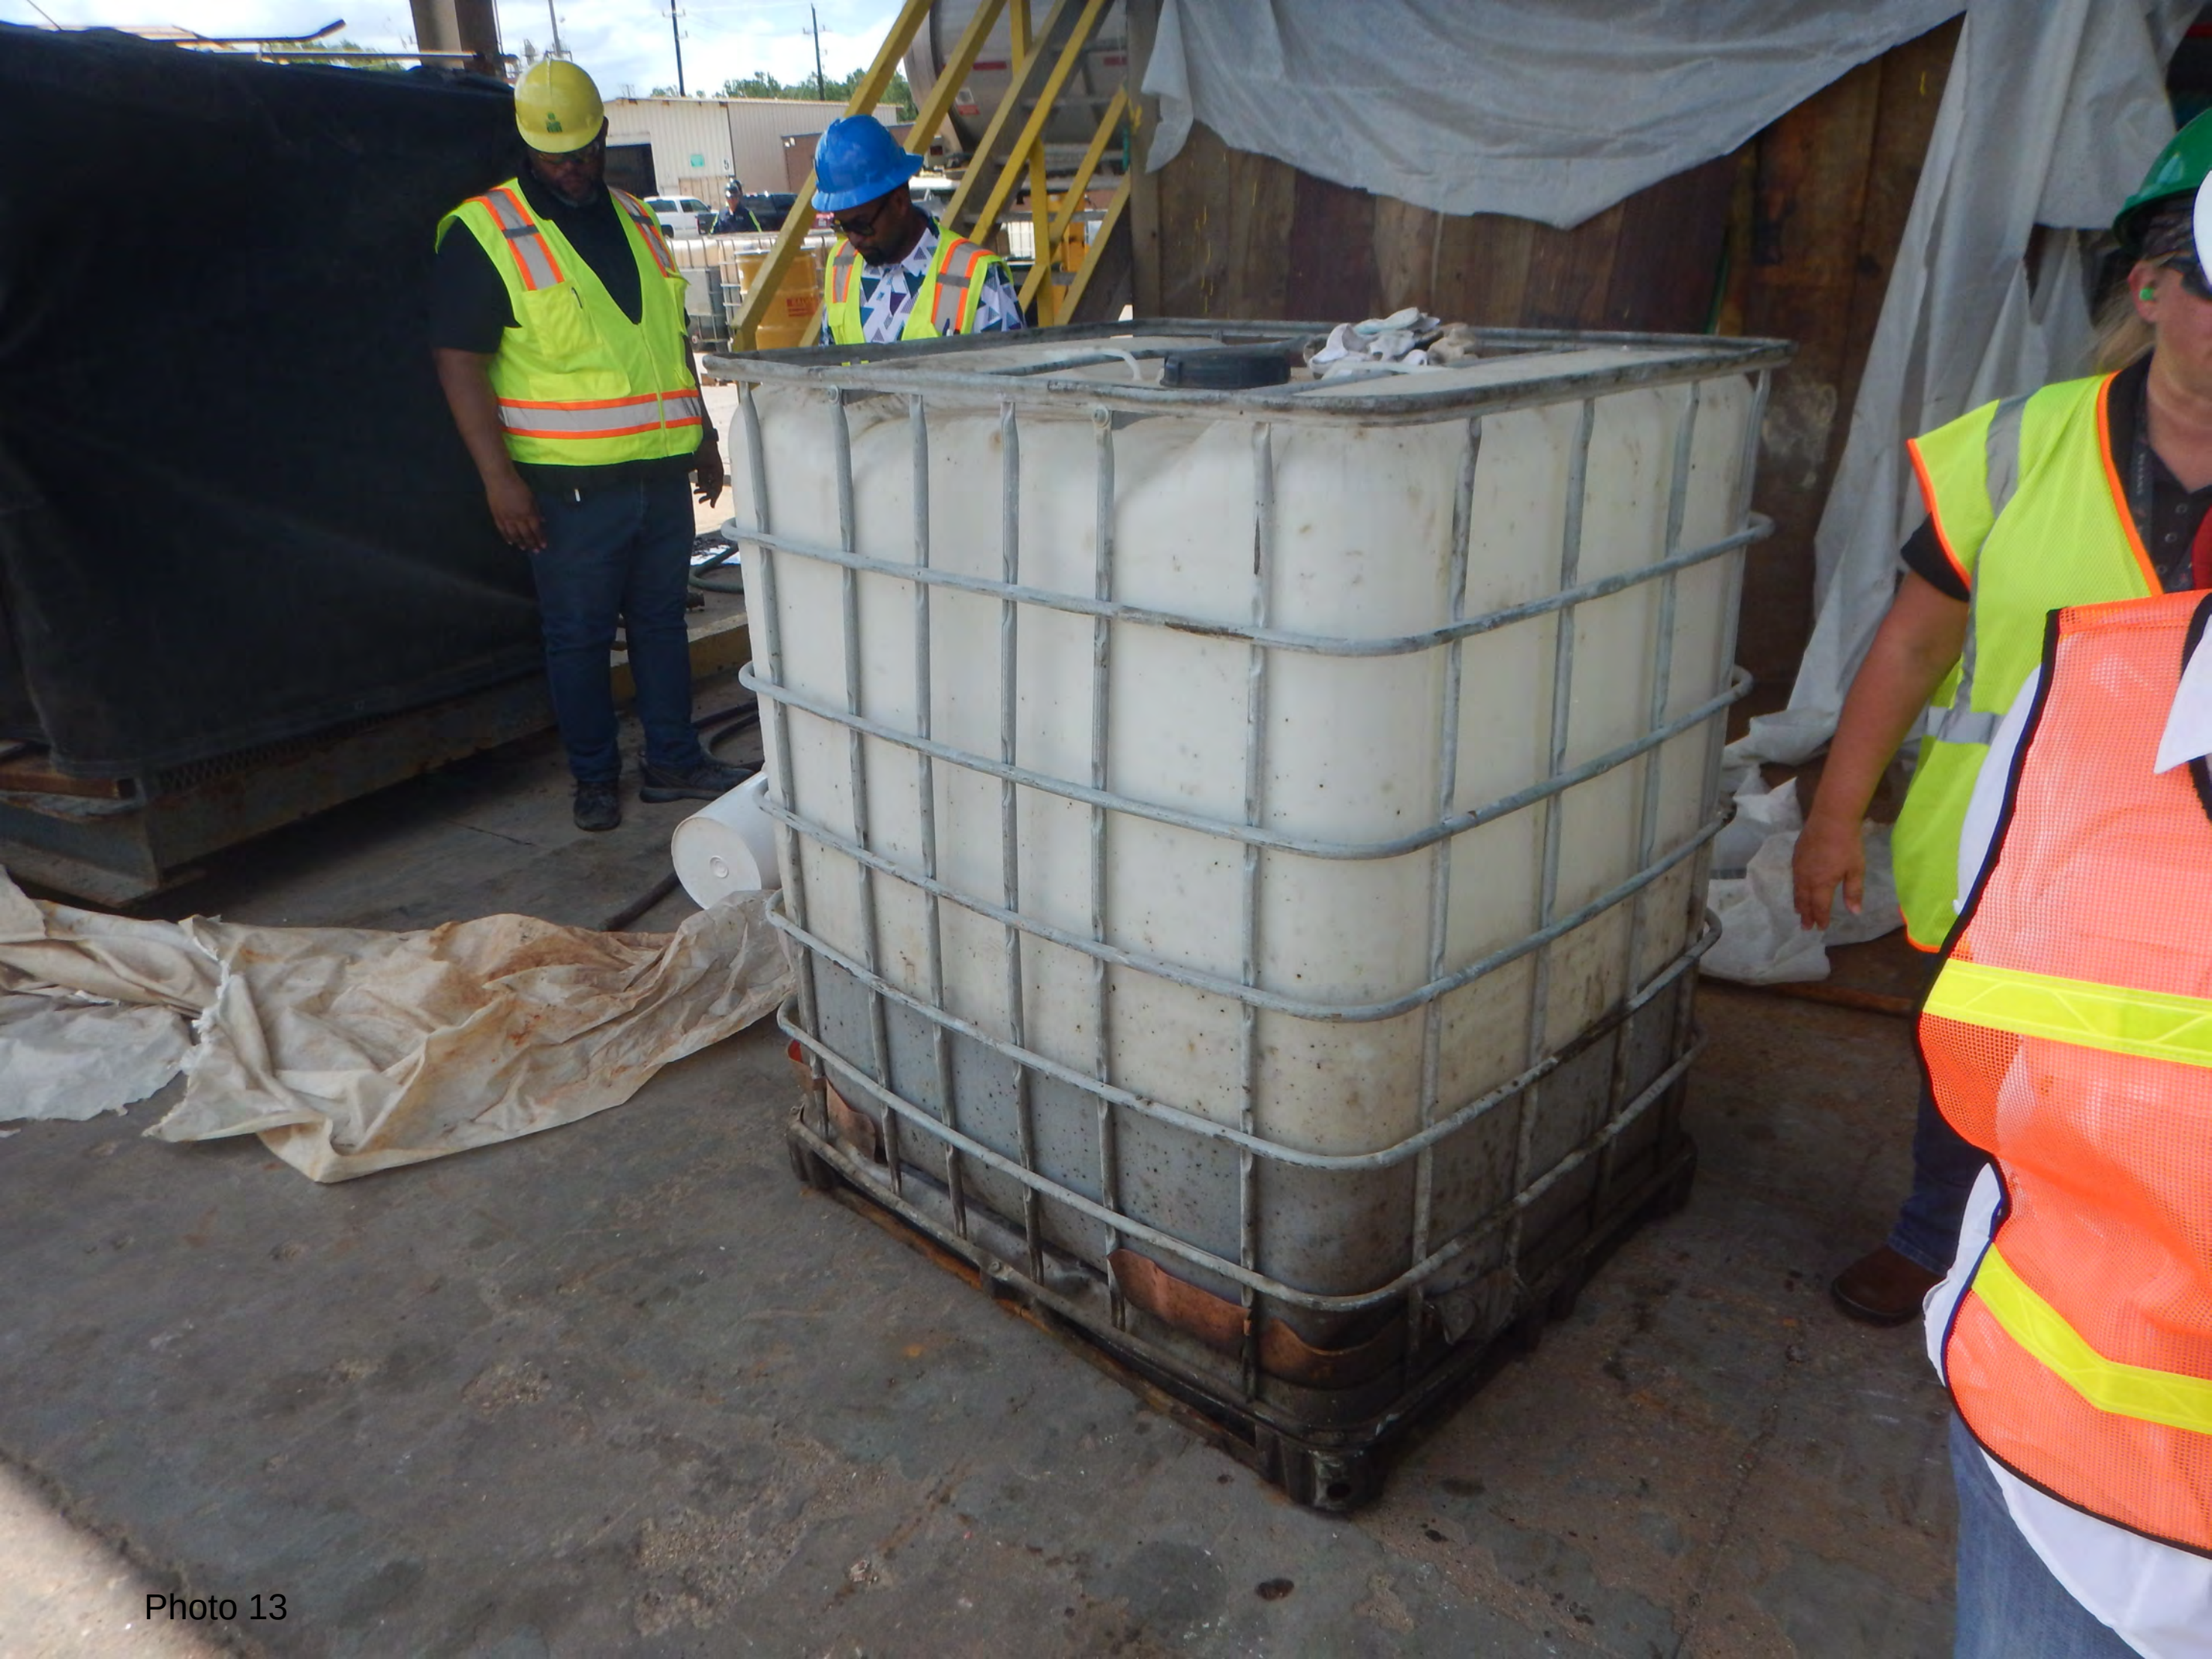
Photo 13

| Photo Number | File Name | | Date | Time | Photographer | Description |
|---|---|---|---|---|---|---|
| 13 | DSCN1071 | .JPG | 26-Jun-23 | 1134 | John Penland | One container (same as photo 12) of hazardous waste located near the rail and specialty wash rack. Container was found unlabeled at the time of inspection. |

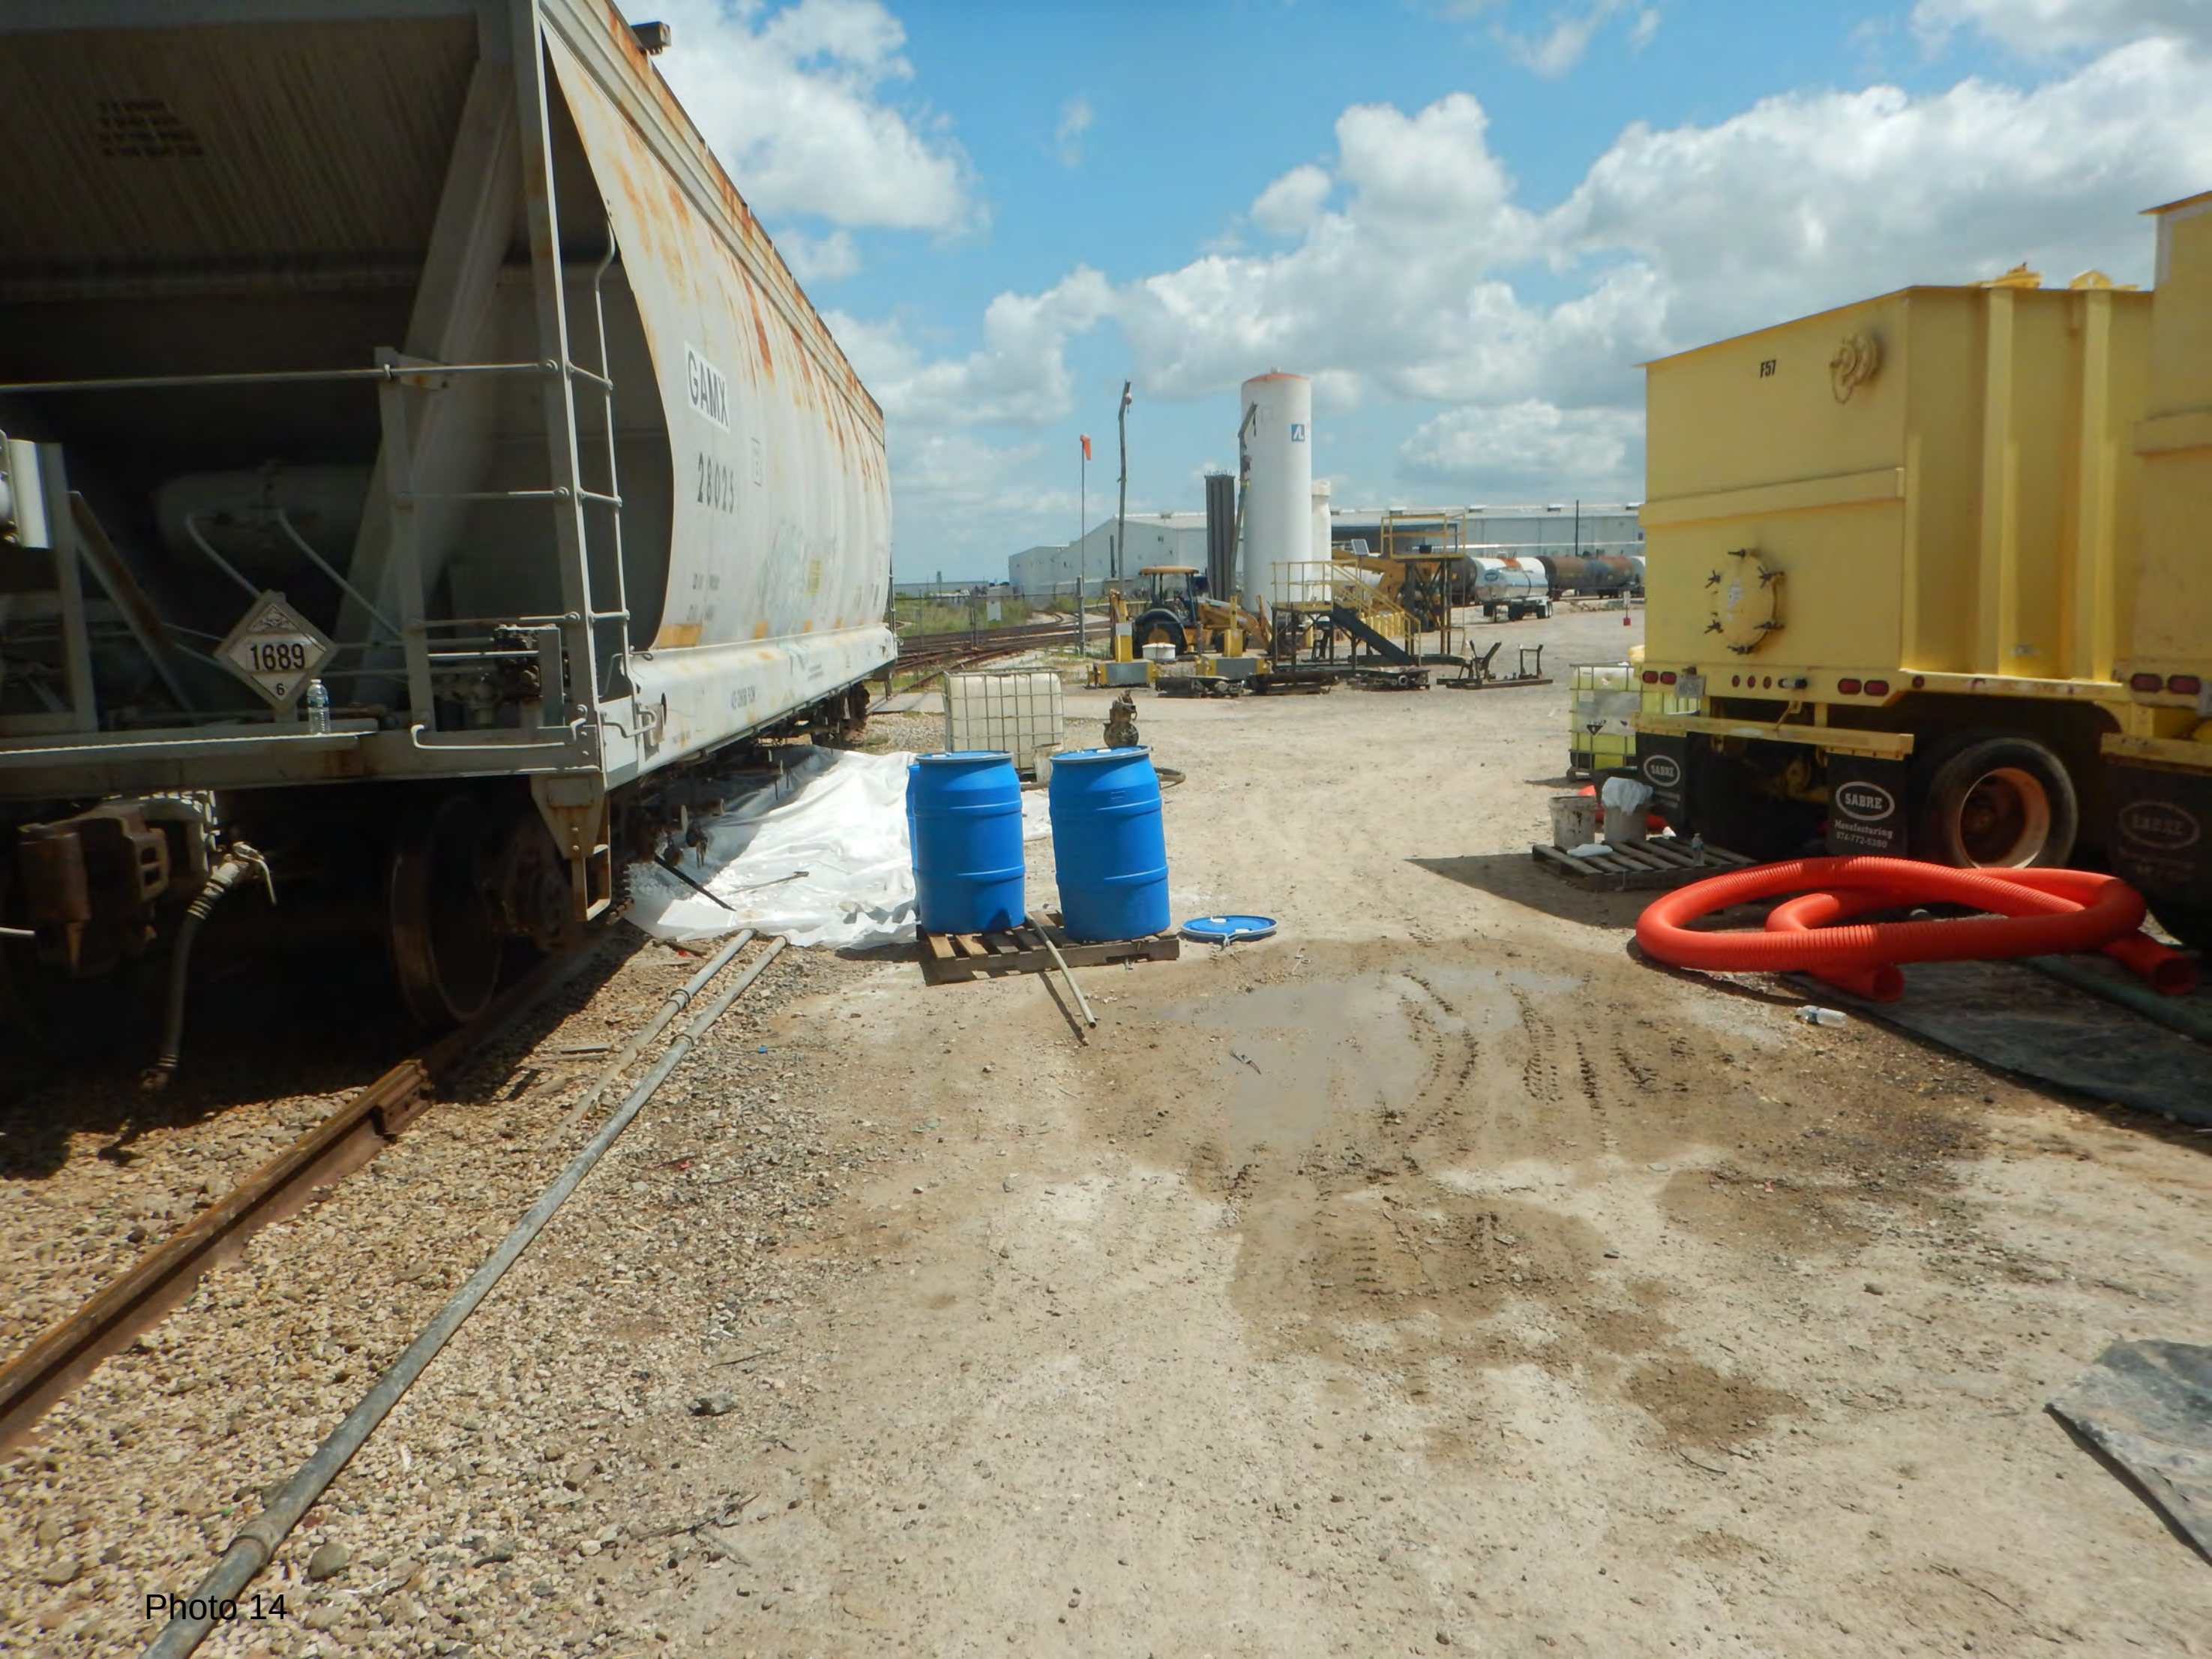
Photo 14

| Photo Number | File Name | | Date | Time | Photographer | Description |
|---|---|---|---|---|---|---|
| 14 | DSCN1072 | .JPG | 26-Jun-23 | 1136 | John Penland | Two containers of hazardous waste residues located in rail and specialty wash area. Containers were found unlabeled at the time of inspection. |

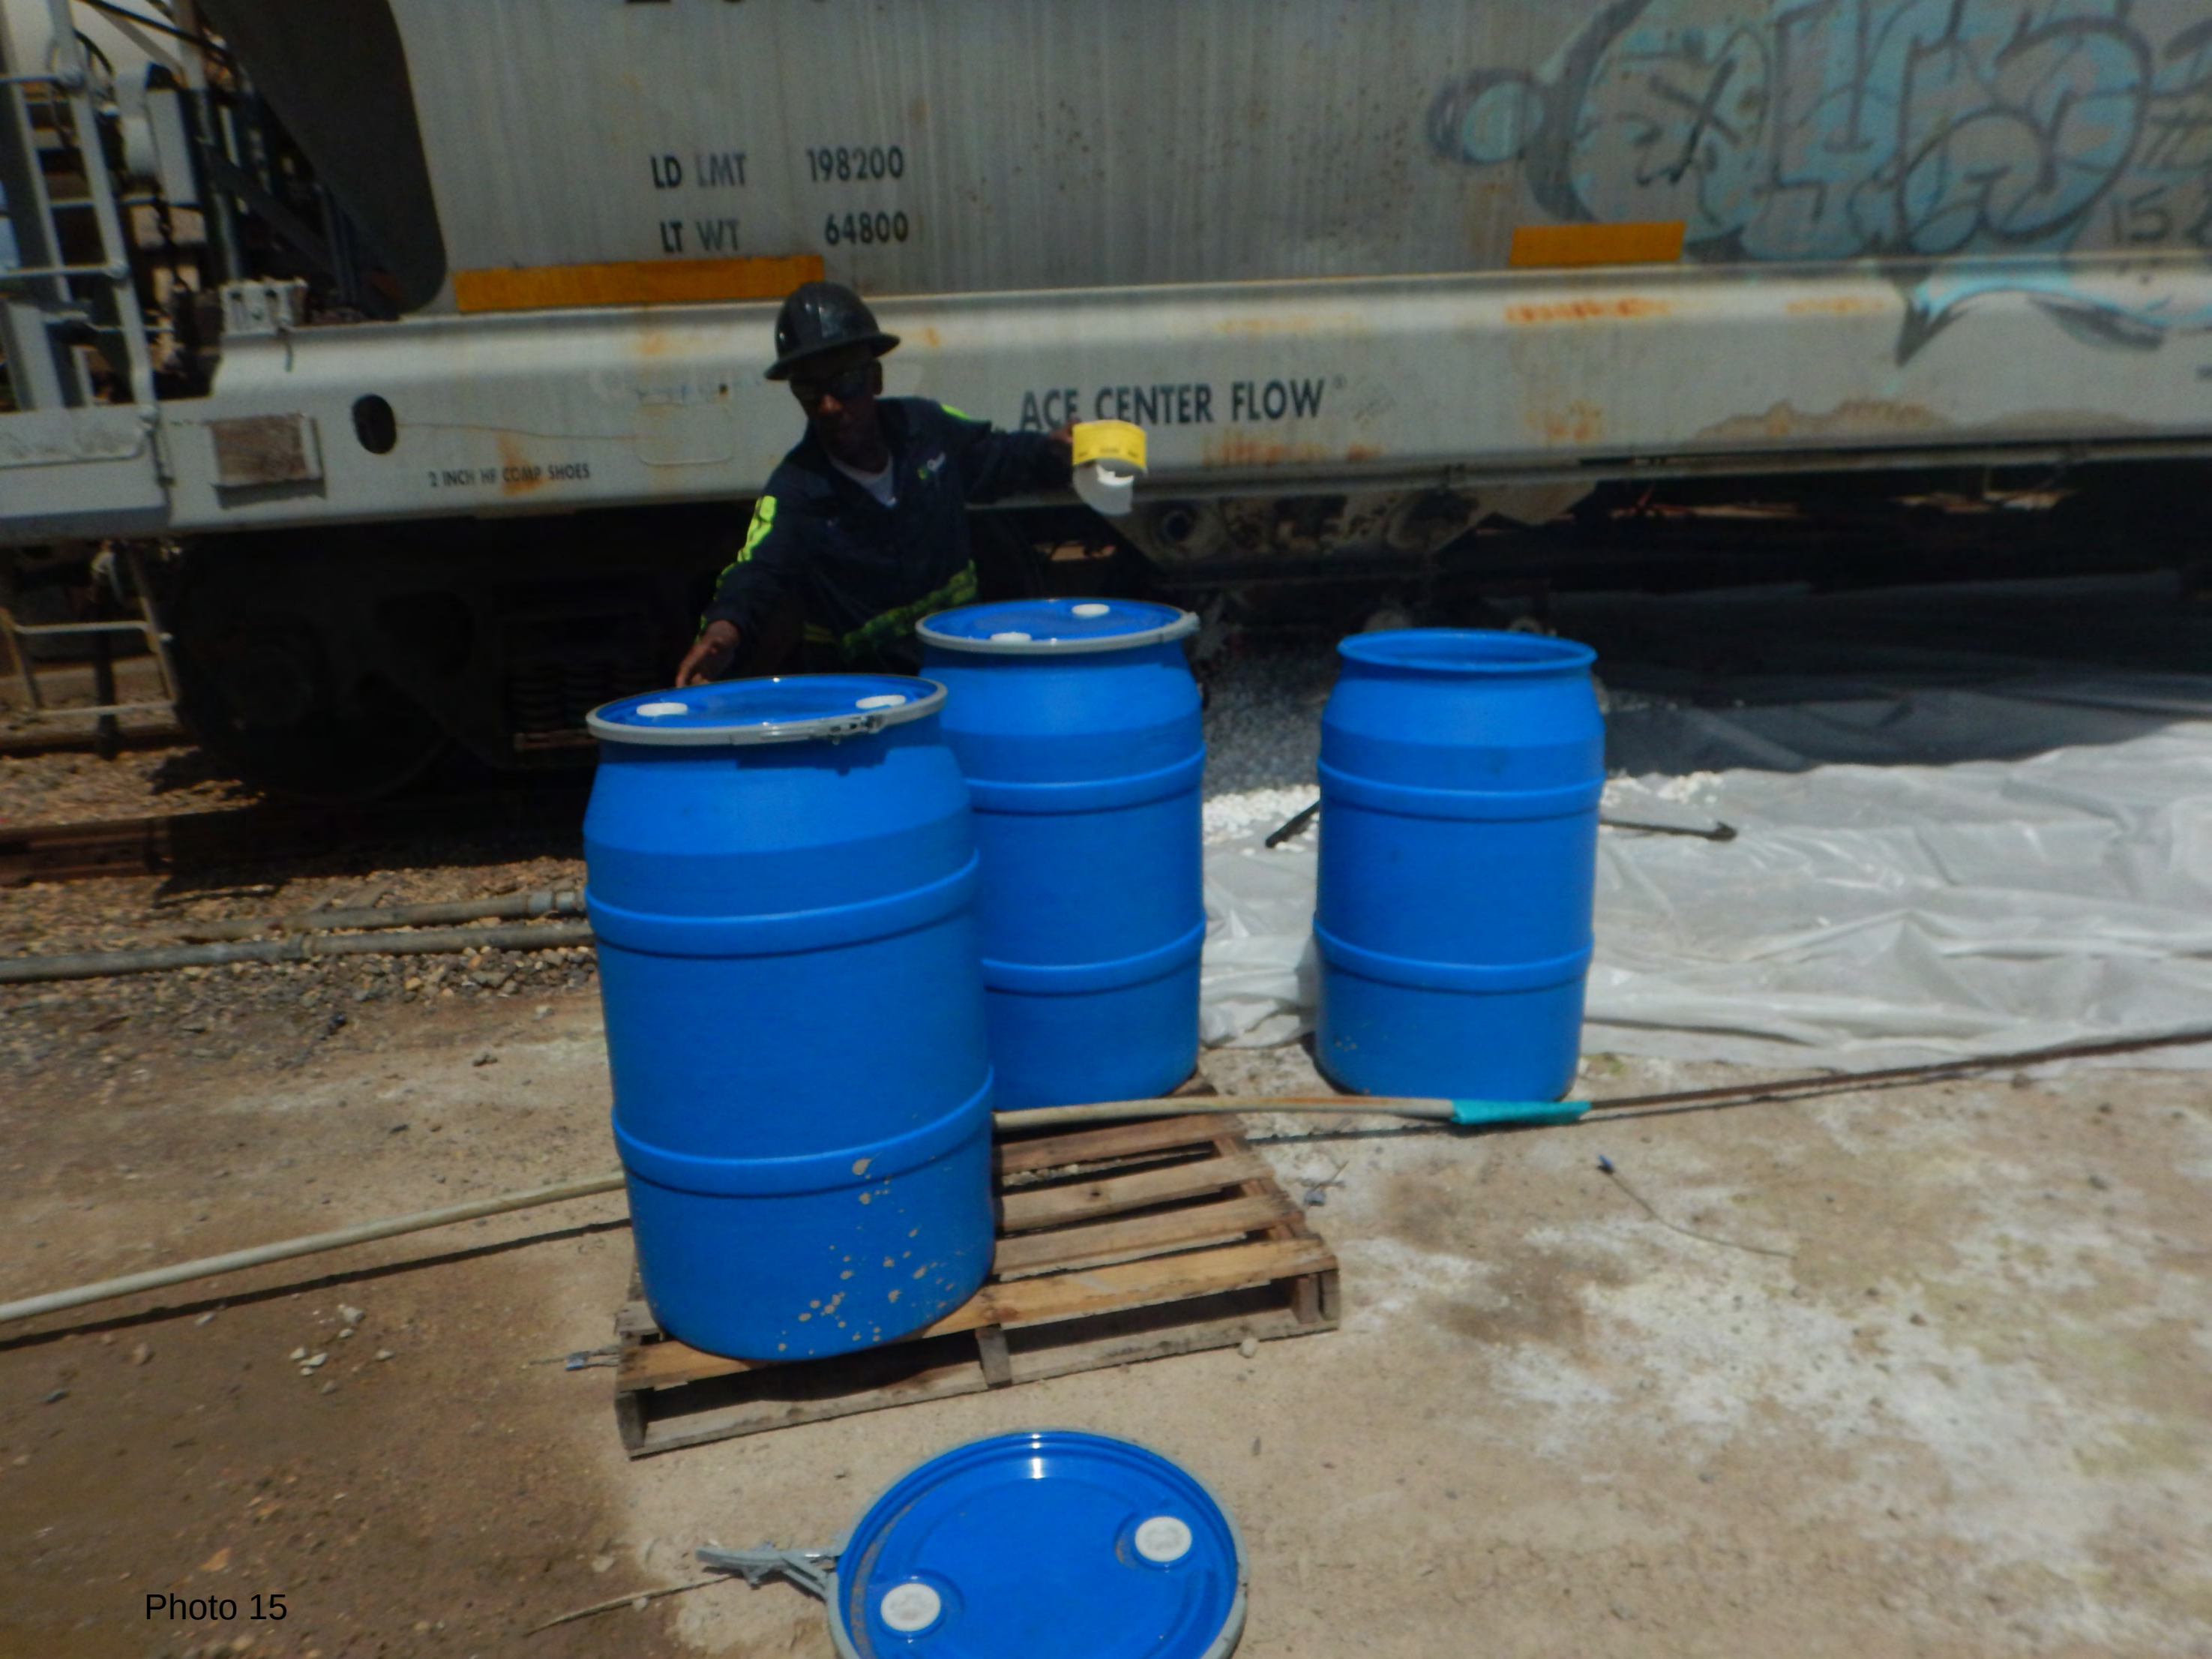
Photo 15

| Photo Number | File Name | | Date | Time | Photographer | Description |
|---|---|---|---|---|---|---|
| 15 | DSCN1073 | .JPG | 26-Jun-23 | 1136 | John Penland | Hazardous waste labels being applied to the containers depicted in photo 14. |

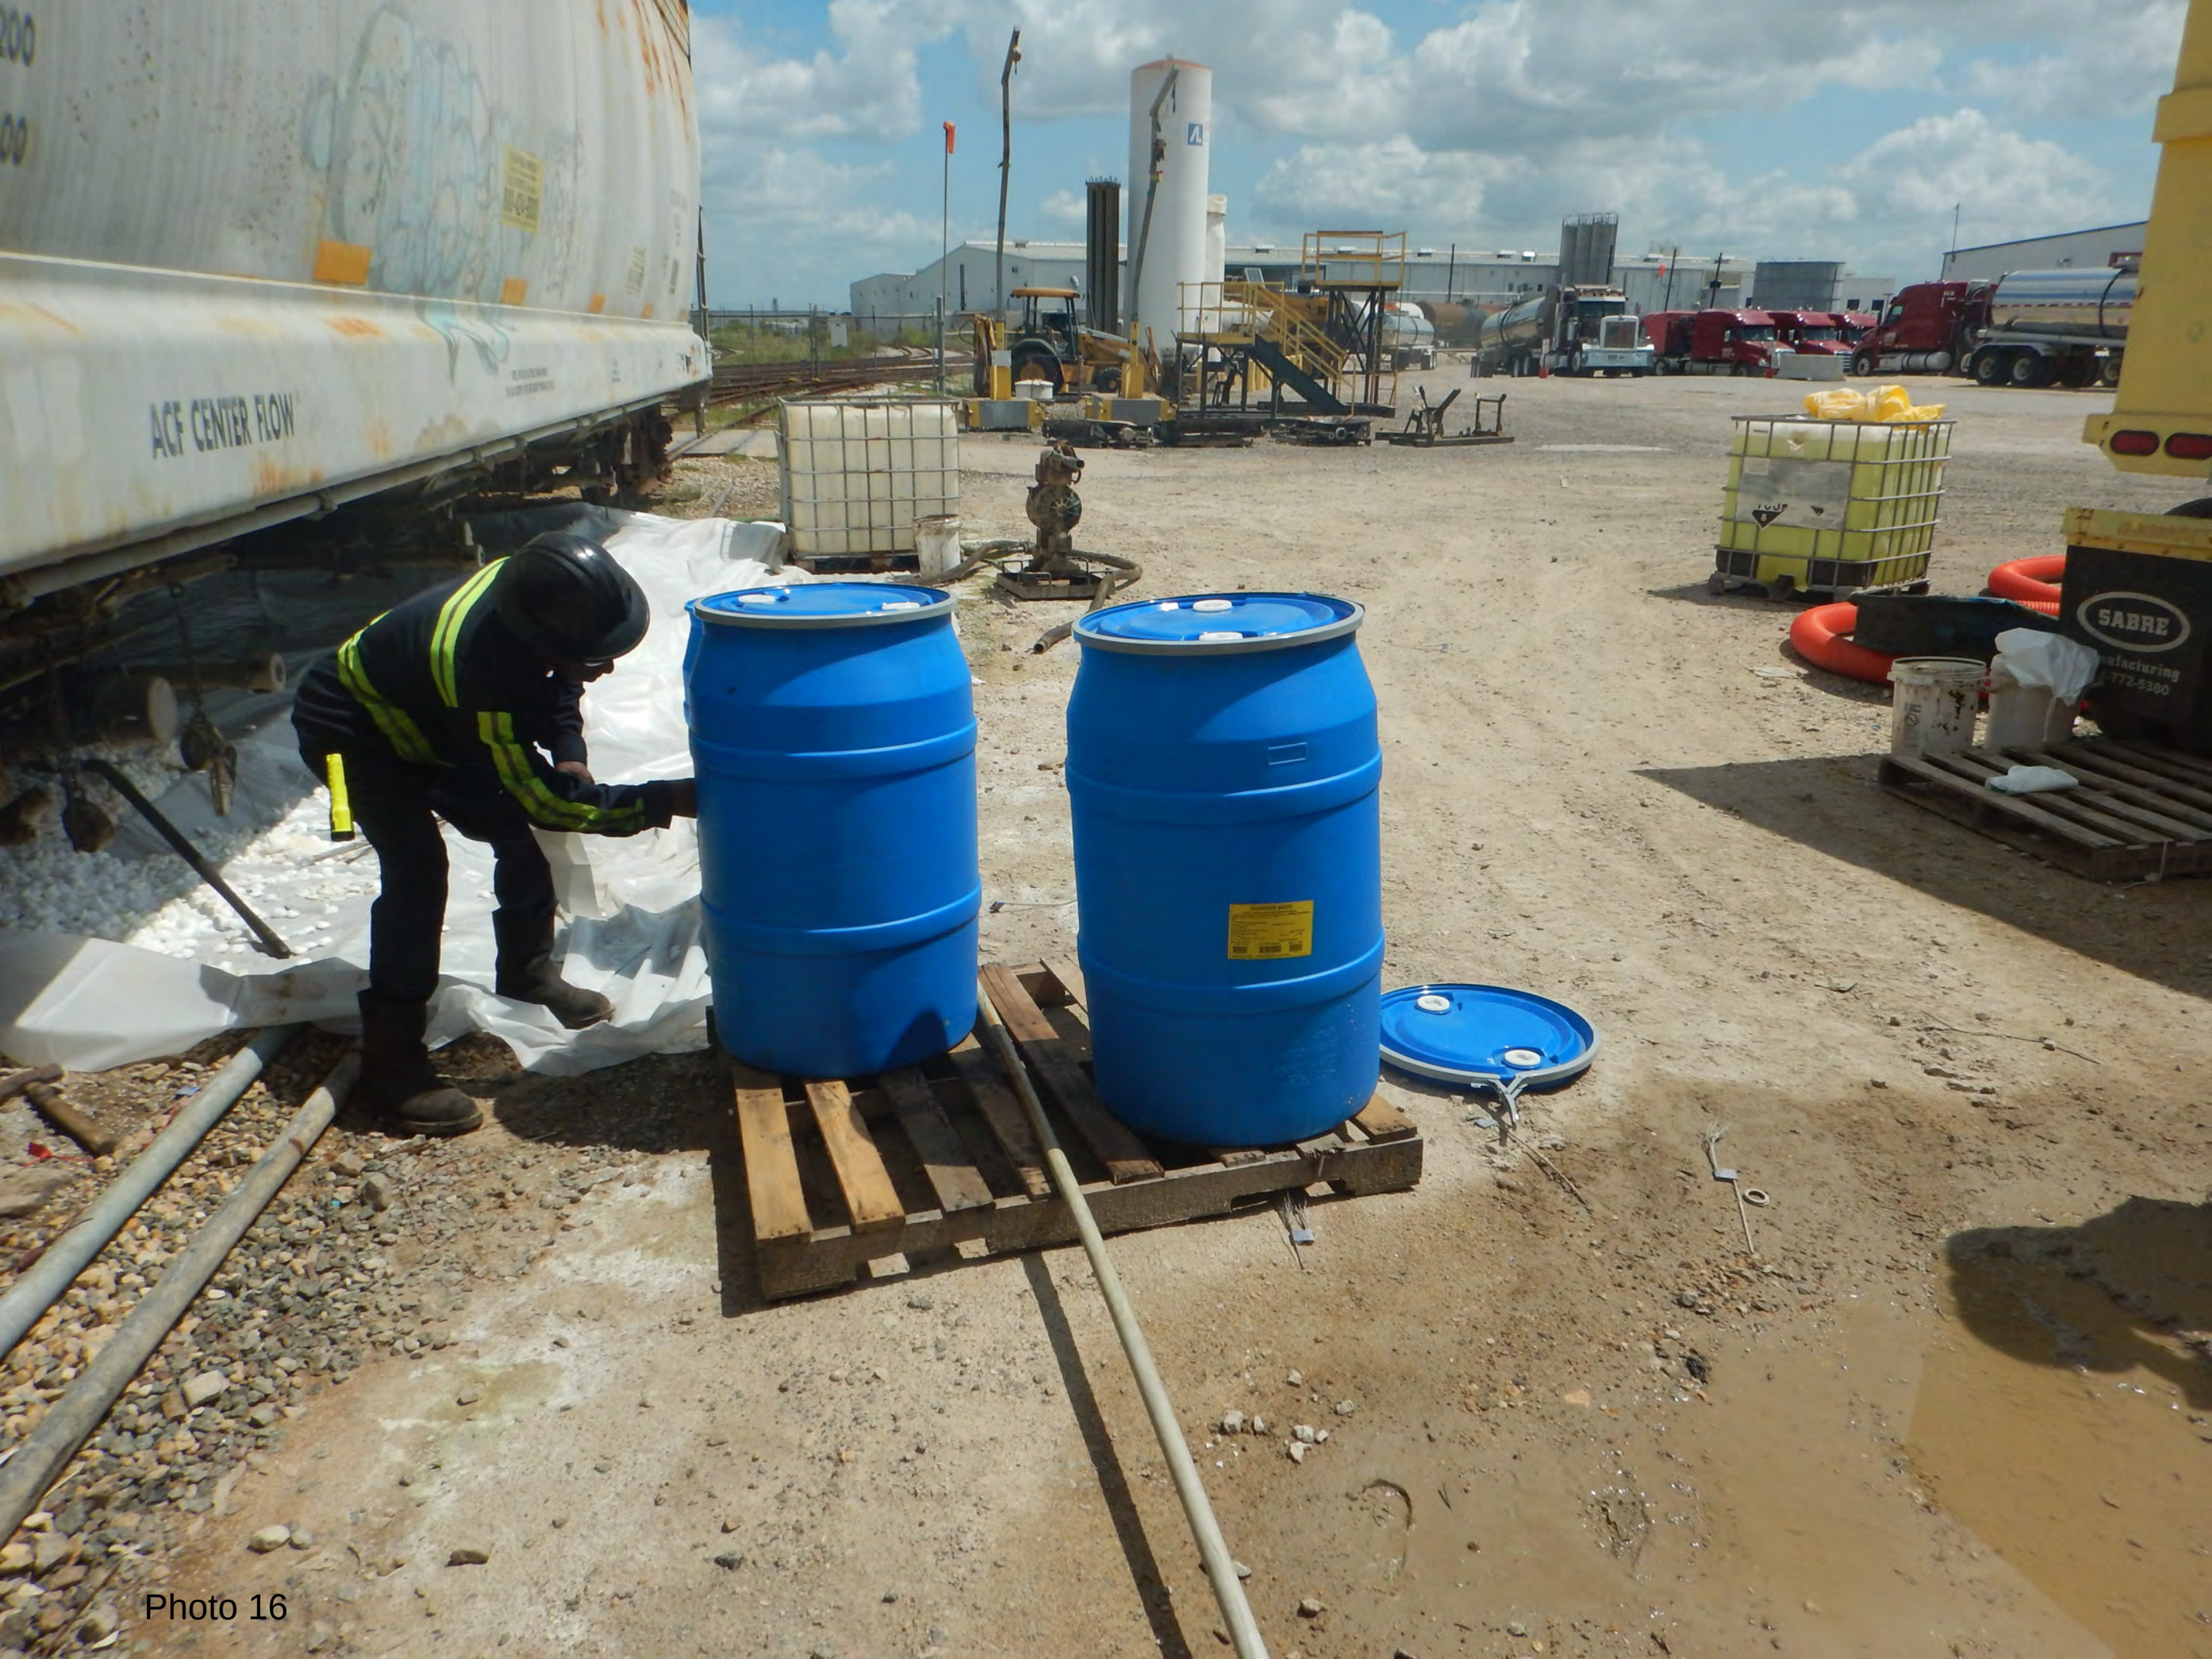
Photo 16

| Photo Number | File Name | | Date | Time | Photographer | Description |
|---|---|---|---|---|---|---|
| 16 | DSCN1074 | .JPG | 26-Jun-23 | 1137 | John Penland | Hazardous waste labels being applied to the containers depicted in photo 14. |

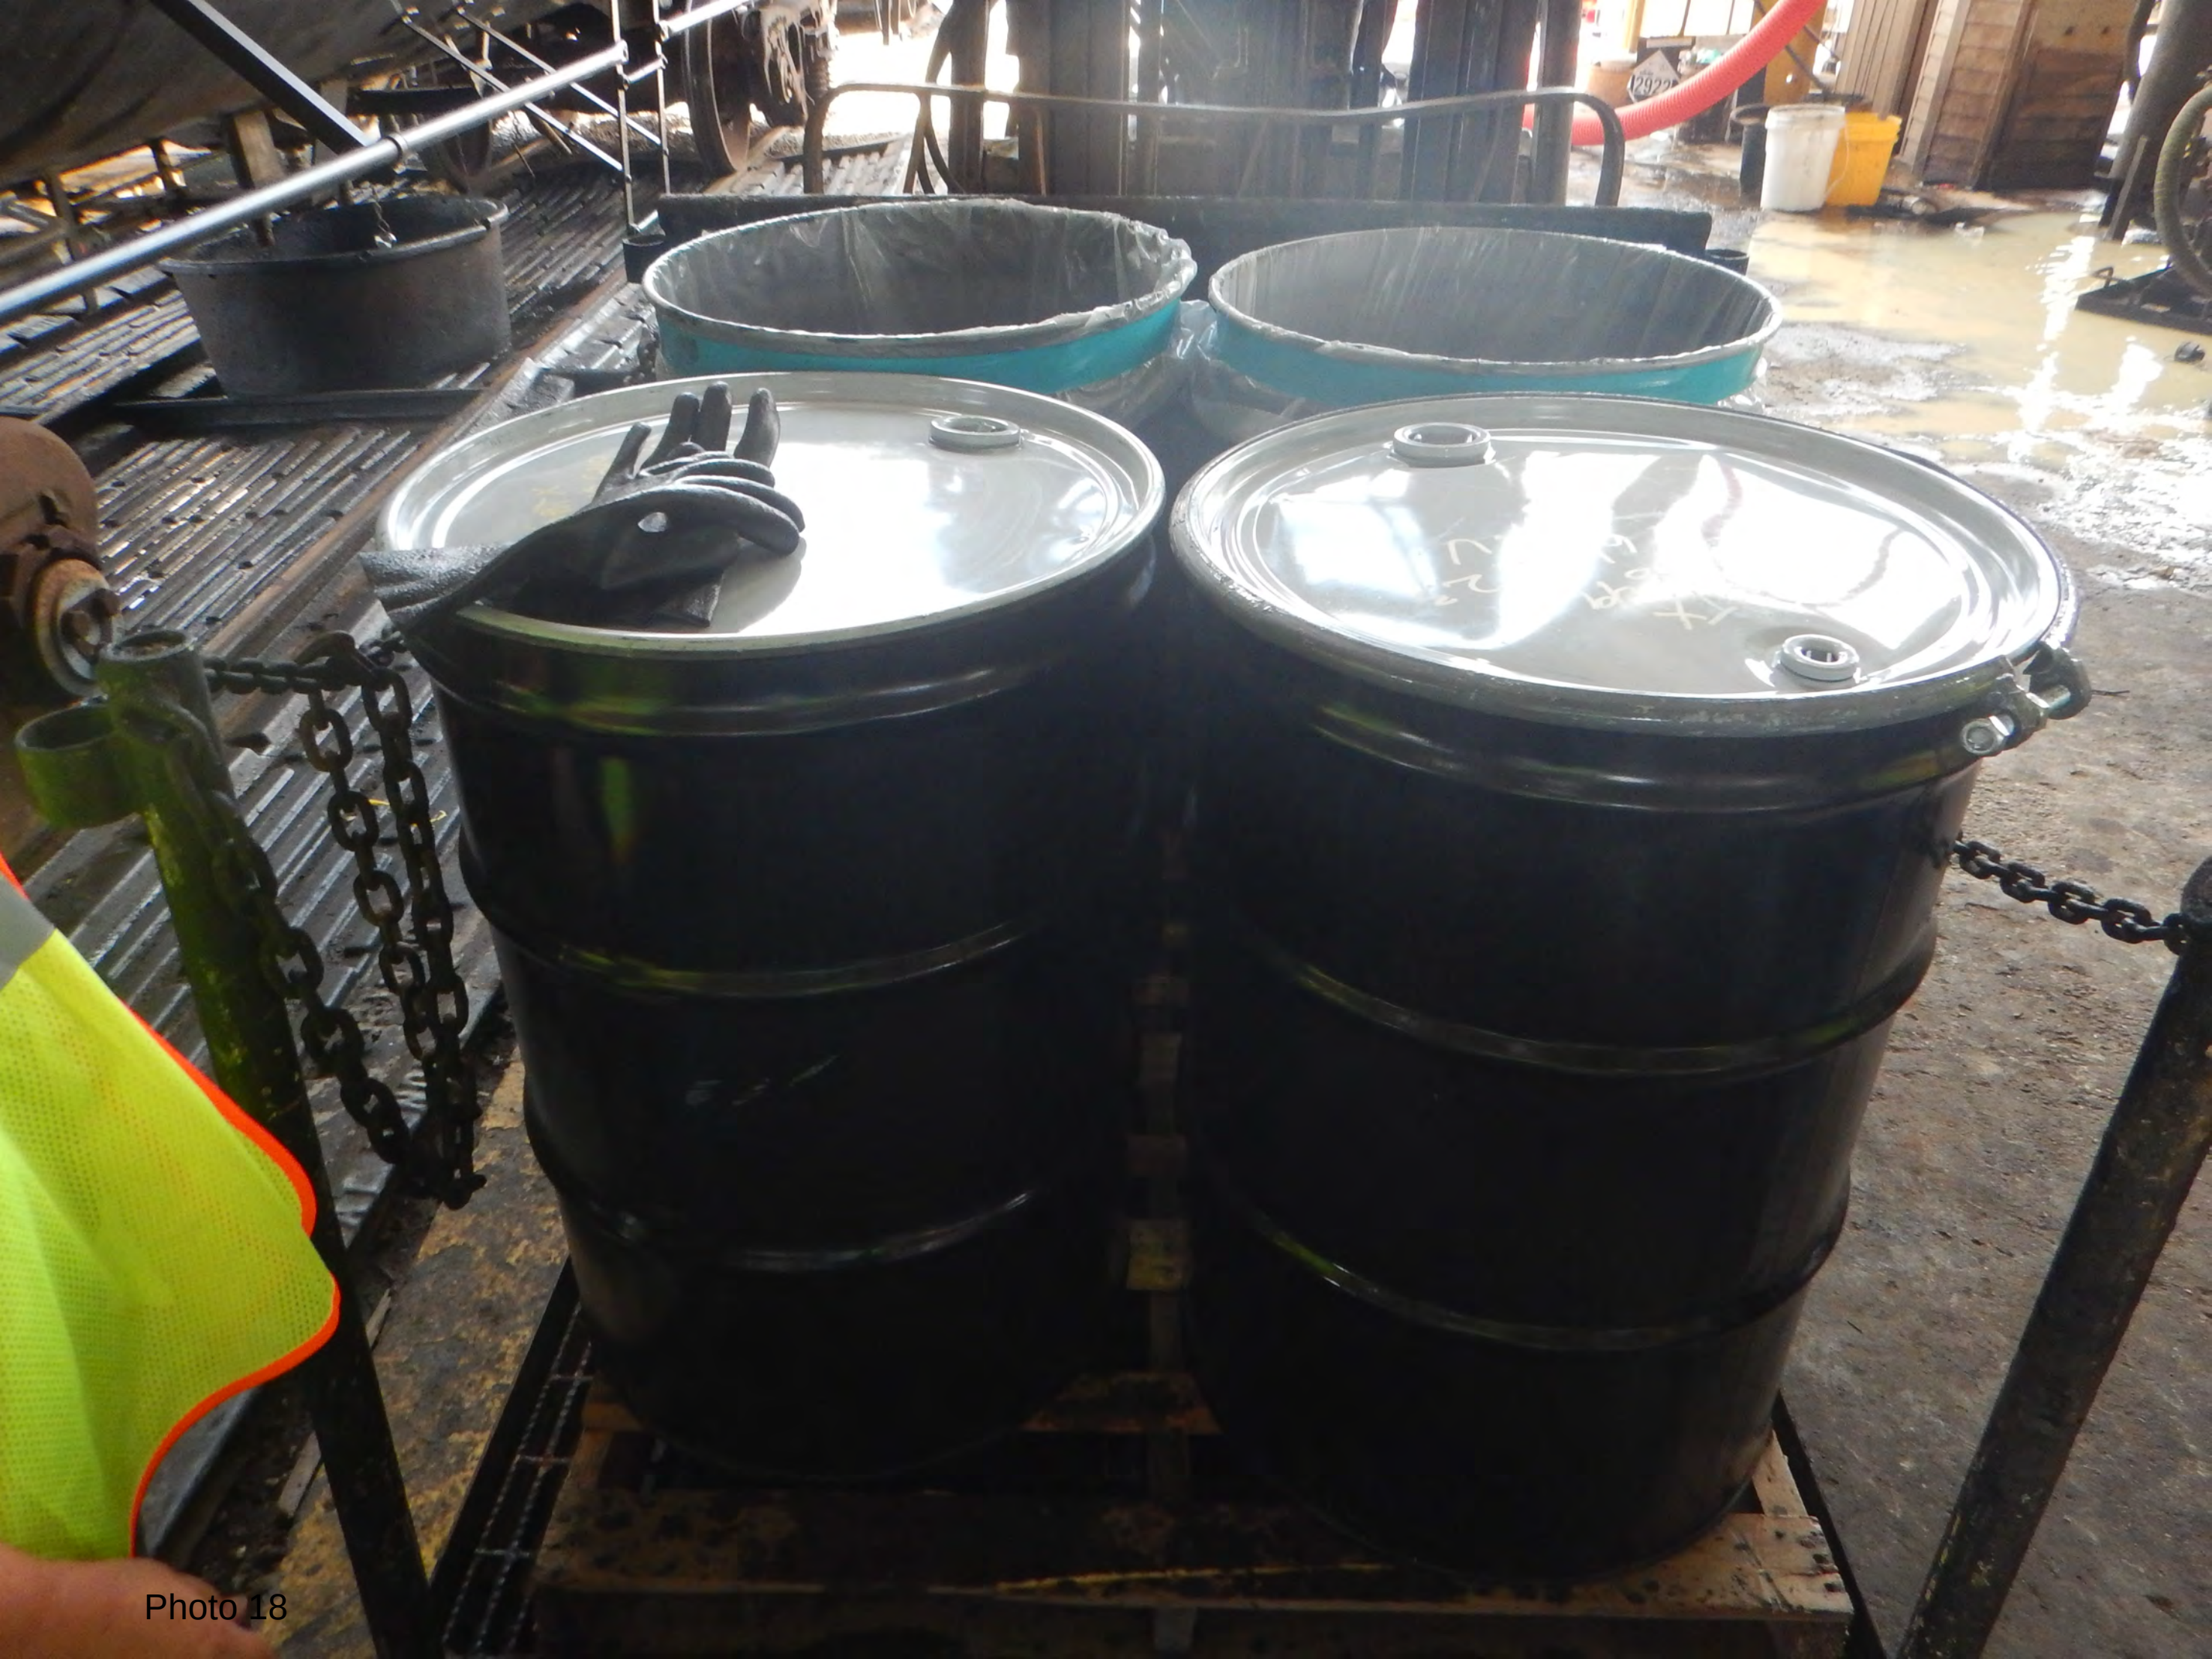
Photo 18

- On June 26, 2023, we found two unlabeled 55-gallon drums of hazardous waste in the rail and specialty wash area. See photos 18 and 19.
- On June 26, 2023, we found one unlabeled 55-gallon drum of hazardous waste “solid heels” in the rail and specialty wash area. See photos 23, 24, and 29.

| Photo Number | File Name | | Date | Time | Photographer | Description |
|---|---|---|---|---|---|---|
| 18 | DSCN1076 | .JPG | 26-Jun-23 | 1138 | John Penland | Two containers of hazardous waste residues located in rail and specialty wash area. Containers were found unlabeled at the time of inspection. |
