**Region 6 - Enforcement & Compliance Assurance Division**  
**INSPECTION REPORT**

| Inspection Date(s): | June 26 – 29, 2023 | |
| Regulatory Program(s) | Large Quantity Generator | |
| Facility Name: | <b>Quala Rail and Specialty</b> | |

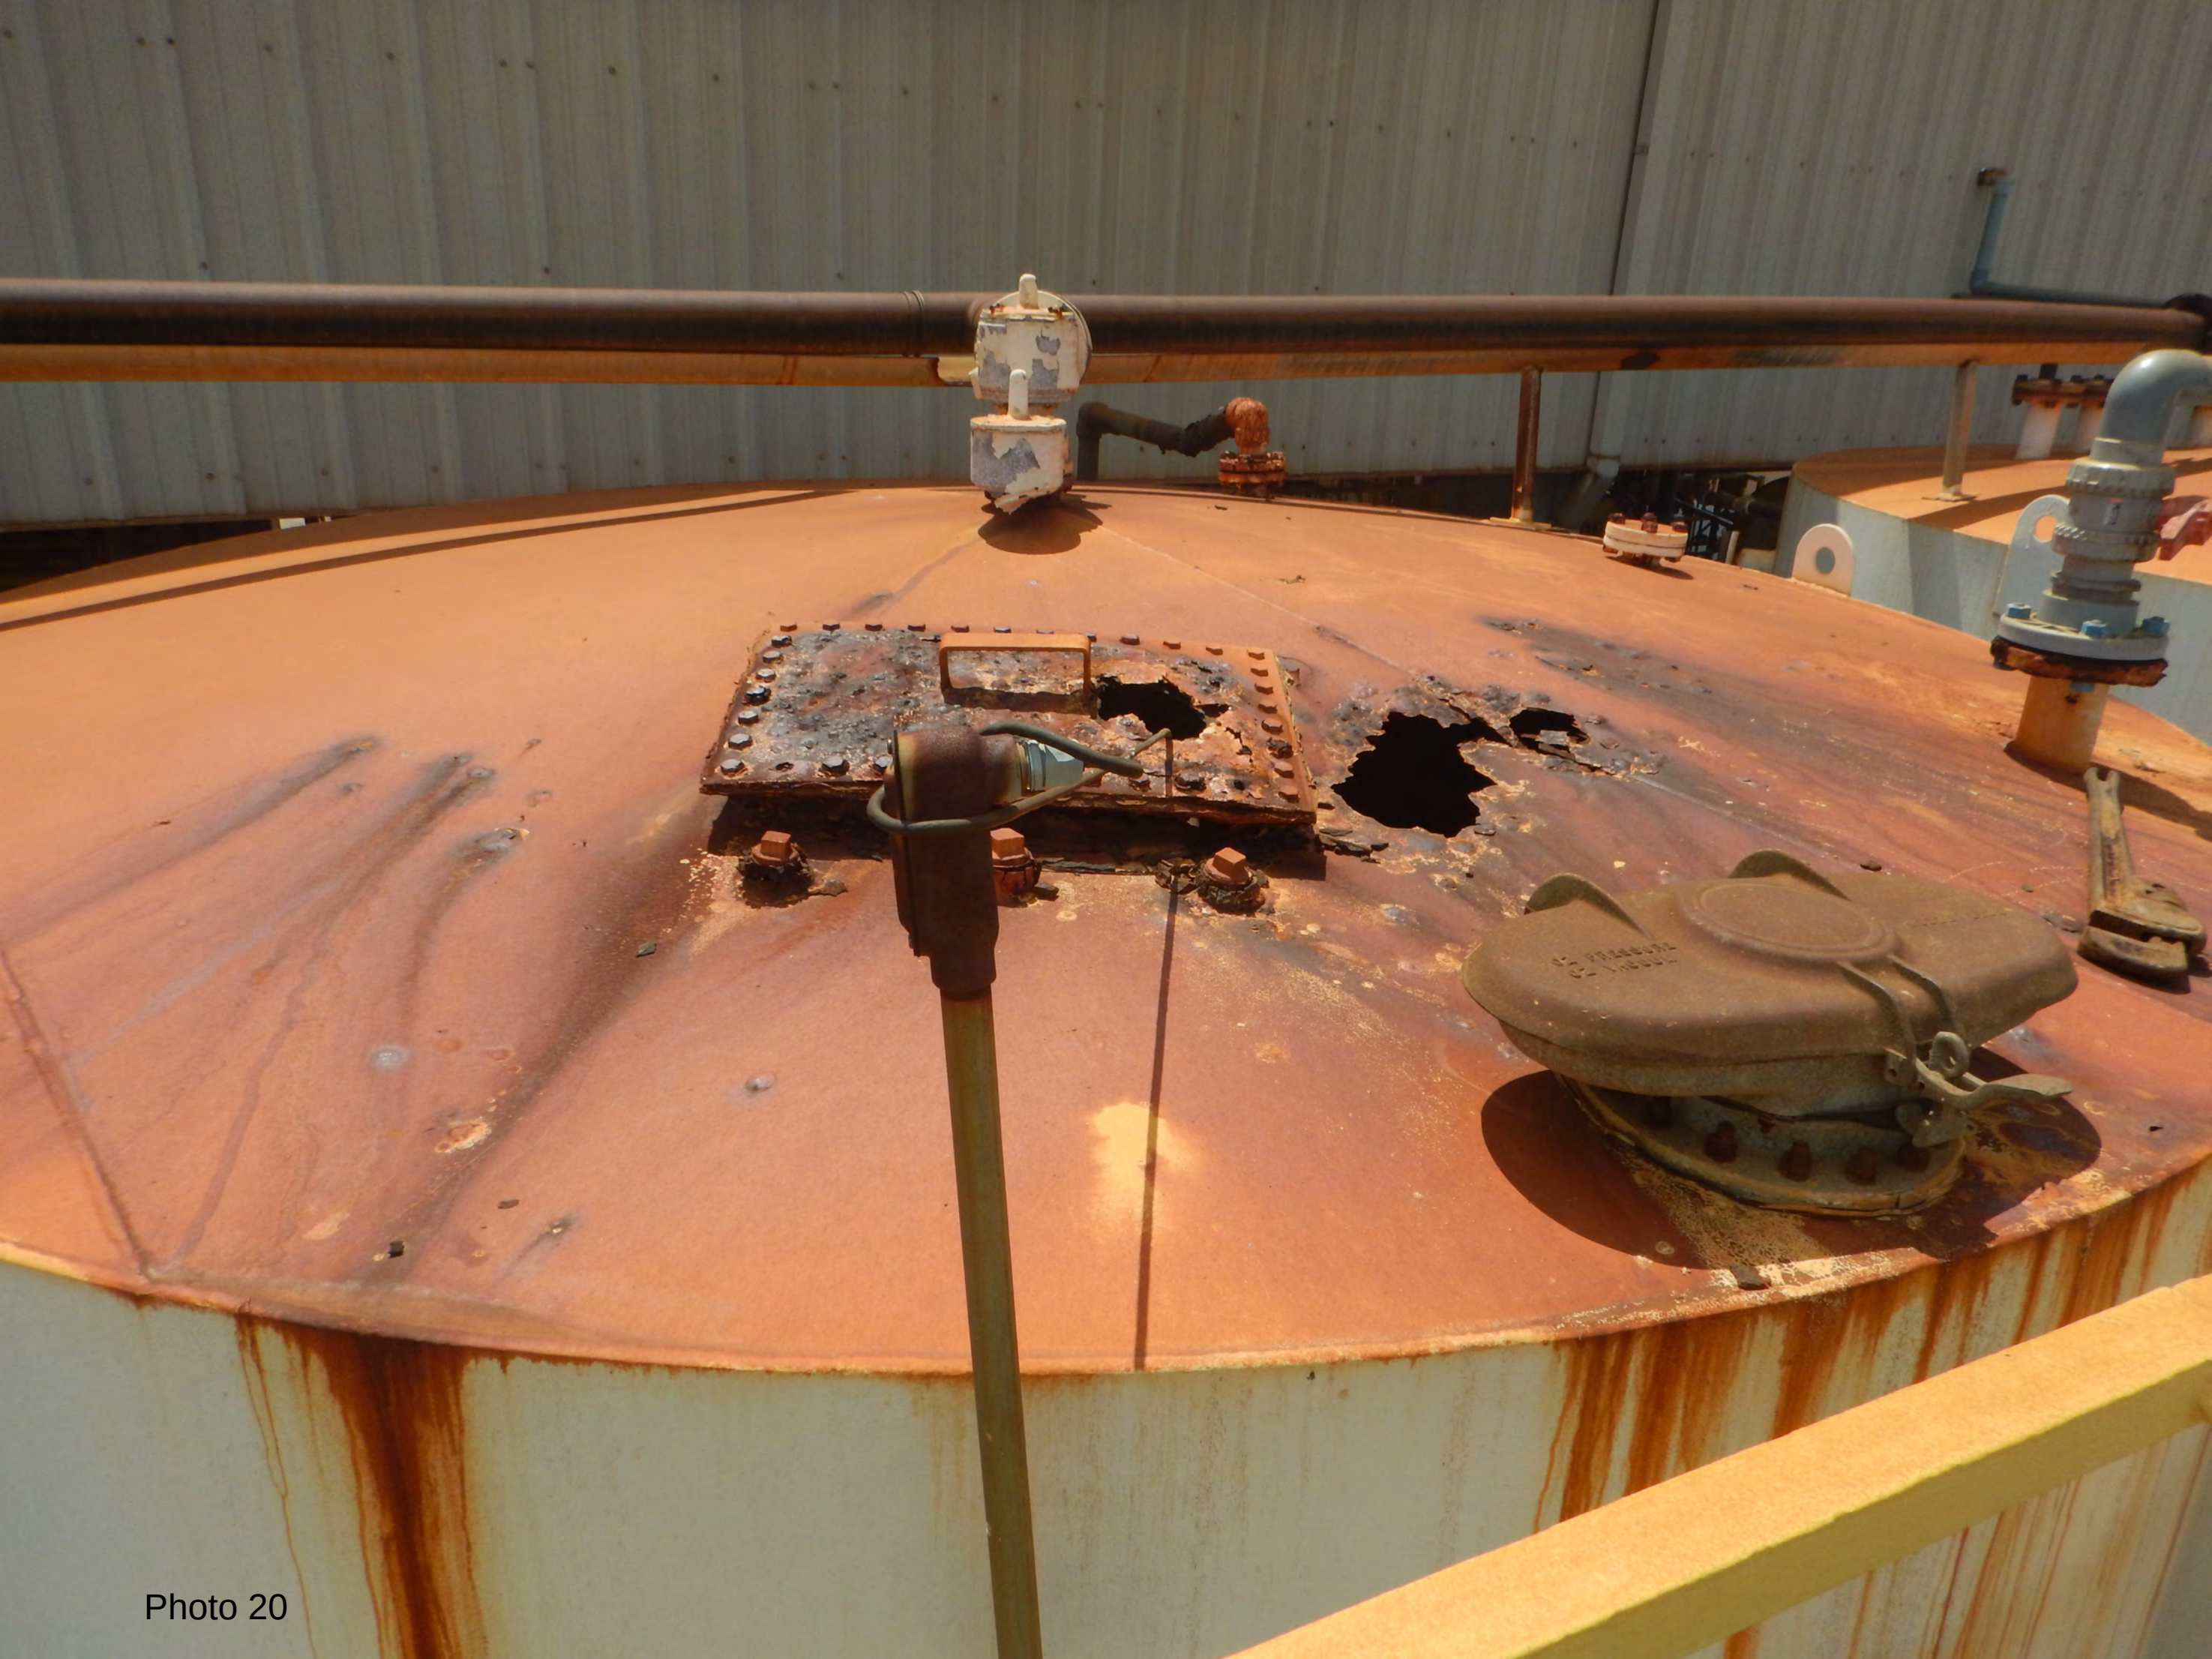
Photo 20

The hazardous waste generator standards require large quantity generators to cease the operation of a hazardous waste tank which has become unfit for use. A tank system becomes unfit for use when it is no longer capable of storing or treating hazardous waste without posing a threat of release of hazardous waste to the environment. During this inspection, we observed holes in the roof of Tank T1 estimated to be larger than 10 inches in diameter. VOC measurements from these openings, using Quala's equipment, exceeded 500ppm above background indicating that hazardous waste was being released to the air from this tank. See photos 20, 21, 22, and 49.

| Photo Number | File Name | | Date | Time | Photographer | Description |
|---|---|---|---|---|---|---|
| 20 | DSCN1078 | .JPG | 26-Jun-23 | 1146 | John Penland | Roof of hazardous waste tank T1 (NOR Unit 6). Large holes penetrate the roof. The largest hole is estimated to exceed 10 inches in diameter. The roof hatch is also open. Collapsed, out of service, fill pipe is visible on the opposite side of the roof from the tank hatch. |

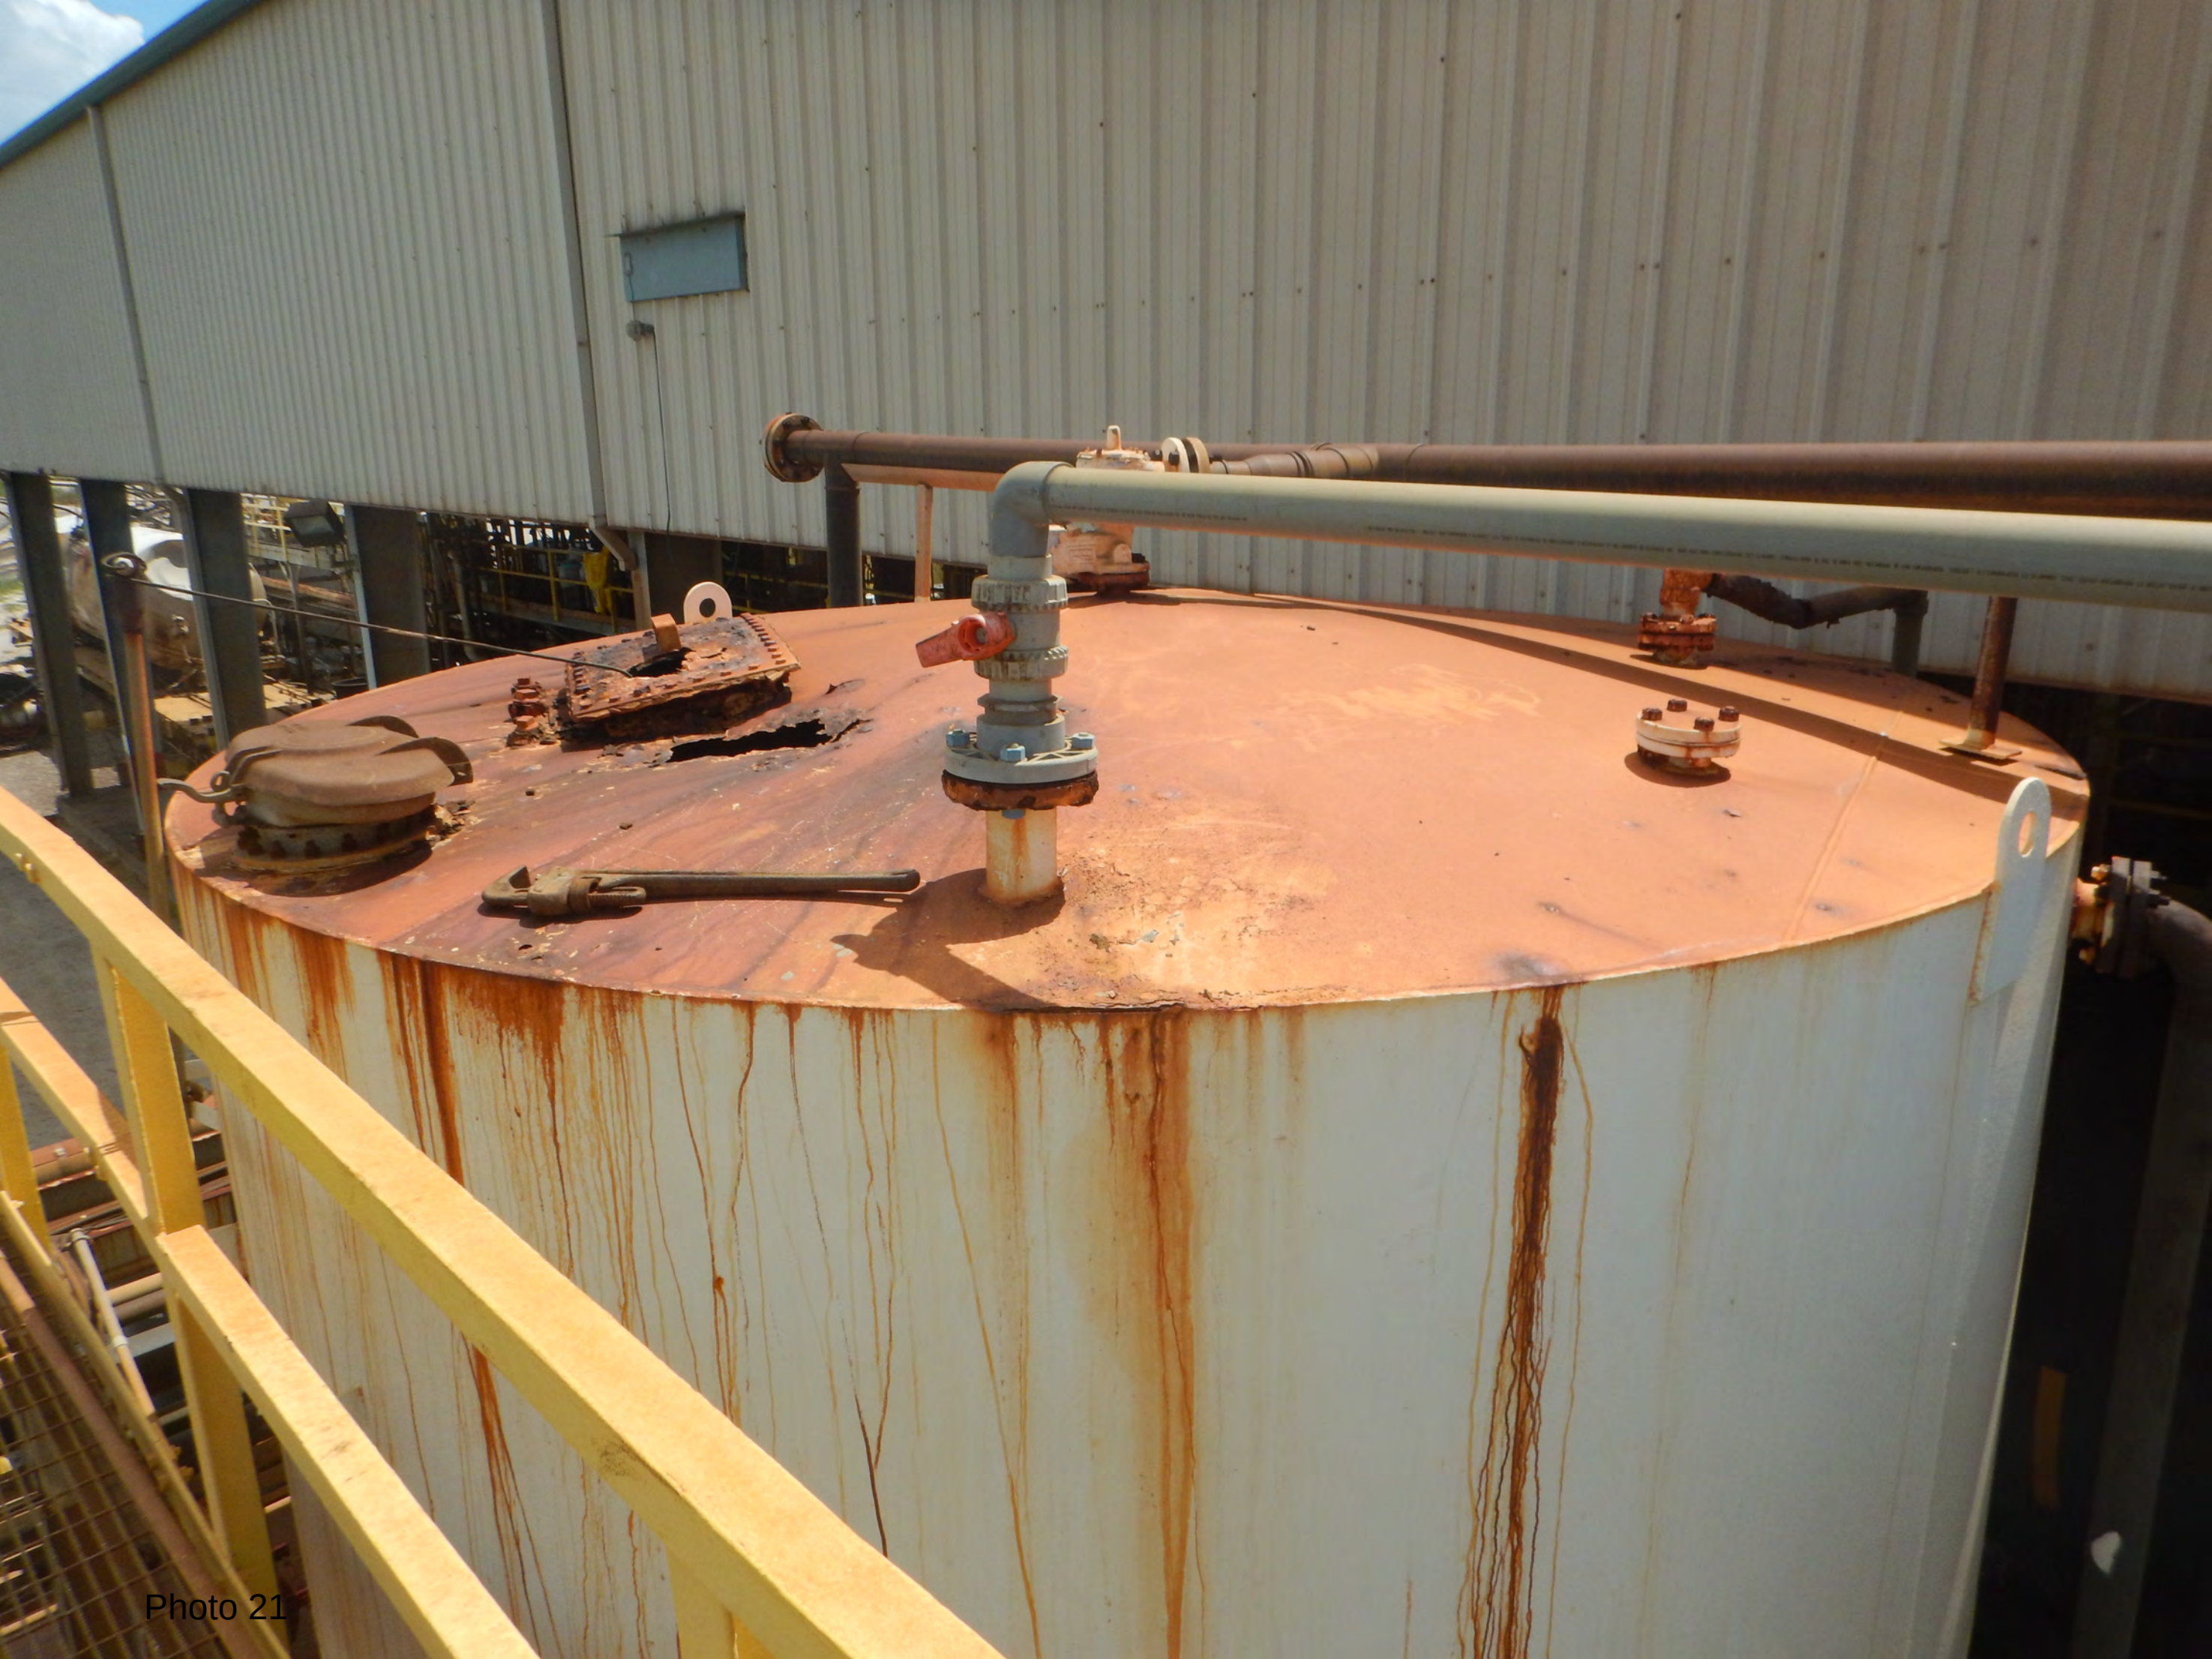
Photo 21

| Photo Number | File Name | | Date | Time | Photographer | Description |
|---|---|---|---|---|---|---|
| 21 | DSCN1079 | .JPG | 26-Jun-23 | 1146 | John Penland | Roof of hazardous waste tank T1 (NOR Unit 6). Large holes penetrate the roof. The largest hole is estimated to exceed 10 inches in diameter. The roof hatch is also open. Collapsed, out-of-service, fill pipe is visible on the opposite side of the roof from the tank hatch. |

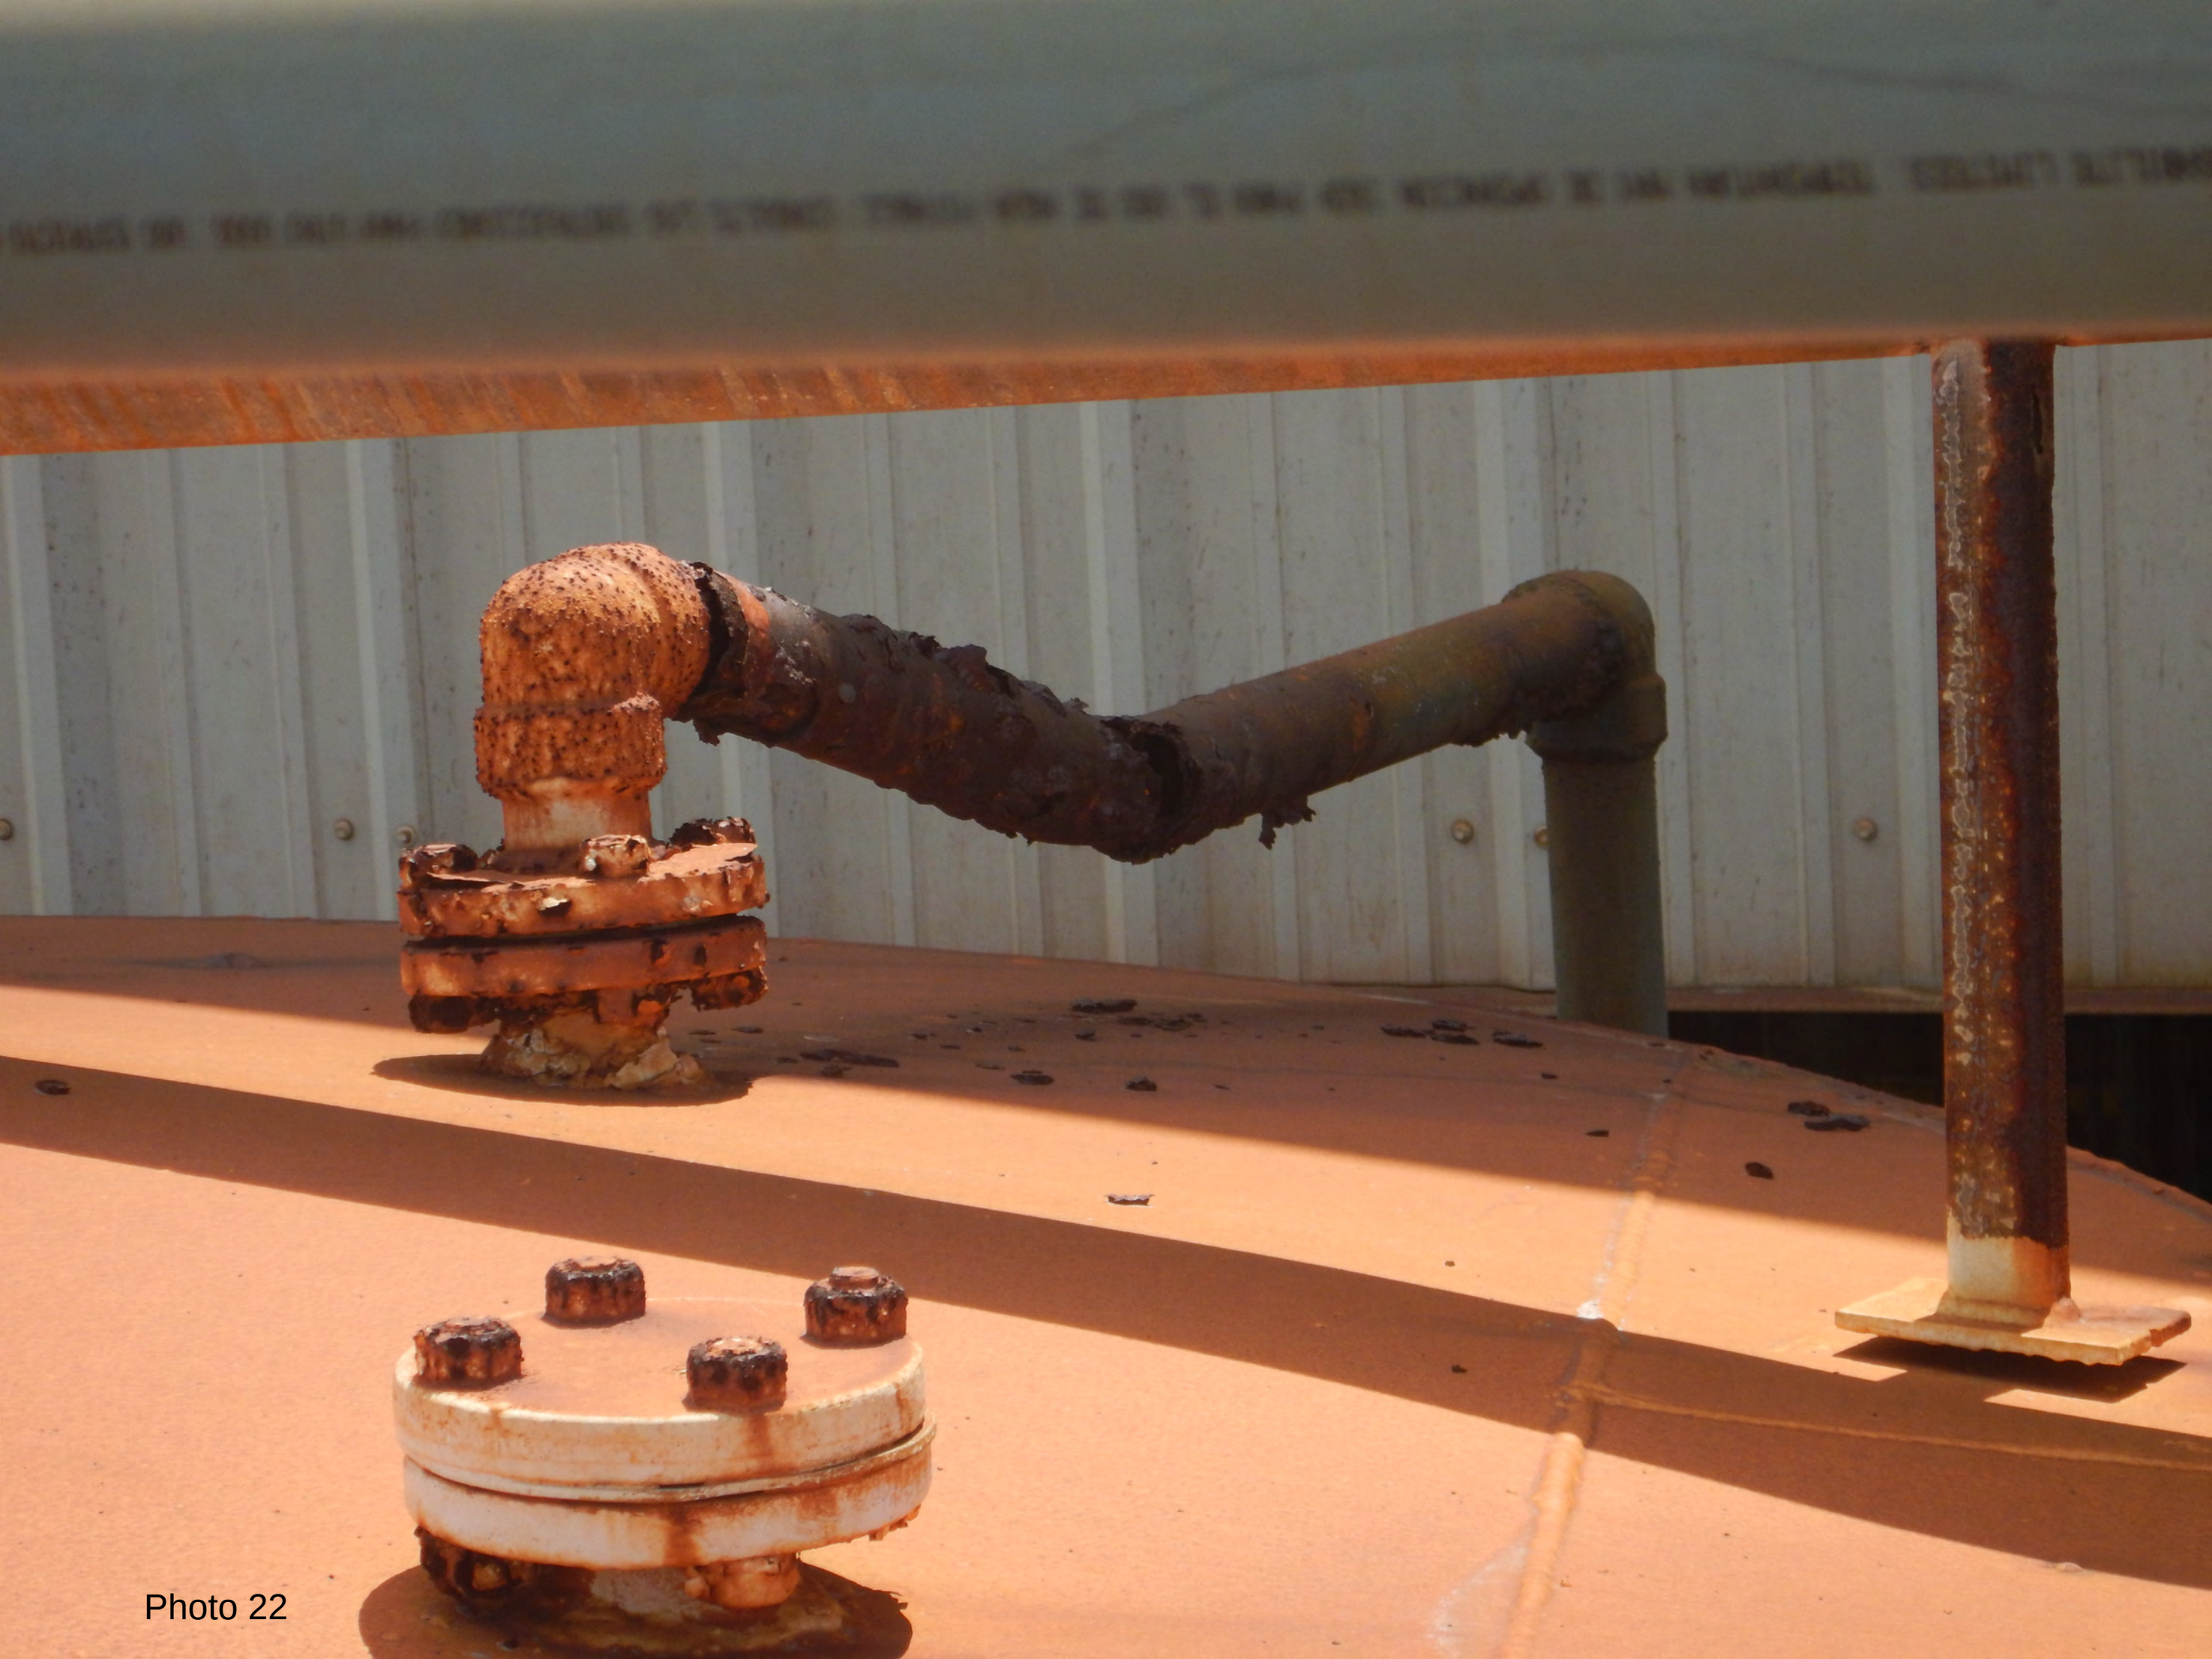
Photo 22

| Photo Number | File Name | | Date | Time | Photographer | Description |
|---|---|---|---|---|---|---|
| 22 | DSCN1080 | .JPG | 26-Jun-23 | 1146 | John Penland | Roof of hazardous waste tank T1 (NOR Unit 6). Close view of the collapsed, out of service, fill pipe. |

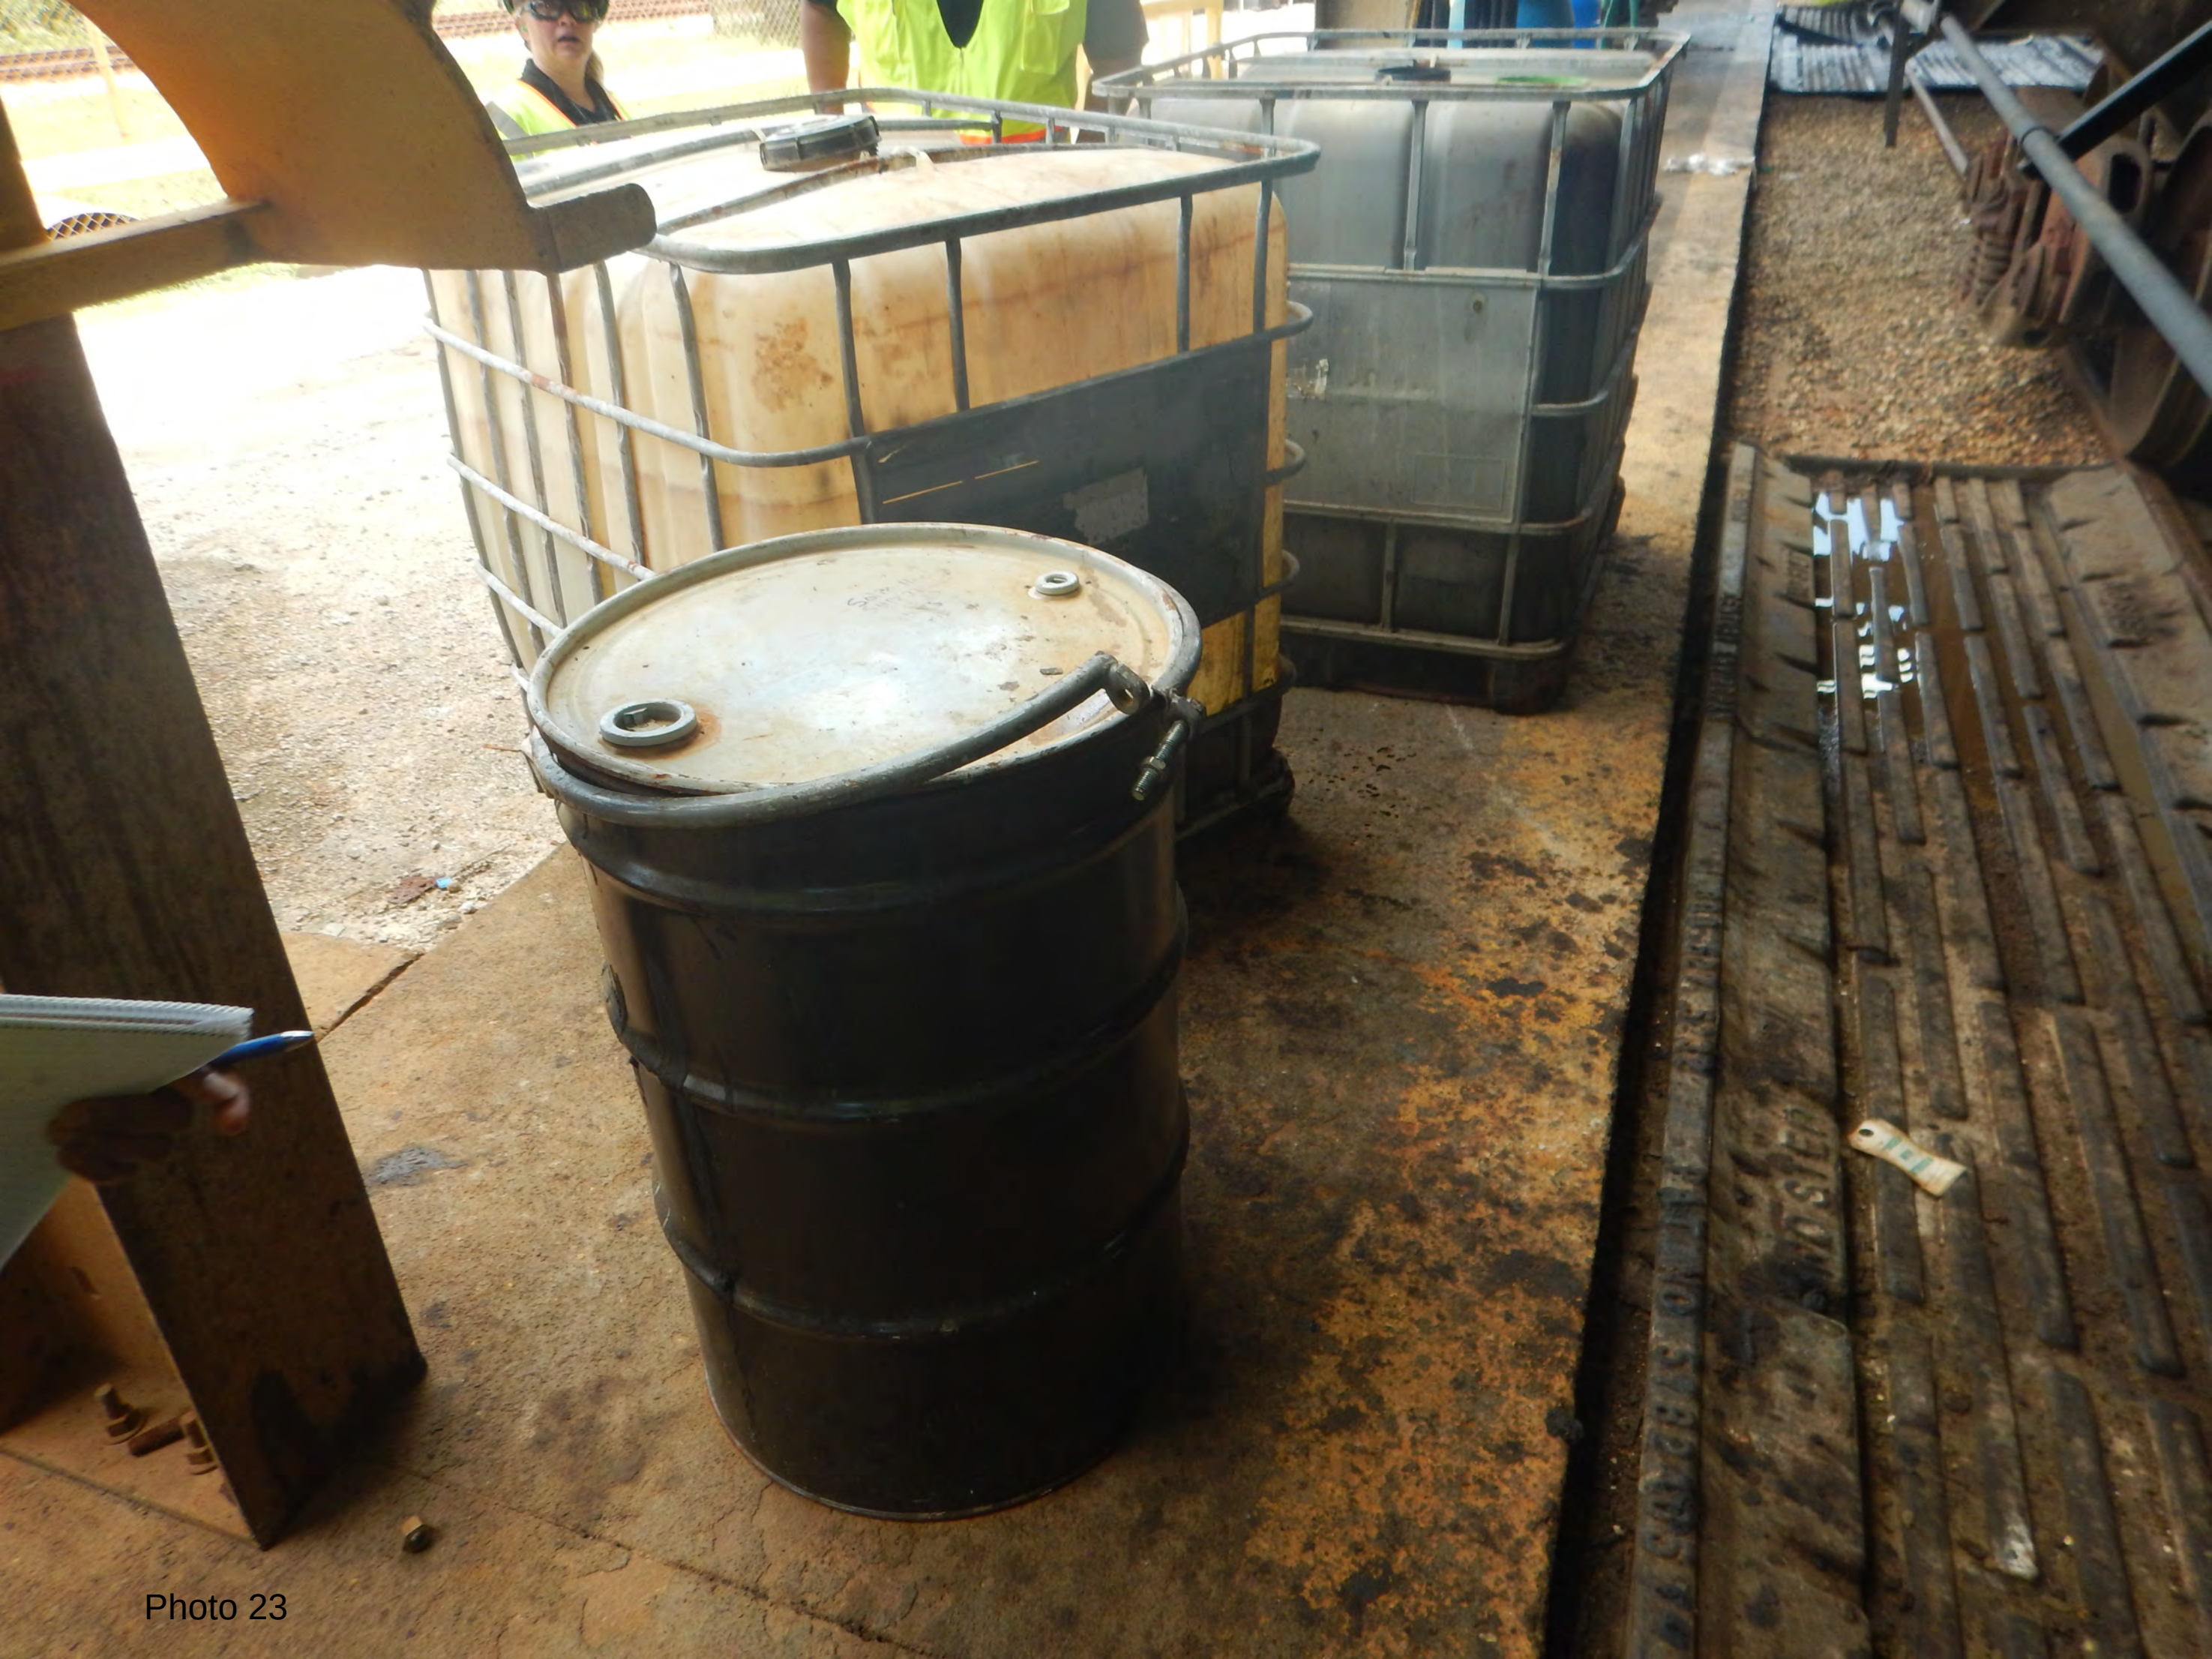
Photo 23

- On June 26, 2023, we found two unlabeled 55-gallon drums of hazardous waste in the rail and specialty wash area. See photos 18 and 19.
- On June 26, 2023, we found one unlabeled 55-gallon drum of hazardous waste “solid heels” in the rail and specialty wash area. See photos 23, 24, and 29.

| Photo Number | File Name | | Date | Time | Photographer | Description |
|---|---|---|---|---|---|---|
| 23 | DSCN1081 | .JPG | 26-Jun-23 | 1159 | John Penland | One container of hazardous waste located near the rail and specialty wash rack. Container was found open and unlabeled at the time of inspection. |

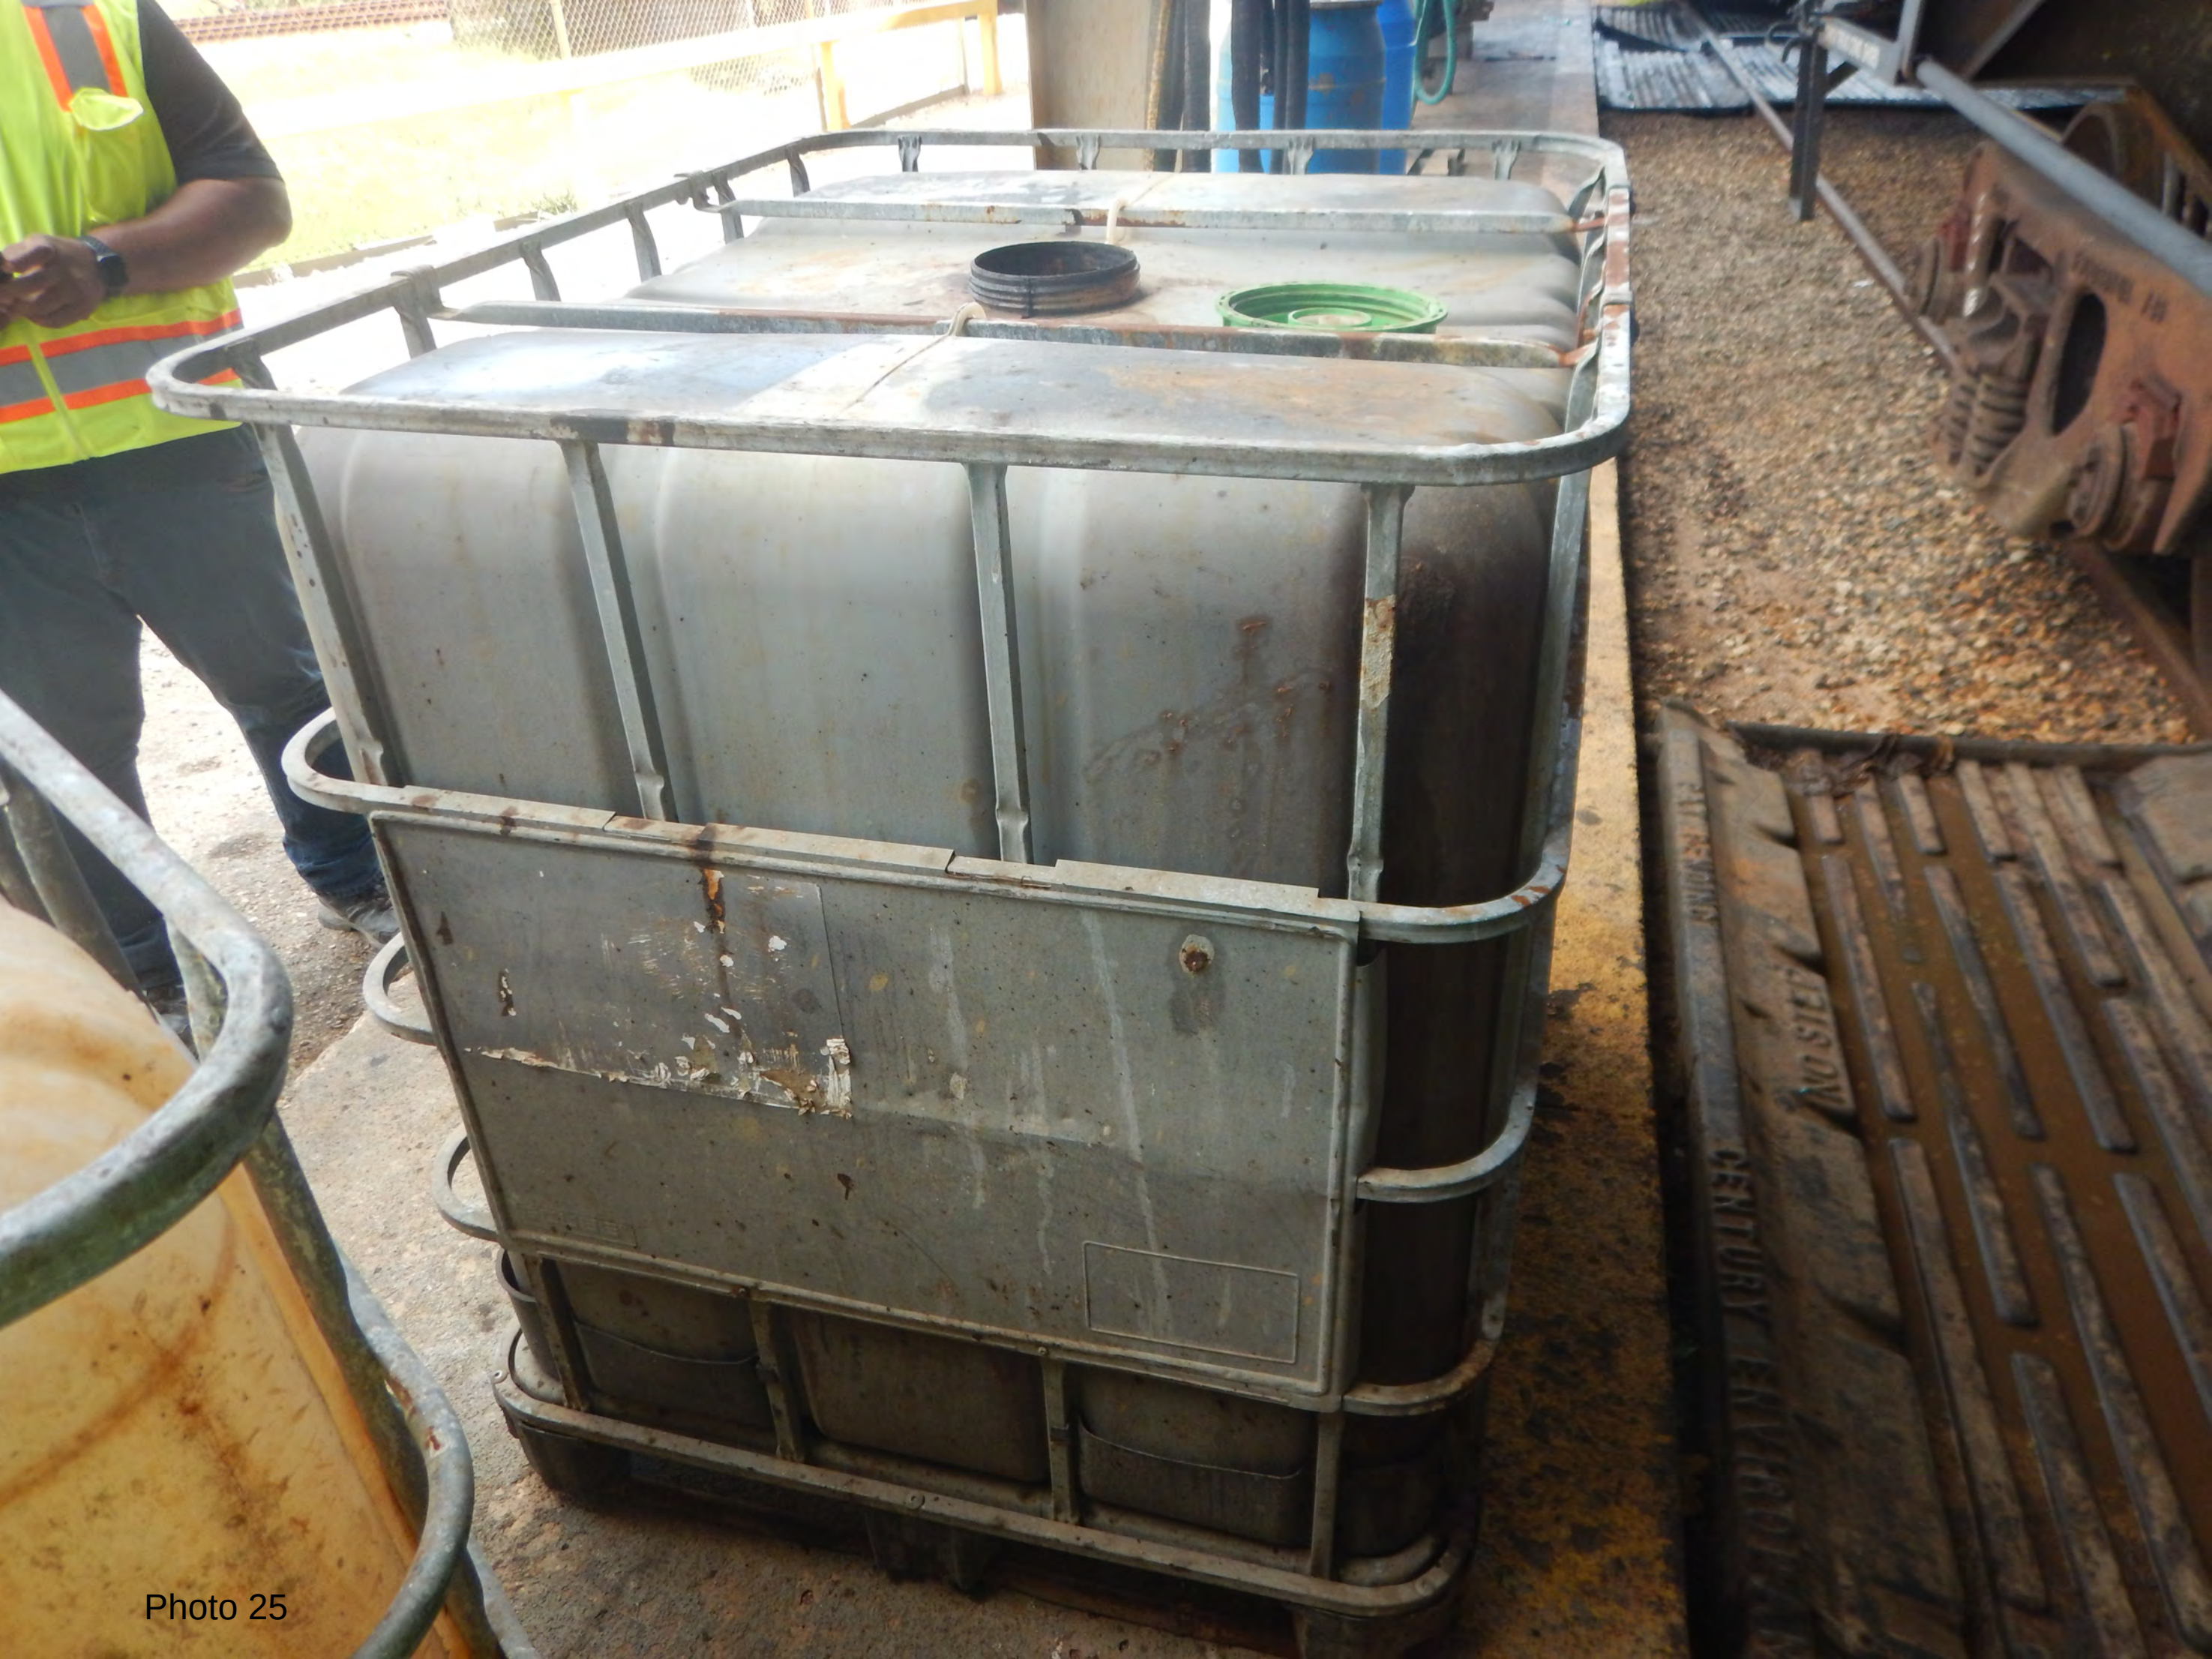
Photo 25

- On June 26, 2023, we found one unlabeled 275-gallon tote of hazardous waste in the rail and specialty wash area. See photo 25.
- On June 26, 2023, we found one unlabeled 275-gallon tote of hazardous waste in the rail and specialty wash area. See photo 30.

| Photo Number | File Name | | Date | Time | Photographer | Description |
|---|---|---|---|---|---|---|
| 25 | DSCN1083 | .JPG | 26-Jun-23 | 1159 | John Penland | One container of hazardous waste located near the rail and specialty wash rack. Container was found open and unlabeled at the time of inspection. |
