**Region 6 - Enforcement & Compliance Assurance Division**  
**INSPECTION REPORT**

| Inspection Date(s): | June 26 – 29, 2023 | |
| Regulatory Program(s) | Large Quantity Generator | |
| Facility Name: | <b>Quala Rail and Specialty</b> | |

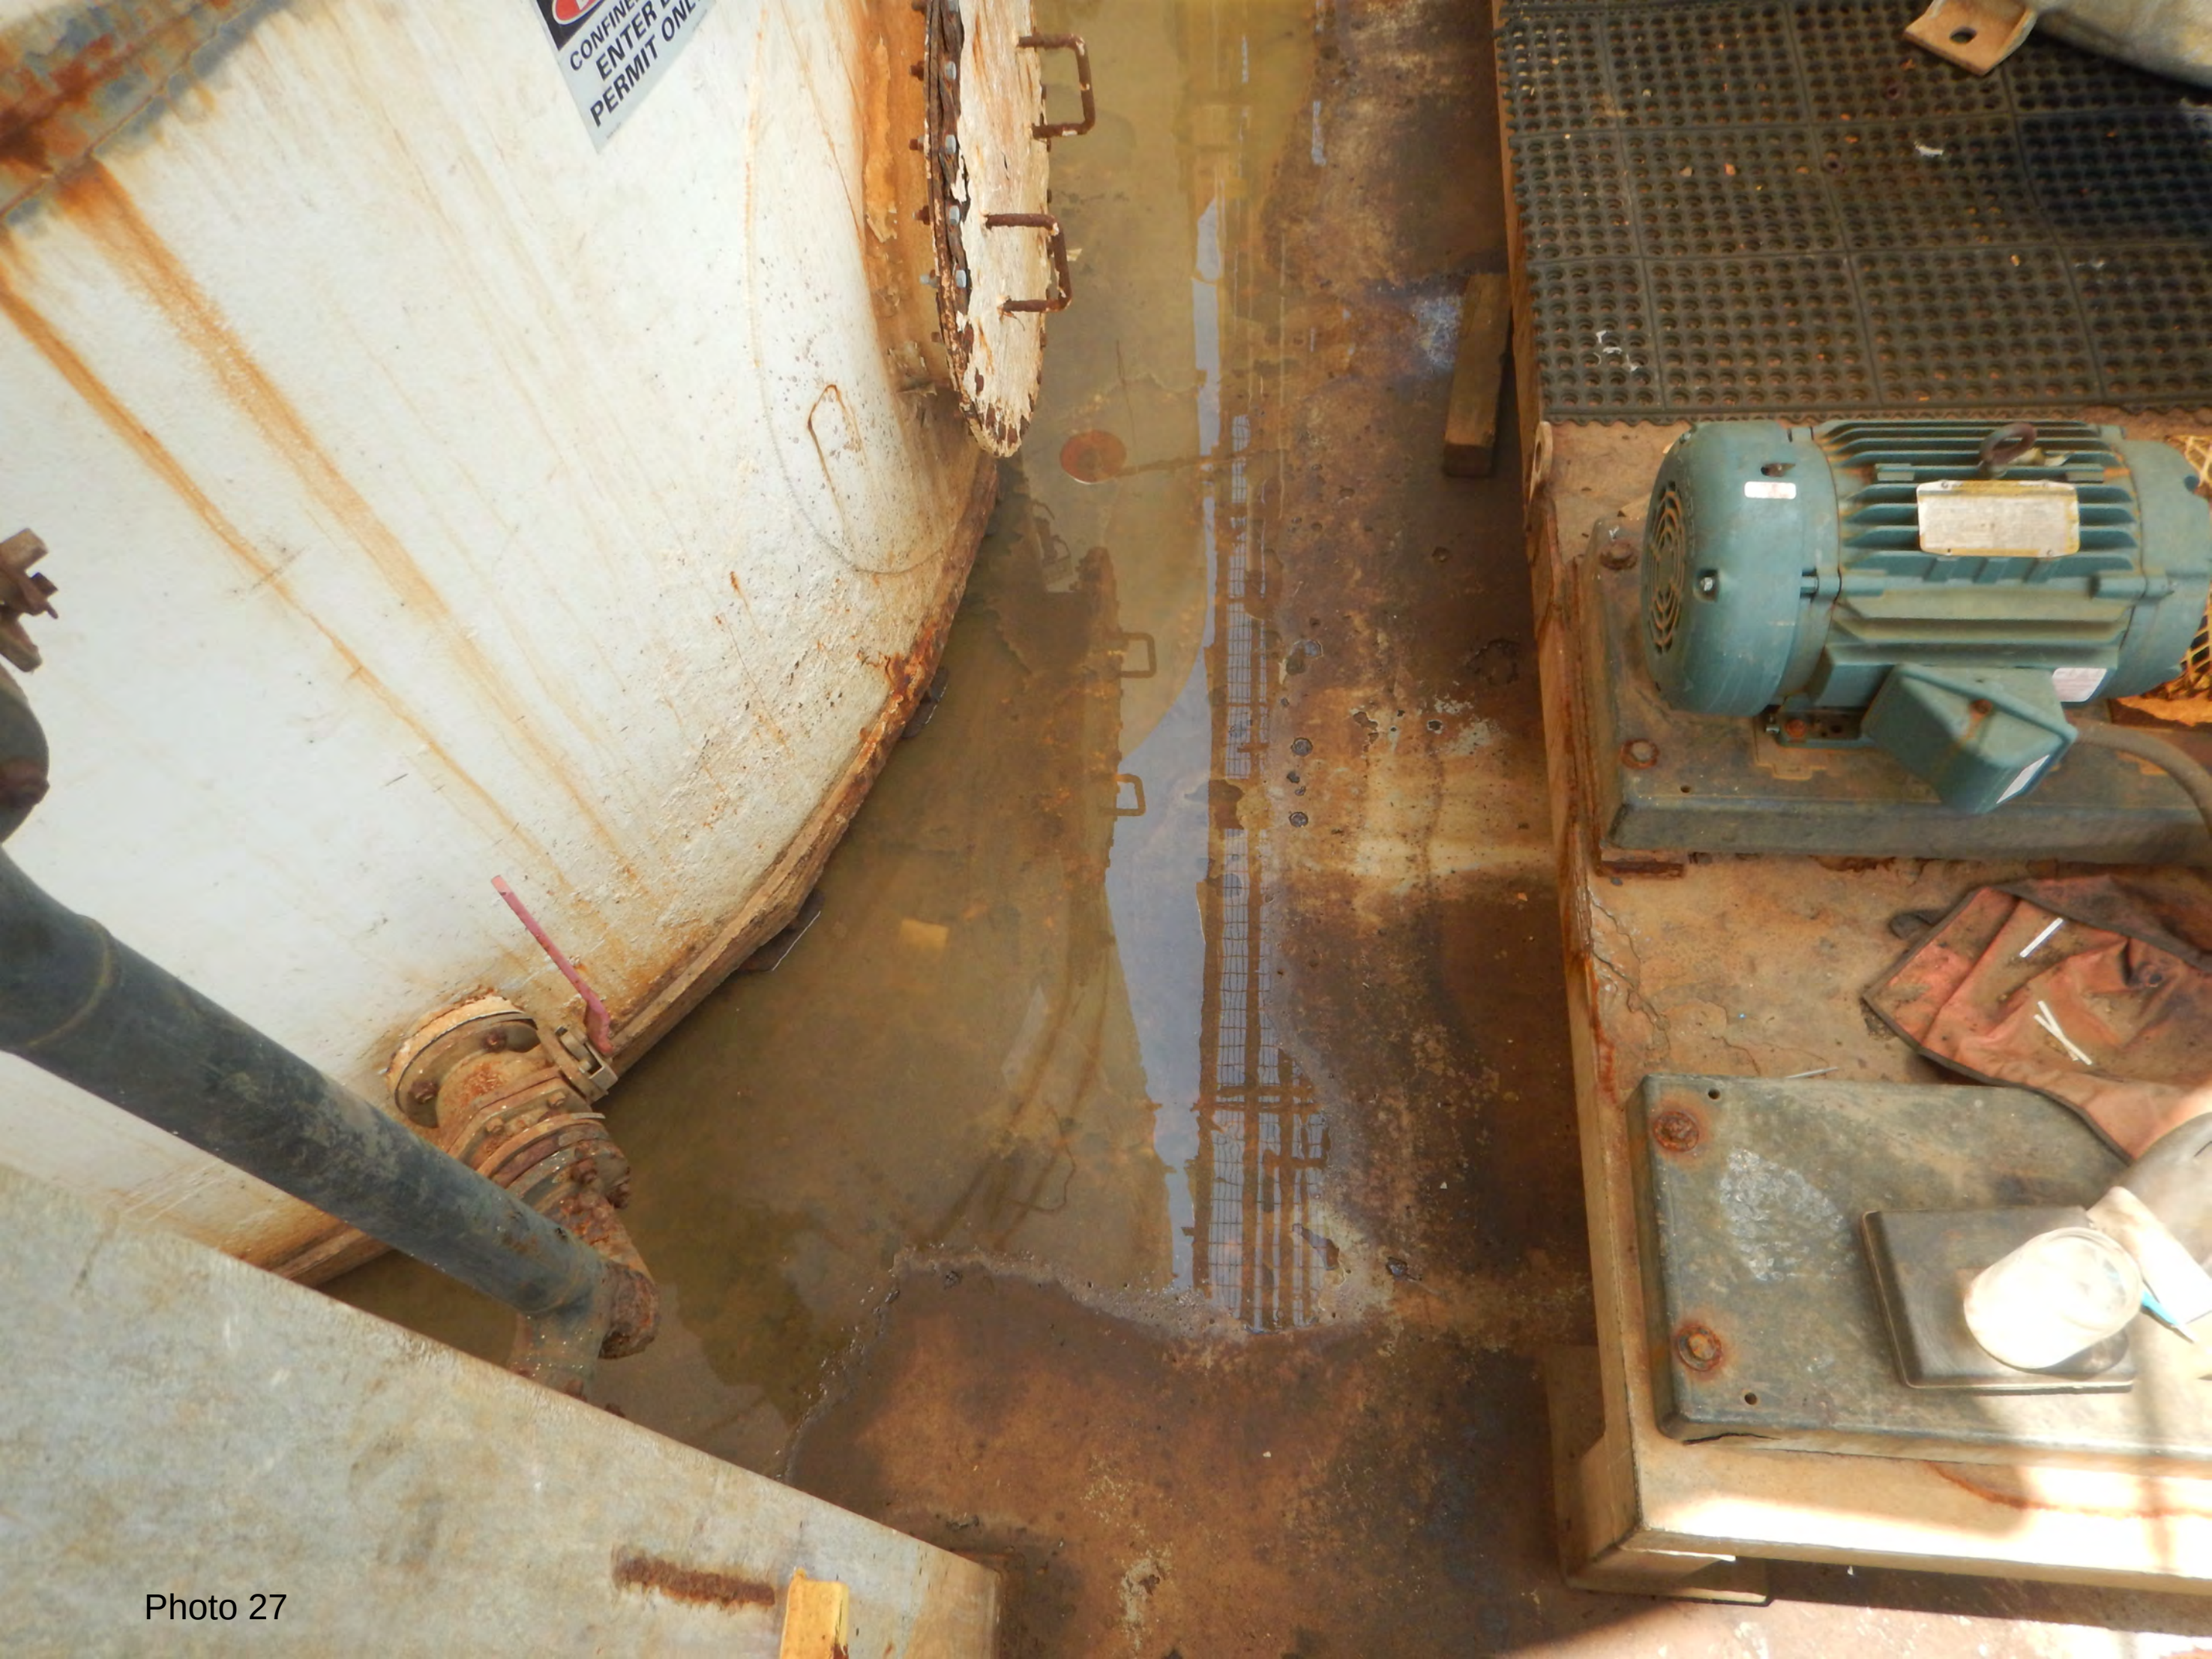
Photo 27

The hazardous waste generator standards require large quantity generators to remove spilled or leaked waste and accumulated precipitation from the secondary containment system for hazardous waste tanks within 24 hours. On both June 26 and June 27, during this inspection, we observed accumulated liquids in the secondary containment of Tank T1 (WMU 006). See photos 27, 28, and 64.

The hazardous waste generator standards require large quantity generators to construct secondary containment systems for hazardous waste tanks using materials that are compatible with the waste contained in the tank and with the operations carried out in the unit. During this inspection, we observed extensive corrosion and pitting of the secondary containment system for Tank T1 (WMU 006). The secondary containment damage is present in the floor of the concrete liner throughout the containment area and pitting appears to extend to a depth of more than 1 inch. See photos 27, 28, and 64.

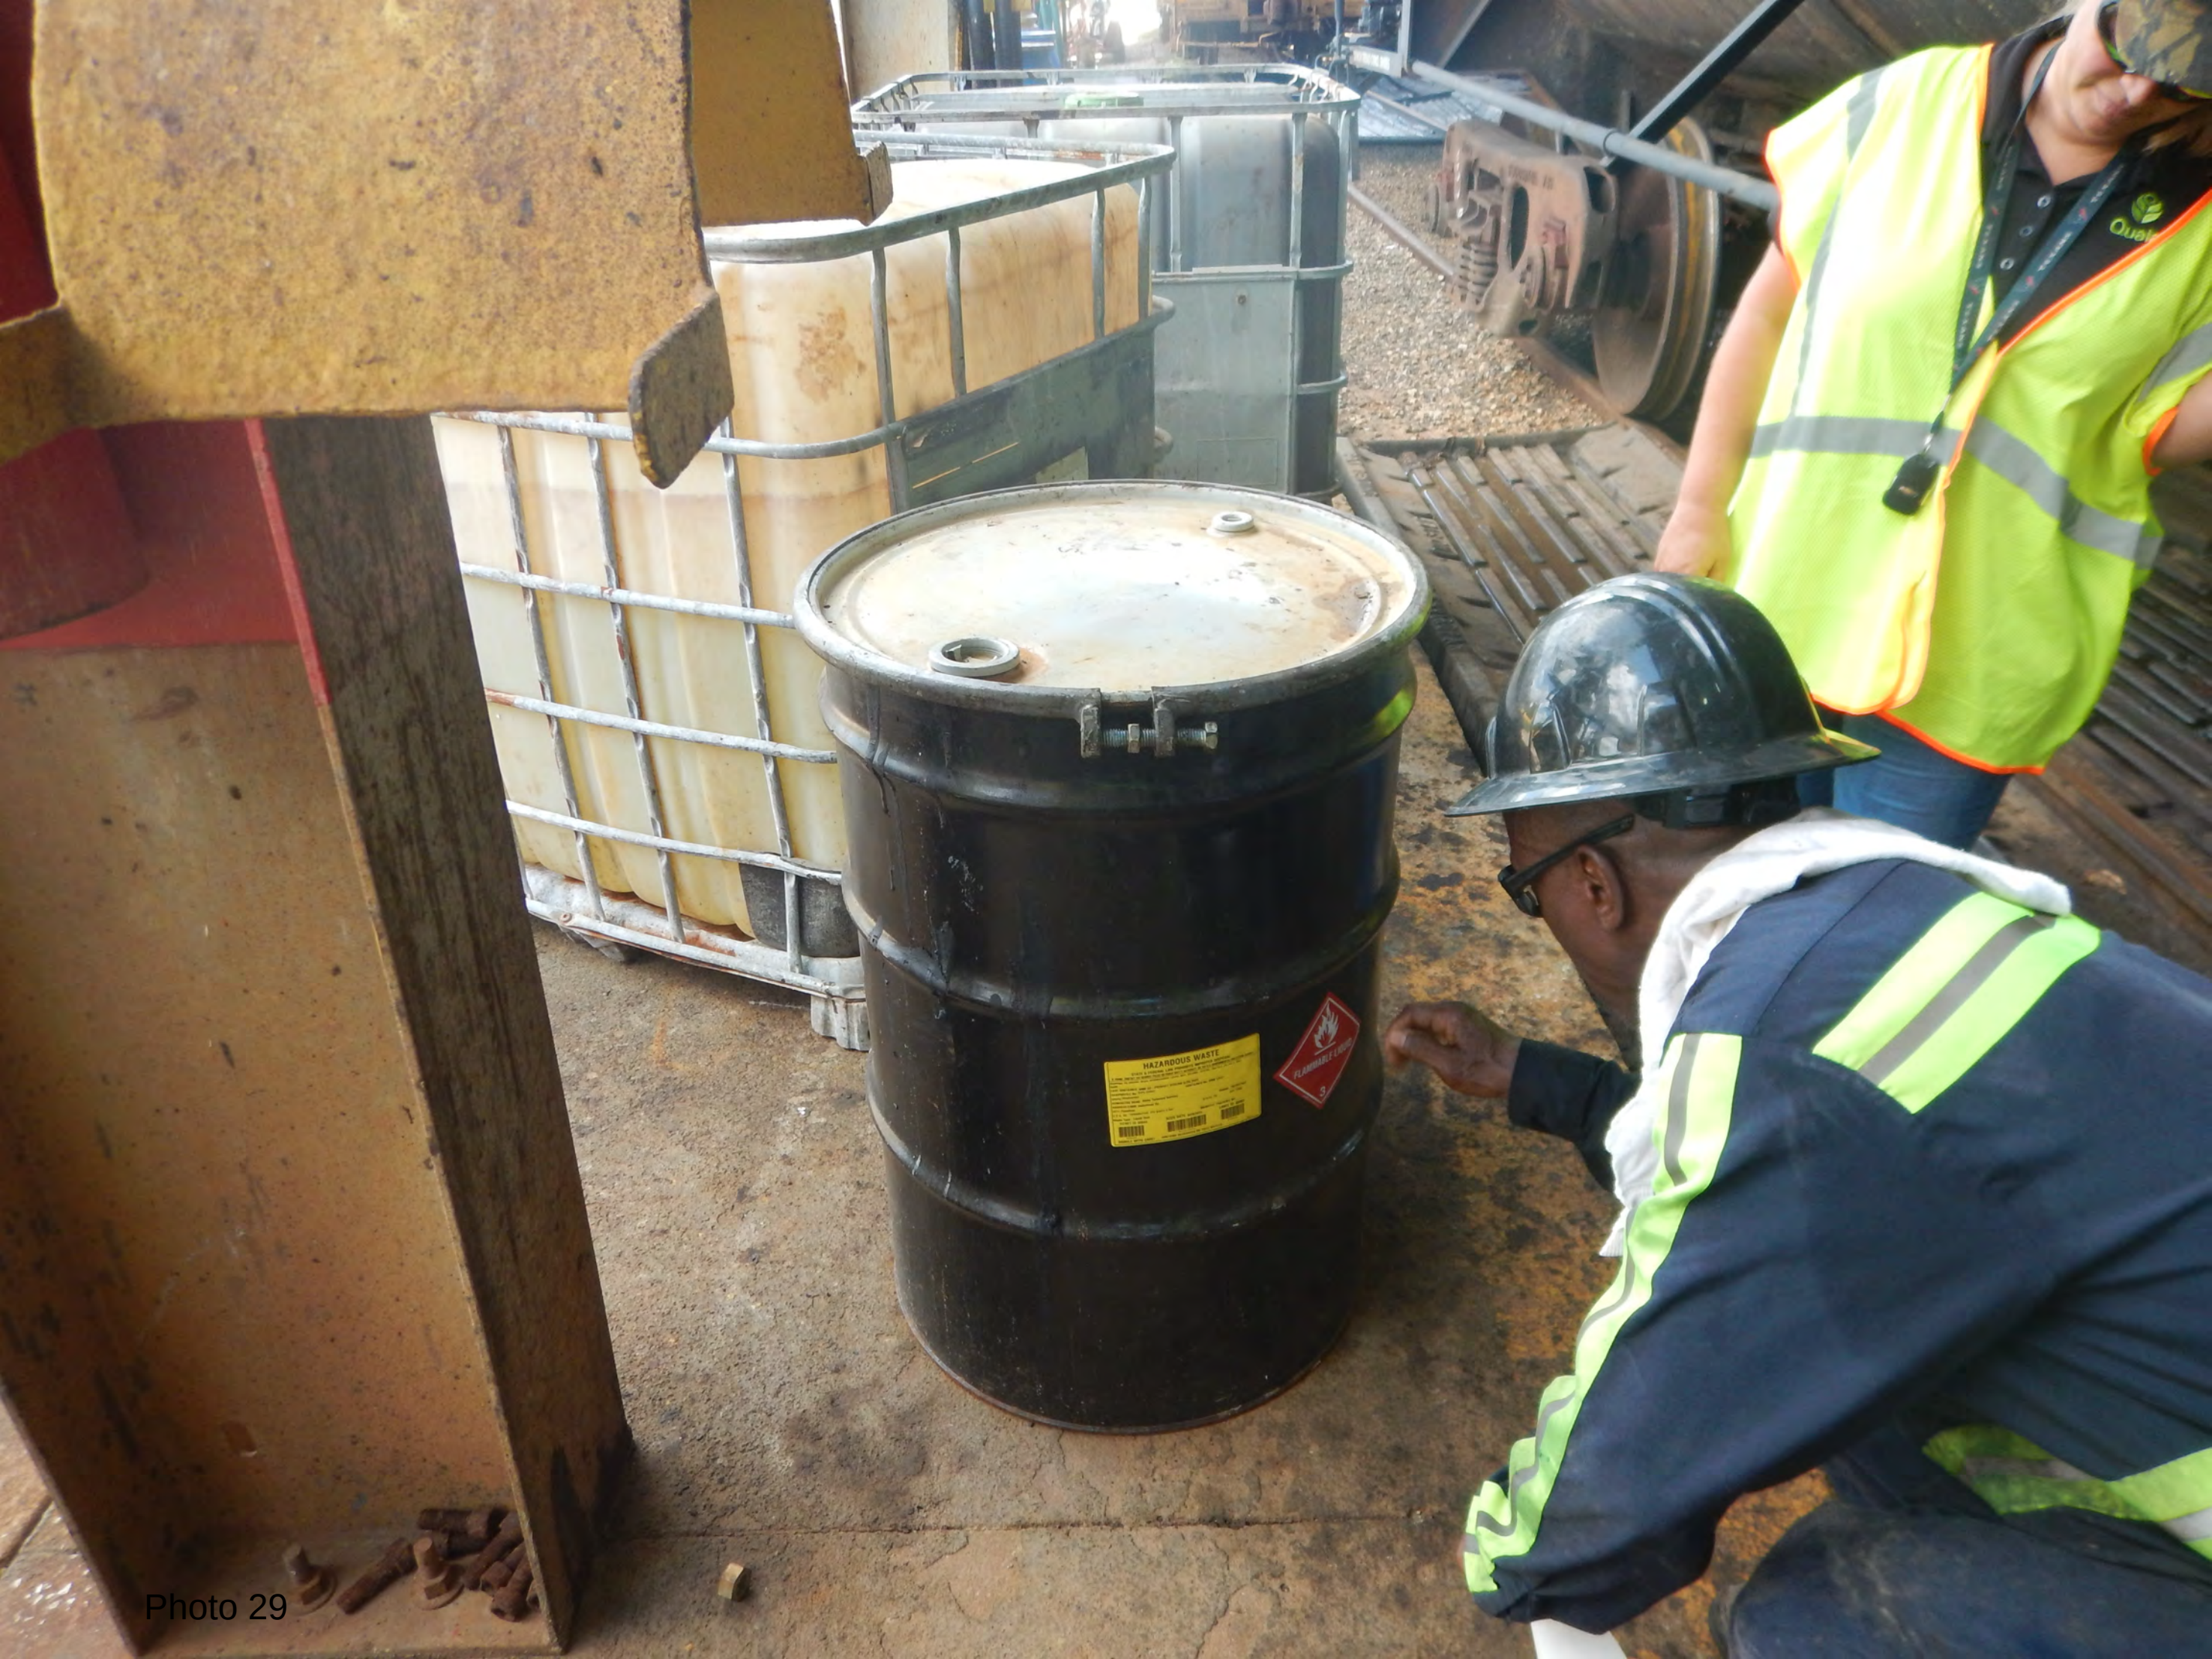
Photo 29

- On June 26, 2023, we found two unlabeled 55-gallon drums of hazardous waste in the rail and specialty wash area. See photos 18 and 19.
- On June 26, 2023, we found one unlabeled 55-gallon drum of hazardous waste “solid heels” in the rail and specialty wash area. See photos 23, 24, and 29.

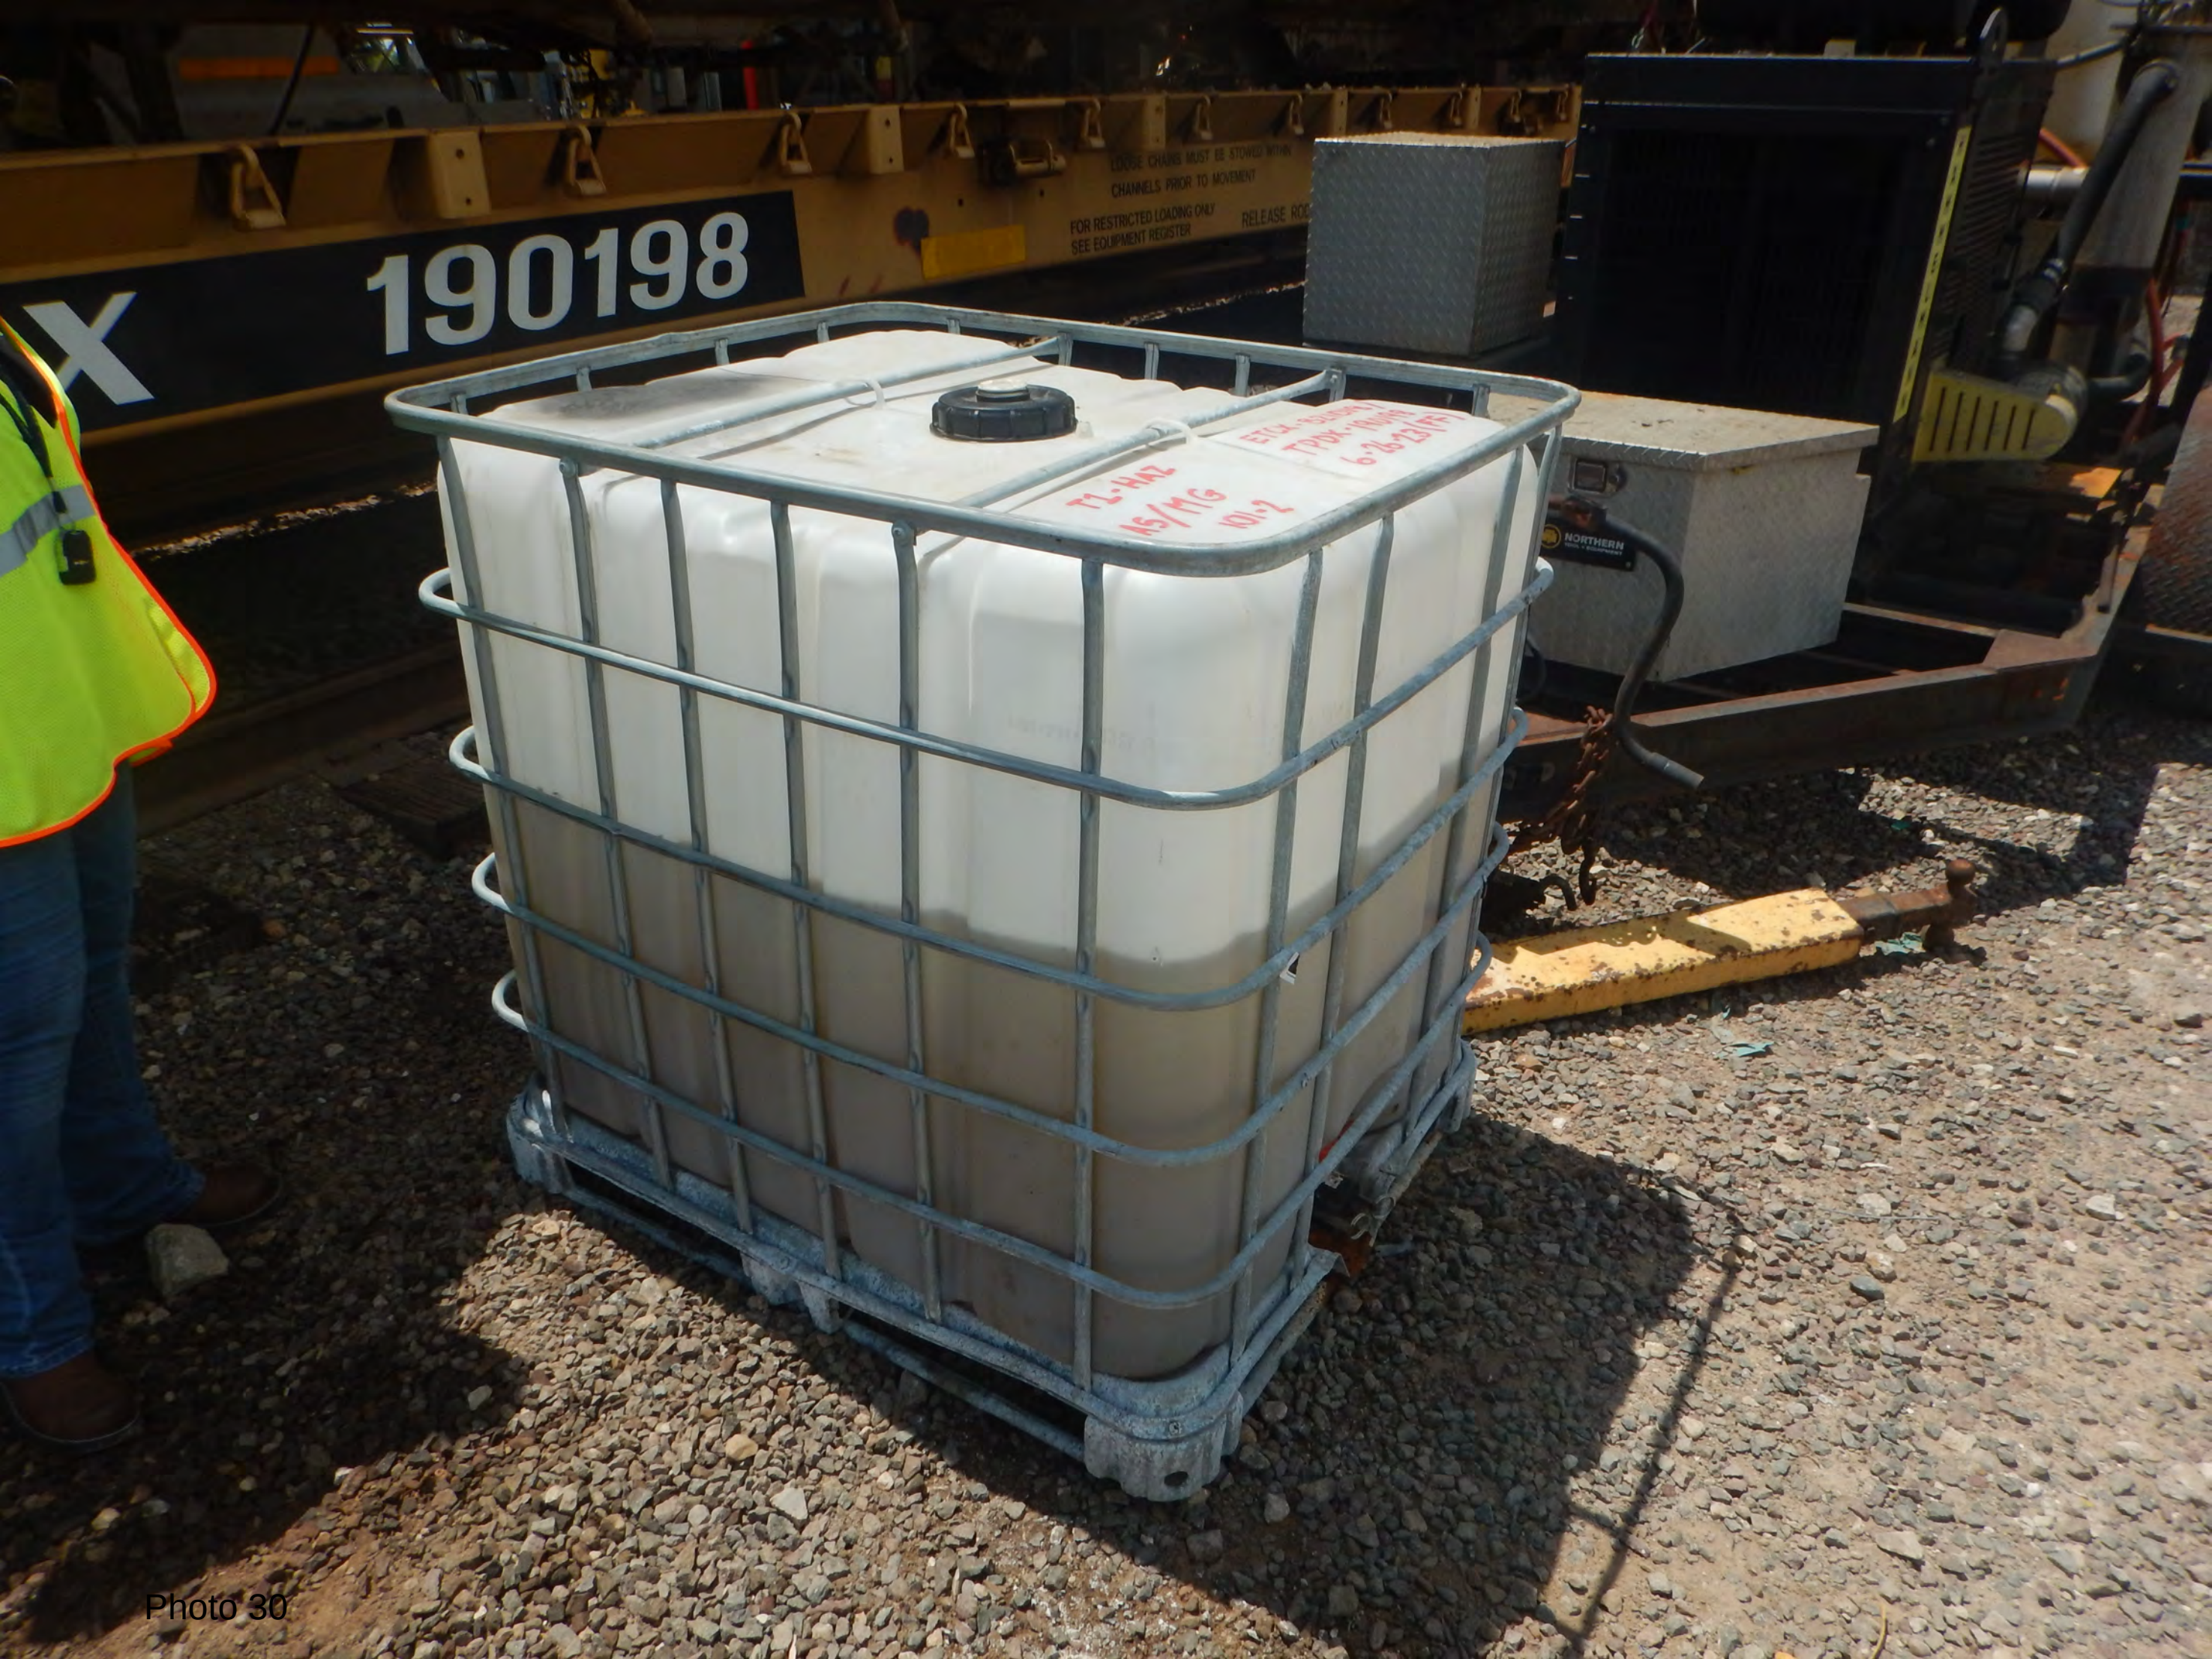
Photo 30

- On June 26, 2023, we found one unlabeled 275-gallon tote of hazardous waste in the rail and specialty wash area. See photo 25.
- On June 26, 2023, we found one unlabeled 275-gallon tote of hazardous waste in the rail and specialty wash area. See photo 30.

| Photo Number | File Name | | Date | Time | Photographer | Description |
|---|---|---|---|---|---|---|
| 30 | DSCN1088 | .JPG | 26-Jun-23 | 1213 | John Penland | One container of hazardous waste located near the rail and specialty wash rack. Container was inadequately labeled at the time of inspection. |

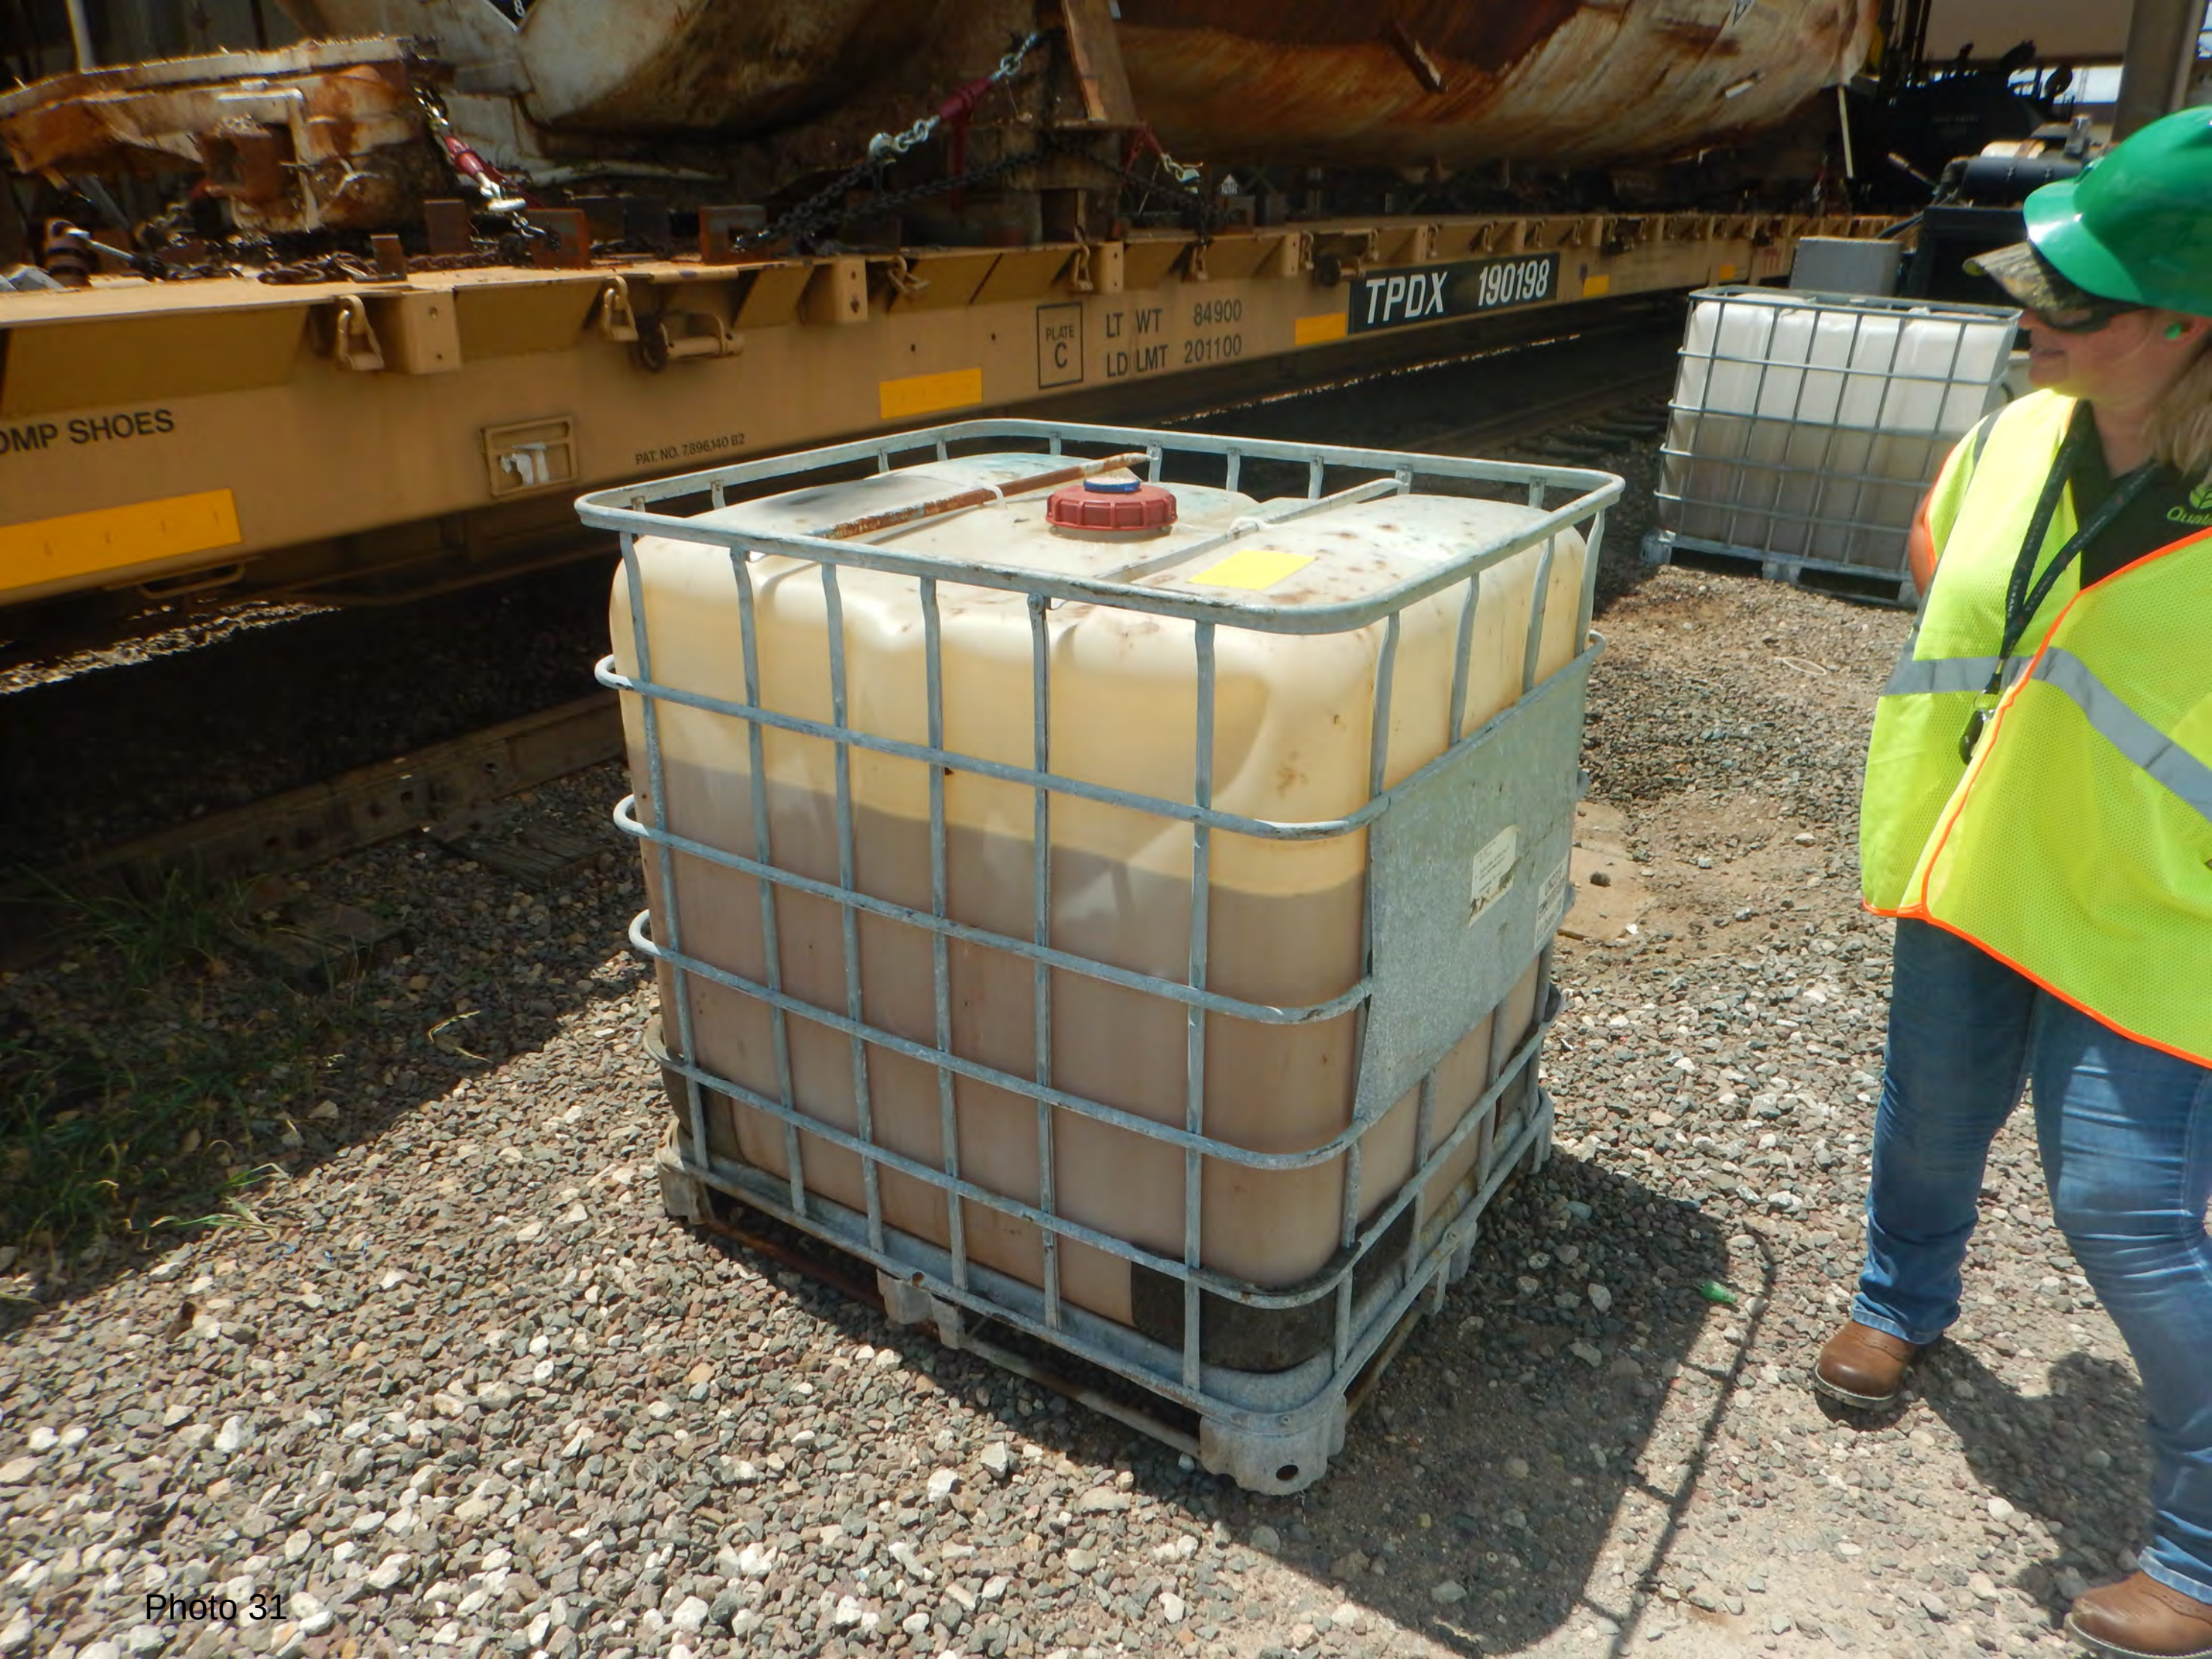
Photo 31

- On June 26, 2023, we found one unlabeled 275-gallon tote of hazardous waste in the rail and specialty wash area. See photo 31.
- On June 27, 2023, we found one unlabeled 55-gallon drum used for the puncture and draining of waste aerosol cans in the trailer maintenance area. See photo 35.

| Photo Number | File Name | | Date | Time | Photographer | Description |
|---|---|---|---|---|---|---|
| 31 | DSCN1089 | .JPG | 26-Jun-23 | 1213 | John Penland | One container of hazardous waste located near the rail and specialty wash rack. Container was found unlabeled at the time of inspection. |

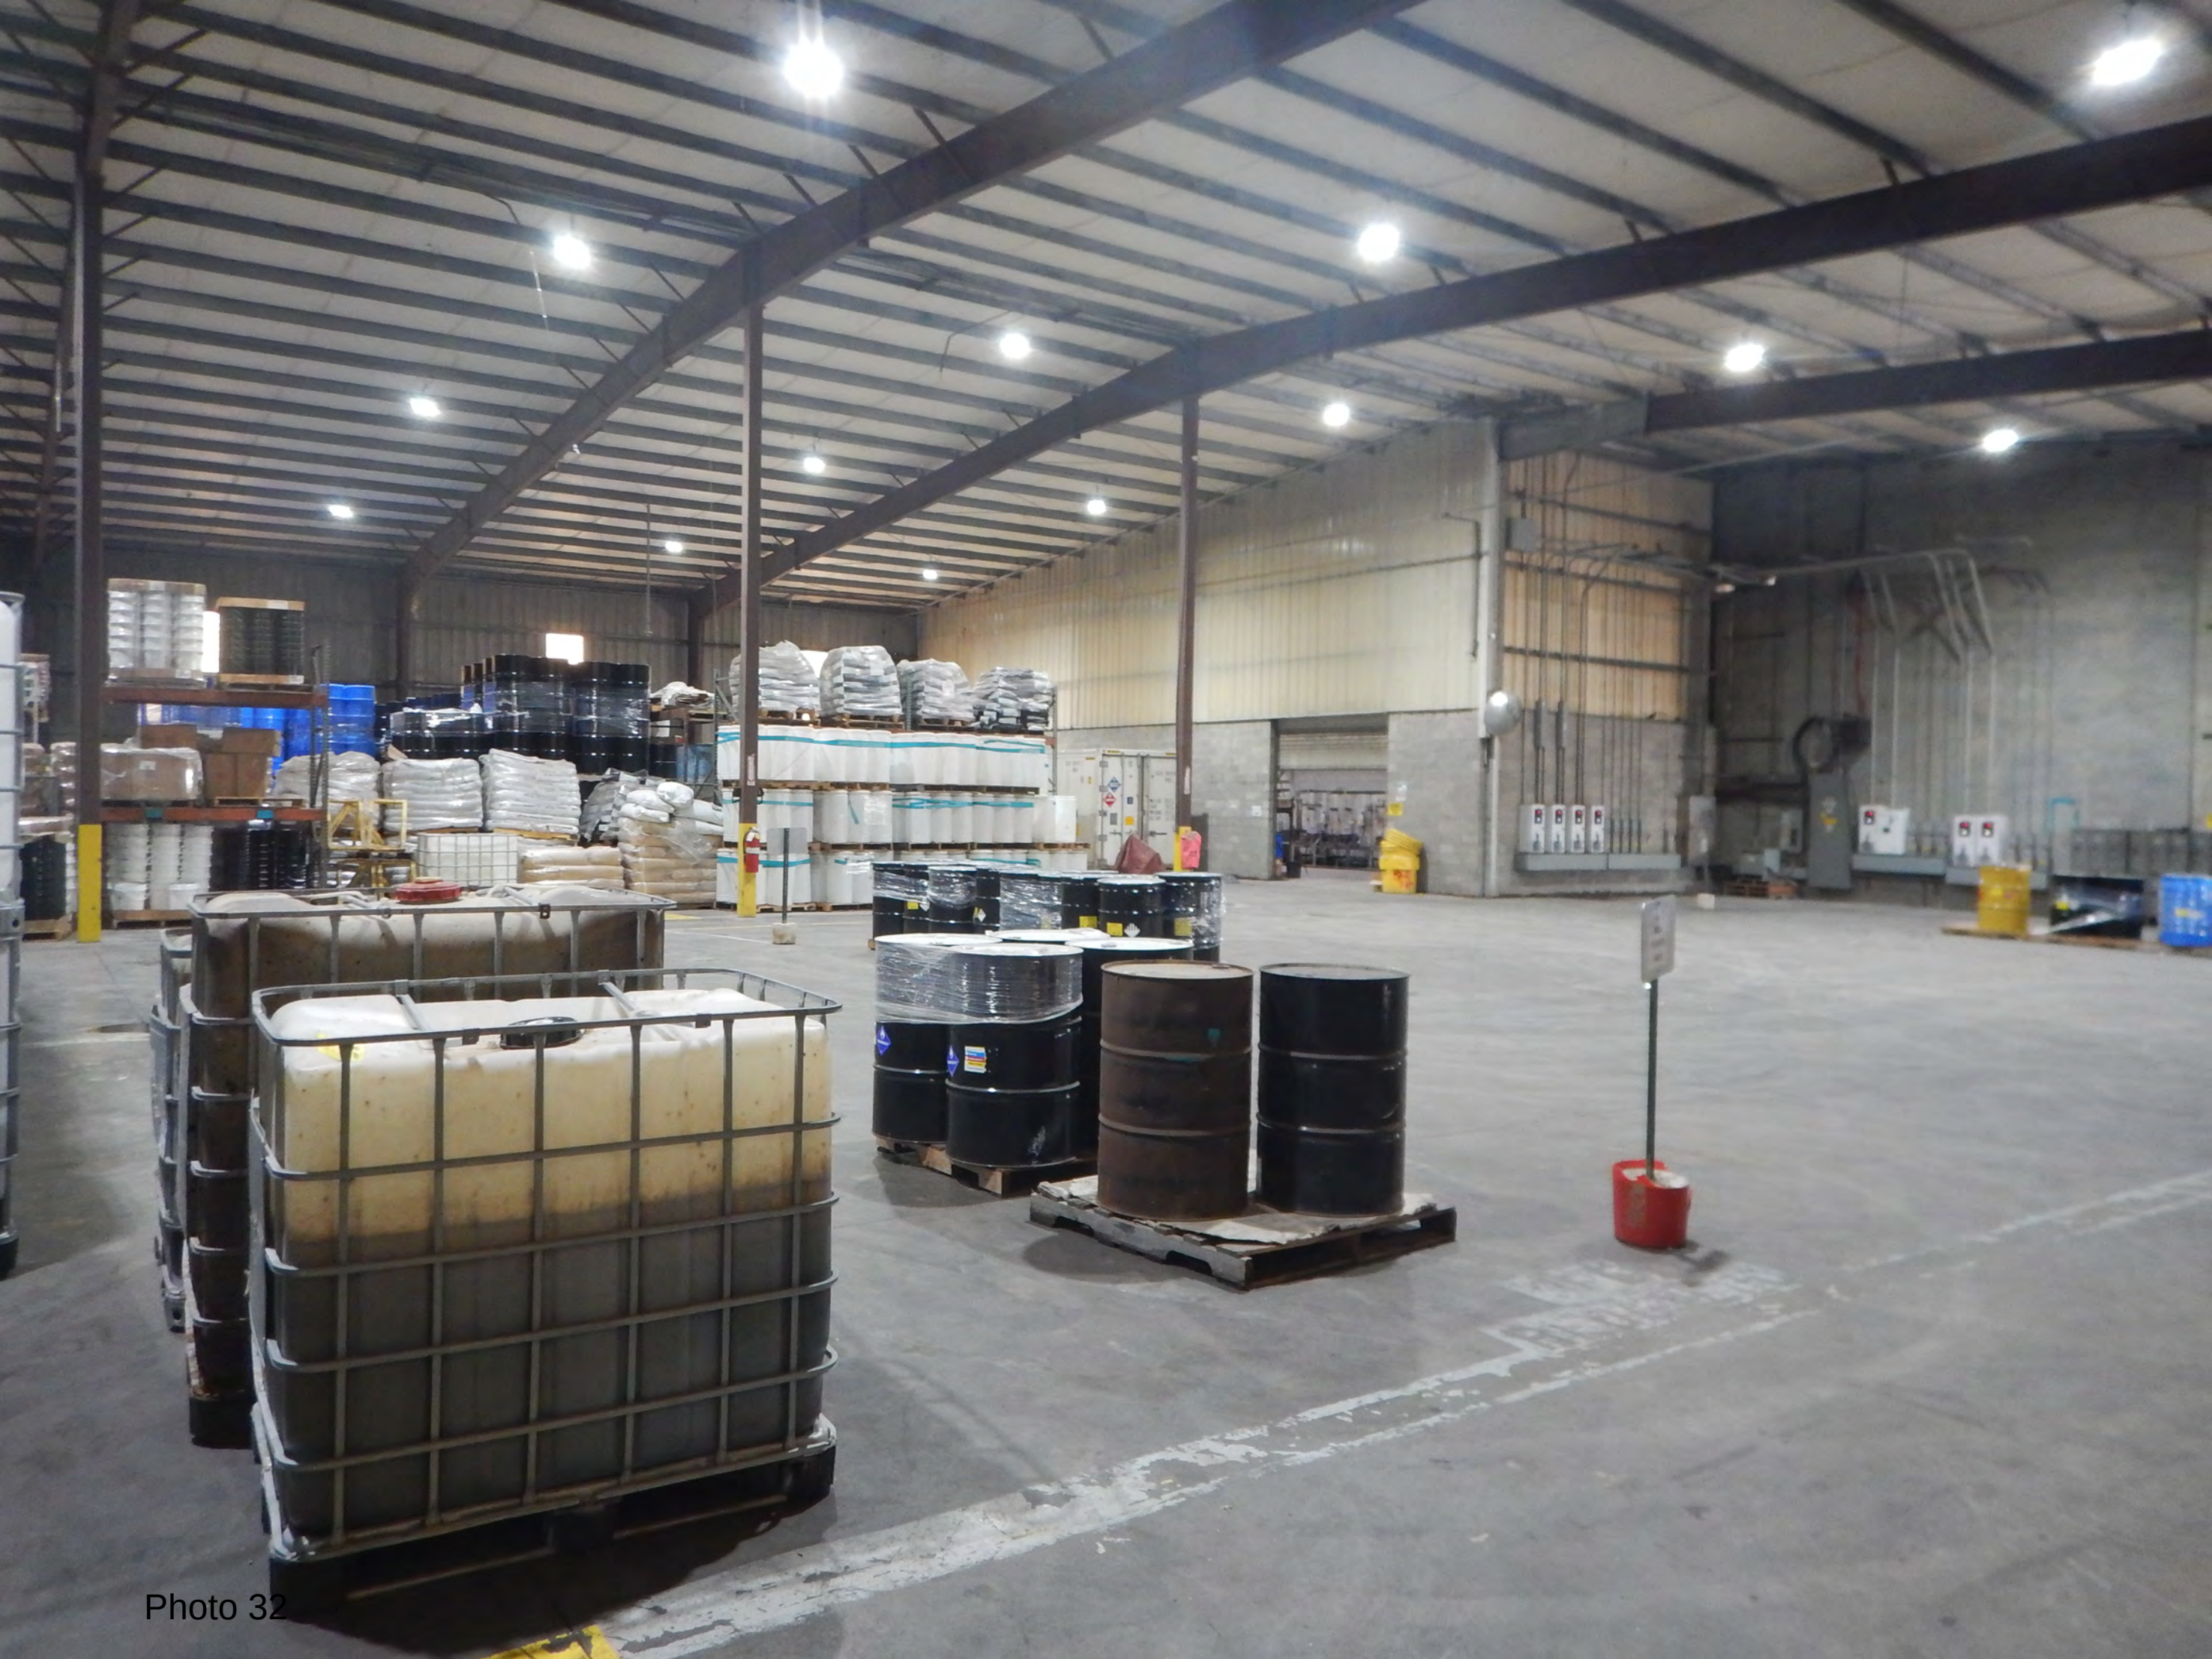
Photo 32

The hazardous waste generator standards require large quantity generators to protect hazardous waste containers from accidental release and generally operate their facility in a manner which minimizes the risk of fire or explosion. During this inspection, we observed that the facility has designated an area near high voltage electrical panels for the accumulation of flammable hazardous waste. See photos 32 and 33.

| Photo Number | File Name | | Date | Time | Photographer | Description |
|---|---|---|---|---|---|---|
| 32 | DSCN1090 | .JPG | 27-Jun-23 | 1029 | John Penland | Overview photo of the warehouse area which is operated as a <90-day hazardous waste container central accumulation area (NOR Unit 8). |
