**Region 6 - Enforcement & Compliance Assurance Division**  
**INSPECTION REPORT**

| Inspection Date(s): | June 26 – 29, 2023 | |
| Regulatory Program(s) | Large Quantity Generator | |
| Facility Name: | <b>Quala Rail and Specialty</b> | |

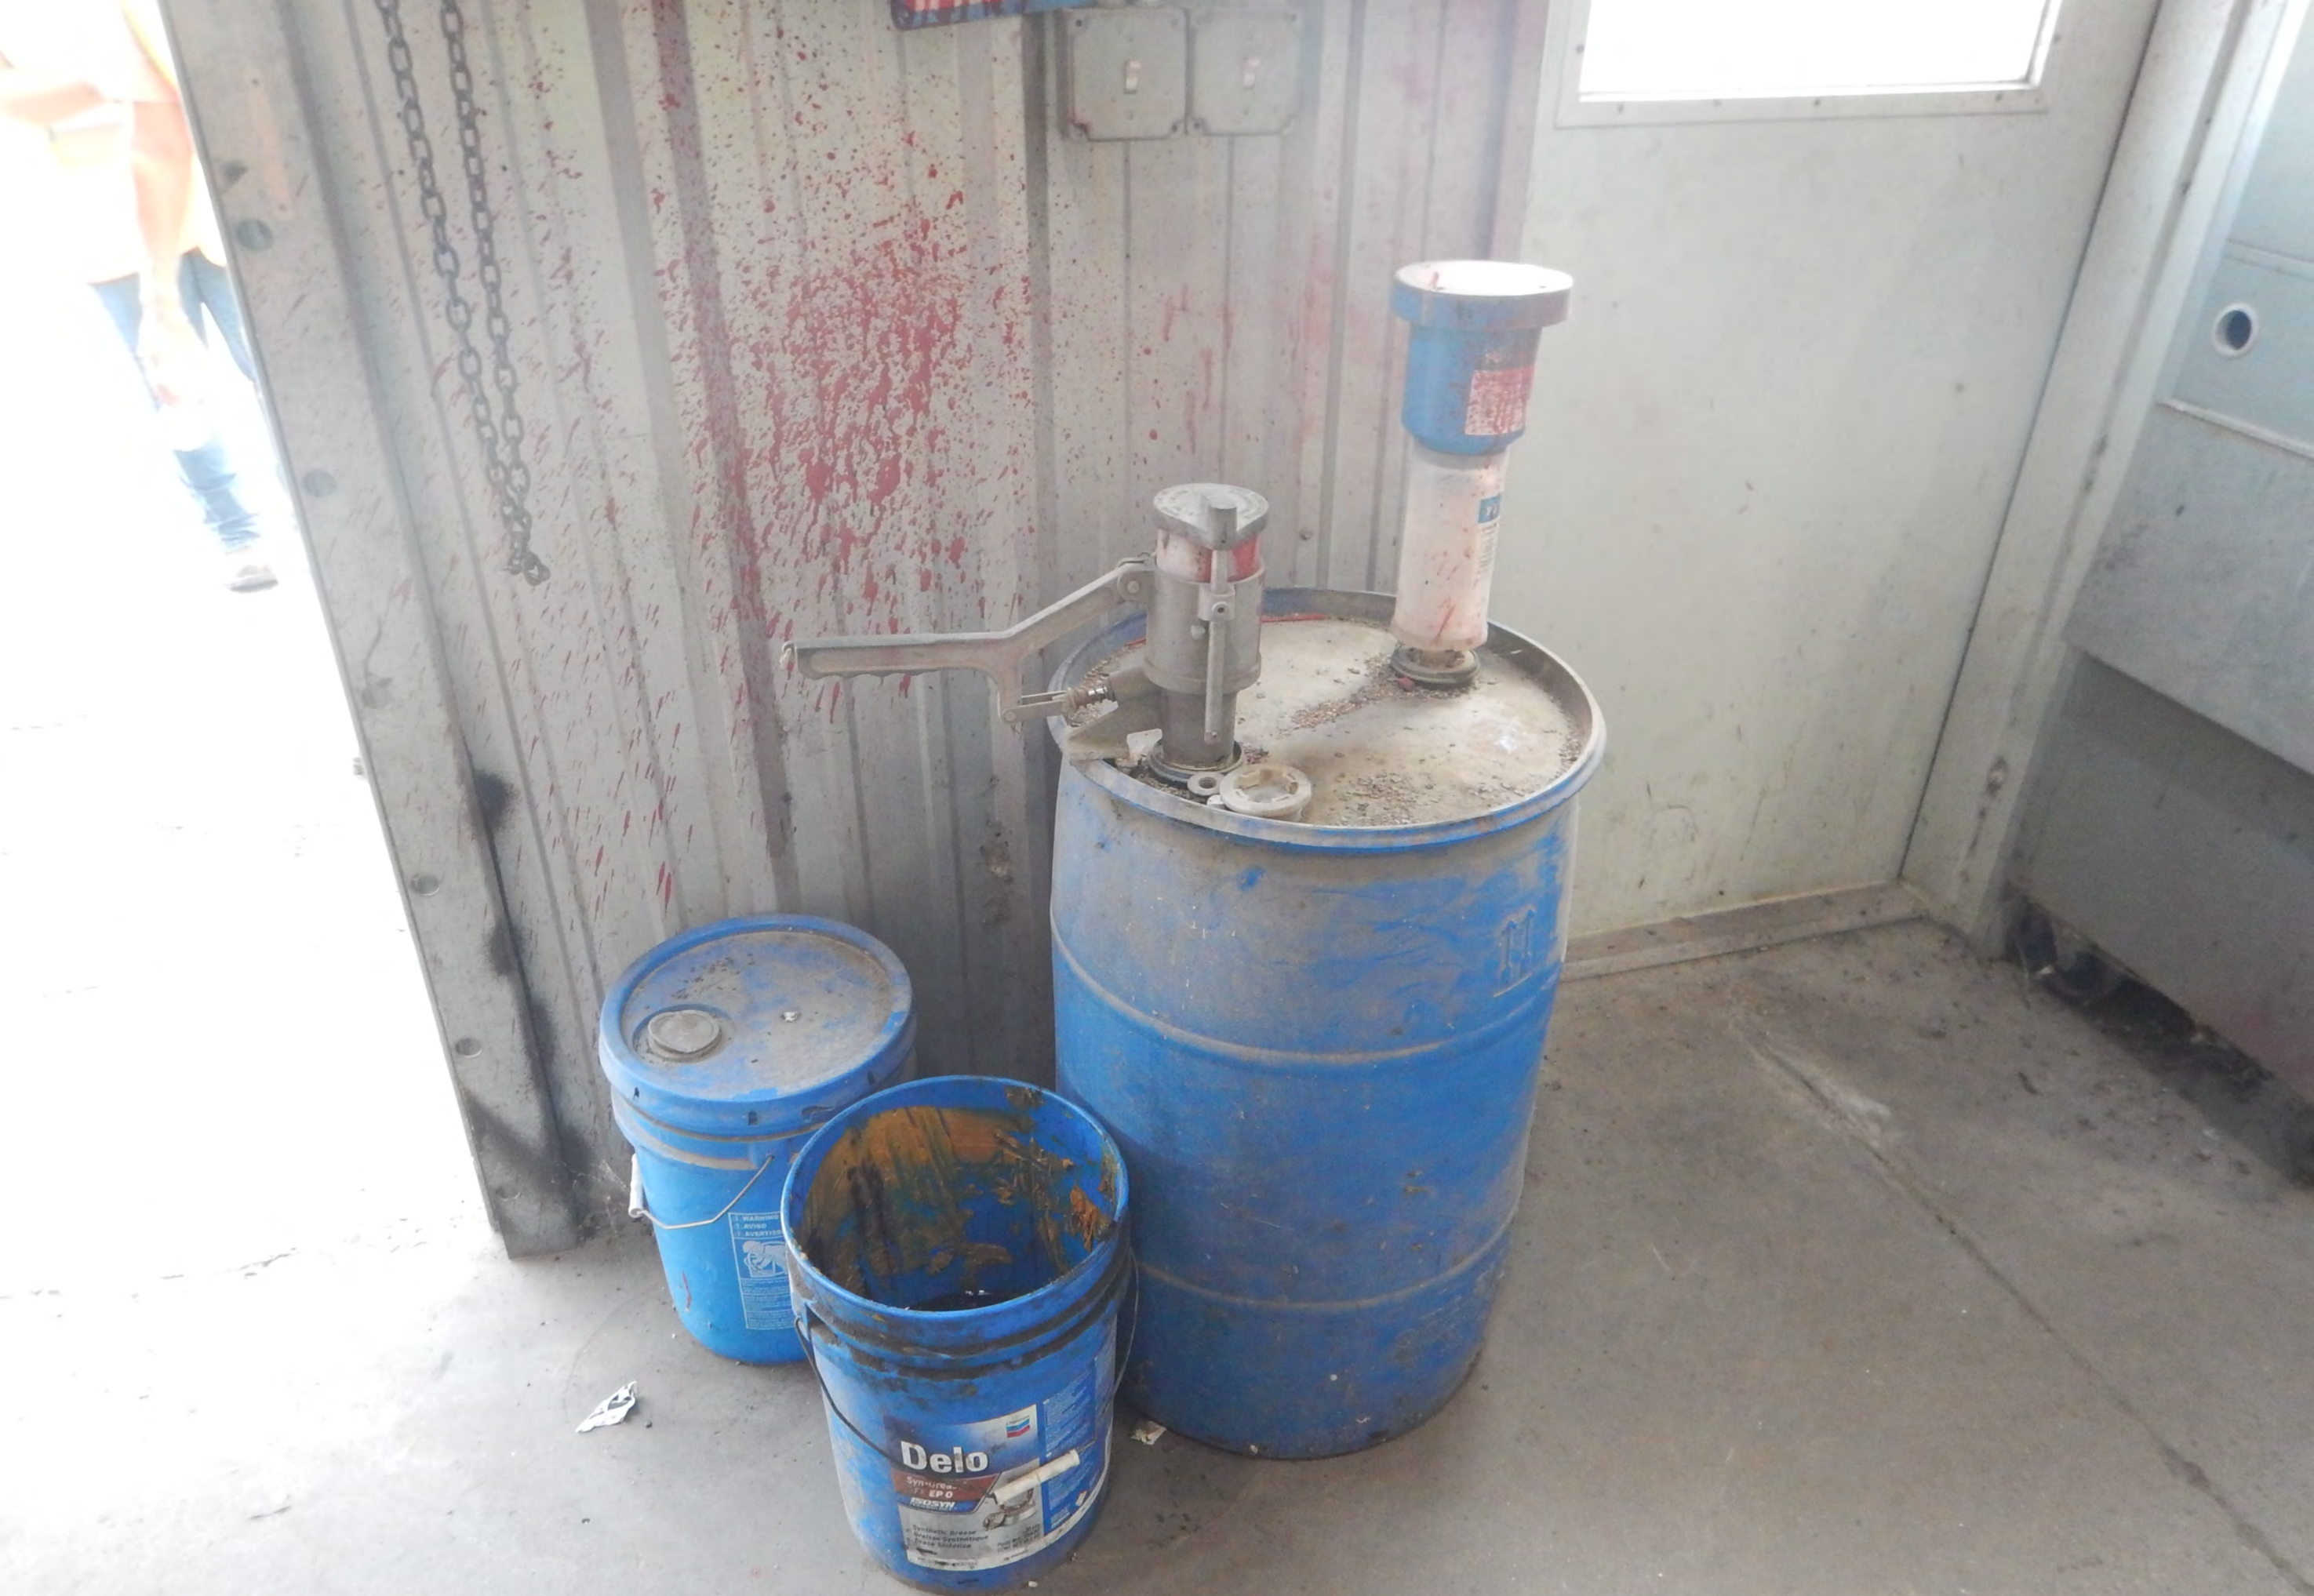
Photo 35

- On June 26, 2023, we found one unlabeled 275-gallon tote of hazardous waste in the rail and specialty wash area. See photo 31.
- On June 27, 2023, we found one unlabeled 55-gallon drum used for the puncture and draining of waste aerosol cans in the trailer maintenance area. See photo 35.

| Photo Number | File Name | | Date | Time | Photographer | Description |
|---|---|---|---|---|---|---|
| 35 | DSCN1093 | .JPG | 27-Jun-23 | 1036 | John Penland | Drum used for the puncture and draining of waste aerosol cans in the trailer maintenance area. Container was found unlabeled at the time of inspection. |

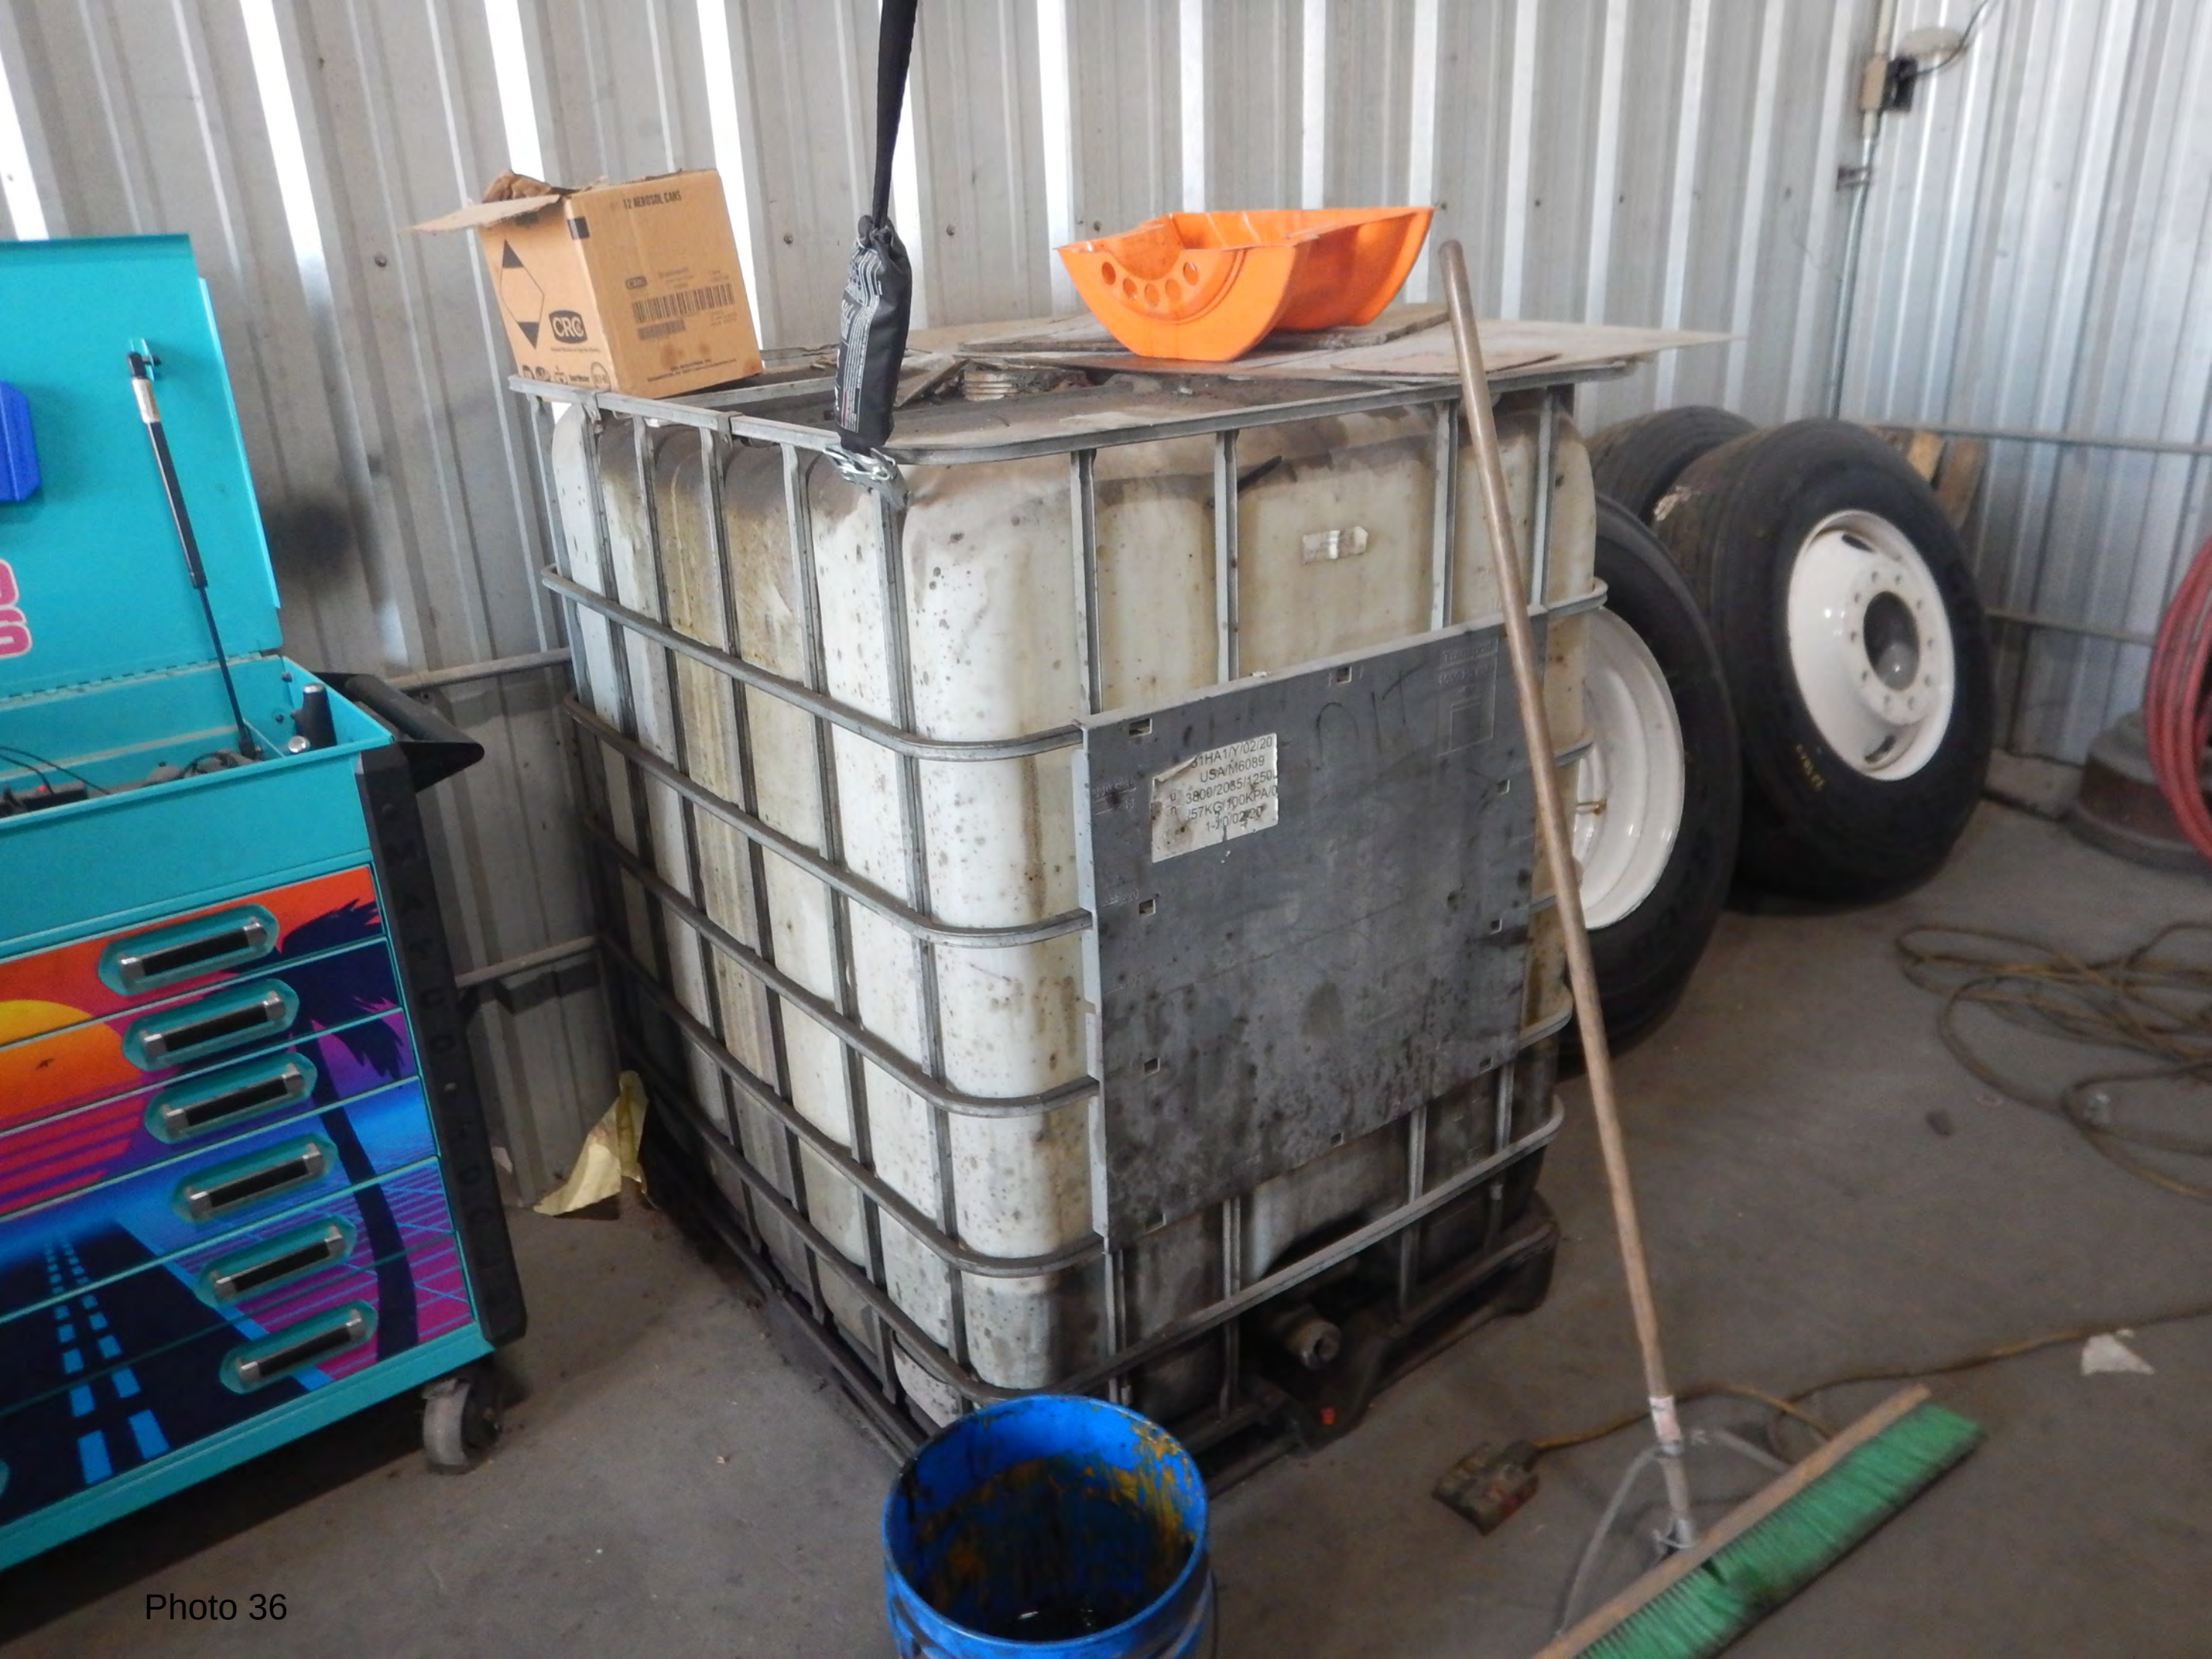
Photo 36

The used oil management standards require generators to label containers used for the accumulation of used oil with the words “Used Oil”. During this inspection, we observed 1 container used for the accumulation of Used Oil which was unlabeled. See photos 36 and 37.

| Photo Number | File Name | | Date | Time | Photographer | Description |
|---|---|---|---|---|---|---|
| 36 | DSCN1094 | .JPG | 27-Jun-23 | 1038 | John Penland | Container used for the accumulation of Used Oil in the trailer maintenance area. Container was found unlabeled at the time of inspection. |

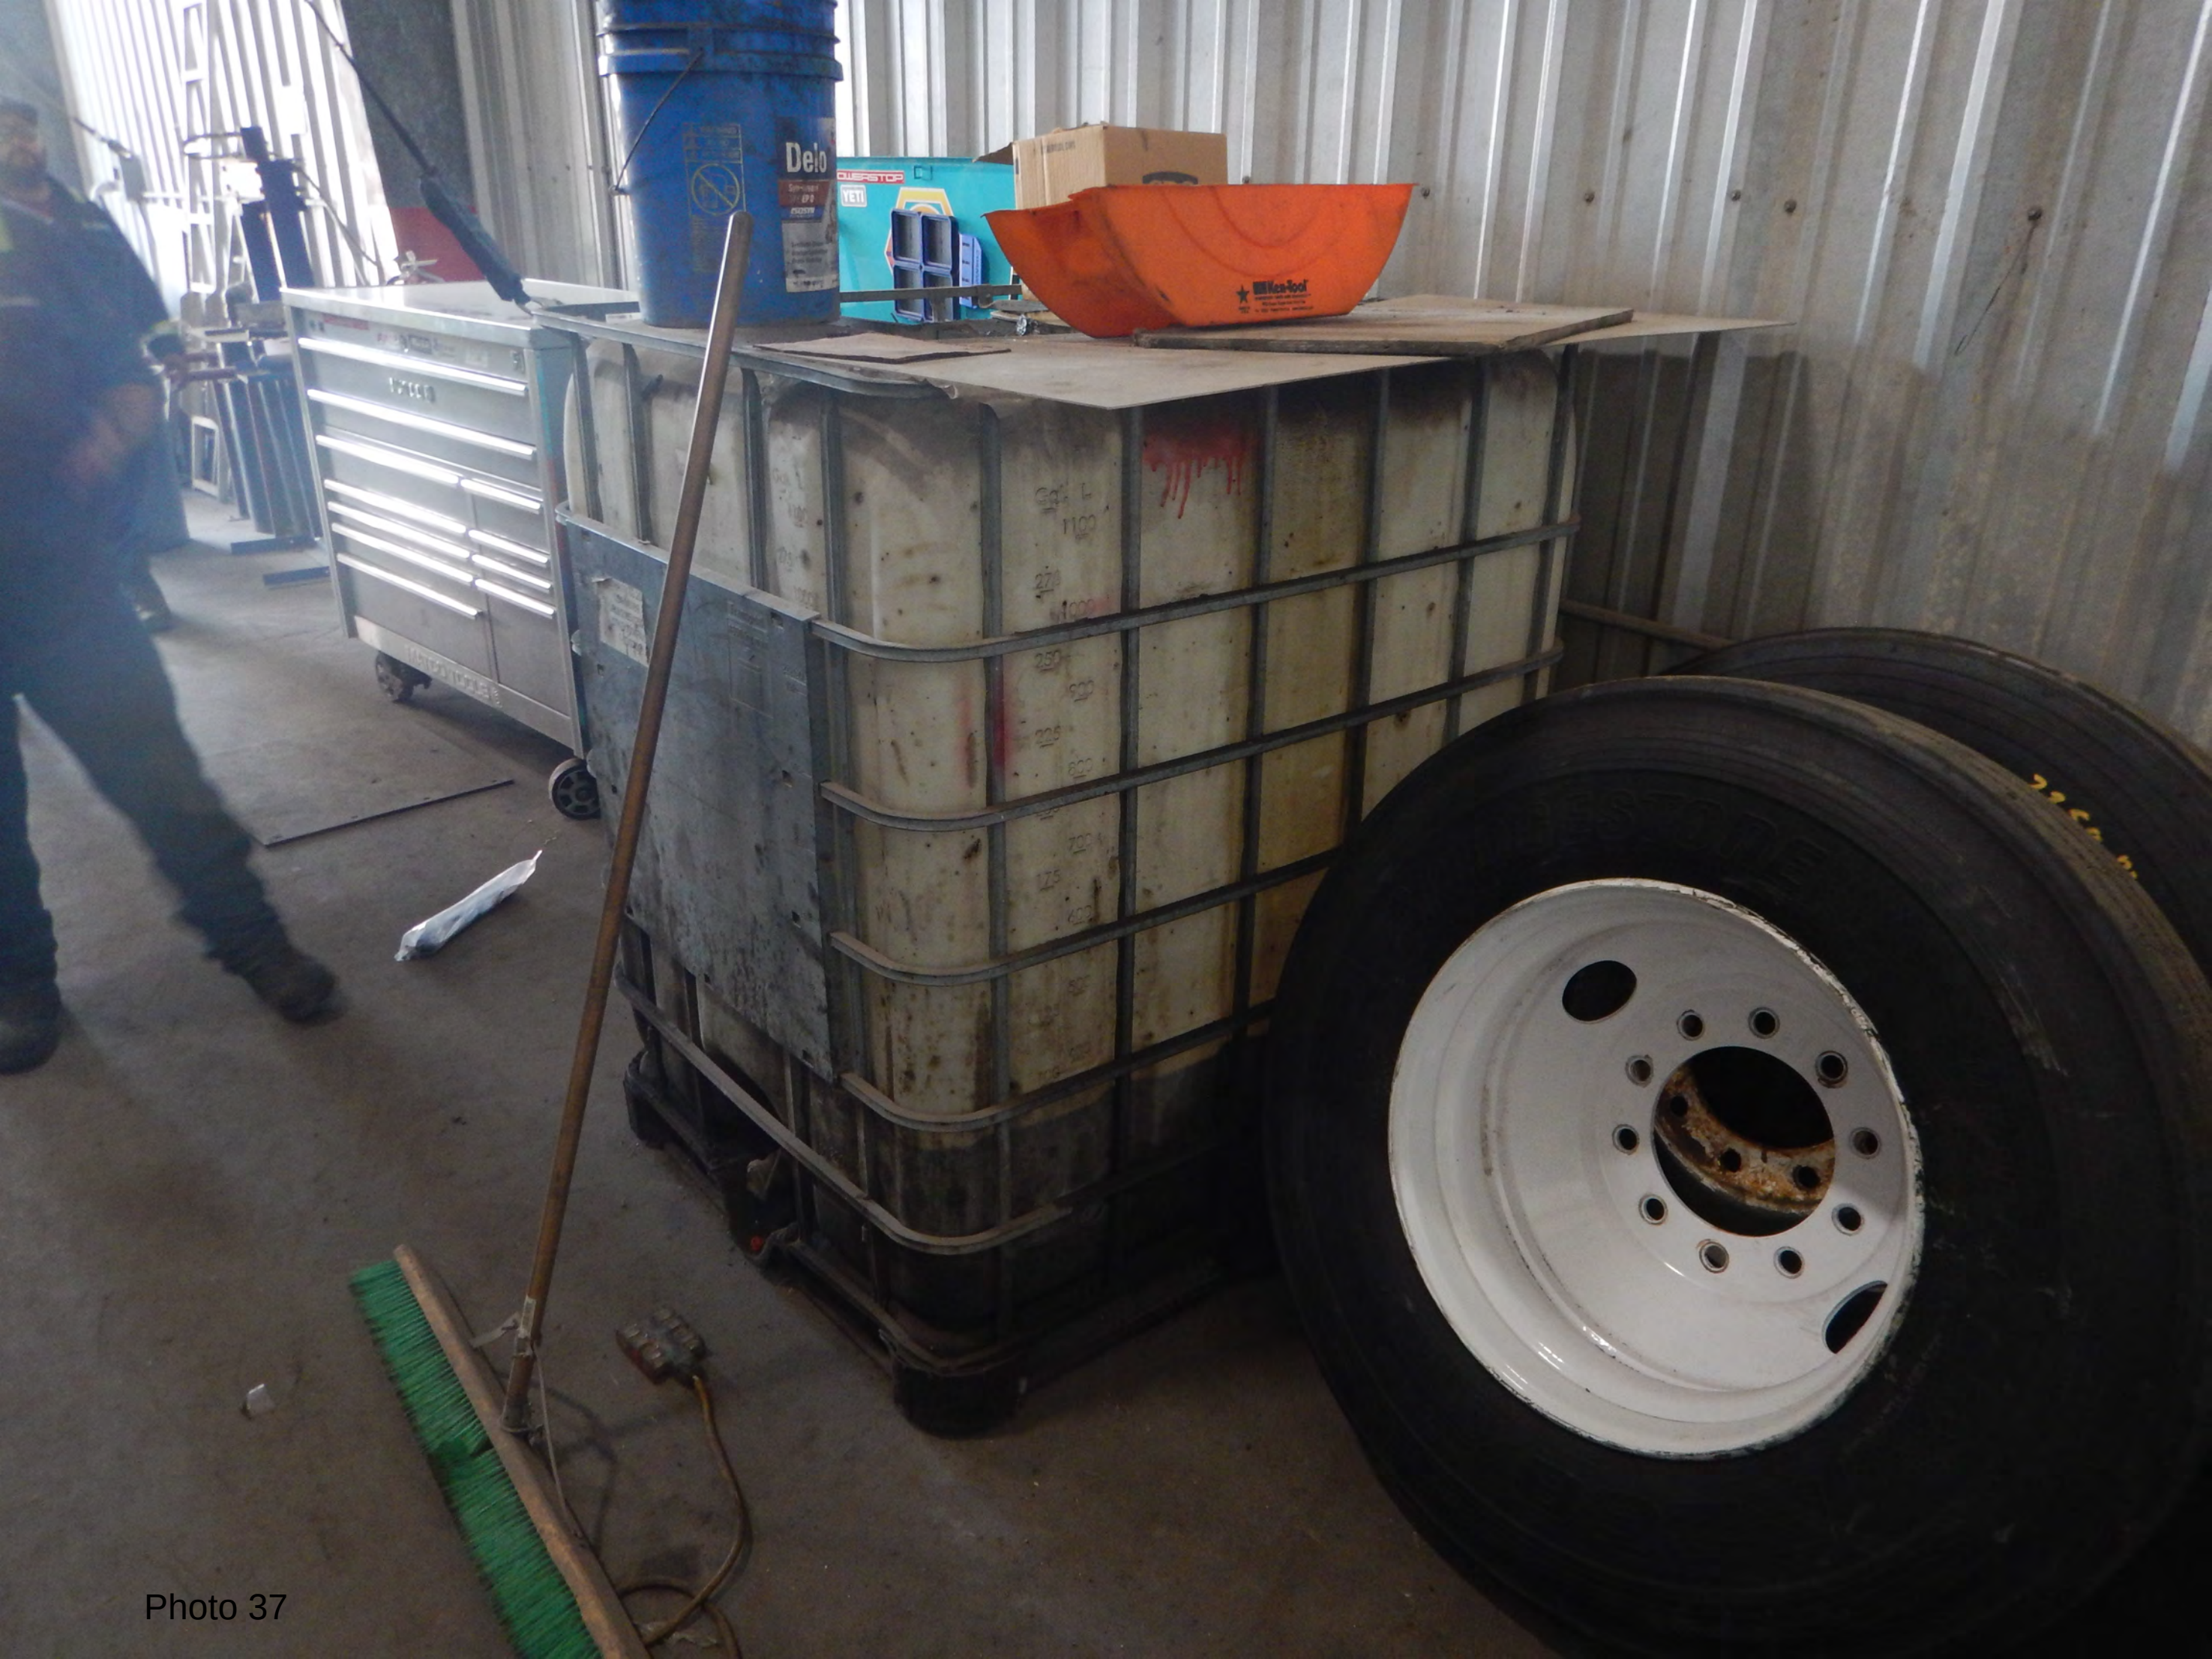
Photo 37

| Photo Number | File Name | | Date | Time | Photographer | Description |
|---|---|---|---|---|---|---|
| 37 | DSCN1095 | .JPG | 27-Jun-23 | 1038 | John Penland | Container used for the accumulation of Used Oil in the trailer maintenance area. Container was found unlabeled at the time of inspection. |

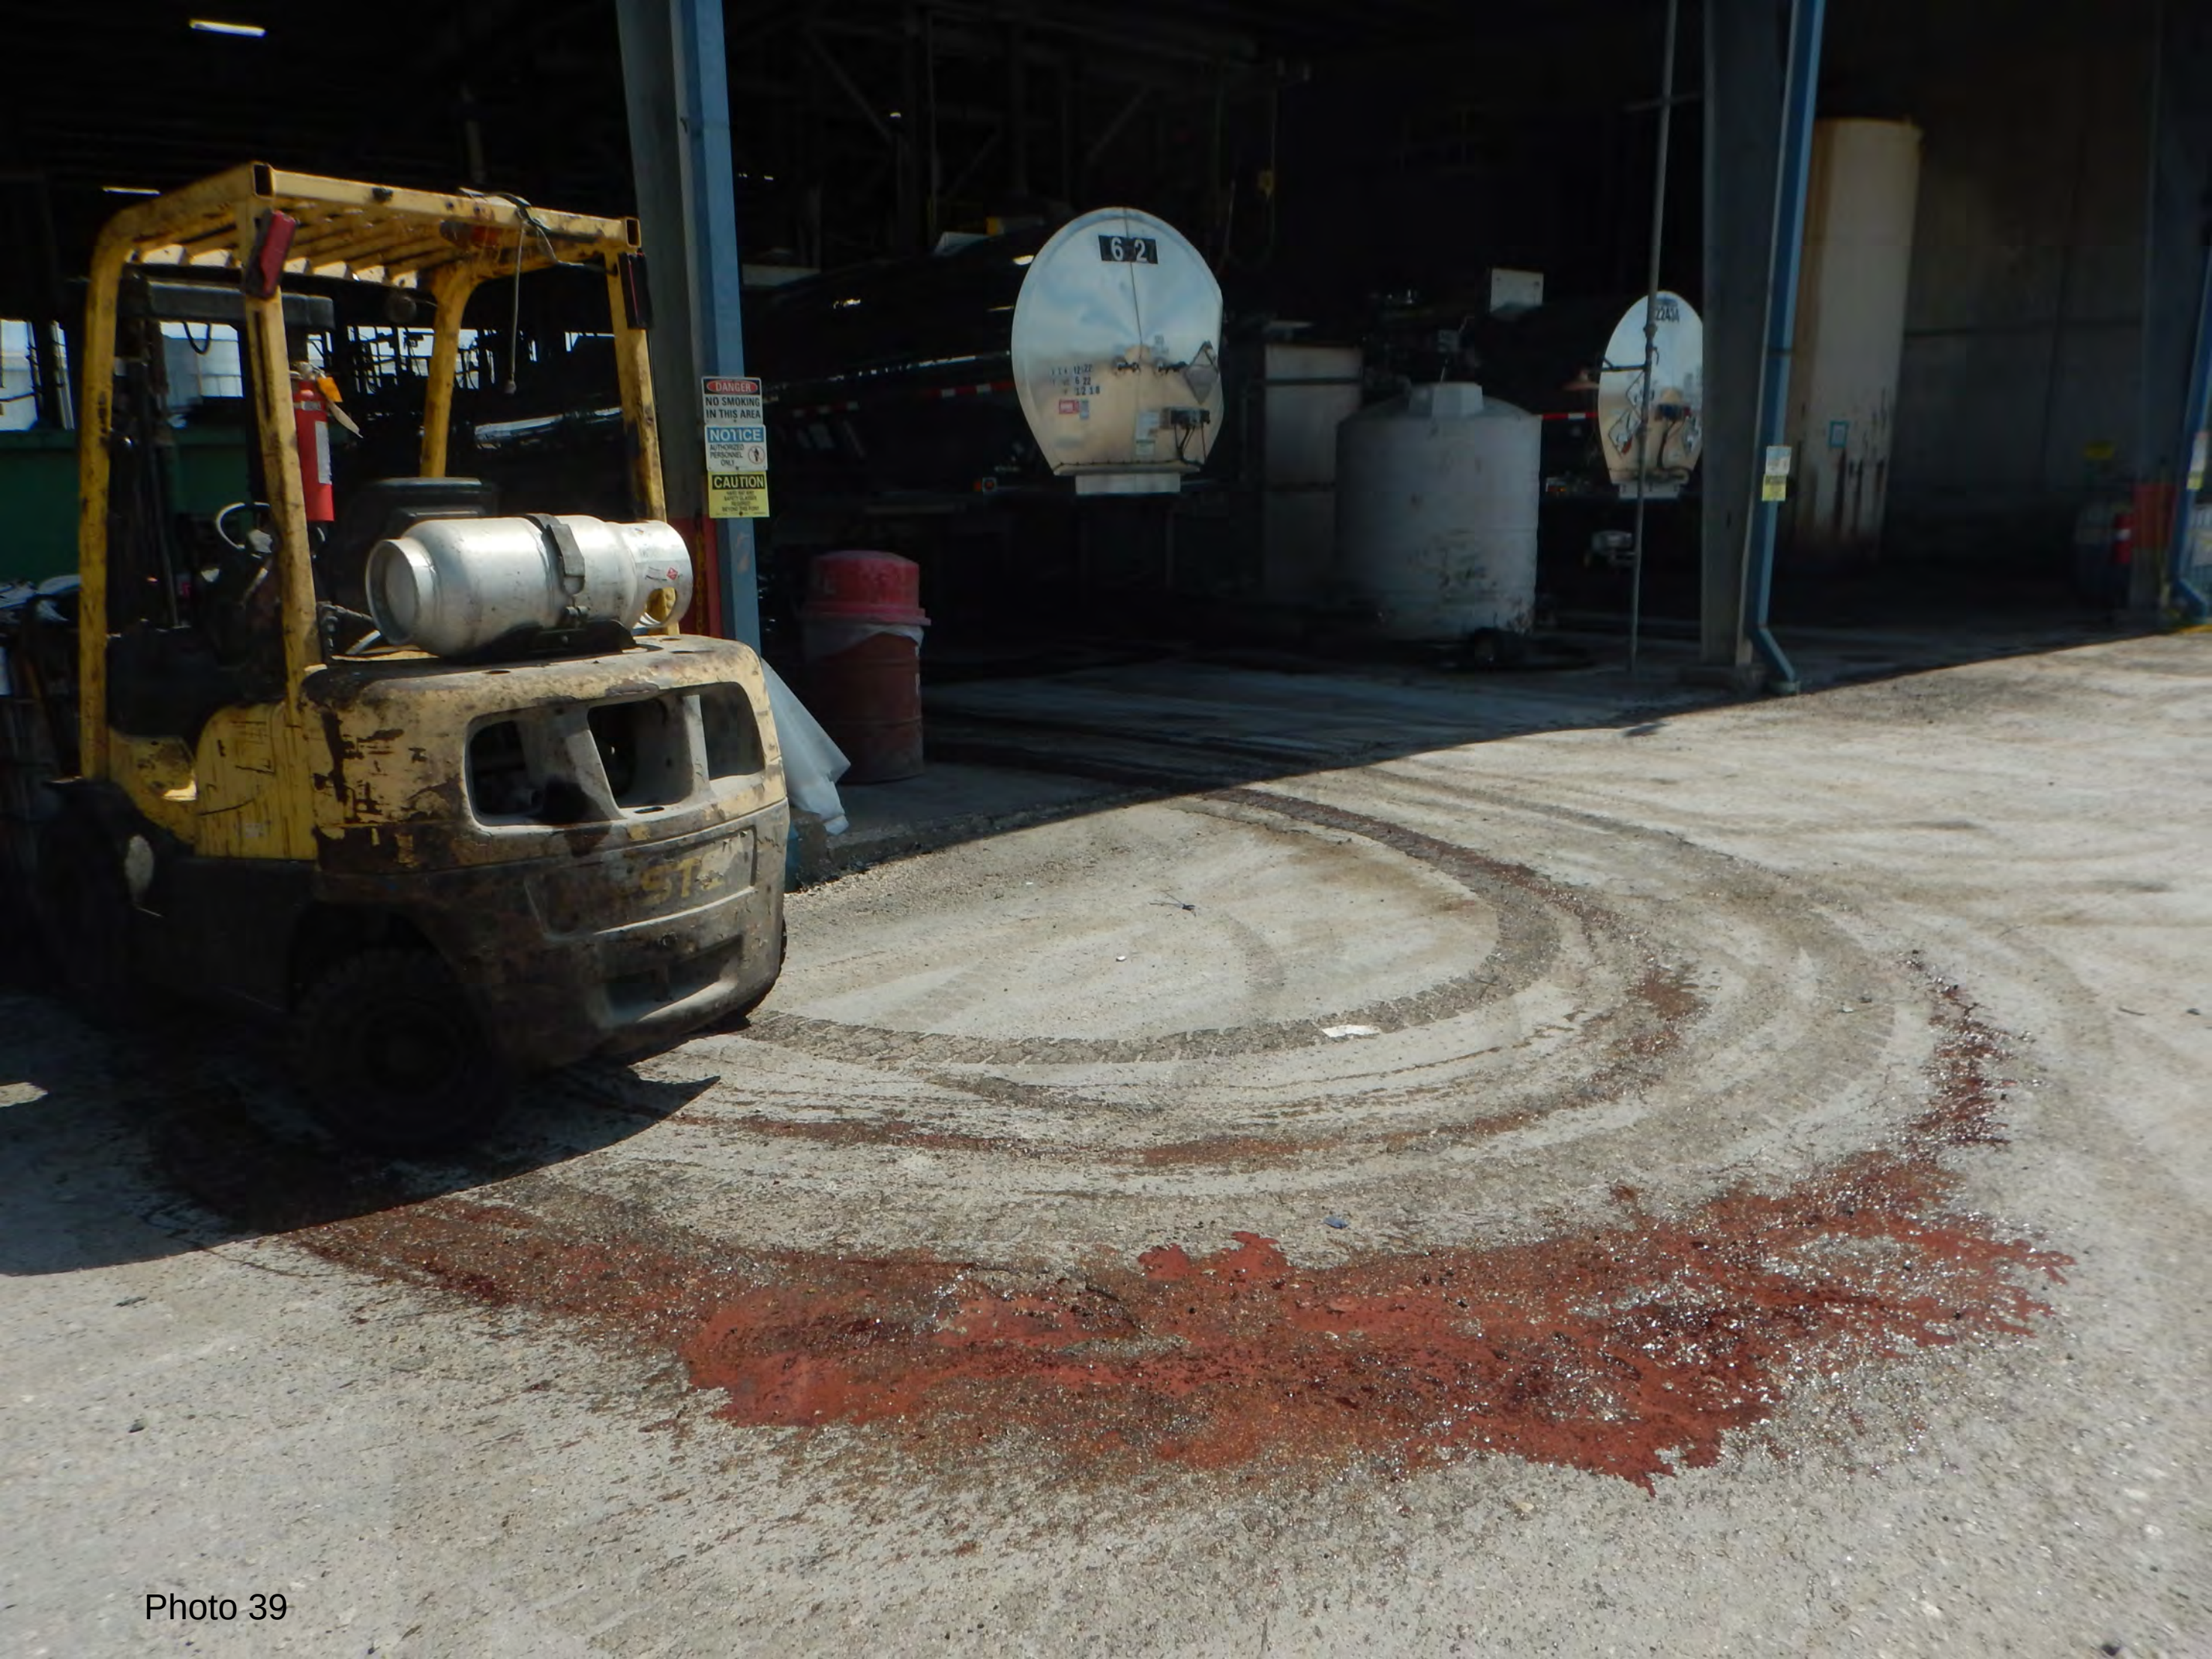
Photo 39

| Photo Number | File Name | | Date | Time | Photographer | Description |
|---|---|---|---|---|---|---|
| 39 | DSCN1097 | .JPG | 27-Jun-23 | 1045 | John Penland | Spill caused by the forklift movement of an open waste container at the trailer wash area. |

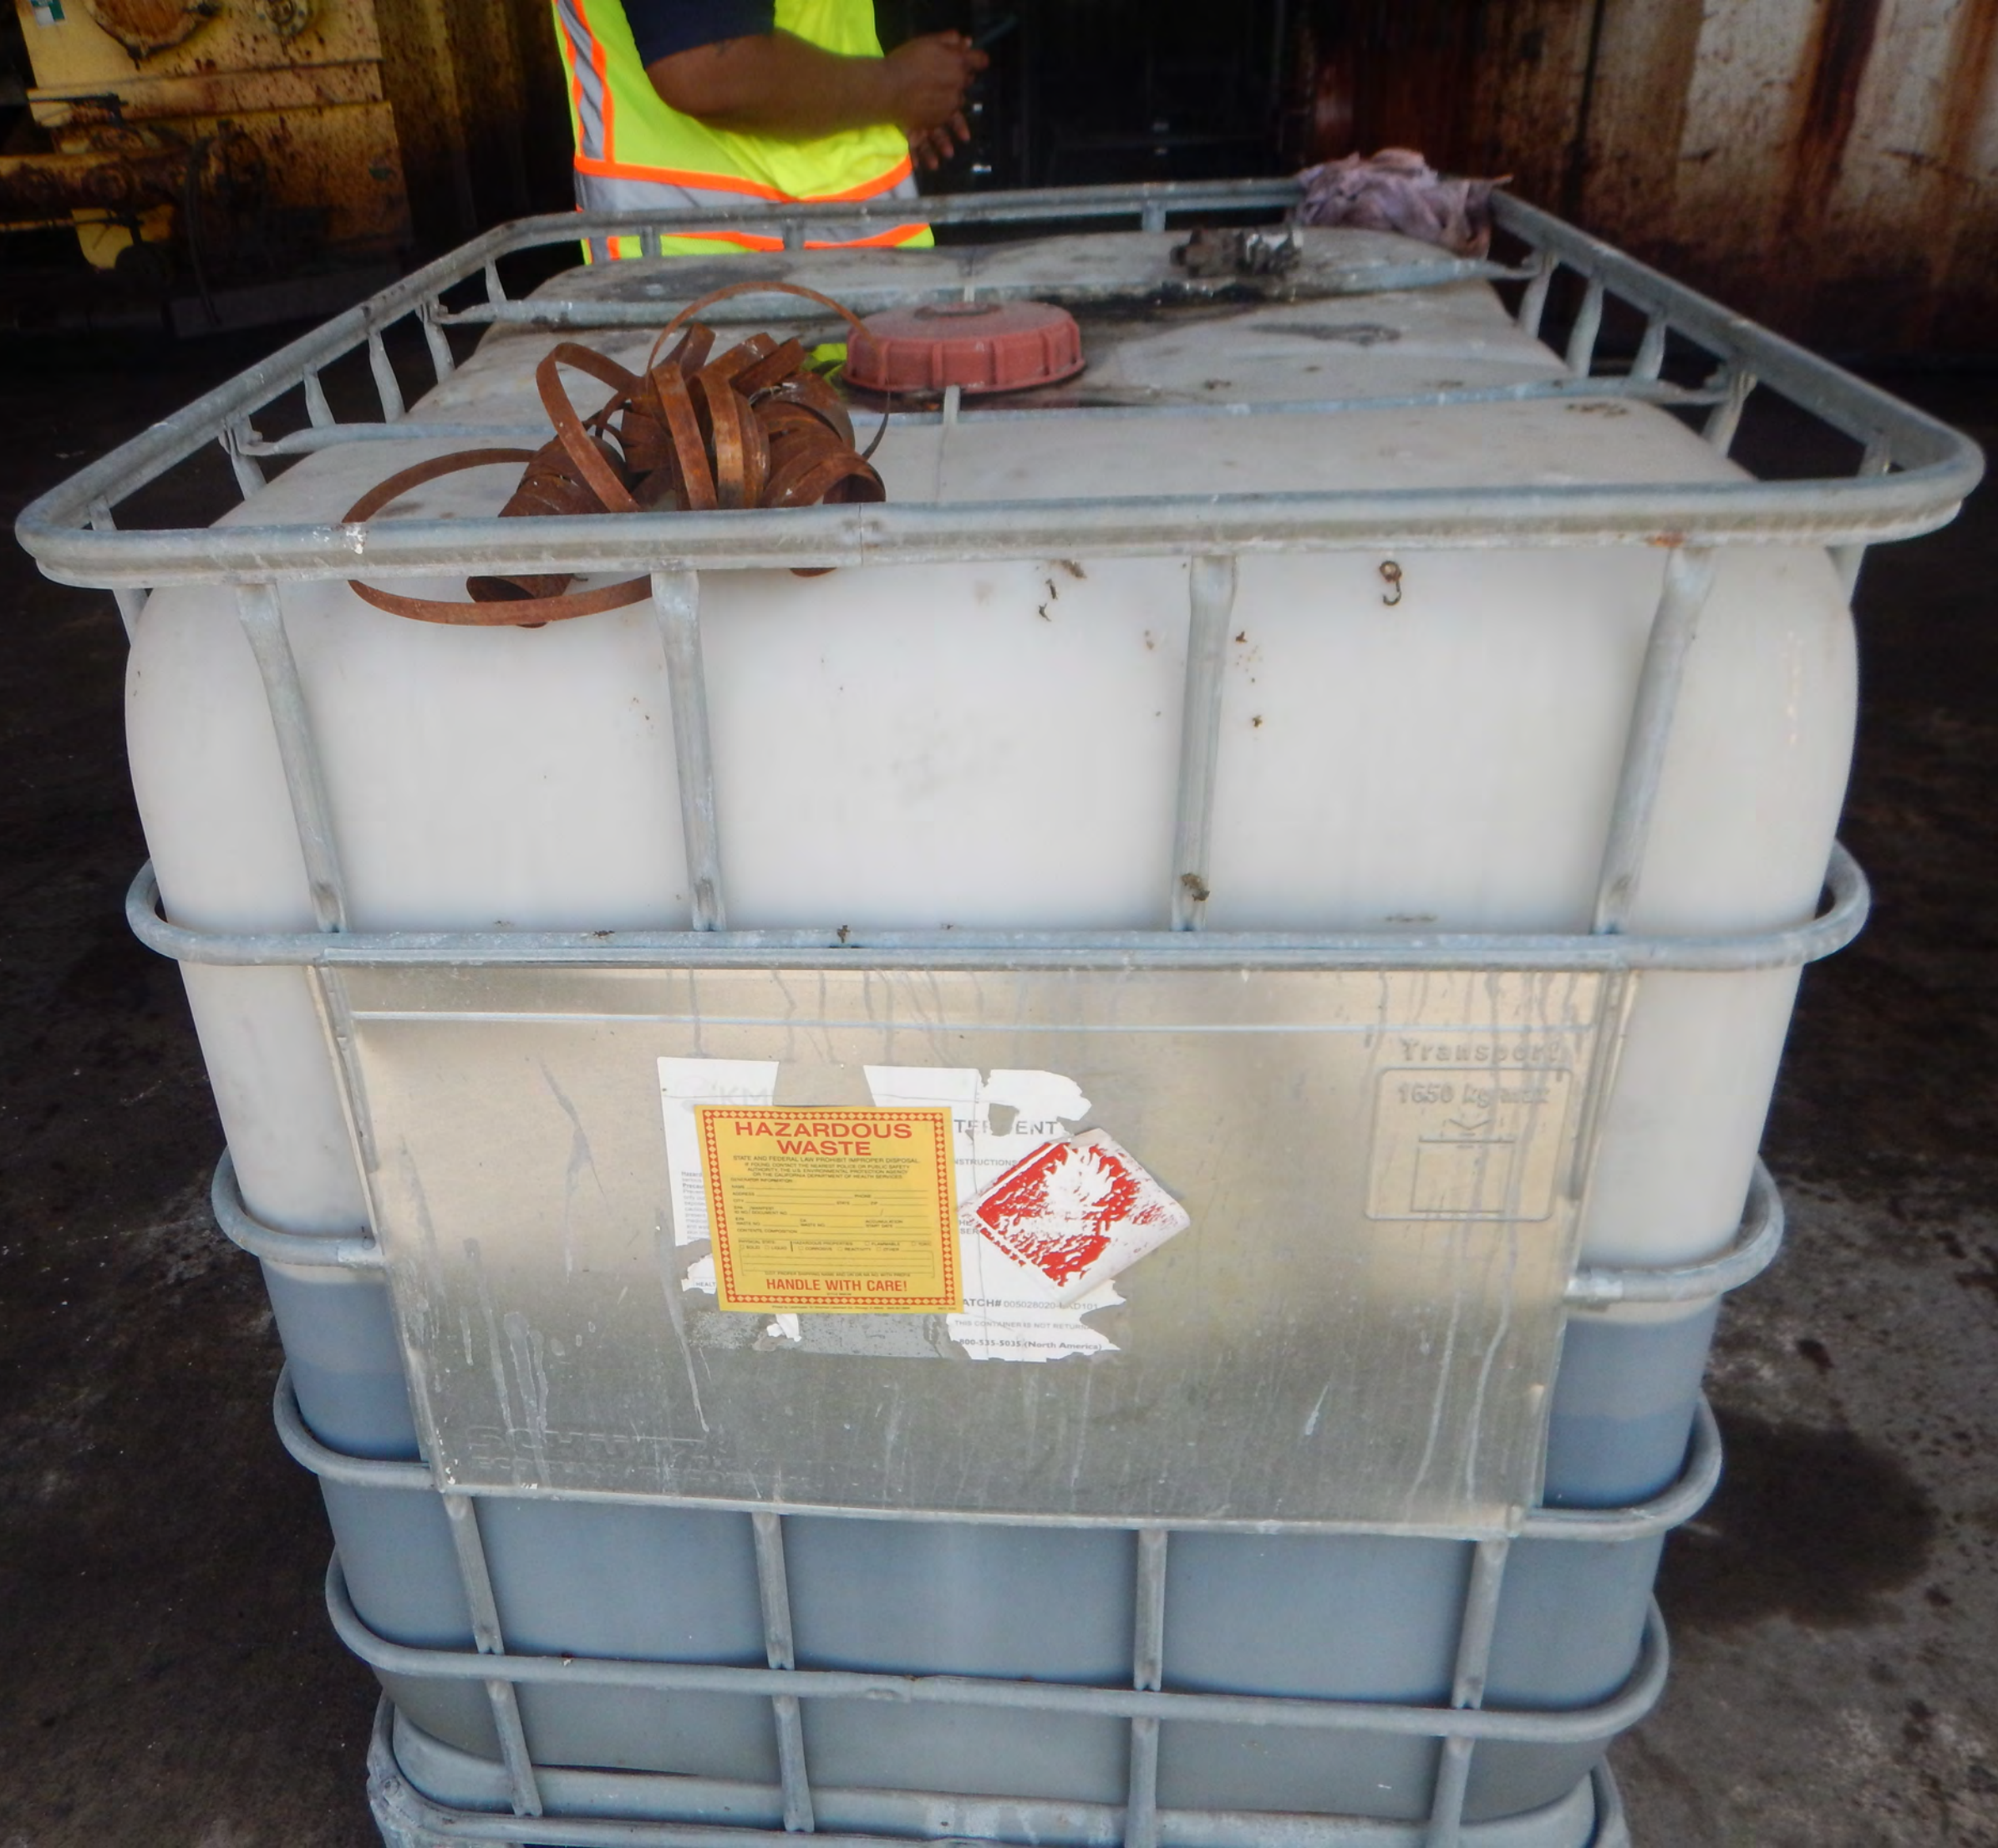
Photo 42

- On June 26, 2023, we found one open 55-gallon drum of alkylsulfuric acid residues in the rail and specialty wash area. See photos 7 and 8.
- On June 26, 2023, we found one open 55-gallon drum of “solid heel” in the rail and specialty wash area. See photos 23, 24, and 29.
- On June 26, 2023, we found one open 275-gallon tote of liquid hazardous waste residue in the rail and specialty wash area. See photo 25.
- On June 27, 2023, we found one open 55-gallon drum of hazardous waste in the trailer wash area. See photo 41.
- On June 27, 2023, we found one open 275-gallon tote of hazardous waste in the trailer wash area. See photo 42 and 43.

| Photo Number | File Name | | Date | Time | Photographer | Description |
|---|---|---|---|---|---|---|
| 42 | DSCN1100 | .JPG | 27-Jun-23 | 1049 | John Penland | One container of hazardous waste in the trailer wash area. Container was found open and inadequately labeled at the time of inspection. |
