**Region 6 - Enforcement & Compliance Assurance Division**  
**INSPECTION REPORT**

| Inspection Date(s): | June 26 – 29, 2023 | |
| Regulatory Program(s) | Large Quantity Generator | |
| Facility Name: | <b>Quala Rail and Specialty</b> | |

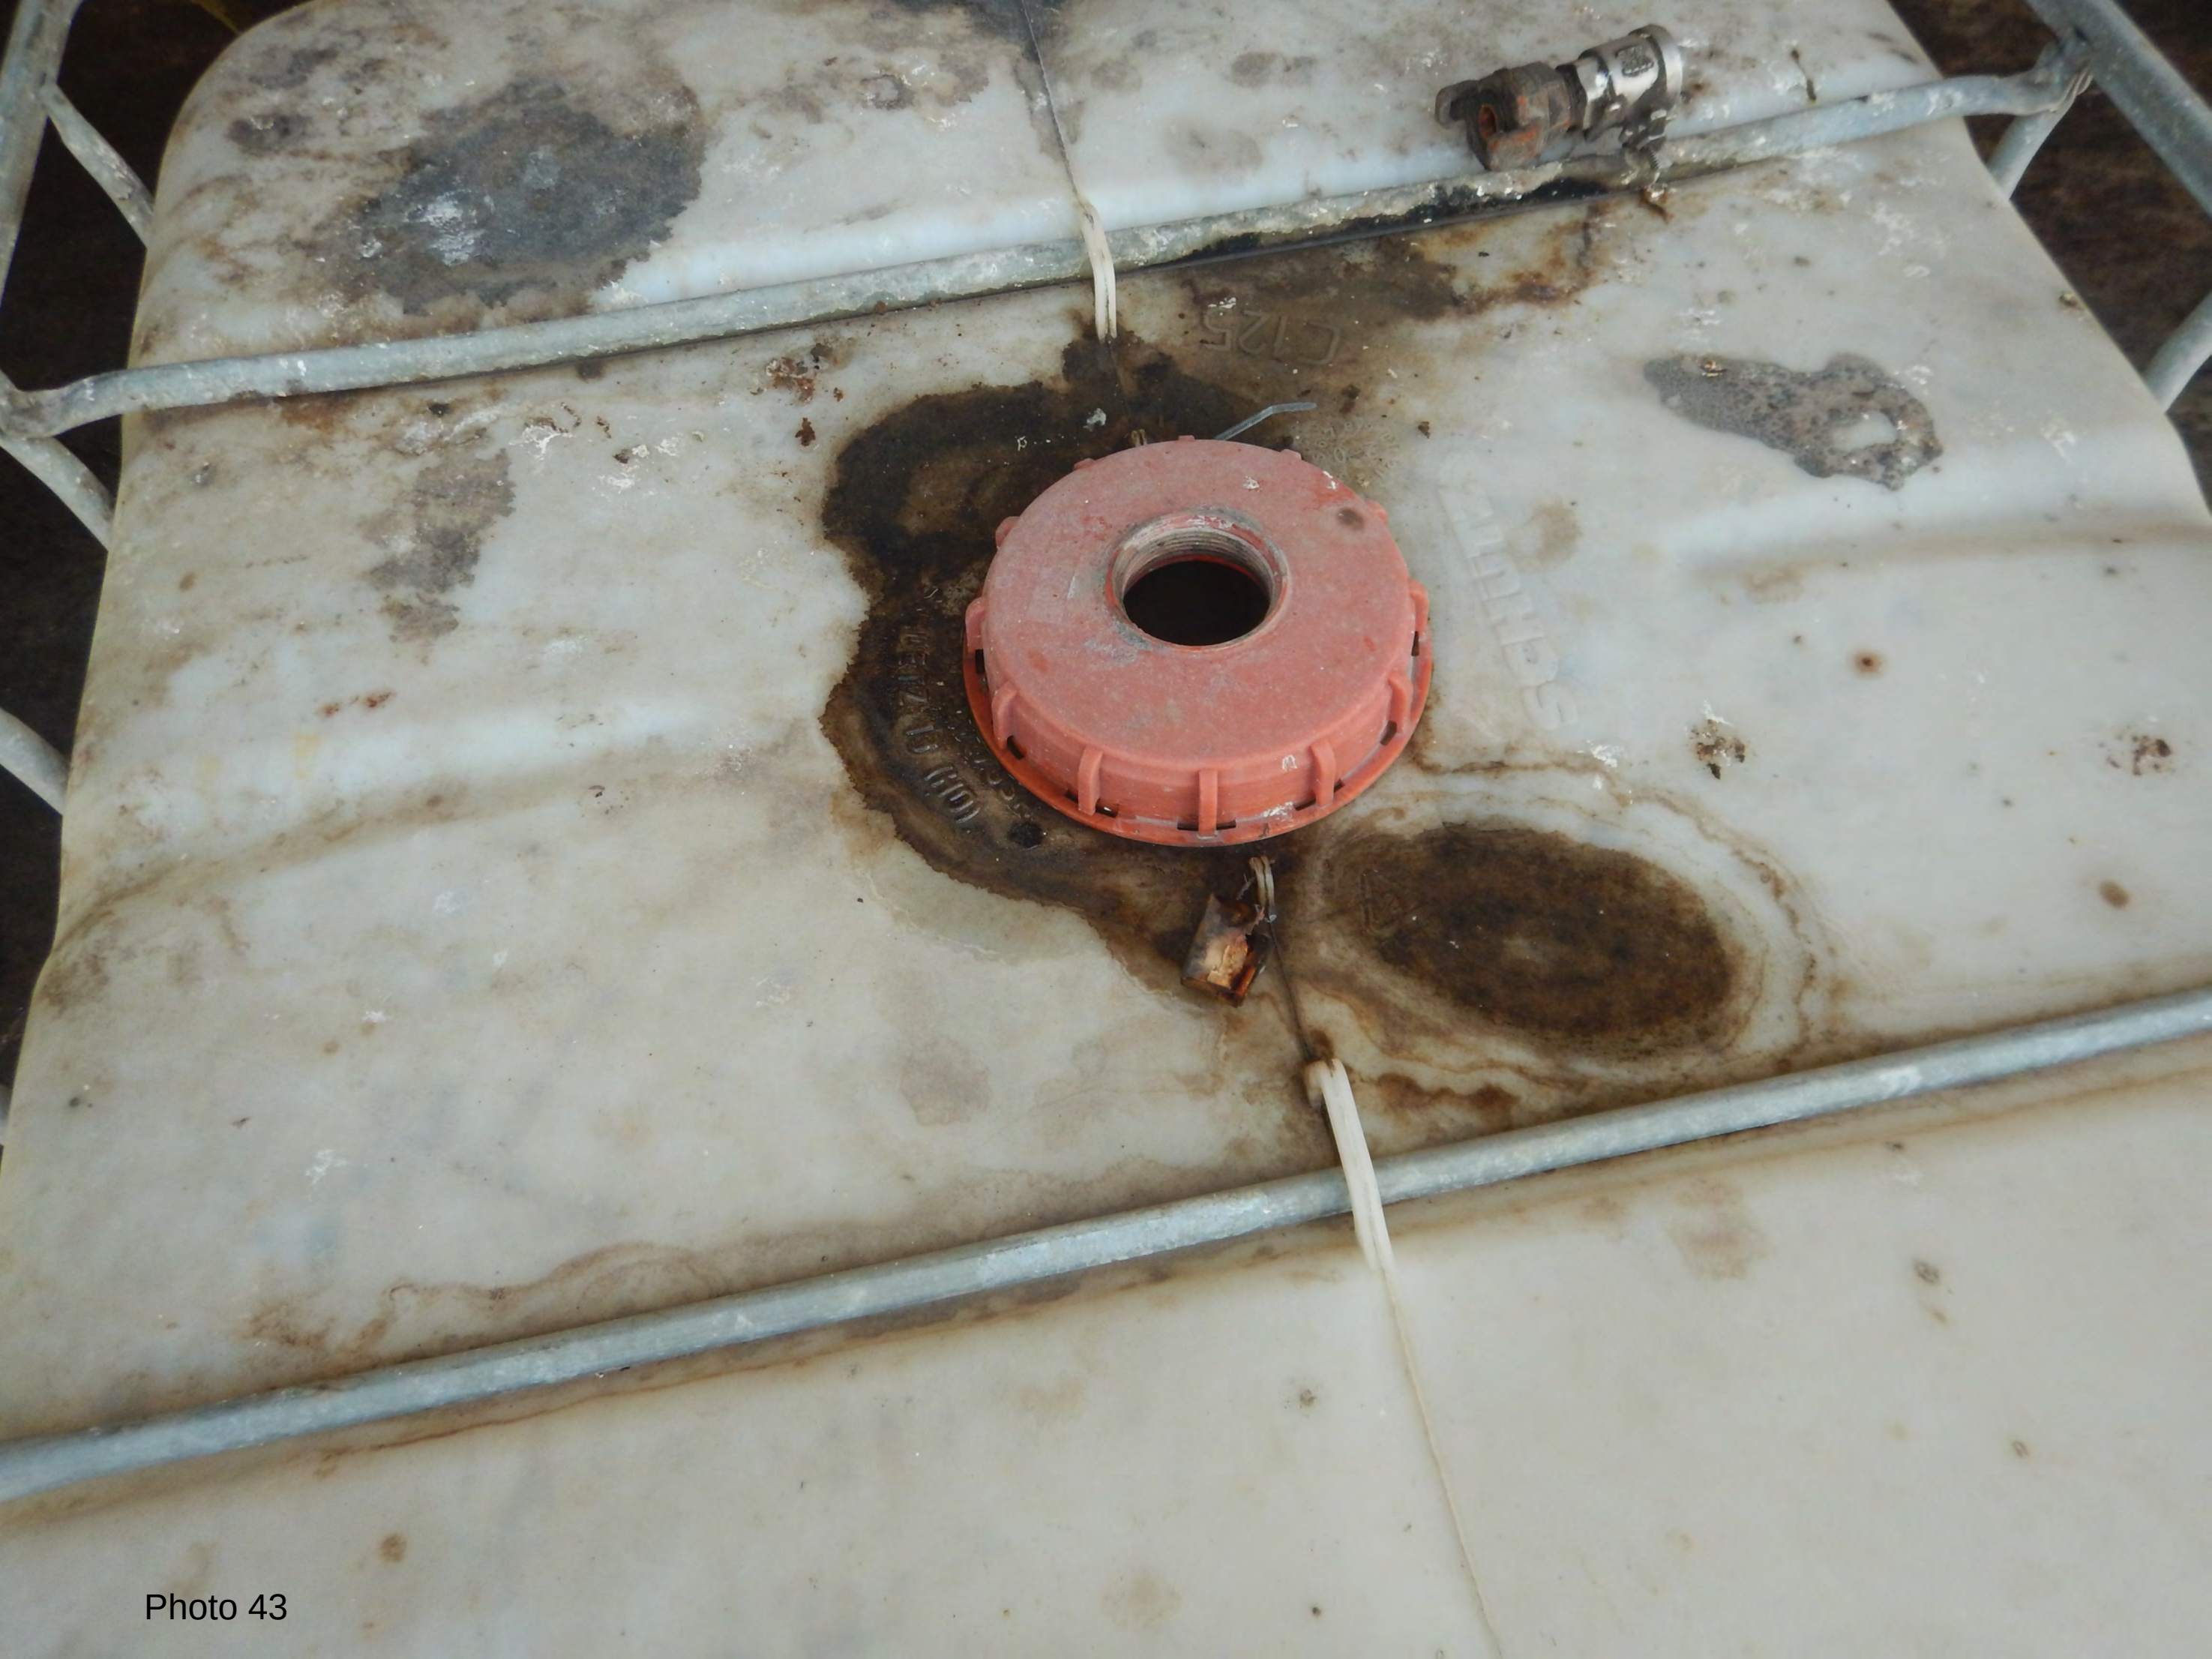
Photo 43

- On June 26, 2023, we found one open 55-gallon drum of alkylsulfuric acid residues in the rail and specialty wash area. See photos 7 and 8.
- On June 26, 2023, we found one open 55-gallon drum of “solid heel” in the rail and specialty wash area. See photos 23, 24, and 29.
- On June 26, 2023, we found one open 275-gallon tote of liquid hazardous waste residue in the rail and specialty wash area. See photo 25.
- On June 27, 2023, we found one open 55-gallon drum of hazardous waste in the trailer wash area. See photo 41.
- On June 27, 2023, we found one open 275-gallon tote of hazardous waste in the trailer wash area. See photo 42 and 43.

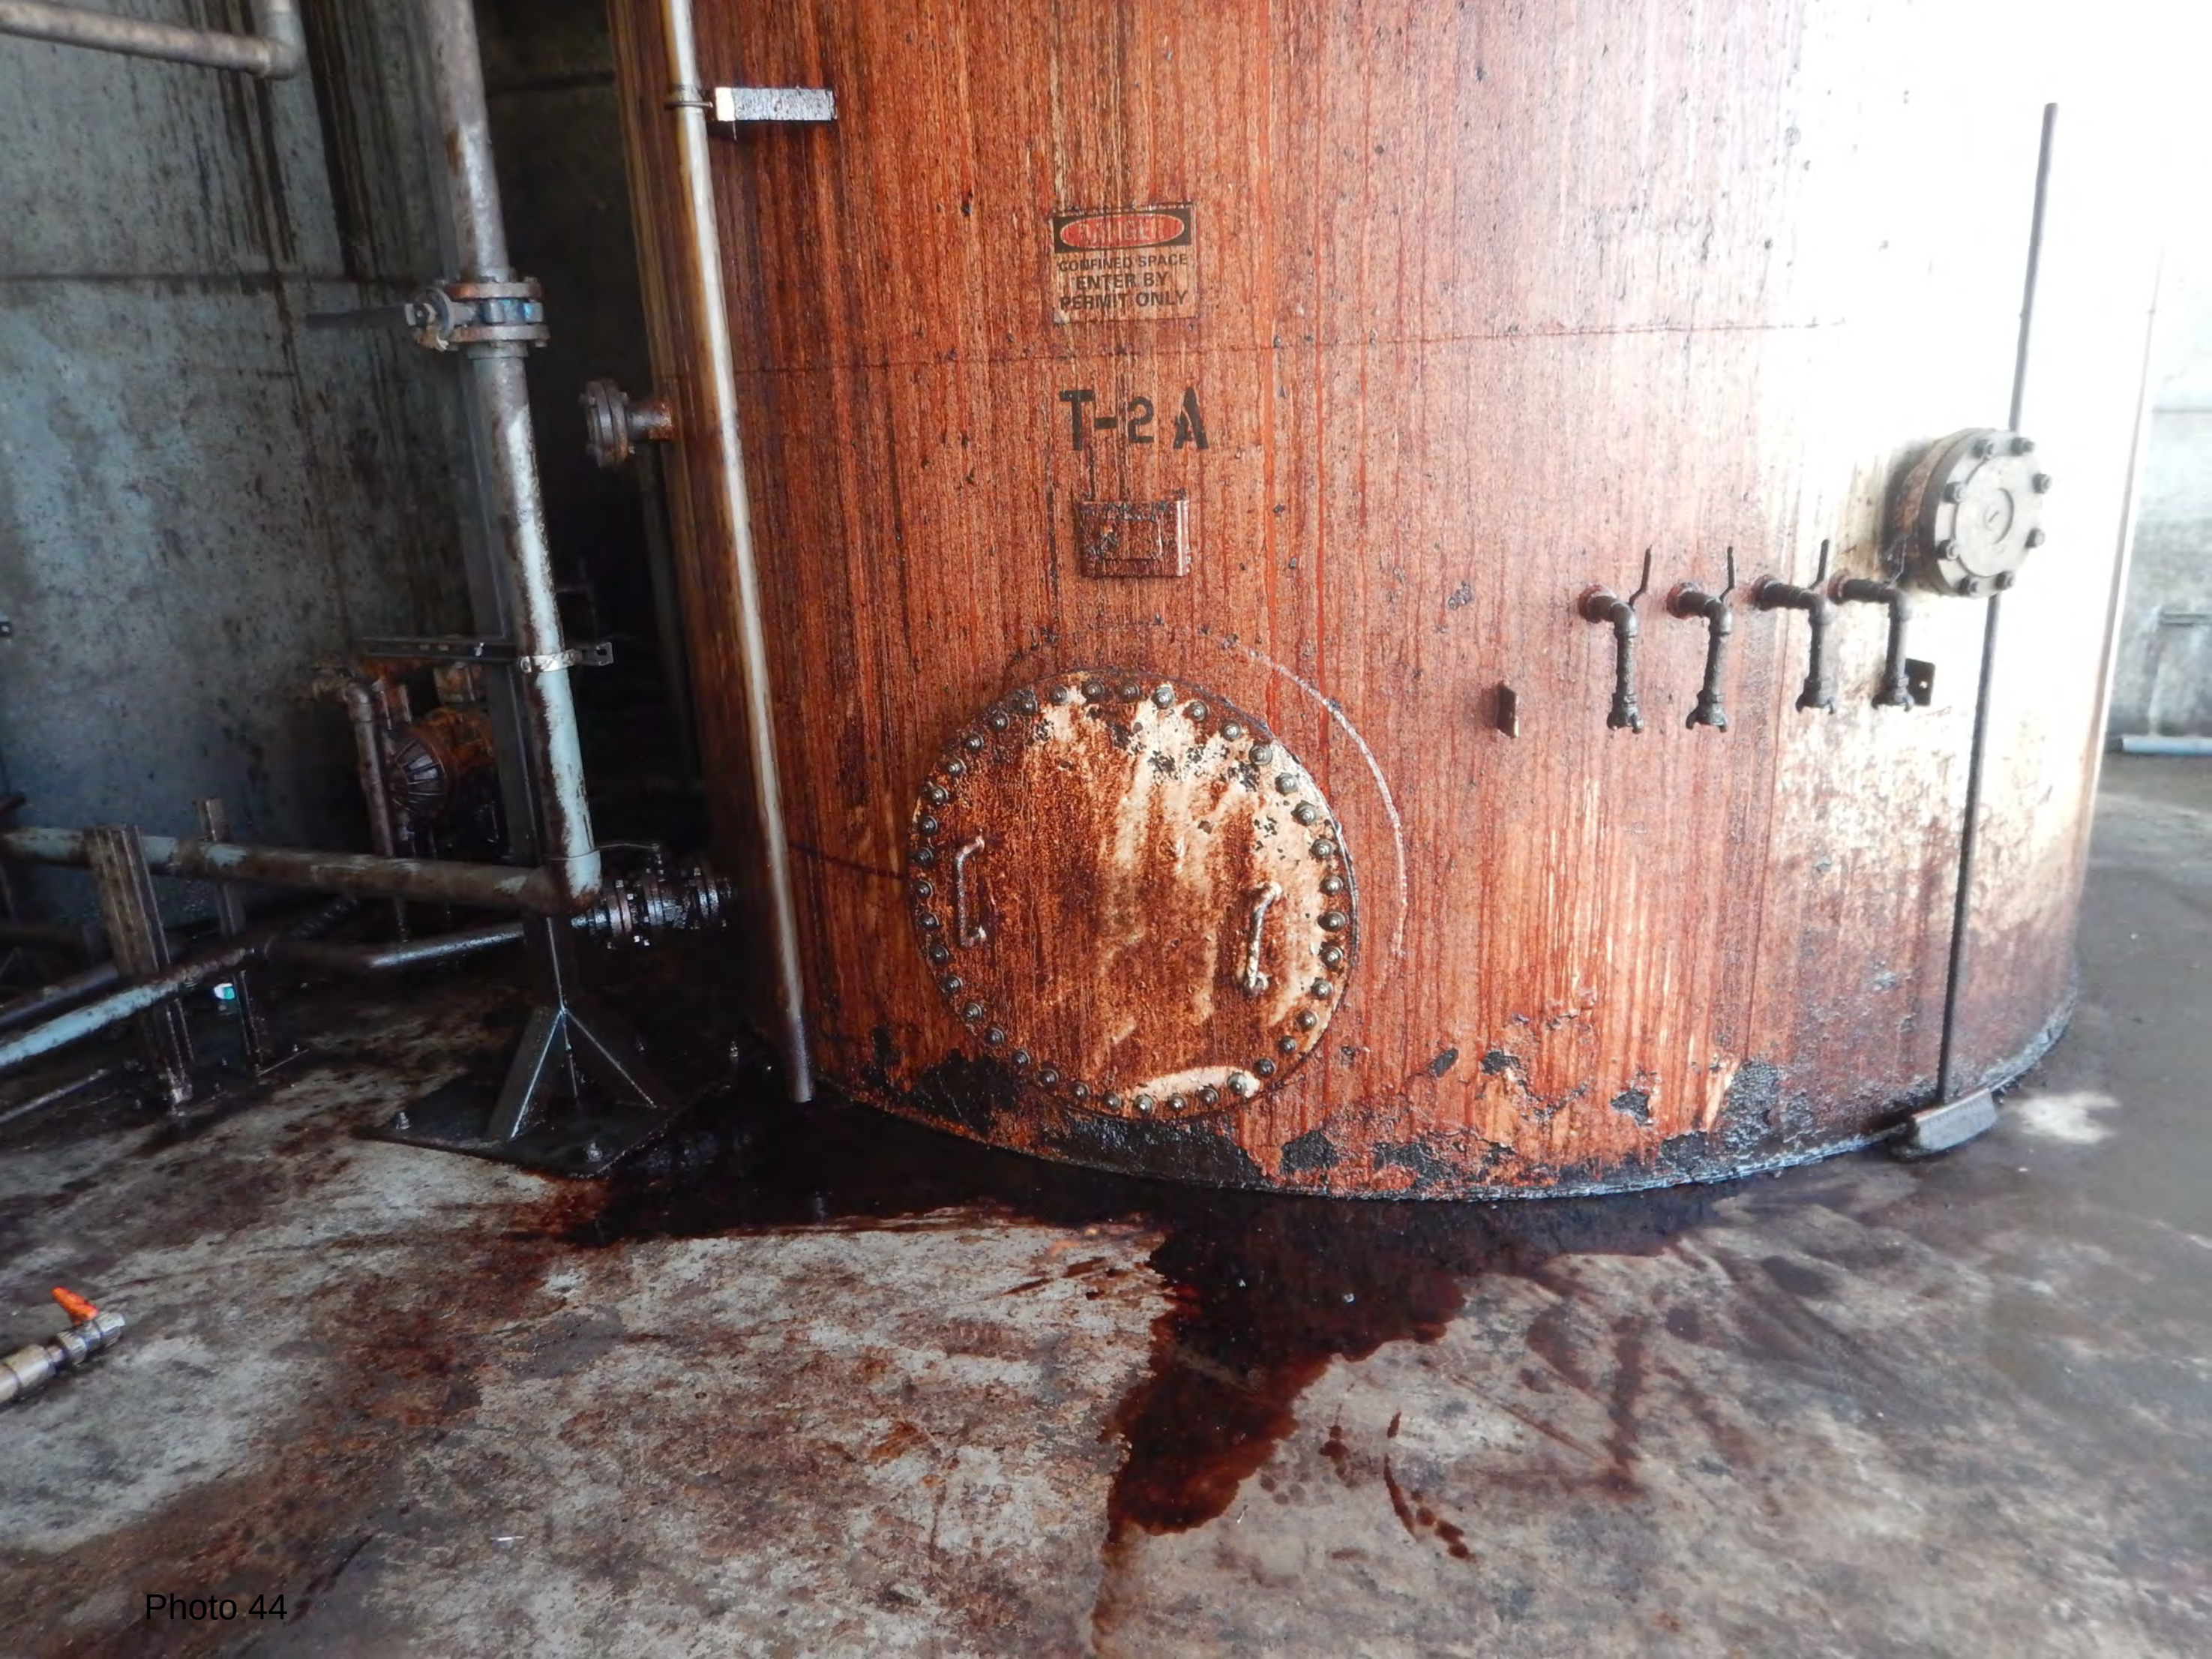
Photo 44

| Photo Number | File Name | | Date | Time | Photographer | Description |
|---|---|---|---|---|---|---|
| 44 | DSCN1102 | .JPG | 27-Jun-23 | 1051 | John Penland | Oily staining and spills around wastewater treatment tank T-2A in the trailer wash area. Spill caused by the overfilling of the wastewater tank overnight. |

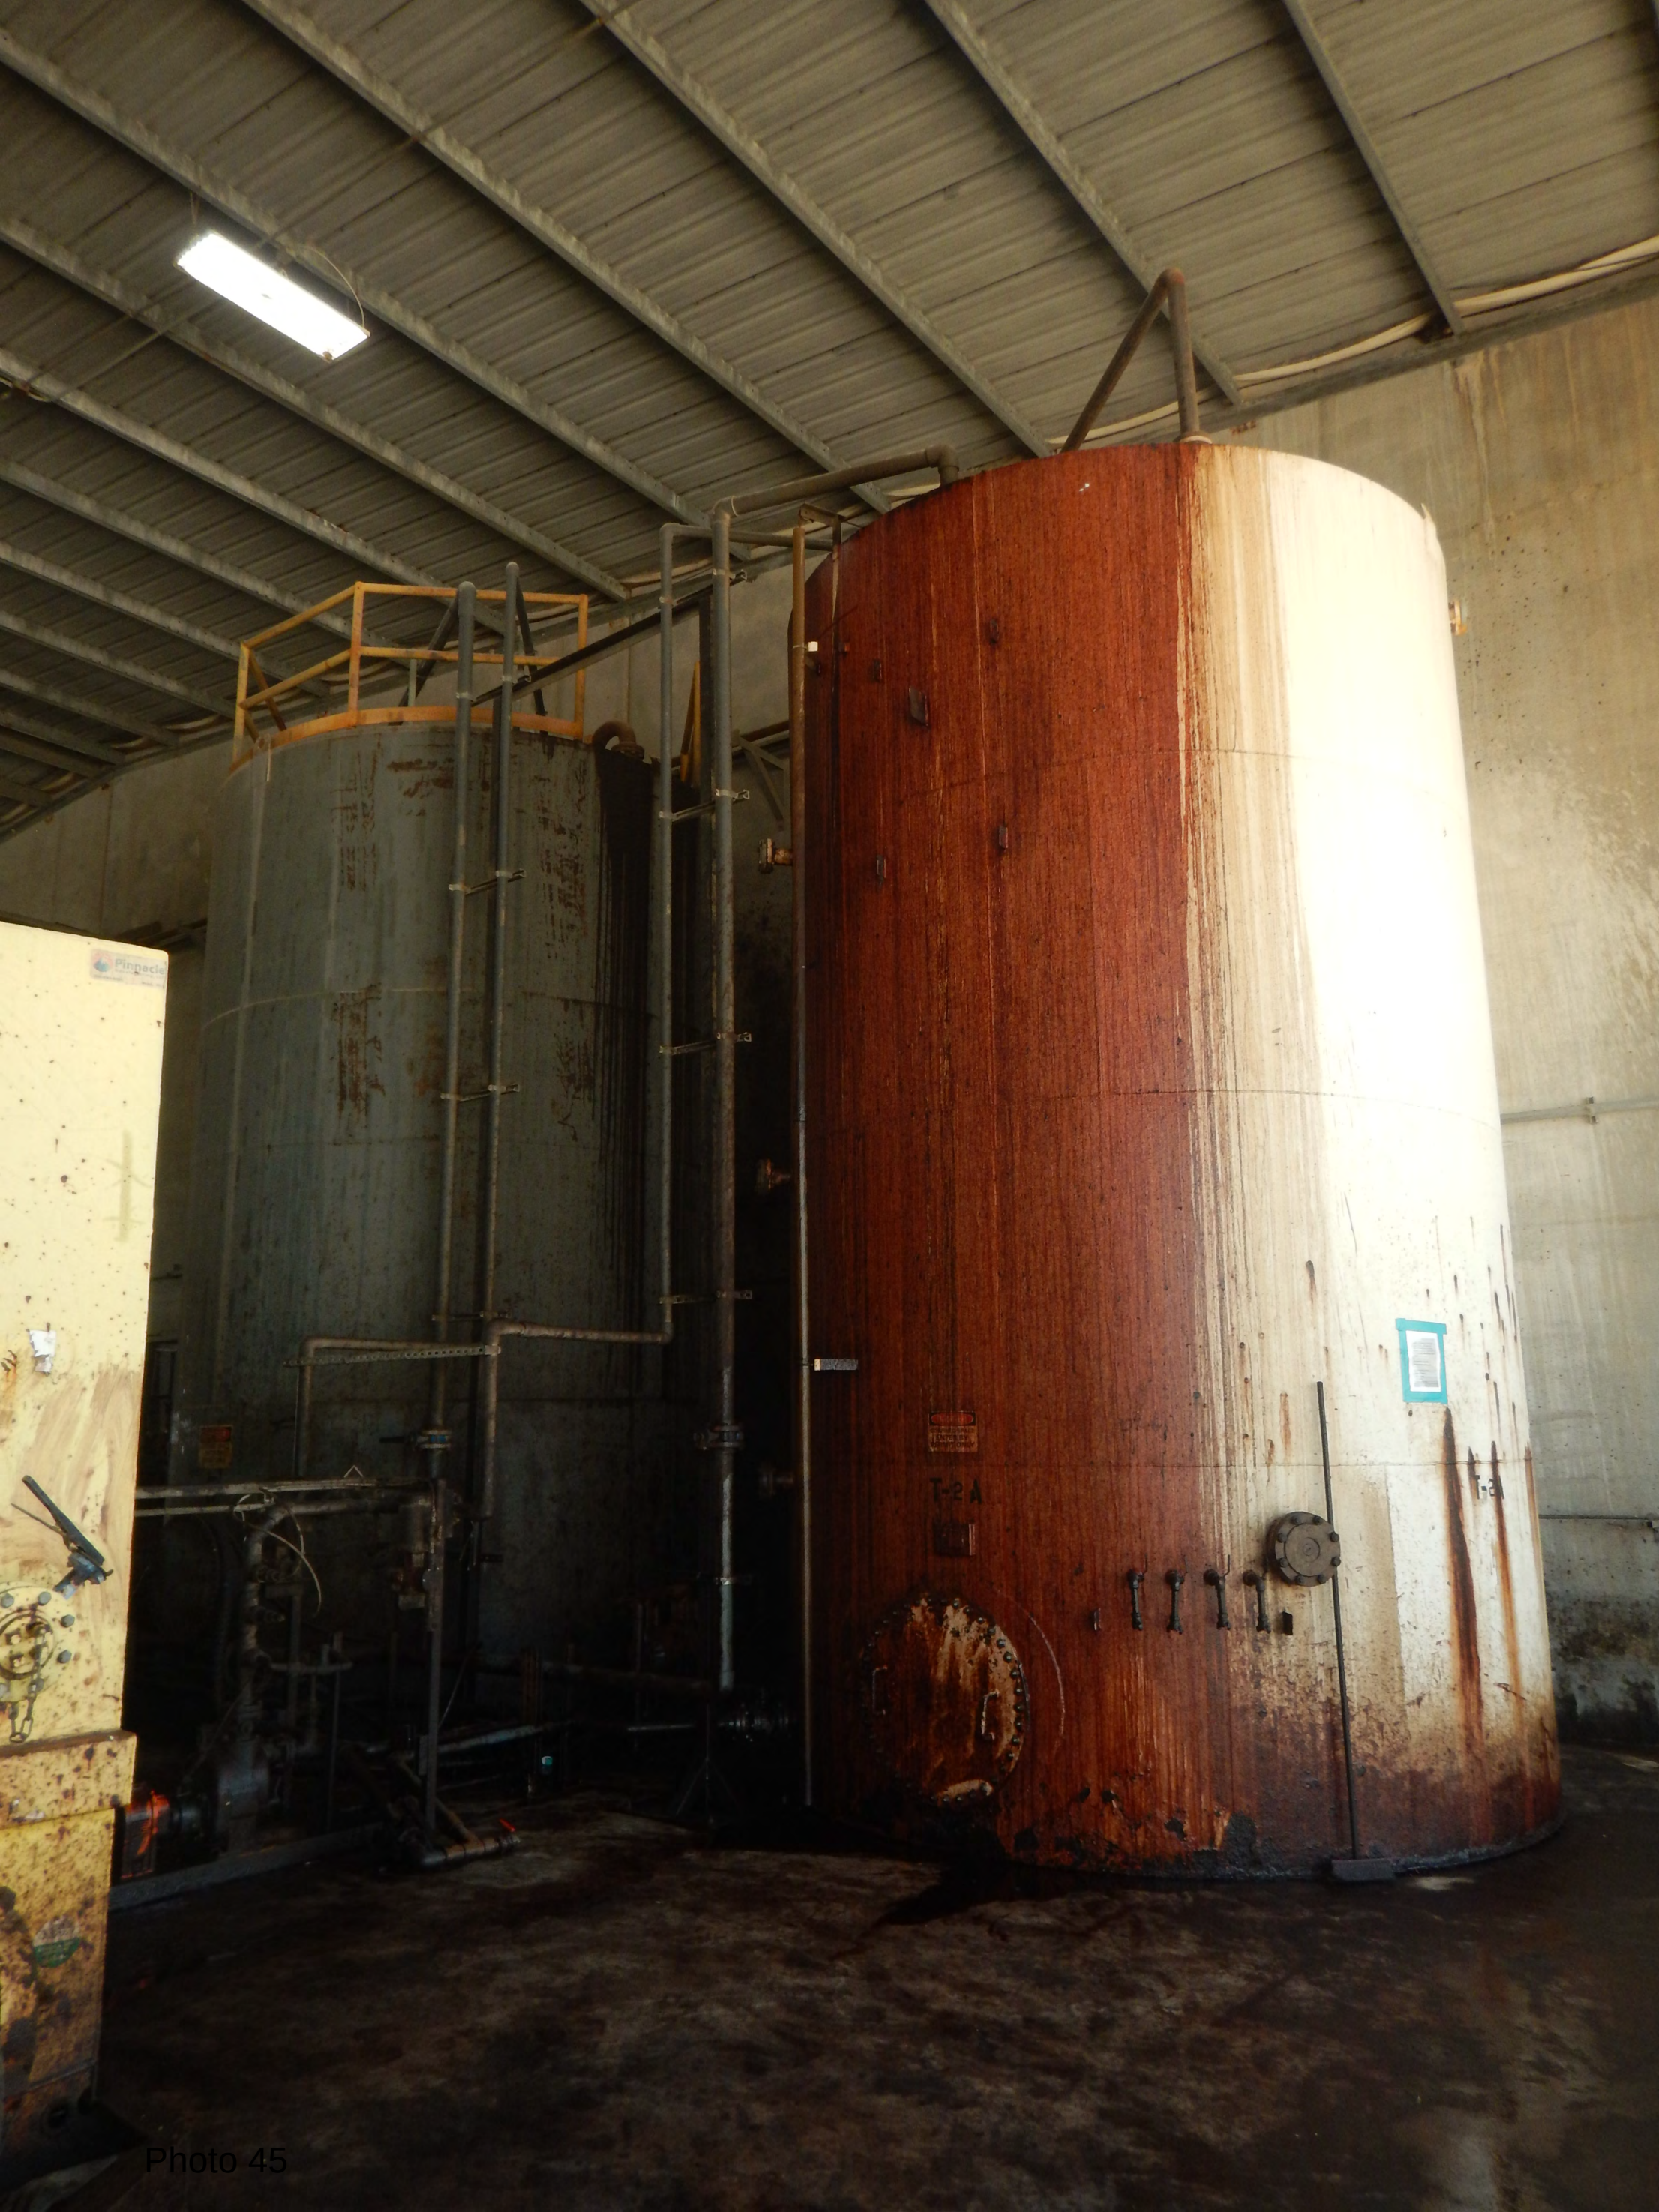
Photo 45

| Photo Number | File Name | | Date | Time | Photographer | Description |
|---|---|---|---|---|---|---|
| 45 | DSCN1103 | .JPG | 27-Jun-23 | 1052 | John Penland | Oily staining and spills around wastewater treatment tank T-2A in the trailer wash area. Spill caused by the overfilling of the wastewater tank overnight. |

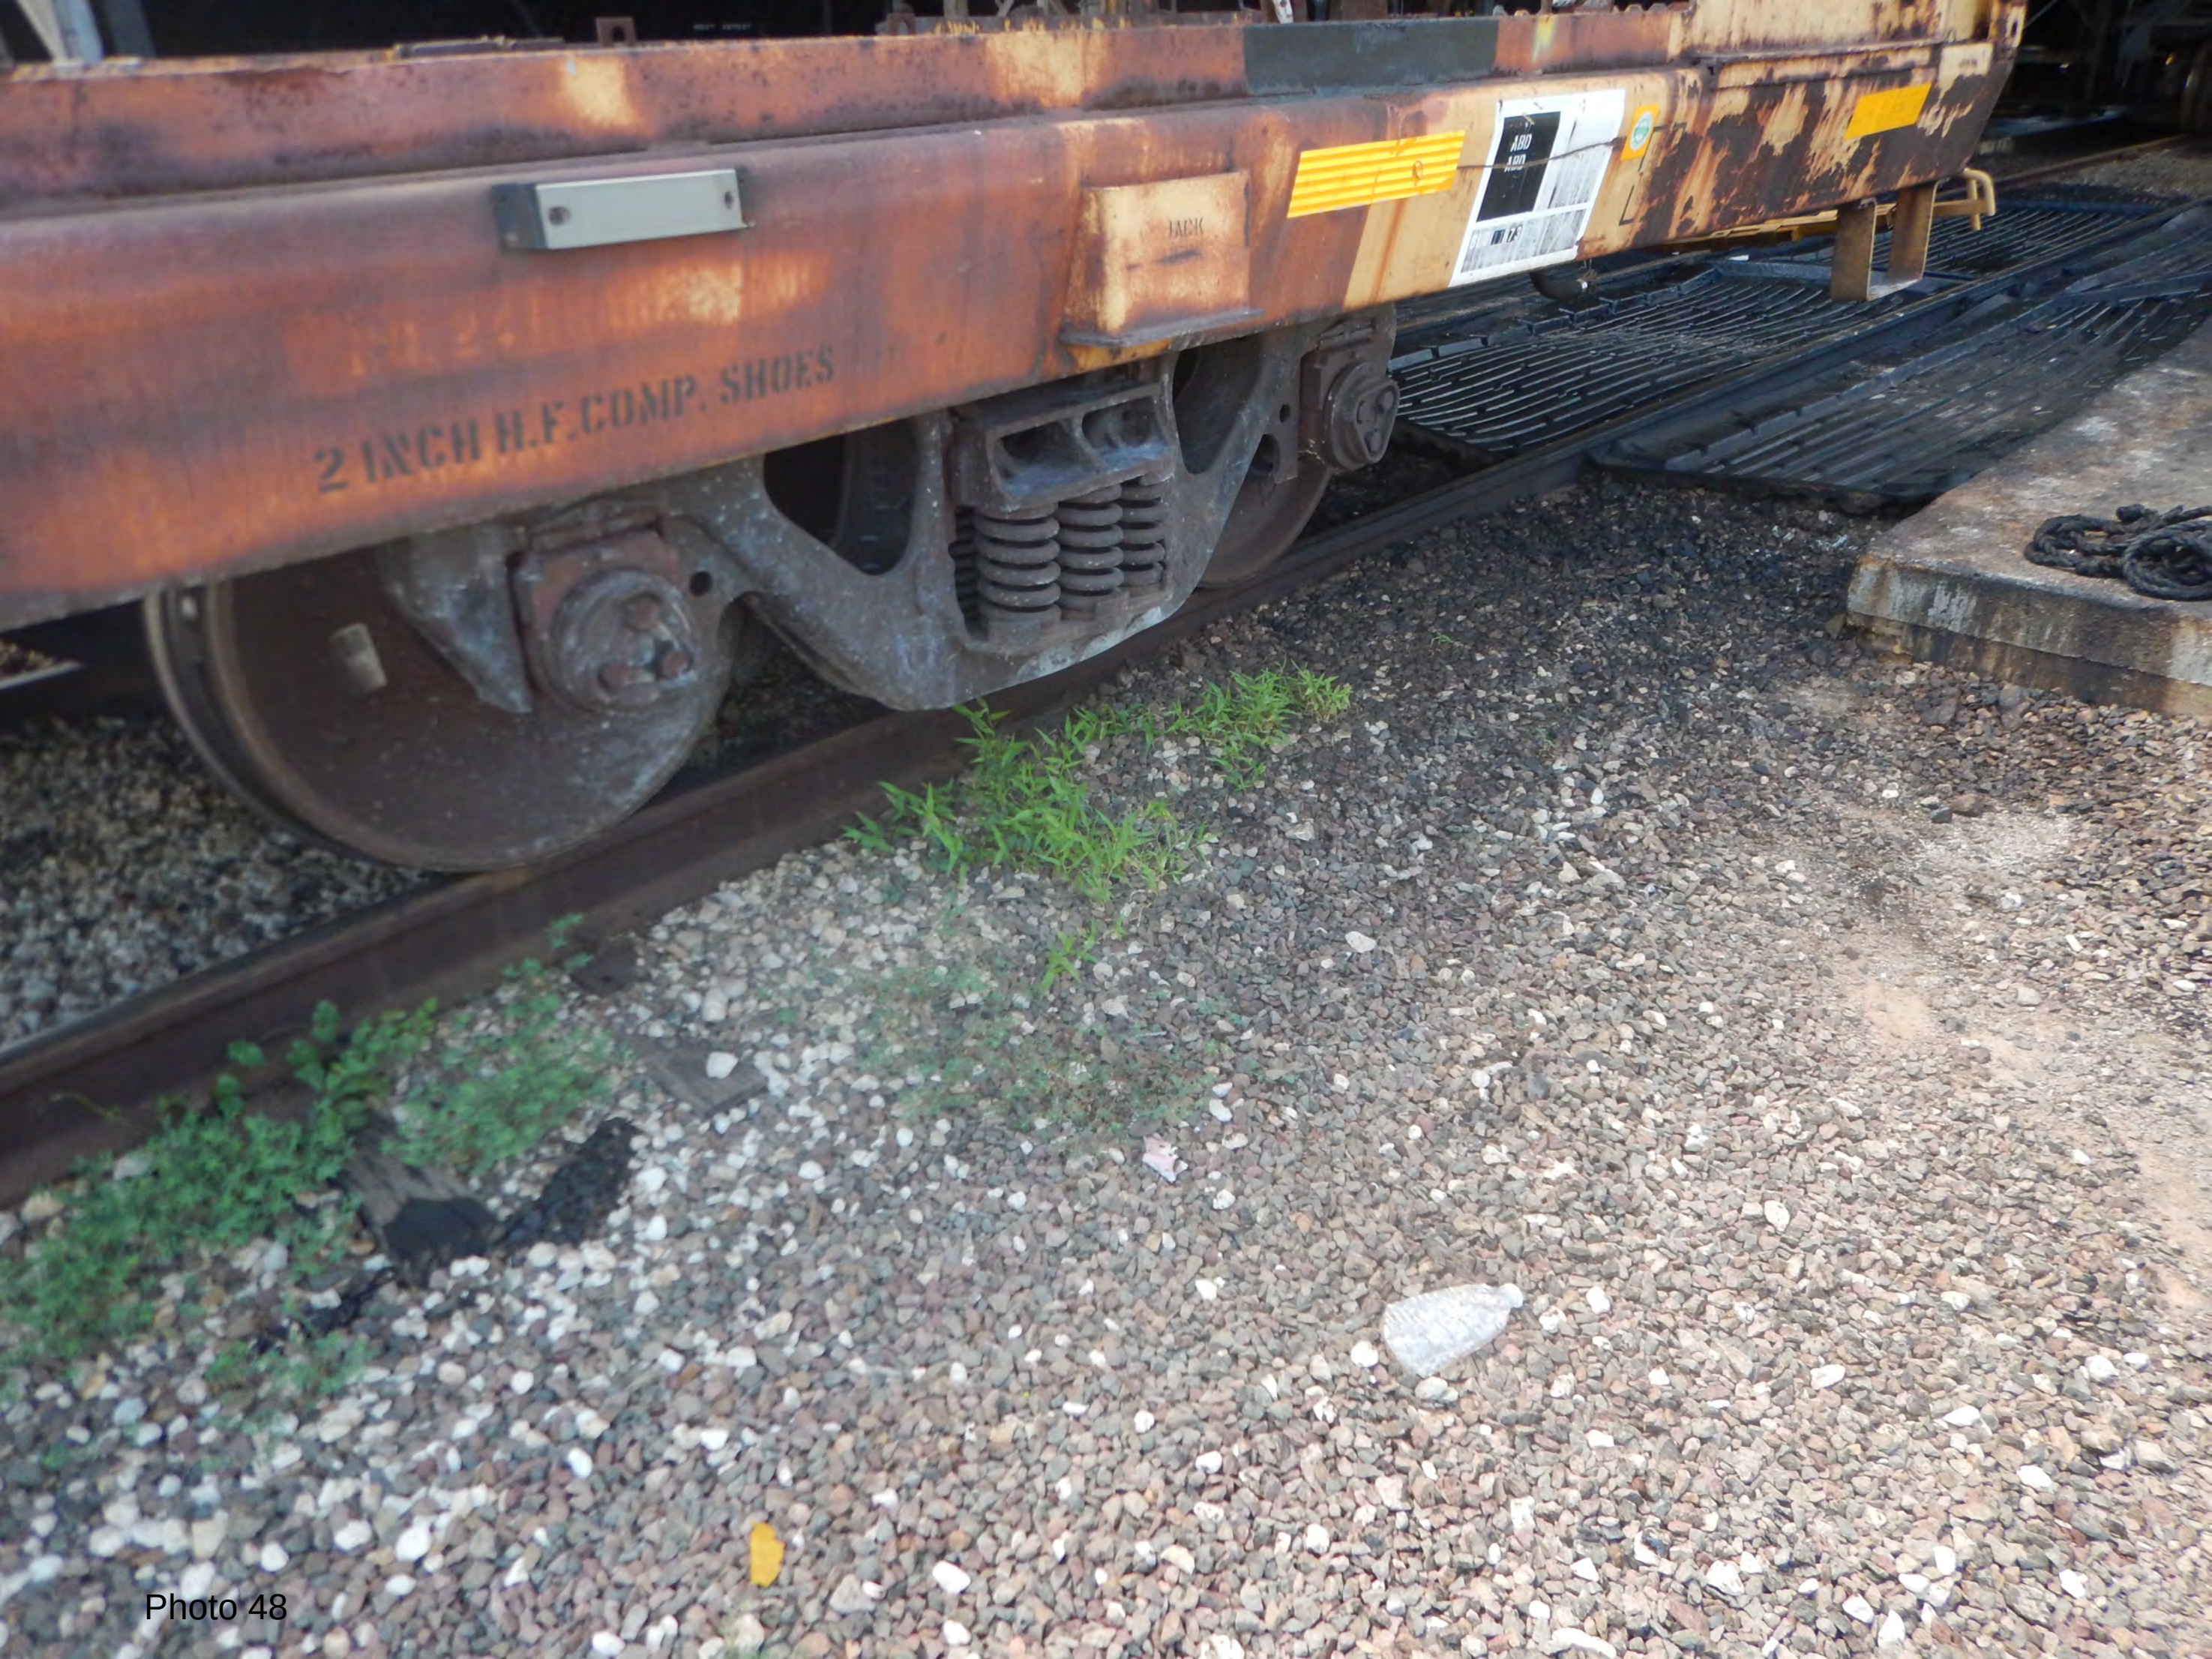
Photo 48

| Photo Number | File Name | | Date | Time | Photographer | Description |
|---|---|---|---|---|---|---|
| 48 | DSCN1106 | .JPG | 27-Jun-23 | 1113 | John Penland | Stained soils present in the rail and specialty wash area. |

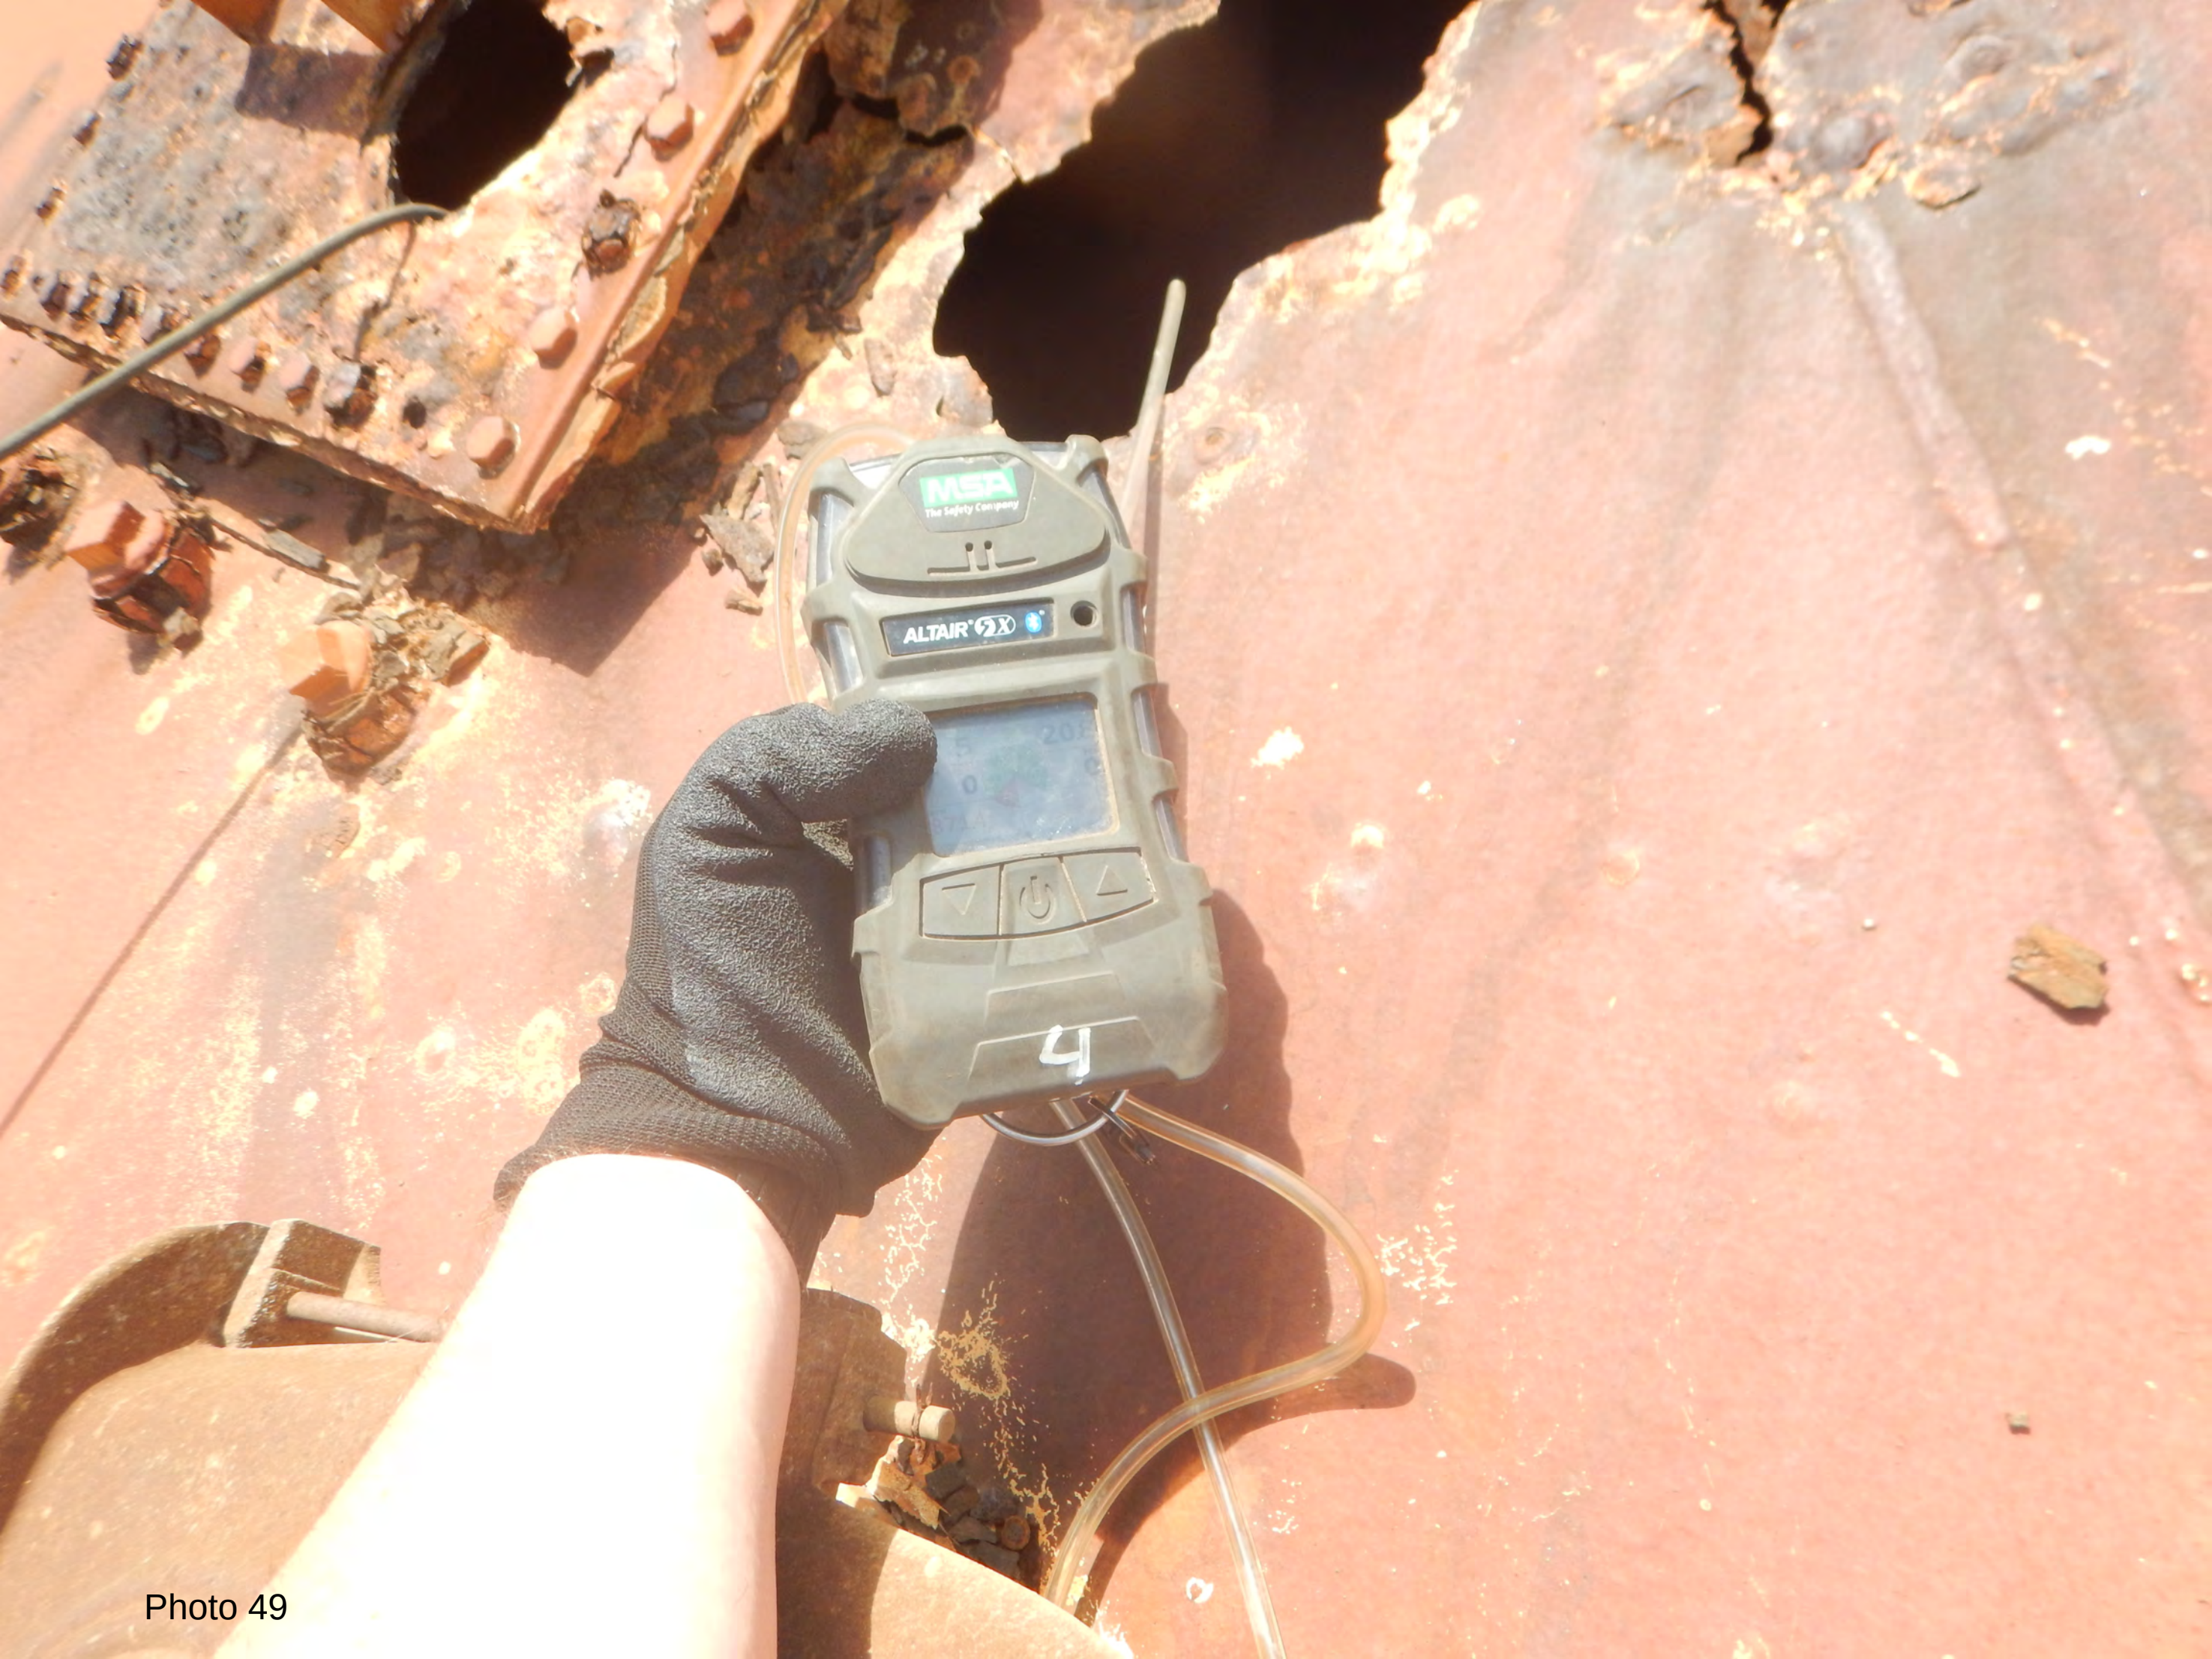
Photo 49

The hazardous waste generator standards require large quantity generators to cease the operation of a hazardous waste tank which has become unfit for use. A tank system becomes unfit for use when it is no longer capable of storing or treating hazardous waste without posing a threat of release of hazardous waste to the environment. During this inspection, we observed holes in the roof of Tank T1 estimated to be larger than 10 inches in diameter. VOC measurements from these openings, using Quala's equipment, exceeded 500ppm above background indicating that hazardous waste was being released to the air from this tank. See photos 20, 21, 22, and 49.

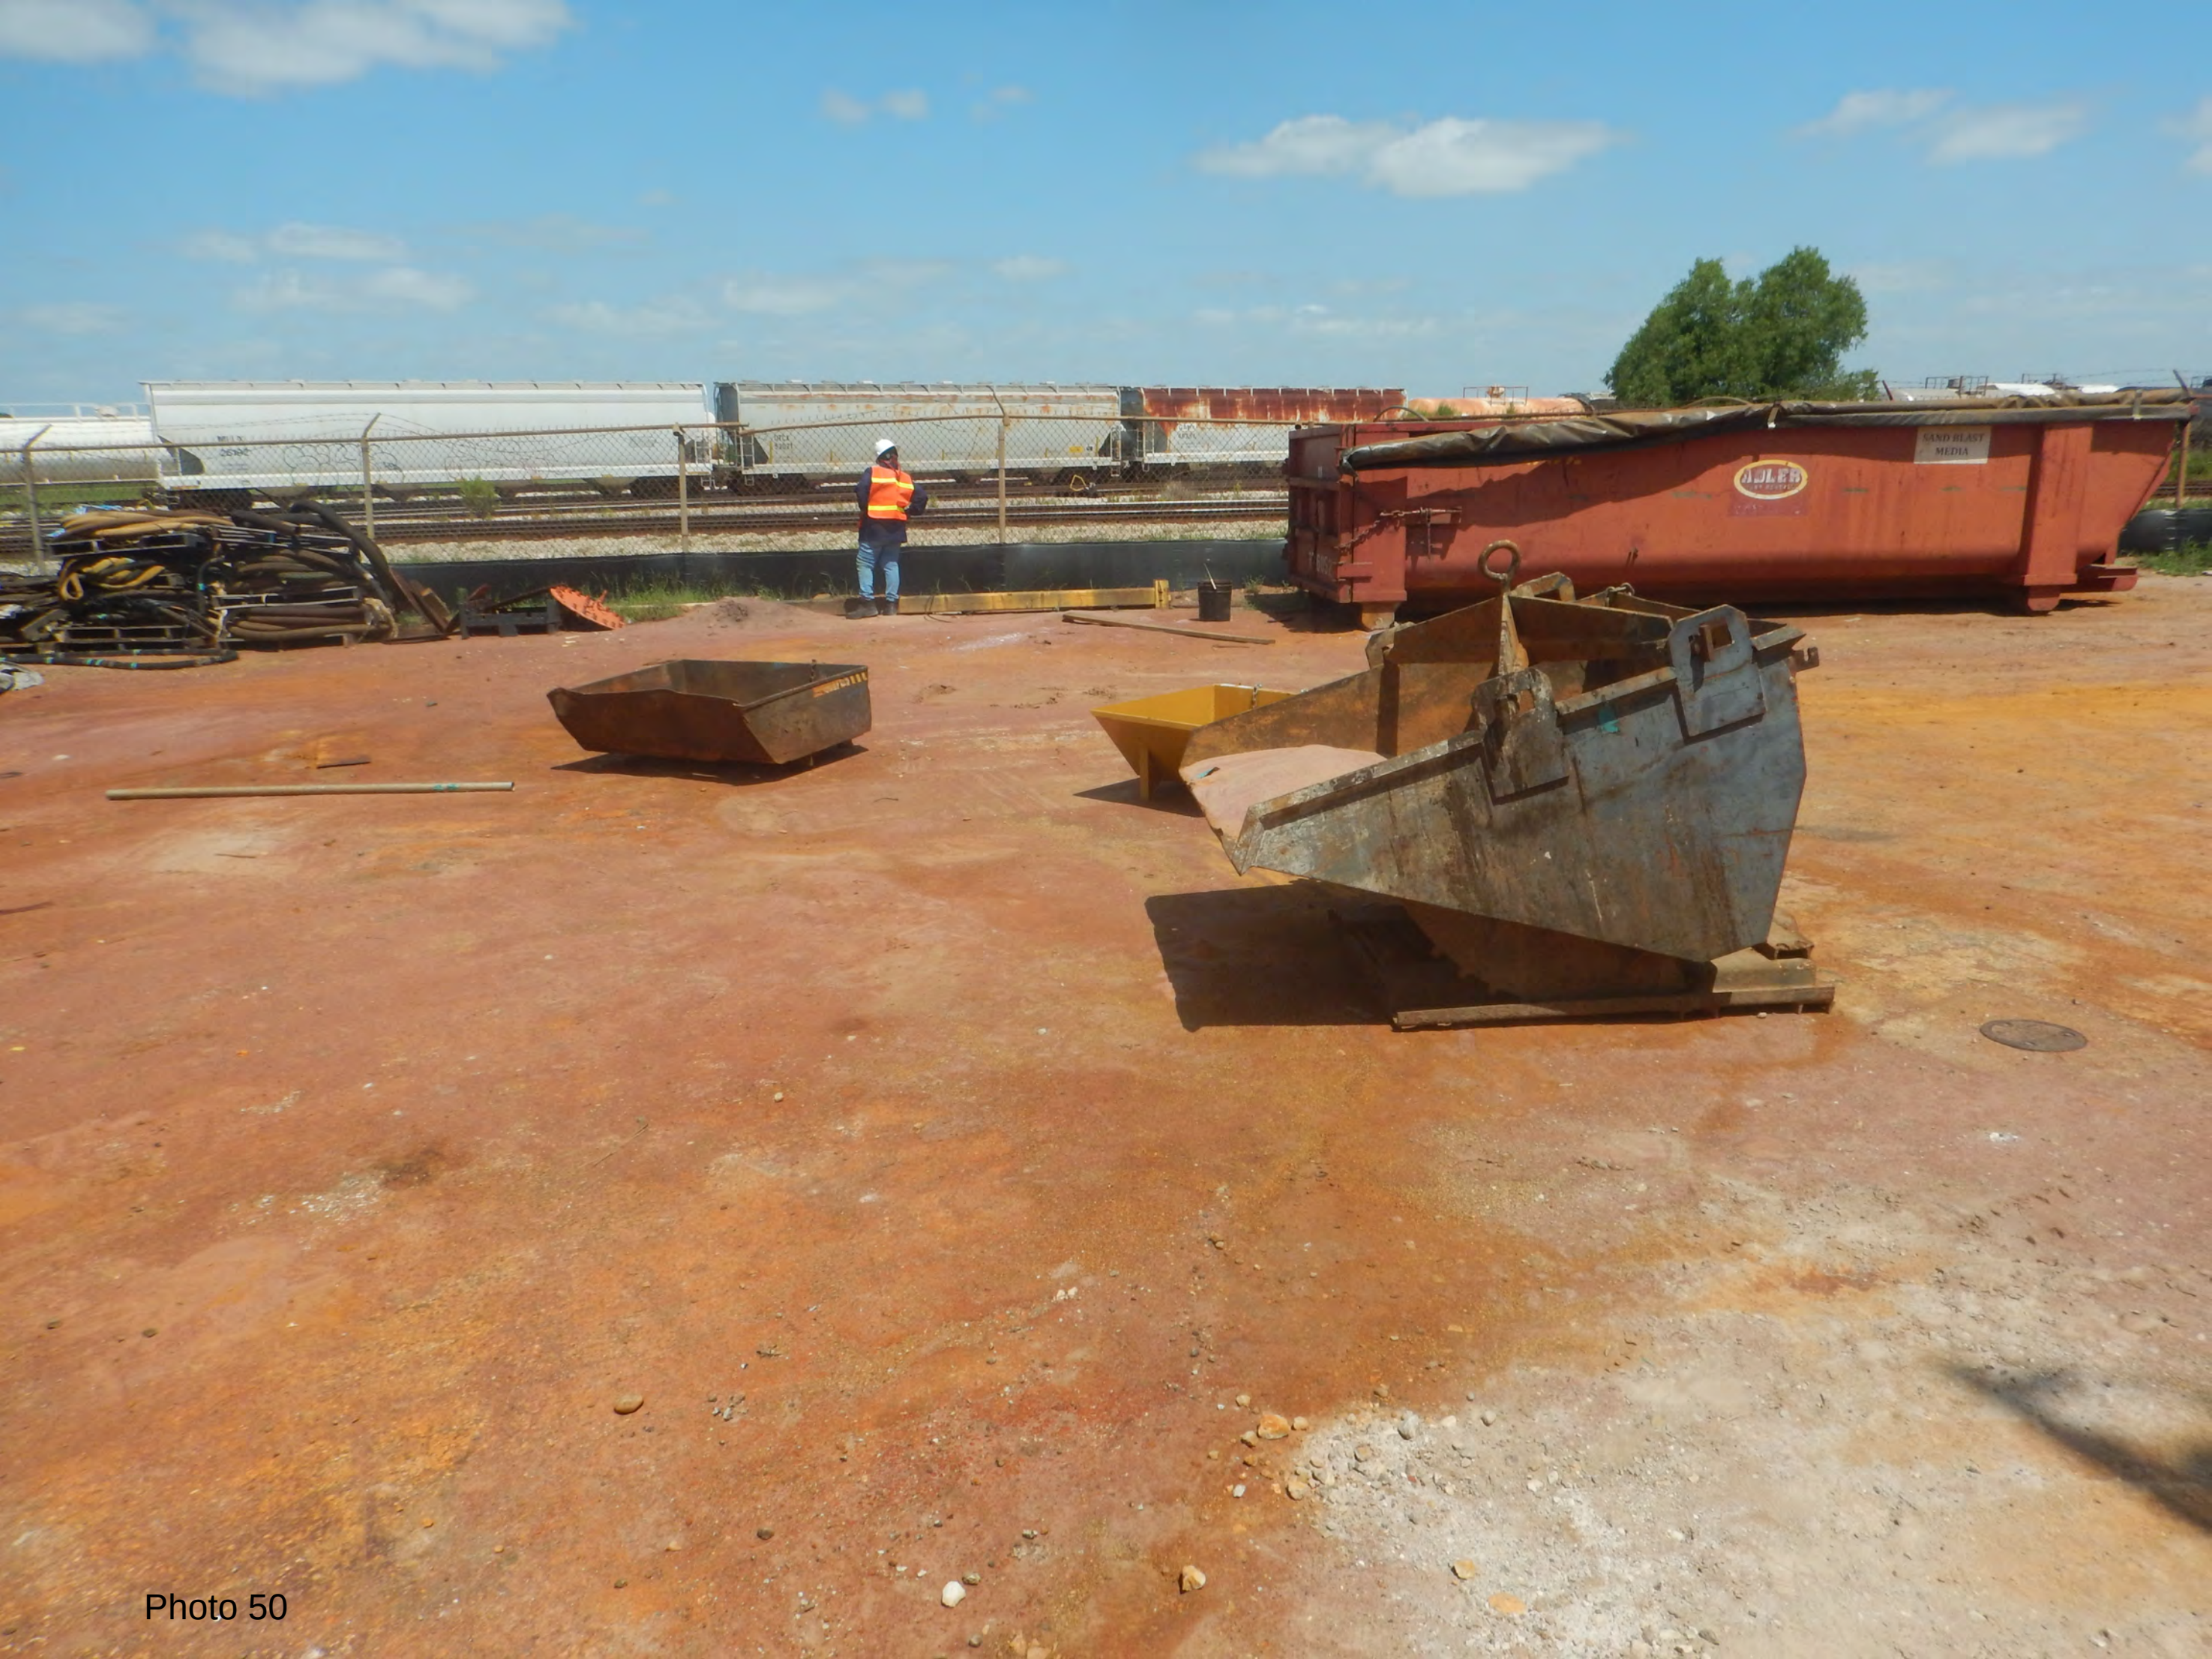
Photo 50

The State of Texas requirements for generators of industrial waste prohibit management of an industrial waste in a manner which could cause the unauthorized discharge of that industrial waste to water of the state. During this inspection, we observed that sand blast media was uncontained in the sand blast area and offsite migration was observed into a drainage ditch outside of the fence line. In this same area, we observed staining of the soils with an unknown black material that also appeared to be following a release pathway from the facility into a drainage ditch. See photos 50 through 53.
