**Region 6 - Enforcement & Compliance Assurance Division**  
**INSPECTION REPORT**

| Inspection Date(s): | June 26 – 29, 2023 | |
| Regulatory Program(s) | Large Quantity Generator | |
| Facility Name: | <b>Quala Rail and Specialty</b> | |

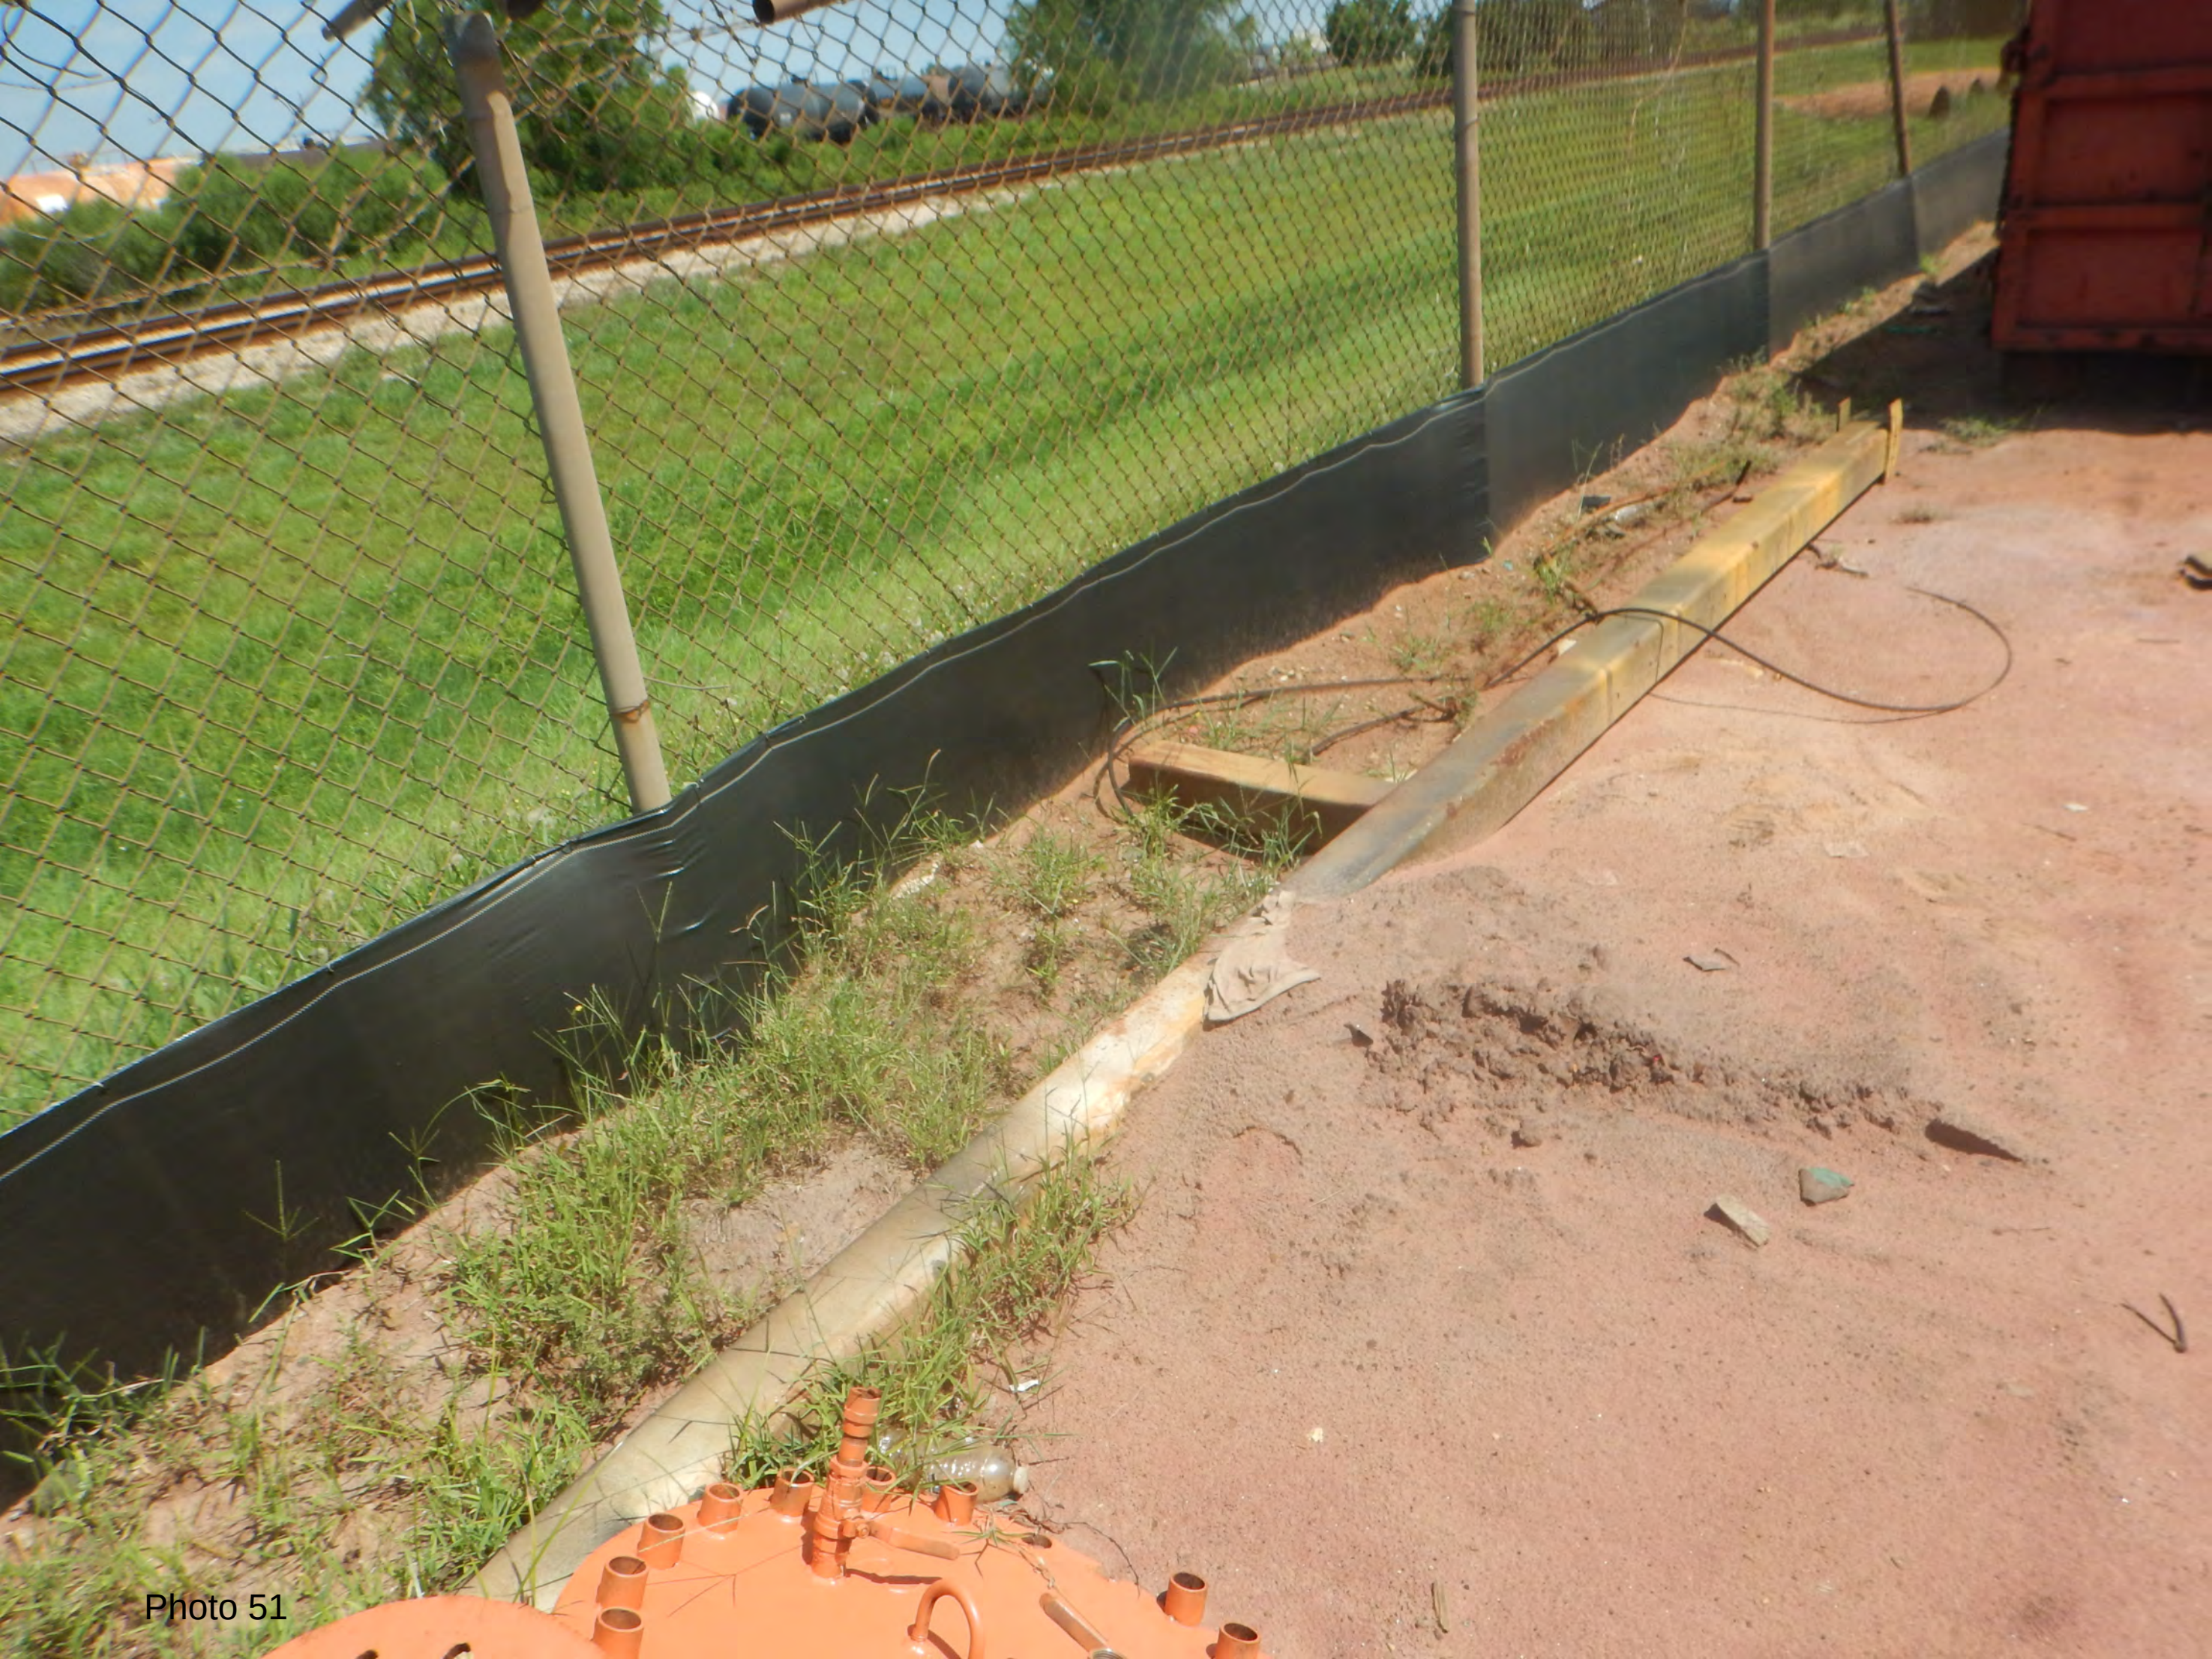
Photo 51

The State of Texas requirements for generators of industrial waste prohibit management of an industrial waste in a manner which could cause the unauthorized discharge of that industrial waste to water of the state. During this inspection, we observed that sand blast media was uncontained in the sand blast area and offsite migration was observed into a drainage ditch outside of the fence line. In this same area, we observed staining of the soils with an unknown black material that also appeared to be following a release pathway from the facility into a drainage ditch. See photos 50 through 53.

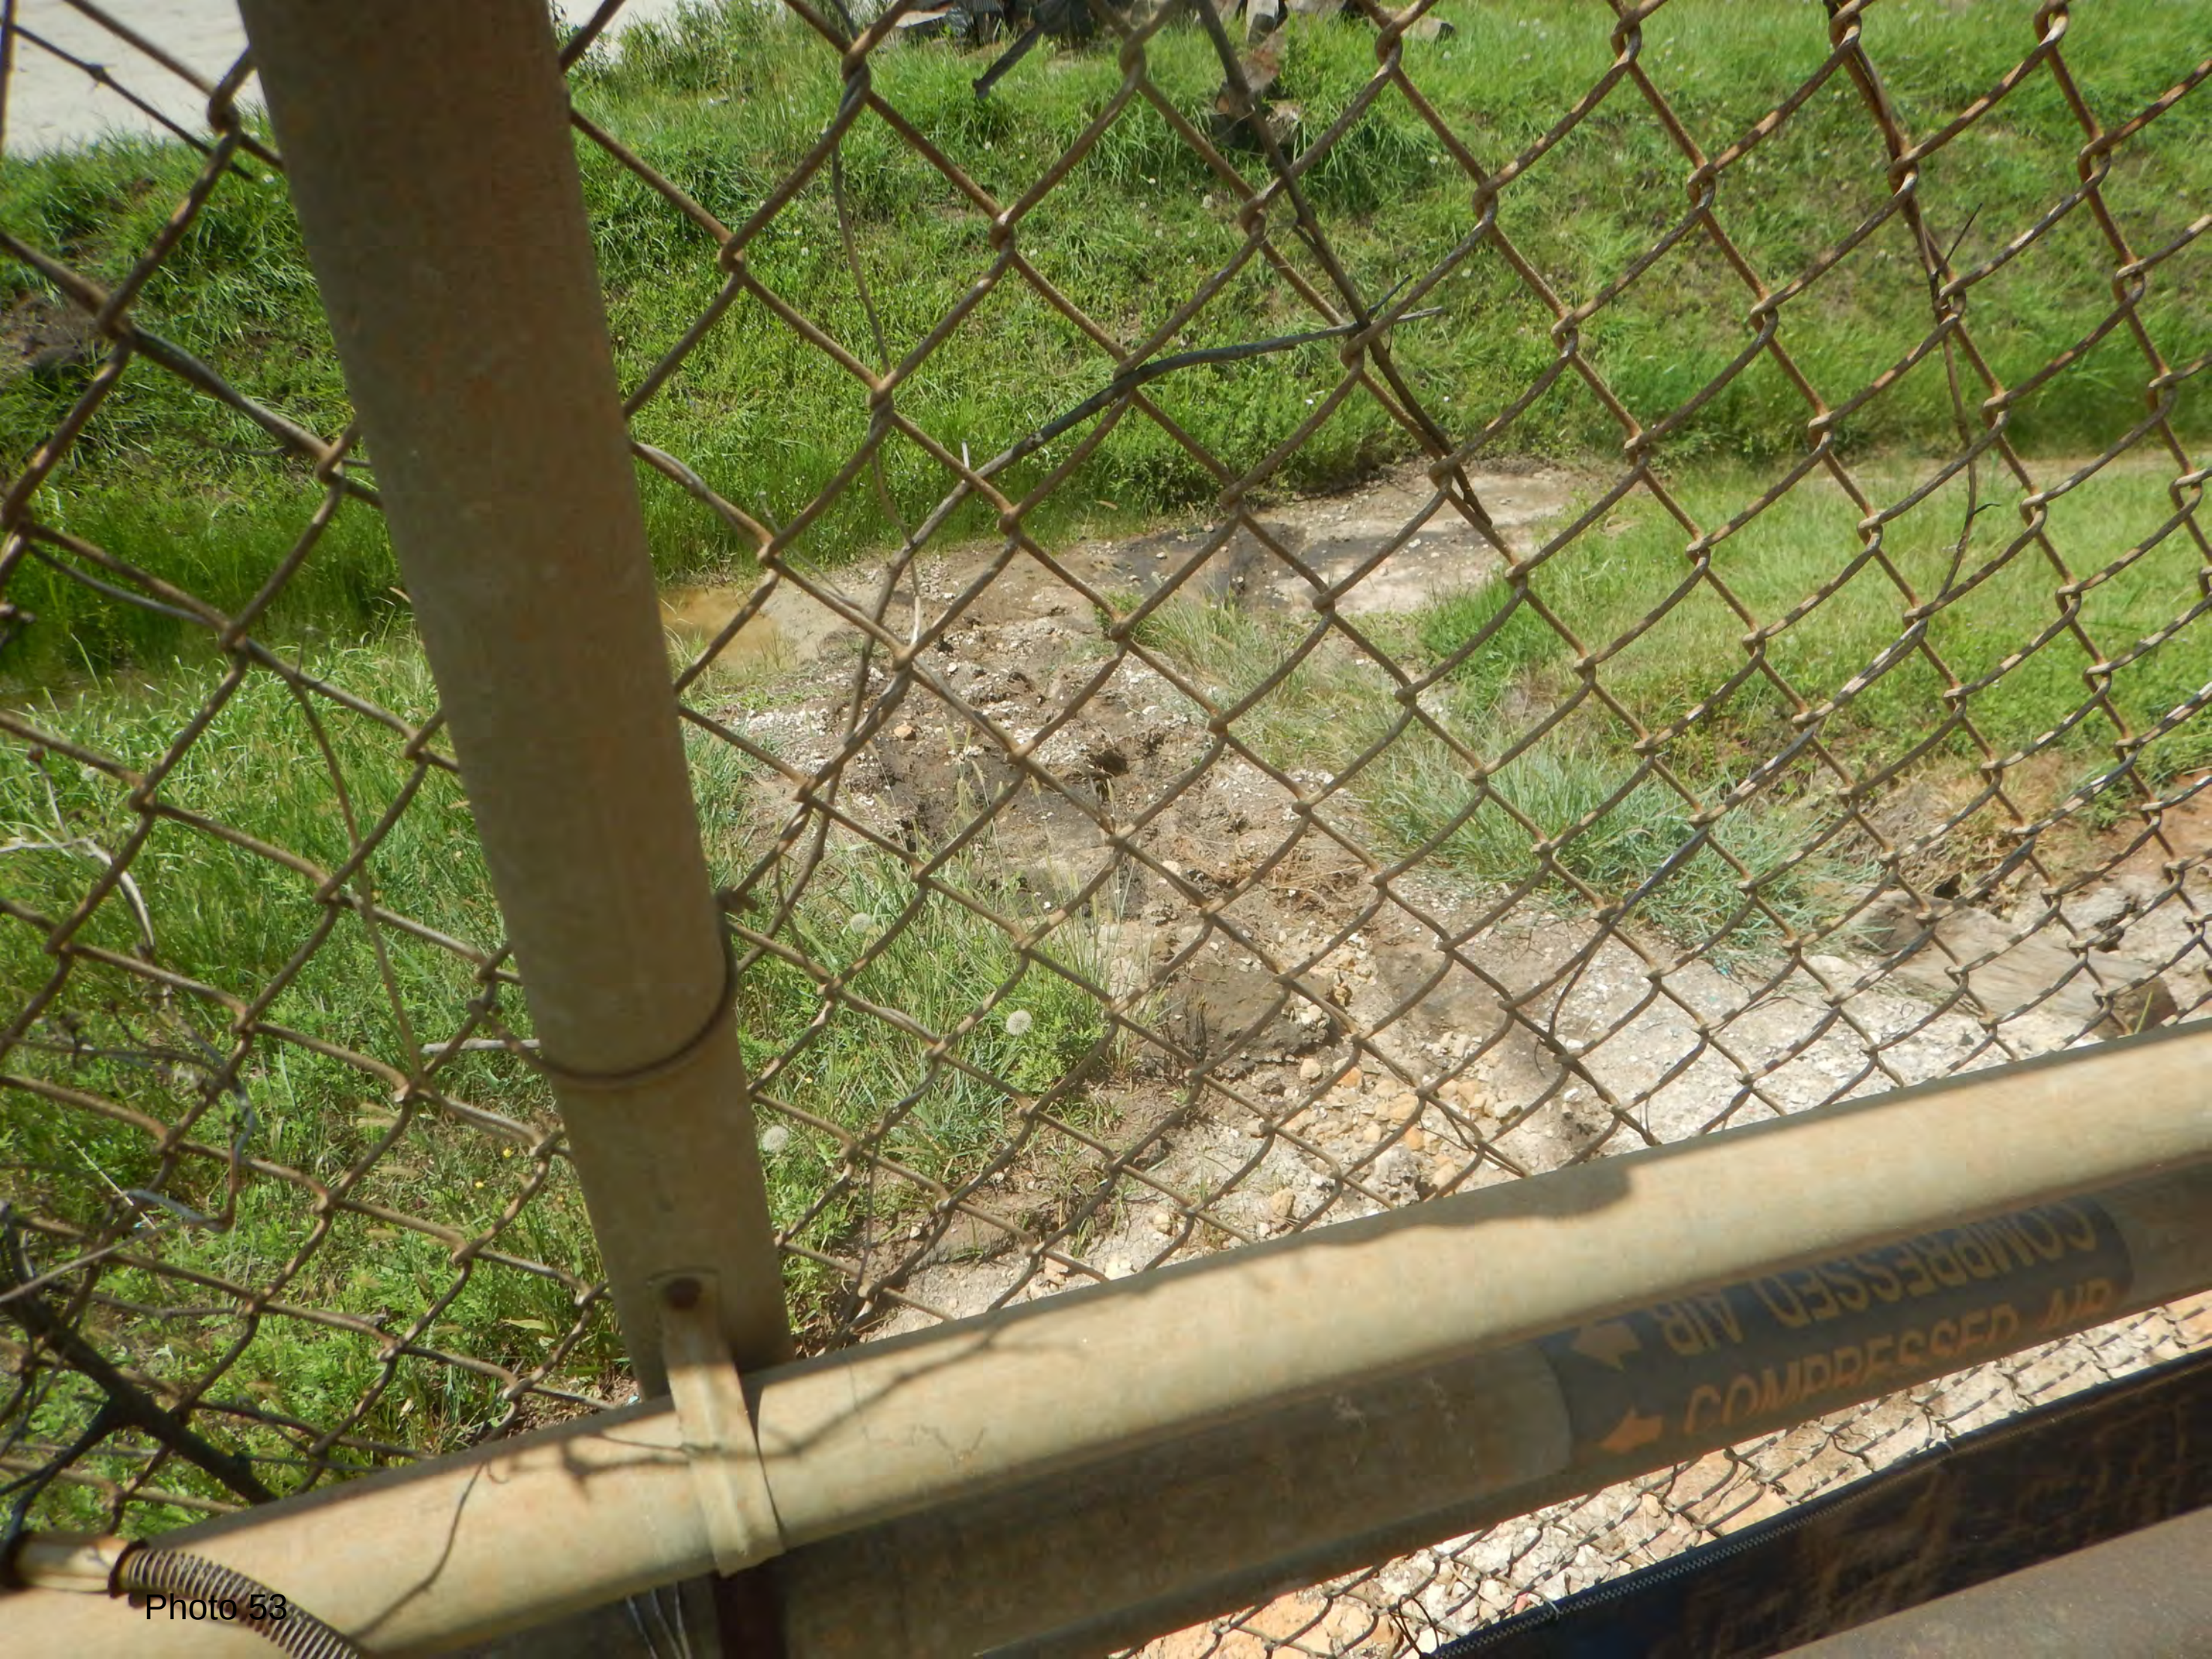
Photo 53

| Photo Number | File Name | | Date | Time | Photographer | Description |
|---|---|---|---|---|---|---|
| 53 | DSCN1111 | .JPG | 27-Jun-23 | 1132 | John Penland | Soil staining and visible indications of offsite release of material through an erosion pathway on west side of sandblast area. |

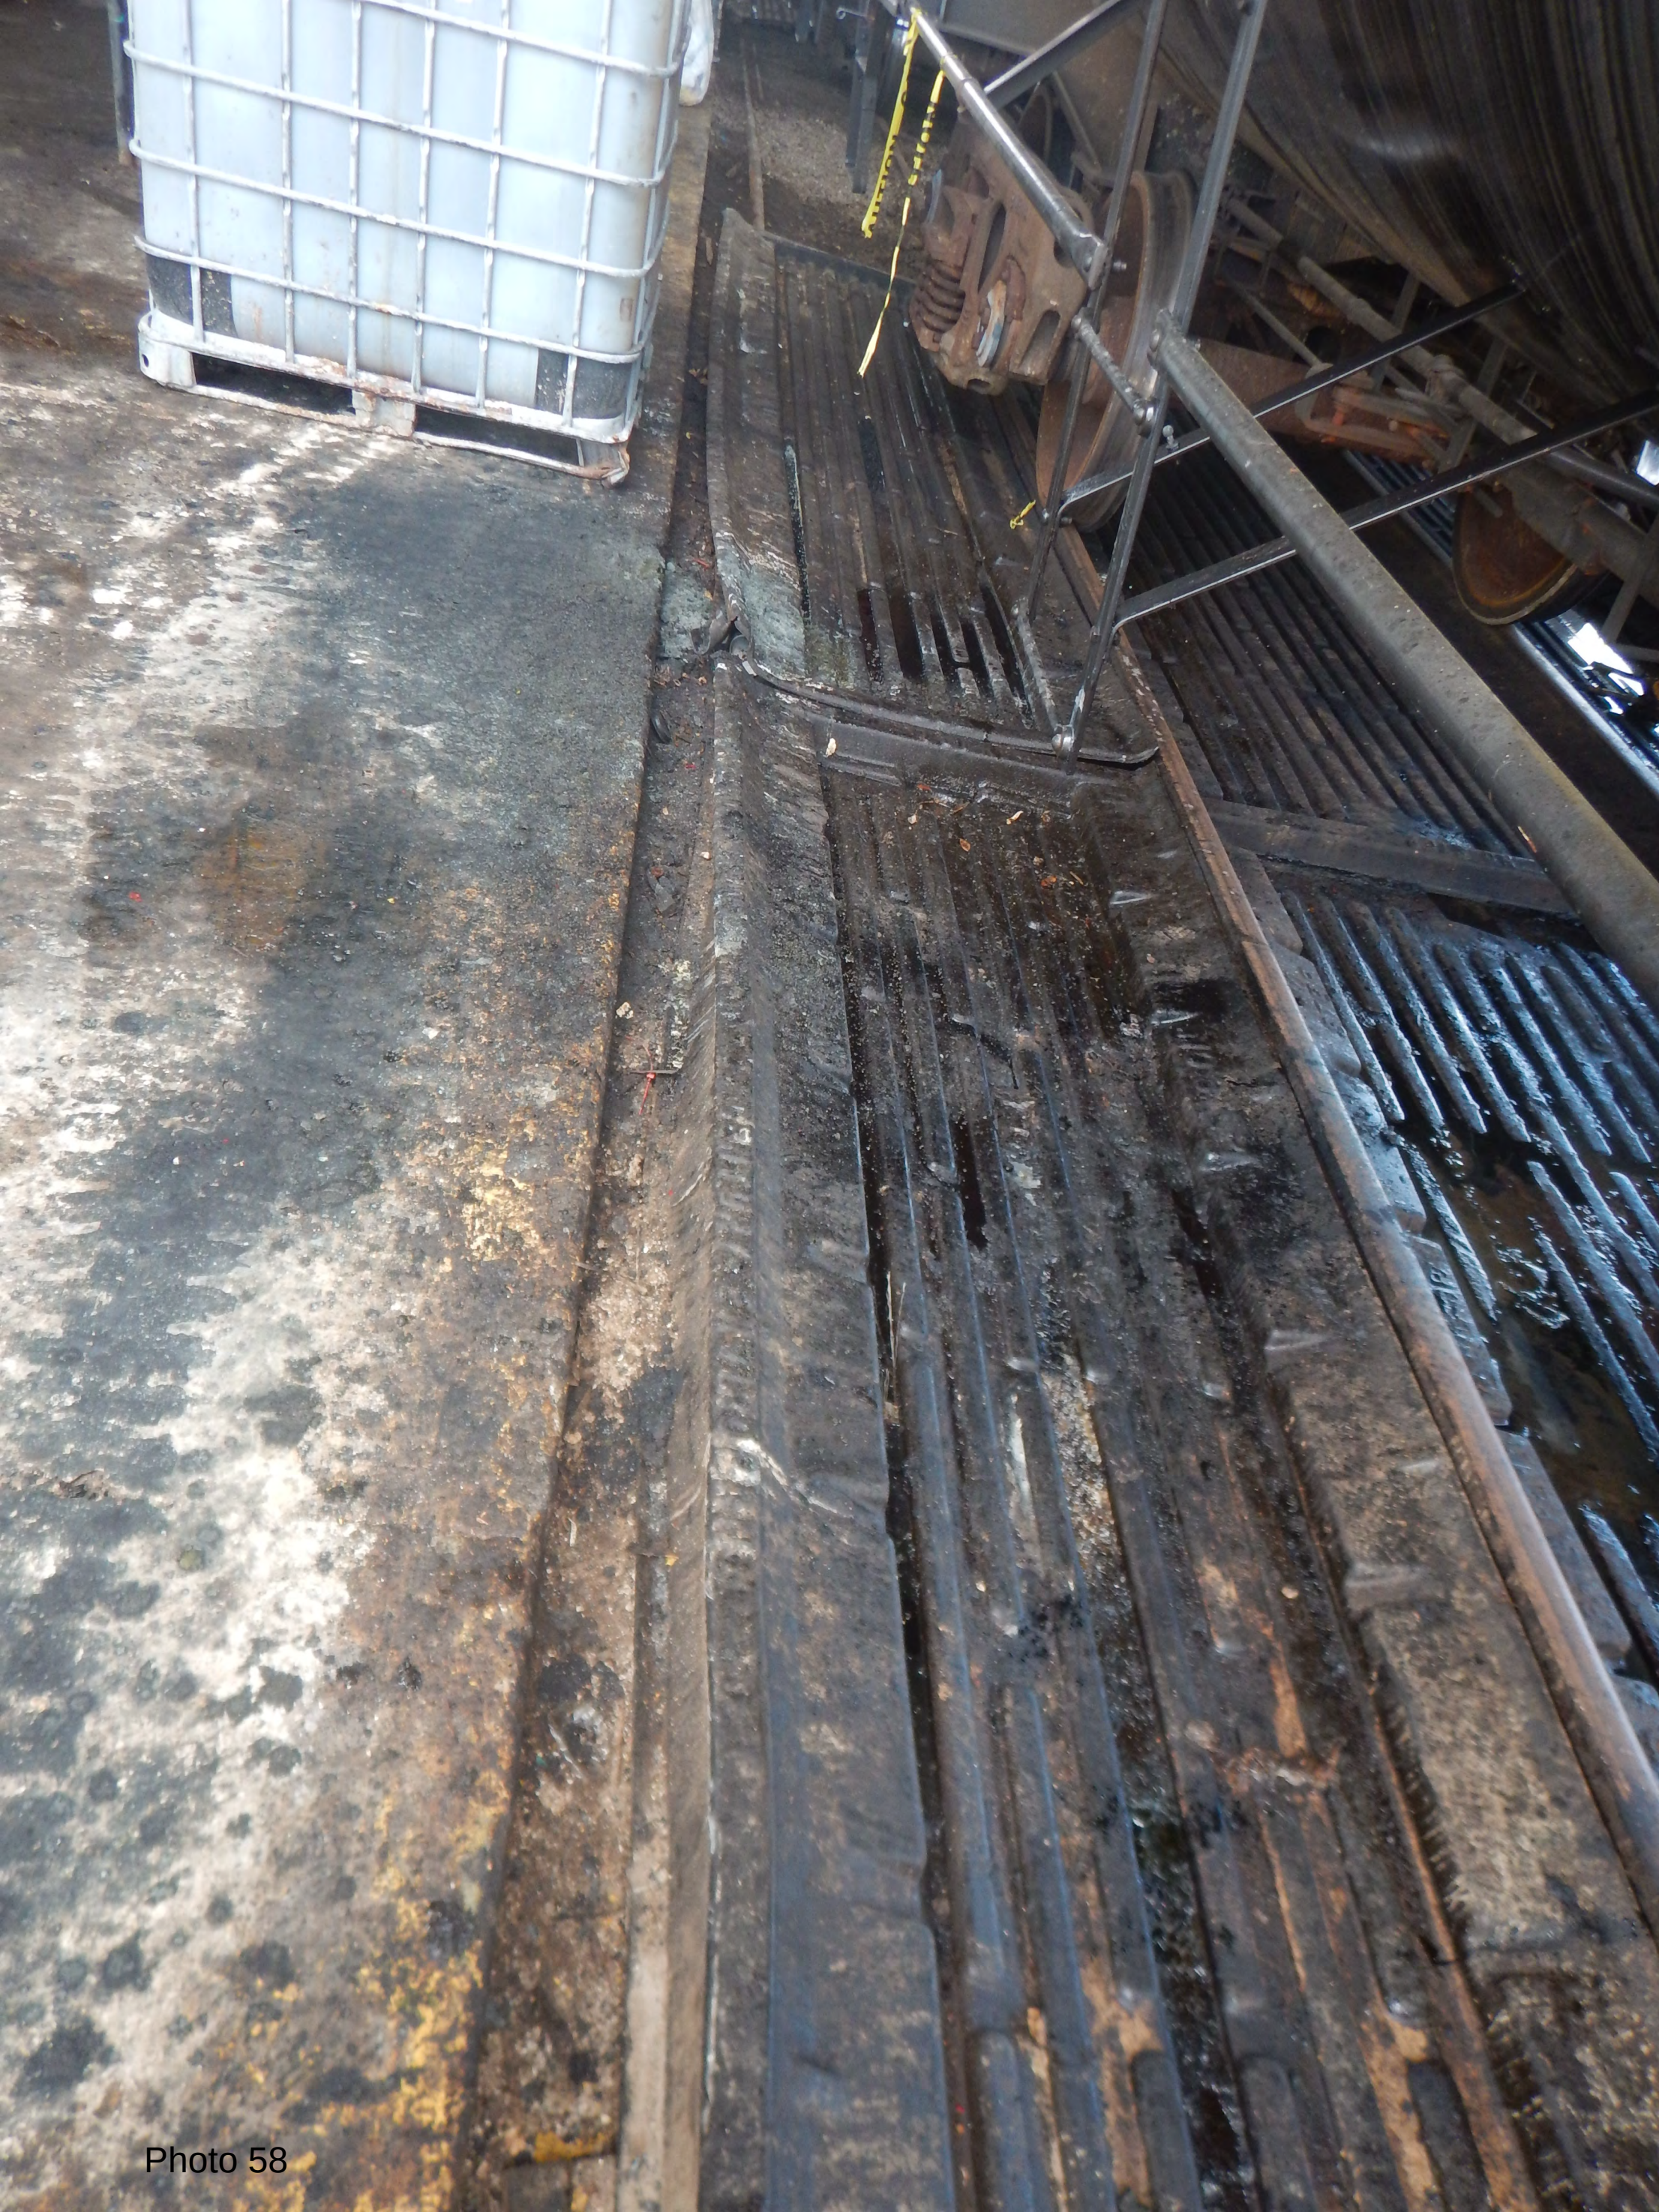
Photo 58

| Photo Number | File Name | | Date | Time | Photographer | Description |
|---|---|---|---|---|---|---|
| 58 | DSCN1116 | .JPG | 27-Jun-23 | 1205 | John Penland | Spills and staining along rail track of rail and specialty wash area |

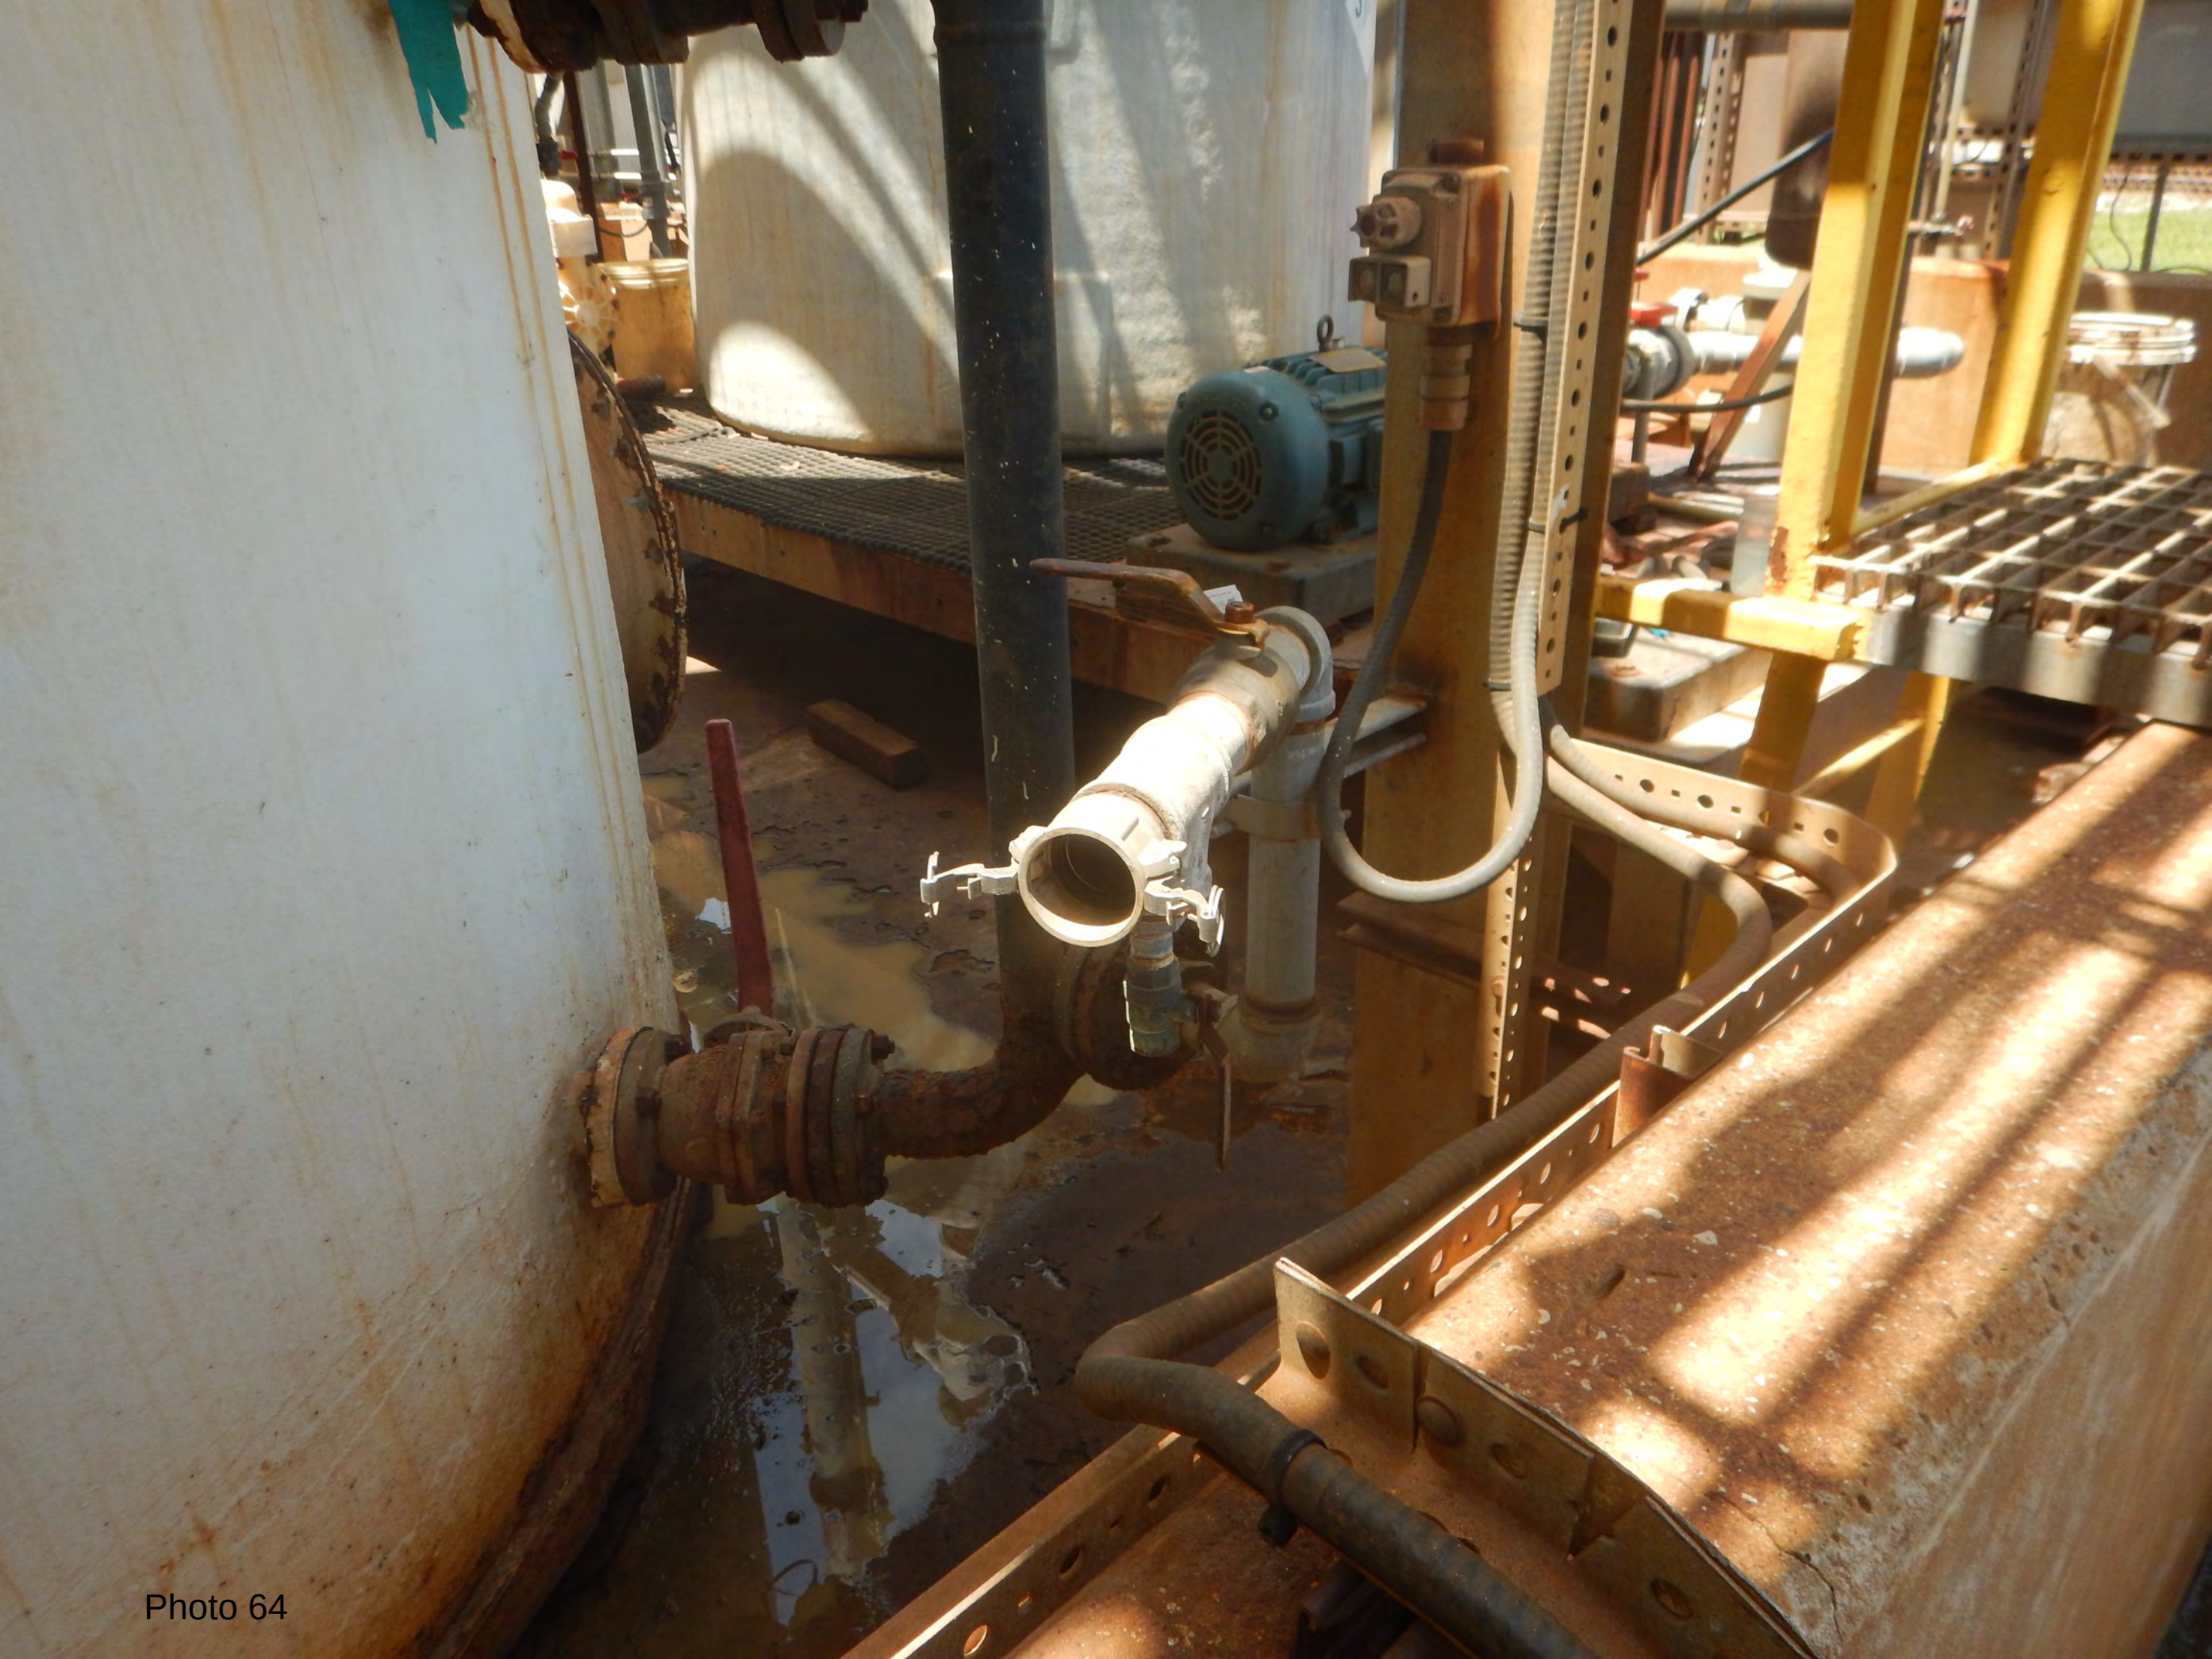
Photo 64

The hazardous waste generator standards require large quantity generators to remove spilled or leaked waste and accumulated precipitation from the secondary containment system for hazardous waste tanks within 24 hours. On both June 26 and June 27, during this inspection, we observed accumulated liquids in the secondary containment of Tank T1 (WMU 006). See photos 27, 28, and 64.

The hazardous waste generator standards require large quantity generators to construct secondary containment systems for hazardous waste tanks using materials that are compatible with the waste contained in the tank and with the operations carried out in the unit. During this inspection, we observed extensive corrosion and pitting of the secondary containment system for Tank T1 (WMU 006). The secondary containment damage is present in the floor of the concrete liner throughout the containment area and pitting appears to extend to a depth of more than 1 inch. See photos 27, 28, and 64.

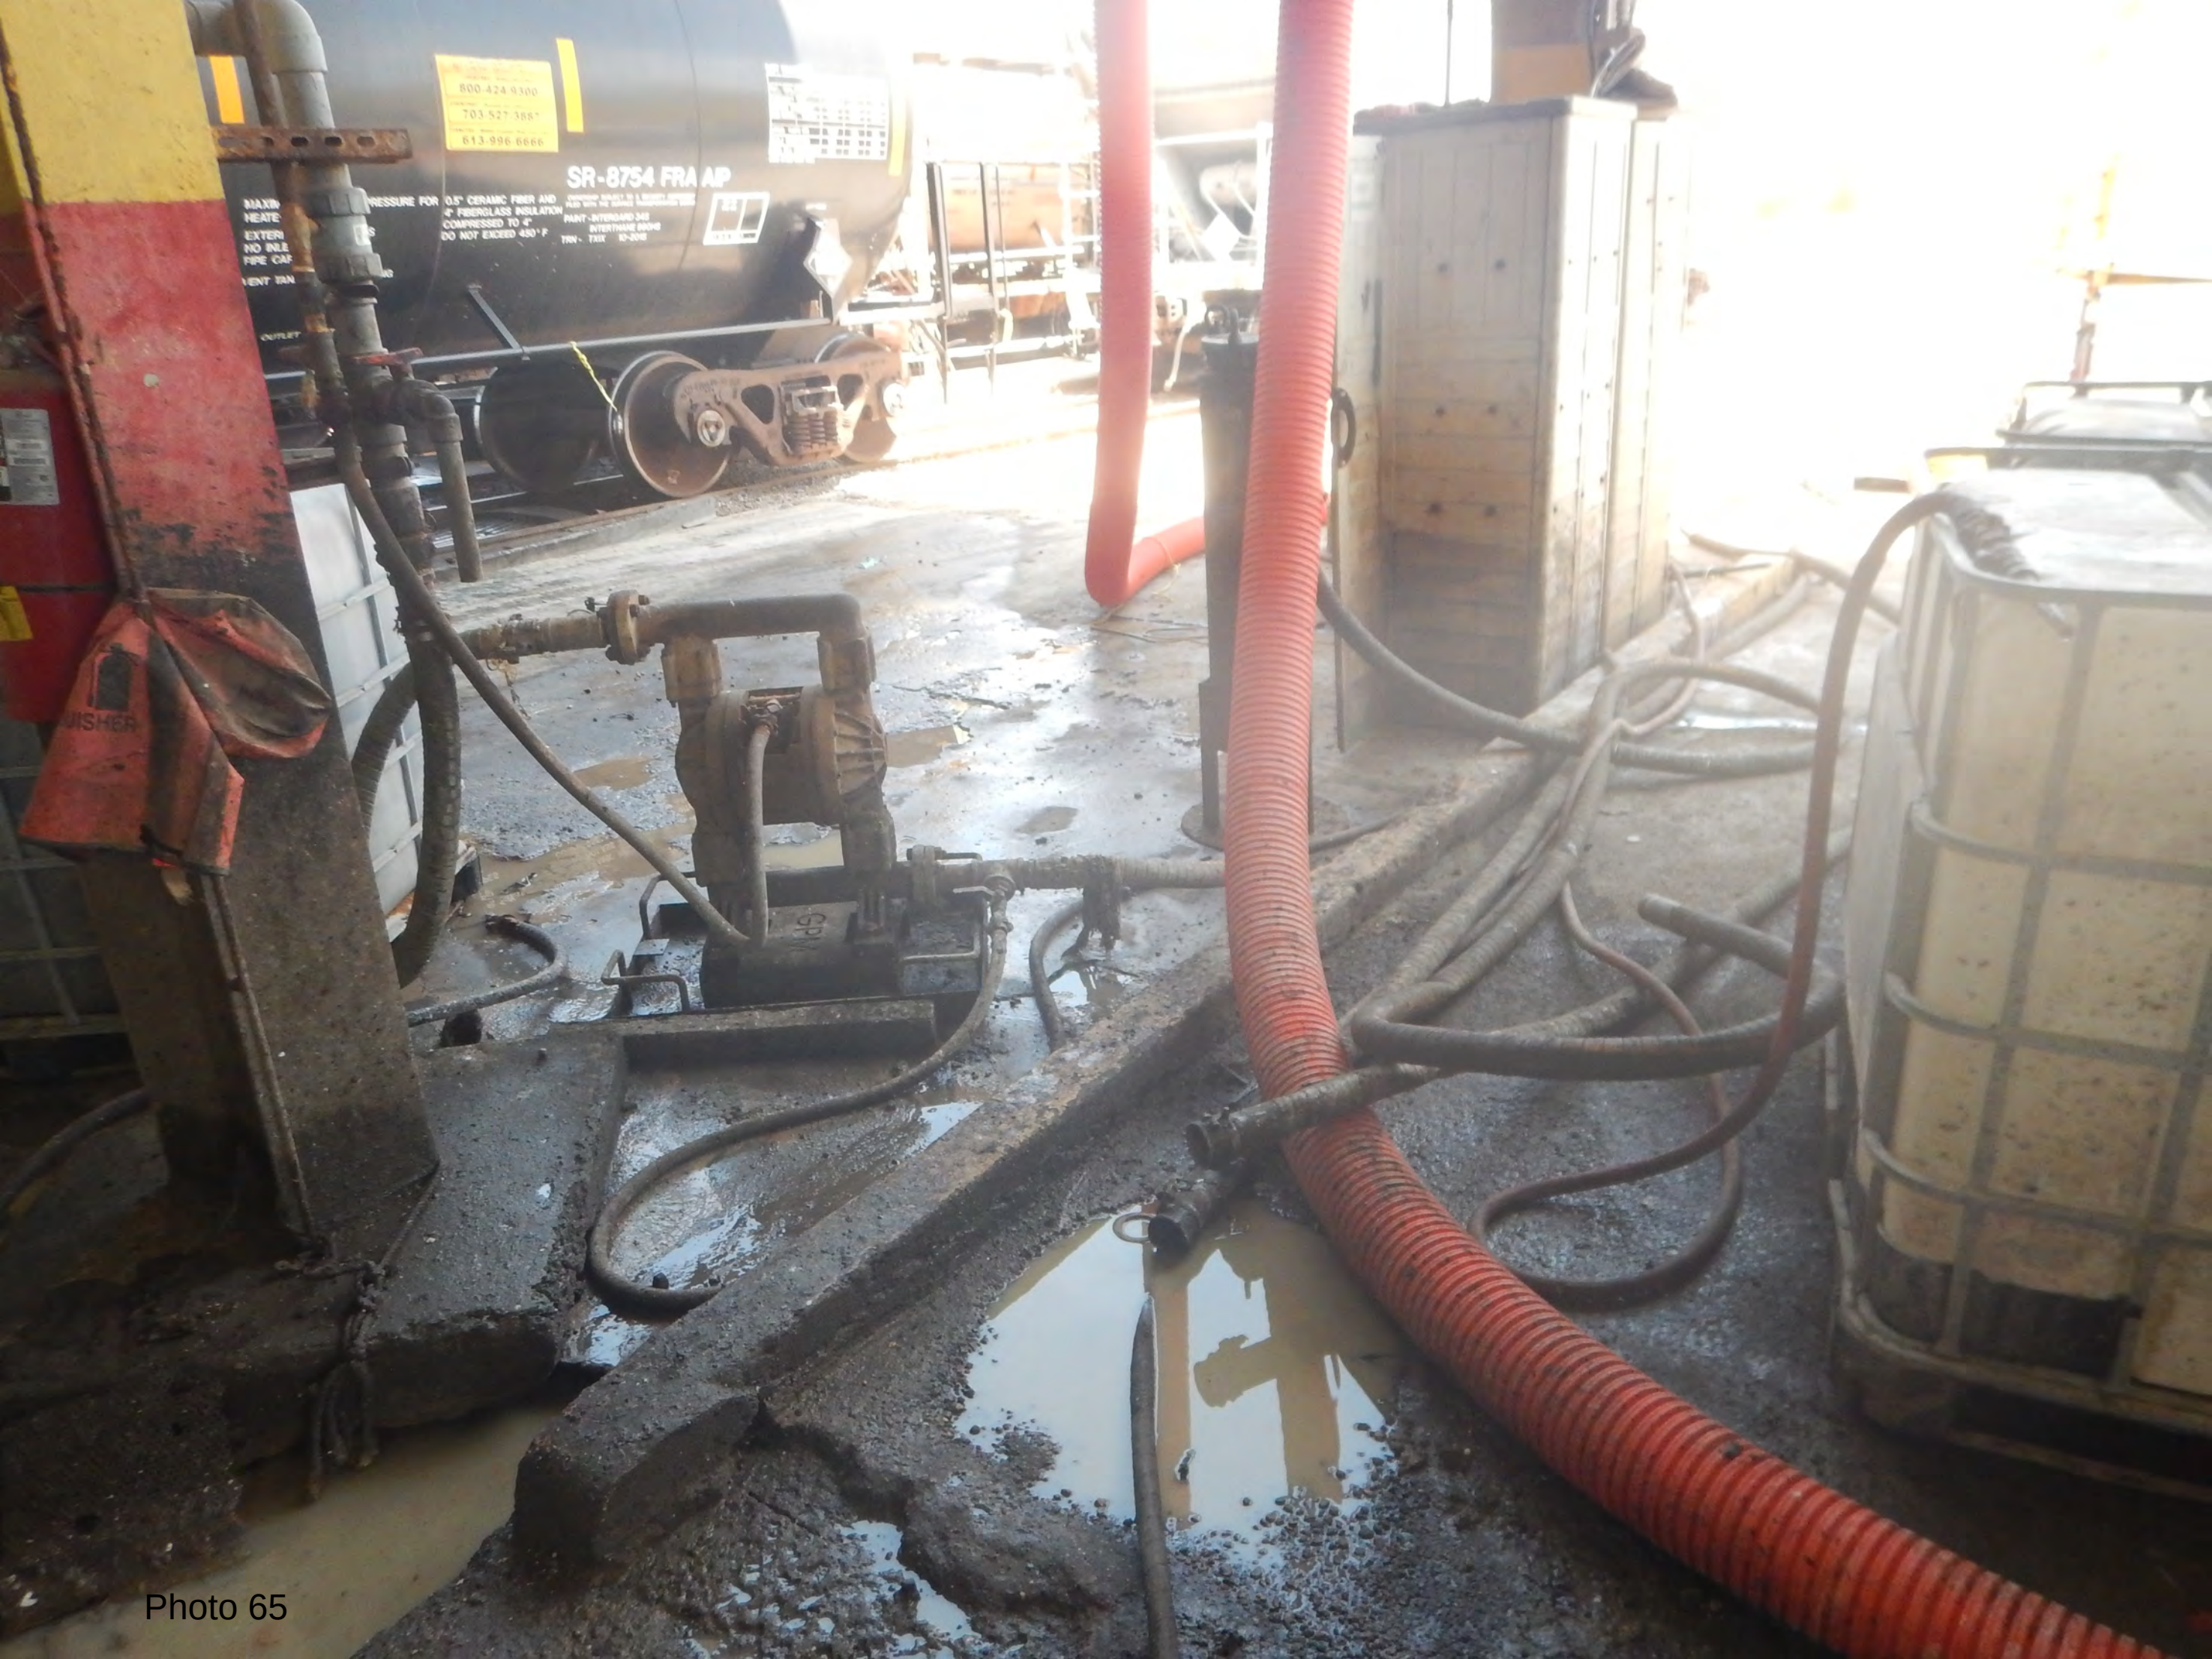
Photo 65

| Photo Number | File Name | | Date | Time | Photographer | Description |
|---|---|---|---|---|---|---|
| 65 | DSCN1123 | .JPG | 27-Jun-23 | 1230 | John Penland | Diaphragm pump and hoses used to drain containers of hazardous waste into tank T-1 |

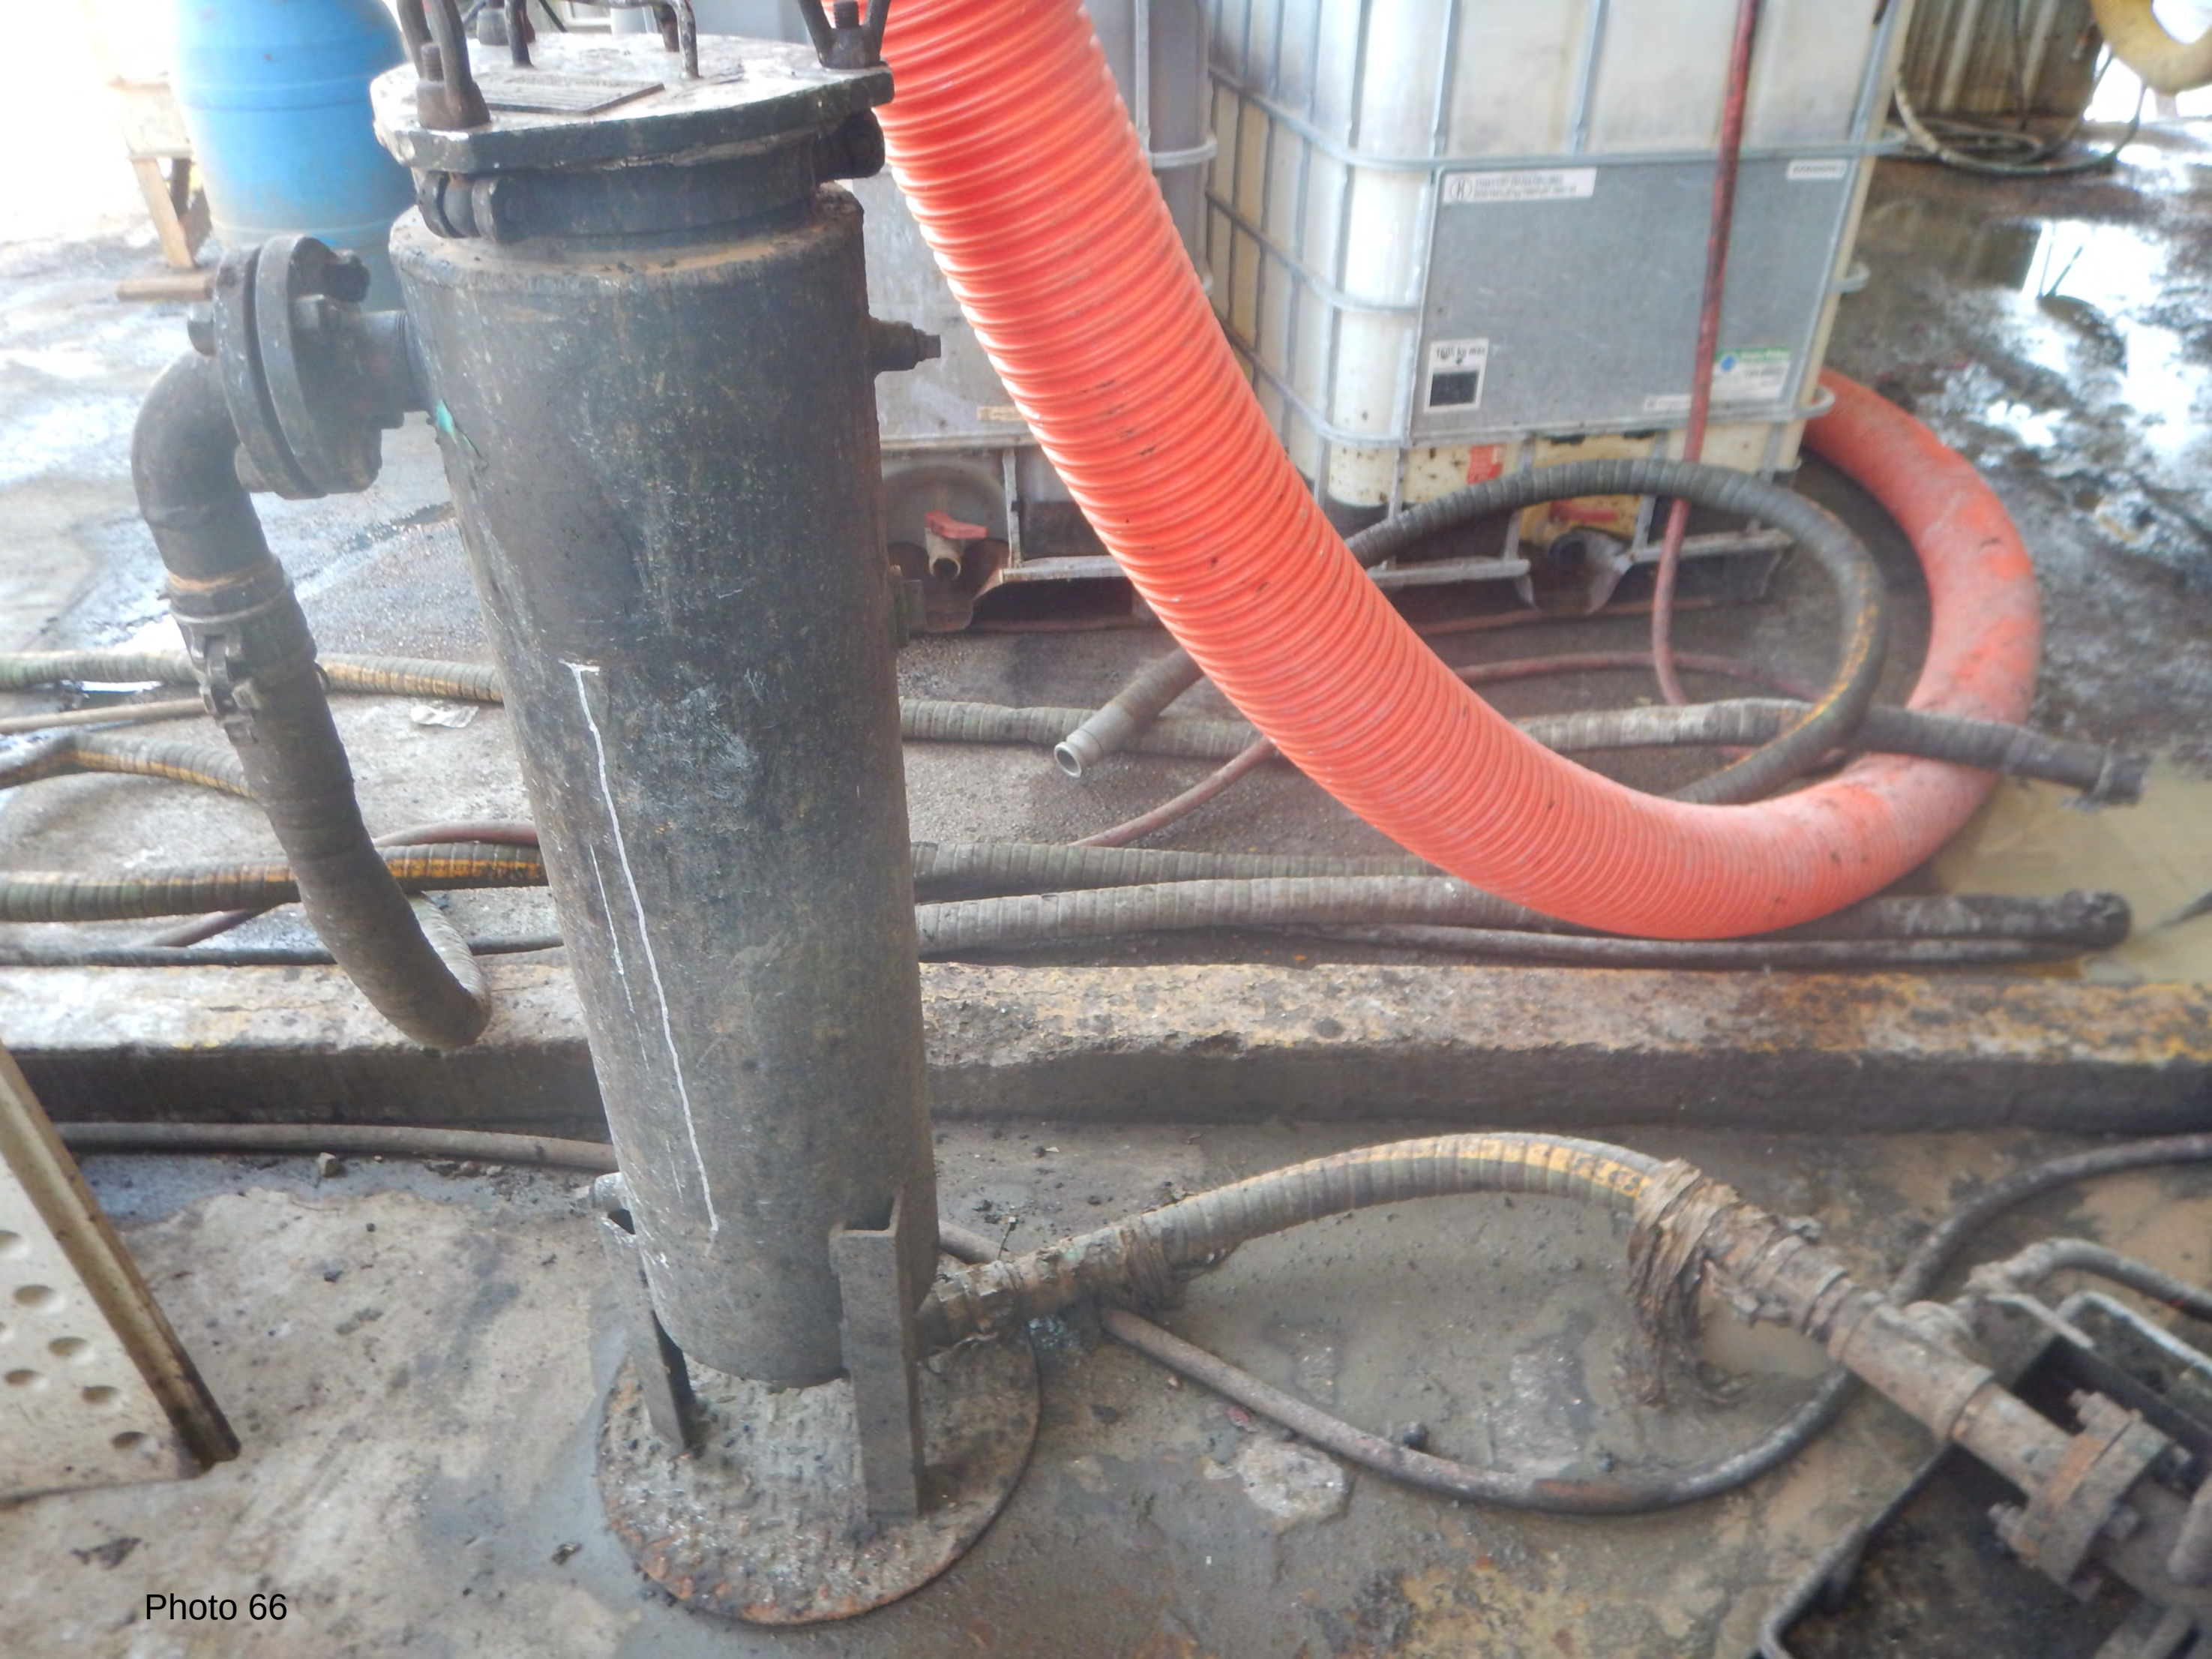
Photo 66

| Photo Number | File Name | | Date | Time | Photographer | Description |
|---|---|---|---|---|---|---|
| 66 | DSCN1124 | .JPG | 27-Jun-23 | 1230 | John Penland | Filter canister on pump line to tank T-1 |
