## Clean Water Act Section 404: Site Visit/Case Development

| Site Name | Sewell Family Development, LLC | | | | |

| Inspection Purpose | Initial site visit | | |

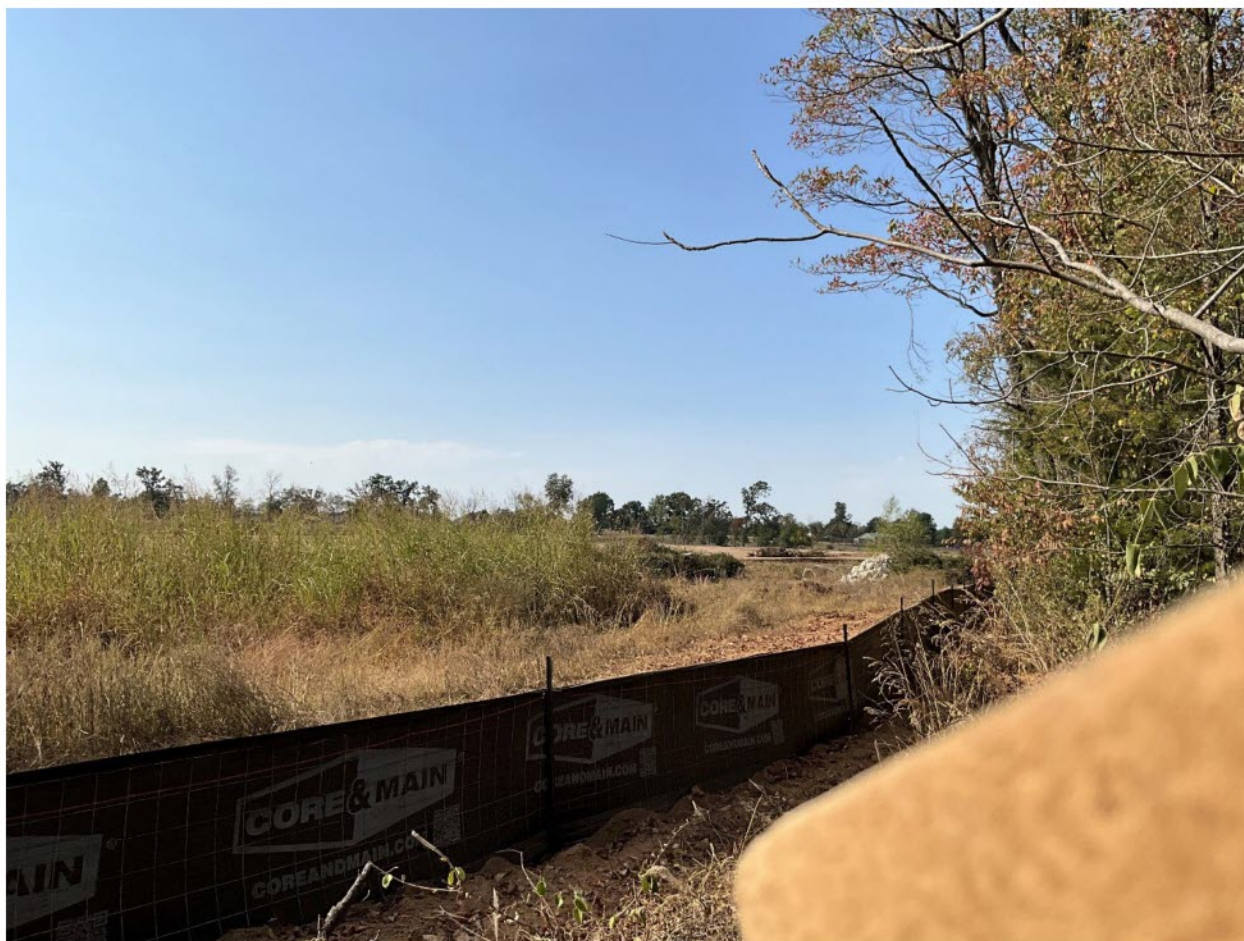
Photo No. 1

| Photo File Name | Date and Time of Photo | Photographer | Description |
|---|---|---|---|
| IMG_0086.JPG | 10/10/2024, 10:44 AM | Chelsey Sherwood | Showing project area that has been cleared with silt fences aligning riparian corridor. Picture taken facing southwest. |

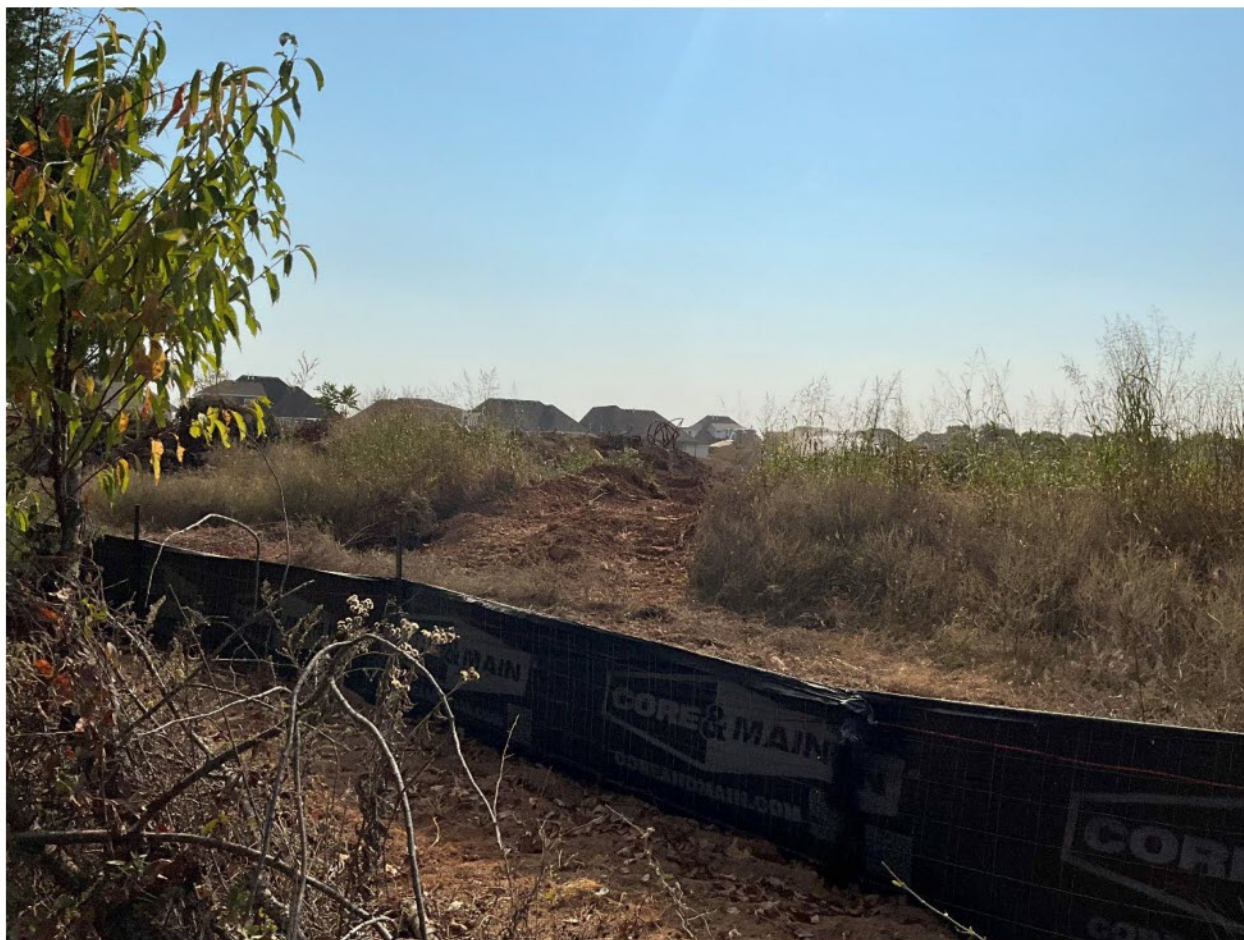
Photo No. 2

| Photo File Name | Date and Time of Photo | Photographer | Description |
|---|---|---|---|
| IMG_0087.JPG | 10/10/2024, 10:44 AM | Chelsey Sherwood | Showing project area that has been cleared with silt fences aligning riparian corridor. Picture taken facing southeast. |

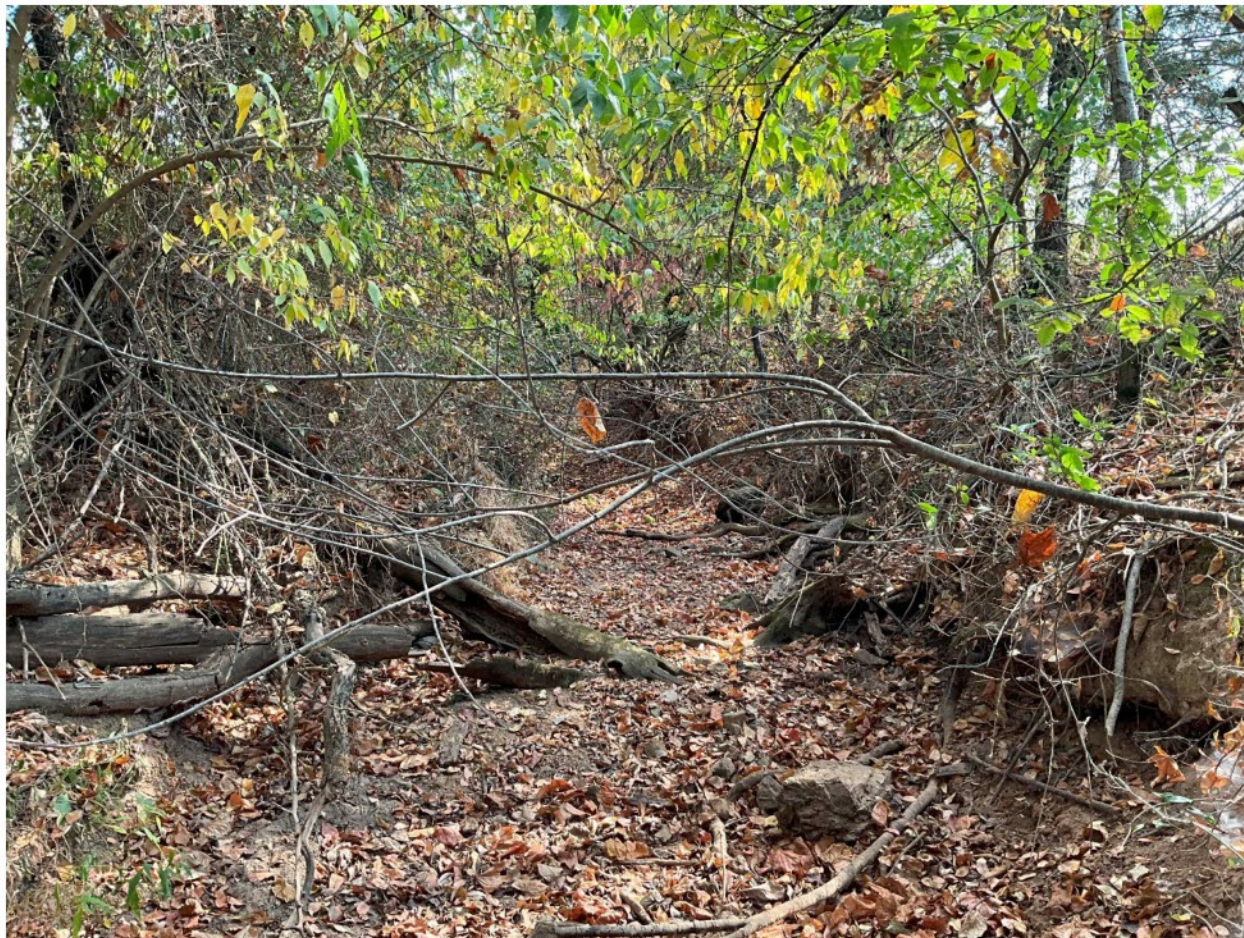
Photo No. 3

| Photo File Name | Date and Time of Photo | Photographer | Description |
|---|---|---|---|
| IMG_0084.JPG | 10/10/2024, 10:42 AM | Chelsey Sherwood | Showing stream channel at the bottom of assessment reach. Picture taken facing east, upstream. |

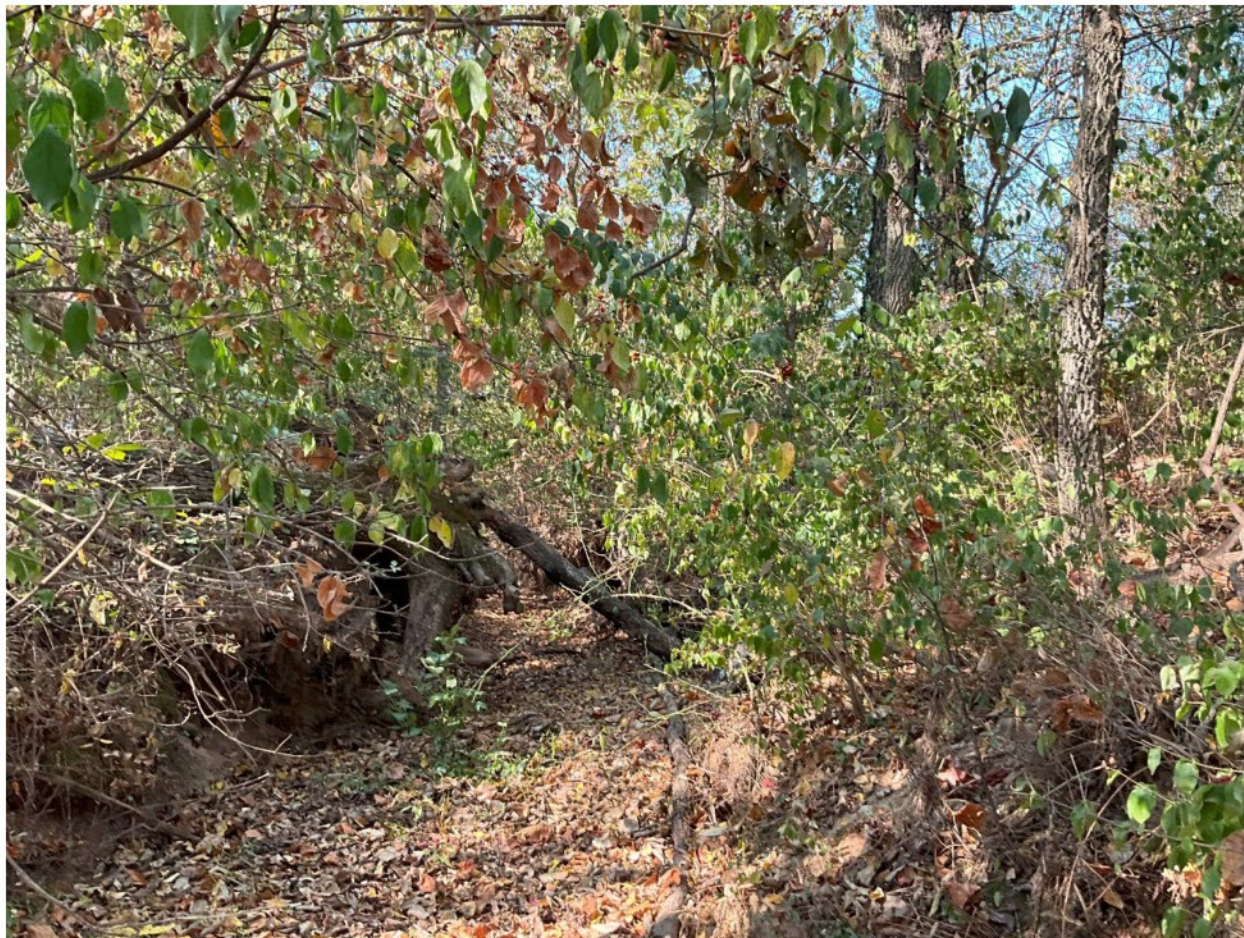
Photo No. 4

| Photo File Name | Date and Time of Photo | Photographer | Description |
|---|---|---|---|
| IMG_0089.JPG | 10/10/2024, 11:00 AM | Chelsey Sherwood | Showing stream channel at the middle of the assessment reach. Picture taken facing west, downstream. |

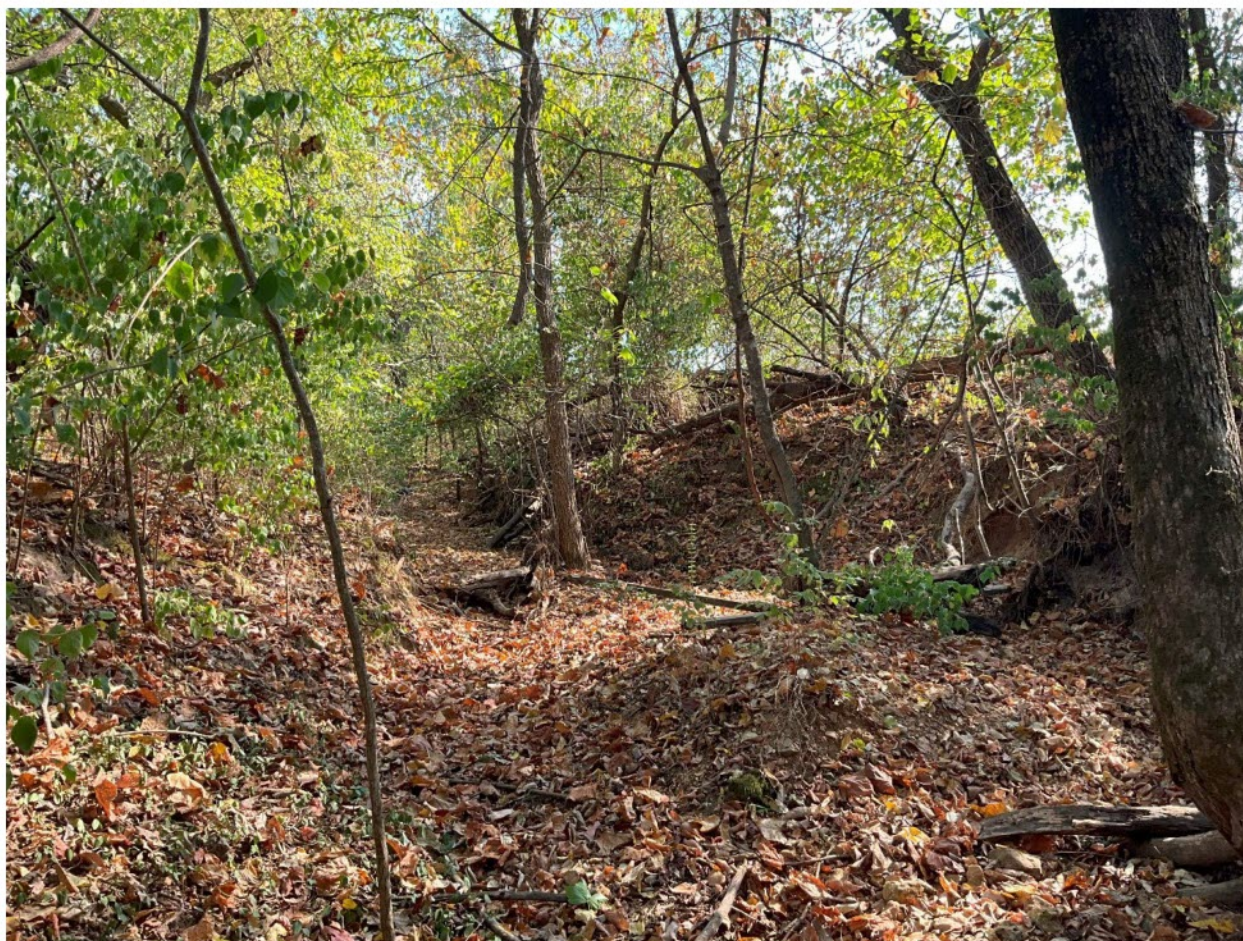
Photo No. 5

| Photo File Name | Date and Time of Photo | Photographer | Description |
|---|---|---|---|
| IMG_0090.JPG | 10/10/2024, 11:00 AM | Chelsey Sherwood | Showing stream channel at the middle of the assessment reach. Picture taken facing east, upstream. |

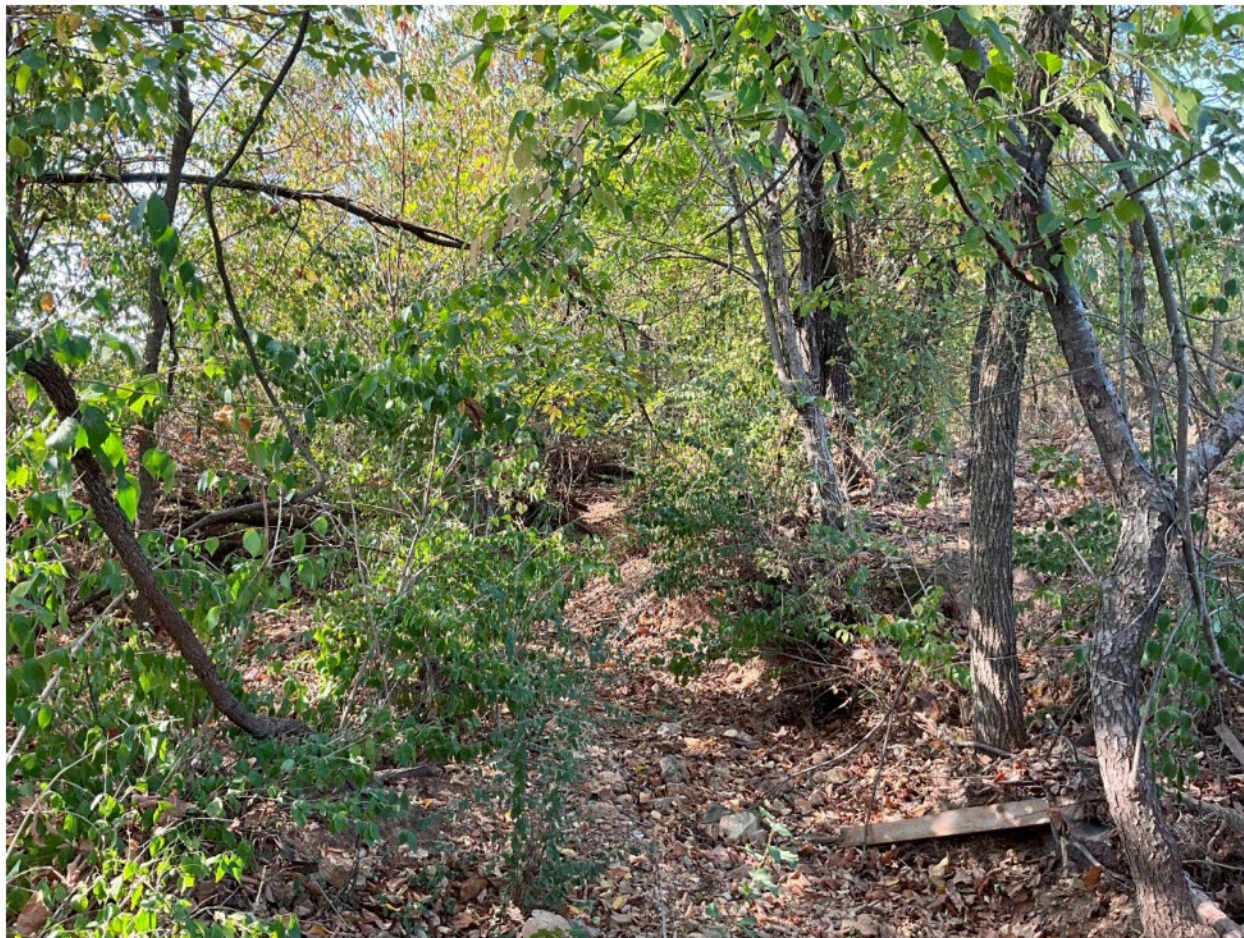
Photo No. 6

| Photo File Name | Date and Time of Photo | Photographer | Description |
|---|---|---|---|
| IMG_0092.JPG | 10/10/2024, 11:04 AM | Chelsey Sherwood | Showing stream channel at the top of the assessment reach. Picture taken facing southwest, downstream. |

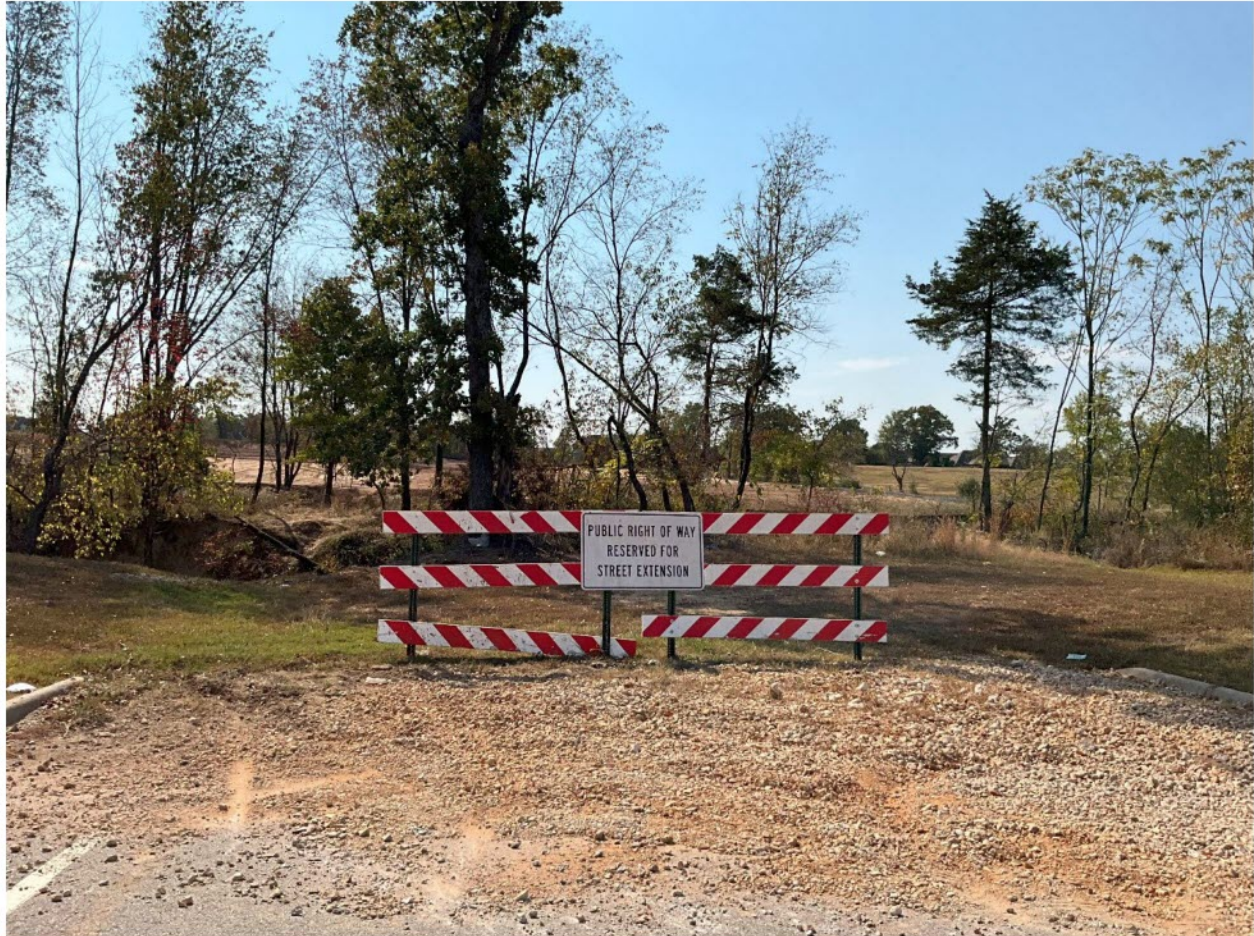
Photo No. 7

| Photo File Name | Date and Time of Photo | Photographer | Description |
|---|---|---|---|
| IMG_0093.JPG | 10/10/2024, 11:42 AM | Chelsey Sherwood | Showing bottom of project area. Note: the stream flows through the riparian area. Picture taken facing south. |
