**SUBJECT:** CLEAN AIR ACT INSPECTION REPORT  
MacroSource, LLC - Creve Coeur, Creve Coeur, Illinois

**Facility Name:** MacroSource, LLC - Creve Coeur,

**Date of Inspection:** 25 July 2023

**APPENDIX A: DIGITAL IMAGE LOG**

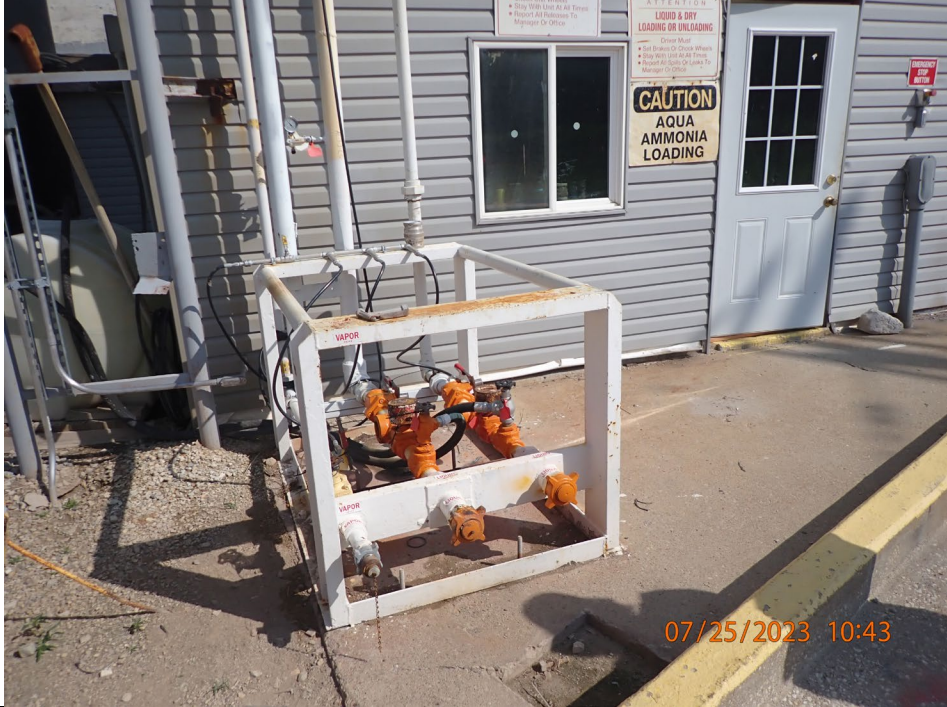
| Image Number | File Name | Date and Time | Description of Image |
|---|---|---|---|
| 1 | P7250082.jpg | 07/25/2023 10:43 hrs | Ammonia unloading |

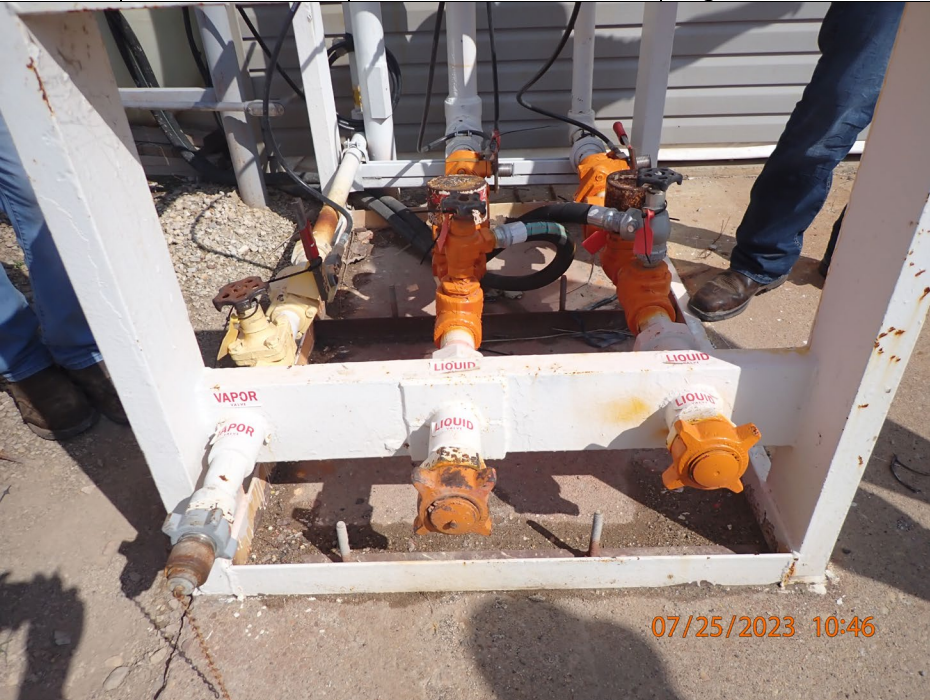
| Image Number | File Name | Date and Time | Description of Image |
|---|---|---|---|
| 2 | P7250083.jpg | 07/25/2023 10:46 hrs | Ammonia Unloading. Manual shutoff and Emergency Shutoff valves on each liquid and vapor line. |

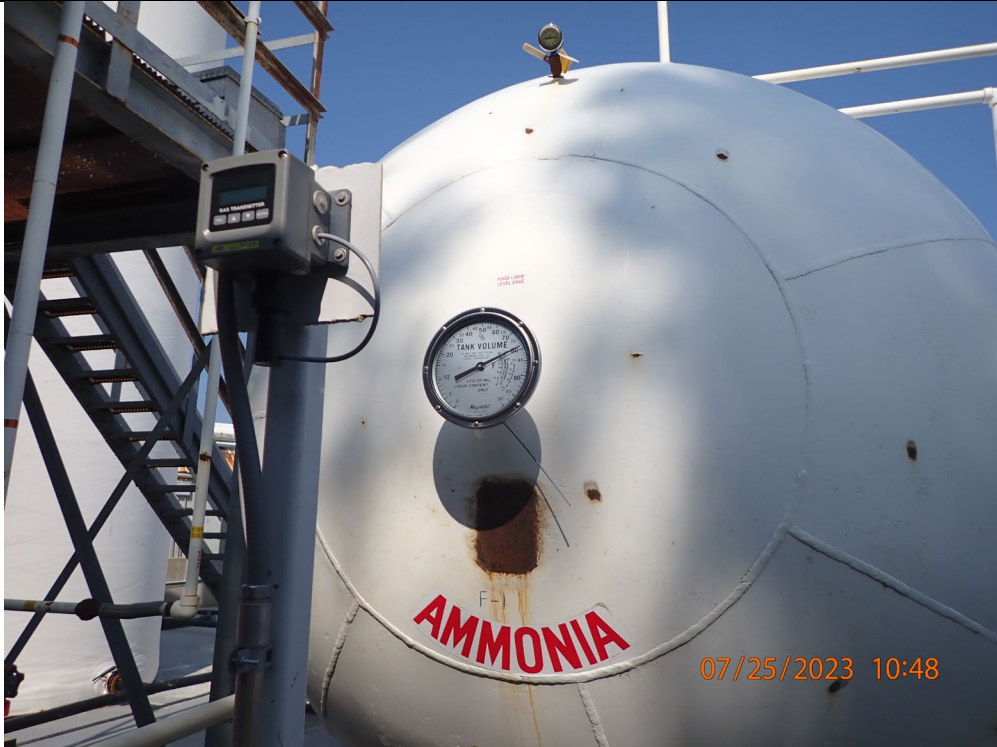
| Image Number | File Name | Date and Time | Description of Image |
|---|---|---|---|
| 3 | P7250084.jpg | 07/25/2023 10:48 hrs | East end of ammonia bullet and ammonia sensor. Grind spots for thickness ntests. |

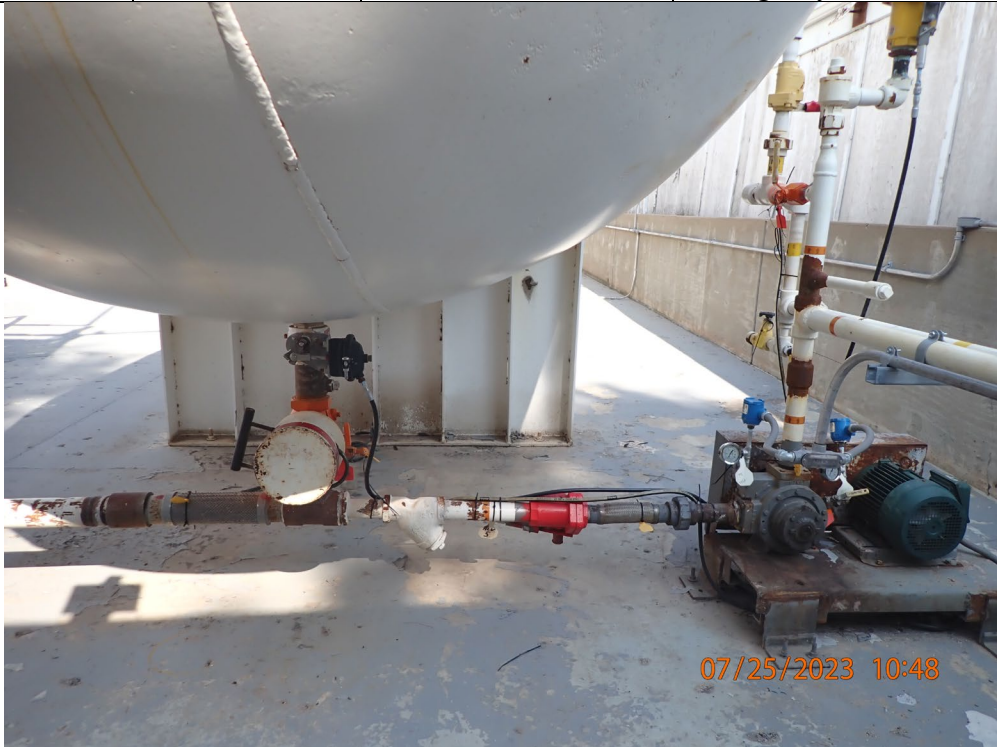
| Image Number | File Name | Date and Time | Description of Image |
|---|---|---|---|
| 4 | P7250085.jpg | 07/25/2023 10:48 hrs | Internal safety valve actuator (black)<br>Emergency shut off valve (red) |

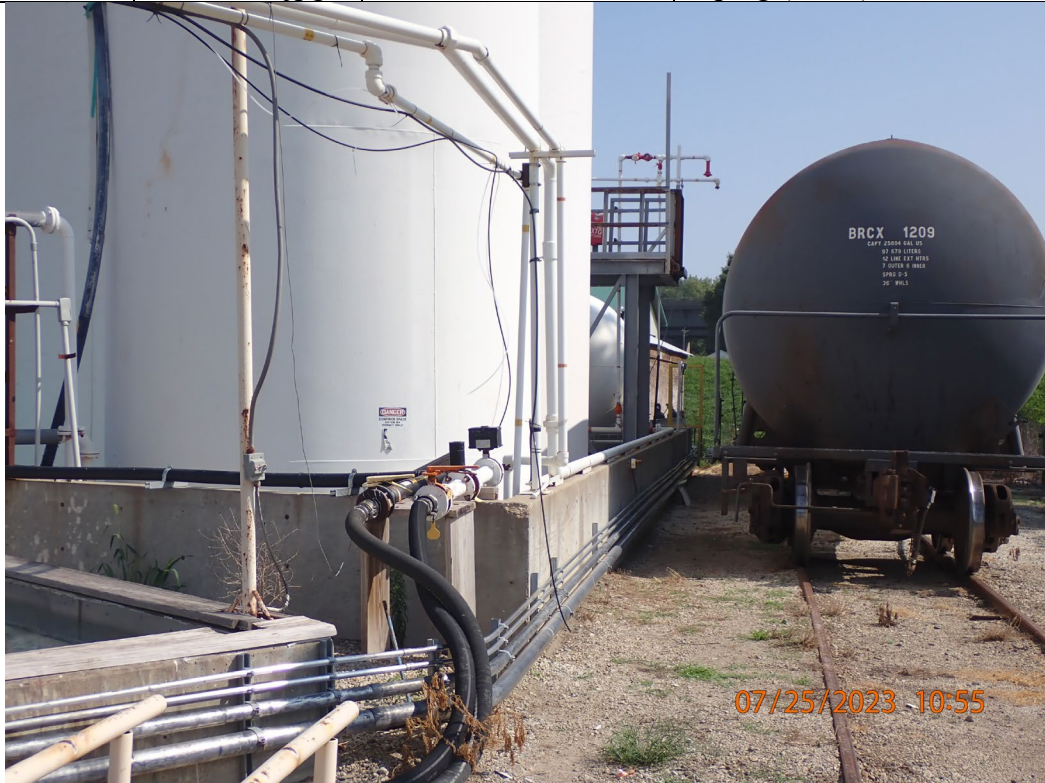
| Image Number | File Name | Date and Time | Description of Image |
|---|---|---|---|
| 5 | P7250086.jpg | 07/25/2023 10:55 hrs | Piping (white) to ammonia bullet |

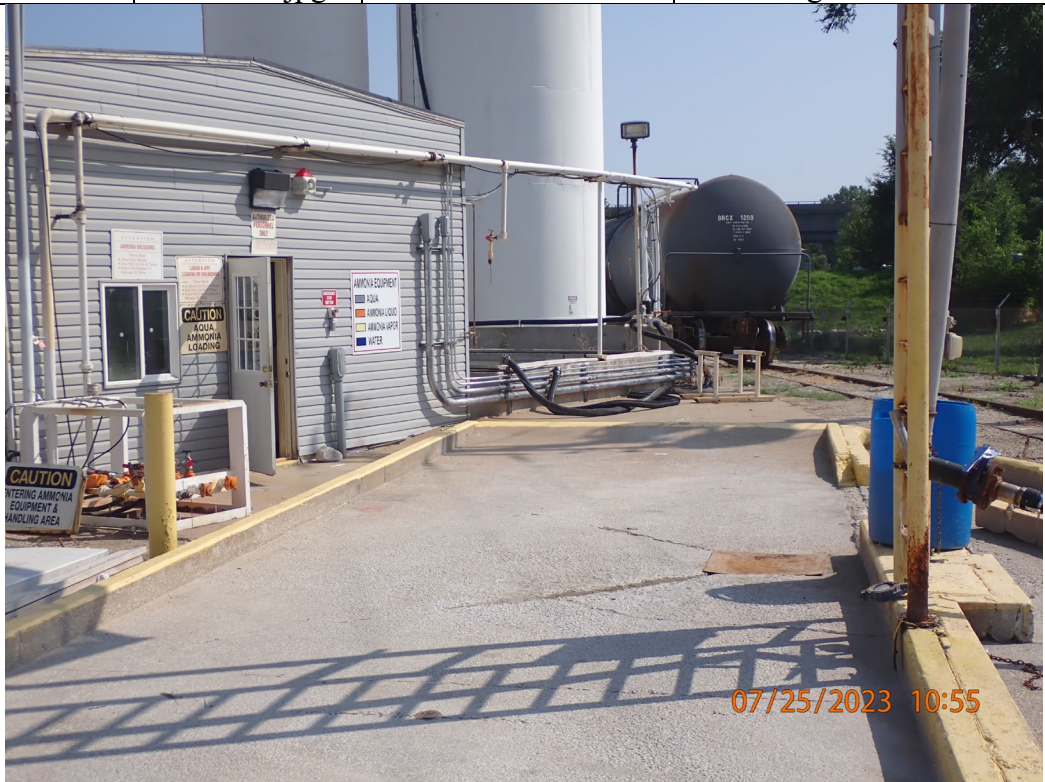
| Image Number | File Name | Date and Time | Description of Image |
|---|---|---|---|
| 6 | P7250087.jpg | 07/25/2023 10:55 hrs | Unloading area with containment. |

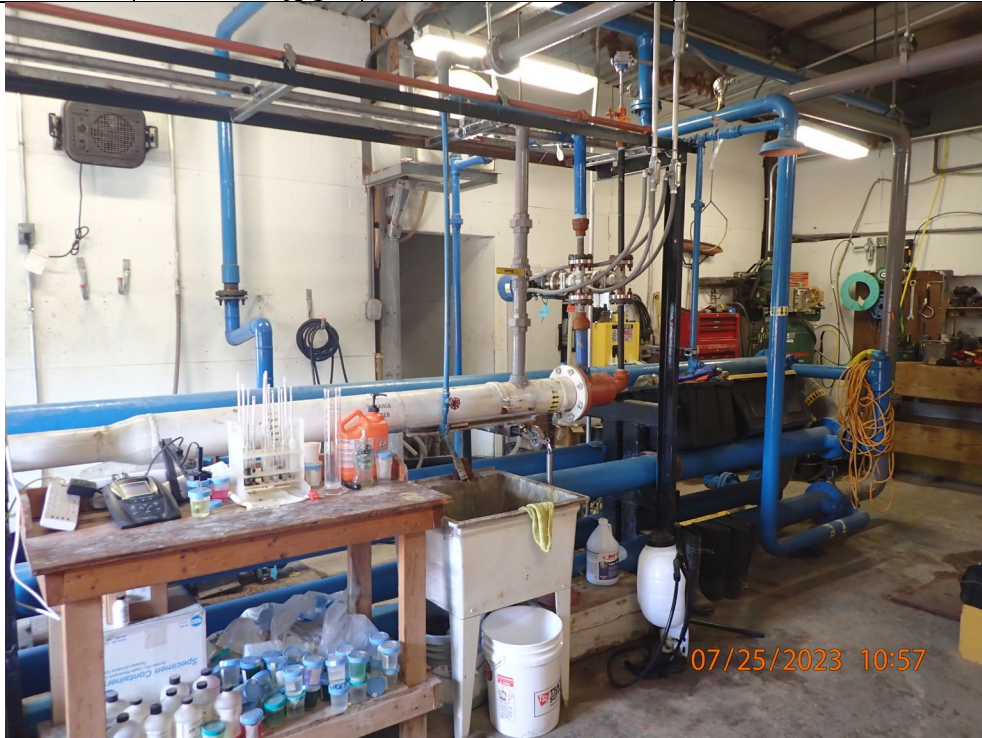
| Image Number | File Name | Date and Time | Description of Image |
|---|---|---|---|
| 7 | P7250088.jpg | 07/25/2023 10:57 hrs | Reactor and heat exchanger |

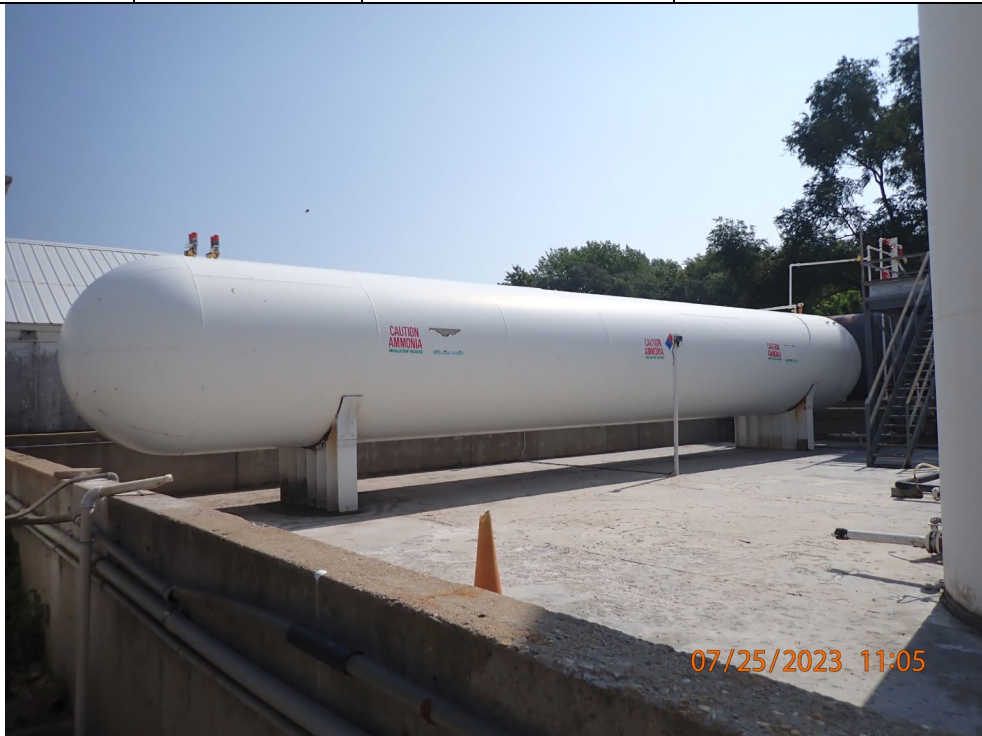
| Image Number | File Name | Date and Time | Description of Image |
|---|---|---|---|
| 8 | P7250089.jpg | 07/25/2023 11:05 hrs | Ammonia bullet. Pressure relief valves on top left. Ammonia sensor in middle of tank. |
