## **RCRA Inspection Report**

Cymer-Dayton LLC  
411 Manufacturers Road  
Dayton, Tennessee 37321  
Rhea County

EPA ID: TND981023674  
NAICS: 325199 - All Other Basic Organic Chemical  
Manufacturing

May 7, 2024, at 9:30 a.m. EDT

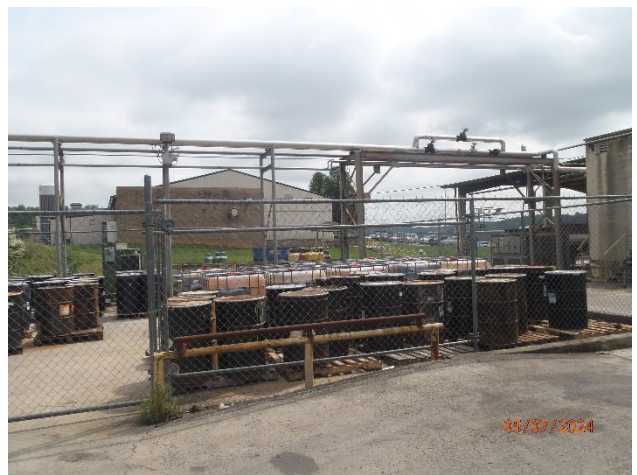
The central accumulation area (CAA) is a fenced in area with a locked gate (Pictures 10-12, 44). There is a ‘90 Day Hazardous Waste Storage Area’ sign near the gate (Picture 25). However, there were no ‘No Smoking’ signs posted along the fence. This is an area of concern.

Picture 10 – HWCAA no signs

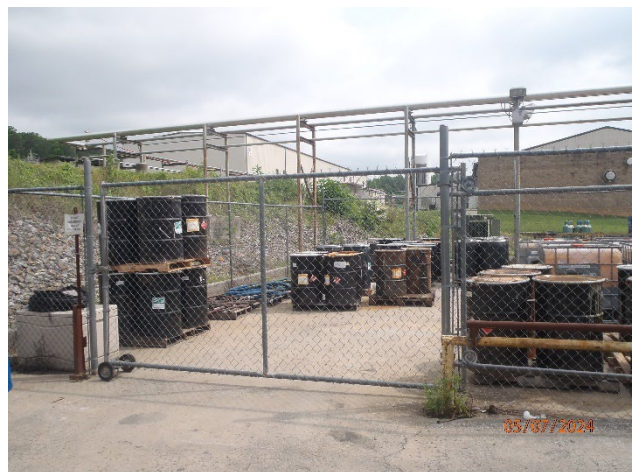
Picture 11 – HWCAA no signs

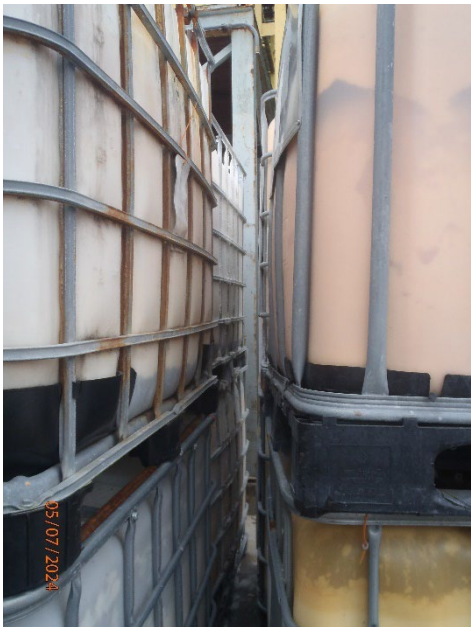
narrow, and the inspectors observed a white substance released to the ground between the totes (Pictures 19-20). One of the totes were observed to be contracting in on itself (Pictures 21-22). Another tote was observed to be bulging (Picture 23).

Picture 21 – Fatty Acid Tote contracting in

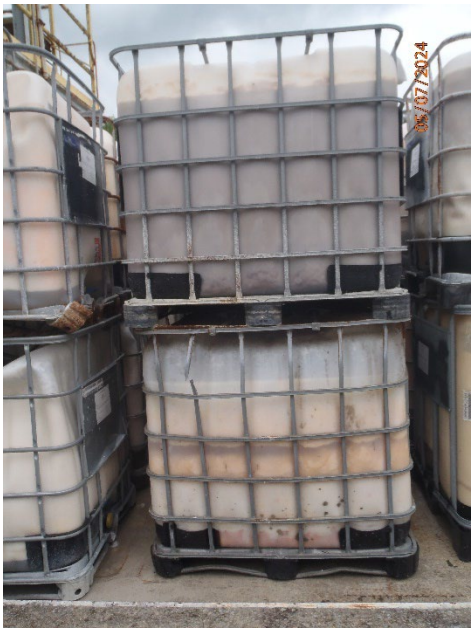
Picture 22 – Fatty Acid Tote contracting in

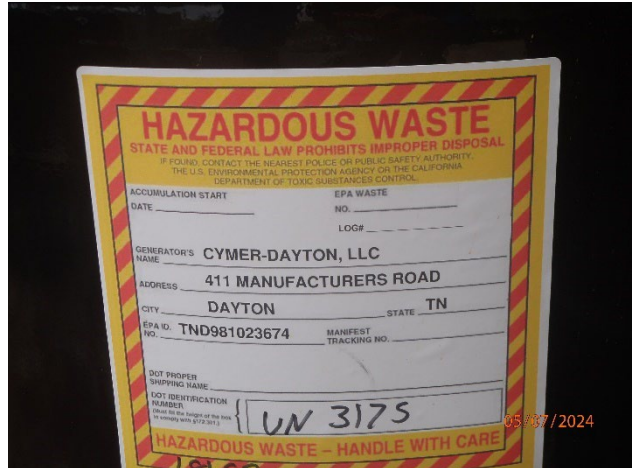
Picture 27 – HWCAA label missing date

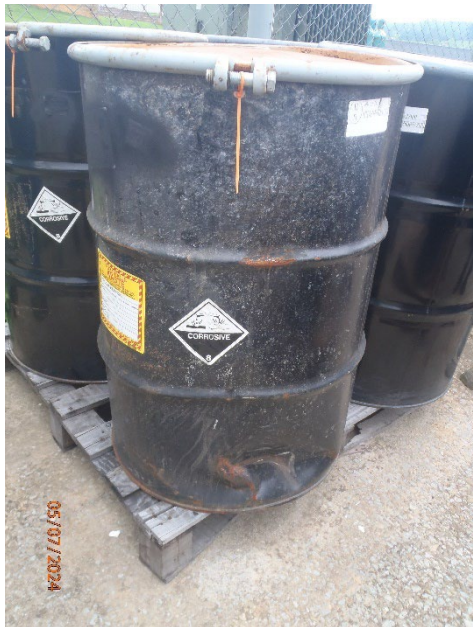
Picture 28 – HWCAA poison ivy

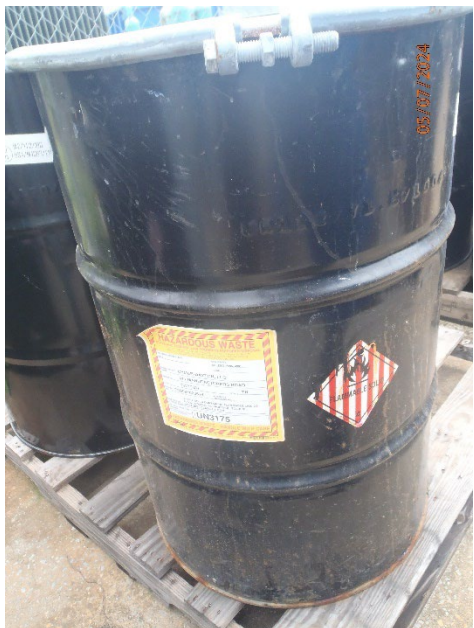
One of the 55-gallon hazardous waste containers dated February 27, 2024, was observed to be damaged near the bottom (Picture 29).

Picture 29 – HWCAA damage HW container

**Pursuant to Tenn. Comp. R. & Regs. 0400-12-01-.03(1)(h)1.(i)(II) [40 C.F.R. § 262.17(a)(1)(ii)], which is a condition of the LQG Permit Exemption, if a container holding hazardous waste is not in good condition, or if it begins to leak, the generator must immediately transfer the hazardous waste from this container to a container that is in good condition, or immediately manage the waste in some other way that complies with the LQG Permit Exemption.**

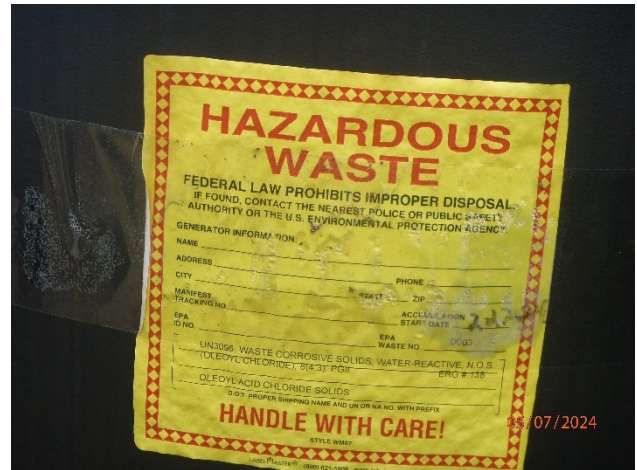
Inside the CAA, there were 98 total containers: thirty-four 55-gallon containers of non-hazardous waste (Picture 35) and sixty-four 55-gallon container of hazardous waste. Of the 64 hazardous waste containers, two of the containers did not have start accumulation dates (Pictures 26, 27, 30, 33). These containers were marked with the waste profile number 68692, Waste Solid Containing Flammable Liquids, and Waste Flammable Solid, D001, F003, F005. Mr. Linn pointed out that the container with the curled label did have an accumulation start date of March 23, 2024, but the ink had been washed off (Pictures 30, 33).

Picture 30 – HWCAA HW container missing date

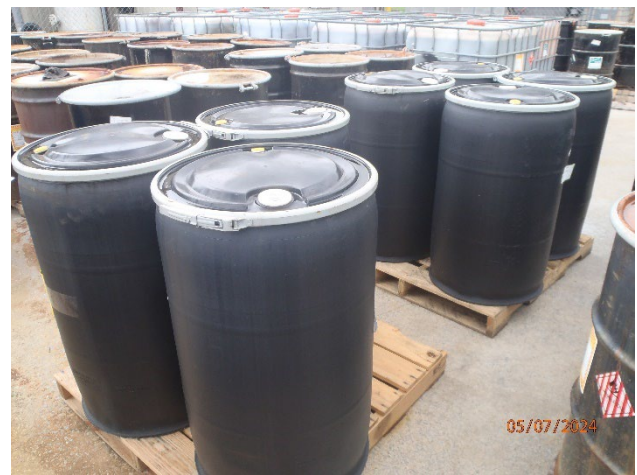
The inspectors observed seven black plastic 55-gallon containers of acid chloride fiberglass insulation hazardous waste. The containers had taped on labels that were faded (Pictures 31, 32, 34). The containers did not have indicators of hazard. Mr. Linn had the hazardous waste inventory and stated that the seven containers were not listed on the inventory. Thus, neither Mr. Linn nor Mr. Riley were aware of when the seven containers were added to the CAA.

Picture 31 – HWCAA damaged HW label

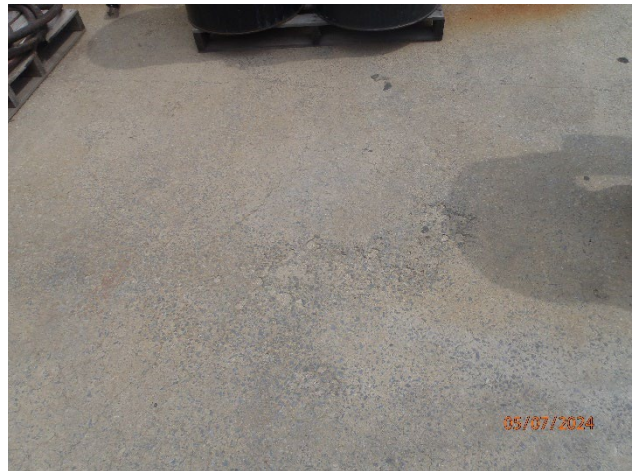
The inspectors observed that the concrete surface of the CAA had several cracks and had not been maintained or repaired (Pictures 38-43). The facility did not maintain by repairing and/or resealing the secondary containment from gaps and cracks. This is an area of concern.

Picture 38 – HWCAA secondary containment damaged

The inspectors recommended installing a roof and/or overhang on CAA to prevent the weather from damaging the container labels and reduce the damage of the secondary containment concrete.

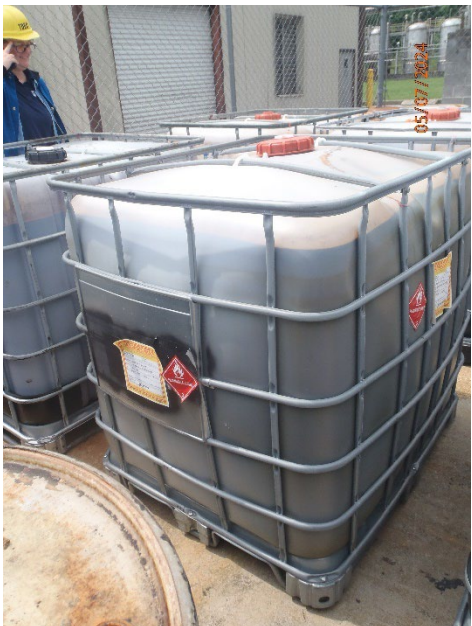
In addition, there were five 275-gallon IBC totes of Hazardous Trench Sludge. One of the totes was visibly bulging (Picture 36).

Picture 36 – HWCAA bulging tote

**Pursuant to Tenn. Comp. R. & Regs. 0400-12-01-.03(1)(h)1.(i)(II) [40 C.F.R. § 262.17(a)(1)(ii)], which is a condition of the LQG Permit Exemption, if a container holding hazardous waste is not in good condition, or if it begins to leak, the generator must immediately transfer the hazardous waste from this container to a container that is in good condition, or immediately manage the waste in some other way that complies with the LQG Permit Exemption.**

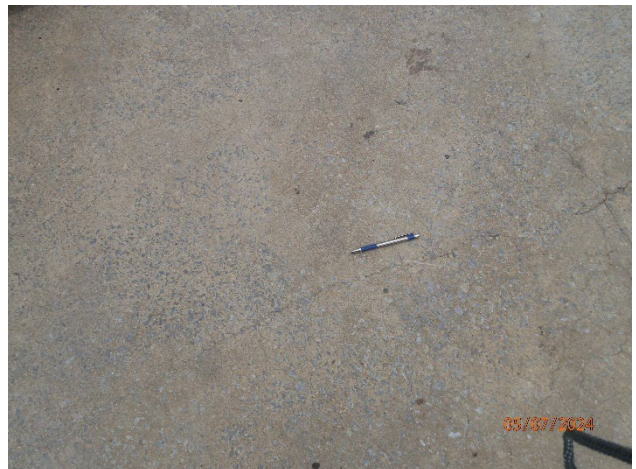
Picture 39 – HWCAA secondary containment cracks

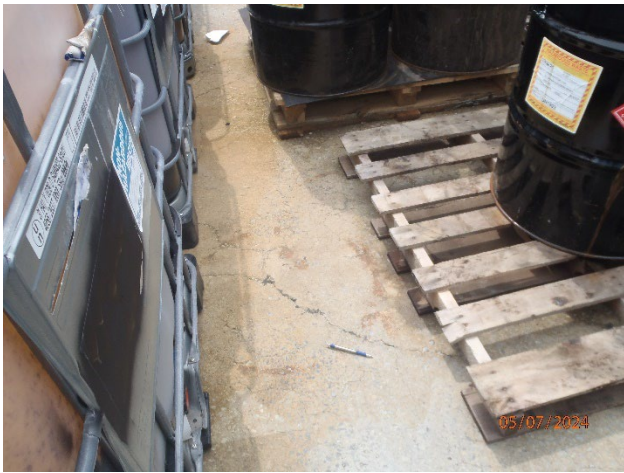
Picture 40 – HWCAA secondary containment cracks

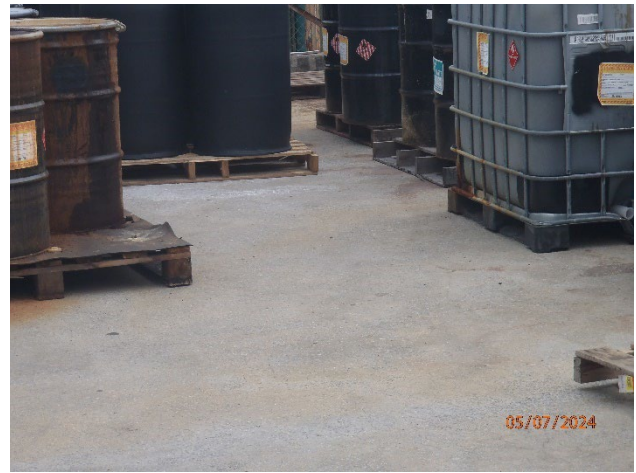
Picture 43 – HWCAA secondary containment cracks and damage

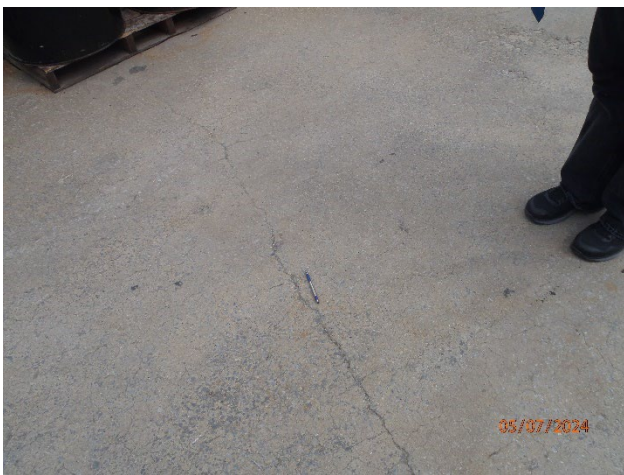
Picture 41 – HWCAA secondary containment cracks

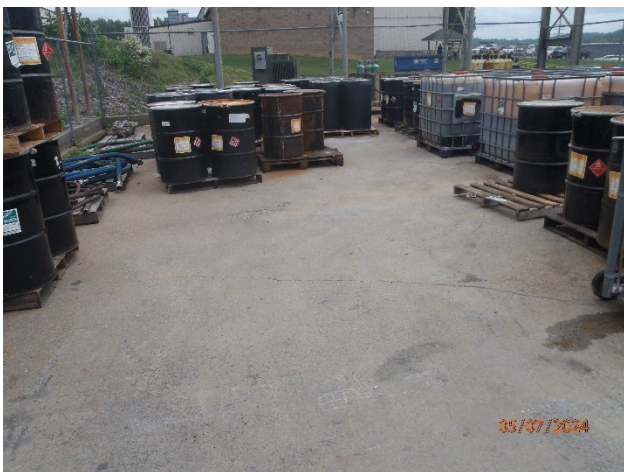
Picture 42 – HWCAA secondary containment cracks and damage

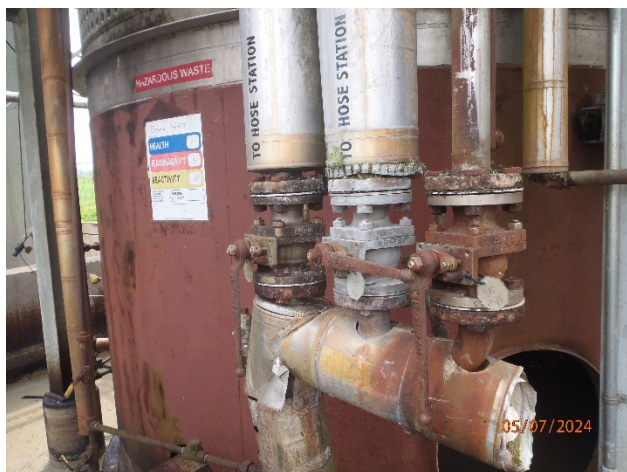
T-62 was out of service at the time of the inspection. Tank T-61 and its ancillary equipment were marked with Subpart BB tags at the valves only (Pictures 52-58). The leak interfaces were not marked in such a manner that they could be distinguished readily from other pieces of equipment. Mr. Linn and Mr. Riley stated that they thought that the tags covered the flanges

Picture 52 – Hazardous Waste T-61 missing BB tags

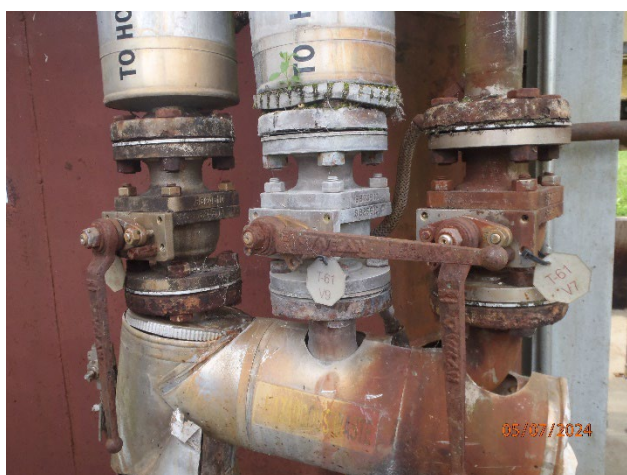
Picture 53 – Hazardous Waste T-61 missing BB tags

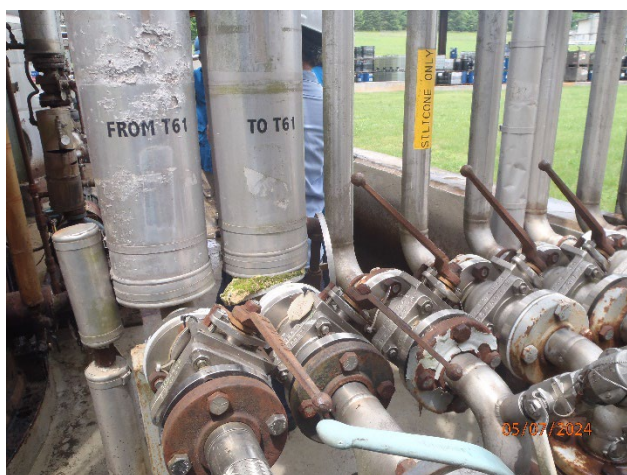
Picture 54 – Hazardous Waste T-61 missing BB tags

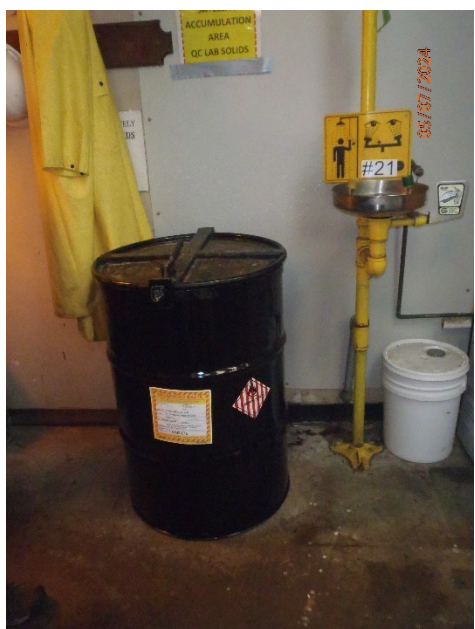
Picture 64 – Lab SAA for PPE/debris/rags

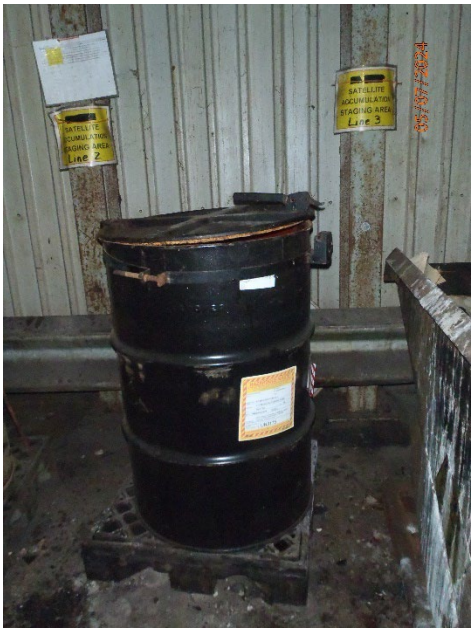
Building 6 had two 55-gallon SAA containers. The inspectors observed a container of Waste Flammable Liquid with an open funnel on a secondary containment pallet, and a container of Waste Solid Containing Flammable Liquid, D001, D035, F003, F005 that was not closed (Pictures 73-75). All containers were observed labeled with indication of the hazards of the contents.

Picture 73 – Building 6 SAA open containers

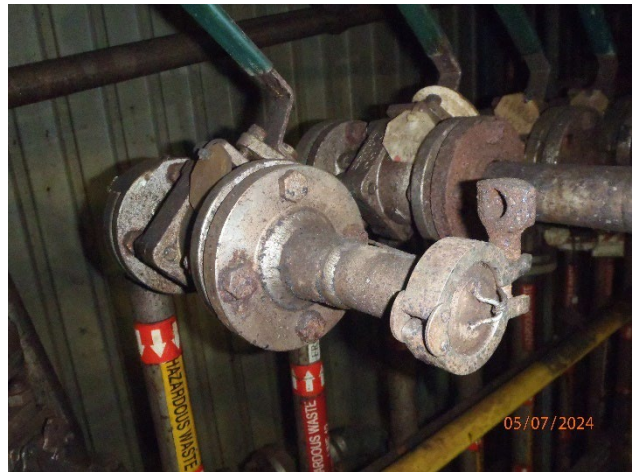
Upstairs, the inspectors observed that the hazardous waste Tank 613, its ancillary equipment, and the adjoining pipe rack were marked with Subpart BB tags at the valves only (Pictures 76-79). Tank 613 is a distillation tank that distills, strips, and adjusts the pH. The leak interfaces were not marked in such a manner that they could be distinguished readily from other pieces of equipment. Cymer is required to determine if the waste in the tank has an average volatile organic concentration of greater than 500 PPM. It does not appear that Cymer conducted this determination.

Picture 76 – Building 6 HW Tank 613 missing BB tags

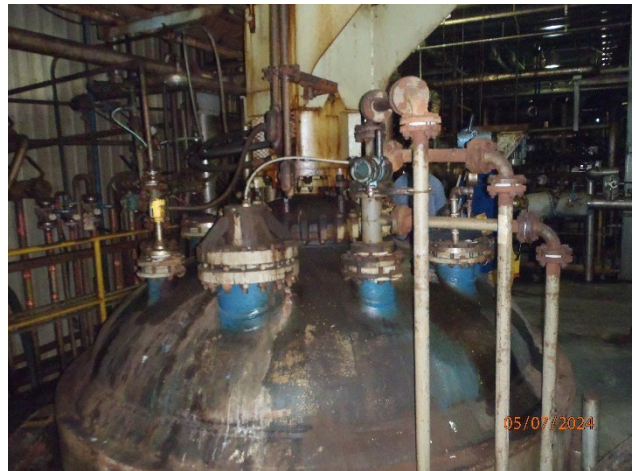
Picture 77 – Building 6 HW Tank 613 missing BB tags

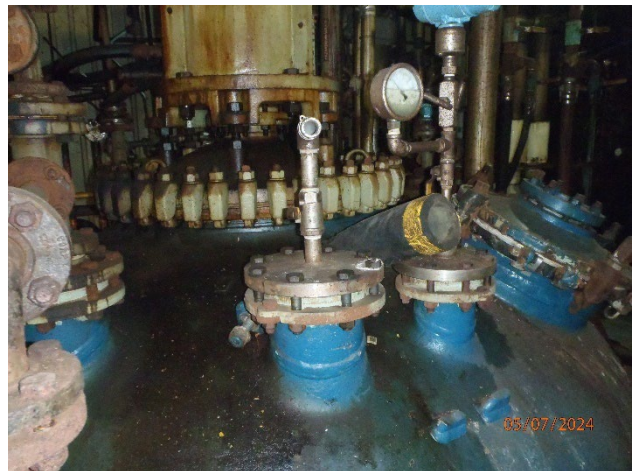
Picture 78 – Building 6 HW Tank 613 roof missing BB tags

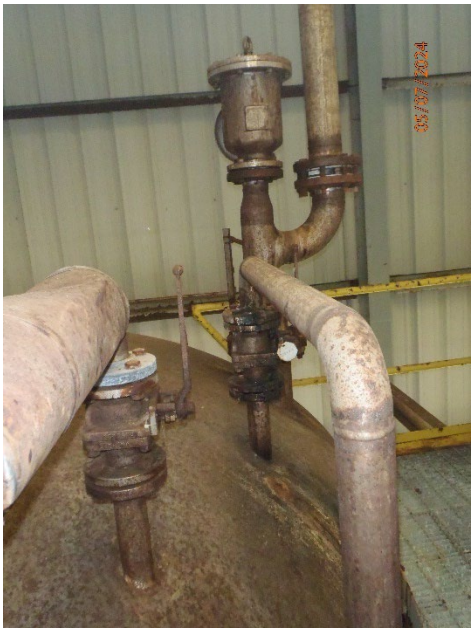
Picture 79 – Building 6 HW Tank 613 roof missing BB tags

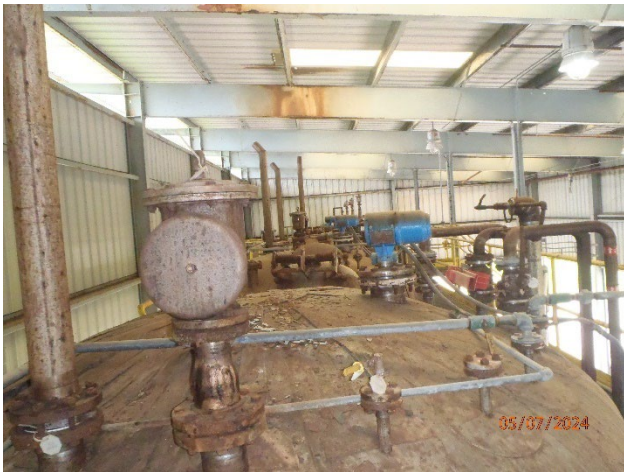
Picture 80 – Building 6 Tank Farm missing BB tags

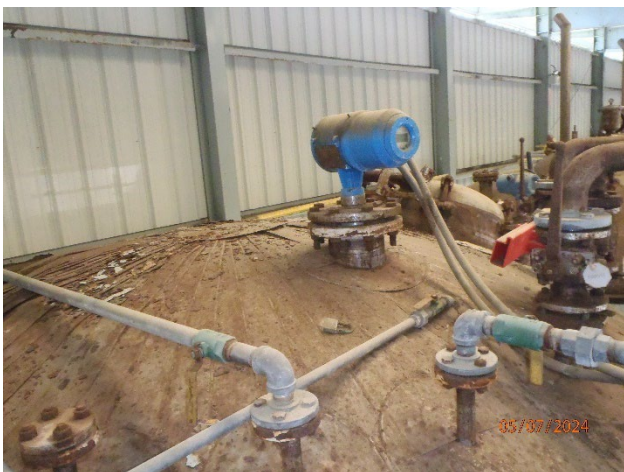
Picture 81 – Building 6 Tank Farm missing BB tags

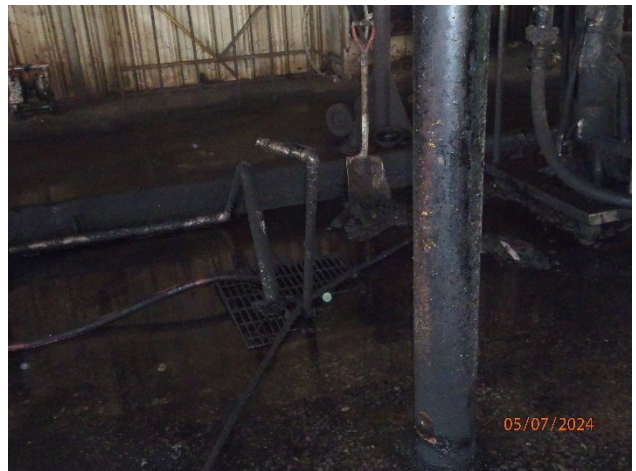
Picture 84 – Building 6 sump drain of resin and water

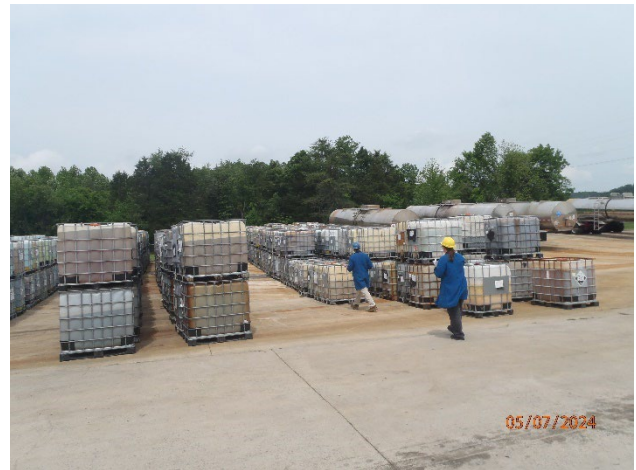
Picture 86 – Building 6 loading area with resin and water on ground

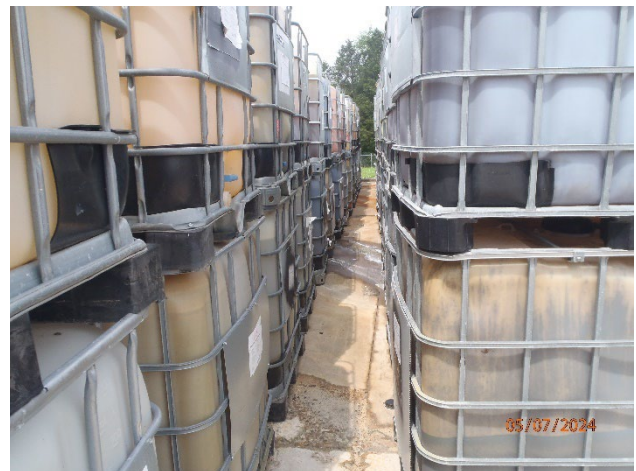
Picture 91 – Tanker Lot with clean out solvent release to ground

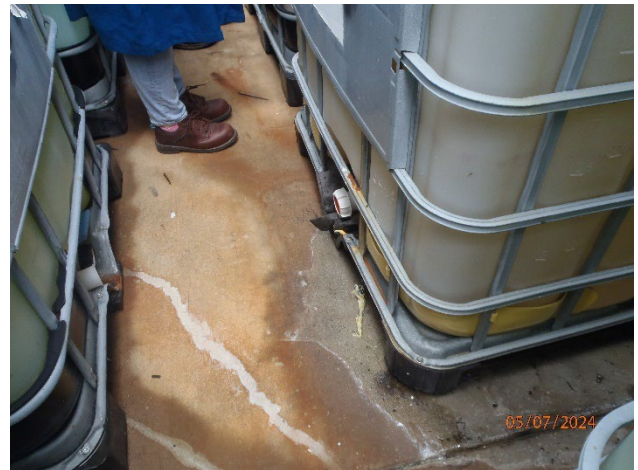
Picture 95 – Tanker Lot with clean out solvent tote leaking

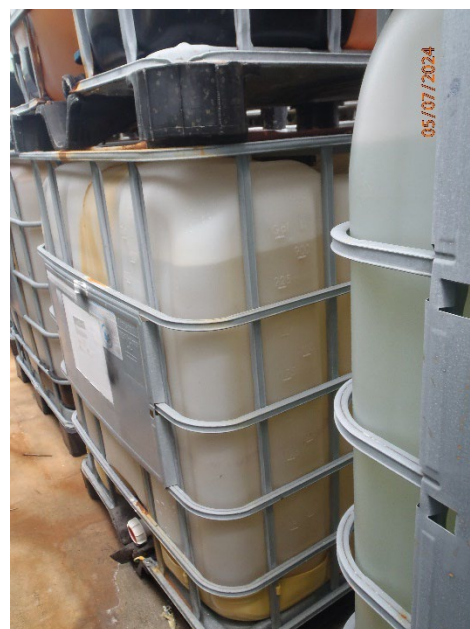
Picture 96 – Tanker Lot with clean out solvent tote leaking

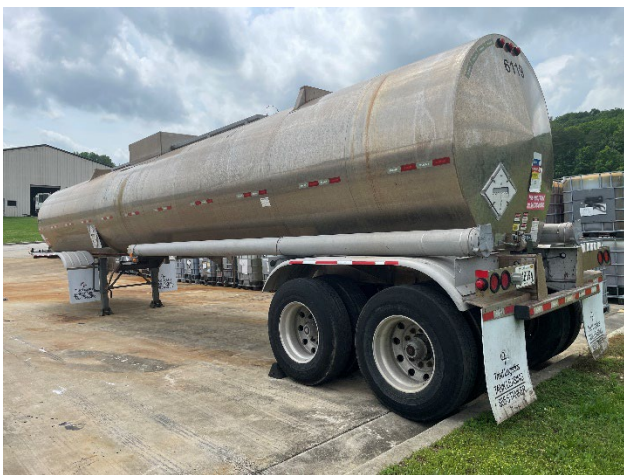
Picture 98 – HW Tanker 6119 not labeled or dated

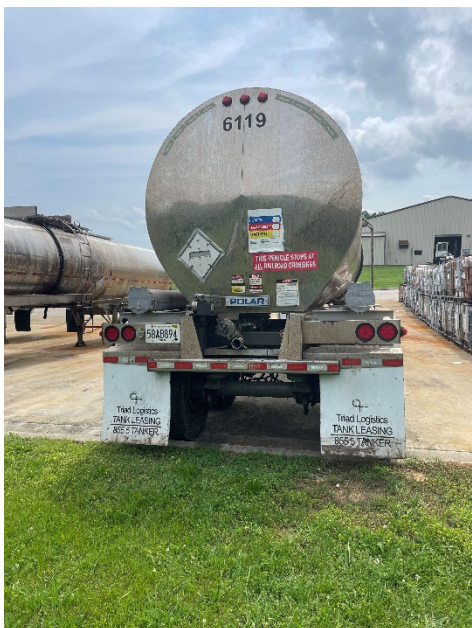
Picture 99 – HW Tanker 6119 not labeled or dated
