**Region 6 Compliance Assurance and Enforcement Division  
INSPECTION REPORT**

| Inspection Date(s): | April 26, 2017 | | |
| Company Name: | Village of Chama | | |
| Facility Name: | Chama Wastewater Treatment Plant | | |

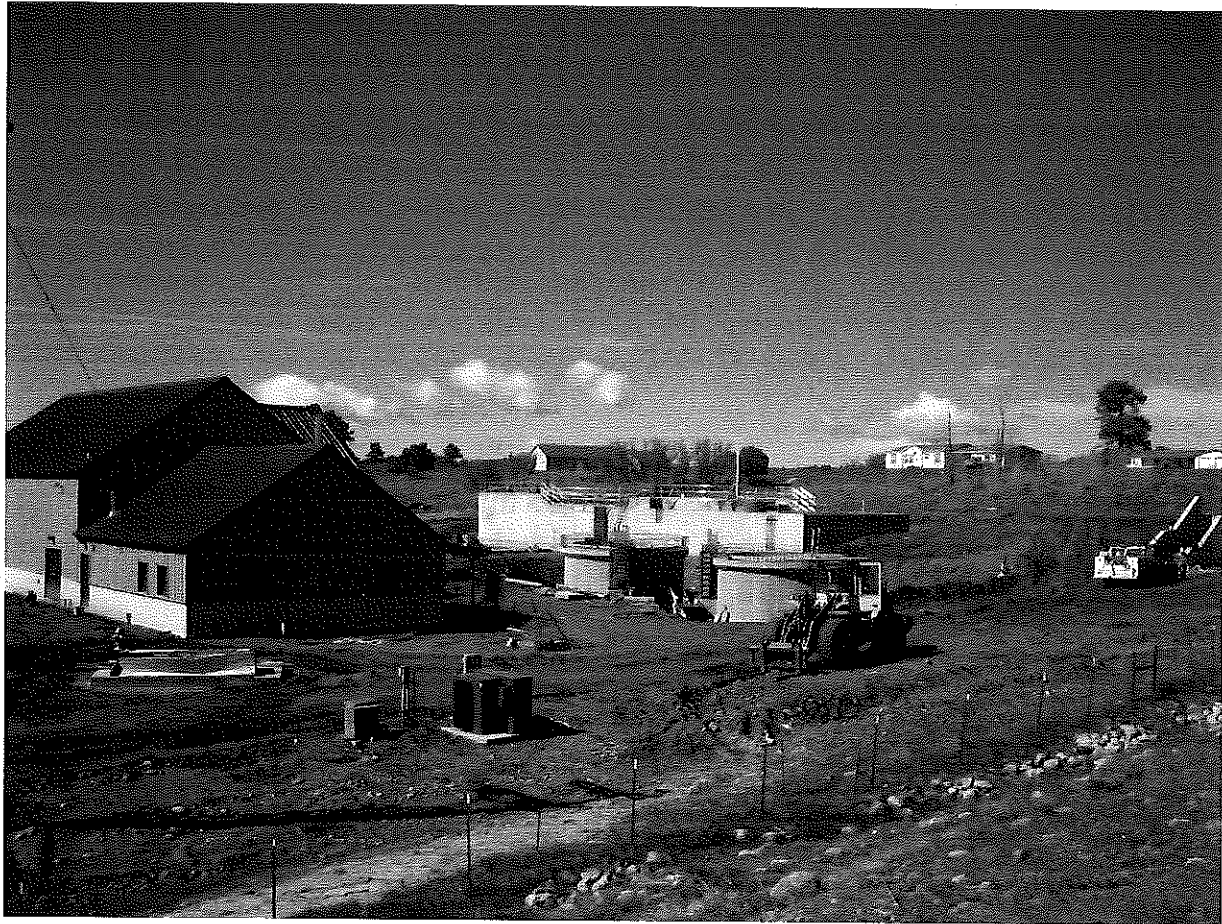
Photo File Name: P4260568

Description: New wastewater treatment plant being built adjacent to old treatment works

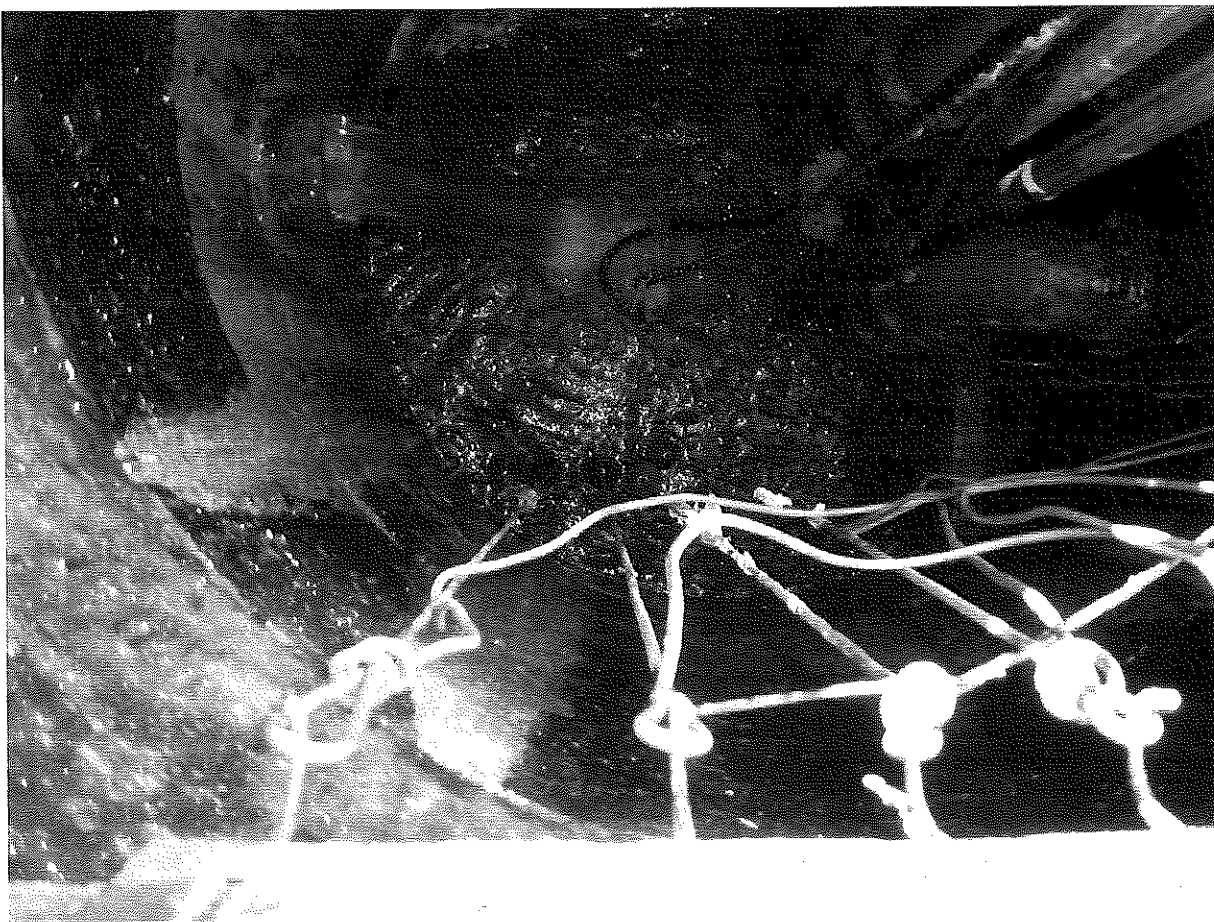
Photo File Name: P4260571

Description: Wet well/lift station to influent treatment works

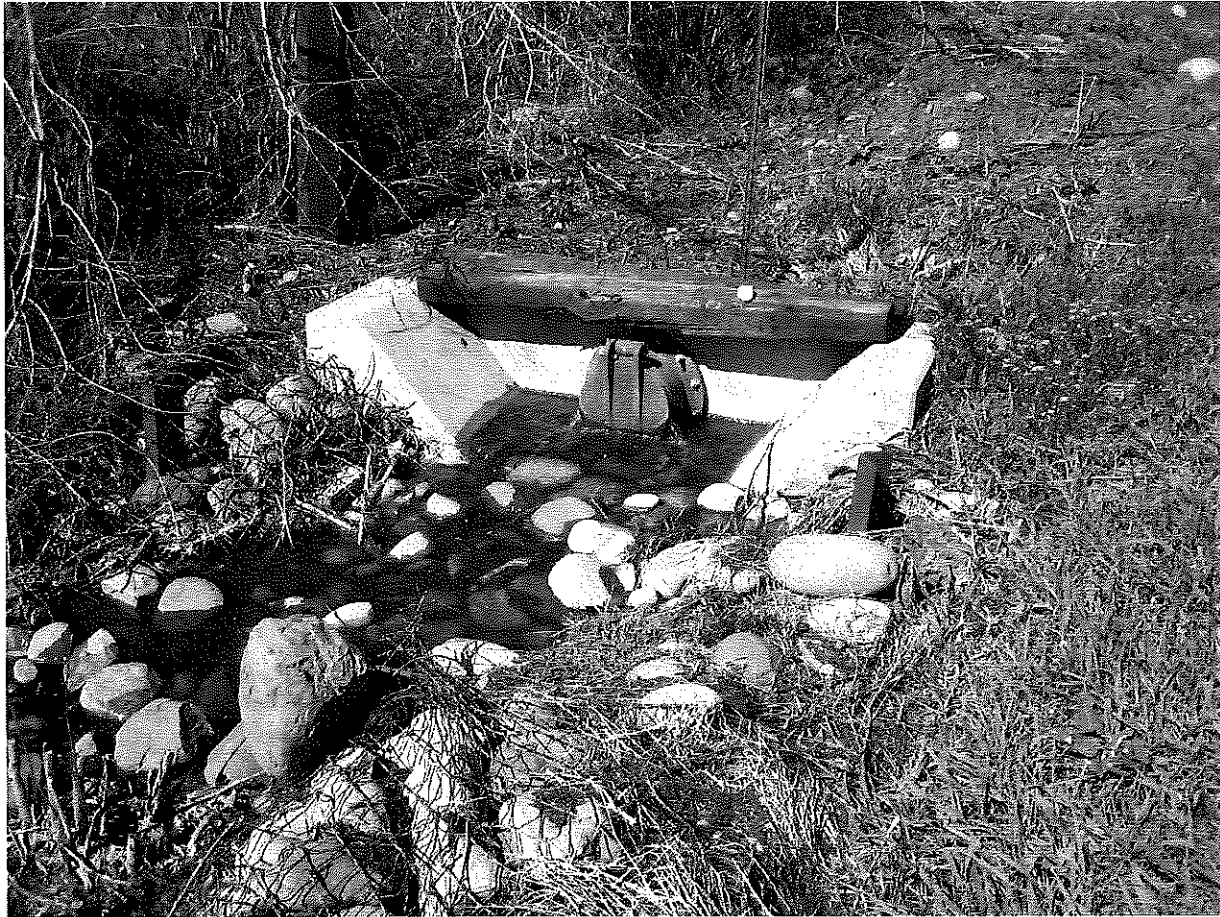
Photo File Name: P4260572

Description: Final effluent discharge from Chama Wastewater Treatment Plant
