## NPDES Compliance Inspection Report

**D. R. Johnson Lumber Co.**

**Permit # ORR221397**

**Inspection Date: January 26, 2021**

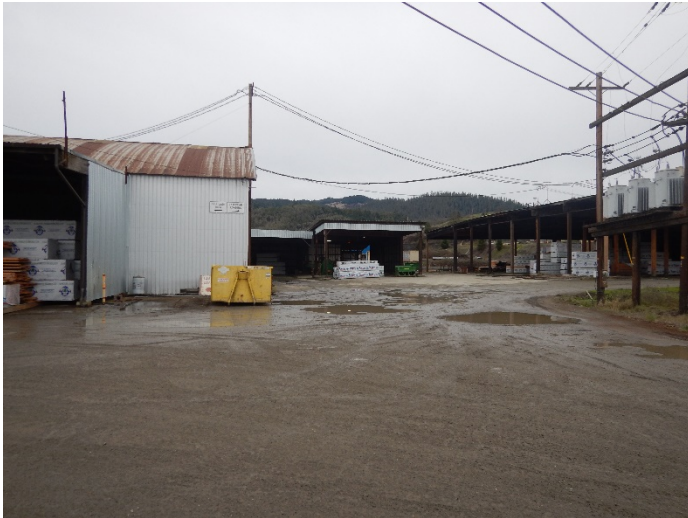
Photo #:03 (DSCN0495)

Description: Facing northwest, photo of pooled stormwater in yard near the beam loading area.

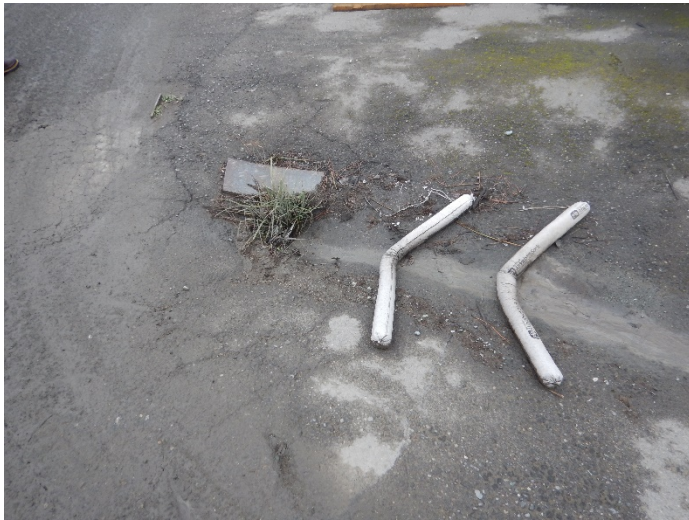
Photo #:09 (DSCN0501)

During my facility walk-through, I noted that Outfall 003 is located and sampled at the end of a roadside drainage ditch that receives stormwater run-off from a series of small drains interspersed throughout the southern section. The areas where these drains receive stormwater run-off pertain to different industrial activities, which indicates that the effluents of each drain would not be considered substantially similar. (See **Attachment B, Photos 9-15, 18, 24**).

Description: Photo of a storm drain that contributes to the roadside drainage ditch leading to Outfall 003.

I explained the issue of comingling stormwater to Mr. Blankenship and Mr. Huffman during the inspection. I explained that taking stormwater samples at an outfall where stormwater from potentially different discharge points and associated effluents has comingled may not be an appropriately representative sample. They both indicated that they would be willing and able to sample at each drain’s discharge point, in addition to the final point at Outfall 003, as soon as required. I explained that, should these changes be required, the appropriate revisions would also need to be made to the SWPCP.

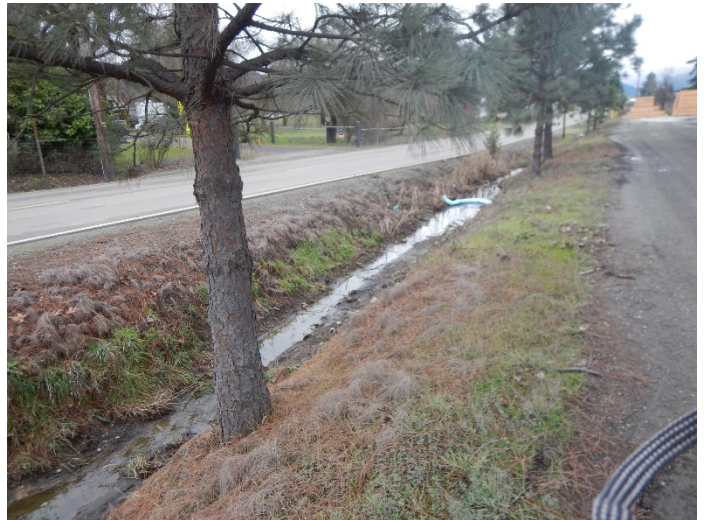
Photo #:10 (DSCN0502)

Description: Facing southwest, photo of the roadside drainage ditch leading to Outfall 003.

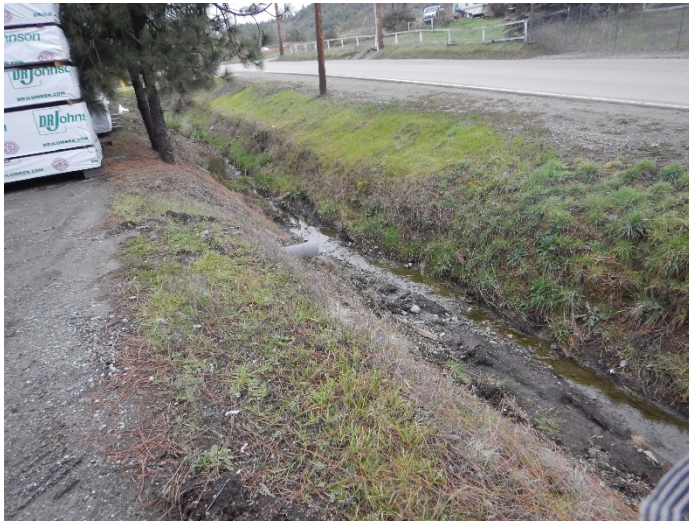
Photo #:11 (DSCN0503)

Description: Facing northeast, photo of one of the storm drains that contributes to the roadside drainage ditch leading to Outfall 003. This is the downspout of the drain from **Photo #9**.

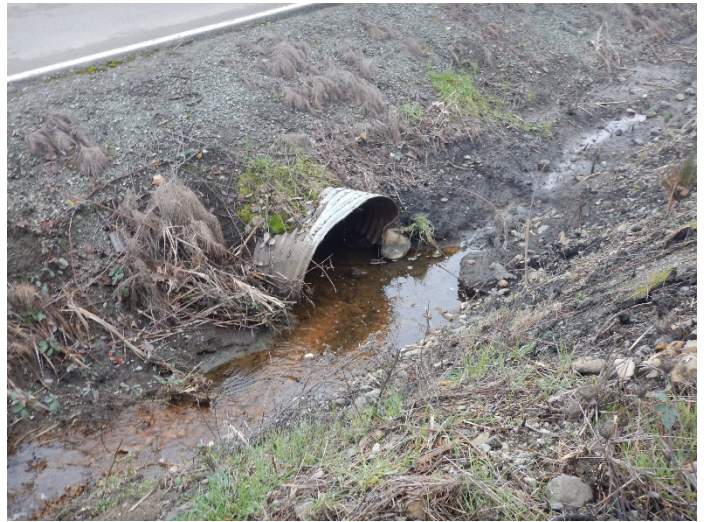
Photo #:12 (DSCN0504)

Description: Facing southwest, photo of Outfall 003. Stormwater samples are taken here, at the mouth of the culvert. Outfall 003 is located at the end of the roadside drainage ditch along Pruner Road. Stormwater at Outfall 003 is discharged off-site to a roadside ditch on the opposite side of Pruner Road.

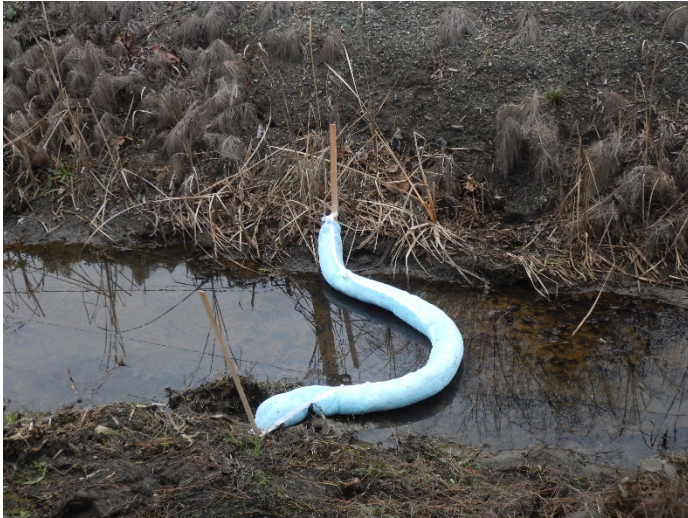
Photo #:13 (DSCN0505)

Description: Facing southeast, photo of a stormwater filter sock within the roadside drainage ditch leading to Outfall 003. Mr. Blankenship informed me that these socks are replaced each week.

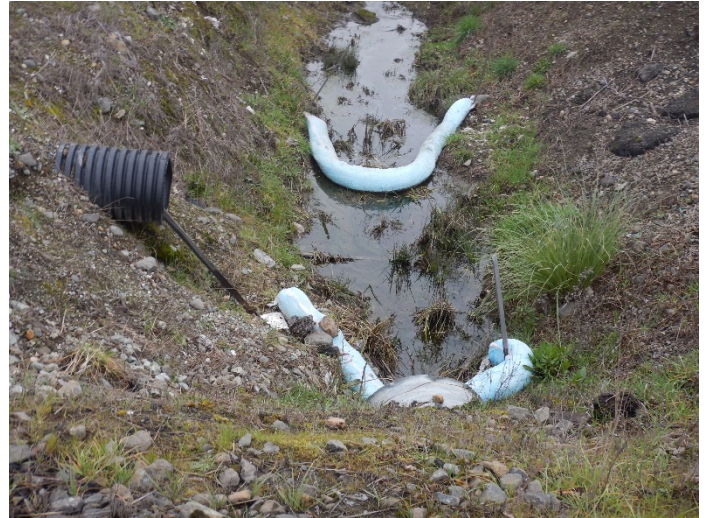
Photo #:14 (DSCN0506)

Description: Facing northeast, photo of one of the storm drain downspouts that contribute to the roadside drainage ditch leading to Outfall 003. Note the filter socks at the entrance to the culvert that connects the drainage ditch under a service road.

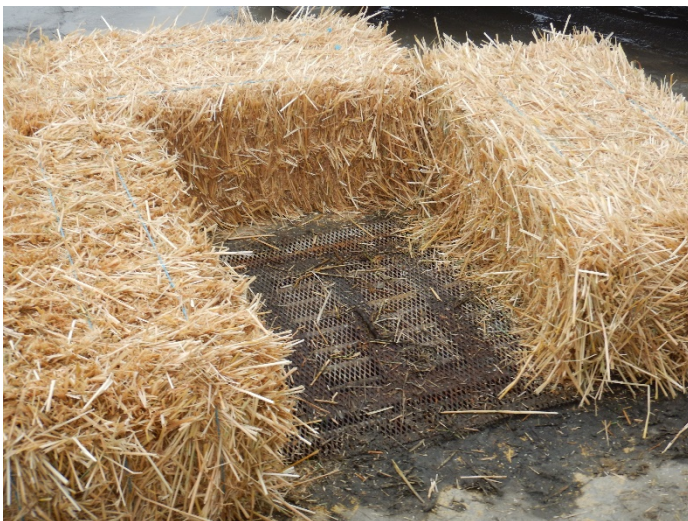
Photo #:15 (DSCN0507)

Description: Photo of a storm drain that connects to the downspout in Photo #14.

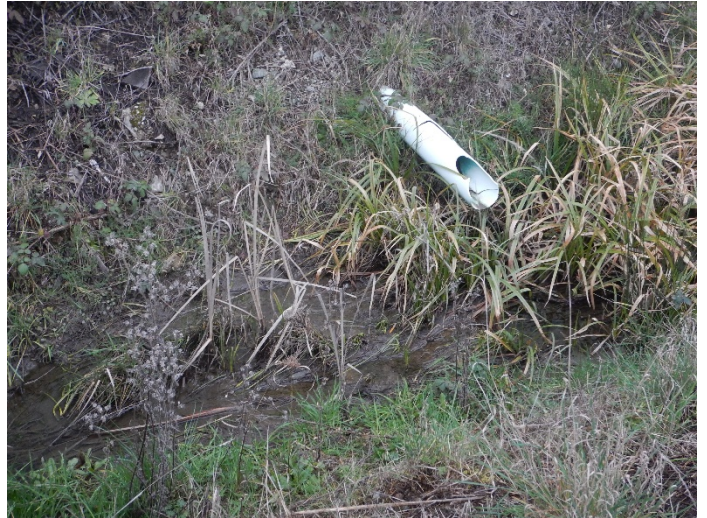
Photo #:18 (DSCN0510)

Description: Facing north, photo of one of the storm drain downspouts that contributes to the roadside drainage ditch leading to Outfall 003.

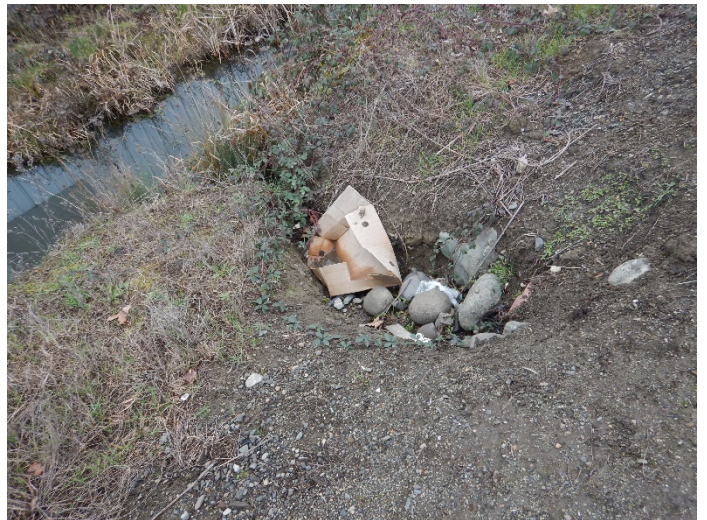
Photo #:20 (DSCN0512)

During my review of the facility, I noted the presence of a fair amount of litter and discarded items along the roadside ditch that ultimately contributes to Outfall 003. Mr. Blankenship picked up the trash that he could carry as we walked along the drainage ditch. I mentioned that regular litter pick-up was an important component of Good Housekeeping. He explained that he regularly picks up litter himself and instructs his employees to do the same when they see any, but that it’s difficult to

Description: Facing northeast, photo of a culvert leading to a small settling ditch on the opposite side of Pruner road (land is owned by D.R. Johnson Lumber Co.). Note the litter present here.

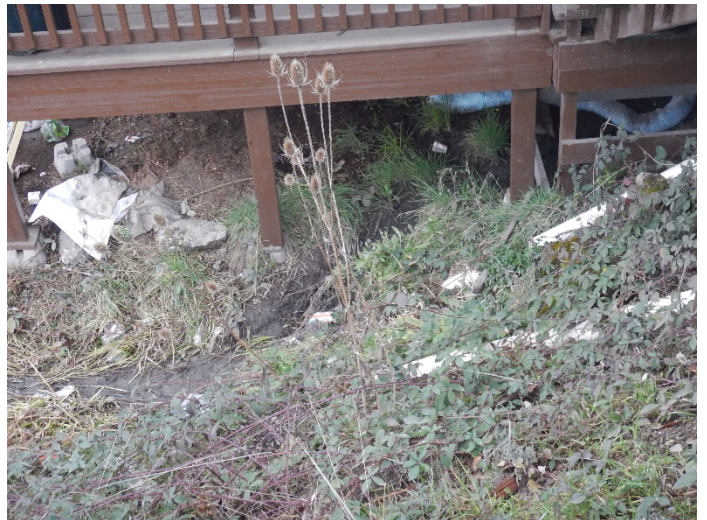
Photo #:24 (DSCN0516)

Description: Facing north, photo of the starting point of the roadside drainage ditch leading to Outfall 003. The ditch begins under the stairs of the office building.

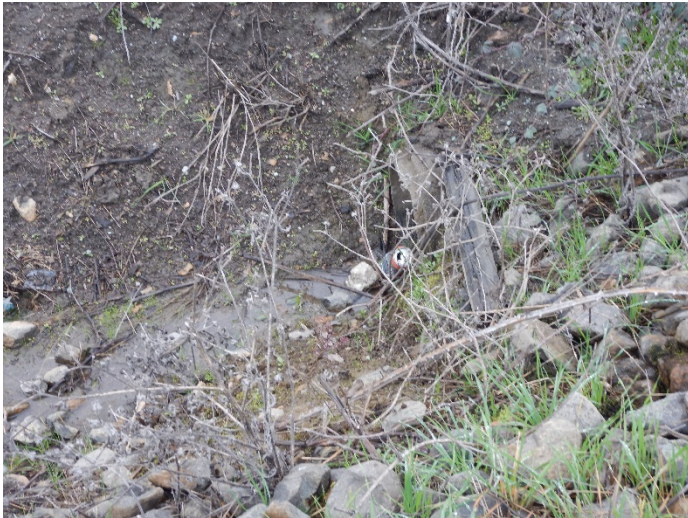
Photo #:27 (DSCN0519)

keep up with the sheer quantity of trash left behind by people who drive and walk on Pruner Road. I noted a similar issue with the drainage ditch leading to Outfall 001, alongside Boyer Road. He stated that he would put forth greater effort to exhibit Good Housekeeping following the inspection.

Description: Facing northeast, photo of drainage ditch along Boyer Road that accepts water from Outfall 001. Note the litter present.

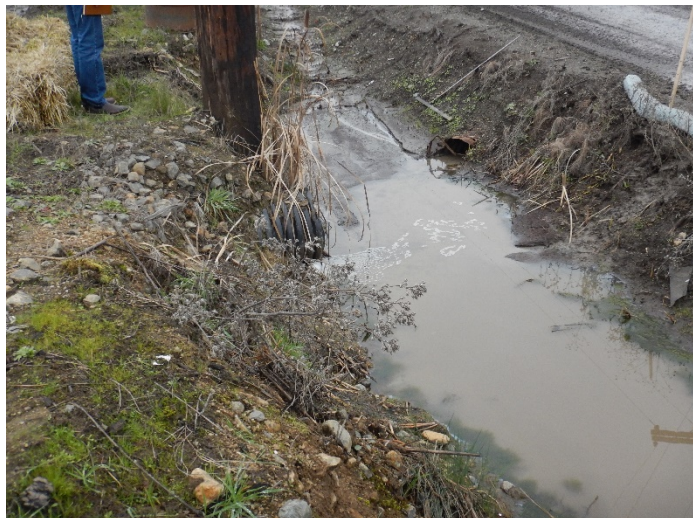
Photo #:29 (DSCN0521)

During the inspection, I noticed a small amount of sheen at Outfall 001 (See **Attachment B, Photos 29 & 30**). Mr. Blankenship also noticed the sheen and immediately addressed it. He called one of his employees and instructed them to bring equipment over to clean up the sheen. They arrived within a few minutes and efficiently cleaned up the sheen. Mr. Blankenship and his employees demonstrated proper execution of O&G clean-up, the procedure for which I was able to locate within their current SWPCP. Mr. Blankenship also mentioned that they had been experiencing issues with truck waste coming off of Boyer Road. Boyer Road is a county road used by D.R. Johnson, C&D Lumber, and the public.

Description: Facing northwest, photo of Outfall 001 (black corrugated pipe on the left). Stormwater samples are taken here, at the spout. The rusted culvert pipe on the right contributes to the same drainage ditch, but is not owned by D.R. Johnson. Note the sheen present from Outfall 001. This was cleaned up during the inspection.

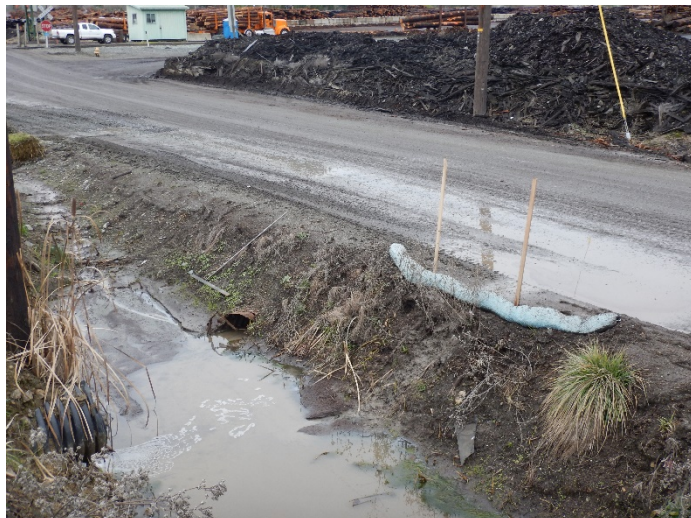
Photo #:30 (DSCN0522)

Description: Facing northwest, photo of Outfall 001 (black corrugated pipe on the left). Stormwater samples are taken here, at the spout. The culvert pipe on the right contributes to the same drainage ditch, but is not owned by D.R. Johnson. Note the sheen present from Outfall 001. This was cleaned up during the inspection.

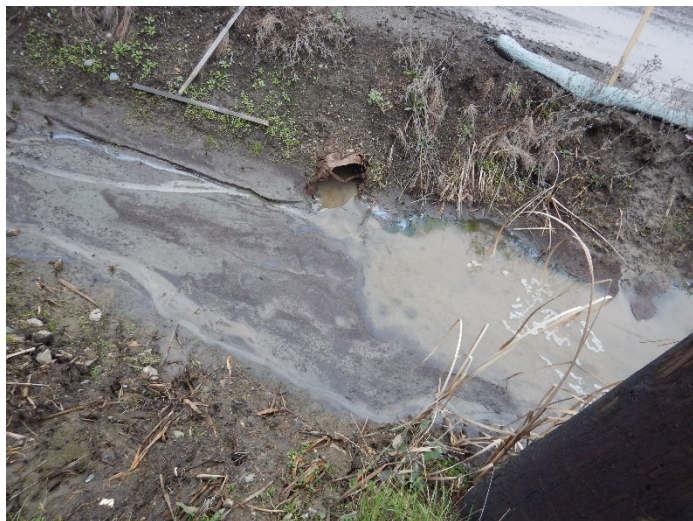
Photo #:31 (DSCN0523)

Description: Facing north, photo of the drain contributing to the drainage ditch along Boyer Road. Note the filter sock, installed by D.R. Johnson. Mr. Blankenship informed me of truck waste issues contributing to the drainage ditches along Boyer Road.

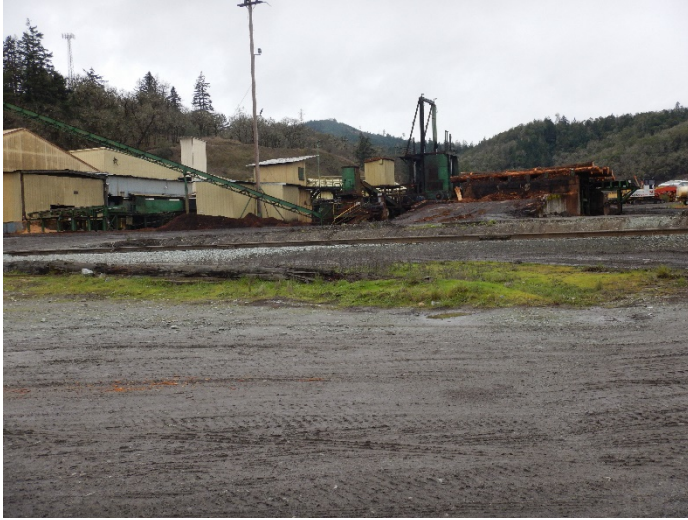
Photo #:33 (DSCN0525)

Description: Facing west, photo of sawmill. Due to parts issues, the sawmill was not operational at the time of the inspection. It had been out-of-service for a few days prior to the inspection.

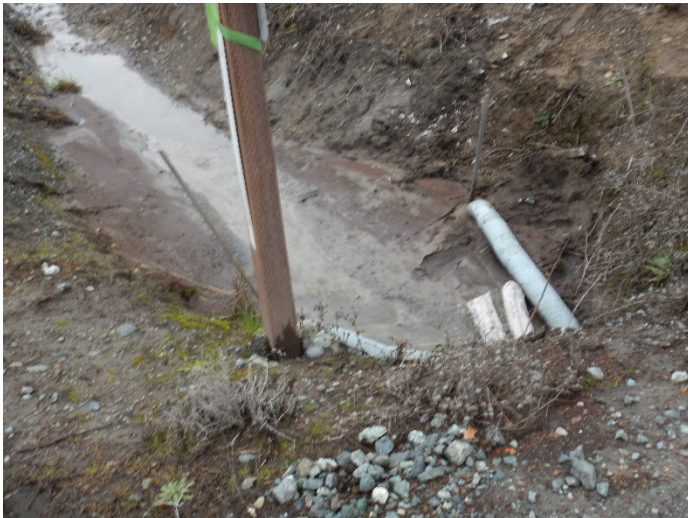
Photo #:35 (DSCN0527)

During my review of the facility at the time of the inspection, I noted a drainage ditch that appeared to discharge stormwater directly off-site through a culvert to a drainage ditch on the northern side of Boyer Road (**See Attachment B, Photos 35 & 36**). This drainage ditch appears to receive stormwater run-off from the sawmill and maintenance shops area.

Mr. Blankenship stated that he had asked ODEQ about the ditch during their last inspection of the facility (July 7, 2015). He indicated that ODEQ had determined that stormwater monitoring and sampling was not required for the discharge point at the time of that inspection. He explained that he conducts visual monitoring of the ditch and associated discharge on an informal basis. Stormwater sampling is not currently conducted at this potential discharge point.

Description: Facing southwest, photo of drainage ditch that connects to a ditch on the north side of Boyer Road. Sampling is not currently conducted here, per ODEQ in 2015.

During the inspection, I explained the representative sampling requirements of the Permit to Mr. Blankenship and Mr. Huffman. I mentioned that they may be required to begin sampling and monitoring at this potential 4<sup>th</sup> outfall, to remain in compliance with their Permit. They both indicated that they would be willing and able to begin conducting stormwater monitoring at the discharge point as soon as required. I

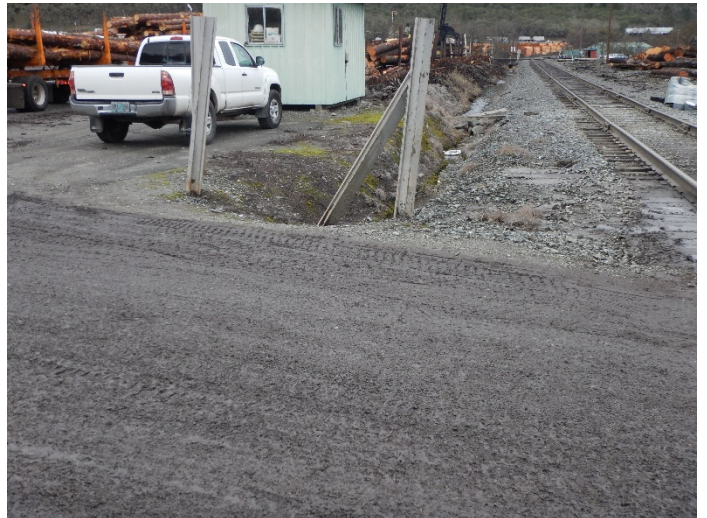
Photo #:36 (DSCN0528)

Description: Facing northeast, photo of the drainage ditch along Boyer that receives the stormwater from the unsampled D.R. Johnson drainage ditch.

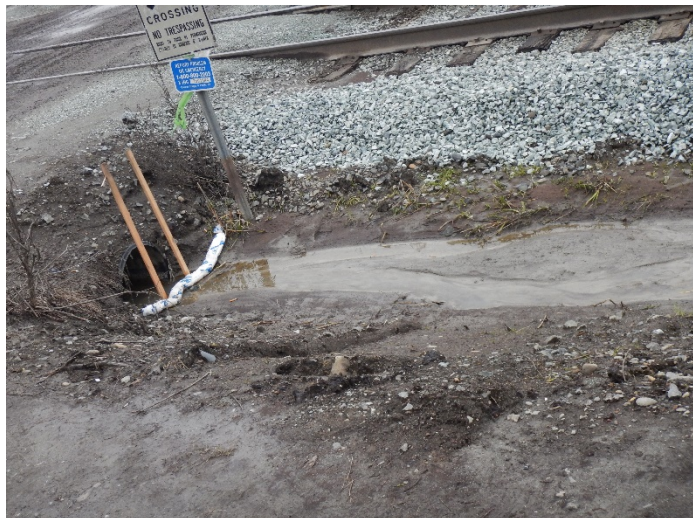
Photo #:41 (DSCN0533)

Description: Facing north, photo of the drainage ditch that contributes to the unsampled potential discharge point. Stormwater from this ditch is connected to the unsampled ditch via the culvert under the service road.
