**Region 6 - Enforcement & Compliance Assurance Division**  
**INSPECTION REPORT**

| Inspection Date(s): | 06/07/2022 | |
| Company Name: | WWW Oil Company | |
| Facility Name: | Whitetail Stuart Lease | |

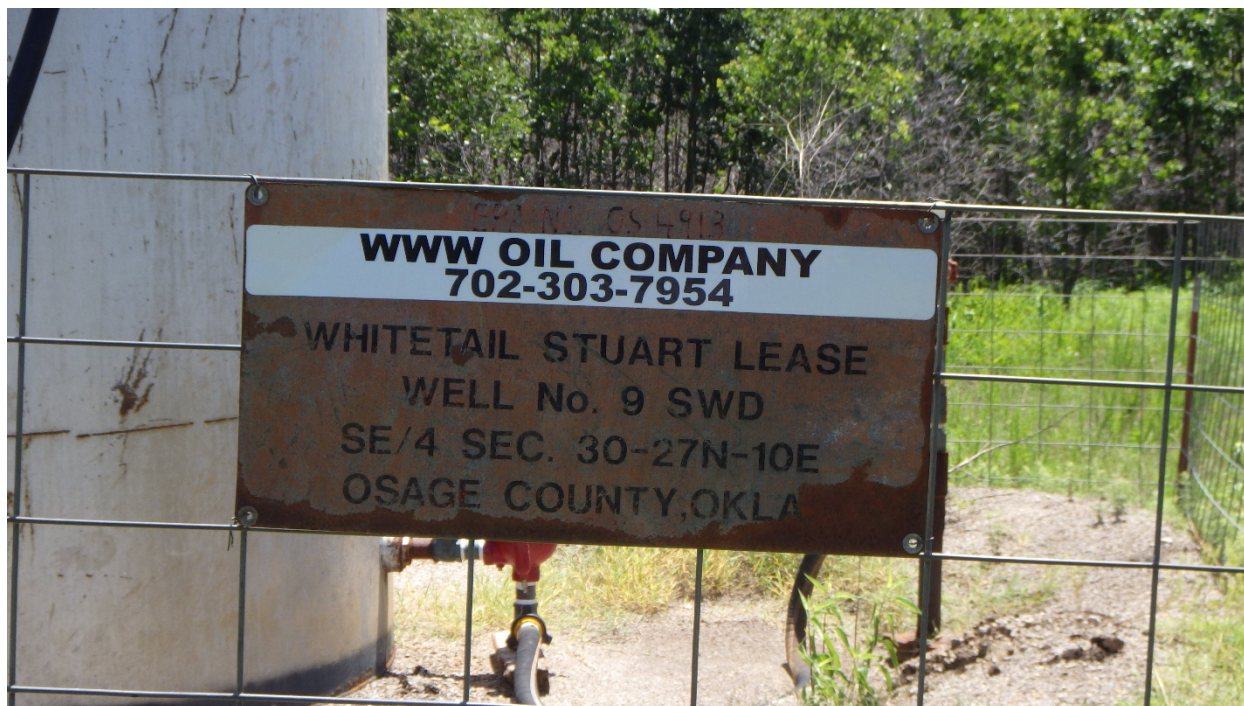
Photo No. 1

**Description:** This was the sign located at the facility which served as the Release Point for the spill.

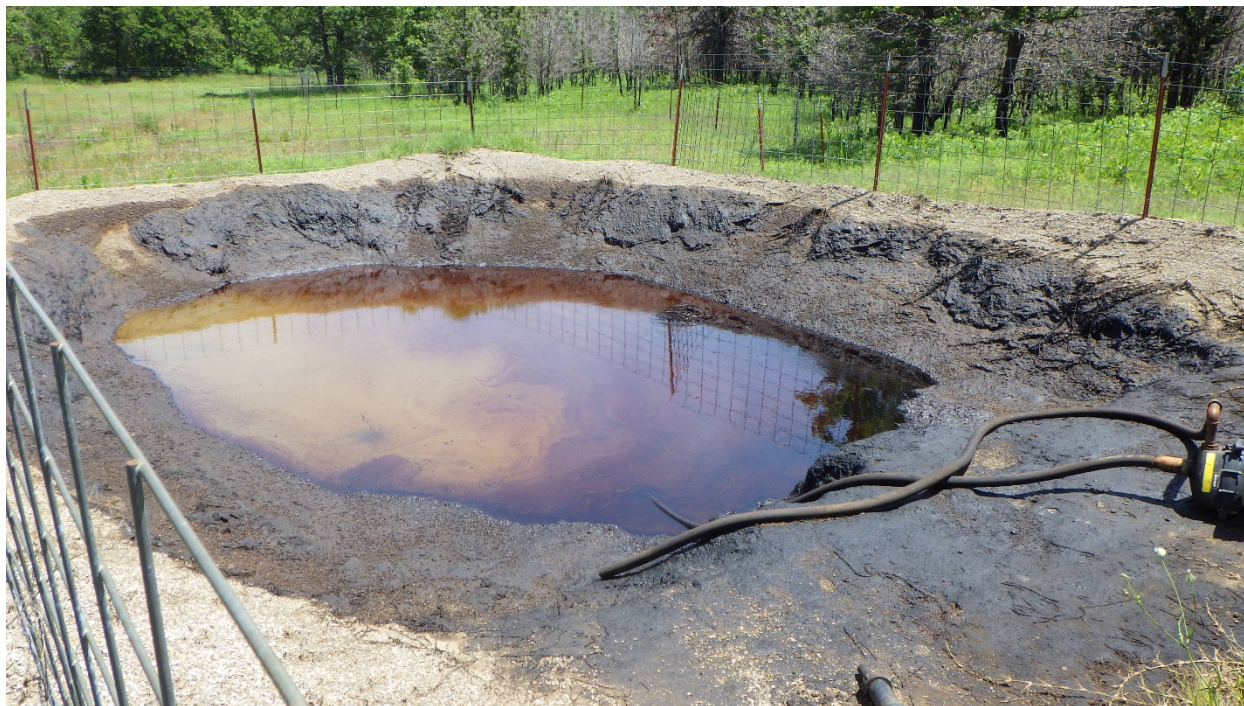
Photo No. 2

During the inspection I observed evidence of a recent spill or a failure to clean up the pit area after a spill event. I observed oil floating on the water in the pit and heavy oil staining on the gravel berm around the pit, this can be seen in photo No. 2 of Appendix 1 (photo log) which is attached to this report. I observed the flow path beginning at the release point continuing east toward the impacted tributary. The flow path was estimated by inspectors Matthew Allen and Carl Wills, to be approximately 85 percent recovered with vegetation. The condition of the flow path can be seen in photos No. 3, 4, 5, 6 and 7. I observed no vegetation and significant soil erosion along the final 20 feet of the flow path as it connected to the Point of Entry (POE) into the main channel of the impacted tributary, evidence of this erosion can be seen in photos No. 6 and 7. Approximately 25 feet downstream from the POE, I observed the remaining portion of an earth dam which was placed across the impacted tributary with a piece of PVC pipe partially buried in the dam. With a properly calibrated YSI Pro 30 conductivity meter, I observed an elevated Total Dissolved Solids (TDS) field reading of 2,144 mg/L. The elevated TDS field reading, and the absence of vegetation suggested the area of soil erosion near the end of the flow path was contaminated with brine and continued to discharge into the tributary during and after rainfall events.

**Description:** This was a pit located at the release point of the spill. At the time of the inspection, crude oil was present on the pit and crude oil stains were present on the berm around the pit, indicating a recent spill or a failure to cleanup after a spill event.

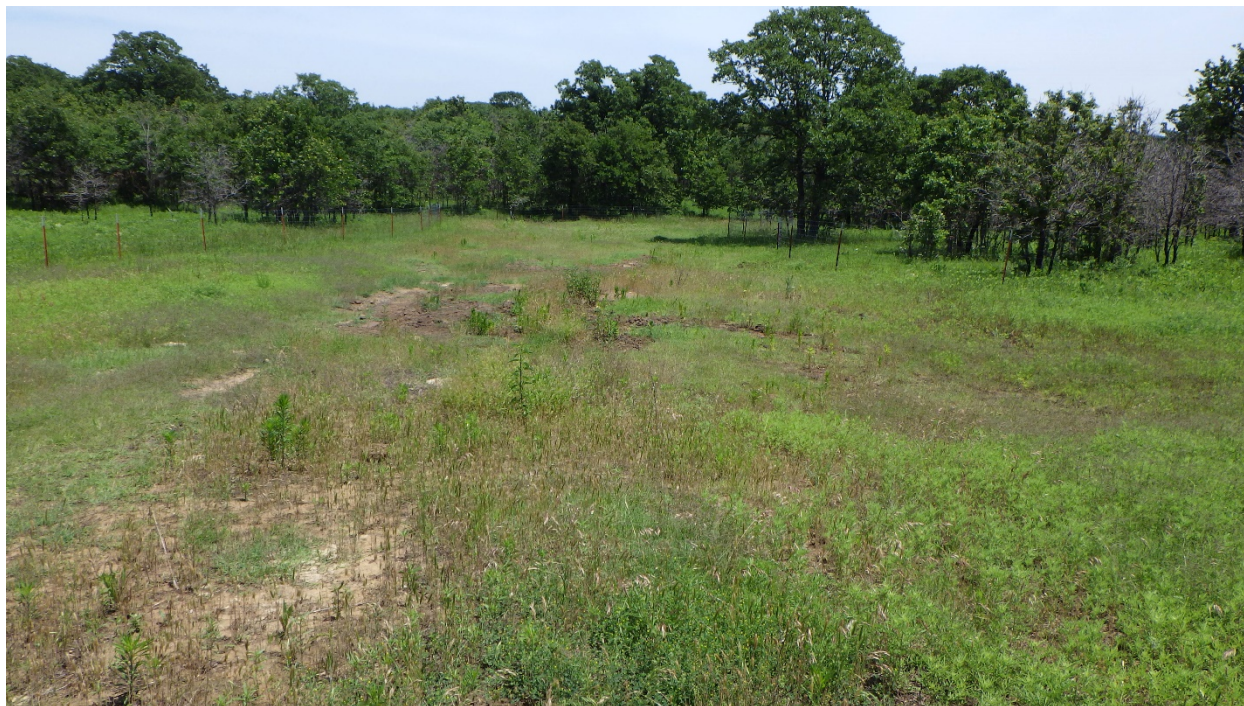
Photo No. 3

**Description:** This was a photo taken at the release point facility, standing at the East end of the facility, with a view looking East down the flowpath of the spill toward the Point of Entry (POE). I estimated the flowpath had recovered with vegetation to approximately 85 percent.

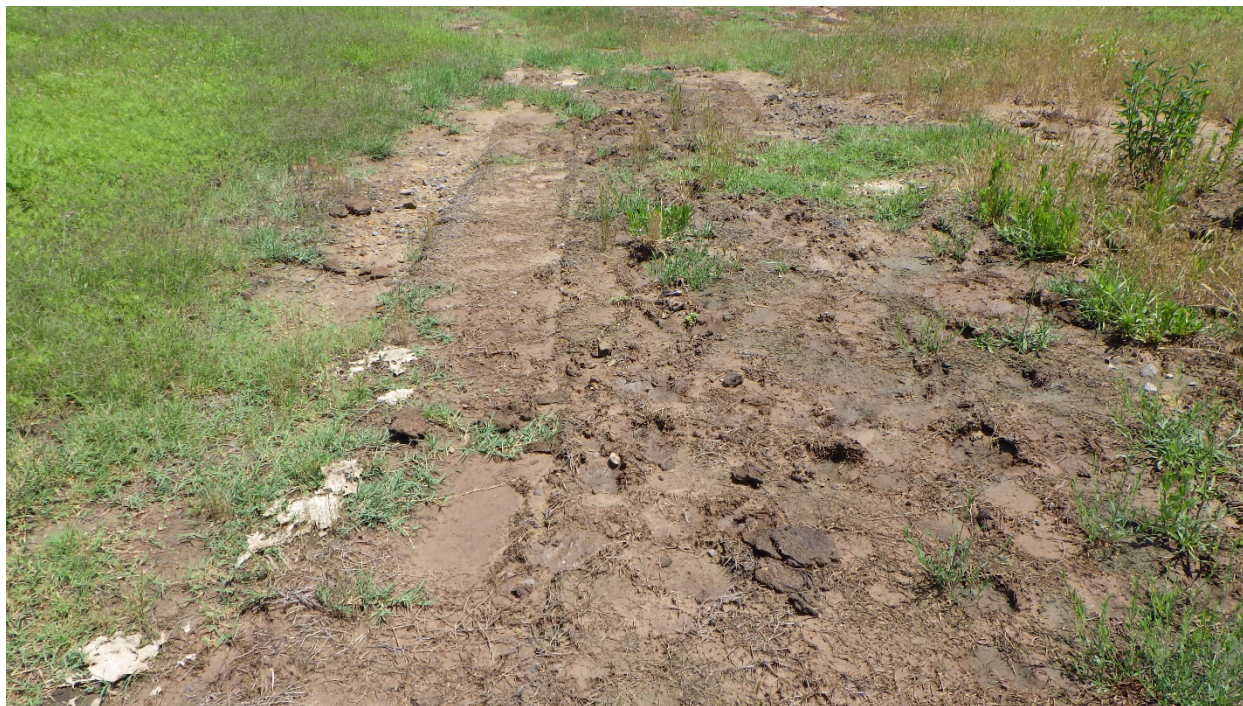
Photo No. 4

**Description:** This was a portion of the flowpath where sod strips were applied but failed to survive. The sod strips had successfully prevented the soil from eroding from the site.

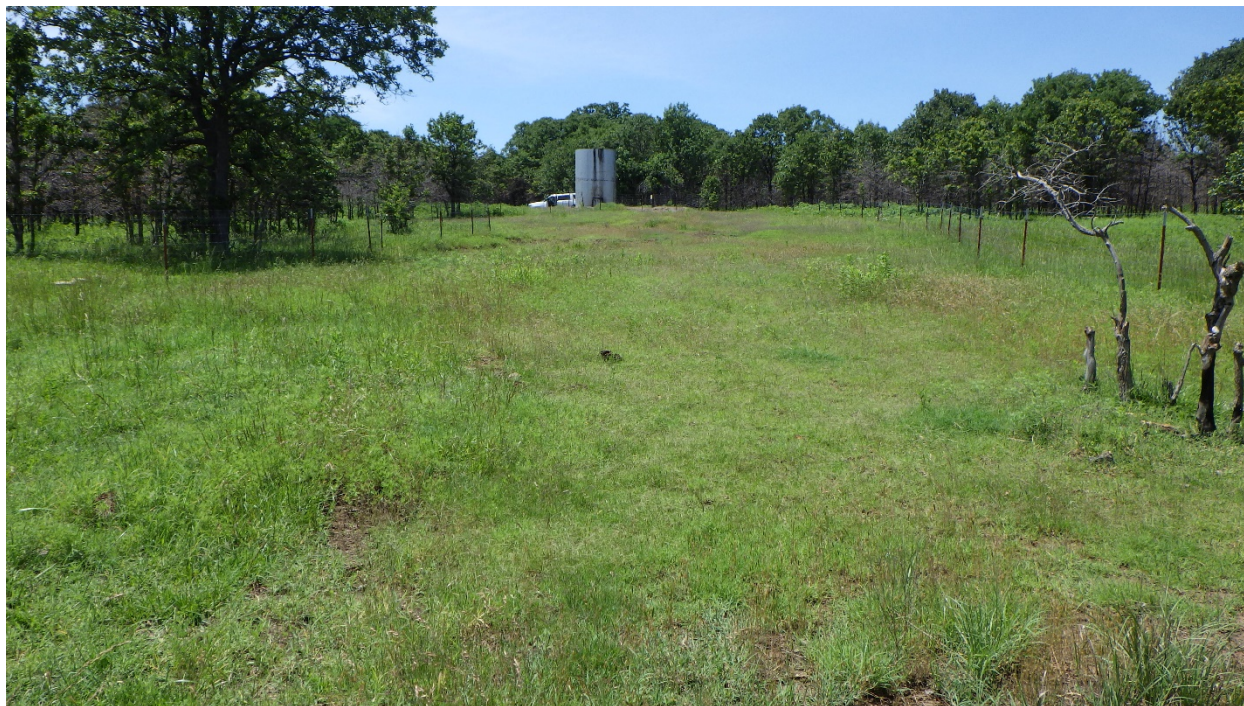
Photo No. 5

**Description:** This was a photo of the flowpath, standing near the POE into the impacted tributary with a view looking west toward the Release Point (silver tank).

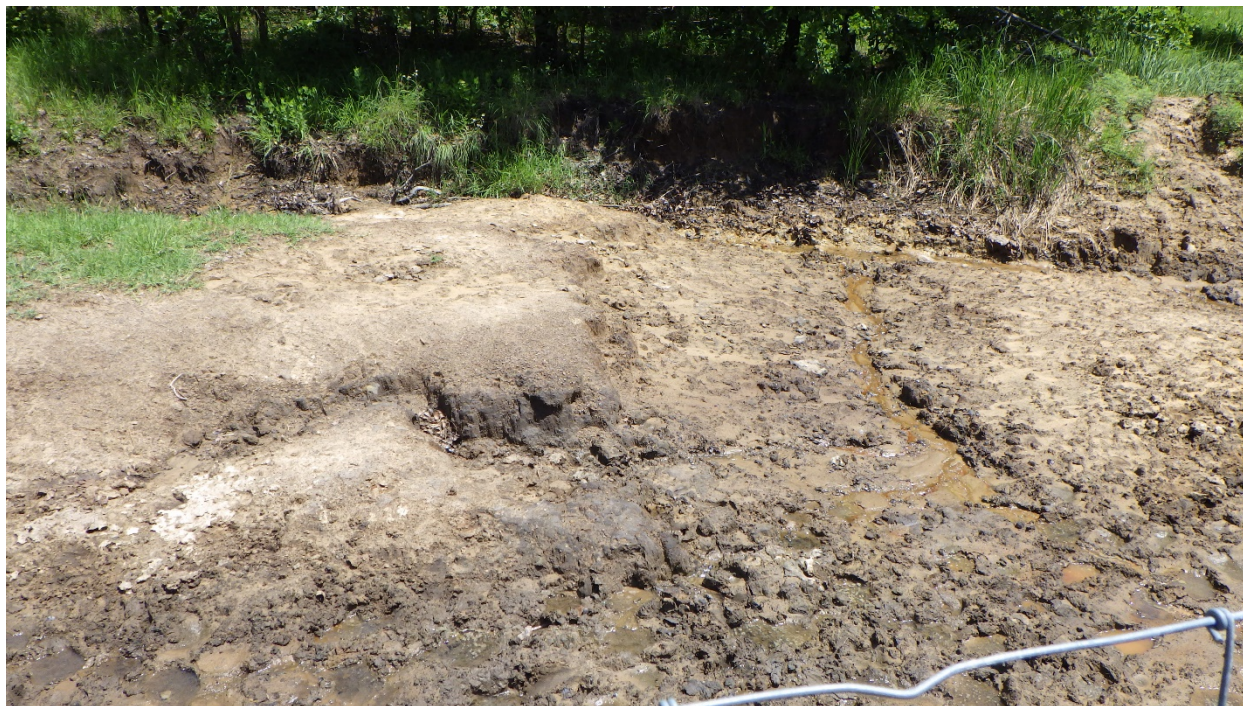
Photo No. 6

**Description:** This was a photo taken approximately 20 feet before the spill/flowpath entered the impacted tributary, looking west to the POE. The bank of the tributary has eroded in the absence of vegetation.

EPA Region 6 inspector observed an elevated level of TDS in the main channel of the impacted tributary, likely due to brine being released from the area of soil erosion at and immediately adjacent the POE into the tributary. The primary area of concern at the time of the inspection was to remove the brine from the area of eroding soil to prevent further discharge of contaminated water into the impacted tributary. The area of erosion should be restored to prevent additional erosion of the west bank of the tributary.

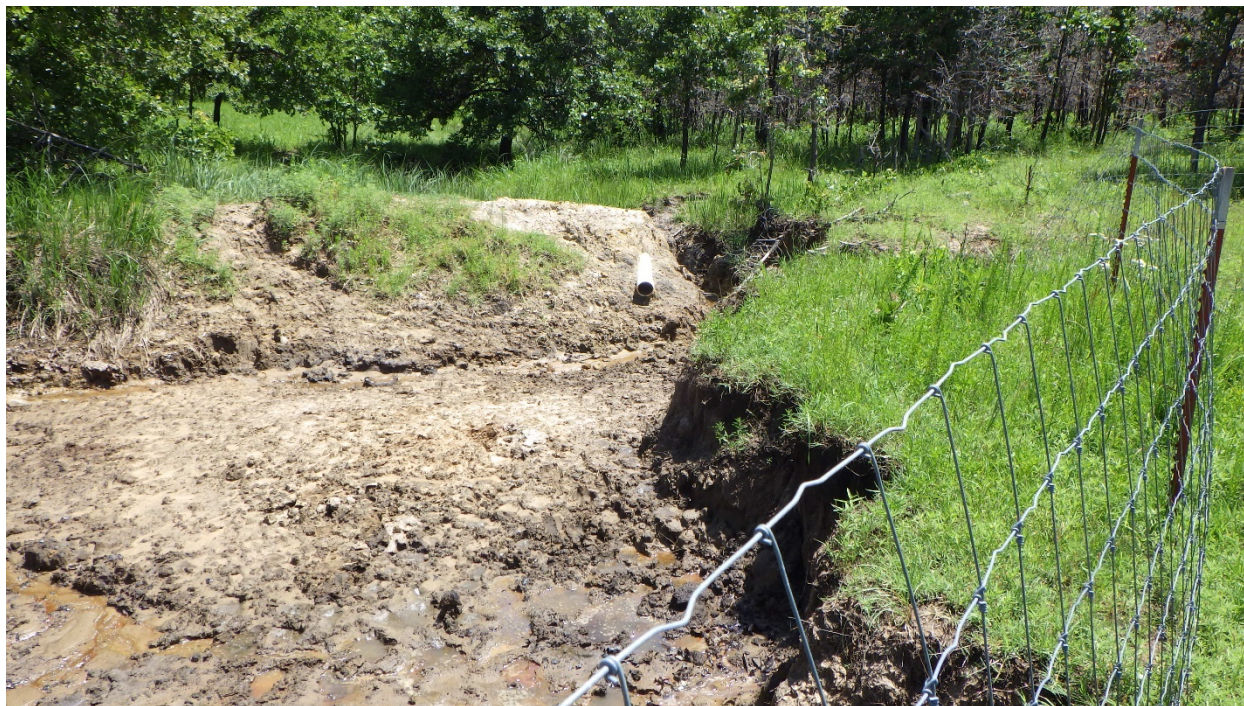
Photo No. 7

**Description:** This was a photo taken approximately 20 feet west from the POE, looking southeast, showing the significant soil erosion of the bank along the impacted tributary.

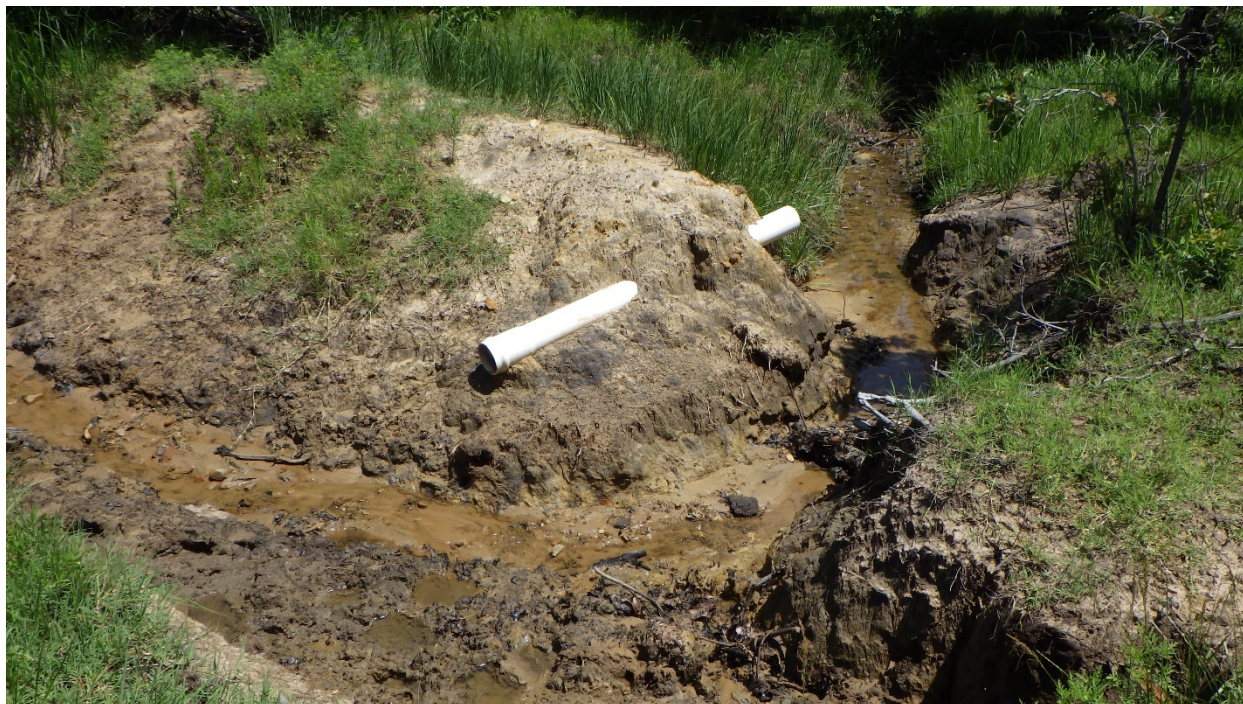
Photo No. 8

**Description:** This was a photo of a piece of PVC pipe installed in the remaining portion of an earth dam. This dam and pipe were located approximately 25 feet downstream from the POE on the impacted tributary.

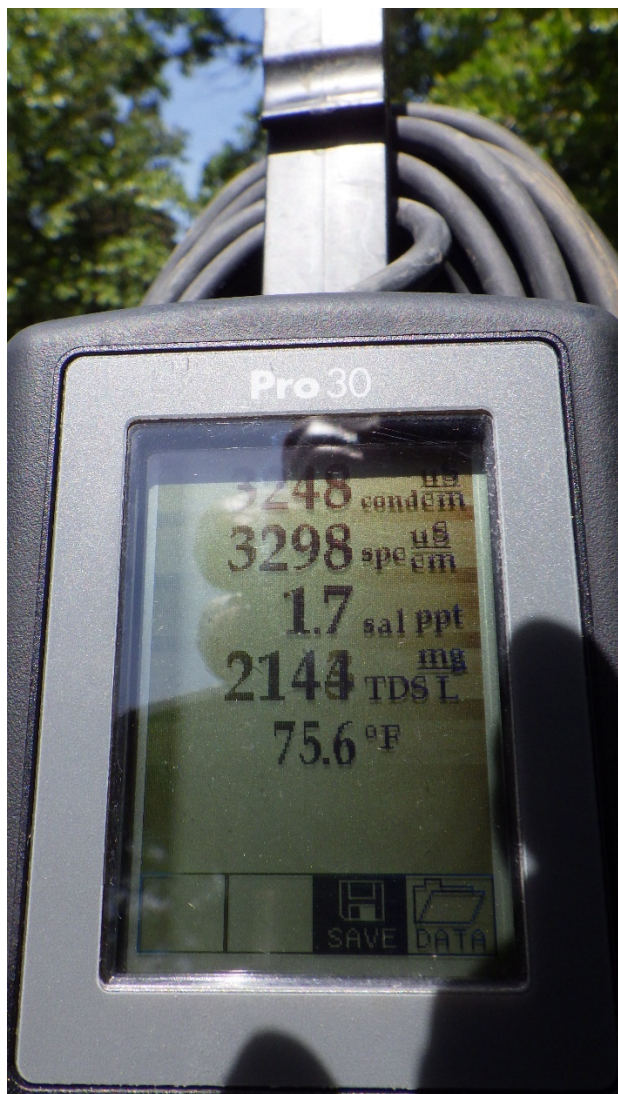
Photo No. 9

**Description:** This was an elevated Total Dissolved Solids (TDS) field reading of 2,144 mg/L taken approximately 40 feet downstream in the main channel of the impacted tributary.

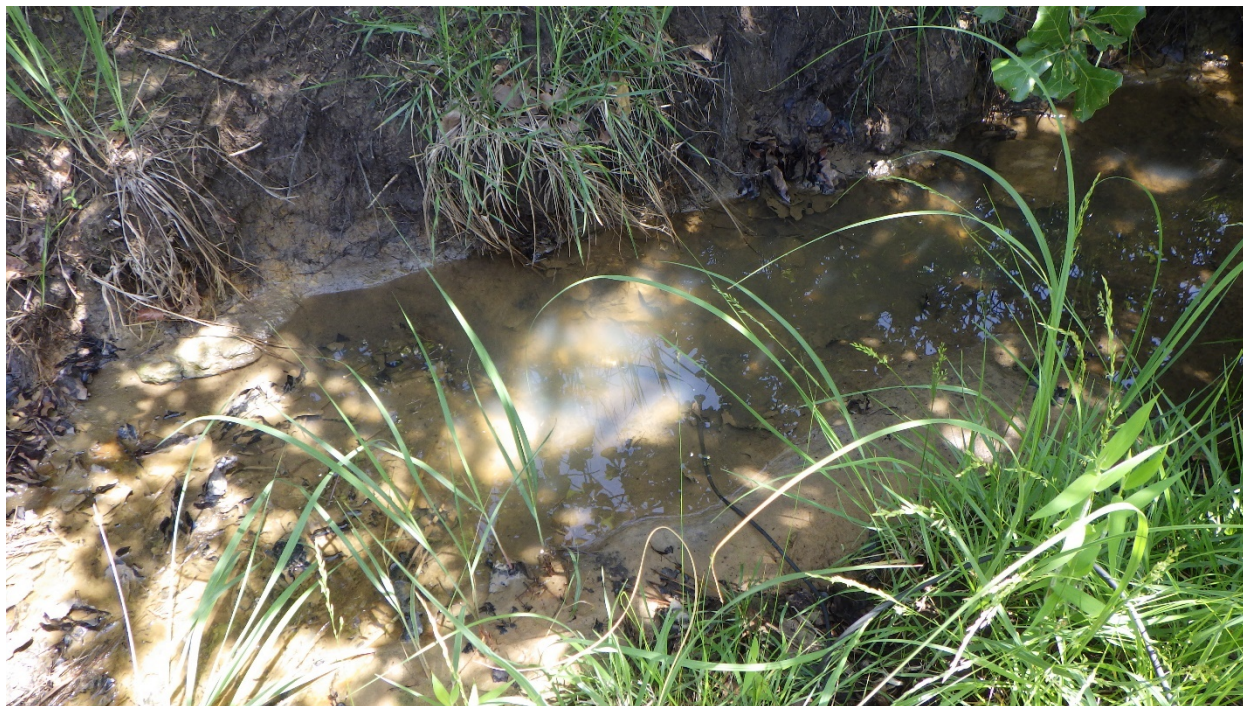
Photo No. 10

**Description:** This was the pool of water in the main channel of the impacted tributary where the elevated TDS field reading of 2,144 mg/L was taken.
