# NPDES Compliance Inspection Report

## Quinault National Fish Hatchery

**NPDES Permit Tracking Number  
# WAG130005**

**Inspection Date: July 28, 2023**

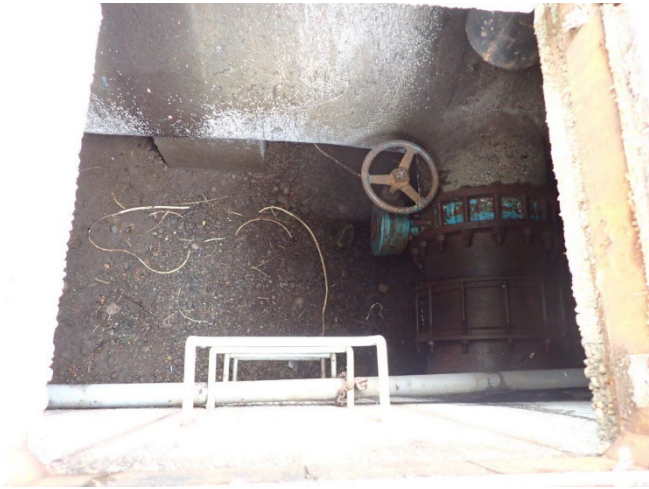
Photo #:01 (P7280210)

I began the site walkthrough with Mr. Fielding and Mr. Van Liew starting at the underground "vault", where a 48-inch and an 18-inch line converge in a mixing zone for all three intake sources for the Facility (**Photo 1**). This vault had a mixing valve that can be opened to allow all intake sources to mix or can be closed to isolate intake sources. Then we drove to the Hatchery Creek and duck pond intake source. See **Attachment B** for a detailed site map and **Attachment C** for a photograph log of pictures taken during

Description: Facility's underground "Vault" where each intake source converges in a mixing zone when the mixing valve is open. Vault includes a low water level and flow alarm.

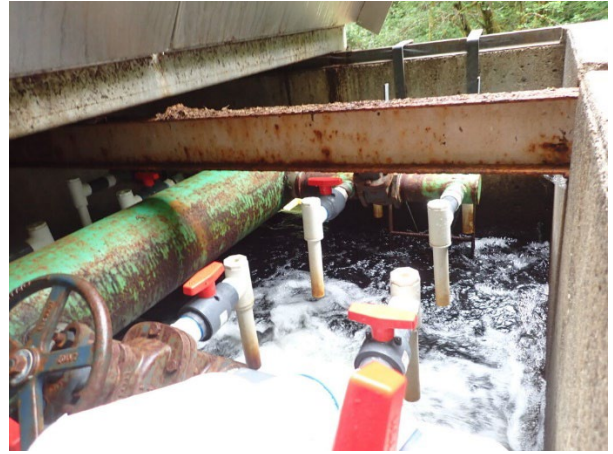
Photo #:02 (P7280213)

At the Hatchery Creek and duck pond intake site, I observed the main intake compartment in which Hatchery Creek and gravity-fed duck pond water mix together and then goes into an 18-inch line (**Photo 2**). I also observed the intake area's primary screening for Hatchery Creek to catch large debris (**Photo 3**). Composite influent sampling consisting of four grab samples at half hour intervals is conducted at this intake area using a 1-liter bottle attached to a stick inside the intake compartment only when the "vault" mixing valve is closed.

Description: Hatchery Creek and duck pond intake site. Both sources mix together and run underground via an 18-inch line.

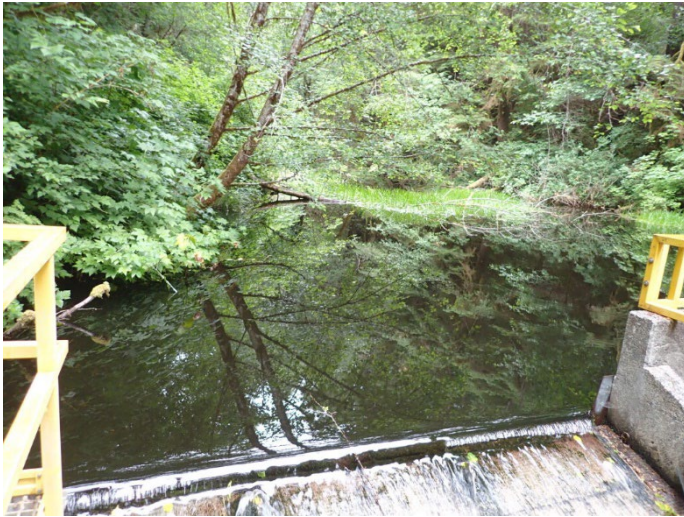
Photo #:03 (P7280215)

Description: Facing northeast, photo of Hatchery Creek flowing over primary screens to catch big debris at the intake area.

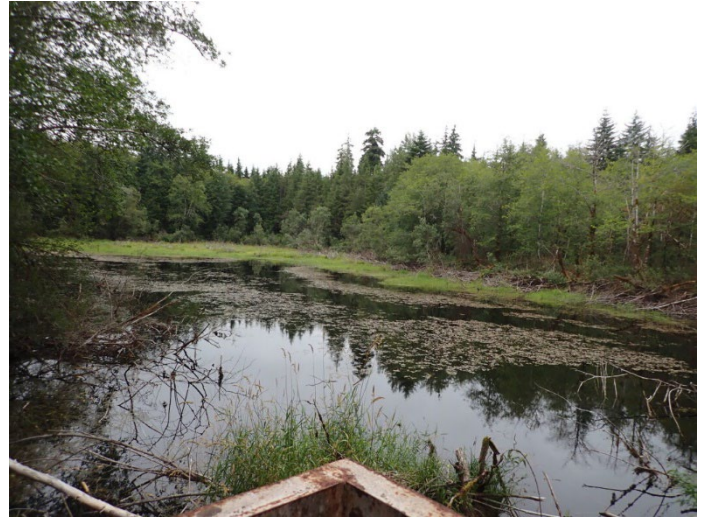
Photo #:04 (P7280223)

Then we drove to the duck pond located approximately 1.25 miles Northeast from the hatchery. The duck pond is an old Bureau of Indian Affairs gravel pit that was abandoned to the USFWS and then filled (**Photo 4**). A line was added to use the water as a hatchery influent source. The duck pond slopes down to the Hatchery Creek intake area via a pipe that begins under the foot platform at the duck pond.

Description: Facing northeast, photo of the Facility's duck pond that serves as a hatchery intake source. Duck pond used to be an old Bureau of Indian Affairs gravel pit.

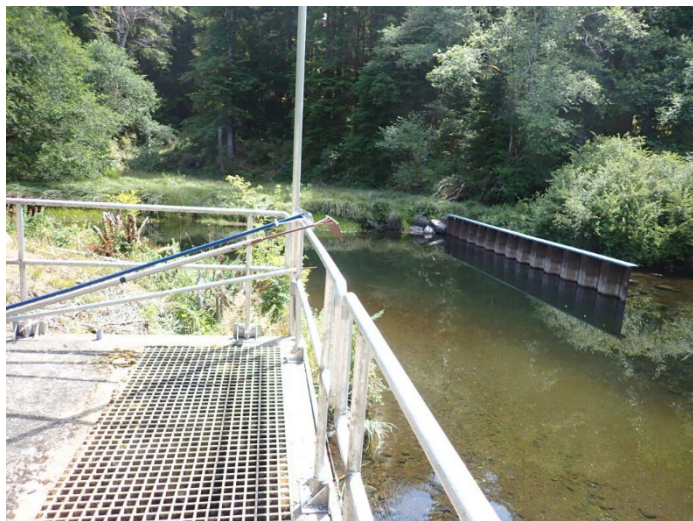
Photo #:05 (P7280230)

We then went to the Cook Creek intake area also located approximately 1.25 miles Southeast from the hatchery. This intake area had a wingwall to divert water for gravel management as well as a bypass mechanism for big debris (**Photo 5**). Cook Creek is the main influent source for the Facility's raceways. No influent sampling is performed at this intake area unless the "vault" mixing valve is closed. Influent samples from here would be flow-proportioned with other intake sources as necessary. Cook Creek influent passes through screen chambers and enters the sand settling basin (**Photo 6**). Solids from the sand settling basin are pumped to the sludge lagoons including during annual settling basin drawdown (**Photo 7 & Photo 8**).

Description: Facing north, photo of Cook Creek intake area that incorporates a wing wall to help divert water and manage gravel.

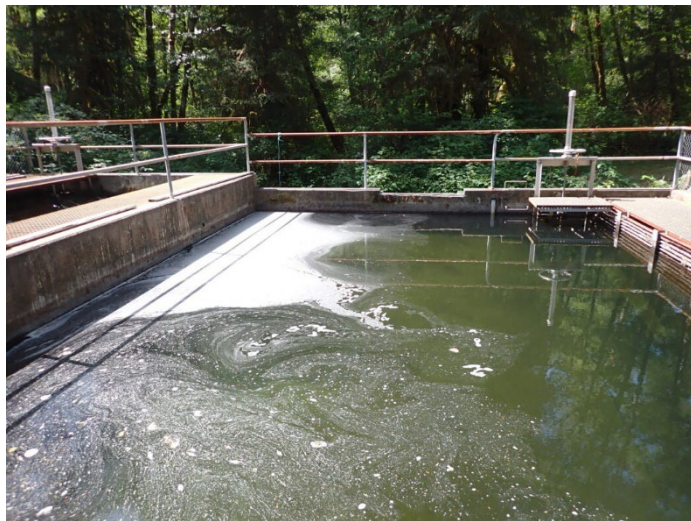
Photo #:06 (P7280238)

Description: Facing east, photo of the sand settling basin after Cook Creek intake water passes through screen chambers.

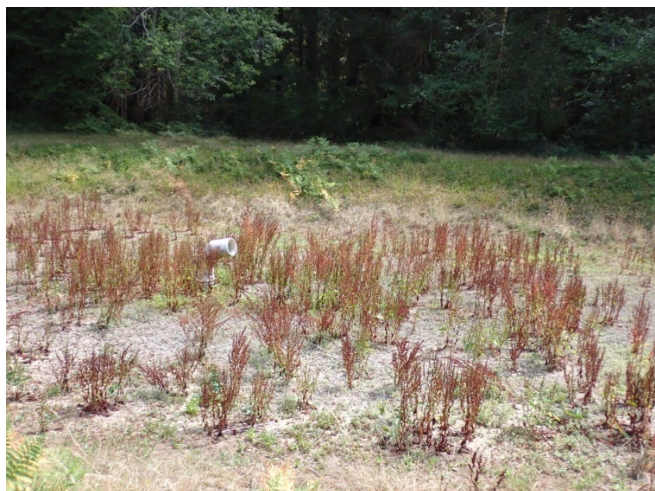
Photo #:07 (P7280241)

Description: Facing east, photo of one of the Facility's sludge lagoons.

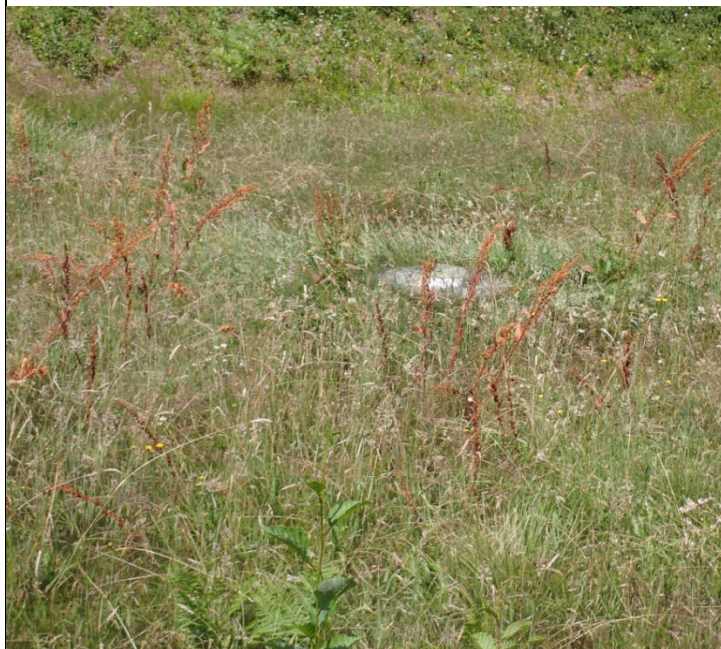
Photo #:08 (P7280243)

Description: Facing west, photo of the other sludge lagoon for the Facility. This lagoon was actively receiving cleaning water from the settling basin at Cook Creek.

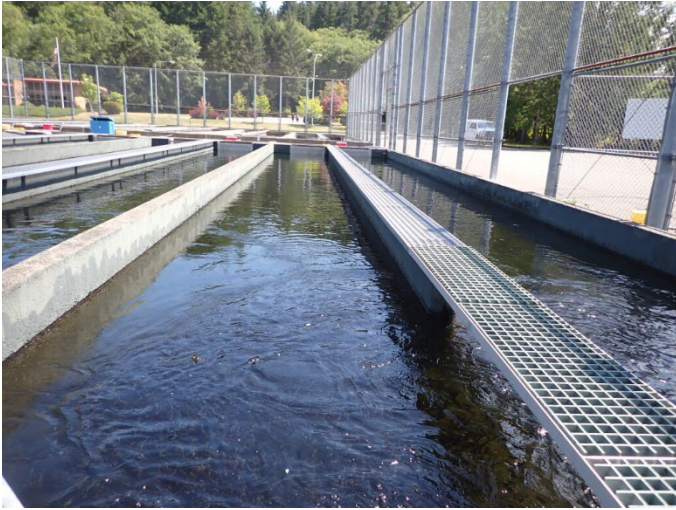
Photo #:09 (P7280246)

We then drove back to the main hatchery where I observed the raceways. Twelve of the raceways were filled with coho salmon and steelhead trout at the time of inspection (**Photo 9**). A 48-inch line supplies water into the raceway headers which "T's off" for each raceway. Representative influent sampling and proportional flow measurements are taken at the raceway headers when multiple intake sources are used via the Facility's "vault" mixing valve in the open position. Each raceway had a small quiescent zone. Raceways are cleaned 3-7 times per week using brushes. Any cleaning water goes into the Facility's inline settling basin.

Description: Facing east, photo of the adult pond raceways, some of which had coho salmon and steelhead trout in them.

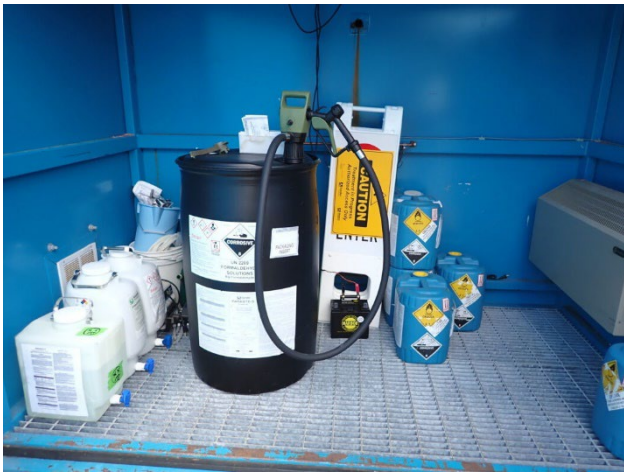
Photo #:11 (P7280258)

Description: Photo of one of the Facility's chemical storage sheds outside with secondary containment.

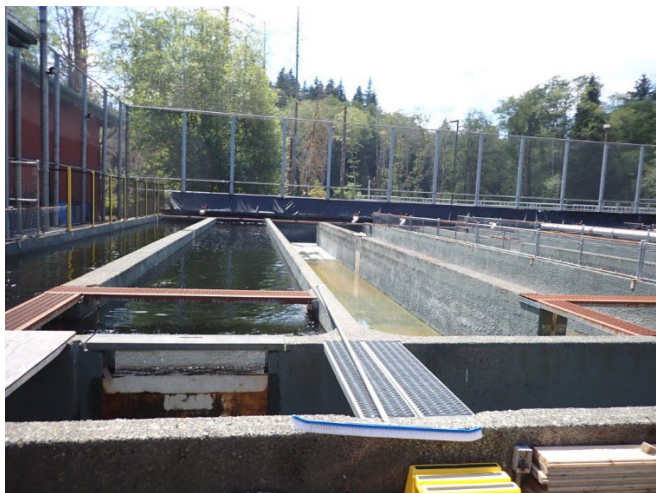
Photo #:13 (P7280265)

Next to the spawning building was an area the Facility calls “E Bank” containing six dual purpose ponds that can hold both adult and juvenile fish (**Photo 13**). Cleaning in these ponds is conducted three times per week using a pump, and cleaning water is pumped into the Facility’s inline settling basin located adjacent to “E Bank”. I observed growth in the inline settling basin in which the Facility planned to clean (**Photo 14**). Drawdown effluent of the inline settling basin is pumped to one of the sludge lagoons.

Description: Facing south, photo of the Facility's "E Bank" of six dual use holding ponds. At the time of inspection, these ponds contained juvenile fish.

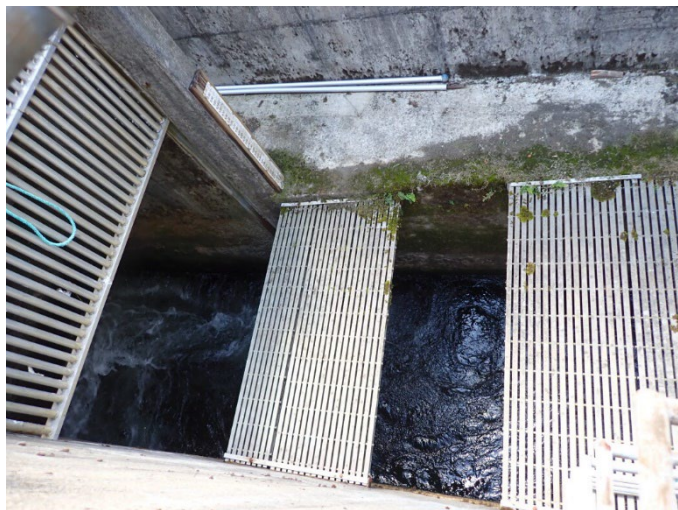
Photo #:15 (P7190272)

Description: Facing south and looking down, photo of the Facility's outfall 001 with active effluent discharge.

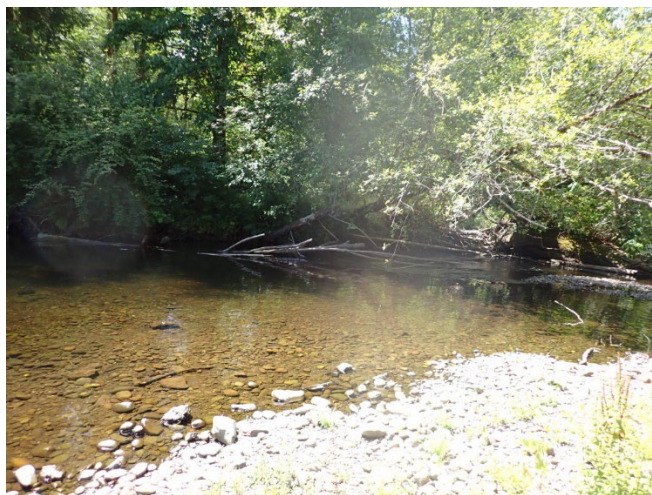
Photo #:16 (P7190276)

We then walked to the Facility’s main effluent discharge point (Outfall 001) that was actively discharging into Cook Creek (**Photo 15**). Cook Creek immediately downstream of Outfall 001 appeared clean and no turbidity was observed (**Photo 16**). Sampling procedures described by Mr. Fielding for effluent discharge comported with permit requirements. We then followed the fish ladder to where it leads to the Facility’s spawning building (**Photo 17 & Photo 18**).

Description: Facing southwest, photo of Cook Creek immediately downstream of outfall 001 discharge.

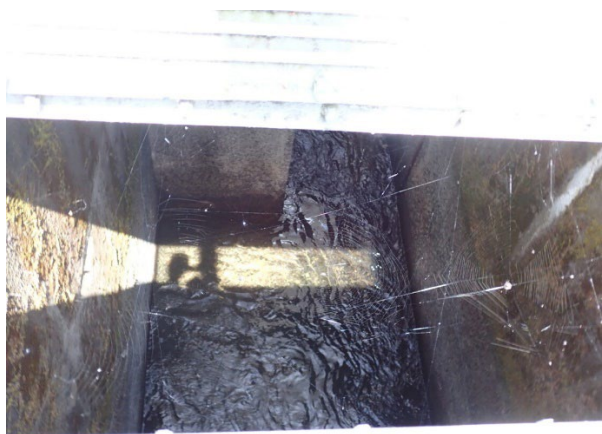
Photo #:17 (P7280281)

Description: Facing northwest and looking down, photo of the Facility's fish ladder that leads to the spawning building. This fish ladder does not contain any boards.

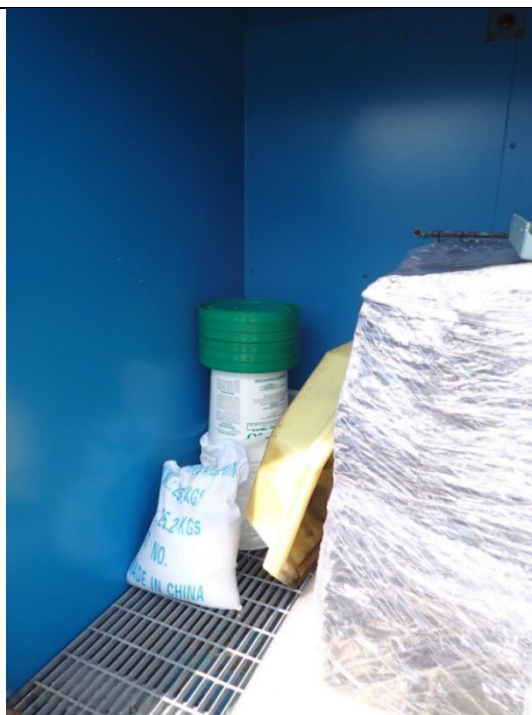
Photo #:20 (P7280288)

We visited the Facility’s egg isolation building that was not in active use at the time of inspection (**Photo 19**). Next to the egg isolation building was another chemical storage shed with built-in secondary containment that met the permit’s material storage requirements (**Photo 20**). I asked Mr. Fielding about other chemical use at the Facility, and he indicated Virkon© was used to disinfect equipment. Post-inspection correspondence with Mr. Fielding confirmed used Virkon© is taken to a grassy area to drain and is not discharged to surface waters. Chlorine is also used to disinfect trucks and then trucks sit outside under the sun to dry.

Description: Photo of another chemical storage shed at the Facility with built-in secondary containment.

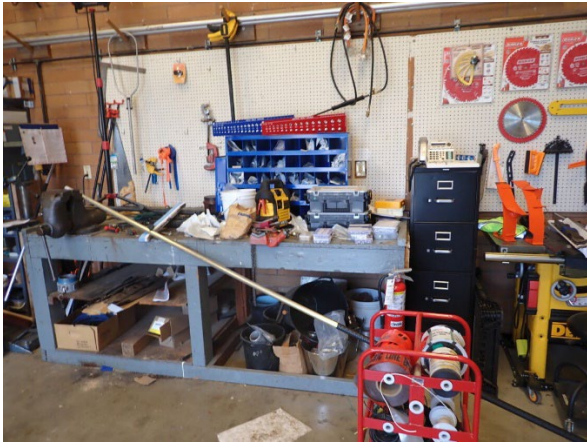
Photo #:21 (P7280290)

We then entered the Facility’s vehicle maintenance and wood shop where minimal maintenance is conducted (**Photo 21**). Any oily rags produced are properly disposed of and any used oil is hauled to the county transfer station once per year.

Description: Photo of the Facility's vehicle maintenance and wood shop where minimal maintenance is conducted.

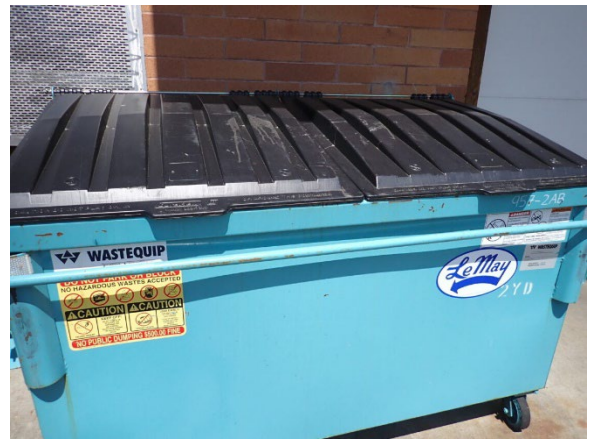
Photo #:22 (P7280293)

We continued walking East where I observed the Facility’s trash dumpster where the Facility may dispose of small amounts of dead fish and waste/unused medicated feed along with domestic trash (**Photo 22**). As we continued walking East, I observed the Facility’s gas and diesel station used for small gas-and diesel-powered equipment and vehicles (**Photo 23**) and an additional diesel station (**Photo 24**). Each of these fuel stations were properly labeled. I also observed a general material storage hut (**Photo 25**) and the Facility’s main flammable and chemical storage area (**Photo 26**). At the time of inspection, a strong odor was observed from an unknown source inside this chemical storage area. Mr. Fielding took note to further investigate the odor.

Description: Facing north, photo of the Facility's trash dumpster that is used to dispose of unused or waste medicated feed and some dead fish along with other domestic trash produced at the Facility. The dumpster is emptied weekly.

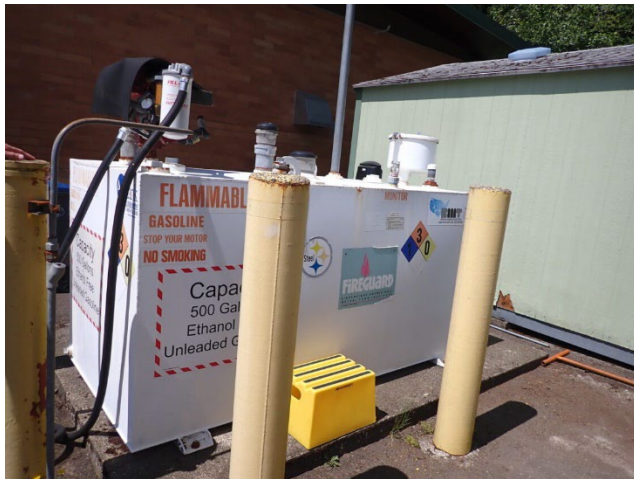
Photo #:23 (P7280294)

Description: Facing northwest, photo of the Facility's diesel and gas station used to fuel vehicles and small gas-or diesel-powered equipment.

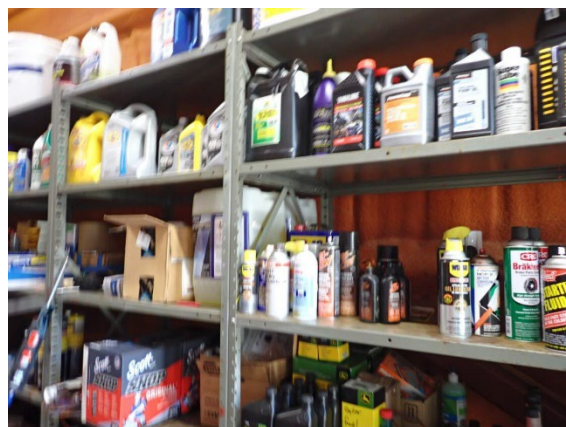
Photo #:26 (P7280303)

During the site walkthrough, there was a strong odor in the flammable and chemical storage shed from an unknown chemical source, suggesting possible leak and/or lack of proper chemical containment and storage.

Description: Photo of inside the Facility's main flammable and chemical storage building where a strong odor was observed.

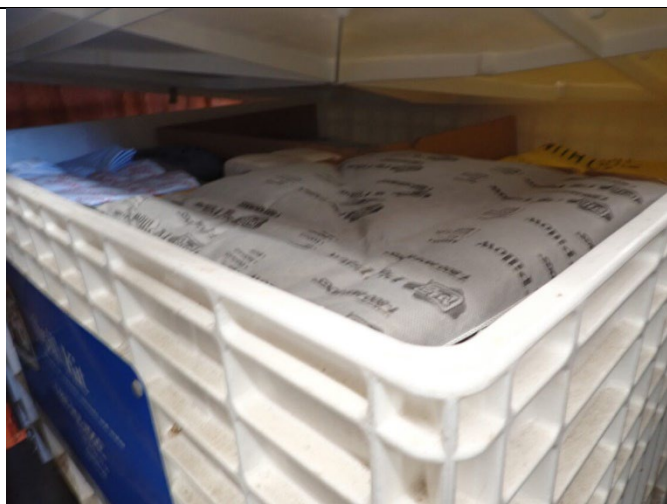
Photo #:27 (P7280307)

Description: Photo of inside the Facility's main spill kit in the equipment storage building.
