## INSPECTION REPORT

<b>Media:</b>	Water
<b>Statute(s)/Program(s):</b>	Clean Water Act, NPDES
<b>Type of inspection:</b>	CEI - Compliance Evaluation Inspection
<b>Access:</b>	Granted
<b>Permittee Name:</b> Falling Springs Quarry	
<b>Facility or Site Name:</b> Falling Springs Quarry	
<b>Facility/Site Physical Address:</b> 2901 Stolle Road	
<b>(City, state, zip code)</b> Dupo, IL 62239	
<b>County/Parish:</b> St. Clair County	
<b>Facility GPS Coordinates:</b> 38.543481, -90.169735	
<b>Mailing address: (If different)</b>	
<b>(City, state, zip code)</b>	
<b>Facility/Site Identifier:</b> Falling Springs Quarry	
<b>Permit Number:</b> No NPDES Permit	
<b>SIC or NAICS:</b> NAICS 1422

Industrial Storm Water Inspection at a Quarry.

**Falling Springs Quarry  
EPA Inspection April 20, 2022  
All photos taken by Cheryl Burdett, Life Scientist/Inspector, U.S. EPA  
Camera: Olympus Tough TG-4**

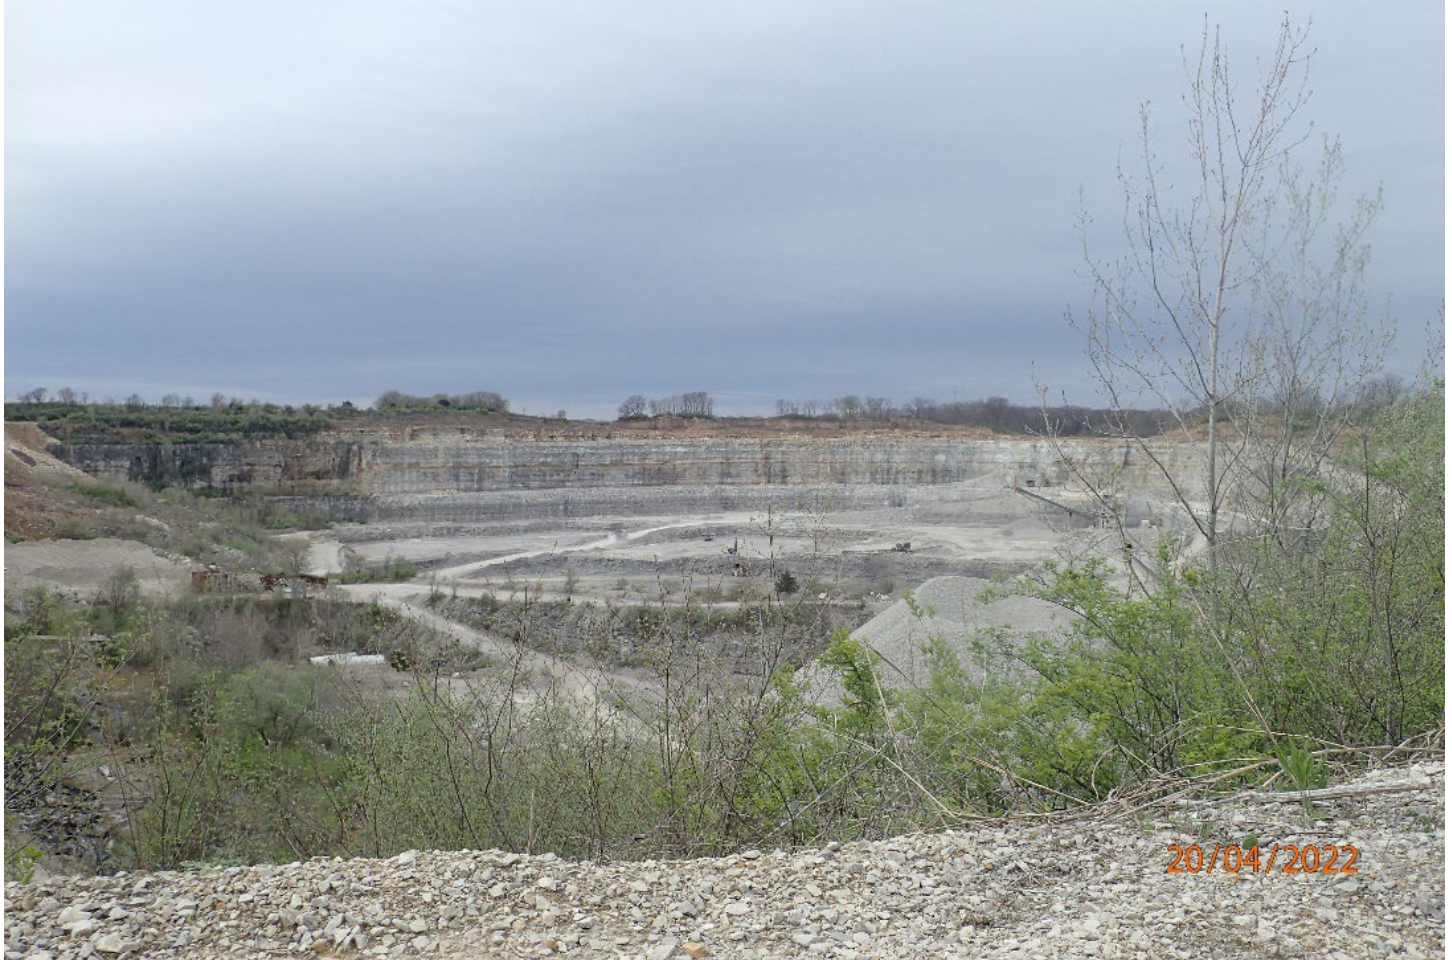
1: P4200010

Description: The active Falling Springs Quarry. The rock face directly across from photographer is the active face. Below approximately 30-40' of overburden is the limestone cap.

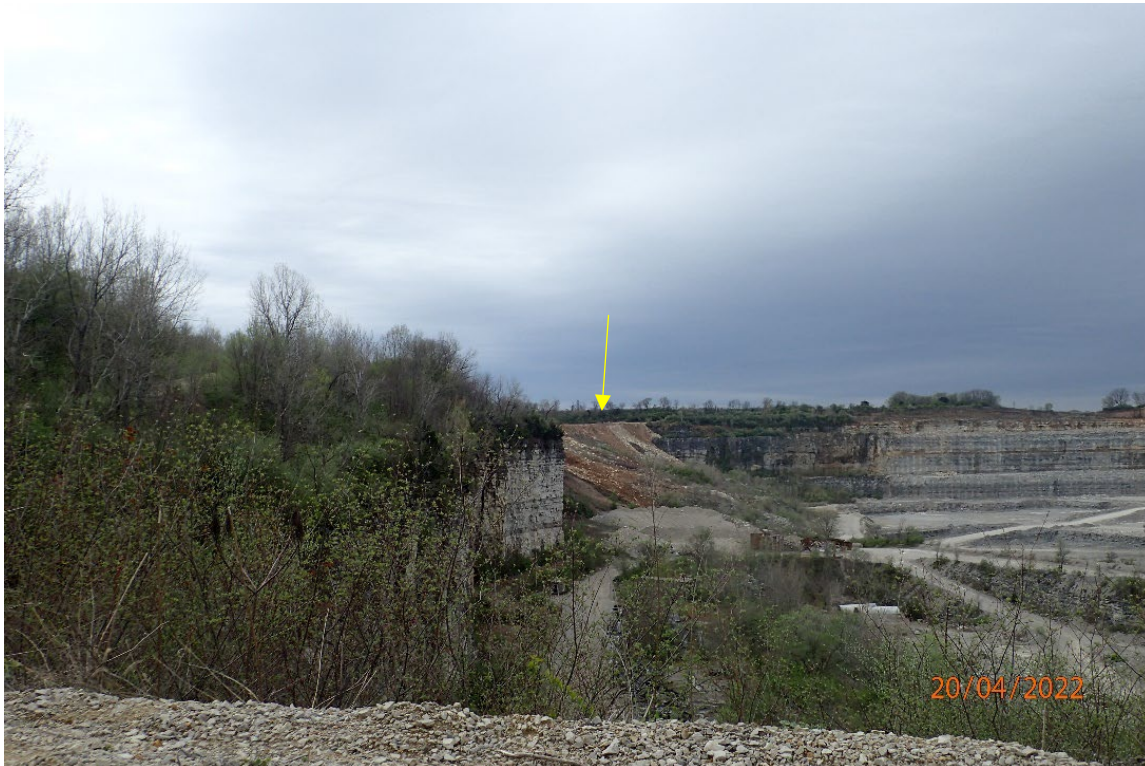
2: P4200011

Description: Dirt and limestone mix is internally dumped on the east side. Yellow arrow is pointing at the dirt and limestone mix.

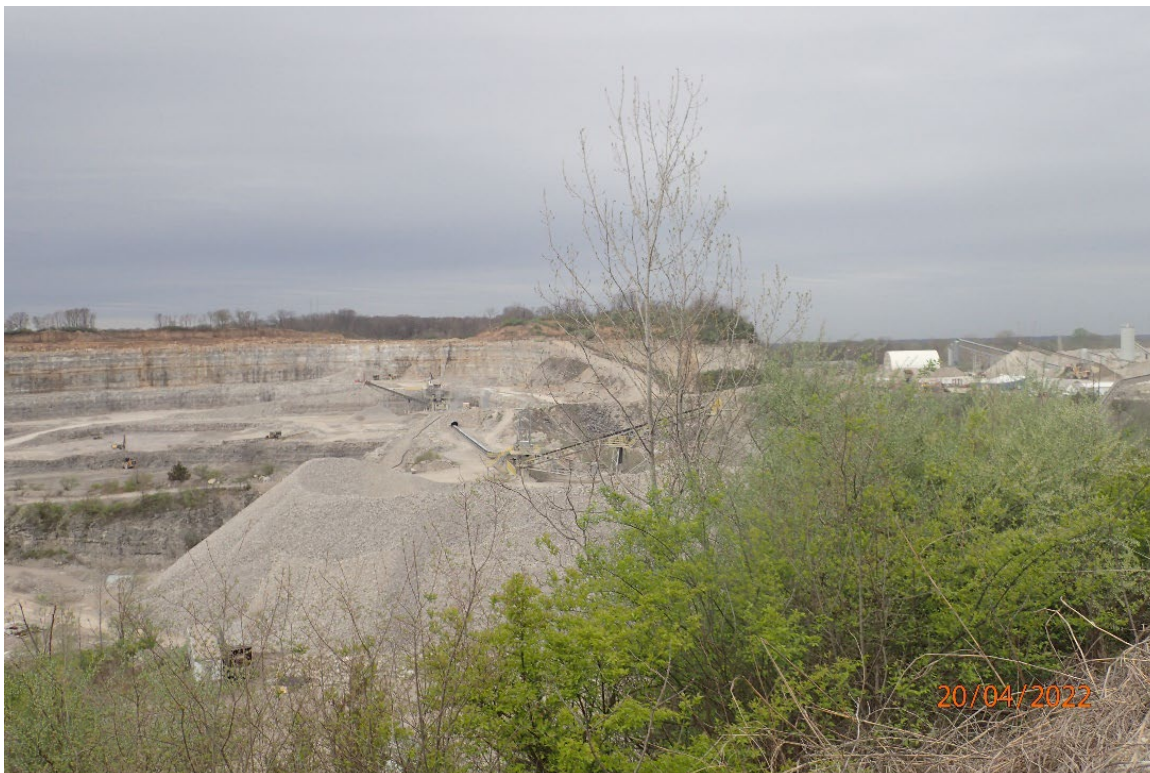
3: P4200012

Description: Limestone crushing operation in the Falling Springs Quarry.

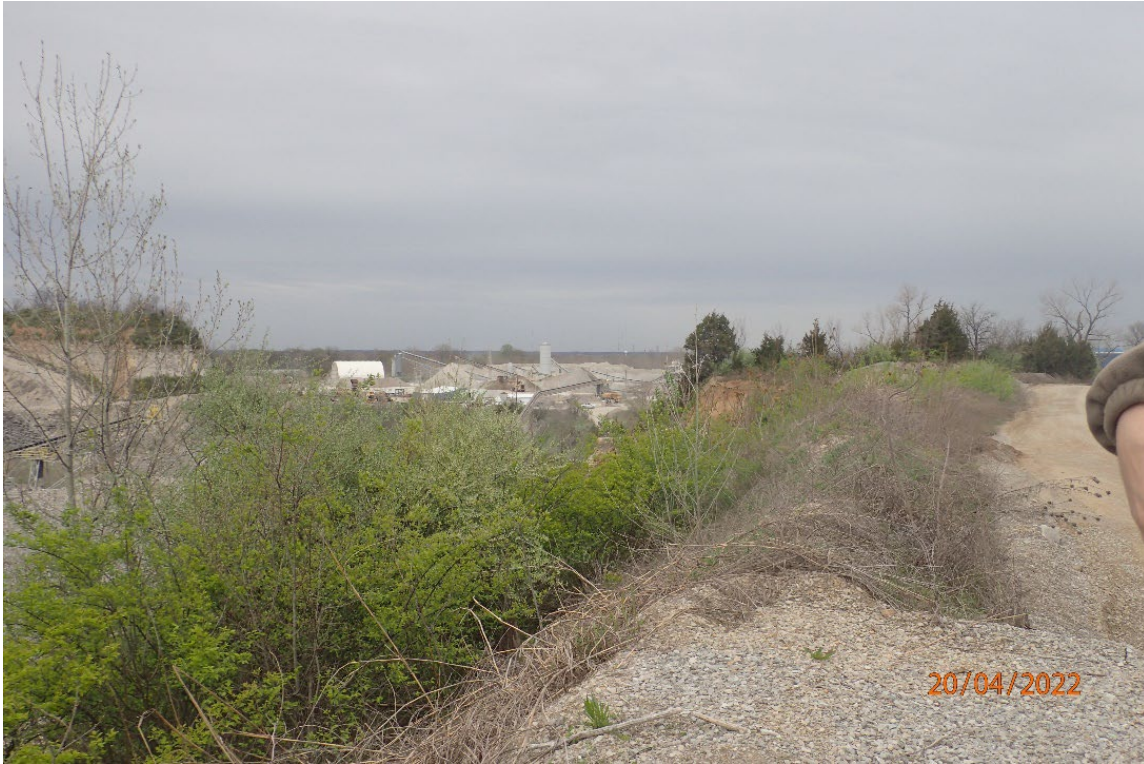
4: P4200013

Description: Limestone crushing operation in the Falling Springs Quarry.

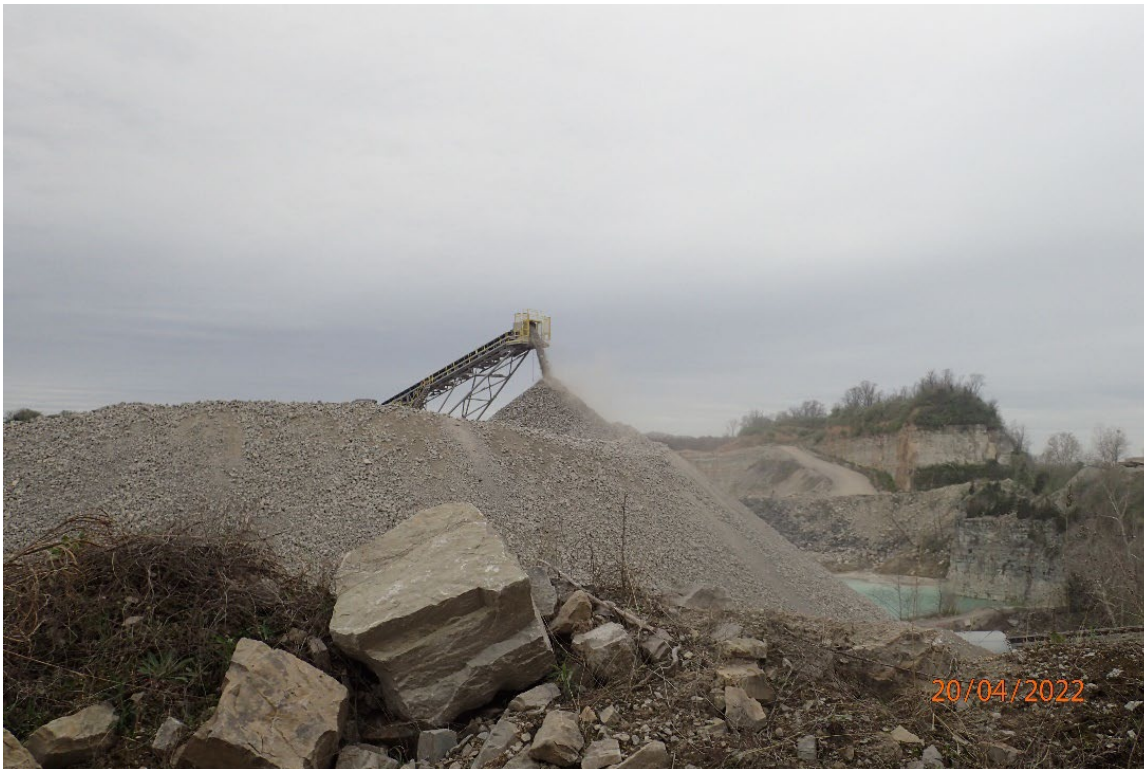
5: P4200014

Description: Limestone is crushed and then piled in the quarry.

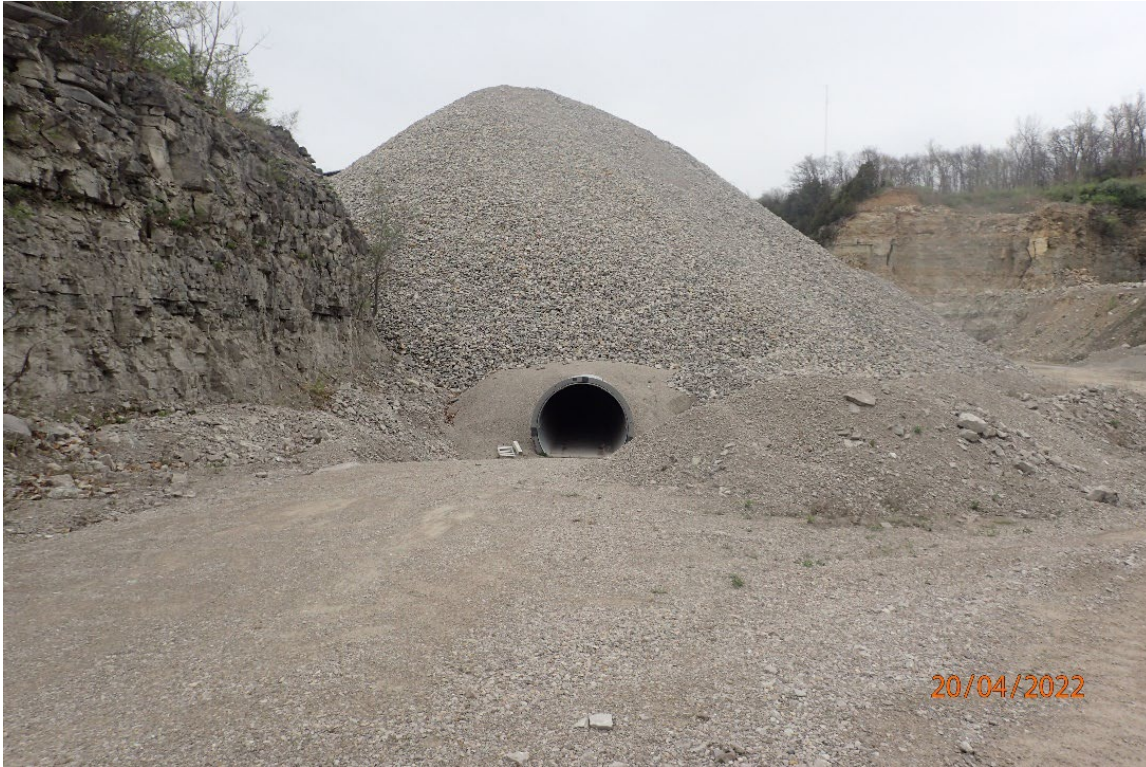
6: P4200015

Description: The crushed rocks are piled on top of a steel tunnel with three foot concrete walls around it. The tunnel contains the conveyor belt for transporting the crushed rock.

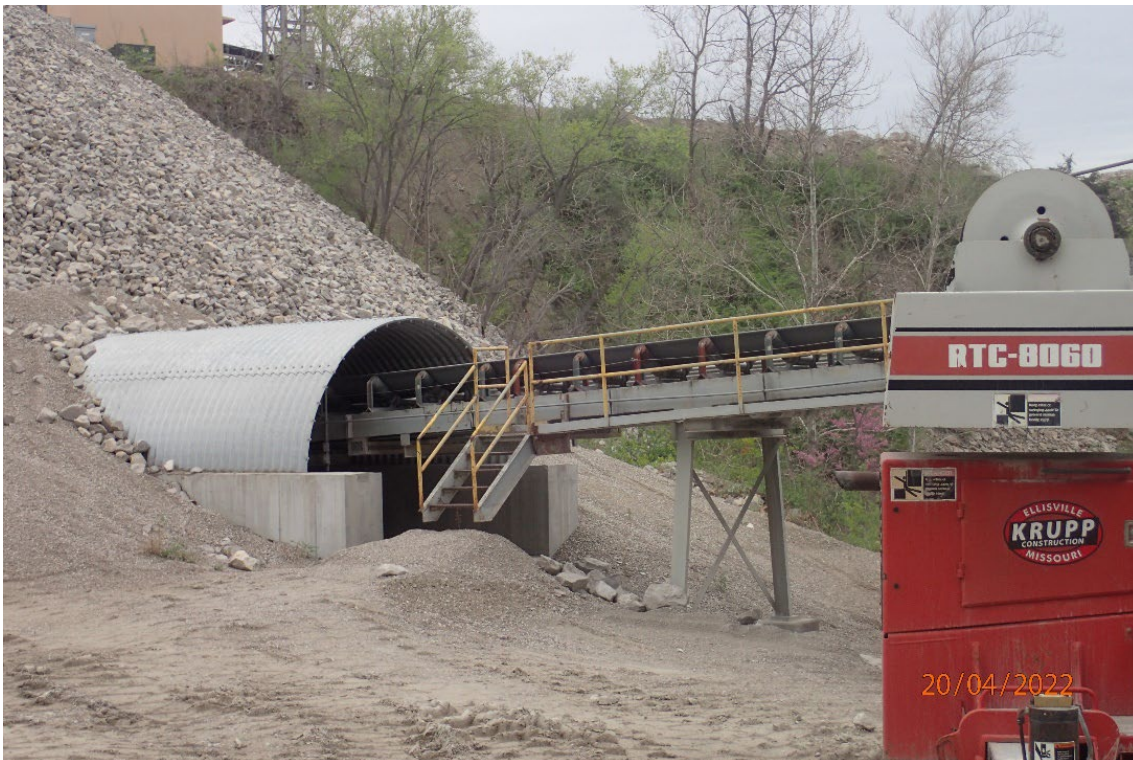
7: P4200016

Description: The conveyor exits the tunnel under the pile of crushed rock.

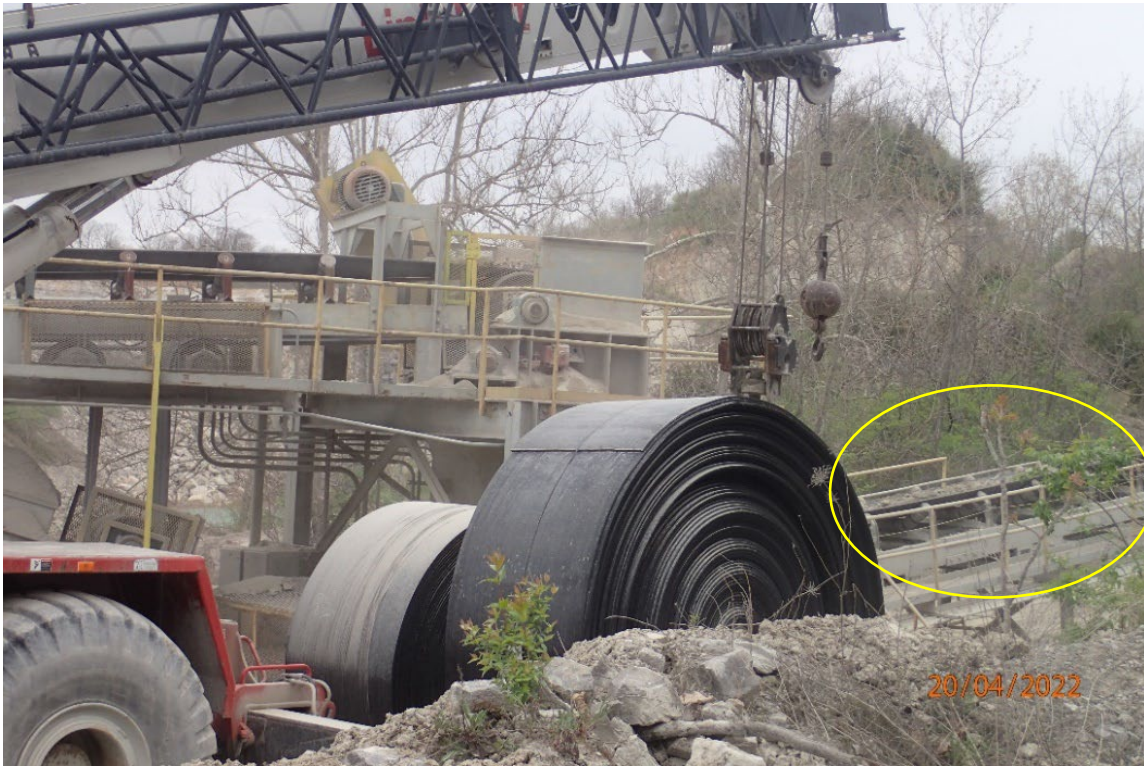
8: P4200017

Description: The conveyor transports the rock (circled with a yellow circle) from under the pile of crushed rock.

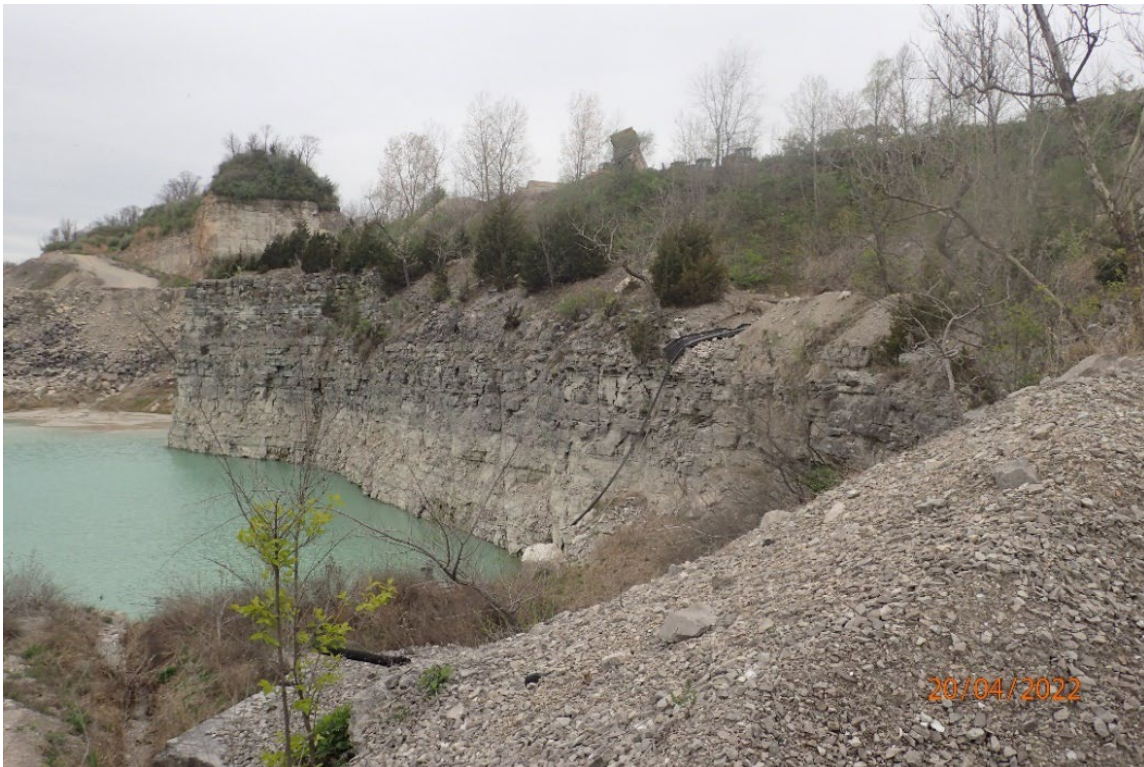
9: P4200018

Description: The pit in the Falling Springs Quarry has a floating pump which pumps pit water up the side of the quarry. The pit is on the northeast side of the quarry.

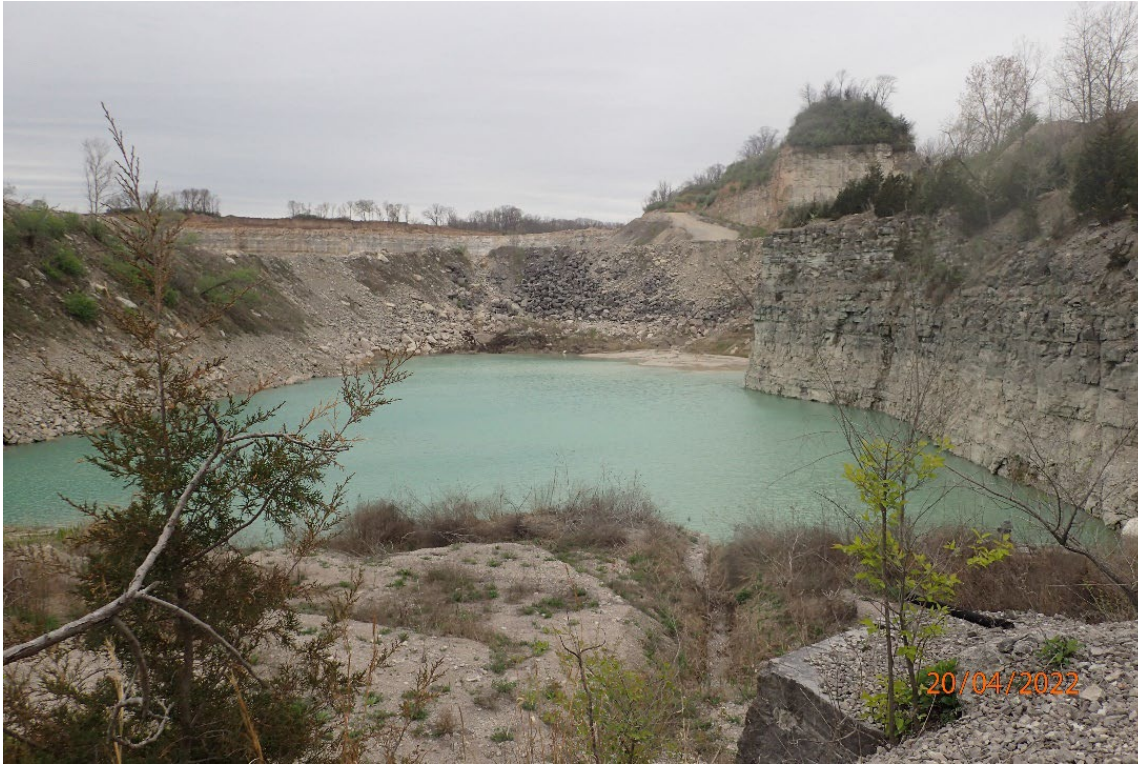
10: P4200019

Description: The water in the pit at Falling Sprins Quarry.

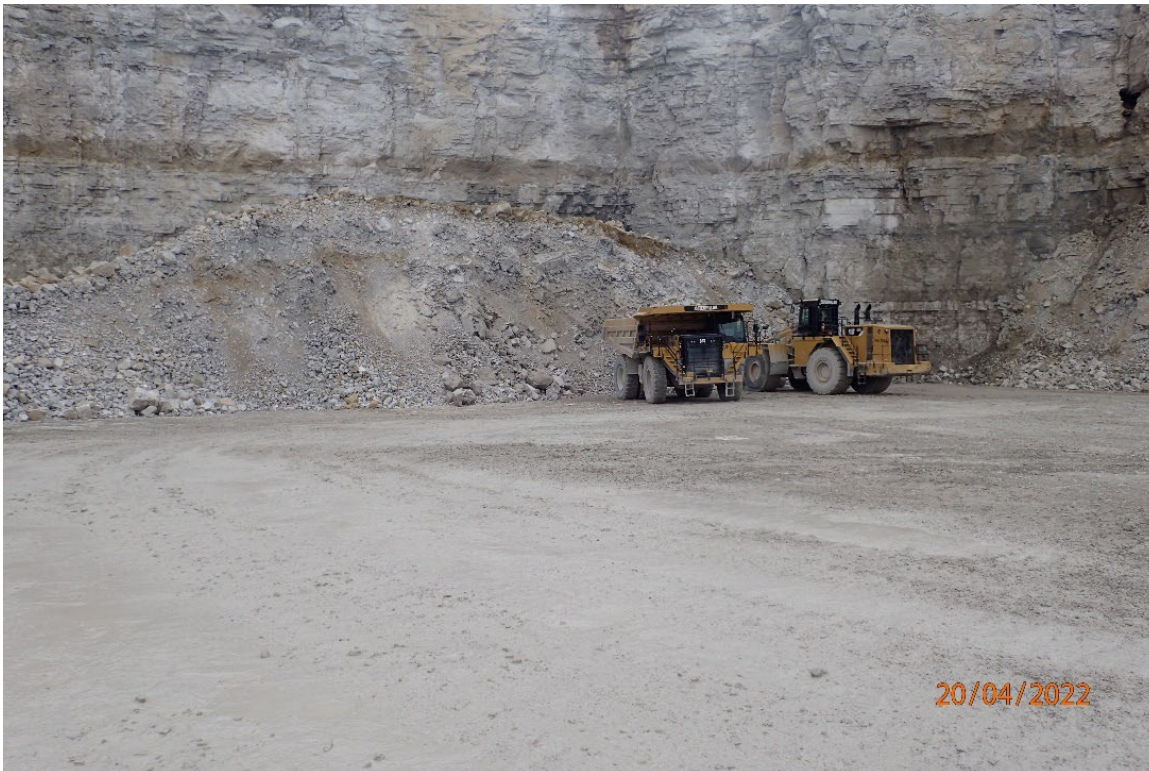
11: P4200020

Description: Trucks scoop up the limestone after it is blasted off the face of the cap.

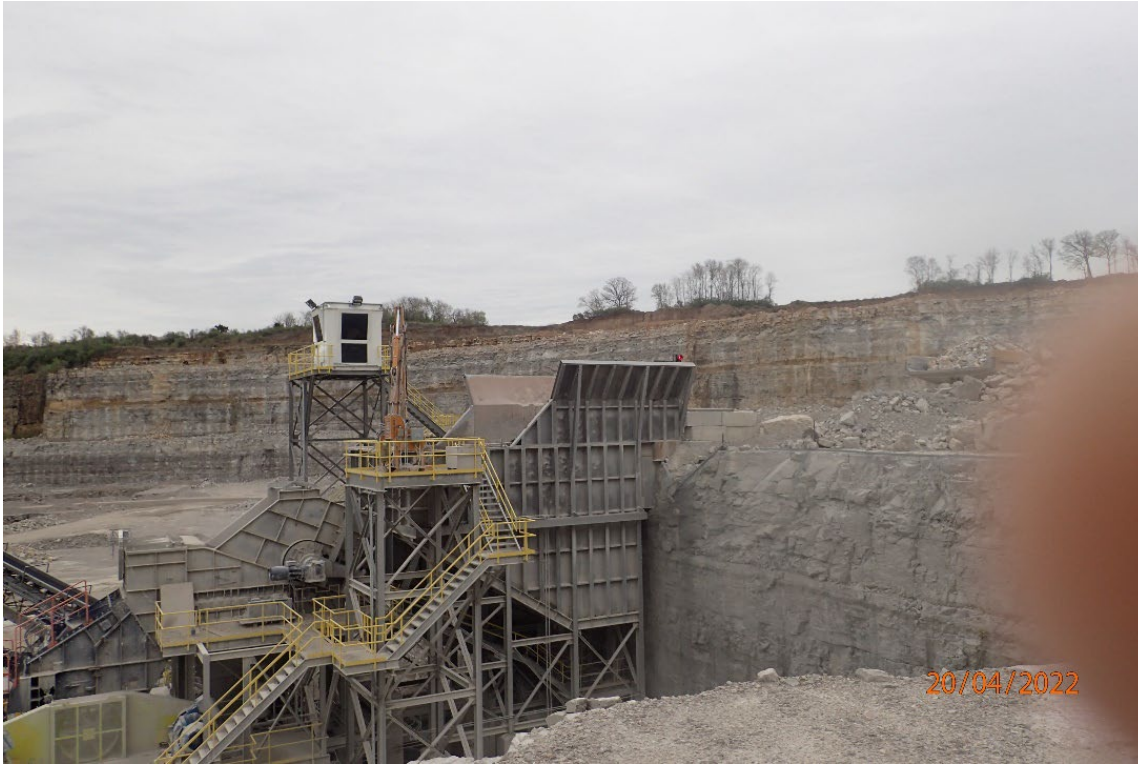
12: P4200021

Description: The trucks dump the limestone into a crusher.

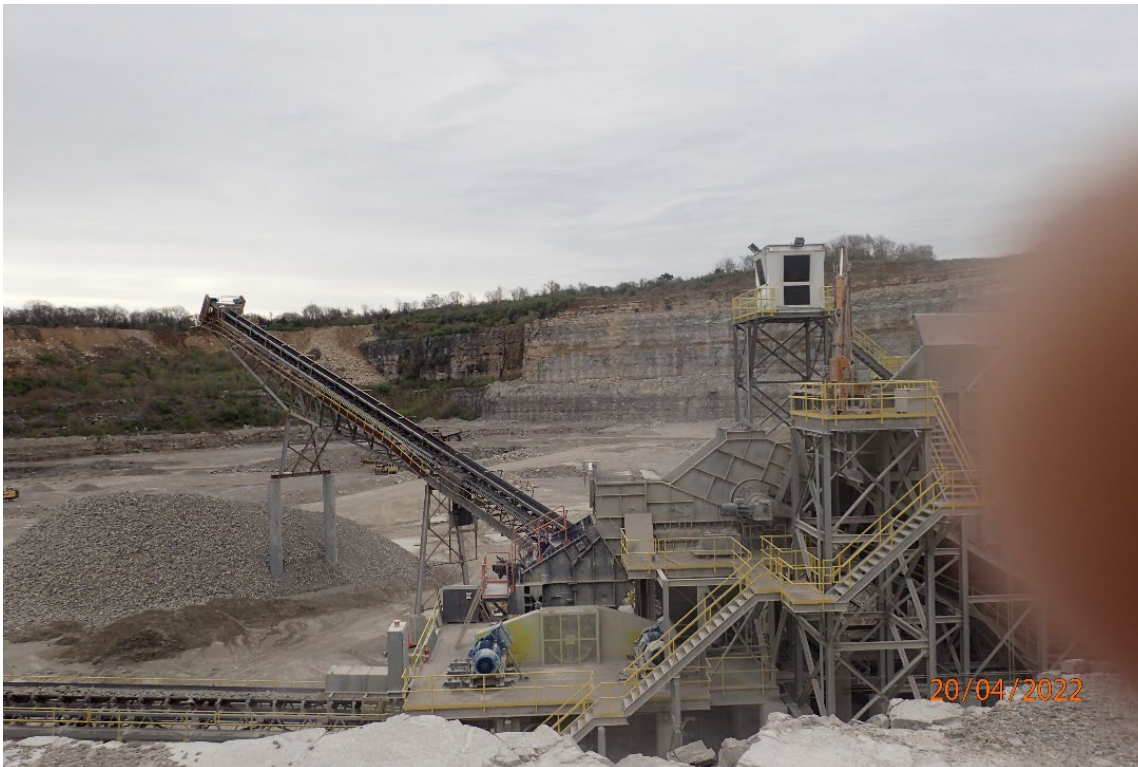
13: P4200022

Description: The fines – smaller pieces of limestone – fall to the bed of the conveyor. The larger pieces go through the crusher.

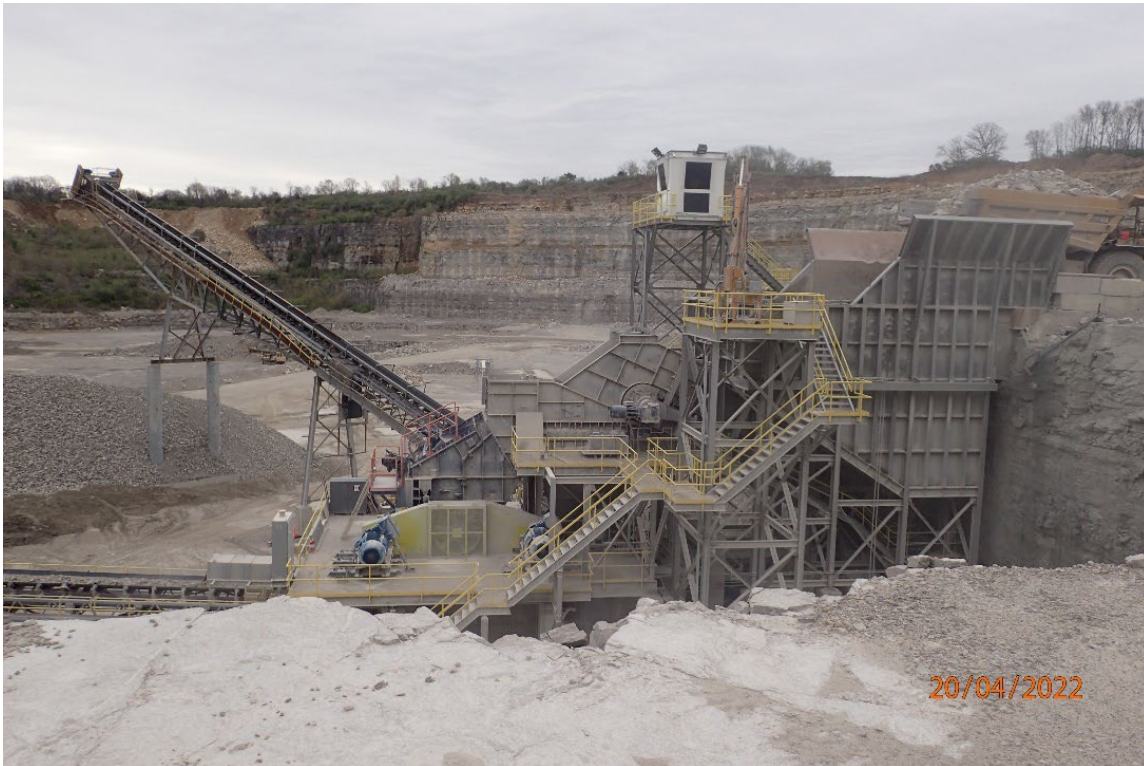
14: P4200023

Description: The fines – smaller pieces of limestone – fall to the bed of the conveyor. The larger pieces go through the crusher.

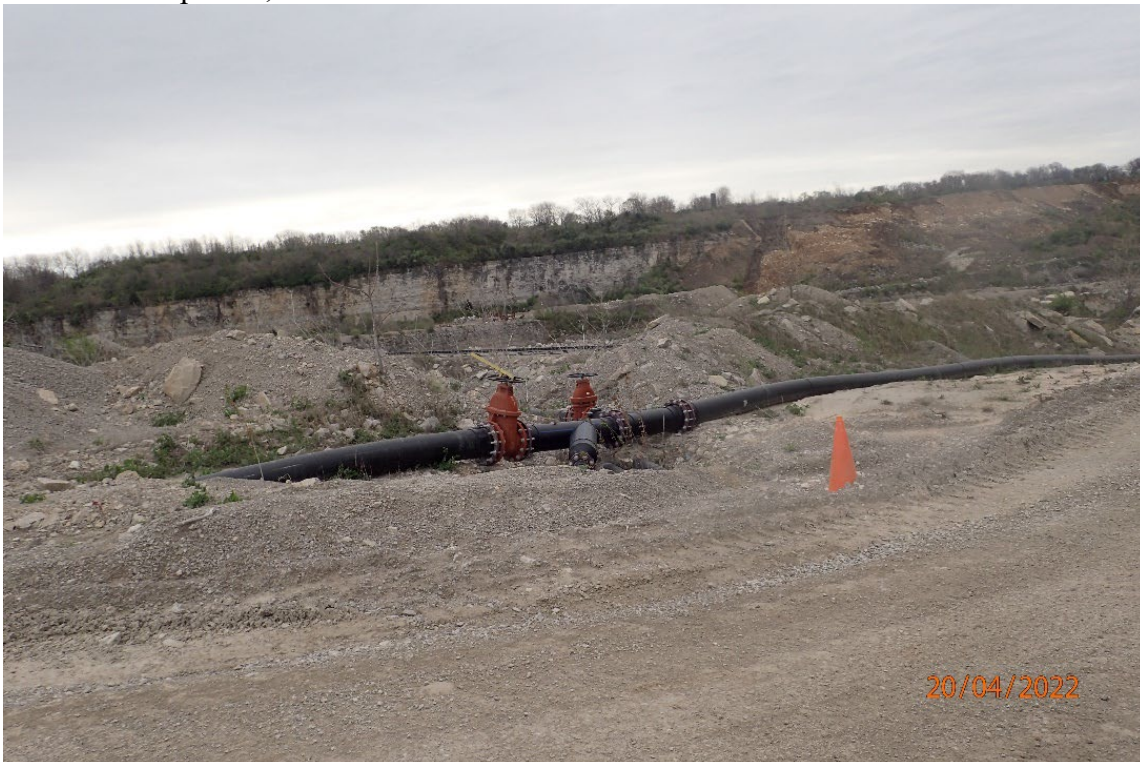
15: P4200024

Description: Valves on the water line allow the water to be directed to a ditch which goes to the sand lakes or to trucks for dust suppression.

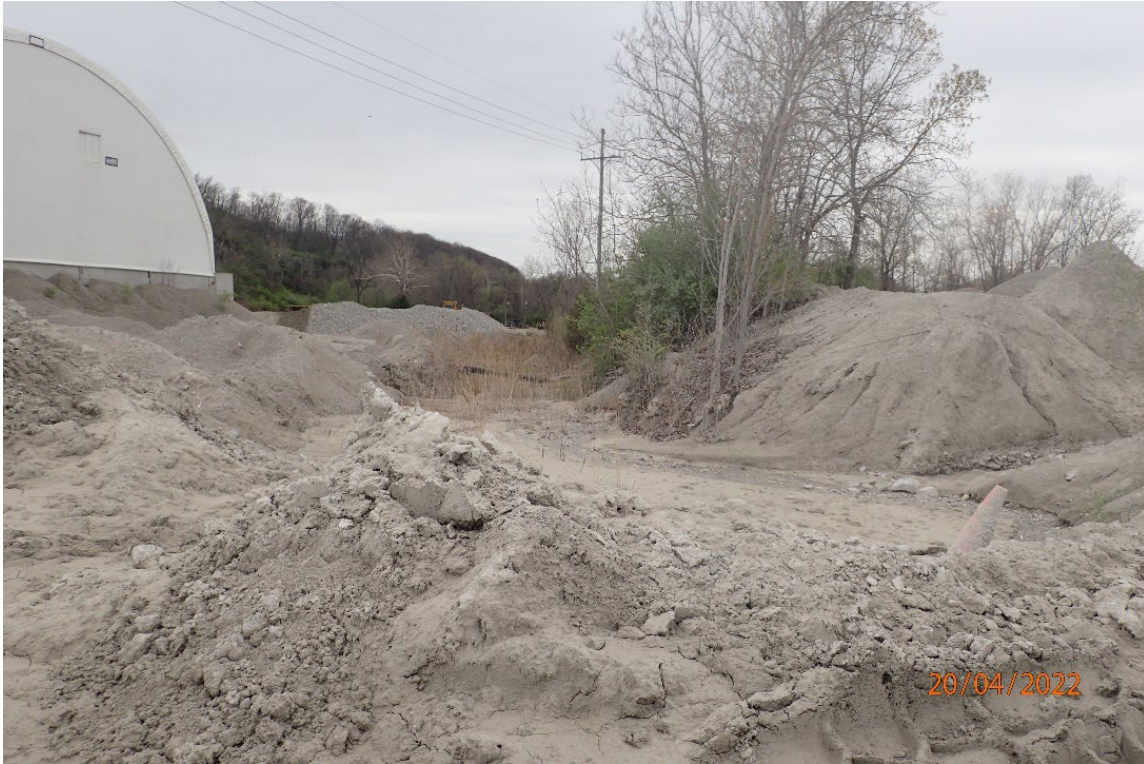
16: P4200025

Description: The ditch which allows flow to go to the sand lakes.

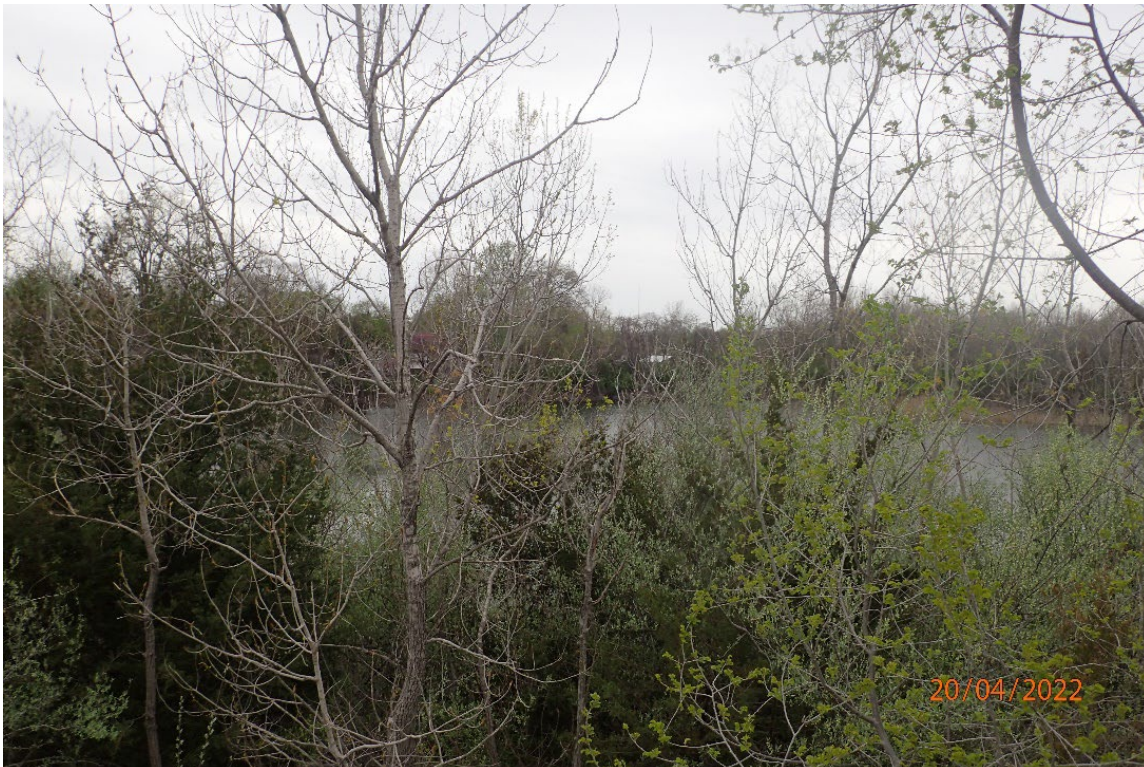
17: P4200026

Description: The sand lakes accept pit water and the water evaporates and infiltrates. There is no outlet for the sand lakes to waters of the United States.

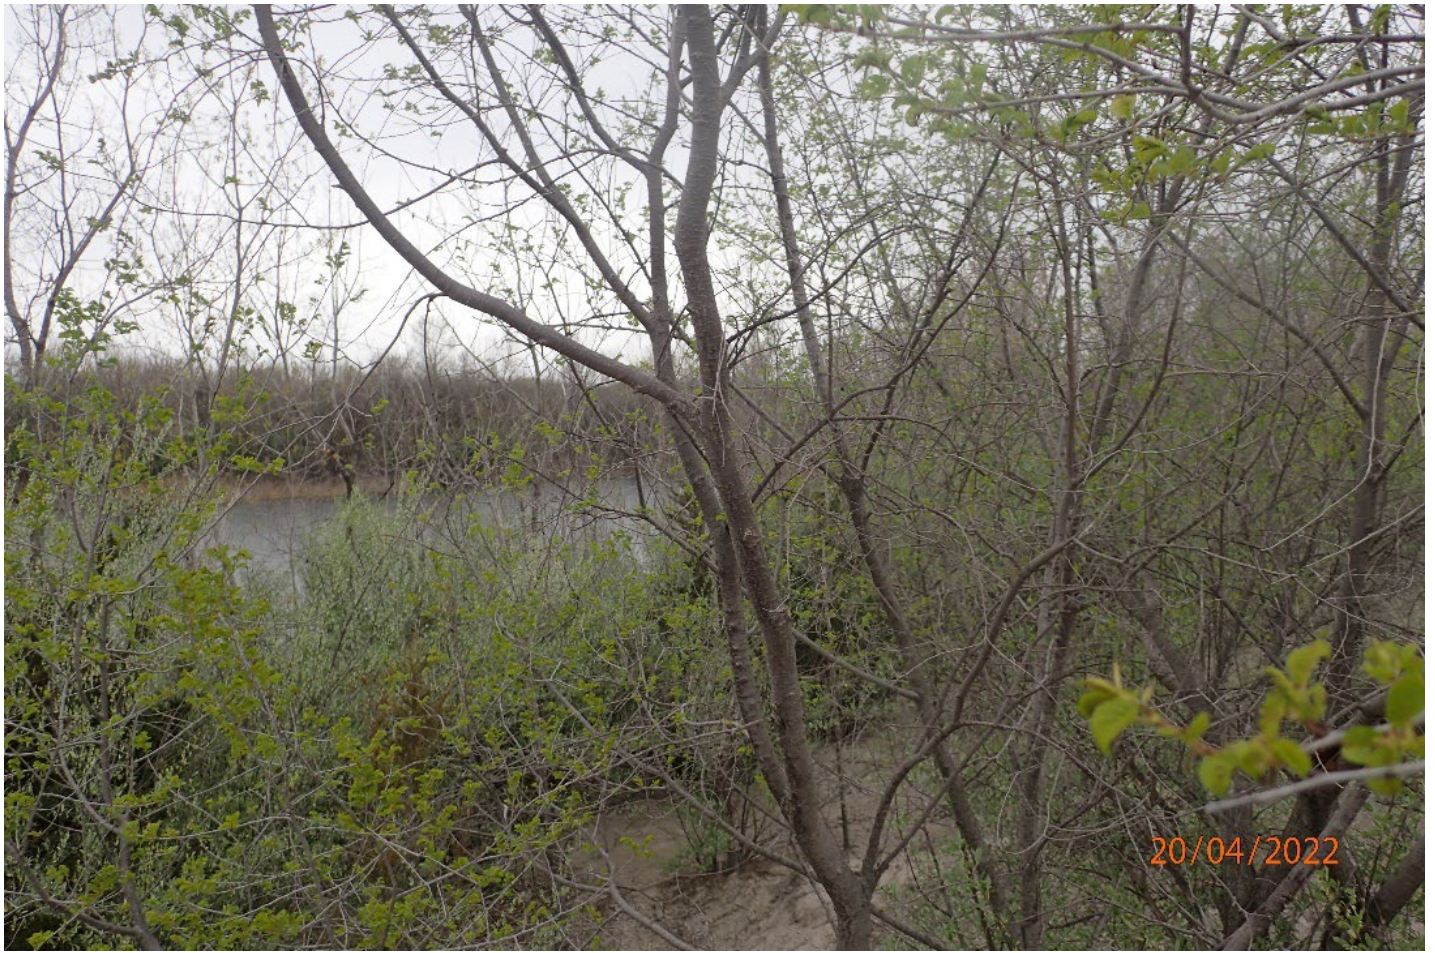
18: P4200027

Description: There was at least ten to fifteen feet of freeboard in the sand lakes.
