## **RCRA Inspection Report**

Bonnell Aluminum, Inc.  
State Highway 53  
Carthage, Tennessee 37030

EPA ID#: TND047000898  
NAICS #: 331314 – Secondary smelting and  
Alloying of Aluminum

May 9, 2024, 9:36 AM

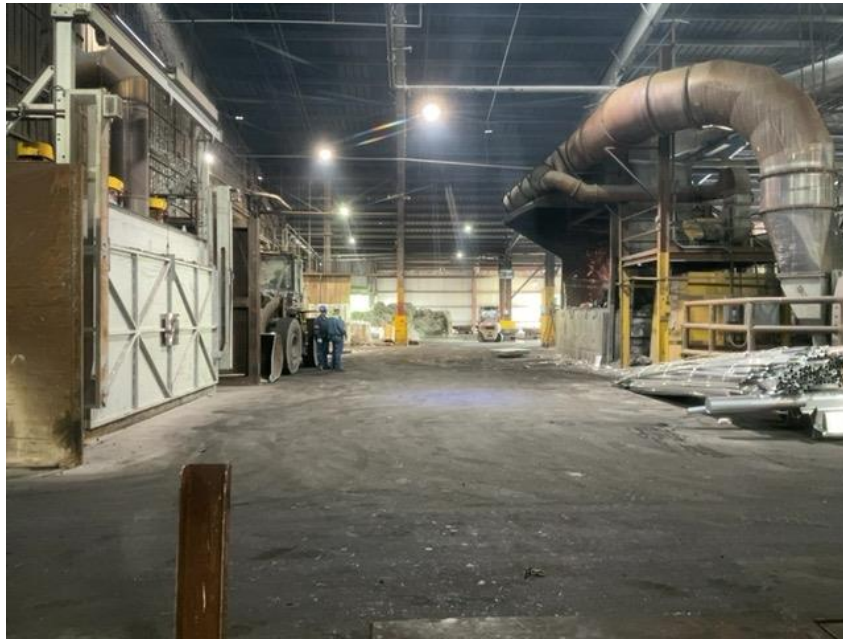
The casting of 18.5-foot aluminum rods is conducted in this area. The casting line heats the aluminum logs in the furnace and saws them into smaller billets. Inspectors observed piles of aluminum saw fines consisting of thin metal scraps in the casting line (Photo 1). Bonnell

Photo 1: Casting Line with metal piles of saw shavings to be sent for recycling.

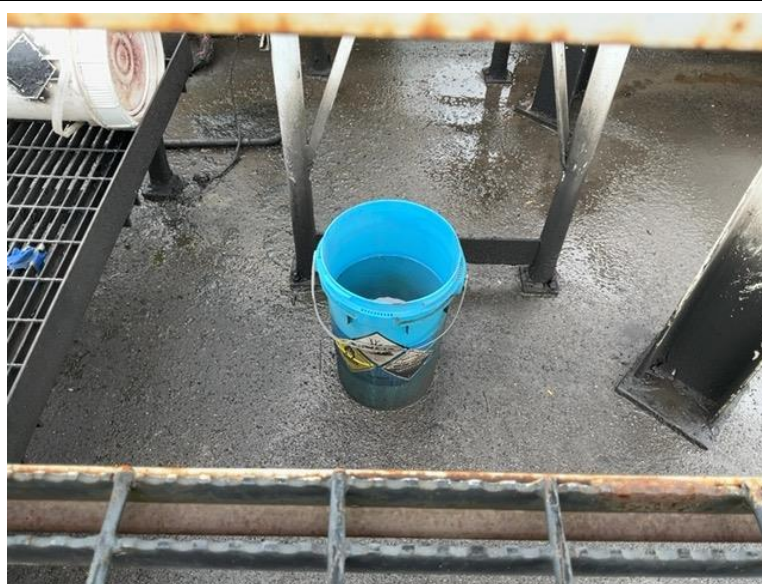
Inspectors observed a small tank farm in secondary containment outside of the oil water separator. Inspectors observed two 3,000-gallon tanks labeled "Used Oil." Inspectors observed an open 5-gallon container full of liquid with dangerous when wet and corrosive DOT regulated placards (Photo 4). Based on the large amount of rain at the facility with the preceding 12 hours and discussion with Mr. Cohoon, this was determined to be rainwater. Inspectors also observed rainwater in the secondary containment.

Photo 4 – 5-gallon open container of rainwater in the containment of the oil water separator.

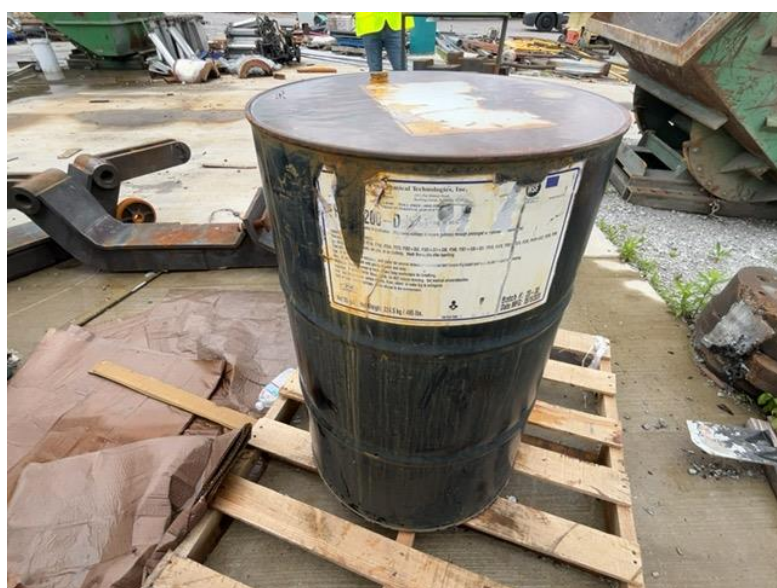
Inspectors observed a 55-gallon container of water glycol (Photo 5). This container had an open bung hole at the top and had accumulated rainwater. Facility representative informed inspectors that this container was staged to be added to the used oil tank.

Photo 5 – 55-gallon container of water-glycol that was open and accumulating rainwater.

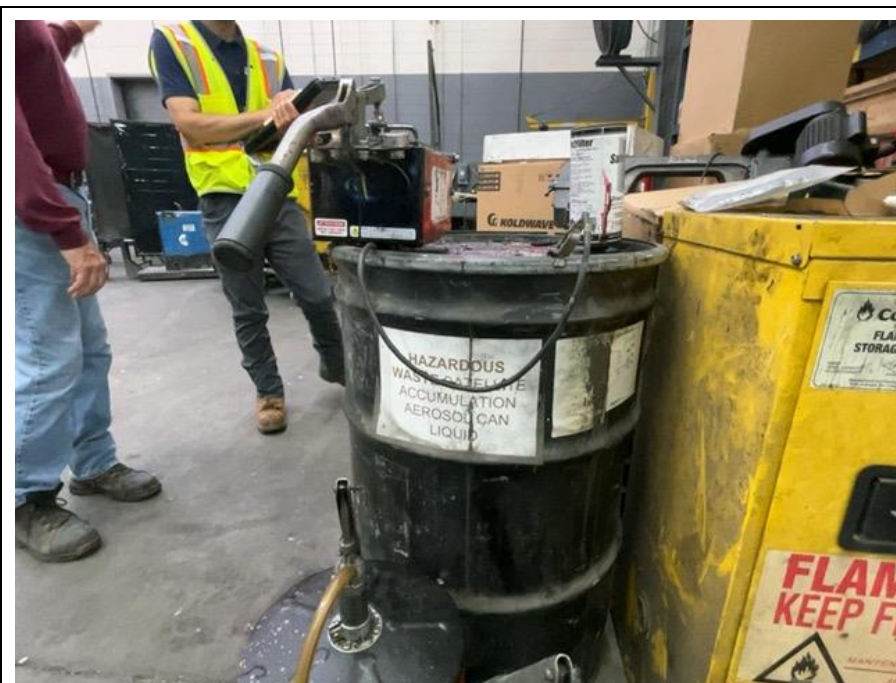
Inspectors observed a 55-gallon closed SAA container for aerosols (Photo 6). This container was labeled with words "Hazardous waste." The container was not marked with an indication of hazards.

**Pursuant to Tenn. Comp. R. & Regs. 0400-12-01-.03(1)(f)1.(v) [40 C.F.R. § 262.15(a)(5)], which is a condition of the SAA Permit Exemption, a generator is required to mark or label its containers (ii) with an indication of the hazards of the contents.**

Photo 6 – Aerosol liquid SAA in the equipment maintenance area. This container was not marked with an indication of hazards of the contents.

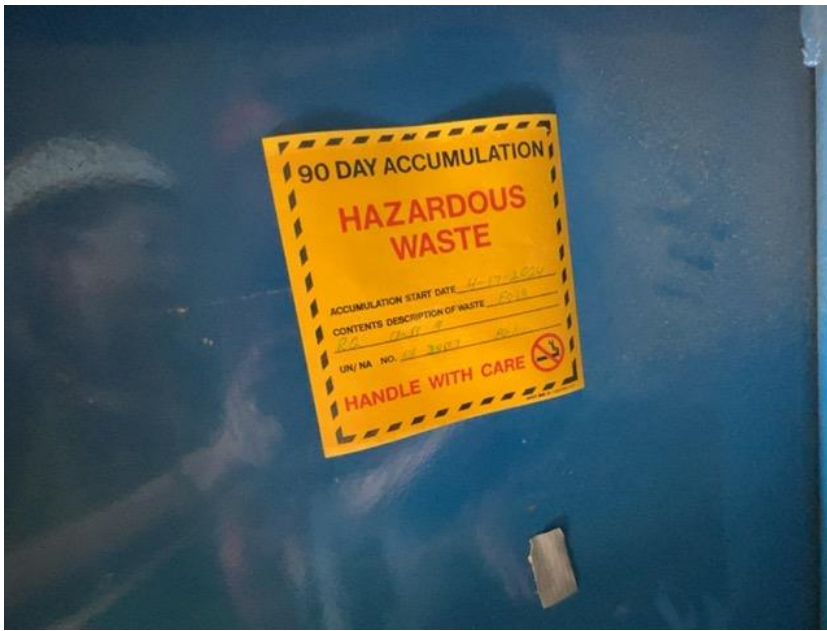
If the aluminum requires painting following the anodizing line, it is brought to the paint line. Aluminum parts are treated with a chromate coating before painting. Waste chromate and rinsewater from this coating is treated in the facility's wastewater treatment plant. Solids are removed with a filter press and shipped as D007 toxic hazardous waste. Inspectors observed a roll off container in containment in an enclosed building near the paint line collecting the filter cake. This container is managed as a central accumulation area (CAA) container and was labeled with the words "Hazardous waste" and dated 4/17/2024. The roll off container was not marked with an indication of the hazards of its contents (Photo 8).

**Pursuant to Tenn. Comp. R. & Regs 0400-12-01-.03(1)(h)1.(v)(I)II. [40 C.F.R. § 262.17(a)(5)(i)], which is a condition of the LQG Permit Exemption, a generator must mark or label its containers with an indication of the hazards of the contents.**

Photo 8 – Roll off container label missing indication of the hazards of its contents.

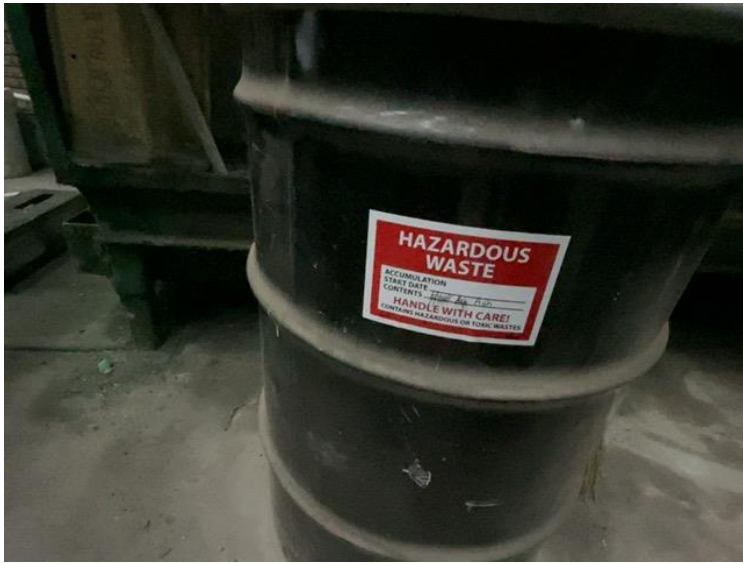
exhibits the hazardous characteristic of toxicity for chromium. Inspectors observed a 55-gallon SAA container of hook ash in this area labeled “Hazardous Waste” (Photo 10). The word toxic was marked on the label, but facility representatives informed inspectors they would add a placard for clearer indication.

Photo 10 – SAA container for hook ash generated in the paint line.

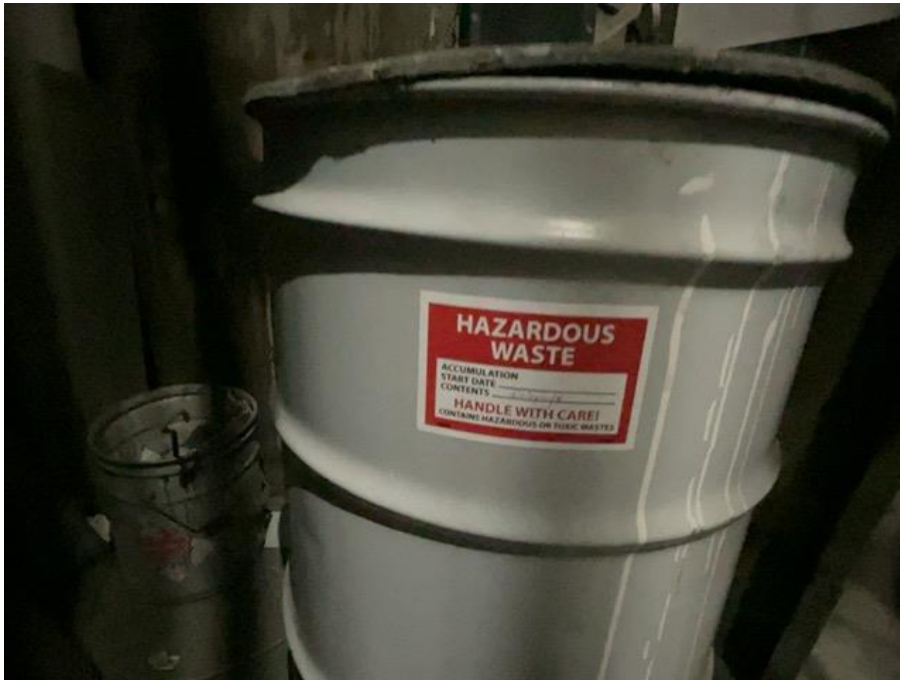
At the time of the CEI, each of the eight SAA containers in the paint booths were marked with the words “hazardous waste, toxic,” however, the container lids that were sitting on top of the containers did not make complete contact with the container rim and were not sealed with a locking ring (Photos 12-13). The SAA containers were connected to a hose piped directly to the gutters collecting paint spray. Some of these hose connections were not properly sealed closed (Photo 14).

**Pursuant to Tenn. Comp. R. & Regs 0400-12-01-.03(1)(f)1(iv) [40 C.F.R. § 262.15(a)(4)], which is a condition of the SAA Permit Exemption, a generator is required to keep containers of hazardous waste closed at all times during accumulation, except when adding, removing, or consolidating waste; or when temporary venting of a container is necessary for the proper operation of equipment, or to prevent dangerous situations, such as build-up of extreme pressure.**

Photo 12 – Open SAA container in paint booth.

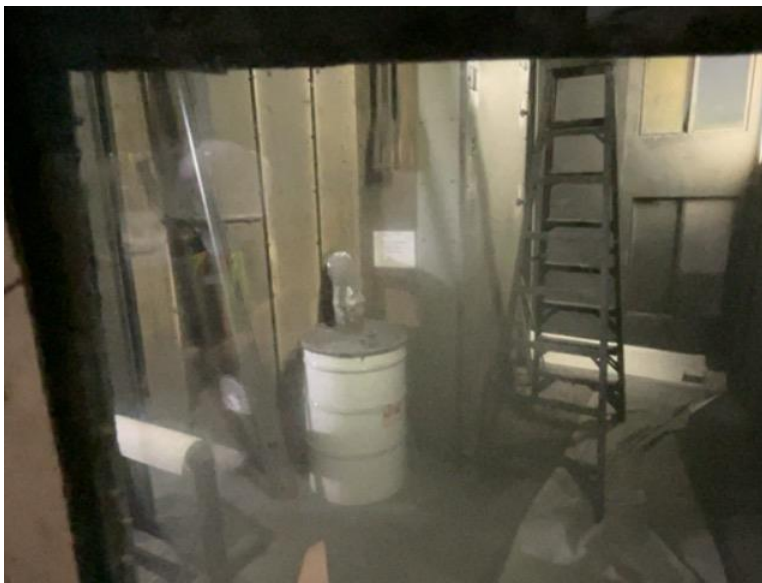
Photo 13 - SAA container in paint booth. The lid was sitting on top and not sealed.

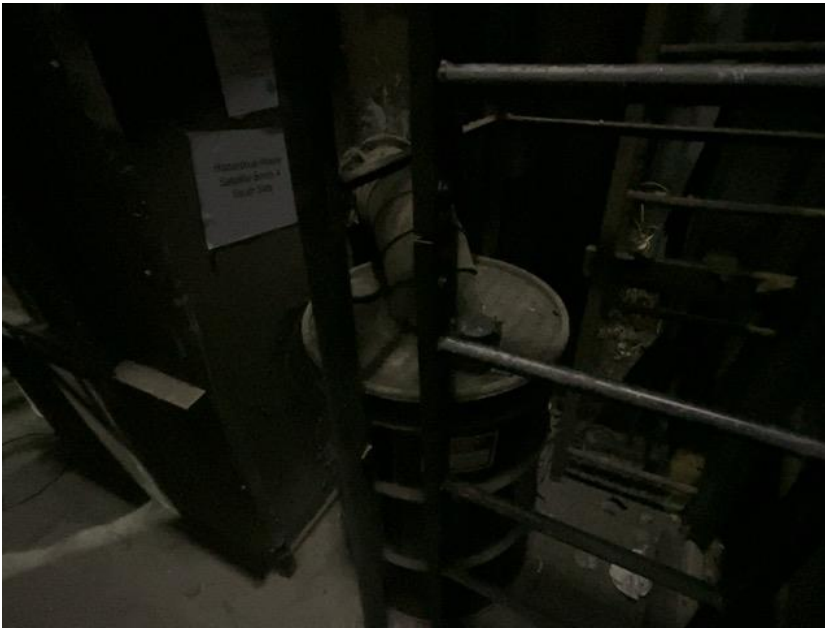
Photo 14 – Hose connected to SAA in paint booth with gaps.

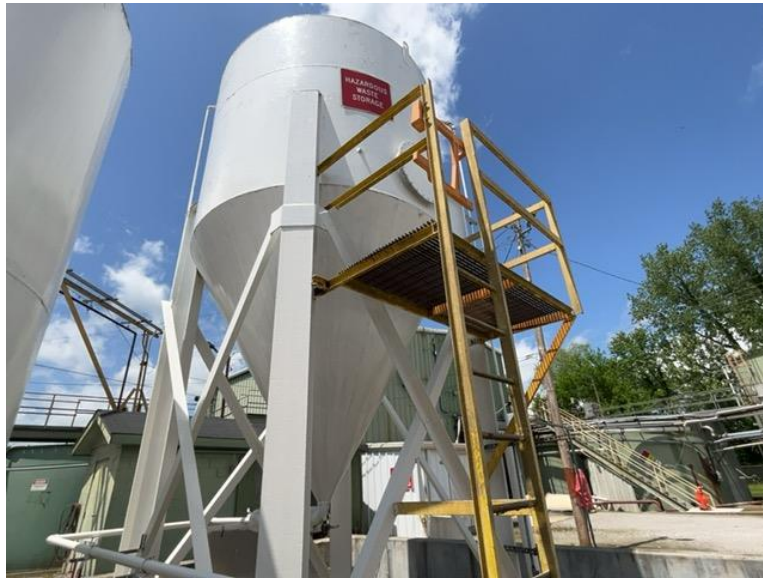
Inspectors observed the 7,500-gallon hazardous waste tank. At the time of the CEI, this tank was labeled “Hazardous Waste Storage,” marked with an NFPA diamond, and dated 5/2/2024 (Photos 15-16). This tank stores solvent waste generated in the paint mixing room. This waste stream is manifested offsite for solvent recovery. All BB equipment connected to the hazardous waste tank was marked with blue identification numbers on the equipment piping’s white paint. (Photos 17-18).

Photo 16 – Hazardous waste solvent tank. This tank was marked with an NFPA diamond on the other side.

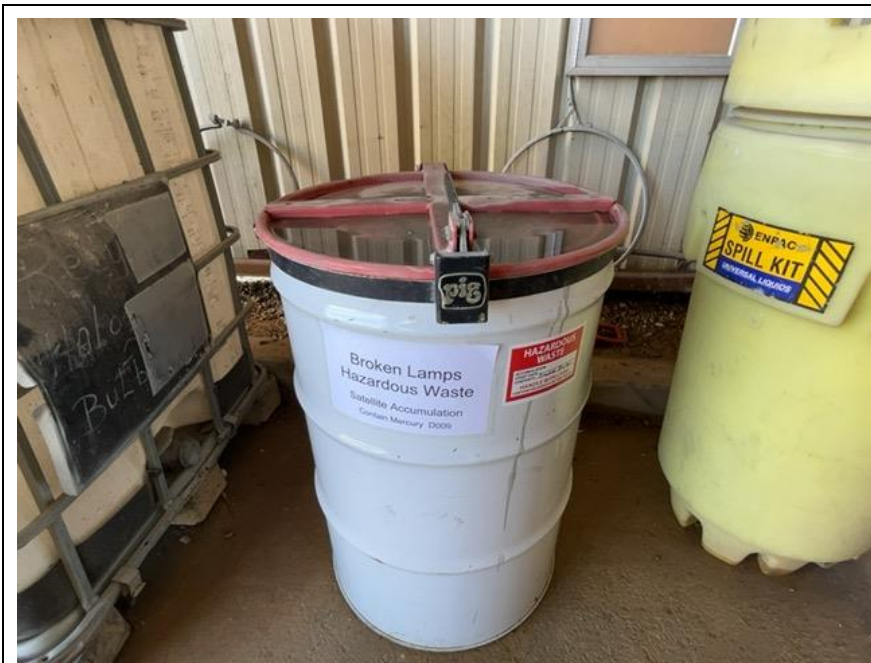
Inspectors observed one hazardous waste container on a pallet in waste row two at the time of the inspection. This container was marked with the words “hazardous waste, scrap paint” the word “toxic” and dated 4/30/2024. Bonnell was also storing a tote for storage of universal waste lamps and a 55-gallon SAA container for storage of broken lamps (Photos 21-22). The universal waste lamp container was empty at the time of the inspection. The 55-gallon container for broken lamps was labeled “Hazardous waste, toxic” and was partially full.

Photo 22 – Container of broken mercury containing lamps in the CAA.
