**Region 9 Enforcement Division**  
**75 Hawthorne Street**  
**San Francisco, CA 94105**

| <b>Inspection Date(s):</b> | June 7, 2023 | | |
| <b>Company Name:</b> | Arizona Public Service Company | | |
| <b>Facility or Site Name:</b> | Four Corners Power Plant | | |

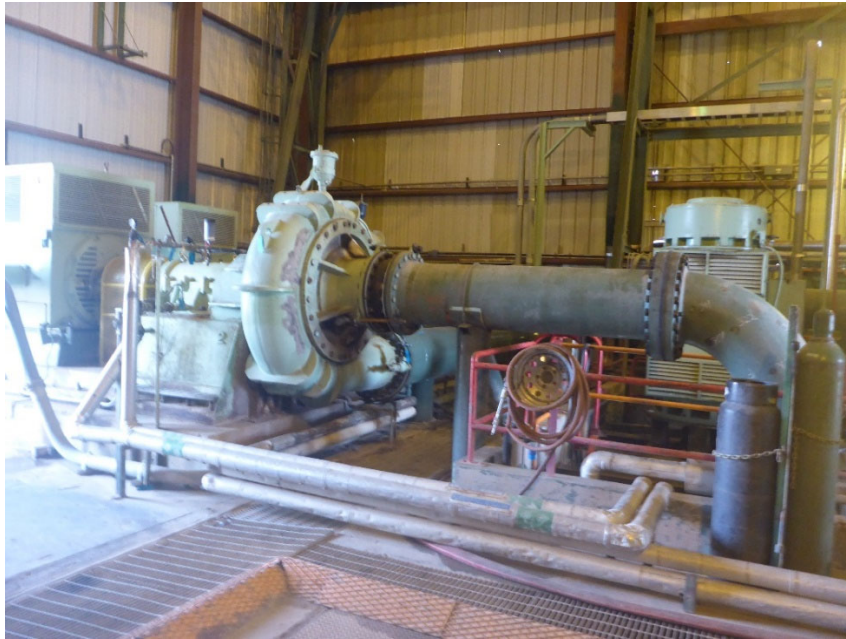
Water from the San Juan River flows to an intake structure (Photos 1 & 2) located approximately 3.5 miles North of the Power Plant at the "River Station". Water from this structure is pumped to the Plant's recirculated cooling water pond, also known as Morgan Lake (Photo 3). A plan approved by the United States Fish and Wildlife Service (USFWS) governs the pumping of river water to Morgan Lake.

*Photo 1 : River station pump gallery.*

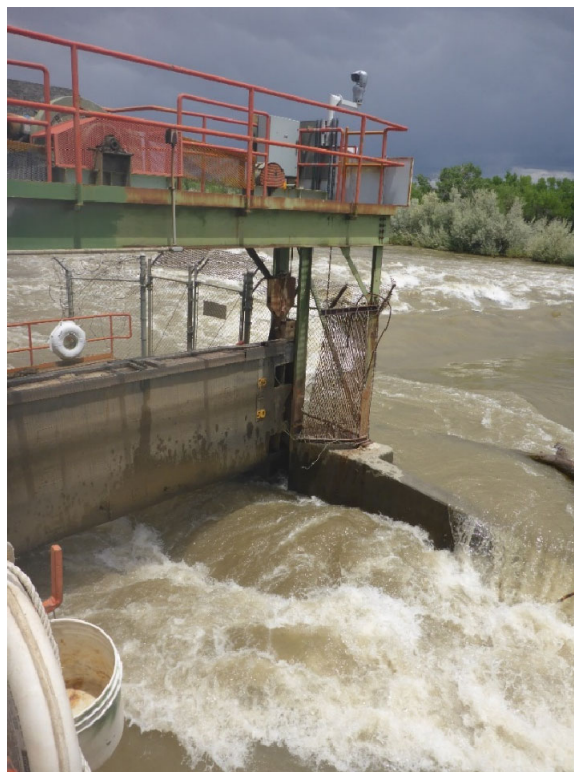
*Photo 2 : Cooling water intake structure in the San Juan River.*

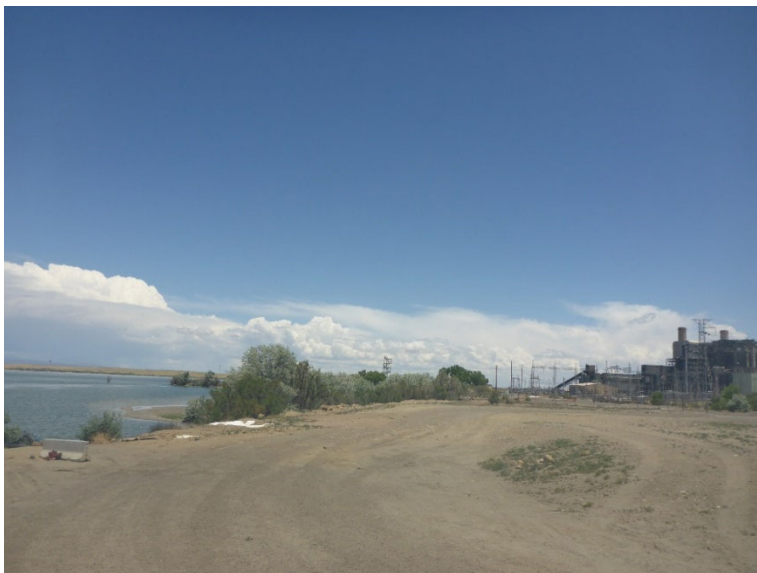
*Photo 3: Morgan Lake on left and APS Four Corners Power Plant on right.*

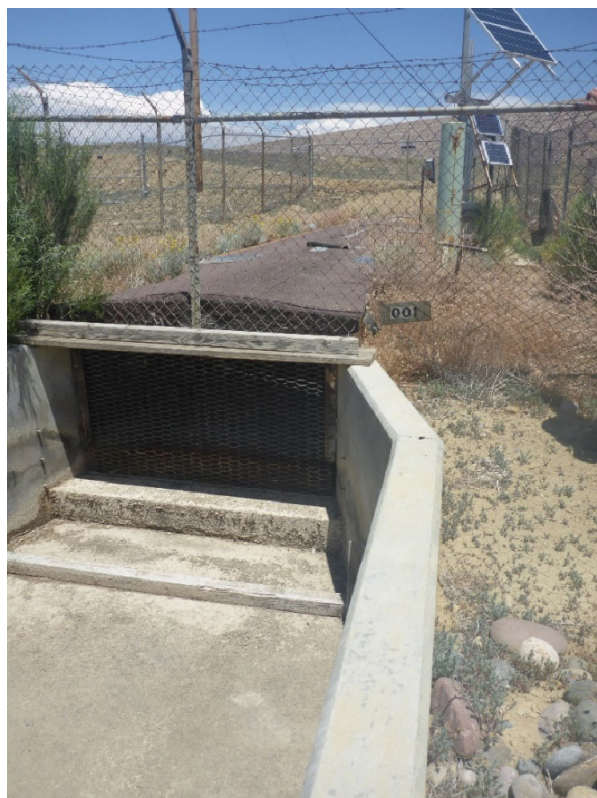
The APS Four Corners Power Plant has one NPDES permitted outfall (Outfall 001 in Photos 4 & 5) that discharges to No Name Wash, which is located near the northeast corner of Morgan Lake. A blowdown structure is used to transport water from Morgan Lake out to No Name Wash, which is a tributary to the Chaco River, and then the San Juan River. Additionally, there are three permitted internal outfalls: 01A, 01E, and 01B. Outfall 01A is the canal (photos 6 & 7) that receives wastewater and stormwater from the plant. The sampling point for Outfall 01A is near the end of the canal (Condenser Cooling Water Canal) prior to water entering Morgan Lake, a man-made cooling water pond. Outfall 01E is located in the canal upstream of outfall

1. At the time of the inspection, Outfall 001 was not discharging. According to facility personnel, no discharge had occurred since June 2022 due to low water levels in the lake. No Discharge was reported from July 2022 through August 2023.
2. At the time of the inspection, new piping had just been constructed between the river station and Morgan Lake. Facility personnel stated that the construction project would also include repaving the road to the river station.
3. For May 2021, the discharger reported a violation of the daily max limit for residual chlorine of 0.2 mg/L at internal Outfall 01A. The reported value was 0.4 mg/L. This is the only reported violation for the five years leading to the date of the inspection.

*Photo 4 : Outfall 001.*

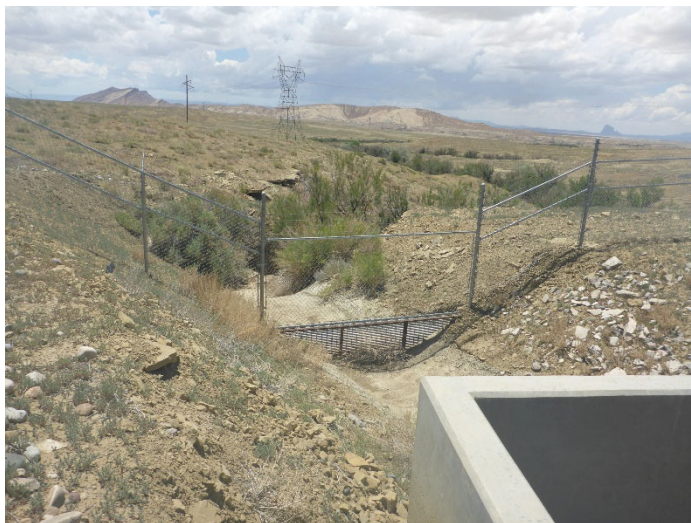
*Photo 5 : Looking downstream from Outfall 001 towards No-Name Wash.*

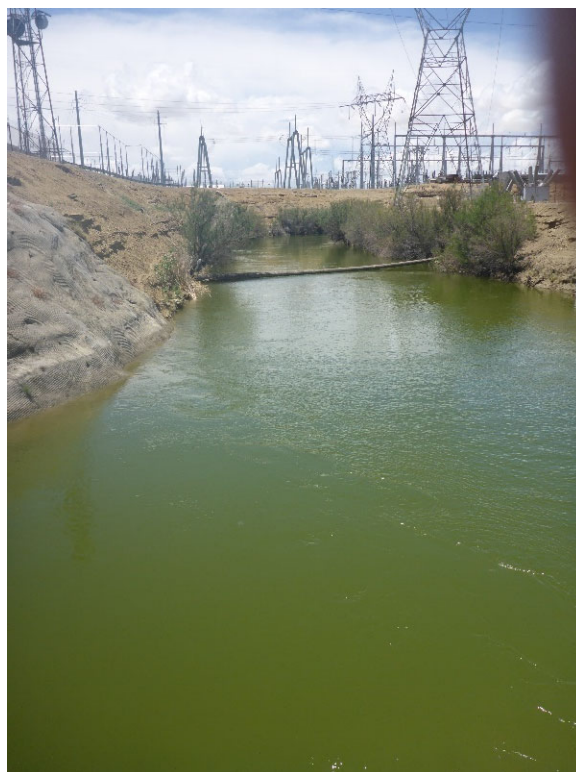
*Photo 6 : Canal.*

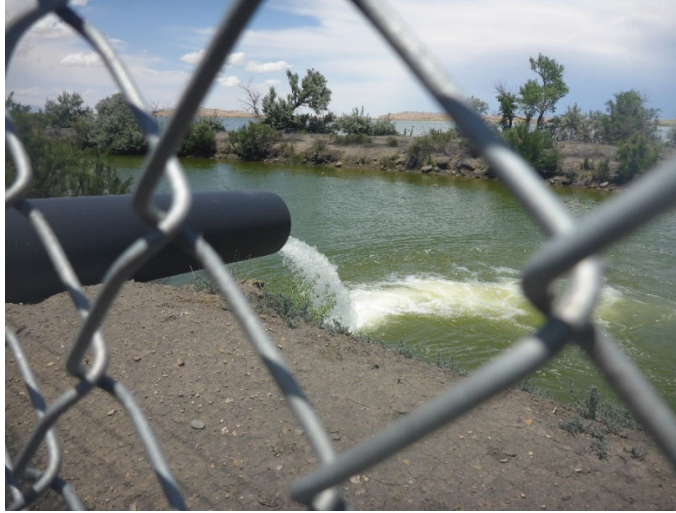
*Photo 7: Discharge of condenser cooling water to the Canal.*
