### INSPECTION REPORT

| Company Name: | Pogue Construction Co., L.P. | |
| Facility Name: | New Elementary School #19 - Prosper I.S.D. - Prosper, TX (COM) | |
| Identification/Permit Number: | TXR1519PW | |

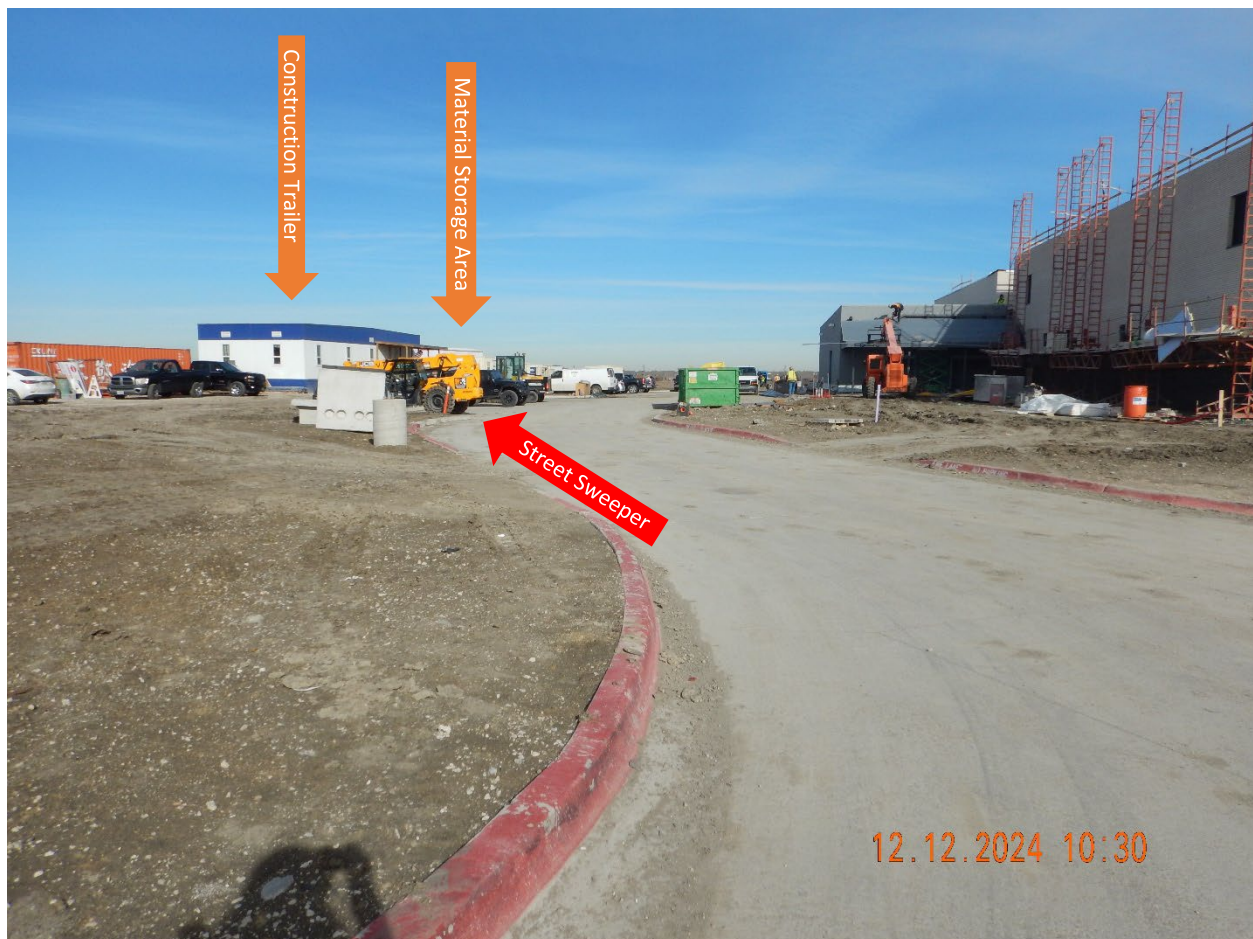
Photo no. 1

- A significant amount of exposed sediment was observed throughout the construction site (**Appendix 1, Photos 1, 4, 6-8, 10-12**). There were no Best Management Practices (BMPs) present to minimize the amount of soil exposed during construction activities as required by Part IV Section A.3 of the CGP.

- Sediment/sediment track-out was observed on the paved areas throughout the site (**Appendix 1, Photo 1, 8, 10-12**).
- One (1) curb inlet along the northern parking lot did not have inlet protection installed (**Appendix 1, Photo 6**). This inlet was located within approximately 20-30 feet of multiple ripped Quikrete Stucco bags. Stucco powdered mix was also observed on the ground along the northern parking lot island (**Appendix 1, Photos 11-12**).

Description: View of the construction trailer, material storage area, and a street sweeper located along the western perimeter of the site. Also pictured is uncontained sediment throughout the west perimeter of the site. This photo was taken at the construction entrance near the intersection of Bancroft Drive and Beverly Drive.

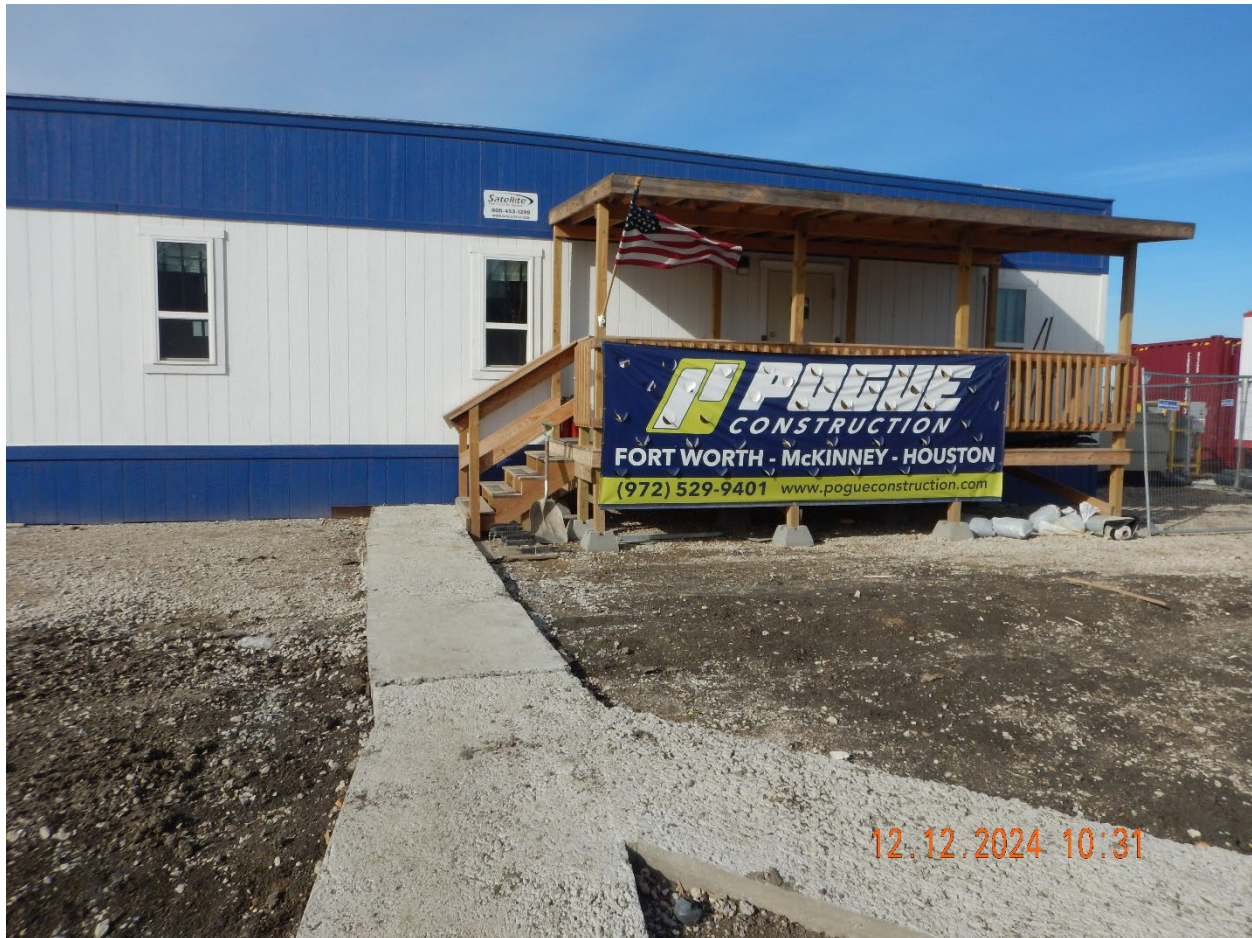
Photo no. 2

Description: Up close view of the construction trailer located along the western perimeter of the site.

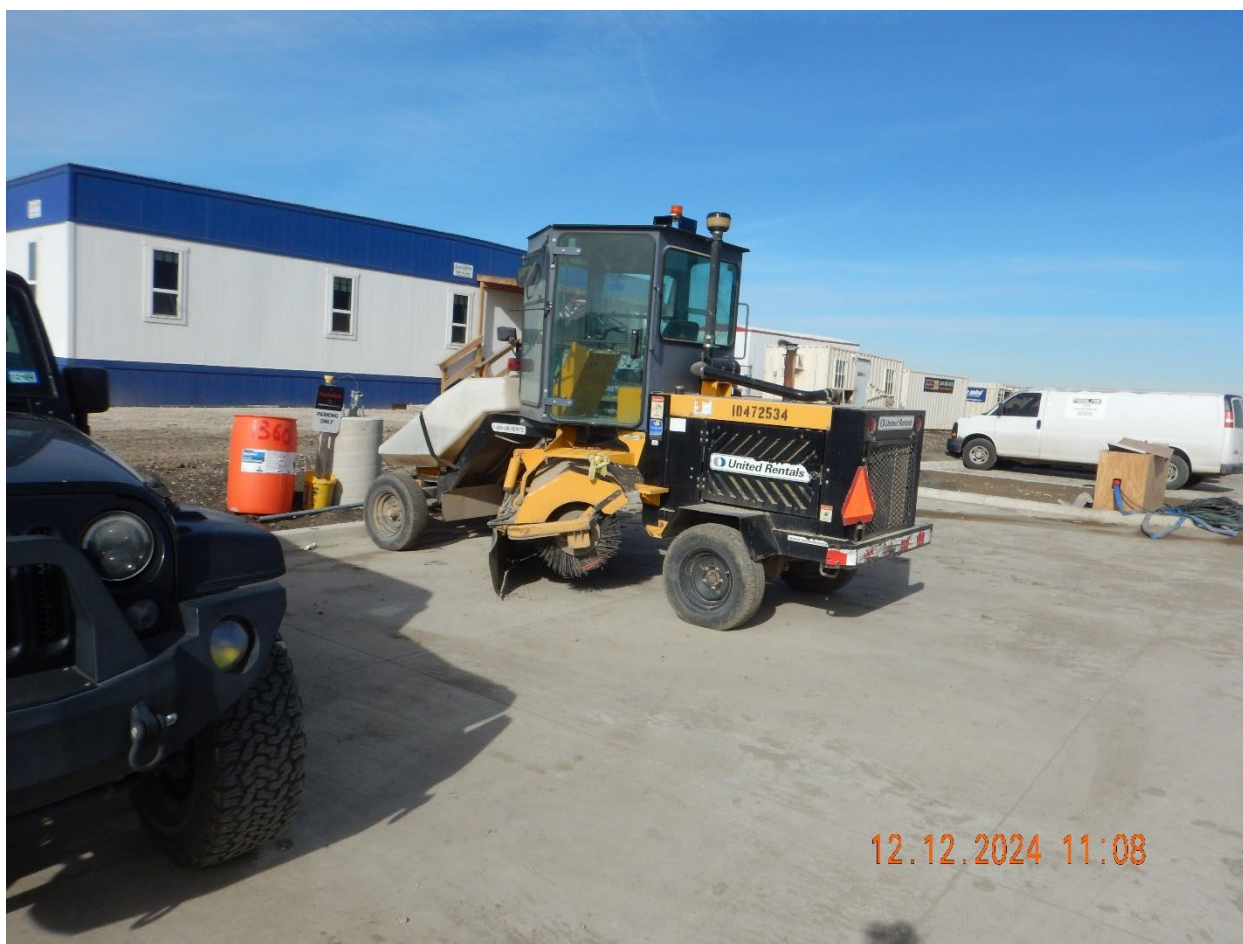
Photo no. 3

Description: Up close view of the street sweeper located near the blue and white construction trailer, along the western perimeter of the site. Also pictured is the material storage area (shipping containers).

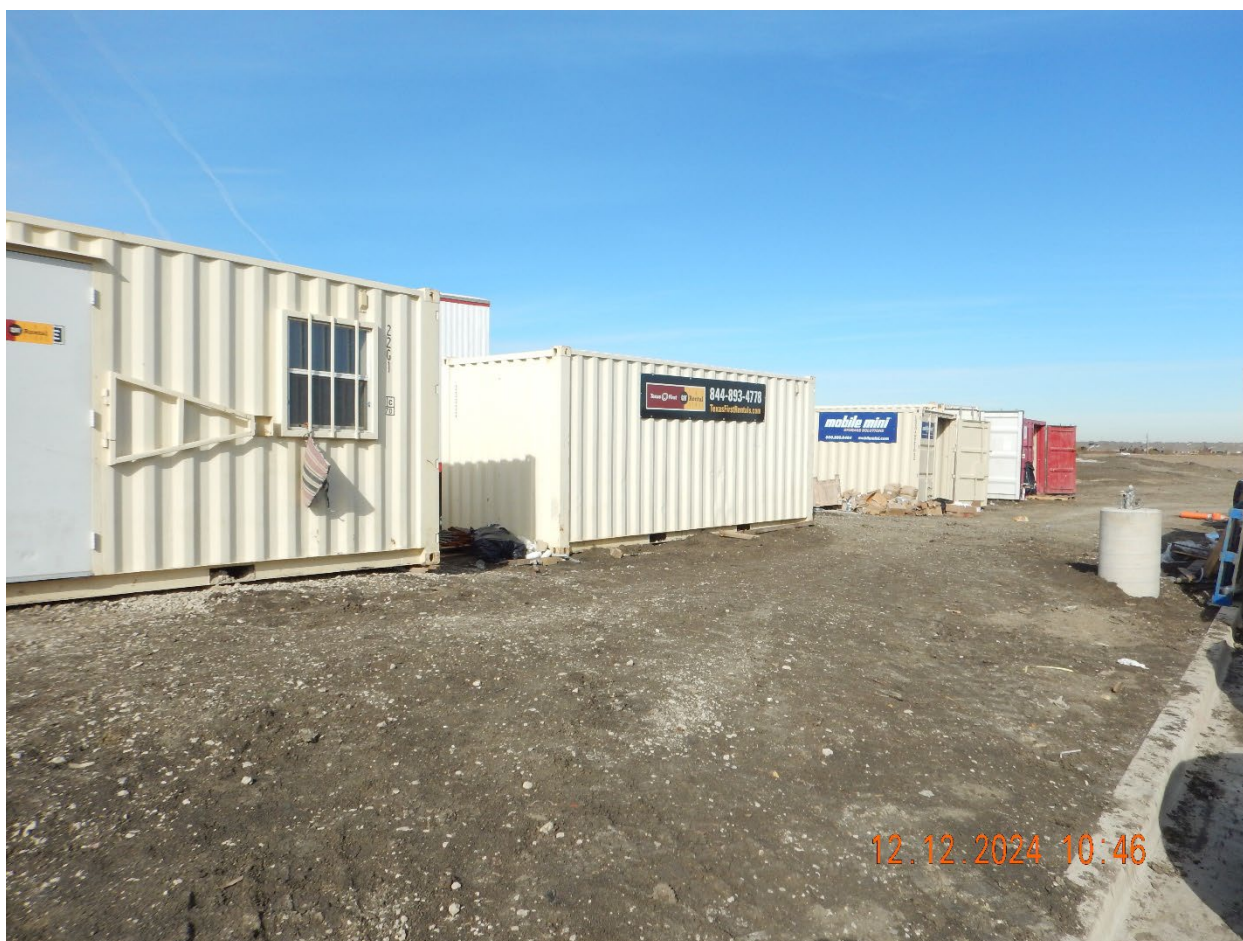
Photo no. 4

Description: Up close view of the material storage area located near the construction trailer along the western perimeter of the site.

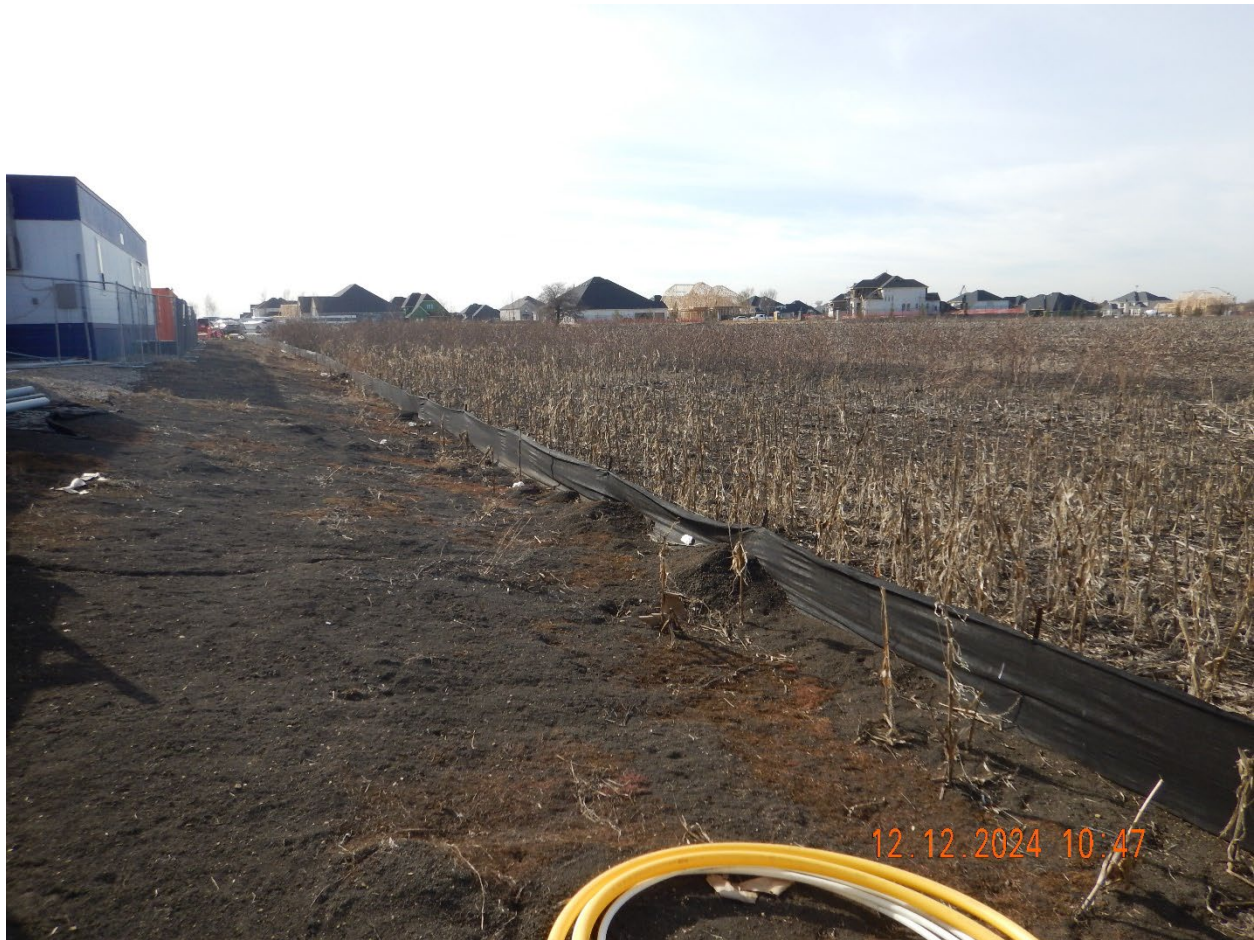
Photo no. 5

Description: View of silt fencing along the west perimeter of the site.

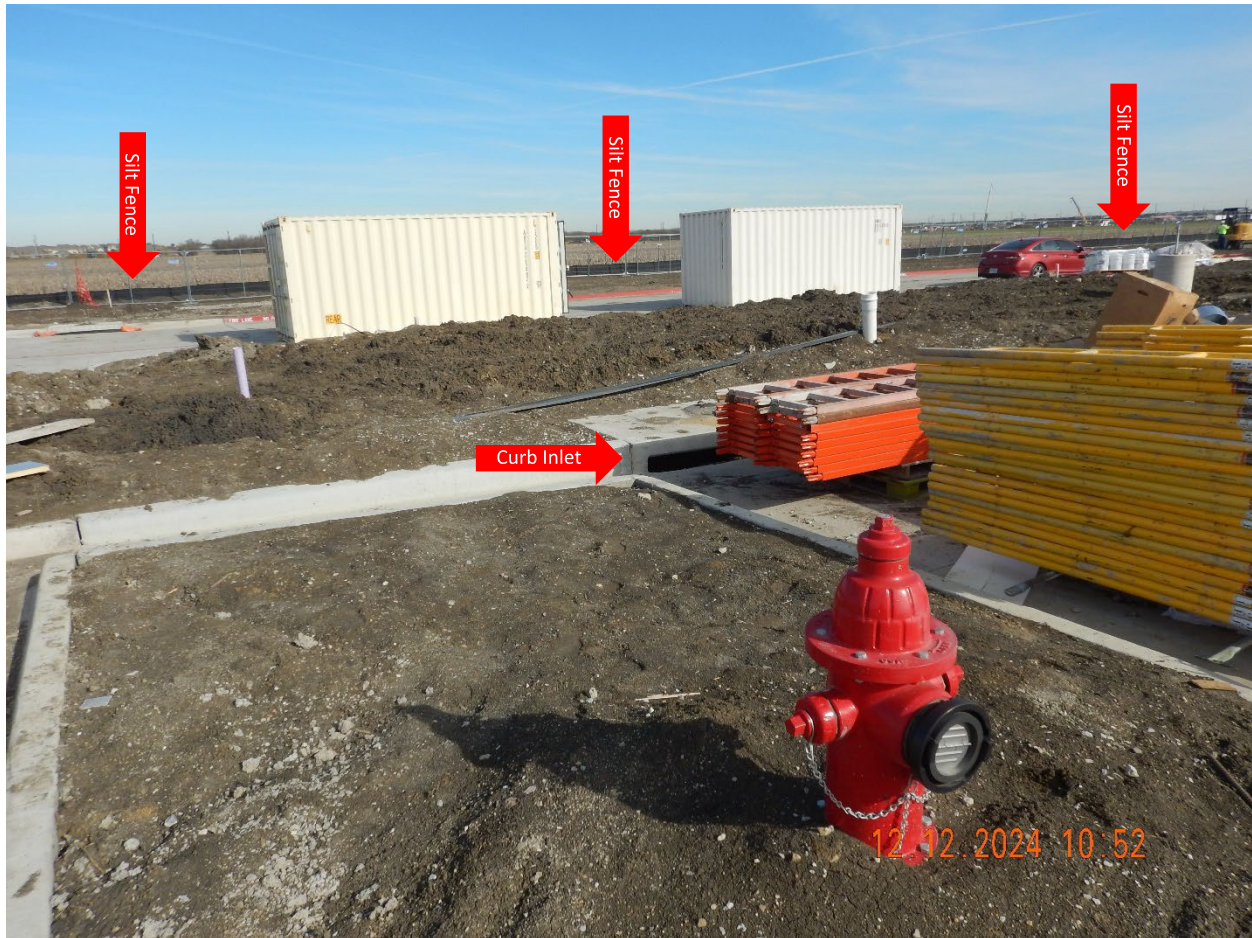
Photo no. 6

Description: View of silt fencing installed along the north perimeter of the site. Also pictured is a curb inlet with no BMPs installed, surrounded by exposed sediment. Shipping containers and site materials were stored along the pavement and parking spaces.

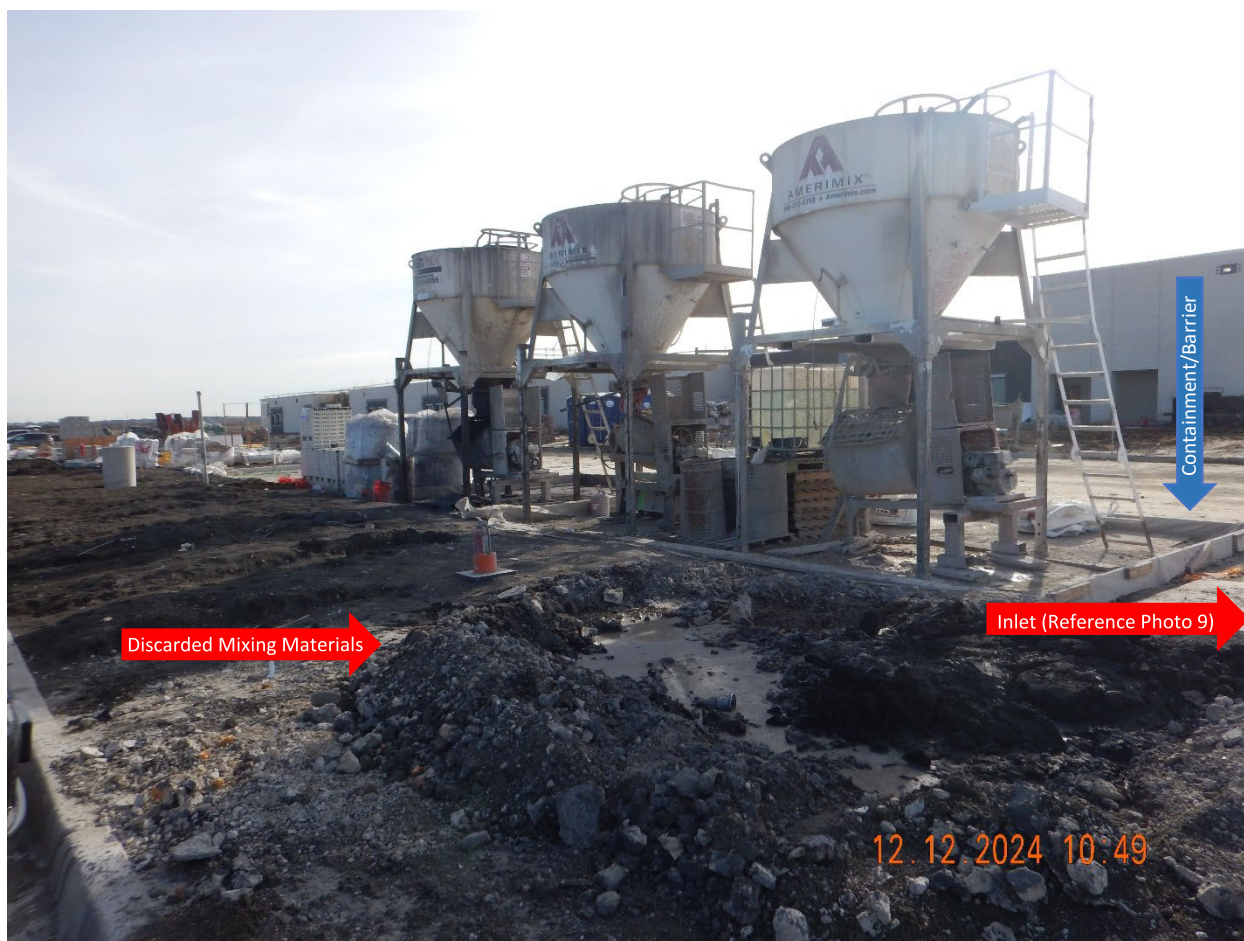
Photo no. 7

- Stucco debris and/or mortar washout was discarded and comingled with the dirt (sediment) near the Amerimix<sup>®</sup> mixers (northern parking lot) (**Appendix 1, Photo 7**). These materials were within approximately 10 feet of an inlet. In addition, pallets stored directly on top of the curb inlet protection (with noticeable trash and other debris immediately at the mouth of the inlet) was also observed (**Appendix 1, Photo 9**).

Description: View of three (3) large Amerimix® continuous mixers along the northern parking lot within a wood containment/barrier. Also pictured is discarded stucco debris and/or mortar mix comingled with the sediment (approximately 10-20 feet from an inlet as shown in Photo 9).

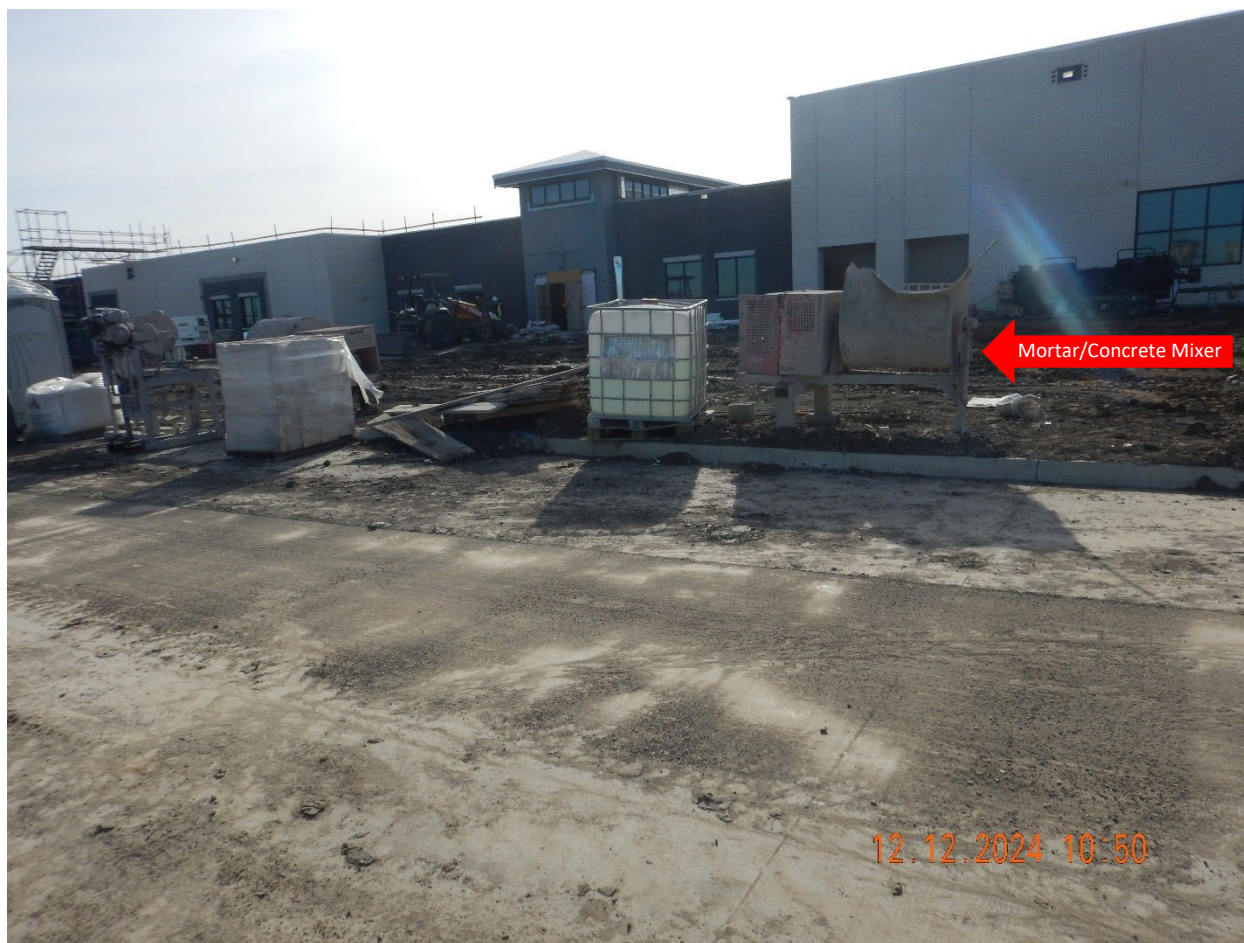
Photo no. 8

Description: View of a mixer north of the structure (school building). Also pictured is uncontained sediment and sediment track-out on the paved areas.

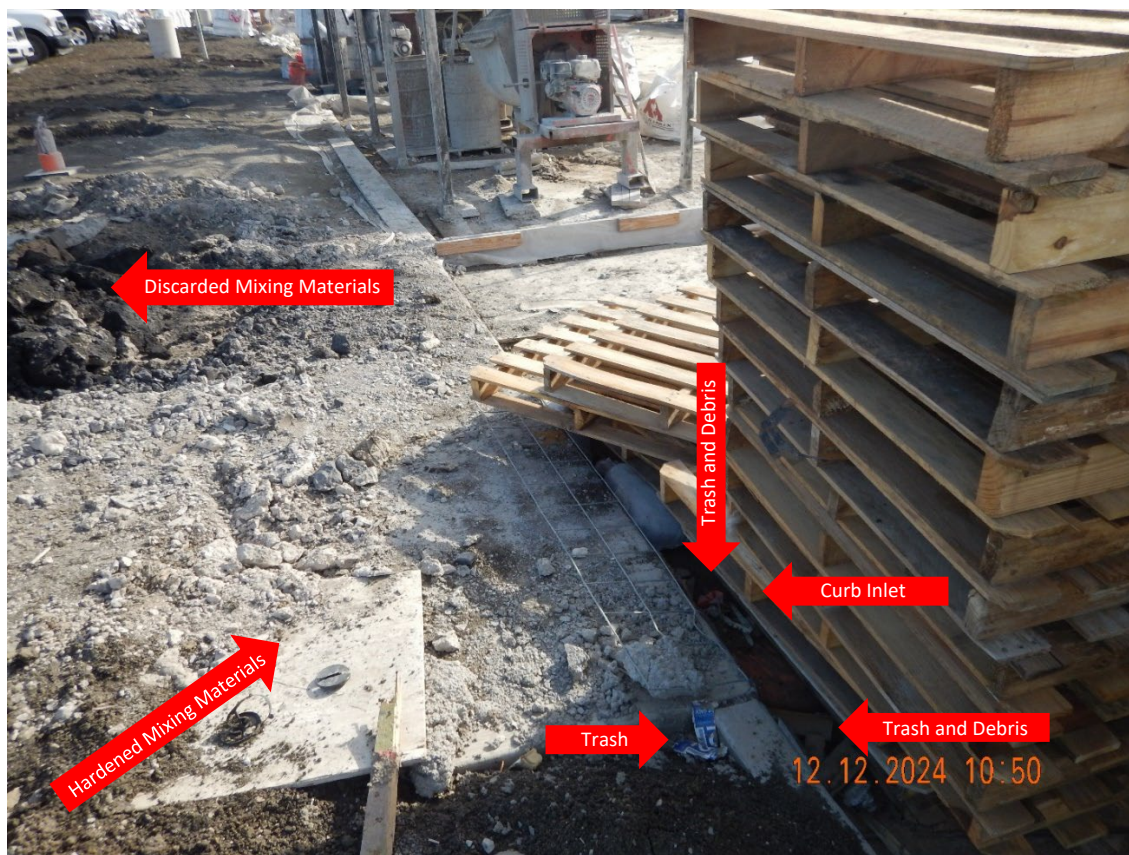
Photo no. 9

Description: View of the curb inlet located near the discarded stucco debris/mortar mixing materials shown in Photo 7. Also pictured is hardened mixing materials and pallets stored directly on top of the curb inlet protection (with noticeable trash and other debris immediately at the mouth of the inlet).

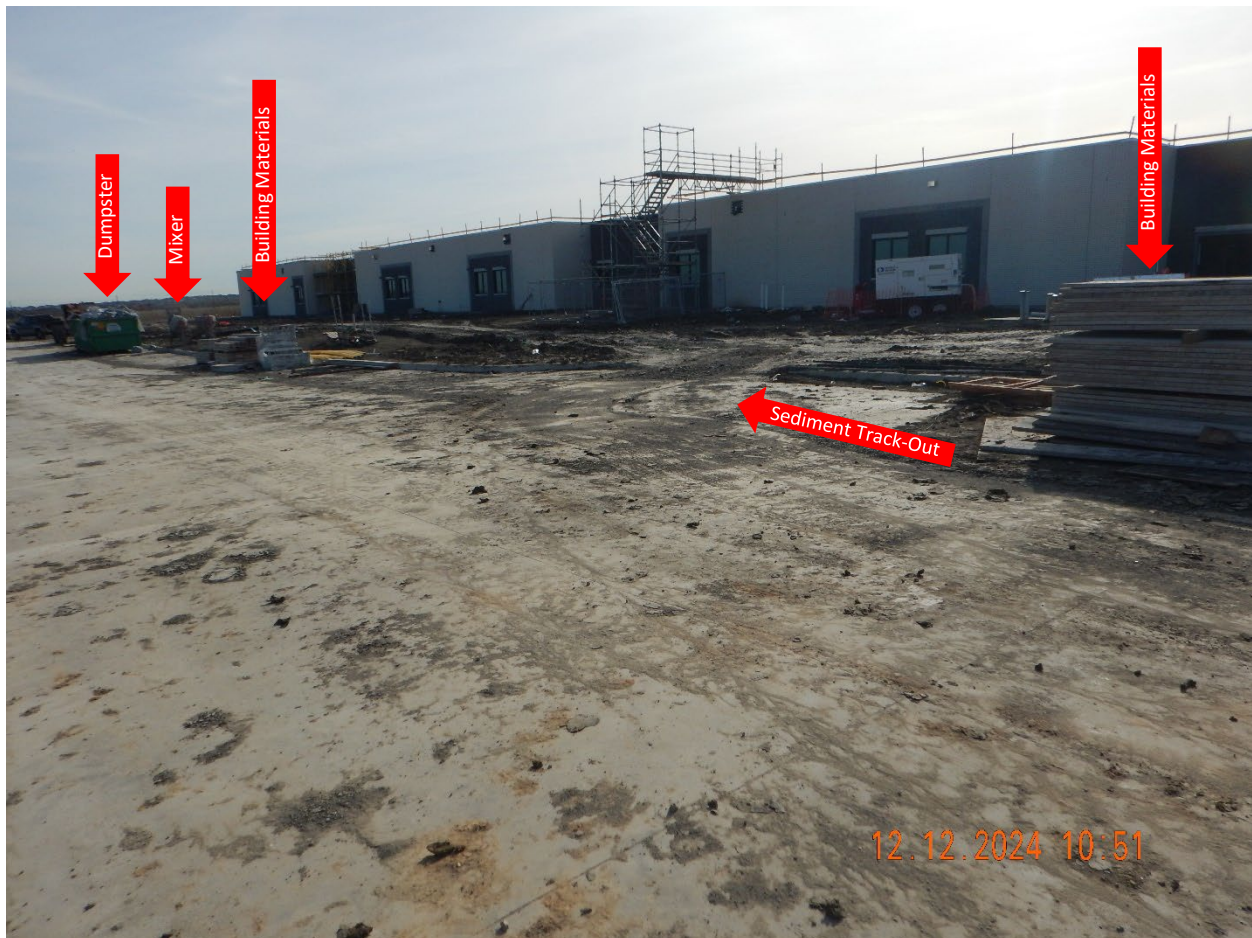
Photo no. 10

Description: View of exposed sediment, sediment track-out, building materials, a mixer, and a full roll-off dumpster north of the school (building).

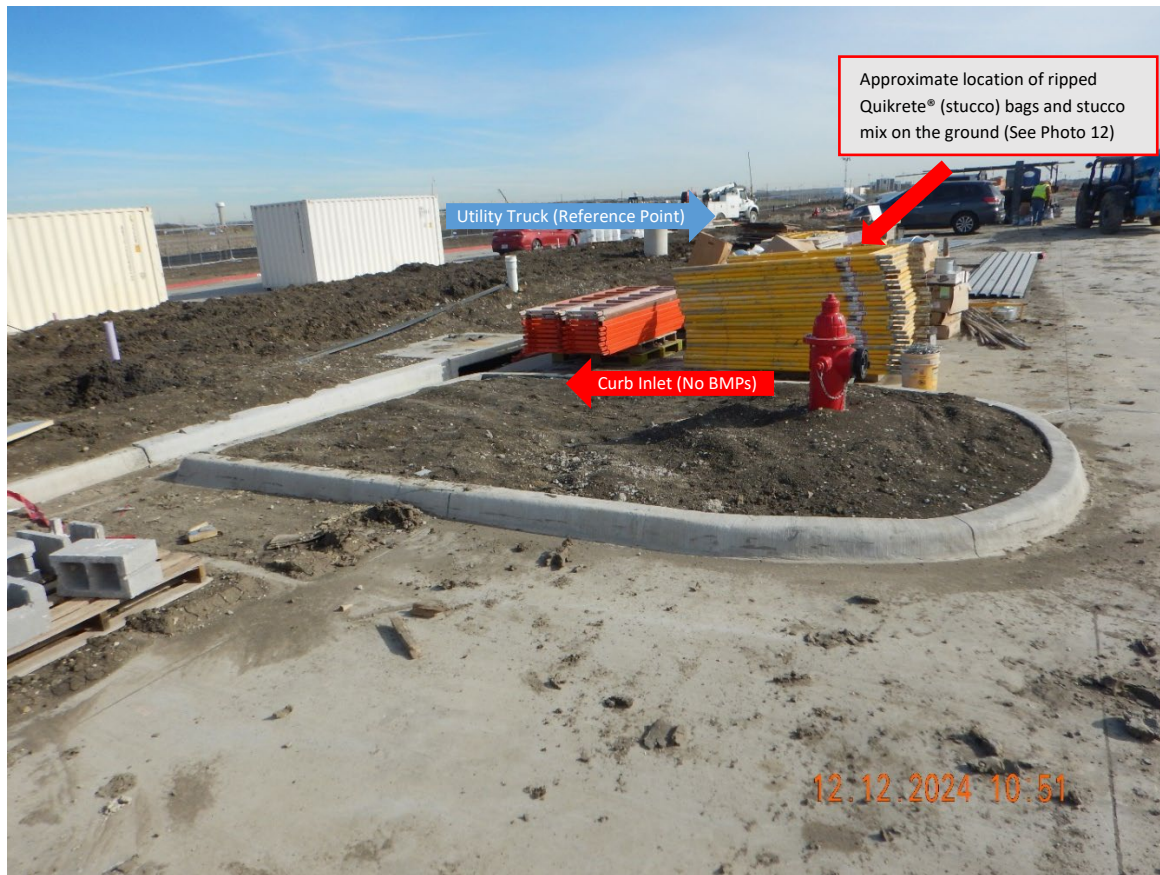
Photo no. 11

Description: View of a curb inlet at the north parking lot with no BMPs installed. Approximately 20-30 feet to the east are multiple ripped Quikrete® (Stucco) bags and powdered stucco debris/mix discarded on the ground (reference Photo 12 for an additional view). Also note the white utility truck as a reference point for showing approximate distance from the curb inlet to the Quikrete® (Stucco) bags/stucco debris/mix in Photo 12.

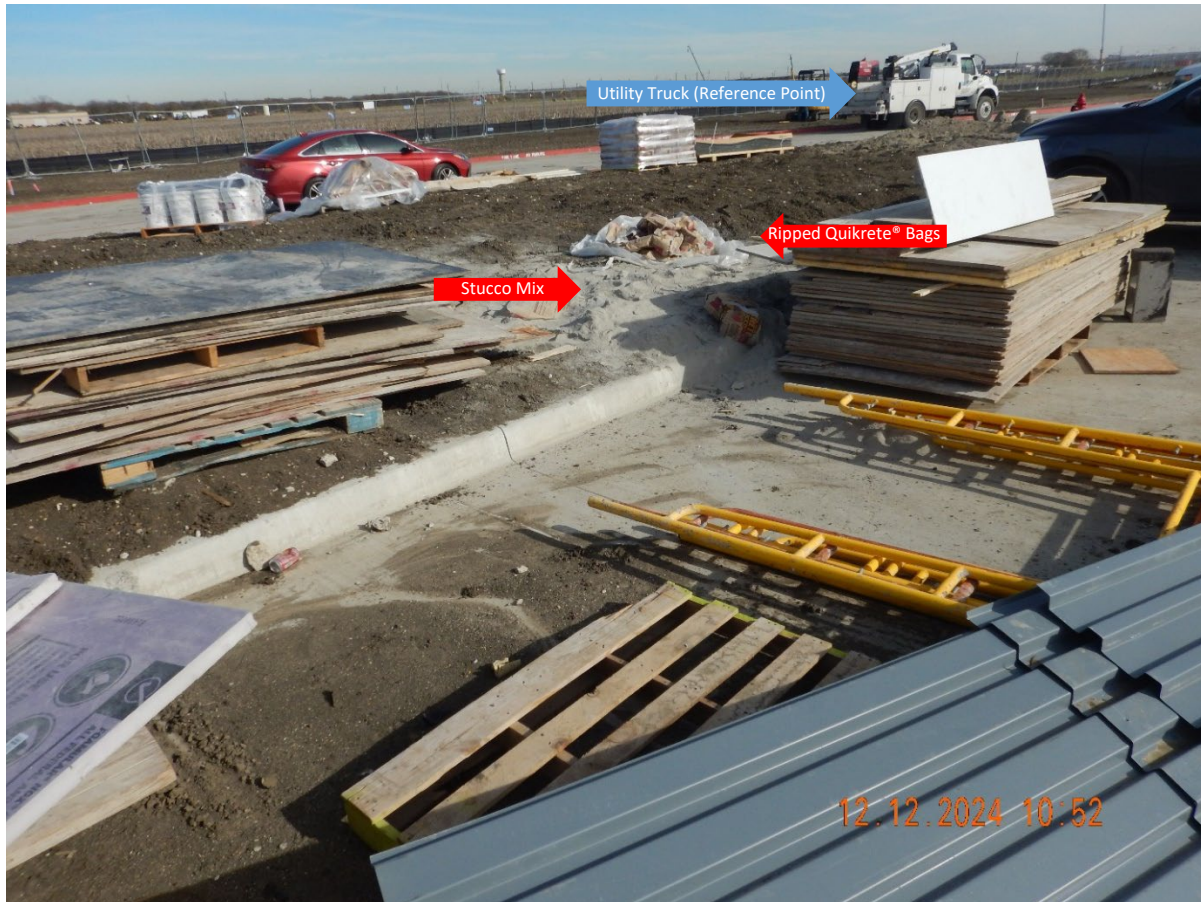
Photo no. 12

Description: View of multiple ripped Quikrete® Stucco bags and stucco debris/mix discarded on the northern parking lot island near the curb (approximately 20-30 feet from an uncovered curb inlet to the west). Also pictured is exposed sediment, sediment on the paved areas, building materials (e.g. wood pallets, wood materials, etc.), and the white utility truck as a reference point for Photo 11.

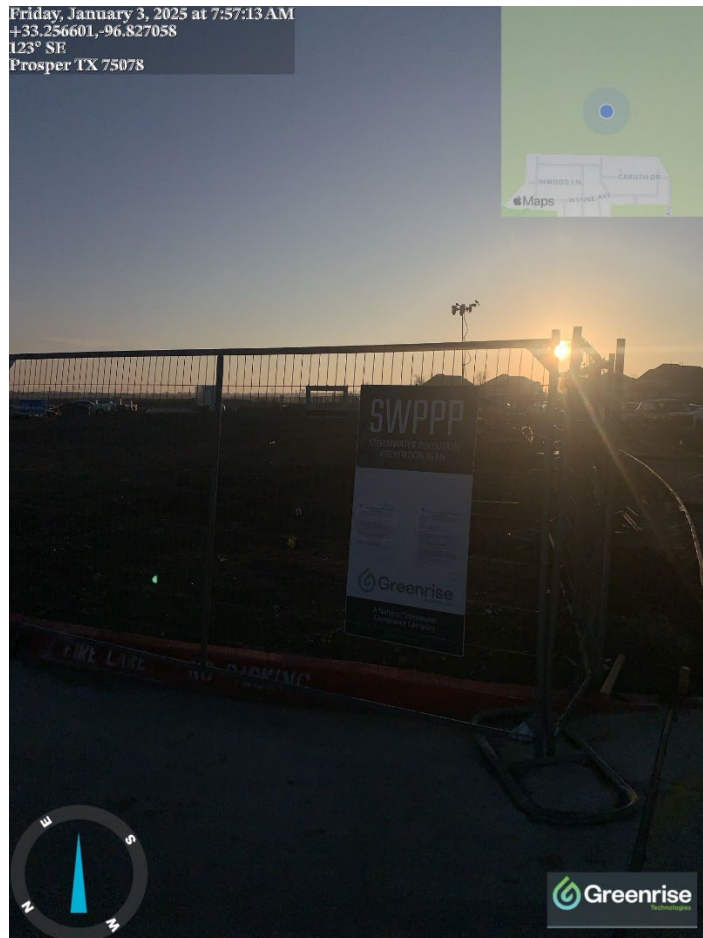
Photo no. 13

- The Construction Site Notice (CSN) was not observed at the time of inspection. However, at a later date, Ms. Stephanie Hale (Production Manager of Greenrise Technologies) provided a photo of the CSN posted on-site (**Appendix 1, Photo 13**) as described in Section IV of this report.

Description: View of a photo of the CSN posted in the vicinity of 33.256601 (north), -96.827058 (west). This photo was taken by Stephanie Hale of Greenrise Technologies on January 3, 2025, and emailed to the inspector on the same date.
