Clean Water Act (CWA) Inspection Report

| Type of Inspection | CEI - Compliance Evaluation Inspection | | | |
| Facility Name | Amalgamated Sugar – Twin Falls | | | |

### Photograph Log – Amalgamated Sugar – Twin Falls

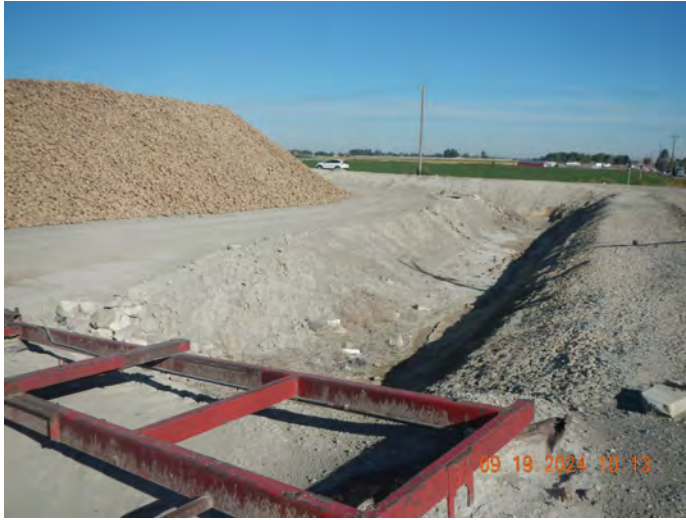
Photo #:01 (DSCN3929)

We first toured the northeast retention basin, located near the beet storage pile (**Photo 1**). The retention basin and collection area are located north of the new "East Pond," which was under active construction at the time

Description: Facing north, photo of northeast stormwater retention basin.

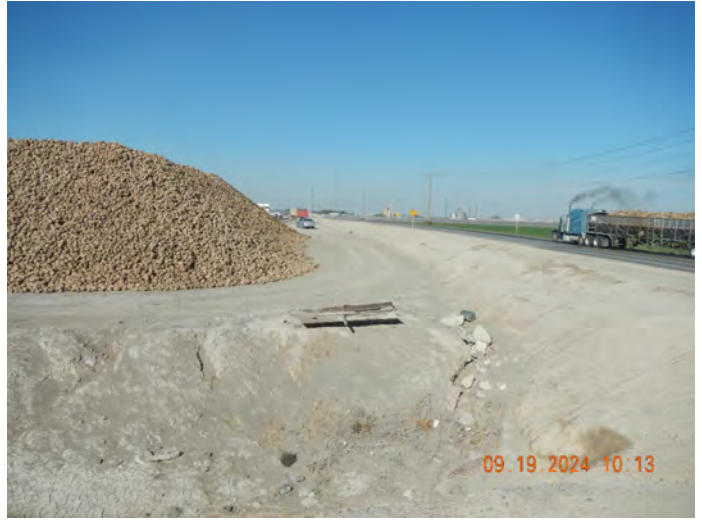
Photo #:02 (DSCN3930)

Description: Facing west, photo of the outlet of the northeast retention basin, extending along the northern perimeter via channel. Channel is bermed to the north along Orchard Drive E.

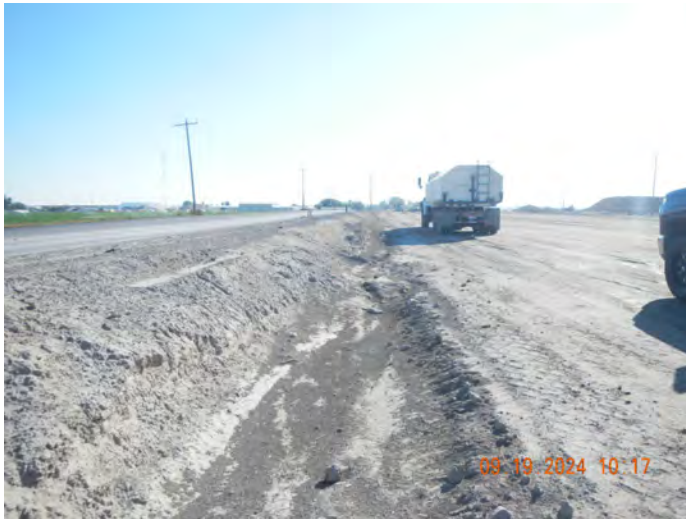
Photo #:03 (DSCN3931)

Description: Facing east, photo of stormwater channel along the northern perimeter between northeast and north retention basins.

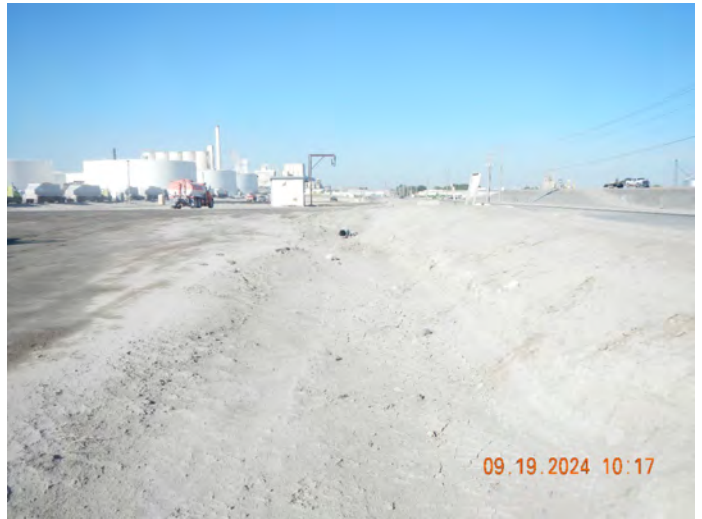
Photo #:04 (DSCN3932)

Description: Facing west, photo of stormwater channel along the northern perimeter between northeast and north retention basins.

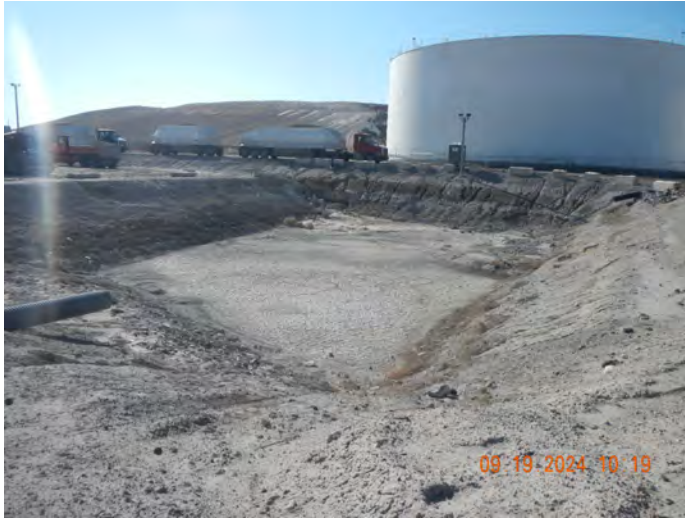
Photo #:05 (DSCN3933)

Description: Facing south, photo of north retention basin, north of the "juice tanks."

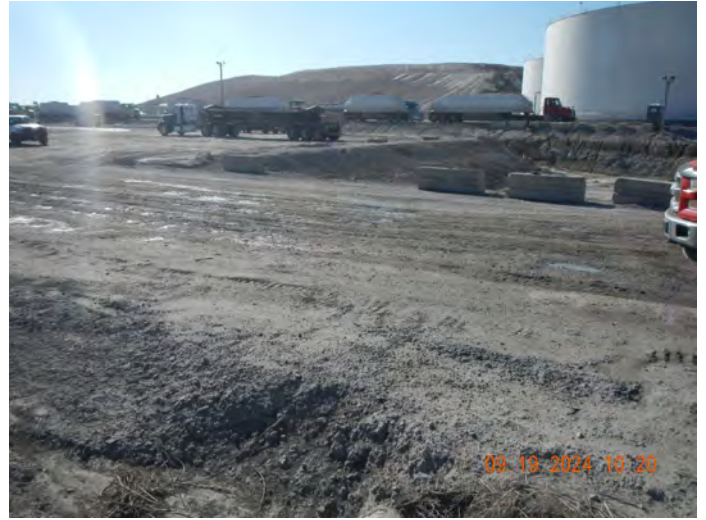
Photo #:06 (DSCN3934)

Description: Facing south, photo of north retention basin's piped connection to the northern stormwater channel along Orchard Drive E.

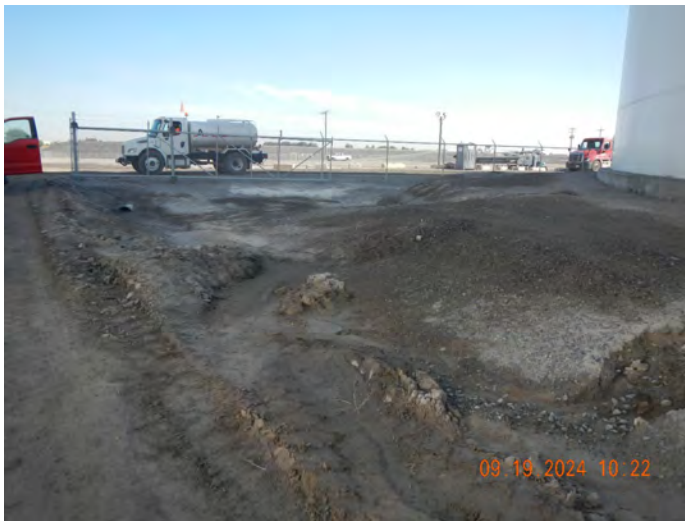
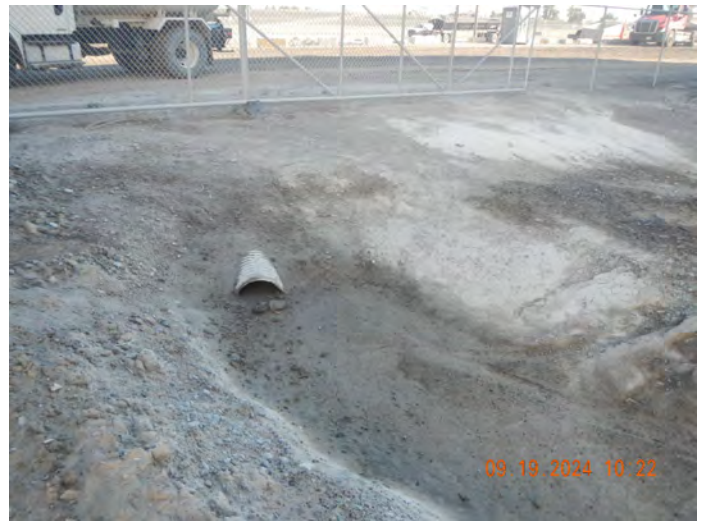
We continued south into the “Juice Tanks” area, south of a fueling area. We observed the stormwater retention basin serving the area to be in need of maintenance, as the culvert connection to the larger retention basin was nearly full of sediment (**Photo 7, Photo 8**).

As discussed earlier in this report, during the Facility walk/drive through of stormwater areas near the “juice tanks,” we observed the culvert connection to the larger retention basin was nearly full of sediment (**Photo 7, Photo 8**). It was discussed that the stormwater retention basin/culvert was in need of maintenance to ensure proper drainage from the juice tank area to the north retention basin (as designed).

Description: Facing north, photo of retention basin along the north end of the "juice tanks." Culvert connection to northern retention basin observed to be in need of maintenance.

| <p>Regulation and/or Permit Requirement:</p> <p>Section 2.1.2.3.a of the 2021 MSGP states that “you must maintain all control measures that are used to achieve the effluent limits in this permit in effective operating condition, as well as all industrials equipment and systems, in order to minimize pollutant discharges.”</p> | |

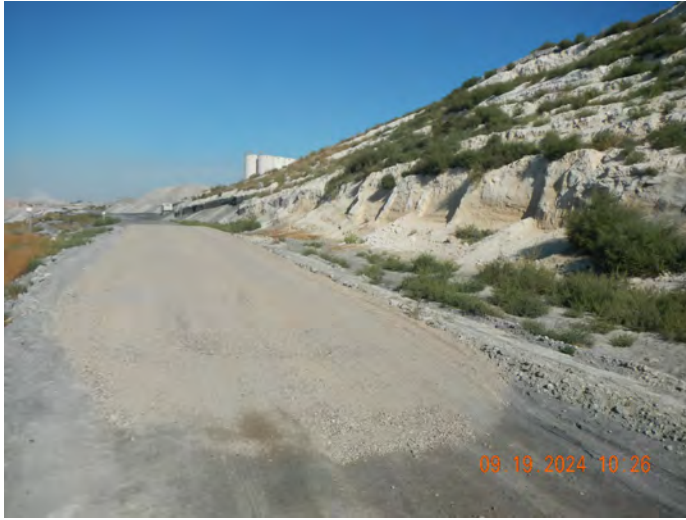
Photo #:09 (DSCN3937)

The tour continued as we travelled south of the PCC pile. We observed the access road that had been repaired following the June 23, 2023, discharge to Rock Creek (**Photo 9**), as well as piping staged within the area. It was discussed that the piping would to be used to connect the wastewater system to the new “East Pond.” It was discussed that following the piping installation, the area would be graded/bermed to promote infiltration along the eastern drainage area, southeast of the PCC pile and north of the canyon rim.

Description: Facing west, photo of repaired access road south of the PCC storage pile.

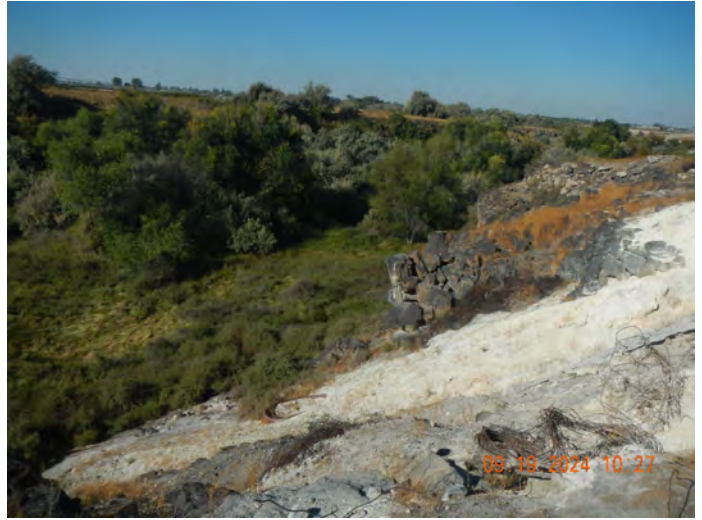
Photo #:10 (DSCN3938)

We then observed the northern rim of the canyon along the southern end of the PCC pile. Within the area we observed the PCC remnants of the June 23, 2023, discharge from the RCC pile (**Photo 10**). Rock Creek was observed to be downslope of a vegetated area within the canyon. We then observed Outfall 001, which consisted of a vegetated/wooded area along the southeastern slope, south of the access road. No discharge or evidence of discharge was observed within the area (**Photo 11**). From the area near Outfall 001, we observed the southern perimeter of the Facility, north of Rock Creek (**Photo 12**).

Description: Facing southwest, photo of northern canyon rim south of the PCC pile. Area had been impacted from June 23, 2023, non-stormwater discharge from the PCC storage pile.

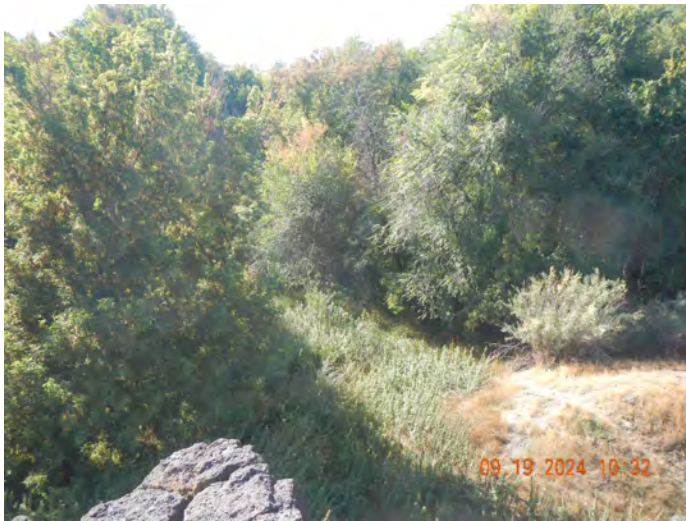
Photo #:11 (DSCN3939)

Description: Facing southeast, photo of Outfall 001. A vegetated area downslope of the southeastern access road, towards Rock Creek.

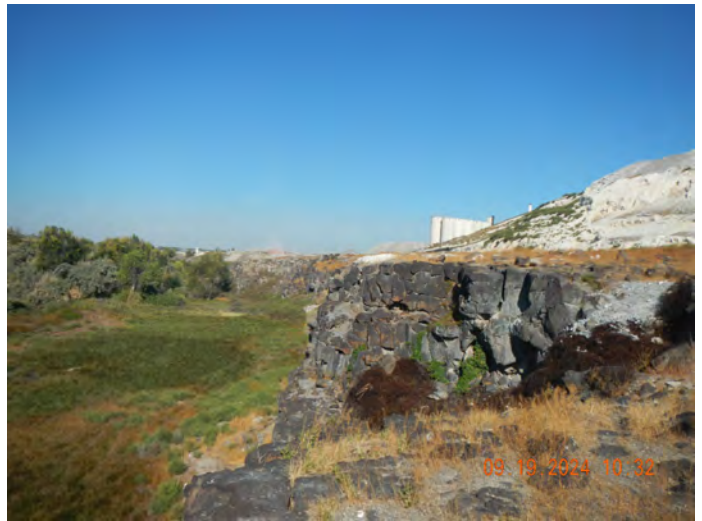
Photo #:12 (DSCN3940)

Description: Facing west, photo of the southern perimeter and vegetated area north of Rock Creek.

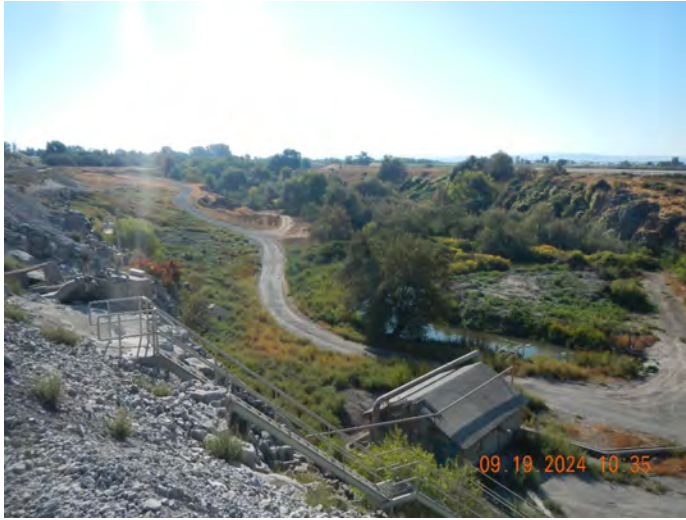
Photo #:13 (DSCN3941)

We continued west along southern perimeter access road and observed the Facility’s separately permitted discharge associated with non-contact cooling water (NPDES Individual Permit No. ID000230) (**Photo 13**). We also observed the wastewater/reuse ponds and area south of the ponds north of Rock Creek (**Photo 14 – Photo 16**). We then travelled north into the outdoor processing plant areas. Stormwater from these areas are directed to various collection points and routed to the wastewater/reuse ponds. We observed accumulated stormwater near a temporary pulp pile, stormwater from this area is collected via drainage and sheetflow to the wastewater/reuse ponds. (**Photo 17, Photo 18**). An empty tote storage area was also observed.

Description: Facing southeast from the southern end of the process water pond, photo of discharge location of permitted outfall associated with Facility's individual NPDES discharge permit.

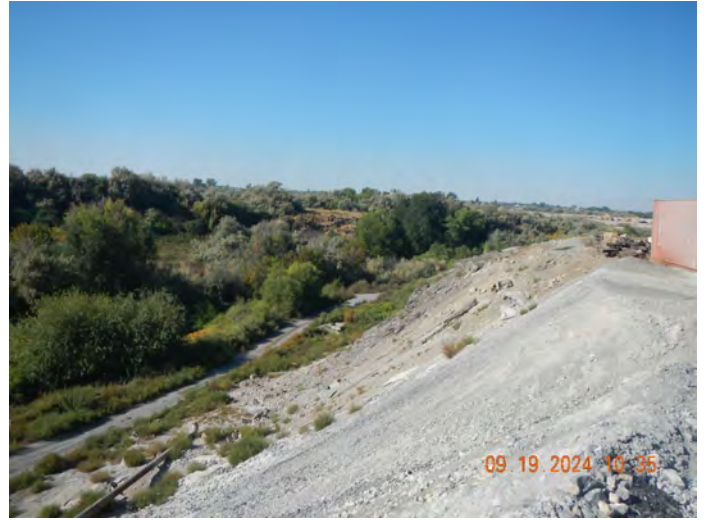
Photo #:14 (DSCN3942)

Description: Facing southwest from the southern end of the process water ponds, photo of the southern perimeter area, north of Rock Creek.

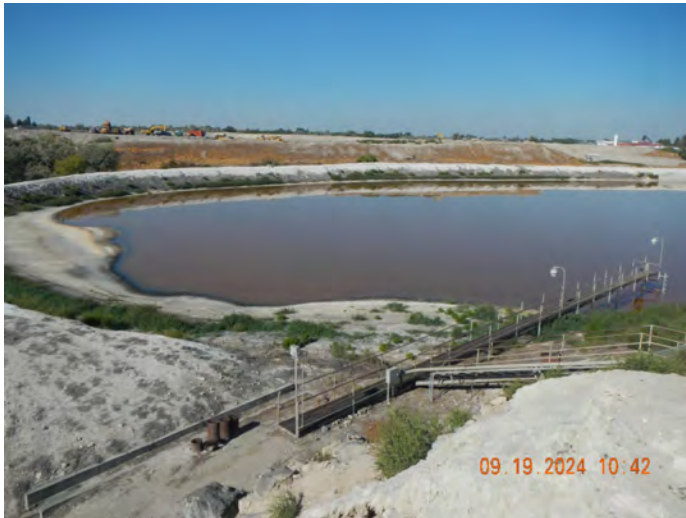
Photo #:15 (DSCN3943)

Description: Facing west, photo of wastewater pond.

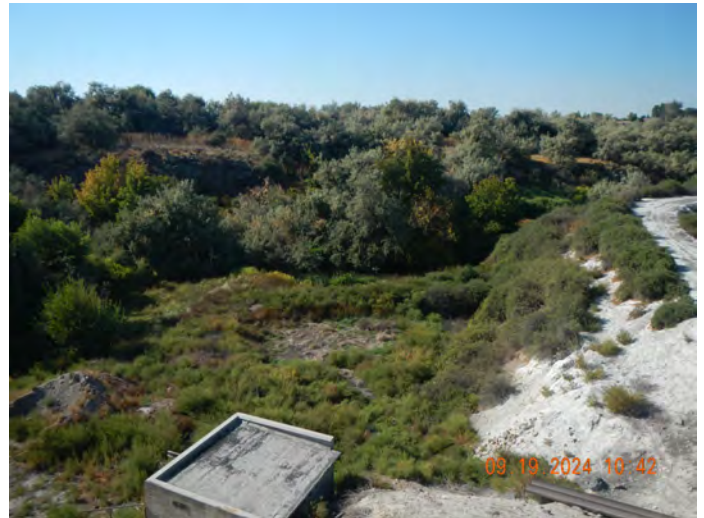
Photo #:16 (DSCN3944)

Description: Facing southwest, photo of area south of wastewater pond.

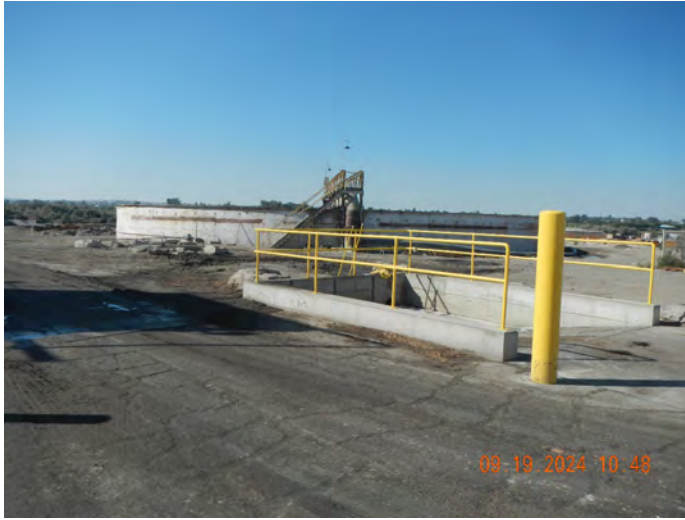
Photo #:17 (DSCN3945)

Description: Facing southwest, photo of surge basin associated with wastewater/process water ponds near pulp storage/factory area.

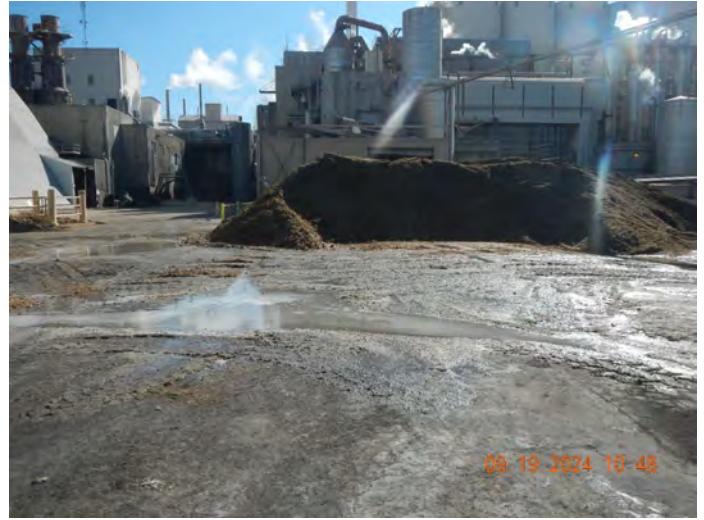
Photo #:18 (DSCN3946)

Description: Facing east, photo of temporary pulp pile. Stormwater is routed to wastewater/process water ponds.

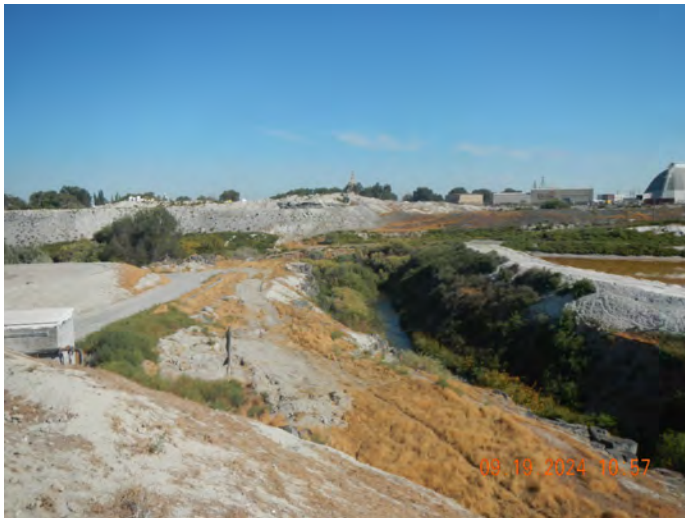
Photo #:19 (DSCN3947)

Description: Facing north, photo of Rock Creek from the “dirt storage area.”

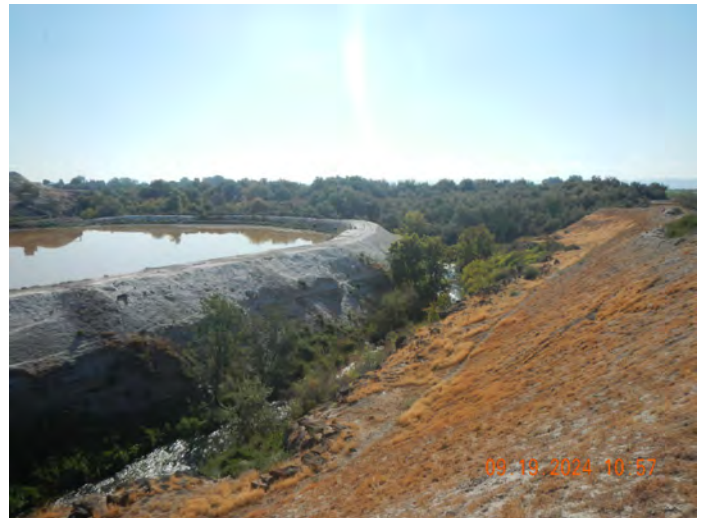
Photo #:20 (DSCN39348)

Description: Facing southeast, photo of Rock Creek from the “dirt storage area.”

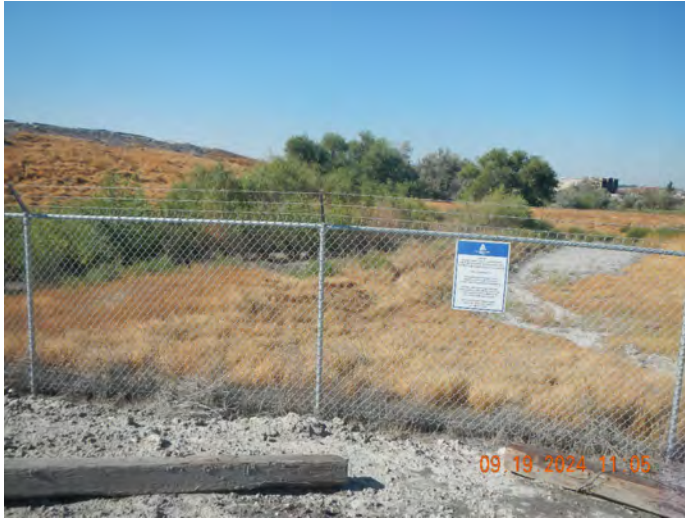
Photo #:21 (DSCN3949)

Description: Facing west from the western stormwater retention basin, photo of overland area within the west pasture towards Outfall 002.

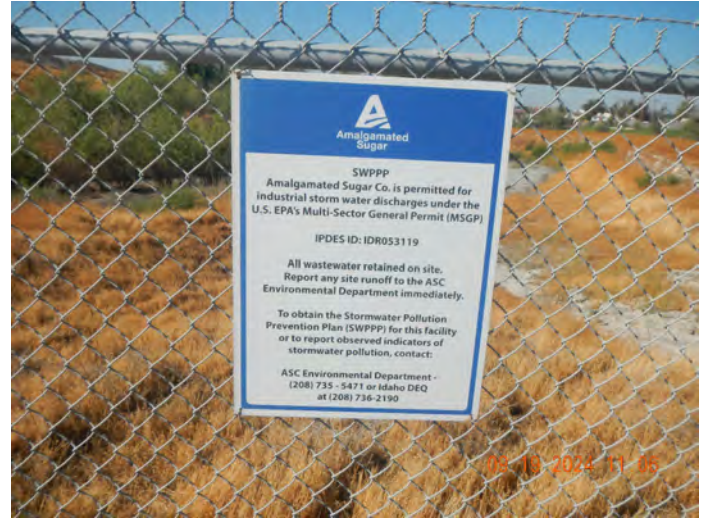
Photo #:22 (DSCN3950)

Description: Facing west, photo of MSGP/stormwater coverage signage, posted west of the main parking area.

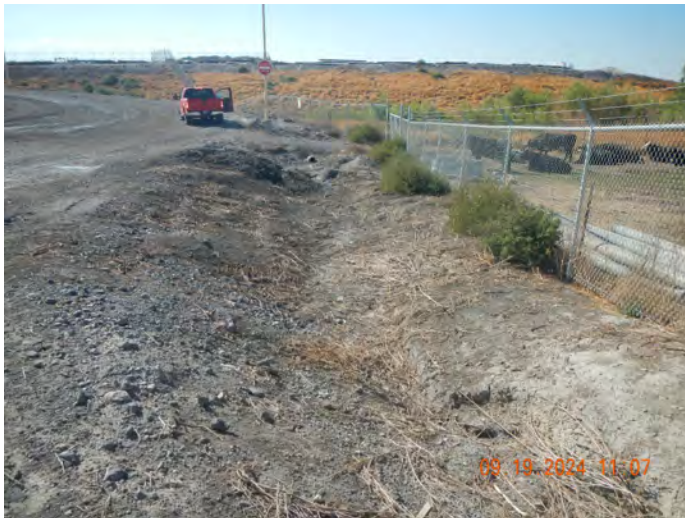
Photo #:23 (DSCN3951)

Description: Facing south, photo of the westernmost stormwater retention basin.
