1982

FIRST QUARTER

INDUSTRIAL HYGIENE SUMMARY - S. W. Ellis  
LABORATORY - BLDG. 550

## HIGH DENSITY REPORT - FIRST QUARTER 1982

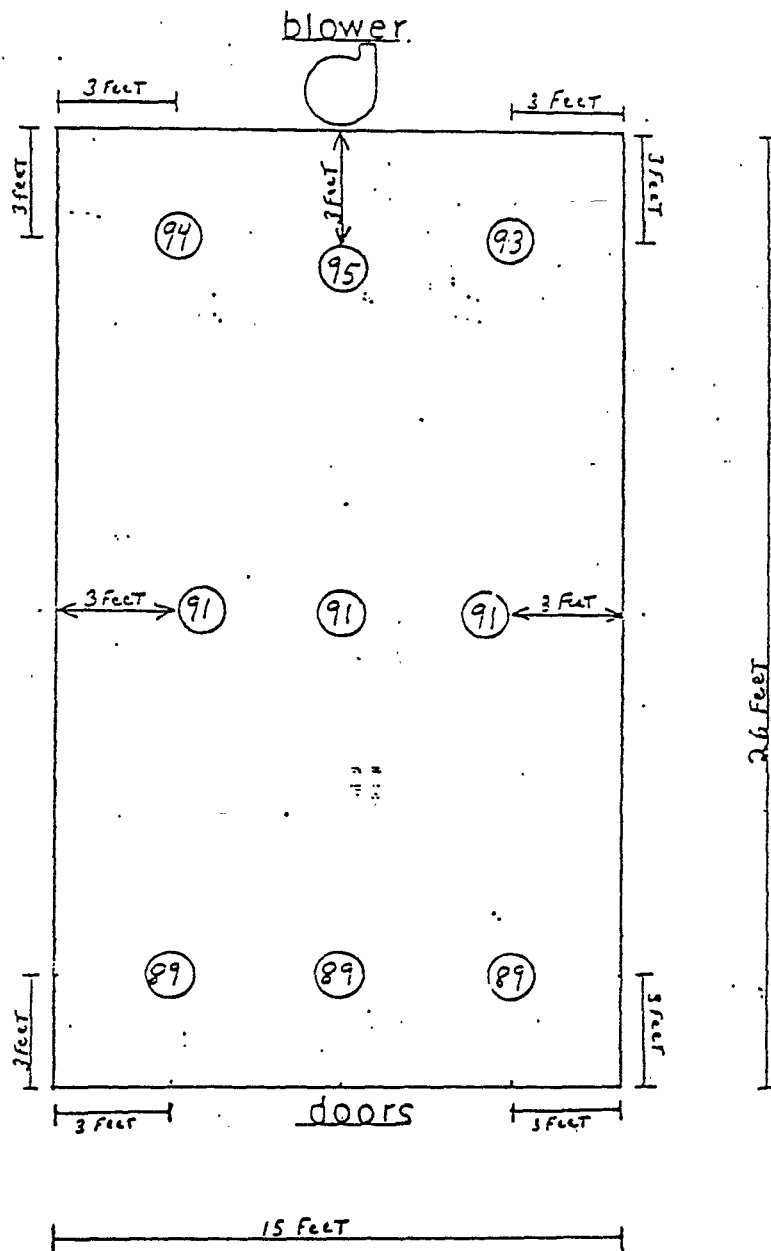
# TABLE IV

A noise survey of the paint spray booth was conducted on March 9, 1982. The average of 9 measurements was 91.3 dBA, 4.3 dBA above the TLV® of 87dBA. This required that the booth be made an ear protection required area when the blower is in operation. An engineering study will be conducted to determine the feasibility of reducing the noise level below 87dBA. Data are in Table IV.

Readings are in dB,  
TLV is 87dBA
